1225/1227 Hubbard Street

Porch Portfolio

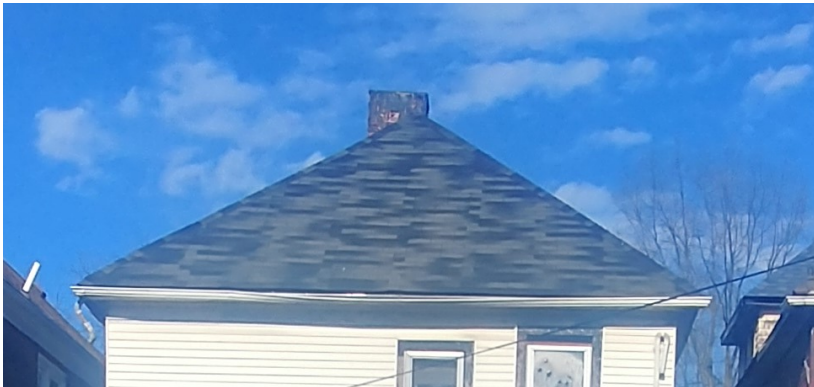
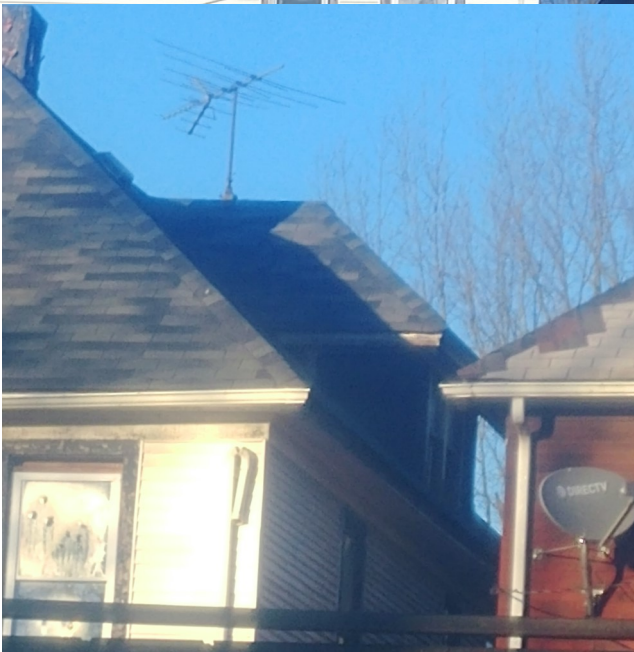
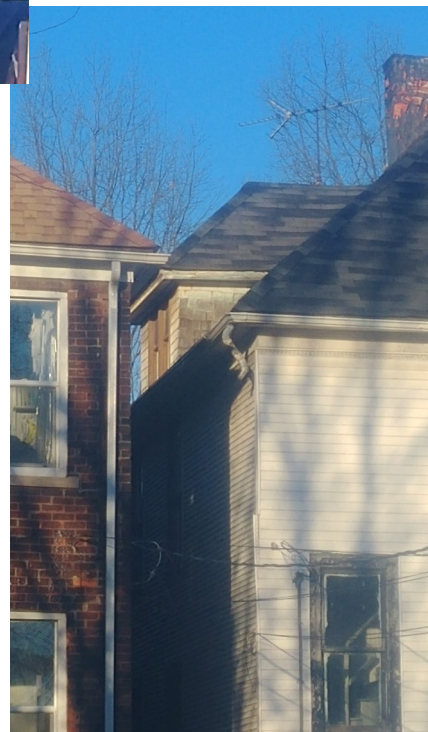
Additional roof line photos.

Upper left. Flat pyramid plane. Rear of house; west side.

Lower left. Dormer. South side.

Lower right. Dormer. North side.
