WINDOW SURVEY

The 2nd story windows were surveyed by a visual survey from the interior using a camera. The survey focused on the existing conditions of the wood frames, operability of the window sashes and condition of the glass. The purpose was to determine if the condition of the windows and frames was suitable to be restored or if new window units were required.

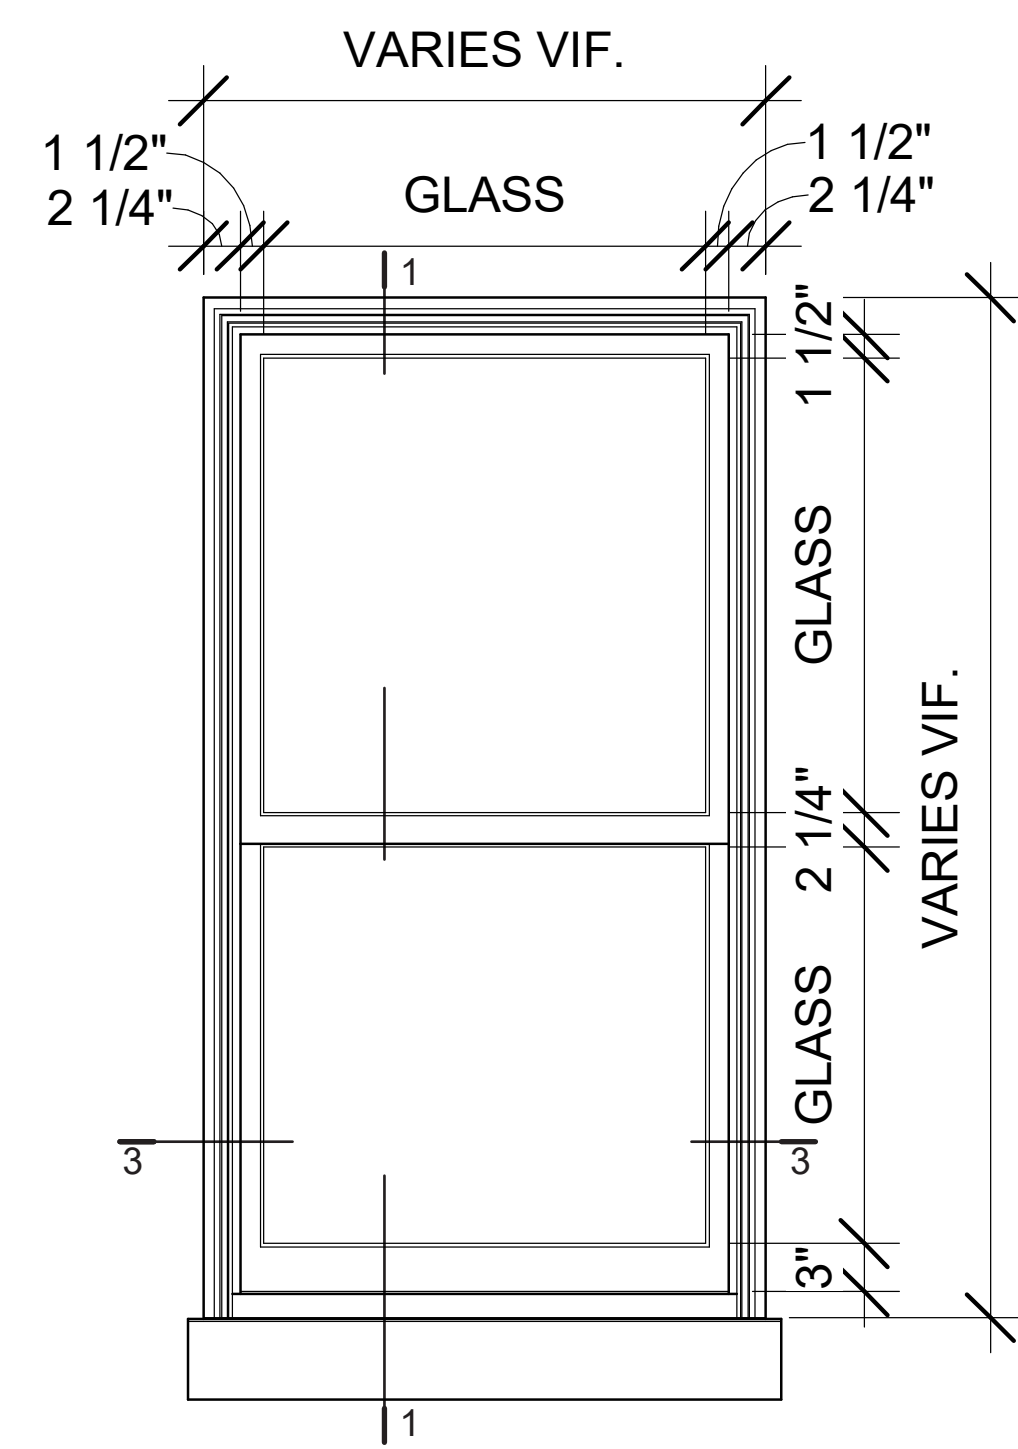
EXISTING WINDOW ELEVATION

The majority of the windows are in poor condition while the second half being in fair condition. In the most extreme locations the wood has deteriorated severely with rot occurring mainly at the sills, lower rail and at the bottom of the side stiles. The majority of windows also have broken or removed ropes and pulleys making the windows inoperable. The majority of windows have either missing or broken glass panes.
