HDC Application for work @ 14935 Westwood – Detroit, MI 48223

Lead Abatement Project for State of Michigan Lead Program

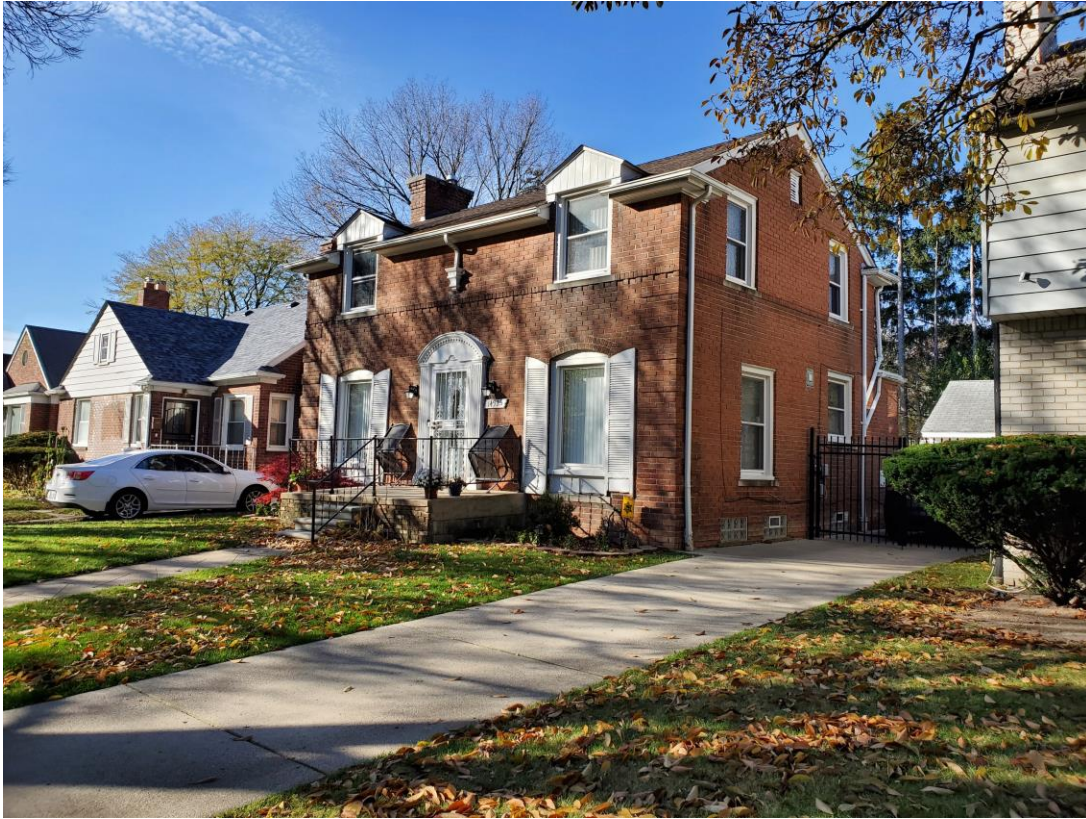
- 14925 Westwood
- Neighbor to left of home
- Property has all vinyl replacement windows
- Property has all aluminum trim on fascia, rake, windows.

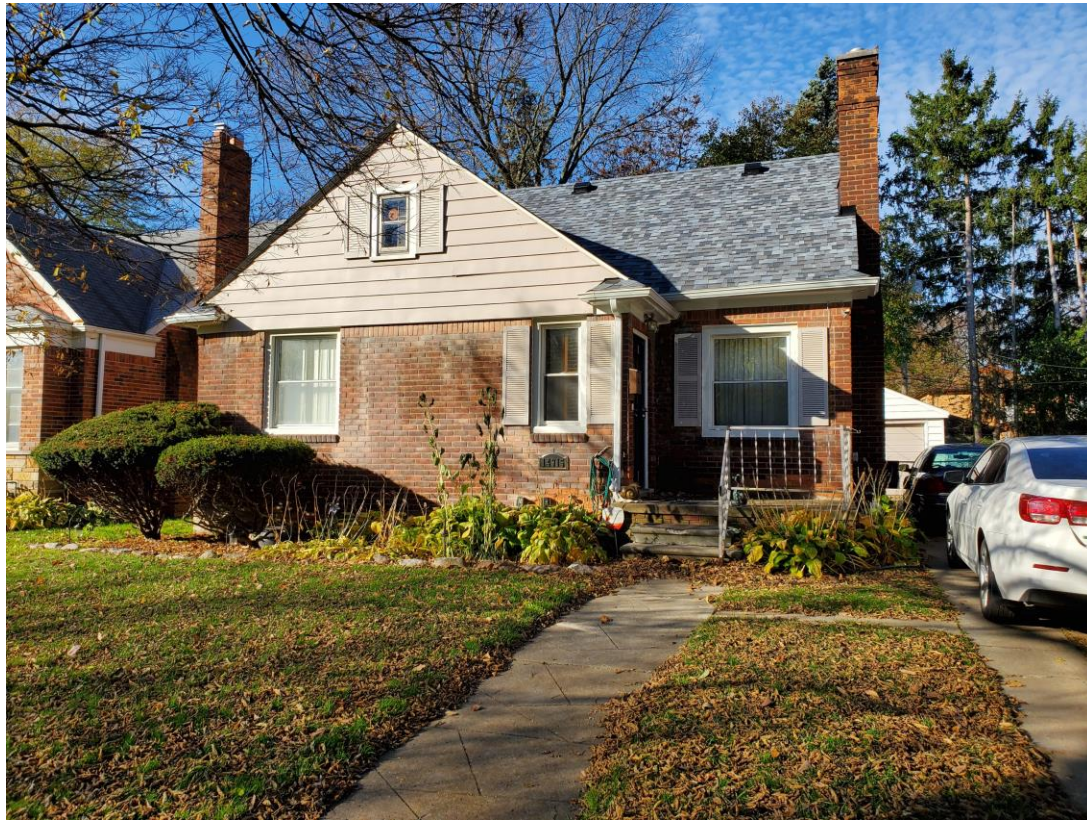
- 14915 Westwood
- Neighbor to left of home
- Property has all vinyl replacement windows
- Property has all aluminum trim on fascia, rake, windows.
- Aluminum siding

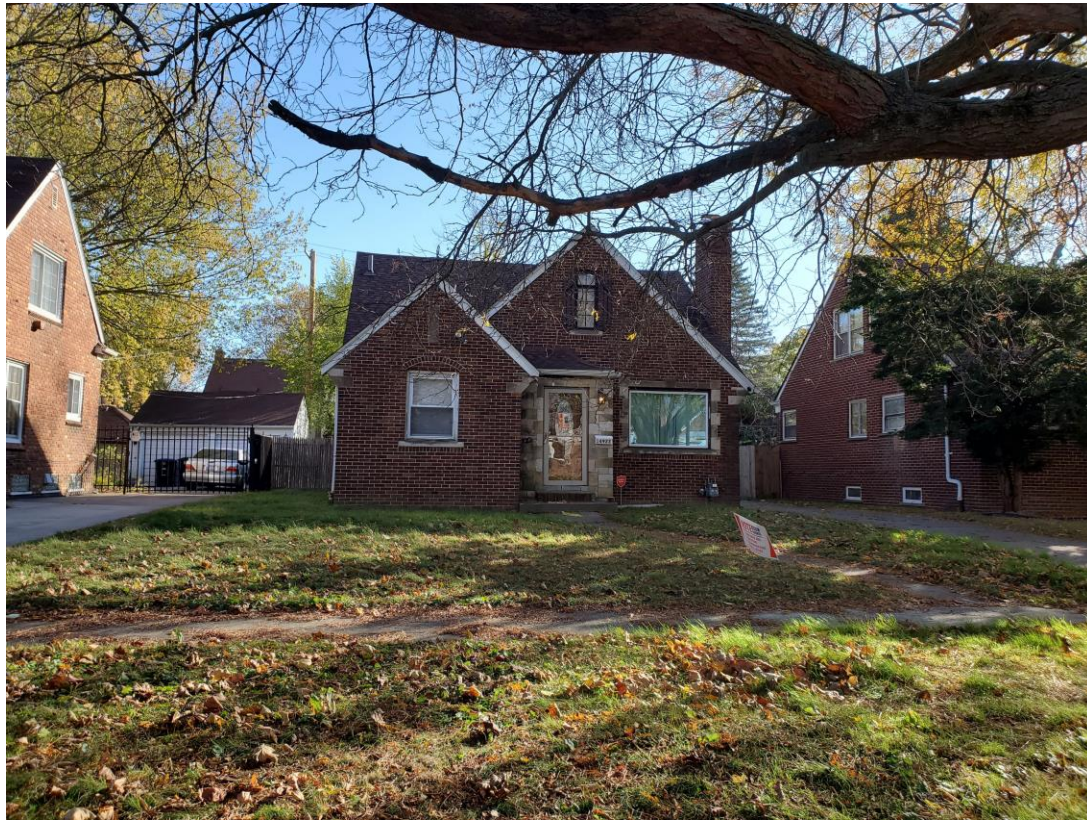
- 14922 Westwood
- Neighbor to left of home
- Property has all vinyl replacement windows
- Property has all aluminum trim on fascia, rake, windows.

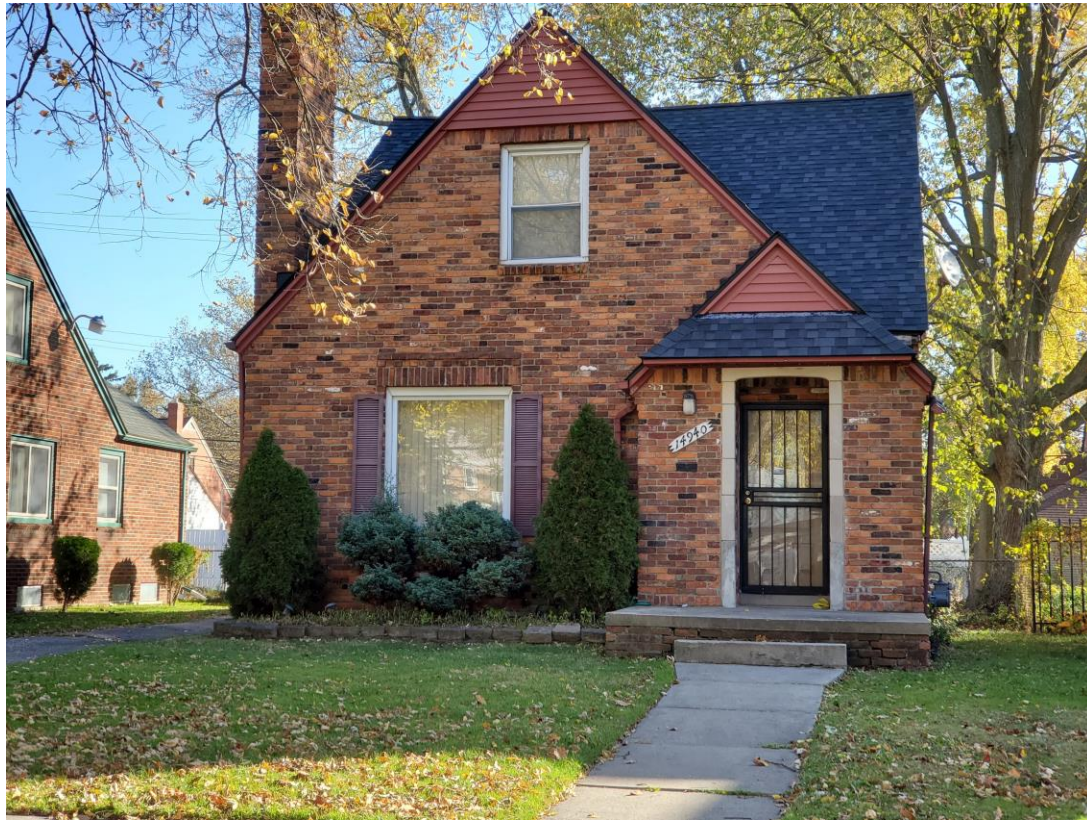
- 14940 Westwood
- Neighbor to left of home
- Property has all vinyl replacement windows
- Property has all aluminum trim on fascia, rake, windows.
- Vinyl Siding

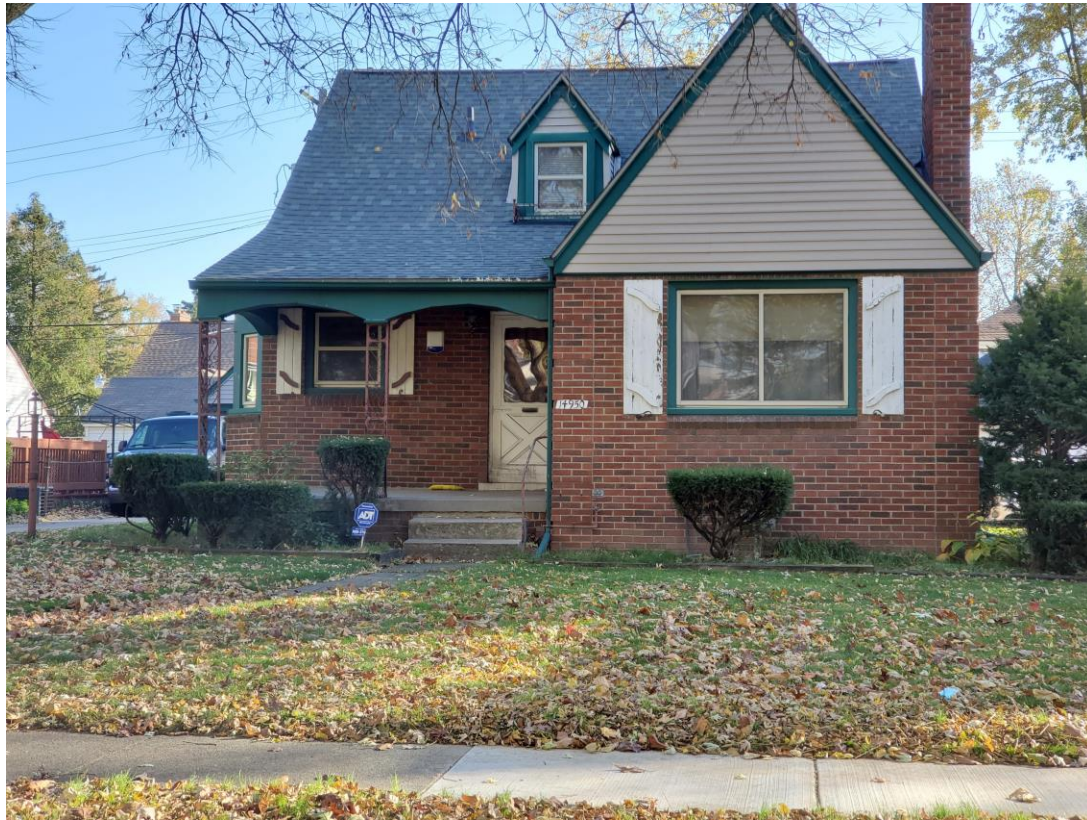
- 14950 Westwood
- Neighbor to left of home
- Property has all vinyl replacement windows
- Property has all aluminum trim on fascia, rake, windows.
- Vinyl Siding

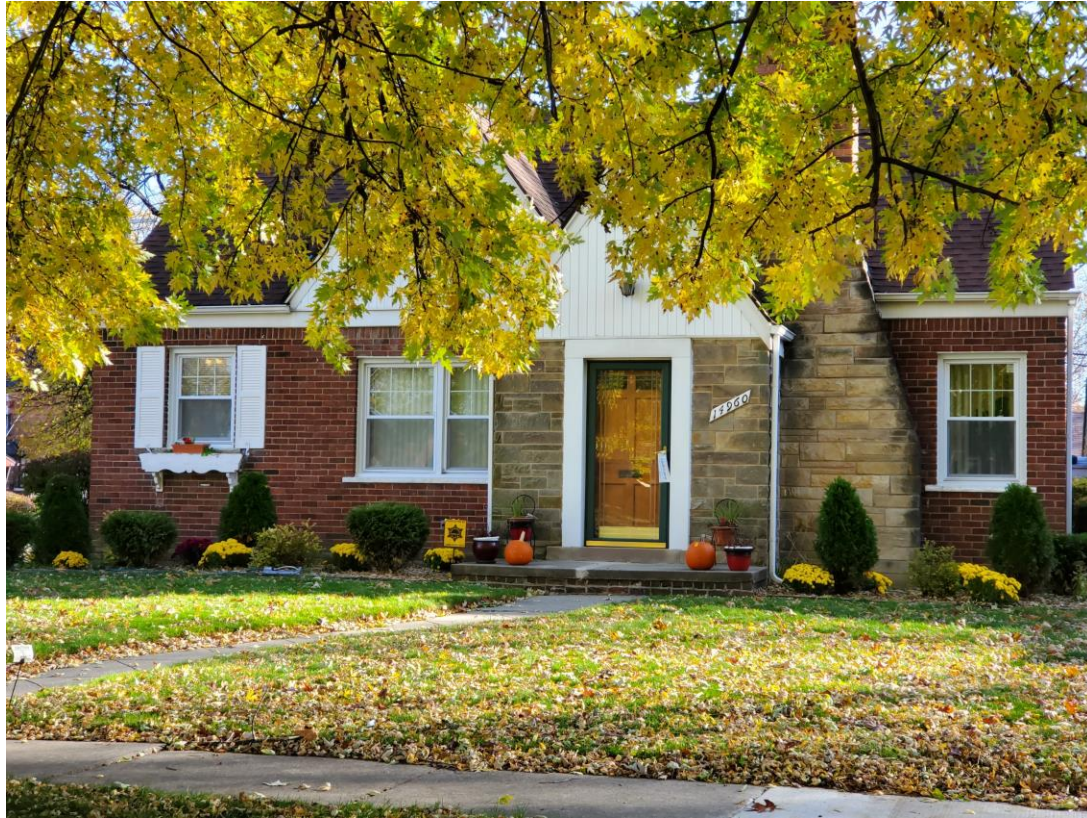
- 14960 Westwood
- Neighbor to left of home
- Property has all vinyl replacement windows
- Property has all aluminum trim on fascia, rake, windows.
- Vinyl Siding
