James Haskins
19365 Warrington Dr
Detroit MI 48221
Sherwood Forest District

Renewal by Andersen 37720 Amrhein Livonia, MI 48150

- Homeowner wants to replace all the windows around house except for one stained glass window unit
- Windows are original steel
- Renewal by Andersen windows are Fibrex (wood composite) material
- Total of 24 windows to be replaced
- Windows exterior color will be black if approved
- Most windows matching style except for bay windows – flankers changed to operable and middle window changed to fixed.
- Windows will match existing mutton bar “pattern”
- Homeowner unable to get quotes for repair

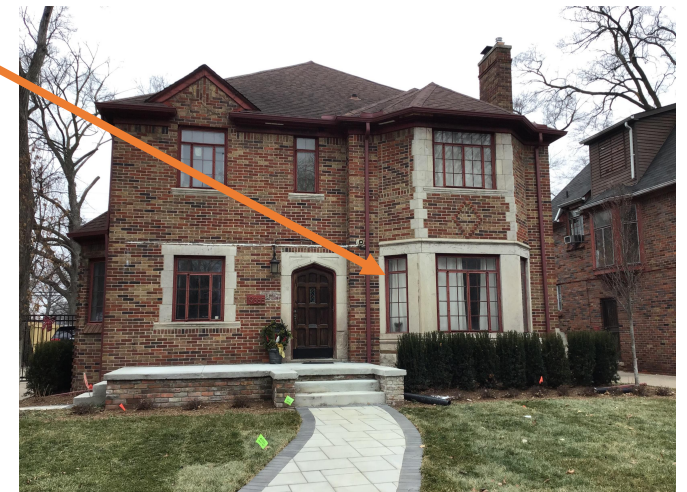
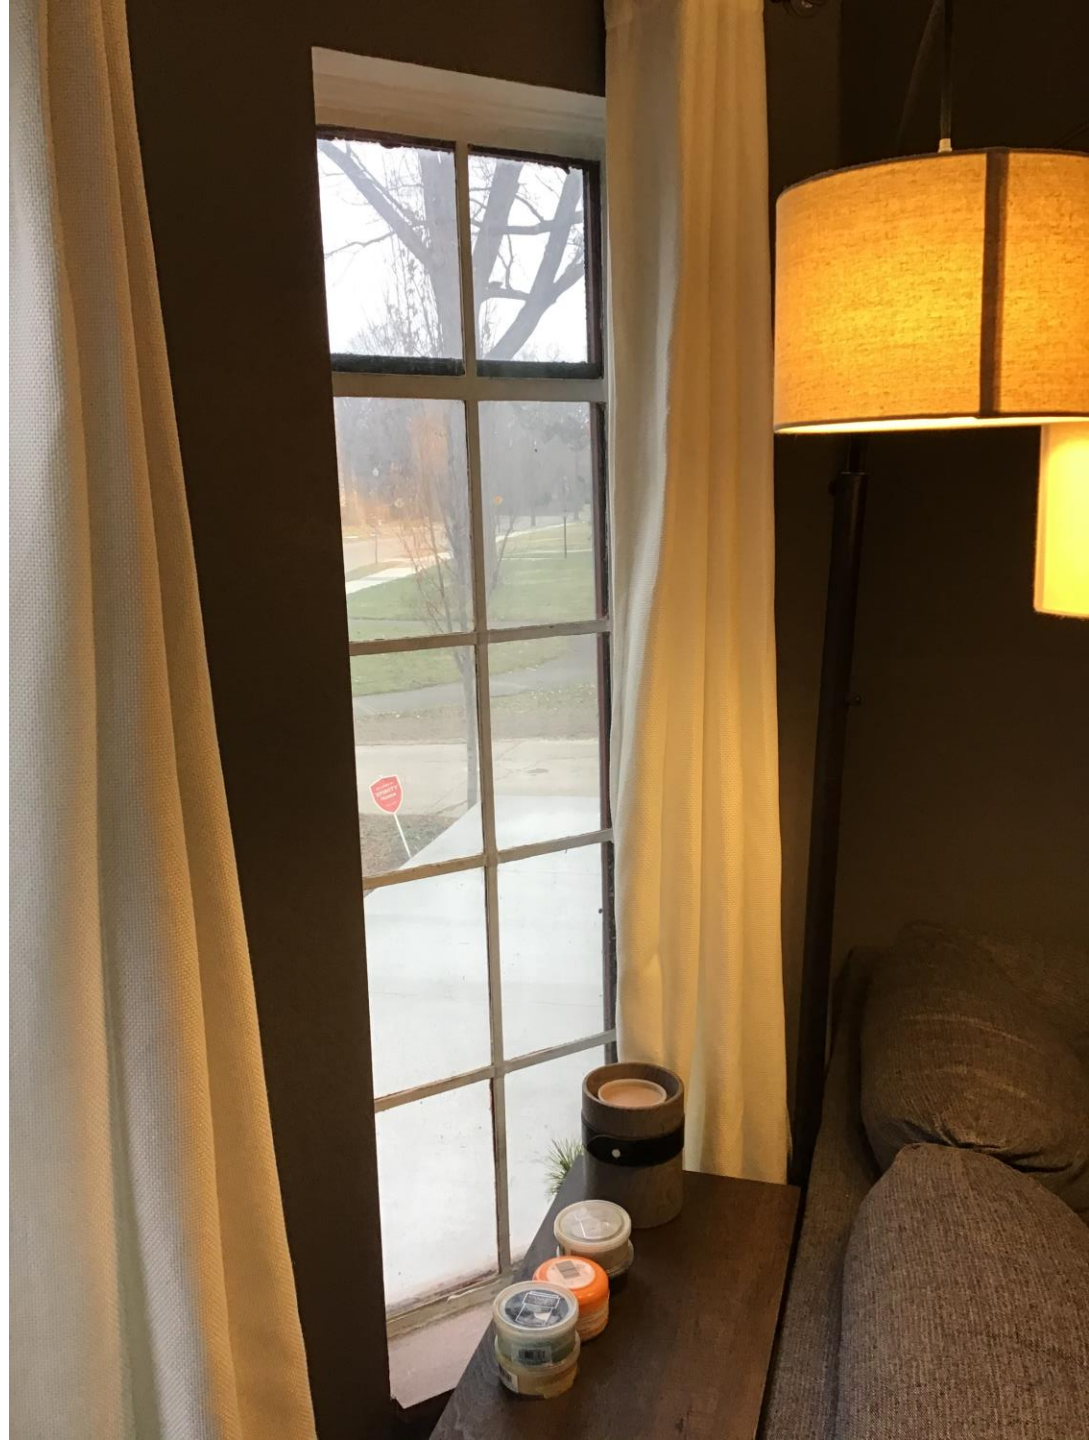
WINDOW OPENING 101 Living Room - Front of House

- Fixed window – Steel casement
- Window is in Living room
- Window is hard to close if opened
- Exterior of window showing signs of rotting around frame

Window: Casement, Single, Left, Base Frame, 2" Brickmould / Traditional, Exterior Black, Interior Black, **Glass:** All Sash: High Performance SmartSun Glass, No Pattern, Tempered Glass, **Hardware:** Black, **Screen:** Fiberglass, Full Screen, **Grille Style:** Grilles Between Glass (GBG), **Grille Pattern:** All Sash: Colonial 2w x 5h, **Misc:** None

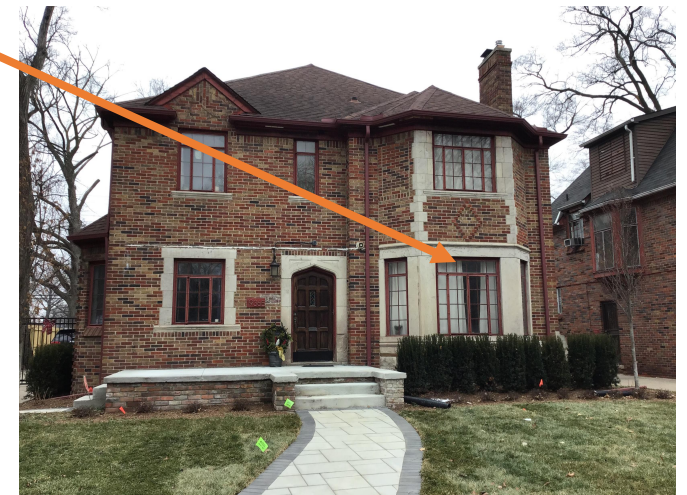
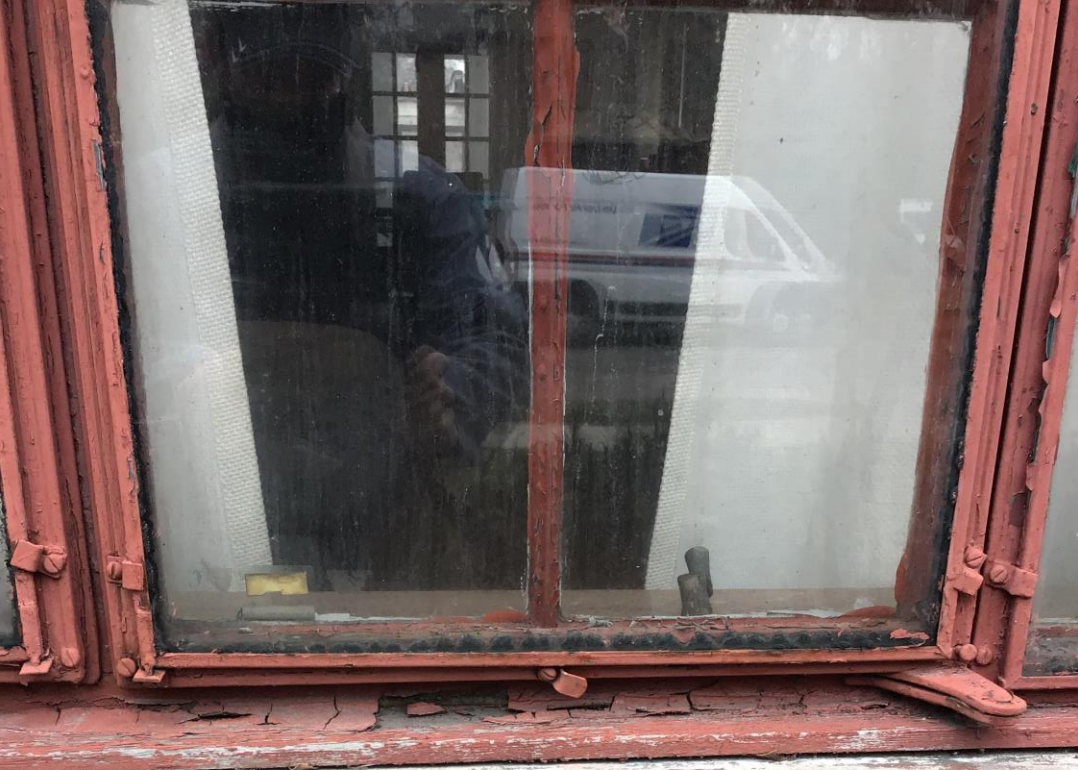
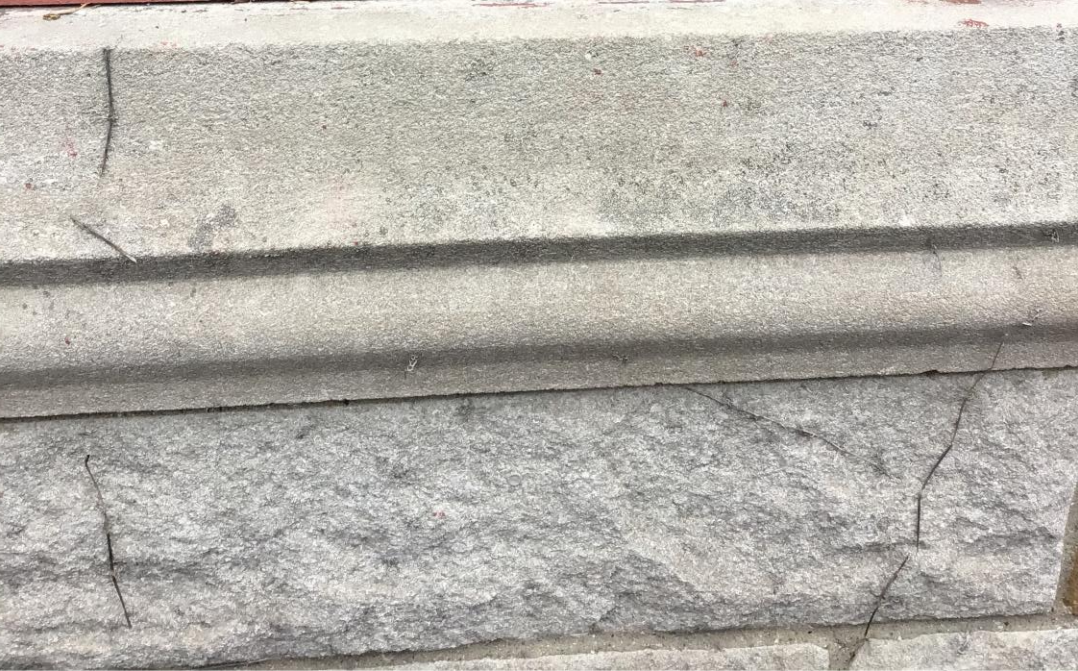
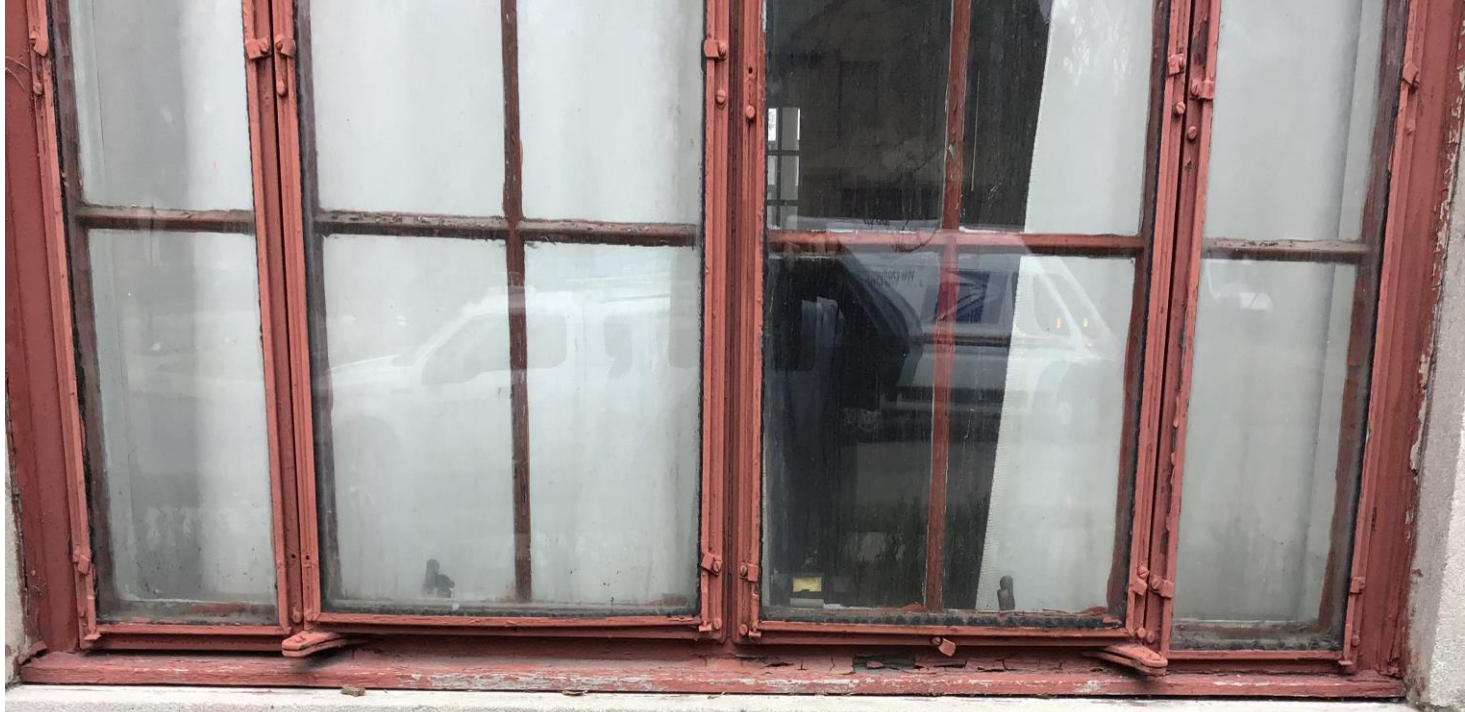
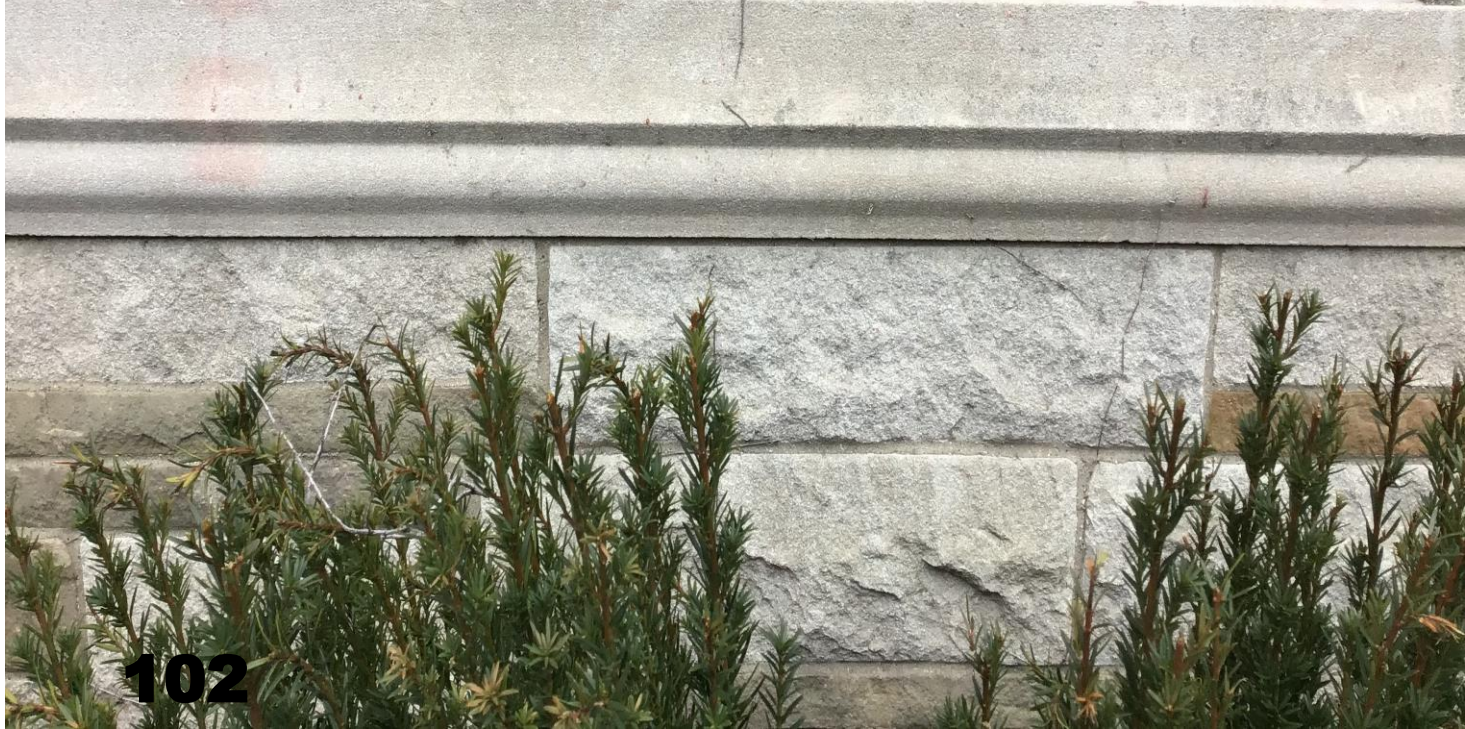
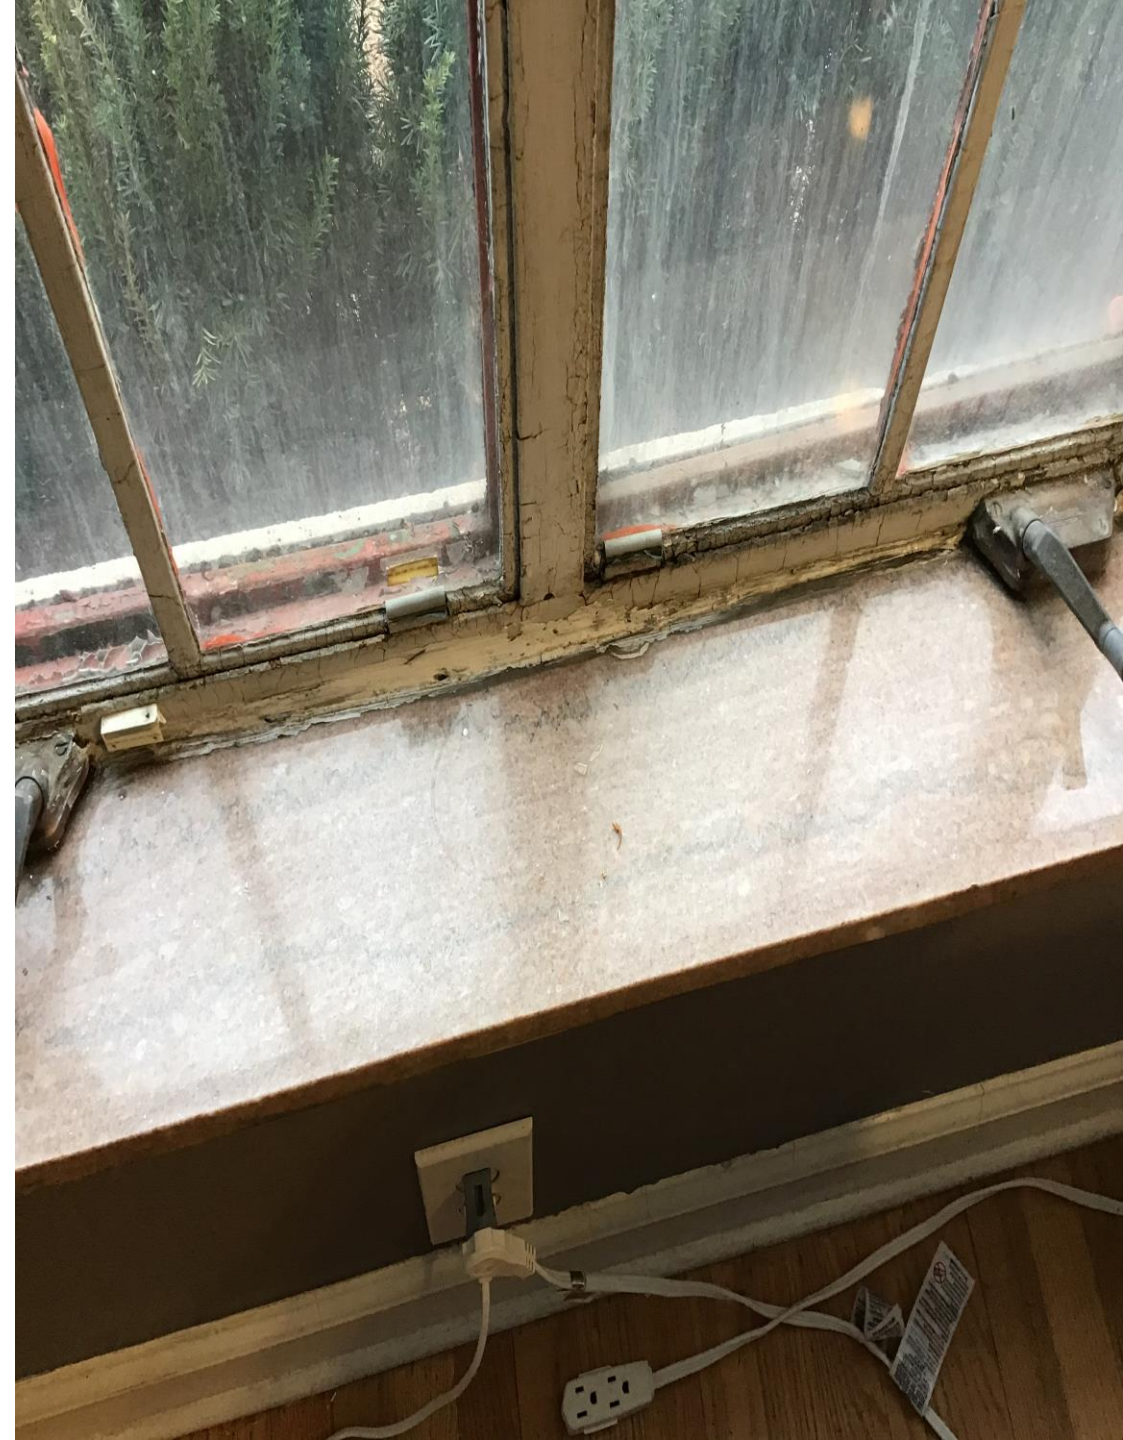
WINDOW OPENING 102 Living Room - Front of House

- Double casement
- Window is in Living room
- Window is hard to close if opened
- Exterior of window showing signs of rotting around frame
- Missing screen

Window: Casement, Fixed Window, Base Frame, Exterior Black, Interior Black, **Glass:** All Sash: High Performance SmartSun Glass, No Pattern, Tempered Glass, **Grille Style:** Grilles Between Glass (GBG), **Grille Pattern:** All Sash: Colonial 6w x 5h, **Misc:** None

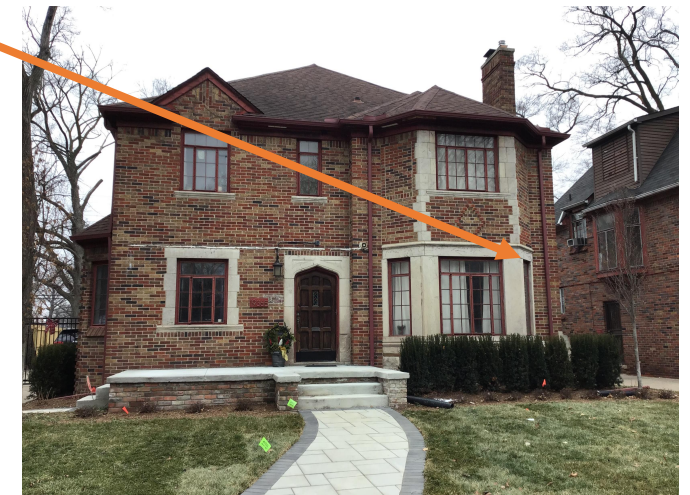
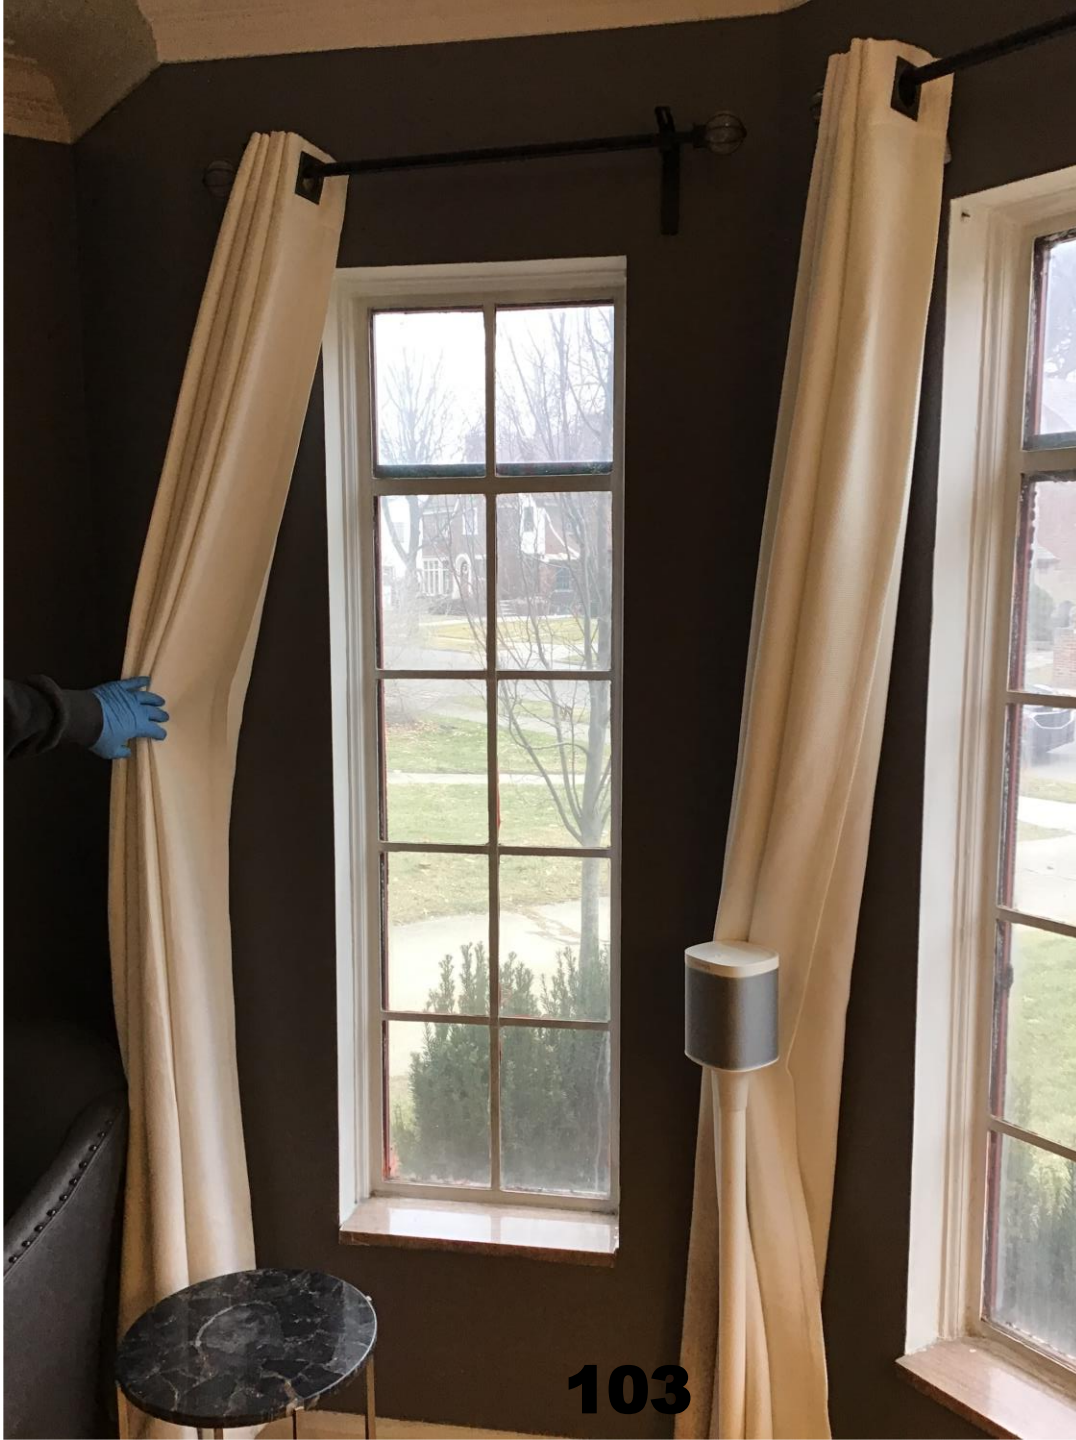
WINDOW OPENING 103

- Fixed window – Steel casement
- Window is in Living room
- Window is hard to close if opened
- Exterior of window showing signs of rotting around frame – bottom exterior sill missing

Window: Casement, Single, Right, Base Frame, 2"

Brickmould / Traditional, Exterior Black, Interior Black, **Glass:**

All Sash: High Performance SmartSun Glass, No Pattern, Tempered Glass, **Hardware:** Black, **Screen:** Fiberglass, Full

Screen, **Grille Style:** Grilles Between Glass (GBG), **Grille**

Pattern: All Sash: Colonial 2w x 5h, **Misc:** None

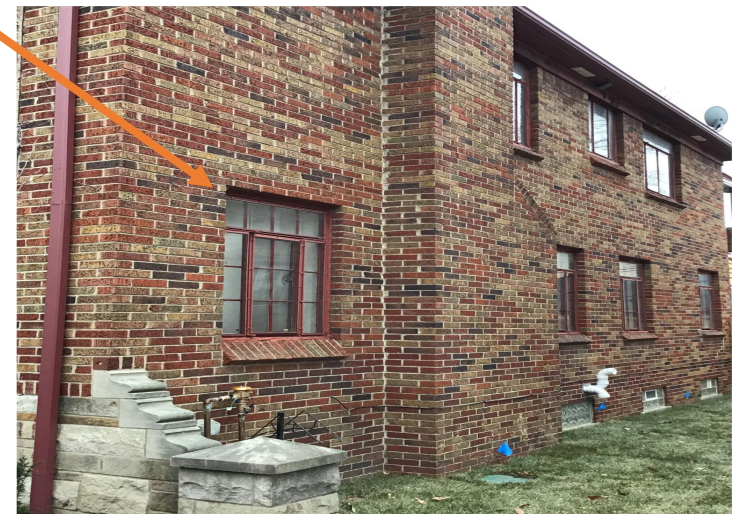
WINDOW OPENING 104

- Single Casement window
- Window is in Living room
- Window is hard to close if opened
- Exterior of window showing signs of rotting around frame

Window: Casement, Single, Left, Base Frame, 2" Brickmould / Traditional, Exterior Black, Interior Black, **Glass:** All Sash: High Performance SmartSun Glass, No Pattern, **Hardware:** Black, **Screen:** Fiberglass, Full Screen, **Grille Style:** Grilles Between Glass (GBG), **Grille Pattern:** All Sash: Colonial 4w x 4h, **Misc:** None

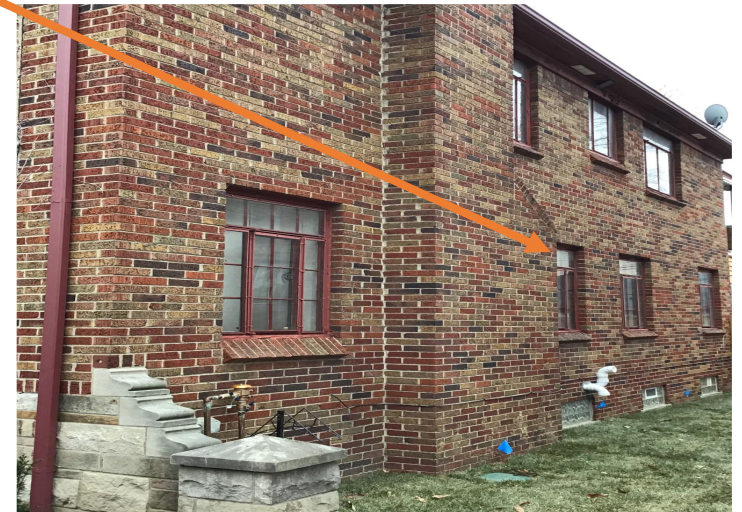
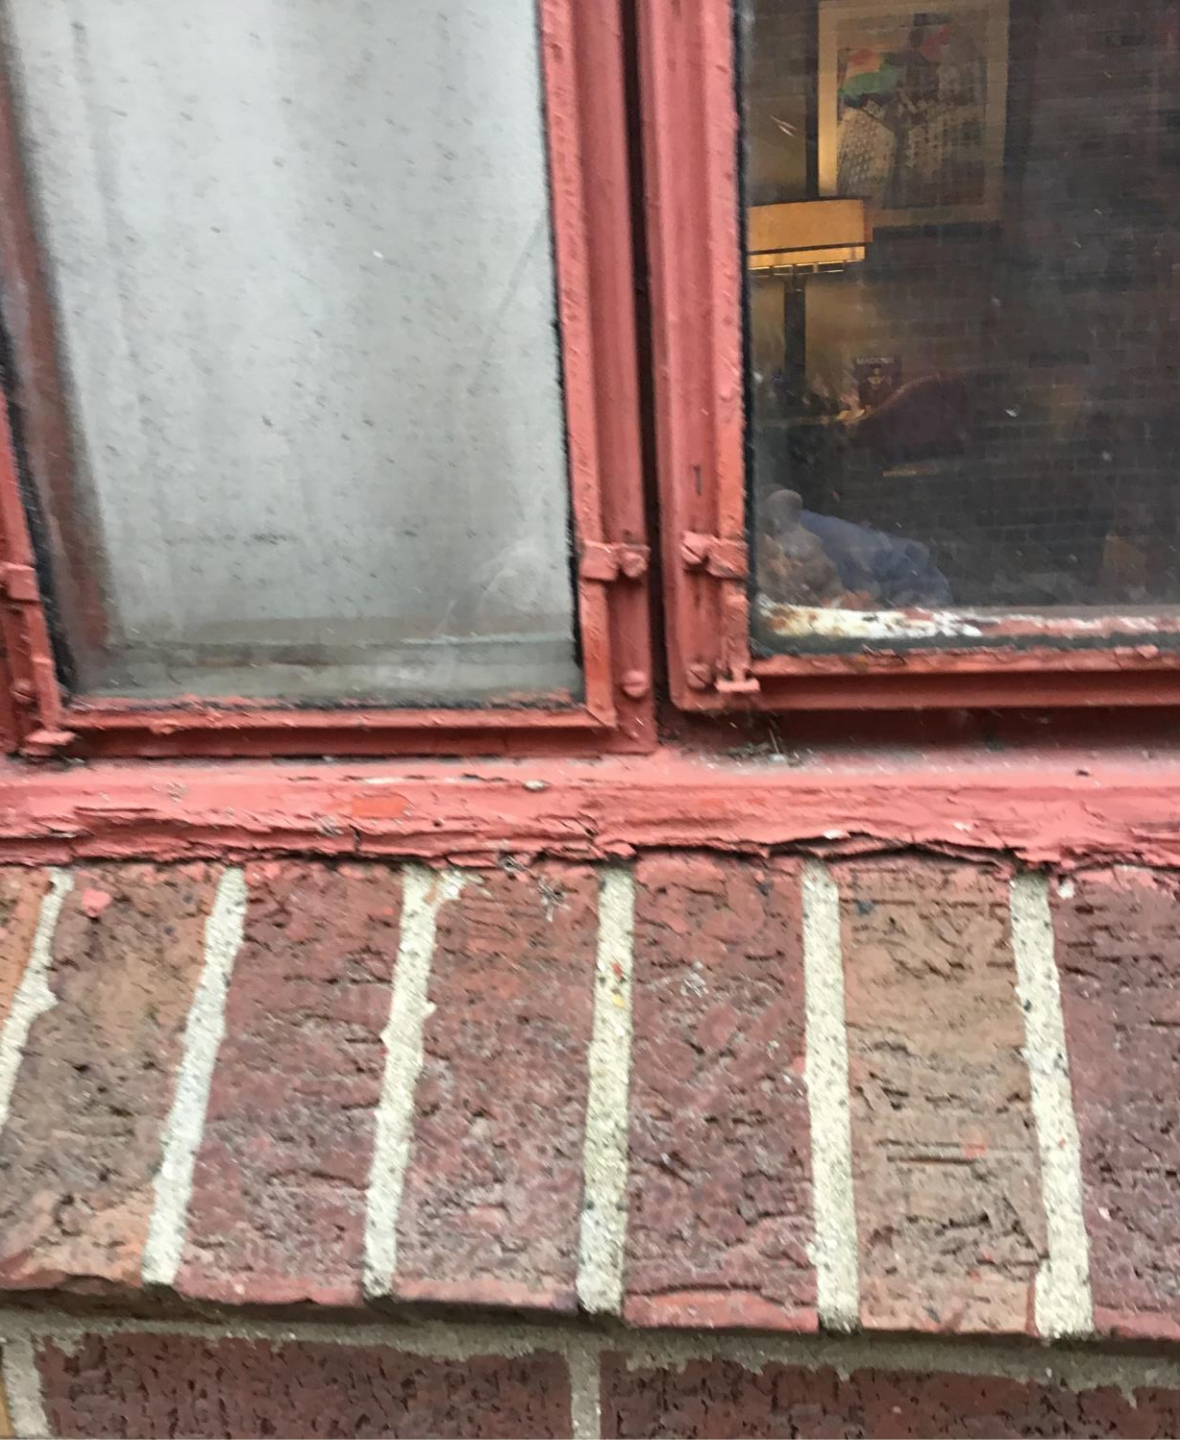
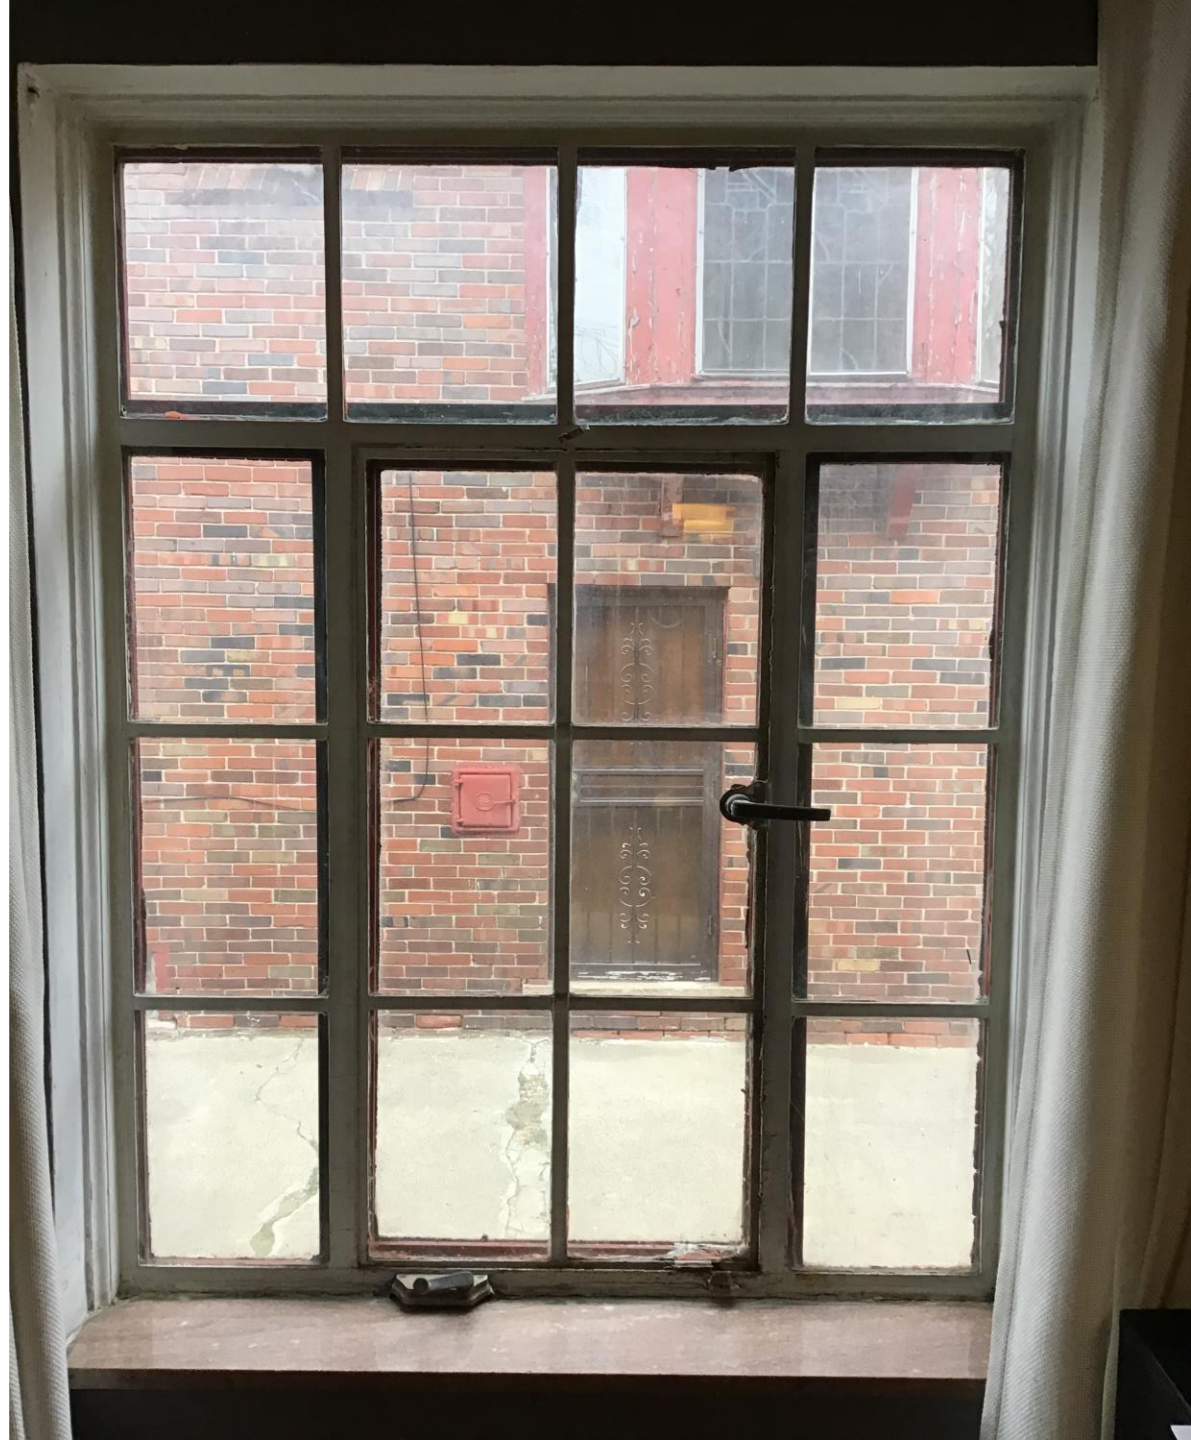
WINDOW OPENING 105

- Single Casement window
- Window is in Living room
- Window doesn't open
- Windowpane cracked
- Missing screen

Window: Casement, Single, Left Base Frame, 2" Brickmould / Traditional, Exterior Black, Interior Black, **Glass:** All Sash: High Performance SmartSun Glass, No Pattern, **Hardware:** Black, **Screen:** Fiberglass, Full Screen, **Grille Style:** Grilles Between Glass (GBG), **Grille Pattern:** All Sash: Colonial 4w x 4h, **Misc:** None

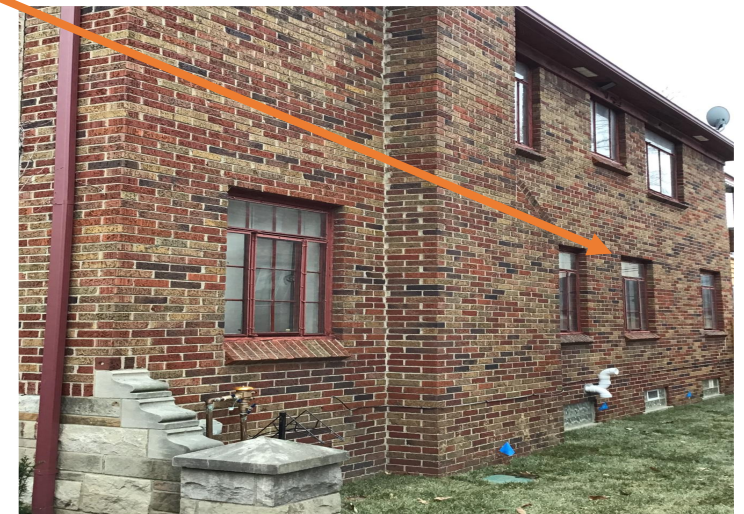
WINDOW OPENING 106

- Single Casement Window
- Window is in Dining room
- Window is hard to close if opened
- Exterior of window is rotting
- Screen missing

Window: Casement, Single, Left, Base Frame, 2" Brickmould / Traditional, Exterior Black, Interior Black, **Glass:** All Sash: High Performance SmartSun Glass, No Pattern, **Hardware:** Black, **Screen:** Fiberglass, Full Screen, **Grille Style:** Grilles Between Glass (GBG), **Grille Pattern:** All Sash: Colonial 4w x 4h, **Misc:** None

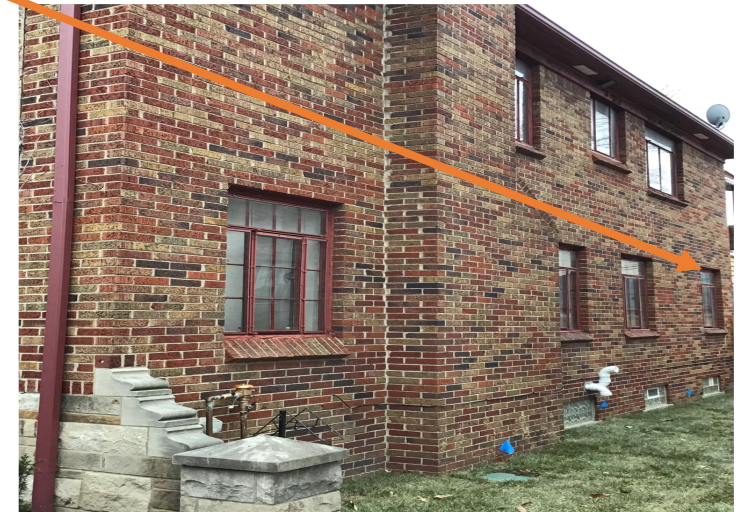
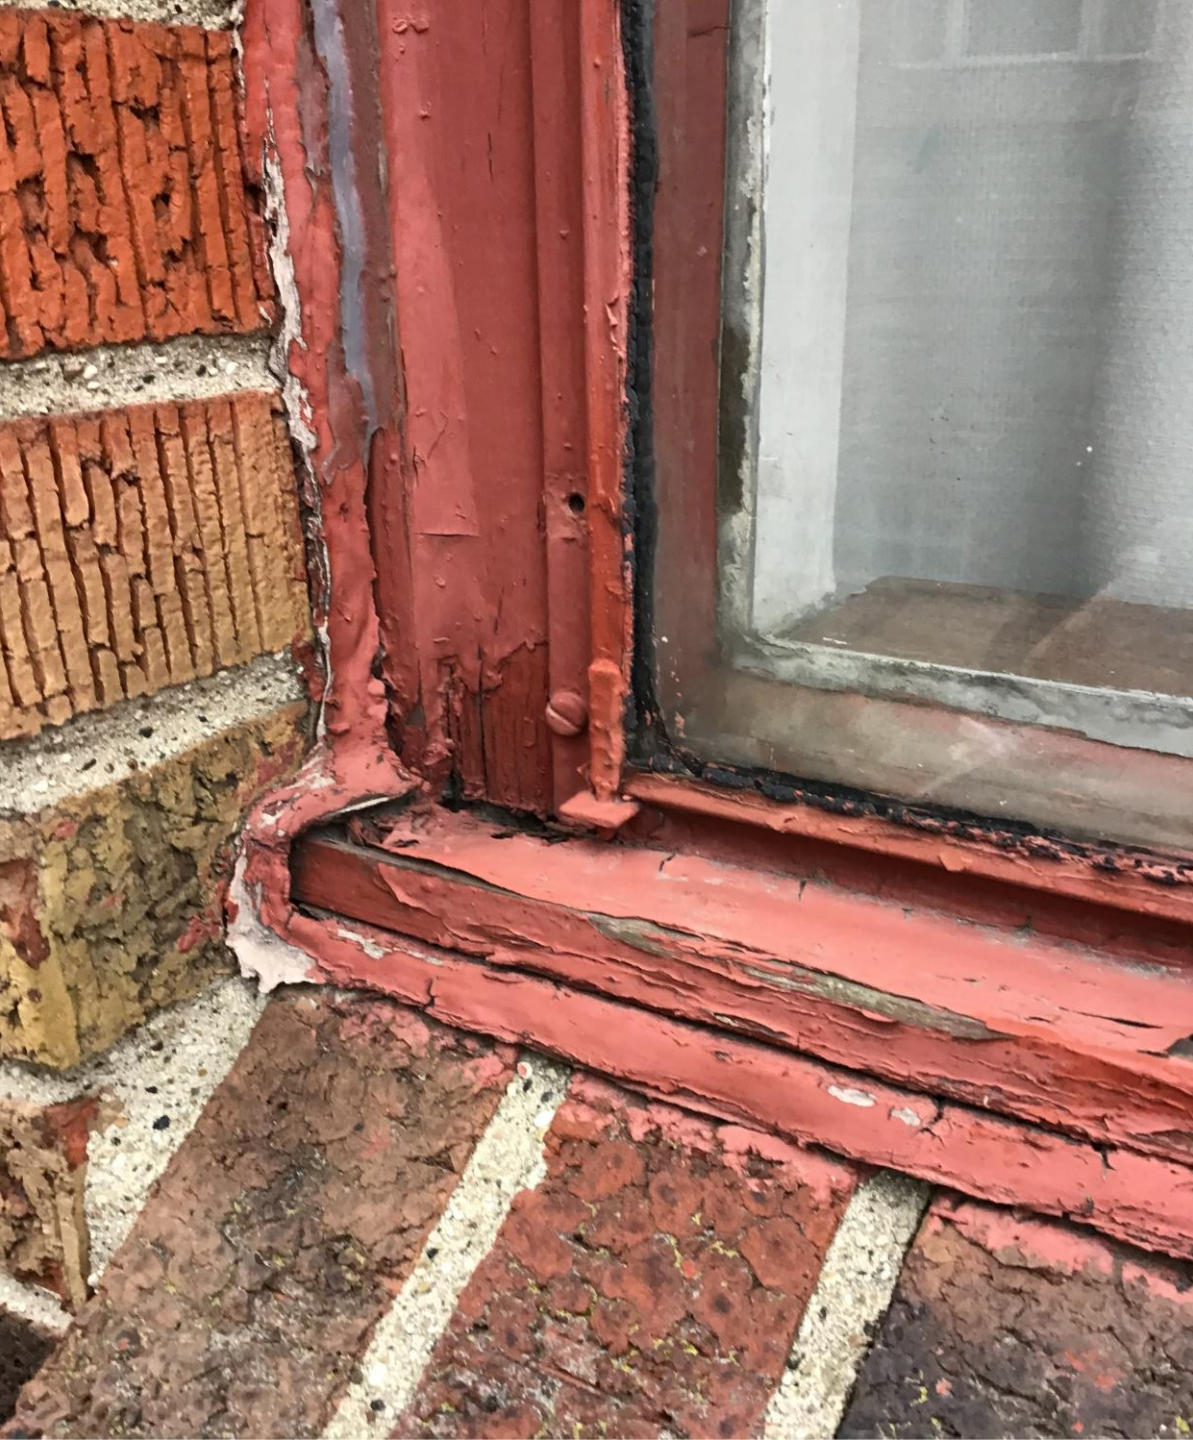
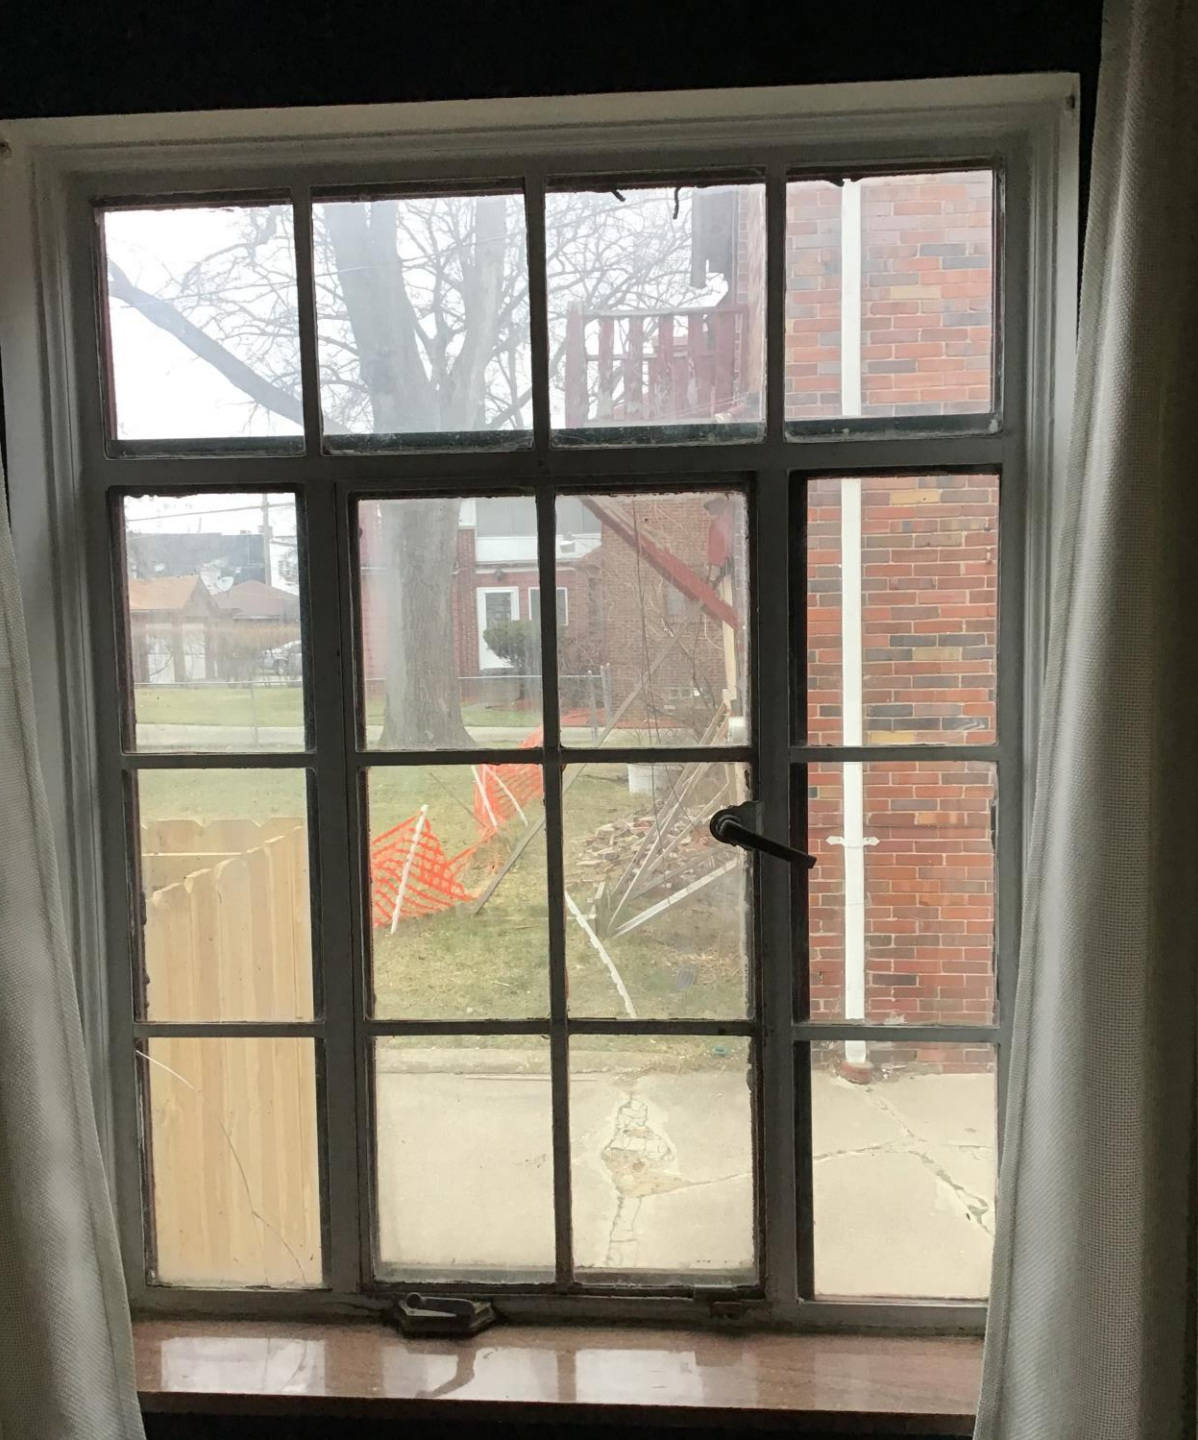
WINDOW OPENING 107

- Single Casement Window
- Window is in Dining room
- Window is hard to close if opened
- Windowpane cracked
- Screen missing

Window: Casement, Single, Left, Base Frame, 2" Brickmould / Traditional, Exterior Black, Interior Black, **Glass:** All Sash: High Performance SmartSun Glass, No Pattern, **Hardware:** Black, **Screen:** Fiberglass, Full Screen, **Grille Style:** Grilles Between Glass (GBG), **Grille Pattern:** All Sash: Colonial 4w x 4h, **Misc:** None
