James Haskins
19365 Warrington Dr
Detroit MI 48221
Sherwood Forest District

Renewal by Andersen 37720 Amrhein Livonia, MI 48150

- Homeowner wants to replace all the windows around house except for one stained glass window unit
- Windows are original steel
- Renewal by Andersen windows are Fibrex (wood composite) material
- Total of 24 windows to be replaced
- Windows exterior color will be black if approved
- Most windows matching style except for bay windows – flankers changed to operable and middle window changed to fixed.
- Windows will match existing mutton bar “pattern”
- Homeowner unable to get quotes for repair

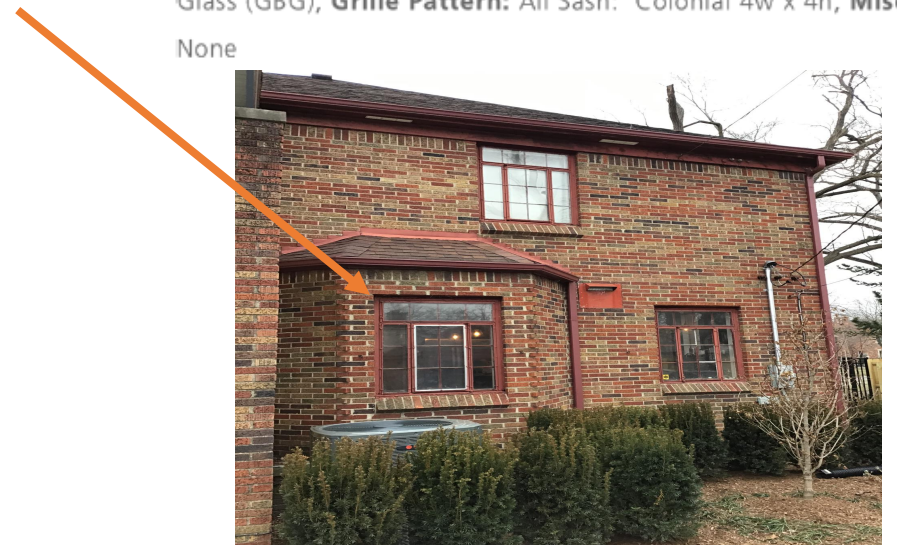
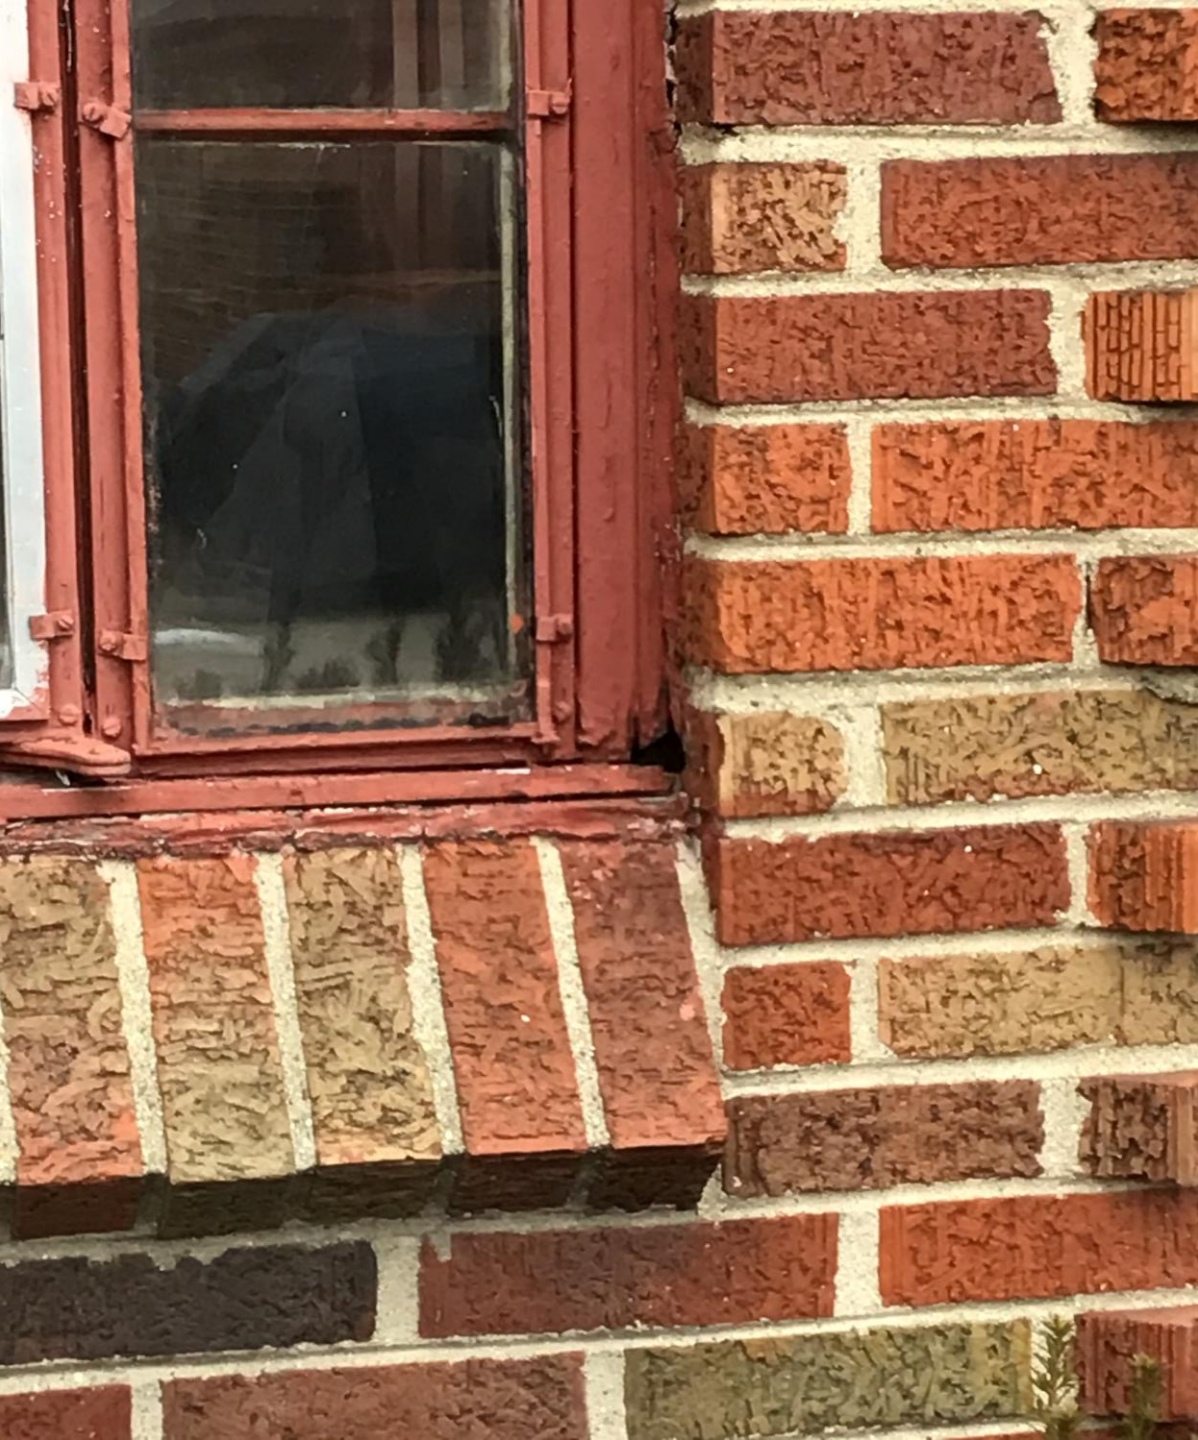
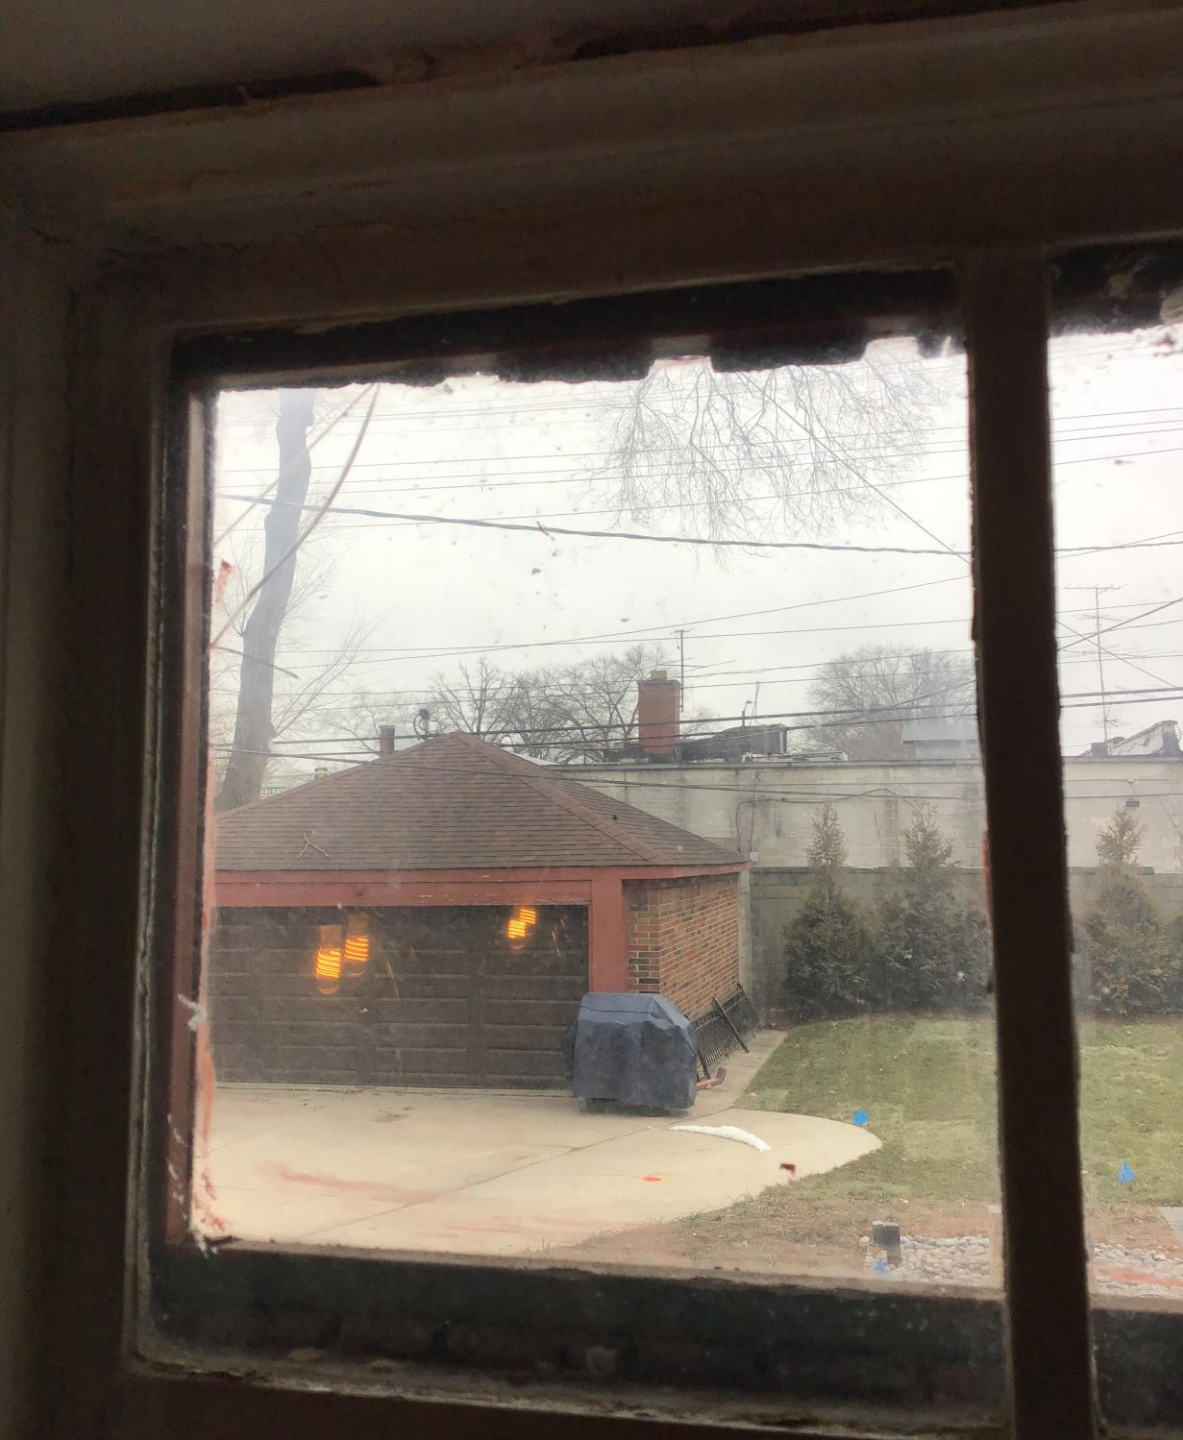
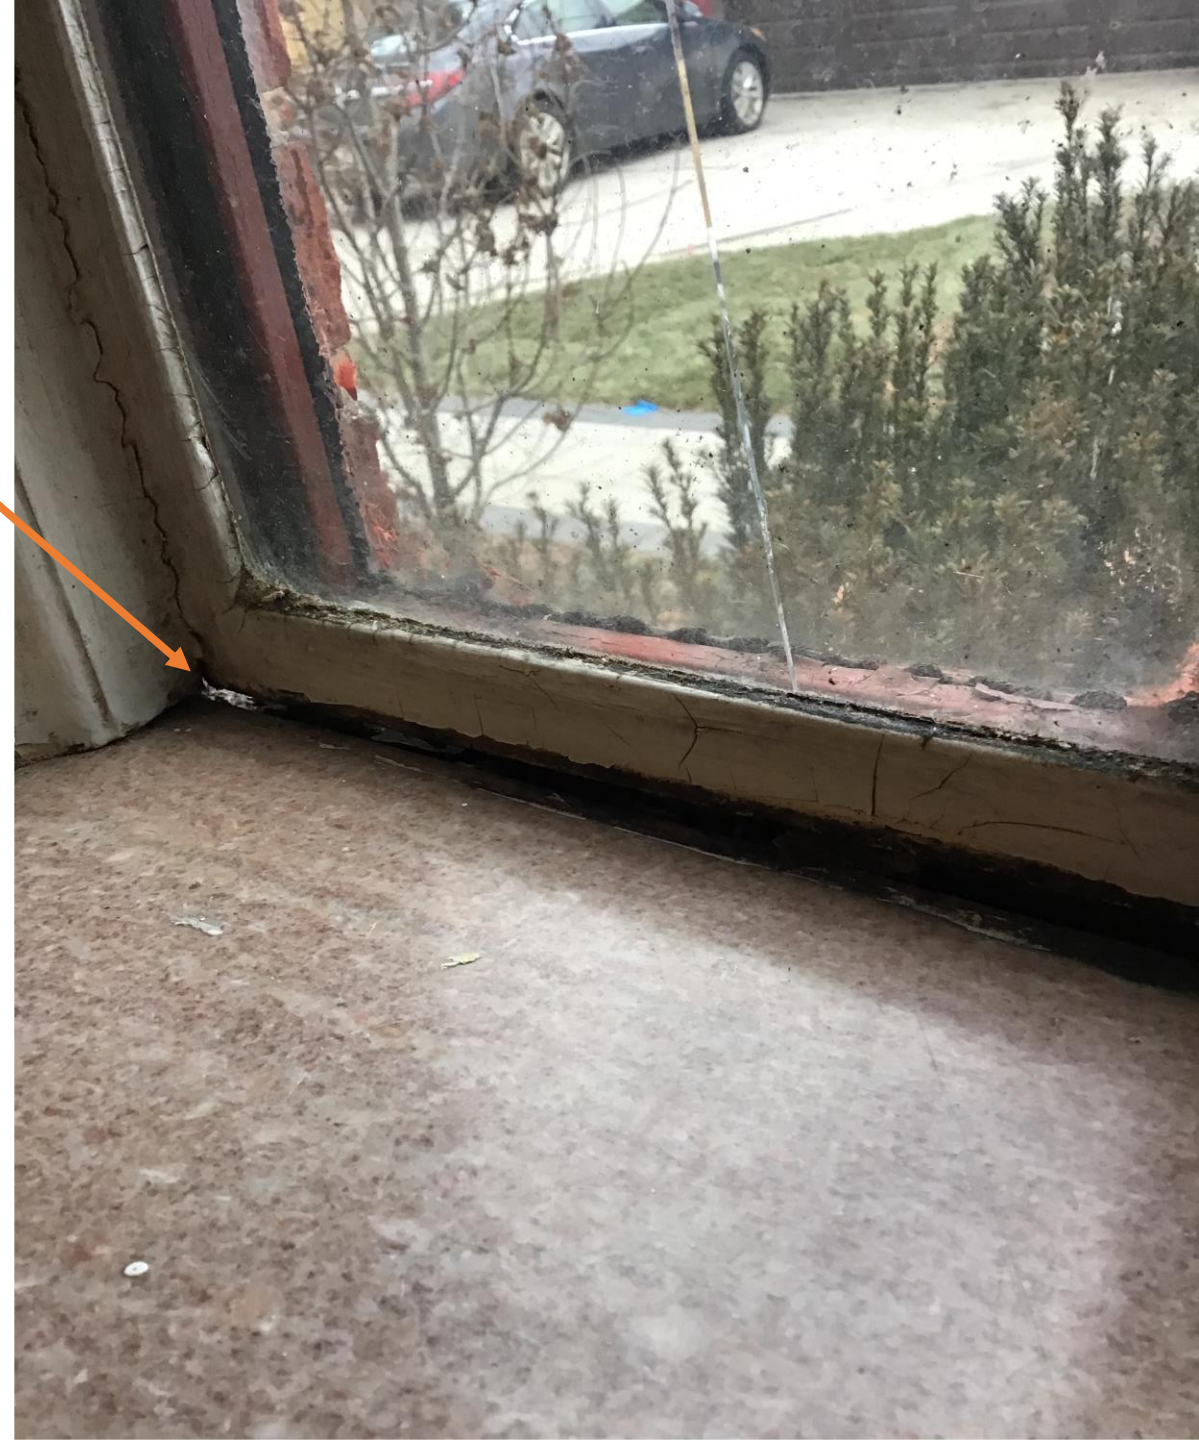
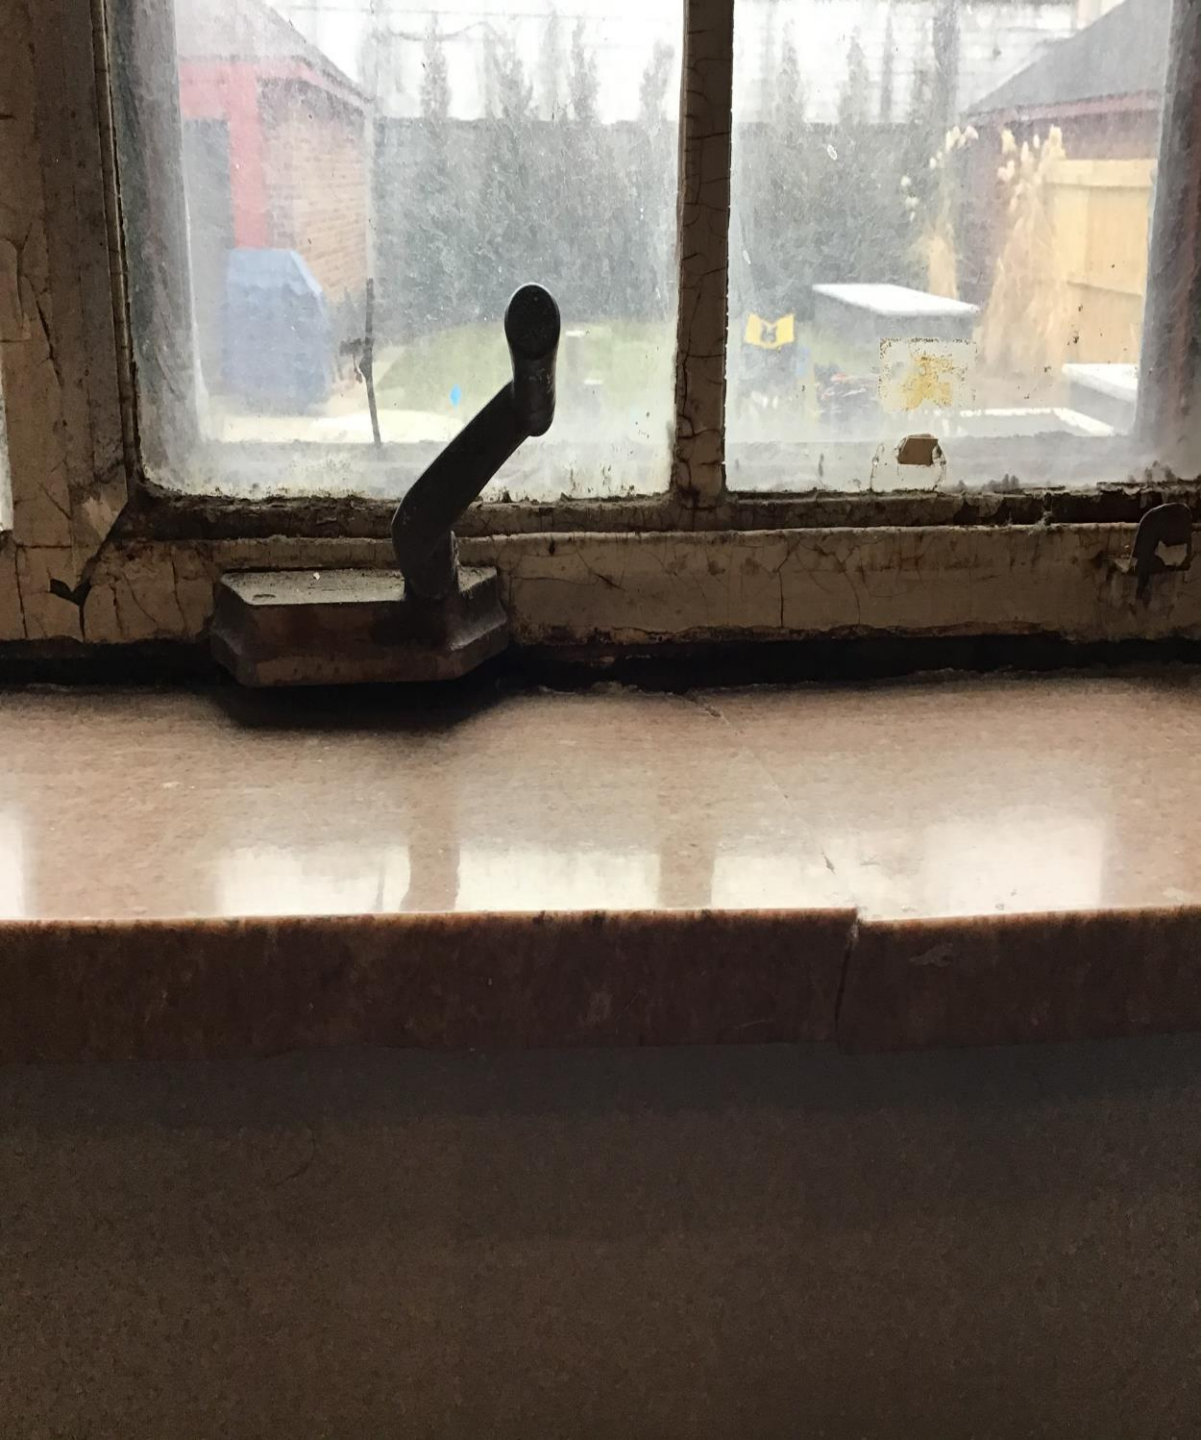
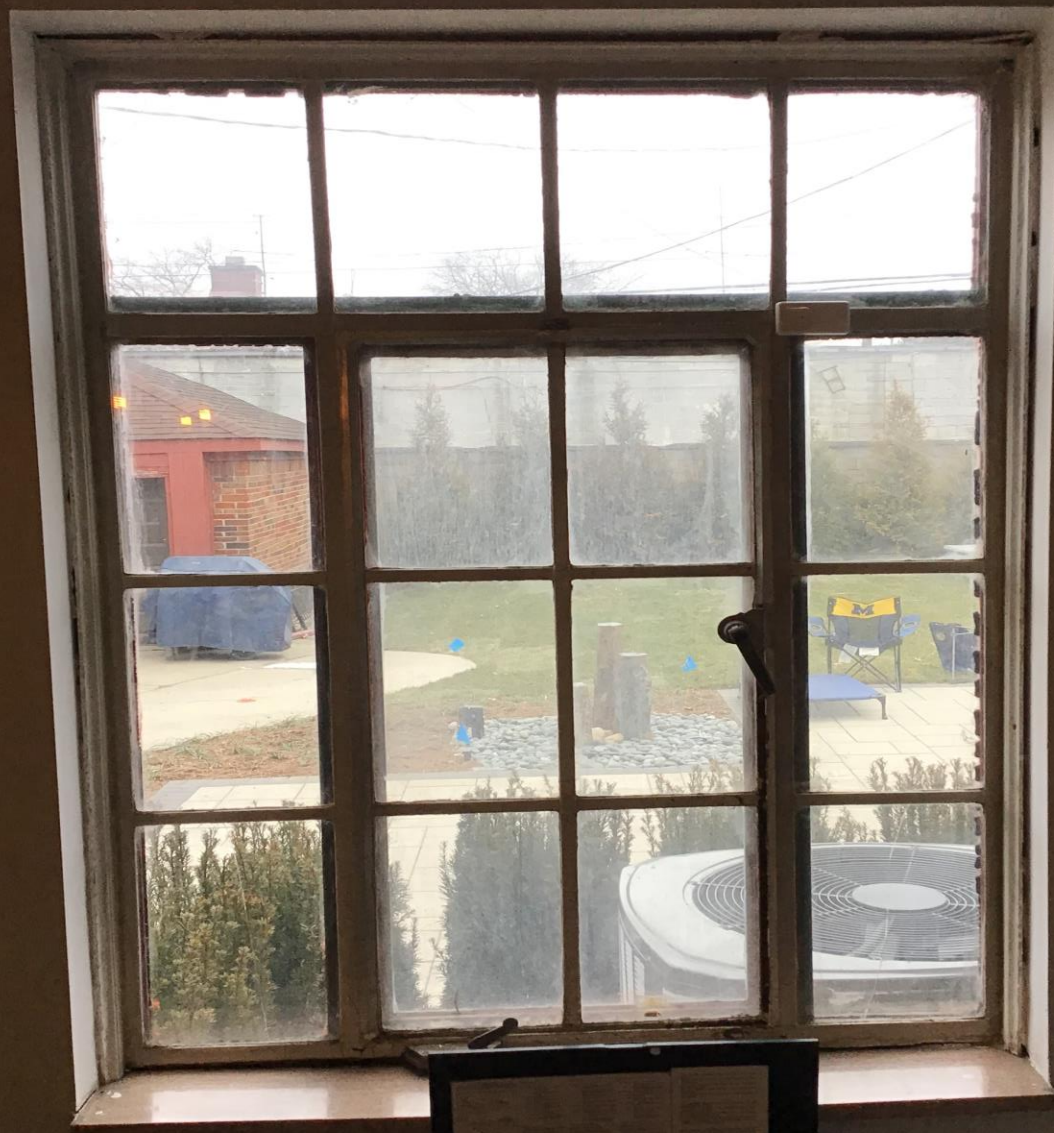
WINDOW OPENING 108

- Single Casement Window
- Window is in Kitchen
- Window doesn't open
- Exterior sill is rotted, can see through
- Interior sill is cracked
- Windowpane cracked
- Screen missing

Window: Casement, Single, Left, Base Frame, 2" Brickmould / Traditional, Exterior Black, Interior Black, **Glass:** All Sash: High Performance SmartSun Glass, No Pattern, **Hardware:** Black, **Screen:** TruScene, Full Screen, **Grille Style:** Grilles Between Glass (GBG), **Grille Pattern:** All Sash: Colonial 4w x 4h, **Misc:** None

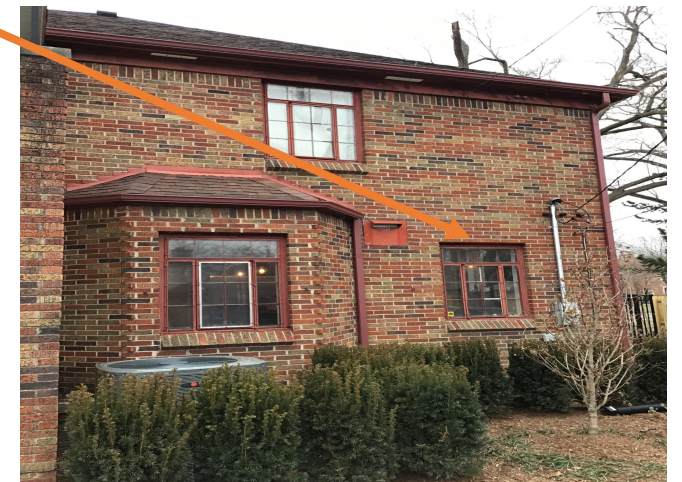
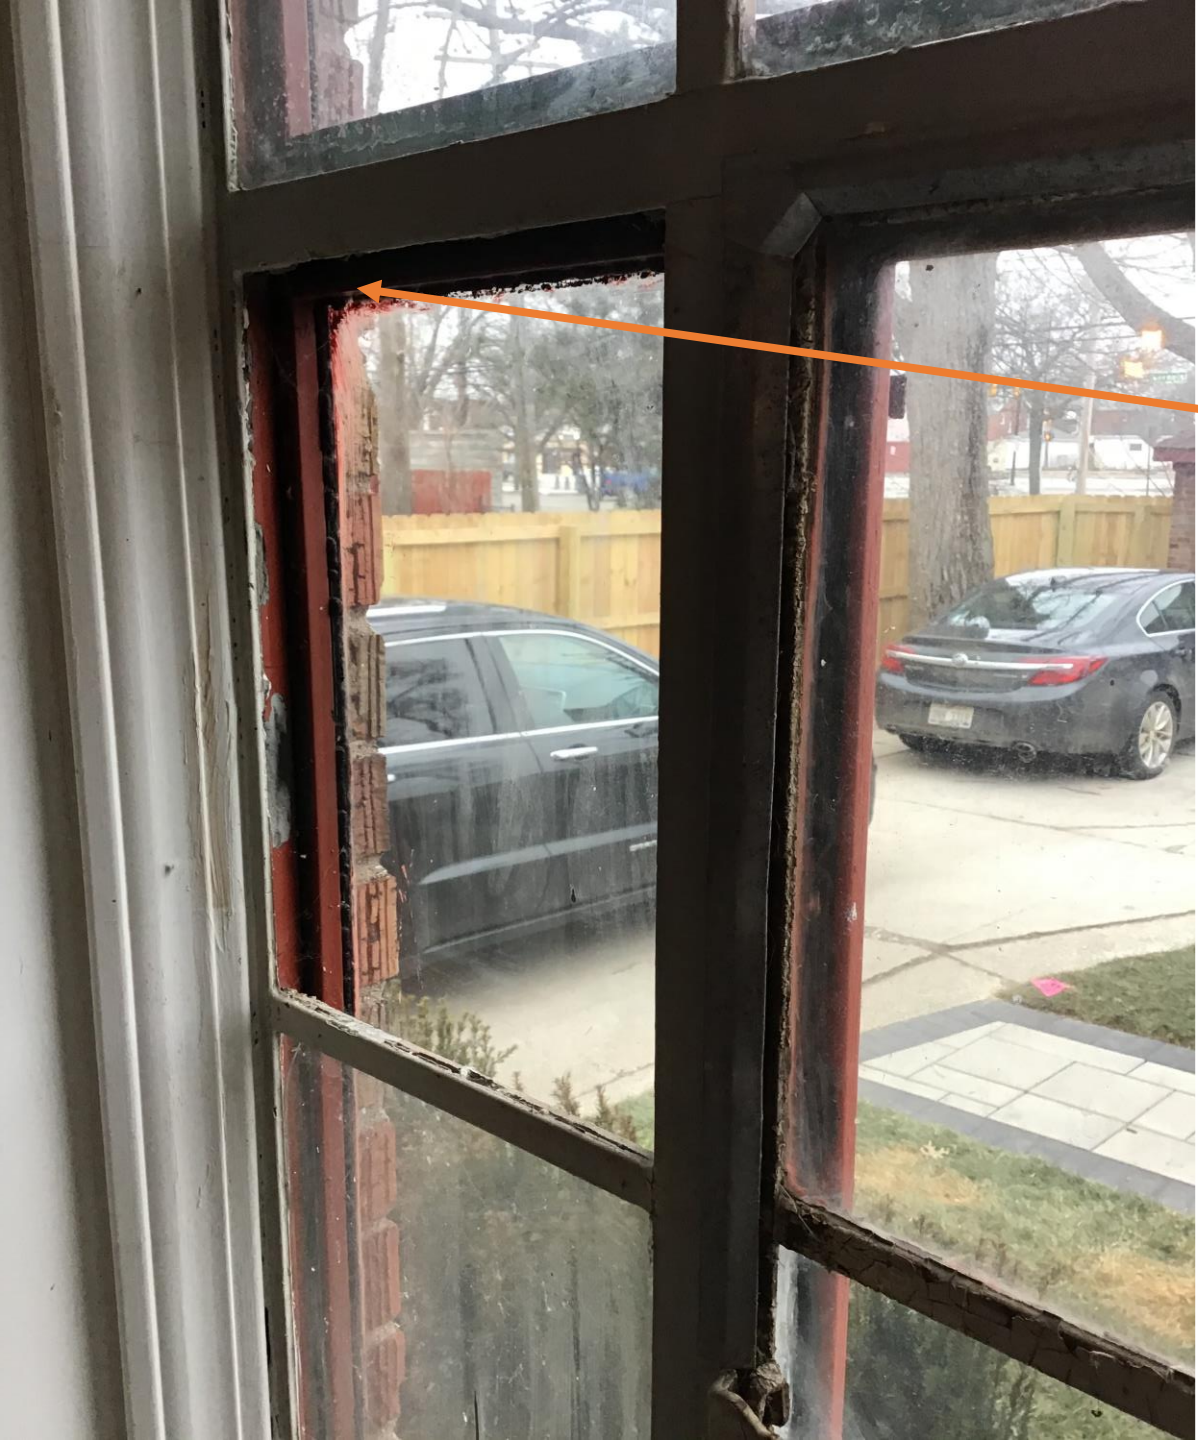
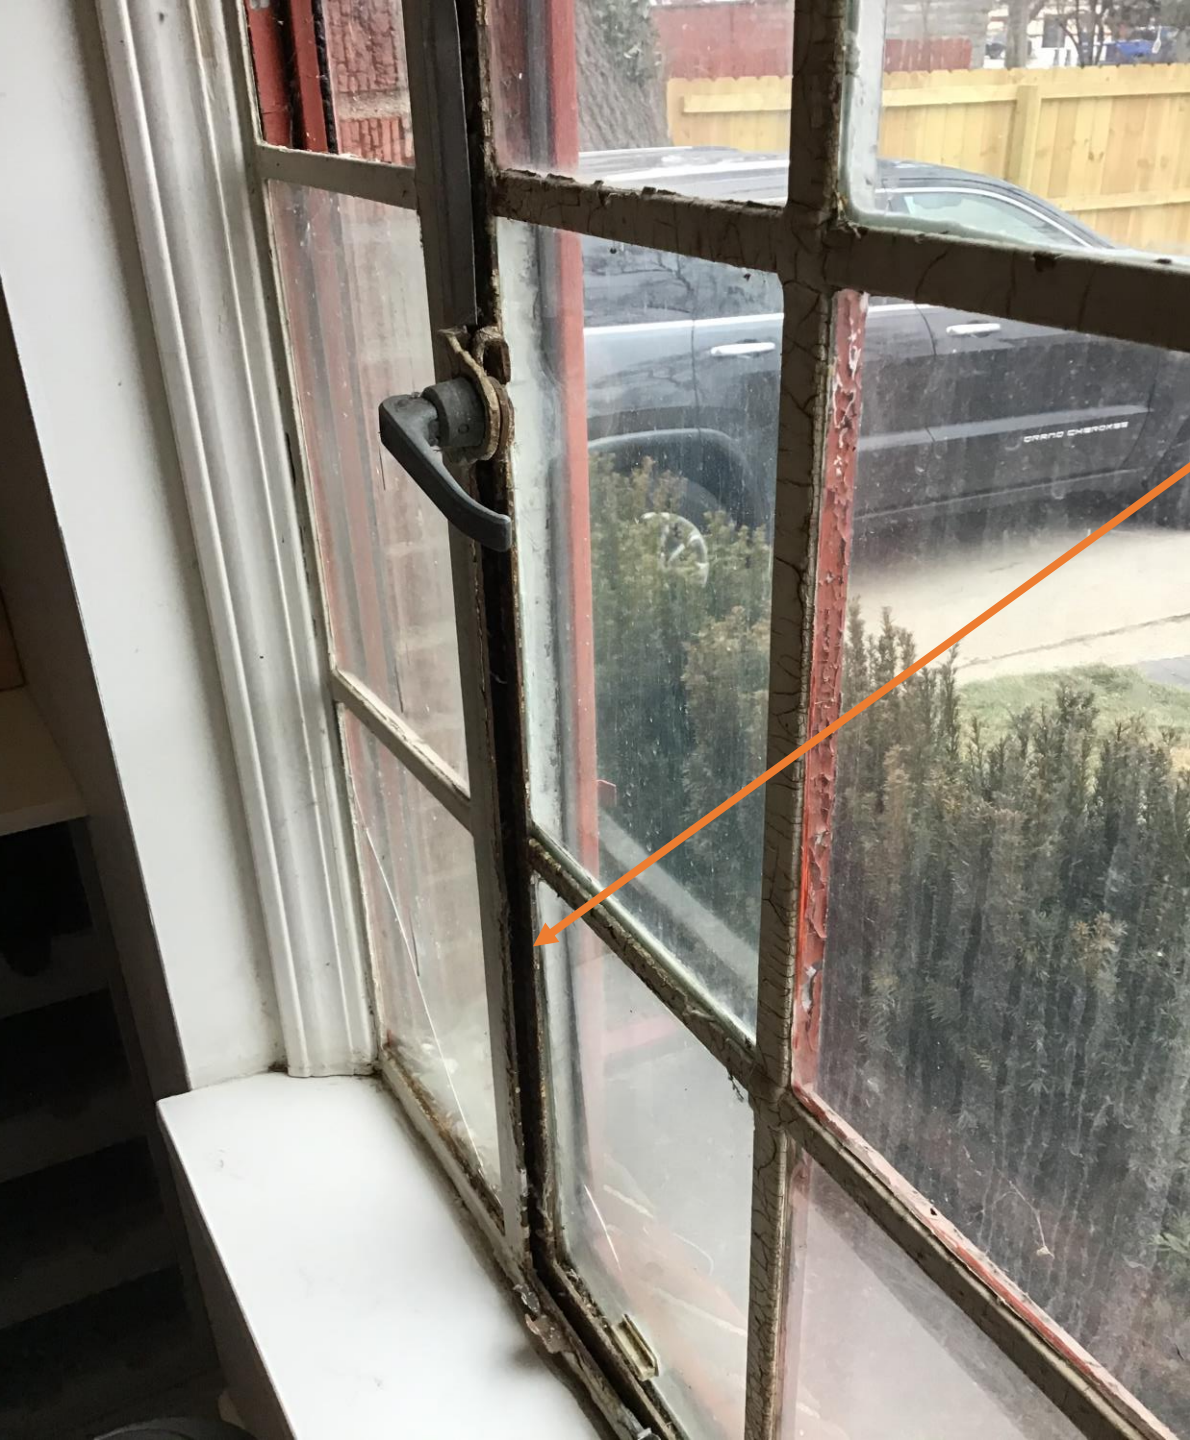
WINDOW OPENING 109 Kitchen - Back of House

- Single Casement Window
- Window is in Kitchen
- Window won't open
- Broken and cracked windowpanes

Window: Casement, Single, Right, Base Frame, 2"

Brickmould / Traditional, Exterior Black, Interior Black, **Glass:**

All Sash: High Performance SmartSun Glass, No Pattern,

Hardware: Black, **Screen:** Fiberglass, Full Screen, **Grille Style:**

Grilles Between Glass (GBG), **Grille Pattern:** All Sash:

Colonial 4w x 4h, **Misc:** None

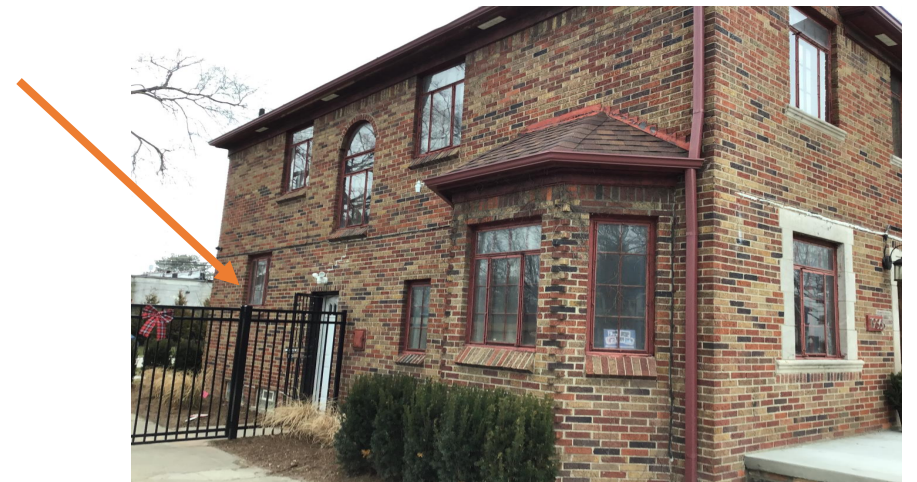
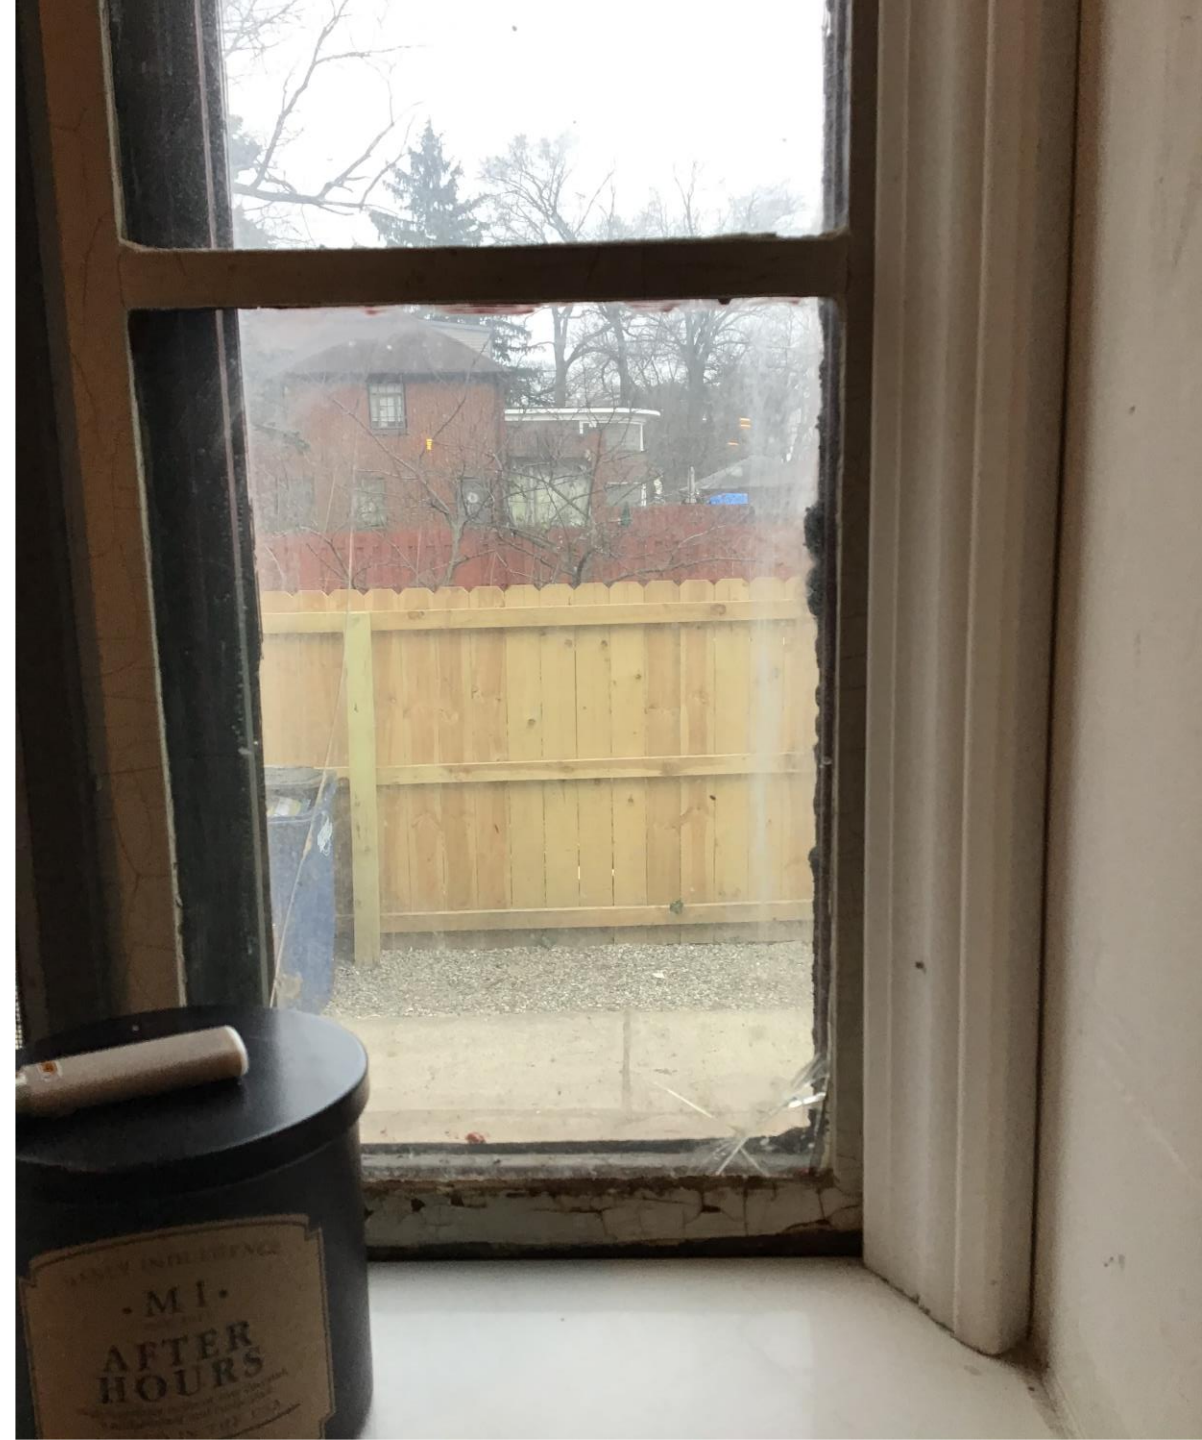
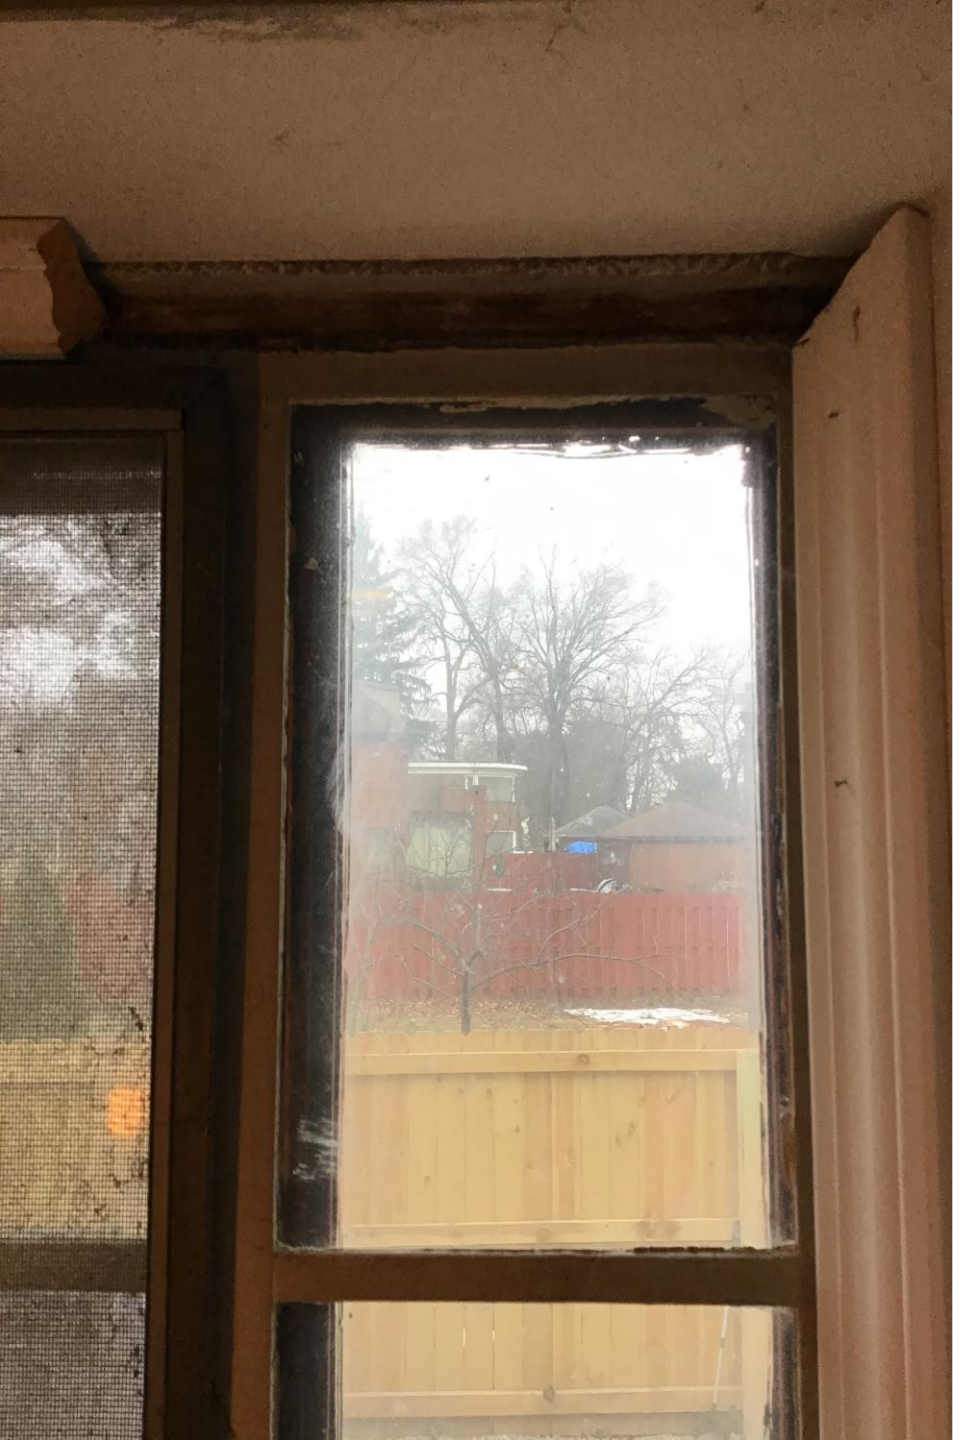
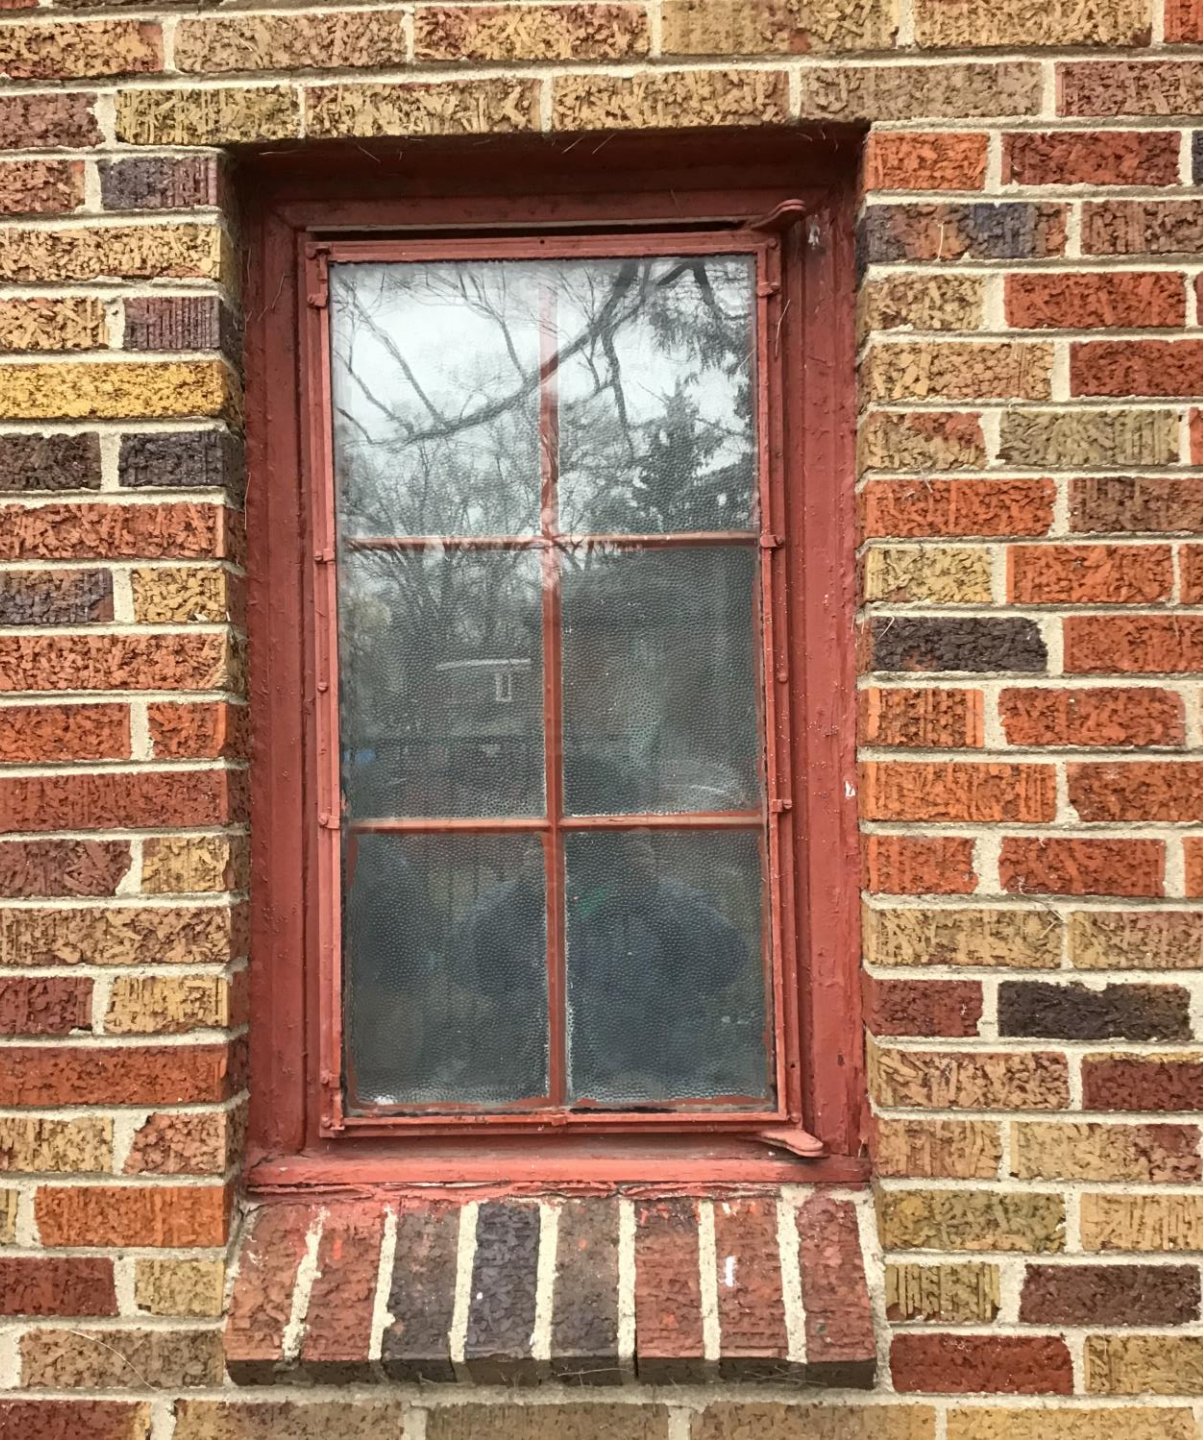
WINDOW OPENING 110 Kitchen – Left side of House

- Single Casement Window
- Window is in Kitchen
- Window won't open
- Exterior of window showing signs of rotting around frame and exterior window shows breakage
- Interior casing is missing/broken

Window: Casement, Single, Left, Base Frame, 2" Brickmould / Traditional, Exterior Black, Interior Black, **Glass:** All Sash: High Performance SmartSun Glass, No Pattern, **Hardware:** Black, **Screen:** TruScene, Full Screen, **Grille Style:** Grilles Between Glass (GBG), **Grille Pattern:** All Sash: Colonial 3w x 4h, **Misc:** None

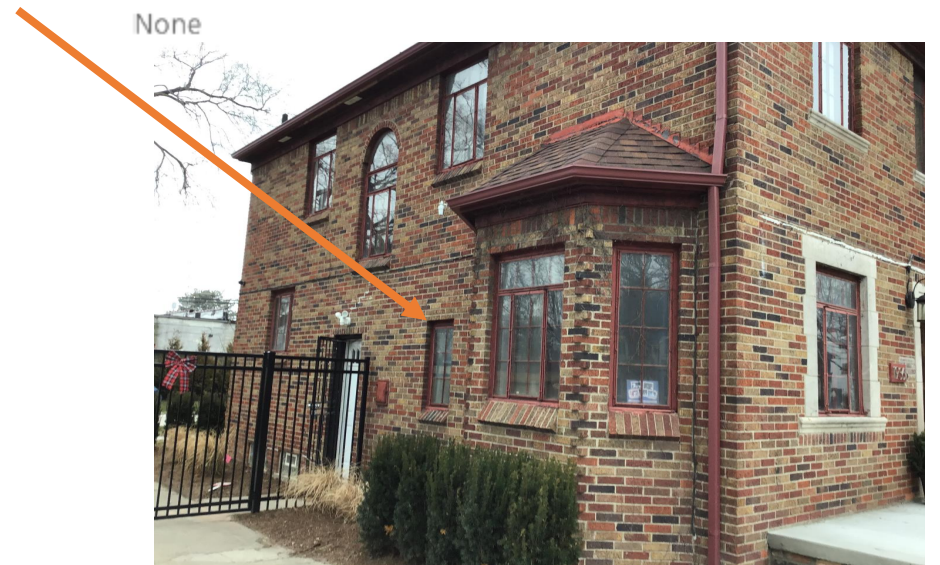
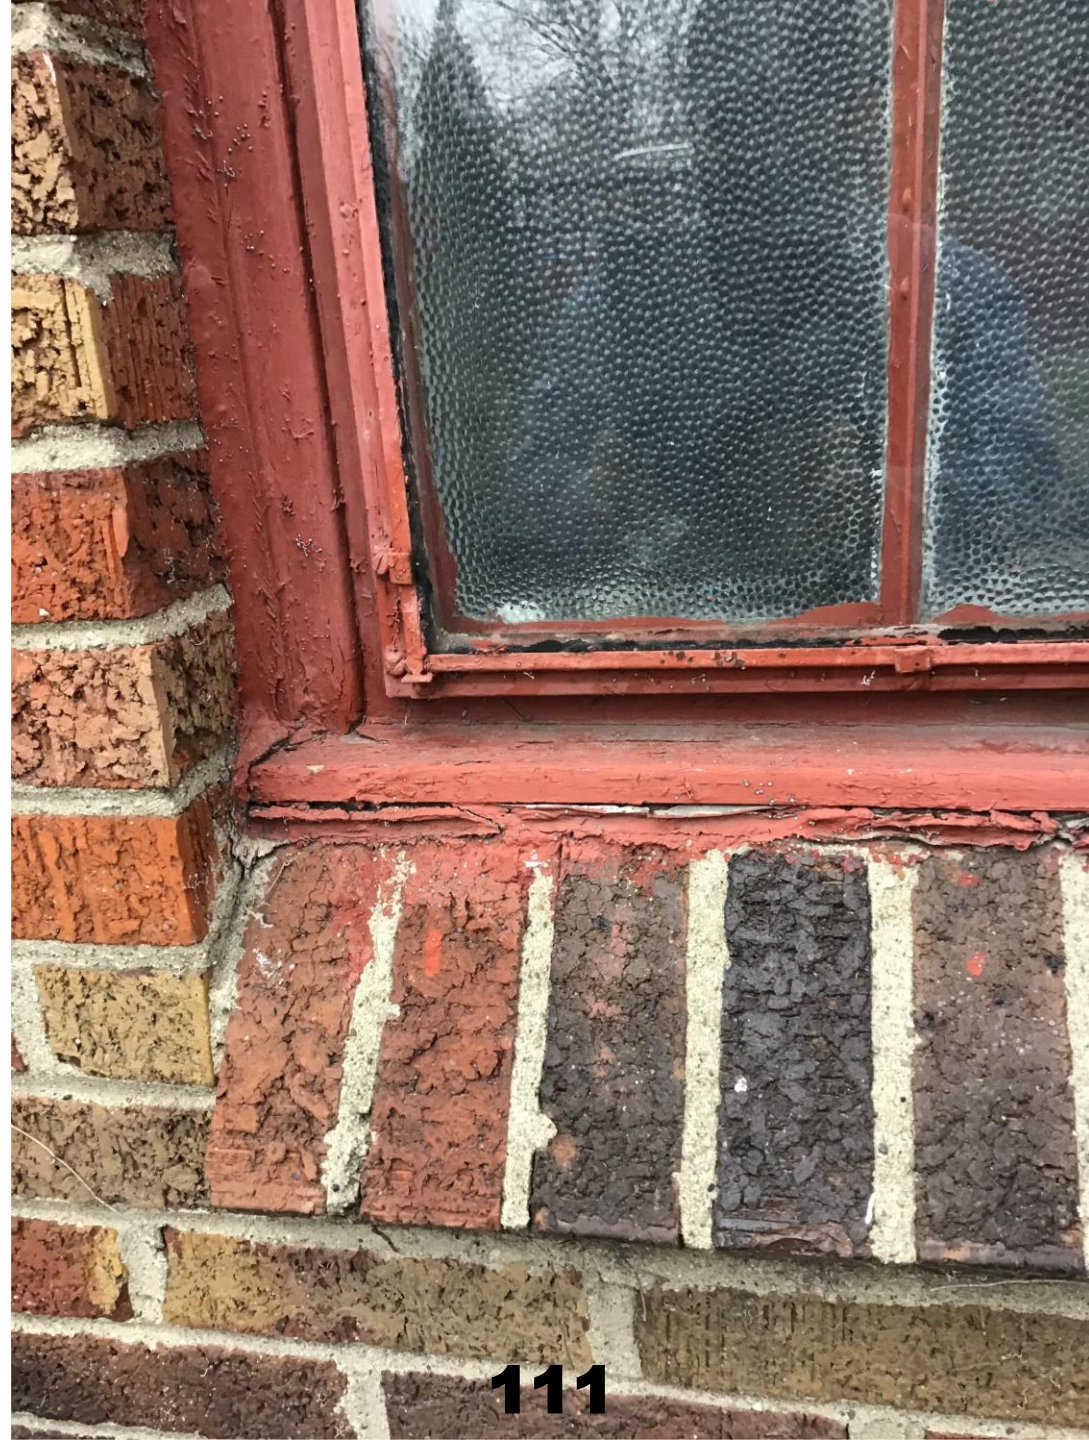
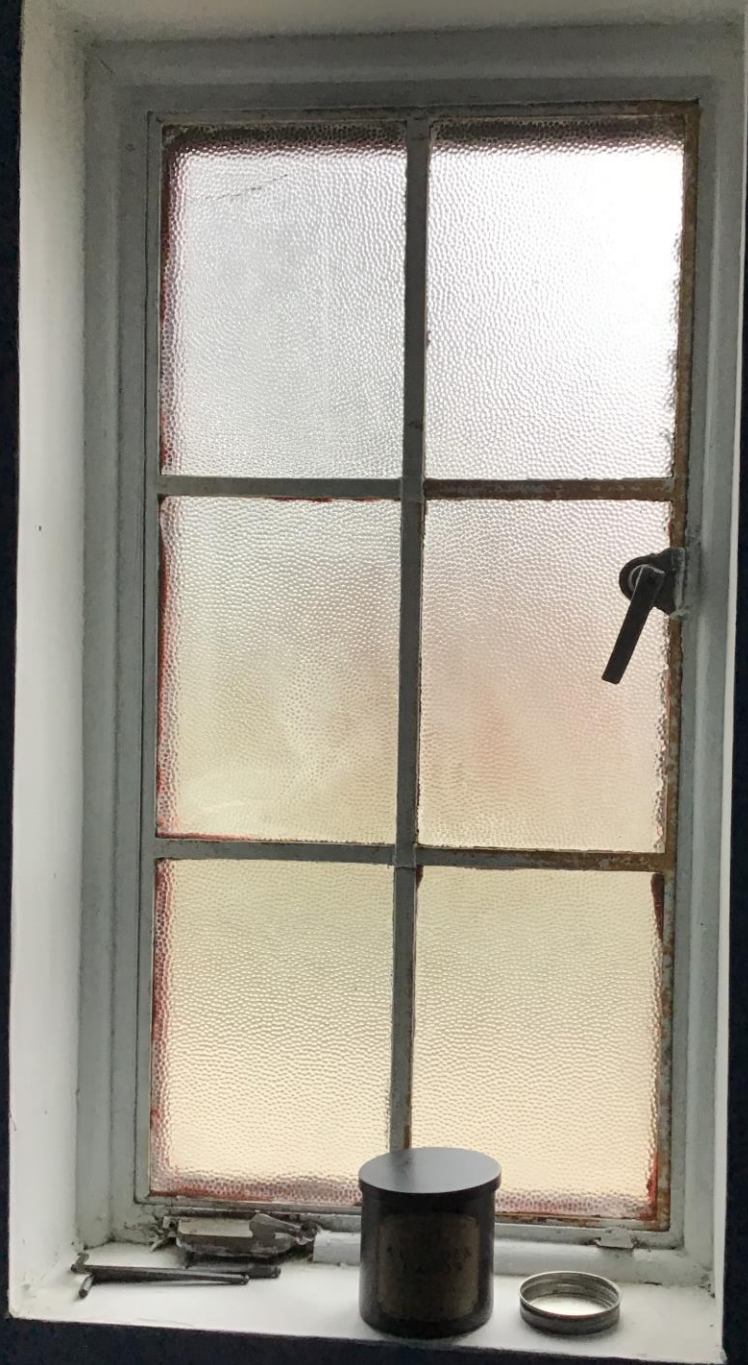
WINDOW OPENING 111

- Single Casement Window
- Window is in Bathroom
- Window doesn't open
- Exterior of window showing signs of rotting around frame

Window: Casement, Single, Left, Base Frame, 2" Brickmould / Traditional, Exterior Black, Interior Black, **Glass:** All Sash: High Performance SmartSun Glass, Obscure, **Hardware:** Black, **Screen:** Fiberglass, Full Screen, **Grille Style:** Grilles Between Glass (GBG), **Grille Pattern:** All Sash: Colonial 2w x 3h, **Misc:** None
