James Haskins
19365 Warrington Dr
Detroit MI 48221
Sherwood Forest District

Renewal by Andersen 37720 Amrhein Livonia, MI 48150

- Homeowner wants to replace all the windows around house except for one stained glass window unit
- Windows are original steel
- Renewal by Andersen windows are Fibrex (wood composite) material
- Total of 24 windows to be replaced
- Windows exterior color will be black if approved
- Most windows matching style except for bay windows – flankers changed to operable and middle window changed to fixed.
- Windows will match existing mutton bar “pattern”
- Homeowner unable to get quotes for repair

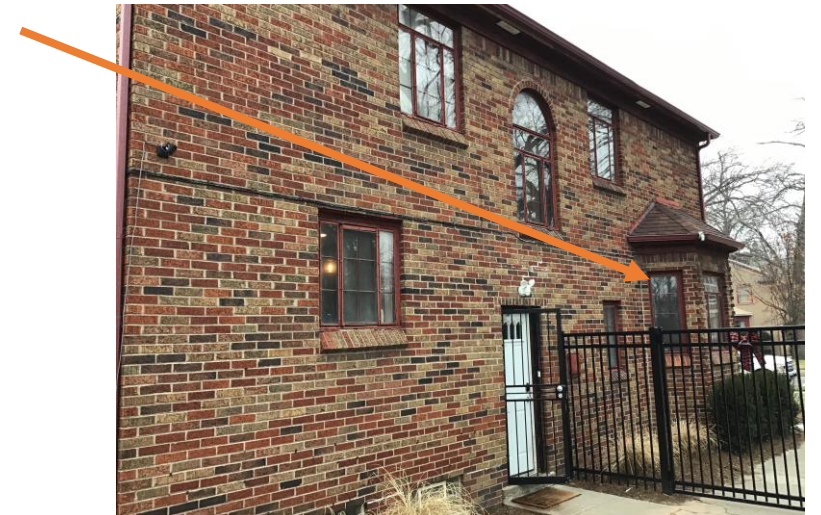
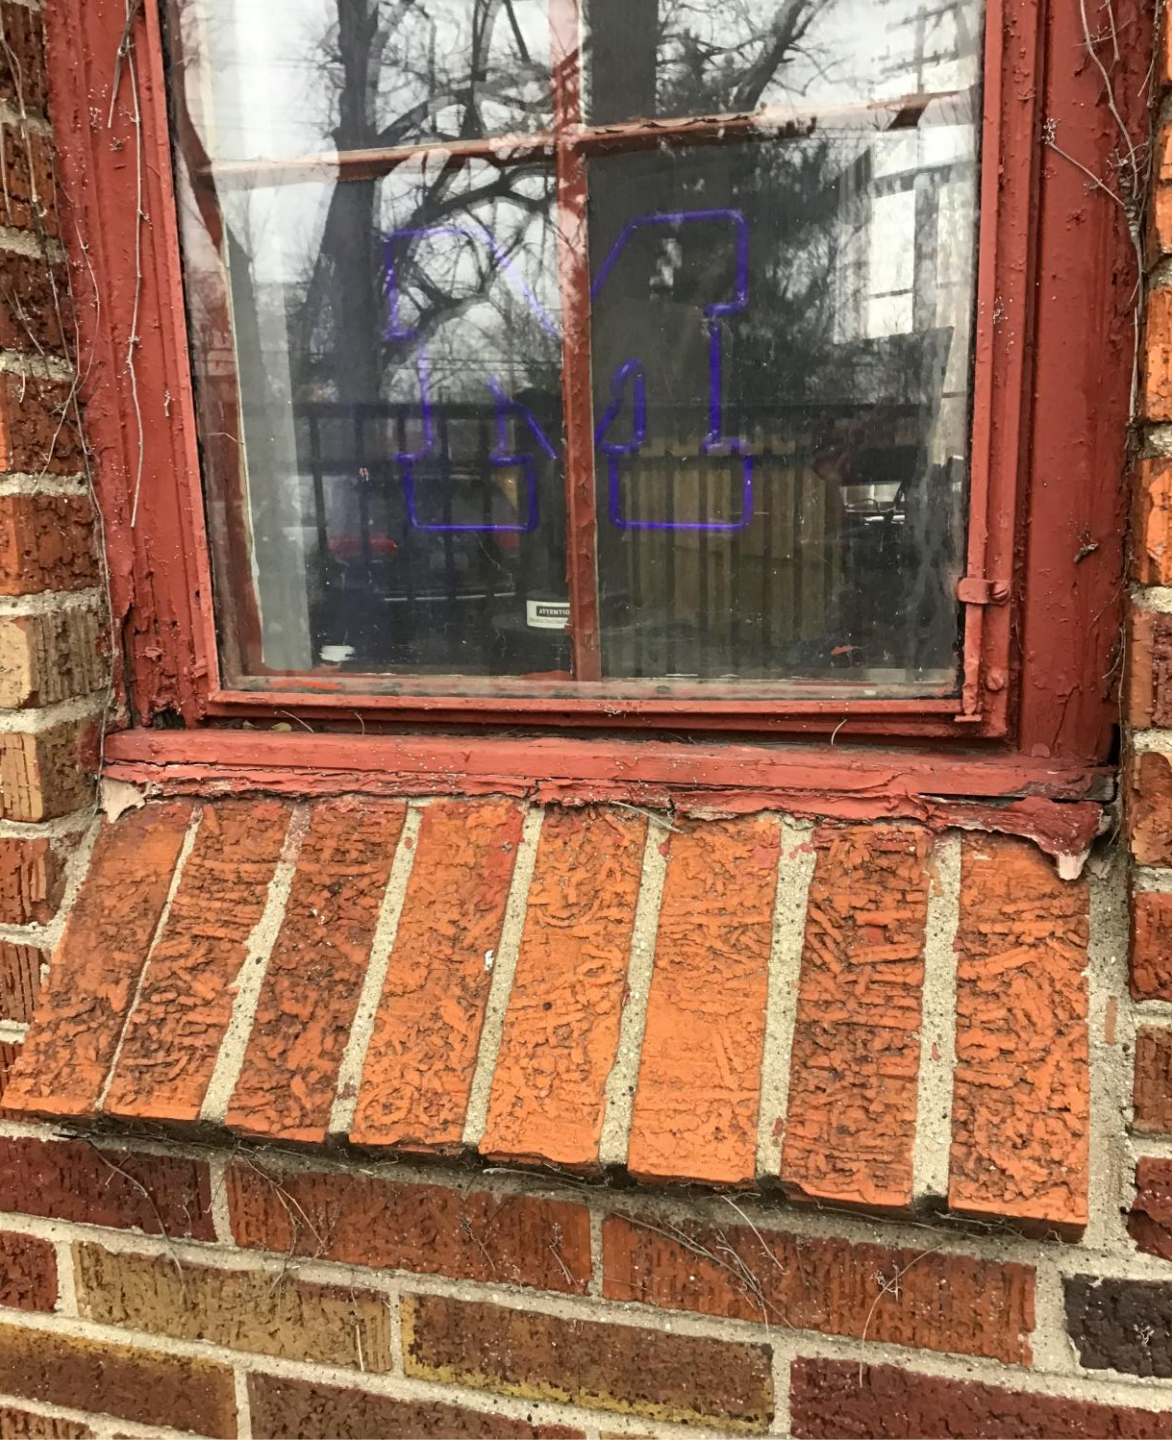
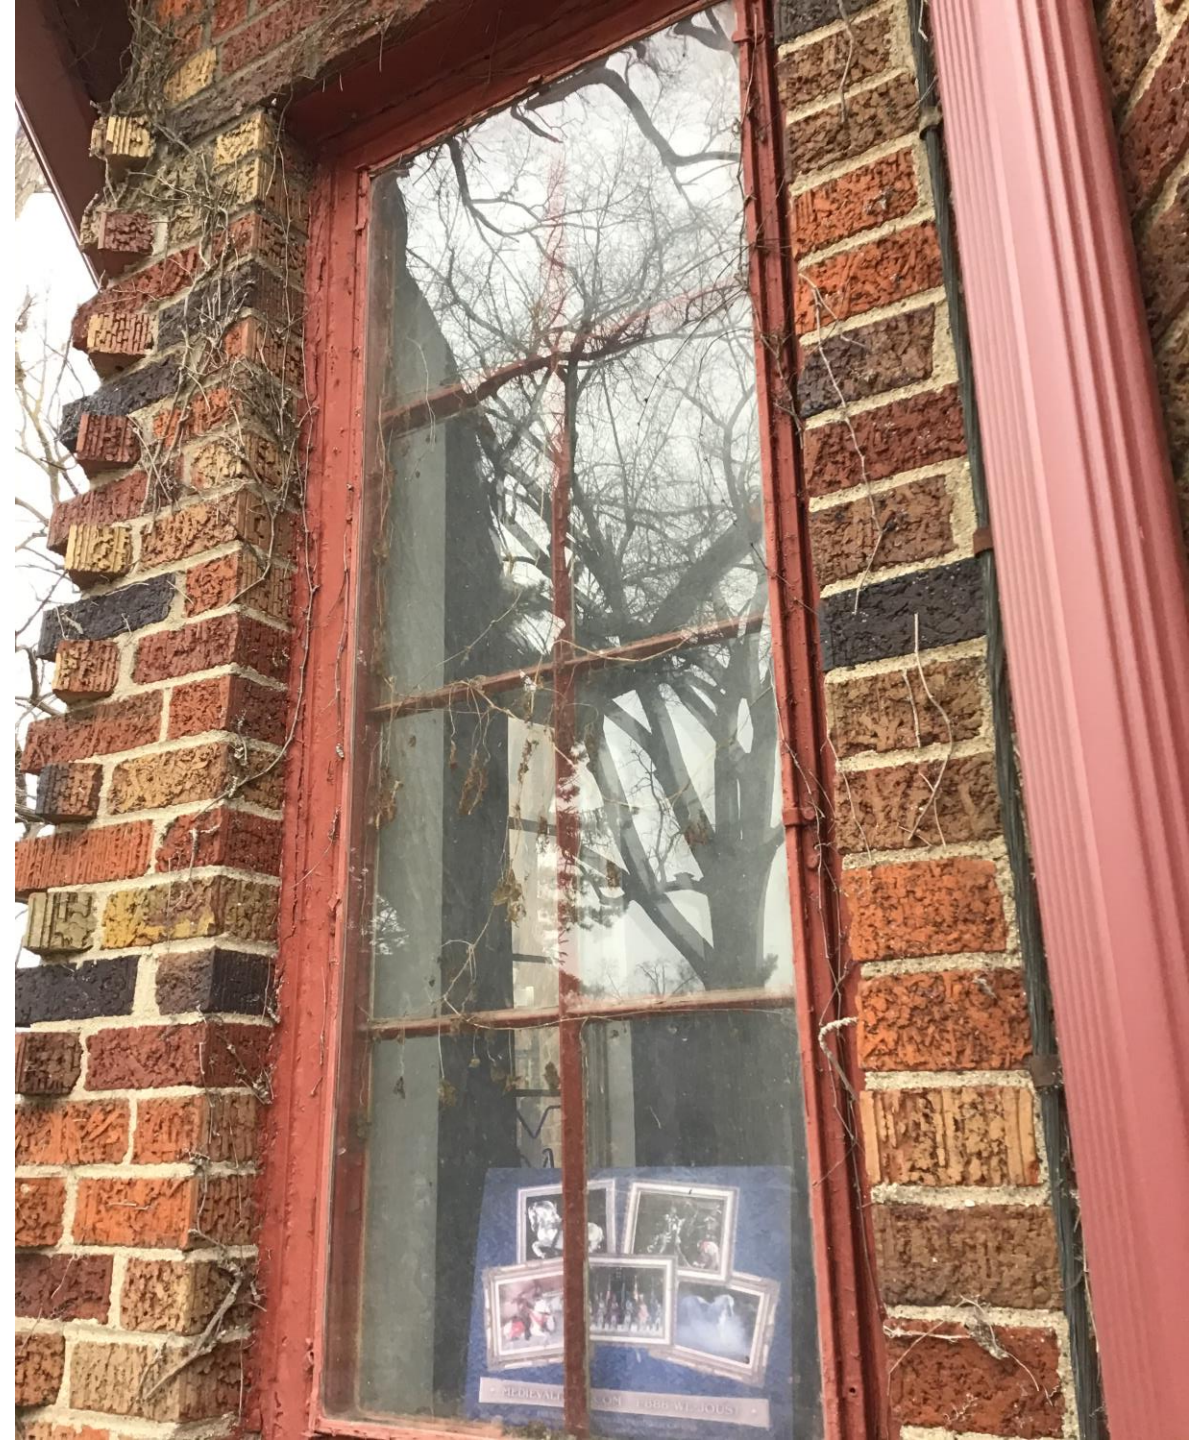
WINDOW OPENING 112 Office - Left side of House

- Fixed window – Steel casement
- Window is in an office
- Window doesn't open
- Ivy stuck between window and storm
- Exterior of window showing signs of rotting around frame

Window: Casement, Single, Left, Base Frame, 2" Brickmould / Traditional, Exterior Black, Interior Black, **Glass:** All Sash: High Performance SmartSun Glass, No Pattern, **Hardware:** Black, **Screen:** Fiberglass, Full Screen, **Grille Style:** Grilles Between Glass (GBG), **Grille Pattern:** All Sash: Colonial 2w x 4h, **Misc:** None

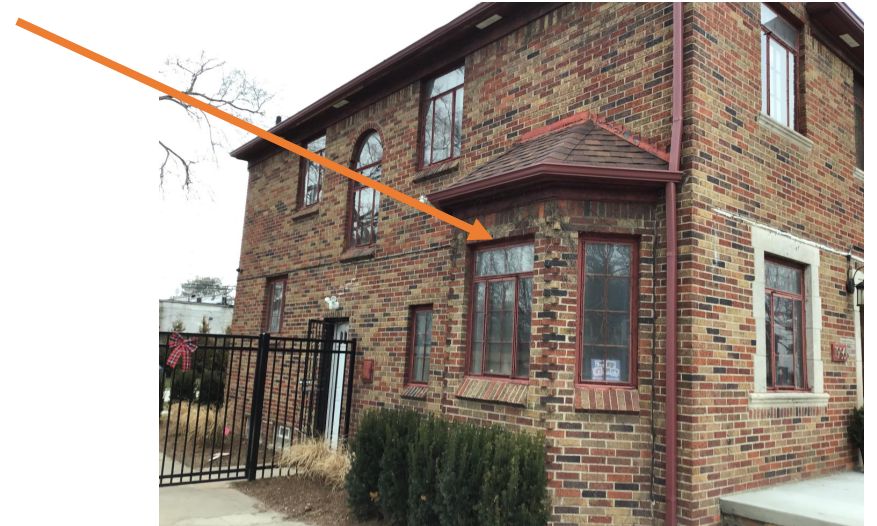
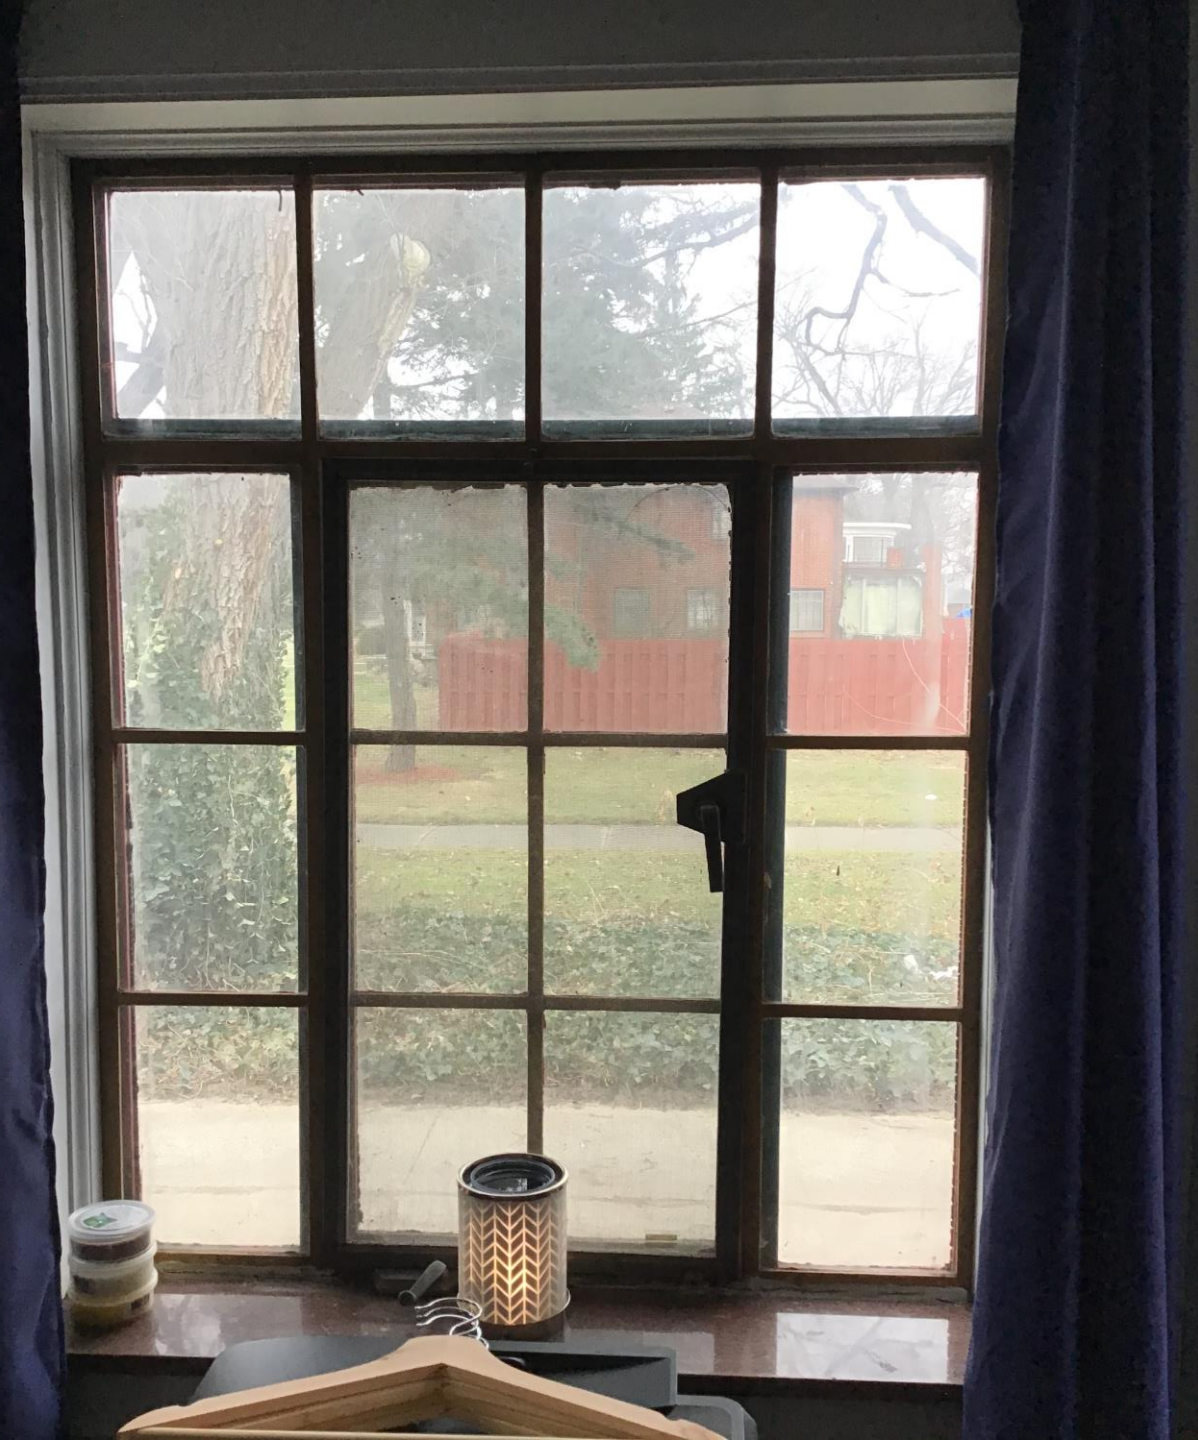
WINDOW OPENING 113 Office - Left side of House

- Casement Single Window
- Window is in an office
- Window is hard to close if opened
- Exterior of window showing signs of rotting around frame

Window: Casement, Fixed Window, Base Frame, Exterior Black, Interior Black, **Glass:** All Sash: High Performance SmartSun Glass, No Pattern, **Grille Style:** Grilles Between Glass (GBG), **Grille Pattern:** All Sash: Colonial 4w x 4h, **Misc:** None

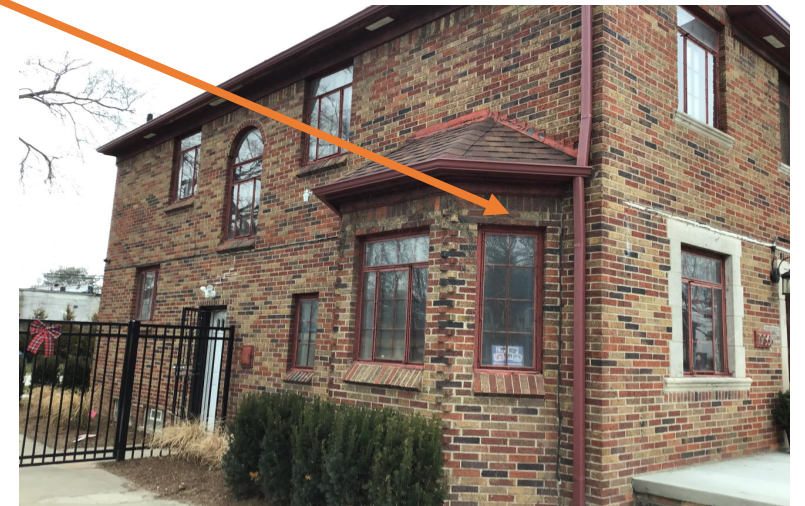
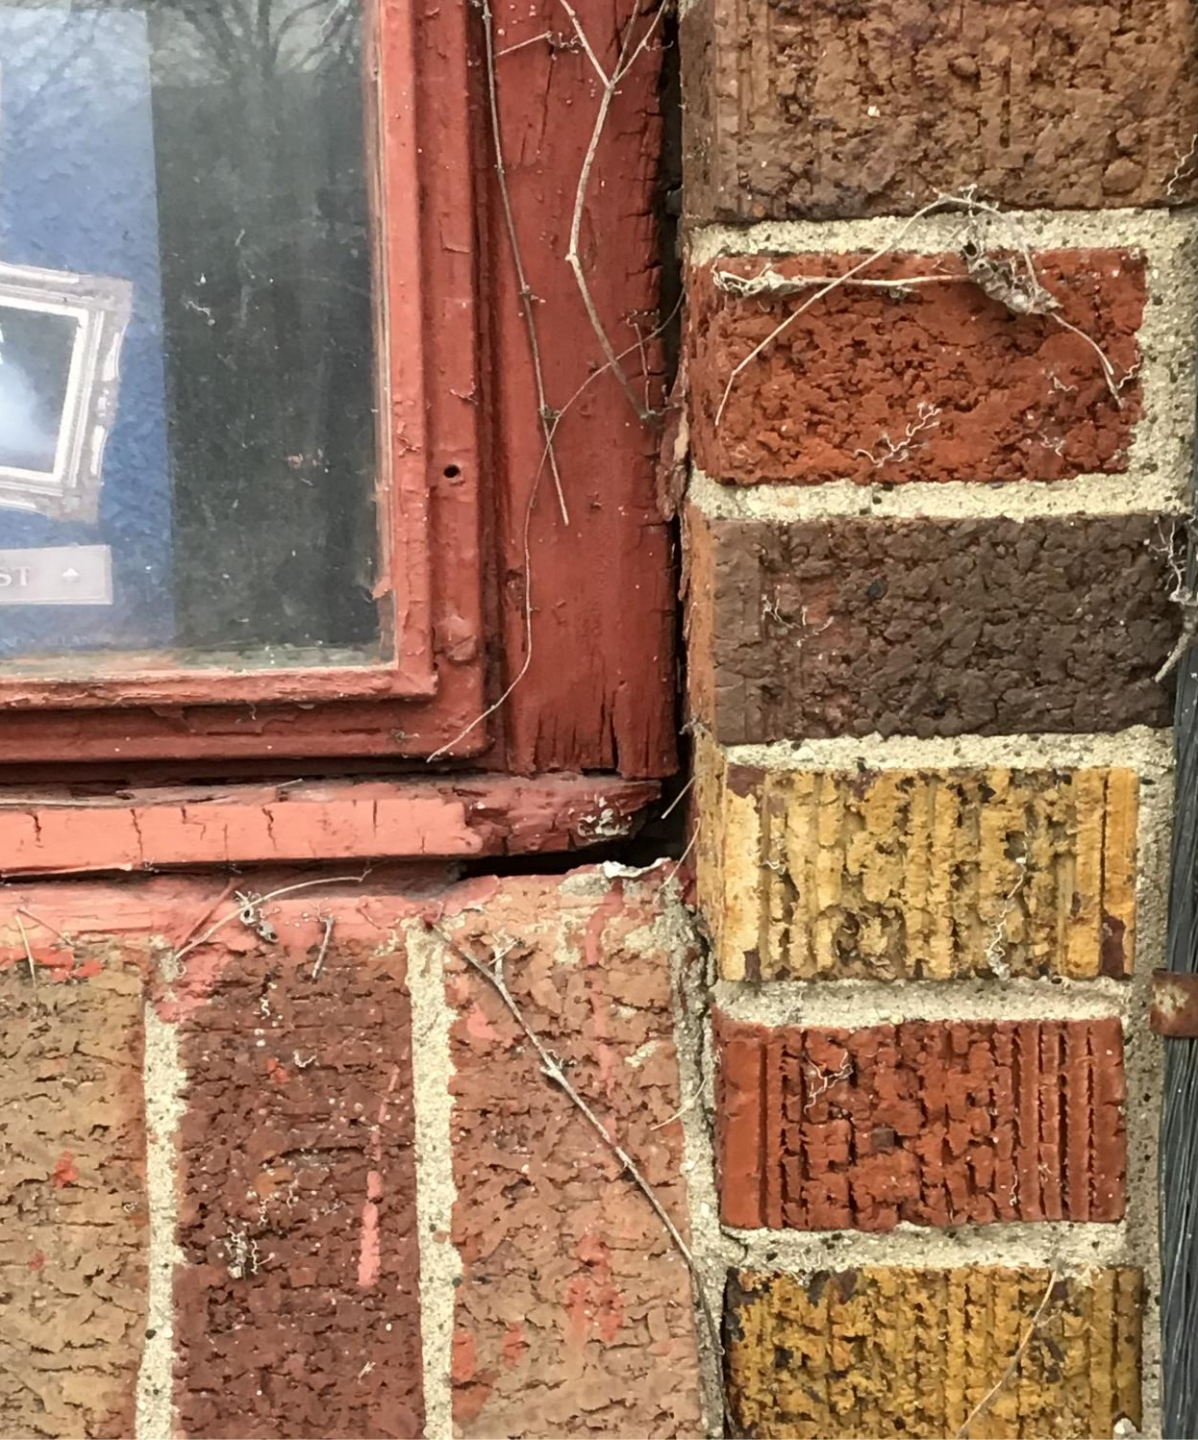
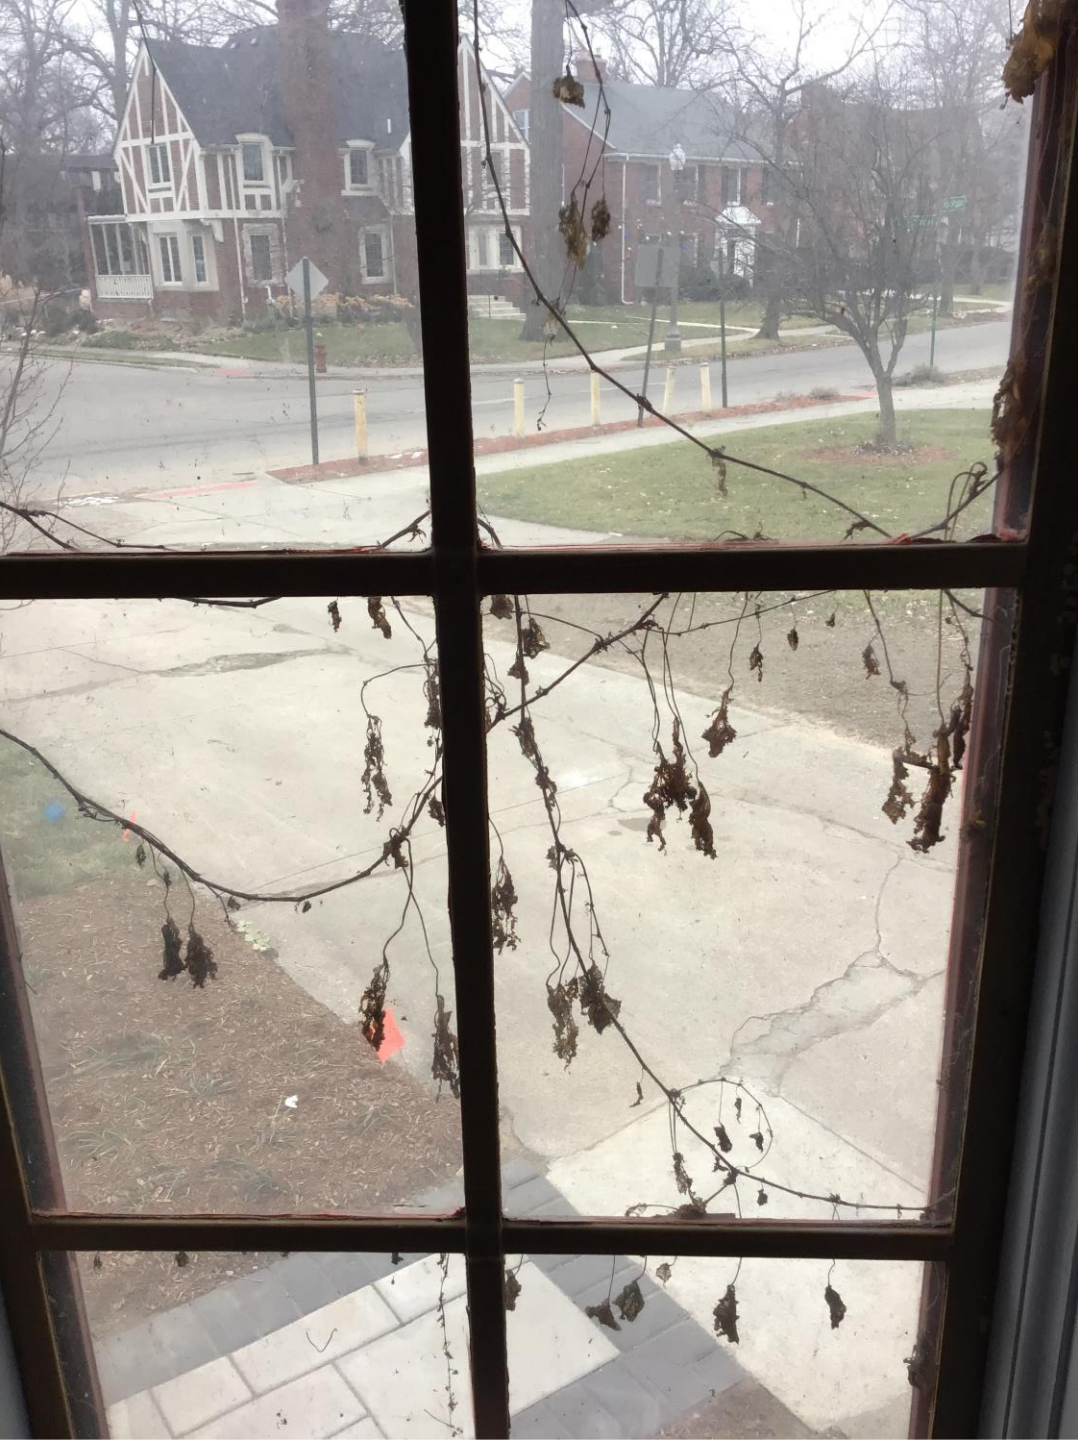
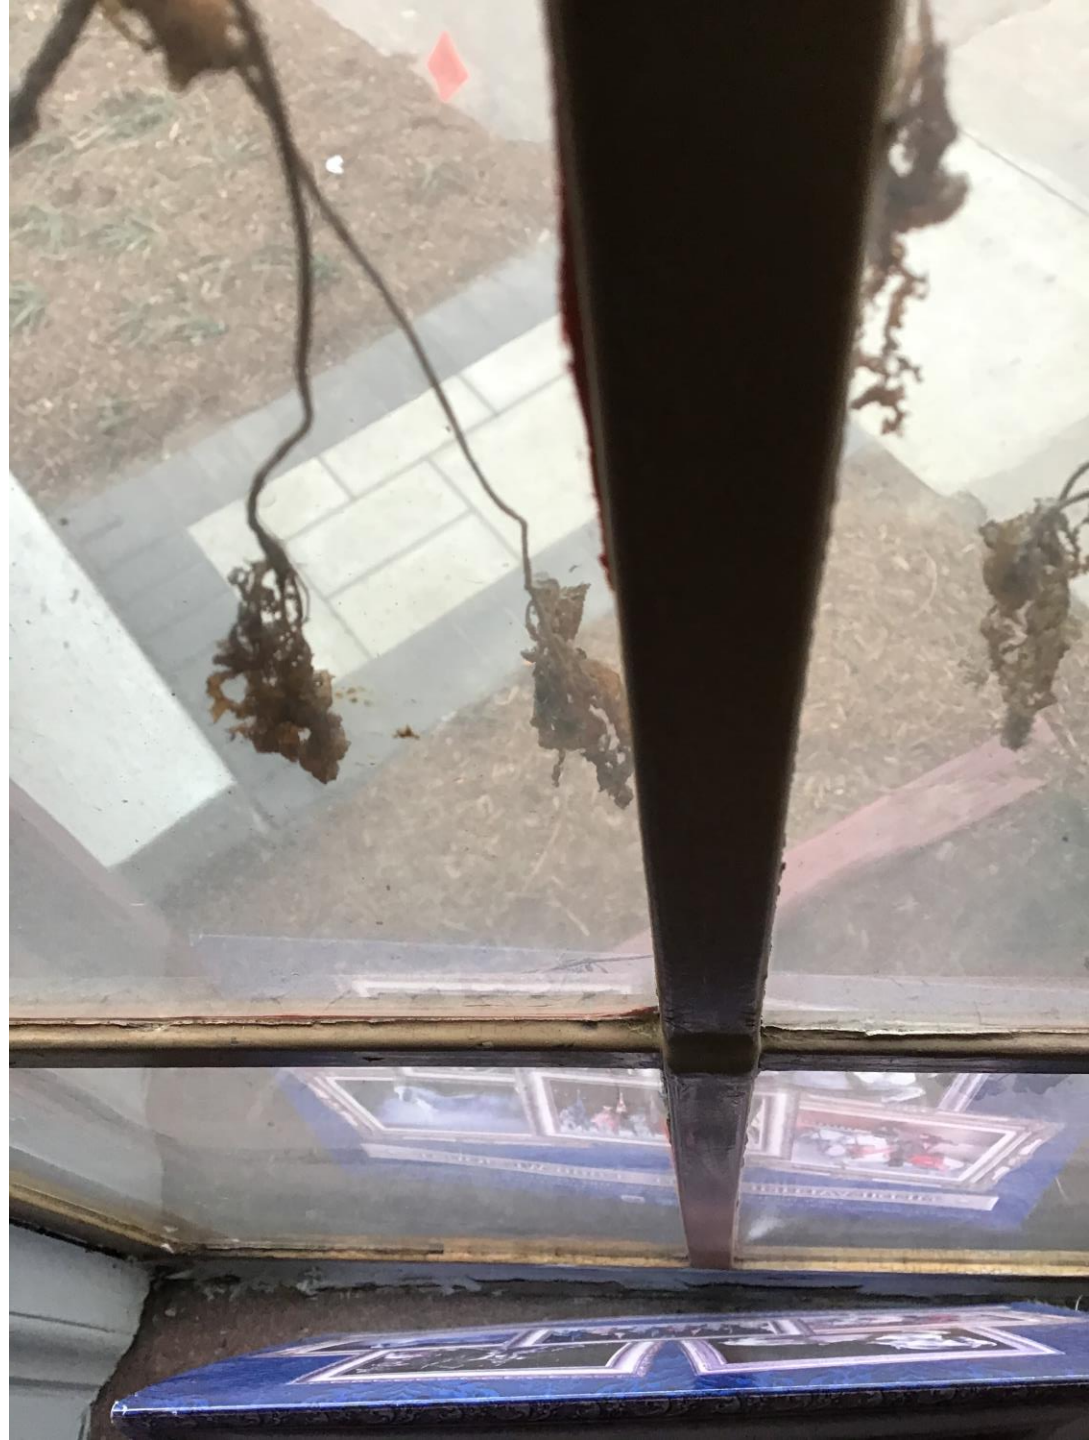
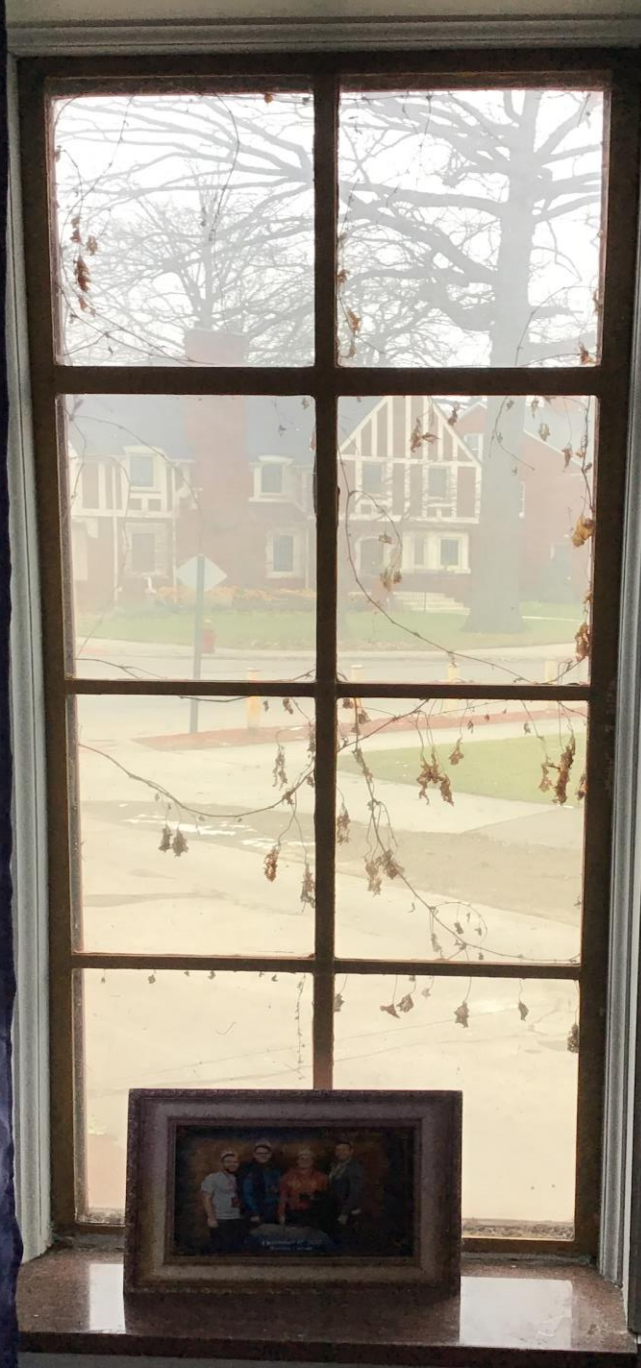
WINDOW OPENING 114 Office - Left side of House

- Fixed window – Steel casement
- Window is in an office
- Ivy stuck between window and storm
- Exterior of window showing signs of rotting around frame

Window: Casement, Single, Right, Base Frame, 2"

Brickmould / Traditional, Exterior Black, Interior Black, **Glass:**

All Sash: High Performance SmartSun Glass, No Pattern,

Hardware: Black, **Screen:** Fiberglass, Full Screen, **Grille Style:**

Grilles Between Glass (GBG), **Grille Pattern:** All Sash:

Colonial 2w x 4h, **Misc:** None

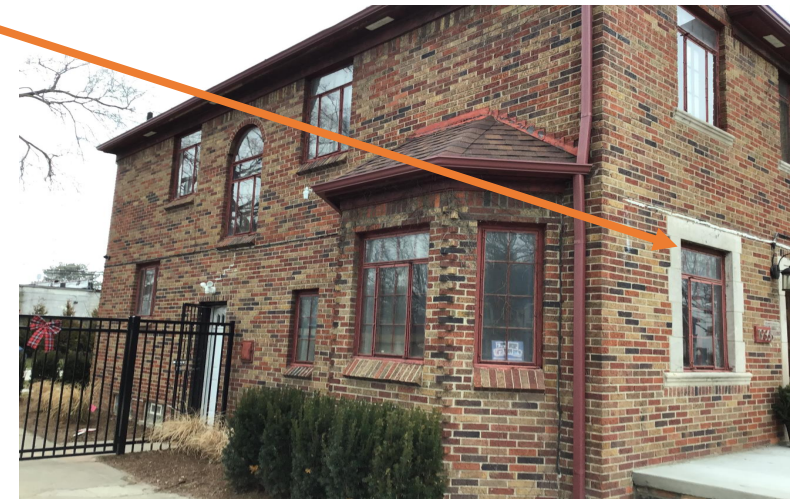
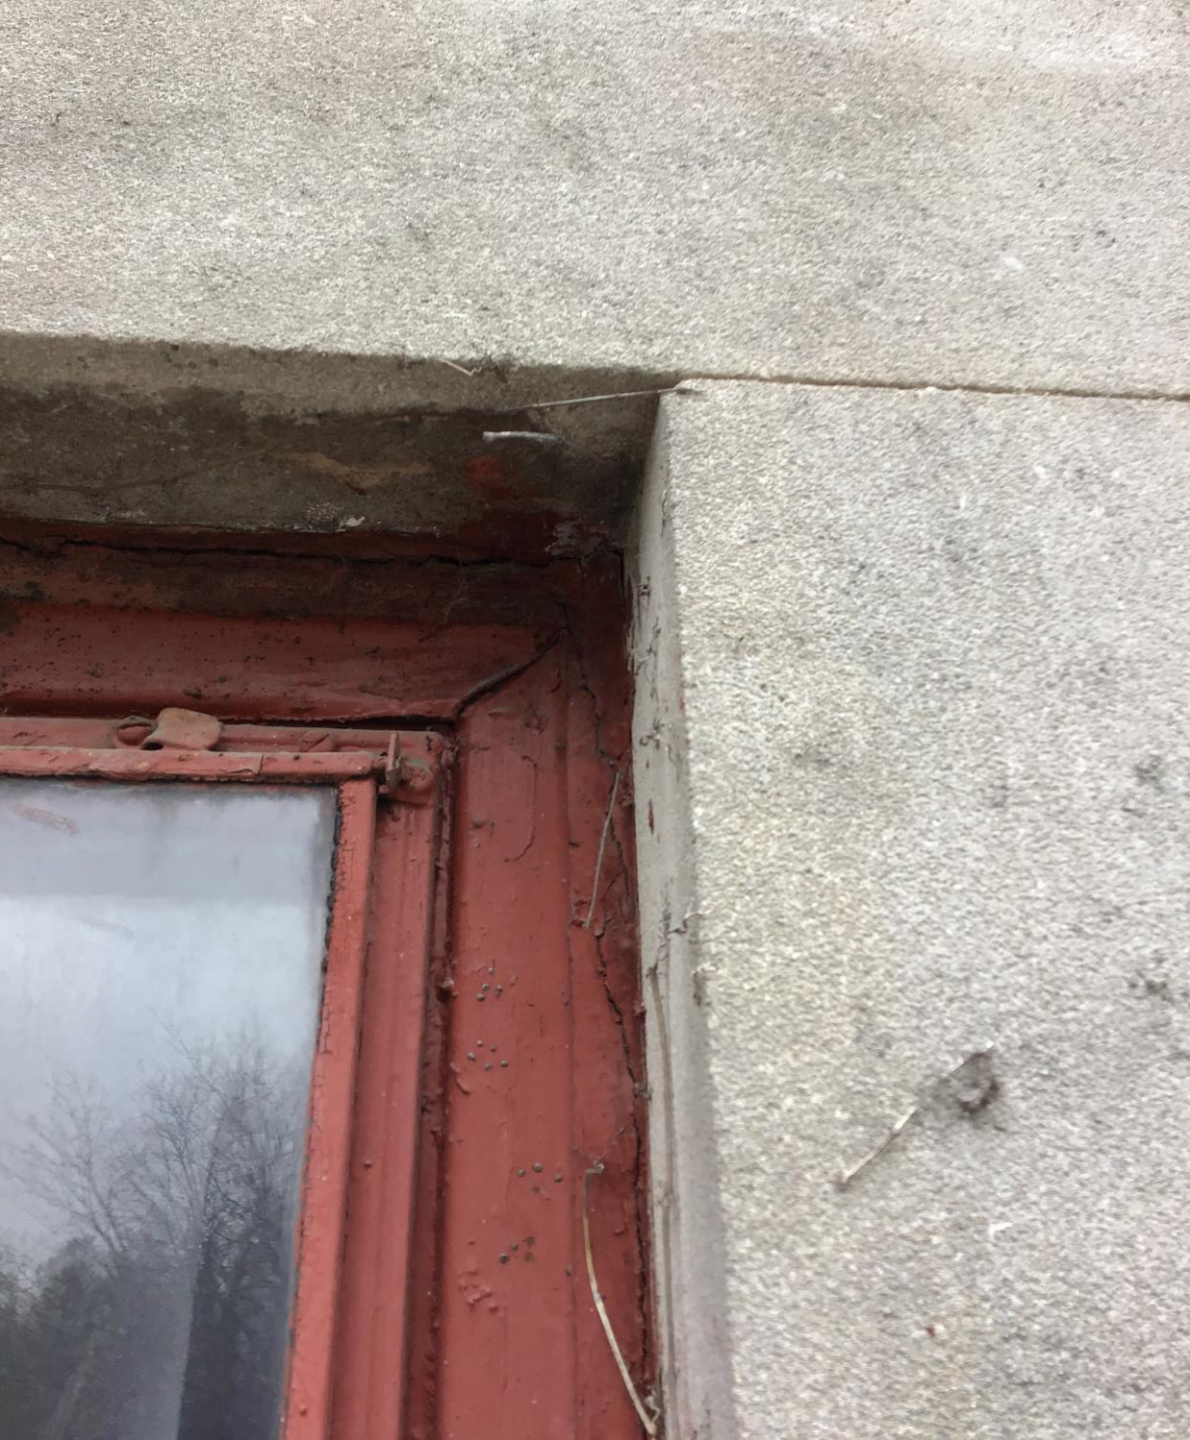
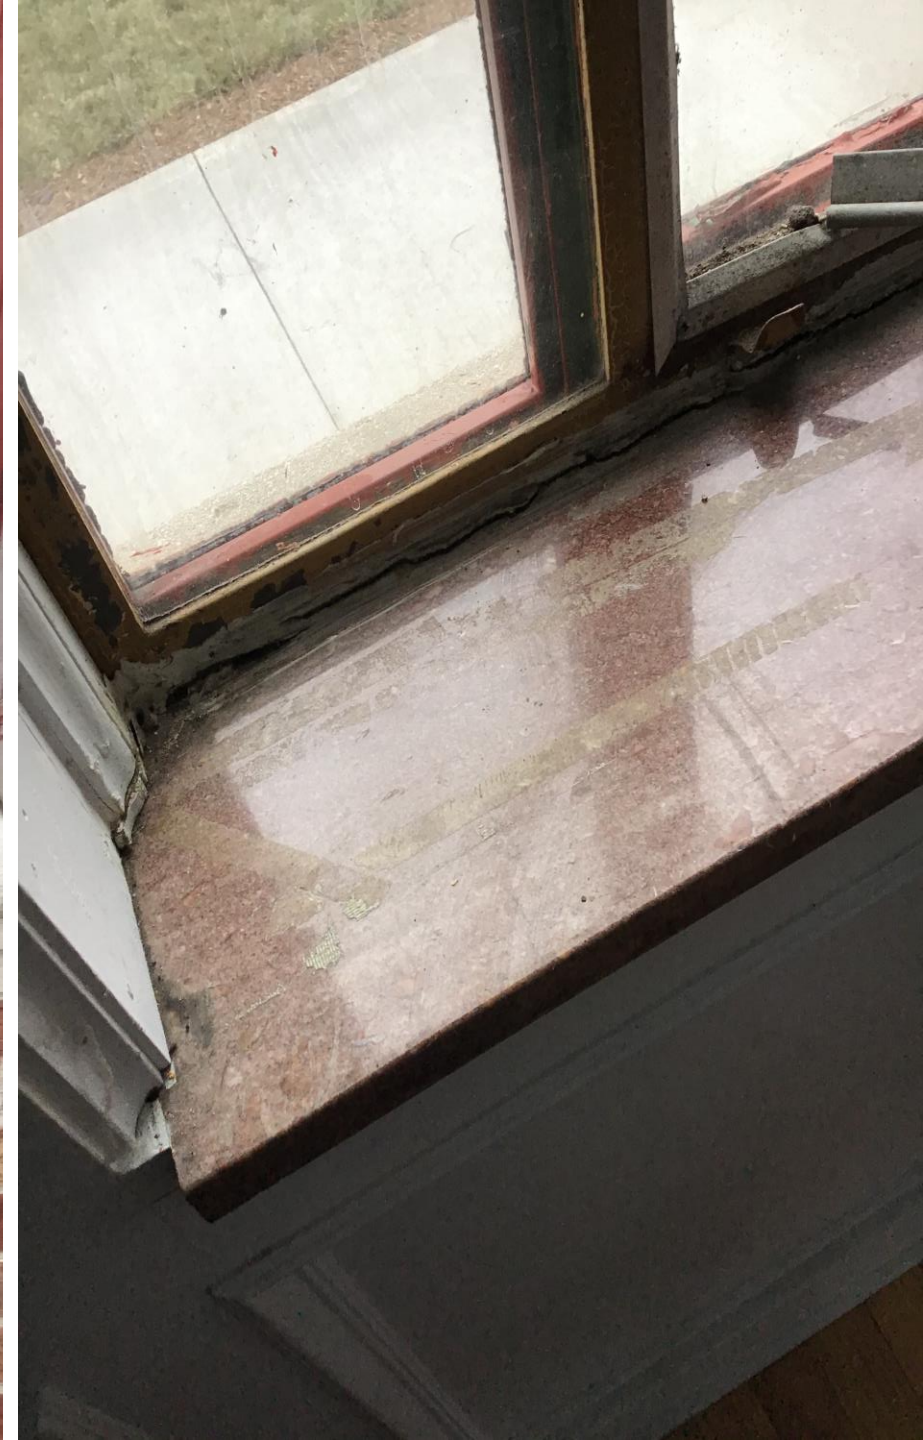
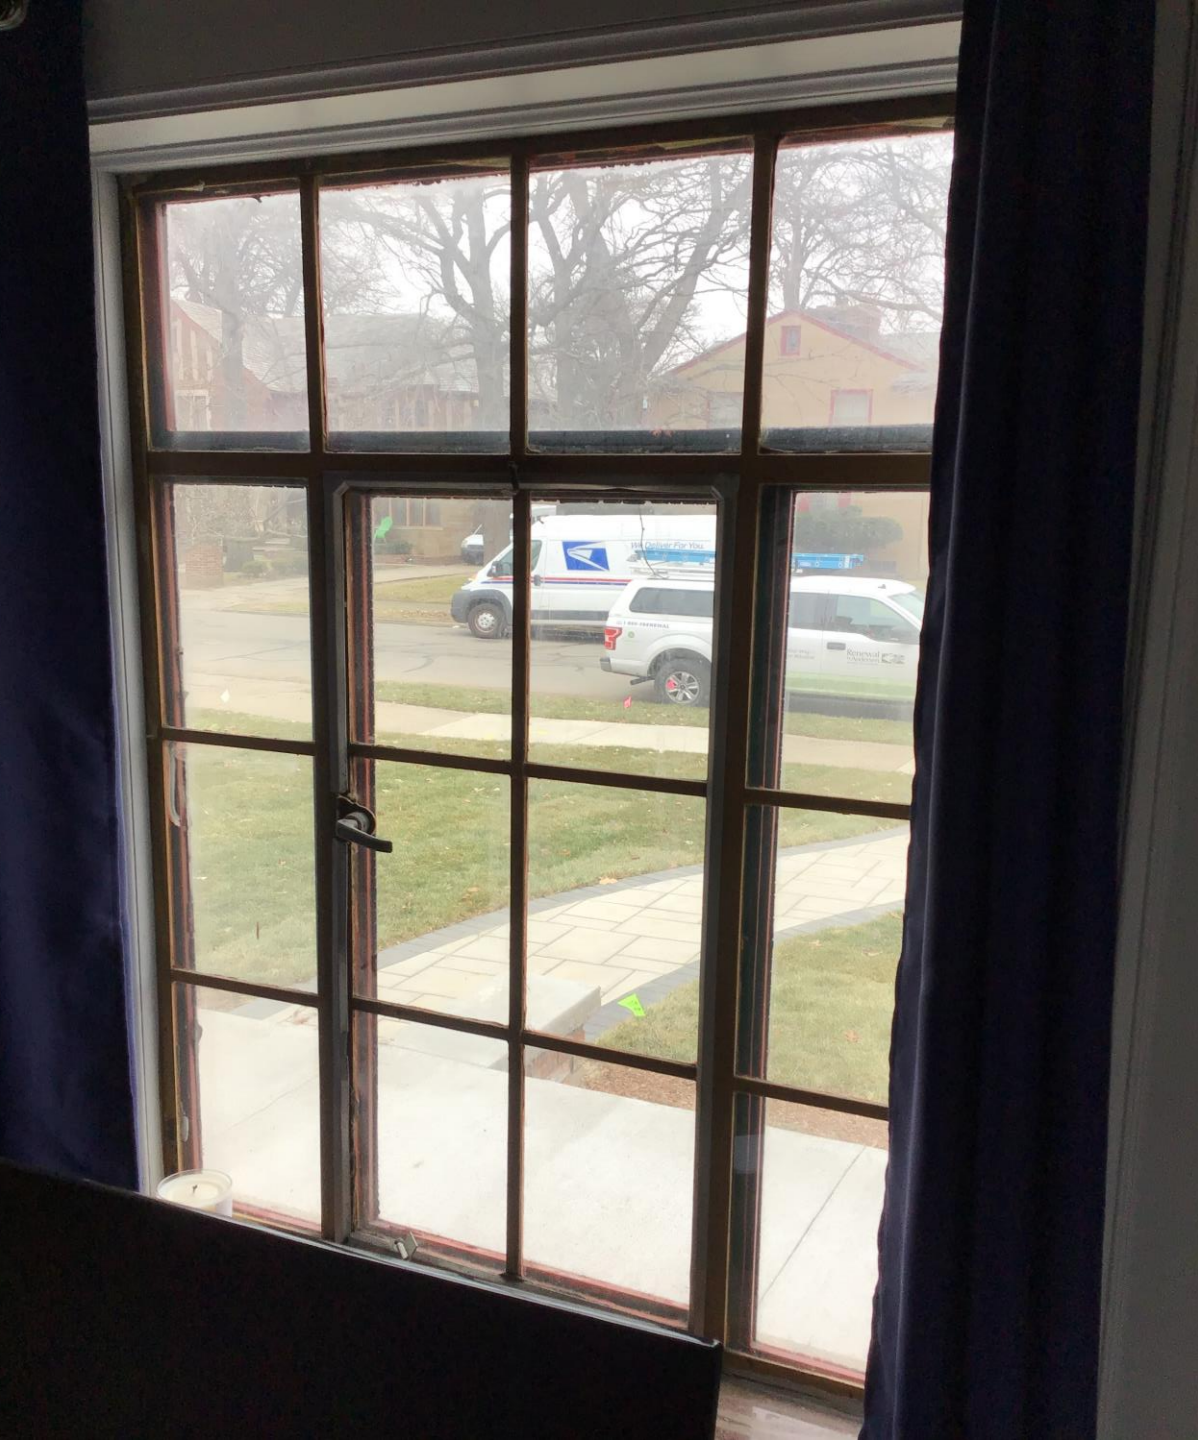
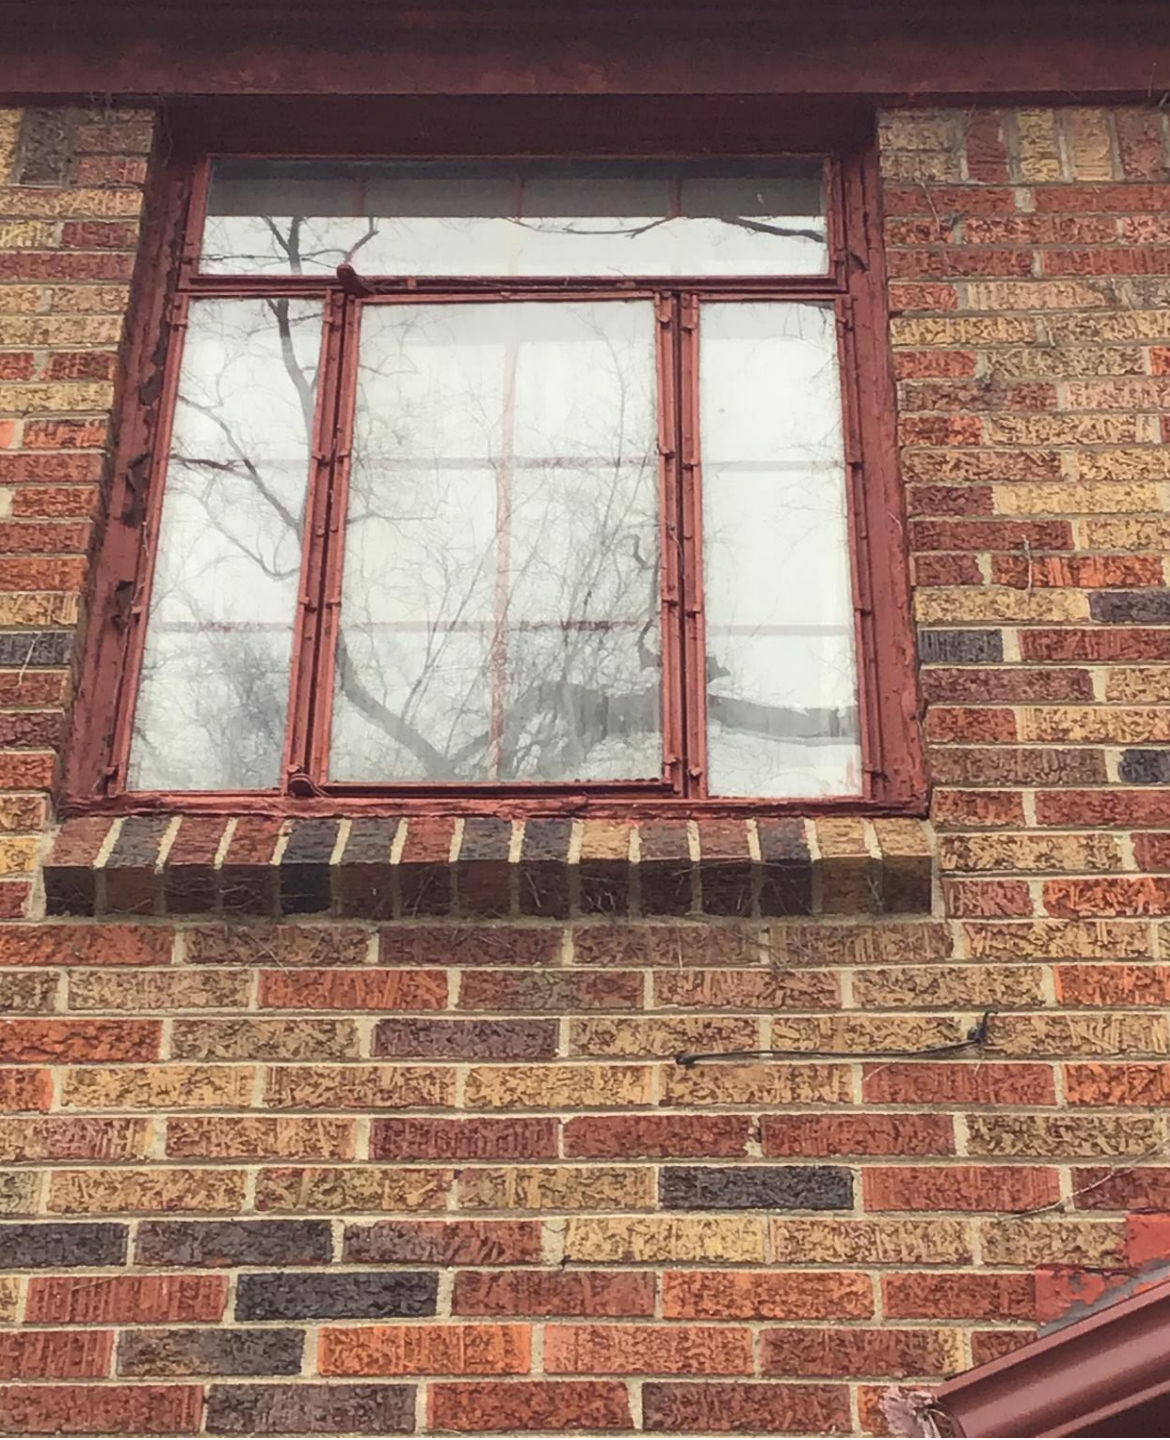
WINDOW OPENING 115 Office - Front of House

- Casement Single Window
- Window is in an office
- Window is hard to close if opened
- Exterior of window showing signs of rotting around frame

Window: Casement, Single, Left, Base Frame, 2" Brickmould / Traditional, Exterior Black, Interior Black, **Glass:** All Sash: High Performance SmartSun Glass, No Pattern, **Hardware:** Black, **Screen:** TruScene, Full Screen, **Grille Style:** Grilles Between Glass (GBG), **Grille Pattern:** All Sash: Colonial 4w x 4h, **Misc:** None
