James Haskins
19365 Warrington Dr
Detroit MI 48221
Sherwood Forest District

Renewal by Andersen 37720 Amrhein Livonia, MI 48150

- Homeowner wants to replace all the windows around house except for one stained glass window unit
- Windows are original steel
- Renewal by Andersen windows are Fibrex (wood composite) material
- Total of 24 windows to be replaced
- Windows exterior color will be black if approved
- Most windows matching style except for bay windows – flankers changed to operable and middle window changed to fixed.
- Windows will match existing mutton bar “pattern”
- Homeowner unable to get quotes for repair

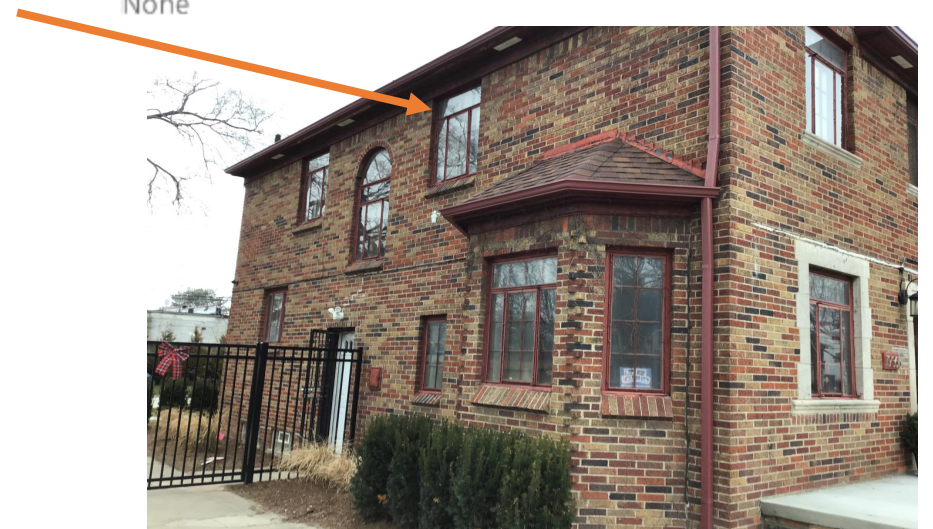
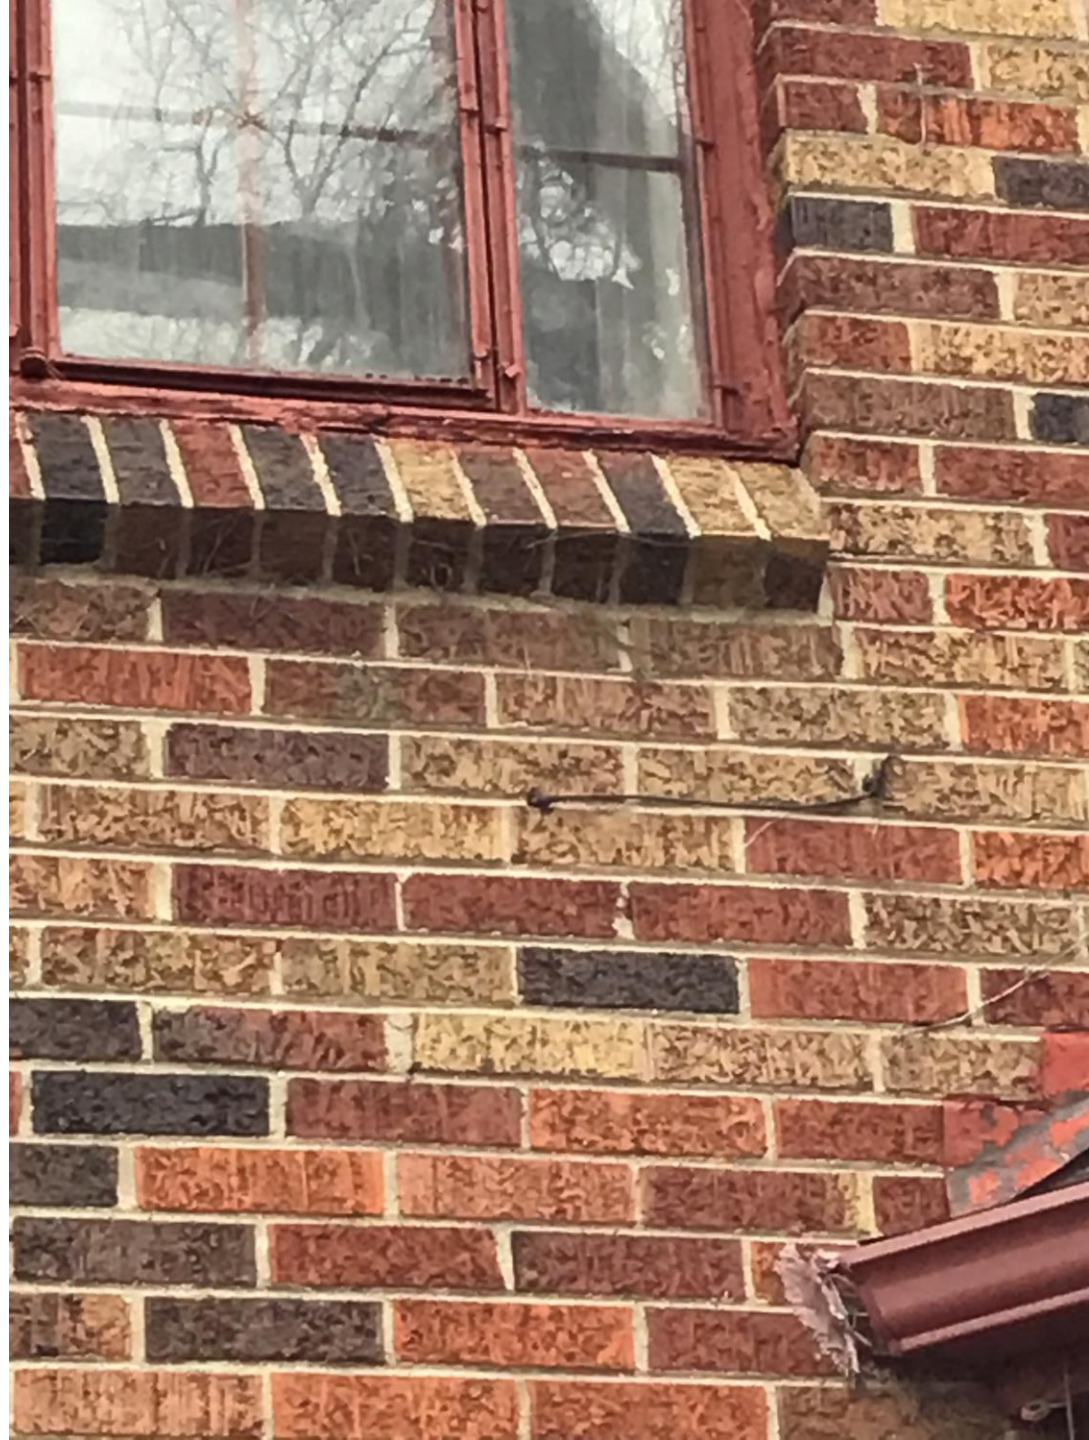
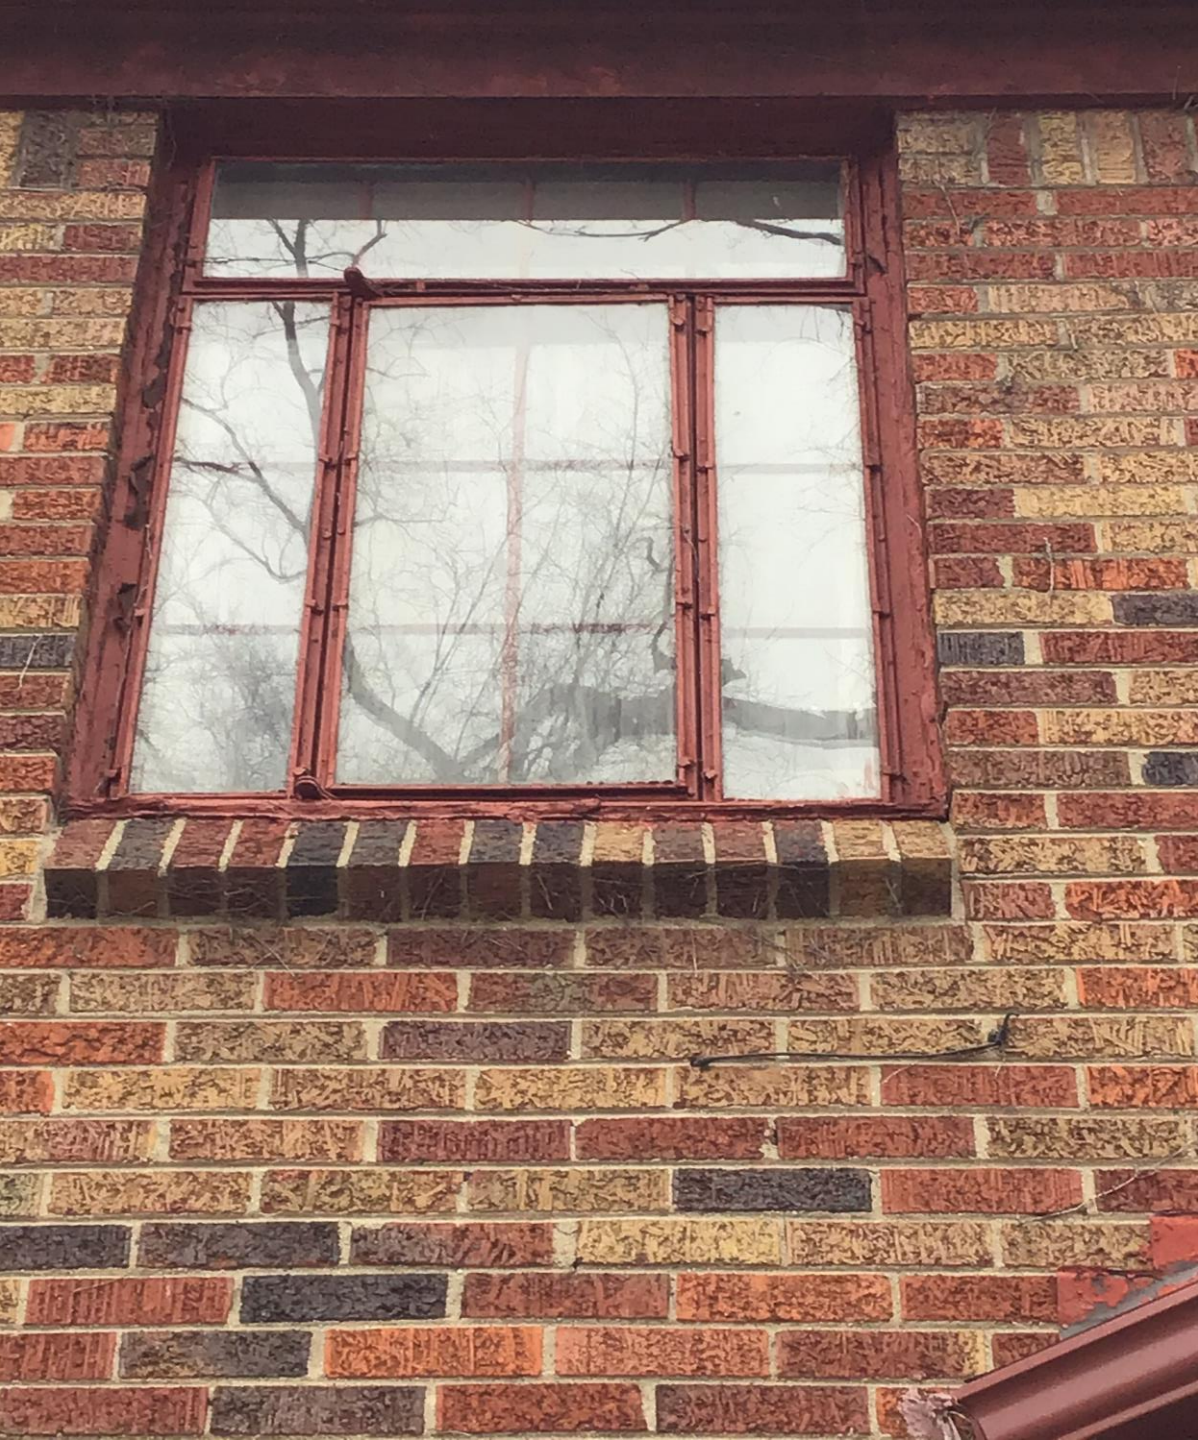
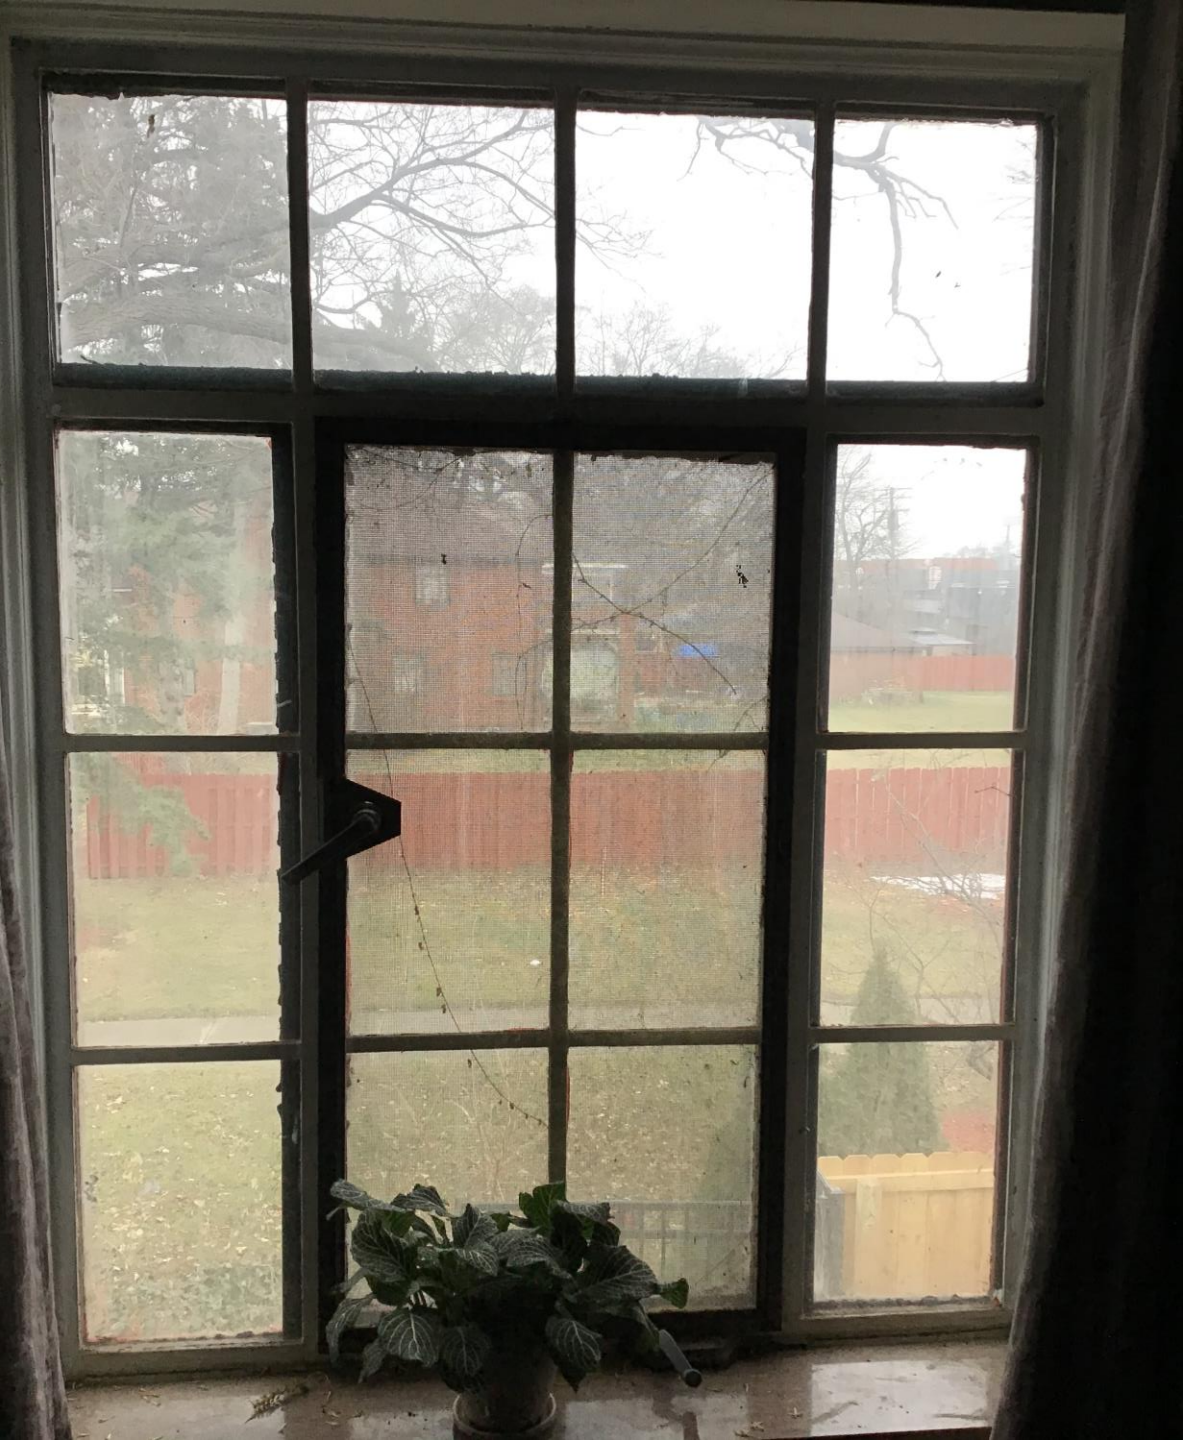
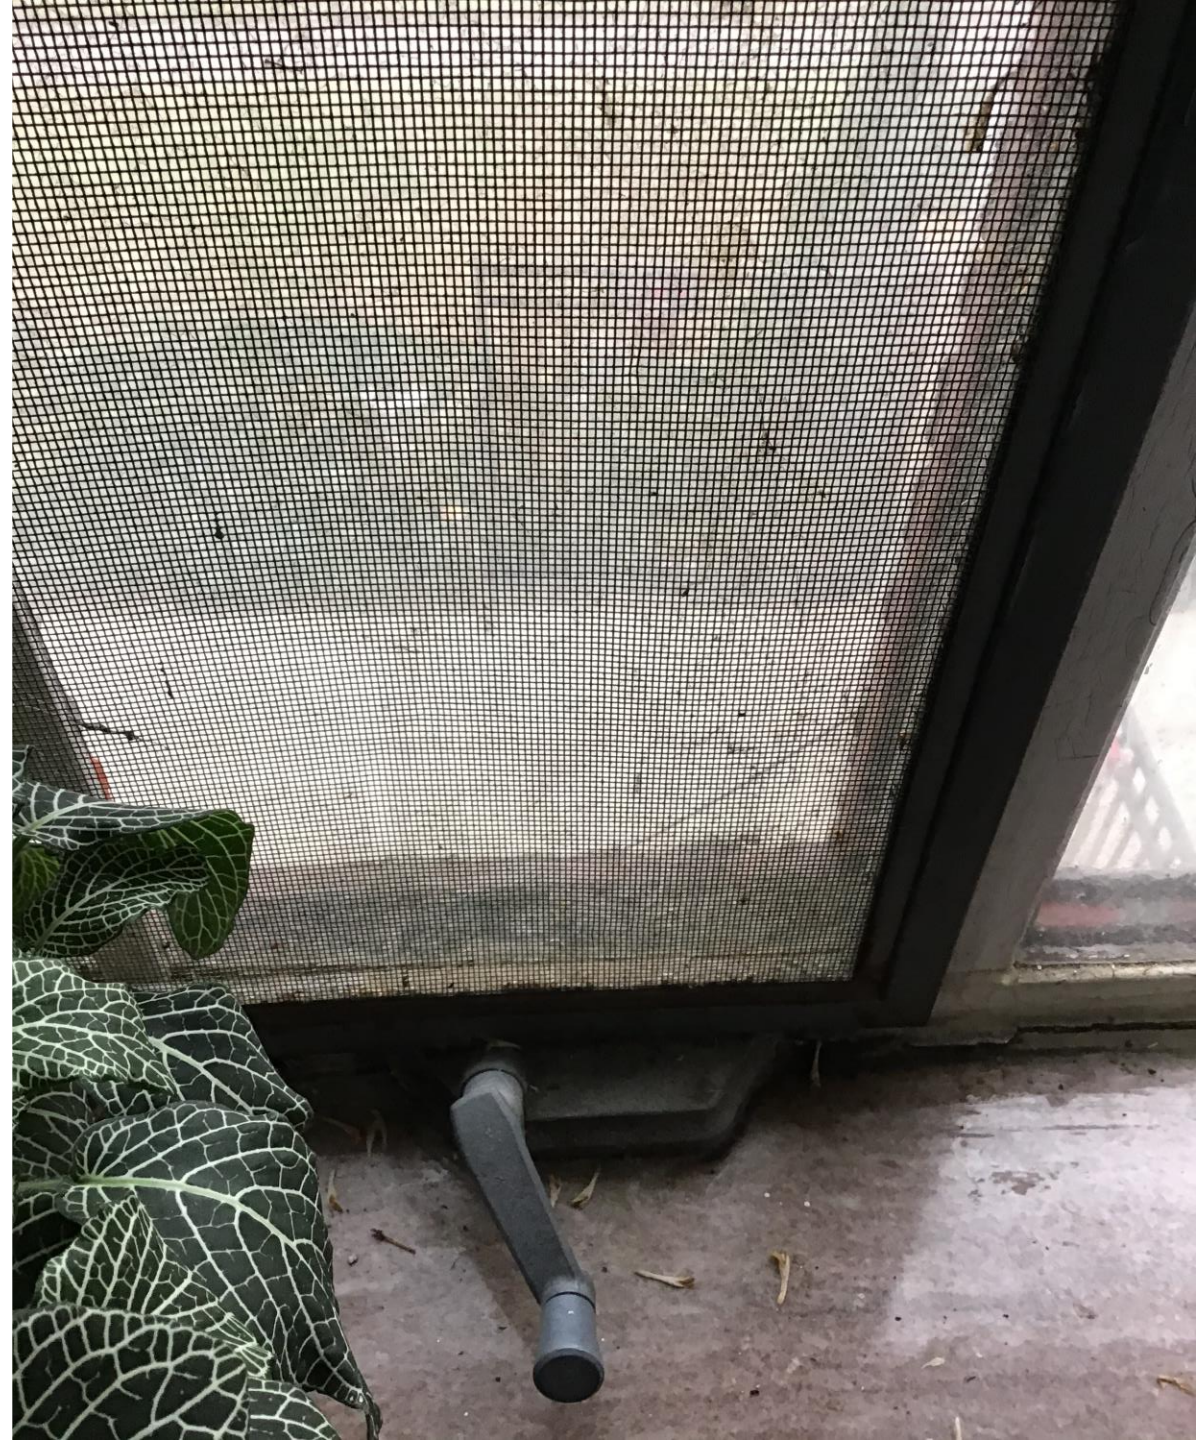
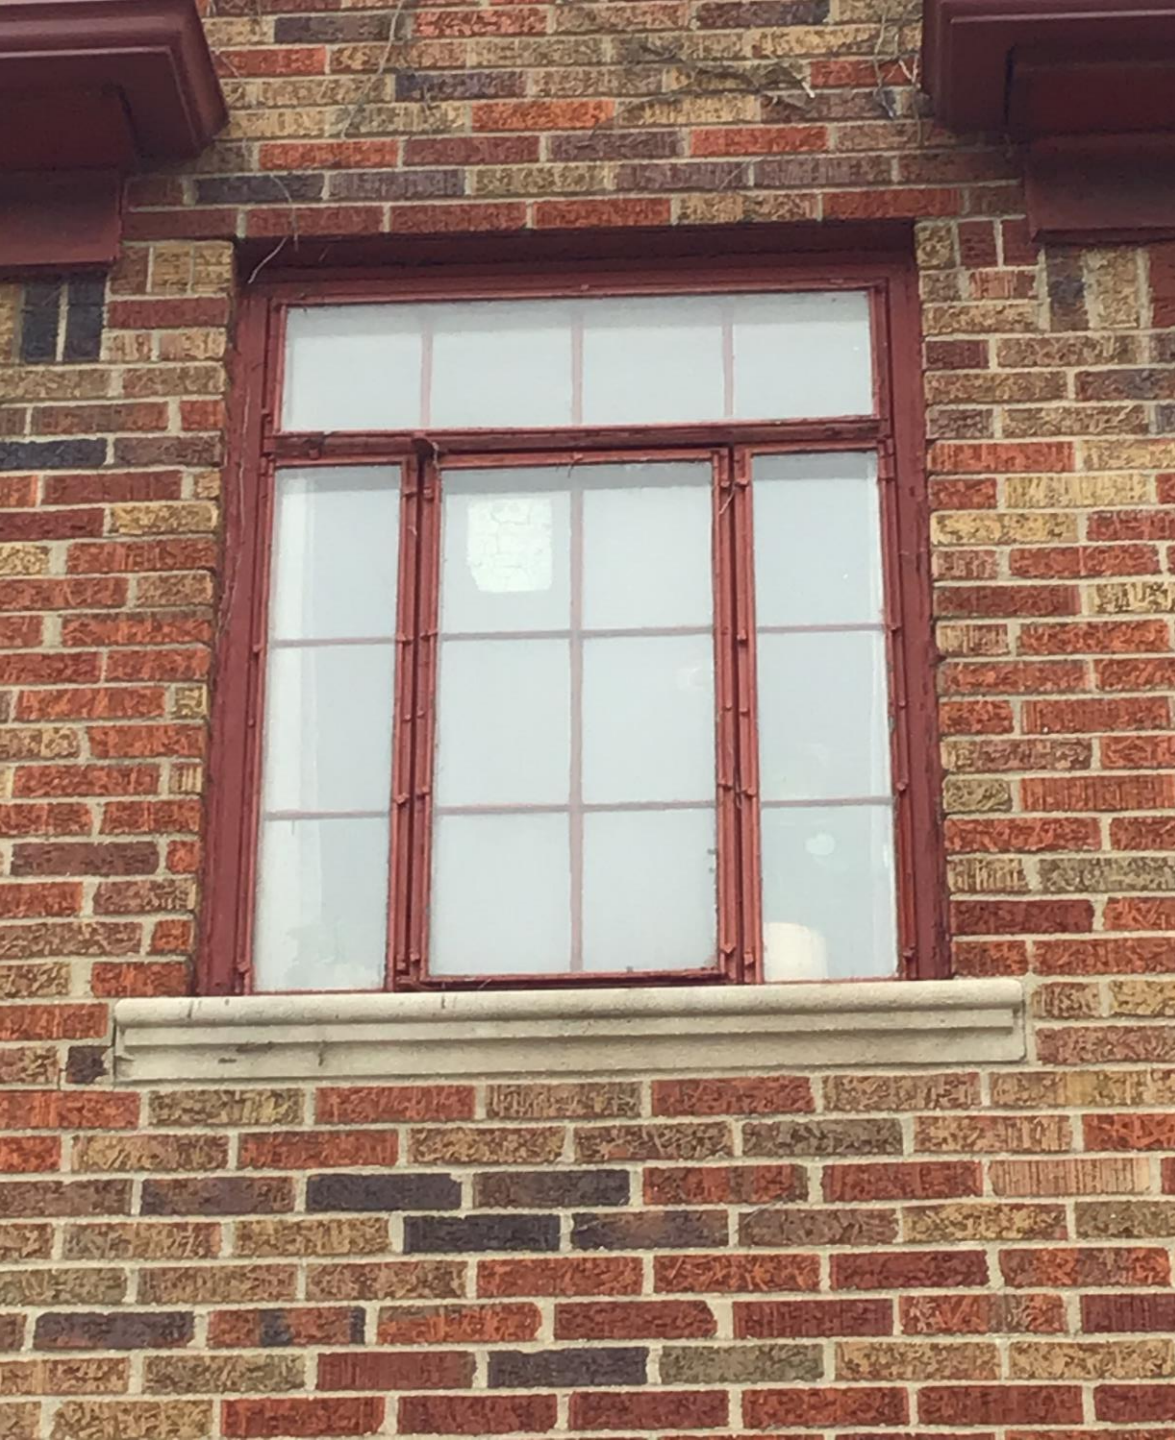
WINDOW OPENING 201 Office – Left side of House

- Casement Single Window
- Window is in an office
- Window is hard to close if opened
- Exterior of window showing signs of rotting around frame

Window: Casement, Single, Left, Base Frame, 2" Brickmould / Traditional, Exterior Black, Interior Black, **Glass:** All Sash: High Performance SmartSun Glass, No Pattern, **Hardware:** Black, **Screen:** Fiberglass, Full Screen, **Grille Style:** Grilles Between Glass (GBG), **Grille Pattern:** All Sash: Colonial 4w x 4h, **Misc:** None

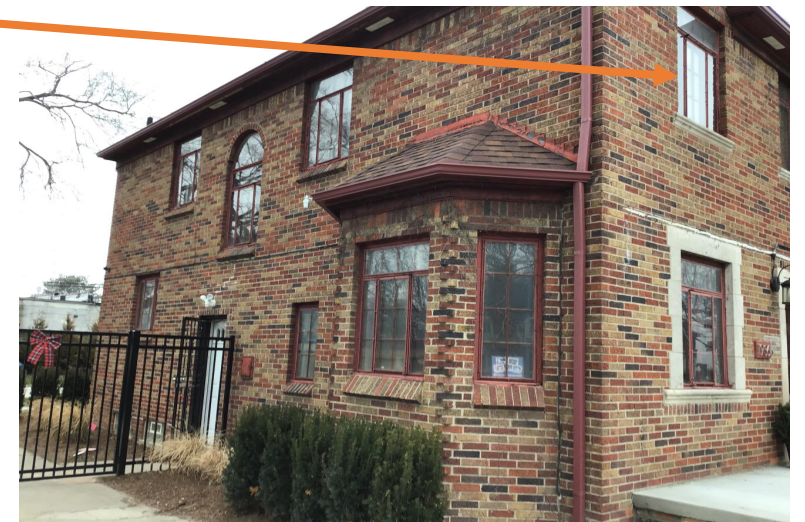
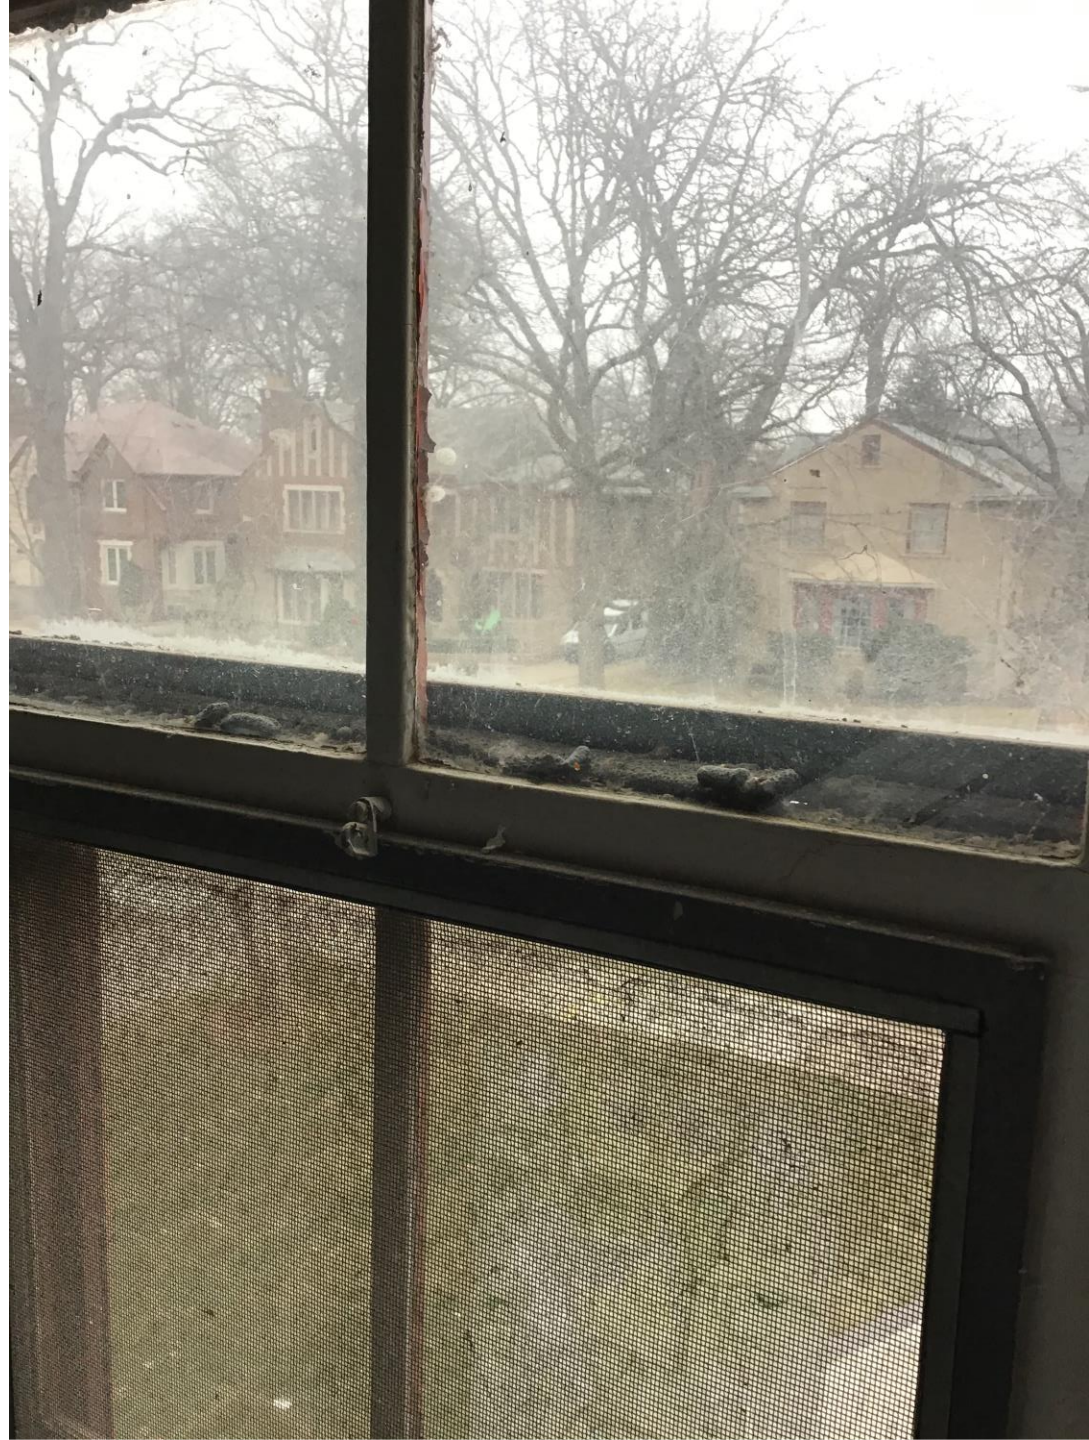
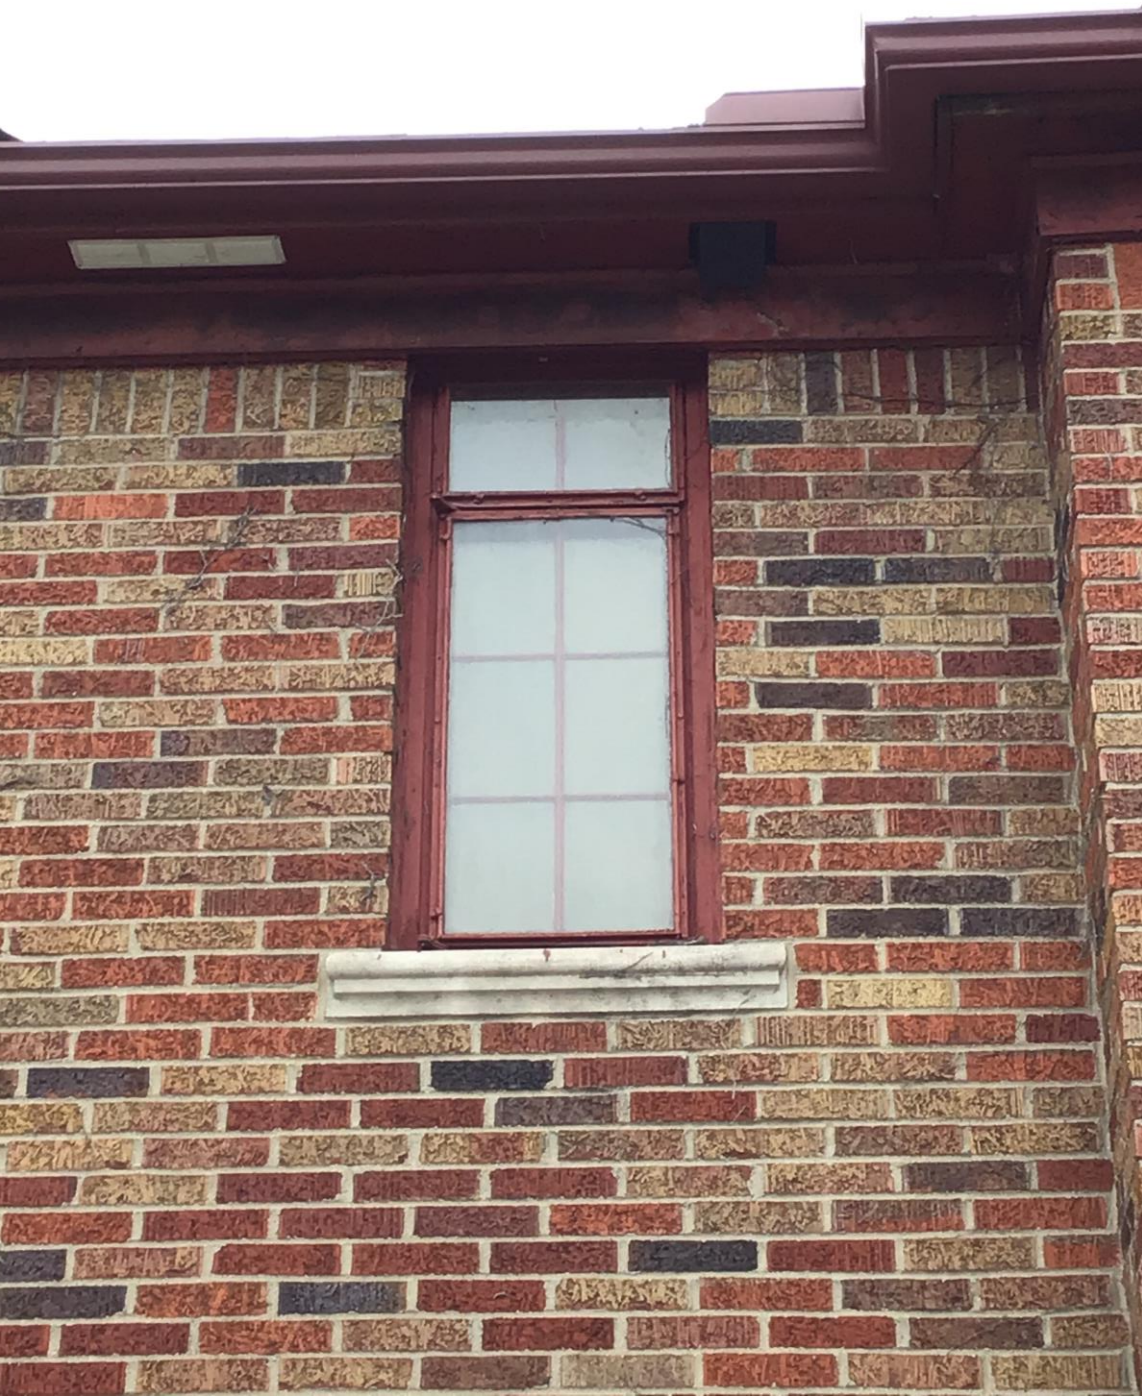
WINDOW OPENING 202 Office – Front of House

- Casement Single Window
- Window is in an office
- Window is hard to close if opened
- Exterior of window showing signs of rotting around frame

Window: Casement, Single, Left, Base Frame, 2" Brickmould / Traditional, Exterior Black, Interior Black, **Glass:** All Sash: High Performance SmartSun Glass, No Pattern, **Hardware:** Black, **Screen:** Fiberglass, Full Screen, **Grille Style:** Grilles Between Glass (GBG), **Grille Pattern:** All Sash: Colonial 4w x 4h, **Misc:** None

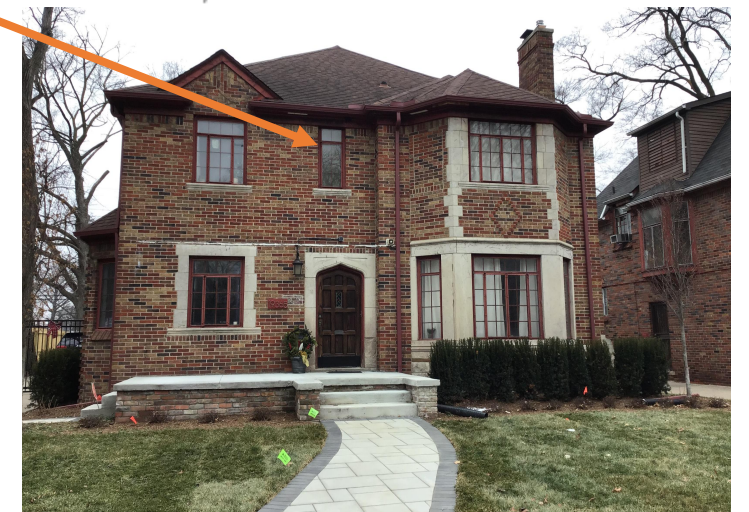
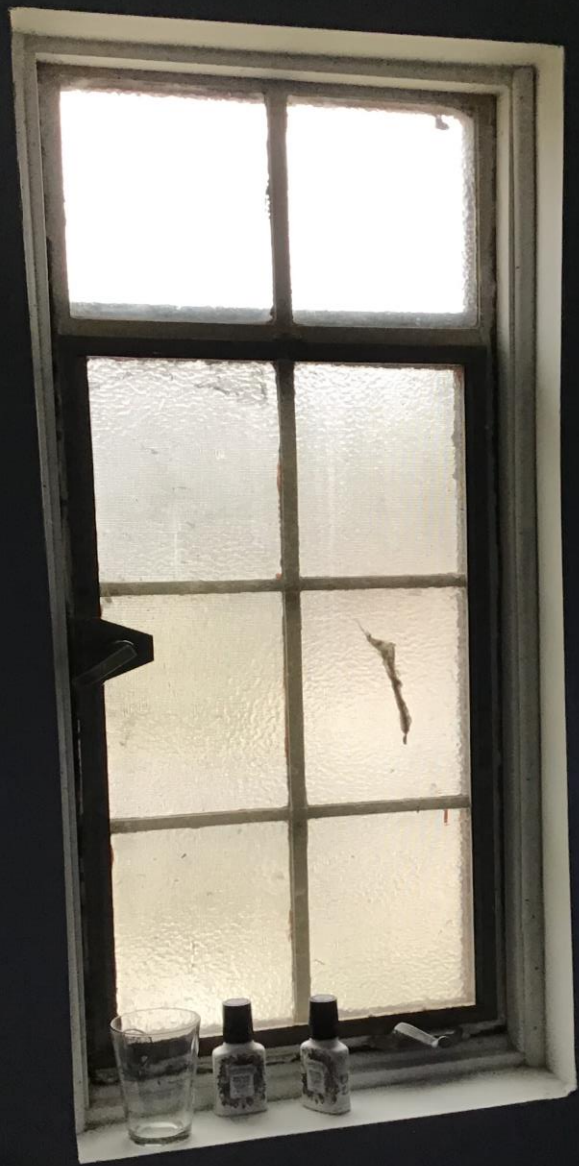
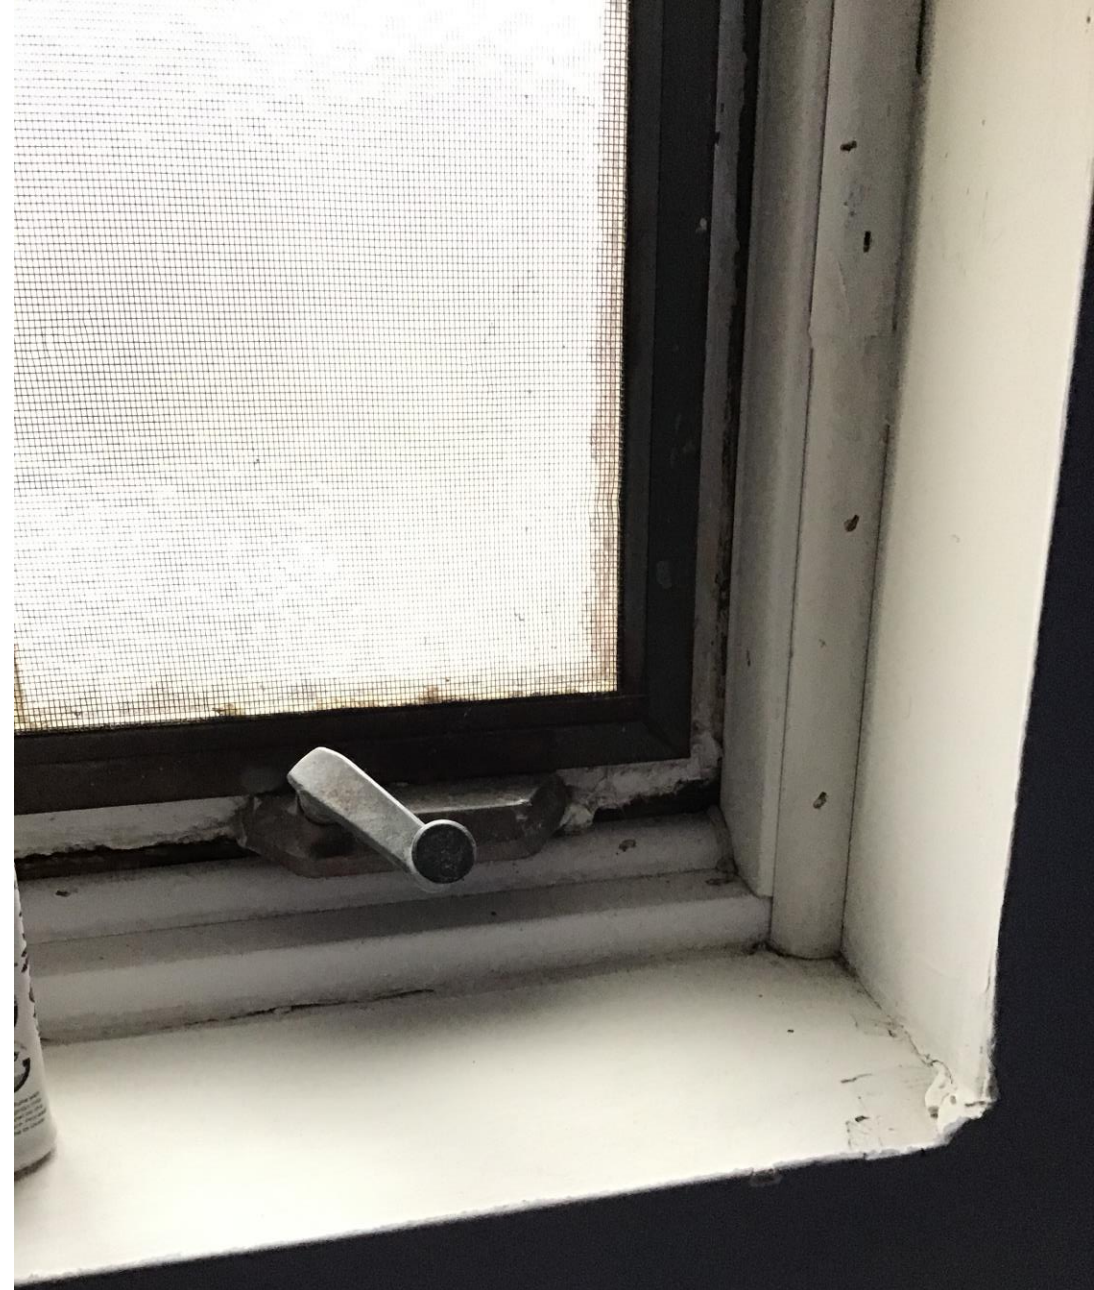
WINDOW OPENING 203 Bathroom - Front of House

- Single Casement Window
- Window is in a bathroom
- Window is hard to close if opened
- Exterior of window showing signs of rotting around frame

Window: Casement, Single, Left, Base Frame, 2" Brickmould / Traditional, Exterior Black, Interior Black, **Glass:** All Sash: High Performance SmartSun Glass, No Pattern, Tempered Glass, **Hardware:** Black, **Screen:** Fiberglass, Full Screen, **Grille Style:** Grilles Between Glass (GBG), **Grille Pattern:** All Sash: Colonial 2w x 4h, **Misc:** None

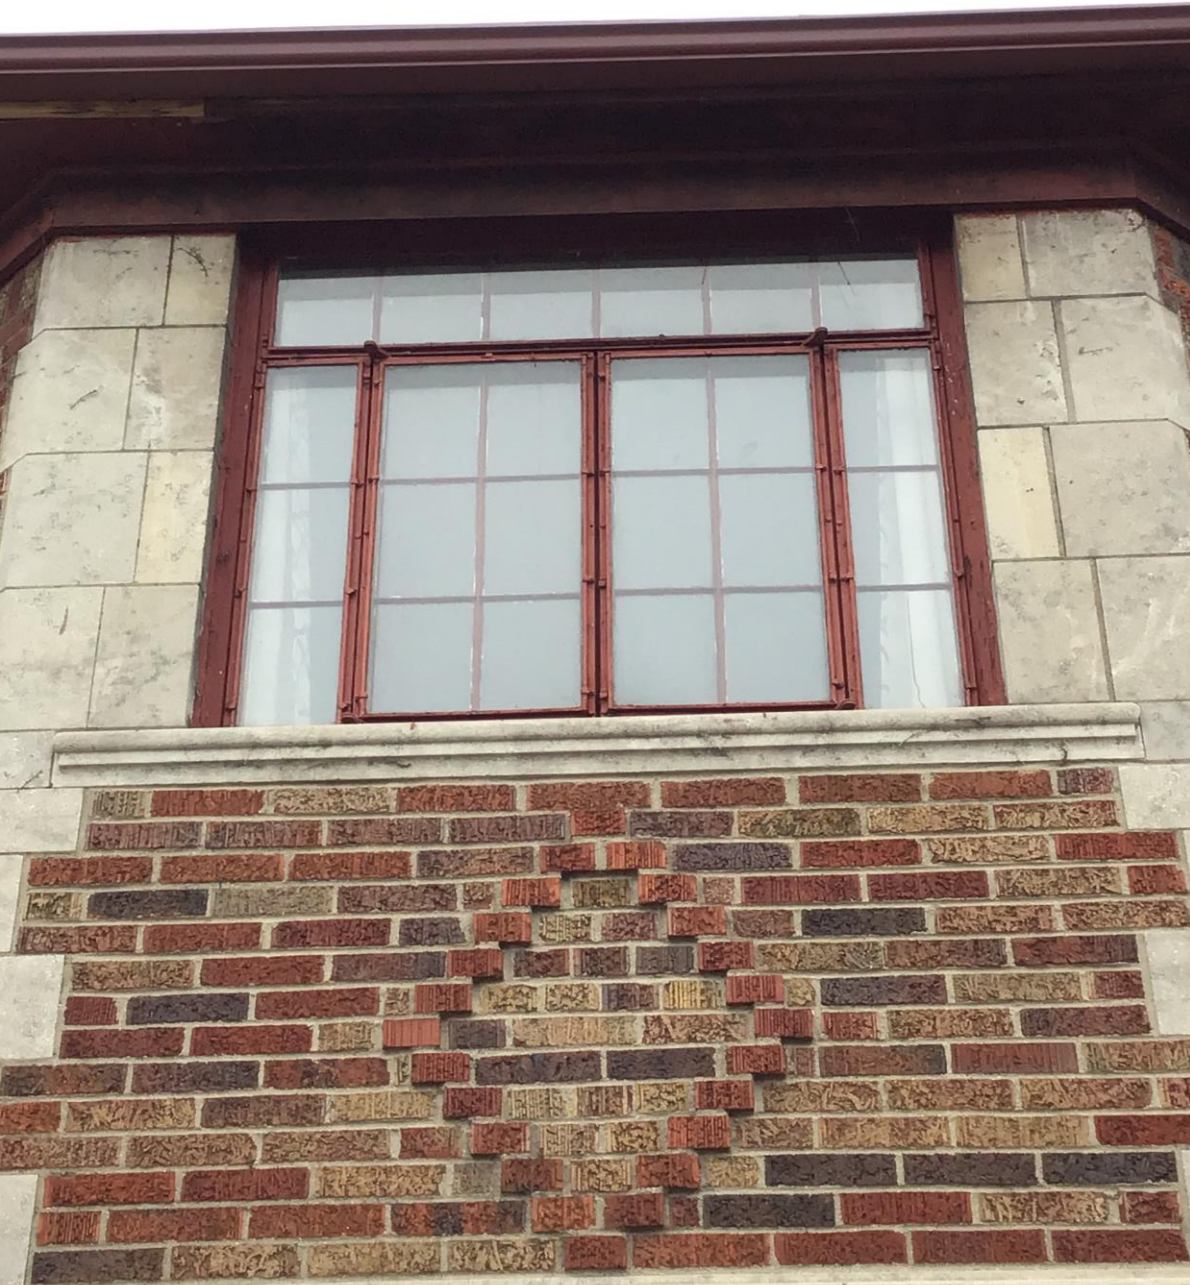
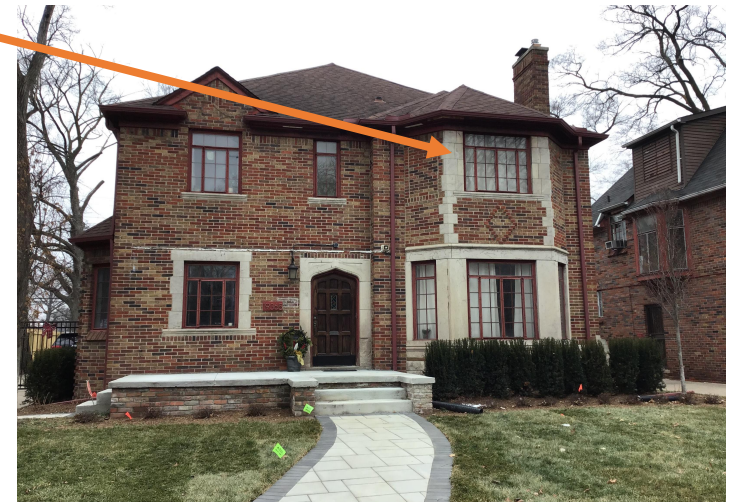
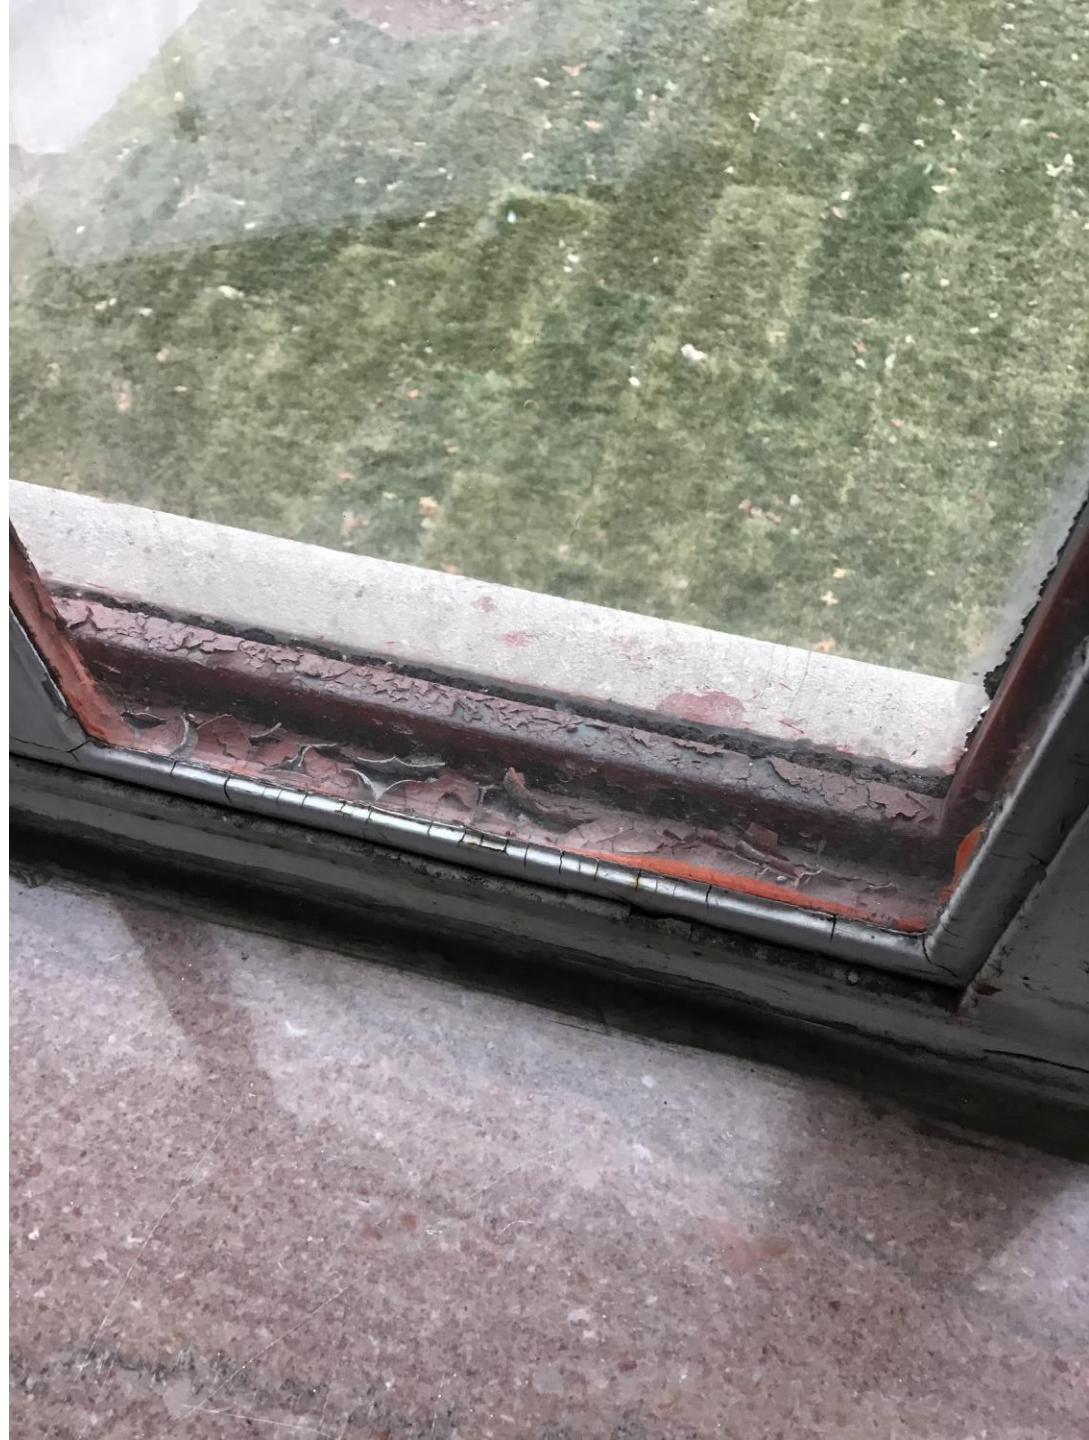
WINDOW OPENING 204 Bedroom - Front of House

- Double Casement Window
- Window is in Bedroom
- Window doesn't open
- Exterior of window showing signs of rotting around frame

Window: Casement, Double, Vented, Base Frame, 2"

Brickmould / Traditional, Exterior Black, Interior Black, **Glass:**

All Sash: High Performance SmartSun Glass, No Pattern,

Hardware: Black, Wide Opening Hinge, **Screen:** TruScene, Full

Screen, **Grille Style:** Grilles Between Glass (GBG), **Grille**

Pattern: All Sash: Colonial 3w x 4h, **Misc:** None

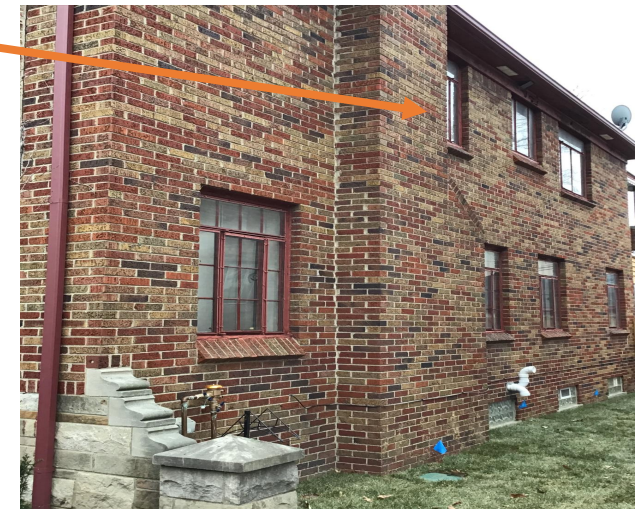
WINDOW OPENING 205 Bedroom – Right side of House

- Single Casement Window
- Window is in Bedroom
- Window is hard to close if opened
- Exterior of window showing signs of rotting around frame

Window: Casement, Single, Right, Base Frame, 2"

Brickmould / Traditional, Exterior Black, Interior Black, **Glass:**

All Sash: High Performance SmartSun Glass, No Pattern,

Hardware: Black, **Screen:** Fiberglass, Full Screen, **Grille Style:**

Grilles Between Glass (GBG), **Grille Pattern:** All Sash:

Colonial 4w x 4h, **Misc:** None

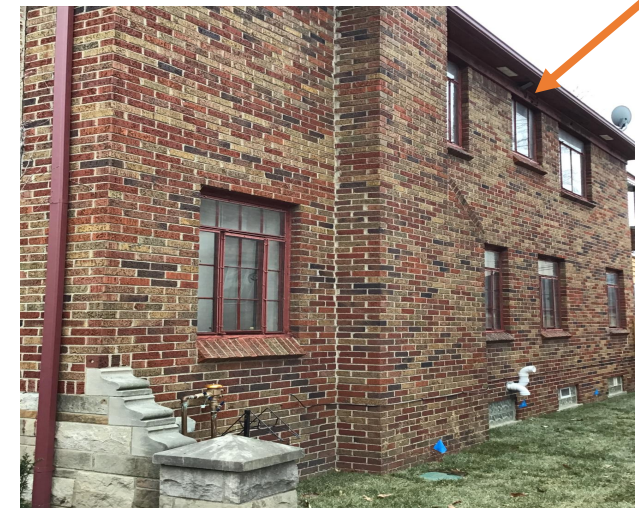
WINDOW OPENING 206 Bedroom - Right side of House

- Single Casement Window
- Window is in Bedroom
- Window is hard to close if opened
- Exterior of window showing signs of rotting around frame

Window: Casement, Single, Right, Base Frame, Exterior Black, Interior Black, **Glass:** All Sash: High Performance SmartSun Glass, Obscure, Tempered Glass, **Hardware:** Black, Wide Opening Hinge, **Screen:** Fiberglass, Full Screen, **Grille Style:** Grilles Between Glass (GBG), **Grille Pattern:** All Sash: Colonial 4w x 4h, **Misc:** None

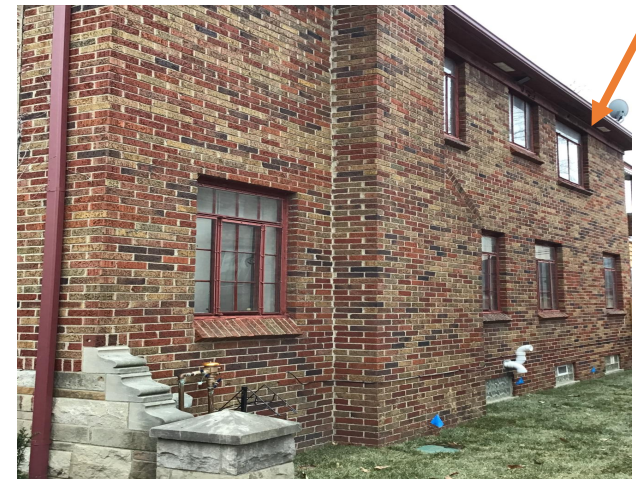
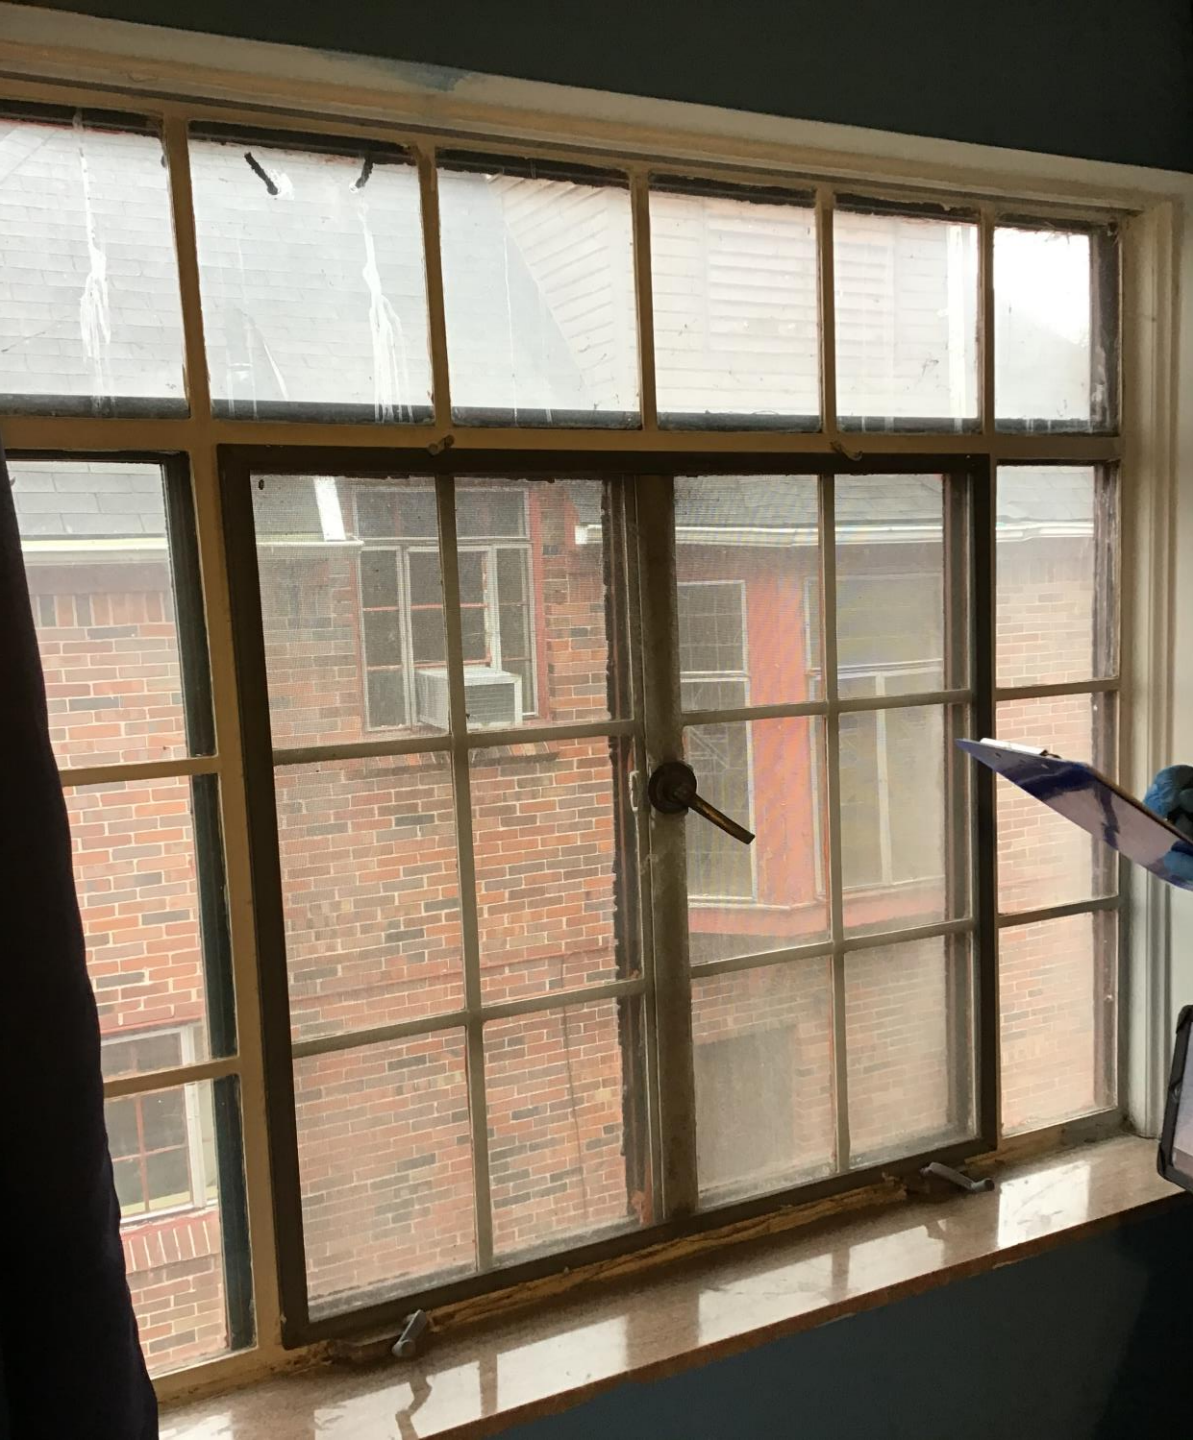
WINDOW OPENING 207 Bedroom - Right side of House

- Double Casement Window
- Window is in Bedroom
- Window is hard to close if opened
- Exterior of window showing signs of rotting around frame

Window: Casement, Double, Vented, Base Frame, 2"

Brickmould / Traditional, Exterior Black, Interior Black, **Glass:**

All Sash: High Performance SmartSun Glass, No Pattern,

Hardware: Black, Wide Opening Hinge, **Screen:** Fiberglass,

Full Screen, **Grille Style:** Grilles Between Glass (GBG), **Grille**

Pattern: All Sash: Colonial 3w x 4h, **Misc:** None
