Marquez Residence
1948 Chicago Blvd
Window and Facade Submission

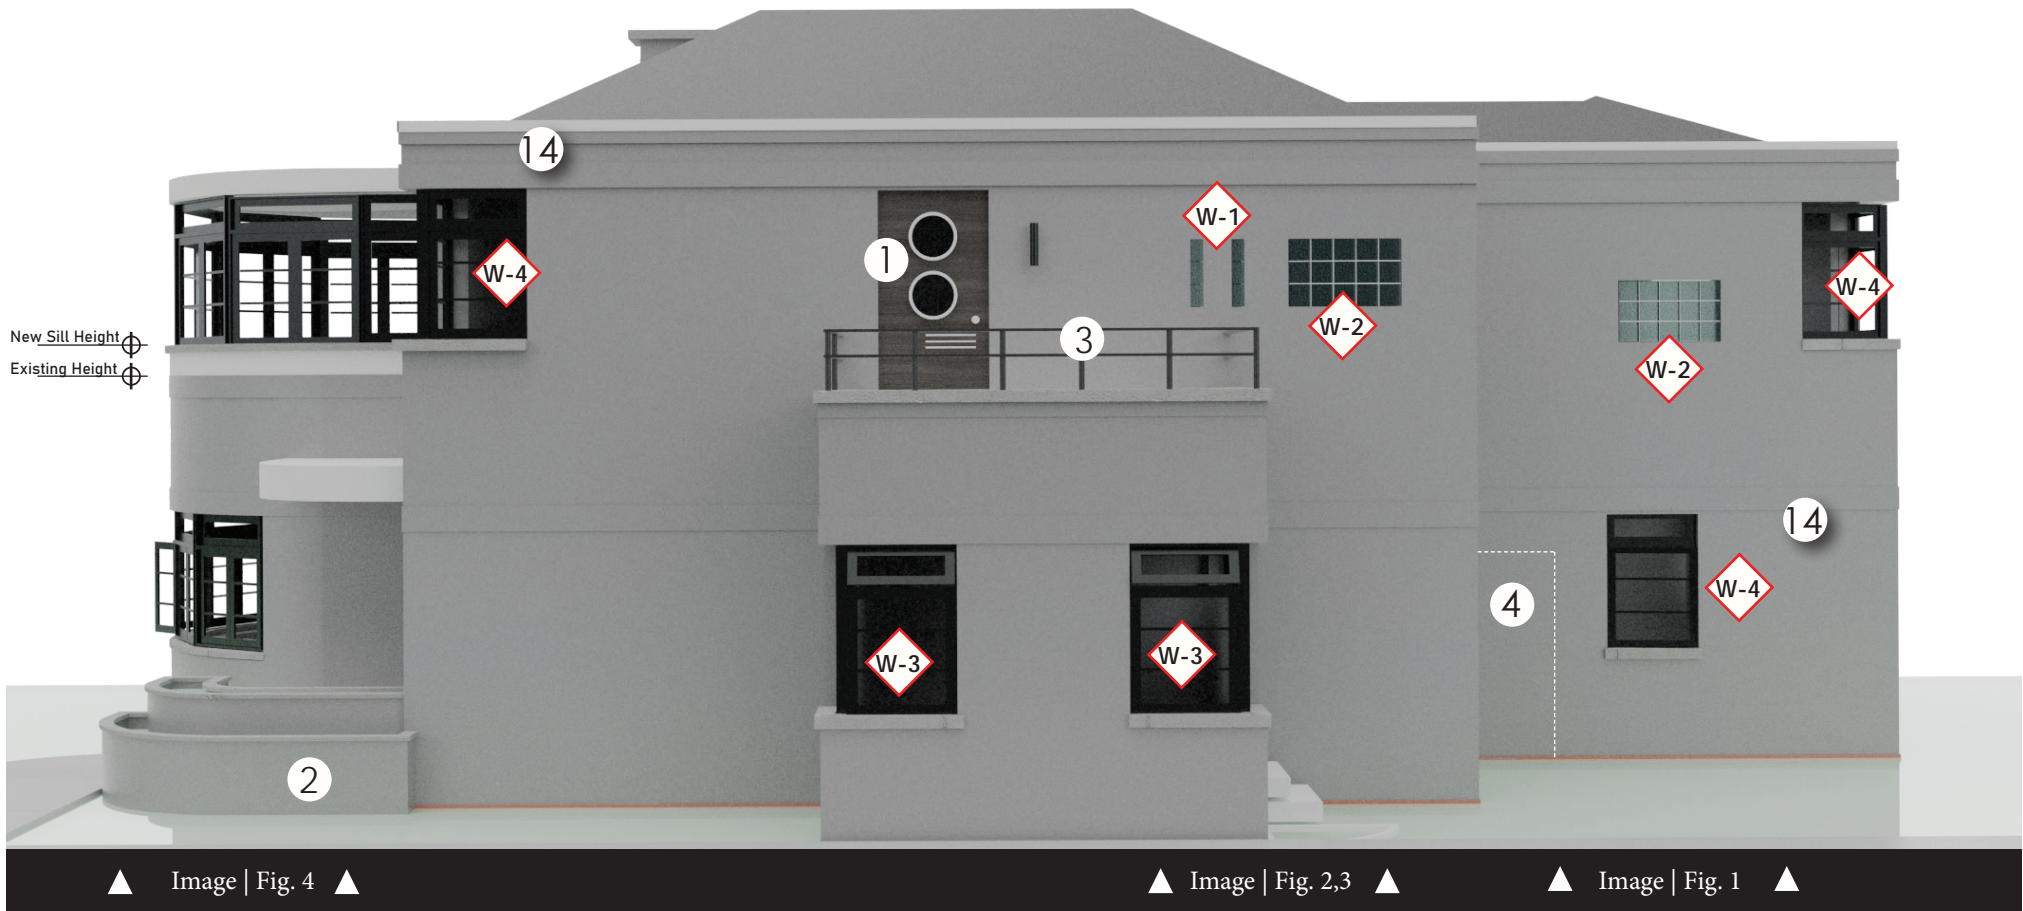
EAST ELEVATION

East Elevation will have (9) total windows replaced. Of the nine windows and (1) door, only (3) windows can be verified as original to the home.

W-1 & W-2 are Glass block windows. They will be replaced with new glass block in the same size. (2) W-3 and (2) W-4 are currently double hung windows and will be replaced with Aluminum Clad Casement windows from Anderson (E-Series).

- 1 New exterior wood door w/ dual porthole windows.
- 2 Demo existing planter, repour concrete footing and restack w/ matching brick.
- 3 Existing railing is the original railing. It will be restored.
- 4 Existing door opening will be bricked in and closed.

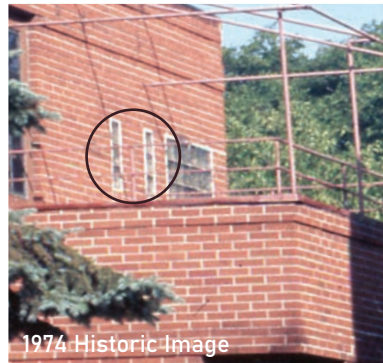
W-1

SIZE: 8" x 27"

MATERIAL: Glass Block

ORIGINAL ARCH: Yes

SOLUTION: Replace existing Glass Block w/ new (7.75" x 7.75") Clear Pattern Glass Block

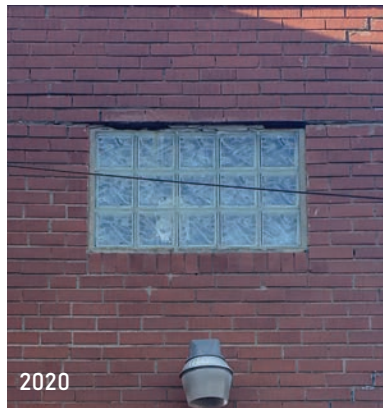
W-2

SIZE: 24" x 40"

EXISTING MATERIAL: Glass Block

ORIGINAL ARCH: Yes

SOLUTION: Replace existing Glass Block w/ new (7.75" x 7.75") Clear Pattern Glass Block

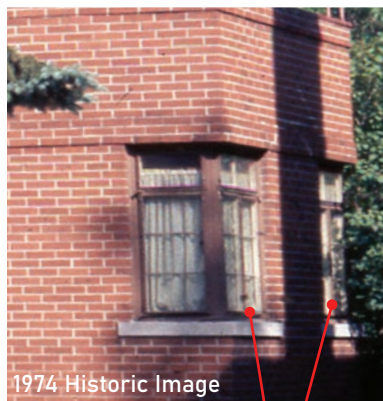
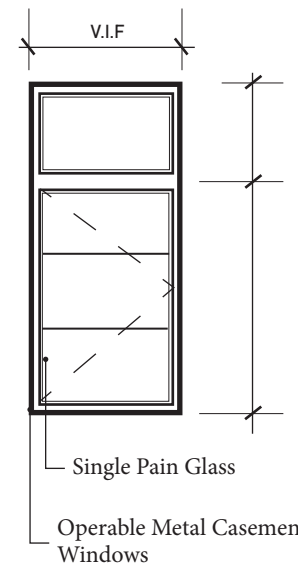
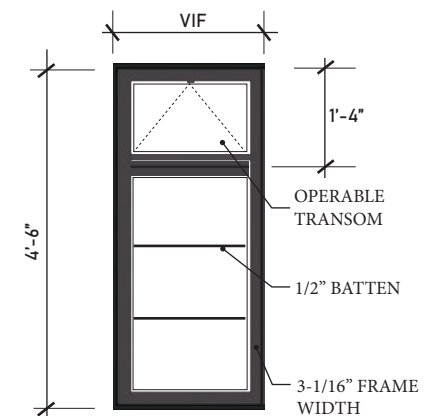
W-3

SIZE: Varies

EXISTING MATERIAL: Glass Block

EXISTING WINDOWS: Not Original

The existing glass block currently installed is NOT original to the home according to the 1974 Historic Boston Ediston Photo.

We propose a historic preservation retrofit with Anderson Windows. Anderson's E-Series are advertised as an architectural low-profile solution for this style of home. We will remove existing glass block and spec the original window to casement

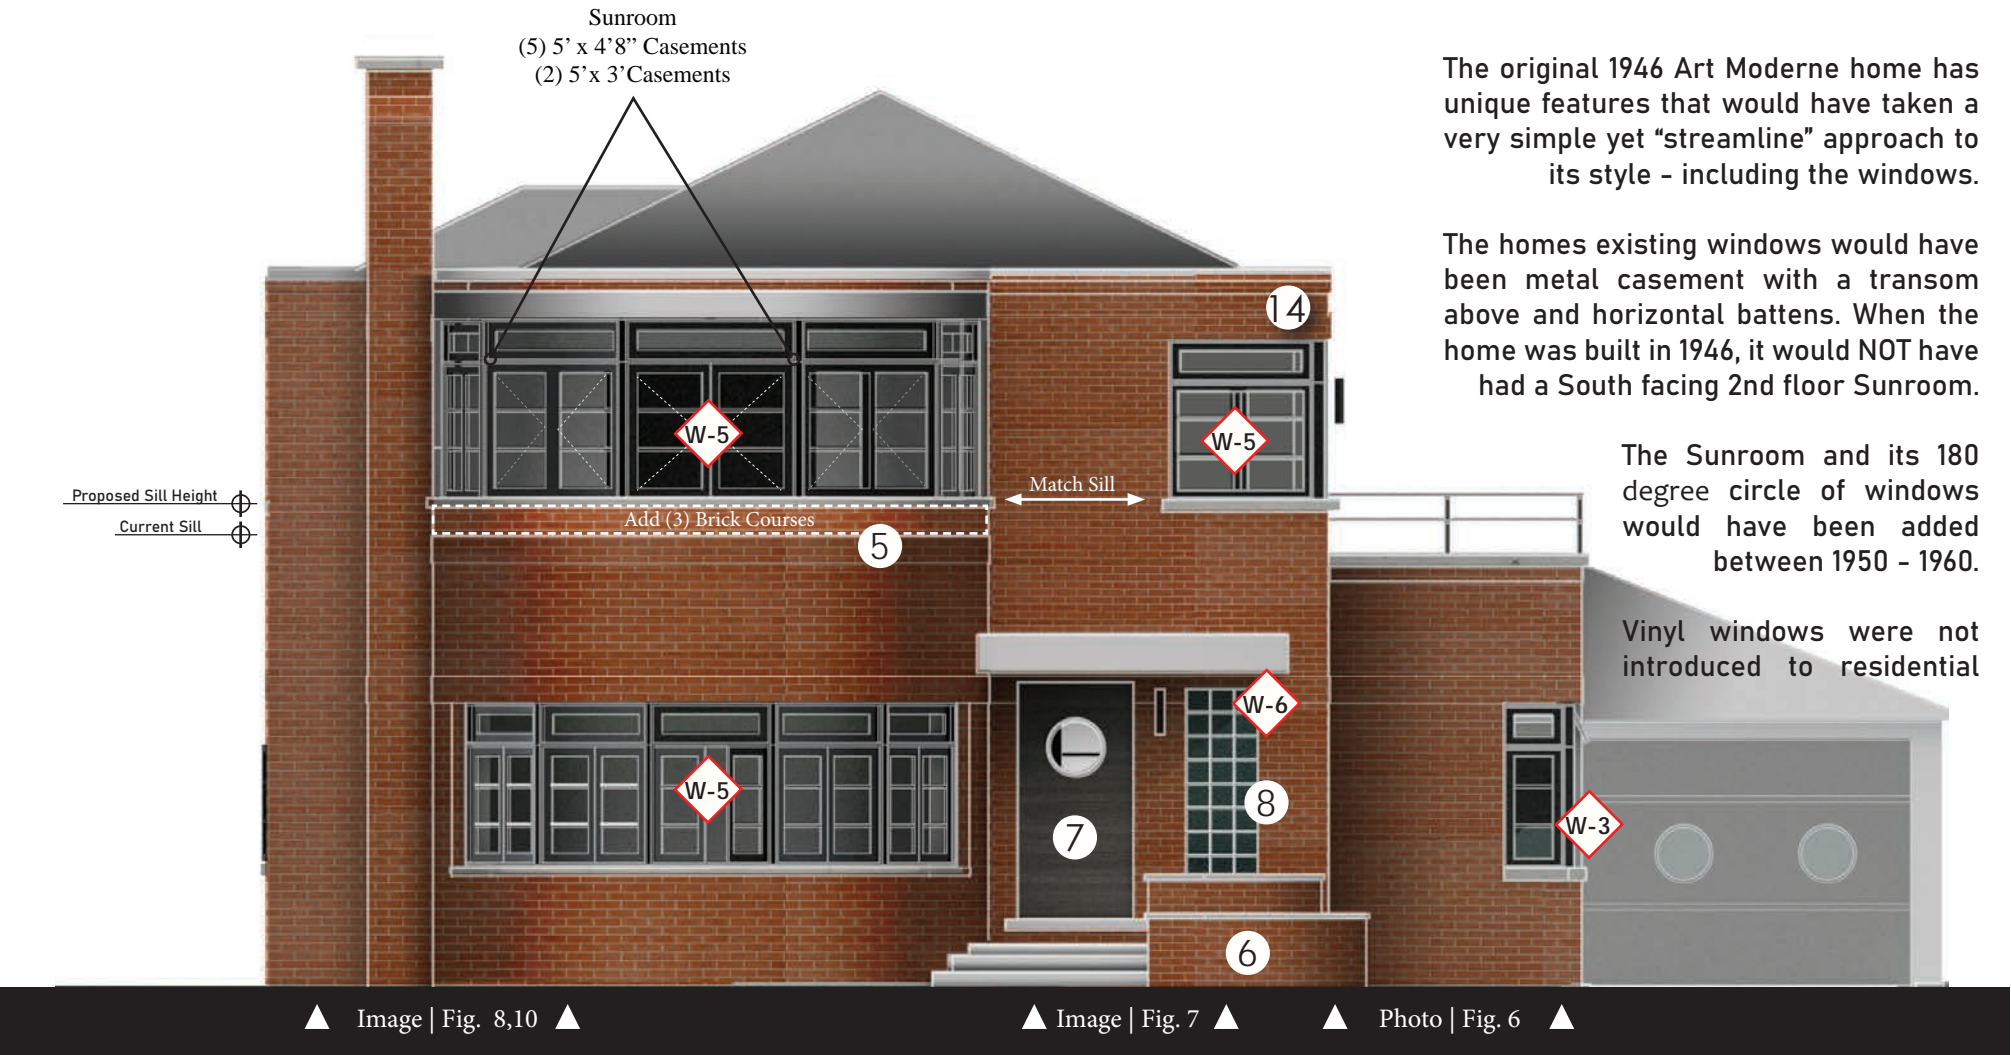
STREET "SOUTH" ELEVATION

- 5 Existing vinyl windows sit below desk height. We propose to add 3-courses of matching brick to align with top of existing stone sills.
- 6 Existing planter foundation has deteriorated and will need to be replaced. Existing planter bricks are not original to home. Repair includes new footing, restacking w/ matching brick, and stone cap.
- 7 Porthole Window front door would have been original to the home. We propose to reintroduce this chic door style back to home
- 8 This glass block is original to this home. We propose to replace dated glass block with new glass block and mortar

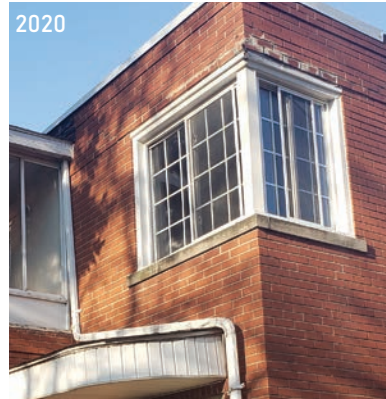
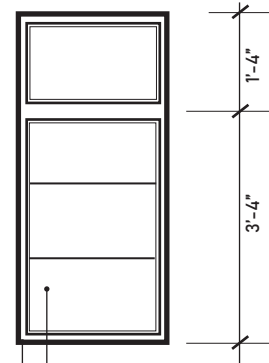
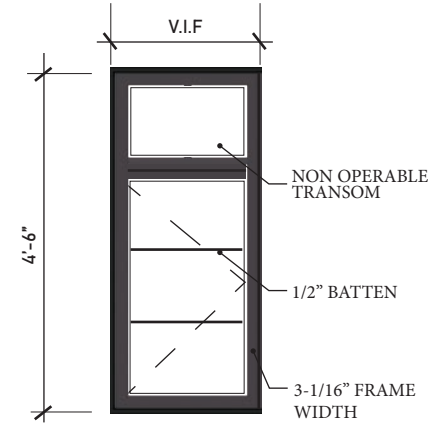
W-4

SIZE: Varies
 EXISTING MATERIAL: Vinyl - Sliding
 EXISTING WINDOWS: Not Original

The existing vinyl sliding/casement windows are NOT original to the home. The windows were installed after 1980. Metal windows are shown in the 1974 and 1980 Historic Boston Ediston Photo.

We propose a historic preservation retrofit with Anderson Windows. Anderson's E-Series are advertised as an architectural low-profile solution for this style of home. We will remove existing vinyl and spec the original window to casement

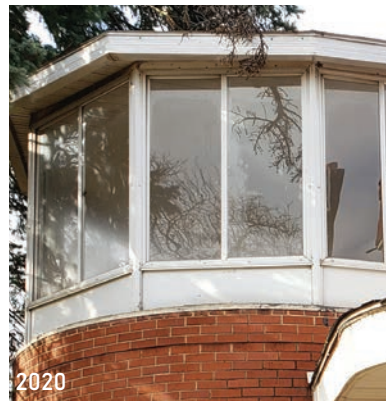
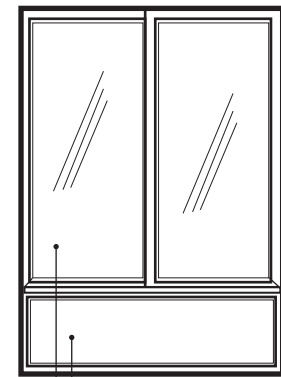
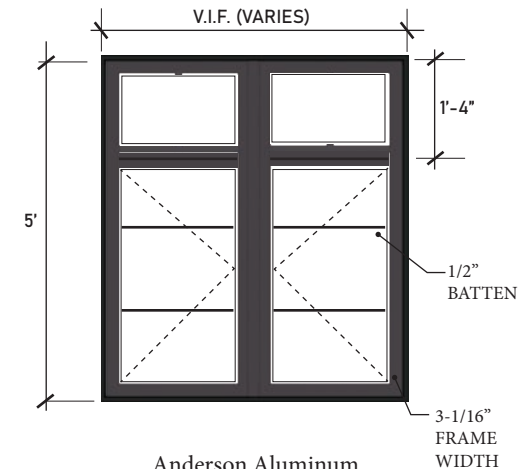
W-5

The existing sunroom vinyl windows are NOT original to home. The 2nd floor sunroom was added before 1974, as the sunroom appears in the 1974 Boston Ediston historic photo. Interior photos of the space provide clear evidence that the sunroom was originally an outdoor porch.

We propose a historic preservation retrofit with Anderson Windows. Their E-Series are Andersons architectural low profile solution for this style of home.

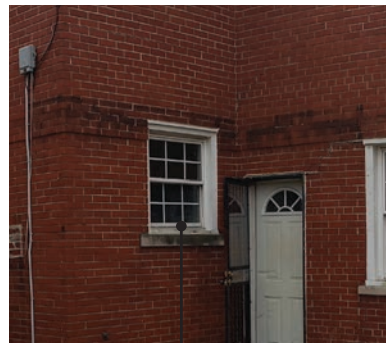
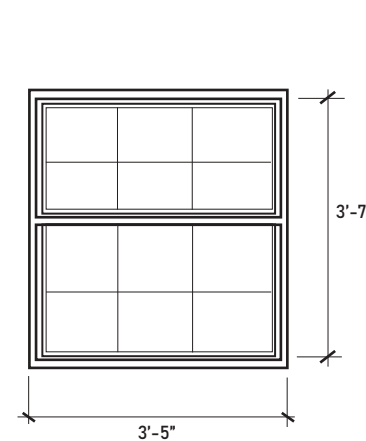
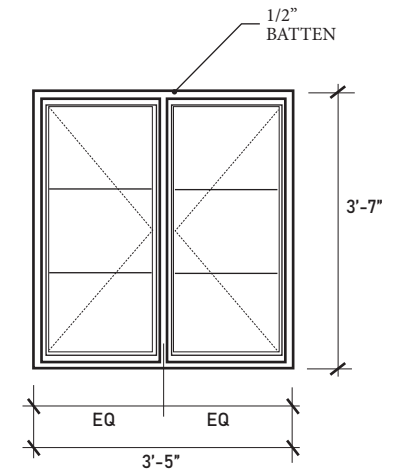
The existing vinyl double hung windows are NOT original to the home. The windows were installed after 1980. Metal windows are shown in the 1974 and 1980 Historic Boston Ediston Photo.

We propose a historic preservation retrofit with Anderson Windows. Anderson's E-Series are advertised as an architectural low-profile solution for this style of home. We will remove existing vinyl and specify the original style/proportions of window to aluminum casement

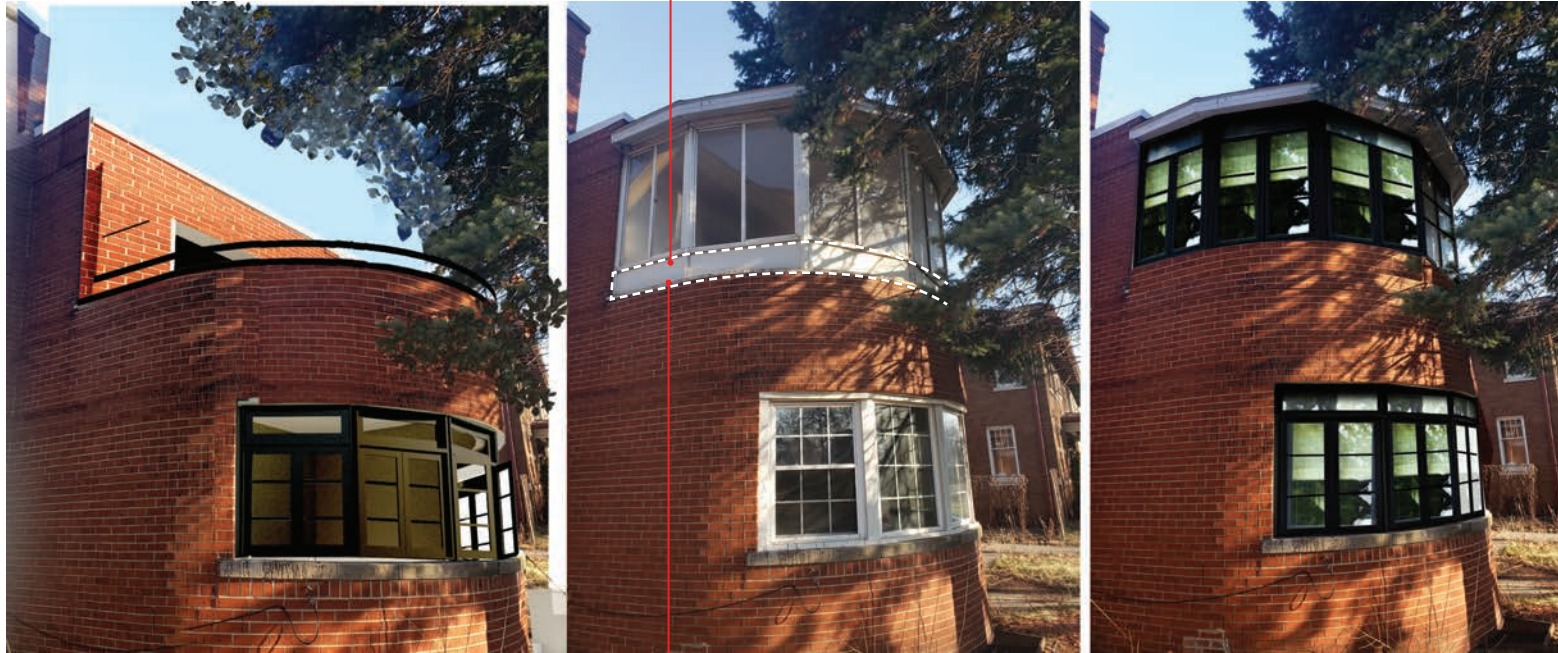
Fig. 8 | (Left) Conceptual Rendering of Original 1946 Outdoor Patio

(Center) 2020 Photo

add brick to bring windows to suitable proportions

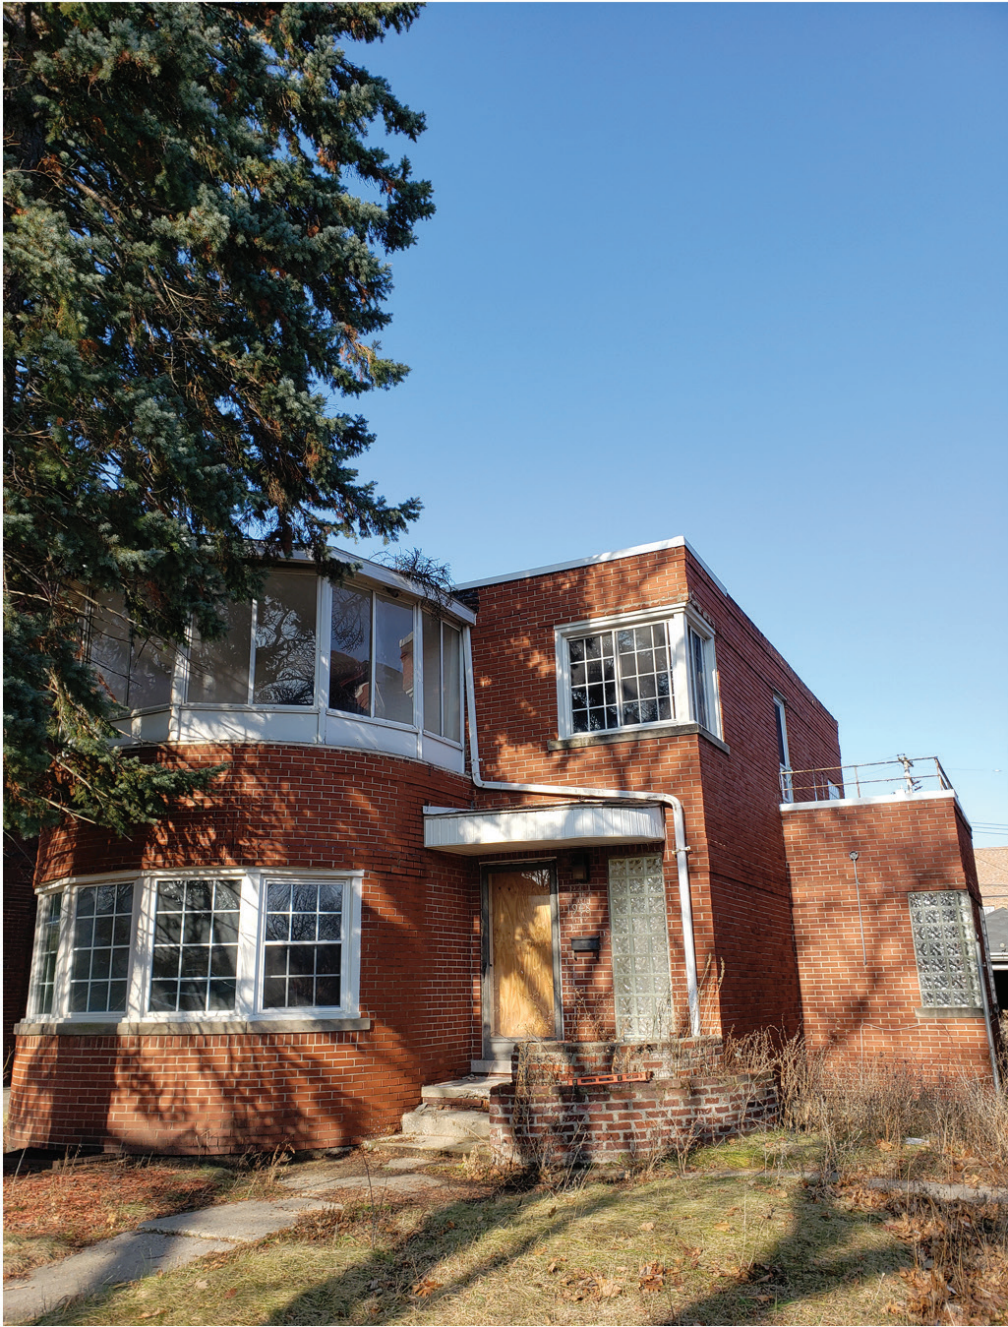
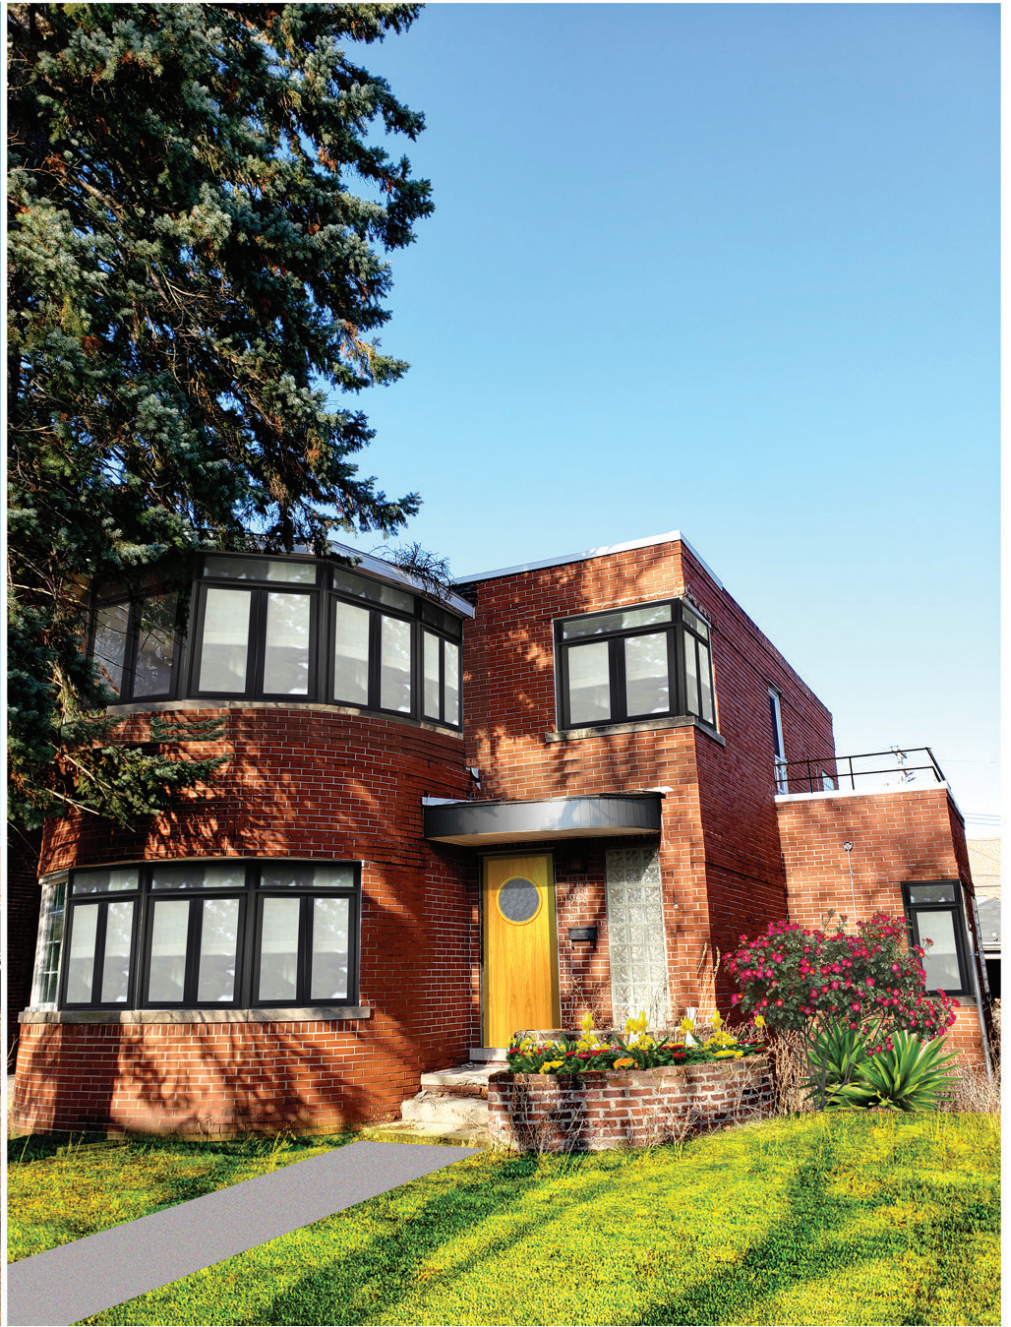
Fig. 10/ Before vs. After Photo Comparison

SOUTH FACADE - BEFORE/AFTER RENDERINGS

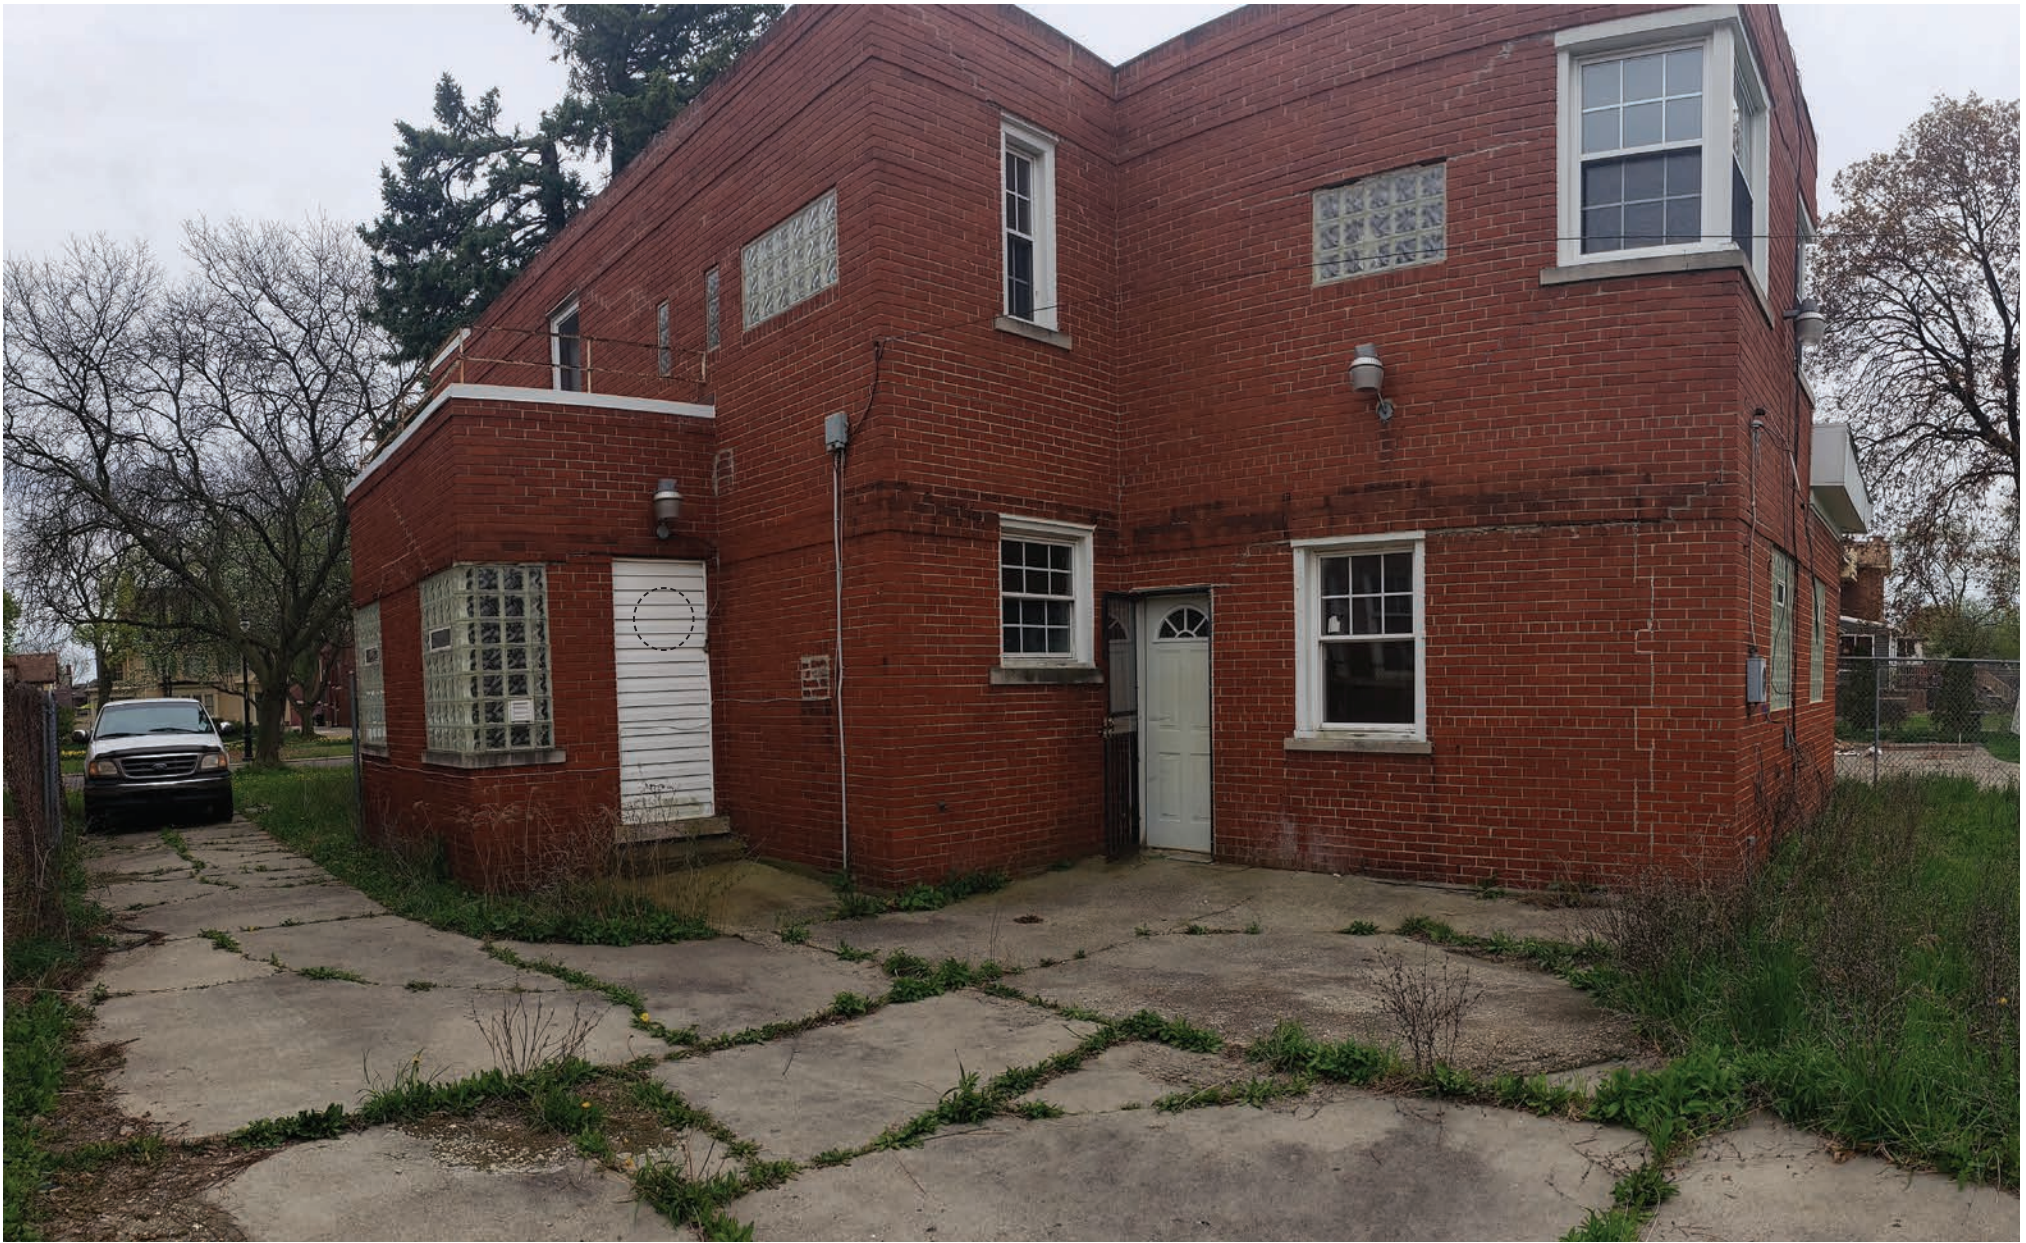
Fig. 12 | The backyard of 1948 Chicago Blvd. -North Elevation

NORTH ELEVATION PHOTO | VIEW LOOKING SOUTH

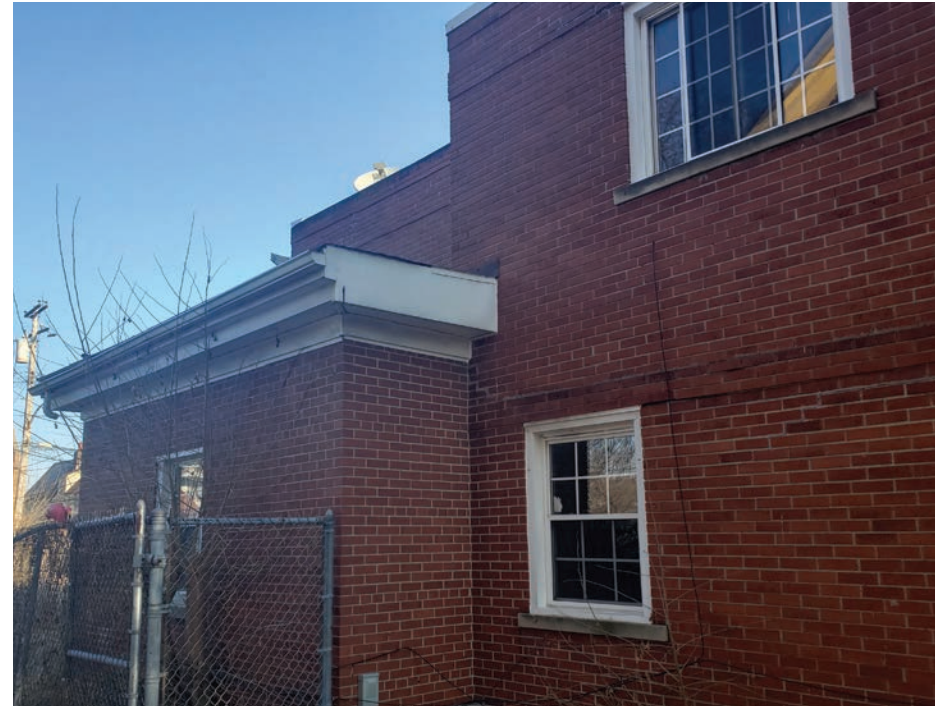
Fig. 14 | The sideyard of 1948 Chicago Blvd. -West Elevation

WEST ELEVATION PHOTO
