# LIVING ROOM - Side A

# Family Room / Living room 7

## 1<sup>st</sup> floor

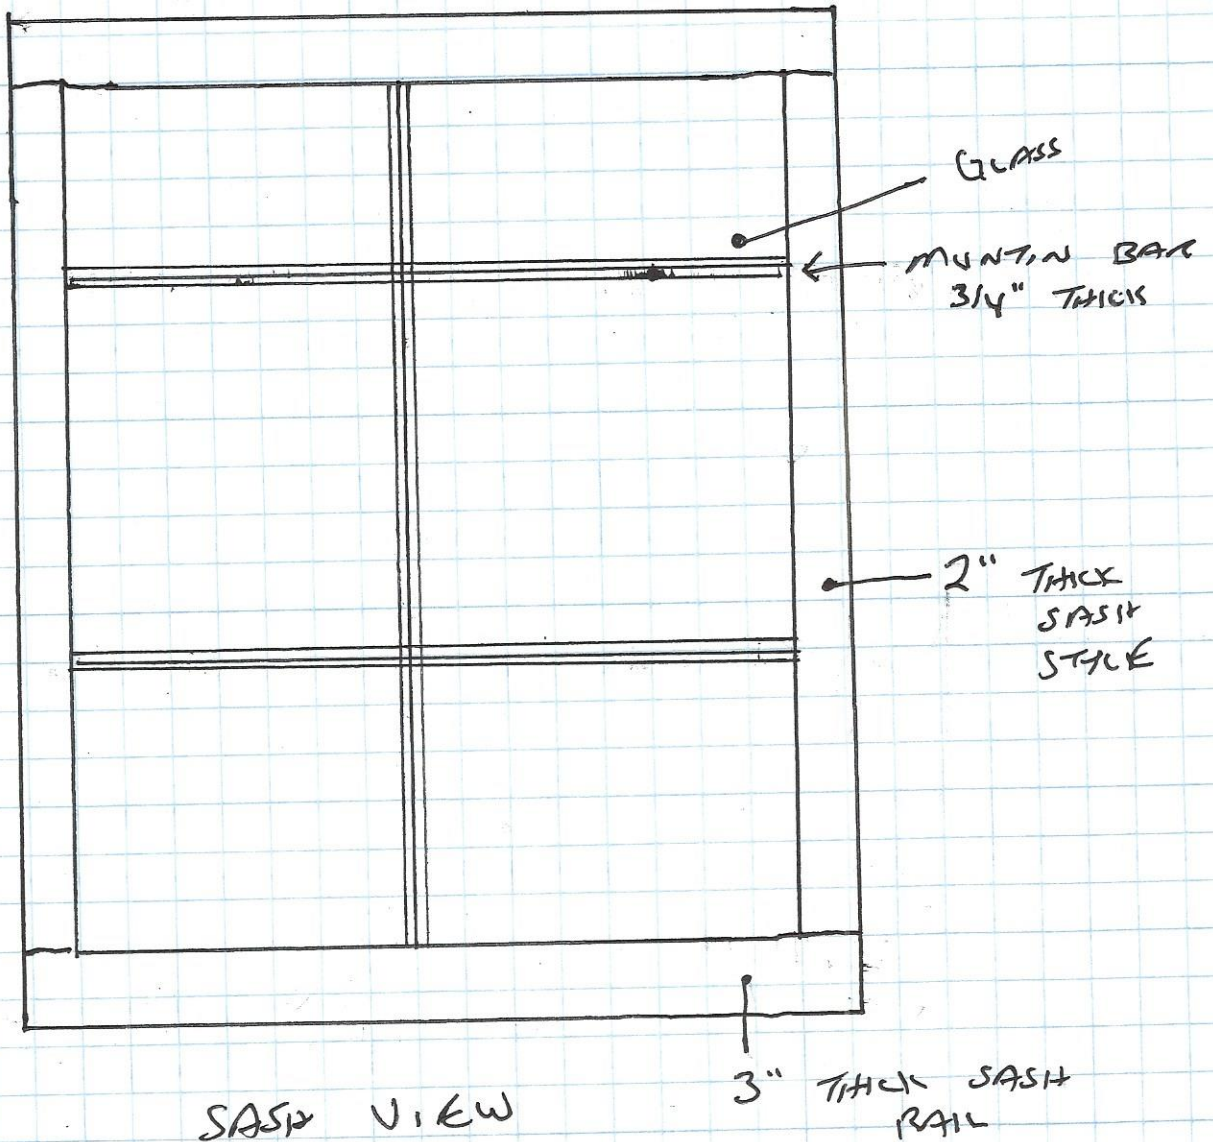
# LIVING ROOM SIDE A

- Brickmole VARIES IN SIZE FROM 1 1/4" - 1 1/2" - 1 3/4" - 2" NOT UNIFORM
- THESE ARE IN A BRICK OPENING, JUST ALL PAINTED TRIM
- FIXED STORM WINDOW IN POOR NON-WORKING CONDITION

- New W/IZs  
will be  
within 3/8"  
on all edges  
& frame

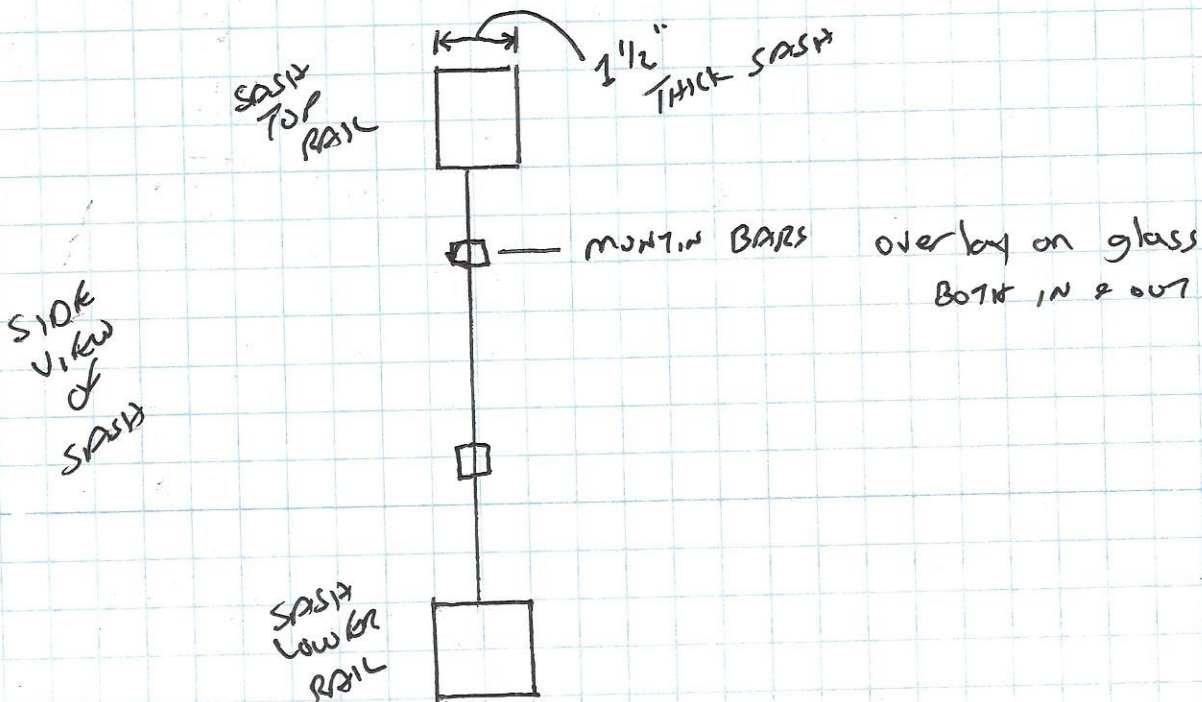
## SASH VIEW

SASH RAIL 3" WIDTH

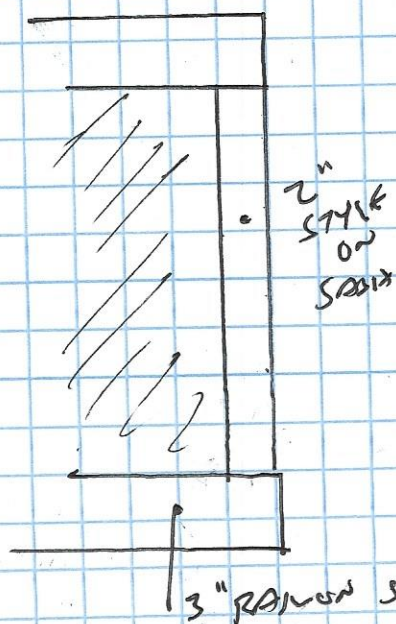
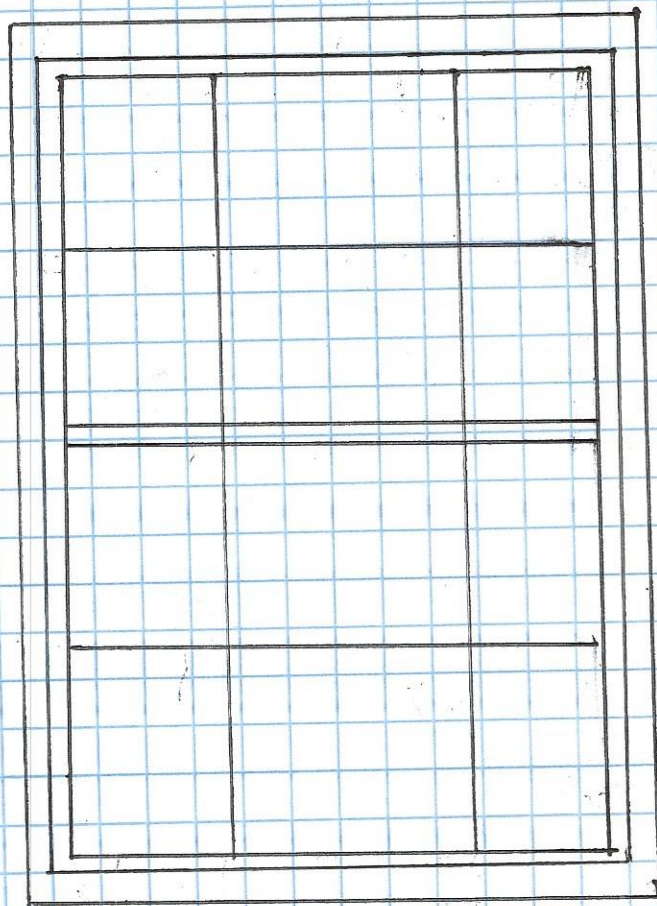
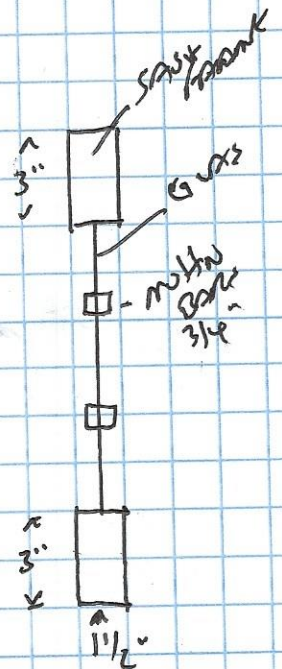
COLONIAL  
MUNTIN STYLE  
BARS  
ON  
UNITS  
6/6

- Double Hung 50/50
- Brick molo is wrapped with aluminum trim coil
- Perimeter of windows is BUTTERED w/ Aluminum siding
- Window TRIM & SIDING are white aluminum

- New units will be within 3/8" of sink on all edges of frame
