# Elevated Blood Lead (EBL) Investigation Report

1772 Seyburn St.  
Detroit, MI 48214  
1912

Date of Inspection: 11/20/2020

Date of Report 11/30/2020

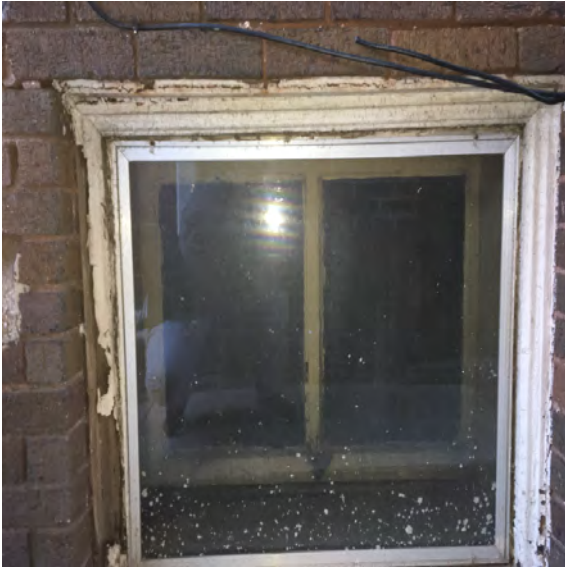
Most Cellar Windows are Covered with Storm Sashes

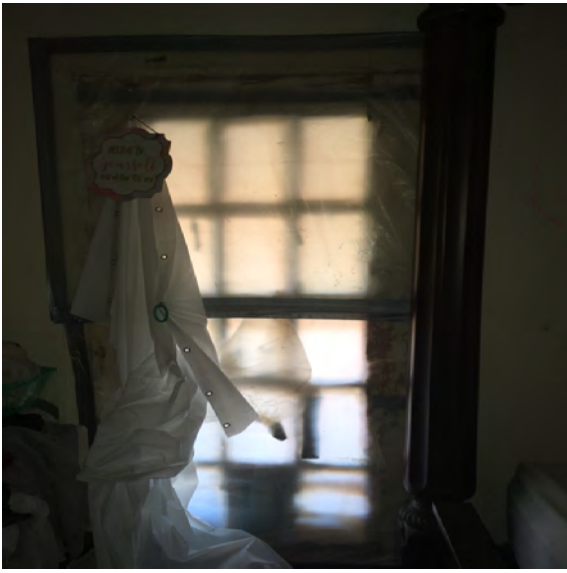
Bedroom 1 Exterior Door Screwed Shut

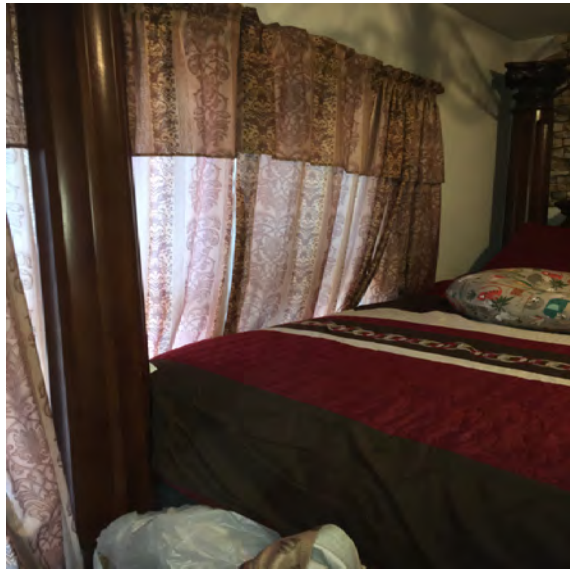
Exterior A Wall Window 1 Furniture Obstruction (Bedroom 3)

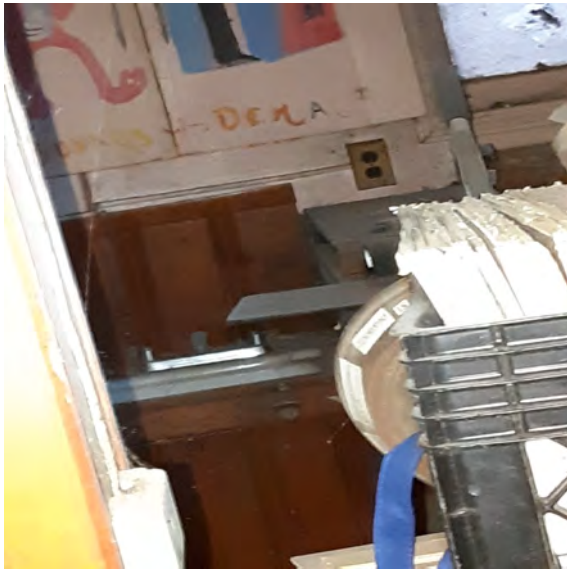
Bar Sink in Basement Not in Use

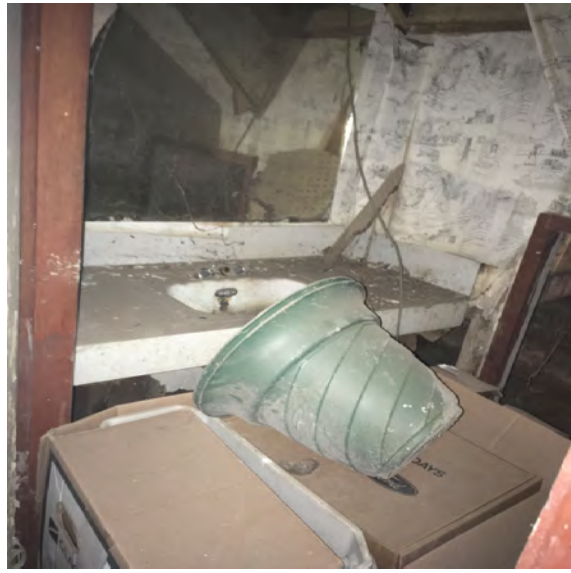
Basement Bathroom (Not In Use)

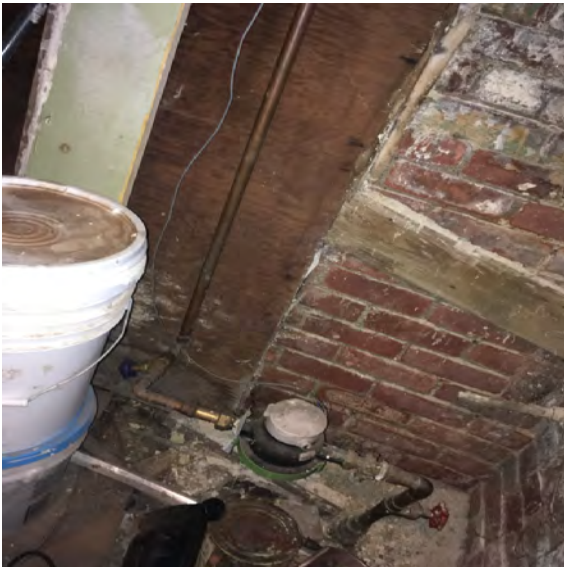
Water Meter with A Cooper Line

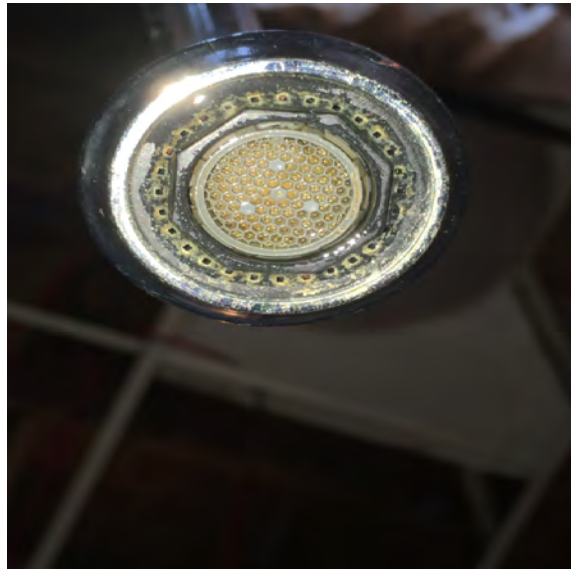
Kitchen Sink Faucet with Aerator

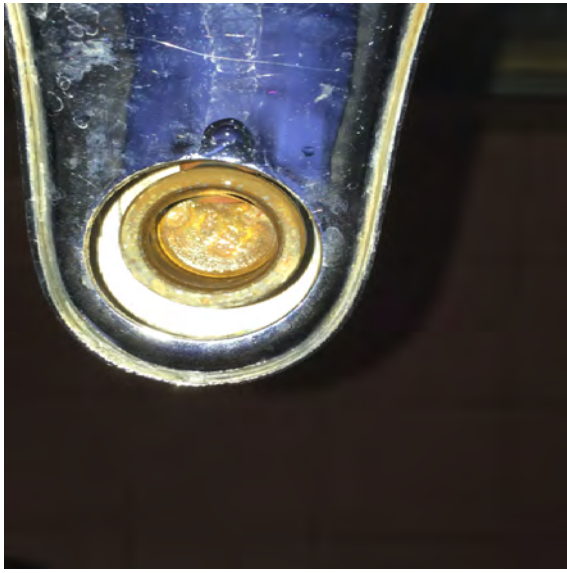
Bathroom Faucet With No Aerator

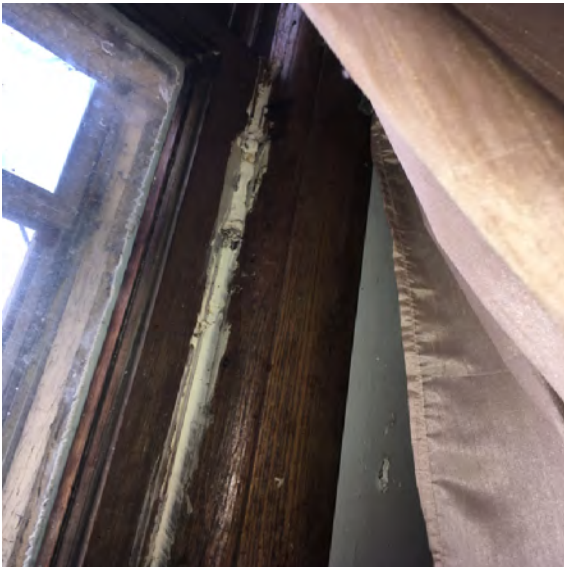
Window Calked Shut (Wall C)
