9710 W Outer Dr

Existing Condition Photos

Current Design Description

A 3-story apartment structure with 10 residential units, constructed in 1940, brick on wood stud wall construction, shingle roof, stone corner details, stone details at palladian window, stone sills, wood detailing at front entry, steel and wood canopy at back entry, wood windows throughout with the exception of steel windows at bathrooms and the lowest level. The addition of a brick shed to house the gas meter was made at a later date.

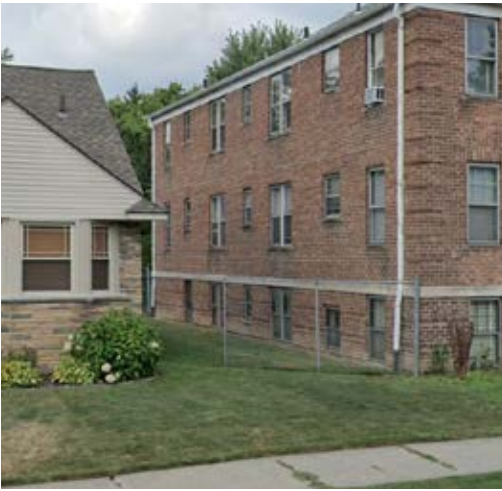
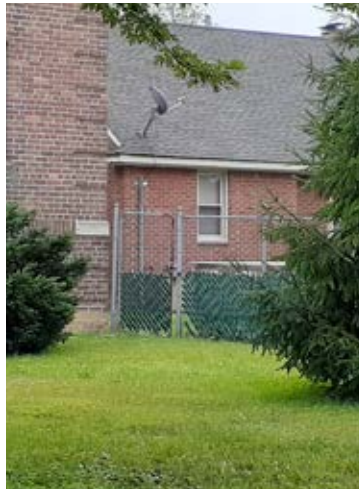
Existing Fence

- Short runs of chain link fence go beyond the property line

10. Install new security fence at perimeter of parking lot and ramp with pedestrian swing gate and remote operated vehicular gates; existing sections of fence on-site to remain

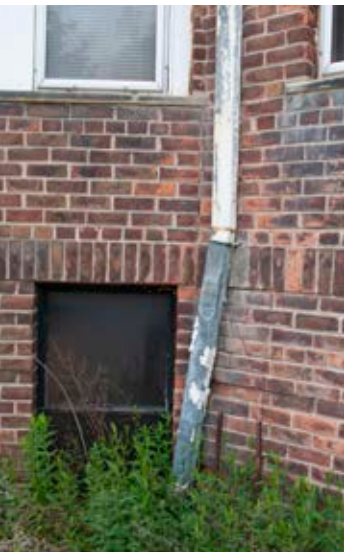
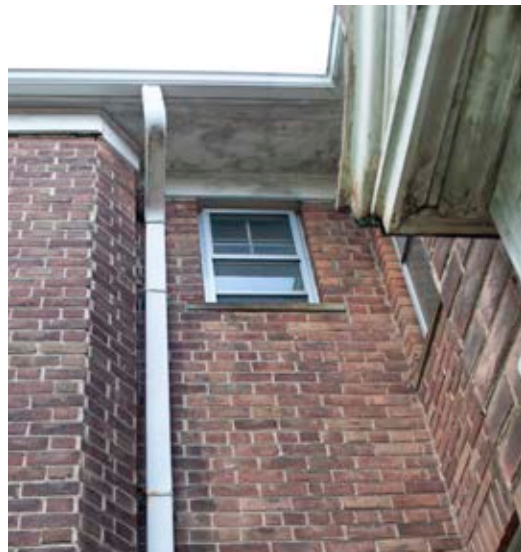
Existing Downspouts

- Downspouts are in good condition and are tied into the City sewer; Paint is flaking off.
- Gutters need painting

8. Repair existing historic woodwork at front entries of 9710 & 9730
9. Scrape and paint all exterior doors, wood features, and gutters; paint and install new 8"x8" brick vents per res. unit in brick facades (avoid front facade) where brick vent is not already existing

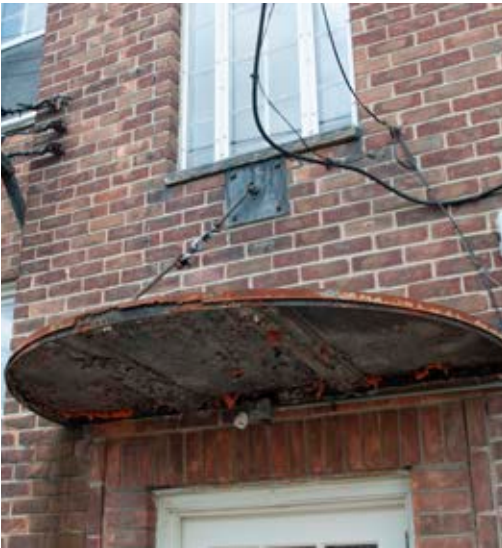
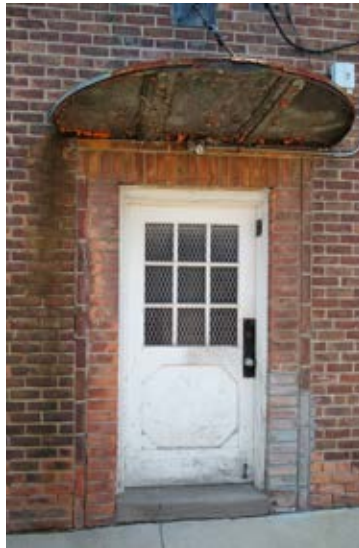
Existing Canopy

- Existing tie back canopy is corroded and in need of repair/reconstruction
- Brick is discolored/damaged around door and canopy due to improper drainage

4. Install new accessible ramp and railing at 9730 new accessible entry
5. Replace existing 9710 steel & wood canopy in kind, and install similar new canopy at new 9730 accessible entry; install downspout at both canopies for water mitigation

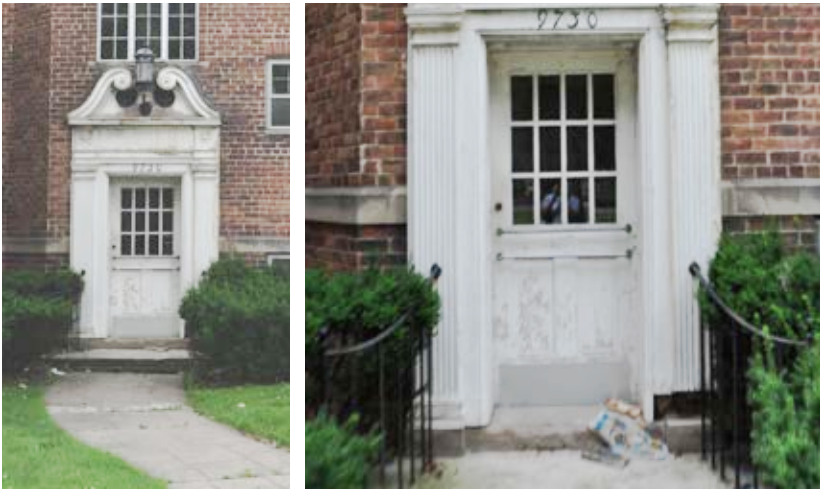
Existing 9730 Front Landing

- Existing landing is damaged and hazardous

6. At 9730 front entry, remove & replace existing concrete landing in kind & restore historic light fixture
7. Replace all other light fixtures at entrances with new; install new exterior sconce at new accessible entry; remove building-mounted security lights; install new security lighting at parking lot & ramp

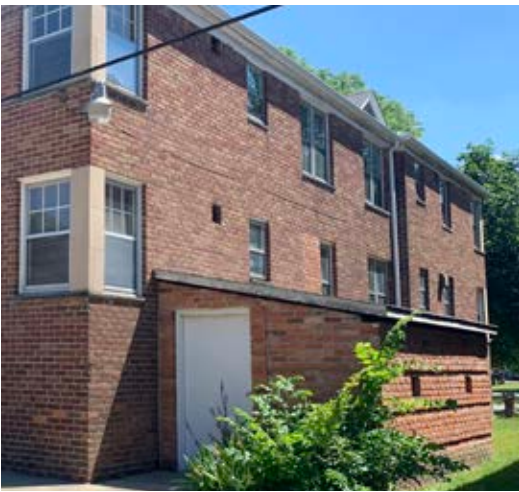
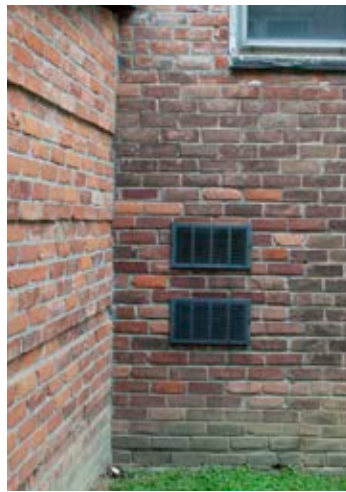
Existing Vents in Masonry

- Existing vents in masonry are located in the kitchens in 9710
- Existing vents in masonry are also located at the mechanical room in 9710

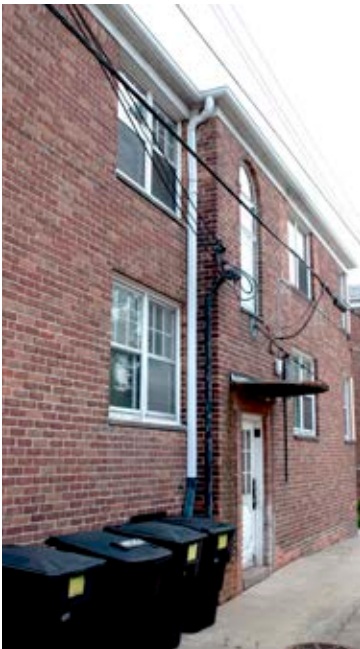
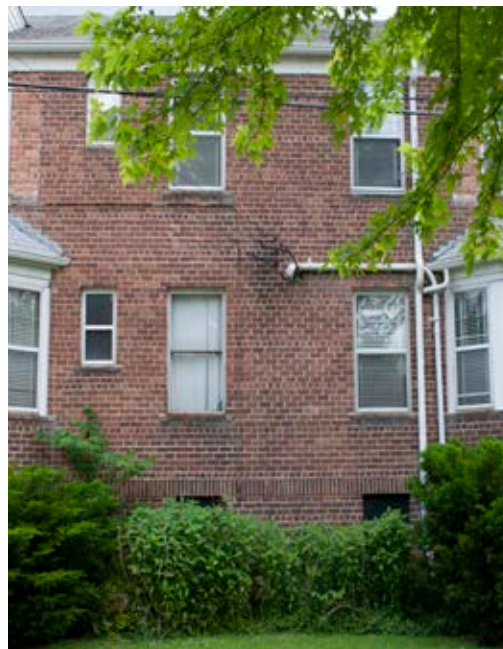
Existing Conduit

- Conduit is building-mounted at the back of both buildings

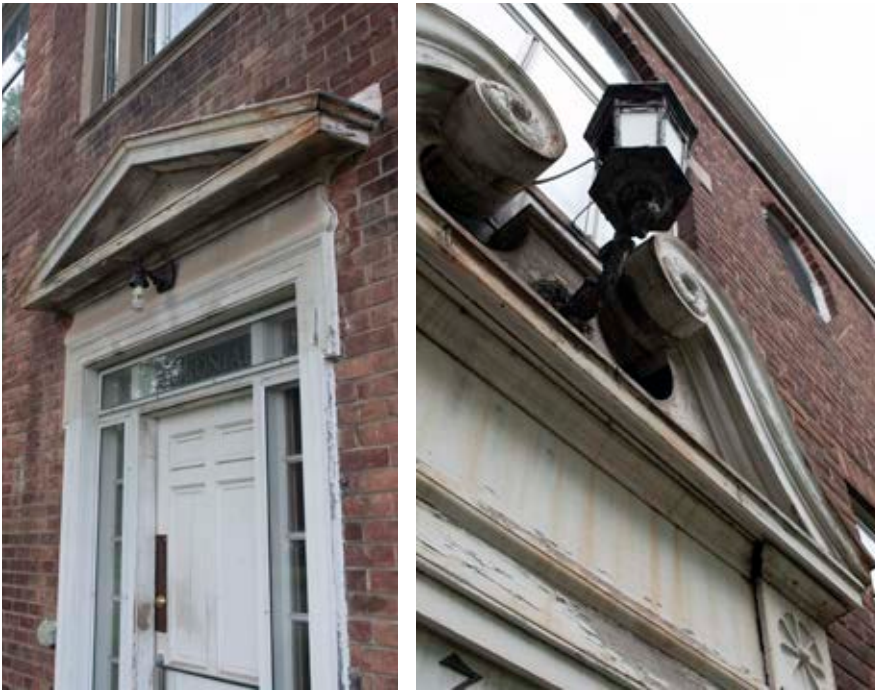
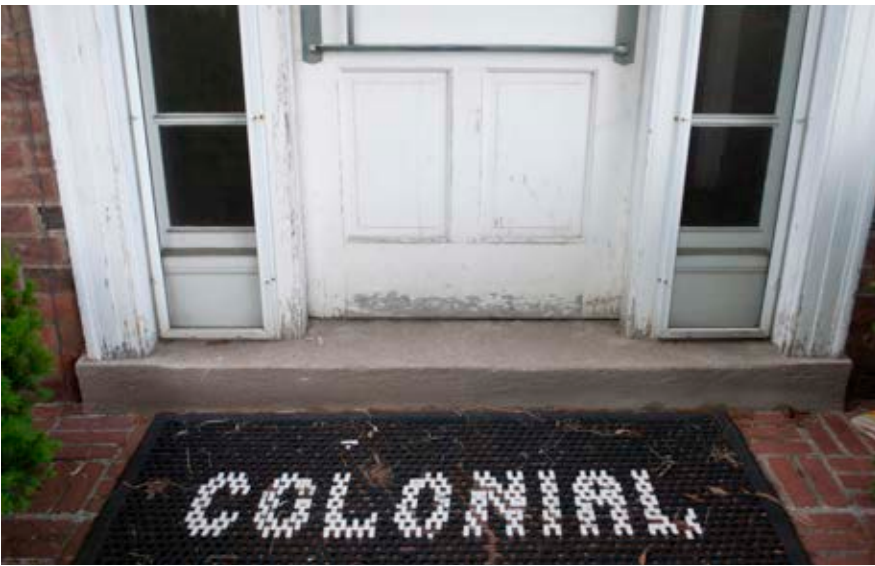
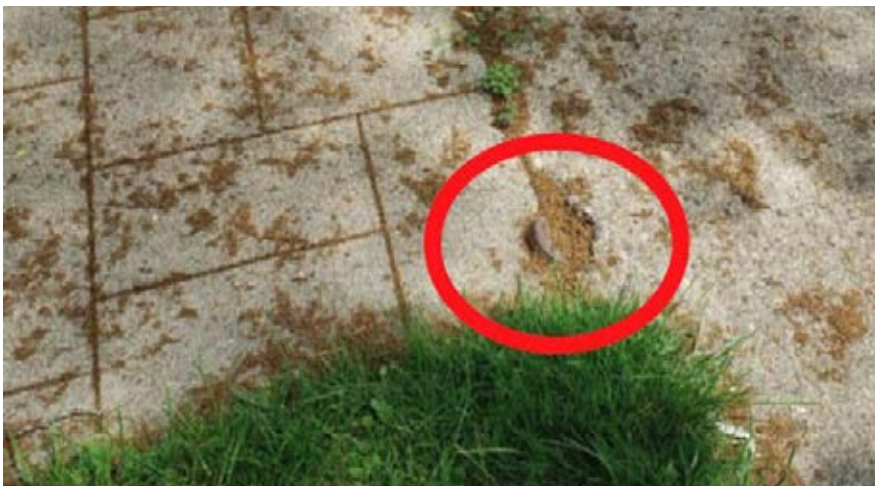
Historic Woodwork & Fixture

- Existing historic woodwork at front entries of both buildings shows deterioration and is in need of repair/reconstruction and new paint to match existing
- Existing historic light is in fair condition, flaking paint and rust should be removed and fixture restored

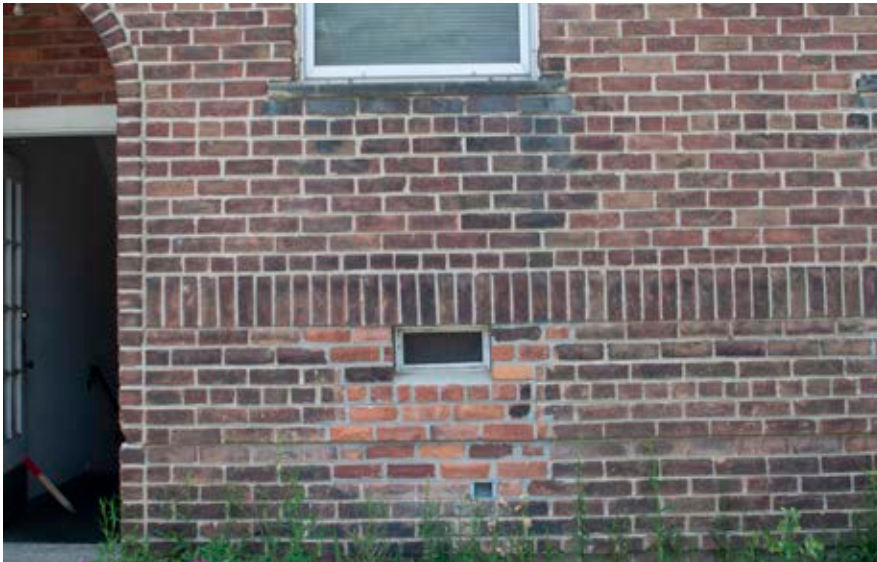
Sill & Brick Discoloration

- Existing stone sills and masonry below are discolored and possibly water damaged
- Existing small windows in utility rooms appear to be added after original construction. The color of these bricks suggests that they were used in conjunction with the addition of the gas shed, and attempt to match the 'cleaned' color of the original bricks.

1. Restore the existing masonry (brick), utilizing repointing, tuckpointing, and cleaning as necessary
2. Replace the existing leaky (non-historic) asphalt shingle roof in kind

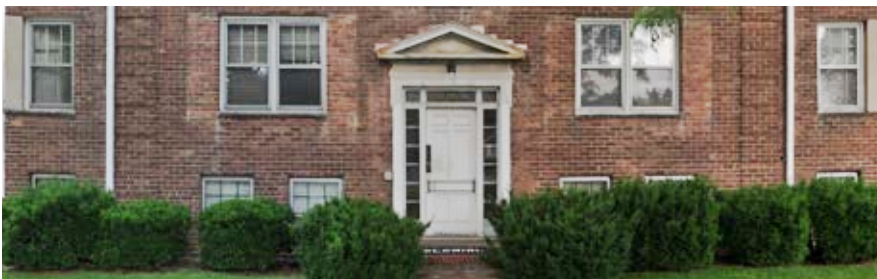
Existing Landscaping

- Existing shrubs line the front facades of both buildings as well as a section of the back facade of 9730, some being dead/dying
- Two coniferous trees and several deciduous trees dot the site at the perimeter of the parking lot and parking lot islands and line the street frontage
- An ornamental tree is adjacent to the 9730 front entry

13. Repair pathway and sidewalk near 9730 front entry; remedy utility cap trip hazard at 9710 front entry
14. Regrade site to slope away from buildings where necessary; remove existing landscaping in order to regrade and replace with similar

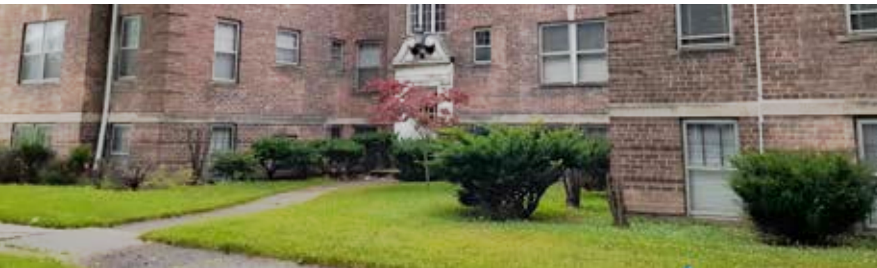
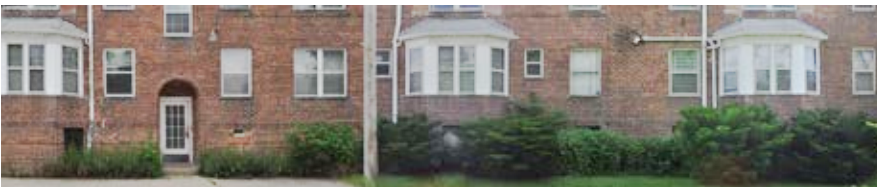
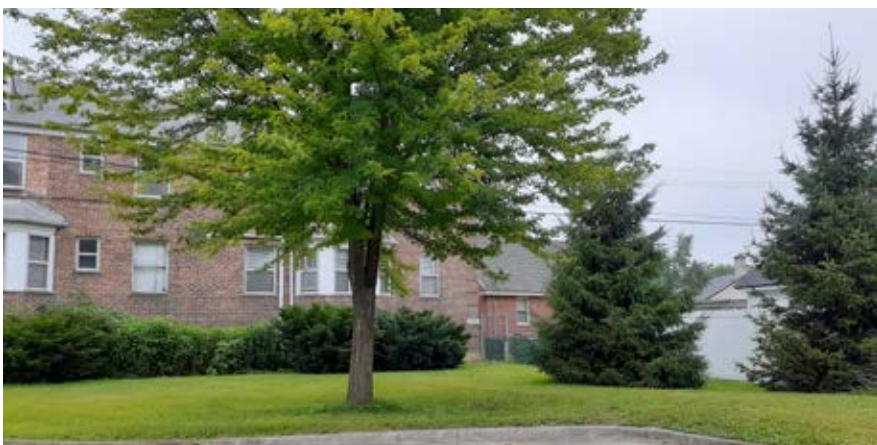
- Existing parking layout has two-directional one-way parking, and only accommodates 33 parking spaces. New residential unit count is 35.
- Existing path between buildings is only 2'-0" wide.
- Existing path and sidewalk near the front of 9730 W Outer Dr front entry is missing a section and heaving.

11. Remove & replace narrow gray concrete pathway between buildings with accessible path (5'-0"W)
12. Re-stripe (to 90 degree spaces & (2) accessible spaces) and reconfigure curbs at existing parking lot to match unit count; remove and replace concrete as needed at parking lot to properly grade

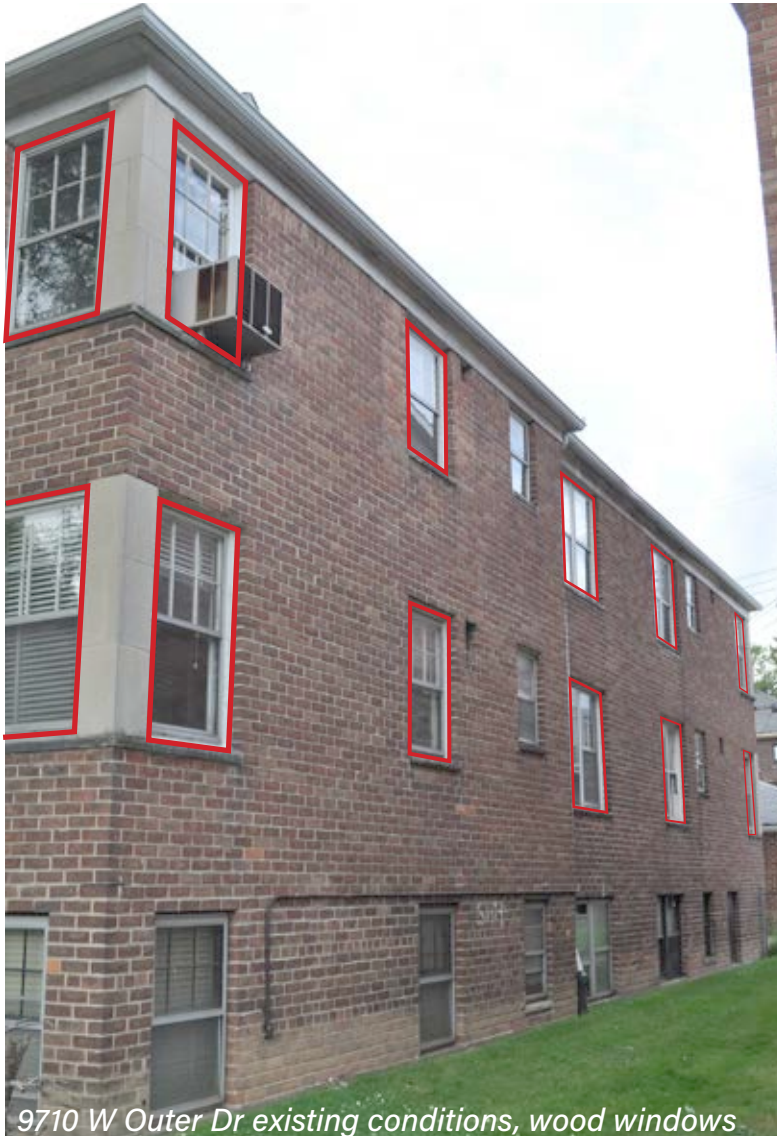
9710 W Outer Dr existing conditions, wood windows

9710 W Outer Dr Existing Wood Windows
Wood construction with steel lintels and stone sills, *highlighted in red*, save for bathroom and Level 00 windows of steel construction.

- Some exterior sills are split, allowing water to enter the building envelope
- The majority of sills are fissured, causing dry rot and material breakdown

- The operability of the windows ranges from inconsistent to very difficult
- They use a tape balance system that is not readily replaced without potential damage to the master frame

- The jamb liner/weatherstrip is in poor conditions and is not a product that is available for replacement
- All windows require re-glazing with new glazing compound, and existing material is unable to be removed without damage to the sashes and breaking the glass

- The glazing compound is falling out and breaking down on all sashes
- The paint is peeling
- The caulking is failing and falling out
- The storm windows are in poor condition with many broken track guides and failing corner joinery, allowing water to get trapped on the exterior sills, and dry rot and decay in 30-40% of the openings

- A true restoration process is not able to be implemented for these windows. Painting and Glazing Repair can be done; however, this approach does not address the described window issues.

Proposed wood window replacement: Quaker H650 DS, thermally-broken aluminum window with custom brick mould, muntins (3-part SDL, pattern to match existing) and mullions (where applicable). This approach will provide a well-functioning, energy efficient replication of the original windows.

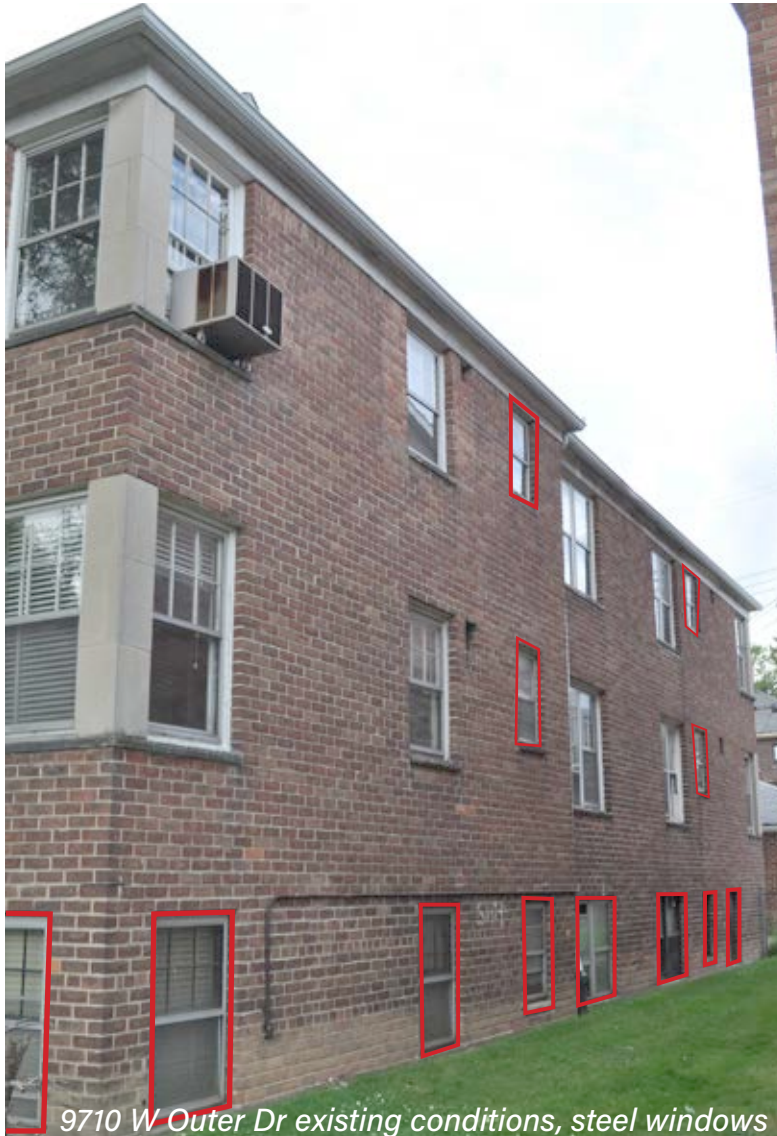
9710 W Outer Dr existing conditions, steel windows

9710 & 9730 W Outer Dr Existing Steel Windows
Steel construction set in wood framed, masonry opening with stone sills, *highlighted in red*; include all bathroom, Level 00, & 9730 windows.

- The weather stripping is rusted and the tape balancers are typically bent, crimped, or torn, making the operation and sash movement stiff and resistant

- There isn't a tight seal at the points of weatherstripping between the sash and master frame causing air infiltration and condensation, which has caused corrosion on the interior painted surfaces

- The exterior paint is worn, peeling, and/or allowing rust and corrosion to bleed thru to the surface
- The butt joint tubular steel framing has mild-to-heavy corrosion at the exterior sill, the sash, and frame joinery

- The storm windows have many broken track guides and failing corner joinery, trapping water on the exterior sill creating rust and corrosion
- The glazing compound is falling out and failing on all sashes

- The exterior perimeter caulking is failing and coming loose from the masonry
- The locks are bent/broken in over 80% of all windows
- These windows do not lend themselves to restoration, as the components are in poor condition and no replacement parts are available; leaving the sashes in place will not resolve the described issues

- All existing window components to be removed and disposed of; abatement may be required. Wood blocking to be set in the jamb cavity.
- Repair fixed decorative windows in the common area stairs wells only.
- New windows to be set directly in the masonry openings and anchored to the wood blocking. Prior to this installation all voids would be insulated.
- Interior plaster returns to be repaired.
- Perimeter caulking to be applied on the interior and exterior, and windows to be cleaned and adjusted.

Proposed steel window replacement:
 Thermal Windows, Inc. Series 700 double hung
 thermally broken aluminum window with custom
 brick mould, muntins (3-part SDL, pattern to
 match existing) and mullions (where applicable).
 This approach will provide a well-functioning,
 energy efficient replacement of the original
 windows with the closest available profile to
 existing. See appendix.

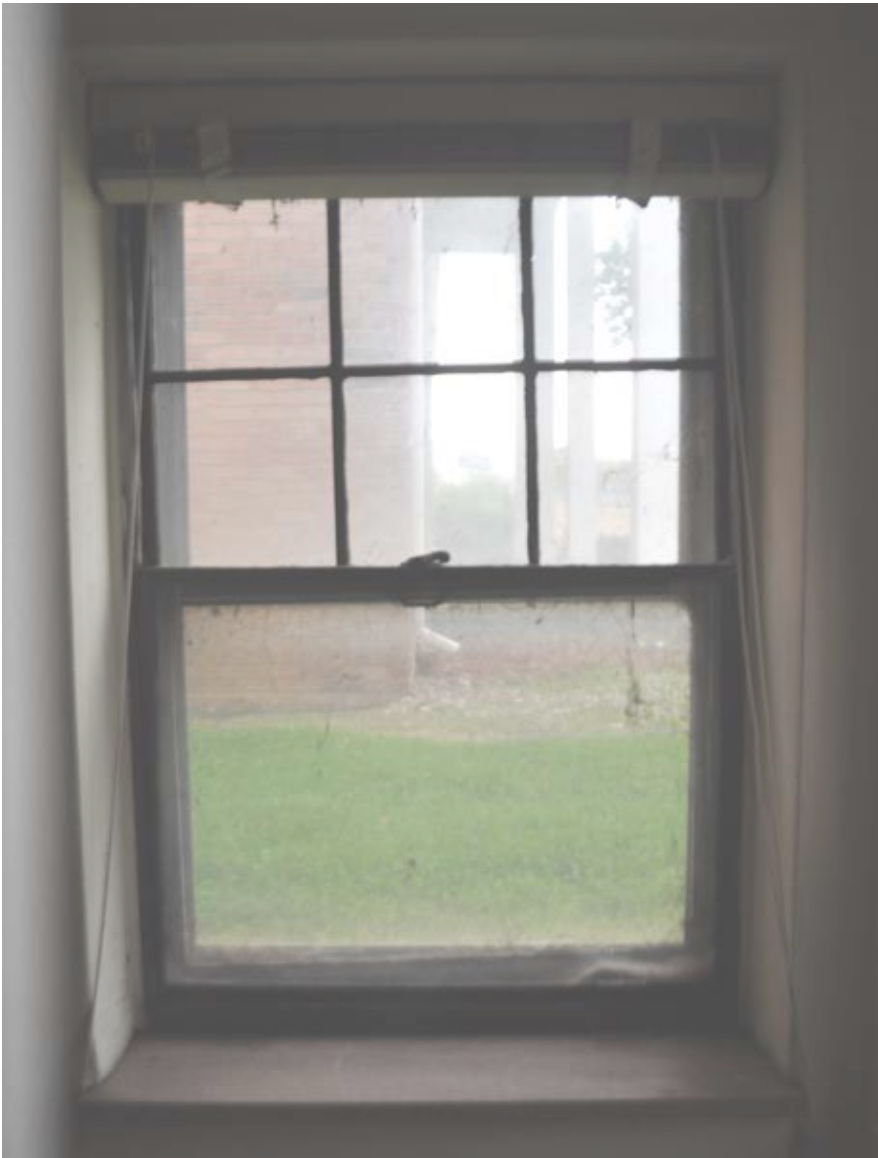
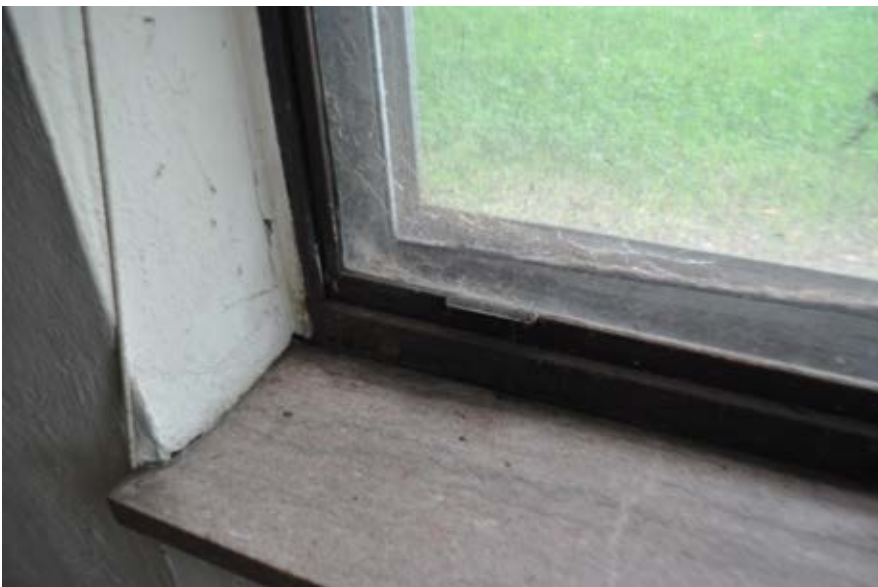
Window A1, Type D1

- Note: Extent of exterior deterioration, dry rot, and loss of operability is not fully apparent in interior photos. Replacement parts for existing windows are unavailable, making restoration of thermal and operable functionality impossible, and long-term maintenance infeasible. Recommendation is for replacement, for quality of life of future tenants and for feasibility of long-term maintenance.
- See Window Assessment (Blackberry) in appendix for further detail and information, including further notes on deterioration beyond repair
- See Appendix for Window Schedule & Measurements

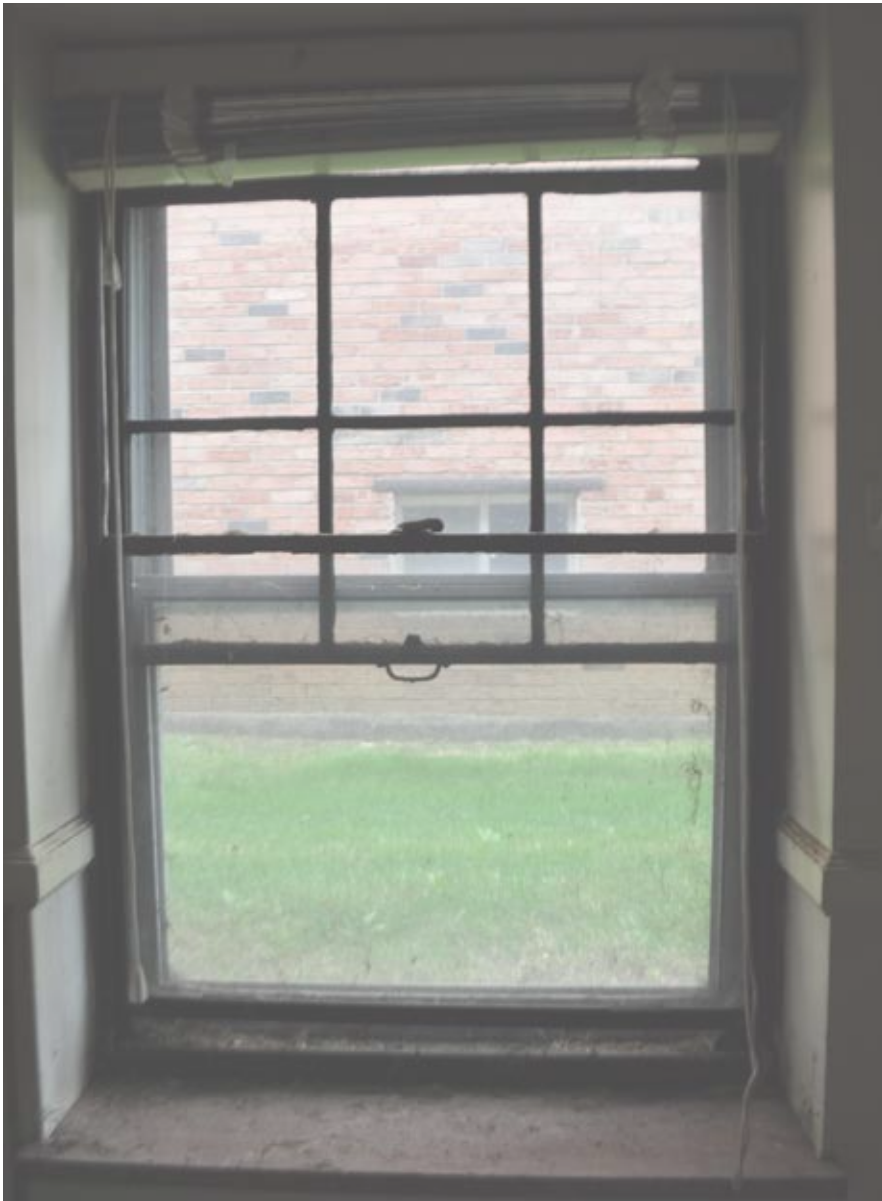
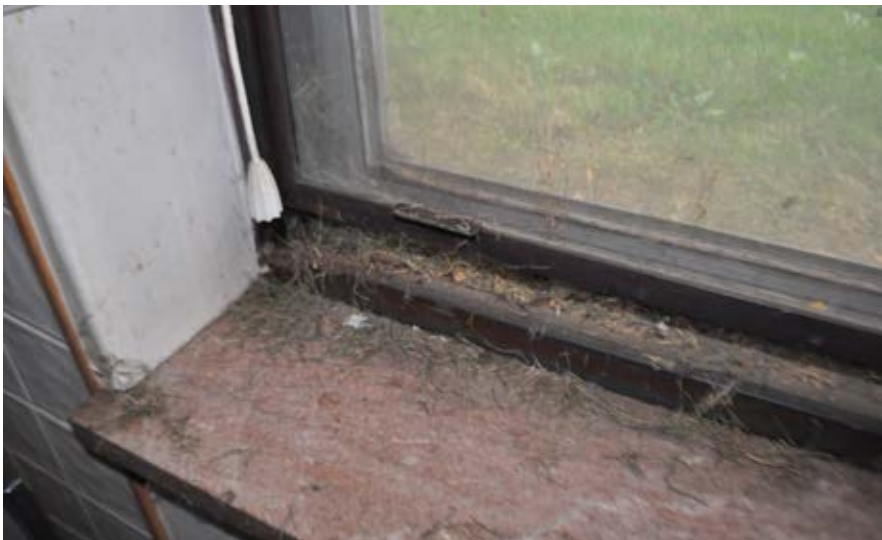
Window A2, Type F1

- Note: Extent of exterior deterioration, dry rot, and loss of operability is not fully apparent in interior photos. Replacement parts for existing windows are unavailable, making restoration of thermal and operable functionality impossible, and long-term maintenance infeasible. Recommendation is for replacement, for quality of life of future tenants and for feasibility of long-term maintenance.
- See Window Assessment (Blackberry) in appendix for further detail and information, including further notes on deterioration beyond repair
- See Appendix for Window Schedule & Measurements

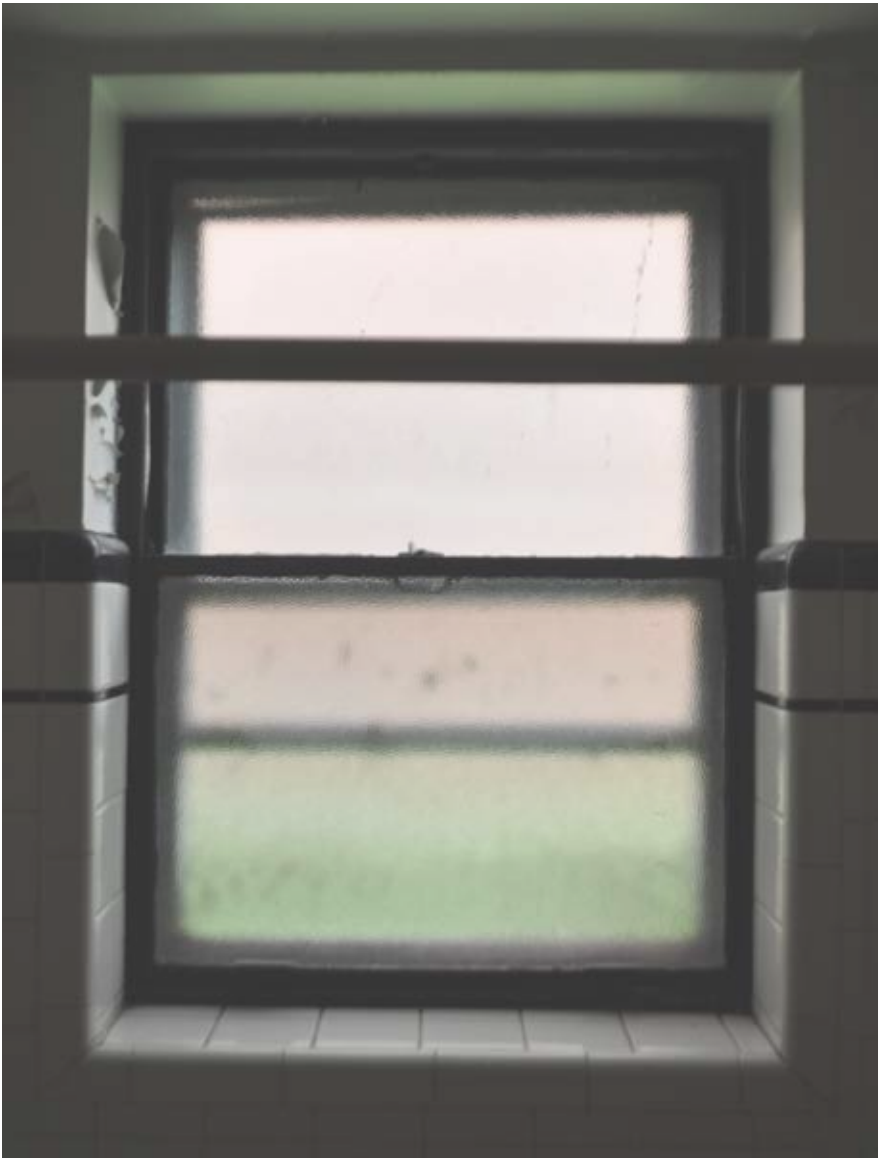
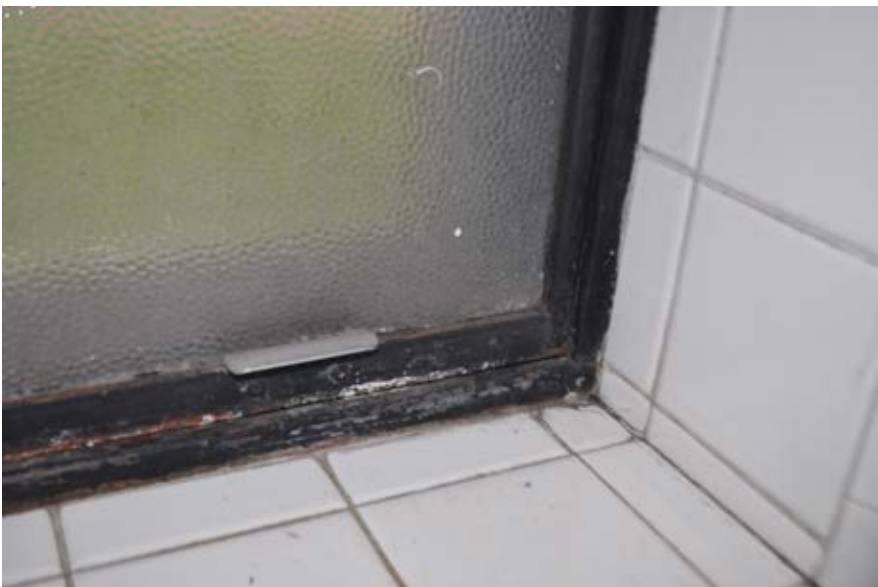
Window A3, Type G1

- Note: Extent of exterior deterioration, dry rot, and loss of operability is not fully apparent in interior photos. Replacement parts for existing windows are unavailable, making restoration of thermal and operable functionality impossible, and long-term maintenance infeasible. Recommendation is for replacement, for quality of life of future tenants and for feasibility of long-term maintenance.
- See Window Assessment (Blackberry) in appendix for further detail and information, including further notes on deterioration beyond repair
- See Appendix for Window Schedule & Measurements

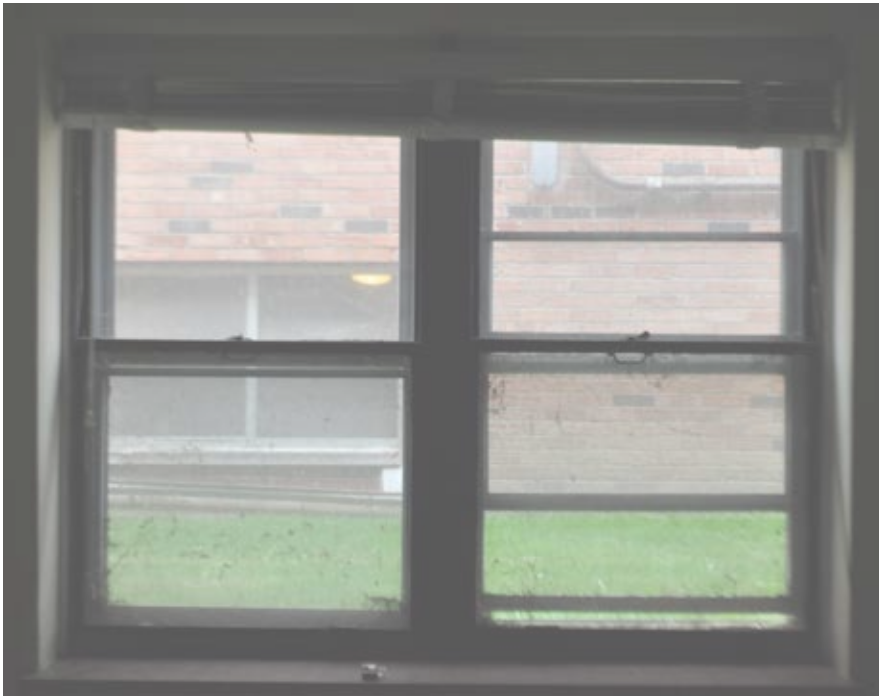
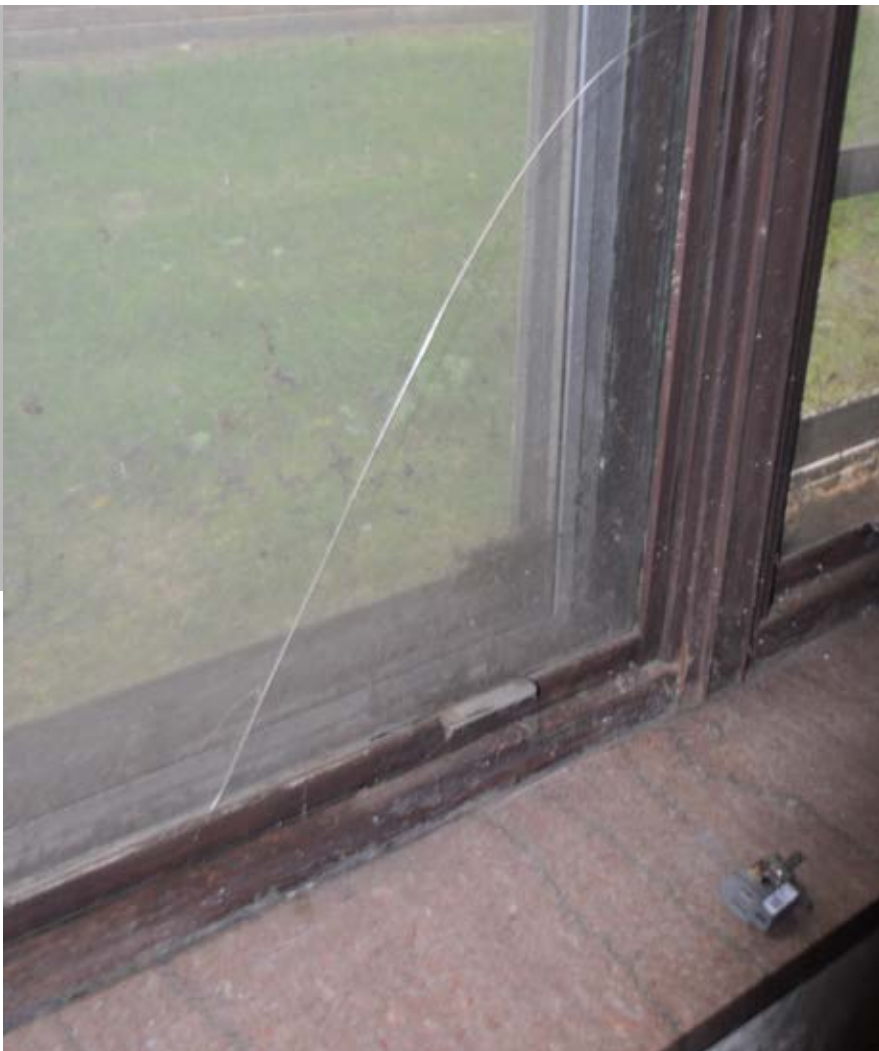
Window A4, Type L1

- Broken Glass
- Note: Extent of exterior deterioration, dry rot, and loss of operability is not fully apparent in interior photos. Replacement parts for existing windows are unavailable, making restoration of thermal and operable functionality impossible, and long-term maintenance infeasible. Recommendation is for replacement, for quality of life of future tenants and for feasibility of long-term maintenance.
- See Window Assessment (Blackberry) in appendix for further detail and information, including further notes on deterioration beyond repair
- See Appendix for Window Schedule & Measurements

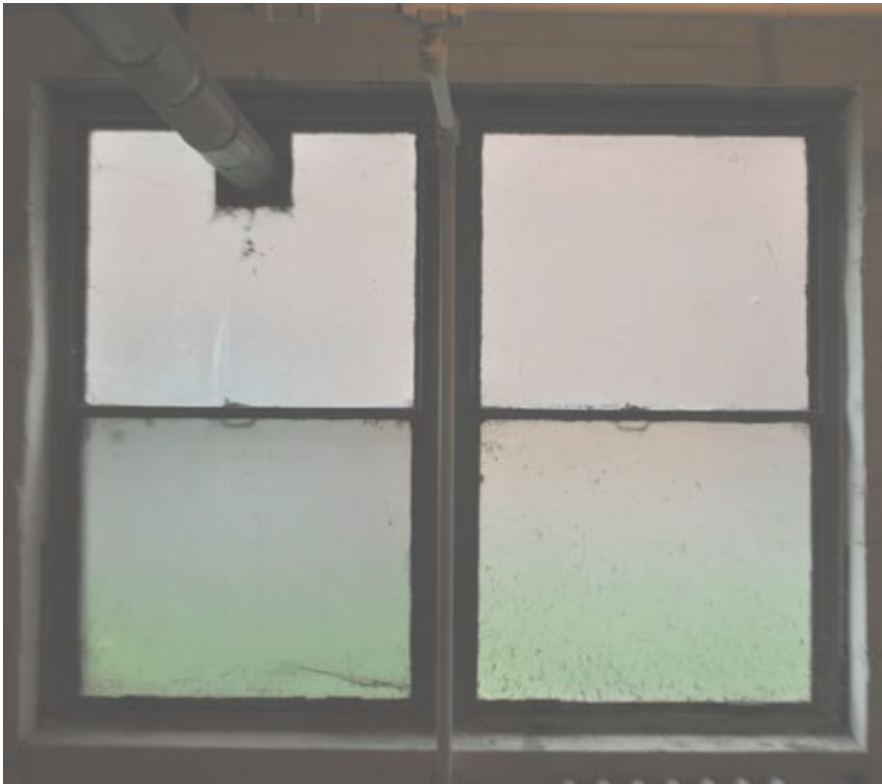
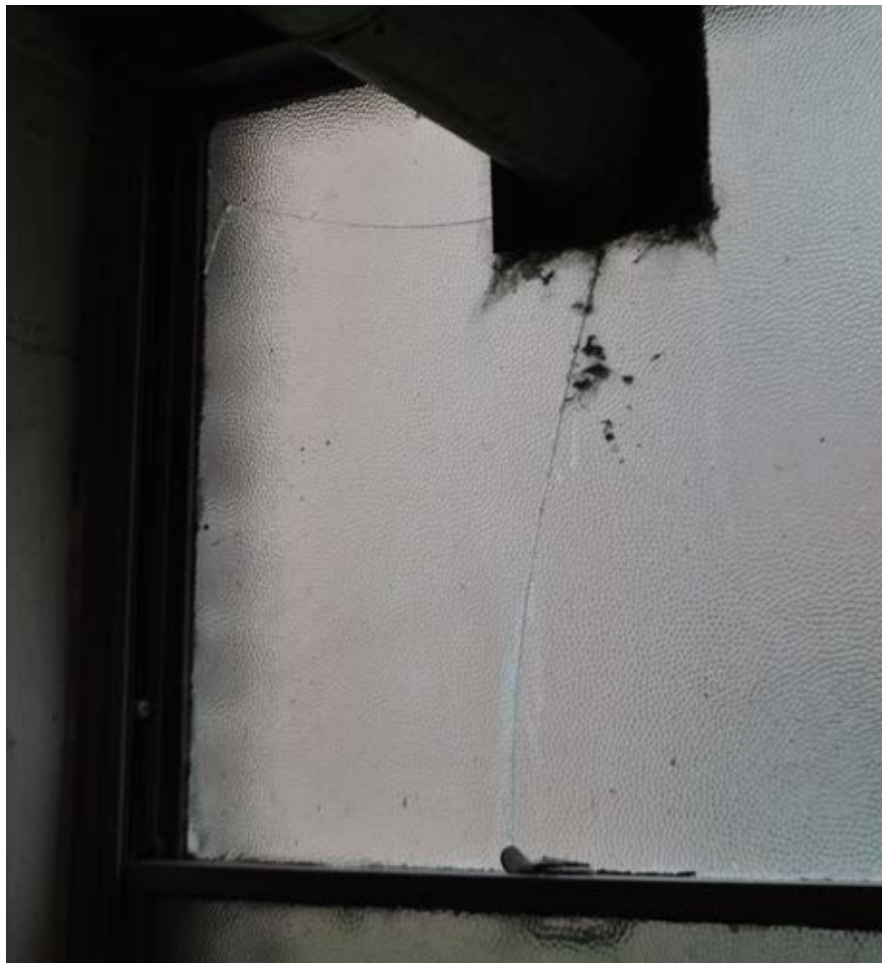
Window A5, Type H1

- Broken Glass
- Note: Extent of exterior deterioration, dry rot, and loss of operability is not fully apparent in interior photos. Replacement parts for existing windows are unavailable, making restoration of thermal and operable functionality impossible, and long-term maintenance infeasible. Recommendation is for replacement, for quality of life of future tenants and for feasibility of long-term maintenance.
- See Window Assessment (Blackberry) in appendix for further detail and information, including further notes on deterioration beyond repair
- See Appendix for Window Schedule & Measurements

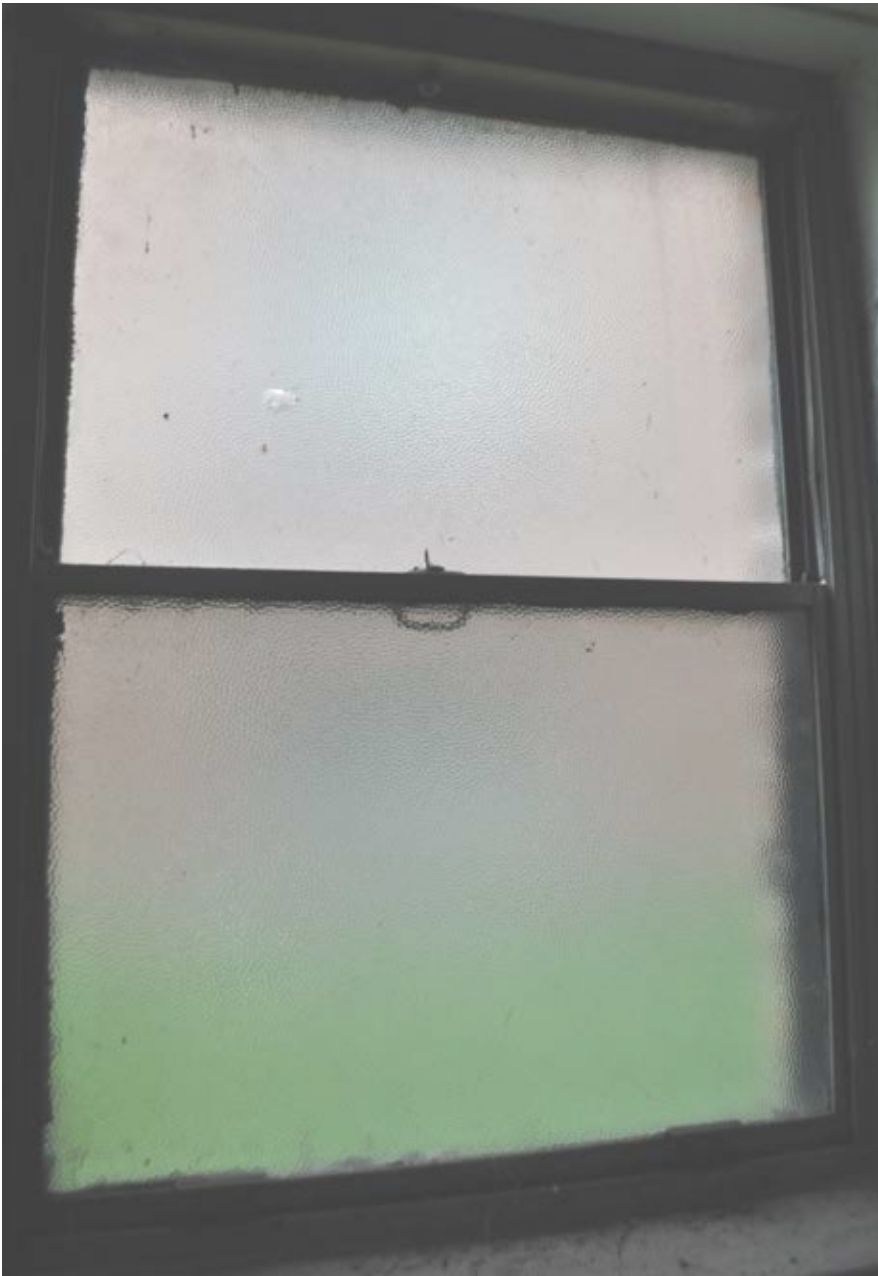
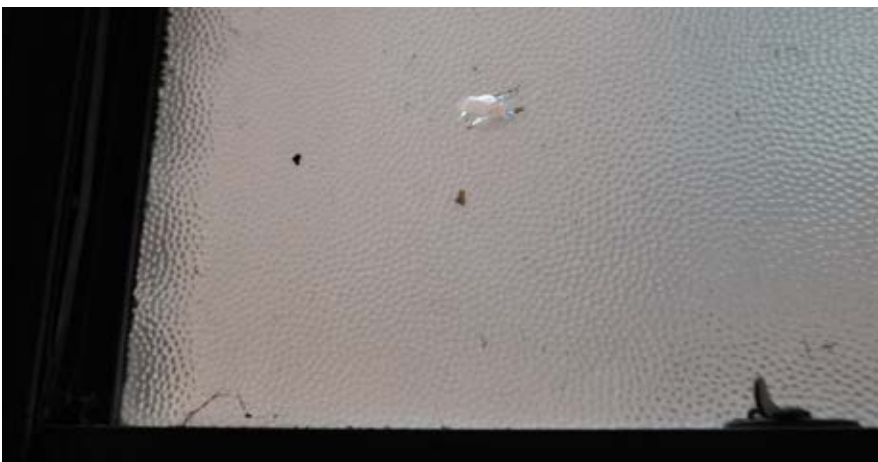
Window A6, Type G1

- Broken Glass
- Note: Extent of exterior deterioration, dry rot, and loss of operability is not fully apparent in interior photos. Replacement parts for existing windows are unavailable, making restoration of thermal and operable functionality impossible, and long-term maintenance infeasible. Recommendation is for replacement, for quality of life of future tenants and for feasibility of long-term maintenance.
- See Window Assessment (Blackberry) in appendix for further detail and information, including further notes on deterioration beyond repair
- See Appendix for Window Schedule & Measurements

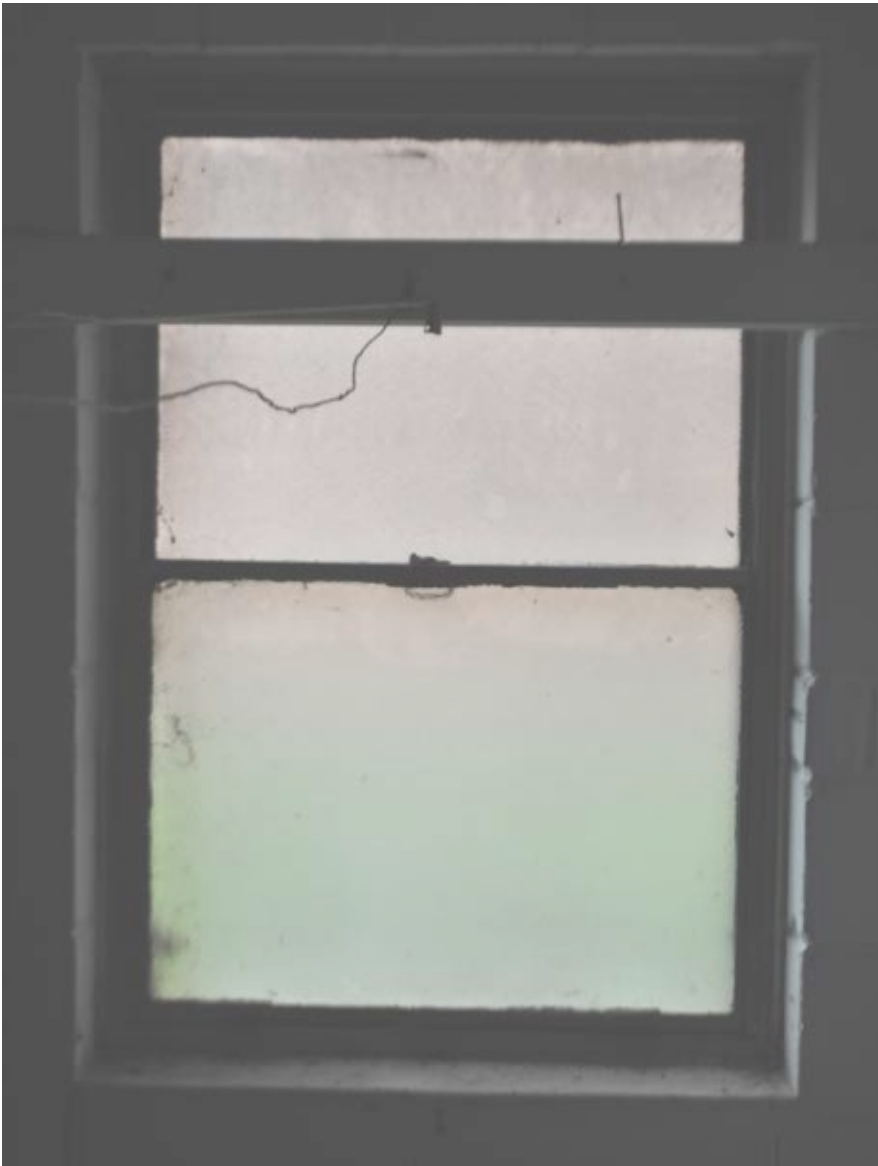
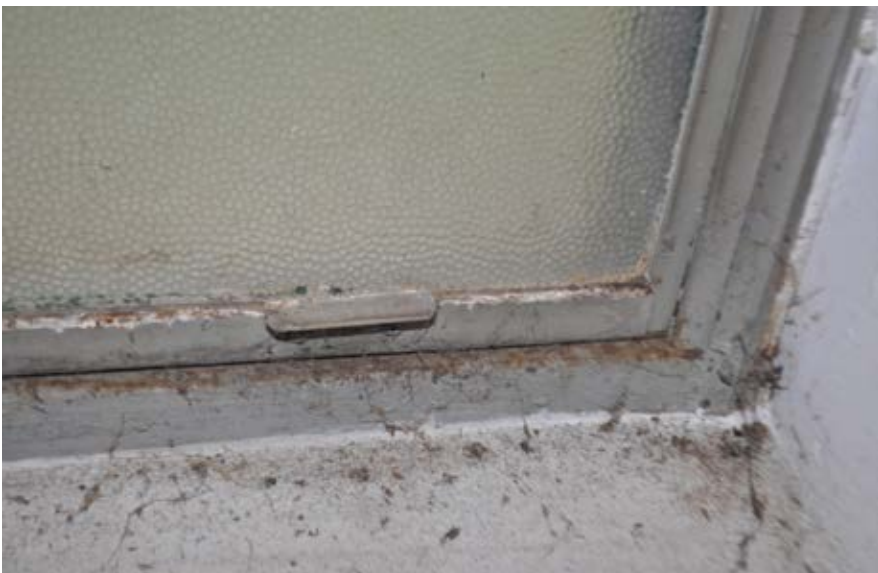
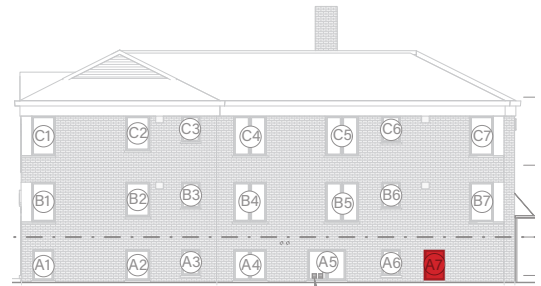
Window A7, Type D2

- Note: Extent of exterior deterioration, dry rot, and loss of operability is not fully apparent in interior photos. Replacement parts for existing windows are unavailable, making restoration of thermal and operable functionality impossible, and long-term maintenance infeasible. Recommendation is for replacement, for quality of life of future tenants and for feasibility of long-term maintenance.
- See Window Assessment (Blackberry) in appendix for further detail and information, including further notes on deterioration beyond repair
- See Appendix for Window Schedule & Measurements
