9710 W Outer Dr

Existing Condition Photos

Current Design Description

A 3-story apartment structure with 10 residential units, constructed in 1940, brick on wood stud wall construction, shingle roof, stone corner details, stone details at palladian window, stone sills, wood detailing at front entry, steel and wood canopy at back entry, wood windows throughout with the exception of steel windows at bathrooms and the lowest level. The addition of a brick shed to house the gas meter was made at a later date.

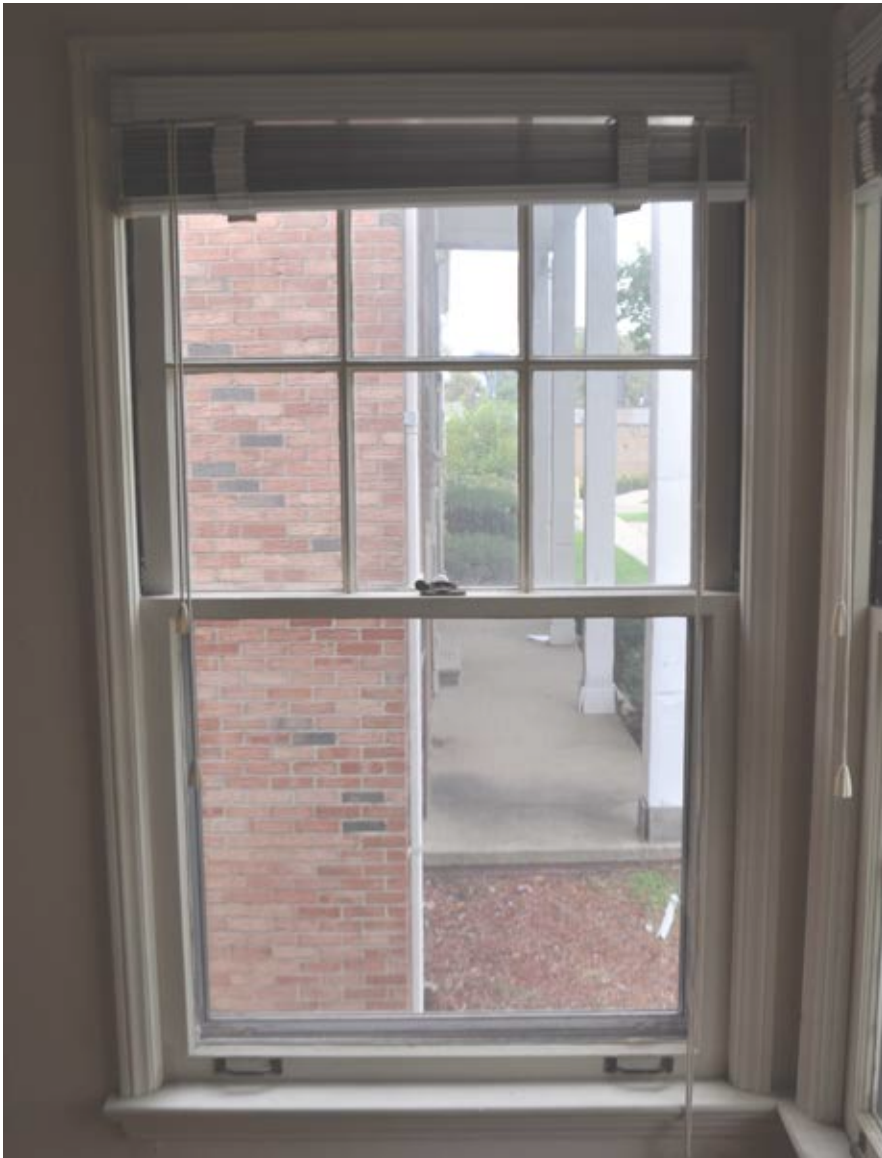
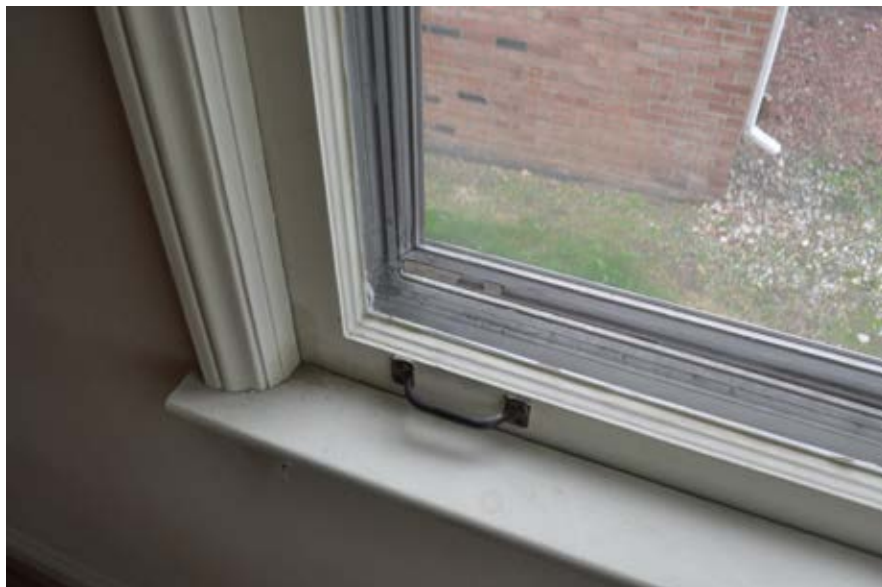
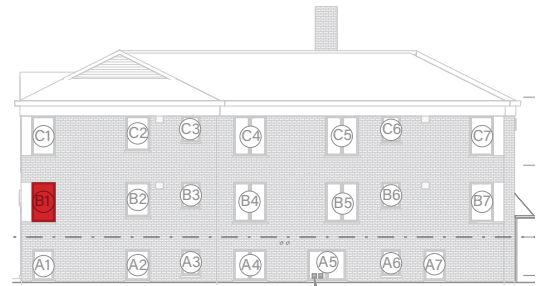
Window B1, Type A1

- Note: Extent of exterior deterioration, dry rot, and loss of operability is not fully apparent in interior photos. Replacement parts for existing windows are unavailable, making restoration of thermal and operable functionality impossible, and long-term maintenance infeasible. Recommendation is for replacement, for quality of life of future tenants and for feasibility of long-term maintenance.
- See Window Assessment (Blackberry) in appendix for further detail and information, including further notes on deterioration beyond repair
- See Appendix for Window Schedule & Measurements

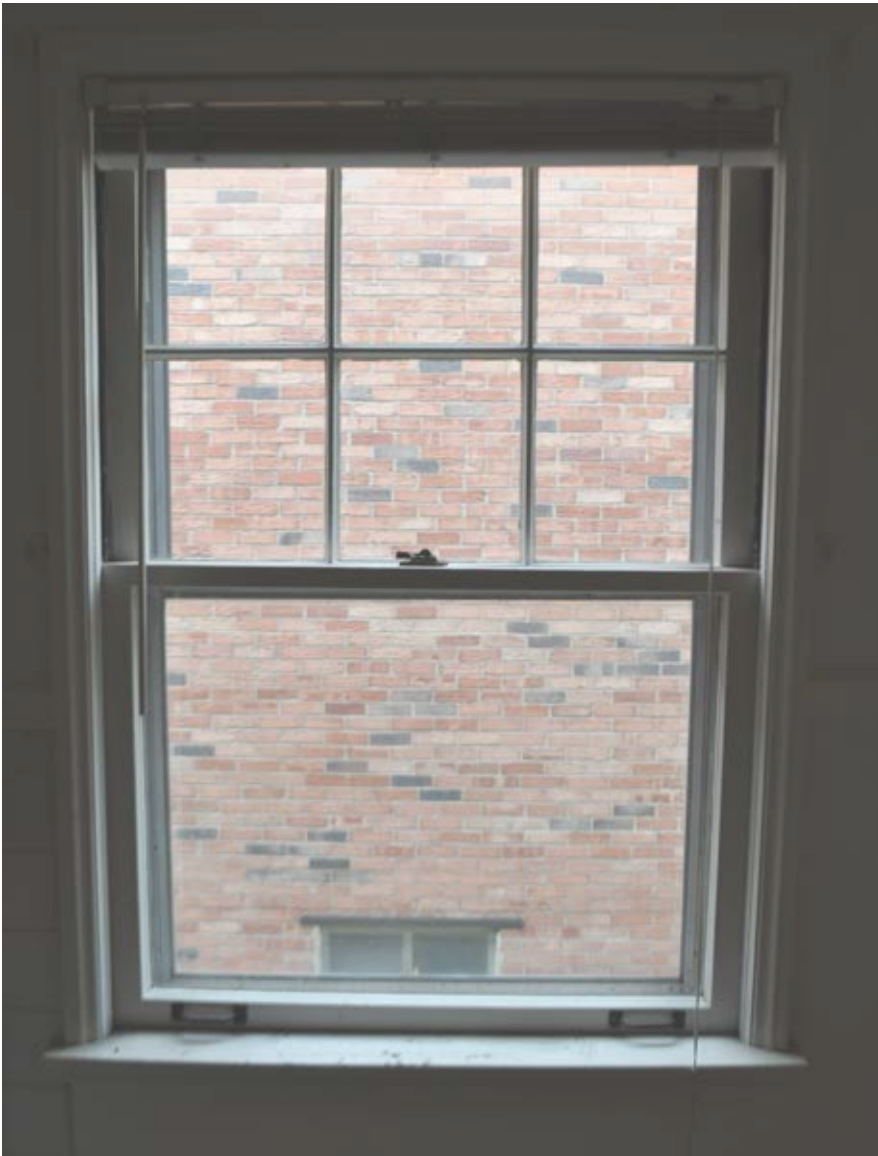
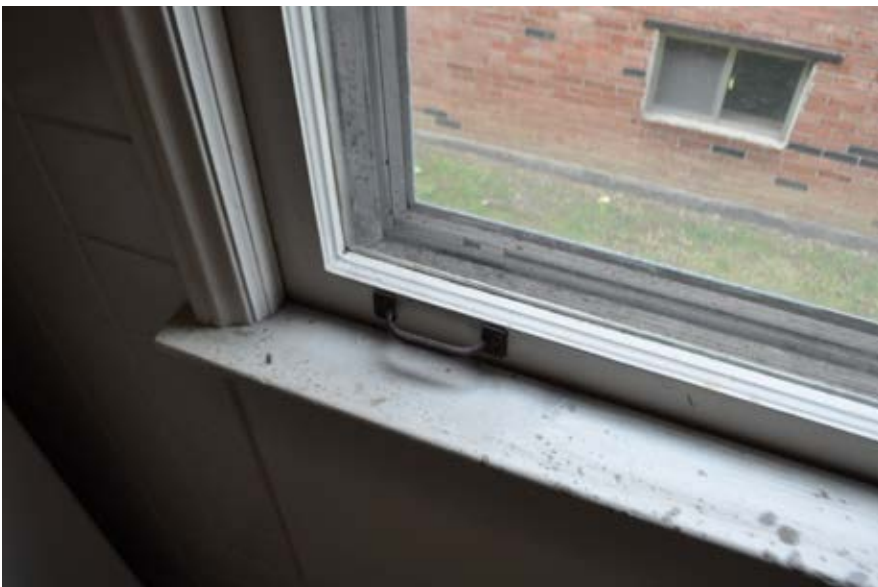
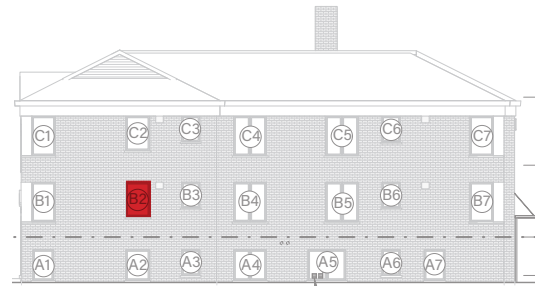
Window B2, Type E1

- Note: Extent of exterior deterioration, dry rot, and loss of operability is not fully apparent in interior photos. Replacement parts for existing windows are unavailable, making restoration of thermal and operable functionality impossible, and long-term maintenance infeasible. Recommendation is for replacement, for quality of life of future tenants and for feasibility of long-term maintenance.
- See Window Assessment (Blackberry) in appendix for further detail and information, including further notes on deterioration beyond repair
- See Appendix for Window Schedule & Measurements

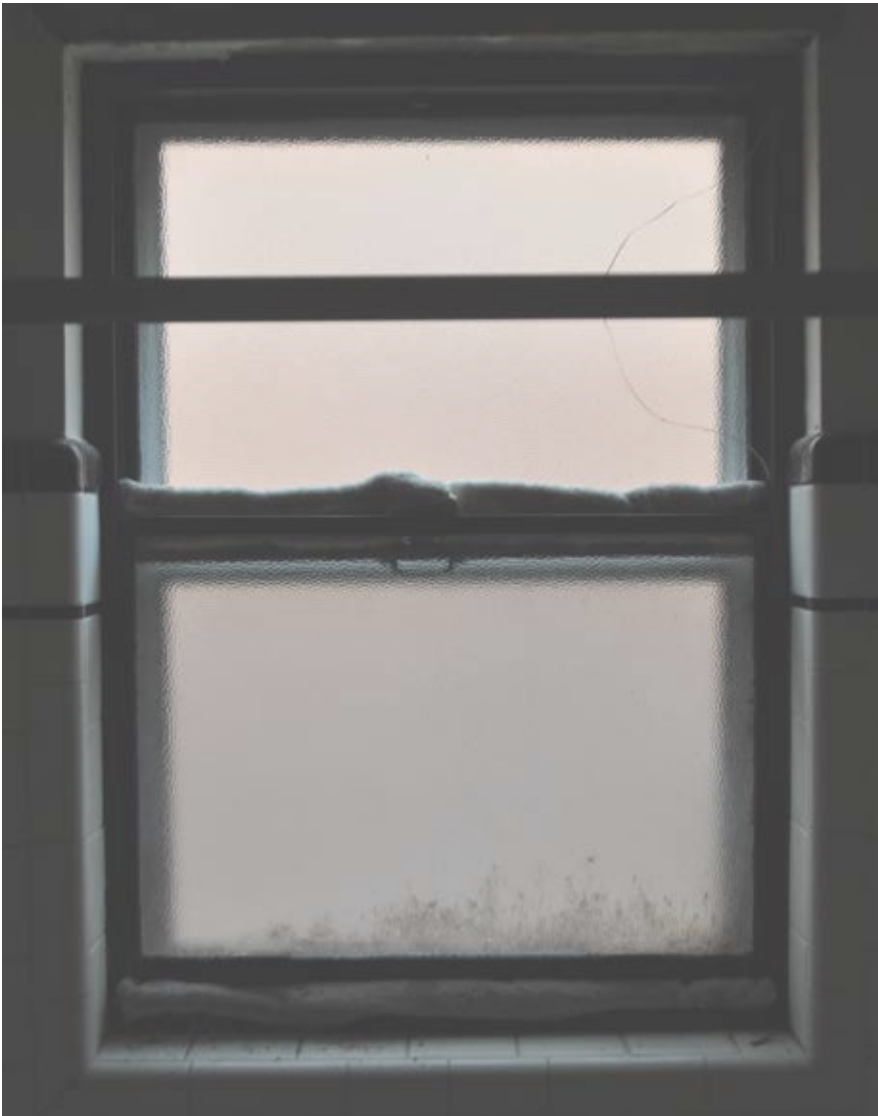
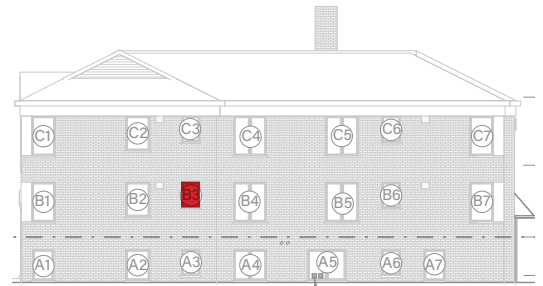
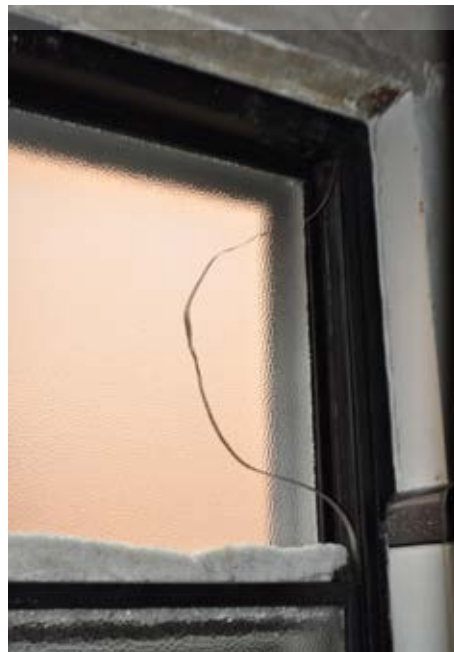
Window B3, Type G1

- Broken Balance
- Note: Extent of exterior deterioration, dry rot, and loss of operability is not fully apparent in interior photos. Replacement parts for existing windows are unavailable, making restoration of thermal and operable functionality impossible, and long-term maintenance infeasible. Recommendation is for replacement, for quality of life of future tenants and for feasibility of long-term maintenance.
- See Window Assessment (Blackberry) in appendix for further detail and information, including further notes on deterioration beyond repair
- See Appendix for Window Schedule & Measurements

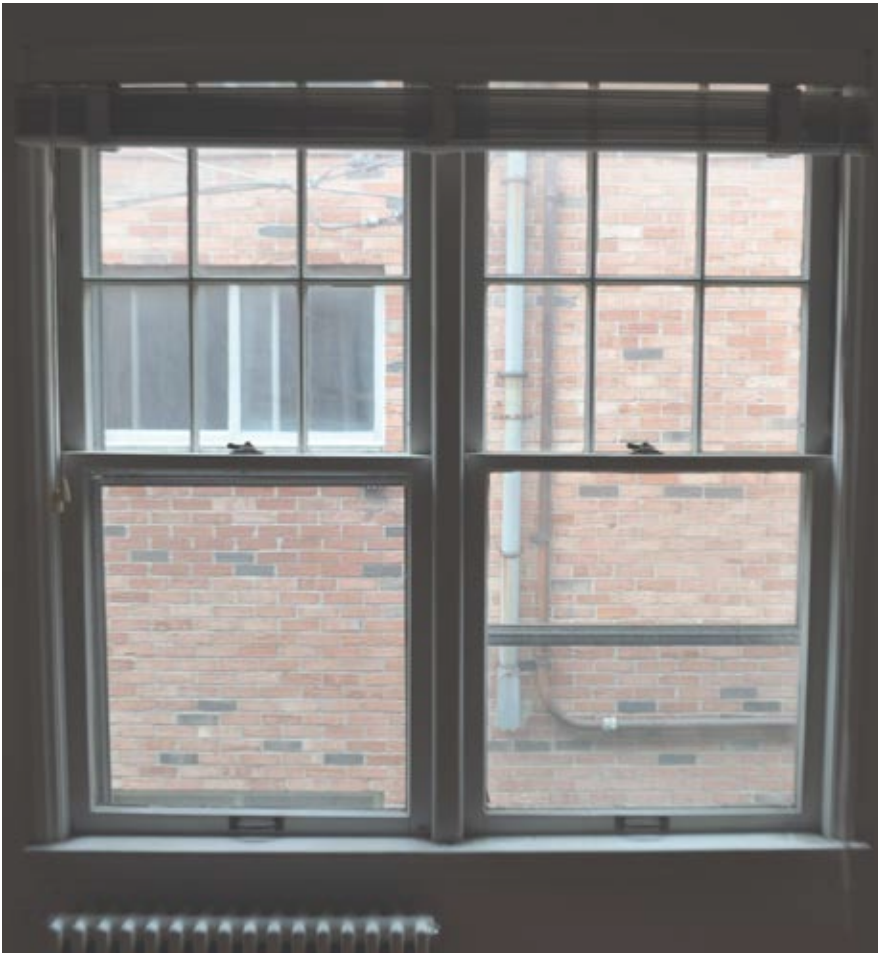
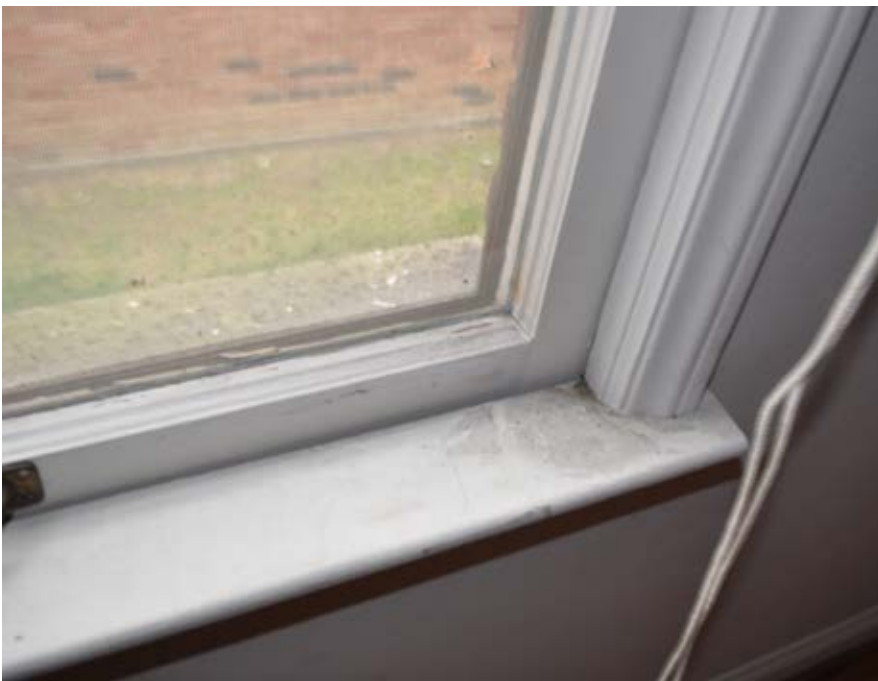
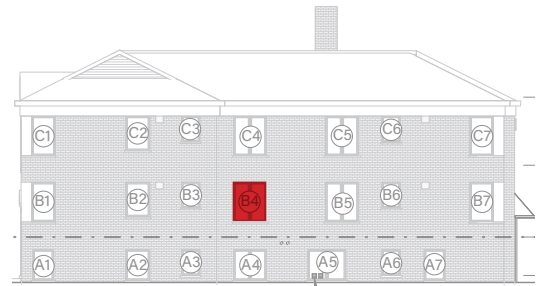
Window B4, Type K1

- Note: Extent of exterior deterioration, dry rot, and loss of operability is not fully apparent in interior photos. Replacement parts for existing windows are unavailable, making restoration of thermal and operable functionality impossible, and long-term maintenance infeasible. Recommendation is for replacement, for quality of life of future tenants and for feasibility of long-term maintenance.
- See Window Assessment (Blackberry) in appendix for further detail and information, including further notes on deterioration beyond repair
- See Appendix for Window Schedule & Measurements

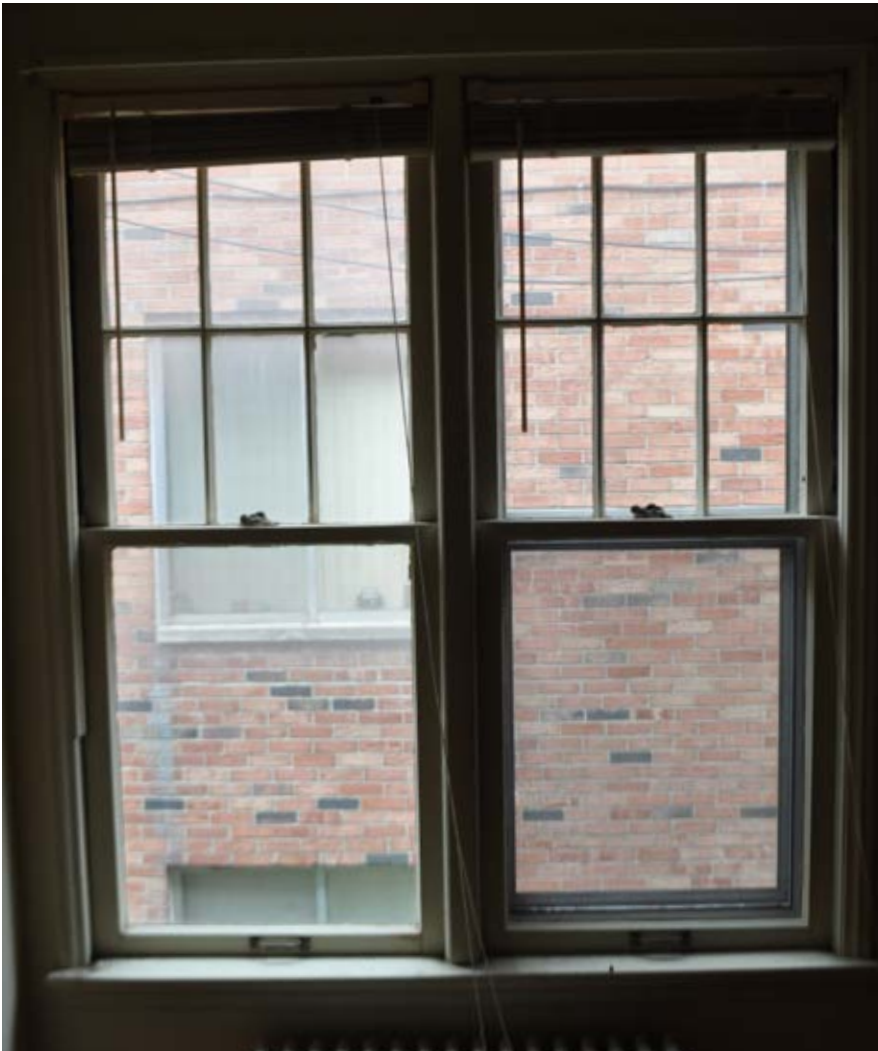
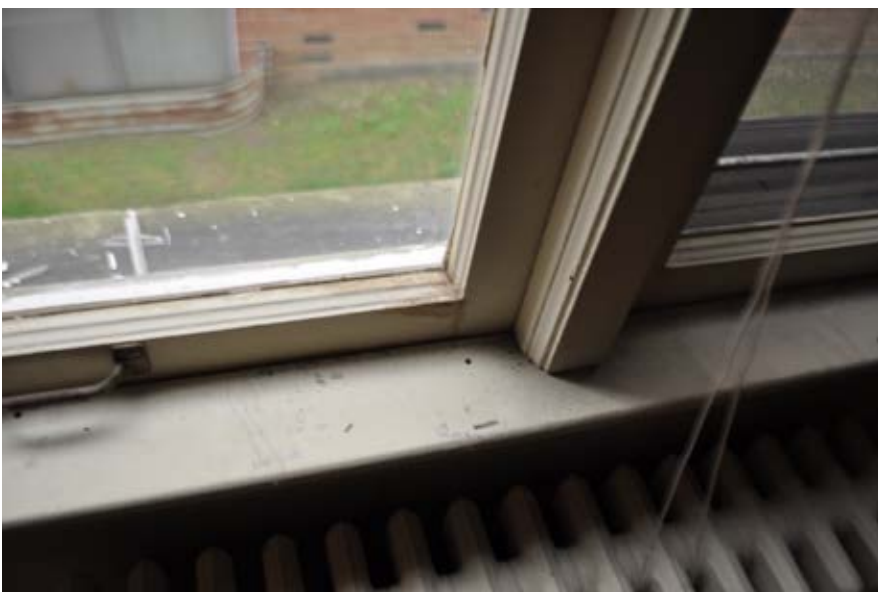
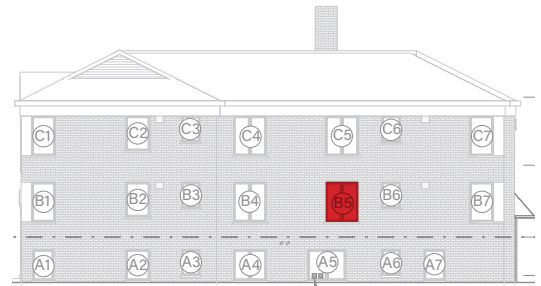
Window B5, Type K1

- Note: Extent of exterior deterioration, dry rot, and loss of operability is not fully apparent in interior photos. Replacement parts for existing windows are unavailable, making restoration of thermal and operable functionality impossible, and long-term maintenance infeasible. Recommendation is for replacement, for quality of life of future tenants and for feasibility of long-term maintenance.
- See Window Assessment (Blackberry) in appendix for further detail and information, including further notes on deterioration beyond repair
- See Appendix for Window Schedule & Measurements

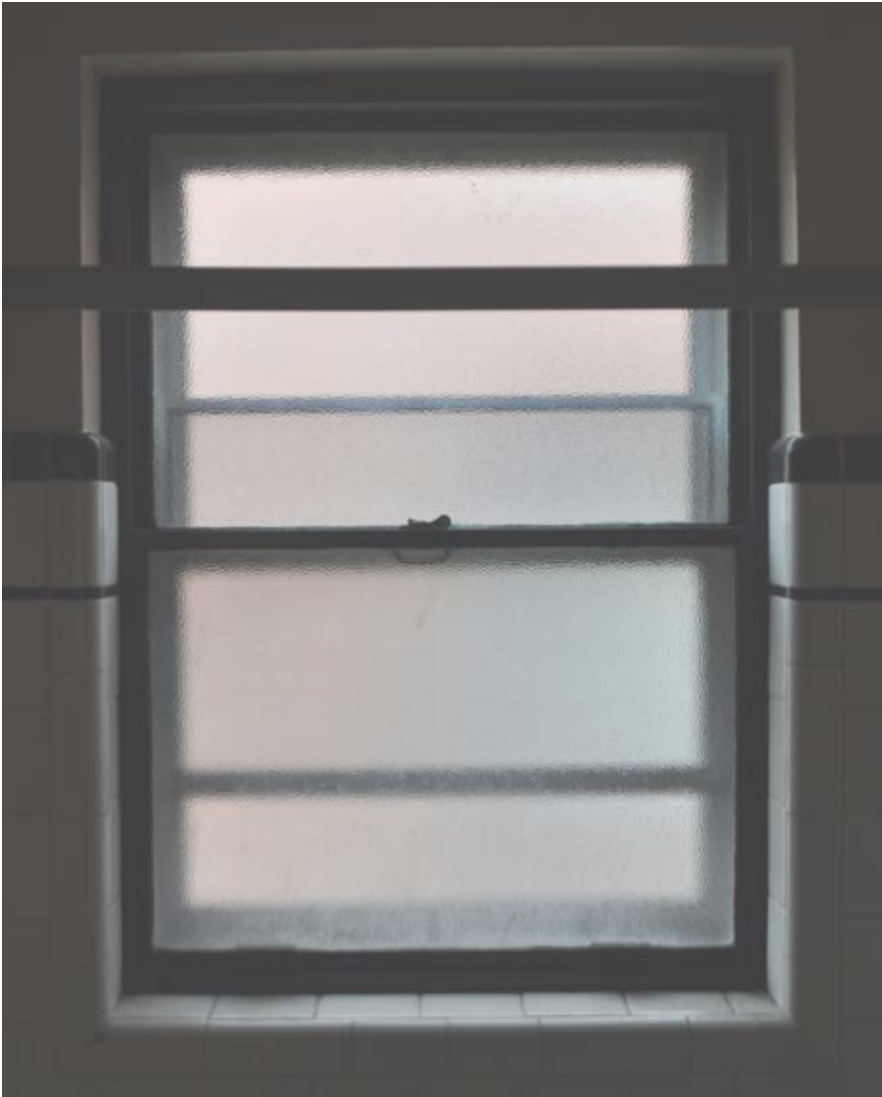
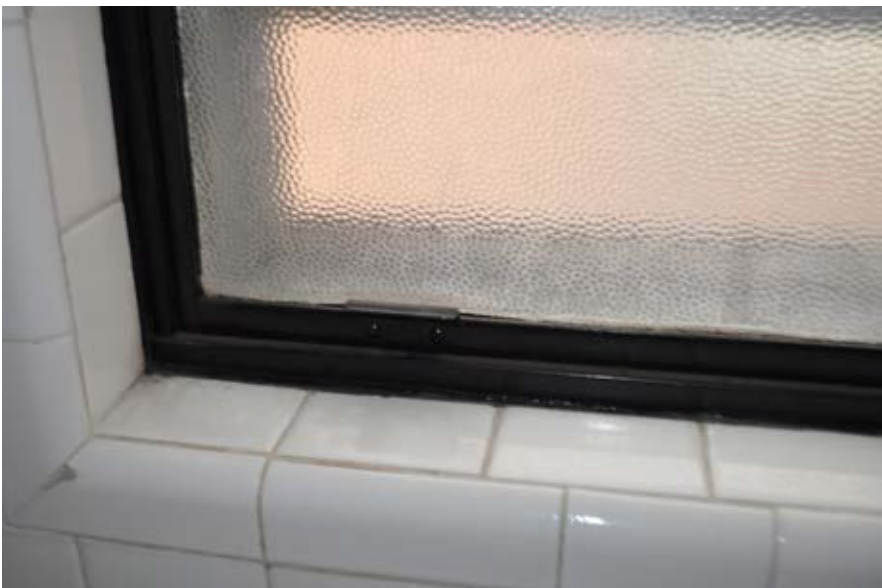
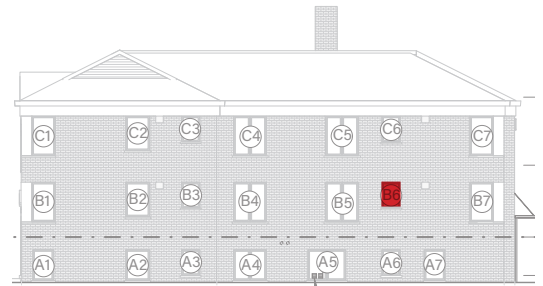
Window B6, Type G1

- Note: Extent of exterior deterioration, dry rot, and loss of operability is not fully apparent in interior photos. Replacement parts for existing windows are unavailable, making restoration of thermal and operable functionality impossible, and long-term maintenance infeasible. Recommendation is for replacement, for quality of life of future tenants and for feasibility of long-term maintenance.
- See Window Assessment (Blackberry) in appendix for further detail and information, including further notes on deterioration beyond repair
- See Appendix for Window Schedule & Measurements

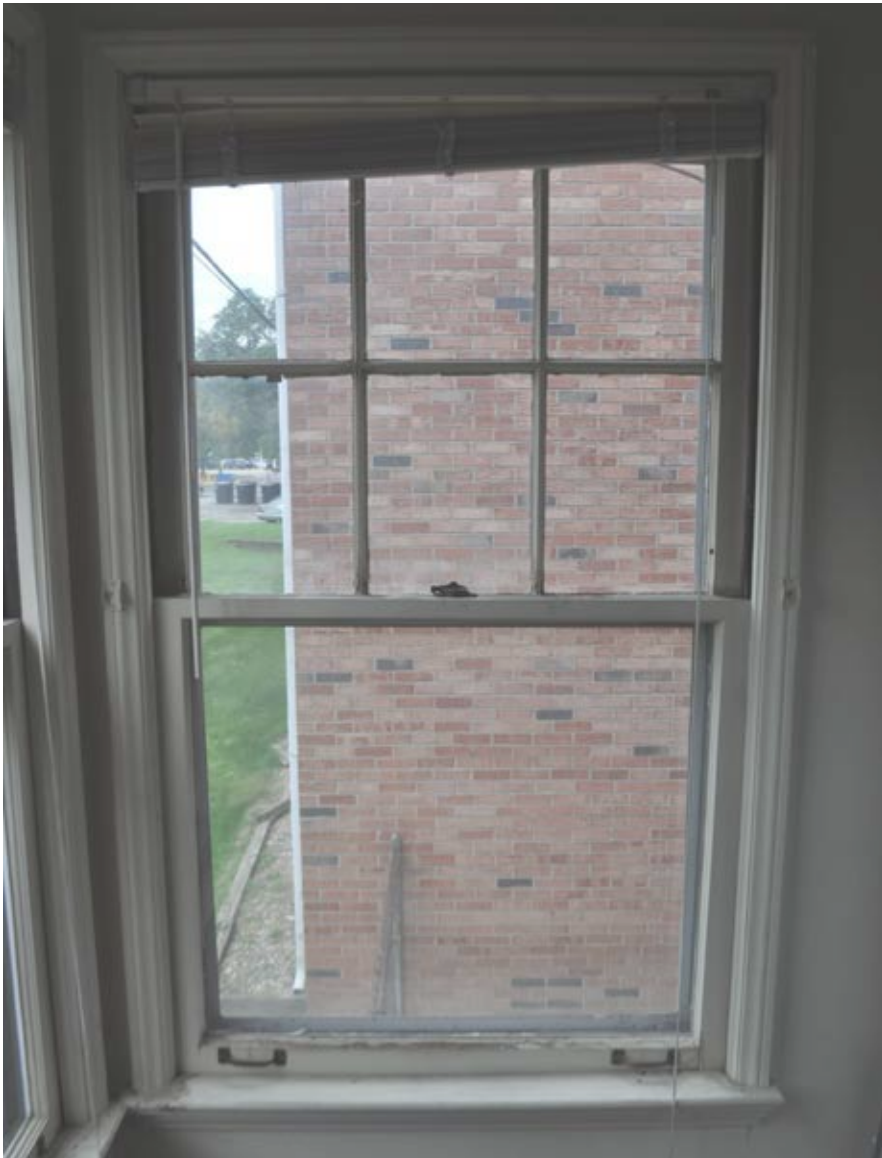
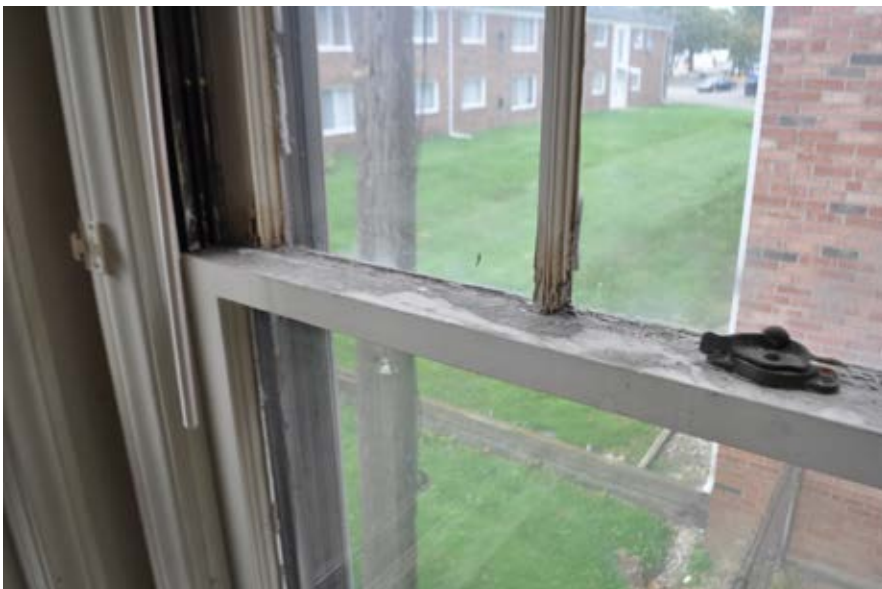
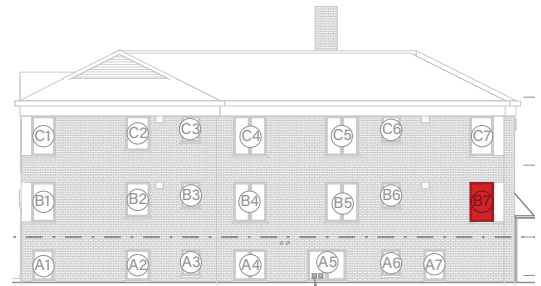
Window B7, Type A1

- Badly Rotted
- Note: Extent of exterior deterioration, dry rot, and loss of operability is not fully apparent in interior photos. Replacement parts for existing windows are unavailable, making restoration of thermal and operable functionality impossible, and long-term maintenance infeasible. Recommendation is for replacement, for quality of life of future tenants and for feasibility of long-term maintenance.
- See Window Assessment (Blackberry) in appendix for further detail and information, including further notes on deterioration beyond repair
- See Appendix for Window Schedule & Measurements

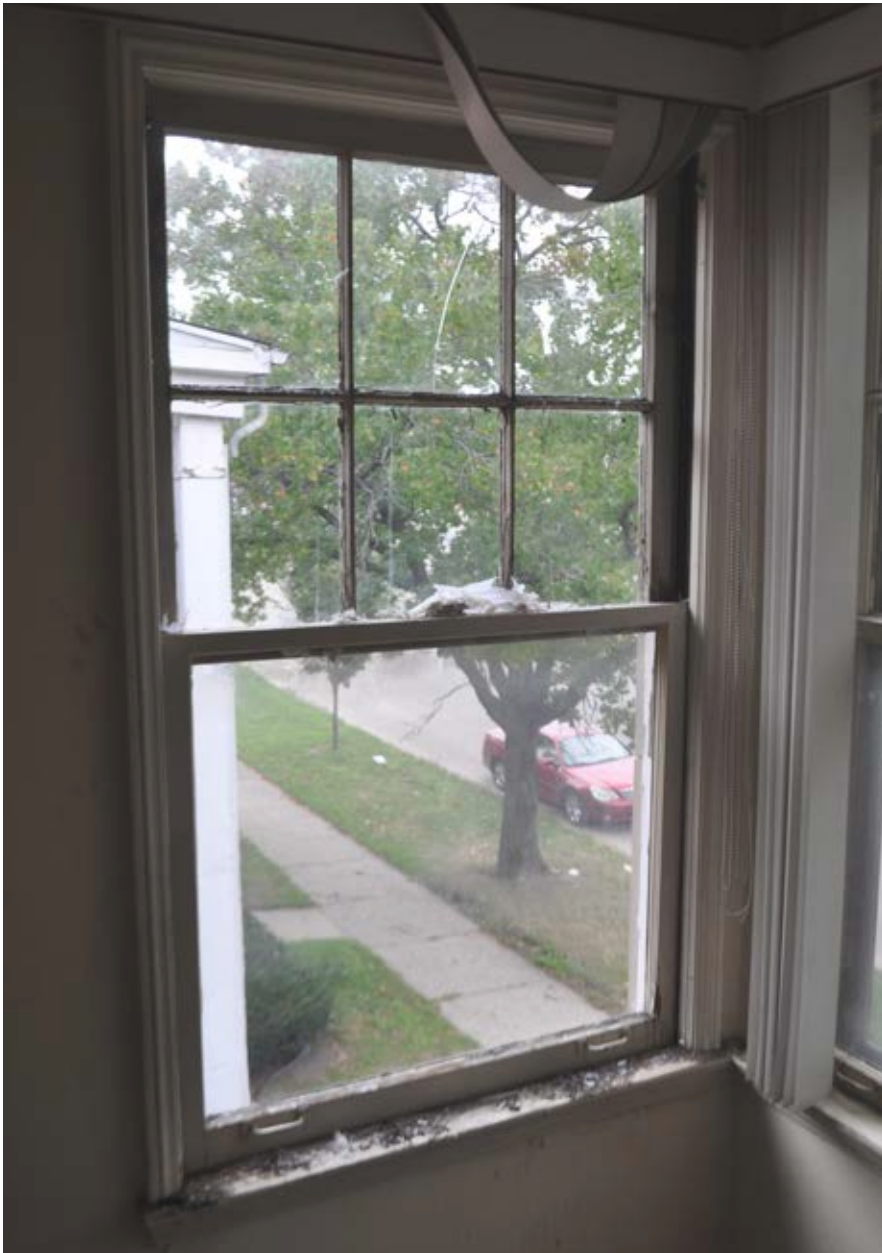
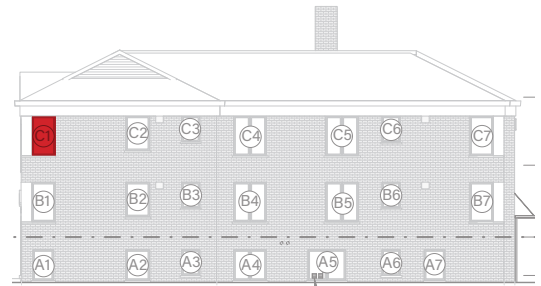
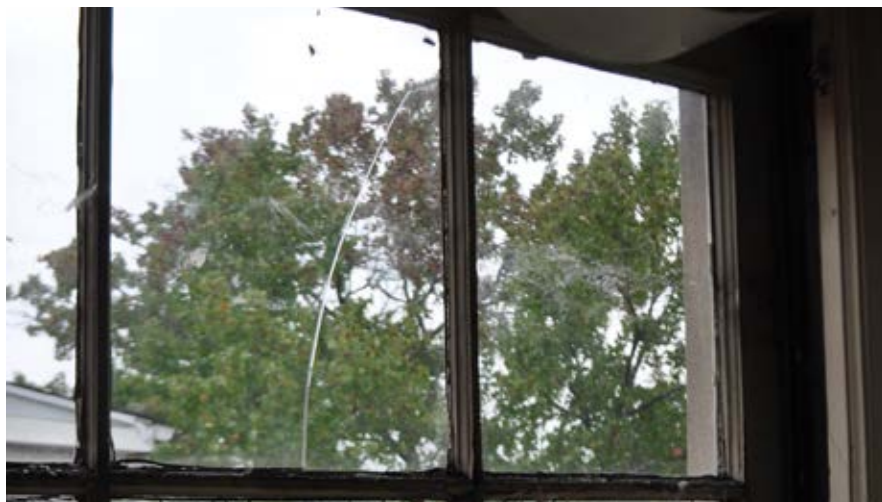
Window C1, Type A1

- Broken Glass
- Note: Extent of exterior deterioration, dry rot, and loss of operability is not fully apparent in interior photos. Replacement parts for existing windows are unavailable, making restoration of thermal and operable functionality impossible, and long-term maintenance infeasible. Recommendation is for replacement, for quality of life of future tenants and for feasibility of long-term maintenance.
- See Window Assessment (Blackberry) in appendix for further detail and information, including further notes on deterioration beyond repair
- See Appendix for Window Schedule & Measurements

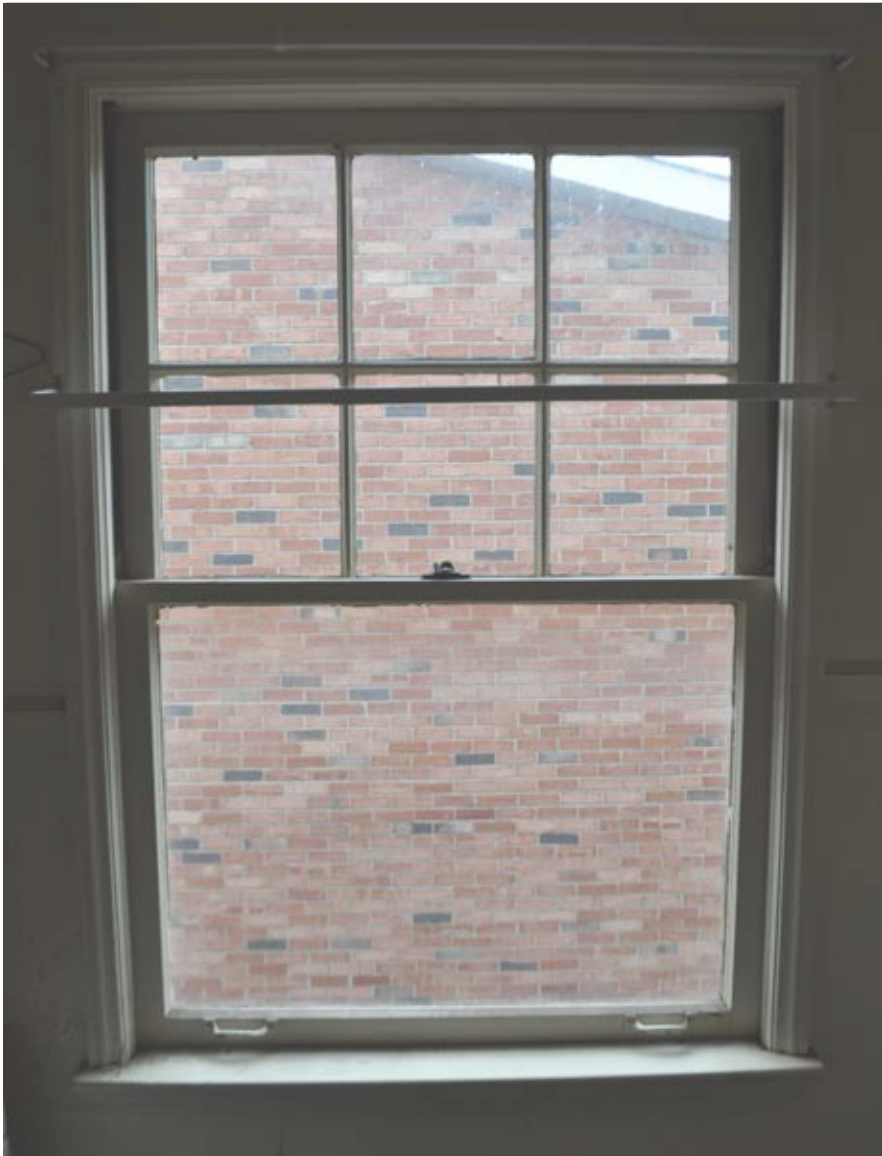
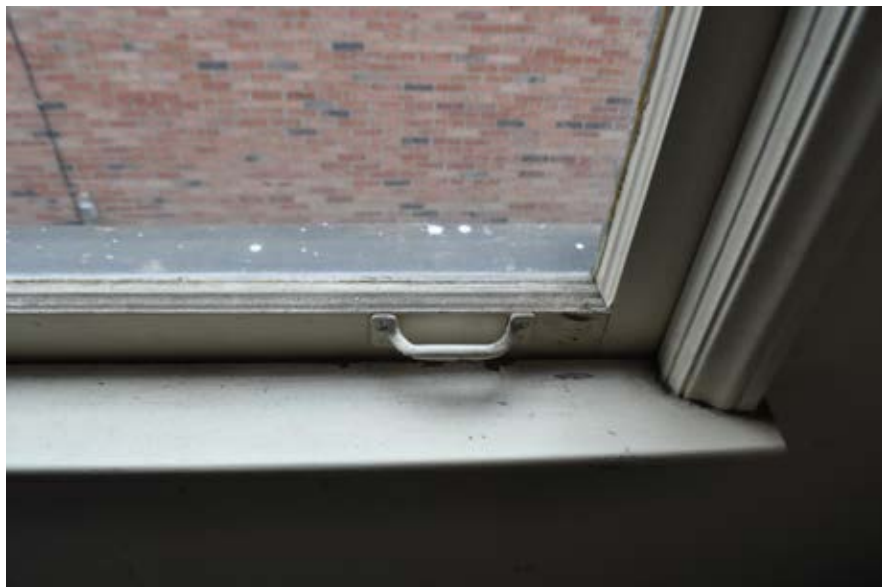
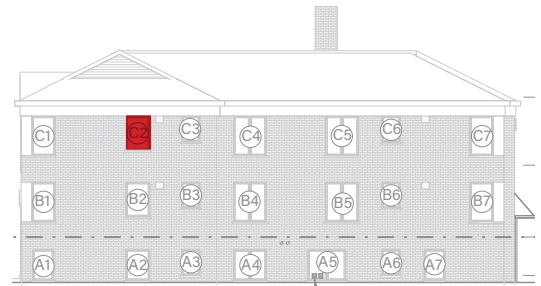
Window C2, Type E1

- Note: Extent of exterior deterioration, dry rot, and loss of operability is not fully apparent in interior photos. Replacement parts for existing windows are unavailable, making restoration of thermal and operable functionality impossible, and long-term maintenance infeasible. Recommendation is for replacement, for quality of life of future tenants and for feasibility of long-term maintenance.
- See Window Assessment (Blackberry) in appendix for further detail and information, including further notes on deterioration beyond repair
- See Appendix for Window Schedule & Measurements

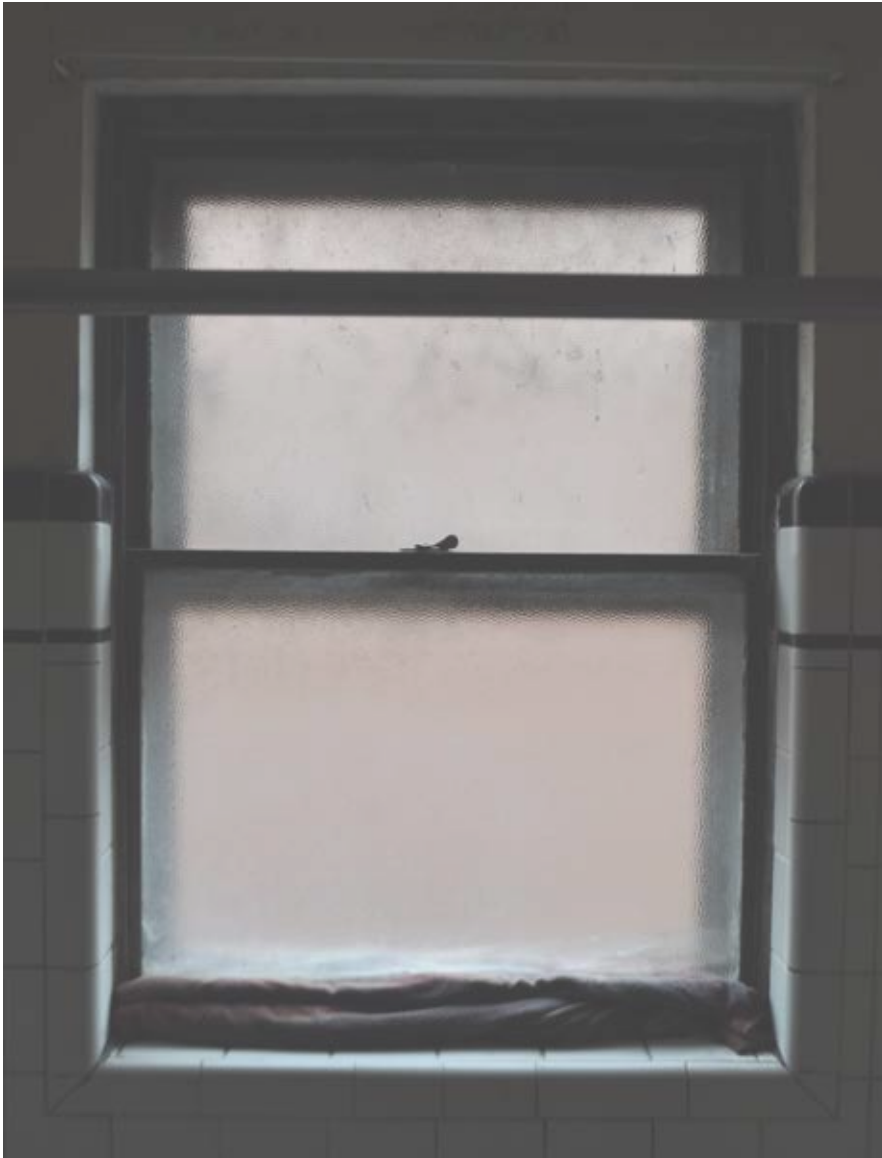
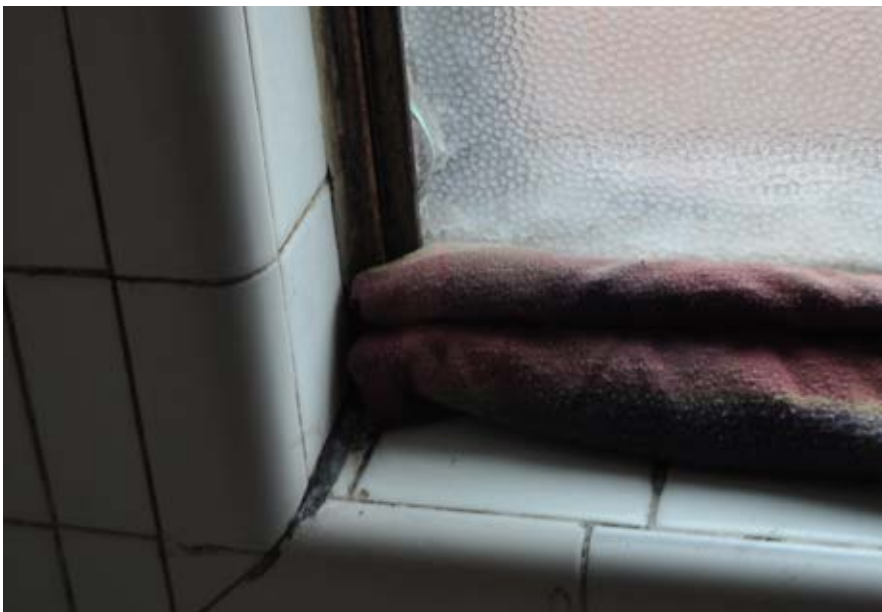
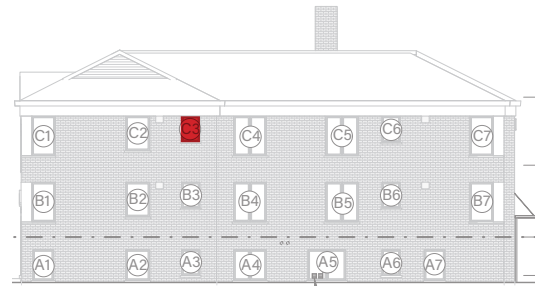
Window C3, Type G1

- Broken Glass
- Note: Extent of exterior deterioration, dry rot, and loss of operability is not fully apparent in interior photos. Replacement parts for existing windows are unavailable, making restoration of thermal and operable functionality impossible, and long-term maintenance infeasible. Recommendation is for replacement, for quality of life of future tenants and for feasibility of long-term maintenance.
- See Window Assessment (Blackberry) in appendix for further detail and information, including further notes on deterioration beyond repair
- See Appendix for Window Schedule & Measurements

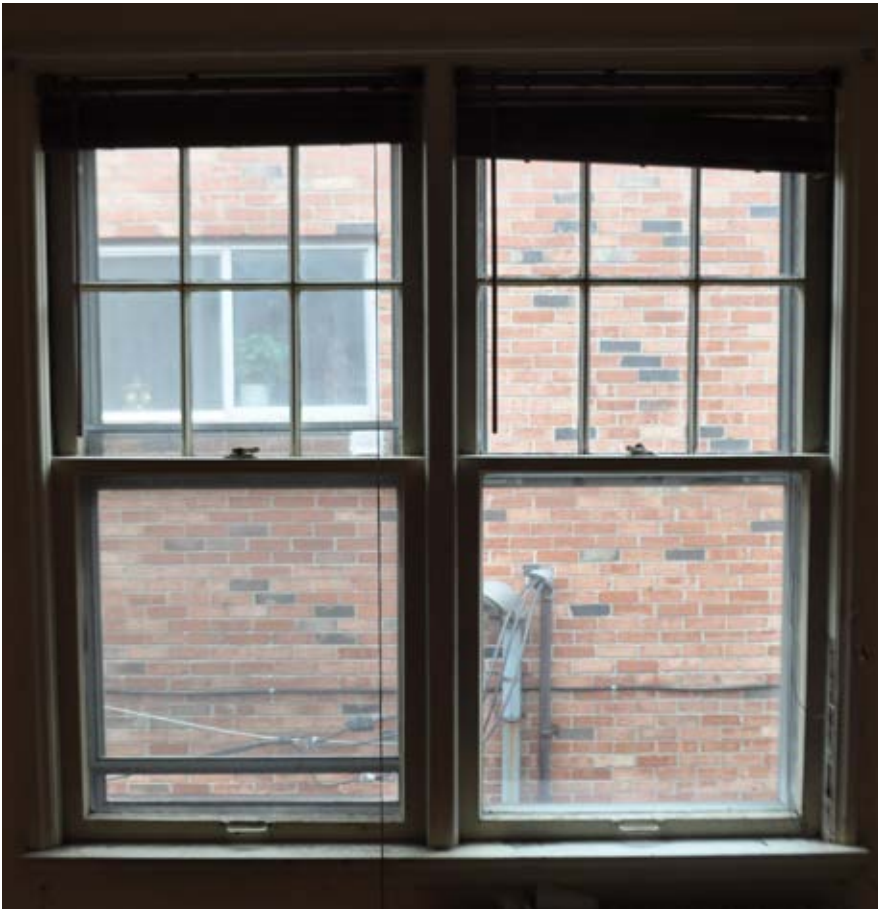
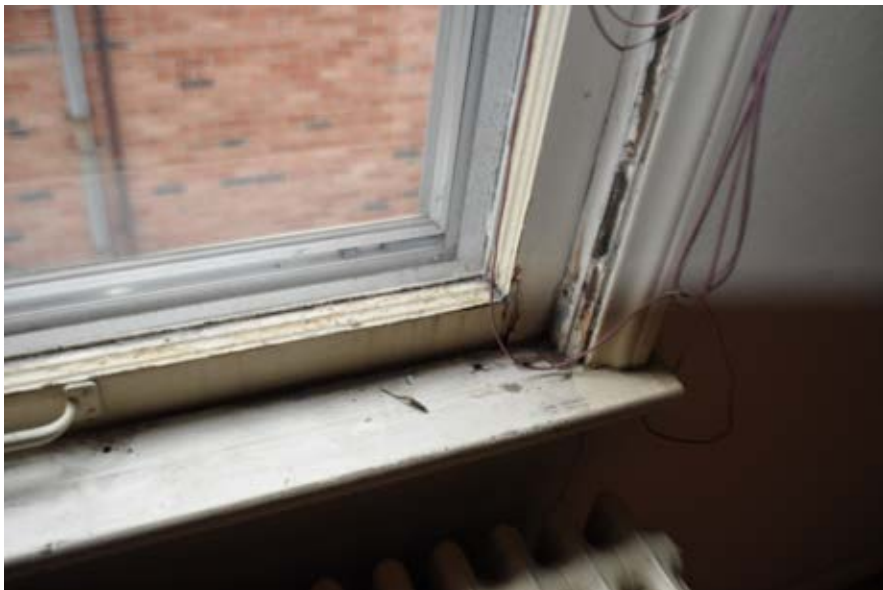
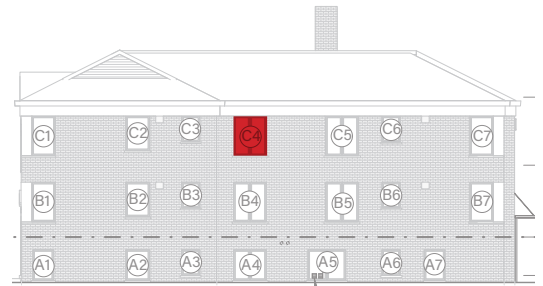
Window C4, Type K1

- Note: Extent of exterior deterioration, dry rot, and loss of operability is not fully apparent in interior photos. Replacement parts for existing windows are unavailable, making restoration of thermal and operable functionality impossible, and long-term maintenance infeasible. Recommendation is for replacement, for quality of life of future tenants and for feasibility of long-term maintenance.
- See Window Assessment (Blackberry) in appendix for further detail and information, including further notes on deterioration beyond repair
- See Appendix for Window Schedule & Measurements

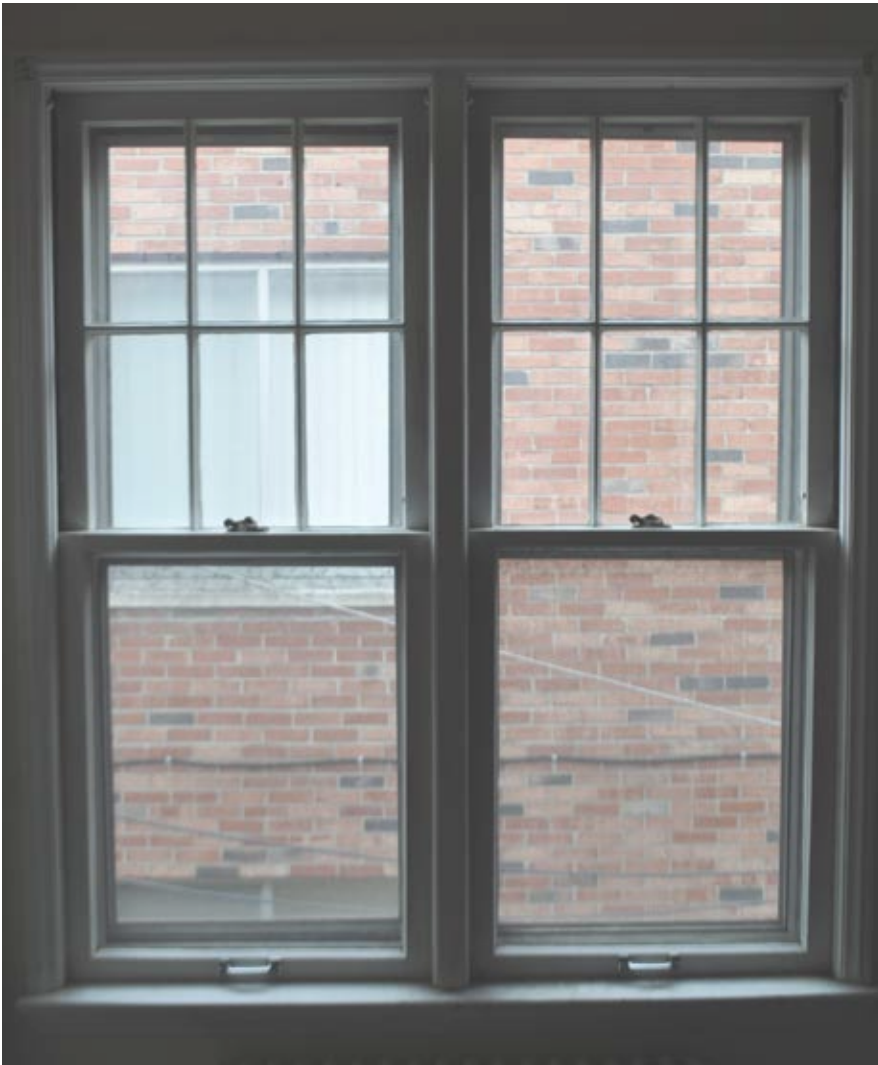
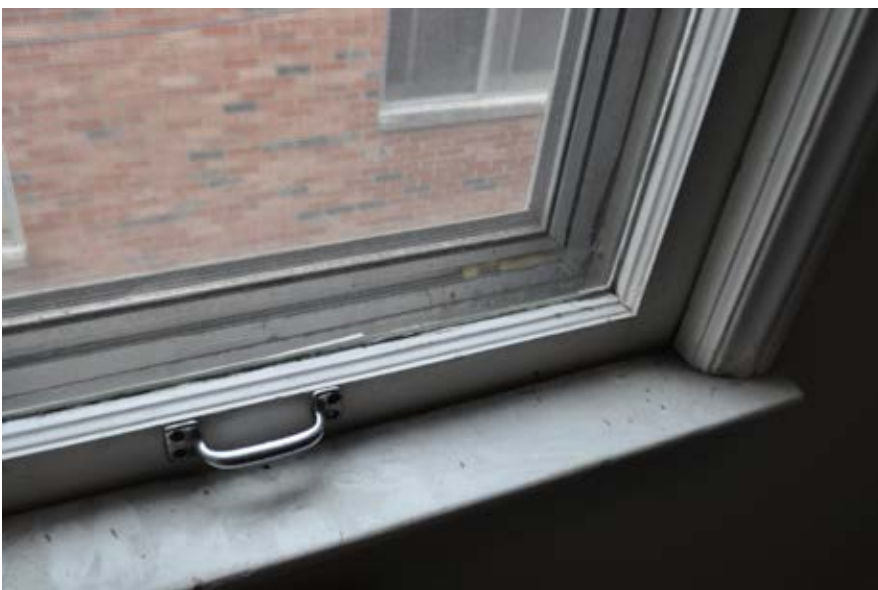
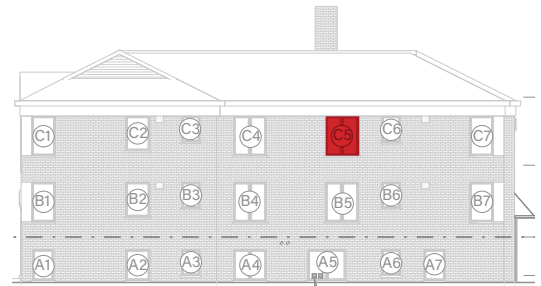
Window C5, Type K1

- Note: Extent of exterior deterioration, dry rot, and loss of operability is not fully apparent in interior photos. Replacement parts for existing windows are unavailable, making restoration of thermal and operable functionality impossible, and long-term maintenance infeasible. Recommendation is for replacement, for quality of life of future tenants and for feasibility of long-term maintenance.
- See Window Assessment (Blackberry) in appendix for further detail and information, including further notes on deterioration beyond repair
- See Appendix for Window Schedule & Measurements
