9710 W Outer Dr

Existing Condition Photos

Current Design Description

A 3-story apartment structure with 10 residential units, constructed in 1940, brick on wood stud wall construction, shingle roof, stone corner details, stone details at palladian window, stone sills, wood detailing at front entry, steel and wood canopy at back entry, wood windows throughout with the exception of steel windows at bathrooms and the lowest level. The addition of a brick shed to house the gas meter was made at a later date.

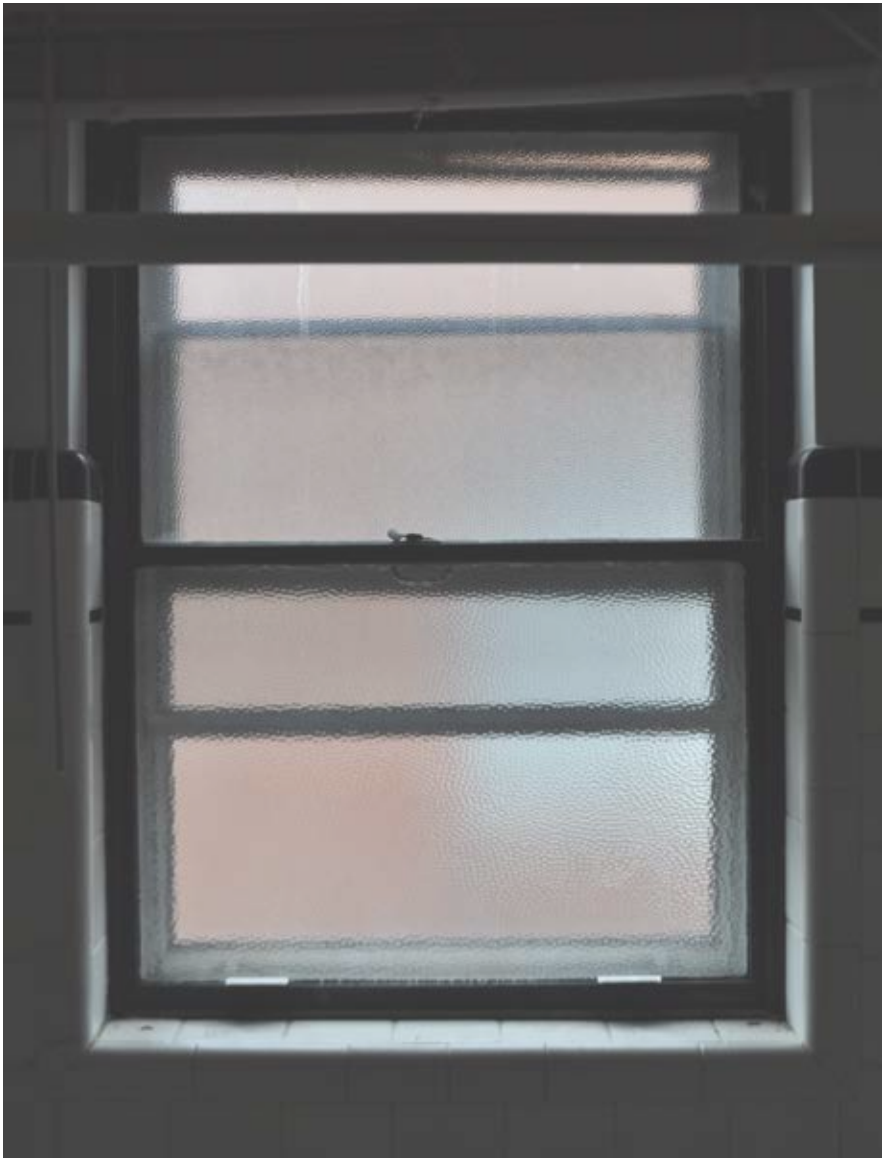
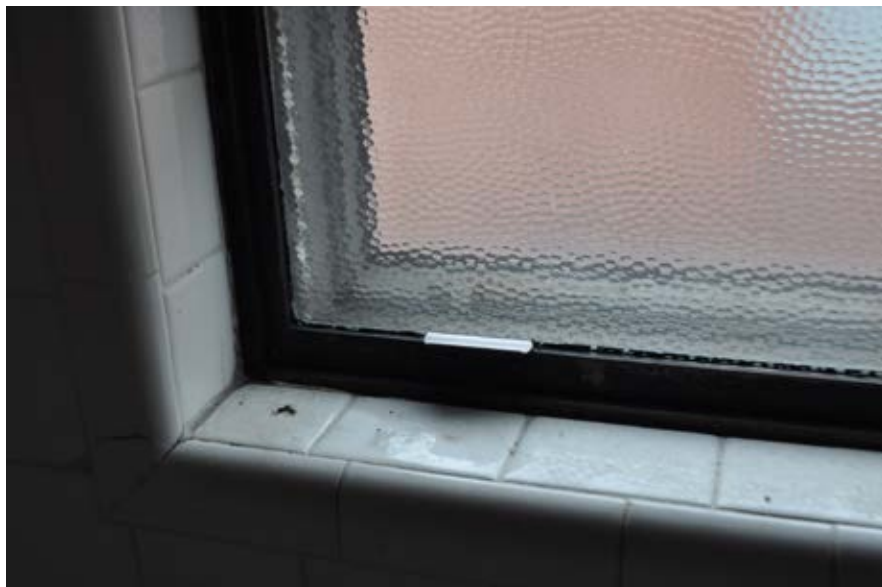
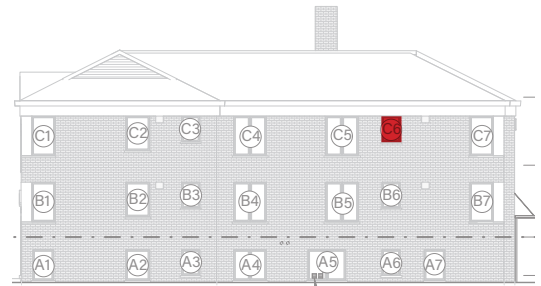
Window C6, Type G1

- Note: Extent of exterior deterioration, dry rot, and loss of operability is not fully apparent in interior photos. Replacement parts for existing windows are unavailable, making restoration of thermal and operable functionality impossible, and long-term maintenance infeasible. Recommendation is for replacement, for quality of life of future tenants and for feasibility of long-term maintenance.
- See Window Assessment (Blackberry) in appendix for further detail and information, including further notes on deterioration beyond repair
- See Appendix for Window Schedule & Measurements

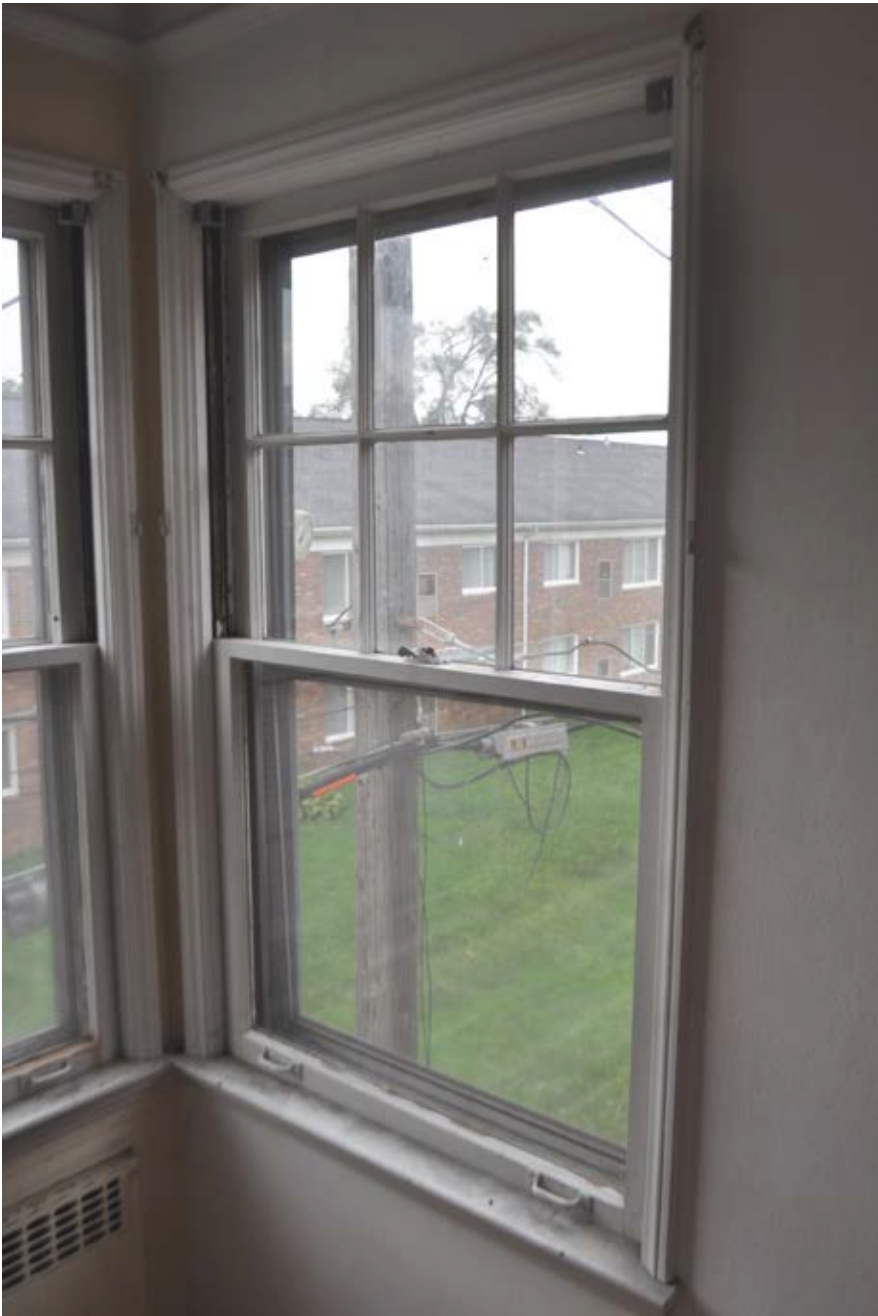
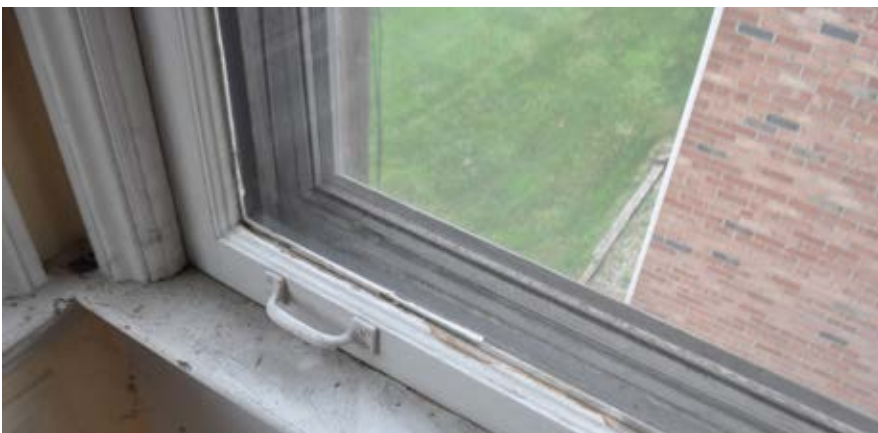
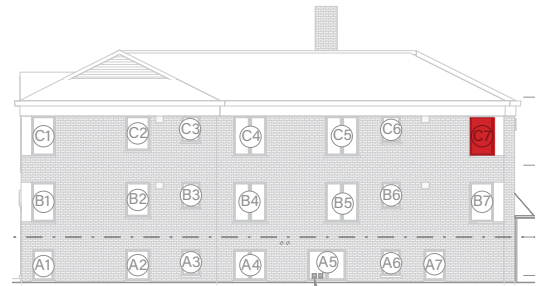
Window C7, Type A1

- Note: Extent of exterior deterioration, dry rot, and loss of operability is not fully apparent in interior photos. Replacement parts for existing windows are unavailable, making restoration of thermal and operable functionality impossible, and long-term maintenance infeasible. Recommendation is for replacement, for quality of life of future tenants and for feasibility of long-term maintenance.
- See Window Assessment (Blackberry) in appendix for further detail and information, including further notes on deterioration beyond repair
- See Appendix for Window Schedule & Measurements

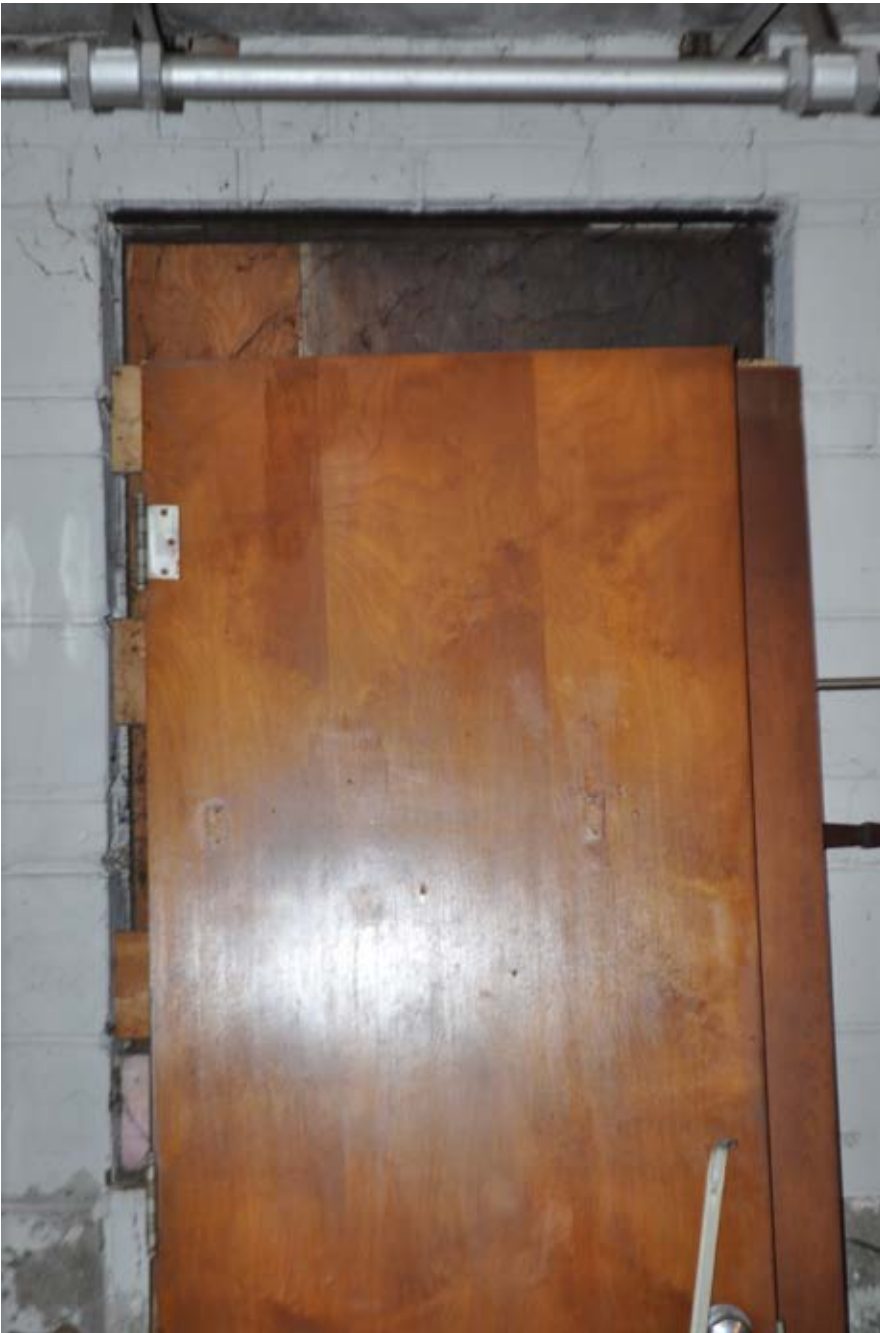
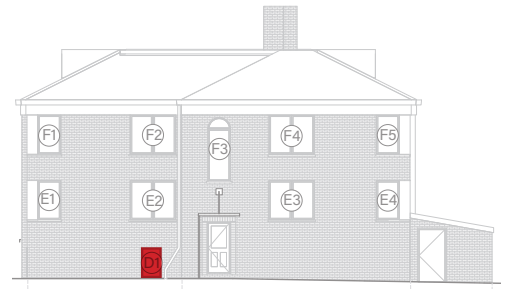
Window D1, Type D1

- Note: Extent of exterior deterioration, dry rot, and loss of operability is not fully apparent in interior photos. Replacement parts for existing windows are unavailable, making restoration of thermal and operable functionality impossible, and long-term maintenance infeasible. Recommendation is for replacement, for quality of life of future tenants and for feasibility of long-term maintenance.
- See Window Assessment (Blackberry) in appendix for further detail and information, including further notes on deterioration beyond repair
- See Appendix for Window Schedule & Measurements

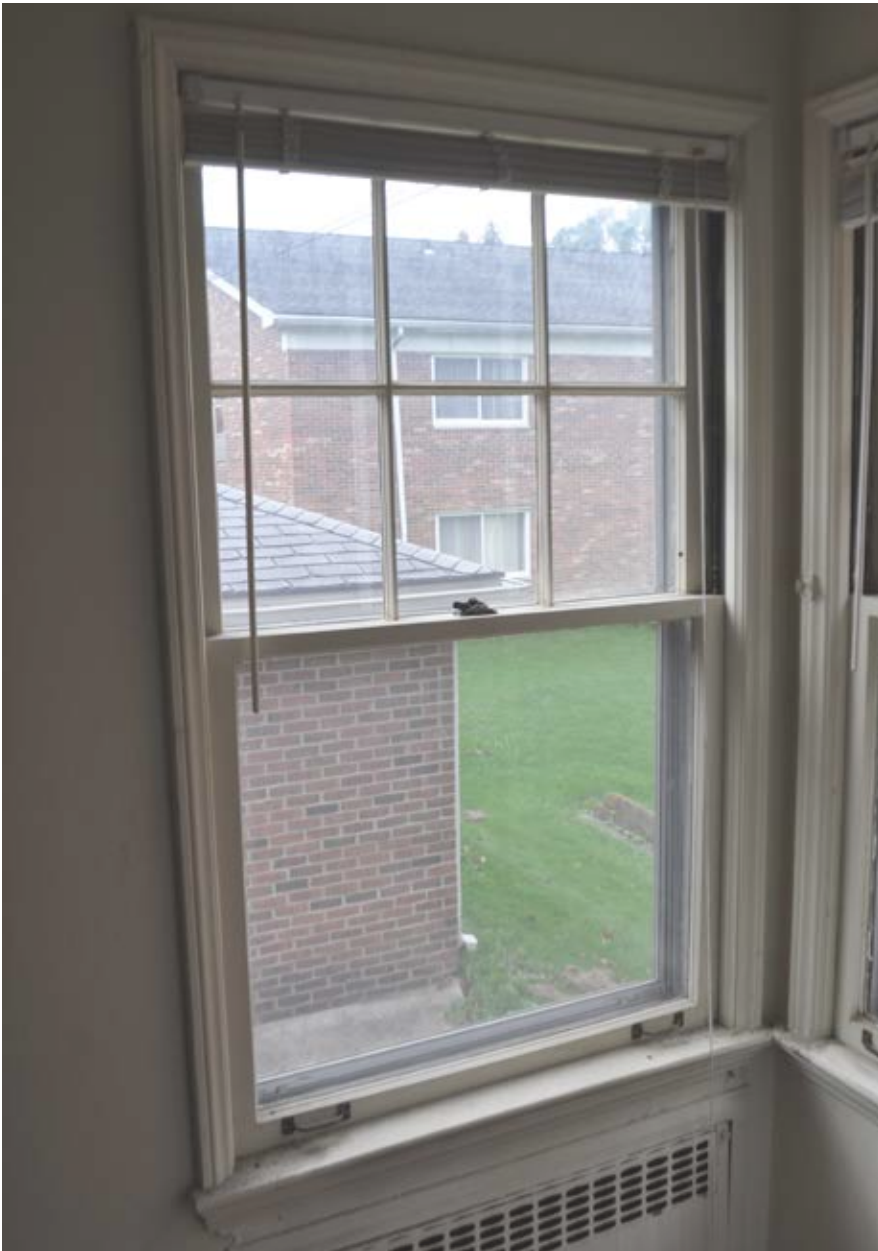
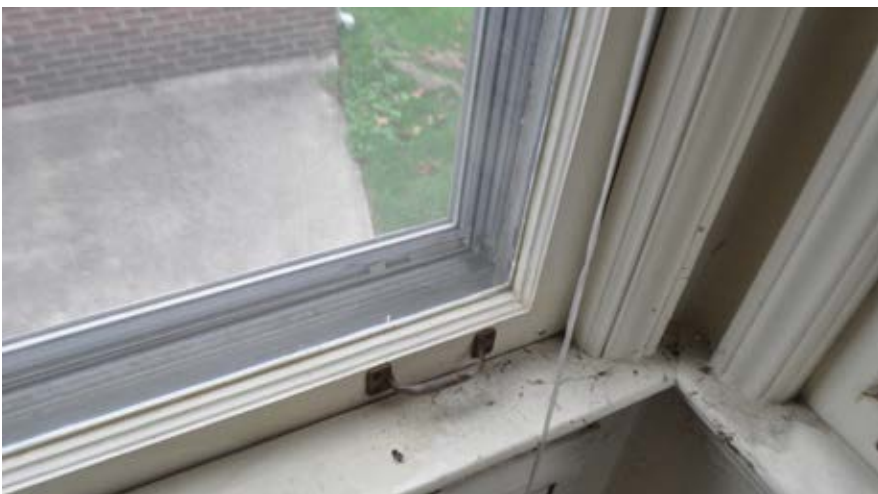
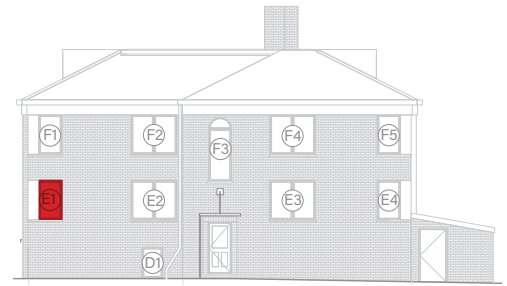
Window E1, Type A1

- Note: Extent of exterior deterioration, dry rot, and loss of operability is not fully apparent in interior photos. Replacement parts for existing windows are unavailable, making restoration of thermal and operable functionality impossible, and long-term maintenance infeasible. Recommendation is for replacement, for quality of life of future tenants and for feasibility of long-term maintenance.
- See Window Assessment (Blackberry) in appendix for further detail and information, including further notes on deterioration beyond repair
- See Appendix for Window Schedule & Measurements

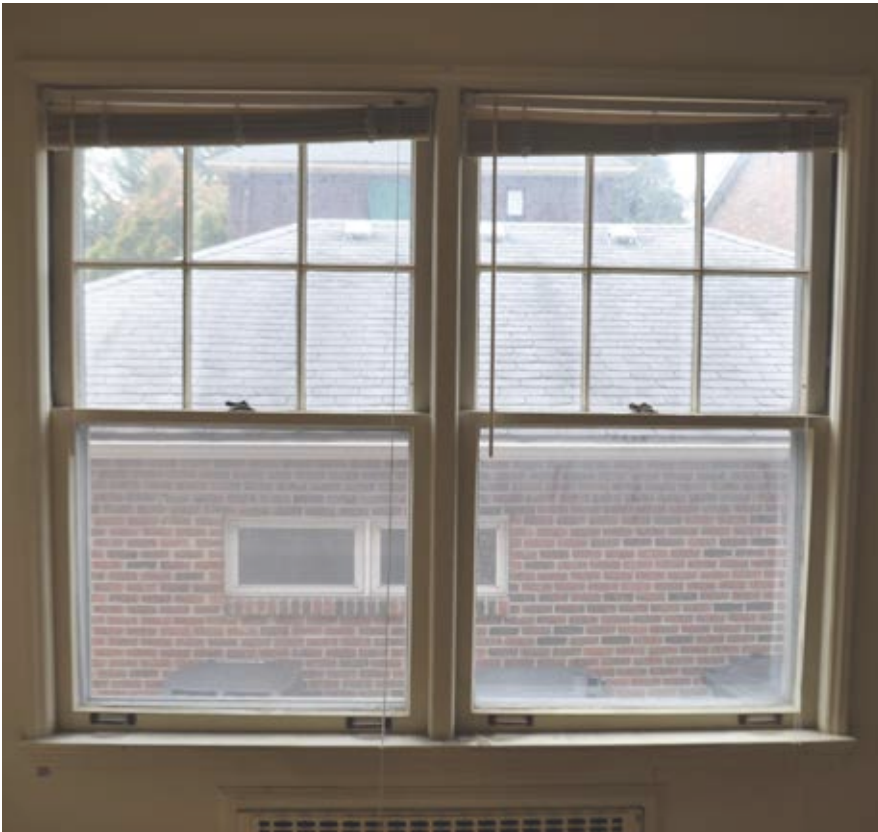
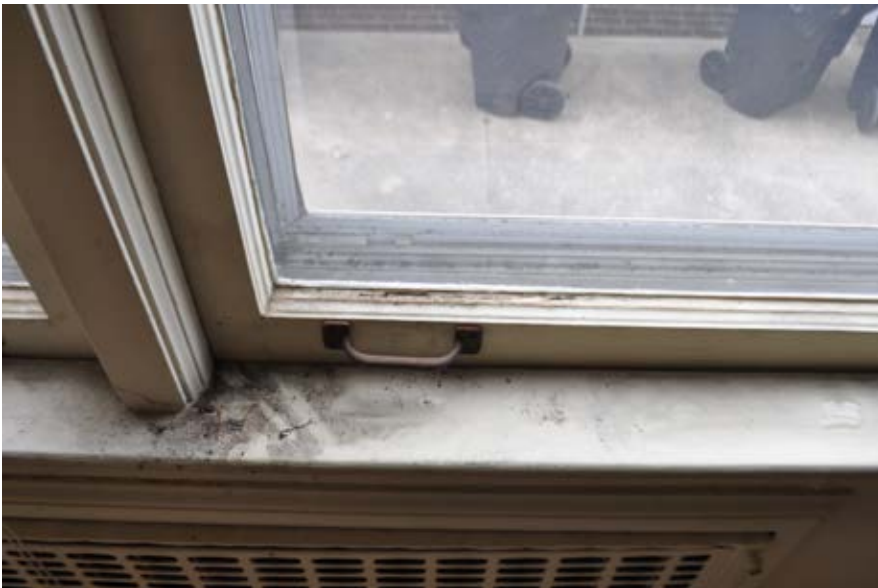
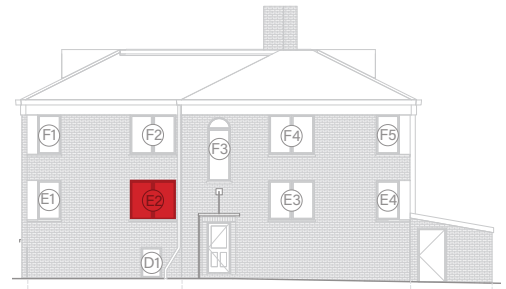
Window E2, Type B1

- Note: Extent of exterior deterioration, dry rot, and loss of operability is not fully apparent in interior photos. Replacement parts for existing windows are unavailable, making restoration of thermal and operable functionality impossible, and long-term maintenance infeasible. Recommendation is for replacement, for quality of life of future tenants and for feasibility of long-term maintenance.
- See Window Assessment (Blackberry) in appendix for further detail and information, including further notes on deterioration beyond repair
- See Appendix for Window Schedule & Measurements

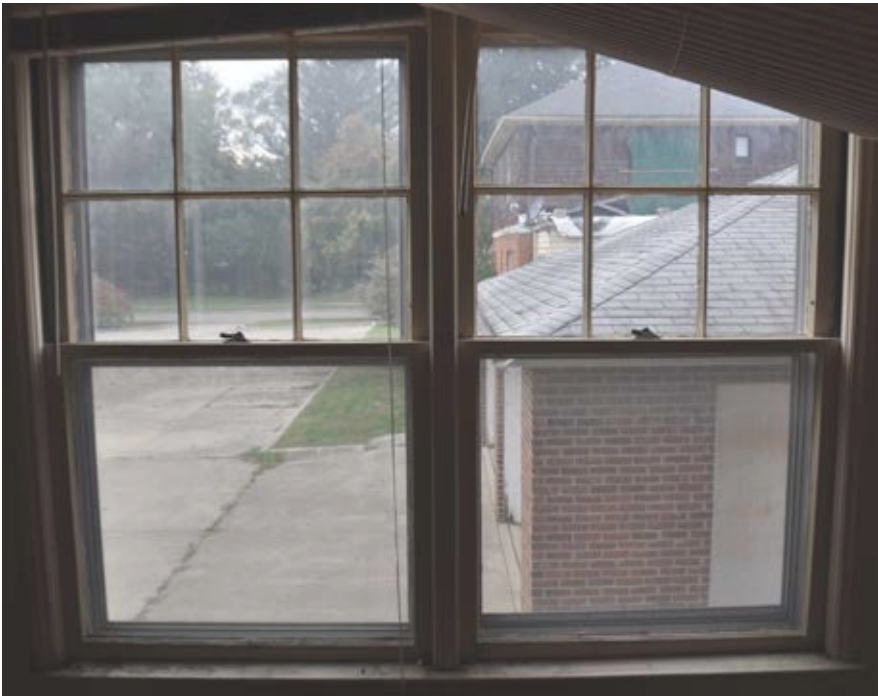
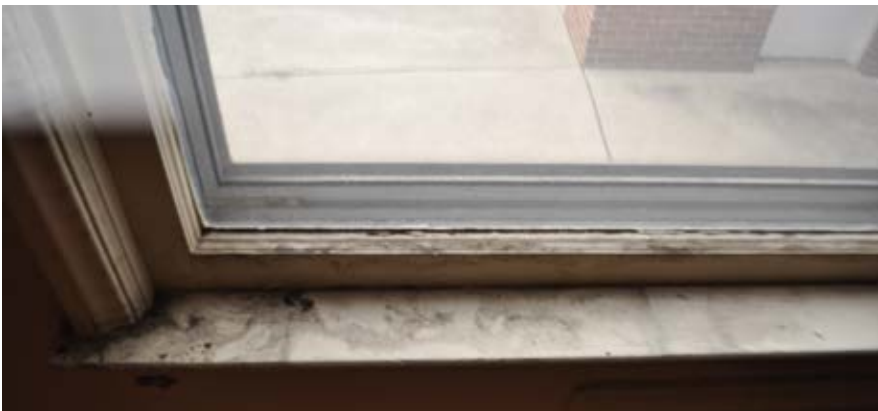
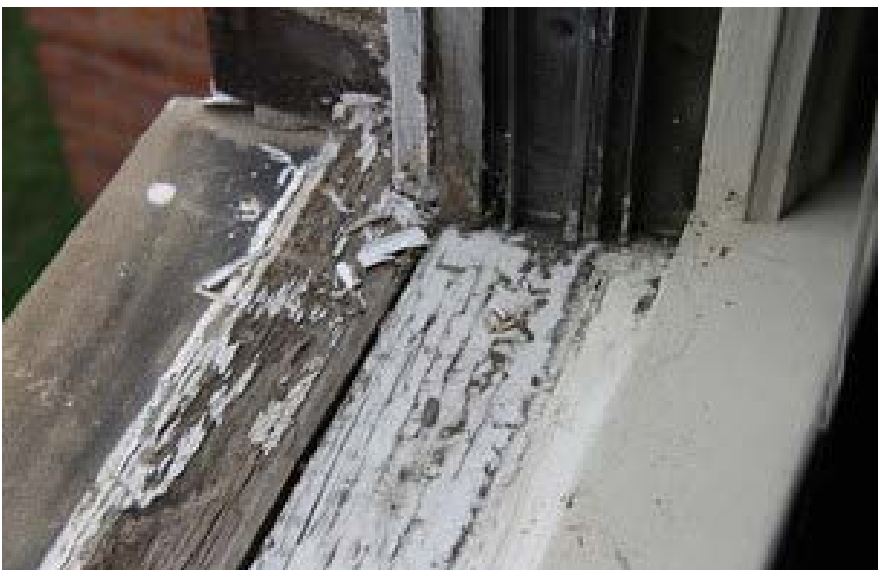
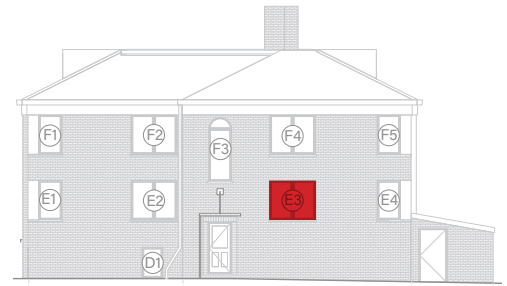
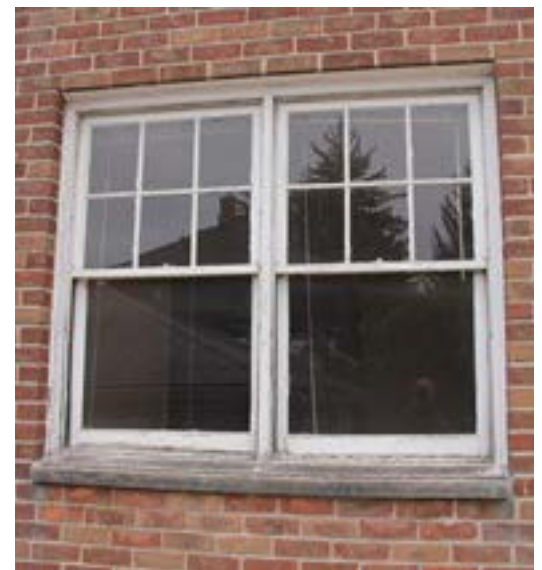
Window E3, Type B1

- Exterior Split Sill
- Note: Extent of exterior deterioration, dry rot, and loss of operability is not fully apparent in interior photos. Replacement parts for existing windows are unavailable, making restoration of thermal and operable functionality impossible, and long-term maintenance infeasible. Recommendation is for replacement, for quality of life of future tenants and for feasibility of long-term maintenance.
- See Window Assessment (Blackberry) in appendix for further detail and information, including further notes on deterioration beyond repair
- See Appendix for Window Schedule & Measurements

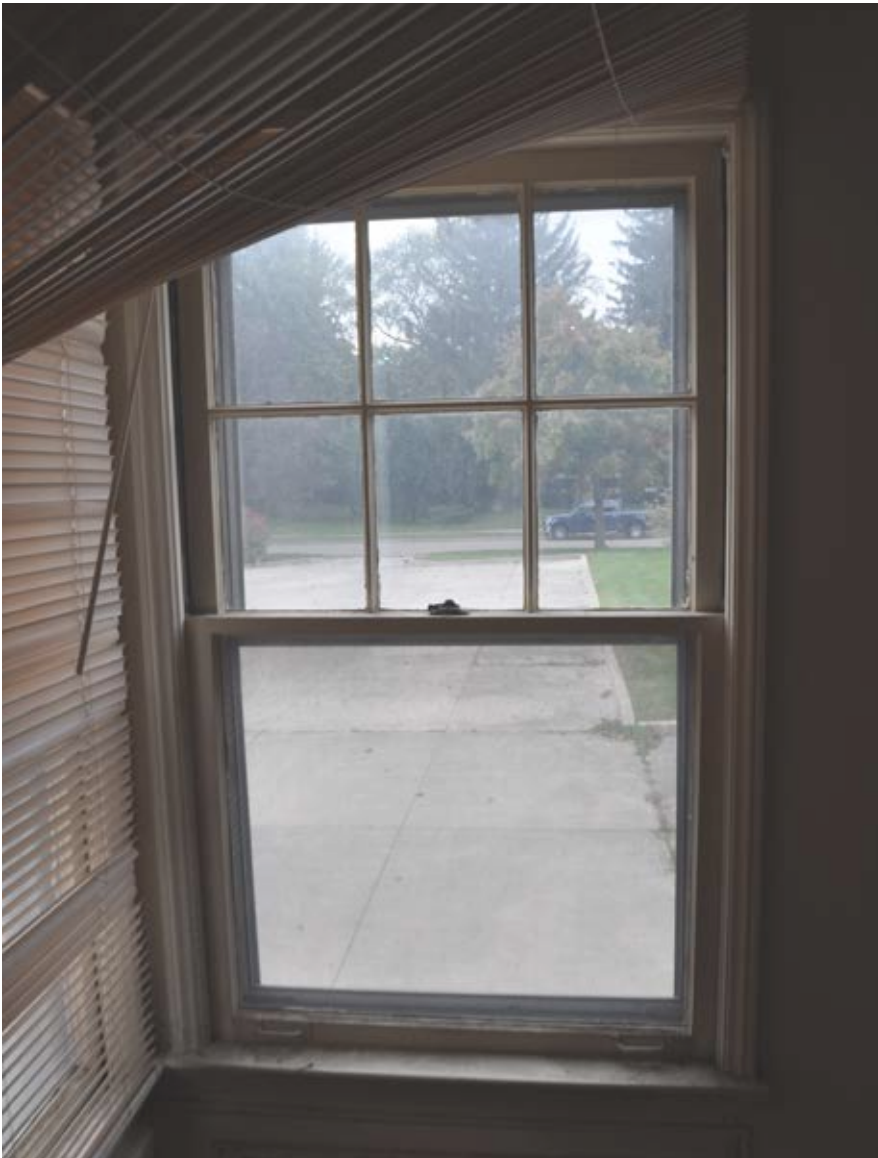
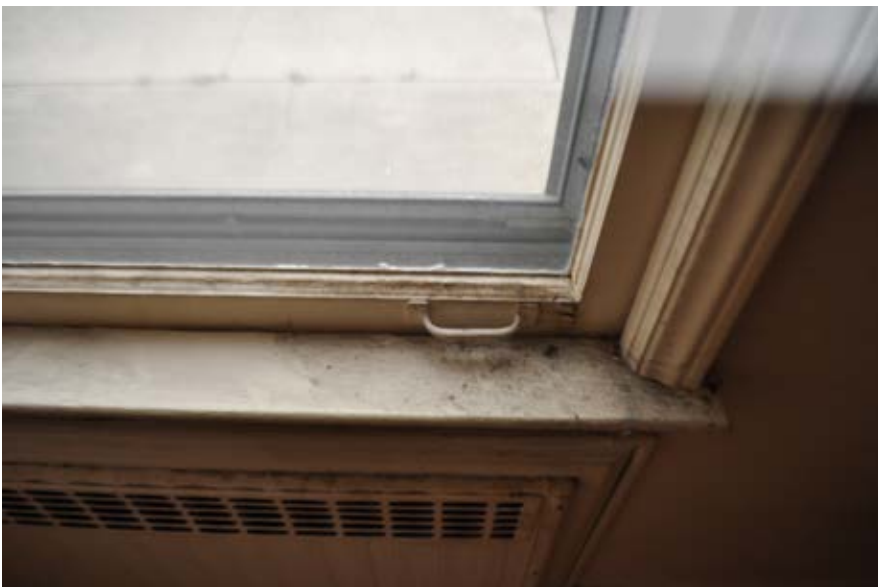
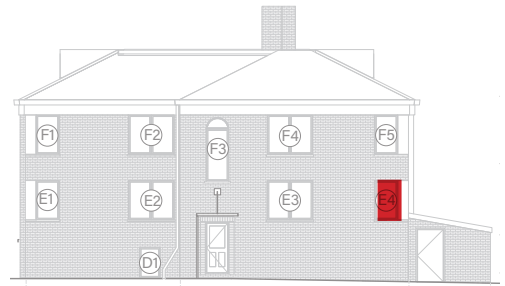
Window E4, Type A1

- Note: Extent of exterior deterioration, dry rot, and loss of operability is not fully apparent in interior photos. Replacement parts for existing windows are unavailable, making restoration of thermal and operable functionality impossible, and long-term maintenance infeasible. Recommendation is for replacement, for quality of life of future tenants and for feasibility of long-term maintenance.
- See Window Assessment (Blackberry) in appendix for further detail and information, including further notes on deterioration beyond repair
- See Appendix for Window Schedule & Measurements

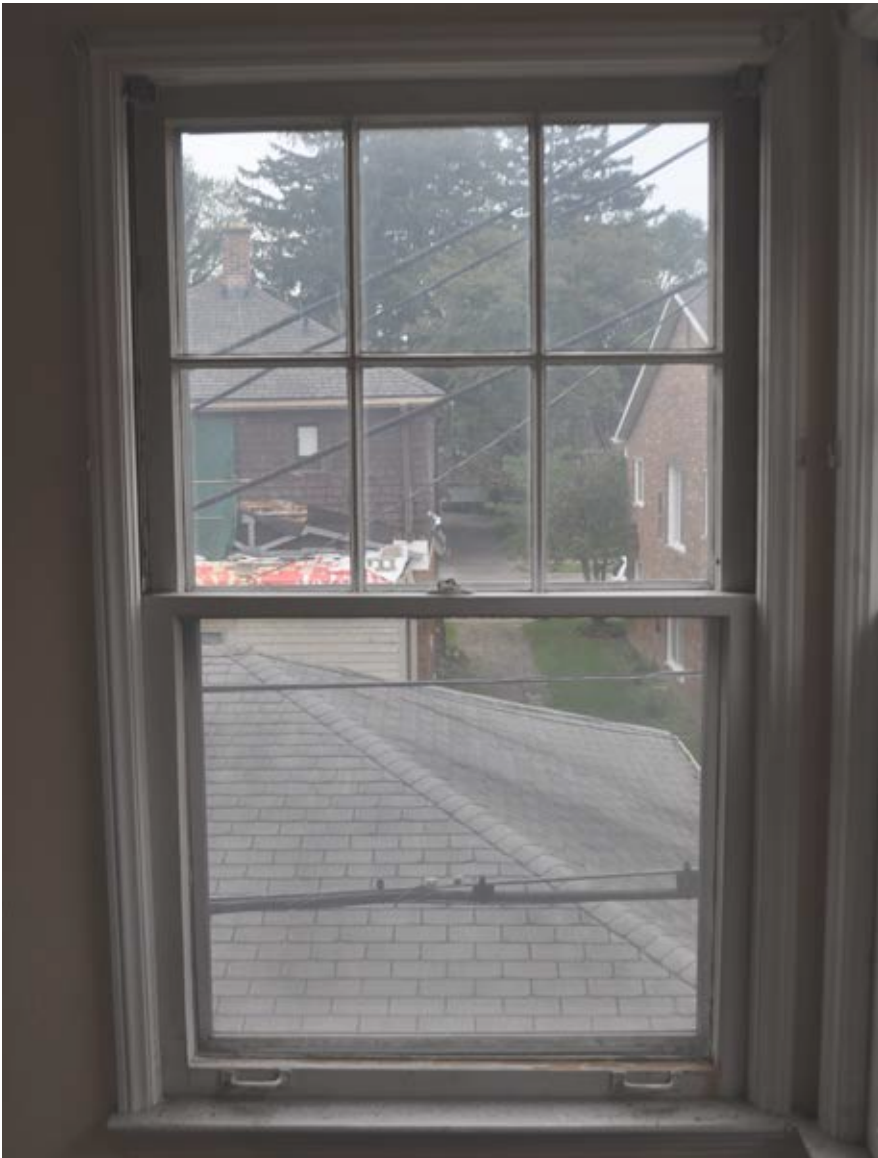
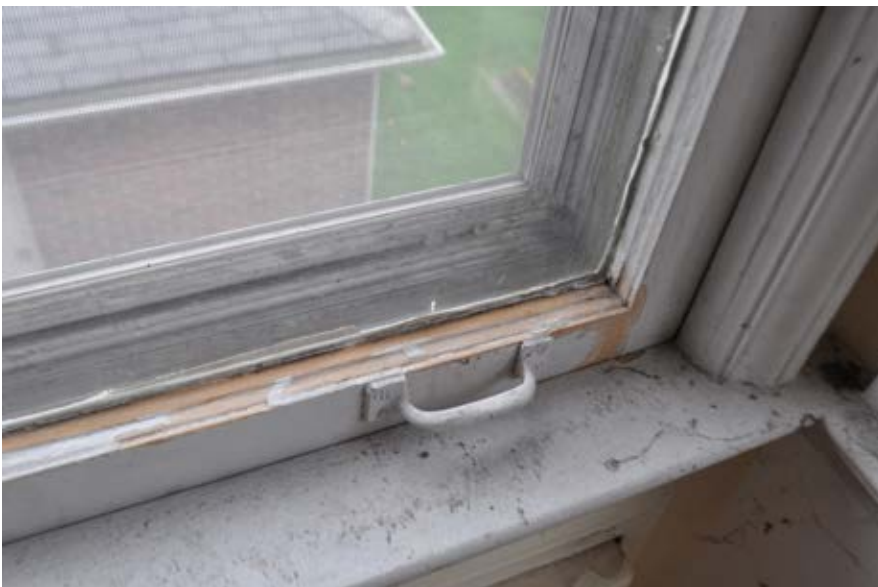
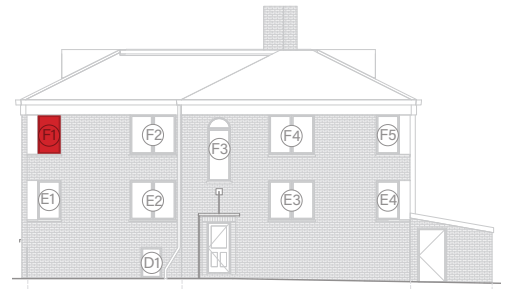
Window F1, Type A1

- Note: Extent of exterior deterioration, dry rot, and loss of operability is not fully apparent in interior photos. Replacement parts for existing windows are unavailable, making restoration of thermal and operable functionality impossible, and long-term maintenance infeasible. Recommendation is for replacement, for quality of life of future tenants and for feasibility of long-term maintenance.
- See Window Assessment (Blackberry) in appendix for further detail and information, including further notes on deterioration beyond repair
- See Appendix for Window Schedule & Measurements

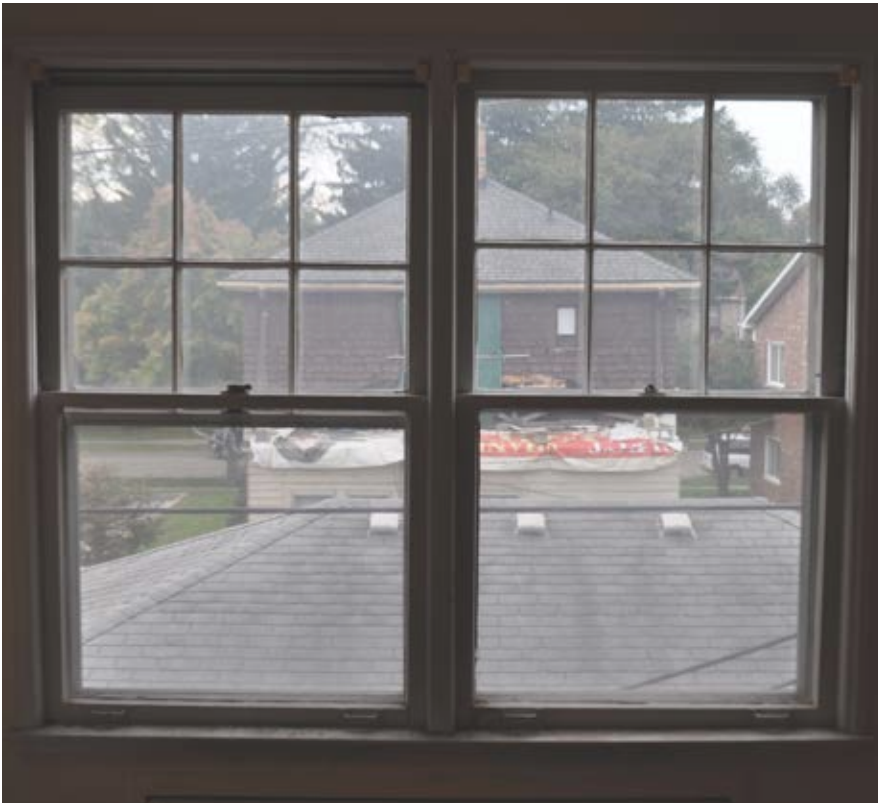
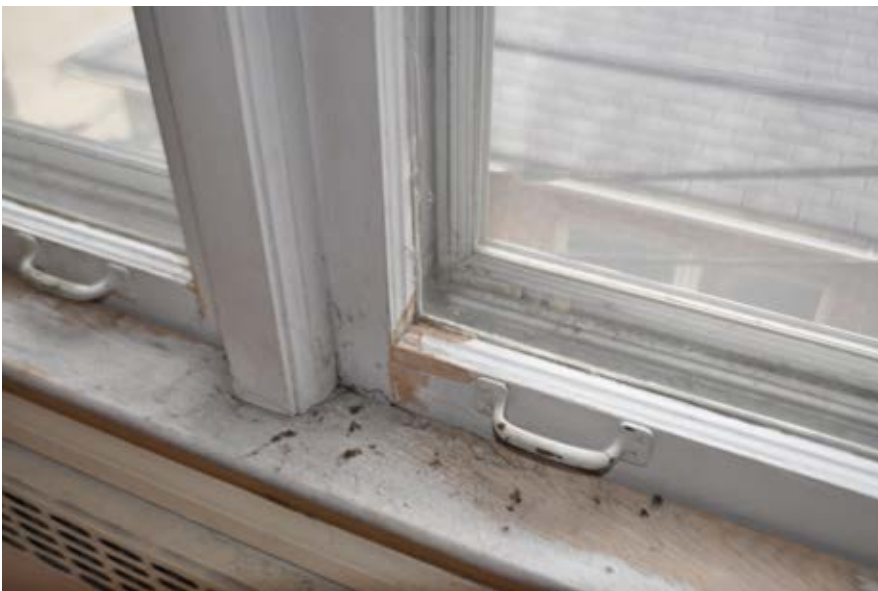
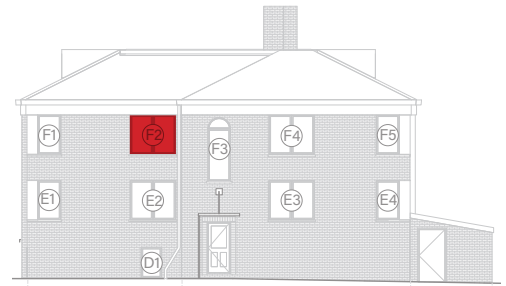
Window F2, Type B1

- Note: Extent of exterior deterioration, dry rot, and loss of operability is not fully apparent in interior photos. Replacement parts for existing windows are unavailable, making restoration of thermal and operable functionality impossible, and long-term maintenance infeasible. Recommendation is for replacement, for quality of life of future tenants and for feasibility of long-term maintenance.
- See Window Assessment (Blackberry) in appendix for further detail and information, including further notes on deterioration beyond repair
- See Appendix for Window Schedule & Measurements

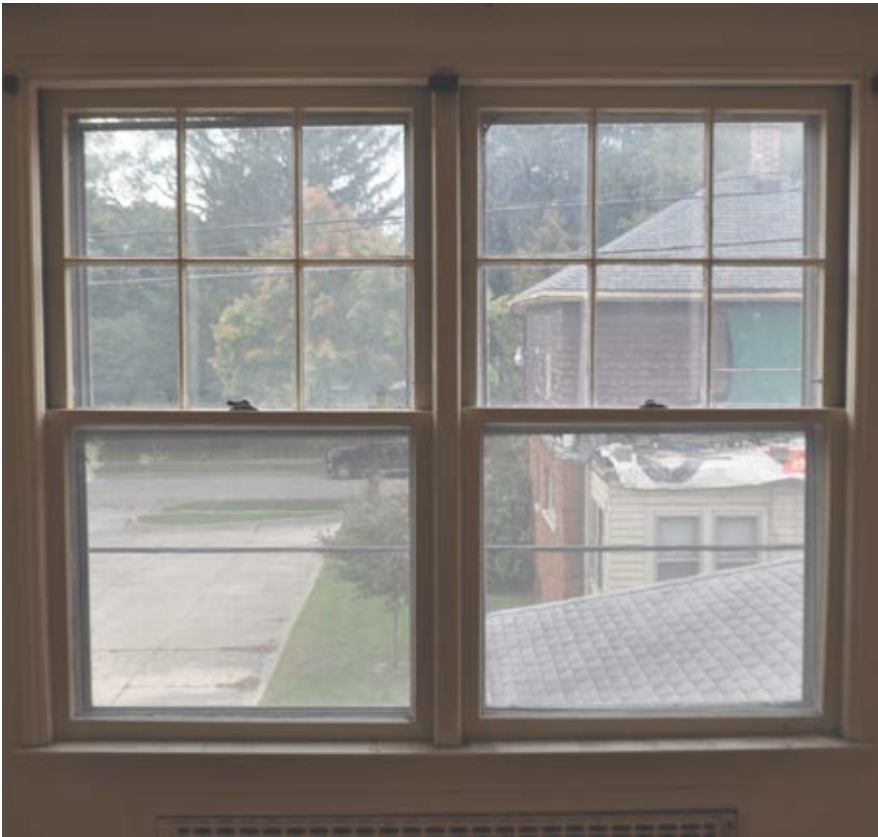
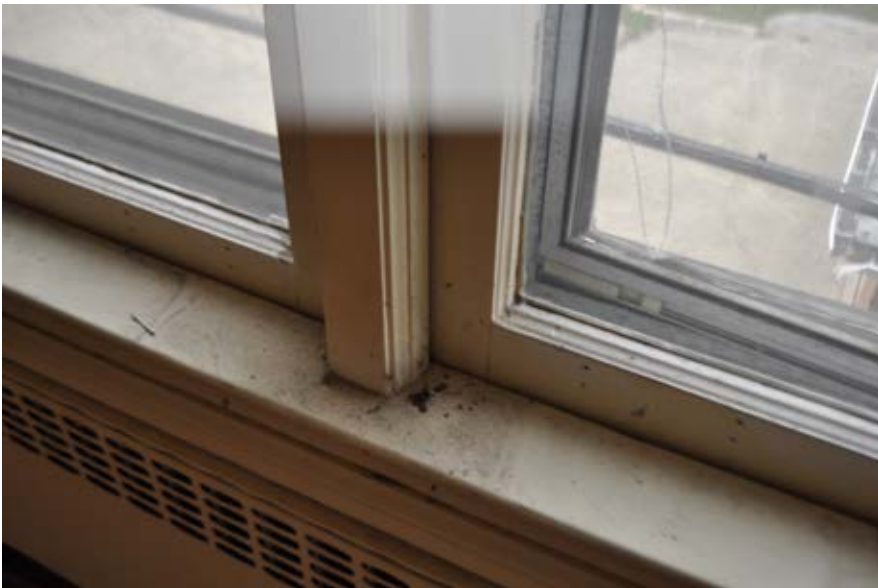
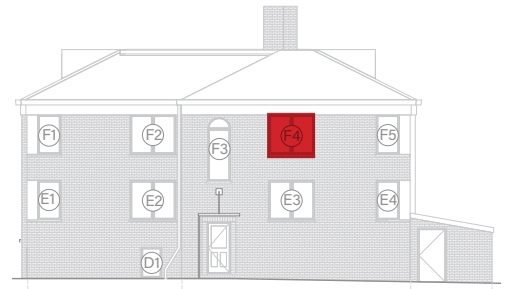
Window F4, Type B1

- Note: Extent of exterior deterioration, dry rot, and loss of operability is not fully apparent in interior photos. Replacement parts for existing windows are unavailable, making restoration of thermal and operable functionality impossible, and long-term maintenance infeasible. Recommendation is for replacement, for quality of life of future tenants and for feasibility of long-term maintenance.
- See Window Assessment (Blackberry) in appendix for further detail and information, including further notes on deterioration beyond repair
- See Appendix for Window Schedule & Measurements

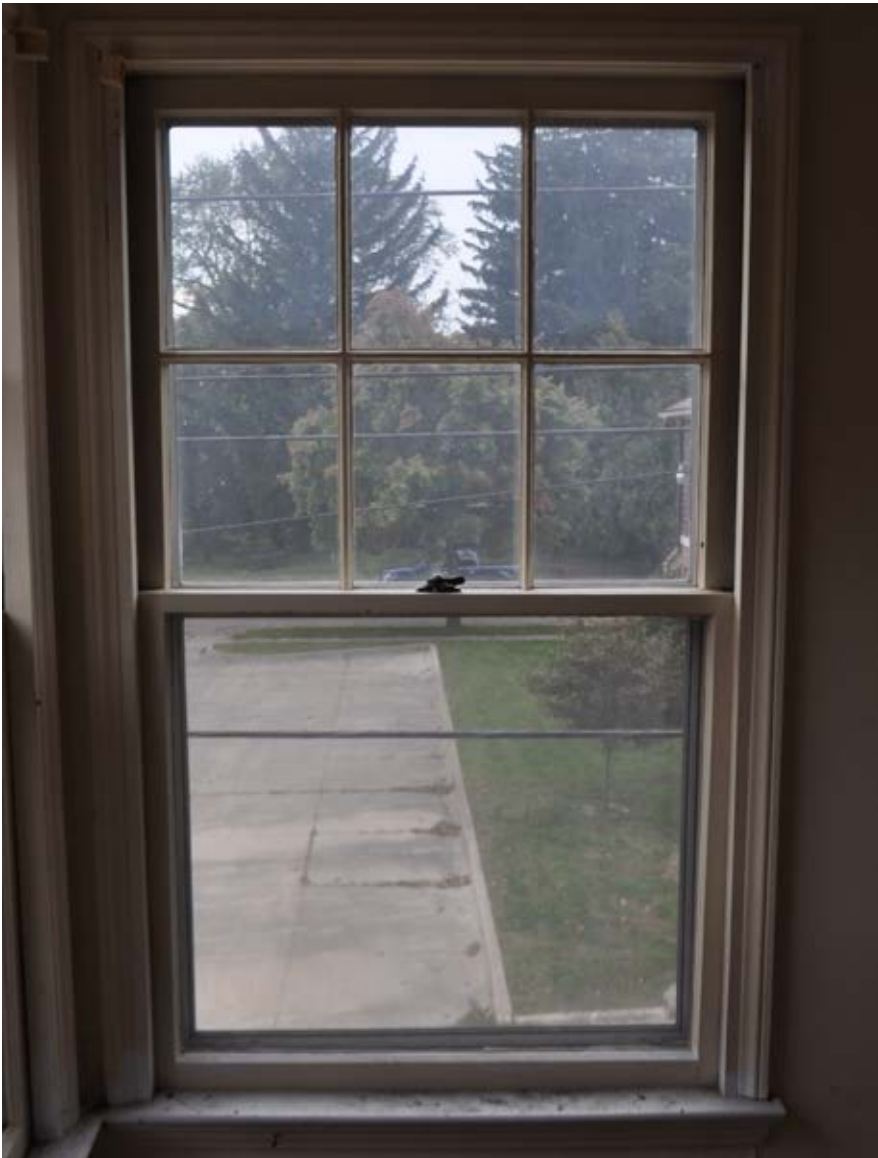
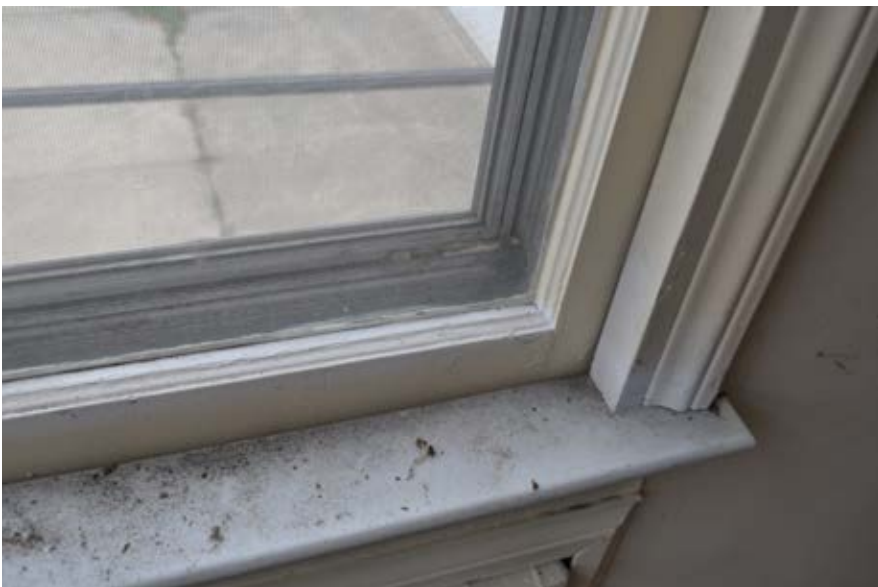
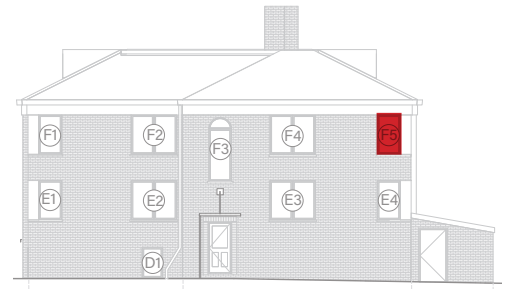
Window F5, Type A1

- Note: Extent of exterior deterioration, dry rot, and loss of operability is not fully apparent in interior photos. Replacement parts for existing windows are unavailable, making restoration of thermal and operable functionality impossible, and long-term maintenance infeasible. Recommendation is for replacement, for quality of life of future tenants and for feasibility of long-term maintenance.
- See Window Assessment (Blackberry) in appendix for further detail and information, including further notes on deterioration beyond repair
- See Appendix for Window Schedule & Measurements

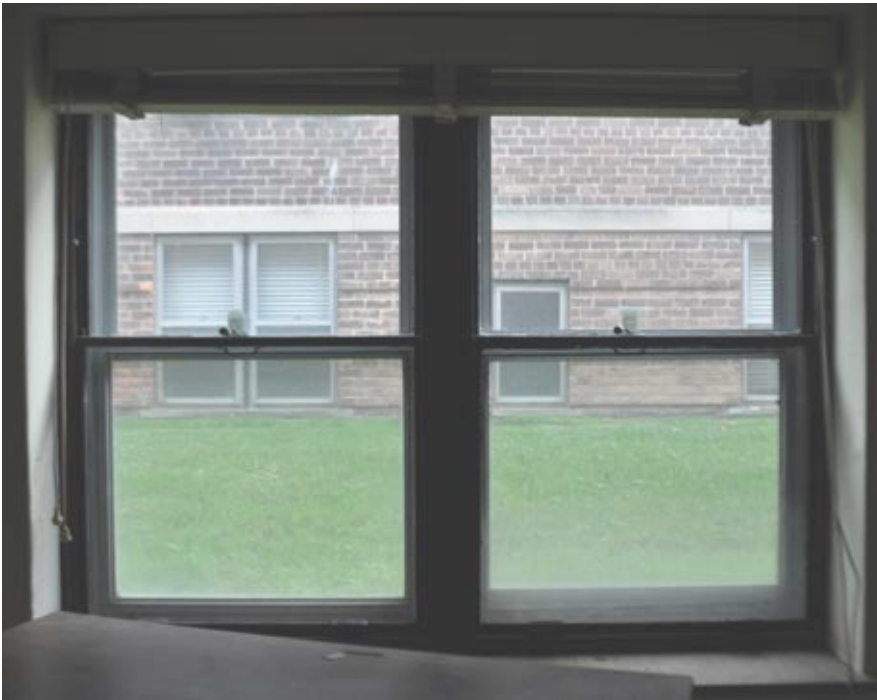
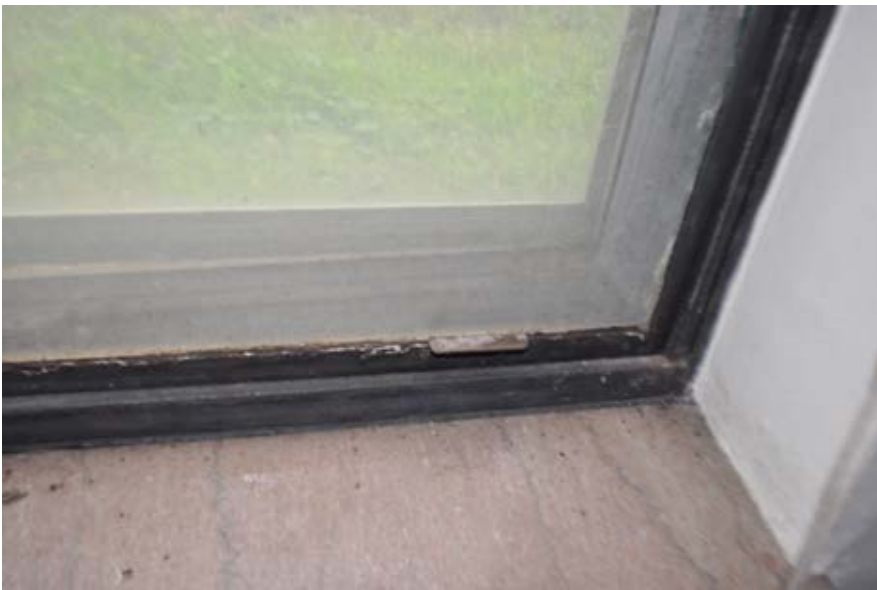
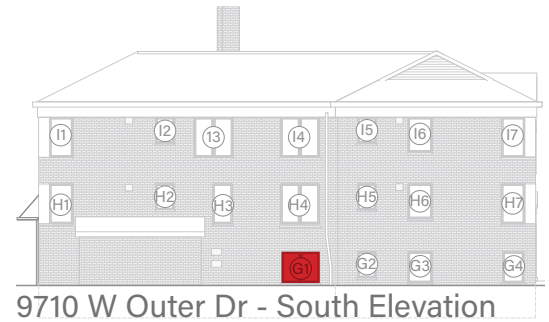
Window G1, Type H1

- Note: Extent of exterior deterioration, dry rot, and loss of operability is not fully apparent in interior photos. Replacement parts for existing windows are unavailable, making restoration of thermal and operable functionality impossible, and long-term maintenance infeasible. Recommendation is for replacement, for quality of life of future tenants and for feasibility of long-term maintenance.
- See Window Assessment (Blackberry) in appendix for further detail and information, including further notes on deterioration beyond repair
- See Appendix for Window Schedule & Measurements

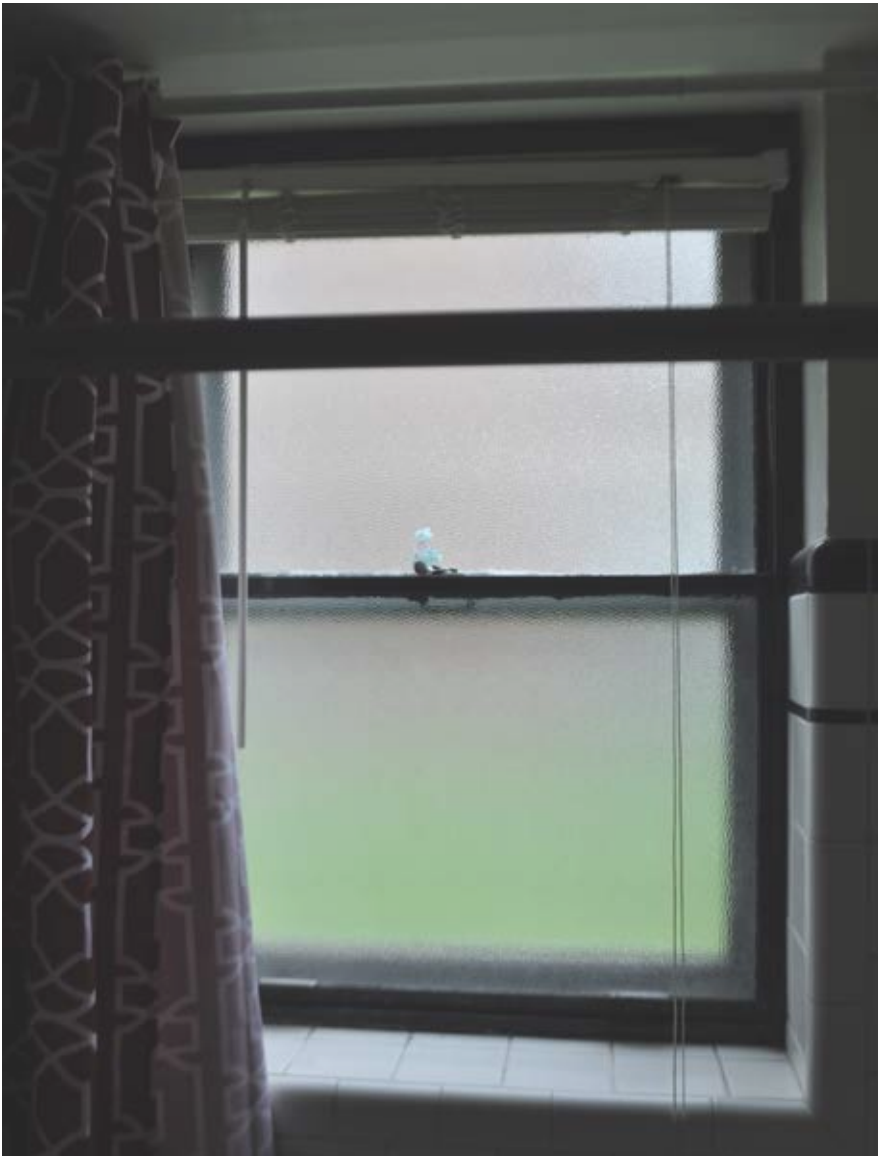
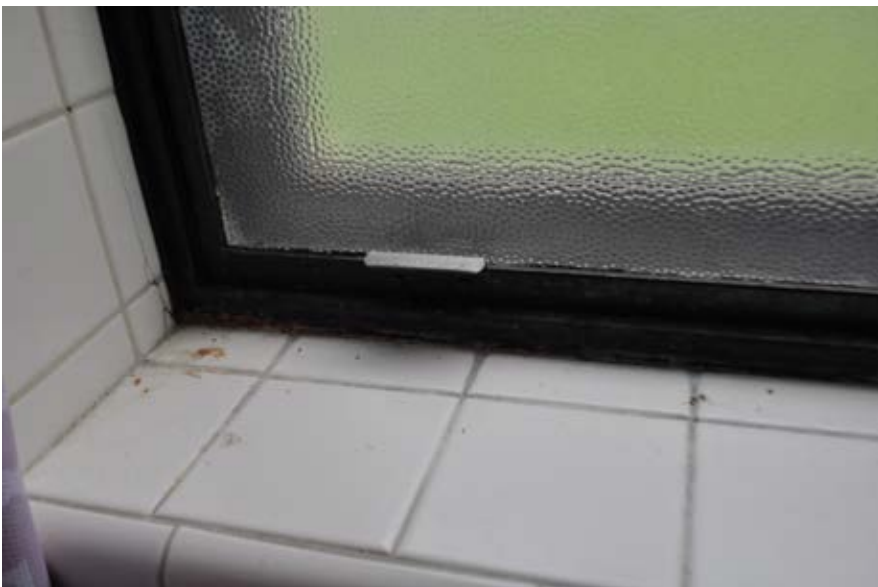
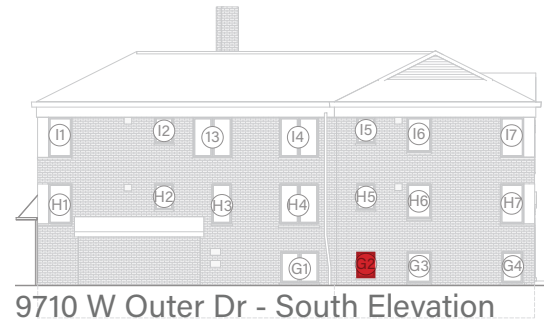
Window G2, Type G1

- Note: Extent of exterior deterioration, dry rot, and loss of operability is not fully apparent in interior photos. Replacement parts for existing windows are unavailable, making restoration of thermal and operable functionality impossible, and long-term maintenance infeasible. Recommendation is for replacement, for quality of life of future tenants and for feasibility of long-term maintenance.
- See Window Assessment (Blackberry) in appendix for further detail and information, including further notes on deterioration beyond repair
- See Appendix for Window Schedule & Measurements
