9710 W Outer Dr

Existing Condition Photos

Current Design Description

A 3-story apartment structure with 10 residential units, constructed in 1940, brick on wood stud wall construction, shingle roof, stone corner details, stone details at palladian window, stone sills, wood detailing at front entry, steel and wood canopy at back entry, wood windows throughout with the exception of steel windows at bathrooms and the lowest level. The addition of a brick shed to house the gas meter was made at a later date.

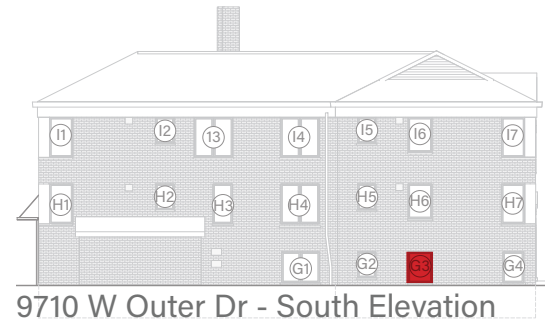
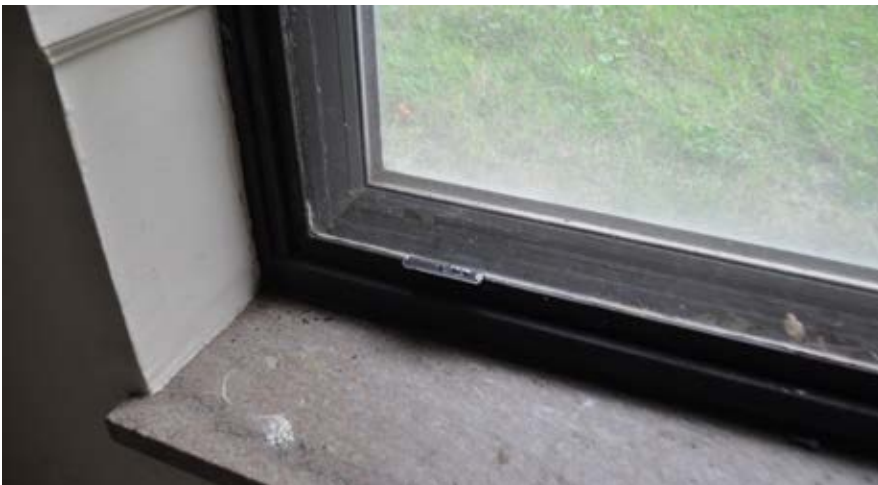
Window G3, Type F2

- Note: Extent of exterior deterioration, dry rot, and loss of operability is not fully apparent in interior photos. Replacement parts for existing windows are unavailable, making restoration of thermal and operable functionality impossible, and long-term maintenance infeasible. Recommendation is for replacement, for quality of life of future tenants and for feasibility of long-term maintenance.
- See Window Assessment (Blackberry) in appendix for further detail and information, including further notes on deterioration beyond repair
- See Appendix for Window Schedule & Measurements

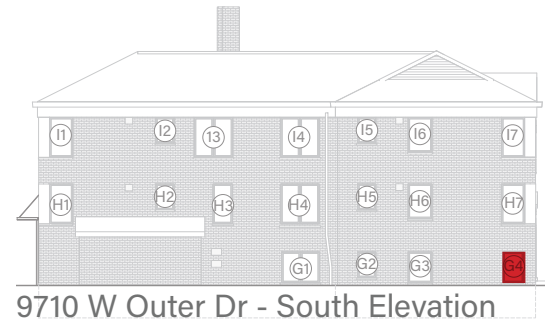
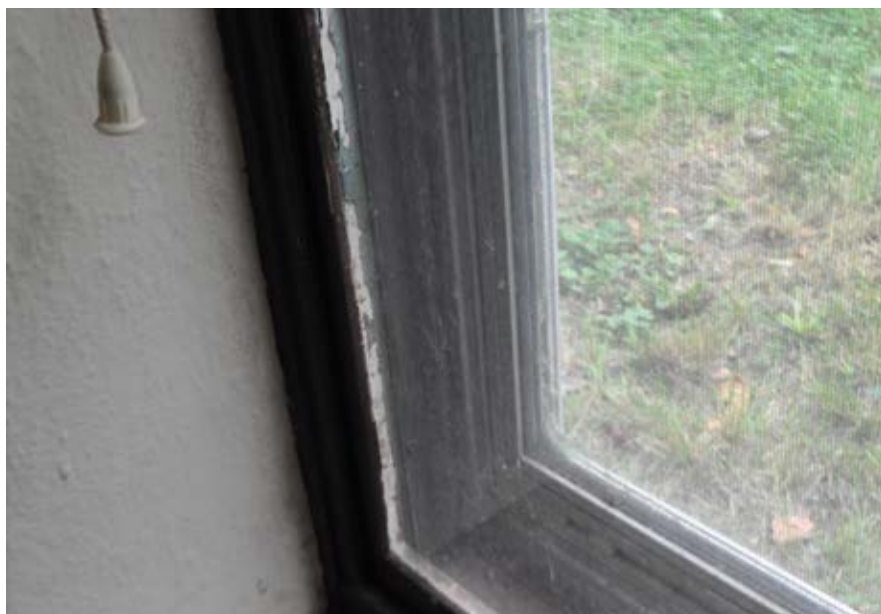
Window G4, Type D1

- Note: Extent of exterior deterioration, dry rot, and loss of operability is not fully apparent in interior photos. Replacement parts for existing windows are unavailable, making restoration of thermal and operable functionality impossible, and long-term maintenance infeasible. Recommendation is for replacement, for quality of life of future tenants and for feasibility of long-term maintenance.
- See Window Assessment (Blackberry) in appendix for further detail and information, including further notes on deterioration beyond repair
- See Appendix for Window Schedule & Measurements

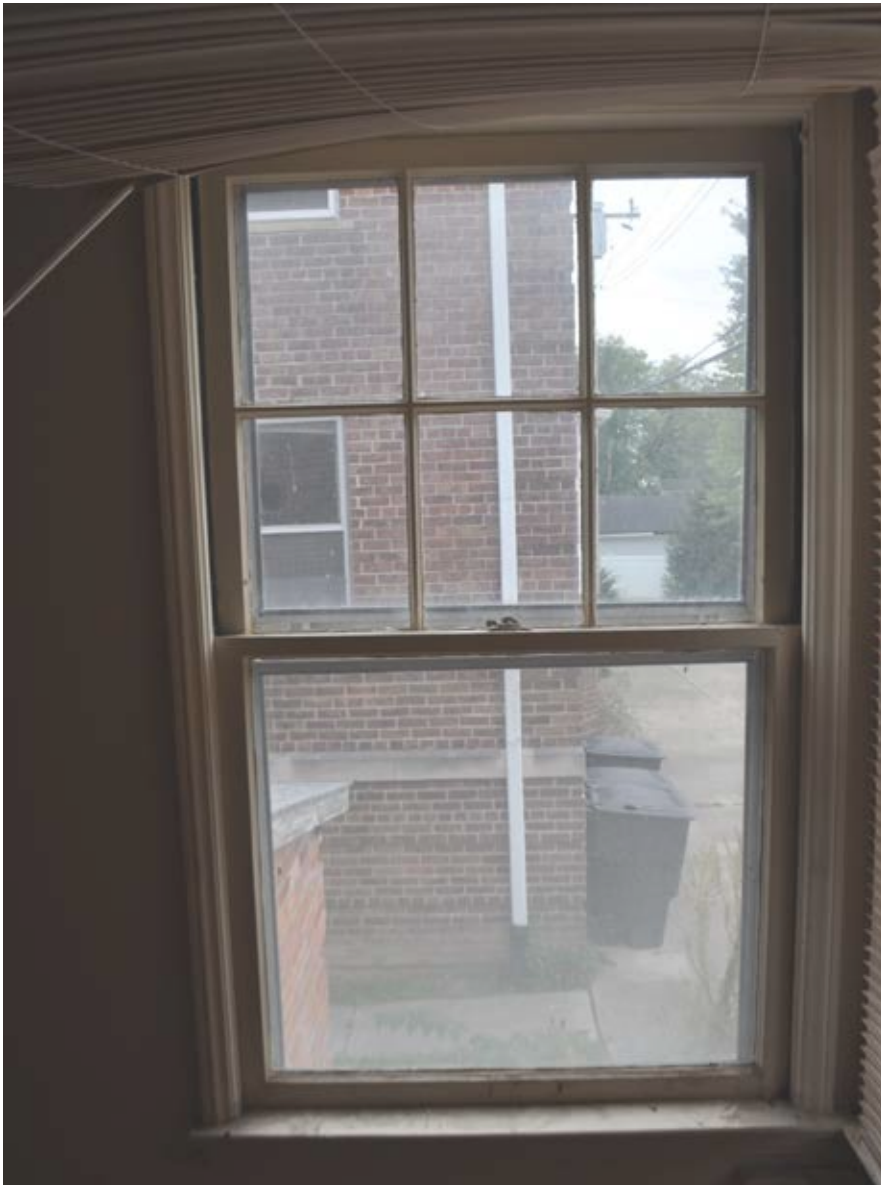
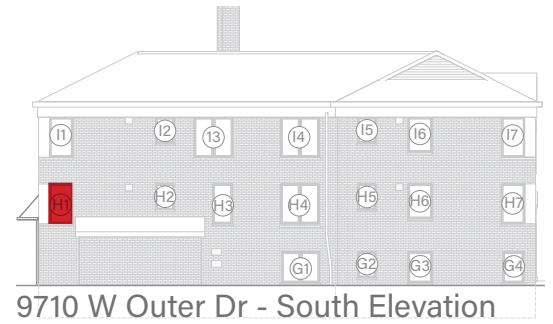
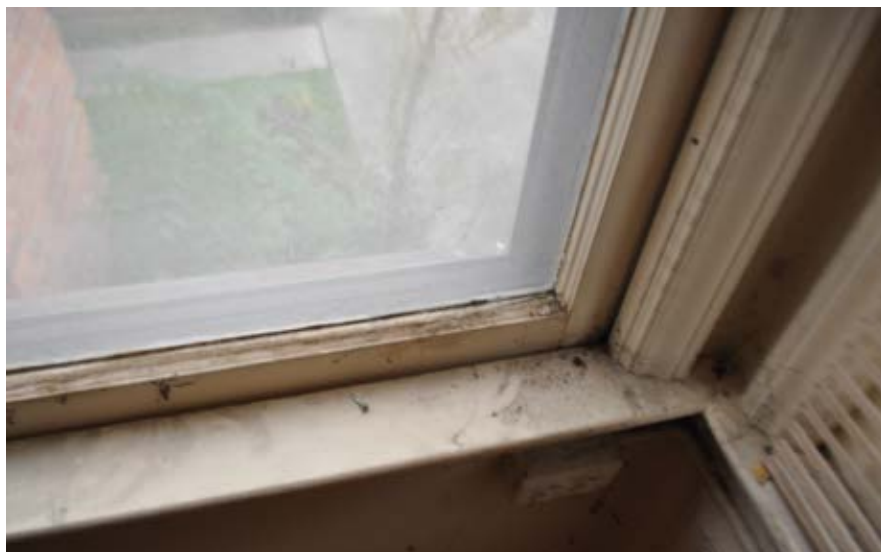
Window H1, Type A1

- Note: Extent of exterior deterioration, dry rot, and loss of operability is not fully apparent in interior photos. Replacement parts for existing windows are unavailable, making restoration of thermal and operable functionality impossible, and long-term maintenance infeasible. Recommendation is for replacement, for quality of life of future tenants and for feasibility of long-term maintenance.
- See Window Assessment (Blackberry) in appendix for further detail and information, including further notes on deterioration beyond repair
- See Appendix for Window Schedule & Measurements

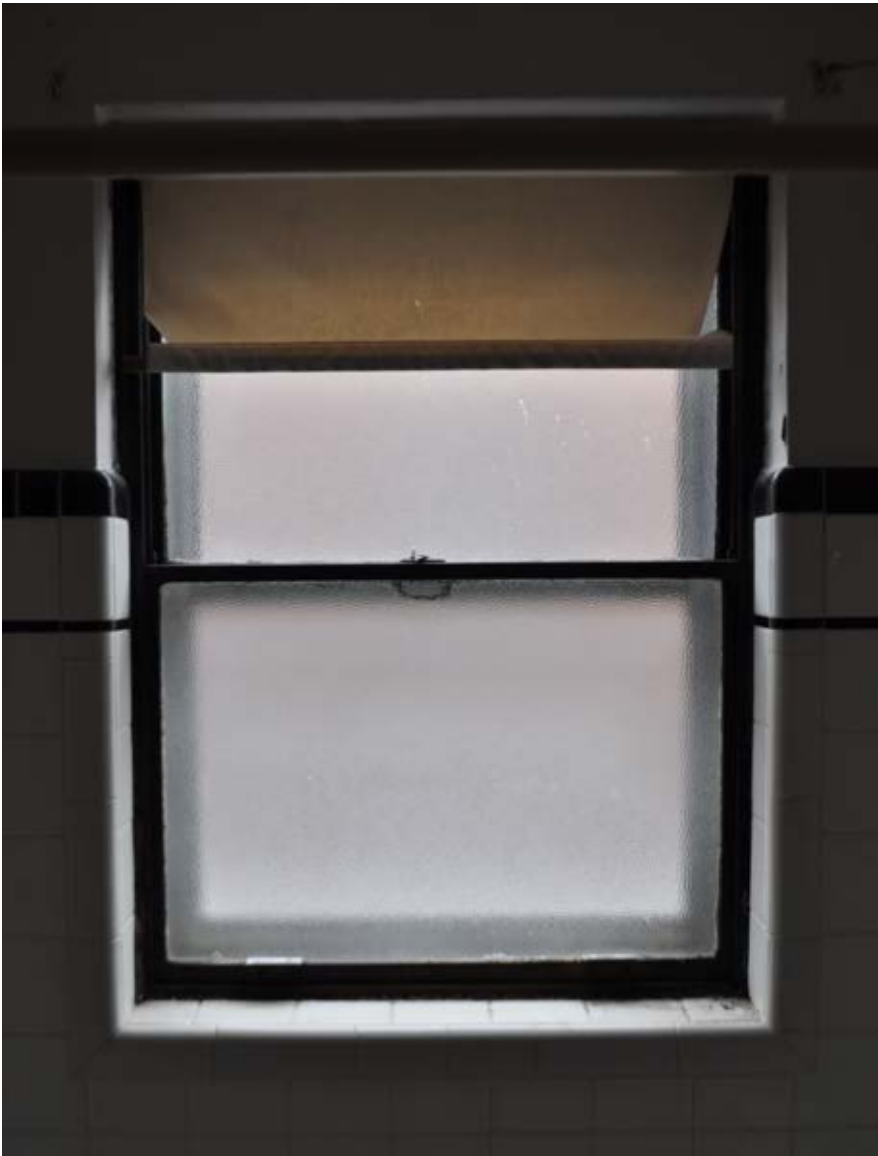
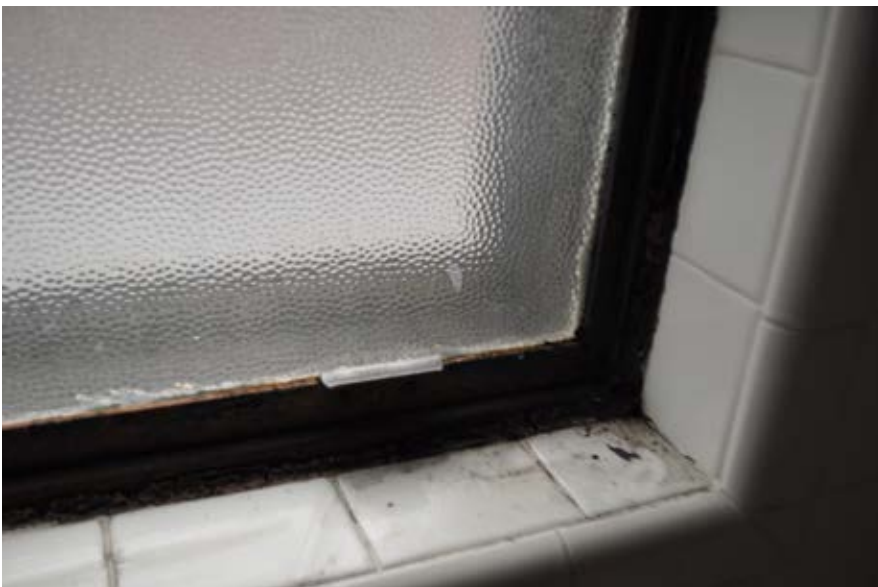
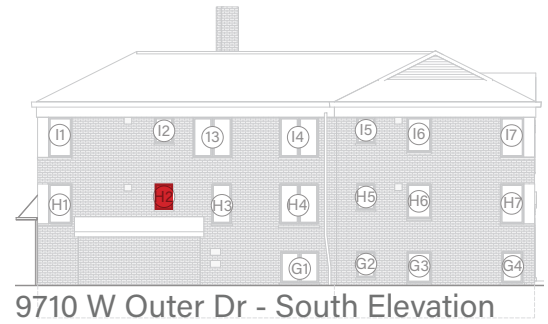
Window H2, Type G1

- Note: Extent of exterior deterioration, dry rot, and loss of operability is not fully apparent in interior photos. Replacement parts for existing windows are unavailable, making restoration of thermal and operable functionality impossible, and long-term maintenance infeasible. Recommendation is for replacement, for quality of life of future tenants and for feasibility of long-term maintenance.
- See Window Assessment (Blackberry) in appendix for further detail and information, including further notes on deterioration beyond repair
- See Appendix for Window Schedule & Measurements

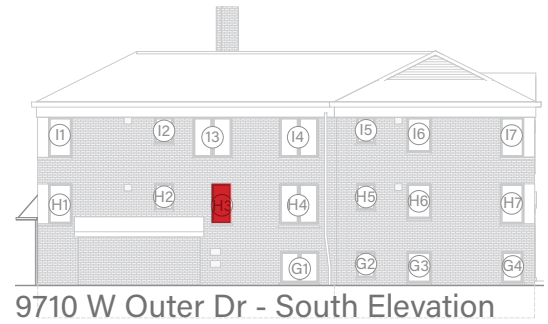
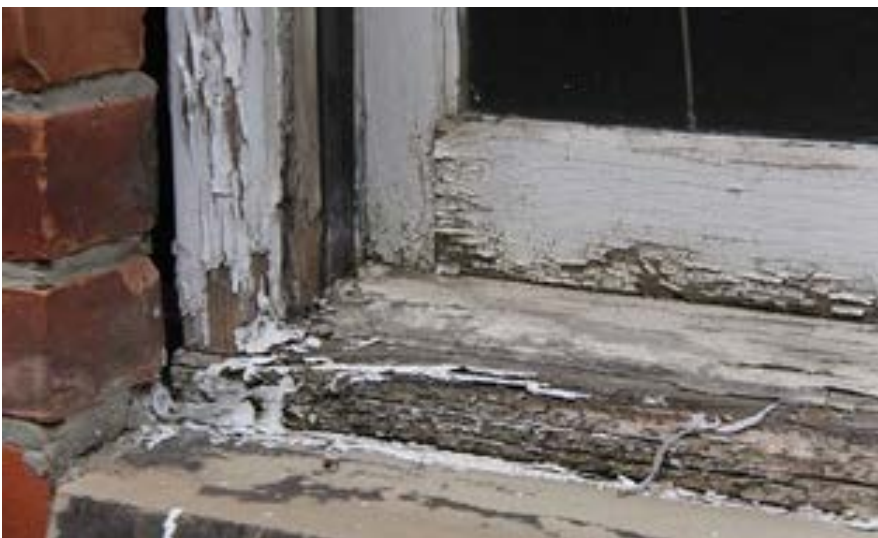
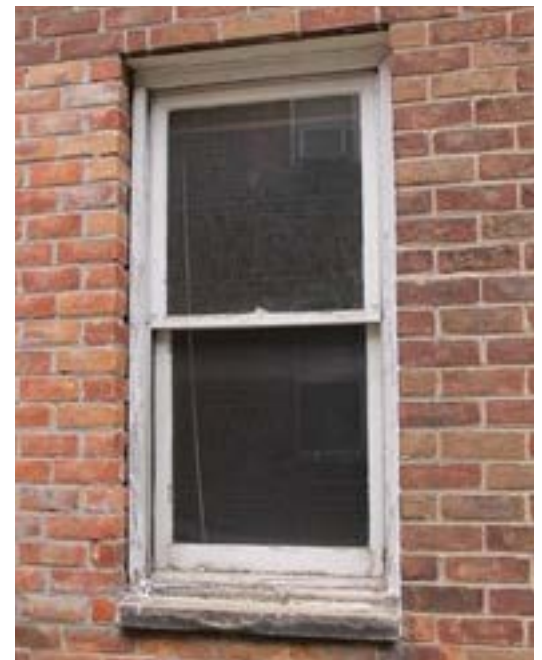
Window H3, Type J1

- Exterior Rotted Sill
- Note: Extent of exterior deterioration, dry rot, and loss of operability is not fully apparent in interior photos. Replacement parts for existing windows are unavailable, making restoration of thermal and operable functionality impossible, and long-term maintenance infeasible. Recommendation is for replacement, for quality of life of future tenants and for feasibility of long-term maintenance.
- See Window Assessment (Blackberry) in appendix for further detail and information, including further notes on deterioration beyond repair
- See Appendix for Window Schedule & Measurements

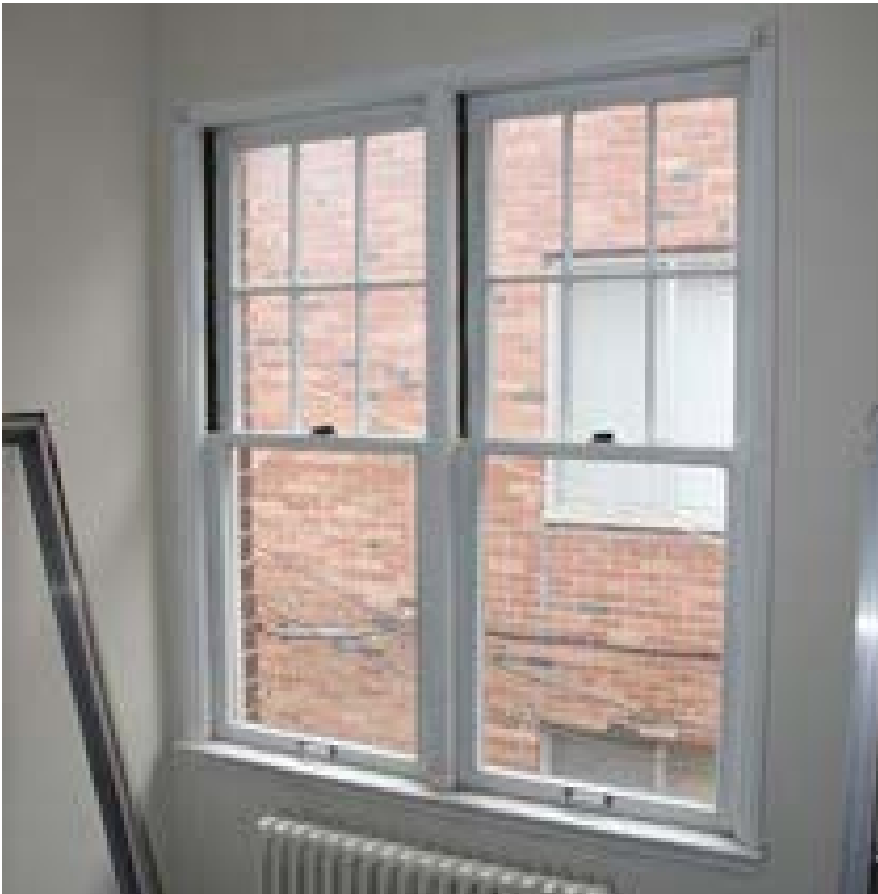
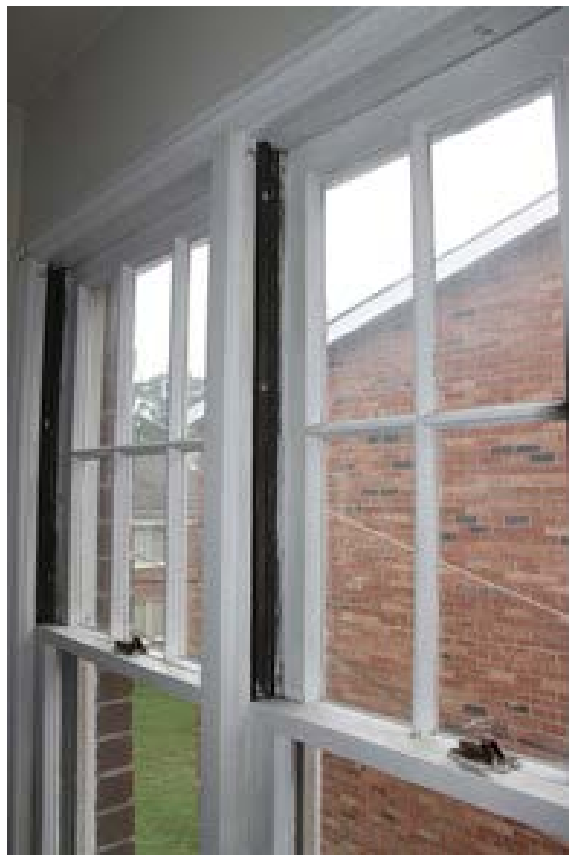
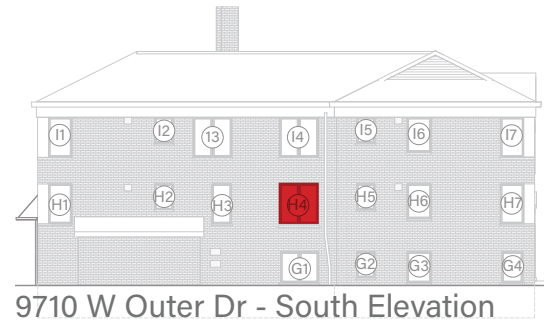
Window H4, Type I1

- Note: Extent of exterior deterioration, dry rot, and loss of operability is not fully apparent in interior photos. Replacement parts for existing windows are unavailable, making restoration of thermal and operable functionality impossible, and long-term maintenance infeasible. Recommendation is for replacement, for quality of life of future tenants and for feasibility of long-term maintenance.
- See Window Assessment (Blackberry) in appendix for further detail and information, including further notes on deterioration beyond repair
- See Appendix for Window Schedule & Measurements

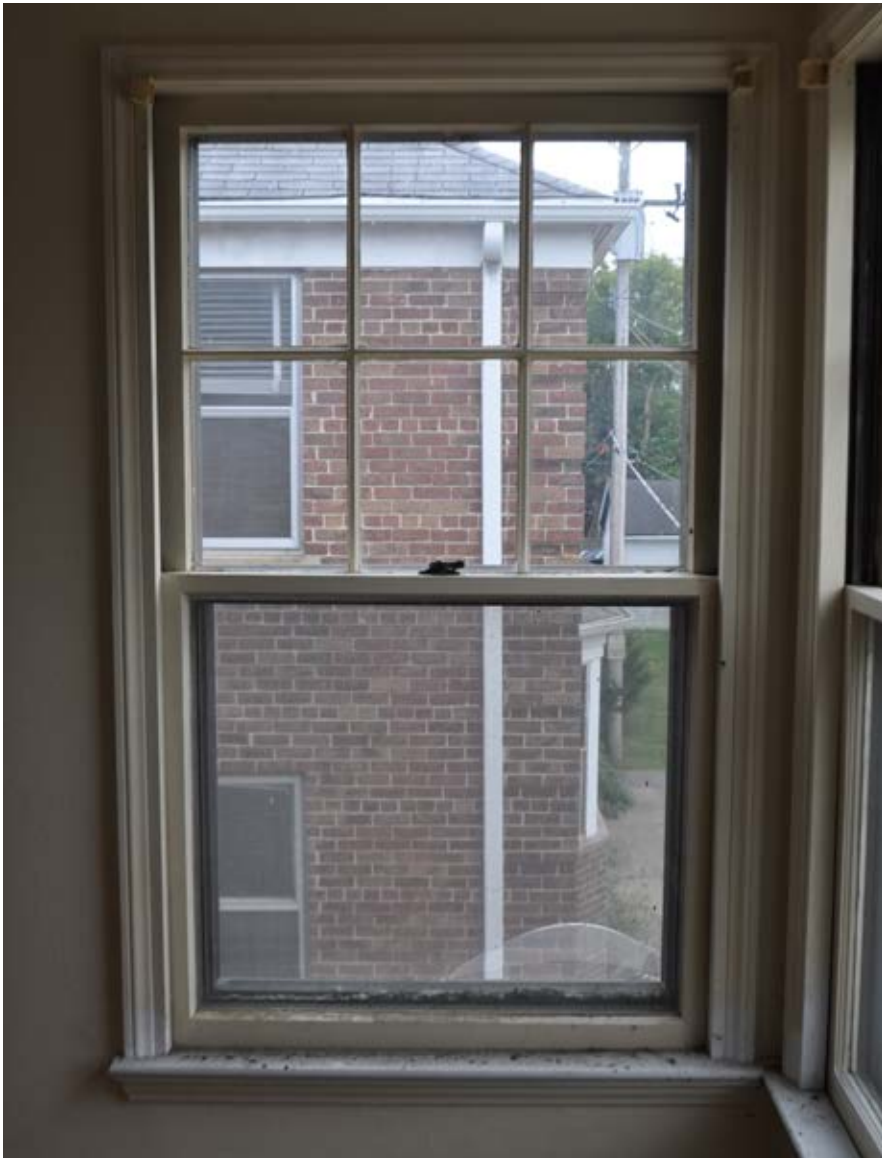
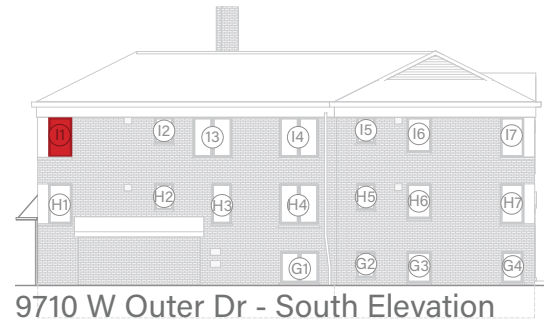
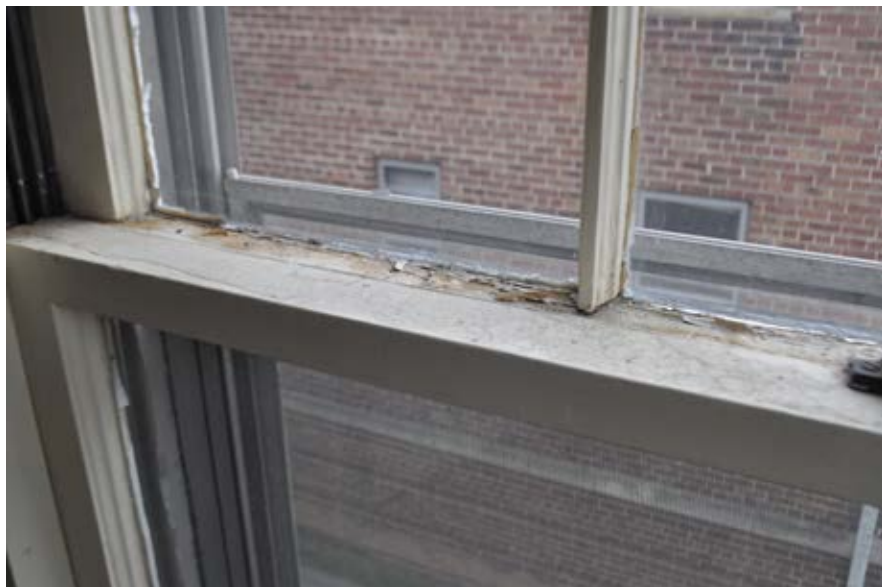
Window I1, Type A1

- Note: Extent of exterior deterioration, dry rot, and loss of operability is not fully apparent in interior photos. Replacement parts for existing windows are unavailable, making restoration of thermal and operable functionality impossible, and long-term maintenance infeasible. Recommendation is for replacement, for quality of life of future tenants and for feasibility of long-term maintenance.
- See Window Assessment (Blackberry) in appendix for further detail and information, including further notes on deterioration beyond repair
- See Appendix for Window Schedule & Measurements

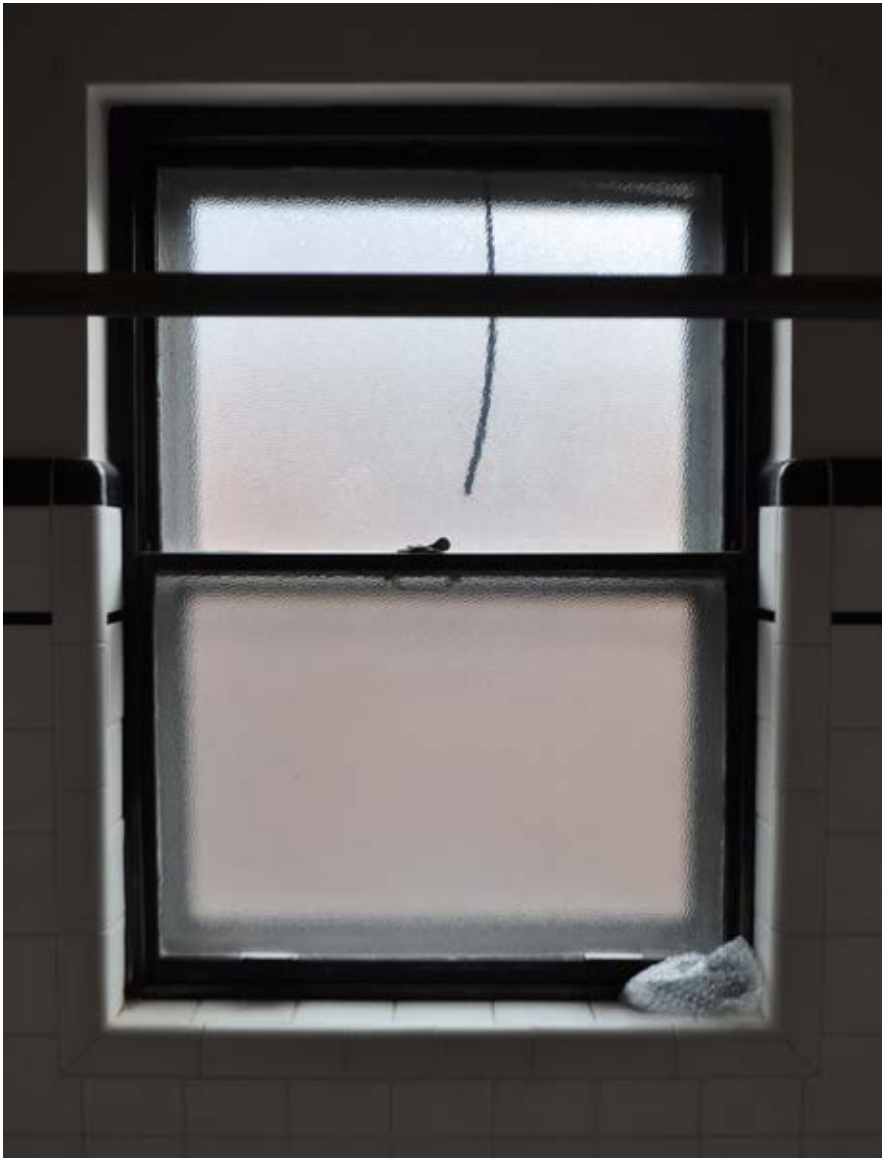
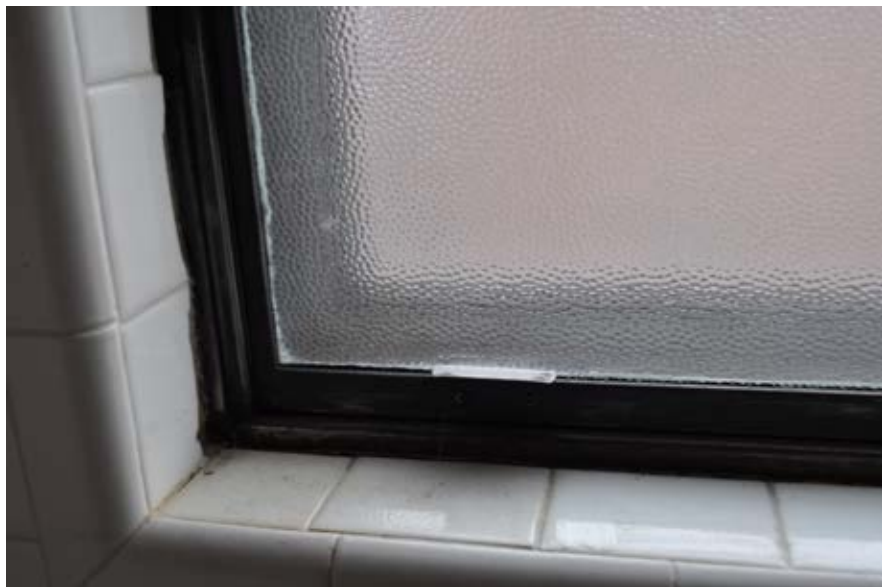
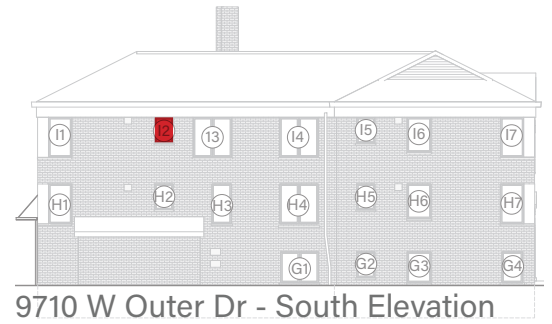
Window I2, Type G1

- Note: Extent of exterior deterioration, dry rot, and loss of operability is not fully apparent in interior photos. Replacement parts for existing windows are unavailable, making restoration of thermal and operable functionality impossible, and long-term maintenance infeasible. Recommendation is for replacement, for quality of life of future tenants and for feasibility of long-term maintenance.
- See Window Assessment (Blackberry) in appendix for further detail and information, including further notes on deterioration beyond repair
- See Appendix for Window Schedule & Measurements

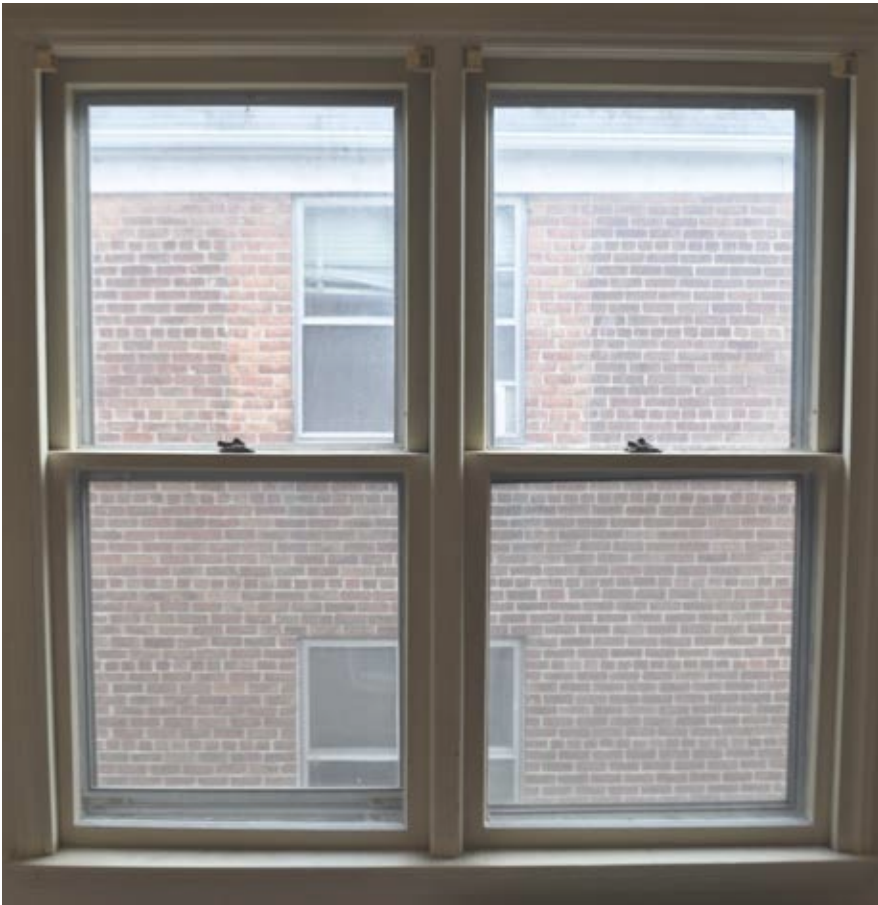
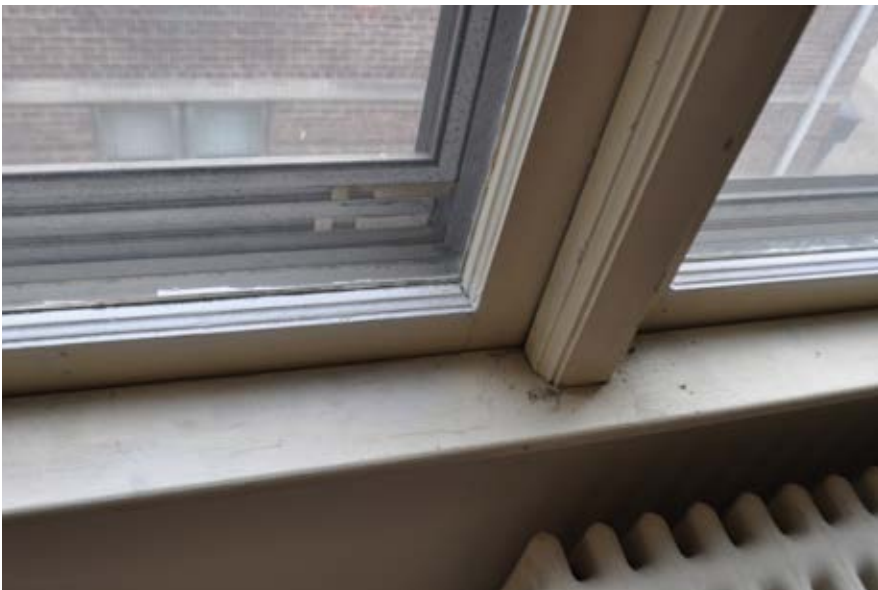
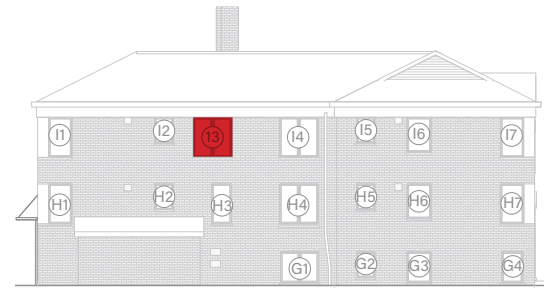
Window I3, Type I1

- Note: Extent of exterior deterioration, dry rot, and loss of operability is not fully apparent in interior photos. Replacement parts for existing windows are unavailable, making restoration of thermal and operable functionality impossible, and long-term maintenance infeasible. Recommendation is for replacement, for quality of life of future tenants and for feasibility of long-term maintenance.
- See Window Assessment (Blackberry) in appendix for further detail and information, including further notes on deterioration beyond repair
- See Appendix for Window Schedule & Measurements

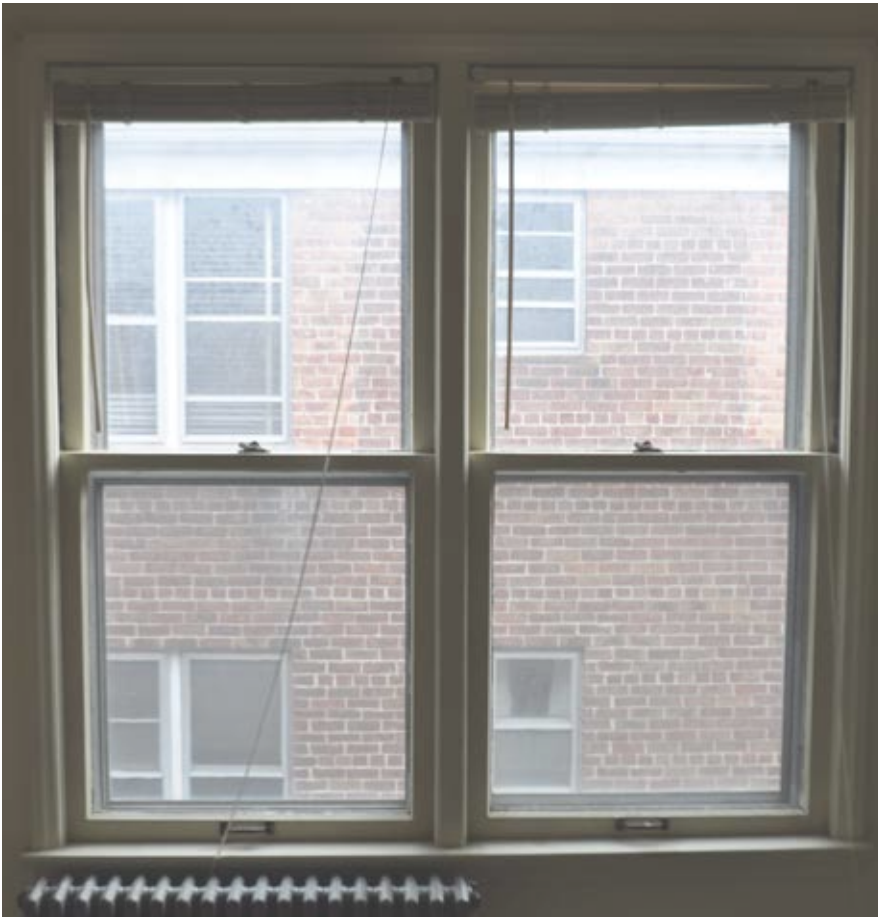
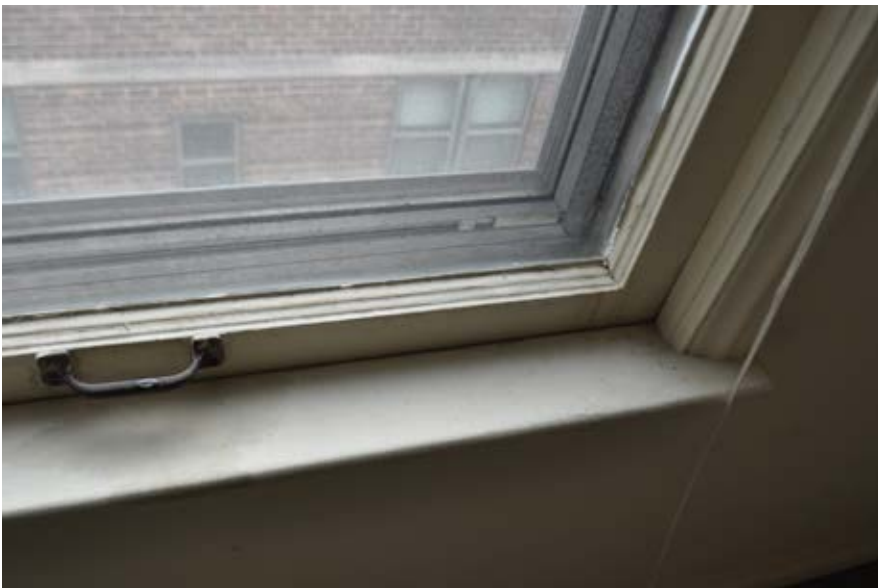
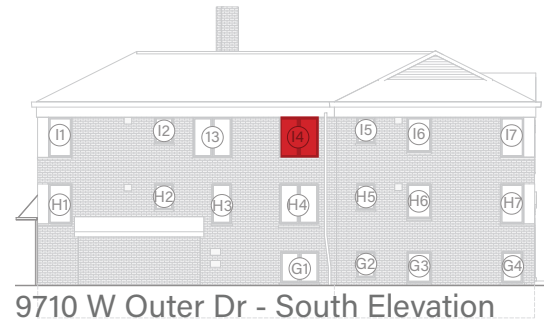
Window I4, Type I1

- Note: Extent of exterior deterioration, dry rot, and loss of operability is not fully apparent in interior photos. Replacement parts for existing windows are unavailable, making restoration of thermal and operable functionality impossible, and long-term maintenance infeasible. Recommendation is for replacement, for quality of life of future tenants and for feasibility of long-term maintenance.
- See Window Assessment (Blackberry) in appendix for further detail and information, including further notes on deterioration beyond repair
- See Appendix for Window Schedule & Measurements

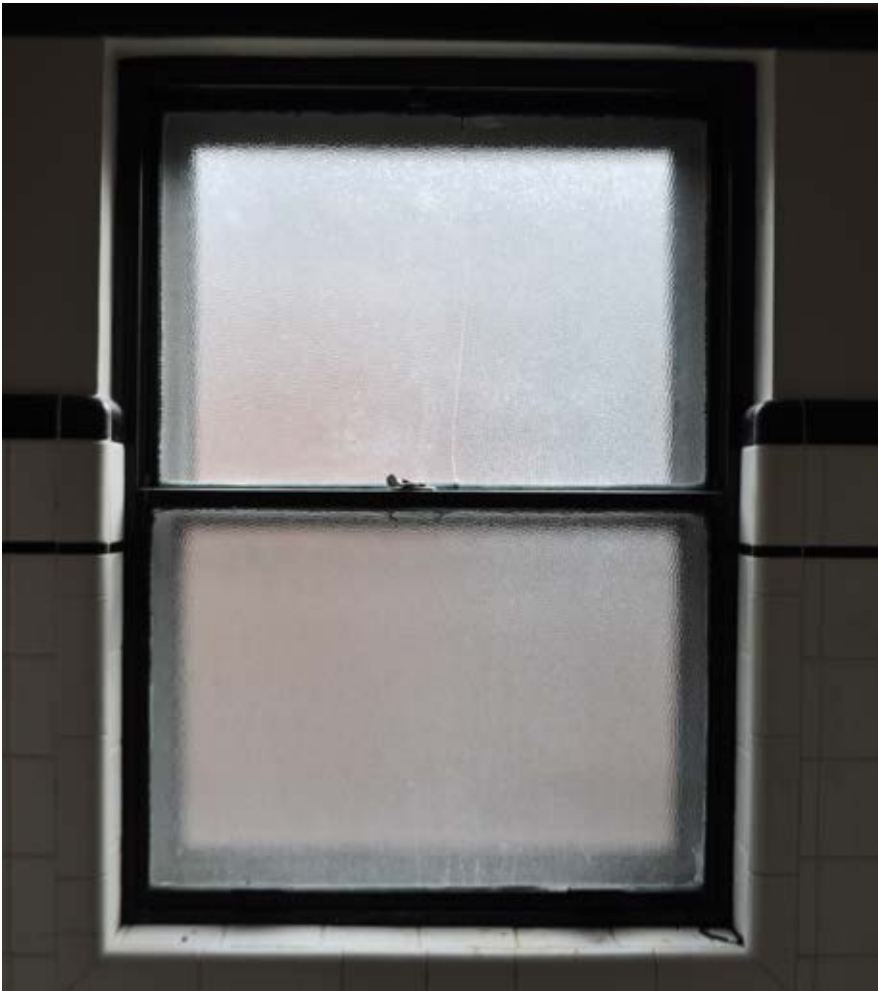
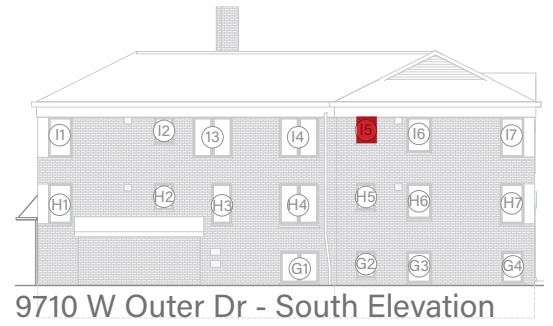
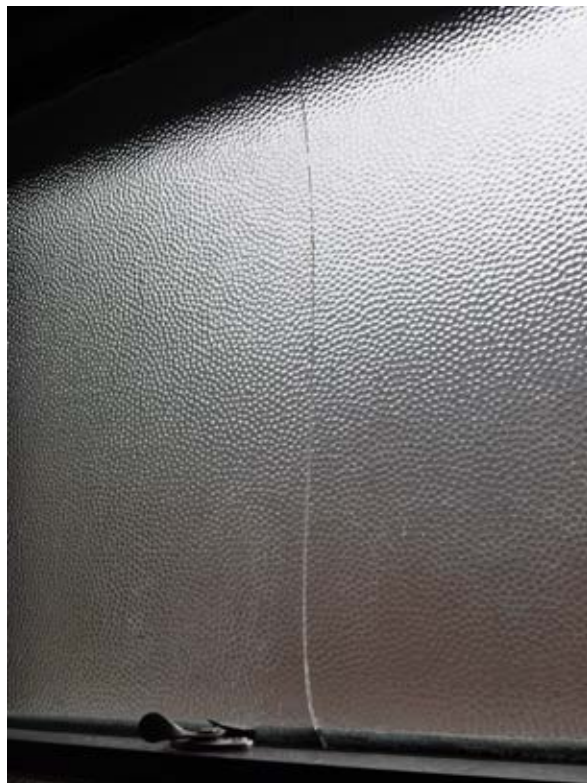
Window I5, Type G1

- Broken Glass
- Note: Extent of exterior deterioration, dry rot, and loss of operability is not fully apparent in interior photos. Replacement parts for existing windows are unavailable, making restoration of thermal and operable functionality impossible, and long-term maintenance infeasible. Recommendation is for replacement, for quality of life of future tenants and for feasibility of long-term maintenance.
- See Window Assessment (Blackberry) in appendix for further detail and information, including further notes on deterioration beyond repair
- See Appendix for Window Schedule & Measurements

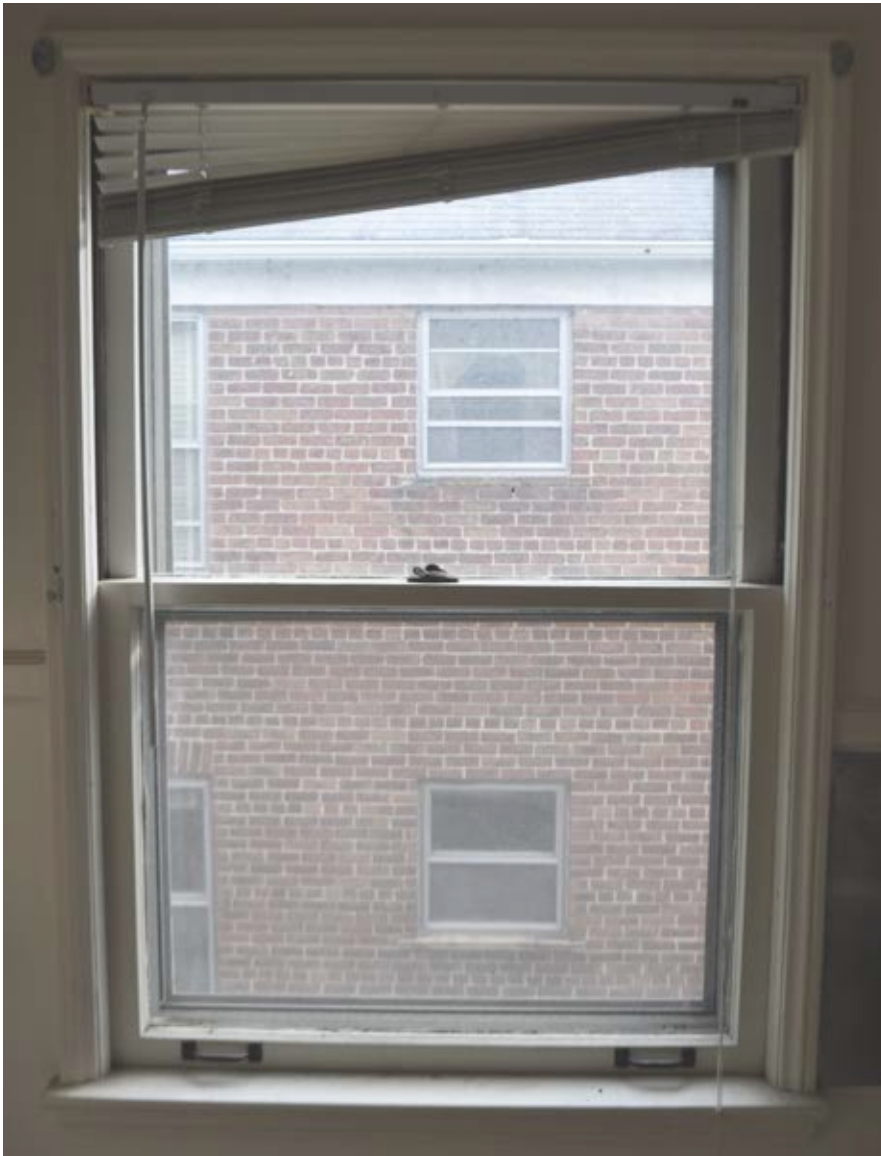
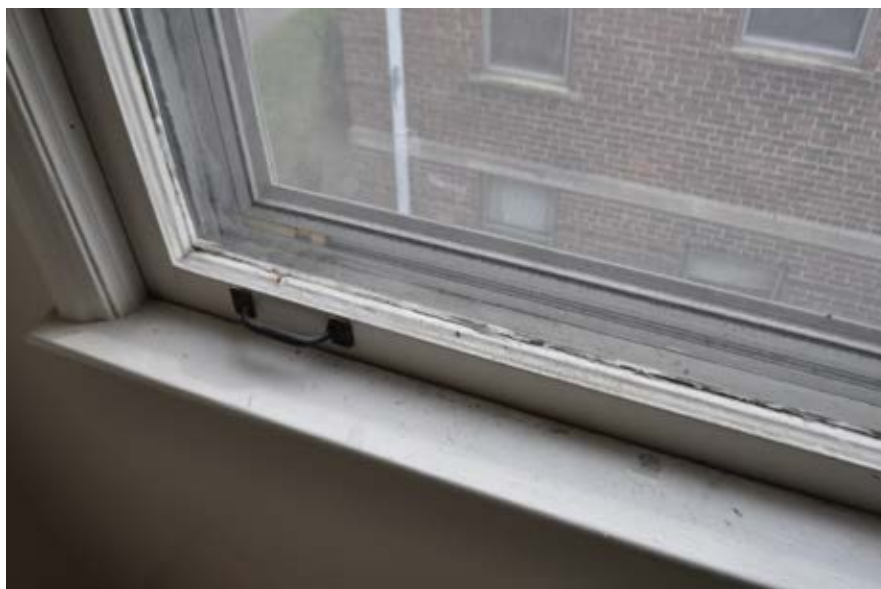
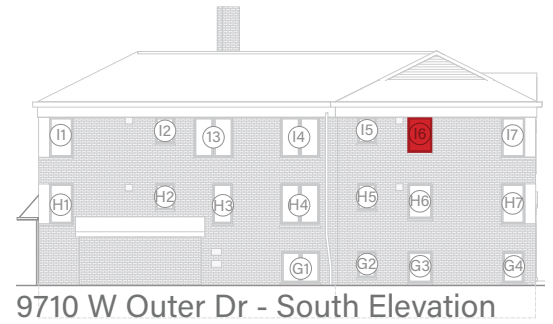
Window I6, Type E2

- Note: Extent of exterior deterioration, dry rot, and loss of operability is not fully apparent in interior photos. Replacement parts for existing windows are unavailable, making restoration of thermal and operable functionality impossible, and long-term maintenance infeasible. Recommendation is for replacement, for quality of life of future tenants and for feasibility of long-term maintenance.
- See Window Assessment (Blackberry) in appendix for further detail and information, including further notes on deterioration beyond repair
- See Appendix for Window Schedule & Measurements

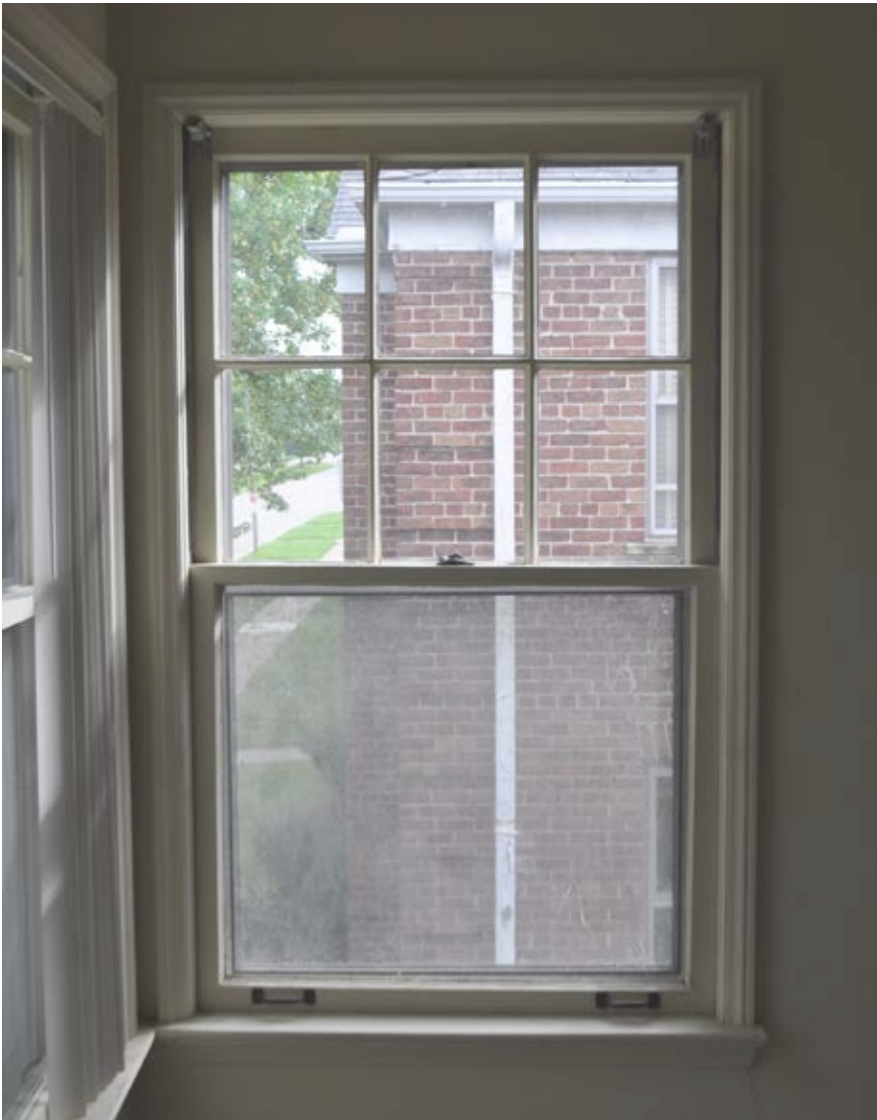
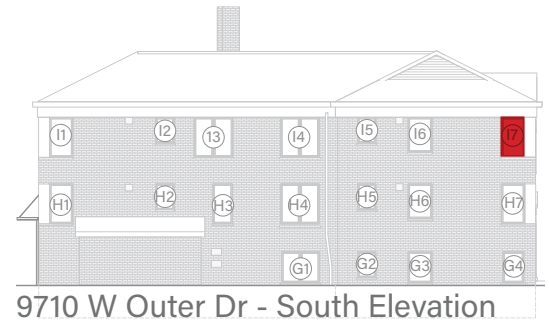
Window 17, Type A1

- Note: Extent of exterior deterioration, dry rot, and loss of operability is not fully apparent in interior photos. Replacement parts for existing windows are unavailable, making restoration of thermal and operable functionality impossible, and long-term maintenance infeasible. Recommendation is for replacement, for quality of life of future tenants and for feasibility of long-term maintenance.
- See Window Assessment (Blackberry) in appendix for further detail and information, including further notes on deterioration beyond repair
- See Appendix for Window Schedule & Measurements

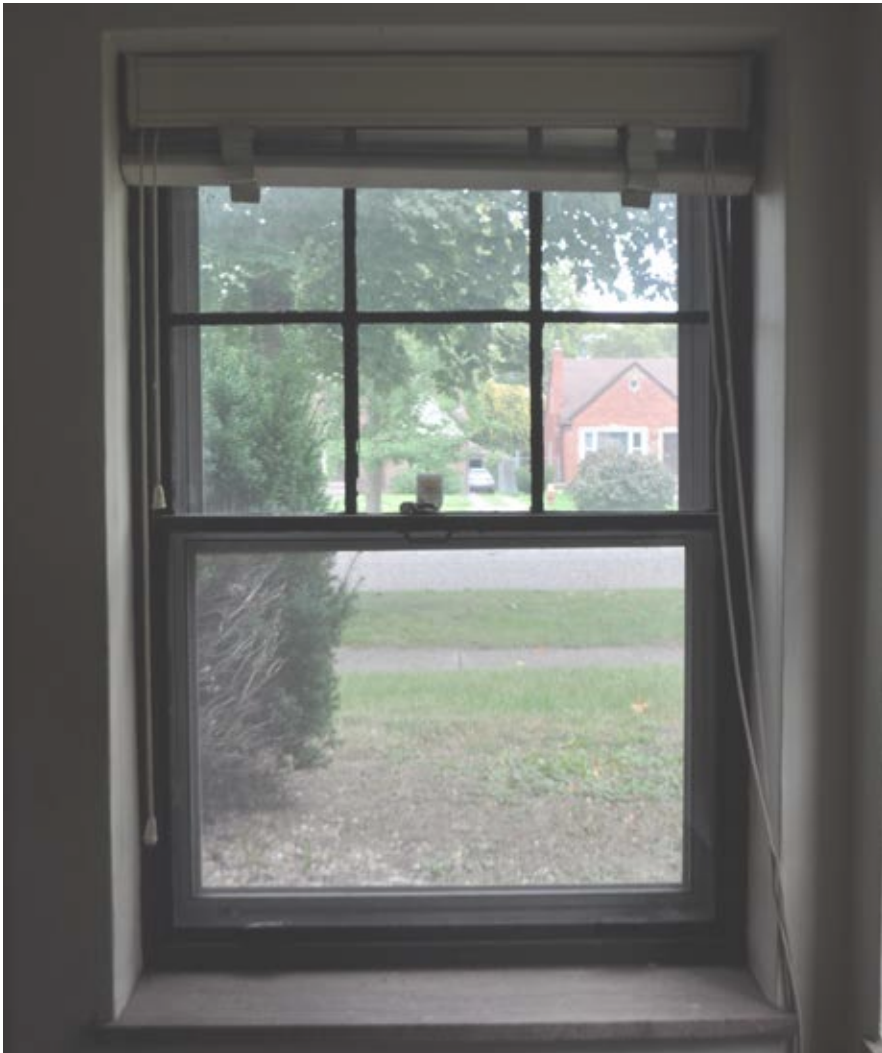
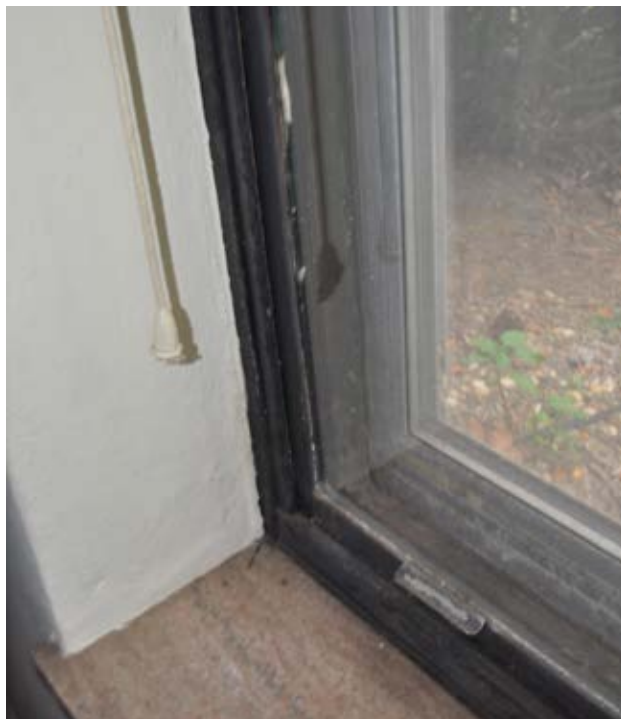
Window J1, Type D1

- Note: Extent of exterior deterioration, dry rot, and loss of operability is not fully apparent in interior photos. Replacement parts for existing windows are unavailable, making restoration of thermal and operable functionality impossible, and long-term maintenance infeasible. Recommendation is for replacement, for quality of life of future tenants and for feasibility of long-term maintenance.
- See Window Assessment (Blackberry) in appendix for further detail and information, including further notes on deterioration beyond repair
- See Appendix for Window Schedule & Measurements
