9710 W Outer Dr

Existing Condition Photos

Current Design Description

A 3-story apartment structure with 10 residential units, constructed in 1940, brick on wood stud wall construction, shingle roof, stone corner details, stone details at palladian window, stone sills, wood detailing at front entry, steel and wood canopy at back entry, wood windows throughout with the exception of steel windows at bathrooms and the lowest level. The addition of a brick shed to house the gas meter was made at a later date.

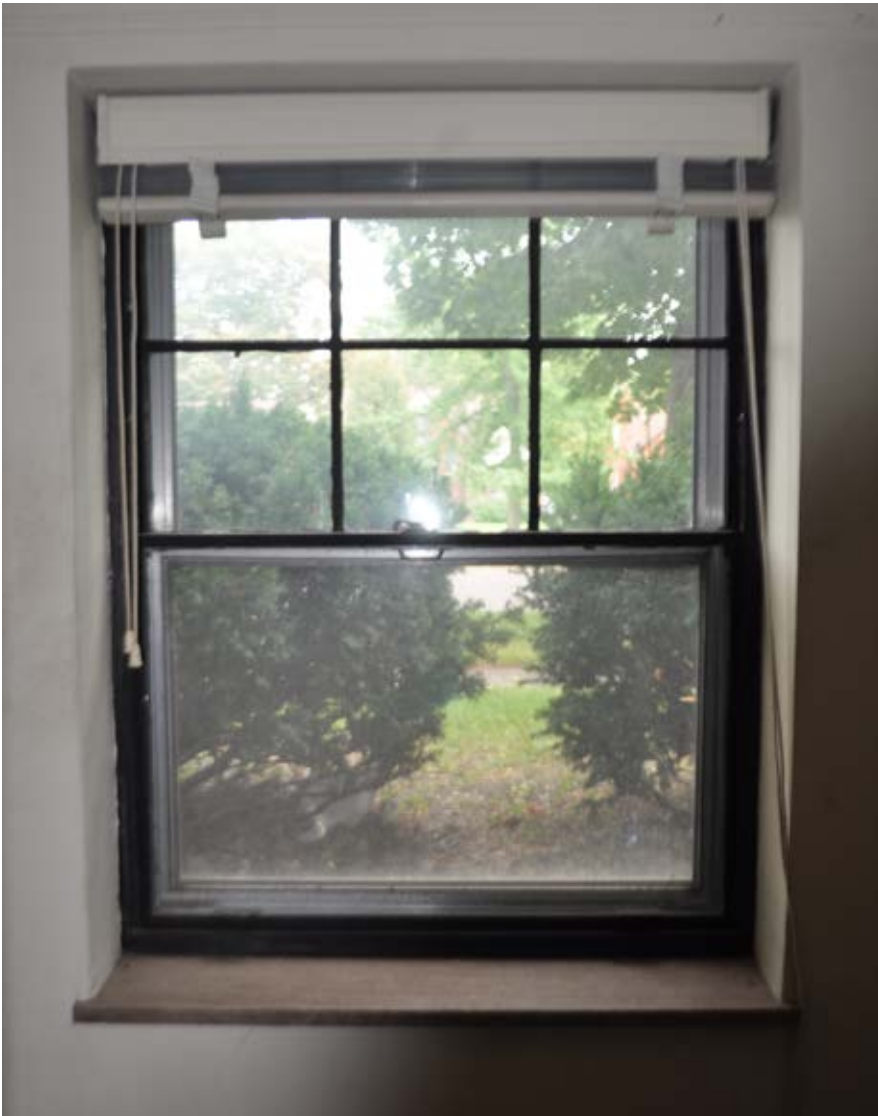
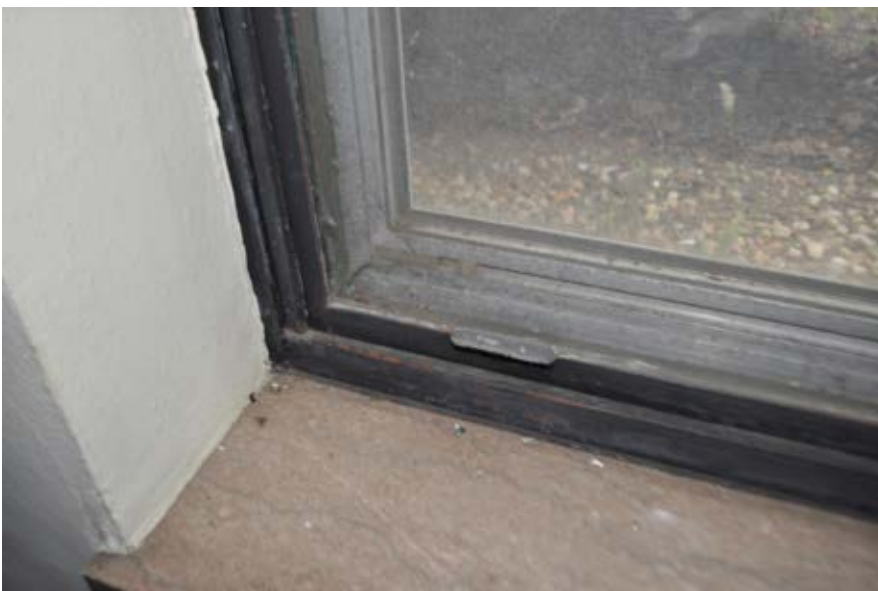
Window J2, Type C1

- Note: Extent of exterior deterioration, dry rot, and loss of operability is not fully apparent in interior photos. Replacement parts for existing windows are unavailable, making restoration of thermal and operable functionality impossible, and long-term maintenance infeasible. Recommendation is for replacement, for quality of life of future tenants and for feasibility of long-term maintenance.
- See Window Assessment (Blackberry) in appendix for further detail and information, including further notes on deterioration beyond repair
- See Appendix for Window Schedule & Measurements

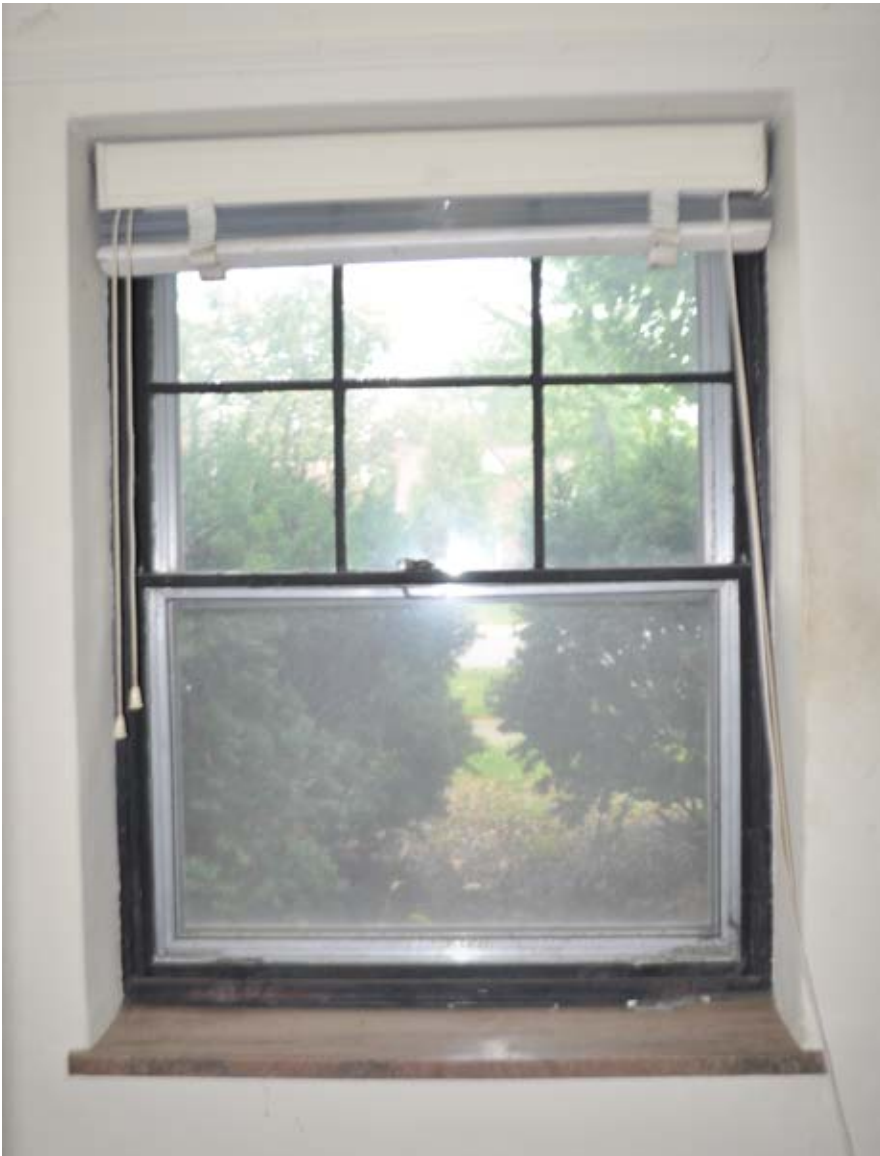
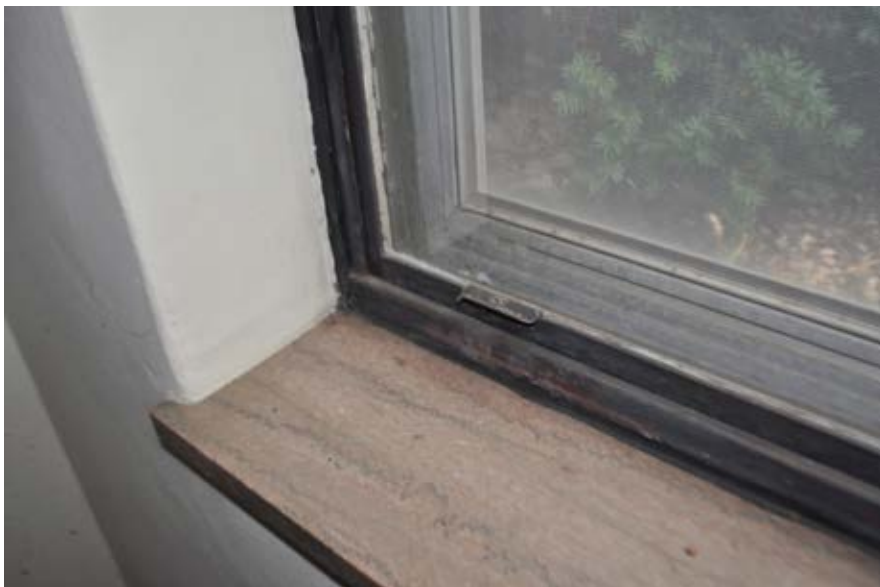
Window J3, Type C1

- Note: Extent of exterior deterioration, dry rot, and loss of operability is not fully apparent in interior photos. Replacement parts for existing windows are unavailable, making restoration of thermal and operable functionality impossible, and long-term maintenance infeasible. Recommendation is for replacement, for quality of life of future tenants and for feasibility of long-term maintenance.
- See Window Assessment (Blackberry) in appendix for further detail and information, including further notes on deterioration beyond repair
- See Appendix for Window Schedule & Measurements

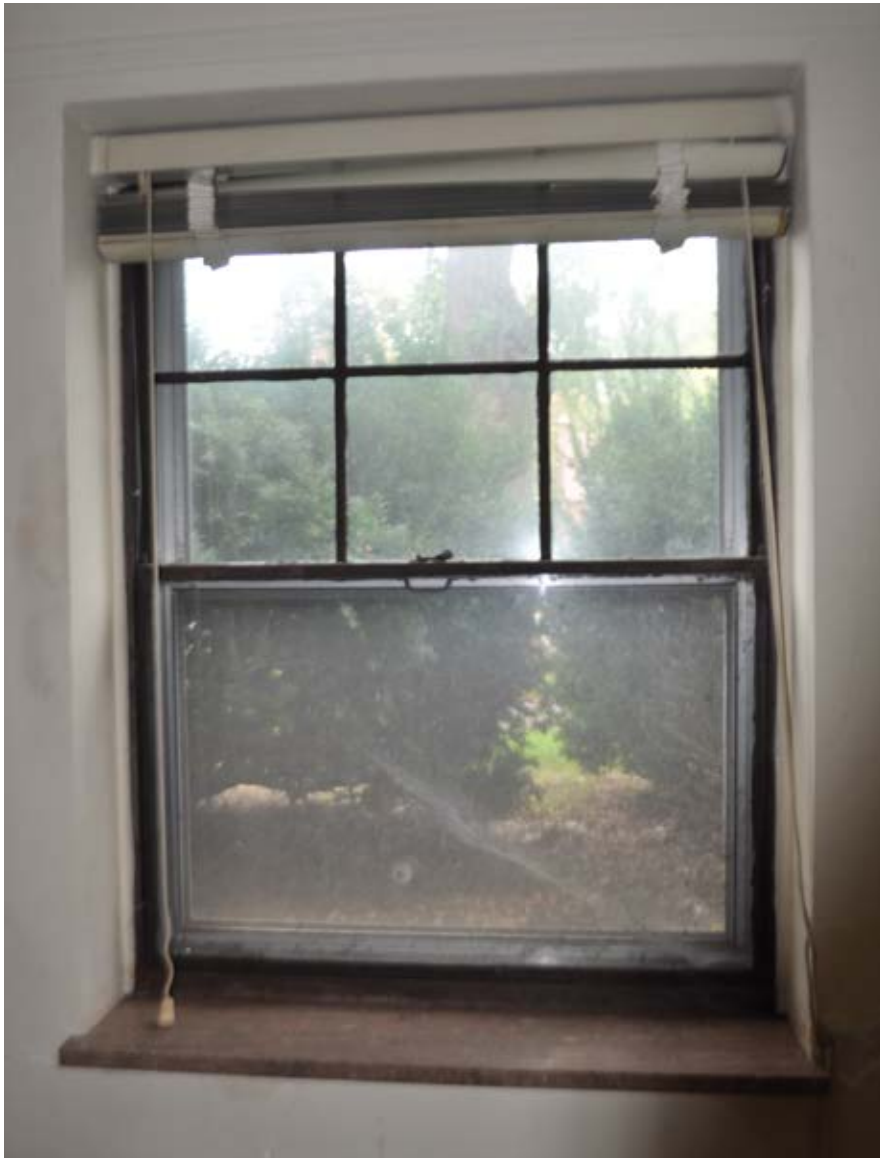
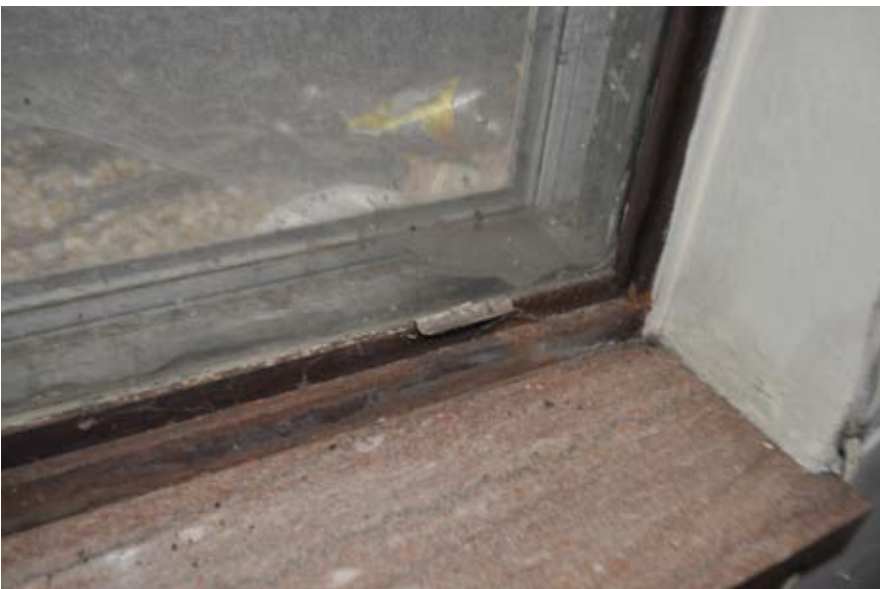
Window J4, Type C1

- Badly Rotted
- Note: Extent of exterior deterioration, dry rot, and loss of operability is not fully apparent in interior photos. Replacement parts for existing windows are unavailable, making restoration of thermal and operable functionality impossible, and long-term maintenance infeasible. Recommendation is for replacement, for quality of life of future tenants and for feasibility of long-term maintenance.
- See Window Assessment (Blackberry) in appendix for further detail and information, including further notes on deterioration beyond repair
- See Appendix for Window Schedule & Measurements

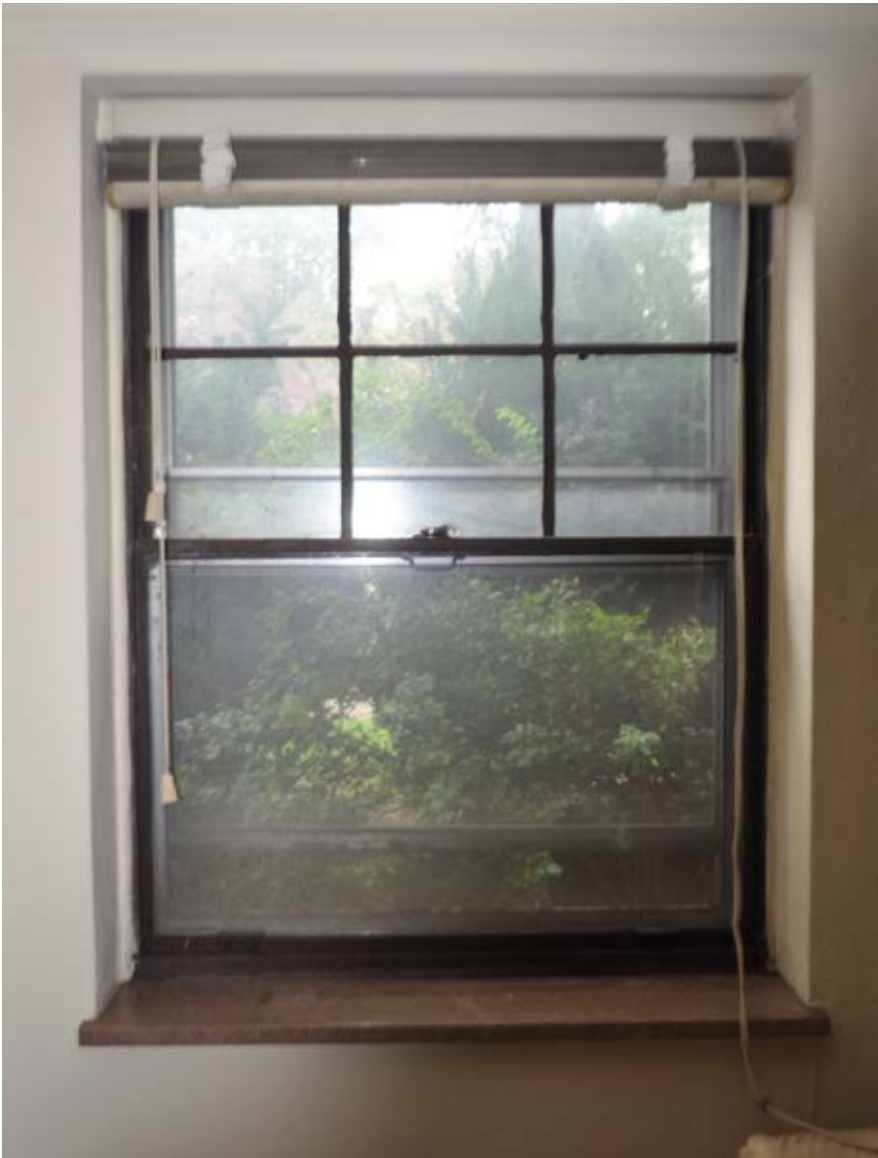
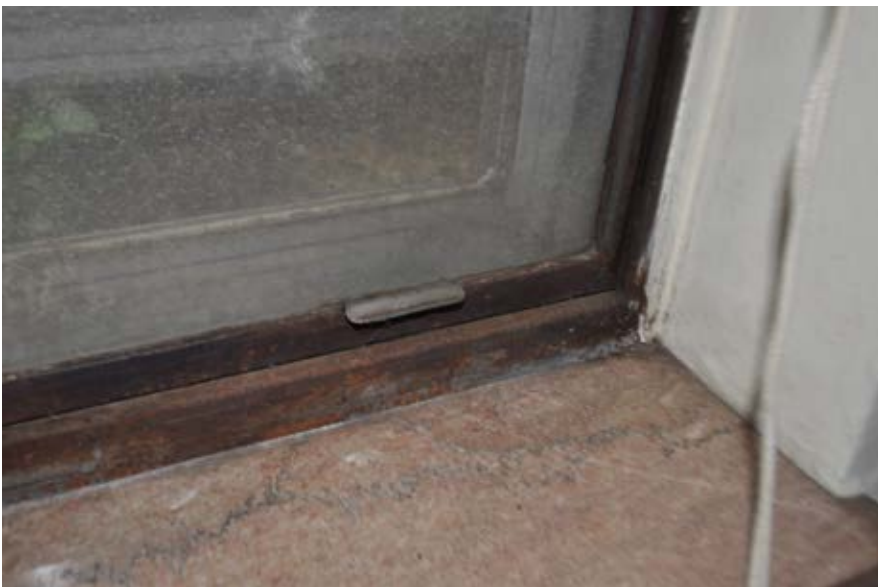
Window J5, Type C1

- Badly Rotted
- Note: Extent of exterior deterioration, dry rot, and loss of operability is not fully apparent in interior photos. Replacement parts for existing windows are unavailable, making restoration of thermal and operable functionality impossible, and long-term maintenance infeasible. Recommendation is for replacement, for quality of life of future tenants and for feasibility of long-term maintenance.
- See Window Assessment (Blackberry) in appendix for further detail and information, including further notes on deterioration beyond repair
- See Appendix for Window Schedule & Measurements

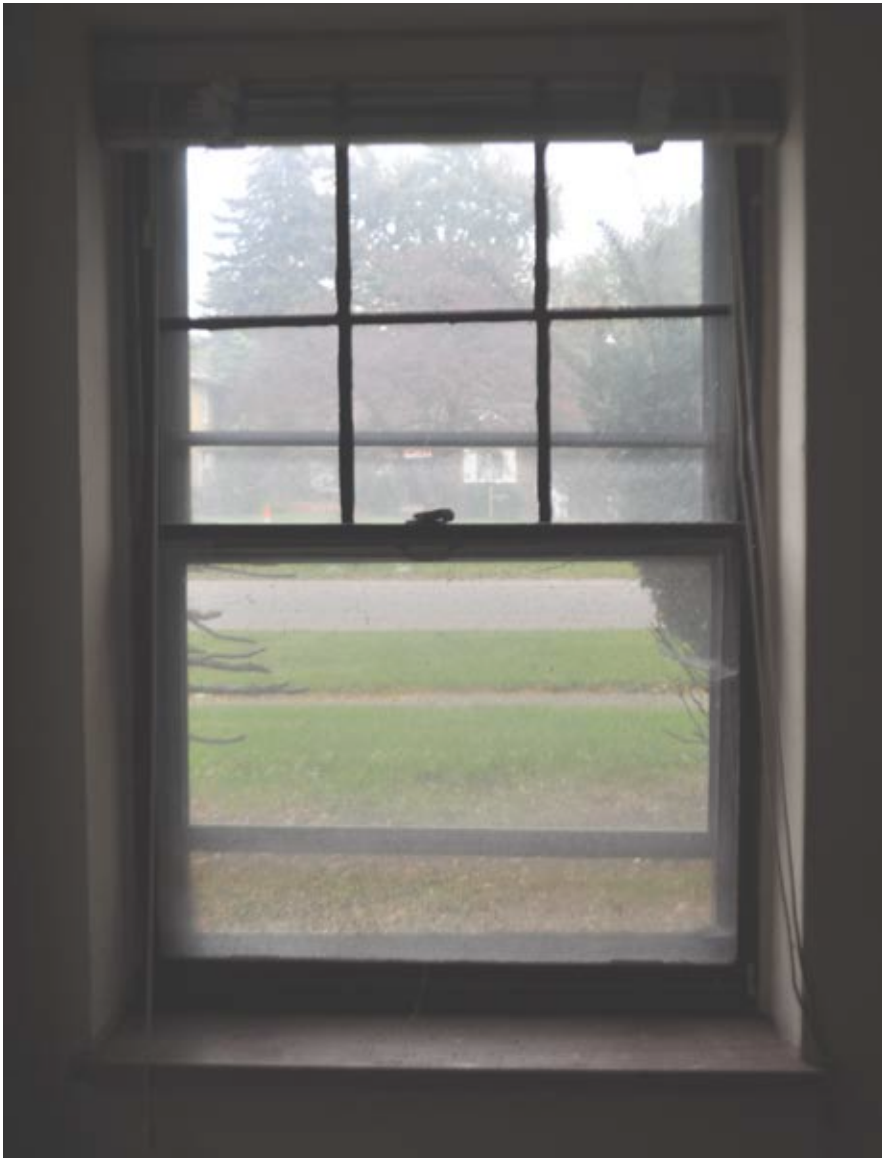
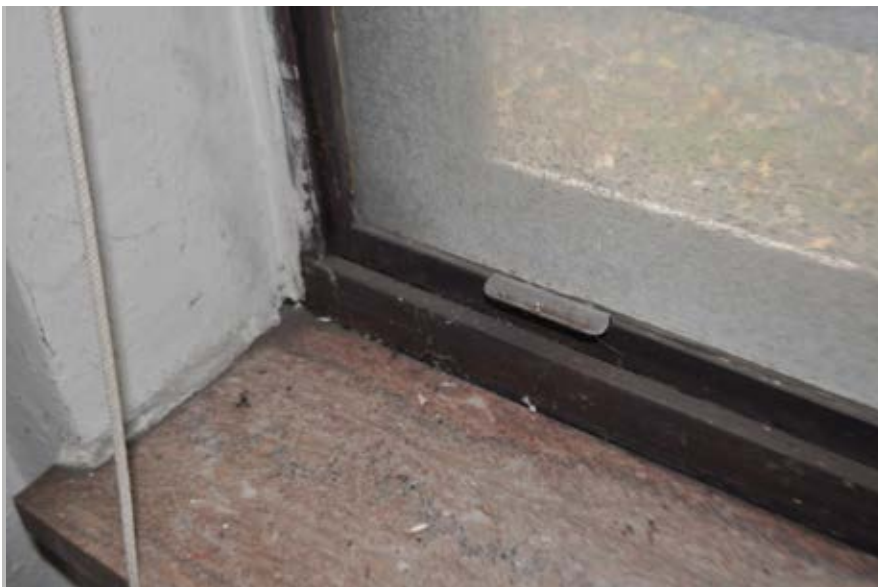
Window J6, Type D1

- Note: Extent of exterior deterioration, dry rot, and loss of operability is not fully apparent in interior photos. Replacement parts for existing windows are unavailable, making restoration of thermal and operable functionality impossible, and long-term maintenance infeasible. Recommendation is for replacement, for quality of life of future tenants and for feasibility of long-term maintenance.
- See Window Assessment (Blackberry) in appendix for further detail and information, including further notes on deterioration beyond repair
- See Appendix for Window Schedule & Measurements

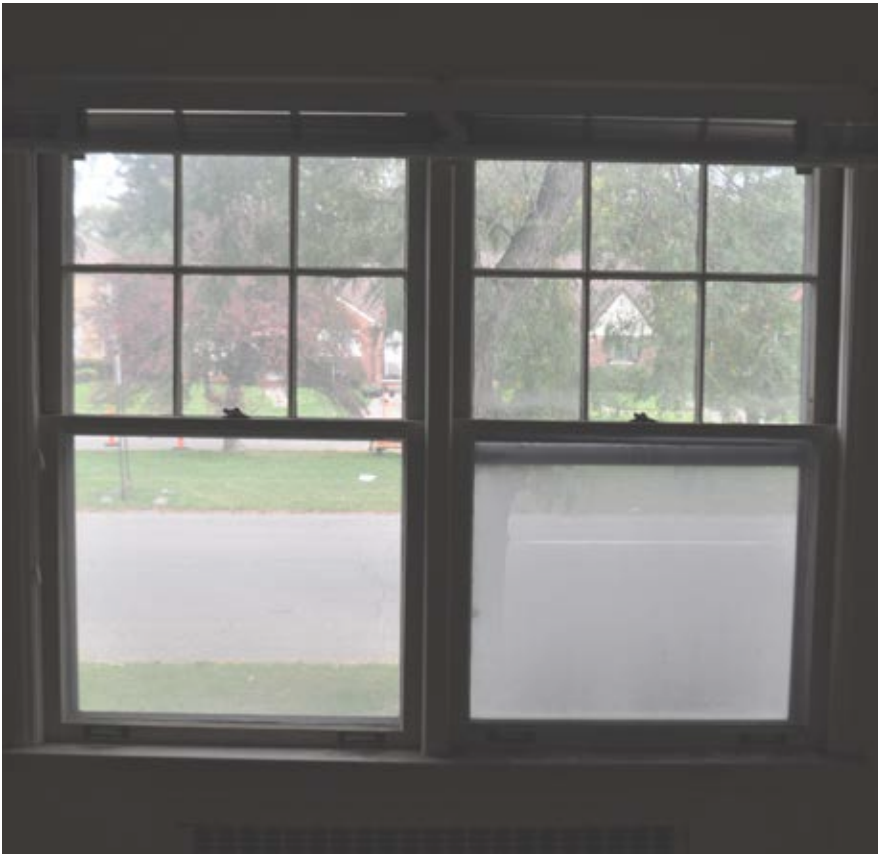
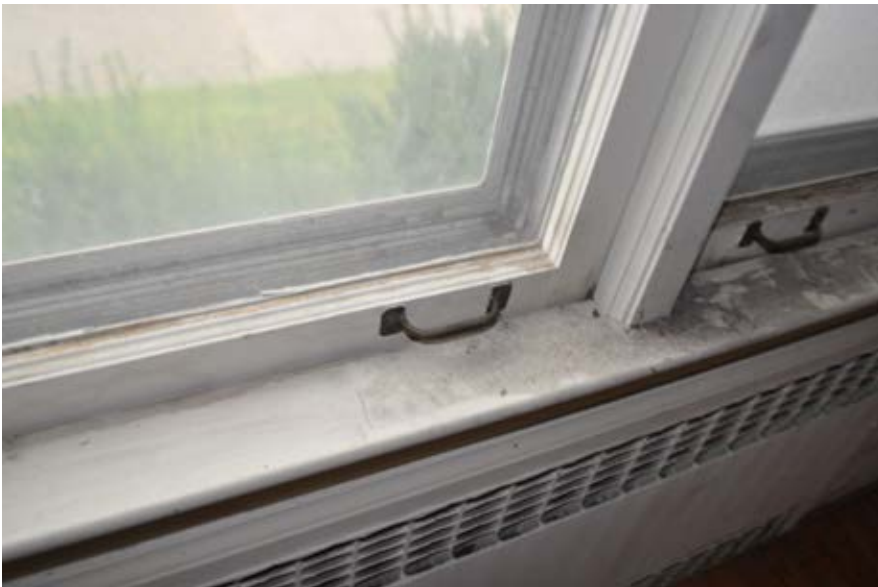
Window K4, Type B1

- Note: Extent of exterior deterioration, dry rot, and loss of operability is not fully apparent in interior photos. Replacement parts for existing windows are unavailable, making restoration of thermal and operable functionality impossible, and long-term maintenance infeasible. Recommendation is for replacement, for quality of life of future tenants and for feasibility of long-term maintenance.
- See Window Assessment (Blackberry) in appendix for further detail and information, including further notes on deterioration beyond repair
- See Appendix for Window Schedule & Measurements

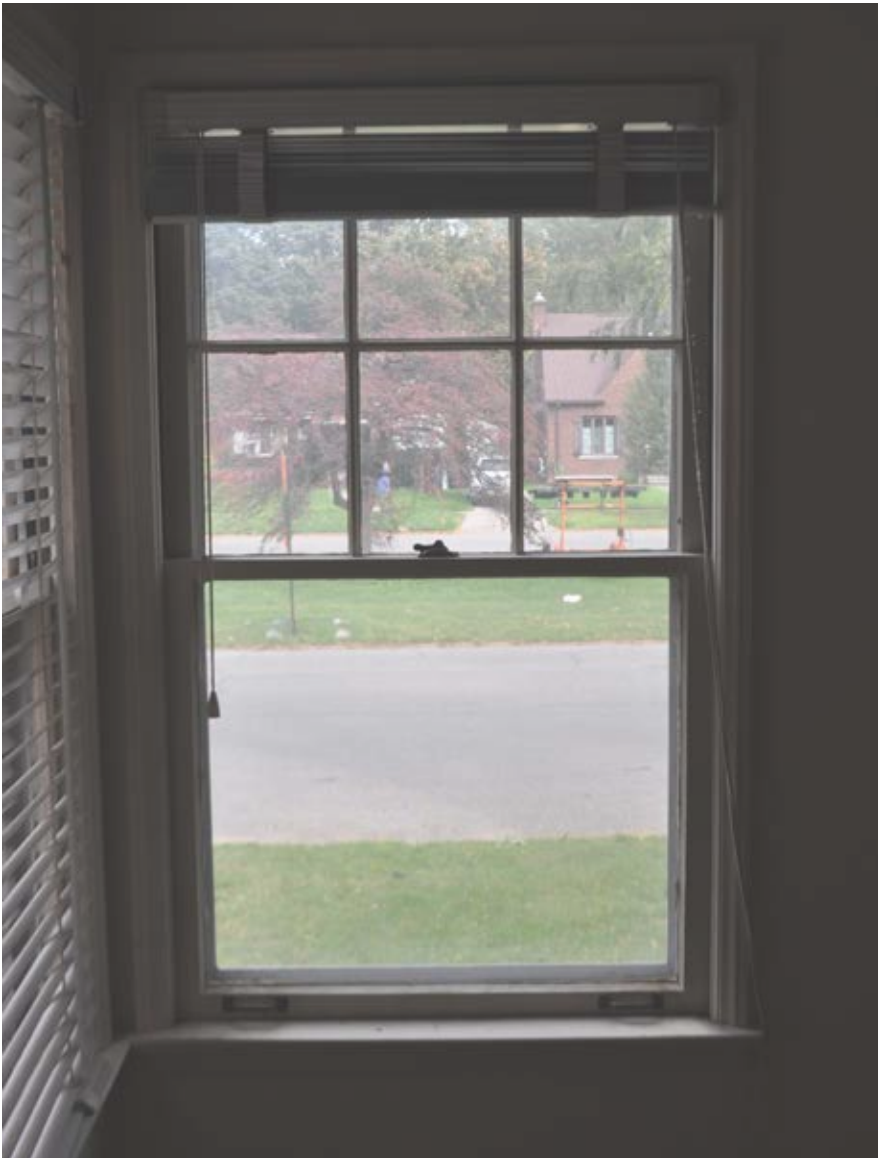
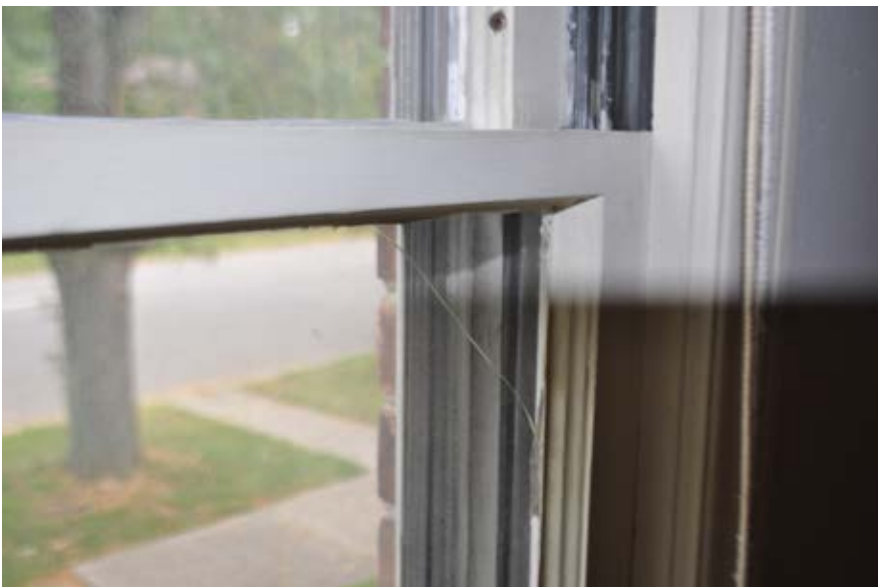
Window K5, Type A1

- Broken Glass
- Note: Extent of exterior deterioration, dry rot, and loss of operability is not fully apparent in interior photos. Replacement parts for existing windows are unavailable, making restoration of thermal and operable functionality impossible, and long-term maintenance infeasible. Recommendation is for replacement, for quality of life of future tenants and for feasibility of long-term maintenance.
- See Window Assessment (Blackberry) in appendix for further detail and information, including further notes on deterioration beyond repair
- See Appendix for Window Schedule & Measurements

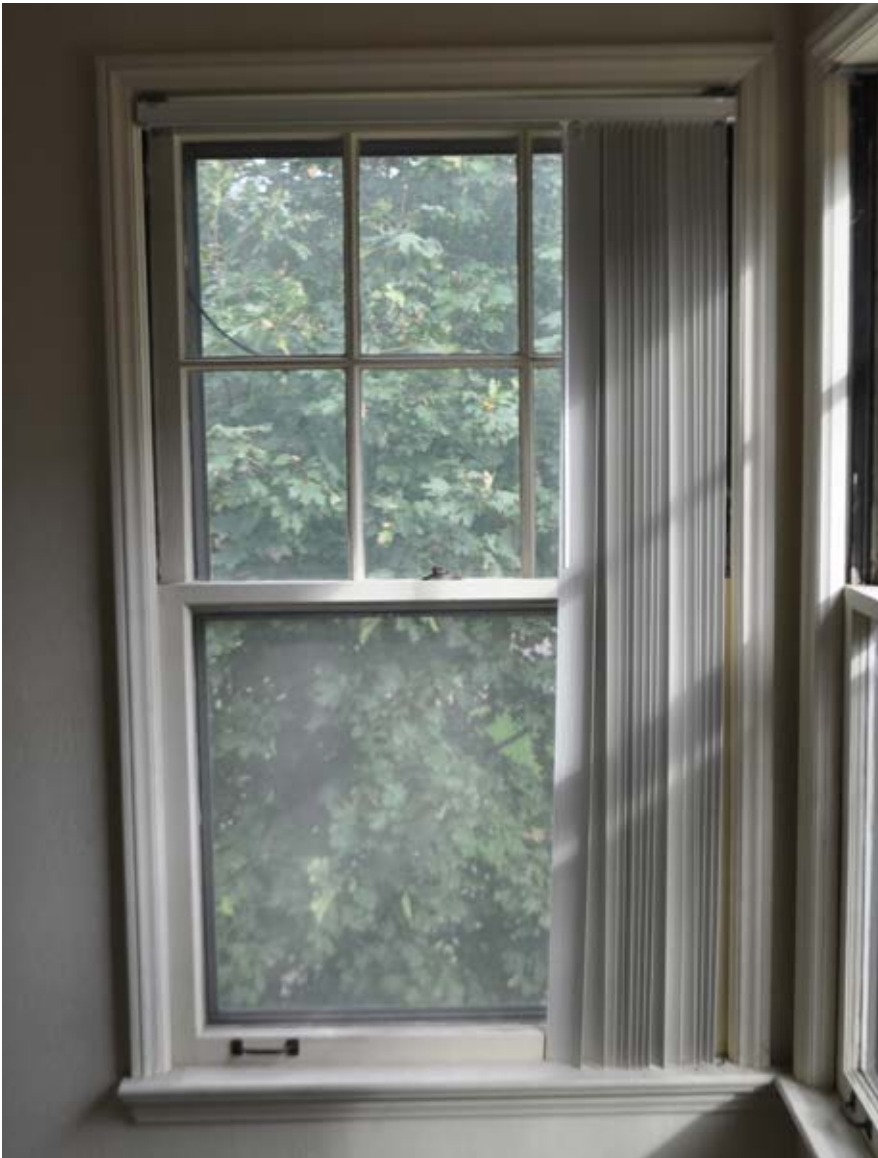
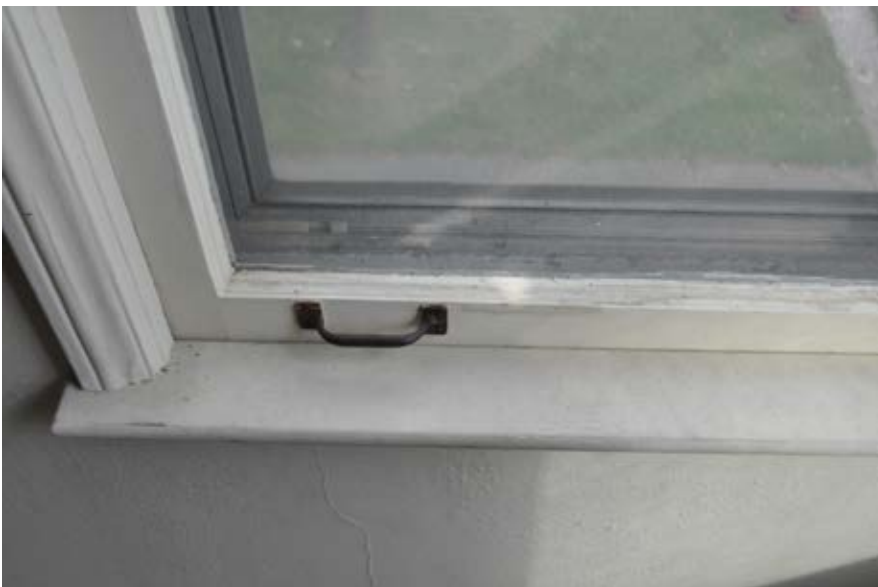
Window L1, Type A1

- Note: Extent of exterior deterioration, dry rot, and loss of operability is not fully apparent in interior photos. Replacement parts for existing windows are unavailable, making restoration of thermal and operable functionality impossible, and long-term maintenance infeasible. Recommendation is for replacement, for quality of life of future tenants and for feasibility of long-term maintenance.
- See Window Assessment (Blackberry) in appendix for further detail and information, including further notes on deterioration beyond repair
- See Appendix for Window Schedule & Measurements

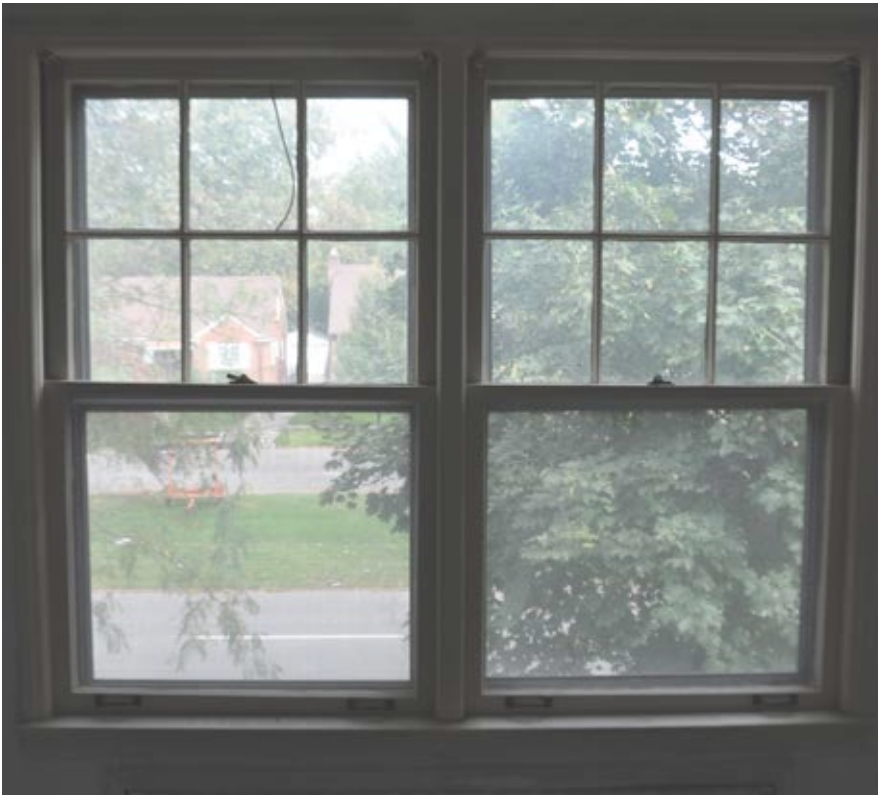
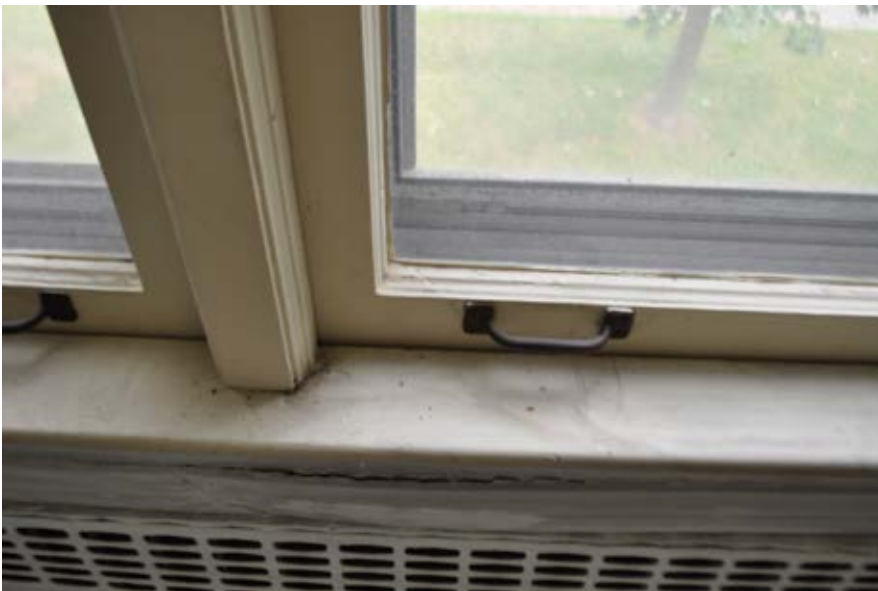
Window L2, Type B1

- Note: Extent of exterior deterioration, dry rot, and loss of operability is not fully apparent in interior photos. Replacement parts for existing windows are unavailable, making restoration of thermal and operable functionality impossible, and long-term maintenance infeasible. Recommendation is for replacement, for quality of life of future tenants and for feasibility of long-term maintenance.
- See Window Assessment (Blackberry) in appendix for further detail and information, including further notes on deterioration beyond repair
- See Appendix for Window Schedule & Measurements

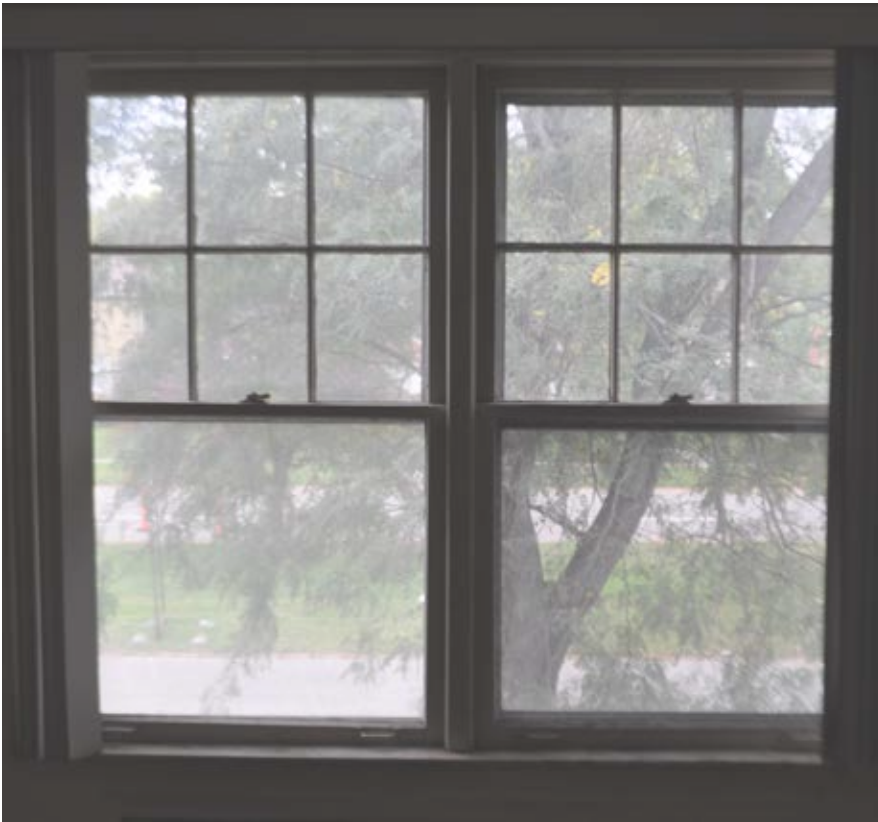
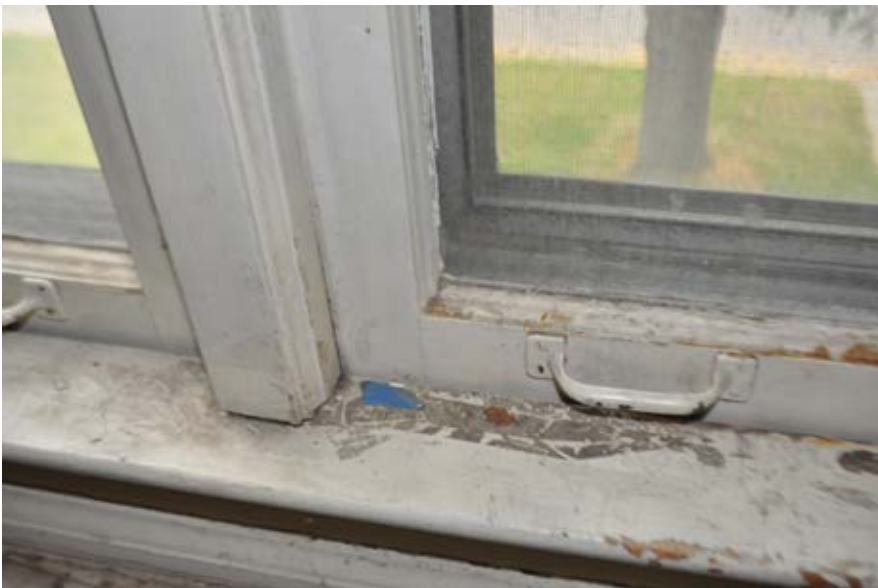
Window L6, Type B1

- Note: Extent of exterior deterioration, dry rot, and loss of operability is not fully apparent in interior photos. Replacement parts for existing windows are unavailable, making restoration of thermal and operable functionality impossible, and long-term maintenance infeasible. Recommendation is for replacement, for quality of life of future tenants and for feasibility of long-term maintenance.
- See Window Assessment (Blackberry) in appendix for further detail and information, including further notes on deterioration beyond repair
- See Appendix for Window Schedule & Measurements

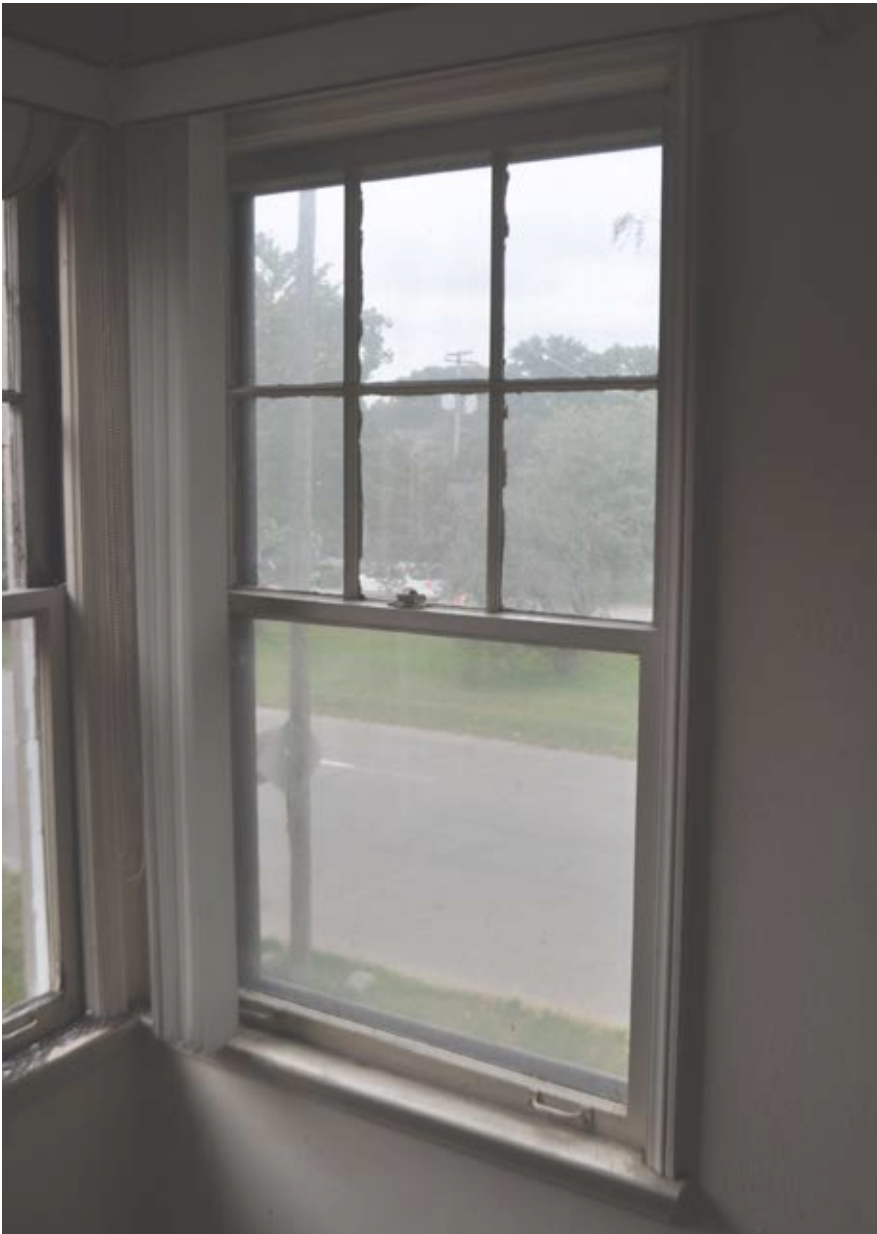
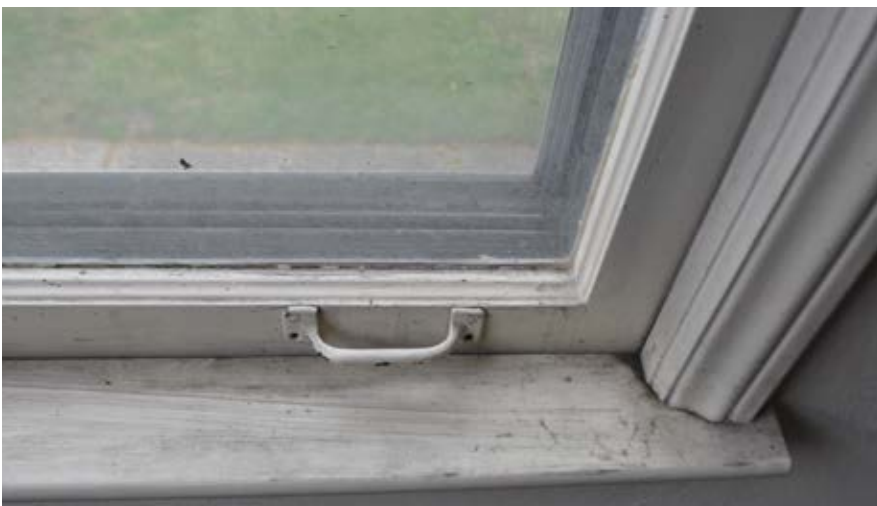
Window L7, Type A1

- Note: Extent of exterior deterioration, dry rot, and loss of operability is not fully apparent in interior photos. Replacement parts for existing windows are unavailable, making restoration of thermal and operable functionality impossible, and long-term maintenance infeasible. Recommendation is for replacement, for quality of life of future tenants and for feasibility of long-term maintenance.
- See Window Assessment (Blackberry) in appendix for further detail and information, including further notes on deterioration beyond repair
- See Appendix for Window Schedule & Measurements

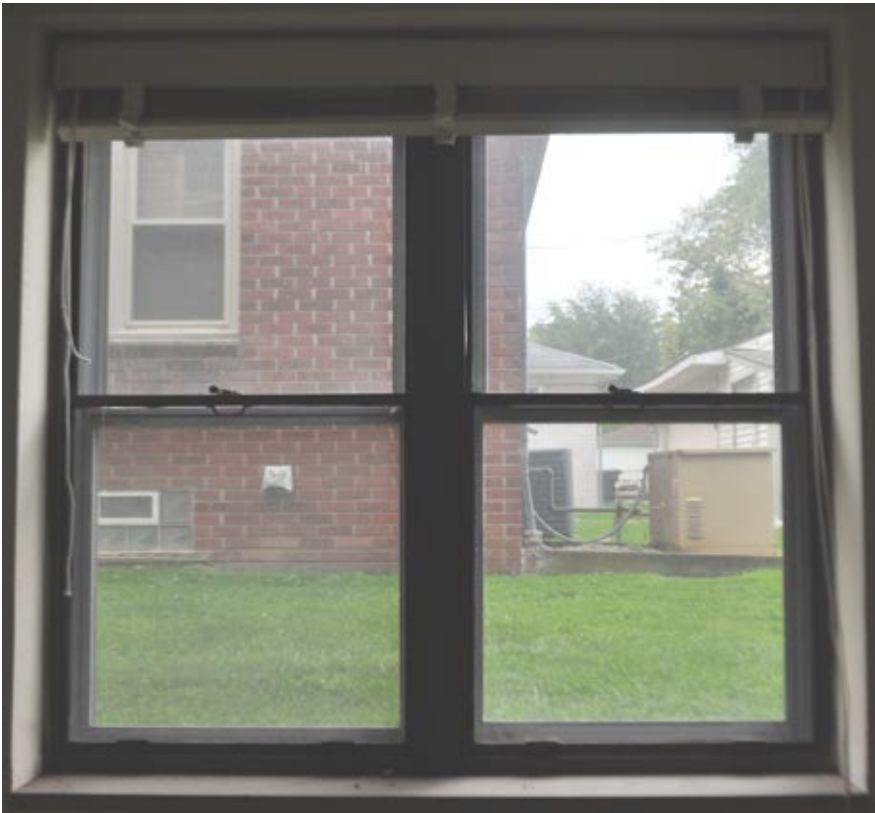
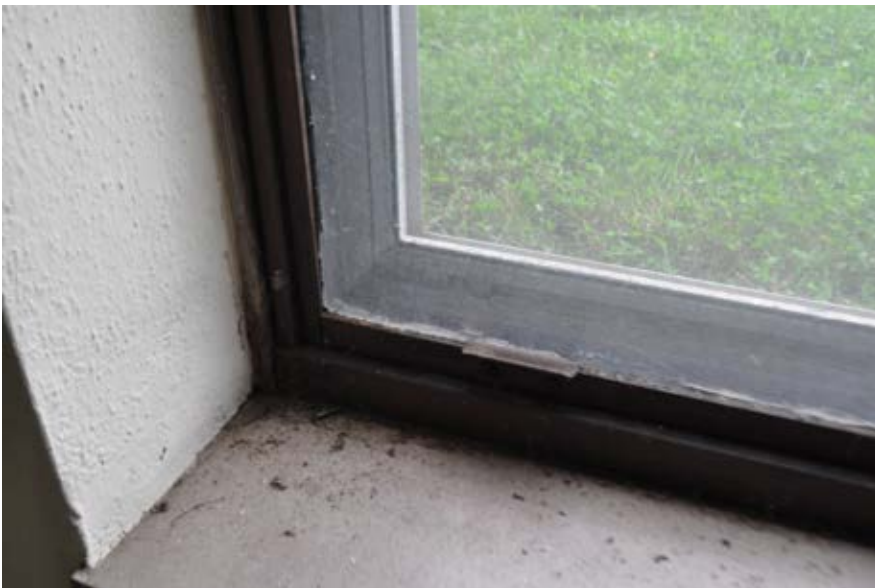
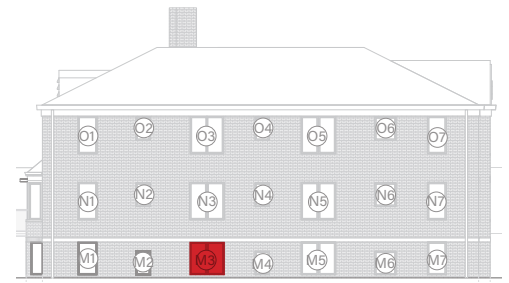
Window M3, Type Y1

- Badly Corroded
- Note: Extent of exterior deterioration, corrosion, and loss of operability is not fully apparent in interior photos. Replacement parts for existing windows are unavailable, making restoration of thermal and operable functionality impossible, and long-term maintenance infeasible. Recommendation is for replacement, for quality of life of future tenants and for feasibility of long-term maintenance.
- See Window Assessment (Blackberry) in appendix for further detail and information, including further notes on deterioration beyond repair
- See Appendix for Window Schedule & Measurements

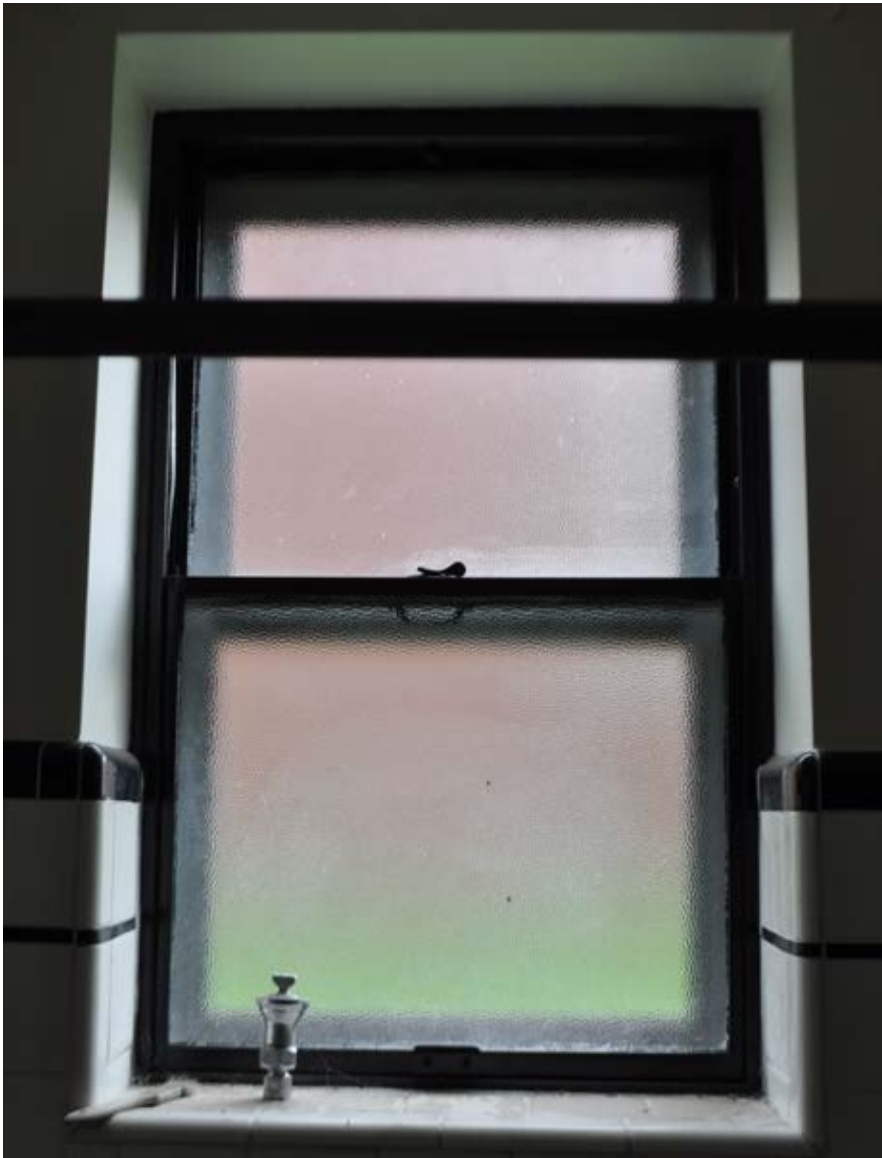
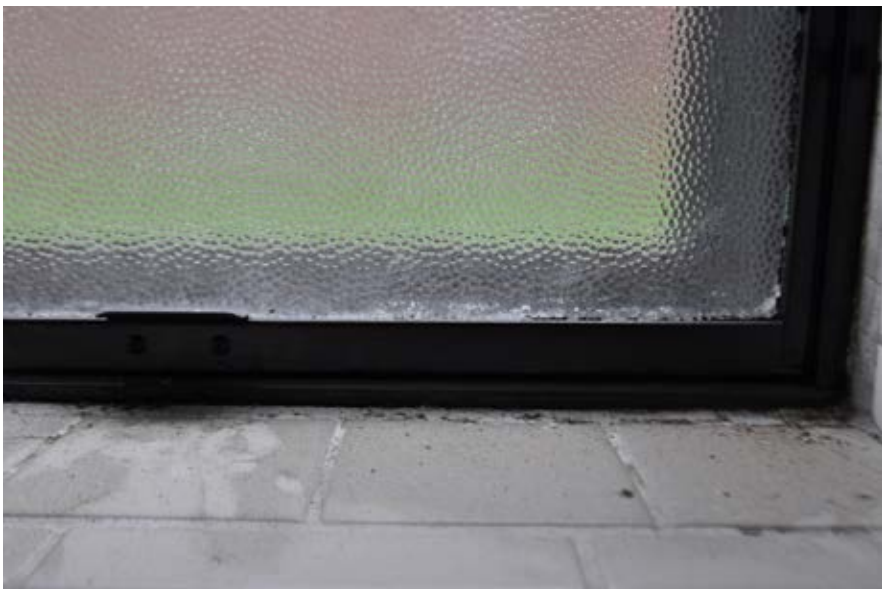
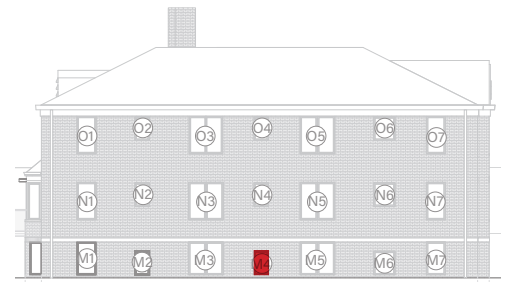
Window M4, Type U2

- Badly Corroded
- Note: Extent of exterior deterioration, corrosion, and loss of operability is not fully apparent in interior photos. Replacement parts for existing windows are unavailable, making restoration of thermal and operable functionality impossible, and long-term maintenance infeasible. Recommendation is for replacement, for quality of life of future tenants and for feasibility of long-term maintenance.
- See Window Assessment (Blackberry) in appendix for further detail and information, including further notes on deterioration beyond repair
- See Appendix for Window Schedule & Measurements

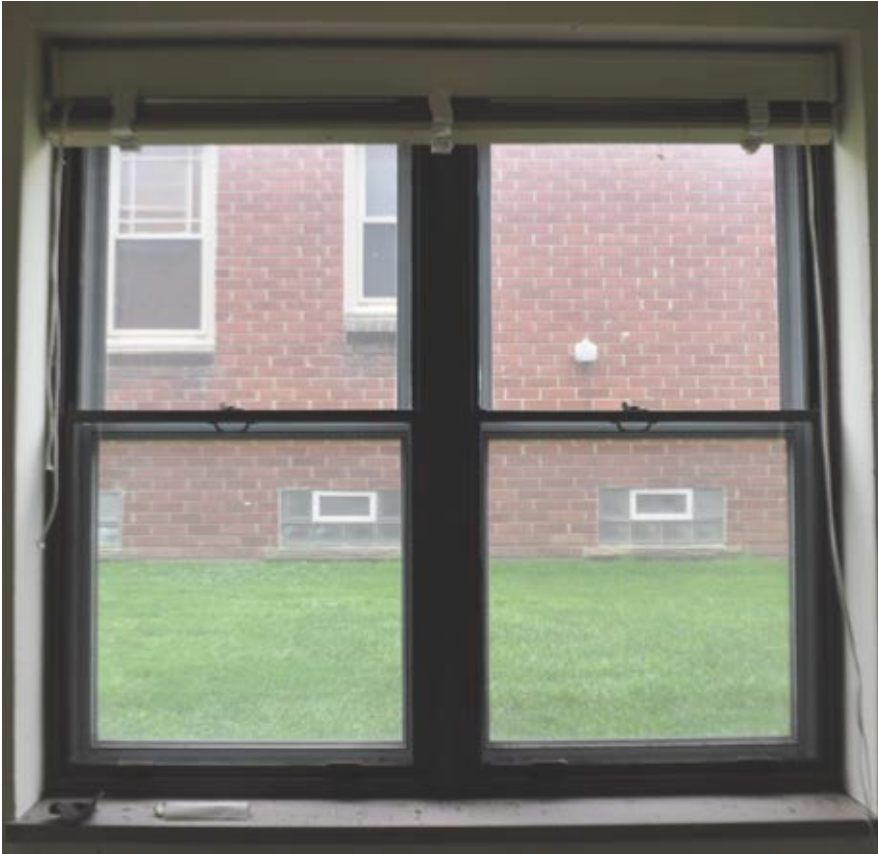
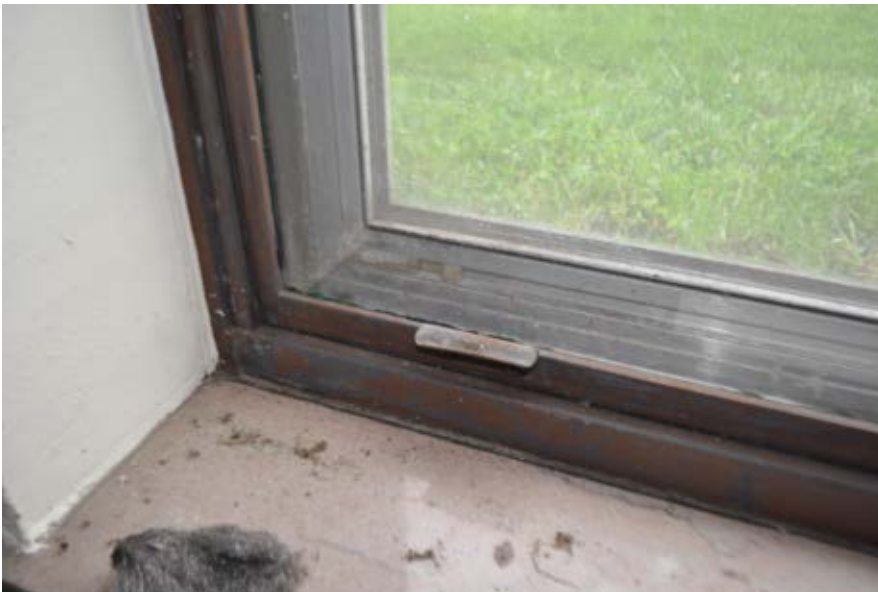
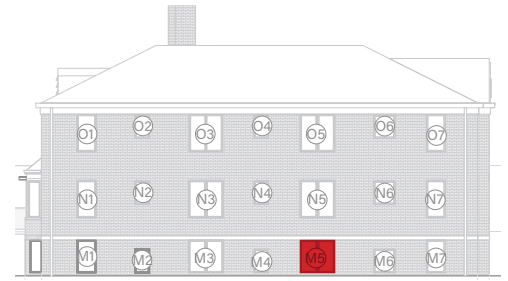
Window M5, Type Y1

- Badly Corroded
- Note: Extent of exterior deterioration, corrosion, and loss of operability is not fully apparent in interior photos. Replacement parts for existing windows are unavailable, making restoration of thermal and operable functionality impossible, and long-term maintenance infeasible. Recommendation is for replacement, for quality of life of future tenants and for feasibility of long-term maintenance.
- See Window Assessment (Blackberry) in appendix for further detail and information, including further notes on deterioration beyond repair
- See Appendix for Window Schedule & Measurements
