9710 W Outer Dr

Existing Condition Photos

Current Design Description

A 3-story apartment structure with 10 residential units, constructed in 1940, brick on wood stud wall construction, shingle roof, stone corner details, stone details at palladian window, stone sills, wood detailing at front entry, steel and wood canopy at back entry, wood windows throughout with the exception of steel windows at bathrooms and the lowest level. The addition of a brick shed to house the gas meter was made at a later date.

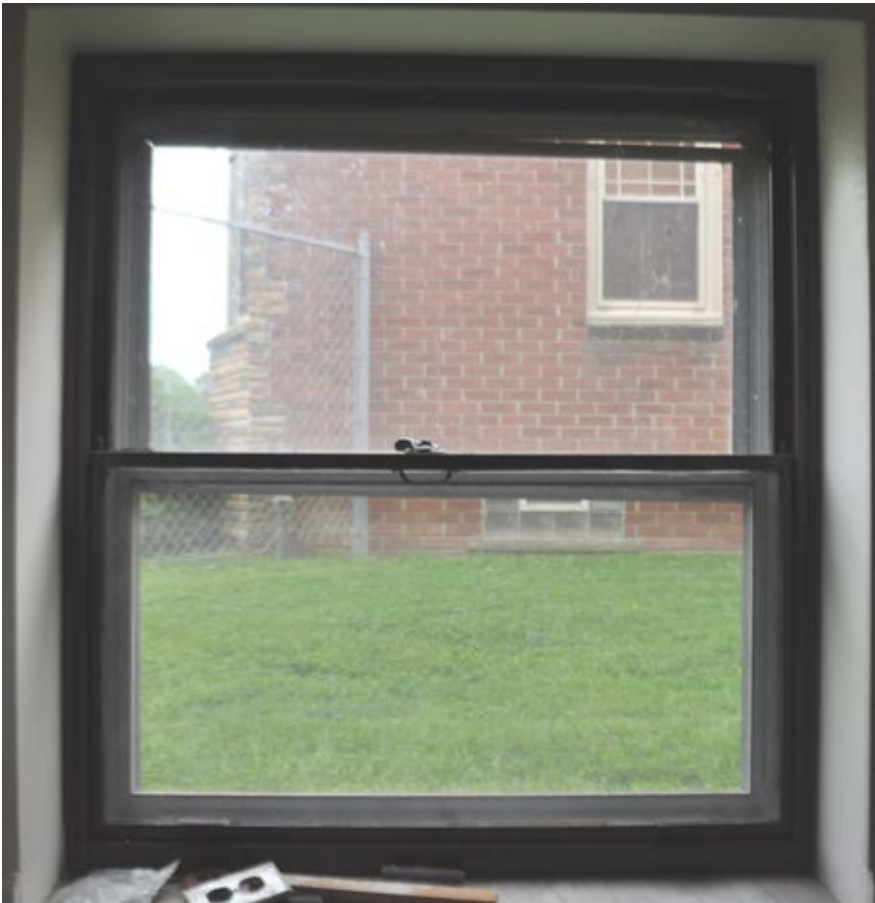
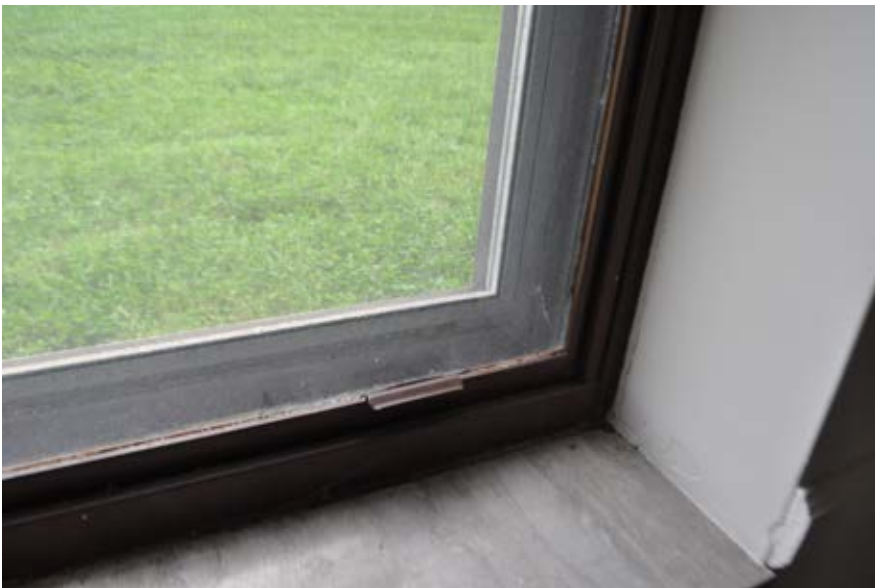
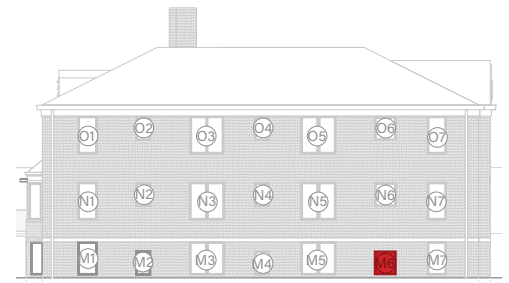
Window M6, Type T2

- Badly Corroded
- Note: Extent of exterior deterioration, corrosion, and loss of operability is not fully apparent in interior photos. Replacement parts for existing windows are unavailable, making restoration of thermal and operable functionality impossible, and long-term maintenance infeasible. Recommendation is for replacement, for quality of life of future tenants and for feasibility of long-term maintenance.
- See Window Assessment (Blackberry) in appendix for further detail and information, including further notes on deterioration beyond repair
- See Appendix for Window Schedule & Measurements

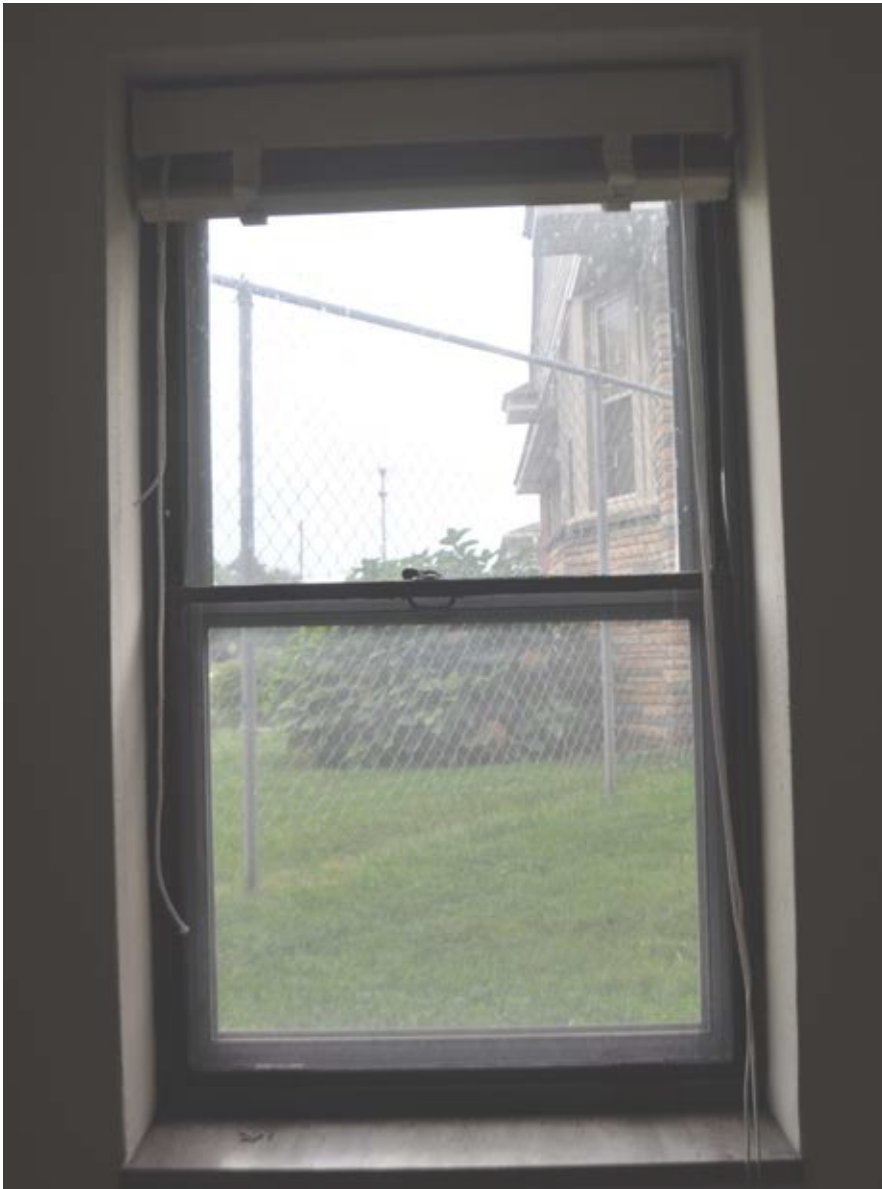
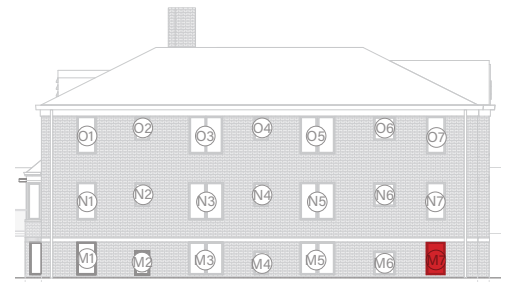
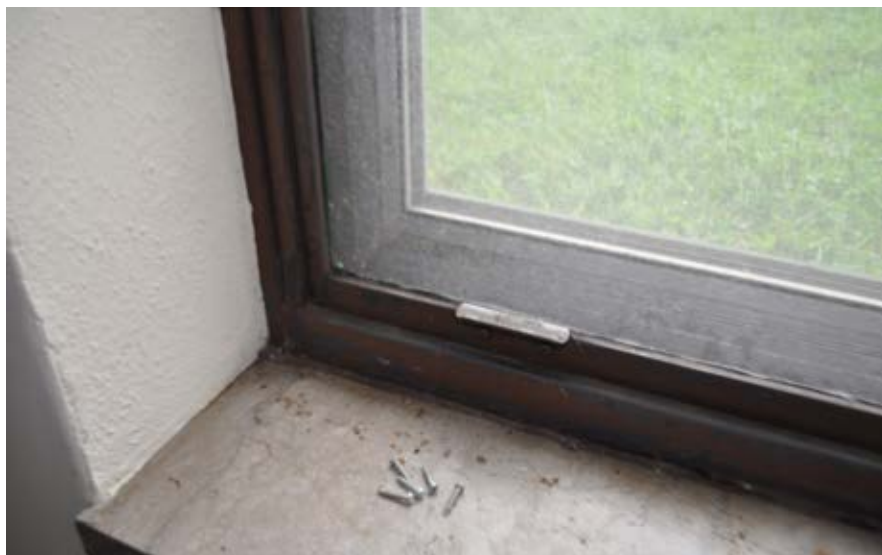
Window M7, Type M2

- Badly Corroded
- Note: Extent of exterior deterioration, corrosion, and loss of operability is not fully apparent in interior photos. Replacement parts for existing windows are unavailable, making restoration of thermal and operable functionality impossible, and long-term maintenance infeasible. Recommendation is for replacement, for quality of life of future tenants and for feasibility of long-term maintenance.
- See Window Assessment (Blackberry) in appendix for further detail and information, including further notes on deterioration beyond repair
- See Appendix for Window Schedule & Measurements

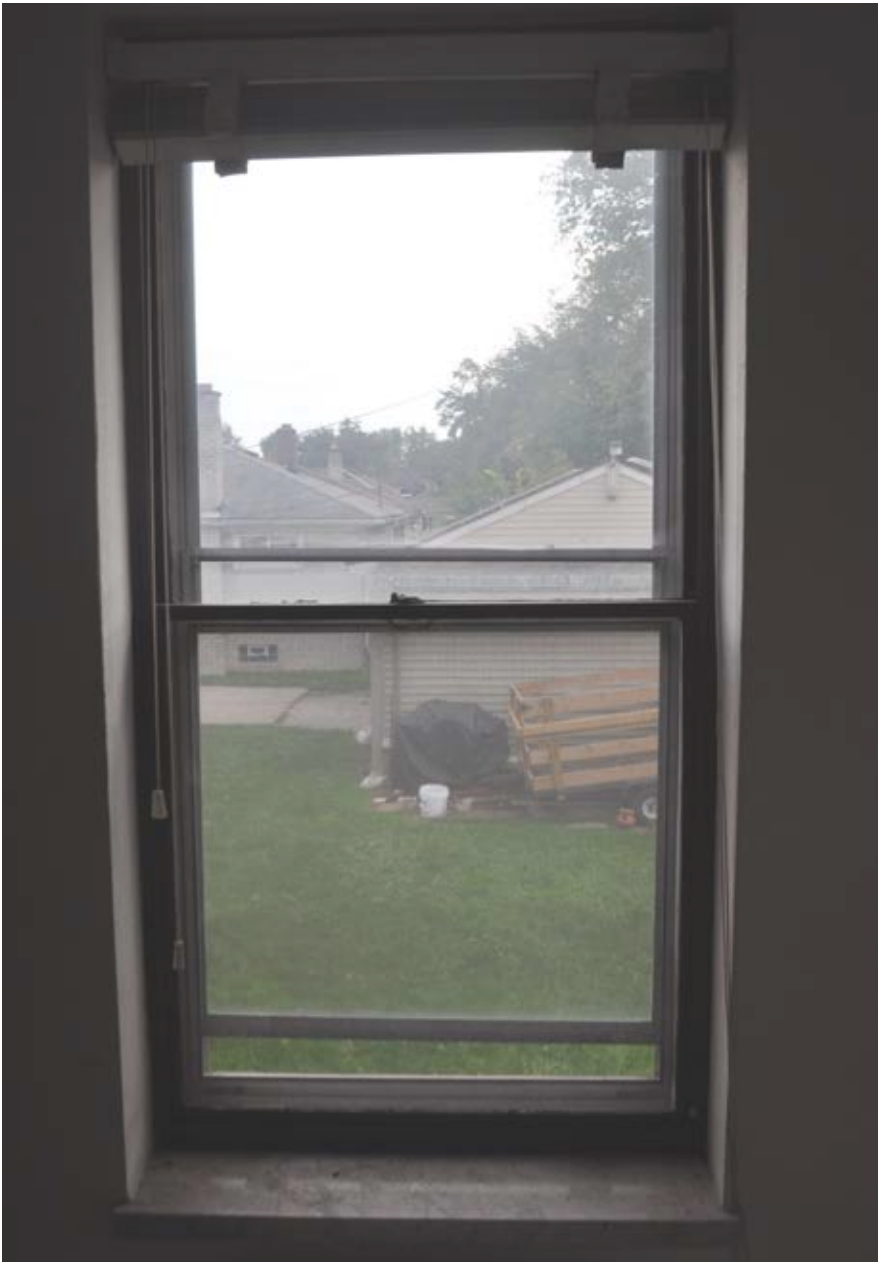
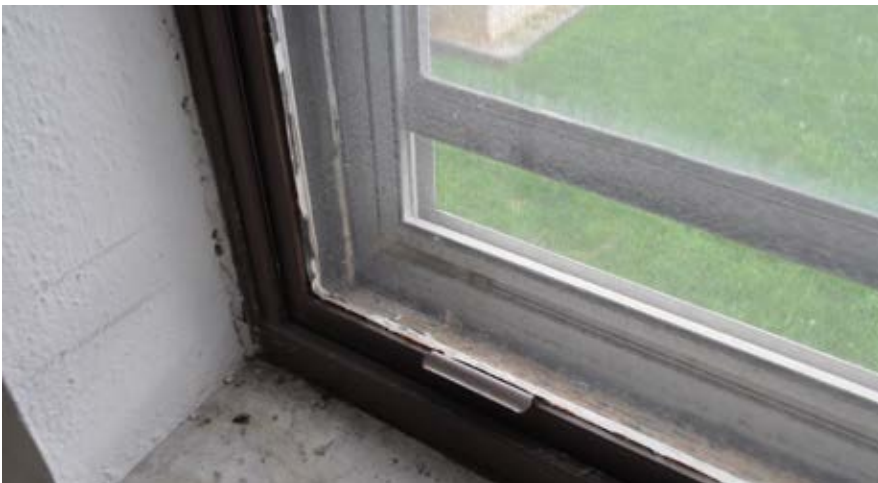
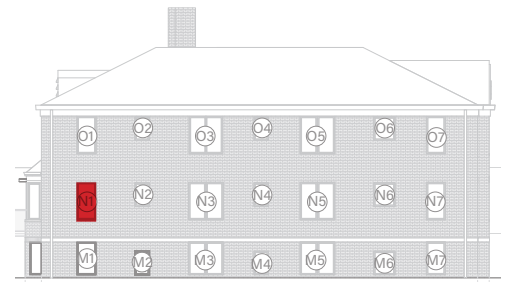
Window N1, Type N2

- Note: Extent of exterior deterioration, corrosion, and loss of operability is not fully apparent in interior photos. Replacement parts for existing windows are unavailable, making restoration of thermal and operable functionality impossible, and long-term maintenance infeasible. Recommendation is for replacement, for quality of life of future tenants and for feasibility of long-term maintenance.
- See Window Assessment (Blackberry) in appendix for further detail and information, including further notes on deterioration beyond repair
- See Appendix for Window Schedule & Measurements

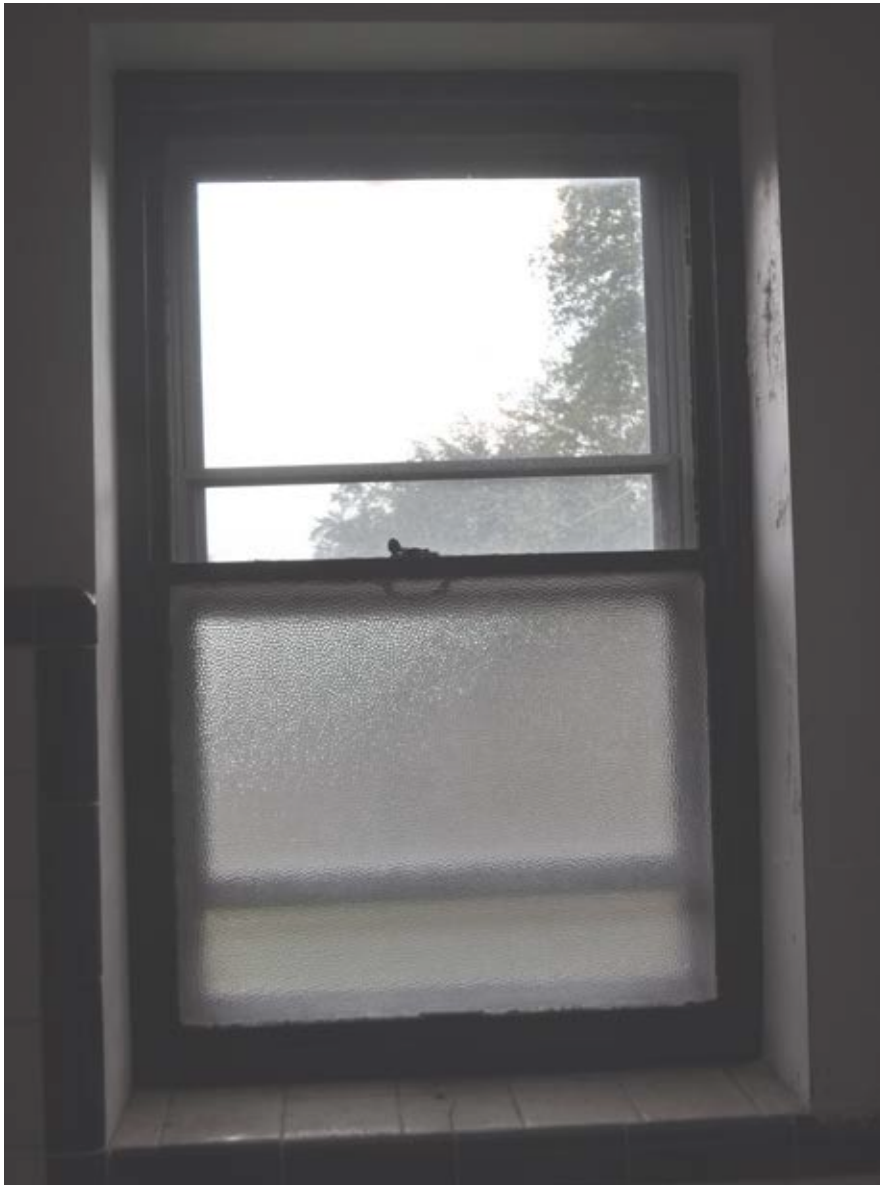
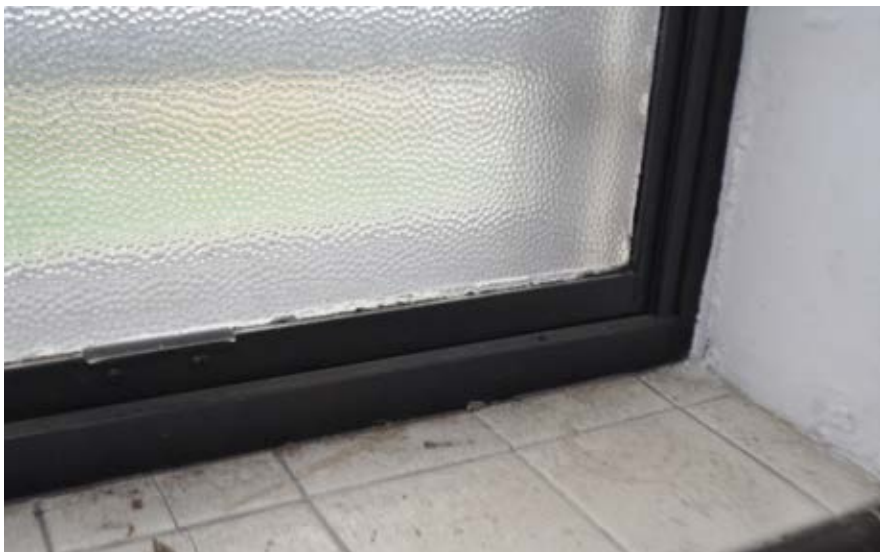
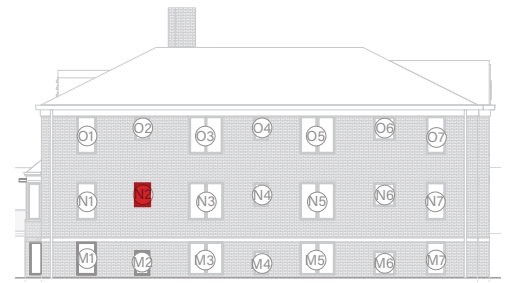
Window N2, Type U2

- Note: Extent of exterior deterioration, corrosion, and loss of operability is not fully apparent in interior photos. Replacement parts for existing windows are unavailable, making restoration of thermal and operable functionality impossible, and long-term maintenance infeasible. Recommendation is for replacement, for quality of life of future tenants and for feasibility of long-term maintenance.
- See Window Assessment (Blackberry) in appendix for further detail and information, including further notes on deterioration beyond repair
- See Appendix for Window Schedule & Measurements

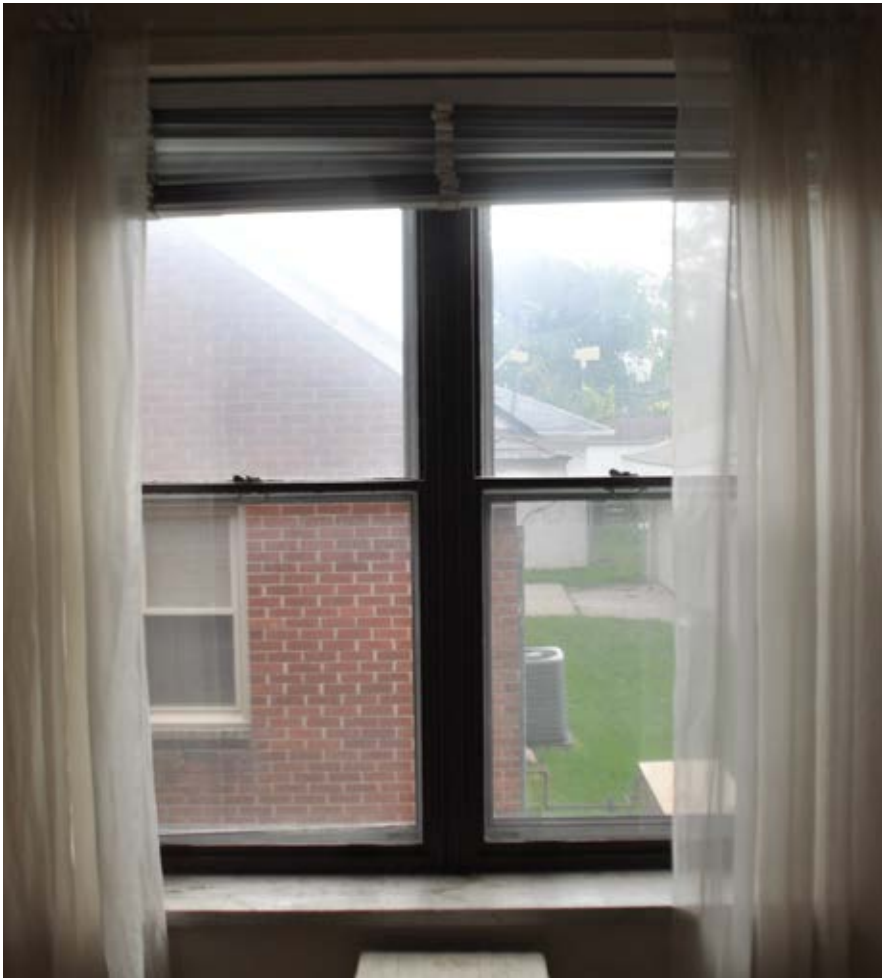
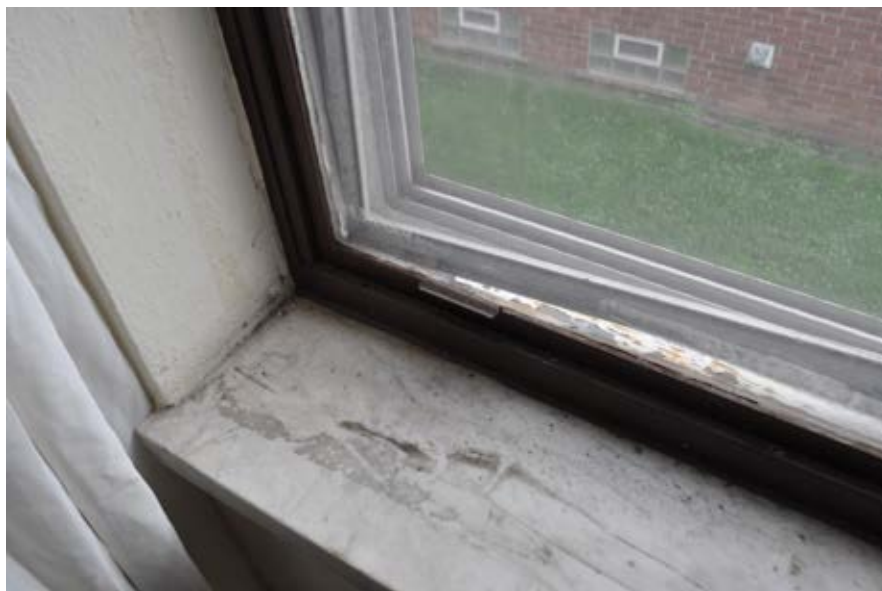
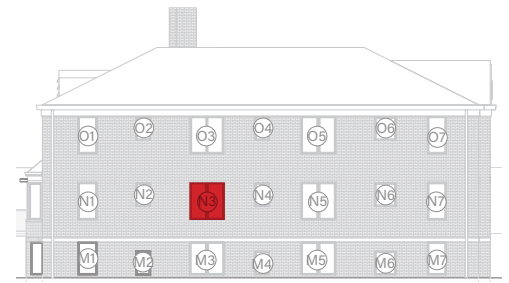
Window N3, Type Z1

- Note: Extent of exterior deterioration, corrosion, and loss of operability is not fully apparent in interior photos. Replacement parts for existing windows are unavailable, making restoration of thermal and operable functionality impossible, and long-term maintenance infeasible. Recommendation is for replacement, for quality of life of future tenants and for feasibility of long-term maintenance.
- See Window Assessment (Blackberry) in appendix for further detail and information, including further notes on deterioration beyond repair
- See Appendix for Window Schedule & Measurements

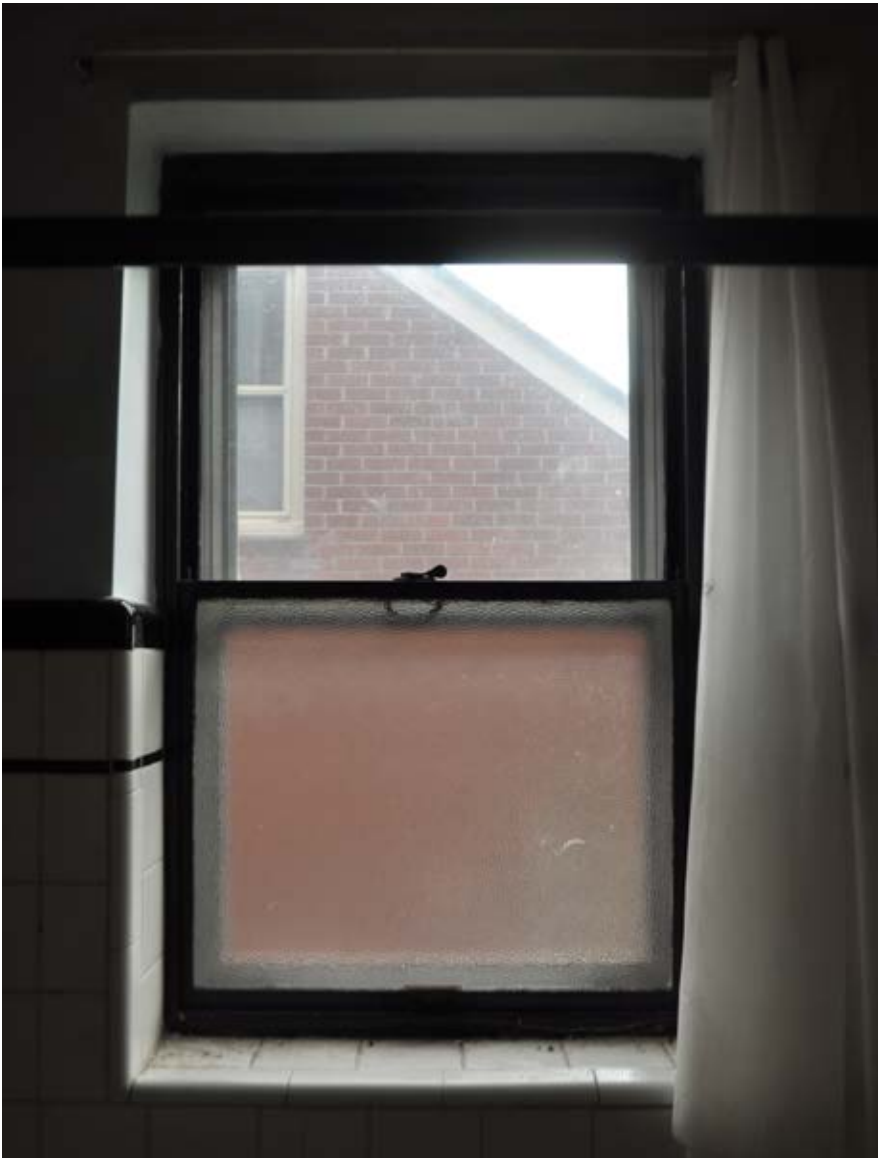
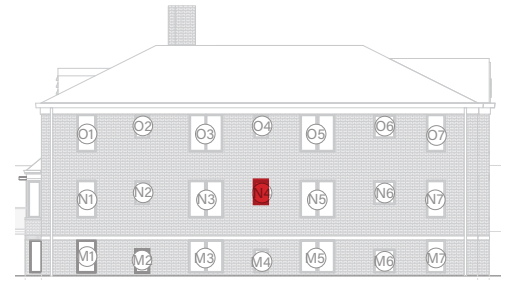
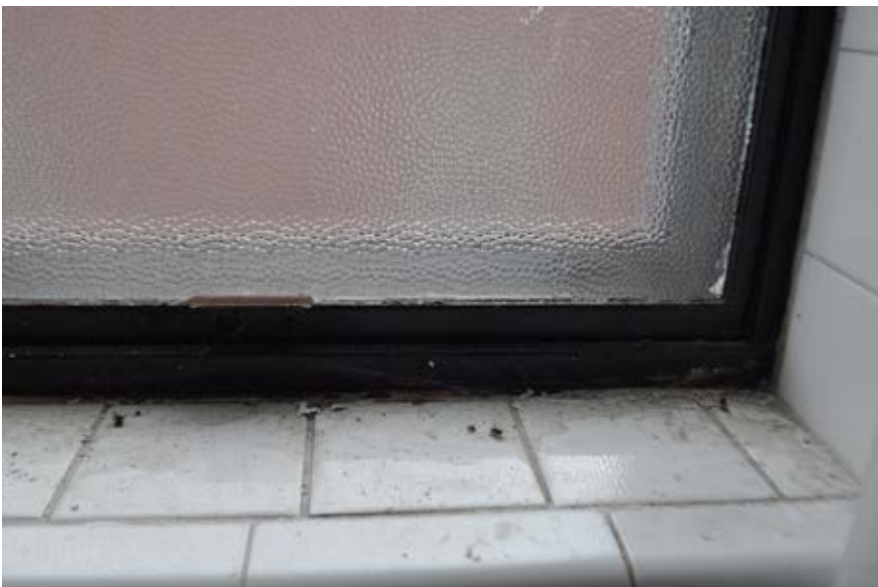
Window N4, Type U2

- Note: Extent of exterior deterioration, corrosion, and loss of operability is not fully apparent in interior photos. Replacement parts for existing windows are unavailable, making restoration of thermal and operable functionality impossible, and long-term maintenance infeasible. Recommendation is for replacement, for quality of life of future tenants and for feasibility of long-term maintenance.
- See Window Assessment (Blackberry) in appendix for further detail and information, including further notes on deterioration beyond repair
- See Appendix for Window Schedule & Measurements

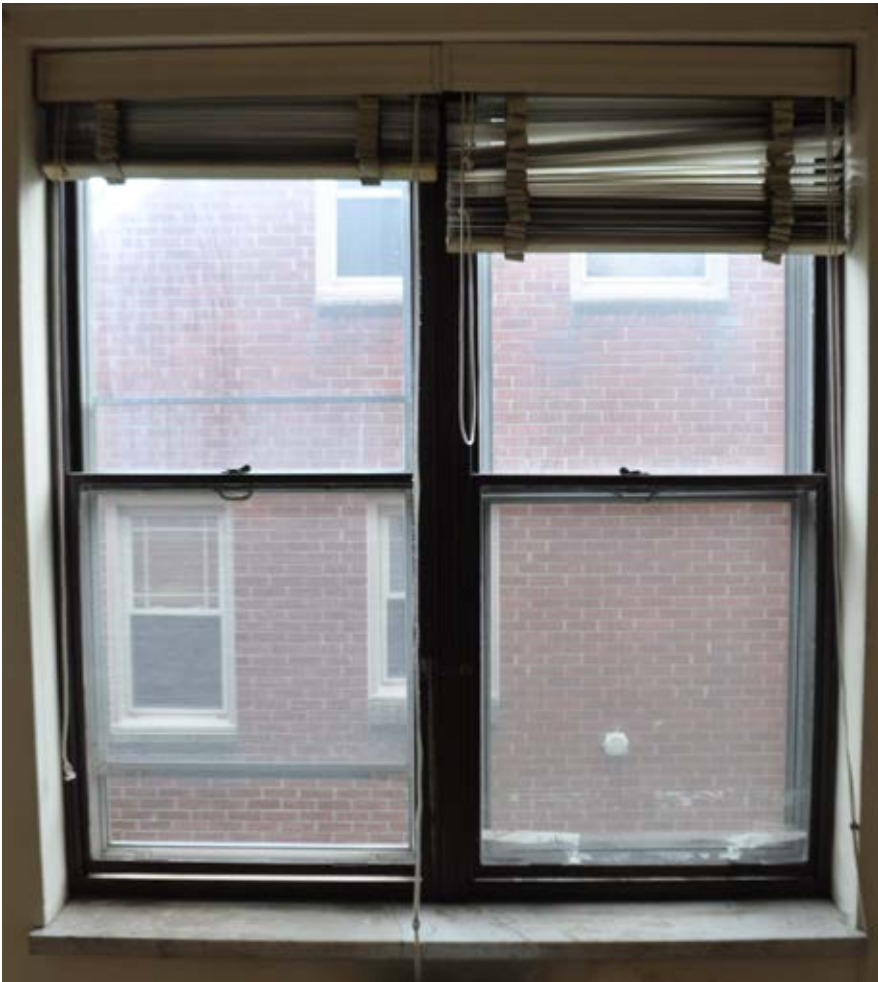
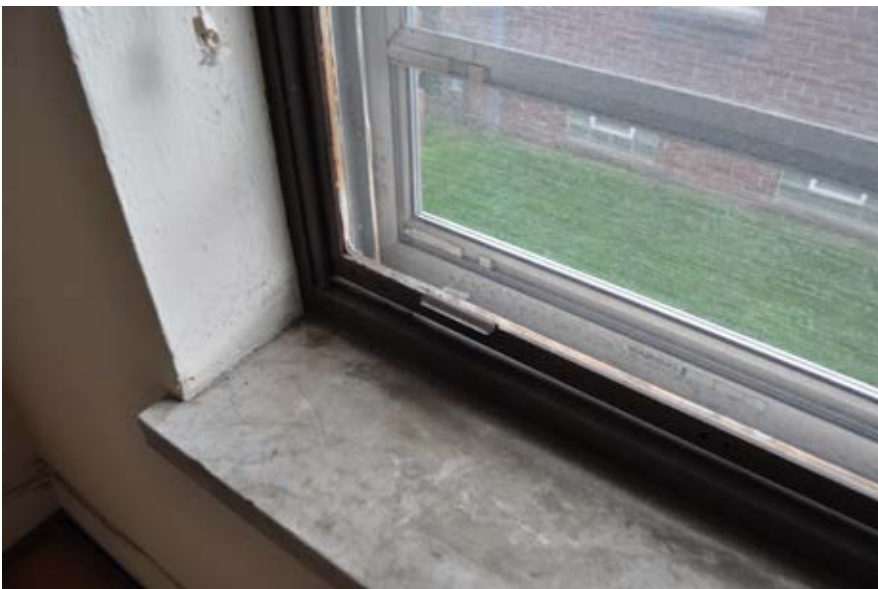
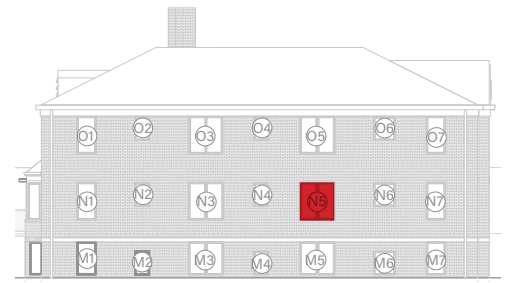
Window N5, Type Z1

- Note: Extent of exterior deterioration, corrosion, and loss of operability is not fully apparent in interior photos. Replacement parts for existing windows are unavailable, making restoration of thermal and operable functionality impossible, and long-term maintenance infeasible. Recommendation is for replacement, for quality of life of future tenants and for feasibility of long-term maintenance.
- See Window Assessment (Blackberry) in appendix for further detail and information, including further notes on deterioration beyond repair
- See Appendix for Window Schedule & Measurements

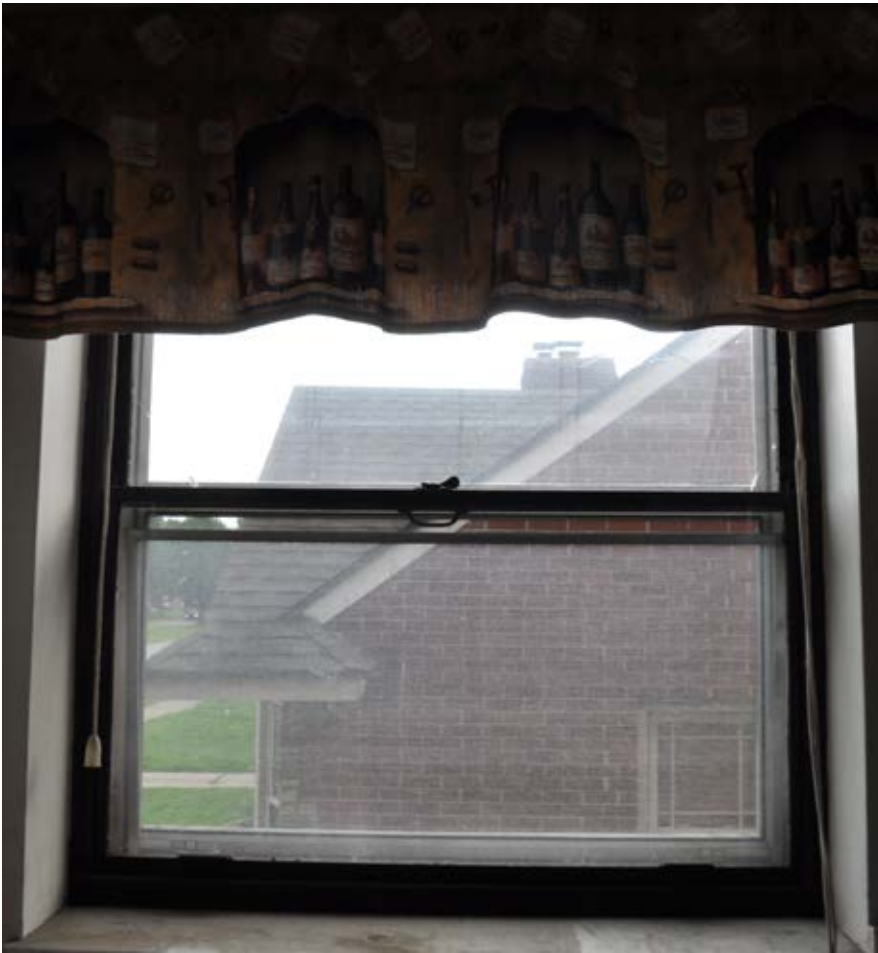
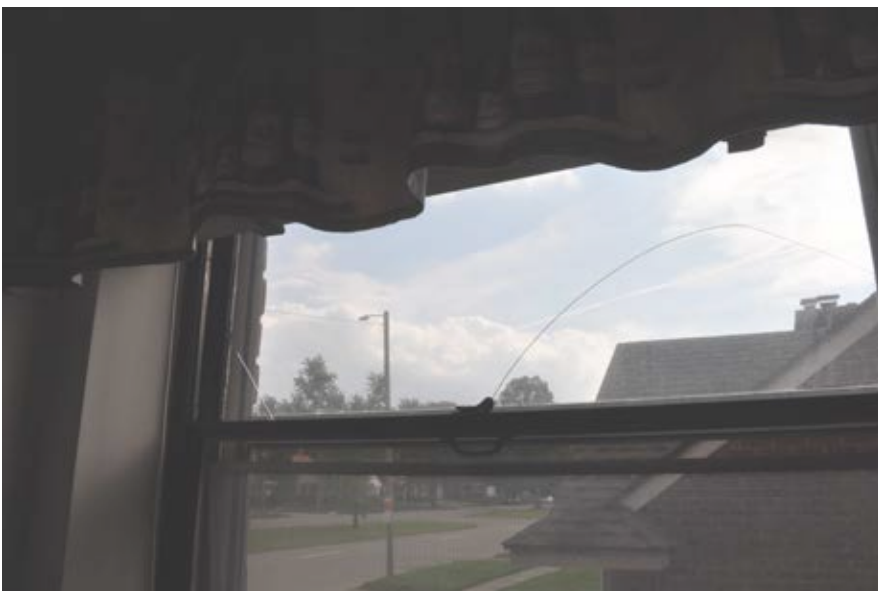
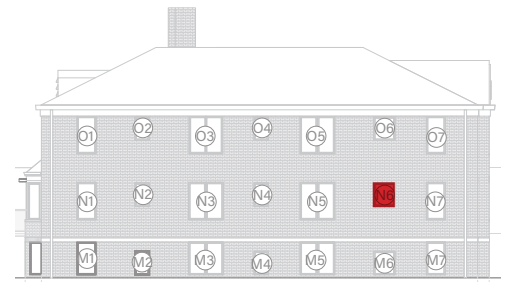
Window N6, Type T2

- Broken Glass
- Note: Extent of exterior deterioration, corrosion, and loss of operability is not fully apparent in interior photos. Replacement parts for existing windows are unavailable, making restoration of thermal and operable functionality impossible, and long-term maintenance infeasible. Recommendation is for replacement, for quality of life of future tenants and for feasibility of long-term maintenance.
- See Window Assessment (Blackberry) in appendix for further detail and information, including further notes on deterioration beyond repair
- See Appendix for Window Schedule & Measurements

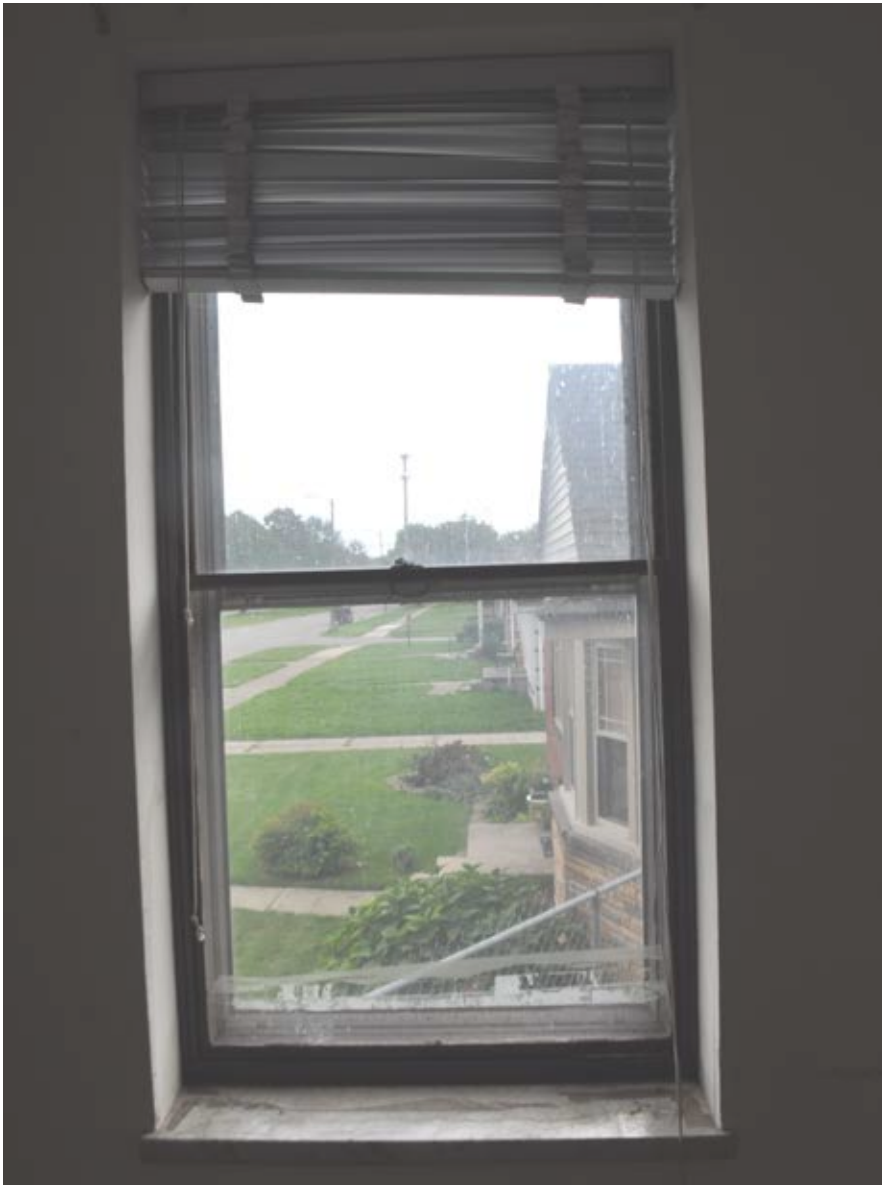
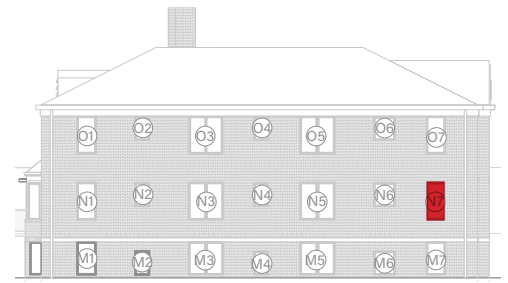
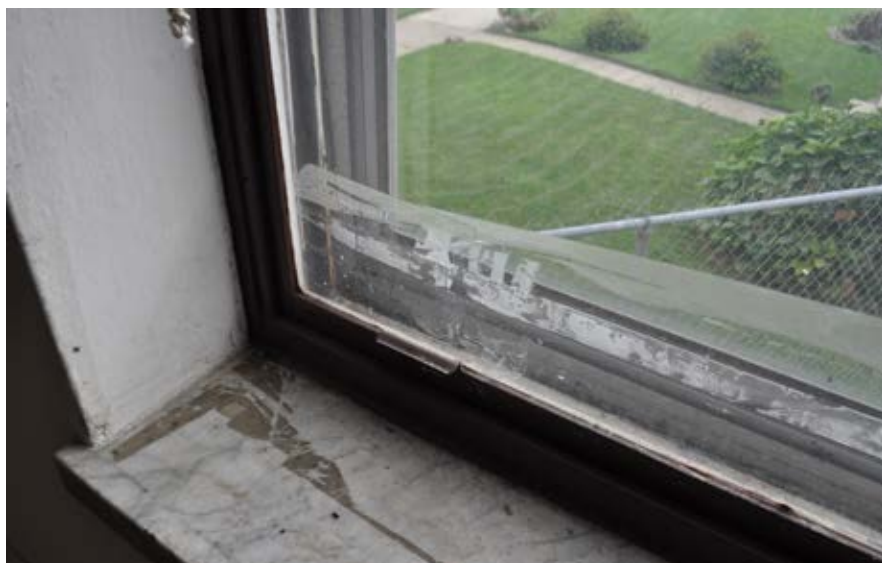
Window N7, Type N2

- Note: Extent of exterior deterioration, corrosion, and loss of operability is not fully apparent in interior photos. Replacement parts for existing windows are unavailable, making restoration of thermal and operable functionality impossible, and long-term maintenance infeasible. Recommendation is for replacement, for quality of life of future tenants and for feasibility of long-term maintenance.
- See Window Assessment (Blackberry) in appendix for further detail and information, including further notes on deterioration beyond repair
- See Appendix for Window Schedule & Measurements

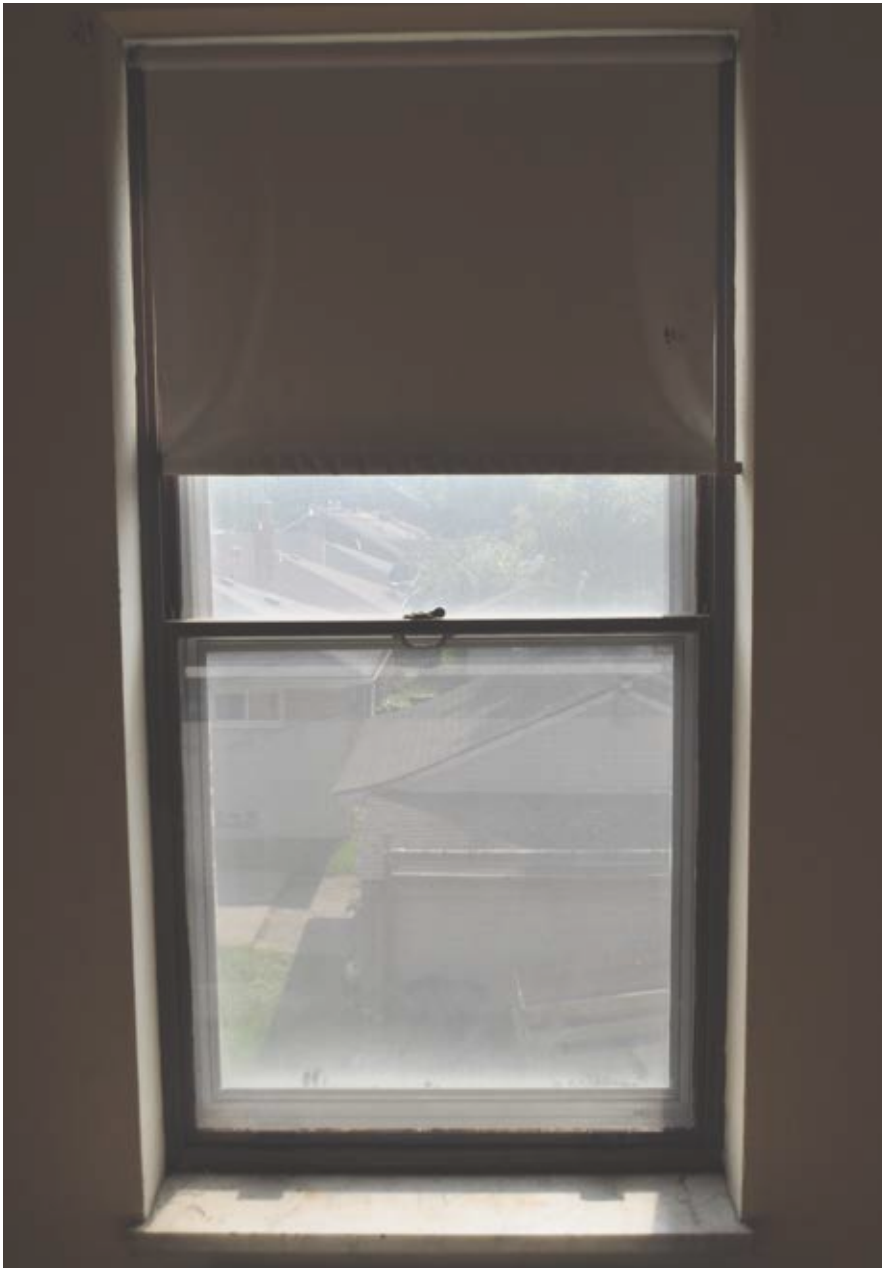
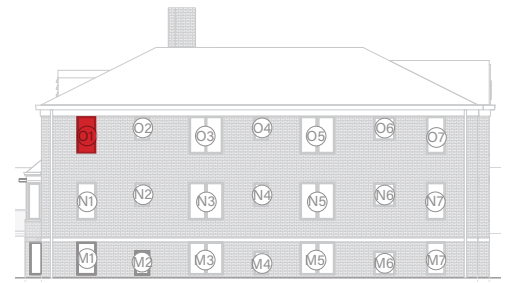
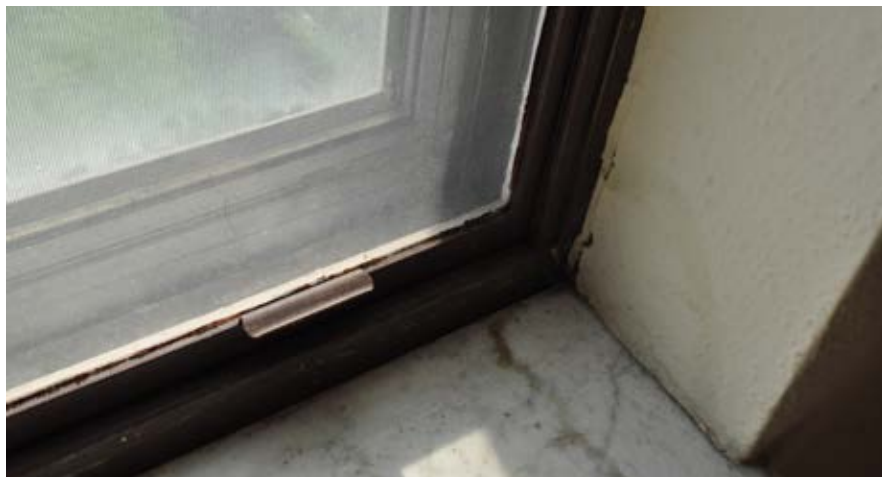
Window O1, Type N2

- Note: Extent of exterior deterioration, corrosion, and loss of operability is not fully apparent in interior photos. Replacement parts for existing windows are unavailable, making restoration of thermal and operable functionality impossible, and long-term maintenance infeasible. Recommendation is for replacement, for quality of life of future tenants and for feasibility of long-term maintenance.
- See Window Assessment (Blackberry) in appendix for further detail and information, including further notes on deterioration beyond repair
- See Appendix for Window Schedule & Measurements

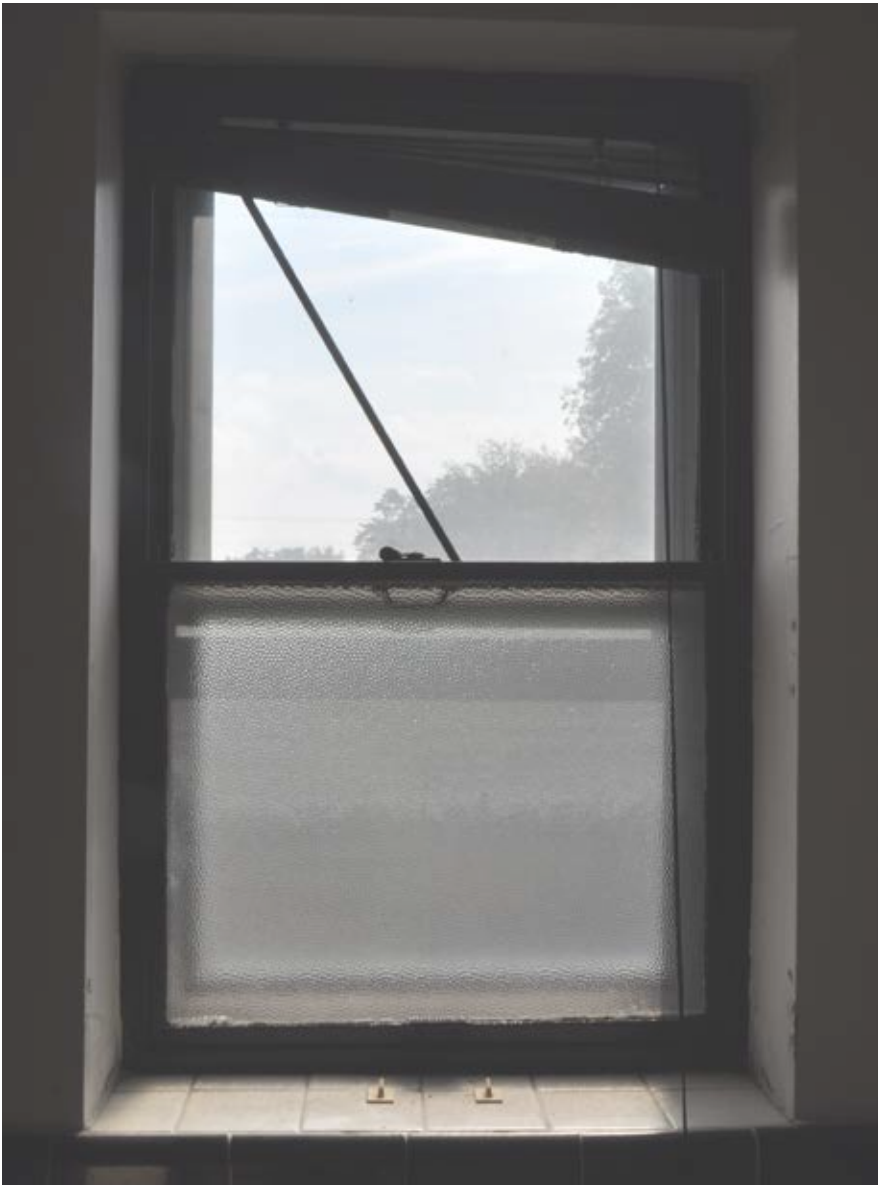
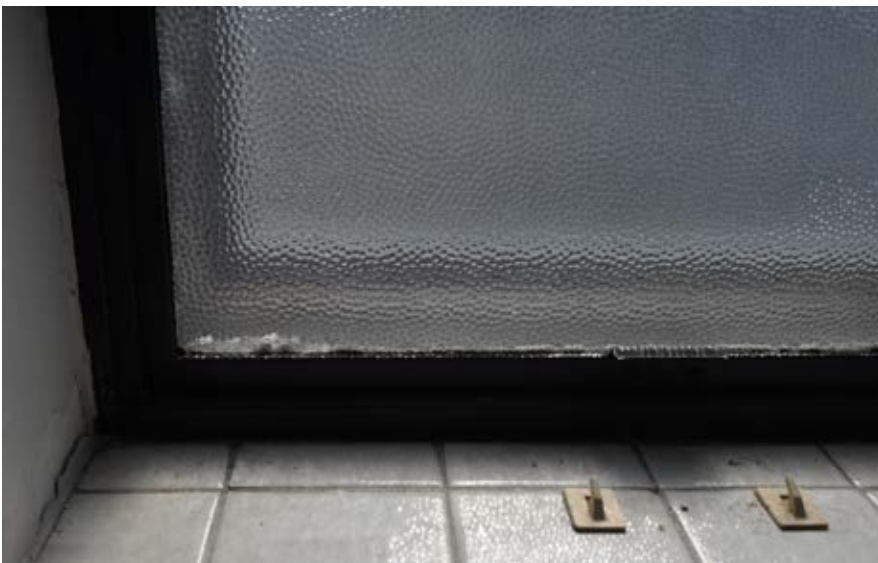
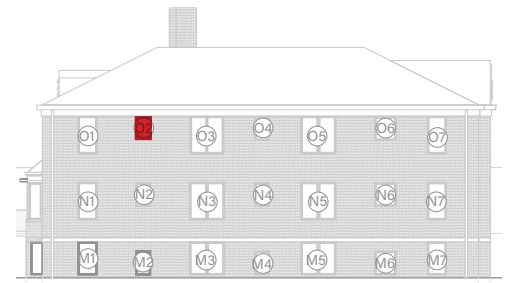
Window O2, Type U2

- Note: Extent of exterior deterioration, corrosion, and loss of operability is not fully apparent in interior photos. Replacement parts for existing windows are unavailable, making restoration of thermal and operable functionality impossible, and long-term maintenance infeasible. Recommendation is for replacement, for quality of life of future tenants and for feasibility of long-term maintenance.
- See Window Assessment (Blackberry) in appendix for further detail and information, including further notes on deterioration beyond repair
- See Appendix for Window Schedule & Measurements

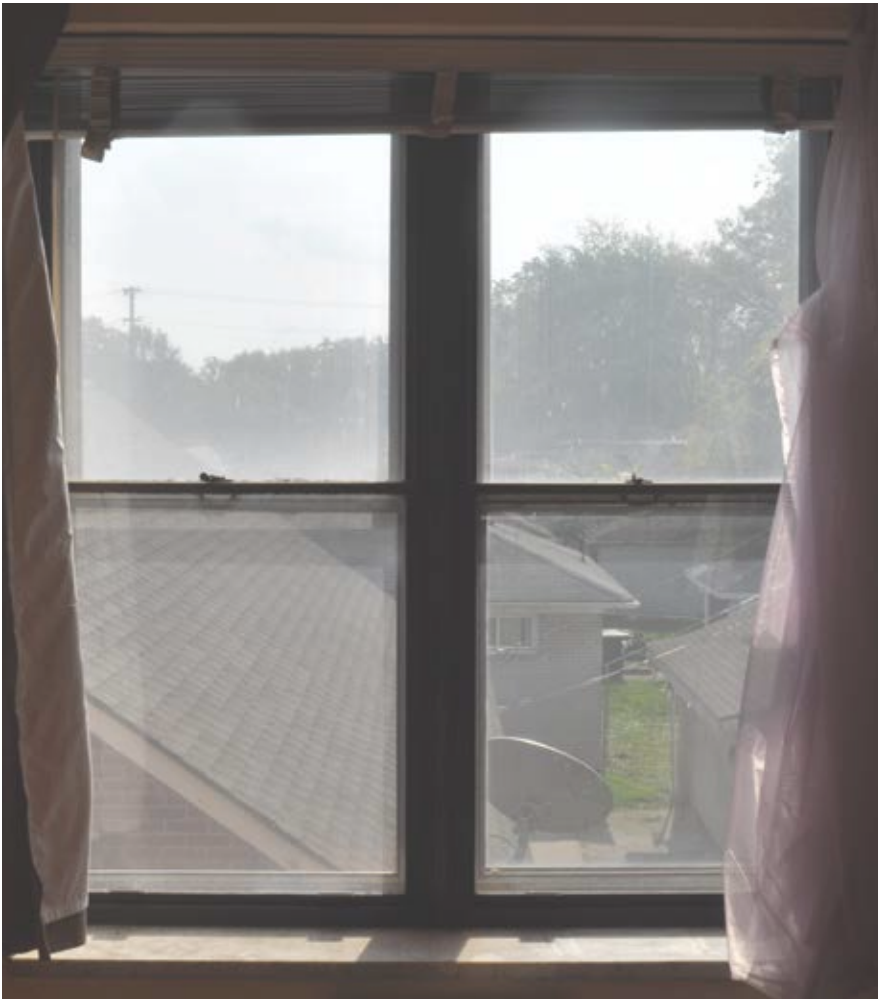
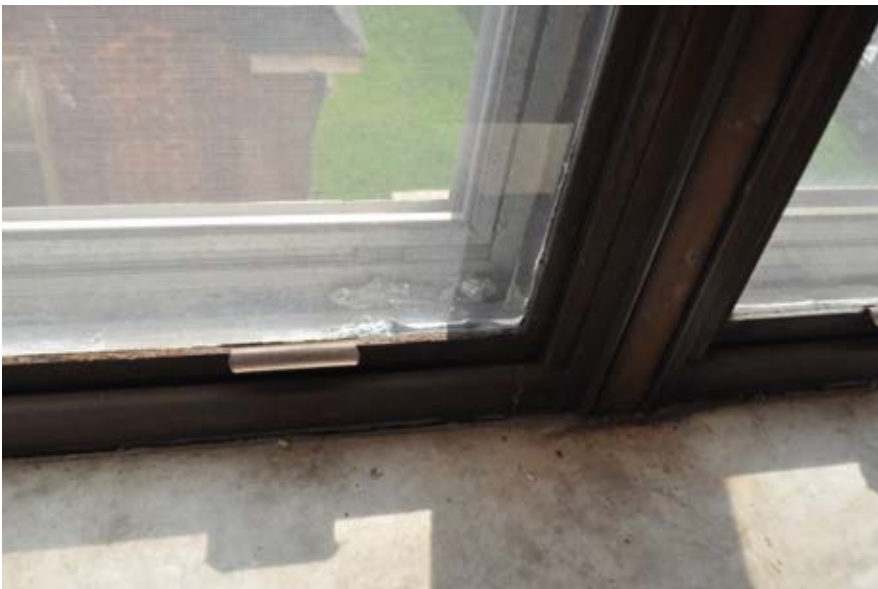
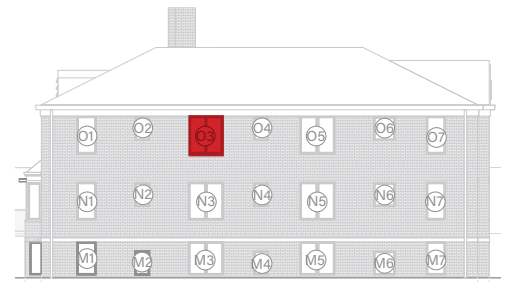
Window O3, Type Z1

- Note: Extent of exterior deterioration, corrosion, and loss of operability is not fully apparent in interior photos. Replacement parts for existing windows are unavailable, making restoration of thermal and operable functionality impossible, and long-term maintenance infeasible. Recommendation is for replacement, for quality of life of future tenants and for feasibility of long-term maintenance.
- See Window Assessment (Blackberry) in appendix for further detail and information, including further notes on deterioration beyond repair
- See Appendix for Window Schedule & Measurements
