9710 W Outer Dr

Existing Condition Photos

Current Design Description

A 3-story apartment structure with 10 residential units, constructed in 1940, brick on wood stud wall construction, shingle roof, stone corner details, stone details at palladian window, stone sills, wood detailing at front entry, steel and wood canopy at back entry, wood windows throughout with the exception of steel windows at bathrooms and the lowest level. The addition of a brick shed to house the gas meter was made at a later date.

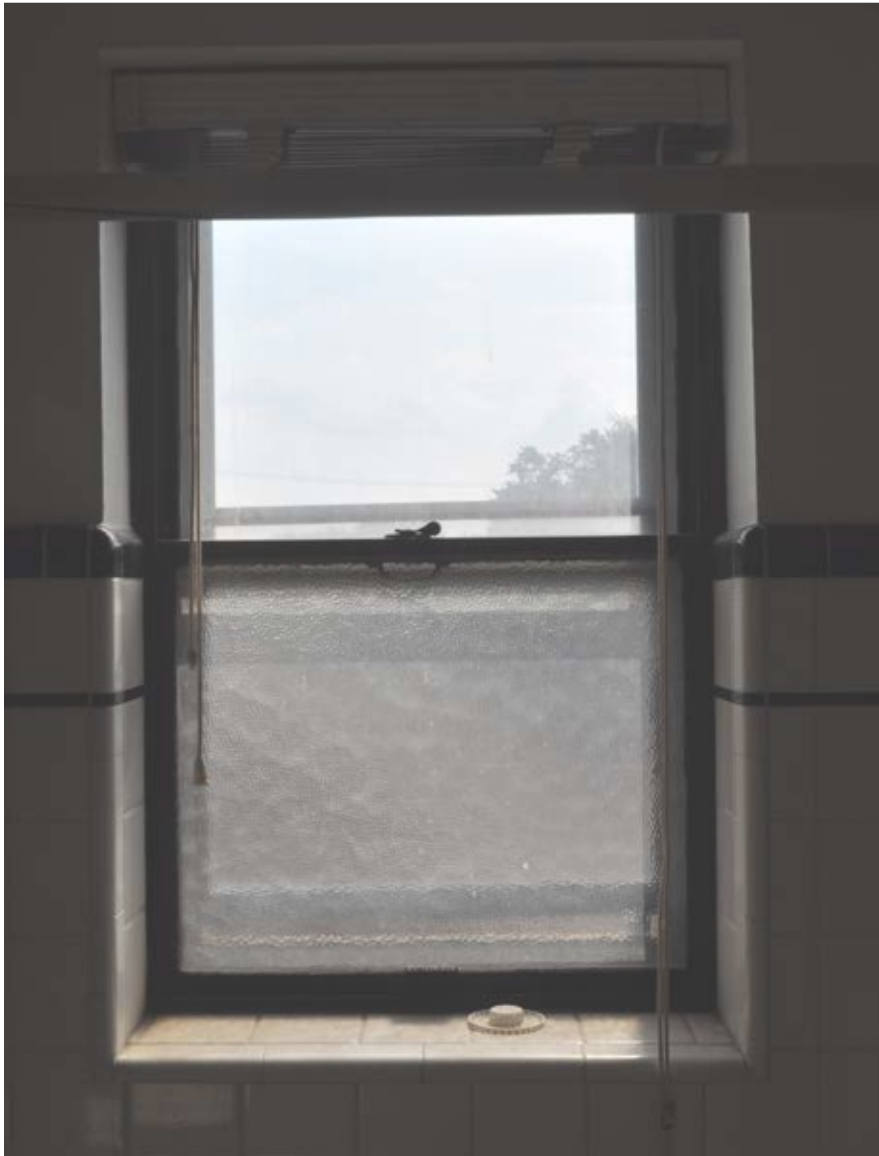
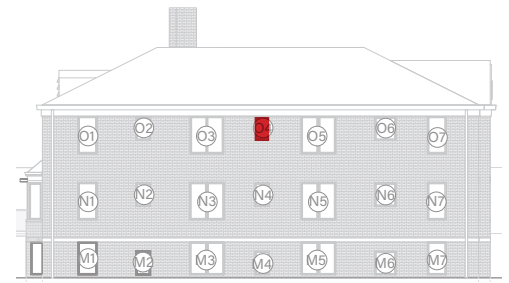
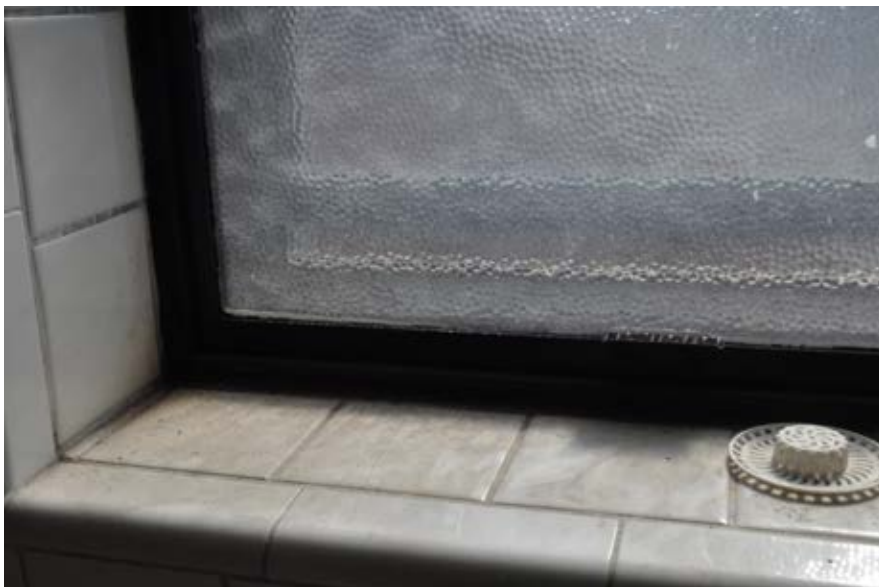
Window O4, Type U2

- Note: Extent of exterior deterioration, corrosion, and loss of operability is not fully apparent in interior photos. Replacement parts for existing windows are unavailable, making restoration of thermal and operable functionality impossible, and long-term maintenance infeasible. Recommendation is for replacement, for quality of life of future tenants and for feasibility of long-term maintenance.
- See Window Assessment (Blackberry) in appendix for further detail and information, including further notes on deterioration beyond repair
- See Appendix for Window Schedule & Measurements

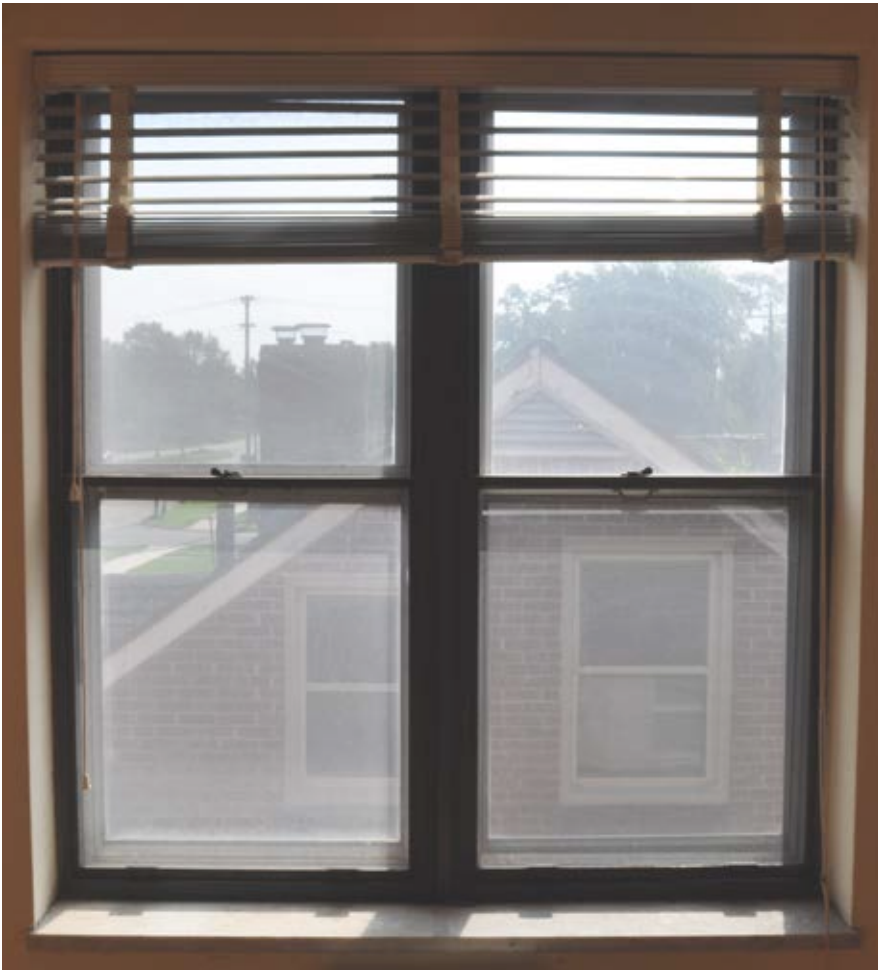
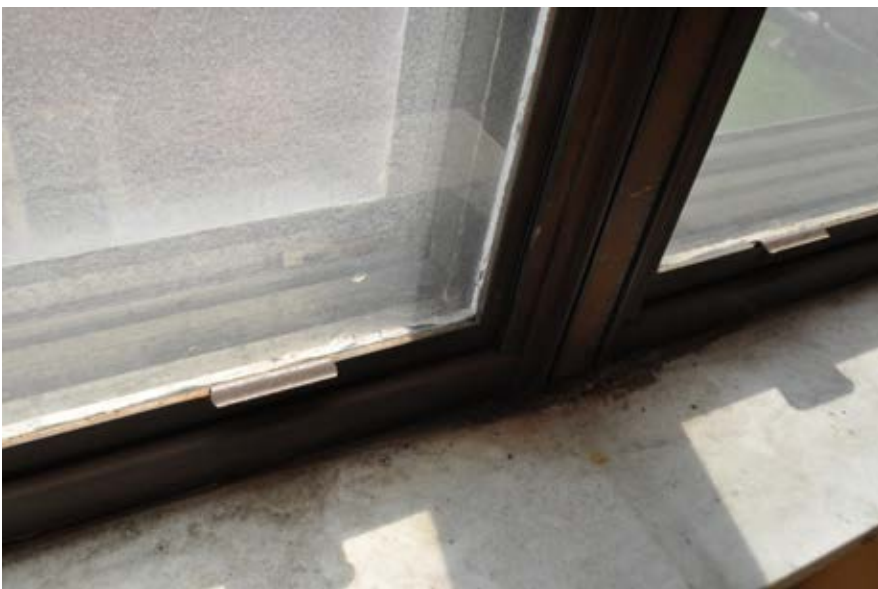
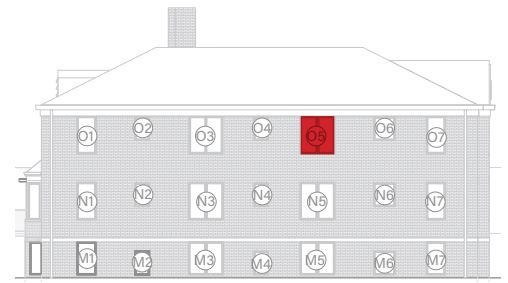
Window O5, Type Z1

- Note: Extent of exterior deterioration, corrosion, and loss of operability is not fully apparent in interior photos. Replacement parts for existing windows are unavailable, making restoration of thermal and operable functionality impossible, and long-term maintenance infeasible. Recommendation is for replacement, for quality of life of future tenants and for feasibility of long-term maintenance.
- See Window Assessment (Blackberry) in appendix for further detail and information, including further notes on deterioration beyond repair
- See Appendix for Window Schedule & Measurements

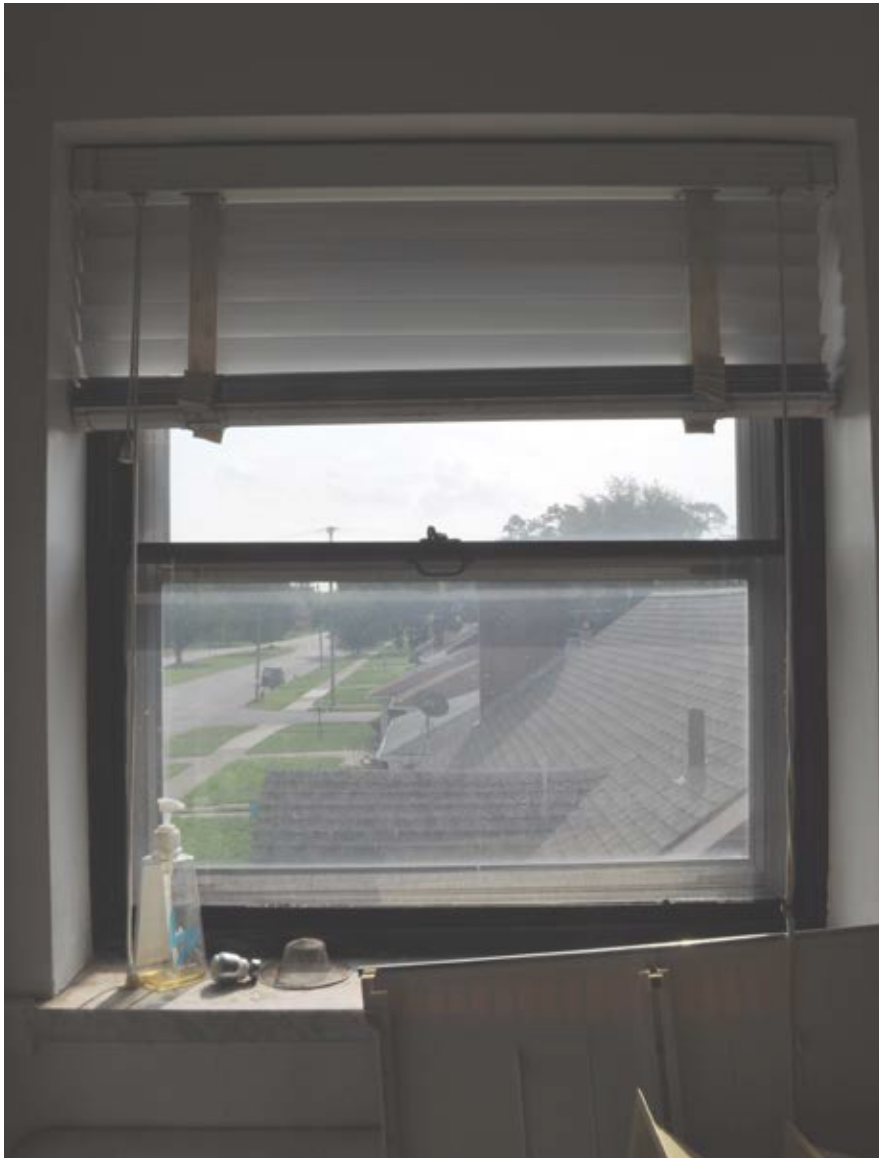
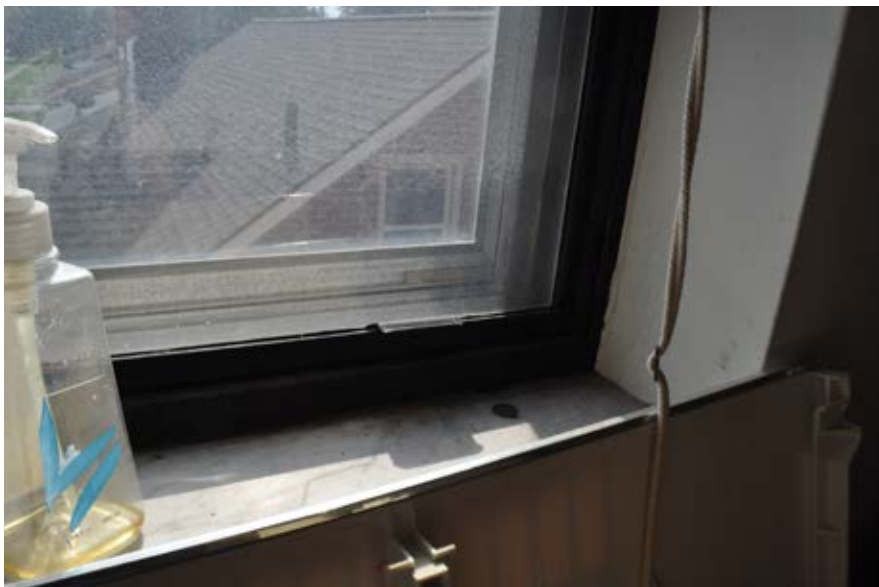
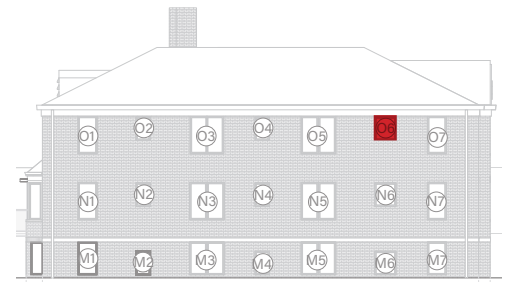
Window O6, Type T2

- Note: Extent of exterior deterioration, corrosion, and loss of operability is not fully apparent in interior photos. Replacement parts for existing windows are unavailable, making restoration of thermal and operable functionality impossible, and long-term maintenance infeasible. Recommendation is for replacement, for quality of life of future tenants and for feasibility of long-term maintenance.
- See Window Assessment (Blackberry) in appendix for further detail and information, including further notes on deterioration beyond repair
- See Appendix for Window Schedule & Measurements

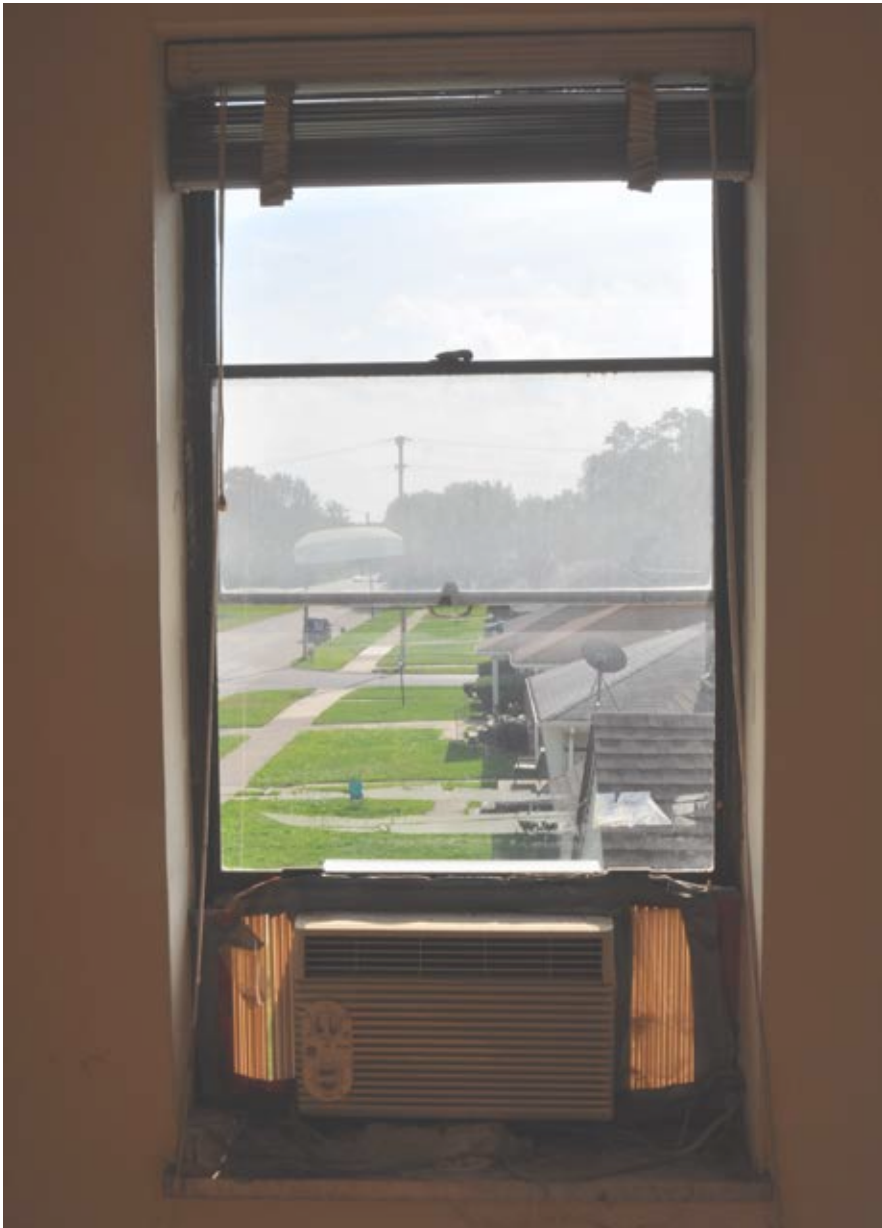
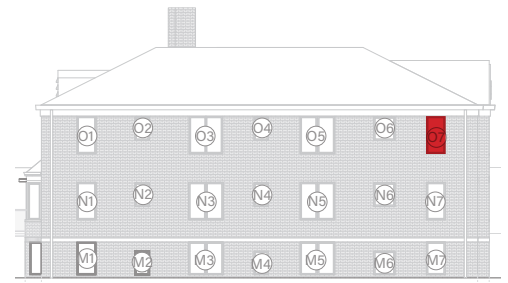
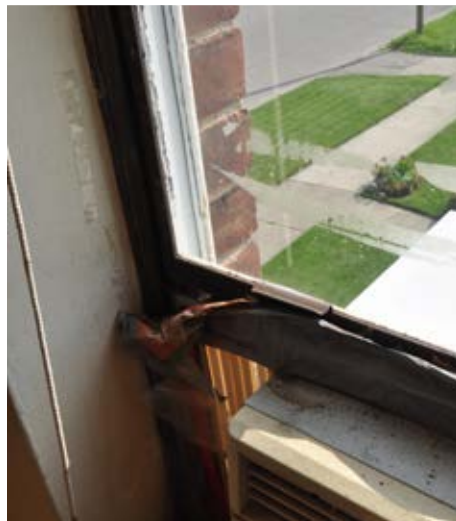
Window O7, Type N2

- Badly Corroded
- Note: Extent of exterior deterioration, corrosion, and loss of operability is not fully apparent in interior photos. Replacement parts for existing windows are unavailable, making restoration of thermal and operable functionality impossible, and long-term maintenance infeasible. Recommendation is for replacement, for quality of life of future tenants and for feasibility of long-term maintenance.
- See Window Assessment (Blackberry) in appendix for further detail and information, including further notes on deterioration beyond repair
- See Appendix for Window Schedule & Measurements

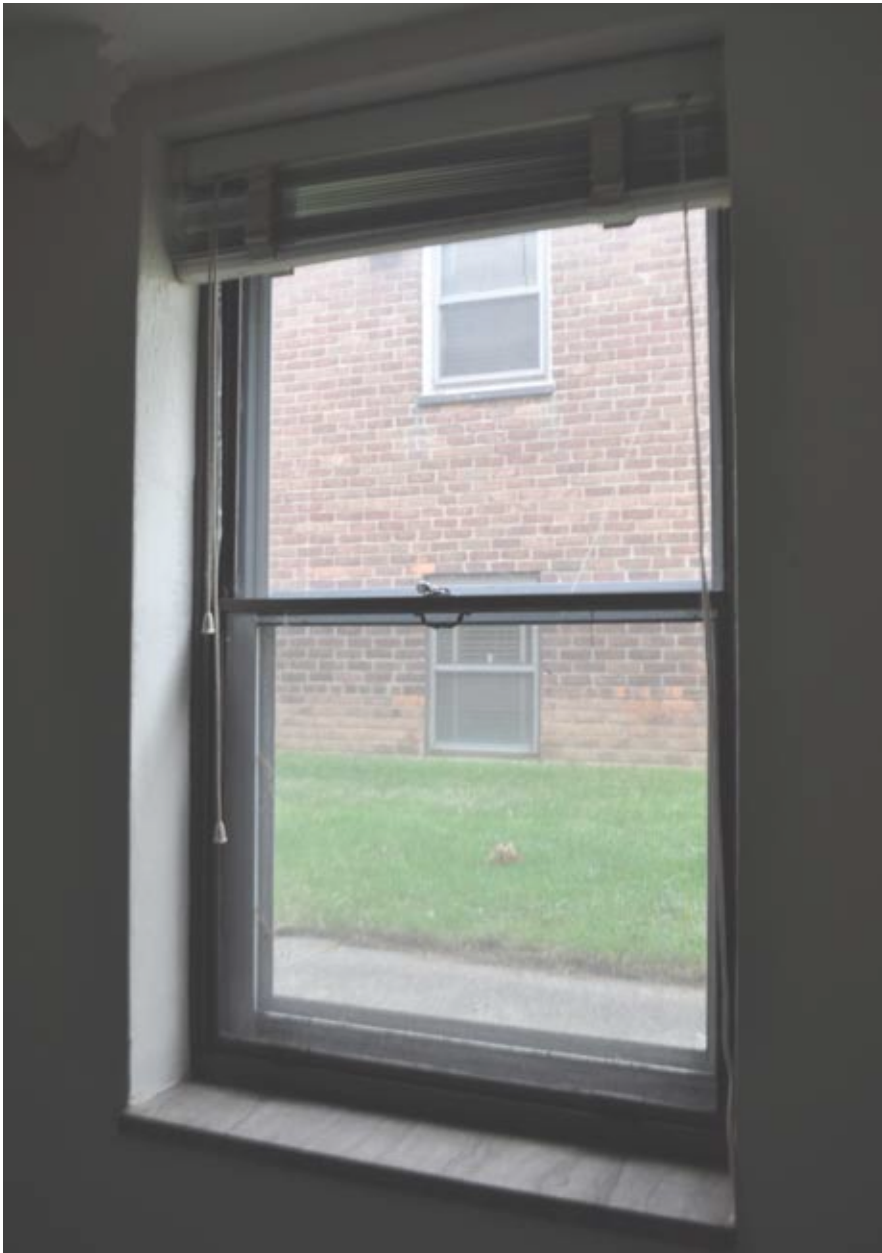
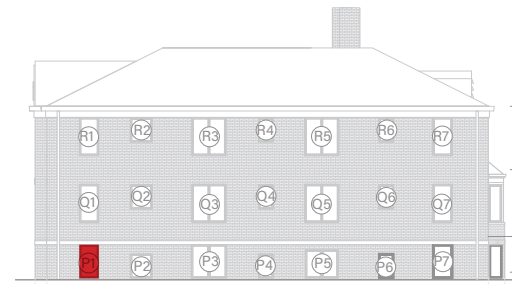
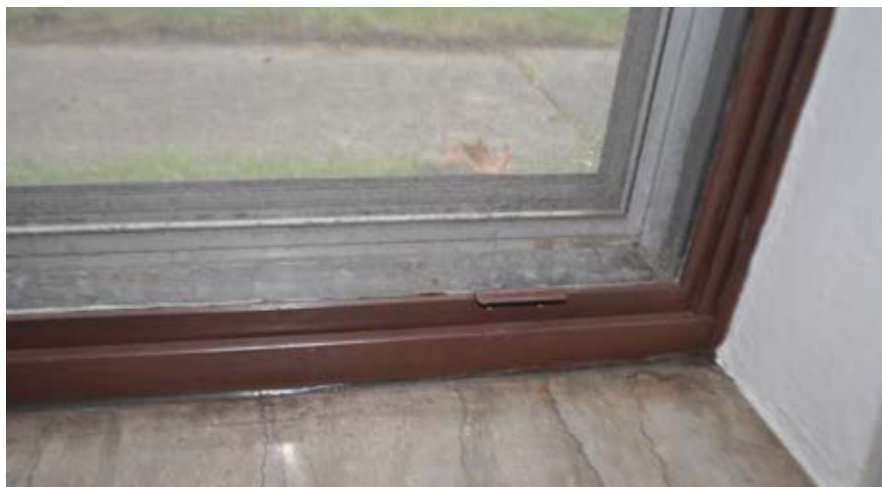
Window P1, Type M2

- Badly Corroded
- Note: Extent of exterior deterioration, corrosion, and loss of operability is not fully apparent in interior photos. Replacement parts for existing windows are unavailable, making restoration of thermal and operable functionality impossible, and long-term maintenance infeasible. Recommendation is for replacement, for quality of life of future tenants and for feasibility of long-term maintenance.
- See Window Assessment (Blackberry) in appendix for further detail and information, including further notes on deterioration beyond repair
- See Appendix for Window Schedule & Measurements

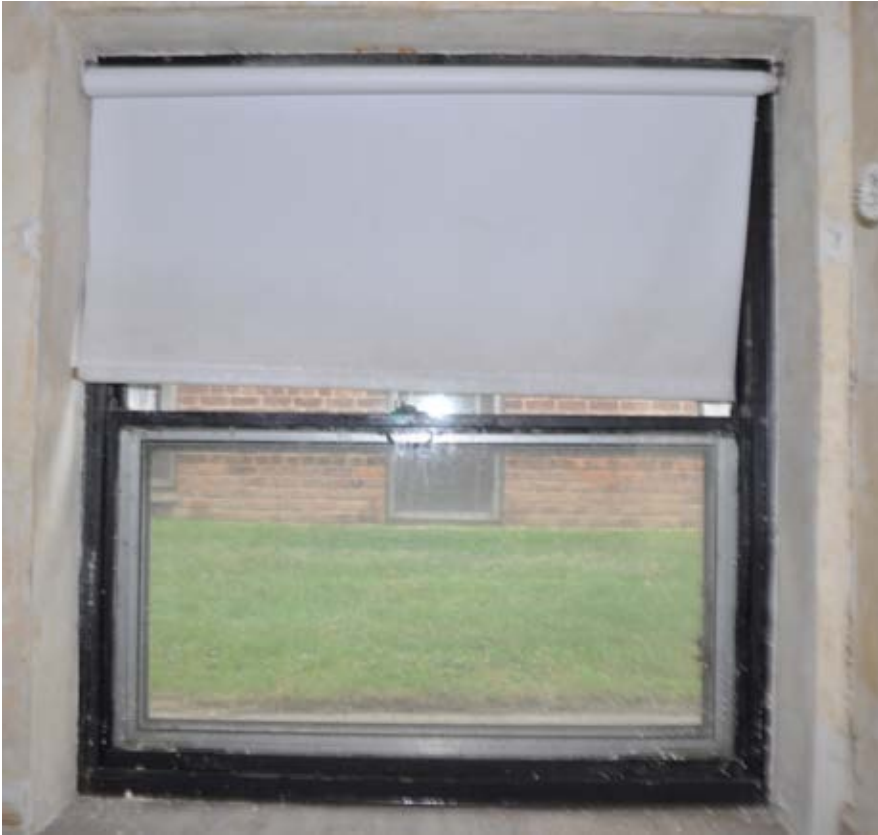
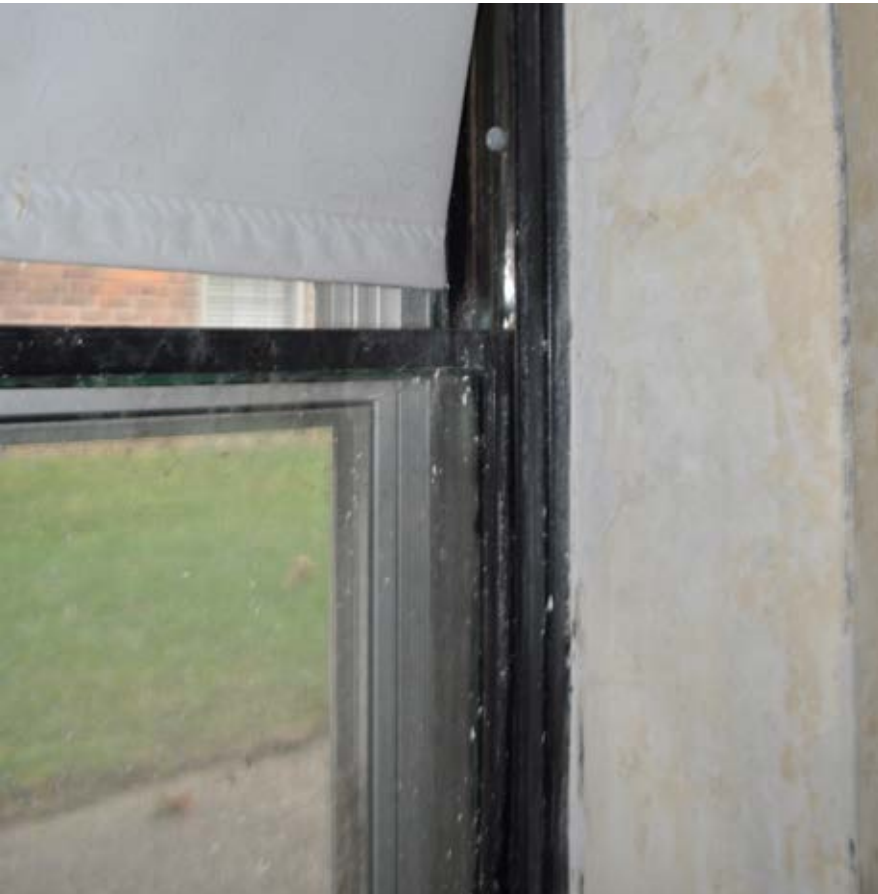
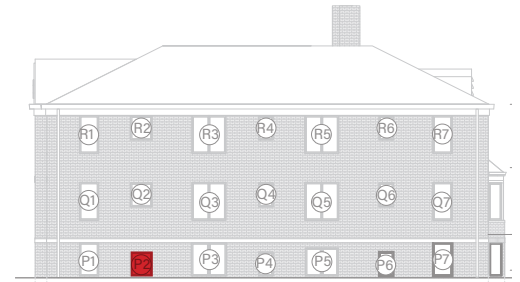
Window P2, Type T2

- Badly Corroded
- Note: Extent of exterior deterioration, corrosion, and loss of operability is not fully apparent in interior photos. Replacement parts for existing windows are unavailable, making restoration of thermal and operable functionality impossible, and long-term maintenance infeasible. Recommendation is for replacement, for quality of life of future tenants and for feasibility of long-term maintenance.
- See Window Assessment (Blackberry) in appendix for further detail and information, including further notes on deterioration beyond repair
- See Appendix for Window Schedule & Measurements

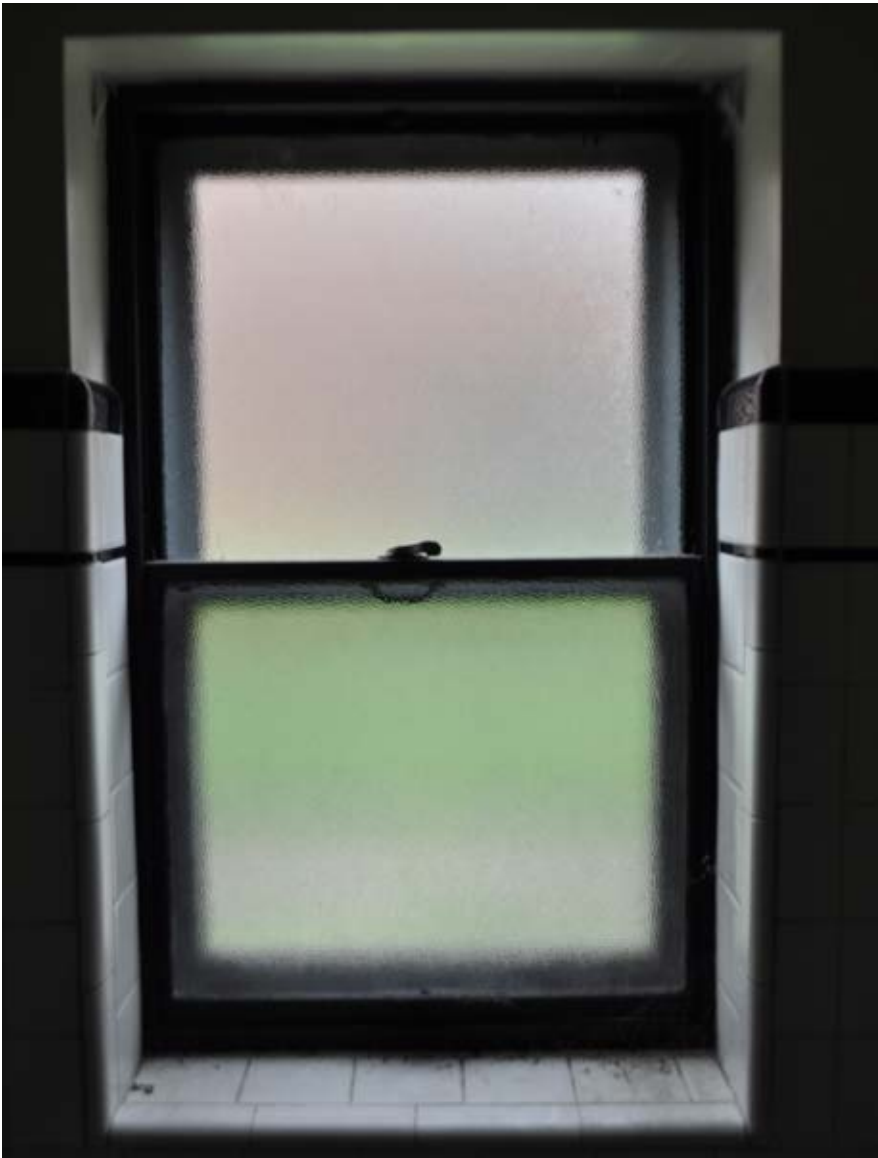
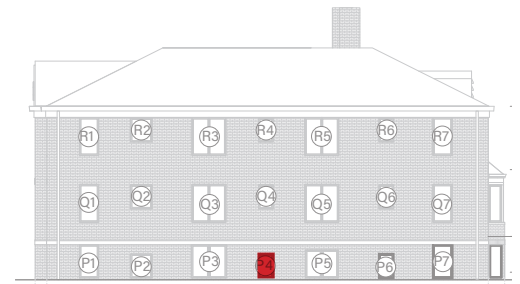
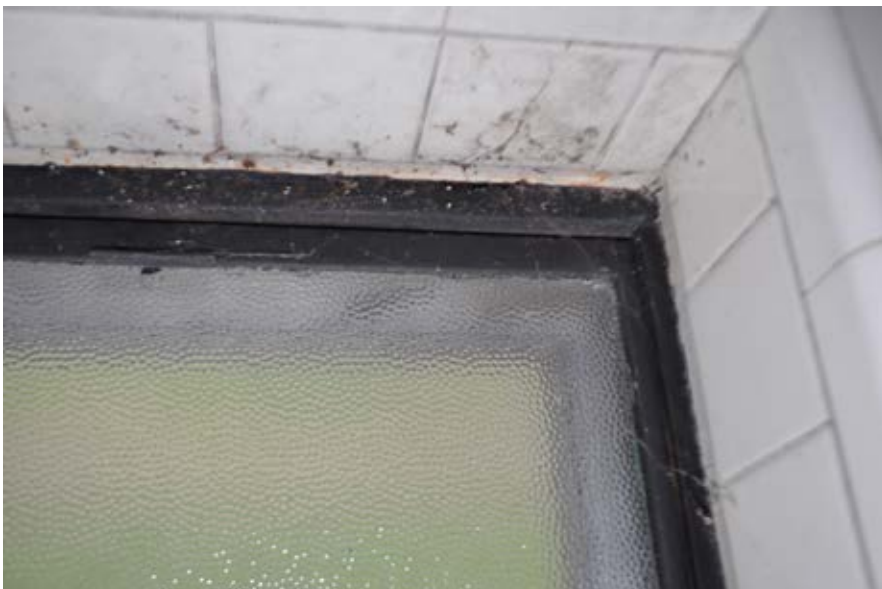
Window P4, Type U2

- Badly Corroded
- Note: Extent of exterior deterioration, corrosion, and loss of operability is not fully apparent in interior photos. Replacement parts for existing windows are unavailable, making restoration of thermal and operable functionality impossible, and long-term maintenance infeasible. Recommendation is for replacement, for quality of life of future tenants and for feasibility of long-term maintenance.
- See Window Assessment (Blackberry) in appendix for further detail and information, including further notes on deterioration beyond repair
- See Appendix for Window Schedule & Measurements

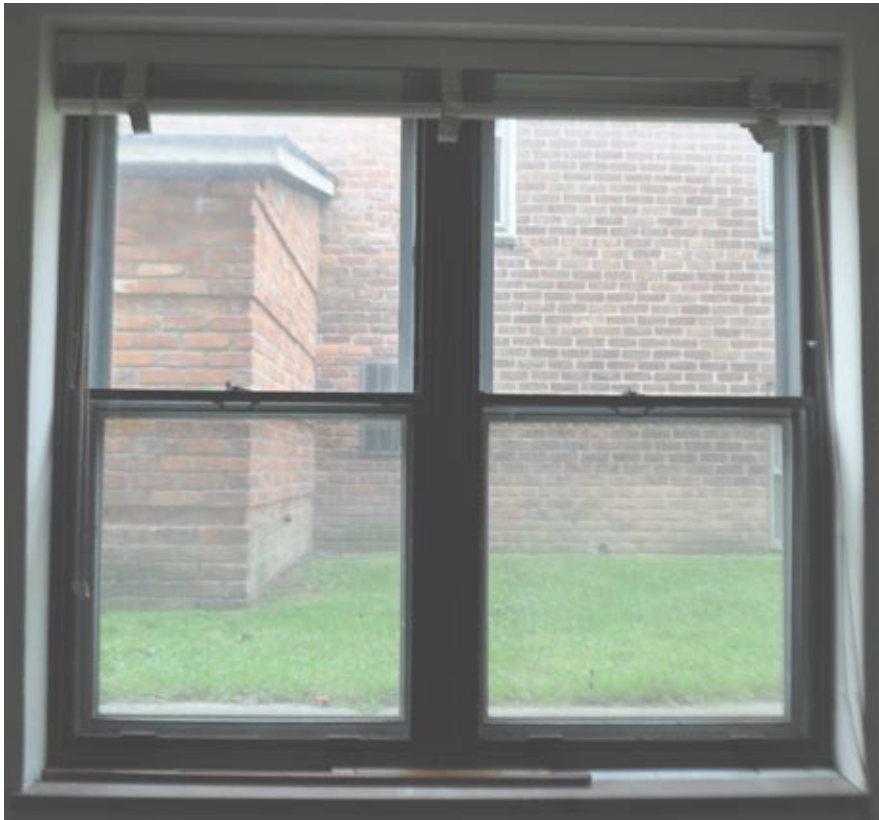
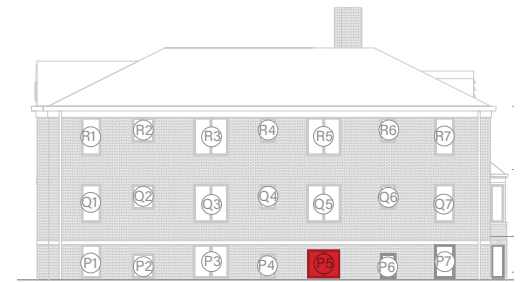
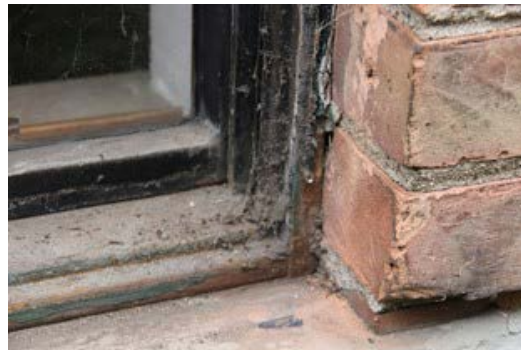
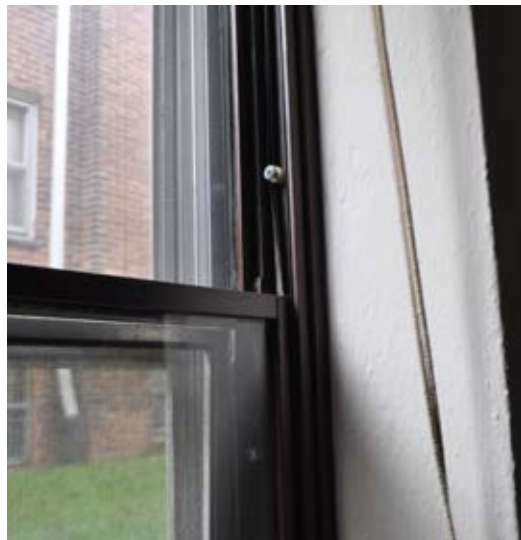
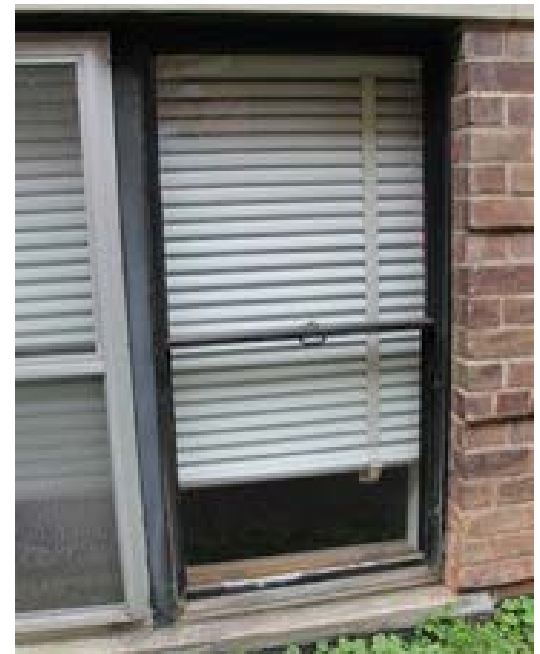
Window P5, Type Y1

- Badly Corroded
- Note: Extent of exterior deterioration, corrosion, and loss of operability is not fully apparent in interior photos. Replacement parts for existing windows are unavailable, making restoration of thermal and operable functionality impossible, and long-term maintenance infeasible. Recommendation is for replacement, for quality of life of future tenants and for feasibility of long-term maintenance.
- See Window Assessment (Blackberry) in appendix for further detail and information, including further notes on deterioration beyond repair
- See Appendix for Window Schedule & Measurements

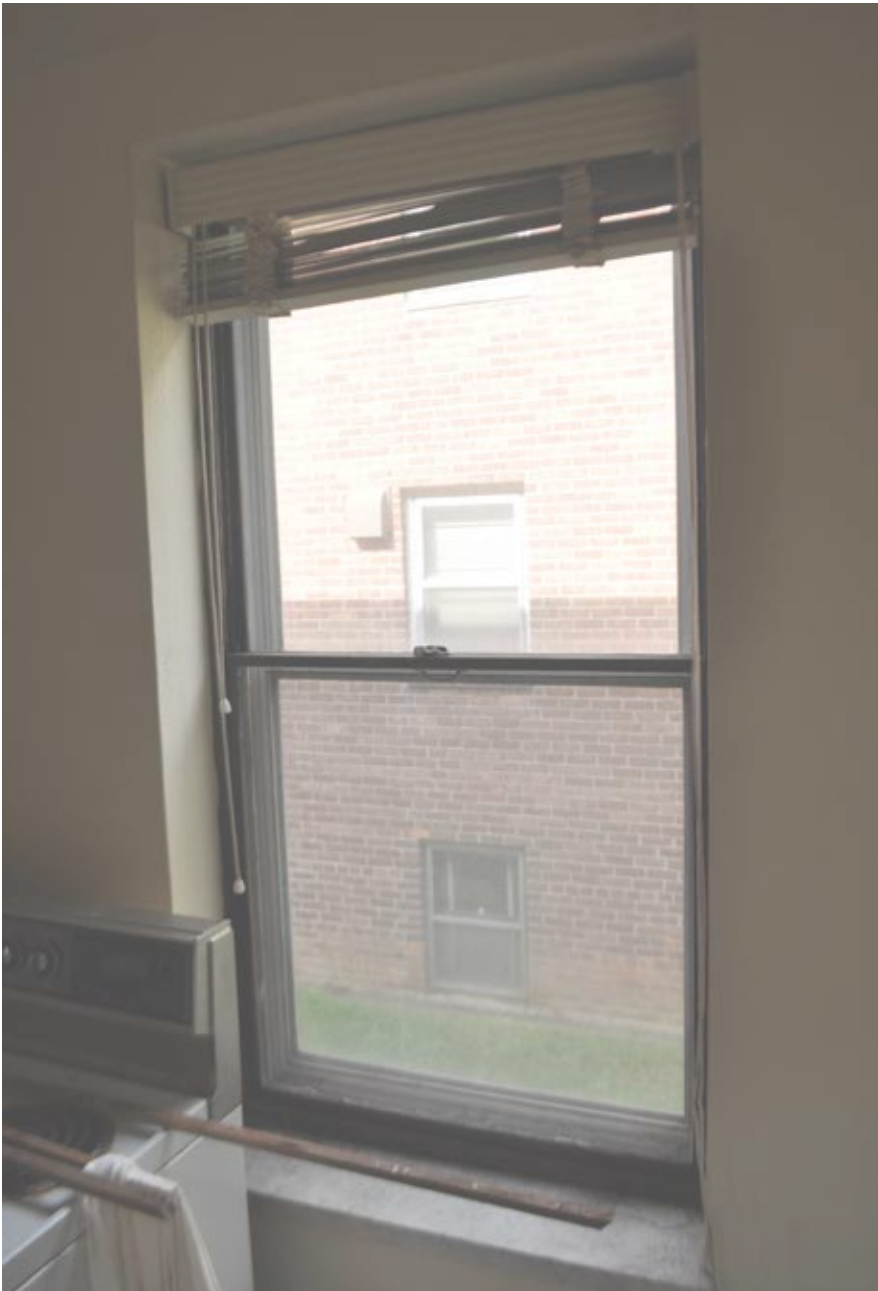
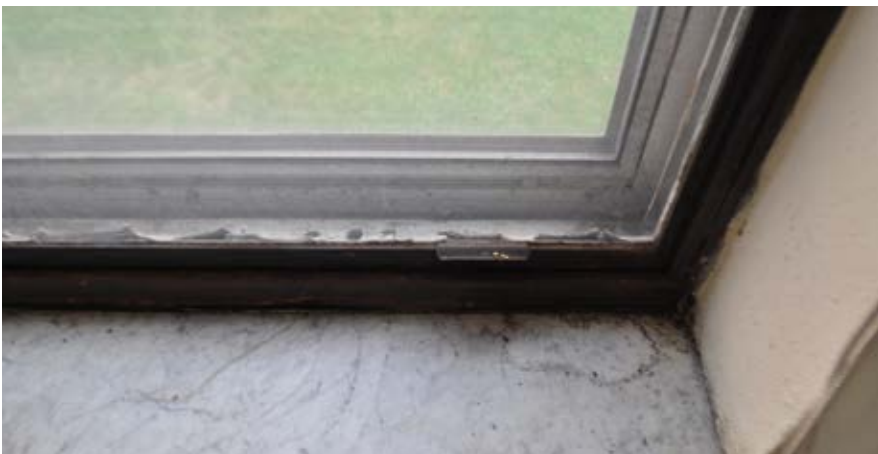
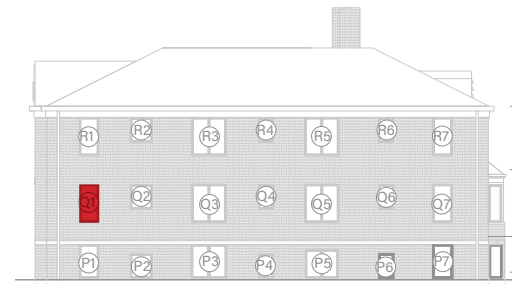
Window Q1, Type N2

- Badly Corroded
- Note: Extent of exterior deterioration, corrosion, and loss of operability is not fully apparent in interior photos. Replacement parts for existing windows are unavailable, making restoration of thermal and operable functionality impossible, and long-term maintenance infeasible. Recommendation is for replacement, for quality of life of future tenants and for feasibility of long-term maintenance.
- See Window Assessment (Blackberry) in appendix for further detail and information, including further notes on deterioration beyond repair
- See Appendix for Window Schedule & Measurements

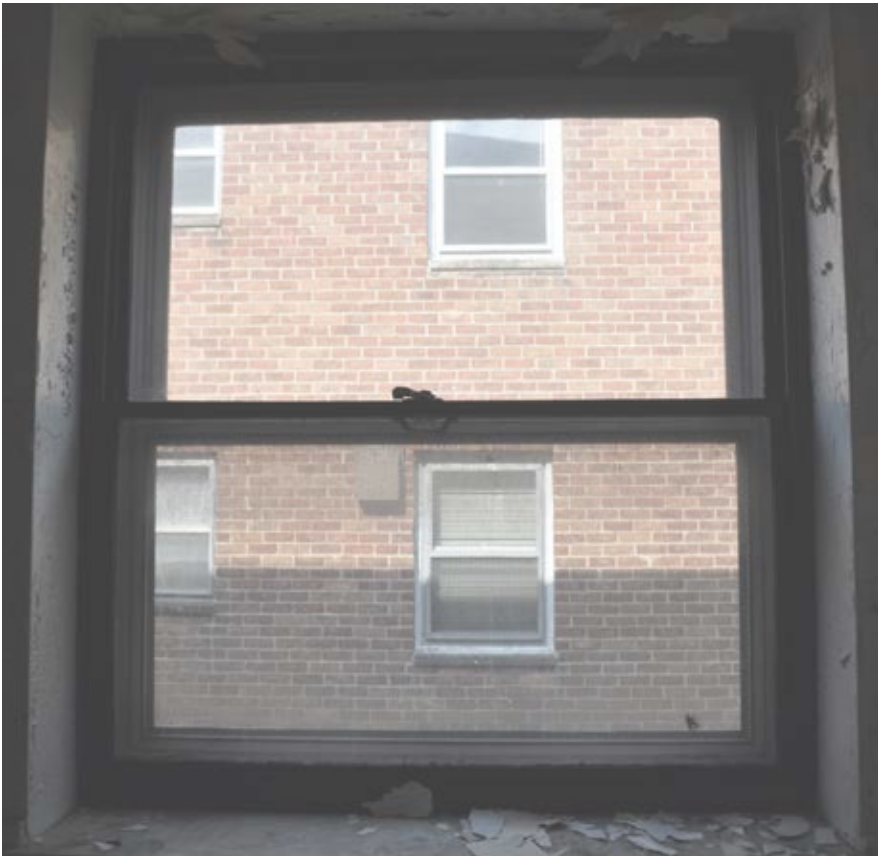
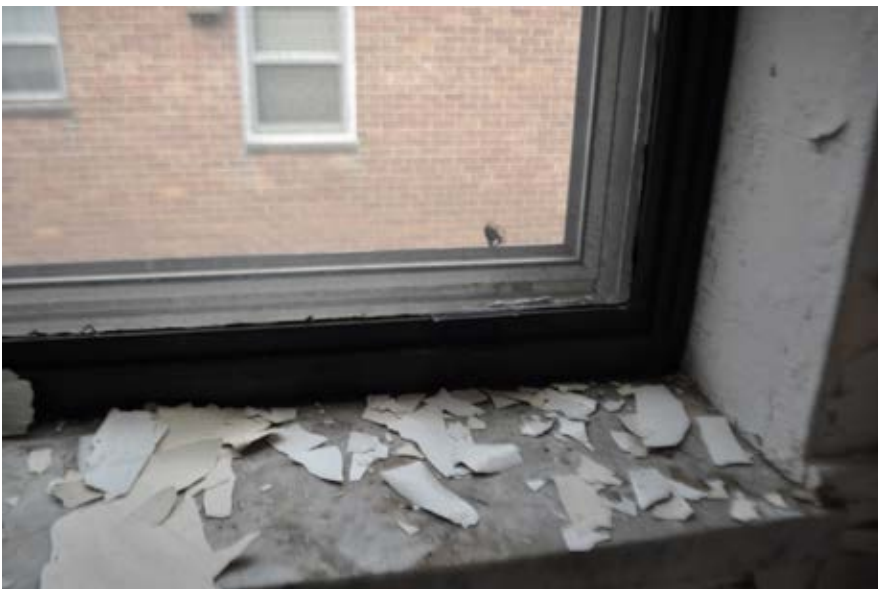
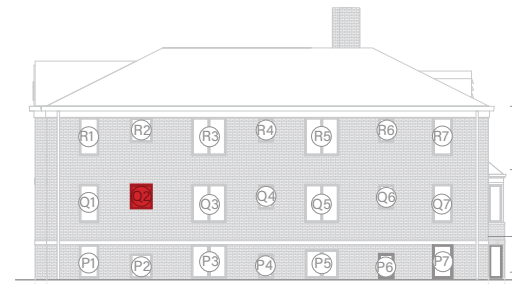
Window Q2, Type T2

- Note: Extent of exterior deterioration, corrosion, and loss of operability is not fully apparent in interior photos. Replacement parts for existing windows are unavailable, making restoration of thermal and operable functionality impossible, and long-term maintenance infeasible. Recommendation is for replacement, for quality of life of future tenants and for feasibility of long-term maintenance.
- See Window Assessment (Blackberry) in appendix for further detail and information, including further notes on deterioration beyond repair
- See Appendix for Window Schedule & Measurements

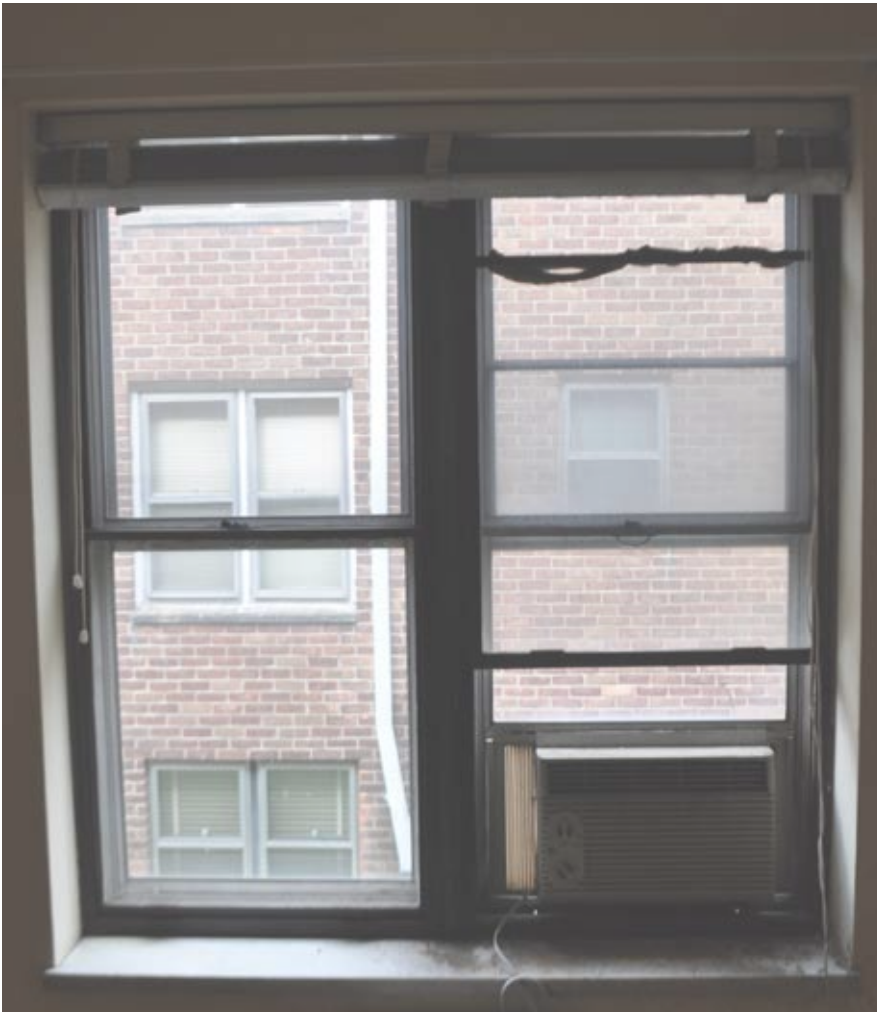
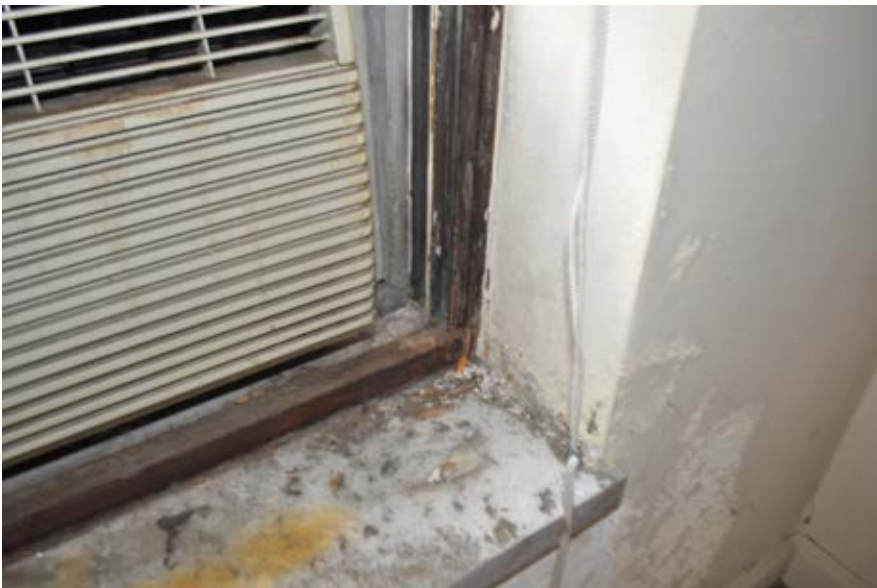
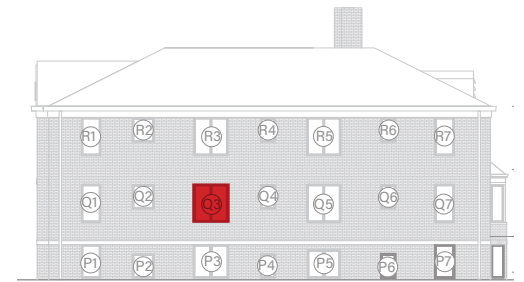
Window Q3, Type Z1

- Badly Corroded
- Note: Extent of exterior deterioration, corrosion, and loss of operability is not fully apparent in interior photos. Replacement parts for existing windows are unavailable, making restoration of thermal and operable functionality impossible, and long-term maintenance infeasible. Recommendation is for replacement, for quality of life of future tenants and for feasibility of long-term maintenance.
- See Window Assessment (Blackberry) in appendix for further detail and information, including further notes on deterioration beyond repair
- See Appendix for Window Schedule & Measurements

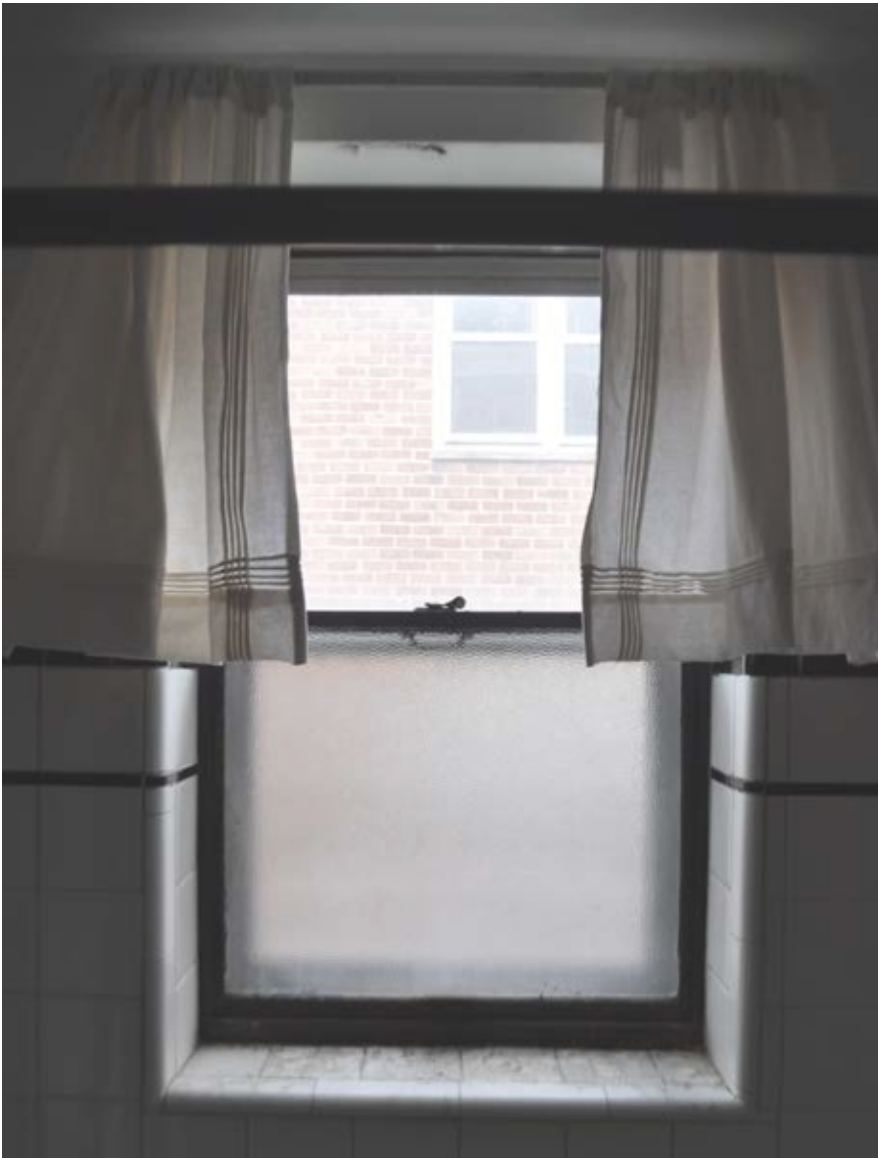
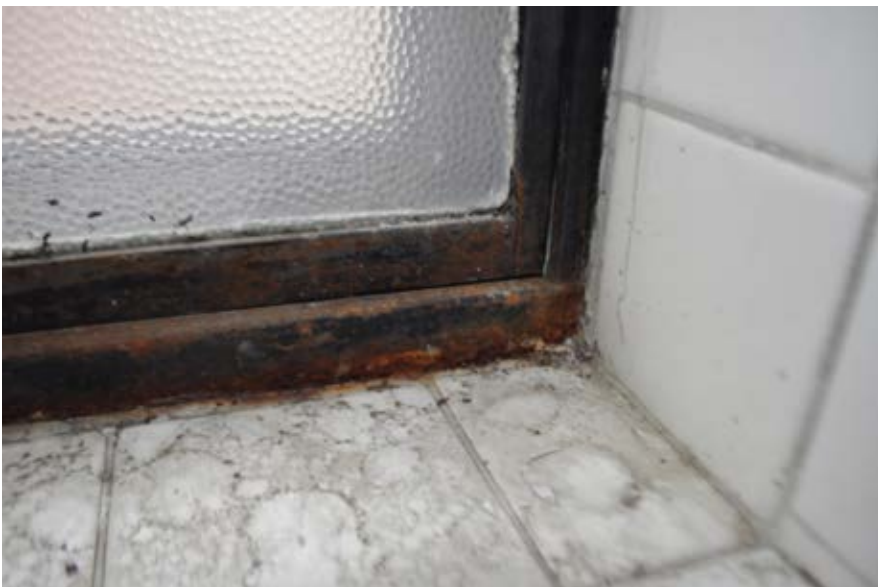
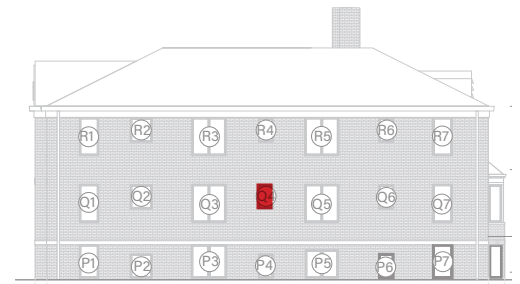
Window Q4, Type U2

- Badly Corroded
- Note: Extent of exterior deterioration, corrosion, and loss of operability is not fully apparent in interior photos. Replacement parts for existing windows are unavailable, making restoration of thermal and operable functionality impossible, and long-term maintenance infeasible. Recommendation is for replacement, for quality of life of future tenants and for feasibility of long-term maintenance.
- See Window Assessment (Blackberry) in appendix for further detail and information, including further notes on deterioration beyond repair
- See Appendix for Window Schedule & Measurements
