9710 W Outer Dr

Existing Condition Photos

Current Design Description

A 3-story apartment structure with 10 residential units, constructed in 1940, brick on wood stud wall construction, shingle roof, stone corner details, stone details at palladian window, stone sills, wood detailing at front entry, steel and wood canopy at back entry, wood windows throughout with the exception of steel windows at bathrooms and the lowest level. The addition of a brick shed to house the gas meter was made at a later date.

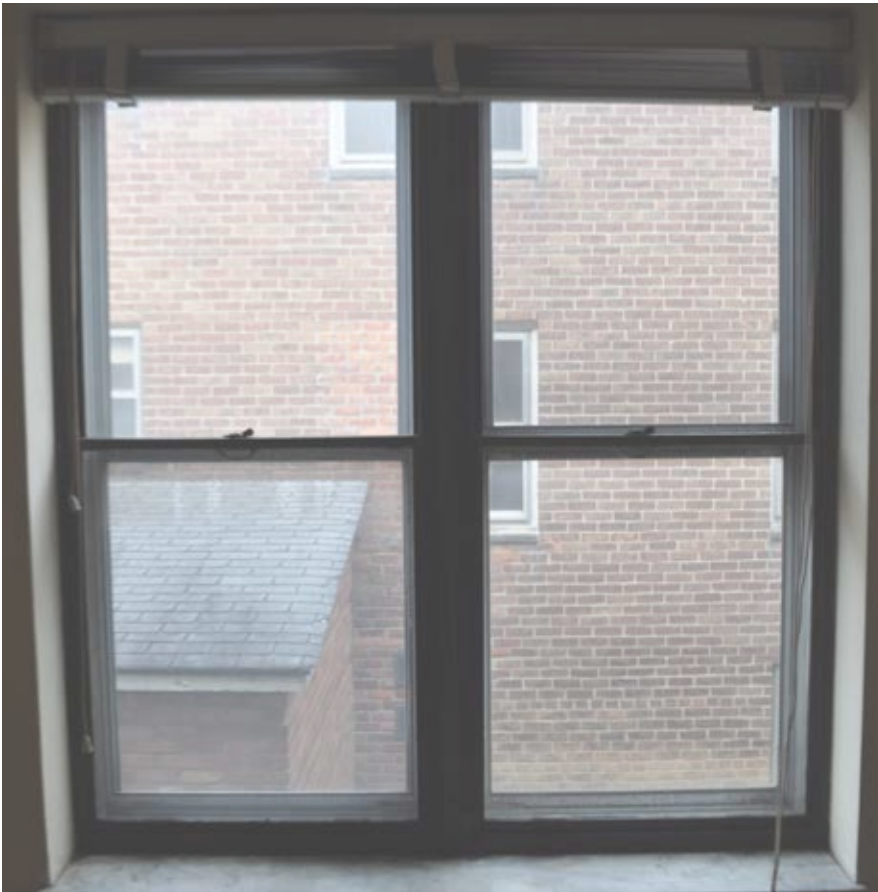
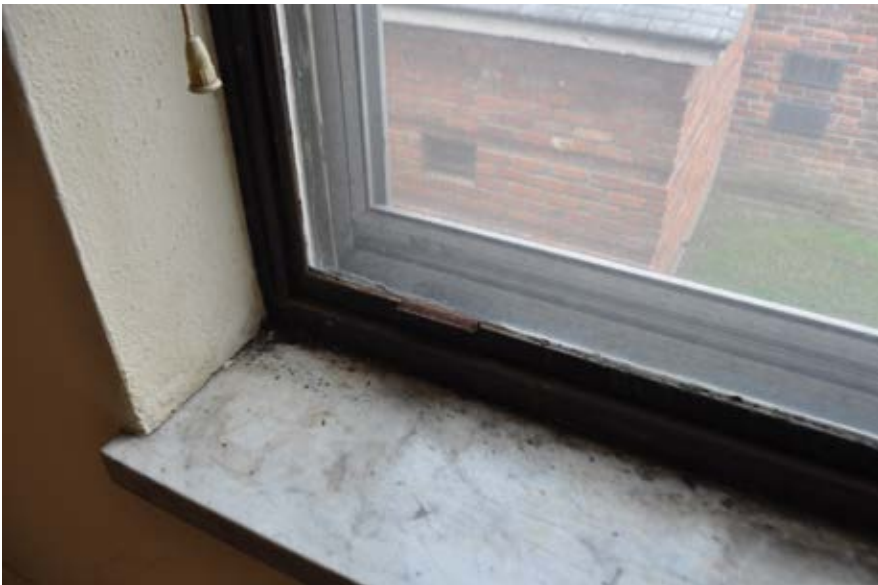
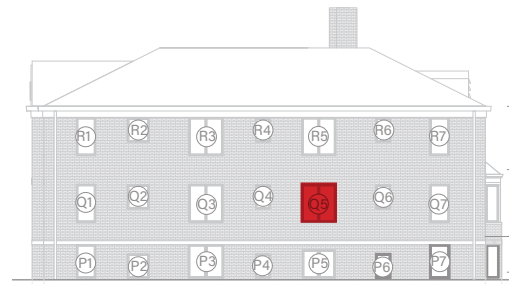
Window Q5, Type Z1

- Note: Extent of exterior deterioration, corrosion, and loss of operability is not fully apparent in interior photos. Replacement parts for existing windows are unavailable, making restoration of thermal and operable functionality impossible, and long-term maintenance infeasible. Recommendation is for replacement, for quality of life of future tenants and for feasibility of long-term maintenance.
- See Window Assessment (Blackberry) in appendix for further detail and information, including further notes on deterioration beyond repair
- See Appendix for Window Schedule & Measurements

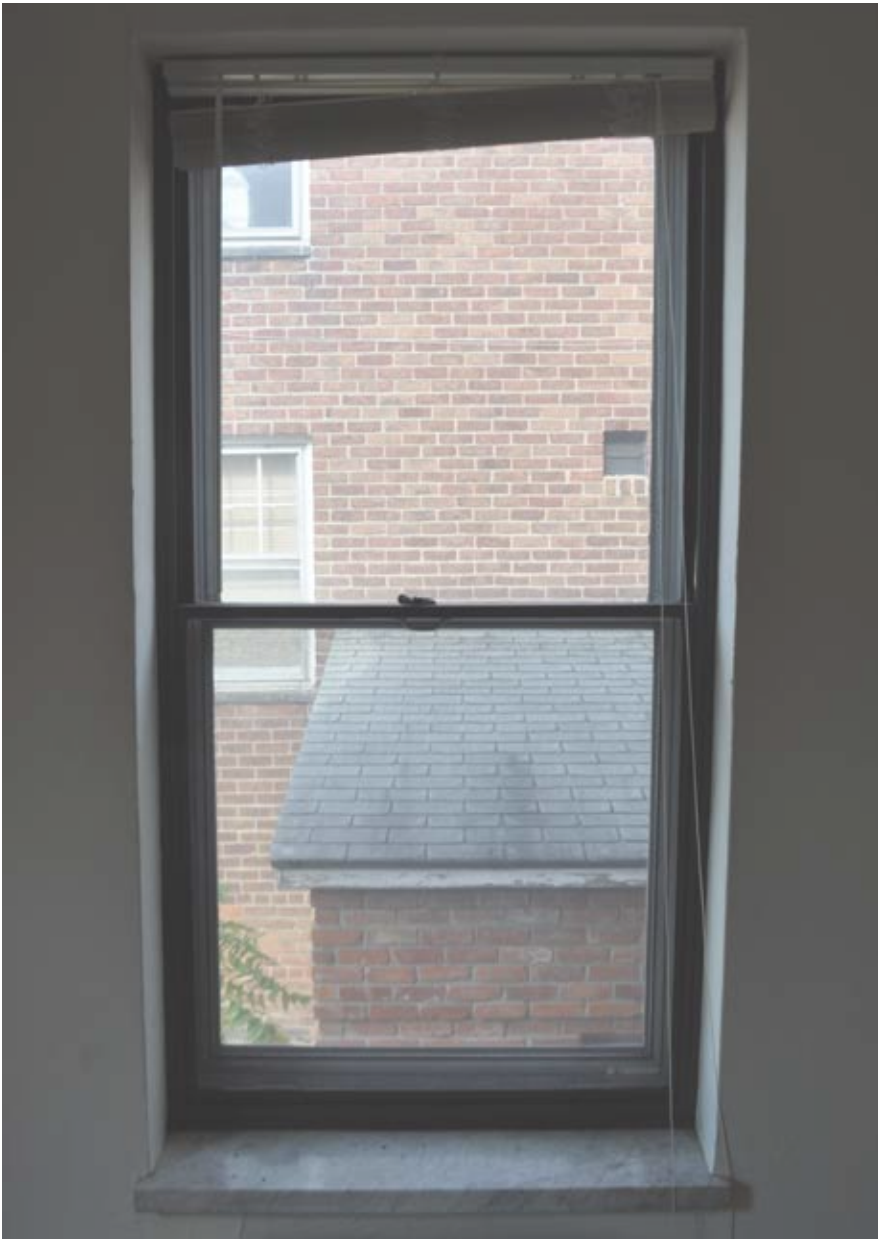
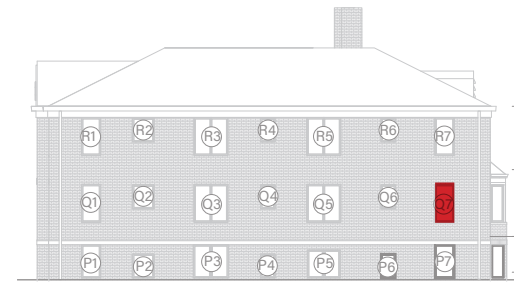
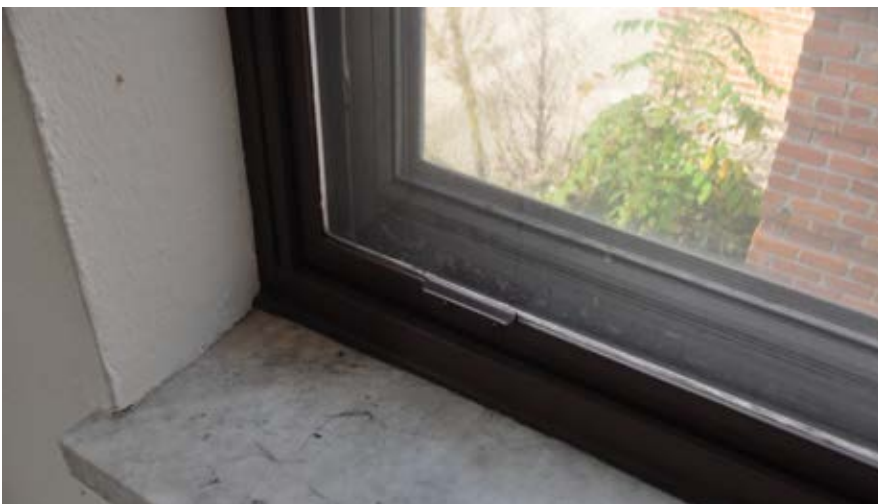
Window Q7, Type N2

- Note: Extent of exterior deterioration, corrosion, and loss of operability is not fully apparent in interior photos. Replacement parts for existing windows are unavailable, making restoration of thermal and operable functionality impossible, and long-term maintenance infeasible. Recommendation is for replacement, for quality of life of future tenants and for feasibility of long-term maintenance.
- See Window Assessment (Blackberry) in appendix for further detail and information, including further notes on deterioration beyond repair
- See Appendix for Window Schedule & Measurements

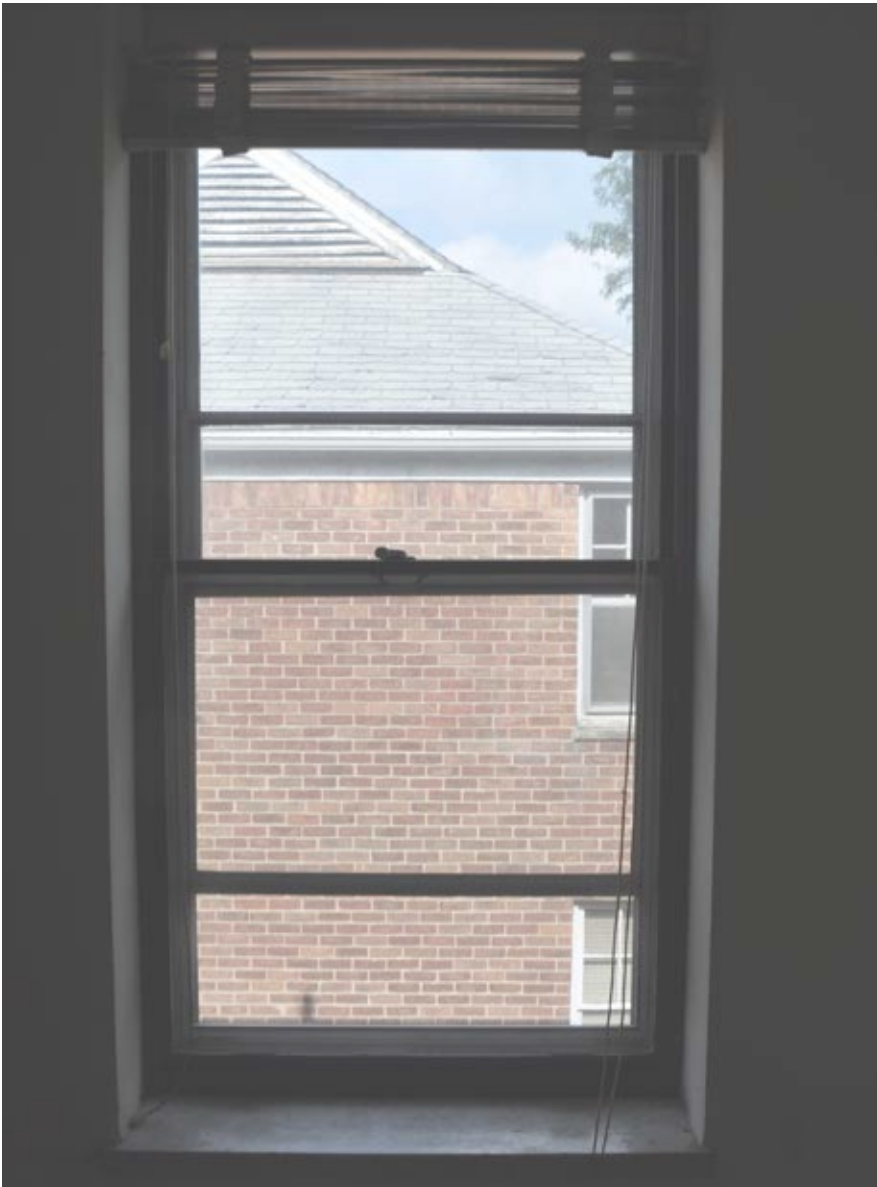
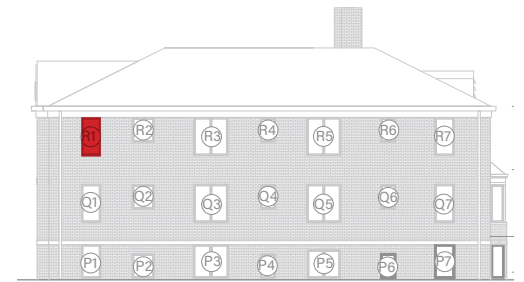
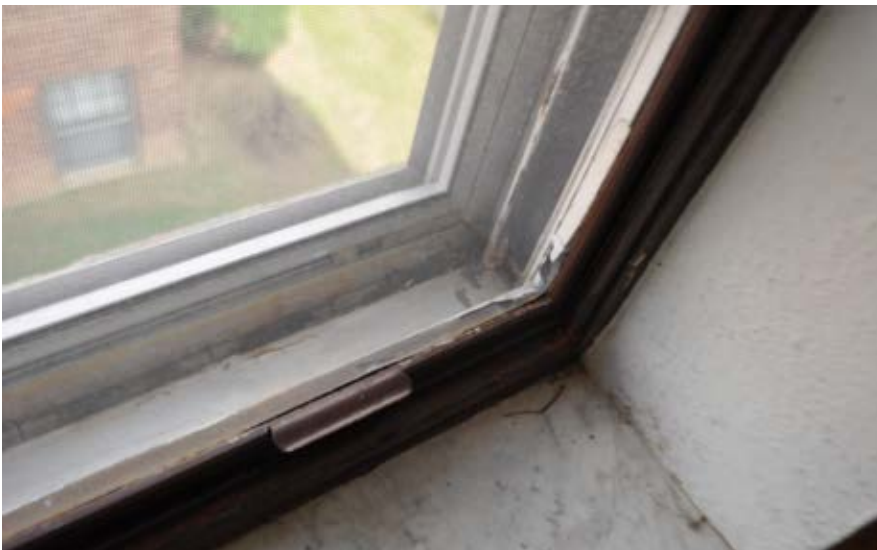
Window R1, Type N2

- Note: Extent of exterior deterioration, corrosion, and loss of operability is not fully apparent in interior photos. Replacement parts for existing windows are unavailable, making restoration of thermal and operable functionality impossible, and long-term maintenance infeasible. Recommendation is for replacement, for quality of life of future tenants and for feasibility of long-term maintenance.
- See Window Assessment (Blackberry) in appendix for further detail and information, including further notes on deterioration beyond repair
- See Appendix for Window Schedule & Measurements

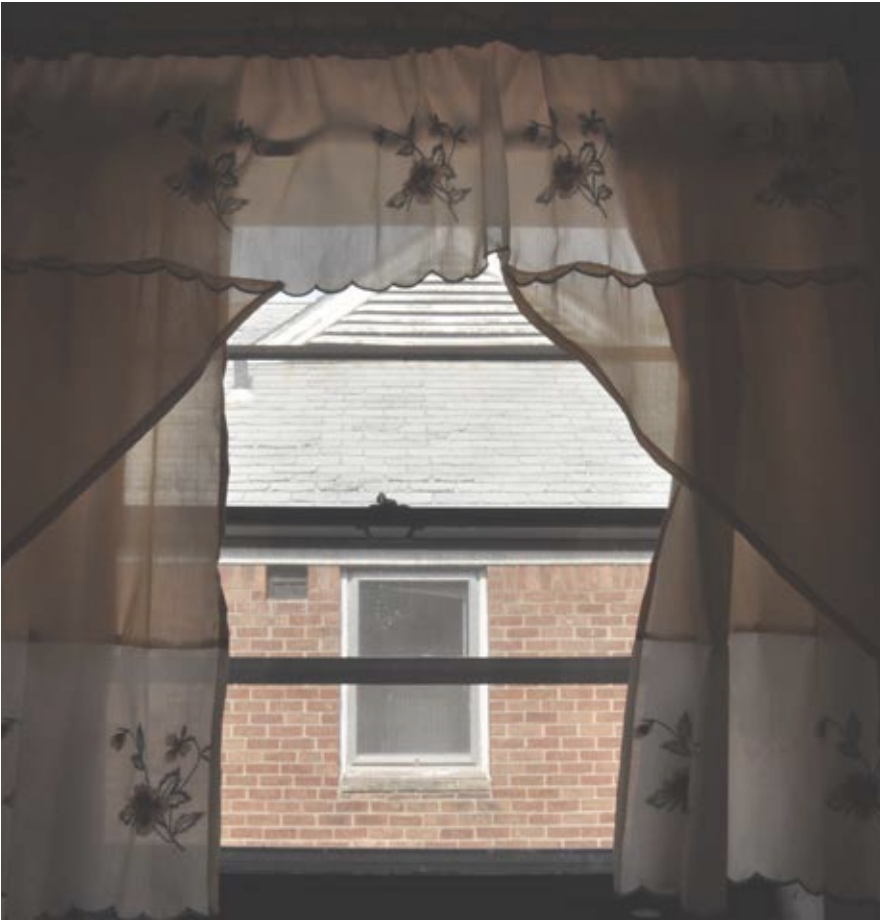
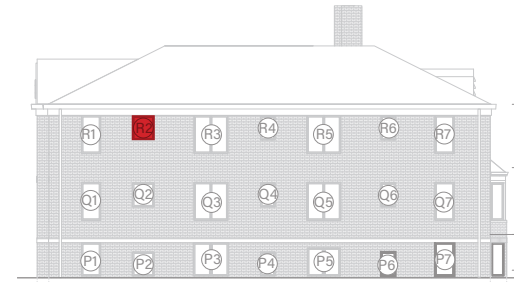
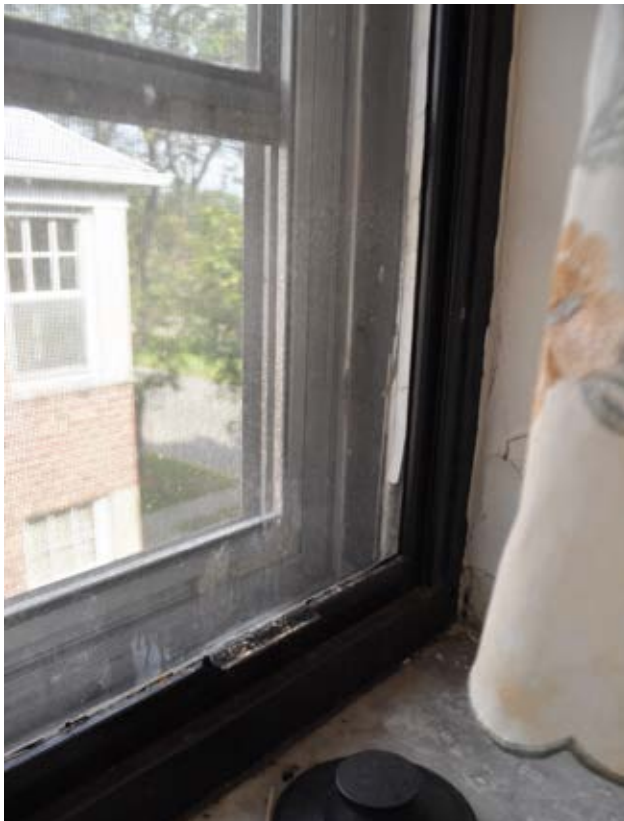
Window R2, Type T2

- Note: Extent of exterior deterioration, corrosion, and loss of operability is not fully apparent in interior photos. Replacement parts for existing windows are unavailable, making restoration of thermal and operable functionality impossible, and long-term maintenance infeasible. Recommendation is for replacement, for quality of life of future tenants and for feasibility of long-term maintenance.
- See Window Assessment (Blackberry) in appendix for further detail and information, including further notes on deterioration beyond repair
- See Appendix for Window Schedule & Measurements

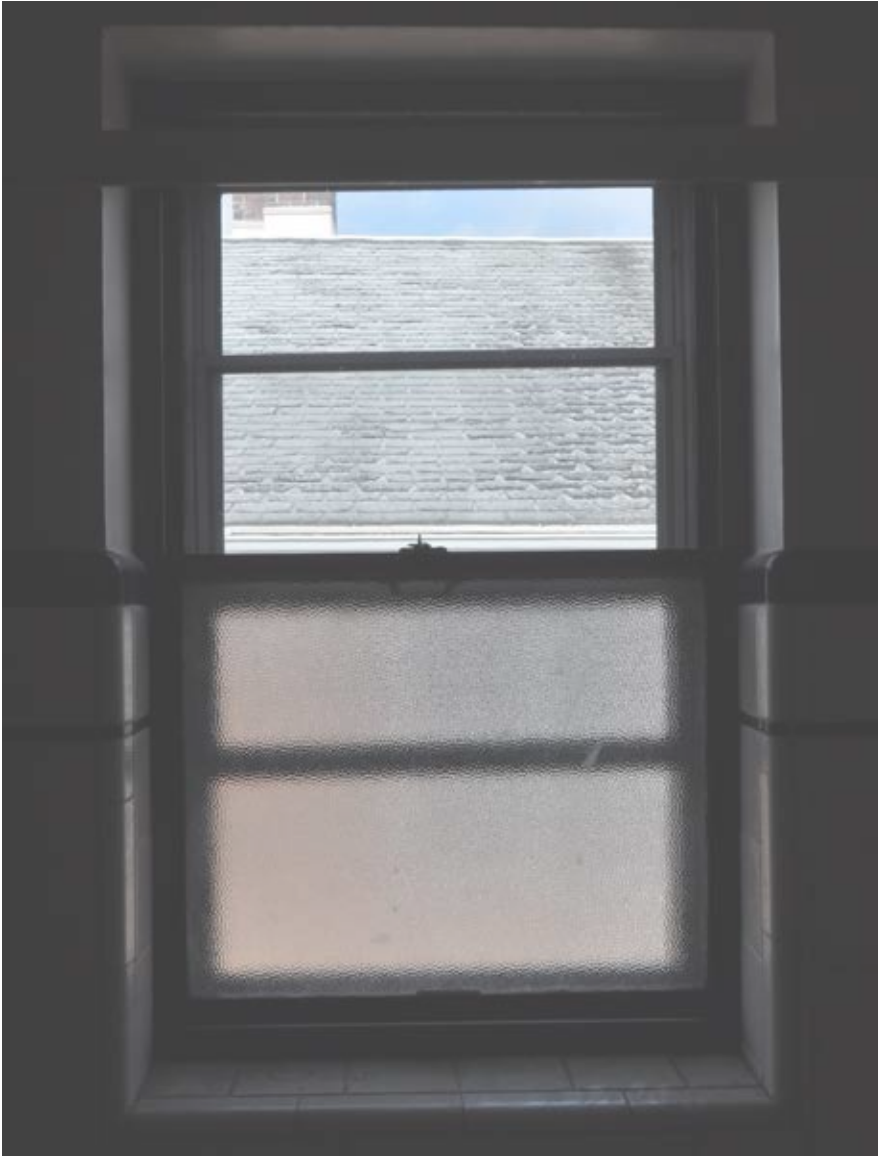
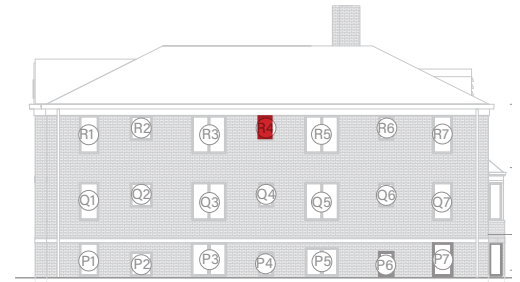
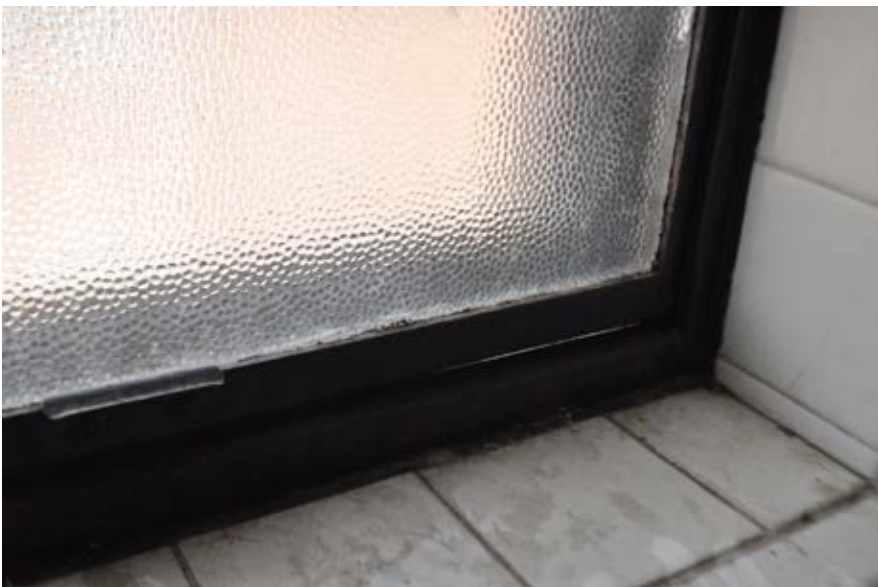
Window R4, Type U2

- Note: Extent of exterior deterioration, corrosion, and loss of operability is not fully apparent in interior photos. Replacement parts for existing windows are unavailable, making restoration of thermal and operable functionality impossible, and long-term maintenance infeasible. Recommendation is for replacement, for quality of life of future tenants and for feasibility of long-term maintenance.
- See Window Assessment (Blackberry) in appendix for further detail and information, including further notes on deterioration beyond repair
- See Appendix for Window Schedule & Measurements

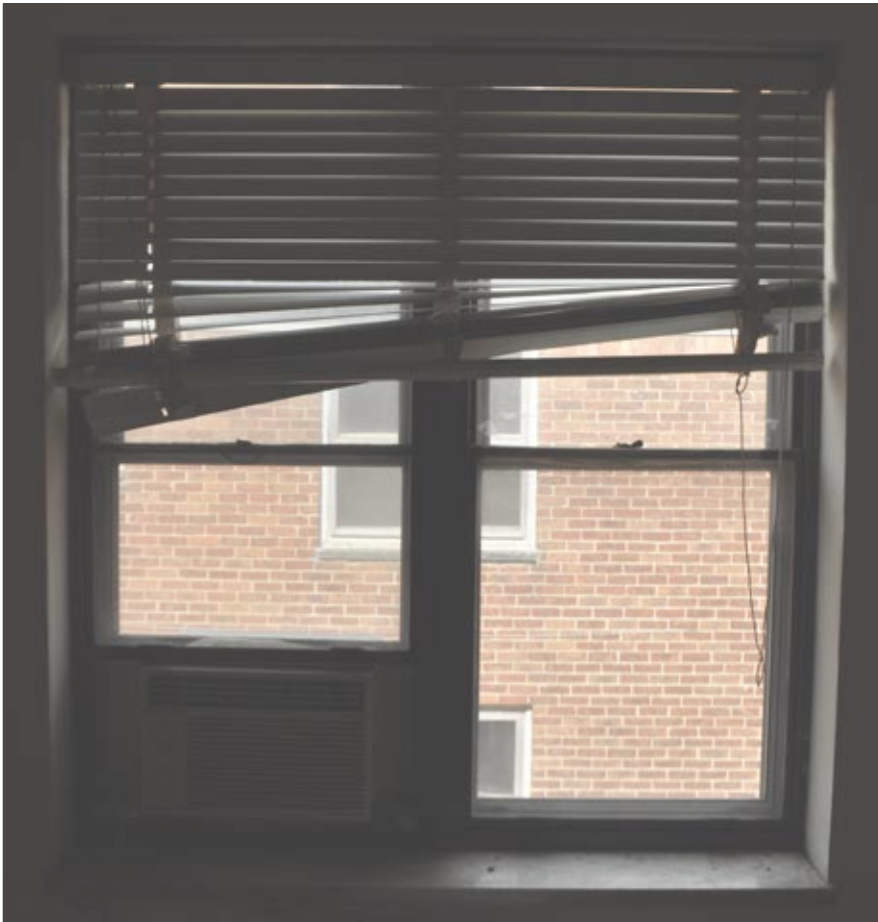
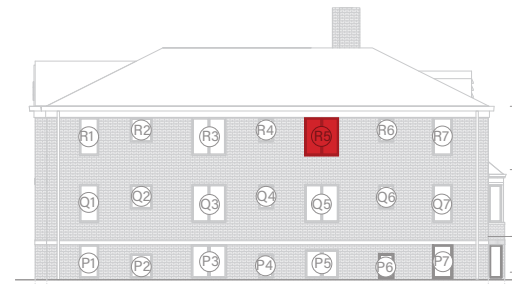
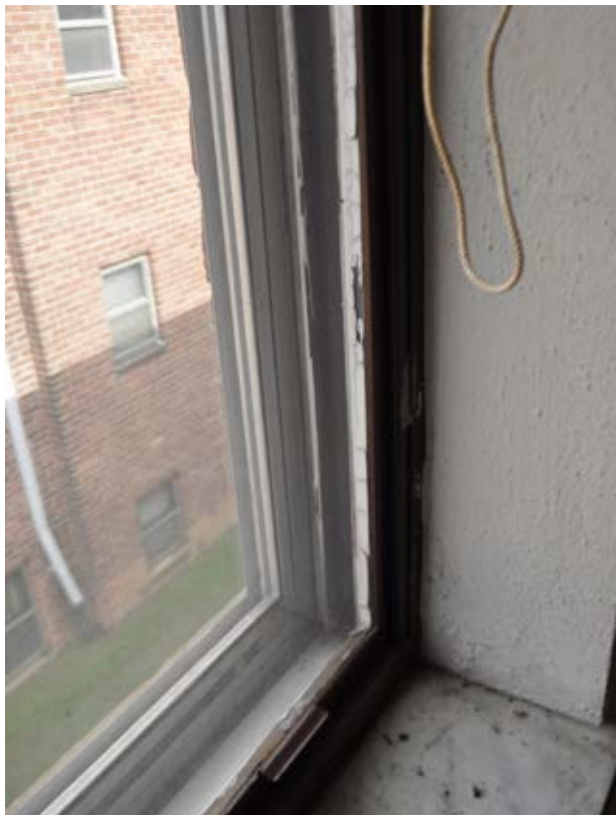
Window R5, Type Z1

- Note: Extent of exterior deterioration, corrosion, and loss of operability is not fully apparent in interior photos. Replacement parts for existing windows are unavailable, making restoration of thermal and operable functionality impossible, and long-term maintenance infeasible. Recommendation is for replacement, for quality of life of future tenants and for feasibility of long-term maintenance.
- See Window Assessment (Blackberry) in appendix for further detail and information, including further notes on deterioration beyond repair
- See Appendix for Window Schedule & Measurements

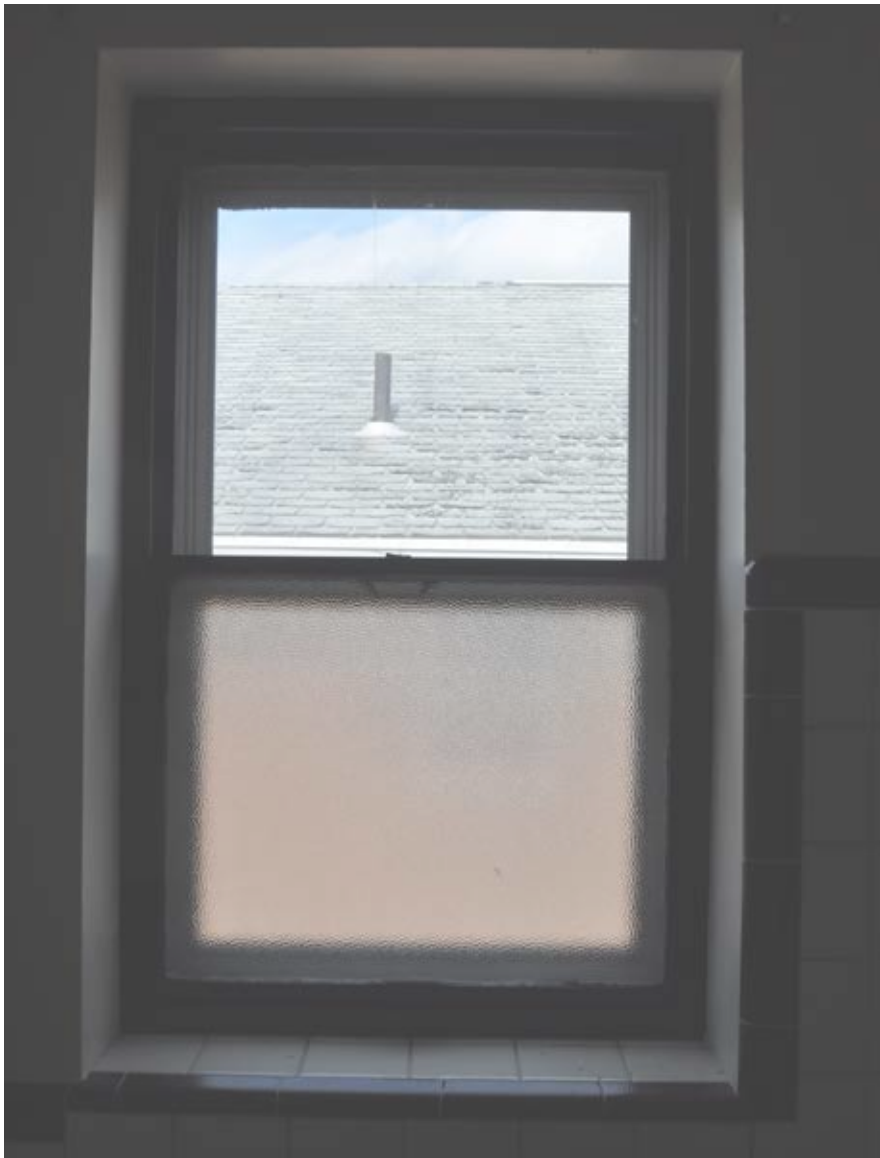
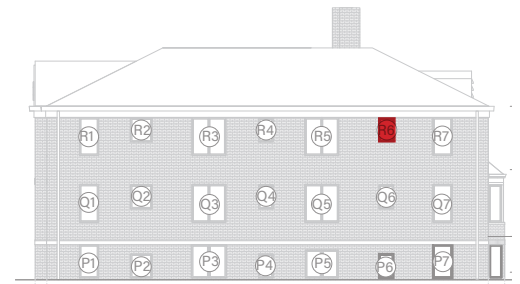
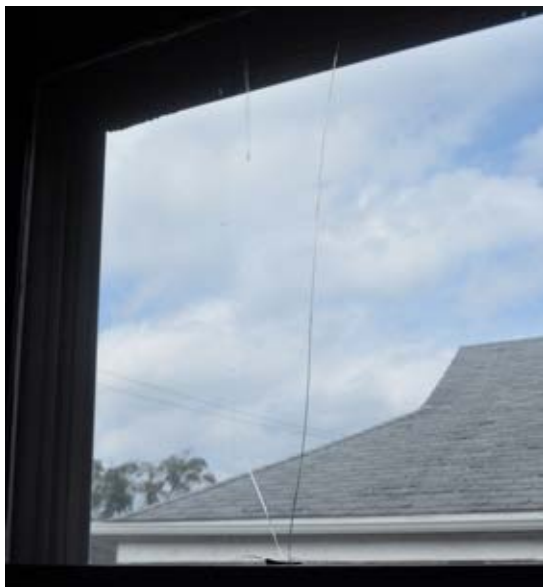
Window R6, Type U2

- Broken Glass
- Note: Extent of exterior deterioration, corrosion, and loss of operability is not fully apparent in interior photos. Replacement parts for existing windows are unavailable, making restoration of thermal and operable functionality impossible, and long-term maintenance infeasible. Recommendation is for replacement, for quality of life of future tenants and for feasibility of long-term maintenance.
- See Window Assessment (Blackberry) in appendix for further detail and information, including further notes on deterioration beyond repair
- See Appendix for Window Schedule & Measurements

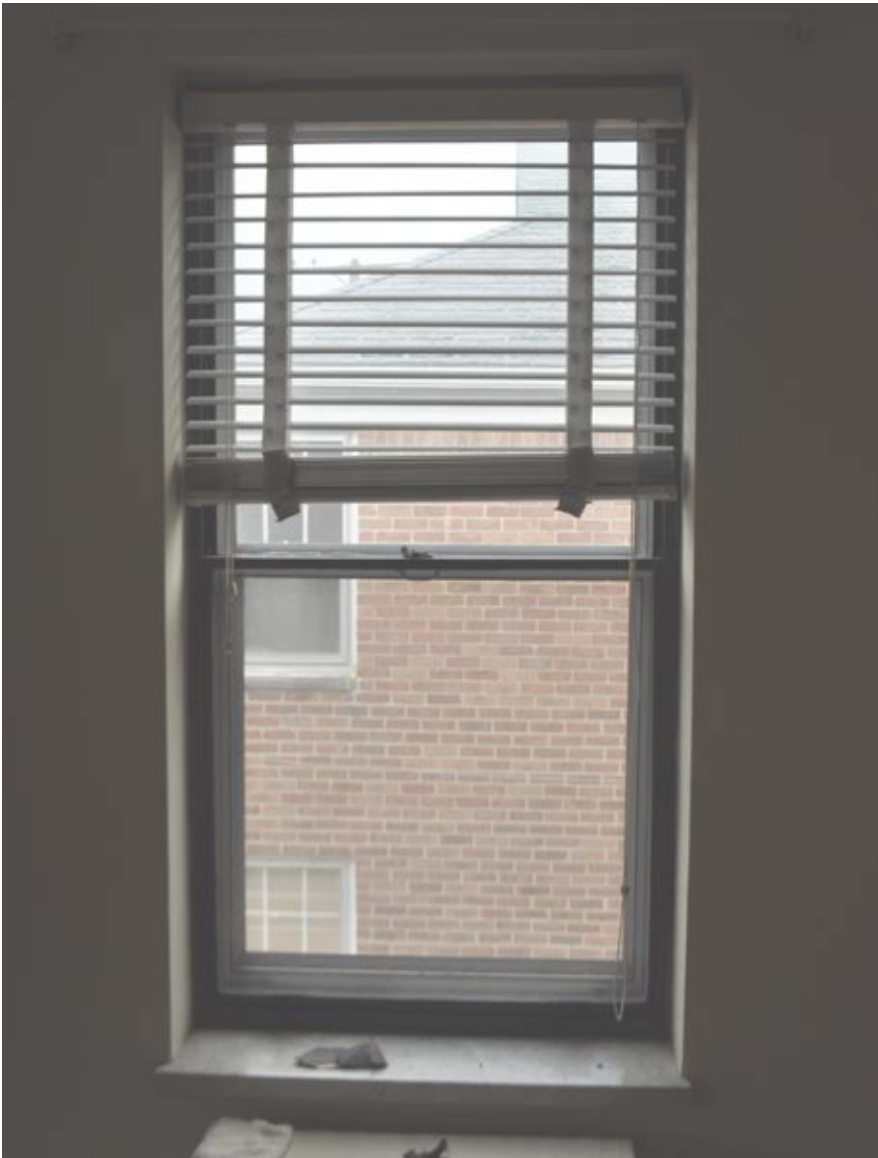
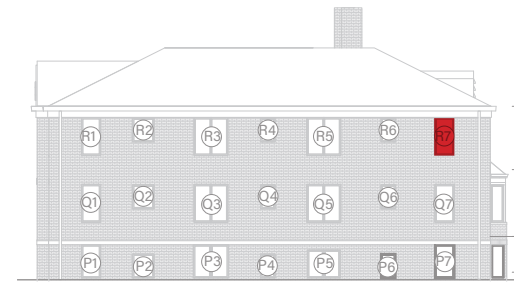
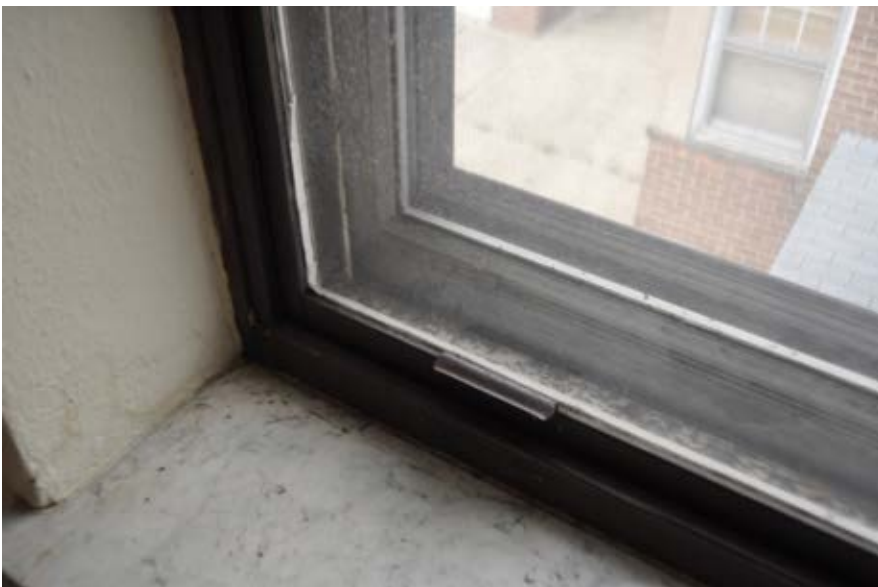
Window R7, Type N2

- Note: Extent of exterior deterioration, corrosion, and loss of operability is not fully apparent in interior photos. Replacement parts for existing windows are unavailable, making restoration of thermal and operable functionality impossible, and long-term maintenance infeasible. Recommendation is for replacement, for quality of life of future tenants and for feasibility of long-term maintenance.
- See Window Assessment (Blackberry) in appendix for further detail and information, including further notes on deterioration beyond repair
- See Appendix for Window Schedule & Measurements

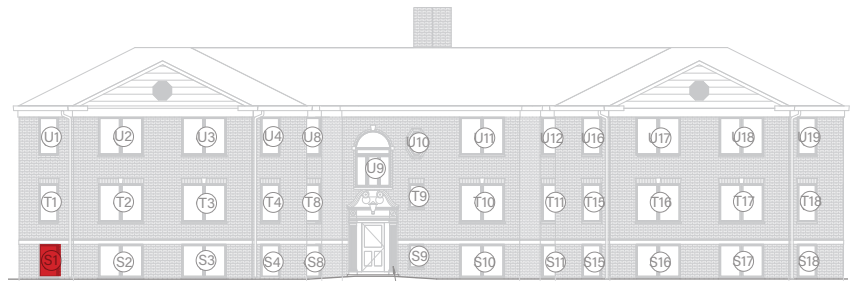
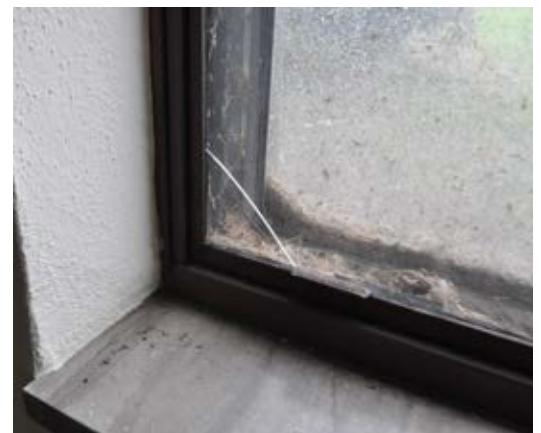
Window S1, Type M1

- Badly Corroded
- Broken Glass
- Note: Extent of exterior deterioration, corrosion, and loss of operability is not fully apparent in interior photos. Replacement parts for existing windows are unavailable, making restoration of thermal and operable functionality impossible, and long-term maintenance infeasible. Recommendation is for replacement, for quality of life of future tenants and for feasibility of long-term maintenance.
- See Window Assessment (Blackberry) in appendix for further detail and information, including further notes on deterioration beyond repair
- See Appendix for Window Schedule & Measurements

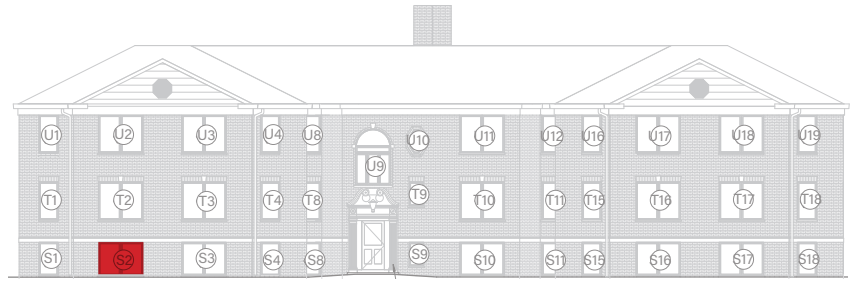
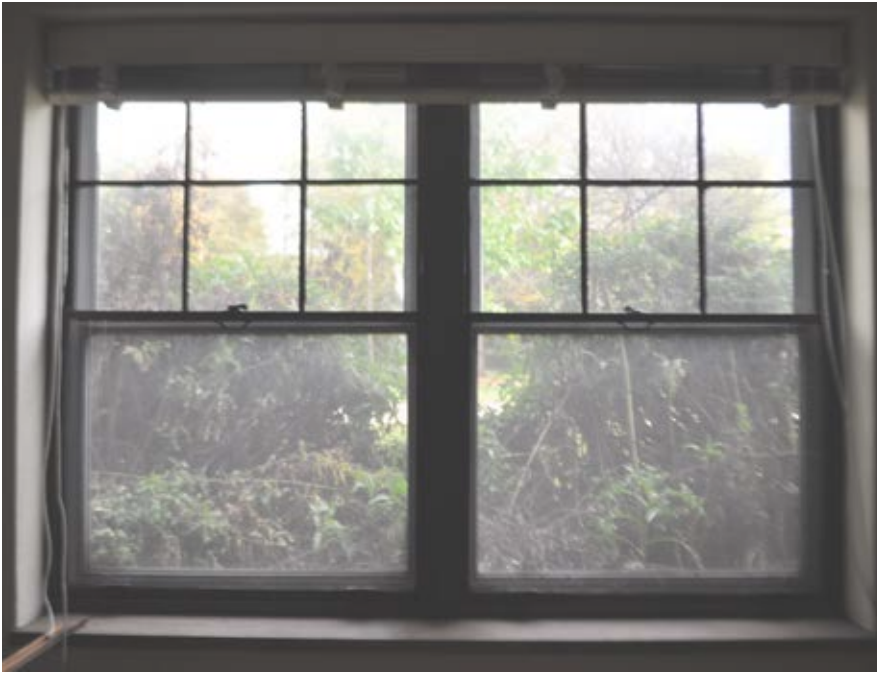
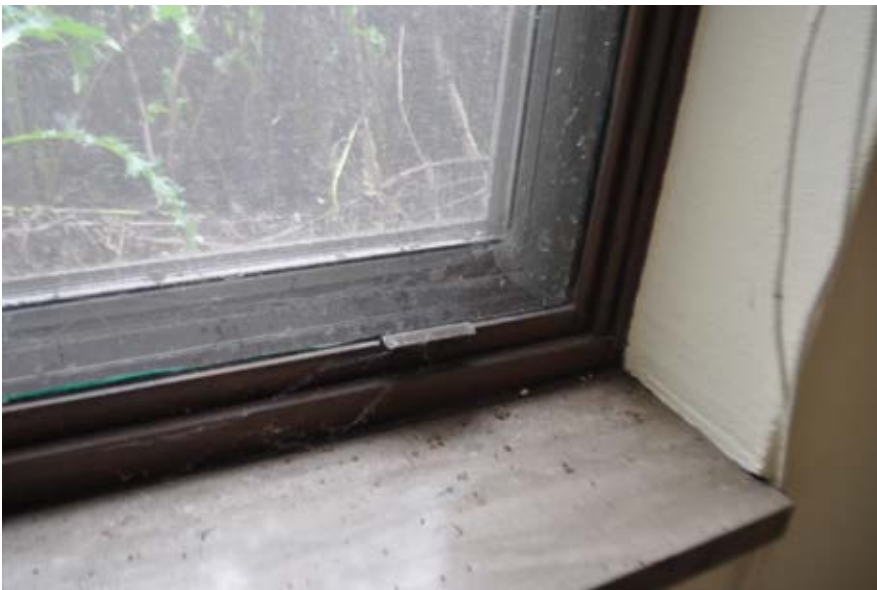
Window S2, Type O1

- Badly Corroded
- Note: Extent of exterior deterioration, corrosion, and loss of operability is not fully apparent in interior photos. Replacement parts for existing windows are unavailable, making restoration of thermal and operable functionality impossible, and long-term maintenance infeasible. Recommendation is for replacement, for quality of life of future tenants and for feasibility of long-term maintenance.
- See Window Assessment (Blackberry) in appendix for further detail and information, including further notes on deterioration beyond repair
- See Appendix for Window Schedule & Measurements

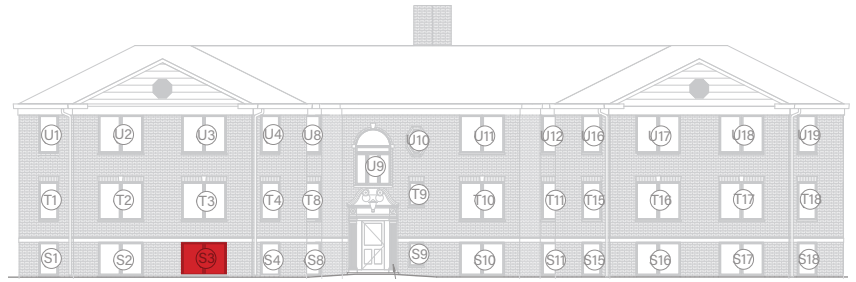
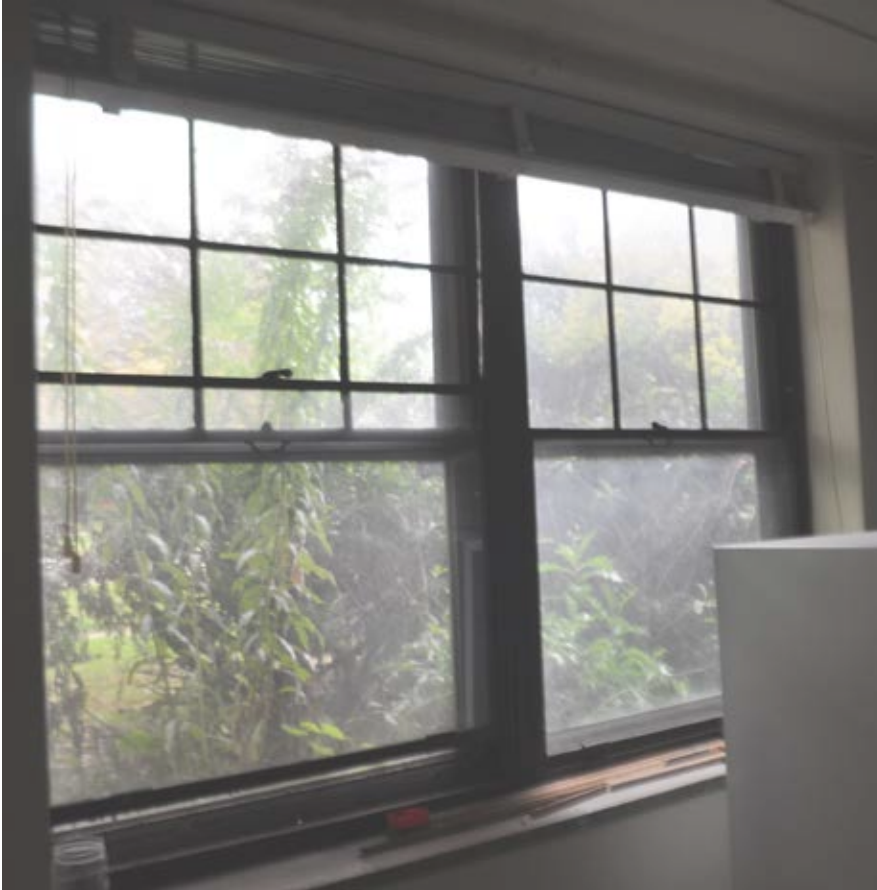
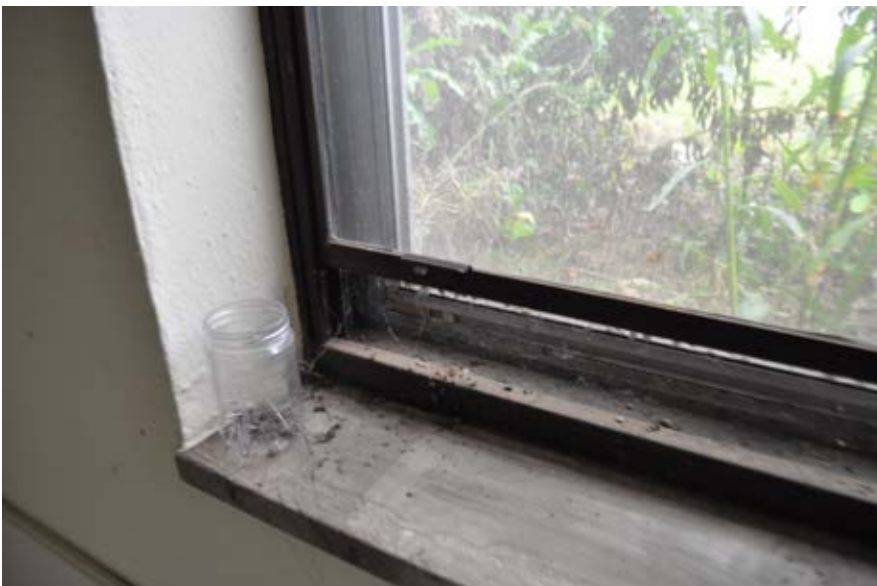
Window S3, Type O1

- Badly Corroded
- Note: Extent of exterior deterioration, corrosion, and loss of operability is not fully apparent in interior photos. Replacement parts for existing windows are unavailable, making restoration of thermal and operable functionality impossible, and long-term maintenance infeasible. Recommendation is for replacement, for quality of life of future tenants and for feasibility of long-term maintenance.
- See Window Assessment (Blackberry) in appendix for further detail and information, including further notes on deterioration beyond repair
- See Appendix for Window Schedule & Measurements

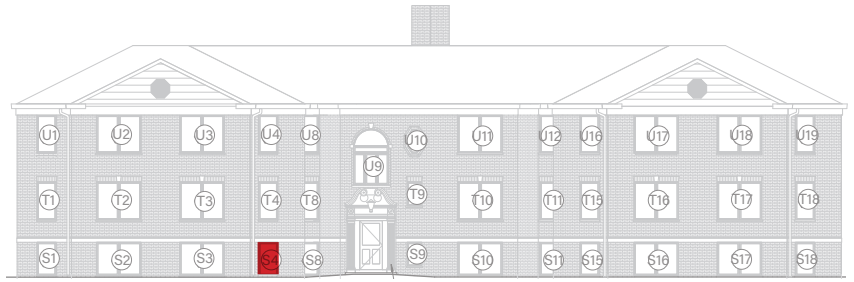
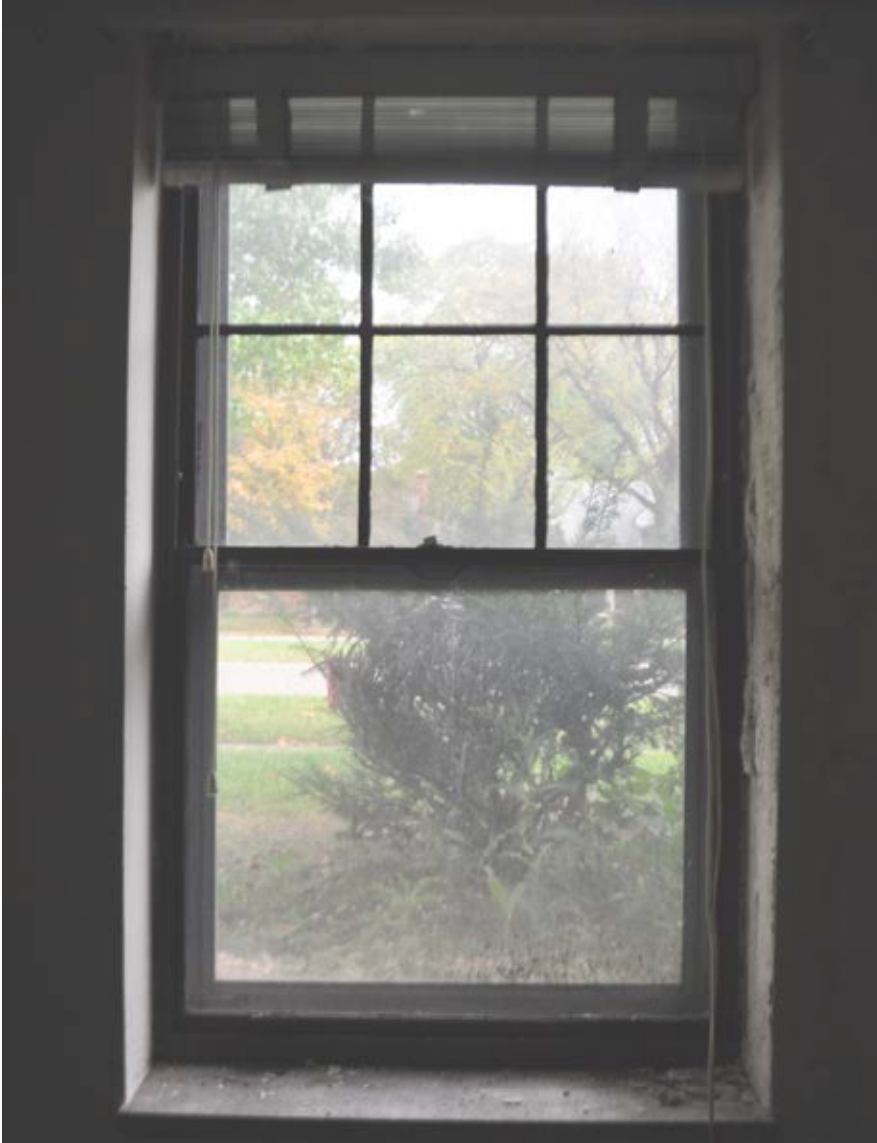
Window S4, Type M1

- Badly Corroded
- Water Infiltration
- Note: Extent of exterior deterioration, corrosion, and loss of operability is not fully apparent in interior photos. Replacement parts for existing windows are unavailable, making restoration of thermal and operable functionality impossible, and long-term maintenance infeasible. Recommendation is for replacement, for quality of life of future tenants and for feasibility of long-term maintenance.
- See Window Assessment (Blackberry) in appendix for further detail and information, including further notes on deterioration beyond repair
- See Appendix for Window Schedule & Measurements

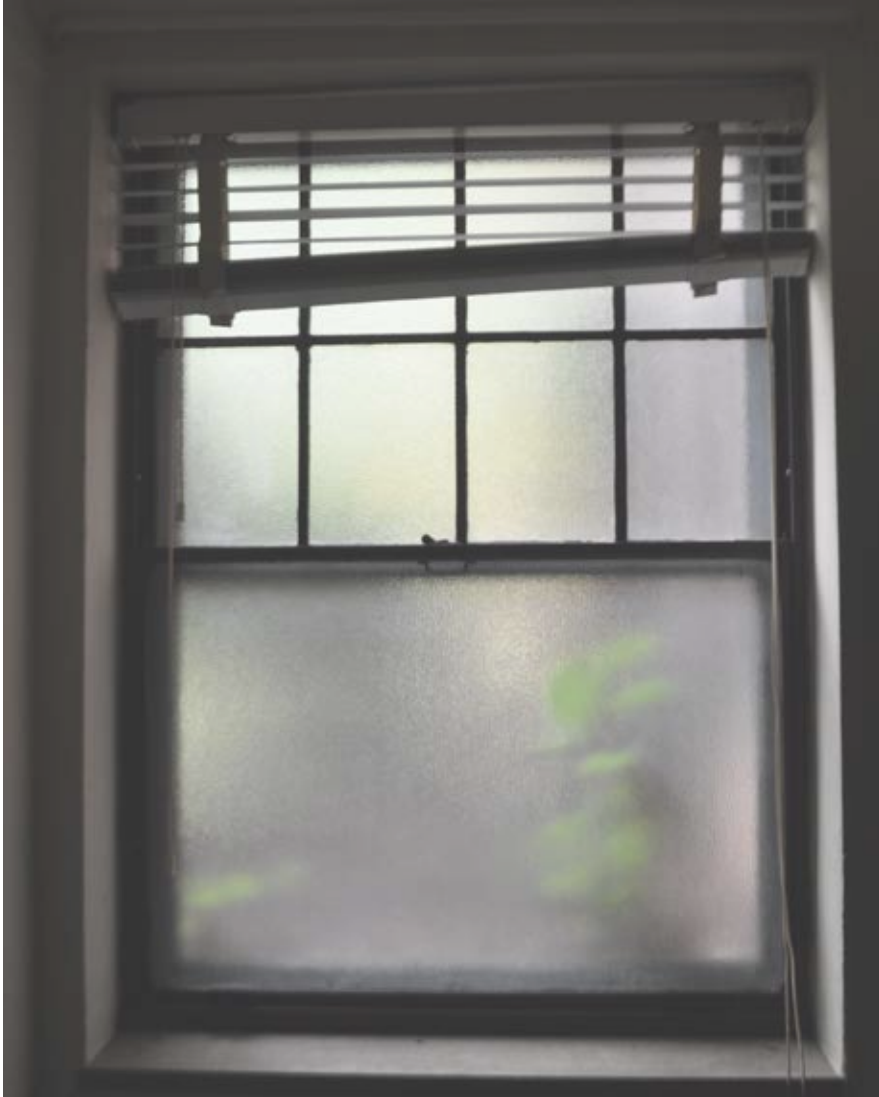
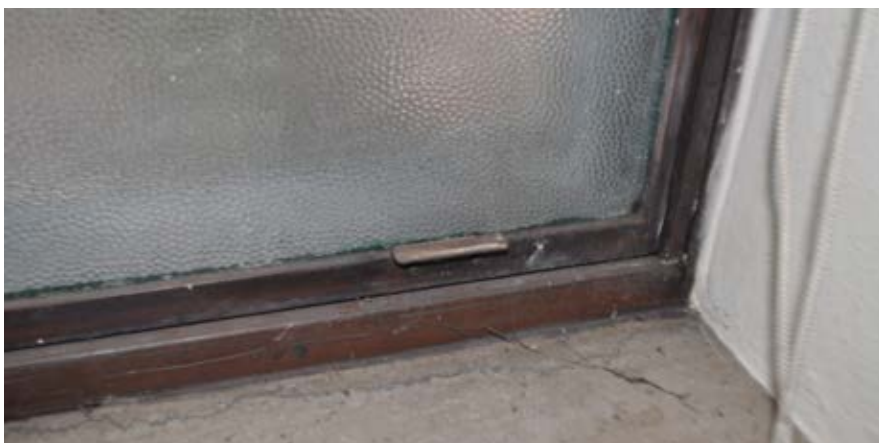
Window S8, Type Q1

- Badly Corroded
- Note: Extent of exterior deterioration, corrosion, and loss of operability is not fully apparent in interior photos. Replacement parts for existing windows are unavailable, making restoration of thermal and operable functionality impossible, and long-term maintenance infeasible. Recommendation is for replacement, for quality of life of future tenants and for feasibility of long-term maintenance.
- See Window Assessment (Blackberry) in appendix for further detail and information, including further notes on deterioration beyond repair
- See Appendix for Window Schedule & Measurements

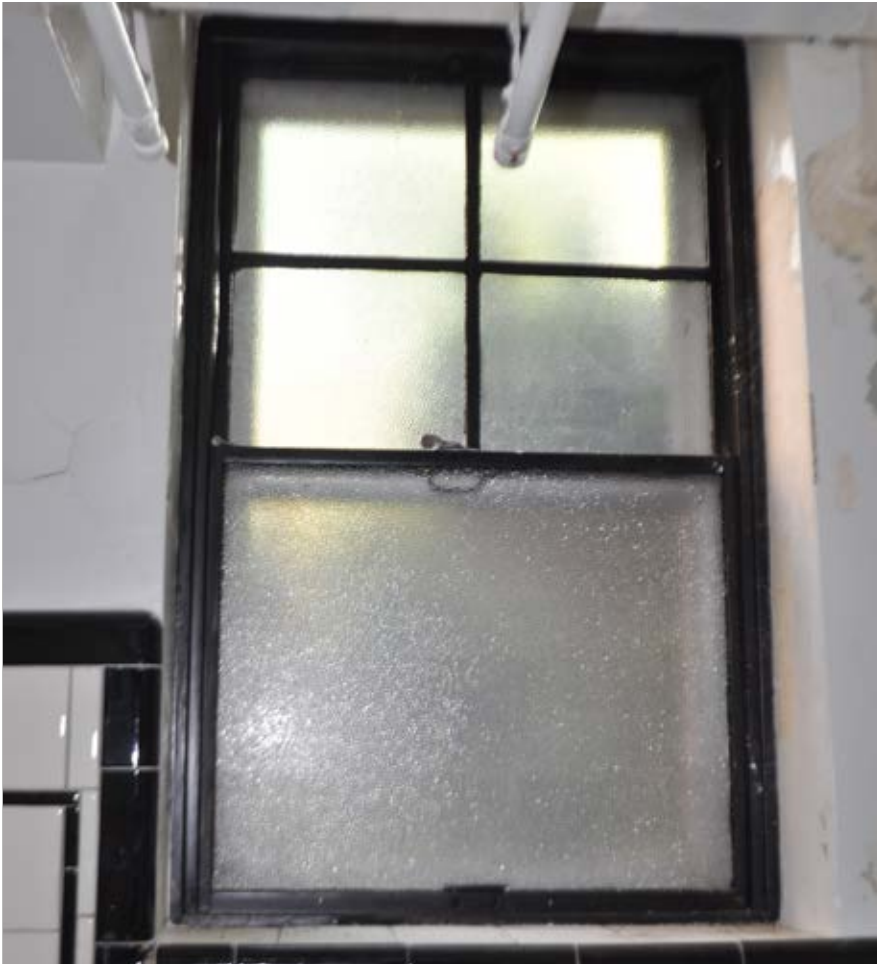
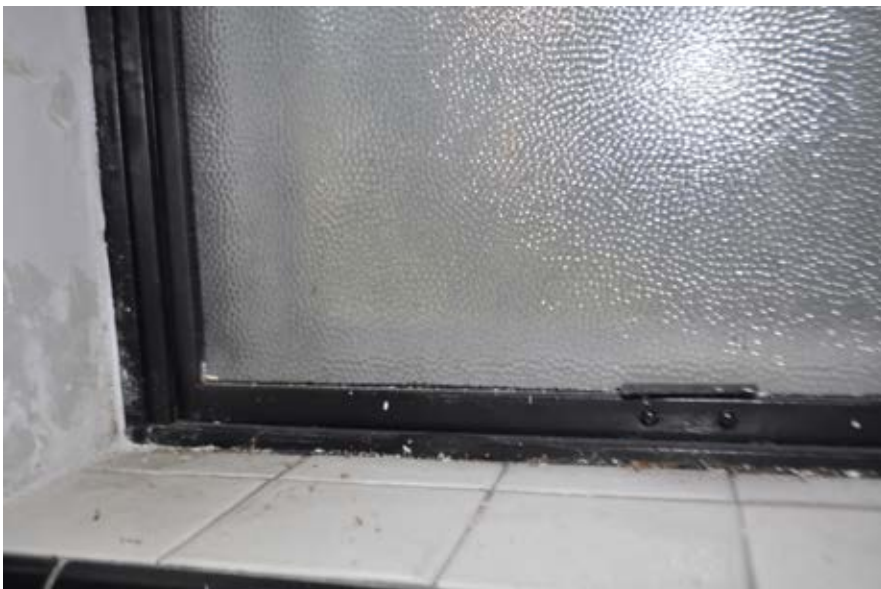
Window S9, Type U1

- Badly Corroded
- Note: Extent of exterior deterioration, corrosion, and loss of operability is not fully apparent in interior photos. Replacement parts for existing windows are unavailable, making restoration of thermal and operable functionality impossible, and long-term maintenance infeasible. Recommendation is for replacement, for quality of life of future tenants and for feasibility of long-term maintenance.
- See Window Assessment (Blackberry) in appendix for further detail and information, including further notes on deterioration beyond repair
- See Appendix for Window Schedule & Measurements
