9710 W Outer Dr

Existing Condition Photos

Current Design Description

A 3-story apartment structure with 10 residential units, constructed in 1940, brick on wood stud wall construction, shingle roof, stone corner details, stone details at palladian window, stone sills, wood detailing at front entry, steel and wood canopy at back entry, wood windows throughout with the exception of steel windows at bathrooms and the lowest level. The addition of a brick shed to house the gas meter was made at a later date.

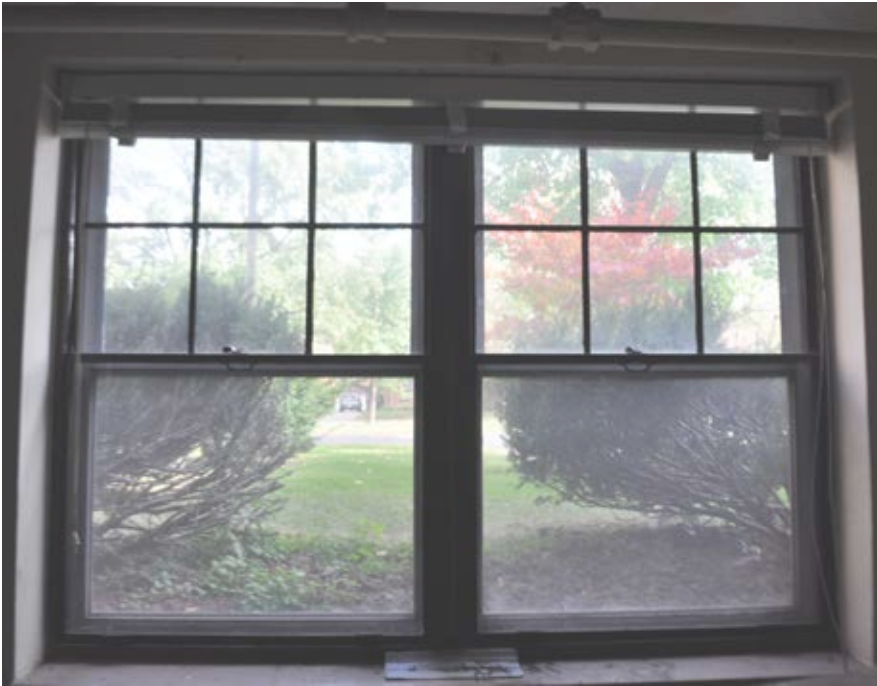
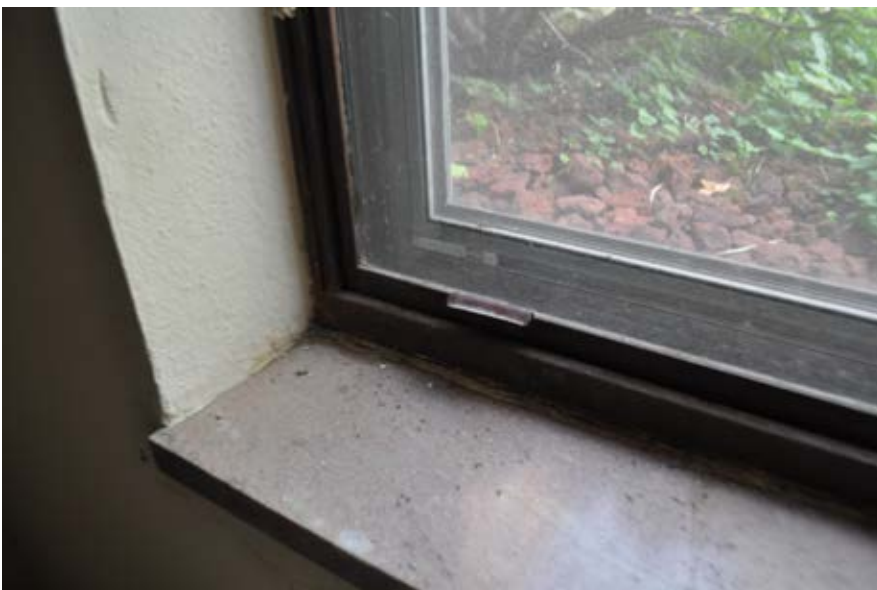
Window S10, Type O1

- Badly Corroded
- Note: Extent of exterior deterioration, corrosion, and loss of operability is not fully apparent in interior photos. Replacement parts for existing windows are unavailable, making restoration of thermal and operable functionality impossible, and long-term maintenance infeasible. Recommendation is for replacement, for quality of life of future tenants and for feasibility of long-term maintenance.
- See Window Assessment (Blackberry) in appendix for further detail and information, including further notes on deterioration beyond repair
- See Appendix for Window Schedule & Measurements

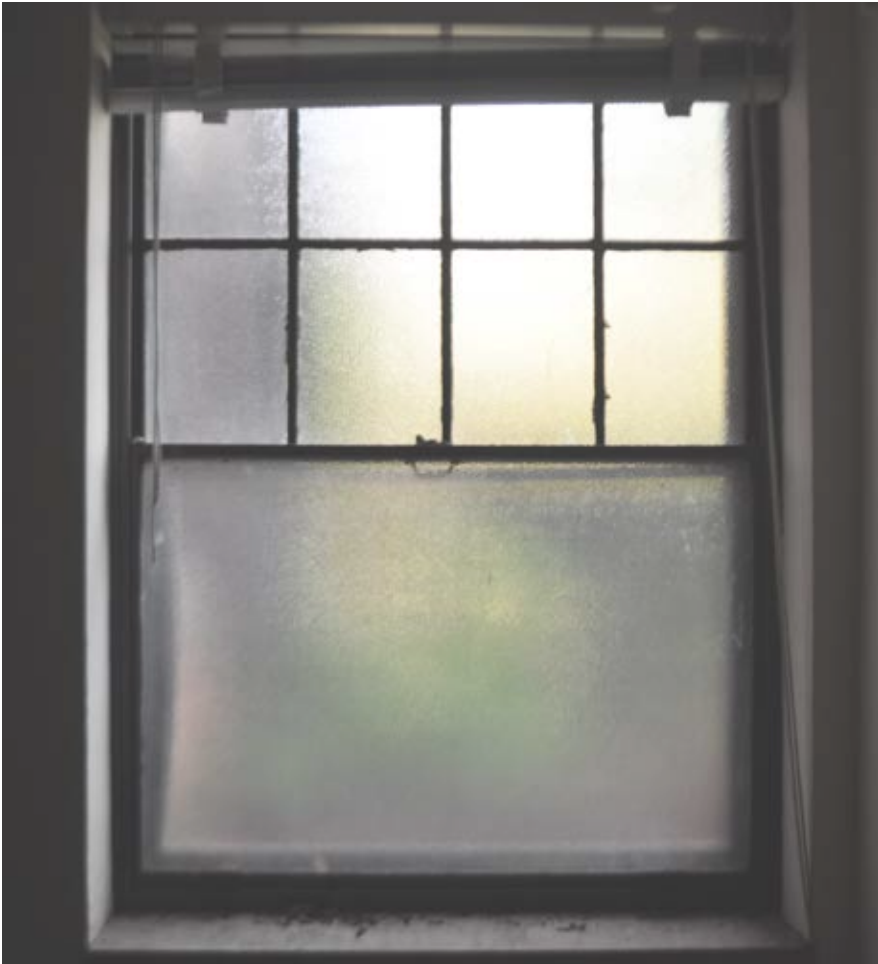
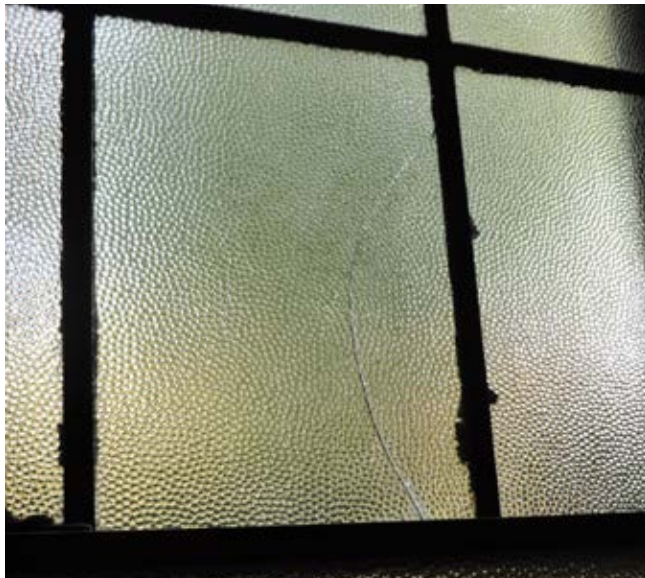
Window S11, Type O1

- Badly Corroded
- Broken Glass
- Note: Extent of exterior deterioration, corrosion, and loss of operability is not fully apparent in interior photos. Replacement parts for existing windows are unavailable, making restoration of thermal and operable functionality impossible, and long-term maintenance infeasible. Recommendation is for replacement, for quality of life of future tenants and for feasibility of long-term maintenance.
- See Window Assessment (Blackberry) in appendix for further detail and information, including further notes on deterioration beyond repair
- See Appendix for Window Schedule & Measurements

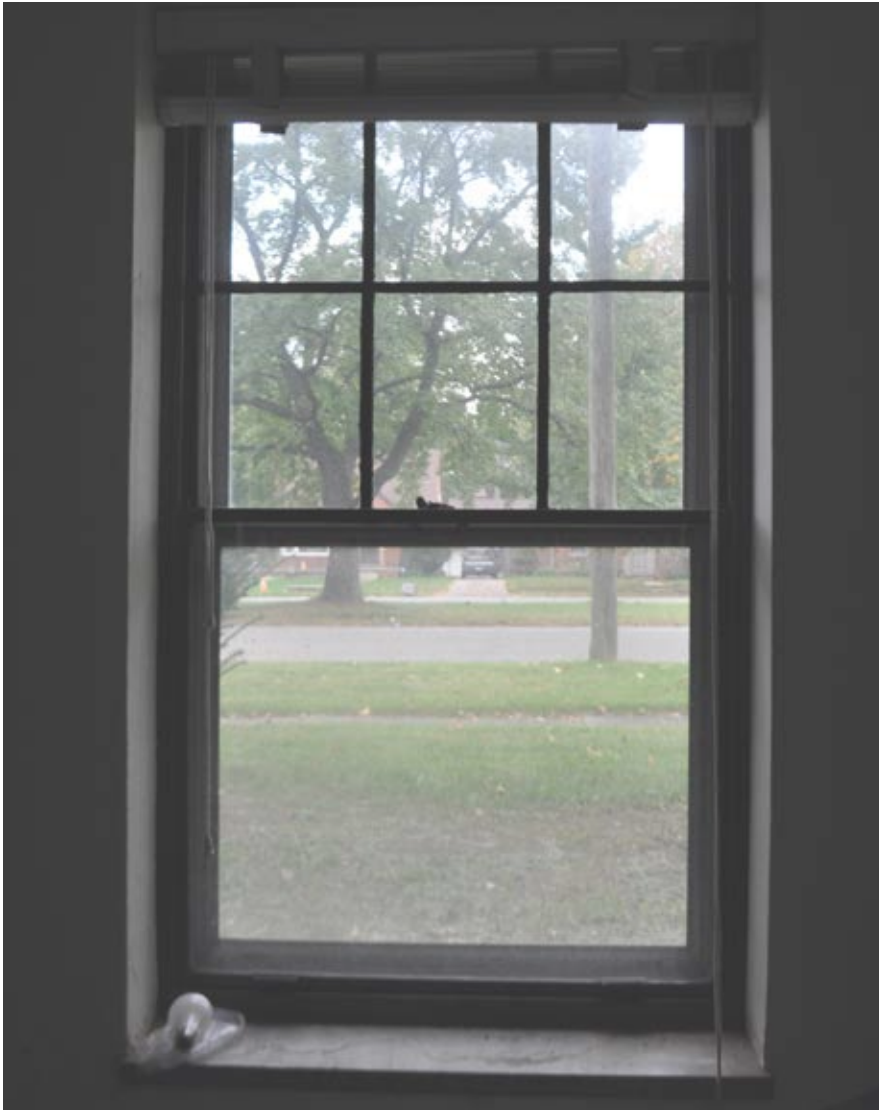
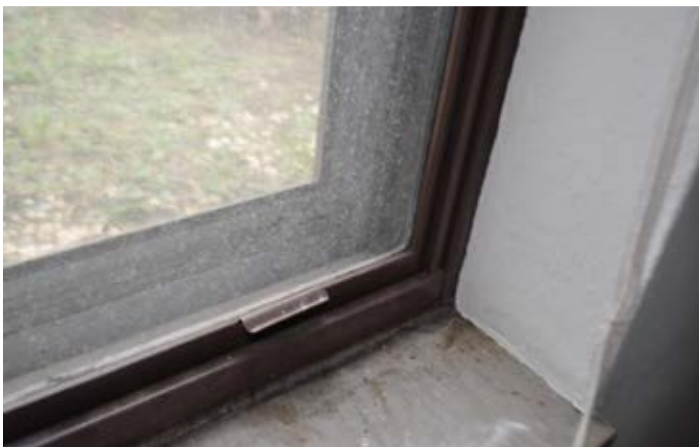
Window S15, Type M1

- Badly Corroded
- Note: Extent of exterior deterioration, corrosion, and loss of operability is not fully apparent in interior photos. Replacement parts for existing windows are unavailable, making restoration of thermal and operable functionality impossible, and long-term maintenance infeasible. Recommendation is for replacement, for quality of life of future tenants and for feasibility of long-term maintenance.
- See Window Assessment (Blackberry) in appendix for further detail and information, including further notes on deterioration beyond repair
- See Appendix for Window Schedule & Measurements

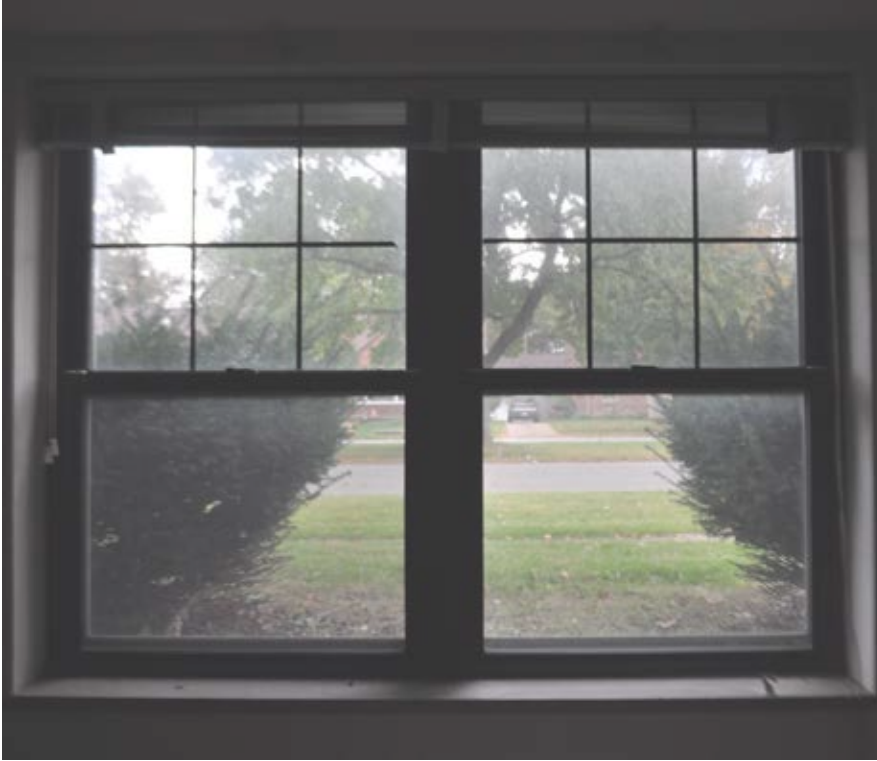
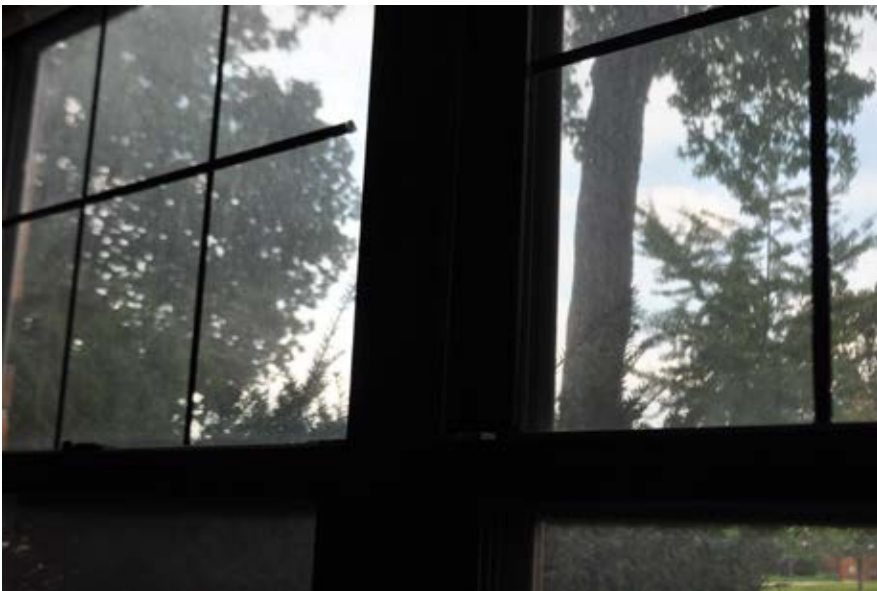
Window S16, TypeO1

- Badly Corroded
- Replacement window, not historic
- Note: Extent of exterior deterioration, corrosion, and loss of operability is not fully apparent in interior photos. Replacement parts for existing windows are unavailable, making restoration of thermal and operable functionality impossible, and long-term maintenance infeasible. Recommendation is for replacement, for quality of life of future tenants and for feasibility of long-term maintenance.
- See Window Assessment (Blackberry) in appendix for further detail and information, including further notes on deterioration beyond repair
- See Appendix for Window Schedule & Measurements

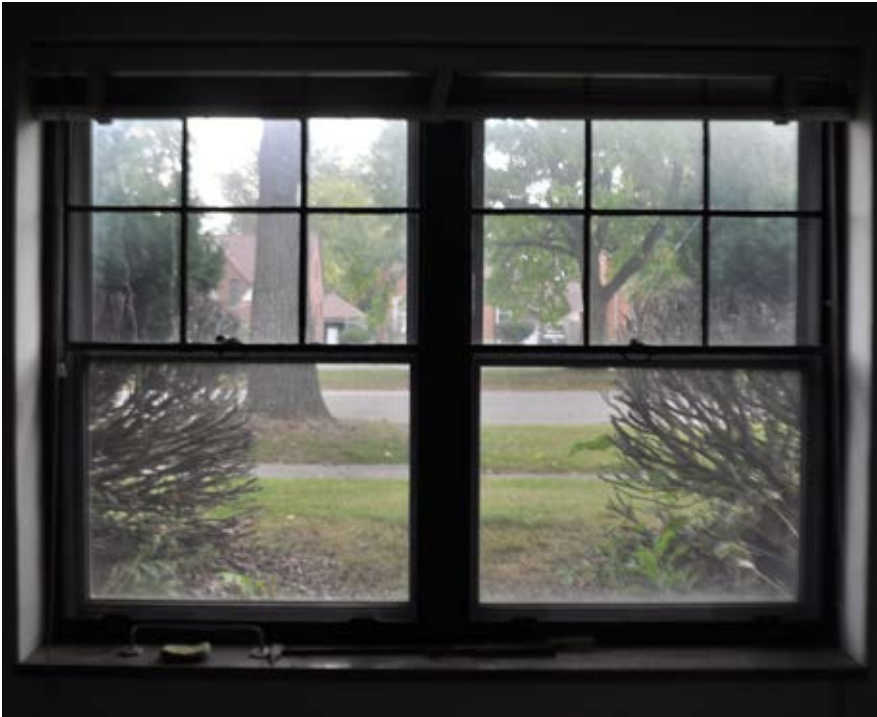
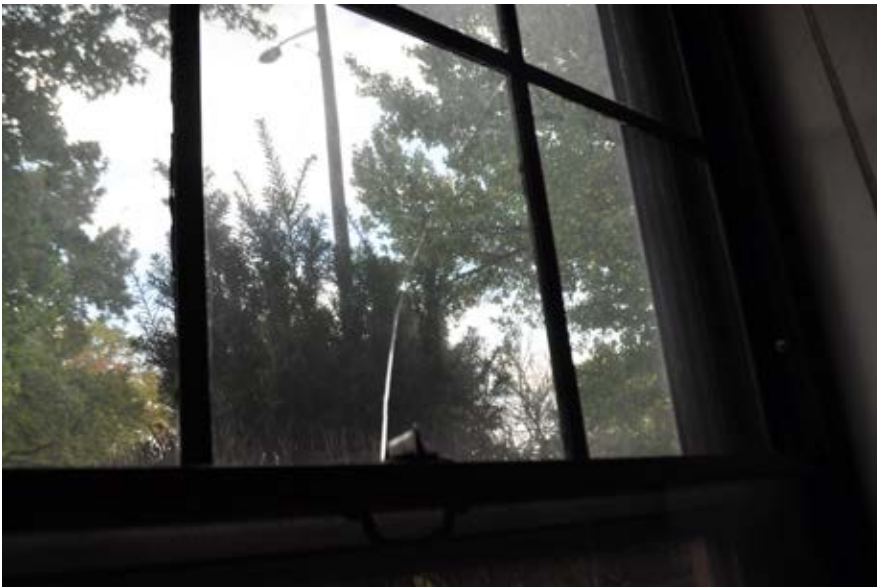
Window S17, Type O1

- Badly Corroded
- Broken Glass
- Note: Extent of exterior deterioration, corrosion, and loss of operability is not fully apparent in interior photos. Replacement parts for existing windows are unavailable, making restoration of thermal and operable functionality impossible, and long-term maintenance infeasible. Recommendation is for replacement, for quality of life of future tenants and for feasibility of long-term maintenance.
- See Window Assessment (Blackberry) in appendix for further detail and information, including further notes on deterioration beyond repair
- See Appendix for Window Schedule & Measurements

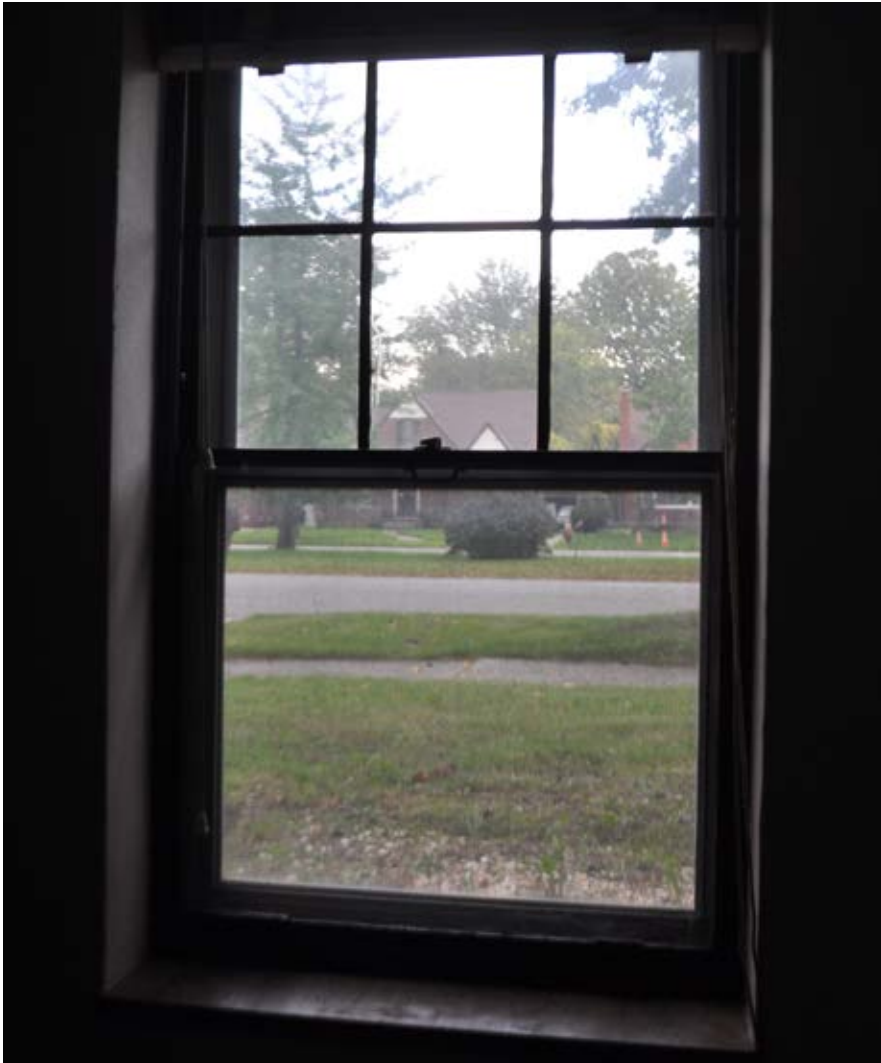
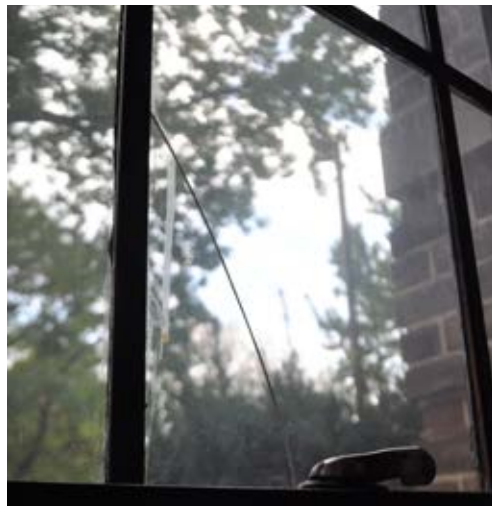
Window S18, Type M1

- Badly Corroded
- Broken Glass
- Note: Extent of exterior deterioration, corrosion, and loss of operability is not fully apparent in interior photos. Replacement parts for existing windows are unavailable, making restoration of thermal and operable functionality impossible, and long-term maintenance infeasible. Recommendation is for replacement, for quality of life of future tenants and for feasibility of long-term maintenance.
- See Window Assessment (Blackberry) in appendix for further detail and information, including further notes on deterioration beyond repair
- See Appendix for Window Schedule & Measurements

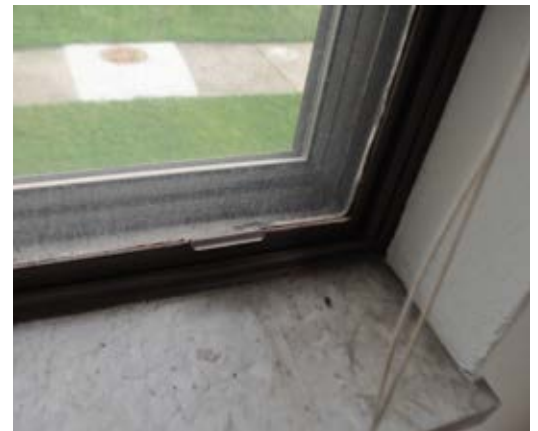
Window T1, Type N1

- Note: Extent of exterior deterioration, corrosion, and loss of operability is not fully apparent in interior photos. Replacement parts for existing windows are unavailable, making restoration of thermal and operable functionality impossible, and long-term maintenance infeasible. Recommendation is for replacement, for quality of life of future tenants and for feasibility of long-term maintenance.
- See Window Assessment (Blackberry) in appendix for further detail and information, including further notes on deterioration beyond repair
- See Appendix for Window Schedule & Measurements

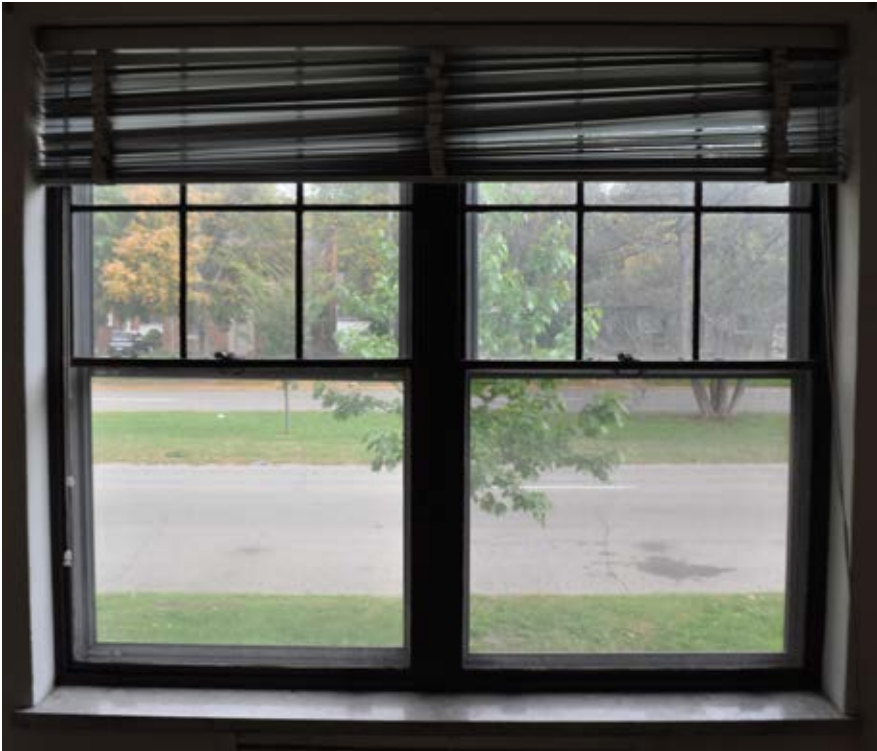
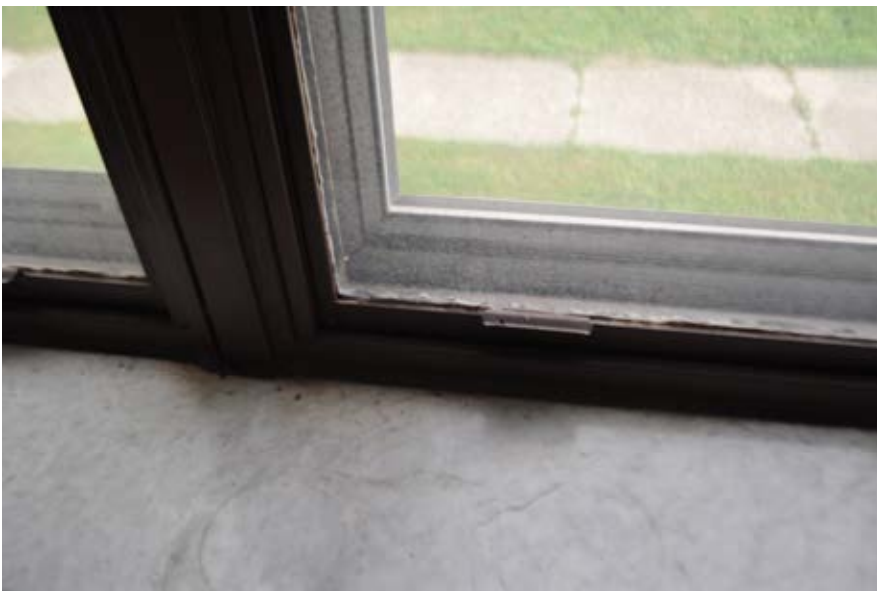
Window T2, Type P1

- Note: Extent of exterior deterioration, corrosion, and loss of operability is not fully apparent in interior photos. Replacement parts for existing windows are unavailable, making restoration of thermal and operable functionality impossible, and long-term maintenance infeasible. Recommendation is for replacement, for quality of life of future tenants and for feasibility of long-term maintenance.
- See Window Assessment (Blackberry) in appendix for further detail and information, including further notes on deterioration beyond repair
- See Appendix for Window Schedule & Measurements

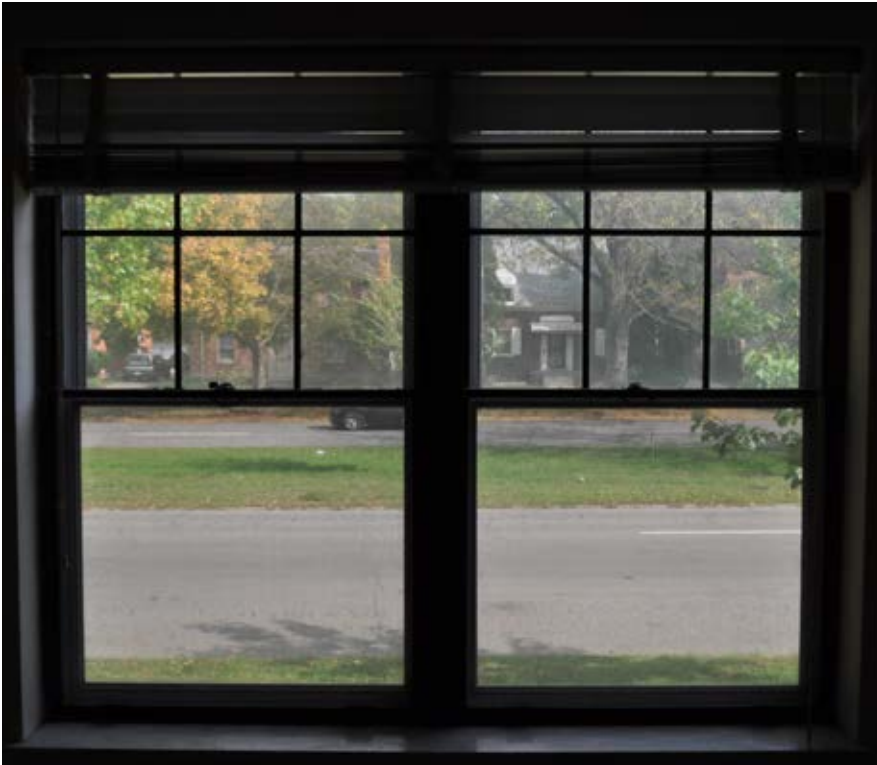
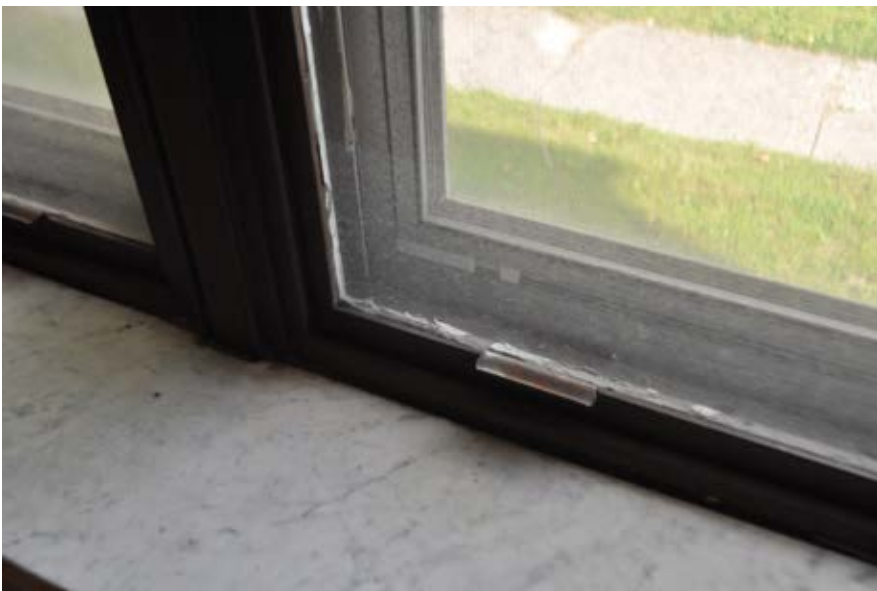
Window T3, Type P1

- Note: Extent of exterior deterioration, corrosion, and loss of operability is not fully apparent in interior photos. Replacement parts for existing windows are unavailable, making restoration of thermal and operable functionality impossible, and long-term maintenance infeasible. Recommendation is for replacement, for quality of life of future tenants and for feasibility of long-term maintenance.
- See Window Assessment (Blackberry) in appendix for further detail and information, including further notes on deterioration beyond repair
- See Appendix for Window Schedule & Measurements

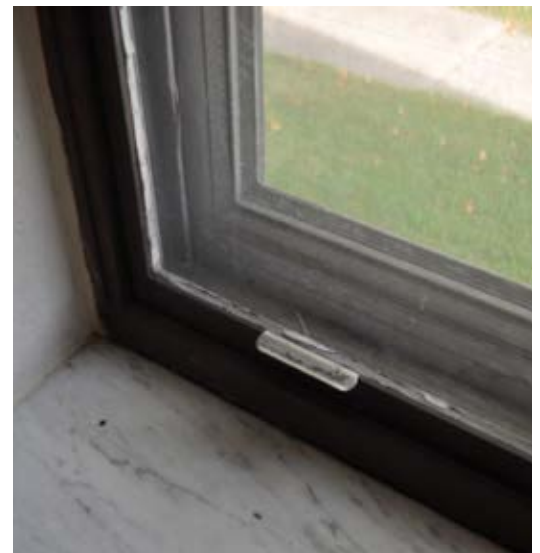
Window T4, Type N1

- Note: Extent of exterior deterioration, corrosion, and loss of operability is not fully apparent in interior photos. Replacement parts for existing windows are unavailable, making restoration of thermal and operable functionality impossible, and long-term maintenance infeasible. Recommendation is for replacement, for quality of life of future tenants and for feasibility of long-term maintenance.
- See Window Assessment (Blackberry) in appendix for further detail and information, including further notes on deterioration beyond repair
- See Appendix for Window Schedule & Measurements

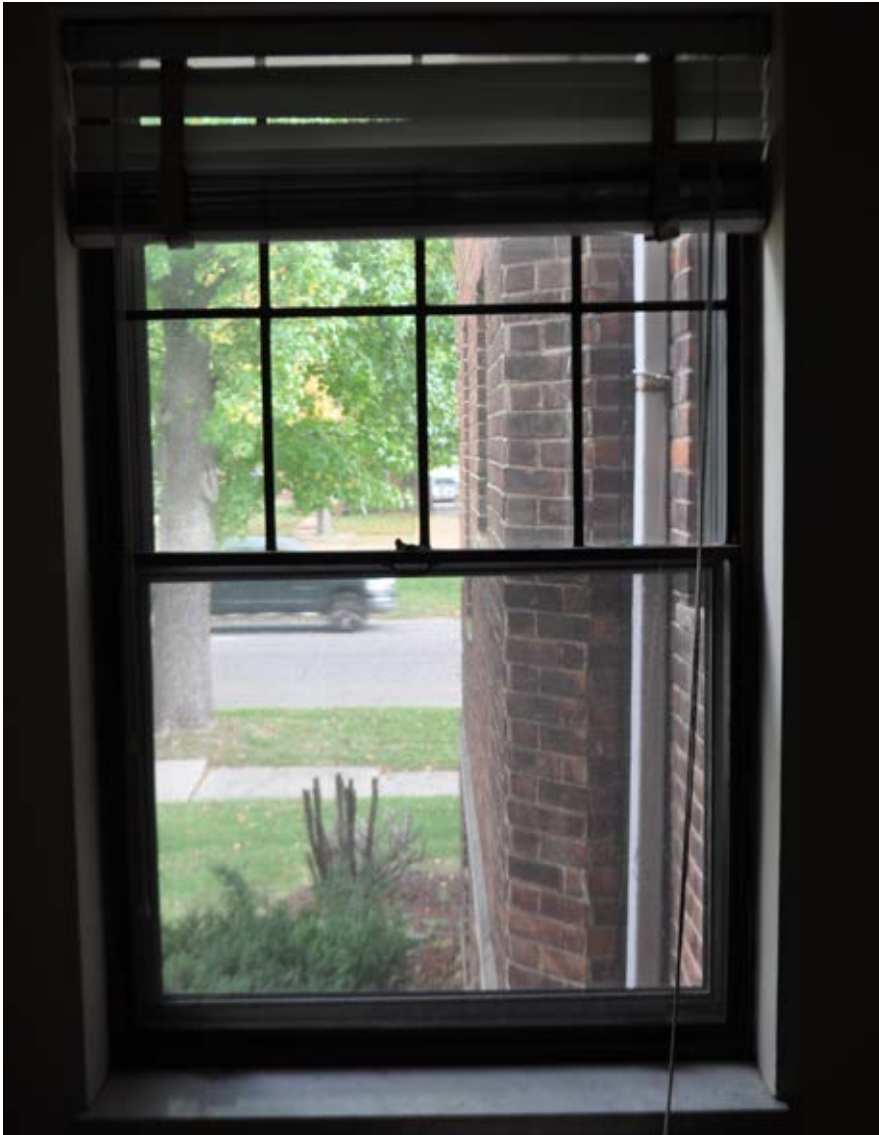
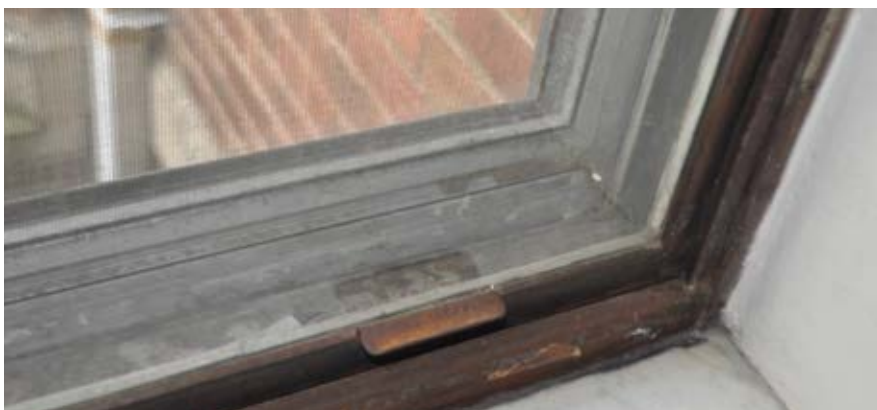
Window T8, Type R1

- Note: Extent of exterior deterioration, corrosion, and loss of operability is not fully apparent in interior photos. Replacement parts for existing windows are unavailable, making restoration of thermal and operable functionality impossible, and long-term maintenance infeasible. Recommendation is for replacement, for quality of life of future tenants and for feasibility of long-term maintenance.
- See Window Assessment (Blackberry) in appendix for further detail and information, including further notes on deterioration beyond repair
- See Appendix for Window Schedule & Measurements

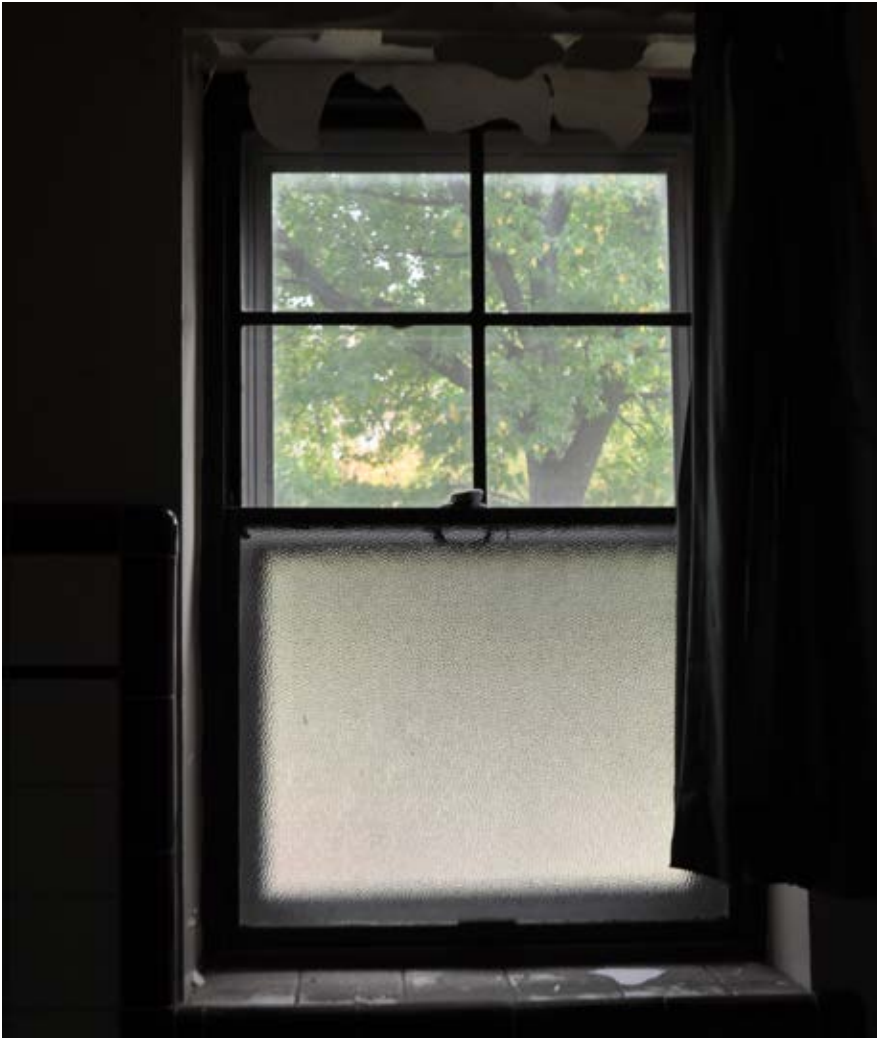
Window T9, Type U1

- Note: Extent of exterior deterioration, corrosion, and loss of operability is not fully apparent in interior photos. Replacement parts for existing windows are unavailable, making restoration of thermal and operable functionality impossible, and long-term maintenance infeasible. Recommendation is for replacement, for quality of life of future tenants and for feasibility of long-term maintenance.
- See Window Assessment (Blackberry) in appendix for further detail and information, including further notes on deterioration beyond repair
- See Appendix for Window Schedule & Measurements

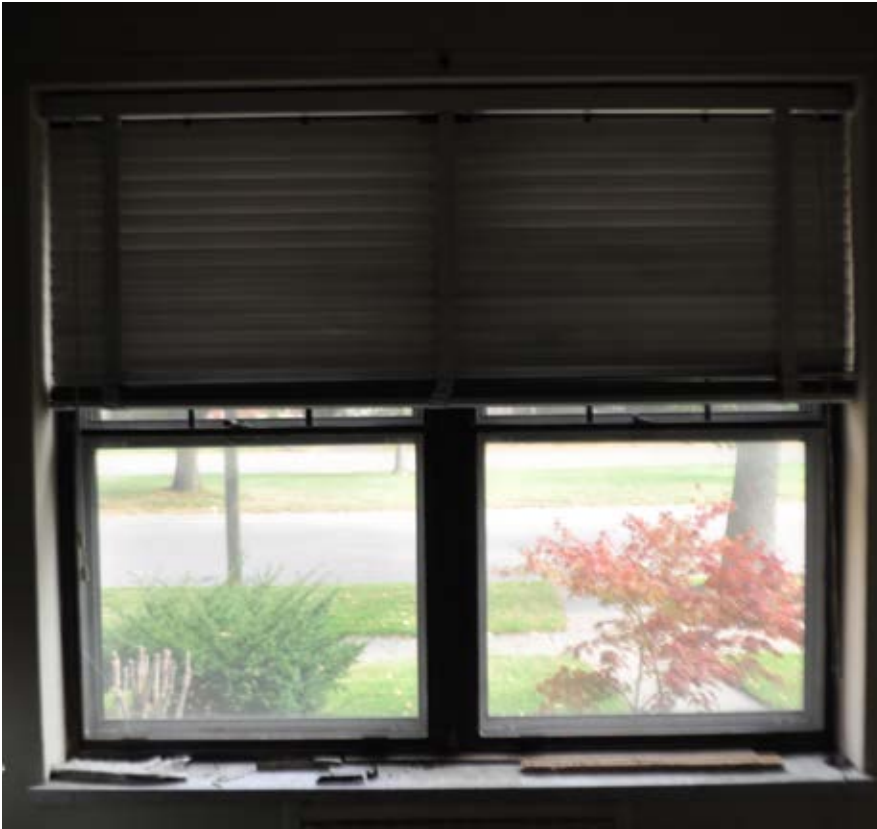
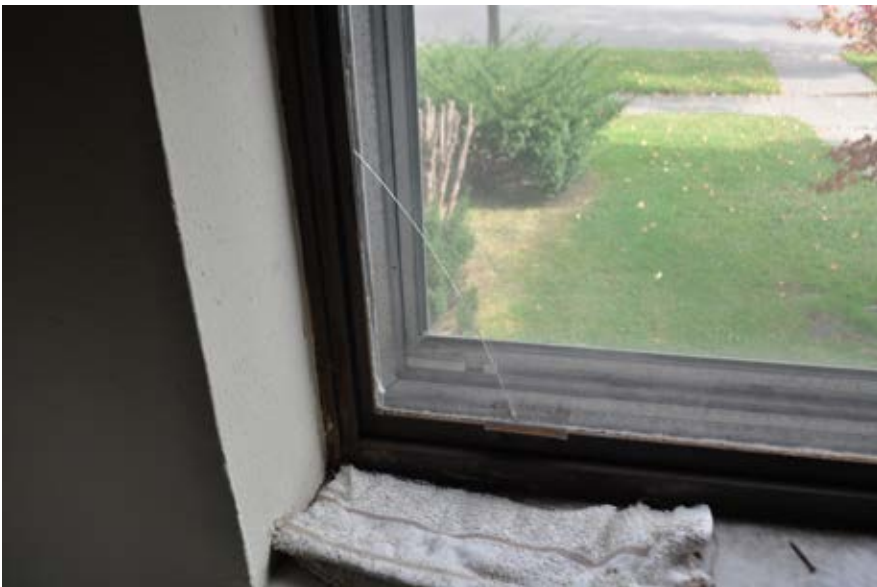
Window T10, Type P1

- Broken Glass
- Note: Extent of exterior deterioration, corrosion, and loss of operability is not fully apparent in interior photos. Replacement parts for existing windows are unavailable, making restoration of thermal and operable functionality impossible, and long-term maintenance infeasible. Recommendation is for replacement, for quality of life of future tenants and for feasibility of long-term maintenance.
- See Window Assessment (Blackberry) in appendix for further detail and information, including further notes on deterioration beyond repair
- See Appendix for Window Schedule & Measurements

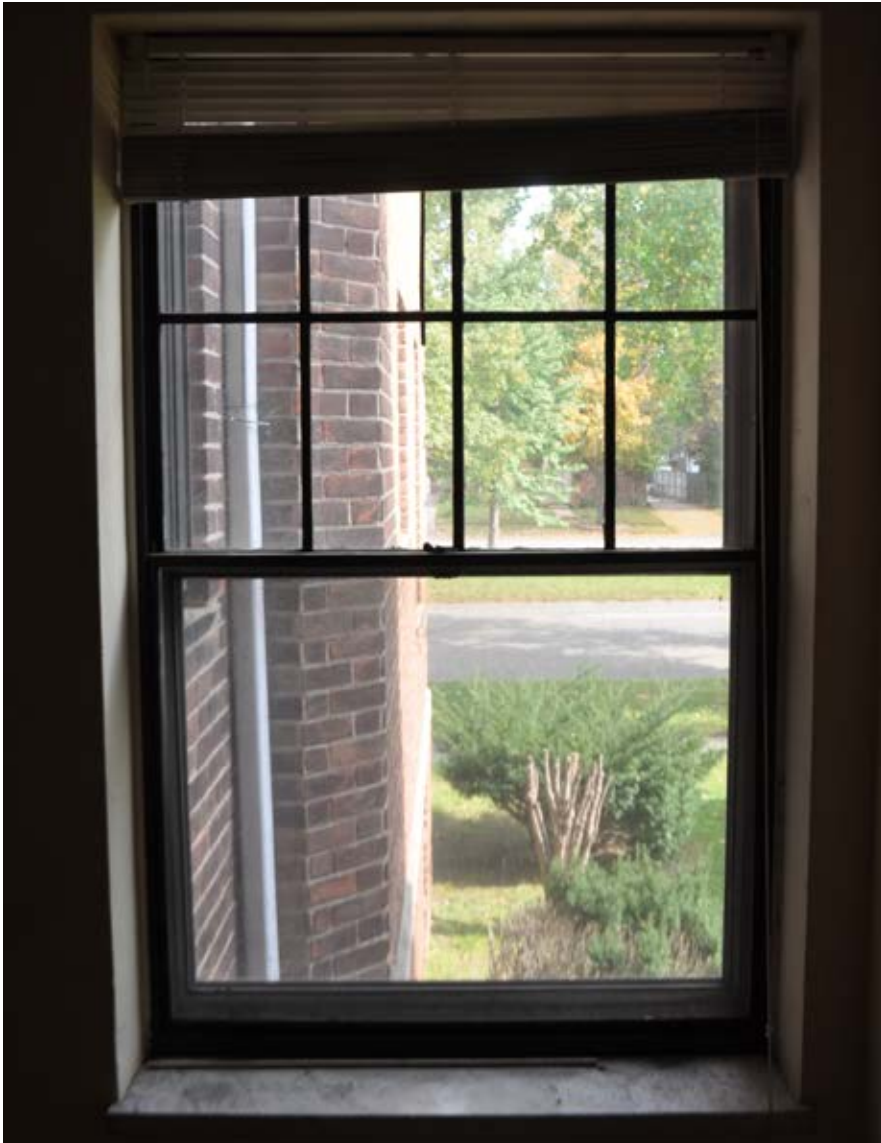
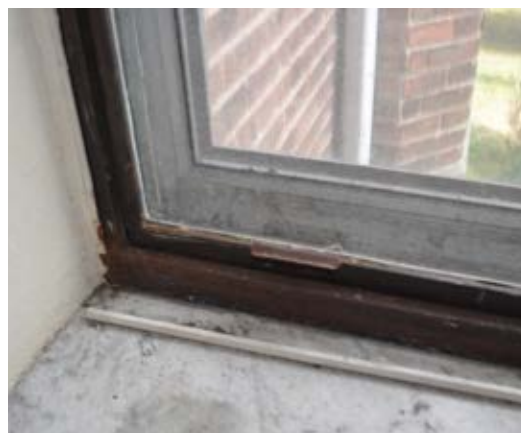
Window T11, Type R1

- Badly Corroded
- Note: Extent of exterior deterioration, corrosion, and loss of operability is not fully apparent in interior photos. Replacement parts for existing windows are unavailable, making restoration of thermal and operable functionality impossible, and long-term maintenance infeasible. Recommendation is for replacement, for quality of life of future tenants and for feasibility of long-term maintenance.
- See Window Assessment (Blackberry) in appendix for further detail and information, including further notes on deterioration beyond repair
- See Appendix for Window Schedule & Measurements

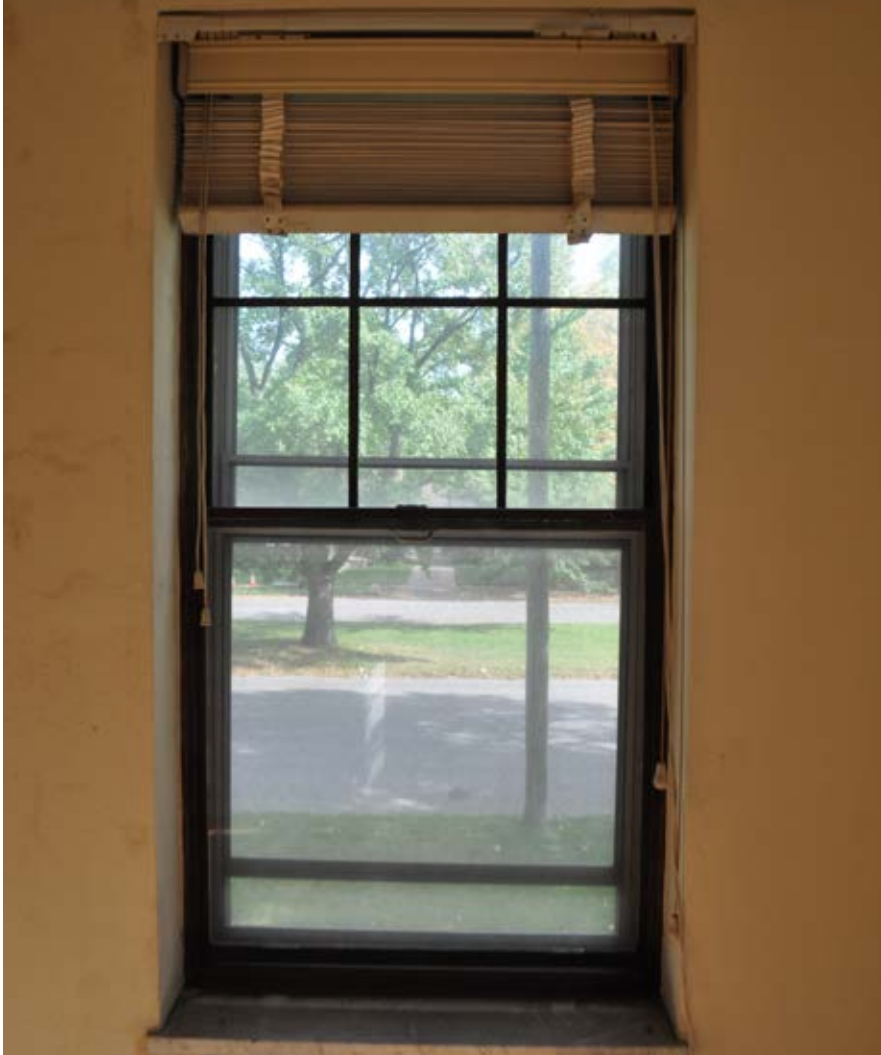
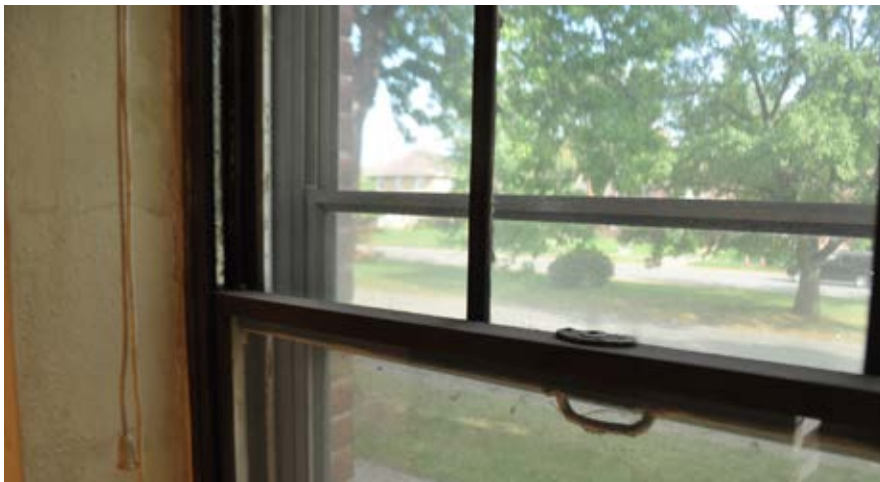
Window T15, Type N1

- Missing Hardware
- Note: Extent of exterior deterioration, corrosion, and loss of operability is not fully apparent in interior photos. Replacement parts for existing windows are unavailable, making restoration of thermal and operable functionality impossible, and long-term maintenance infeasible. Recommendation is for replacement, for quality of life of future tenants and for feasibility of long-term maintenance.
- See Window Assessment (Blackberry) in appendix for further detail and information, including further notes on deterioration beyond repair
- See Appendix for Window Schedule & Measurements

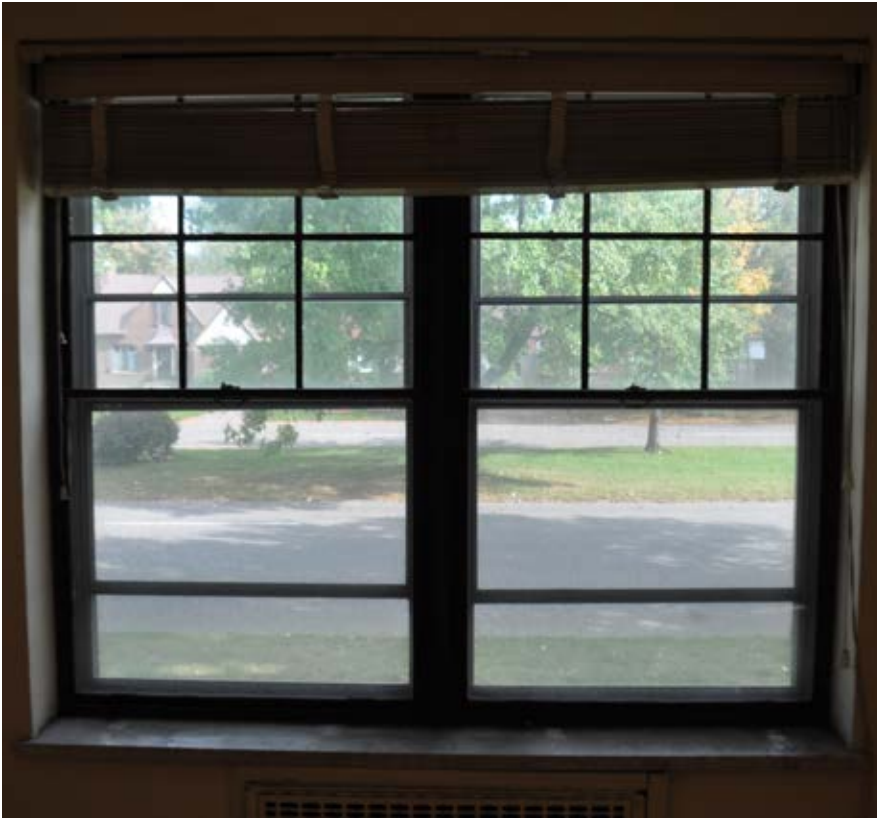
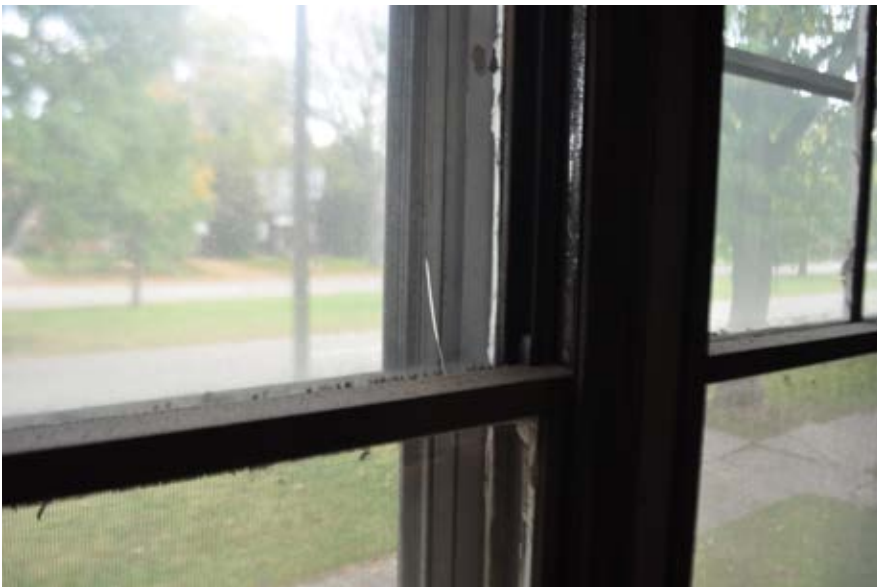
Window T16, Type P1

- Broken Glass
- Note: Extent of exterior deterioration, corrosion, and loss of operability is not fully apparent in interior photos. Replacement parts for existing windows are unavailable, making restoration of thermal and operable functionality impossible, and long-term maintenance infeasible. Recommendation is for replacement, for quality of life of future tenants and for feasibility of long-term maintenance.
- See Window Assessment (Blackberry) in appendix for further detail and information, including further notes on deterioration beyond repair
- See Appendix for Window Schedule & Measurements

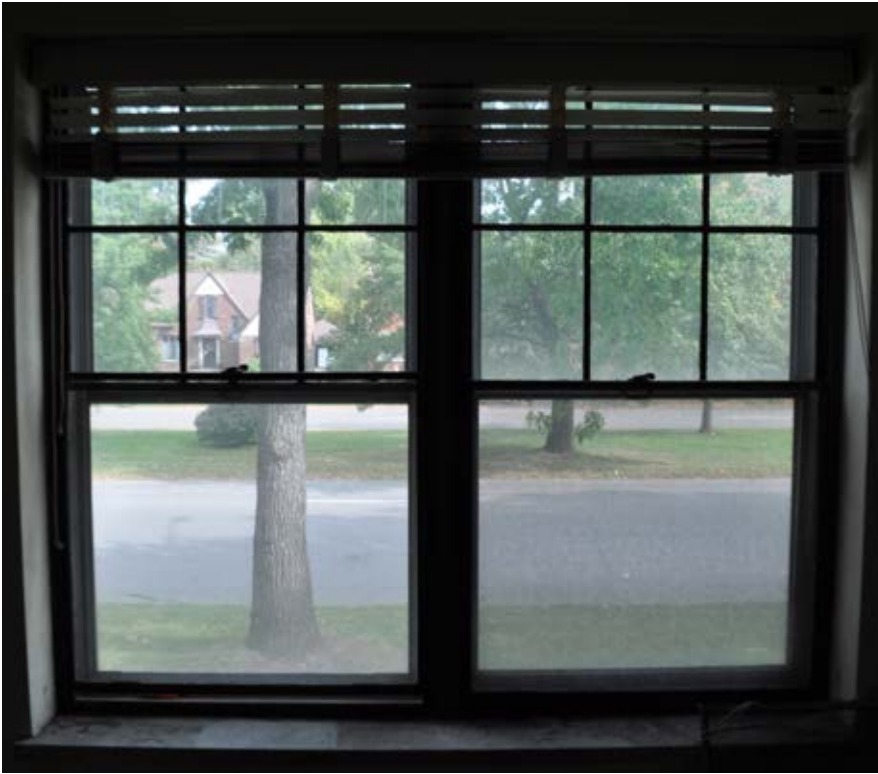
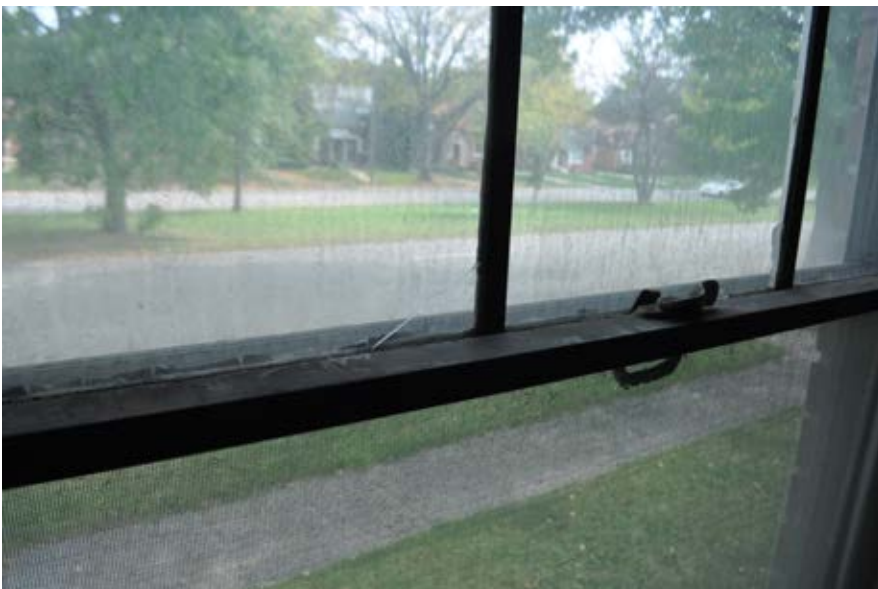
Window T17, Type P1

- Broken Glass
- Note: Extent of exterior deterioration, corrosion, and loss of operability is not fully apparent in interior photos. Replacement parts for existing windows are unavailable, making restoration of thermal and operable functionality impossible, and long-term maintenance infeasible. Recommendation is for replacement, for quality of life of future tenants and for feasibility of long-term maintenance.
- See Window Assessment (Blackberry) in appendix for further detail and information, including further notes on deterioration beyond repair
- See Appendix for Window Schedule & Measurements
