9710 W Outer Dr

Existing Condition Photos

Current Design Description

A 3-story apartment structure with 10 residential units, constructed in 1940, brick on wood stud wall construction, shingle roof, stone corner details, stone details at palladian window, stone sills, wood detailing at front entry, steel and wood canopy at back entry, wood windows throughout with the exception of steel windows at bathrooms and the lowest level. The addition of a brick shed to house the gas meter was made at a later date.

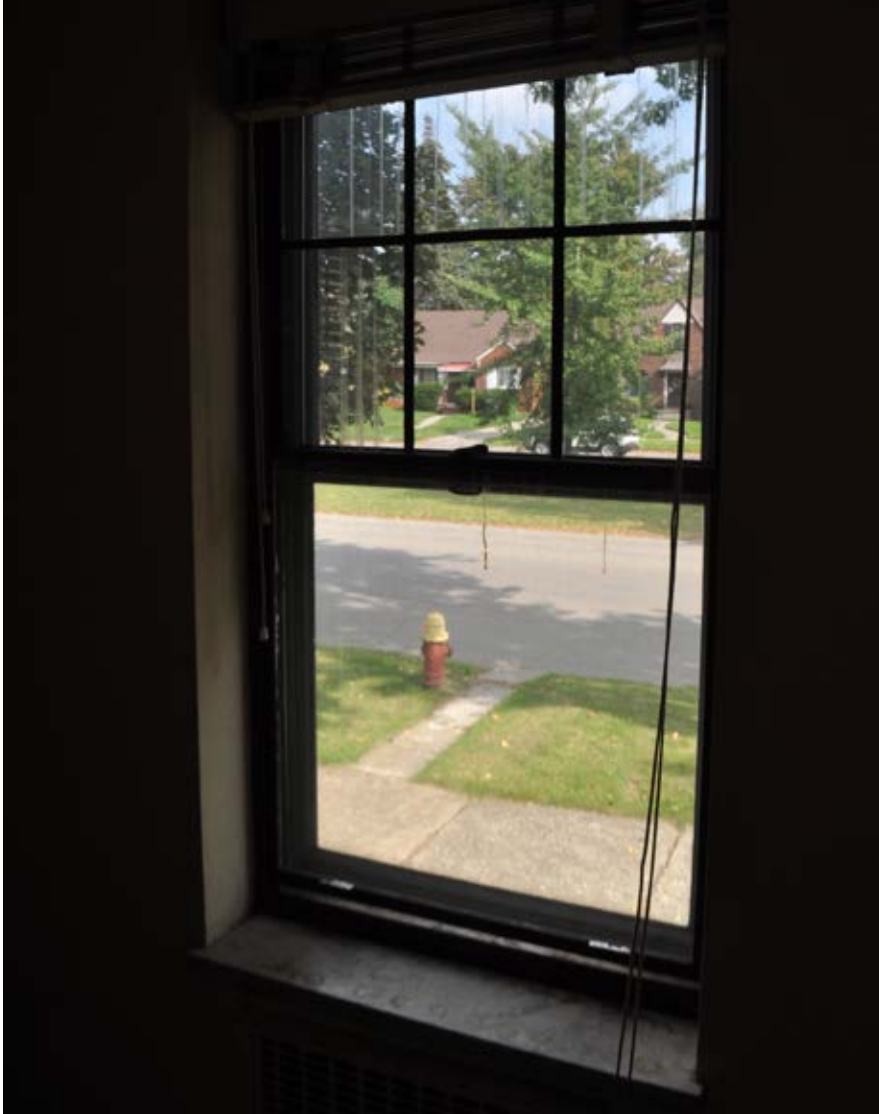
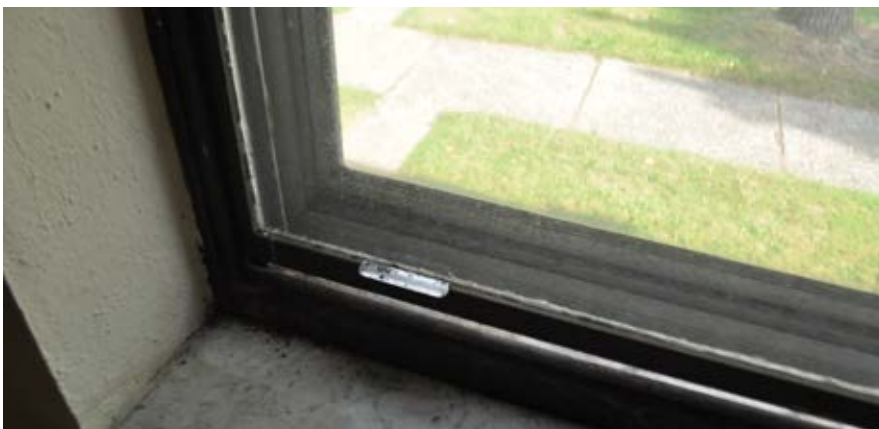
Window T18, Type N1

- Note: Extent of exterior deterioration, corrosion, and loss of operability is not fully apparent in interior photos. Replacement parts for existing windows are unavailable, making restoration of thermal and operable functionality impossible, and long-term maintenance infeasible. Recommendation is for replacement, for quality of life of future tenants and for feasibility of long-term maintenance.
- See Window Assessment (Blackberry) in appendix for further detail and information, including further notes on deterioration beyond repair
- See Appendix for Window Schedule & Measurements

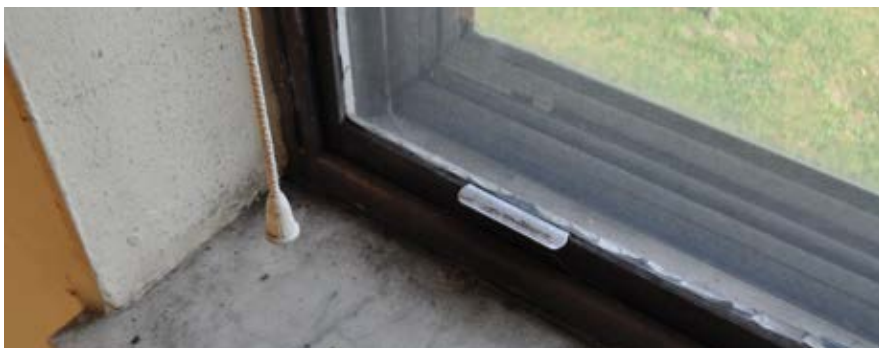
Window U1, Type N1

- Note: Extent of exterior deterioration, corrosion, and loss of operability is not fully apparent in interior photos. Replacement parts for existing windows are unavailable, making restoration of thermal and operable functionality impossible, and long-term maintenance infeasible. Recommendation is for replacement, for quality of life of future tenants and for feasibility of long-term maintenance.
- See Window Assessment (Blackberry) in appendix for further detail and information, including further notes on deterioration beyond repair
- See Appendix for Window Schedule & Measurements

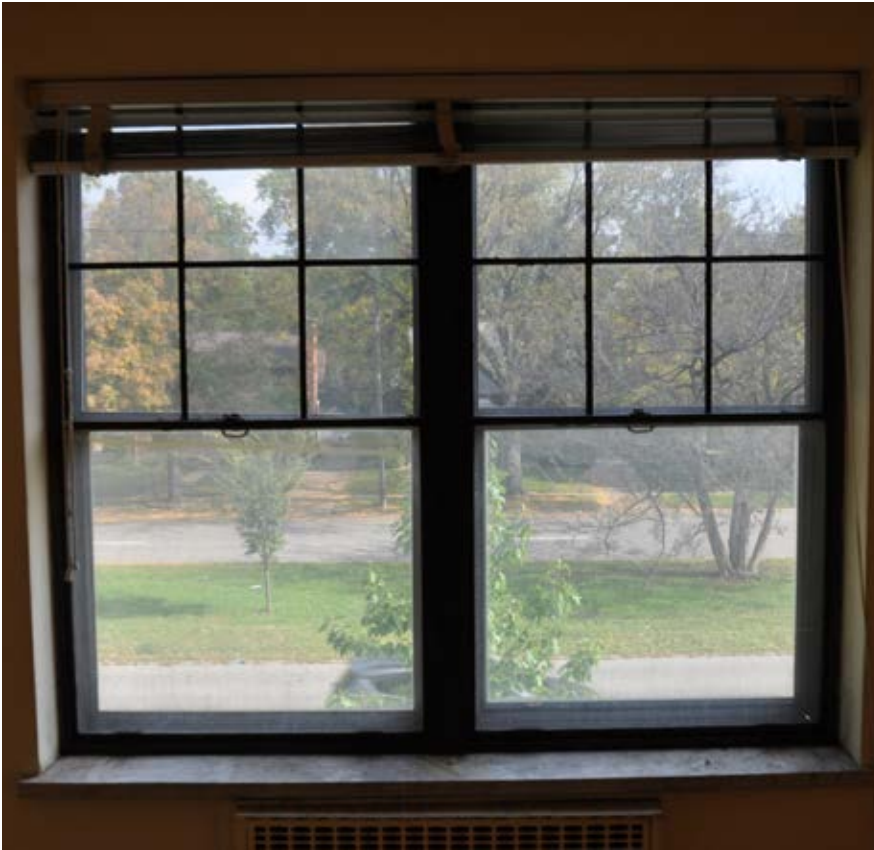
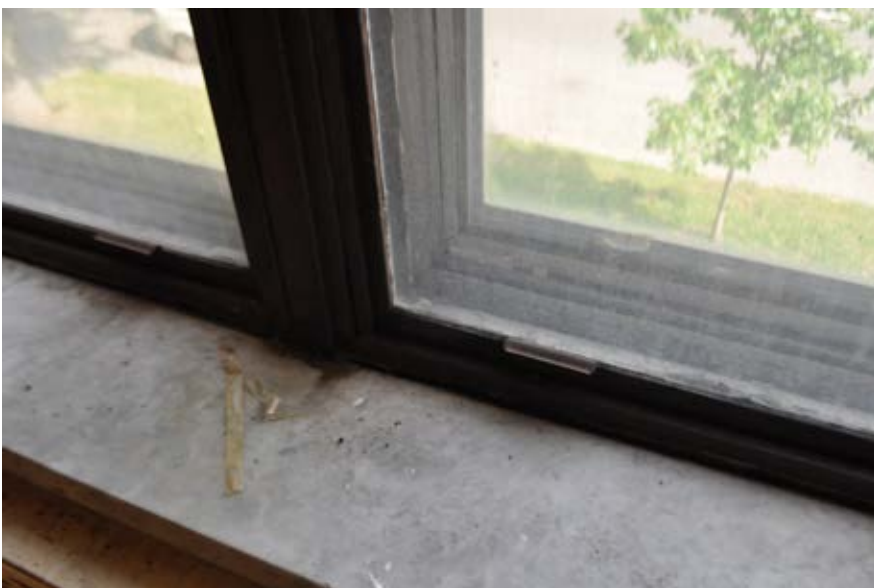
Window U2, Type P1

- Note: Extent of exterior deterioration, corrosion, and loss of operability is not fully apparent in interior photos. Replacement parts for existing windows are unavailable, making restoration of thermal and operable functionality impossible, and long-term maintenance infeasible. Recommendation is for replacement, for quality of life of future tenants and for feasibility of long-term maintenance.
- See Window Assessment (Blackberry) in appendix for further detail and information, including further notes on deterioration beyond repair
- See Appendix for Window Schedule & Measurements

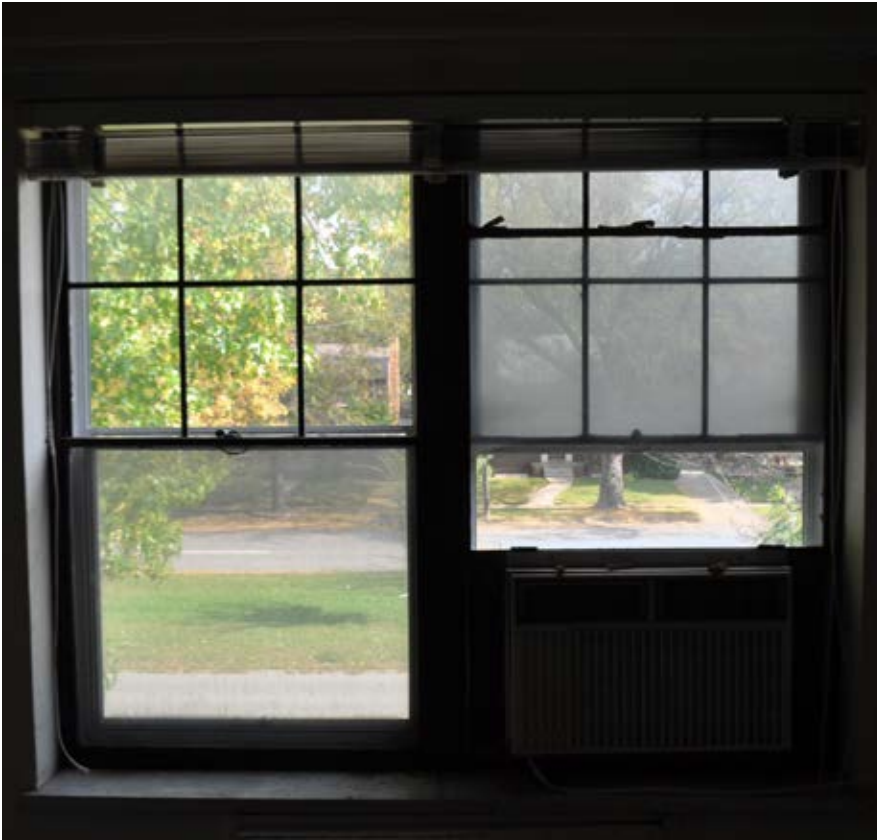
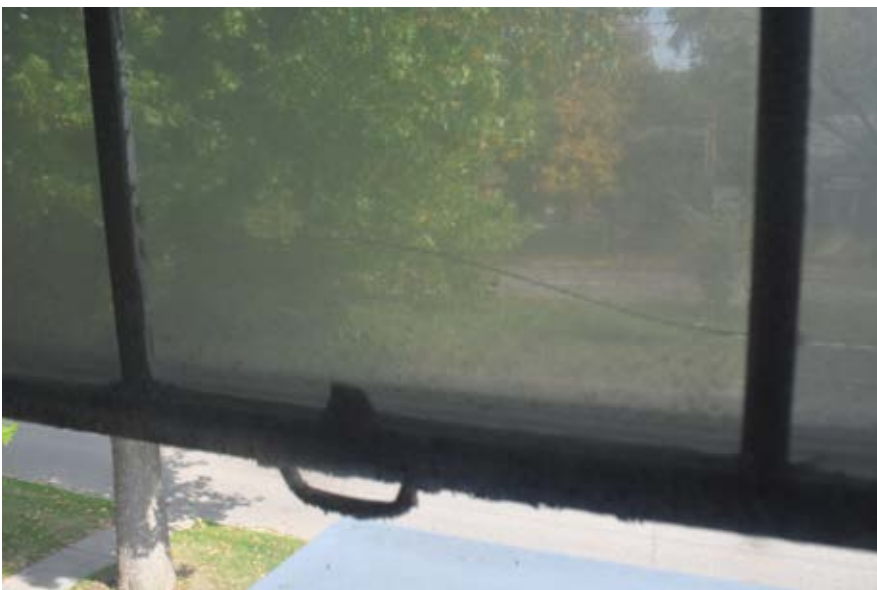
Window U3, Type P1

- Broken Glass
- Note: Extent of exterior deterioration, corrosion, and loss of operability is not fully apparent in interior photos. Replacement parts for existing windows are unavailable, making restoration of thermal and operable functionality impossible, and long-term maintenance infeasible. Recommendation is for replacement, for quality of life of future tenants and for feasibility of long-term maintenance.
- See Window Assessment (Blackberry) in appendix for further detail and information, including further notes on deterioration beyond repair
- See Appendix for Window Schedule & Measurements

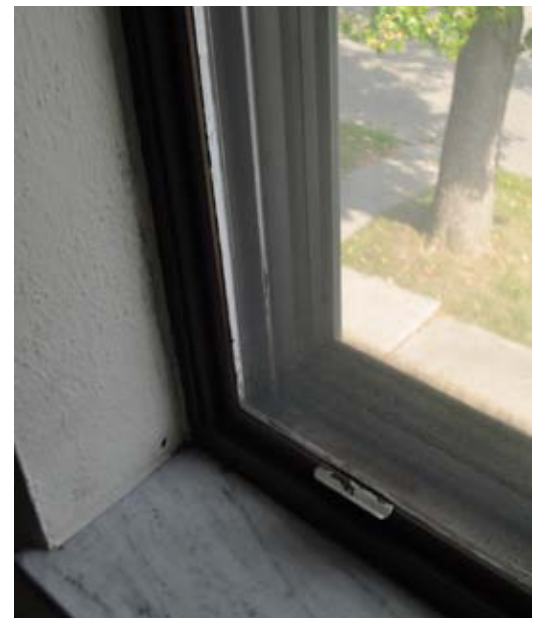
Window U4, Type N1

- Note: Extent of exterior deterioration, corrosion, and loss of operability is not fully apparent in interior photos. Replacement parts for existing windows are unavailable, making restoration of thermal and operable functionality impossible, and long-term maintenance infeasible. Recommendation is for replacement, for quality of life of future tenants and for feasibility of long-term maintenance.
- See Window Assessment (Blackberry) in appendix for further detail and information, including further notes on deterioration beyond repair
- See Appendix for Window Schedule & Measurements

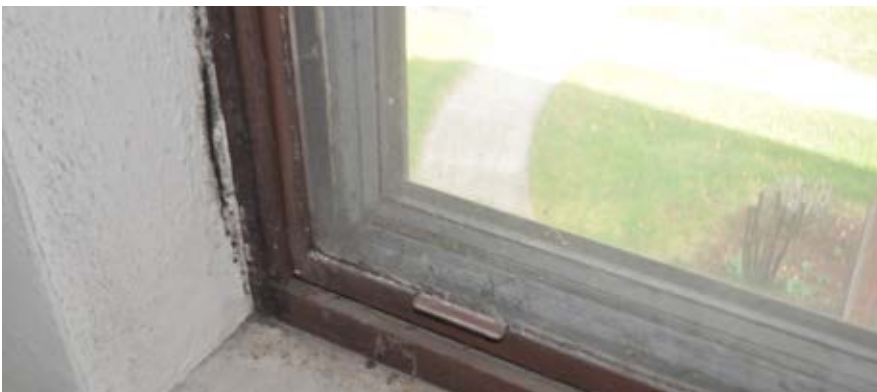
Window U8, Type R1

- Note: Extent of exterior deterioration, corrosion, and loss of operability is not fully apparent in interior photos. Replacement parts for existing windows are unavailable, making restoration of thermal and operable functionality impossible, and long-term maintenance infeasible. Recommendation is for replacement, for quality of life of future tenants and for feasibility of long-term maintenance.
- See Window Assessment (Blackberry) in appendix for further detail and information, including further notes on deterioration beyond repair
- See Appendix for Window Schedule & Measurements

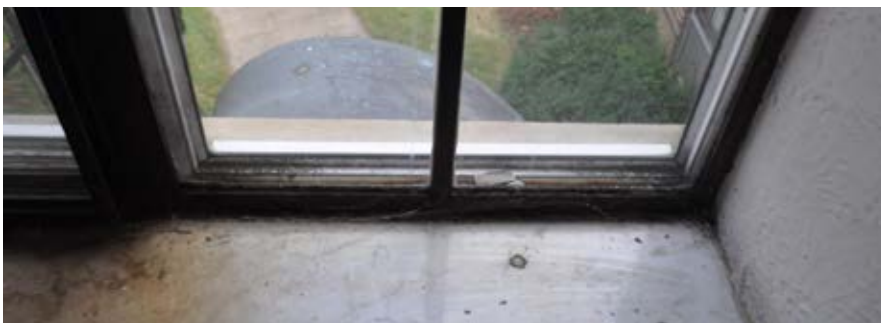
Window U9, Type S5

- Existing Fixed Window at Common Area Stairwell to be repaired
- See Appendix for Window Schedule & Measurements
- See Window Assessment & Survey by Blackberry in appendices for further details and information

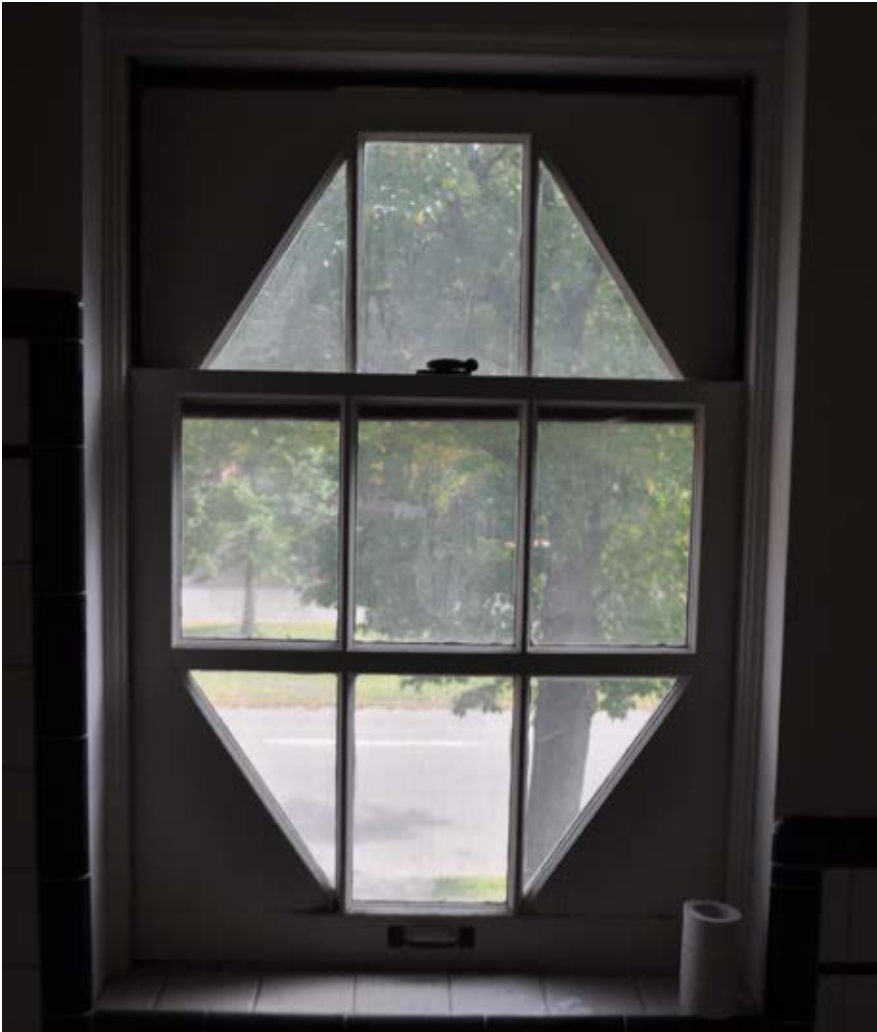
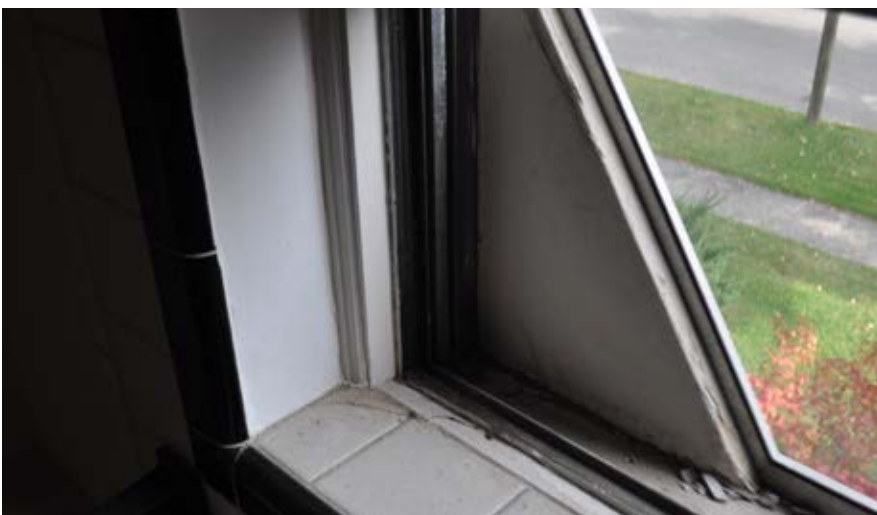
Window U10, Type S6

- Note: Extent of exterior deterioration, corrosion, and loss of operability is not fully apparent in interior photos. Replacement parts for existing windows are unavailable, making restoration of thermal and operable functionality impossible, and long-term maintenance infeasible. Recommendation is for replacement, for quality of life of future tenants and for feasibility of long-term maintenance.
- See Window Assessment (Blackberry) in appendix for further detail and information, including further notes on deterioration beyond repair
- See Appendix for Window Schedule & Measurements

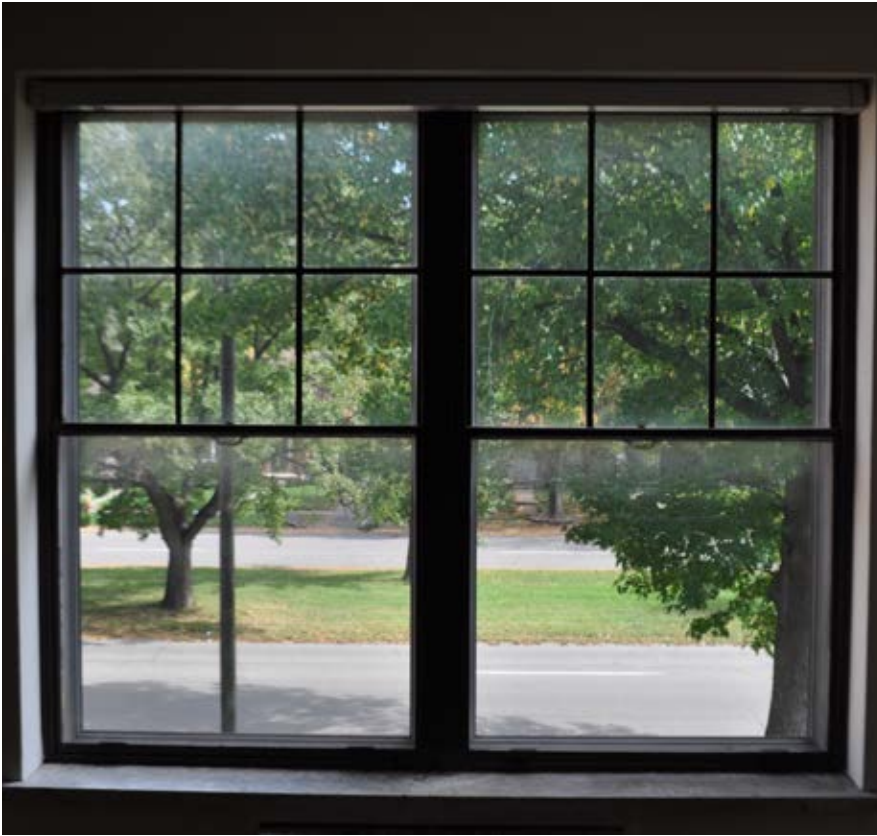
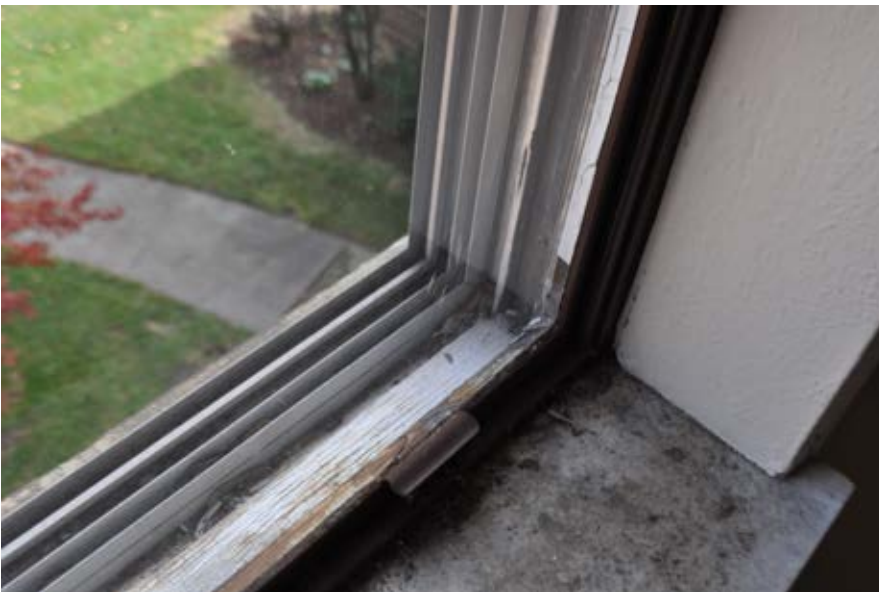
Window U11, Type P1

- Note: Extent of exterior deterioration, corrosion, and loss of operability is not fully apparent in interior photos. Replacement parts for existing windows are unavailable, making restoration of thermal and operable functionality impossible, and long-term maintenance infeasible. Recommendation is for replacement, for quality of life of future tenants and for feasibility of long-term maintenance.
- See Window Assessment (Blackberry) in appendix for further detail and information, including further notes on deterioration beyond repair
- See Appendix for Window Schedule & Measurements

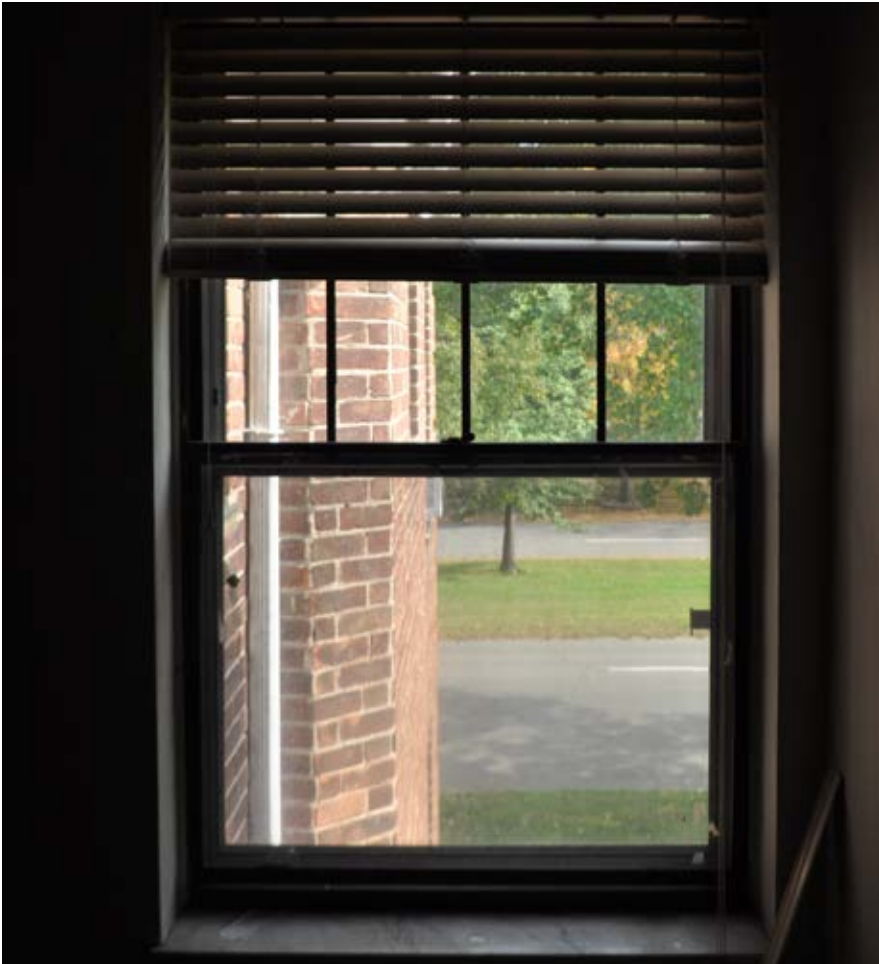
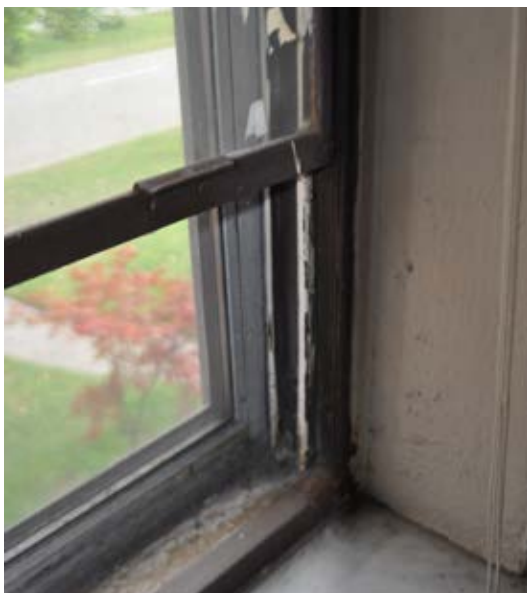
Window U12, Type R1

- Note: Extent of exterior deterioration, corrosion, and loss of operability is not fully apparent in interior photos. Replacement parts for existing windows are unavailable, making restoration of thermal and operable functionality impossible, and long-term maintenance infeasible. Recommendation is for replacement, for quality of life of future tenants and for feasibility of long-term maintenance.
- See Window Assessment (Blackberry) in appendix for further detail and information, including further notes on deterioration beyond repair
- See Appendix for Window Schedule & Measurements

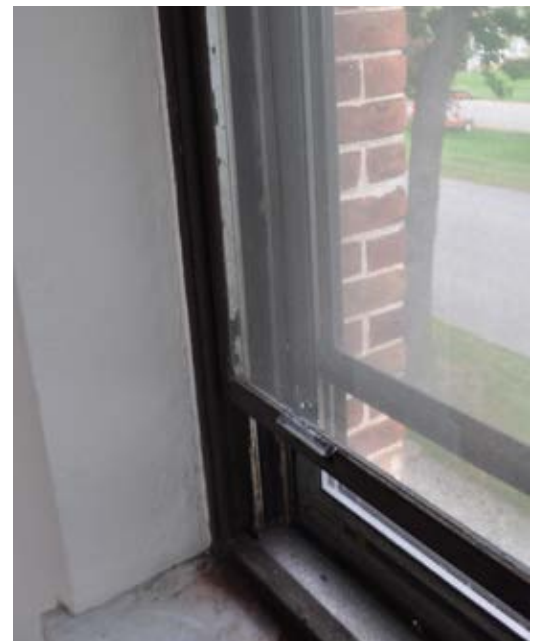
Window U16, Type N1

- Note: Extent of exterior deterioration, corrosion, and loss of operability is not fully apparent in interior photos. Replacement parts for existing windows are unavailable, making restoration of thermal and operable functionality impossible, and long-term maintenance infeasible. Recommendation is for replacement, for quality of life of future tenants and for feasibility of long-term maintenance.
- See Window Assessment (Blackberry) in appendix for further detail and information, including further notes on deterioration beyond repair
- See Appendix for Window Schedule & Measurements

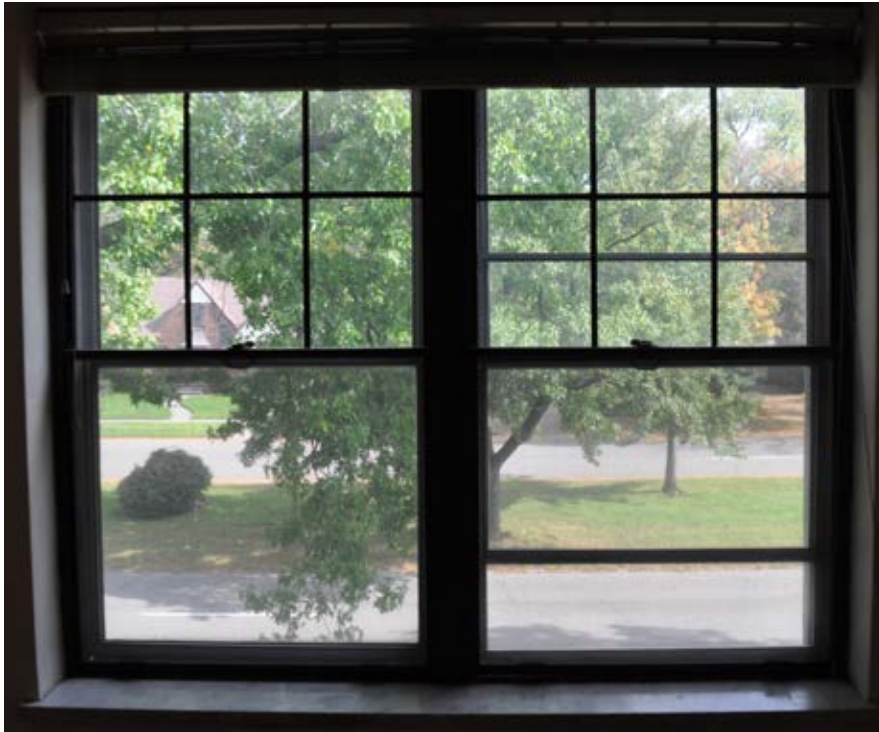
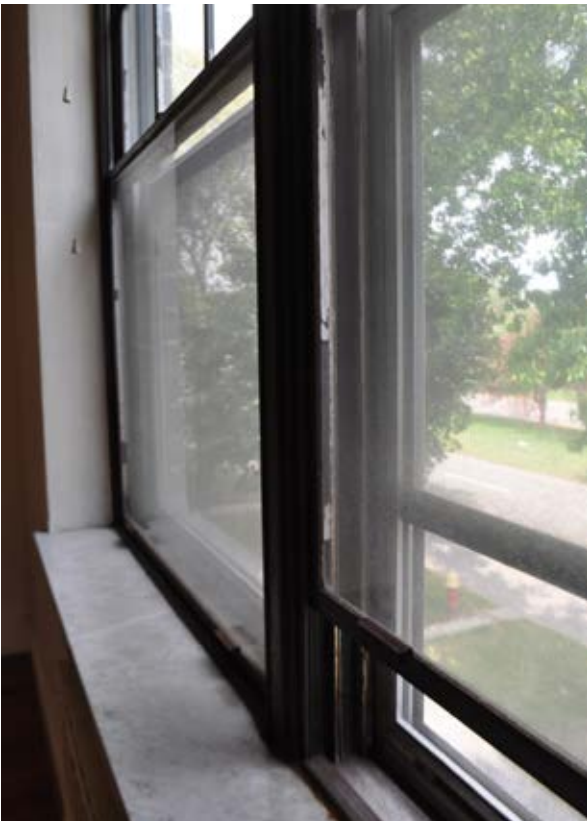
Window U17, Type P1

- Note: Extent of exterior deterioration, corrosion, and loss of operability is not fully apparent in interior photos. Replacement parts for existing windows are unavailable, making restoration of thermal and operable functionality impossible, and long-term maintenance infeasible. Recommendation is for replacement, for quality of life of future tenants and for feasibility of long-term maintenance.
- See Window Assessment (Blackberry) in appendix for further detail and information, including further notes on deterioration beyond repair
- See Appendix for Window Schedule & Measurements

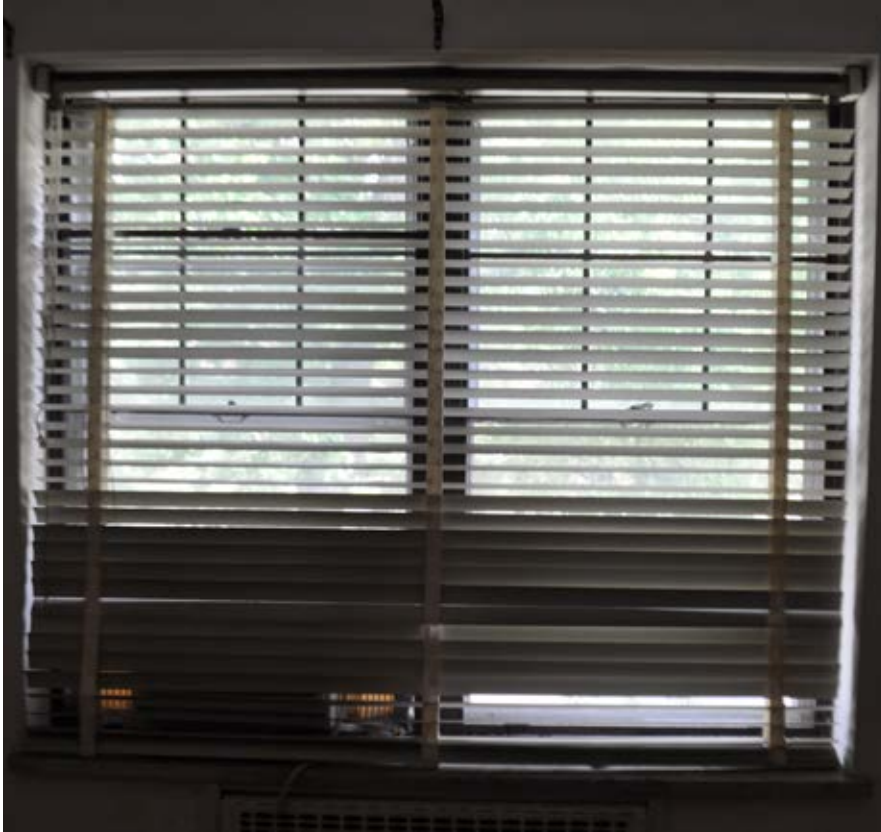
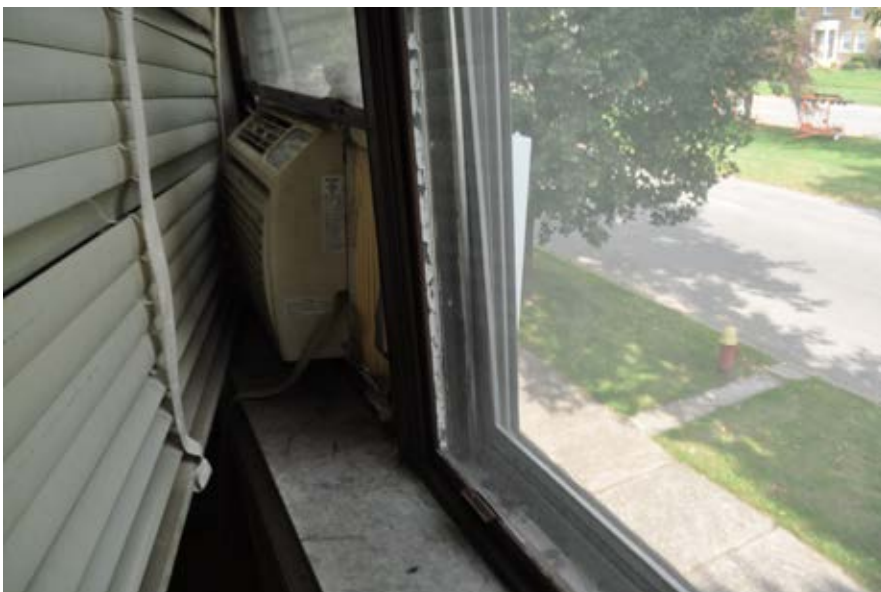
Window U18, Type P1

- Note: Extent of exterior deterioration, corrosion, and loss of operability is not fully apparent in interior photos. Replacement parts for existing windows are unavailable, making restoration of thermal and operable functionality impossible, and long-term maintenance infeasible. Recommendation is for replacement, for quality of life of future tenants and for feasibility of long-term maintenance.
- See Window Assessment (Blackberry) in appendix for further detail and information, including further notes on deterioration beyond repair
- See Appendix for Window Schedule & Measurements

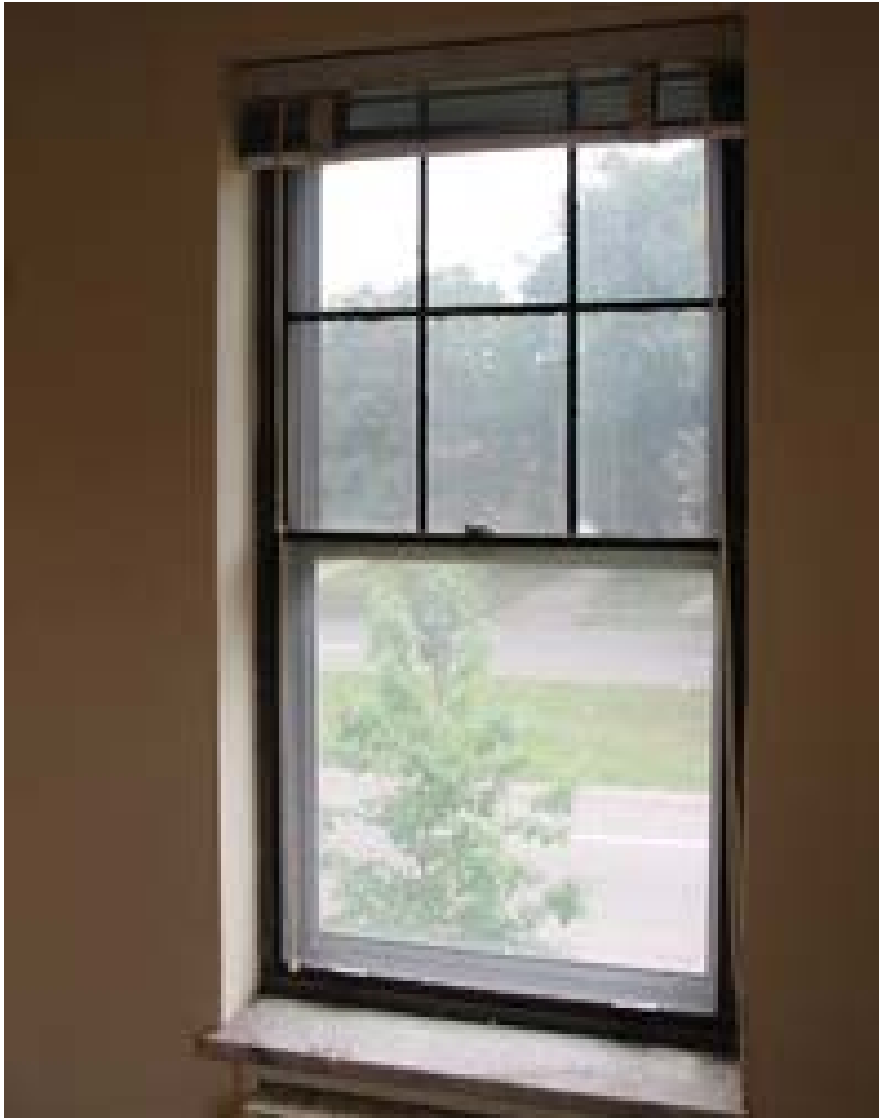
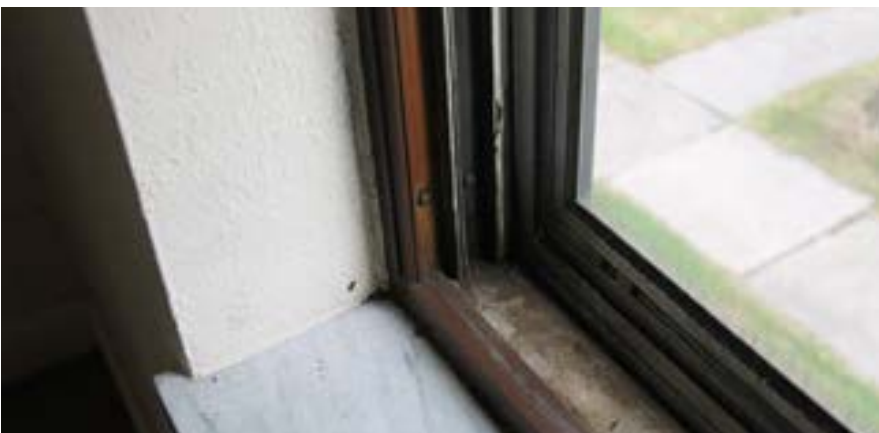
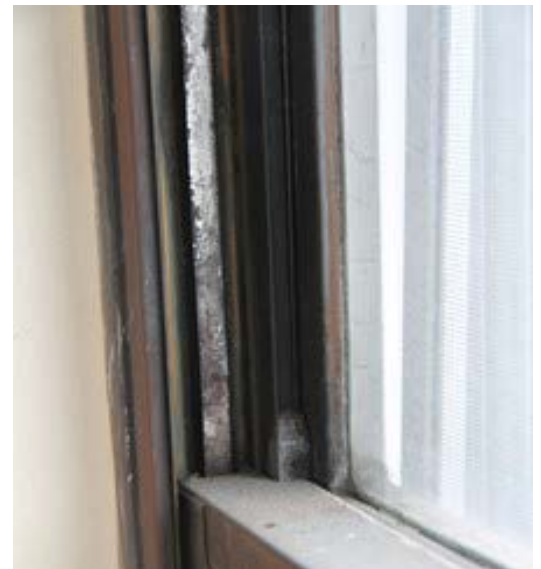
Window U19, Type N1

- Interior Rusted Balance Tape
- See Jamb Track
- Note: Extent of exterior deterioration, corrosion, and loss of operability is not fully apparent in interior photos. Replacement parts for existing windows are unavailable, making restoration of thermal and operable functionality impossible, and long-term maintenance infeasible. Recommendation is for replacement, for quality of life of future tenants and for feasibility of long-term maintenance.
- See Window Assessment (Blackberry) in appendix for further detail and information, including further notes on deterioration beyond repair
- See Appendix for Window Schedule & Measurements

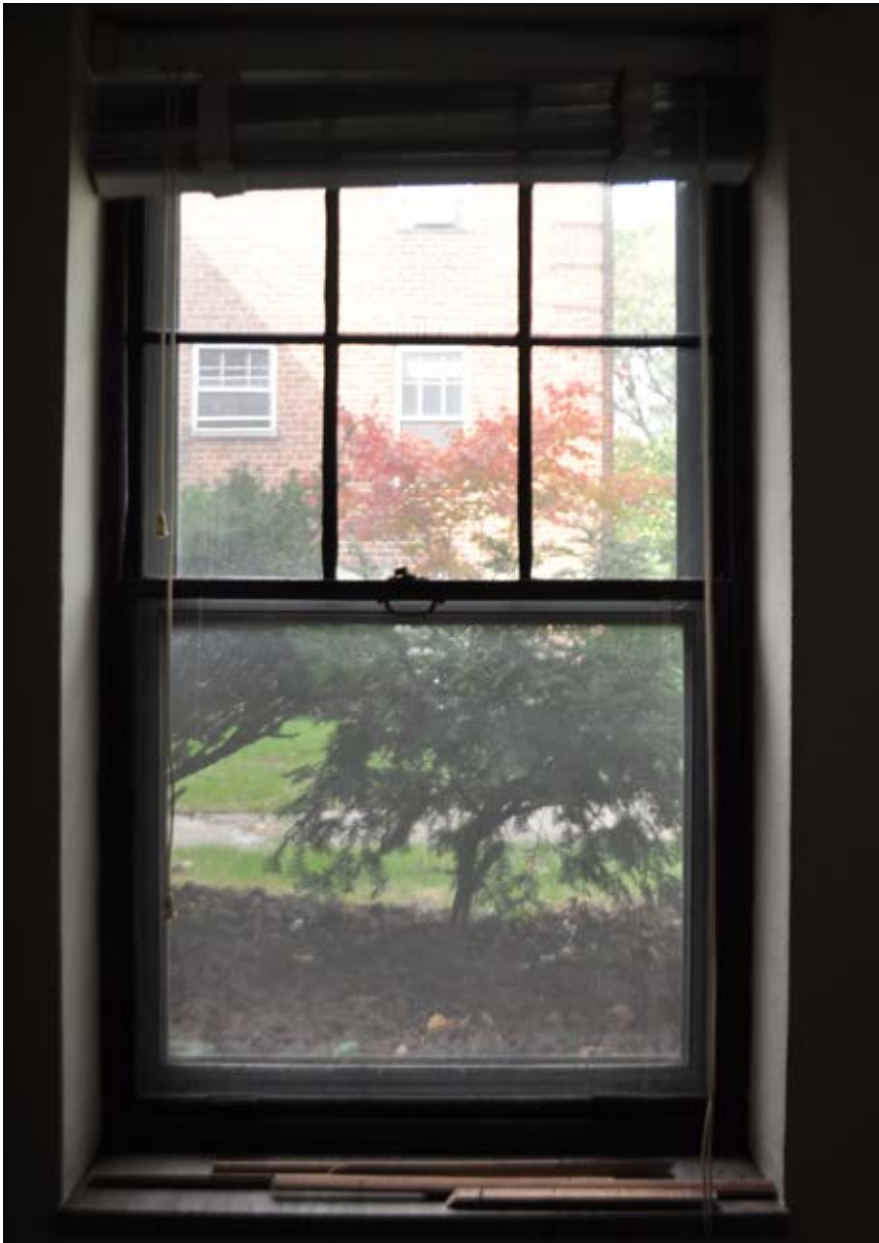
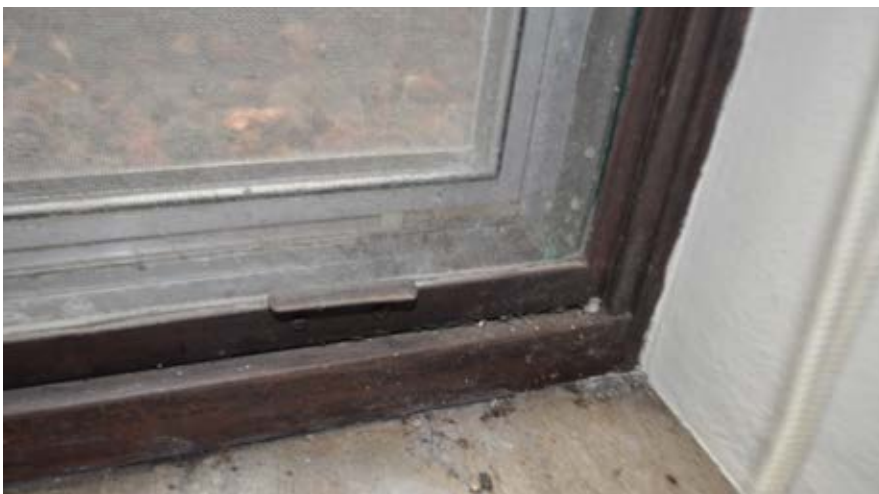
Window S5, Type U1

- Badly Corroded
- Note: Extent of exterior deterioration, corrosion, and loss of operability is not fully apparent in interior photos. Replacement parts for existing windows are unavailable, making restoration of thermal and operable functionality impossible, and long-term maintenance infeasible. Recommendation is for replacement, for quality of life of future tenants and for feasibility of long-term maintenance.
- See Window Assessment (Blackberry) in appendix for further detail and information, including further notes on deterioration beyond repair
- See Appendix for Window Schedule & Measurements

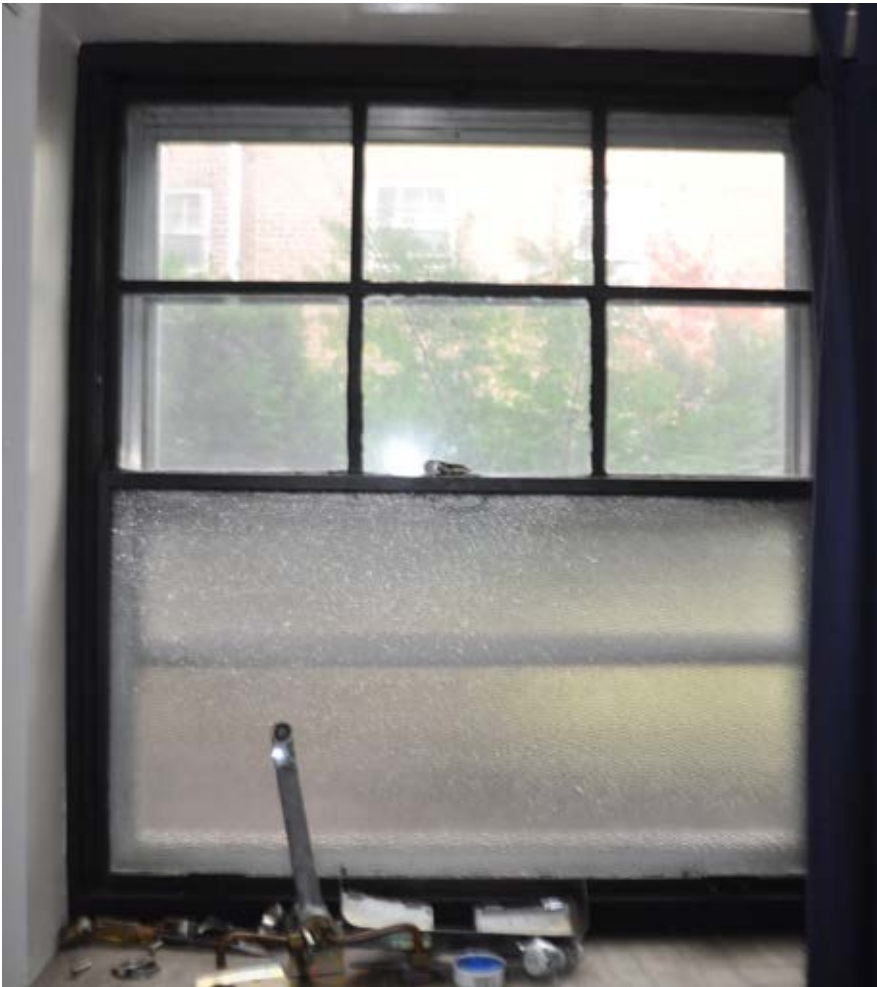
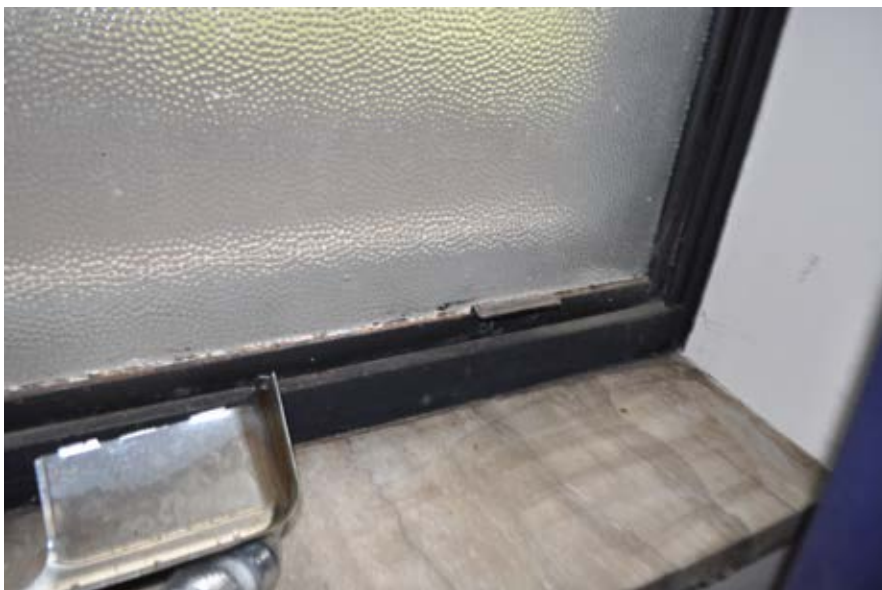
Window S6, Type T1

- Badly Corroded
- Note: Extent of exterior deterioration, corrosion, and loss of operability is not fully apparent in interior photos. Replacement parts for existing windows are unavailable, making restoration of thermal and operable functionality impossible, and long-term maintenance infeasible. Recommendation is for replacement, for quality of life of future tenants and for feasibility of long-term maintenance.
- See Window Assessment (Blackberry) in appendix for further detail and information, including further notes on deterioration beyond repair
- See Appendix for Window Schedule & Measurements

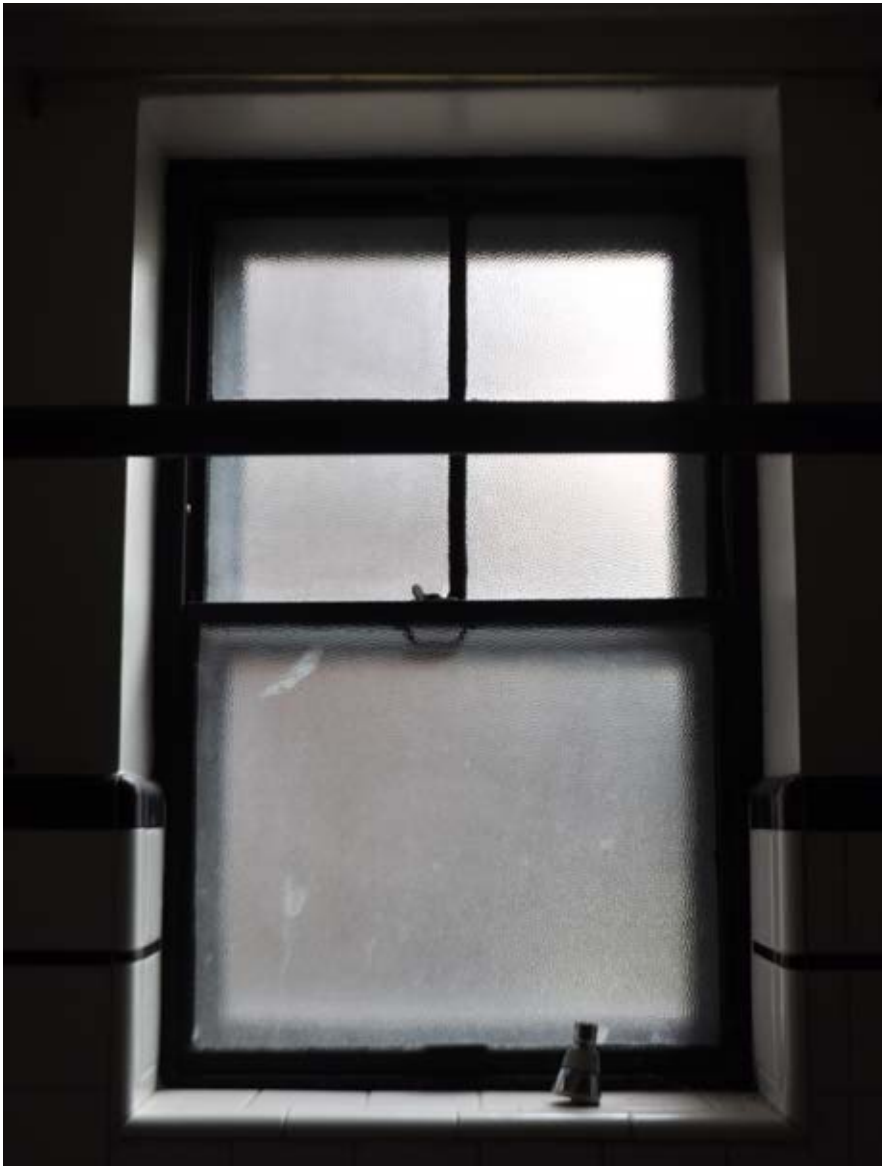
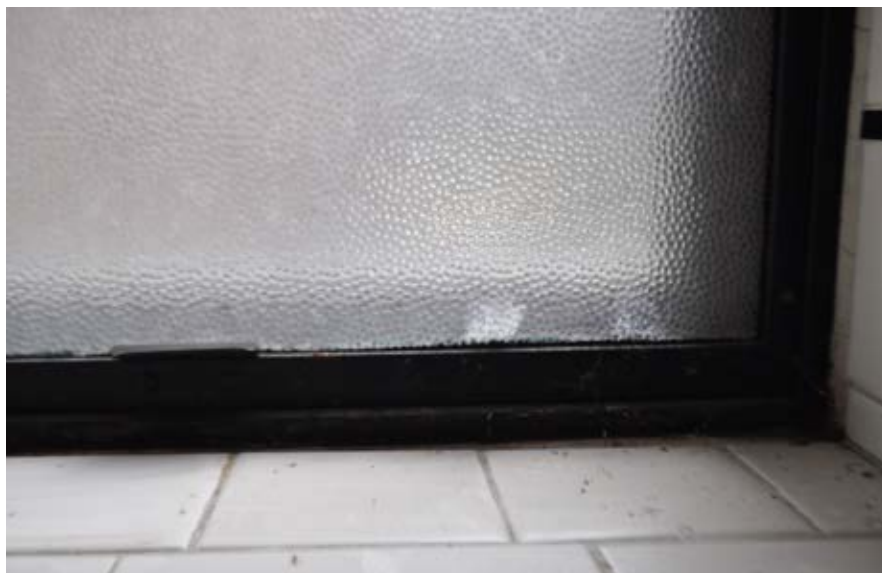
Window S7, Type M1

- Badly Corroded
- Note: Extent of exterior deterioration, corrosion, and loss of operability is not fully apparent in interior photos. Replacement parts for existing windows are unavailable, making restoration of thermal and operable functionality impossible, and long-term maintenance infeasible. Recommendation is for replacement, for quality of life of future tenants and for feasibility of long-term maintenance.
- See Window Assessment (Blackberry) in appendix for further detail and information, including further notes on deterioration beyond repair
- See Appendix for Window Schedule & Measurements

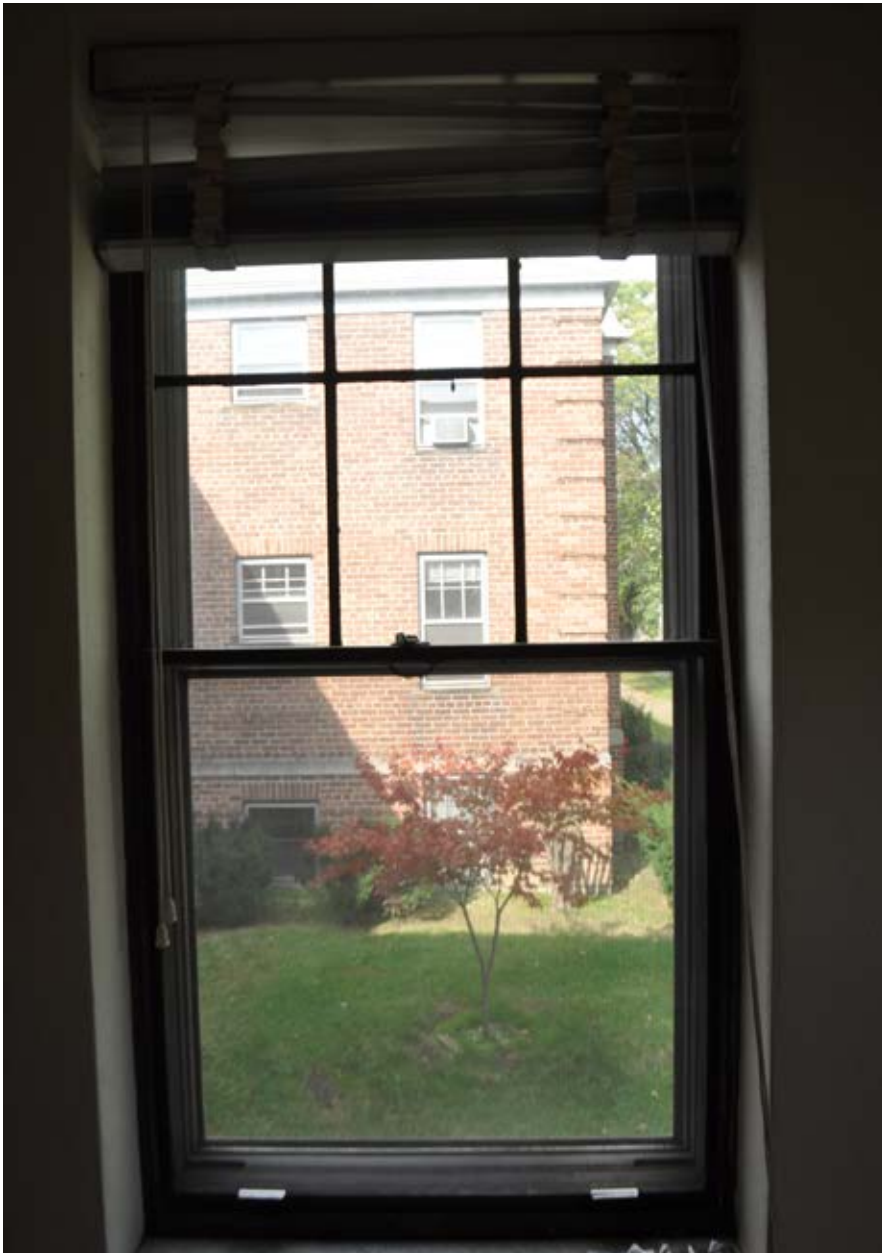
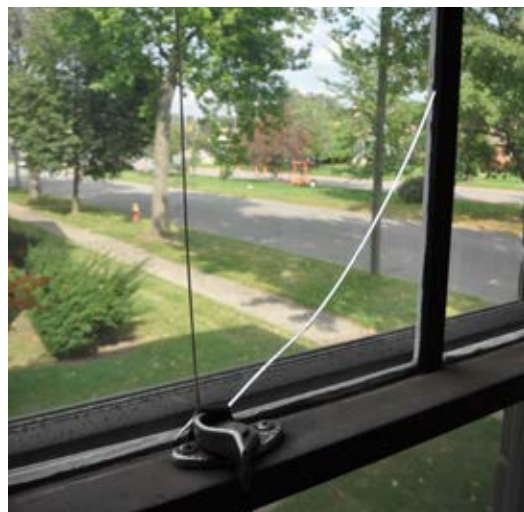
Window T5, Type U1

- Broken Glass
- Note: Extent of exterior deterioration, corrosion, and loss of operability is not fully apparent in interior photos. Replacement parts for existing windows are unavailable, making restoration of thermal and operable functionality impossible, and long-term maintenance infeasible. Recommendation is for replacement, for quality of life of future tenants and for feasibility of long-term maintenance.
- See Window Assessment (Blackberry) in appendix for further detail and information, including further notes on deterioration beyond repair
- See Appendix for Window Schedule & Measurements
