9710 W Outer Dr

Existing Condition Photos

Current Design Description

A 3-story apartment structure with 10 residential units, constructed in 1940, brick on wood stud wall construction, shingle roof, stone corner details, stone details at palladian window, stone sills, wood detailing at front entry, steel and wood canopy at back entry, wood windows throughout with the exception of steel windows at bathrooms and the lowest level. The addition of a brick shed to house the gas meter was made at a later date.

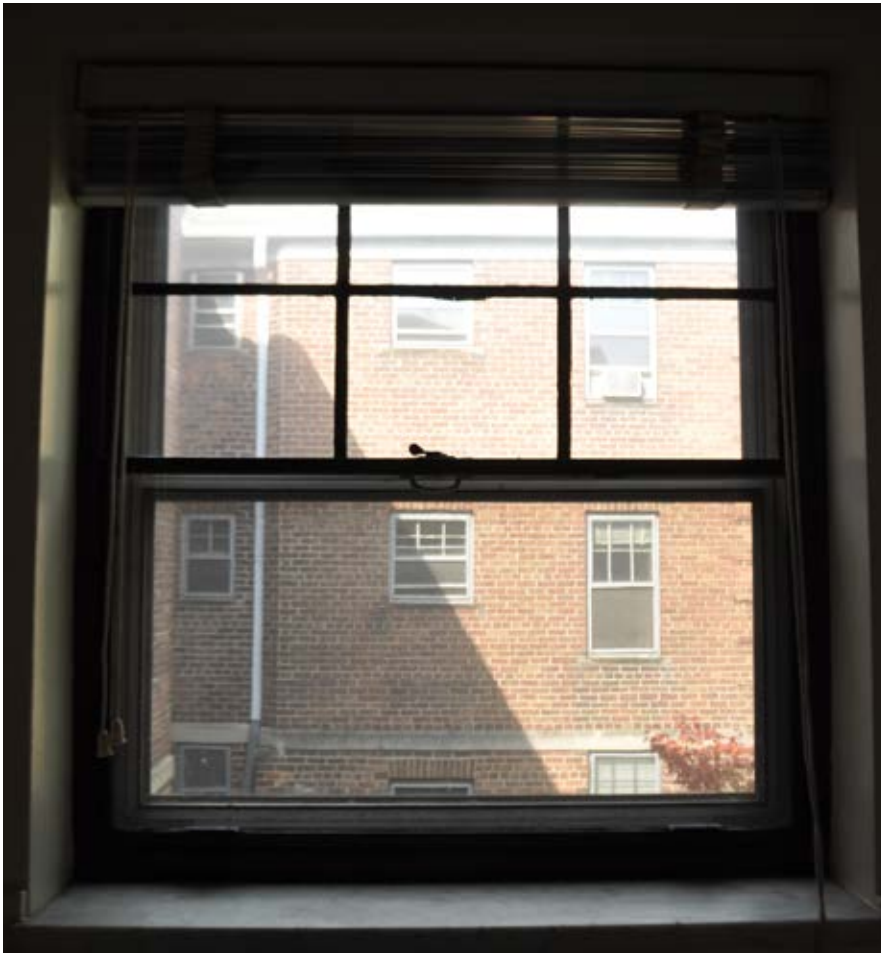
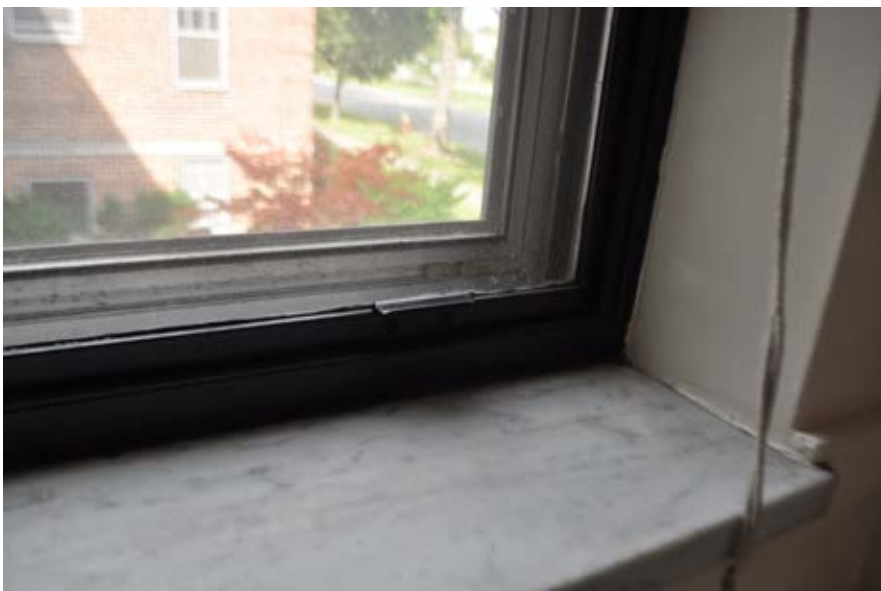
Window T6, Type T1

- Note: Extent of exterior deterioration, corrosion, and loss of operability is not fully apparent in interior photos. Replacement parts for existing windows are unavailable, making restoration of thermal and operable functionality impossible, and long-term maintenance infeasible. Recommendation is for replacement, for quality of life of future tenants and for feasibility of long-term maintenance.
- See Window Assessment (Blackberry) in appendix for further detail and information, including further notes on deterioration beyond repair
- See Appendix for Window Schedule & Measurements

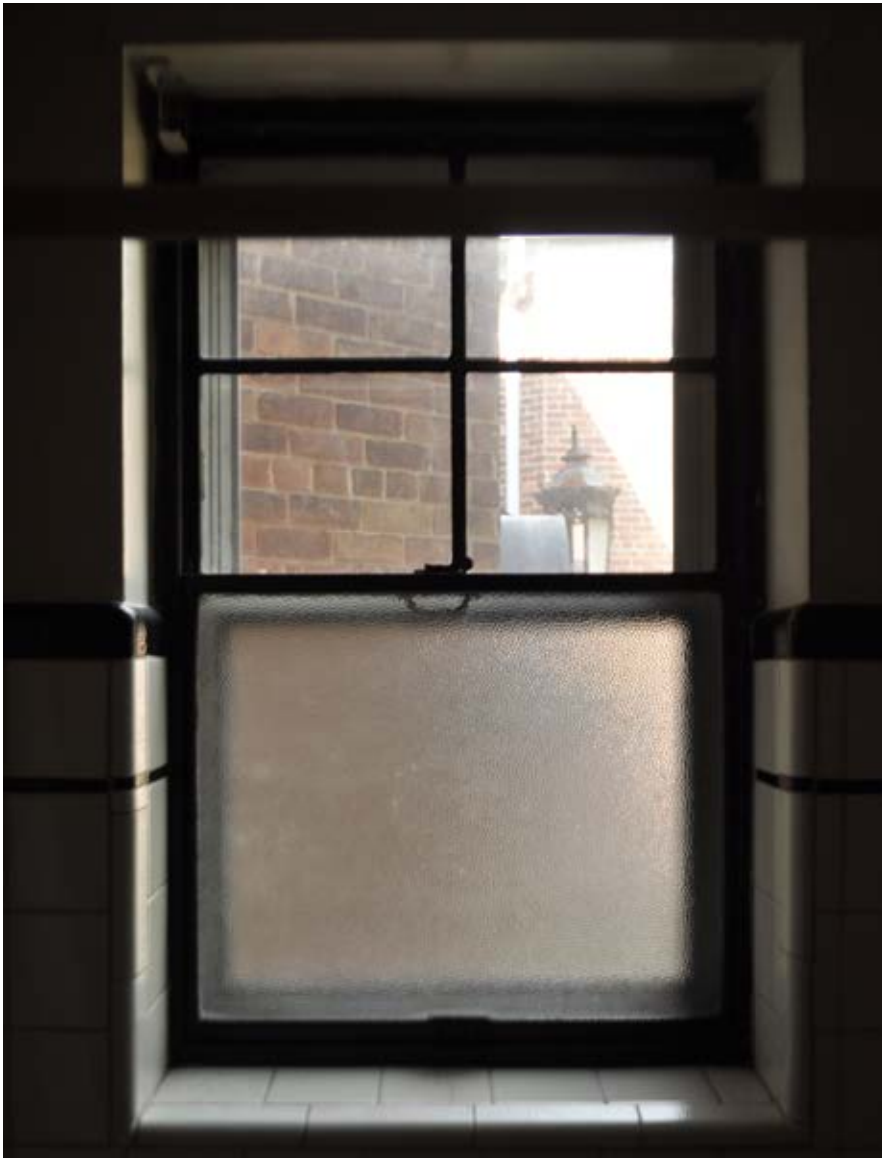
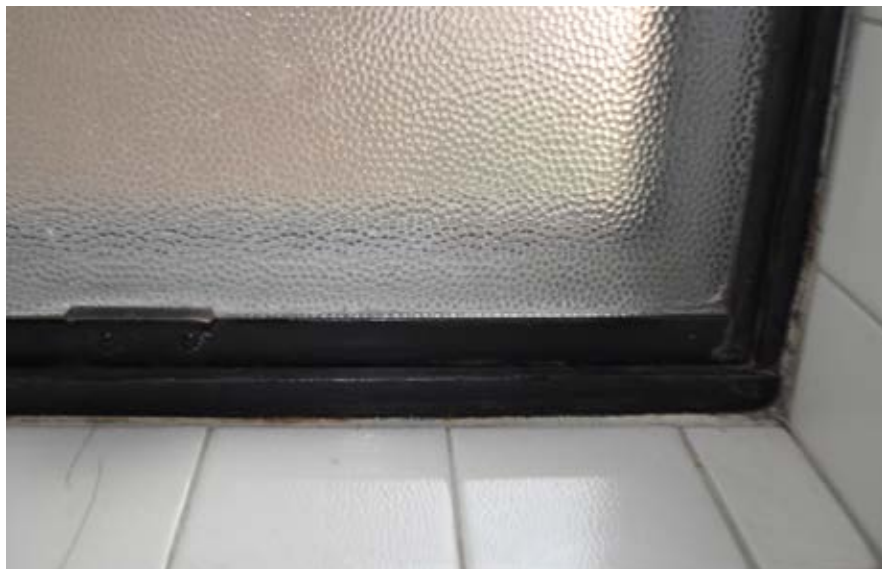
Window T7, Type N1

- Note: Extent of exterior deterioration, corrosion, and loss of operability is not fully apparent in interior photos. Replacement parts for existing windows are unavailable, making restoration of thermal and operable functionality impossible, and long-term maintenance infeasible. Recommendation is for replacement, for quality of life of future tenants and for feasibility of long-term maintenance.
- See Window Assessment (Blackberry) in appendix for further detail and information, including further notes on deterioration beyond repair
- See Appendix for Window Schedule & Measurements

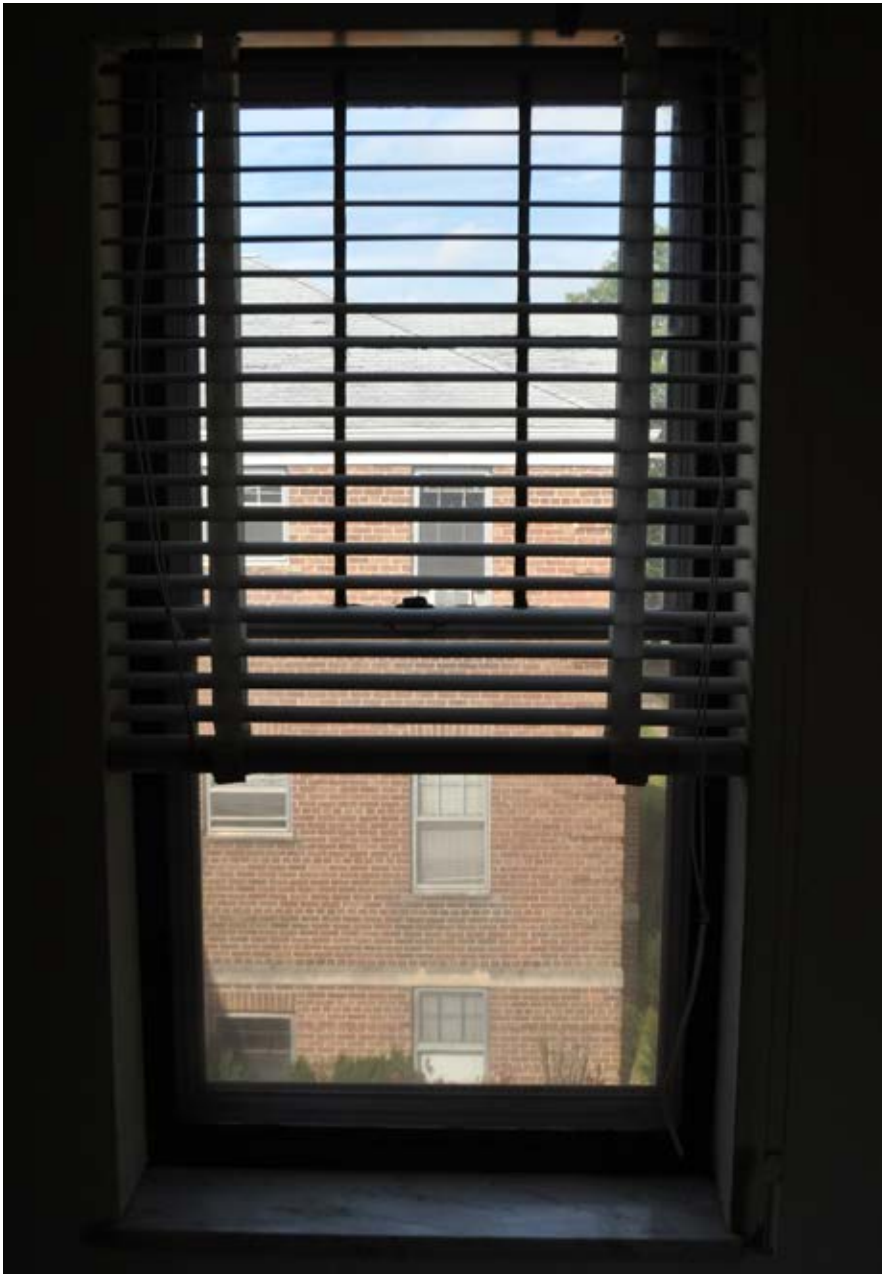
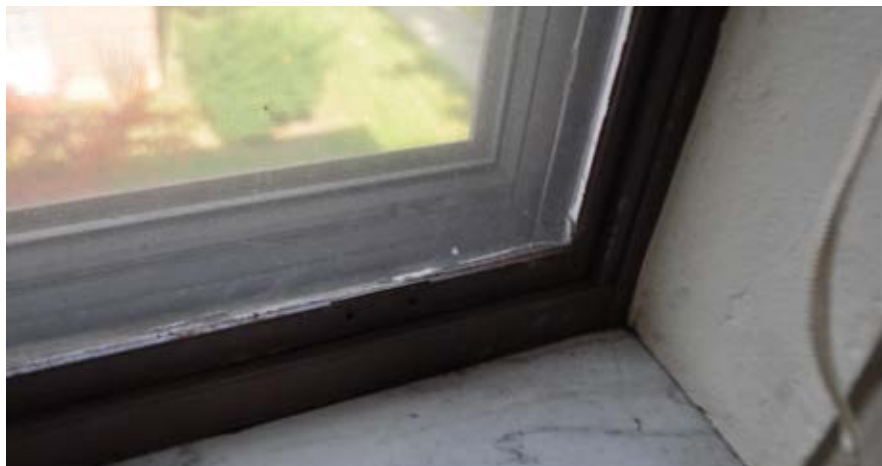
Window U5, Type U1

- Note: Extent of exterior deterioration, corrosion, and loss of operability is not fully apparent in interior photos. Replacement parts for existing windows are unavailable, making restoration of thermal and operable functionality impossible, and long-term maintenance infeasible. Recommendation is for replacement, for quality of life of future tenants and for feasibility of long-term maintenance.
- See Window Assessment (Blackberry) in appendix for further detail and information, including further notes on deterioration beyond repair
- See Appendix for Window Schedule & Measurements

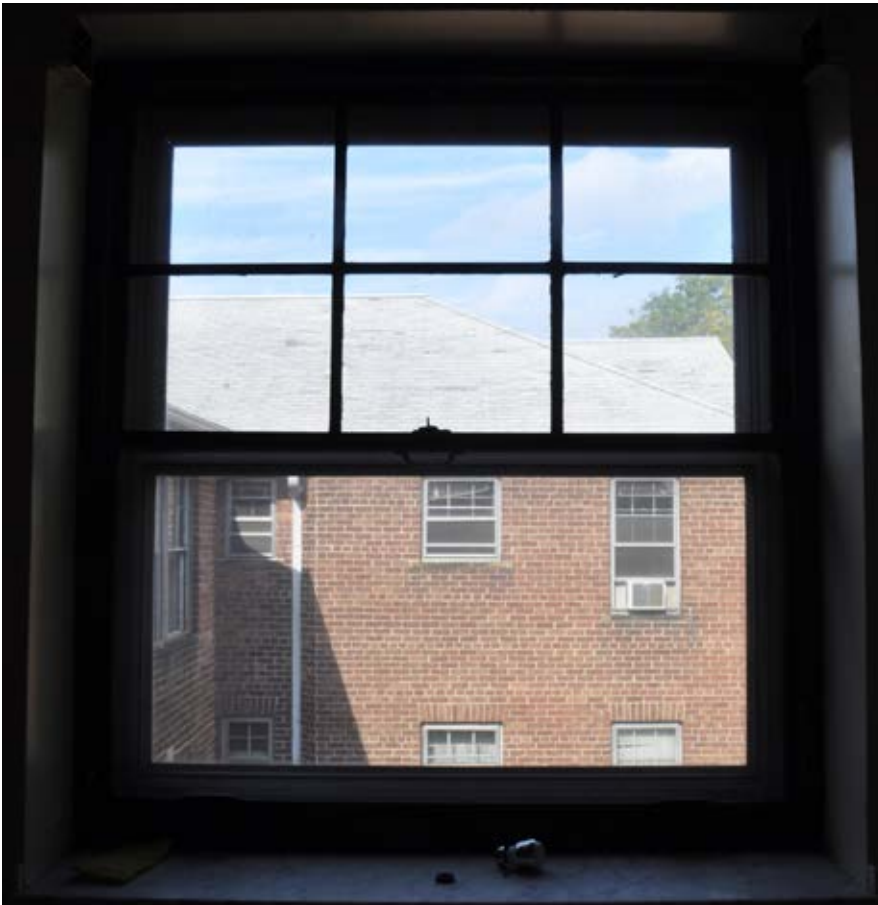
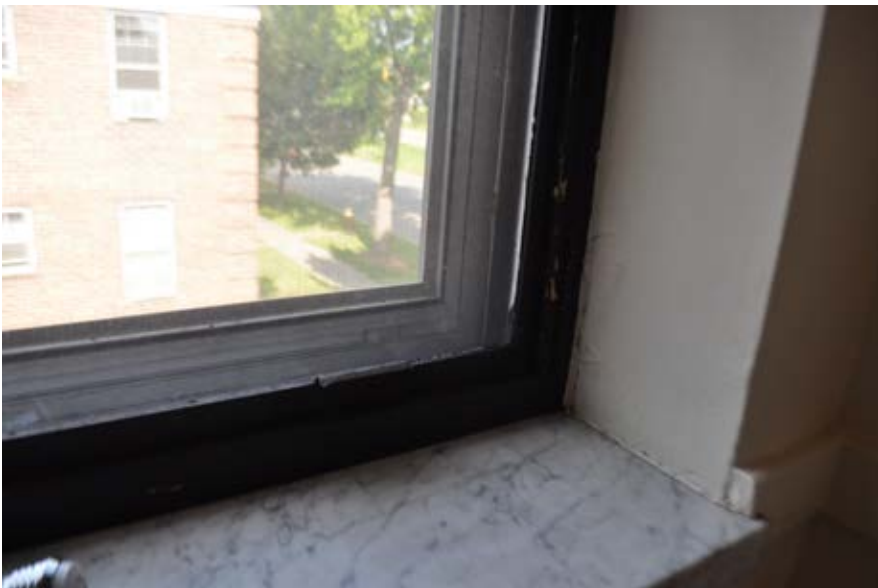
Window U6, Type T1

- Note: Extent of exterior deterioration, corrosion, and loss of operability is not fully apparent in interior photos. Replacement parts for existing windows are unavailable, making restoration of thermal and operable functionality impossible, and long-term maintenance infeasible. Recommendation is for replacement, for quality of life of future tenants and for feasibility of long-term maintenance.
- See Window Assessment (Blackberry) in appendix for further detail and information, including further notes on deterioration beyond repair
- See Appendix for Window Schedule & Measurements

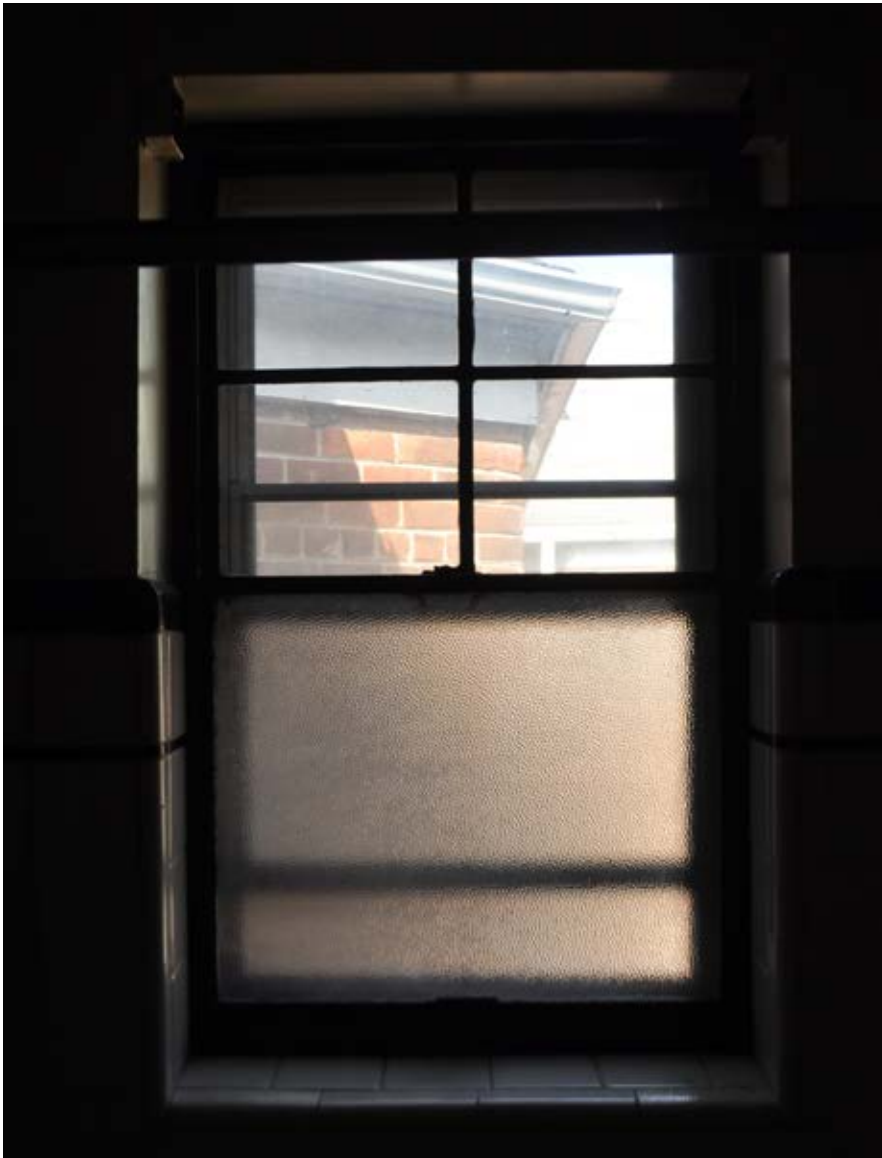
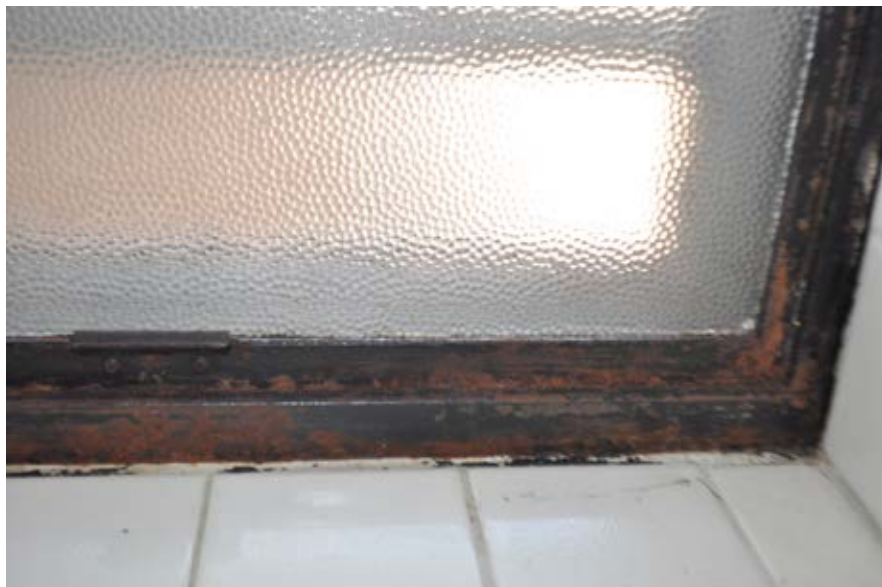
Window U7, Type N1

- Badly Corroded
- Note: Extent of exterior deterioration, corrosion, and loss of operability is not fully apparent in interior photos. Replacement parts for existing windows are unavailable, making restoration of thermal and operable functionality impossible, and long-term maintenance infeasible. Recommendation is for replacement, for quality of life of future tenants and for feasibility of long-term maintenance.
- See Window Assessment (Blackberry) in appendix for further detail and information, including further notes on deterioration beyond repair
- See Appendix for Window Schedule & Measurements

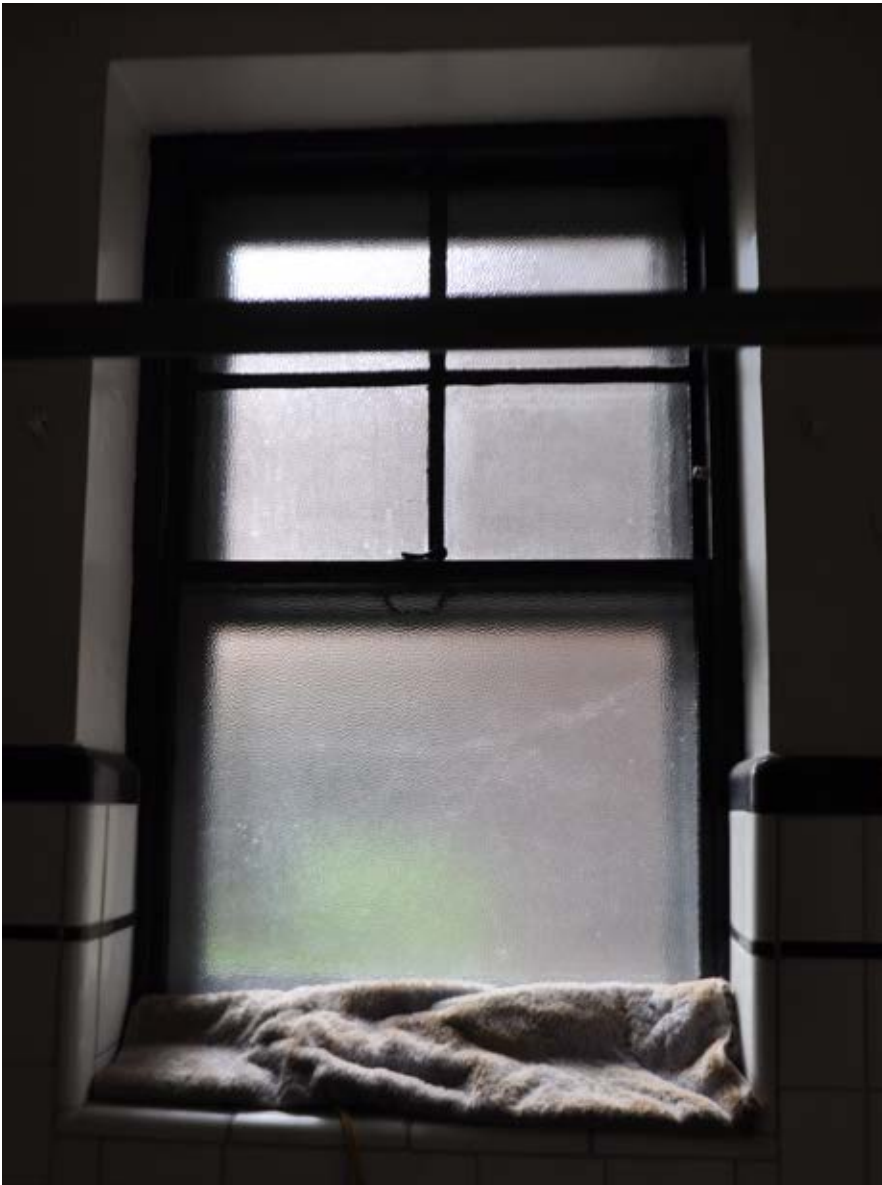
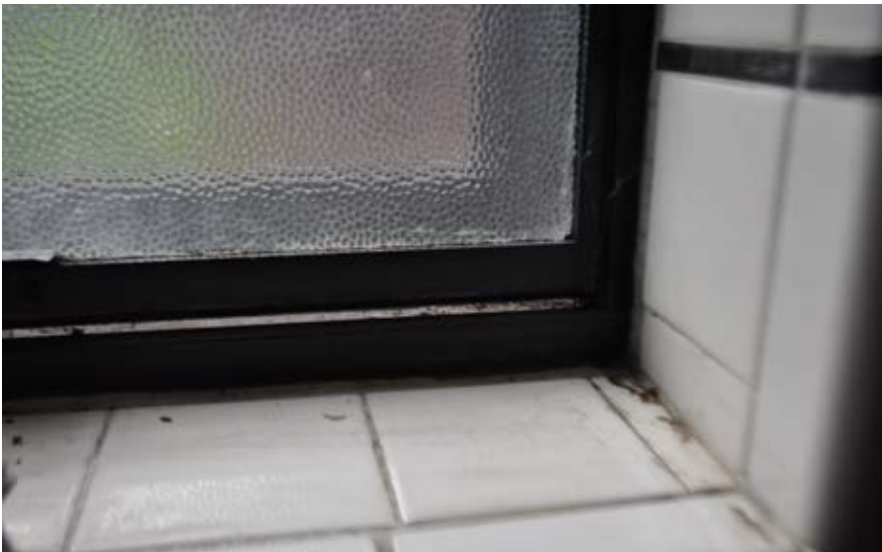
Window S12, Type M1

- Badly Corroded
- Note: Extent of exterior deterioration, corrosion, and loss of operability is not fully apparent in interior photos. Replacement parts for existing windows are unavailable, making restoration of thermal and operable functionality impossible, and long-term maintenance infeasible. Recommendation is for replacement, for quality of life of future tenants and for feasibility of long-term maintenance.
- See Window Assessment (Blackberry) in appendix for further detail and information, including further notes on deterioration beyond repair
- See Appendix for Window Schedule & Measurements

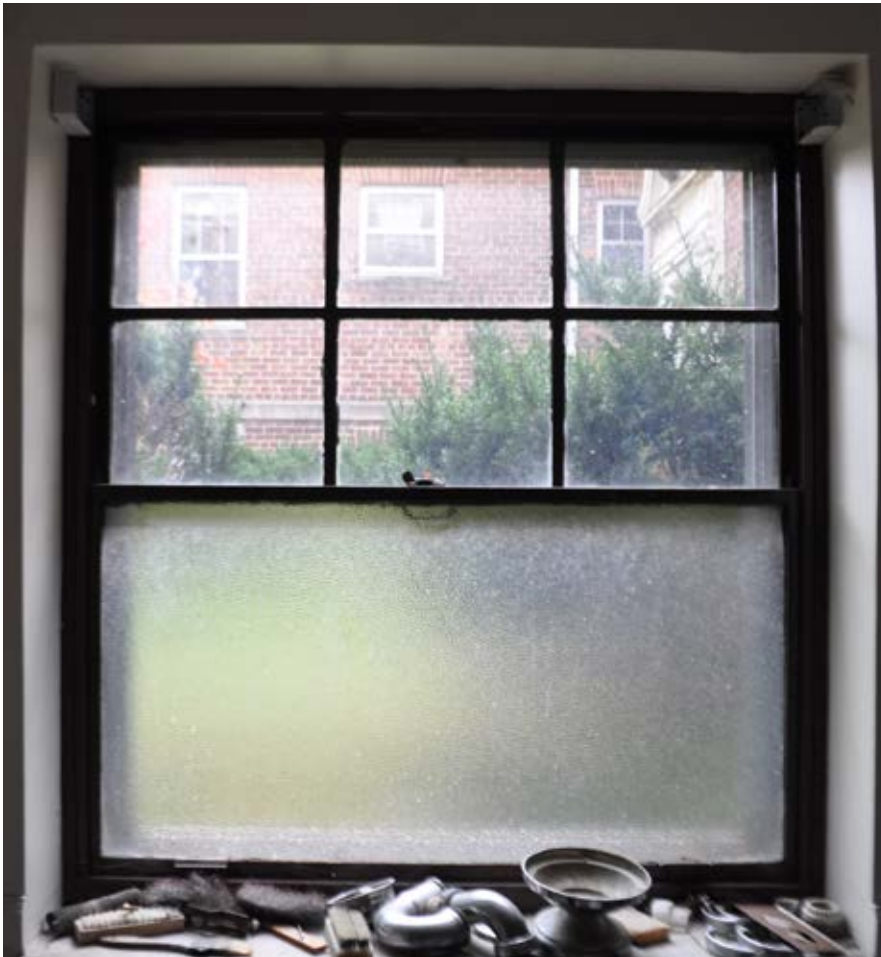
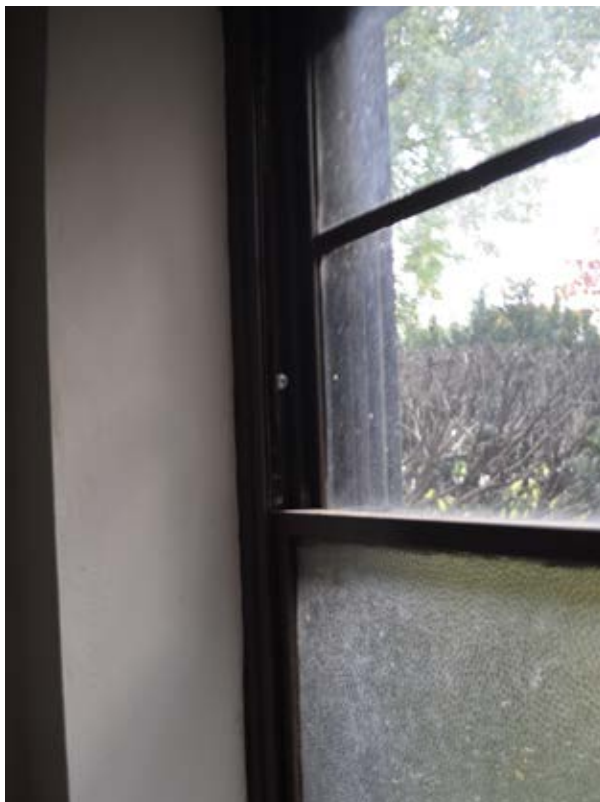
Window S13, Type T1

- Badly Corroded
- Note: Extent of exterior deterioration, corrosion, and loss of operability is not fully apparent in interior photos. Replacement parts for existing windows are unavailable, making restoration of thermal and operable functionality impossible, and long-term maintenance infeasible. Recommendation is for replacement, for quality of life of future tenants and for feasibility of long-term maintenance.
- See Window Assessment (Blackberry) in appendix for further detail and information, including further notes on deterioration beyond repair
- See Appendix for Window Schedule & Measurements

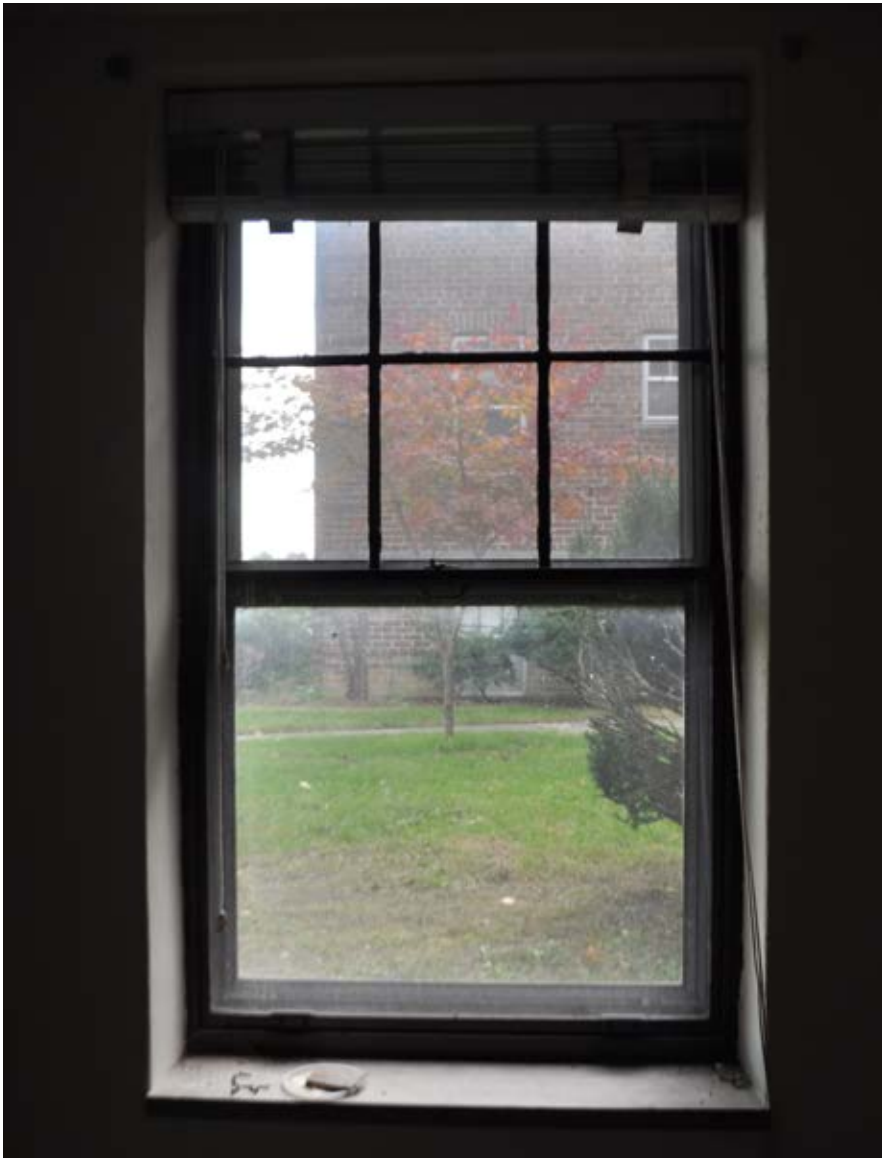
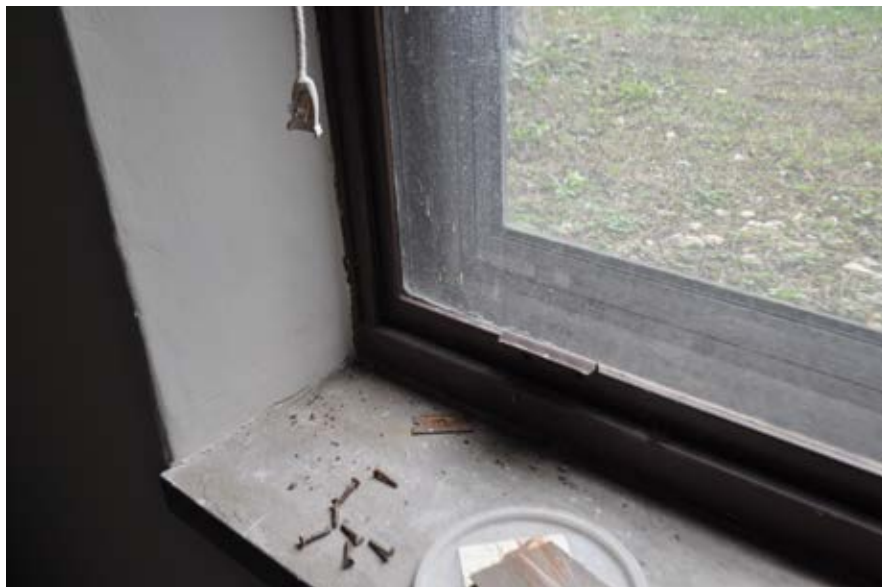
Window S14, Type U1

- Badly Corroded
- Note: Extent of exterior deterioration, corrosion, and loss of operability is not fully apparent in interior photos. Replacement parts for existing windows are unavailable, making restoration of thermal and operable functionality impossible, and long-term maintenance infeasible. Recommendation is for replacement, for quality of life of future tenants and for feasibility of long-term maintenance.
- See Window Assessment (Blackberry) in appendix for further detail and information, including further notes on deterioration beyond repair
- See Appendix for Window Schedule & Measurements

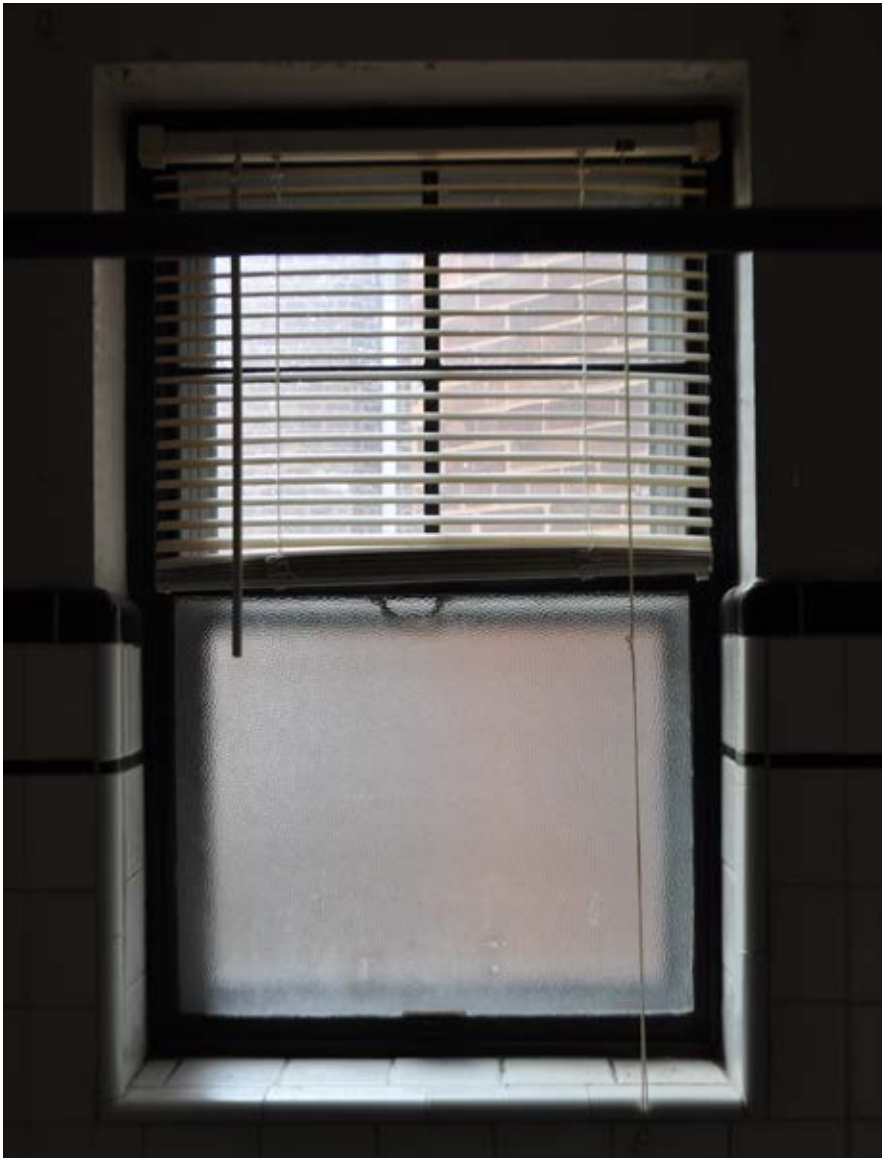
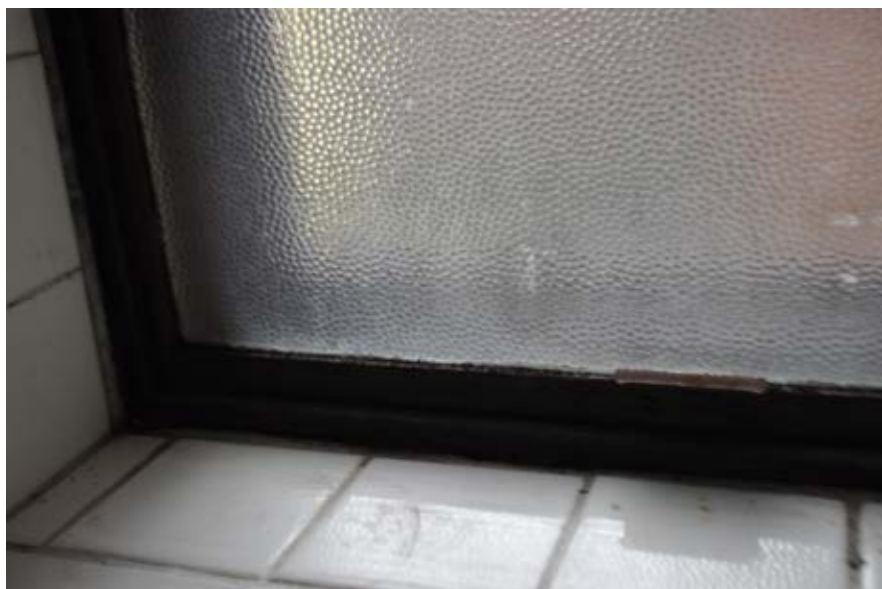
Window T12, Type N1

- Note: Extent of exterior deterioration, corrosion, and loss of operability is not fully apparent in interior photos. Replacement parts for existing windows are unavailable, making restoration of thermal and operable functionality impossible, and long-term maintenance infeasible. Recommendation is for replacement, for quality of life of future tenants and for feasibility of long-term maintenance.
- See Window Assessment (Blackberry) in appendix for further detail and information, including further notes on deterioration beyond repair
- See Appendix for Window Schedule & Measurements

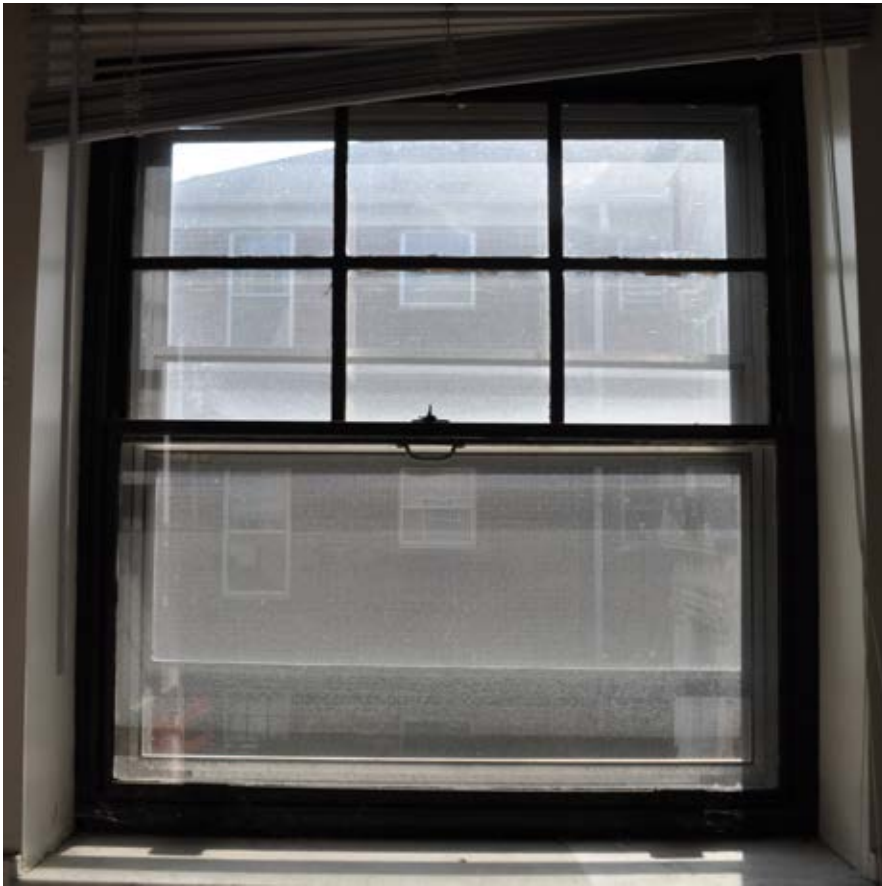
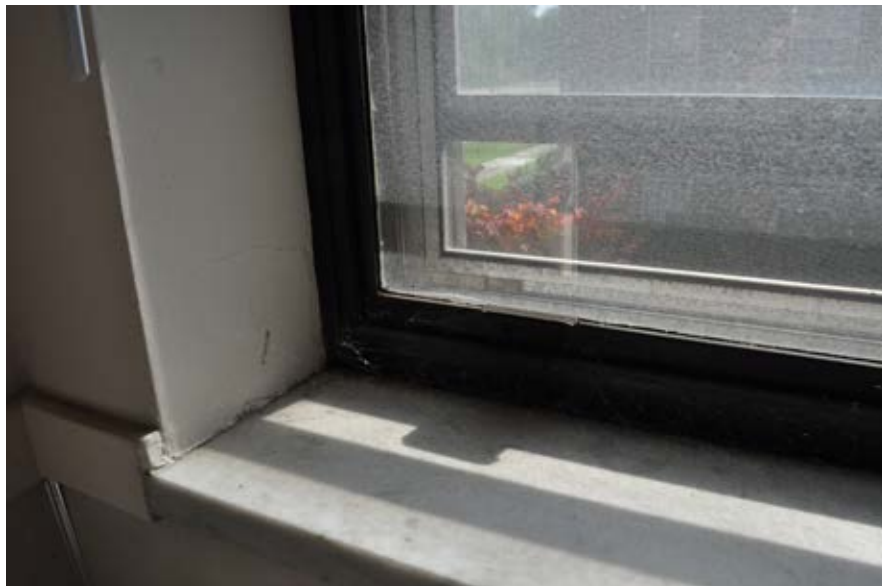
Window T13, Type T1

- Note: Extent of exterior deterioration, corrosion, and loss of operability is not fully apparent in interior photos. Replacement parts for existing windows are unavailable, making restoration of thermal and operable functionality impossible, and long-term maintenance infeasible. Recommendation is for replacement, for quality of life of future tenants and for feasibility of long-term maintenance.
- See Window Assessment (Blackberry) in appendix for further detail and information, including further notes on deterioration beyond repair
- See Appendix for Window Schedule & Measurements

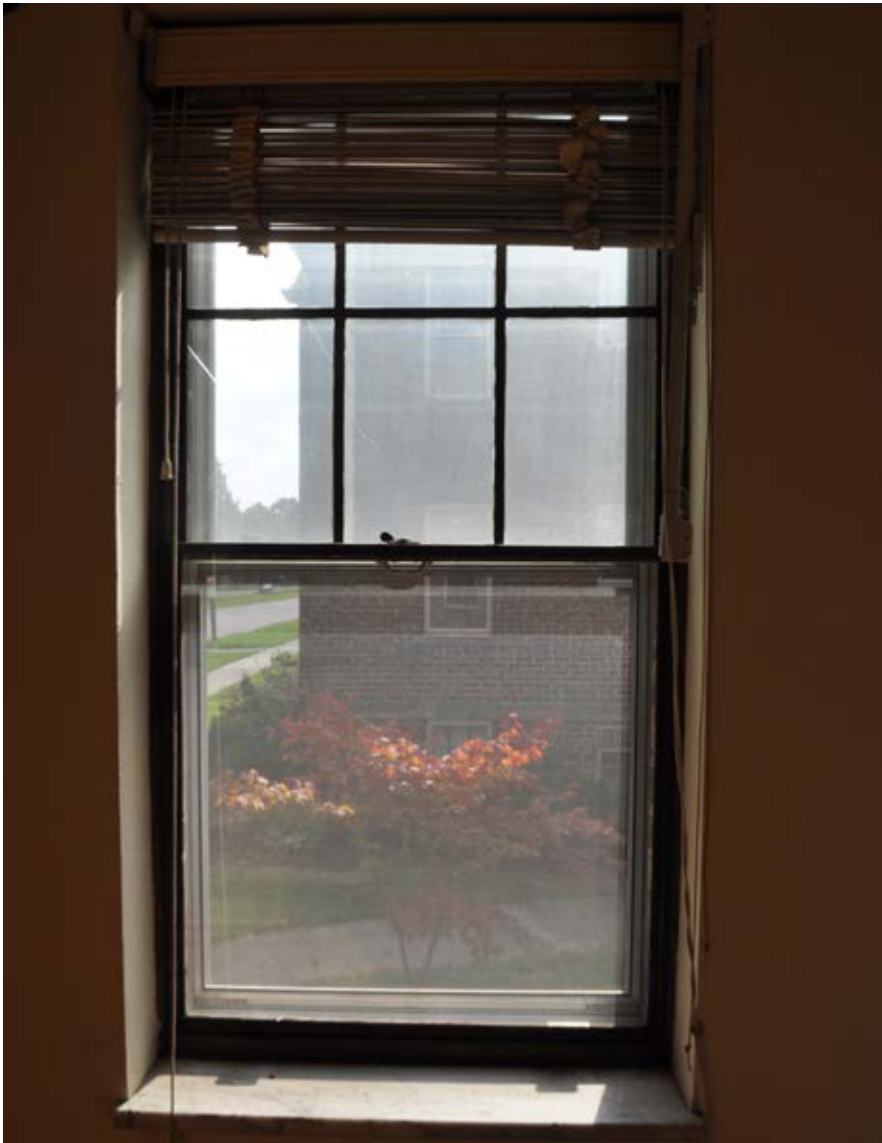
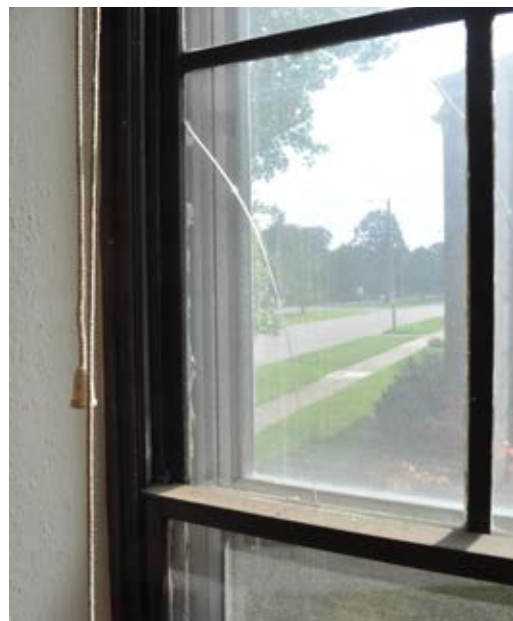
Window T14, Type U1

- Broken Glass
- Note: Extent of exterior deterioration, corrosion, and loss of operability is not fully apparent in interior photos. Replacement parts for existing windows are unavailable, making restoration of thermal and operable functionality impossible, and long-term maintenance infeasible. Recommendation is for replacement, for quality of life of future tenants and for feasibility of long-term maintenance.
- See Window Assessment (Blackberry) in appendix for further detail and information, including further notes on deterioration beyond repair
- See Appendix for Window Schedule & Measurements

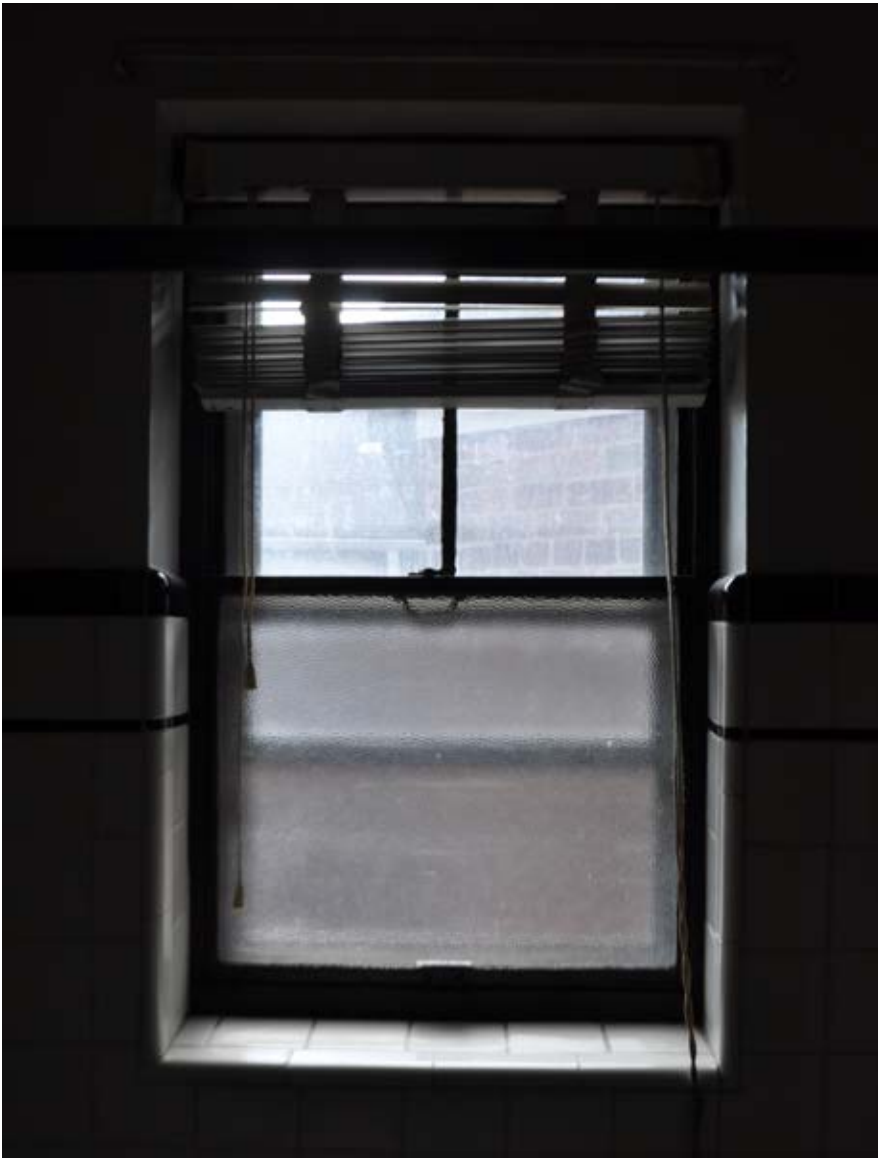
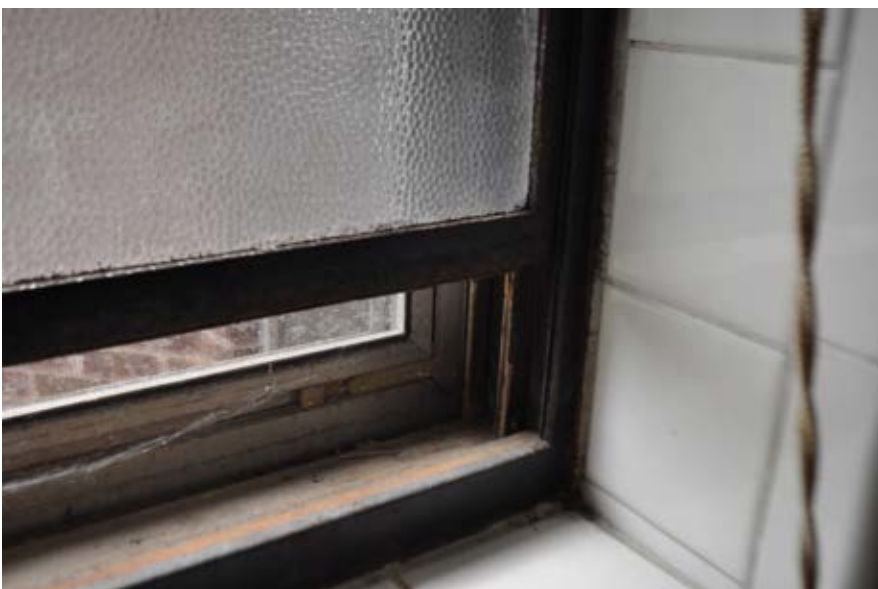
Window U13, Type N1

- Note: Extent of exterior deterioration, corrosion, and loss of operability is not fully apparent in interior photos. Replacement parts for existing windows are unavailable, making restoration of thermal and operable functionality impossible, and long-term maintenance infeasible. Recommendation is for replacement, for quality of life of future tenants and for feasibility of long-term maintenance.
- See Window Assessment (Blackberry) in appendix for further detail and information, including further notes on deterioration beyond repair
- See Appendix for Window Schedule & Measurements

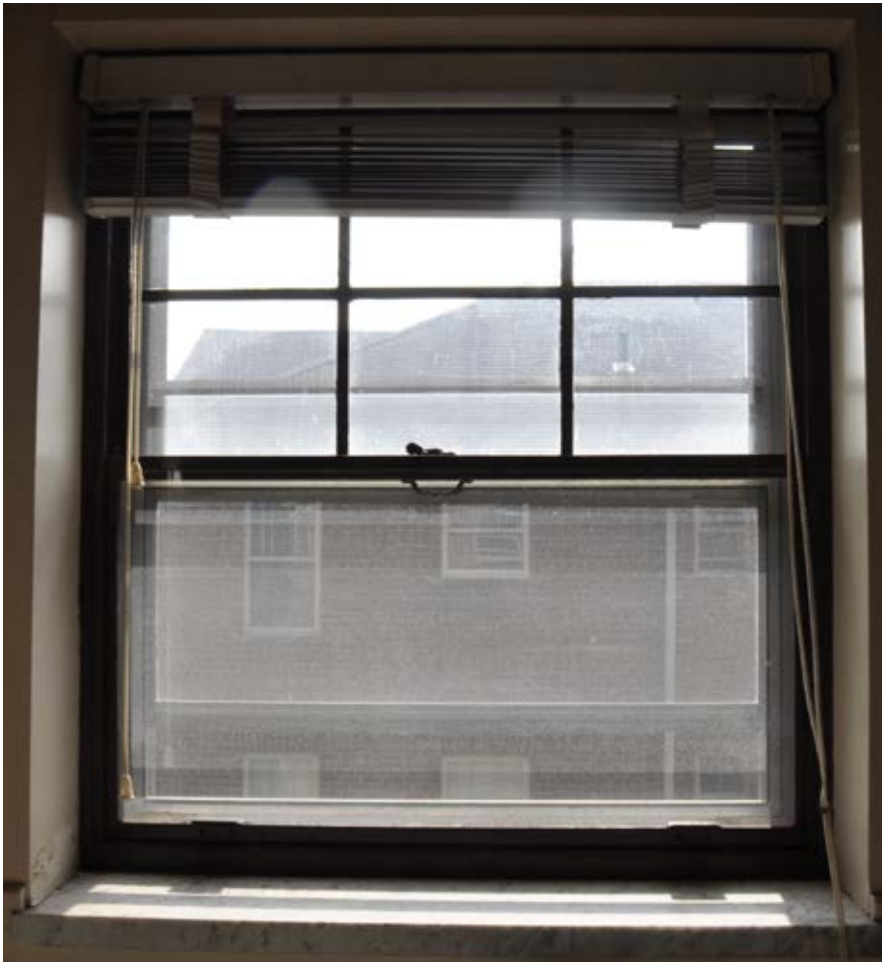
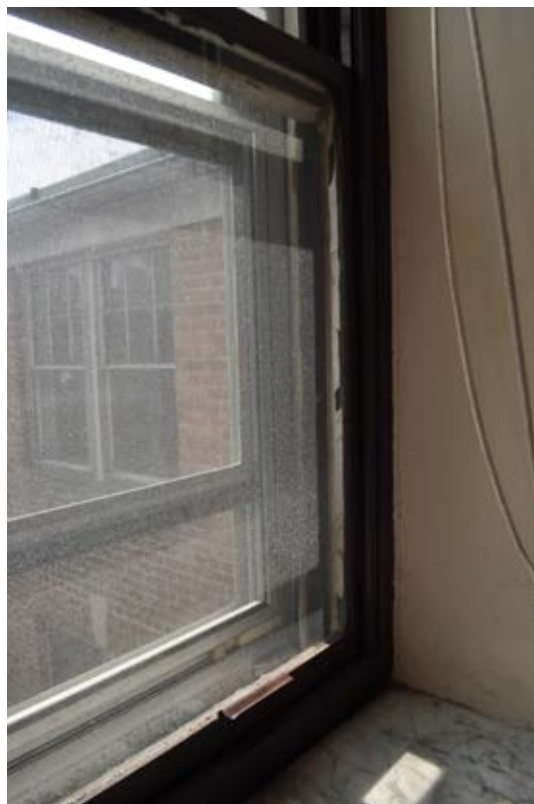
Window U14, Type T1

- Note: Extent of exterior deterioration, corrosion, and loss of operability is not fully apparent in interior photos. Replacement parts for existing windows are unavailable, making restoration of thermal and operable functionality impossible, and long-term maintenance infeasible. Recommendation is for replacement, for quality of life of future tenants and for feasibility of long-term maintenance.
- See Window Assessment (Blackberry) in appendix for further detail and information, including further notes on deterioration beyond repair
- See Appendix for Window Schedule & Measurements

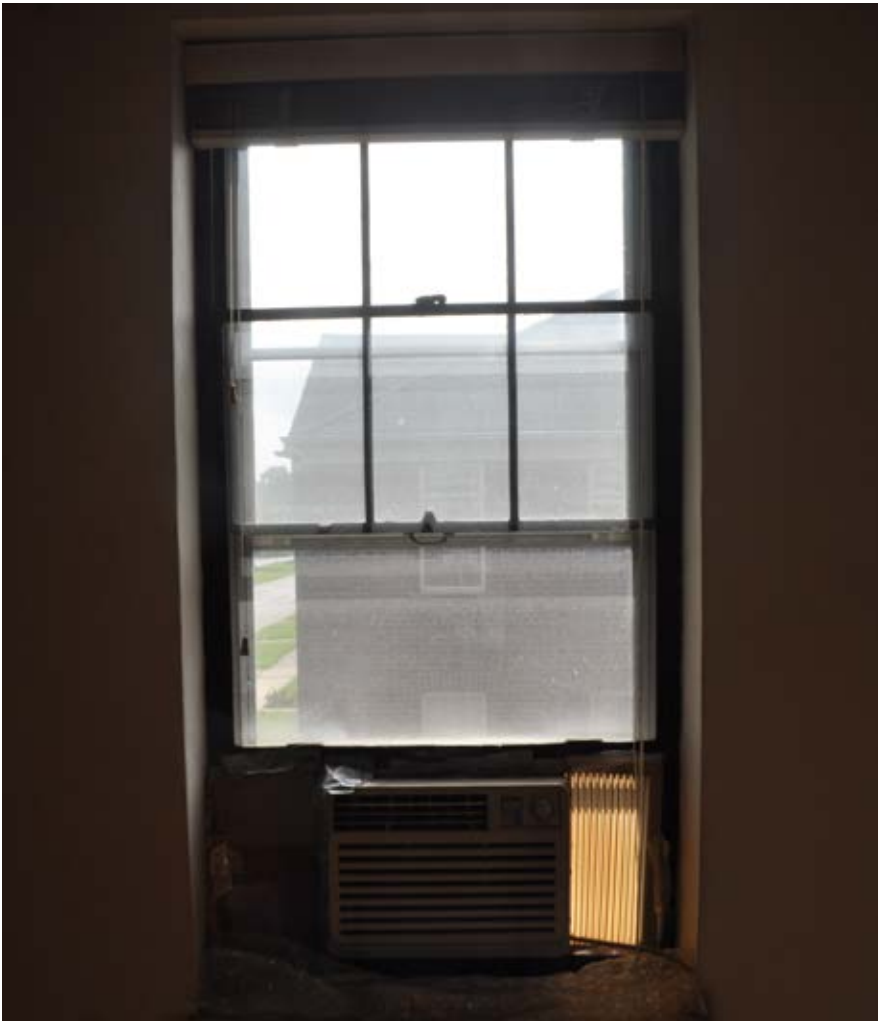
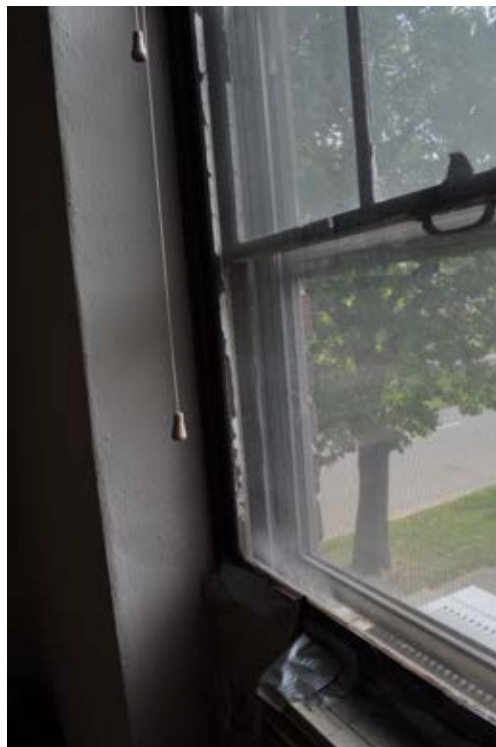
Window U15, Type U1

- Note: Extent of exterior deterioration, corrosion, and loss of operability is not fully apparent in interior photos. Replacement parts for existing windows are unavailable, making restoration of thermal and operable functionality impossible, and long-term maintenance infeasible. Recommendation is for replacement, for quality of life of future tenants and for feasibility of long-term maintenance.
- See Window Assessment (Blackberry) in appendix for further detail and information, including further notes on deterioration beyond repair
- See Appendix for Window Schedule & Measurements
