9710 W Outer Dr

Existing Condition Photos

Current Design Description

A 3-story apartment structure with 10 residential units, constructed in 1940, brick on wood stud wall construction, shingle roof, stone corner details, stone details at palladian window, stone sills, wood detailing at front entry, steel and wood canopy at back entry, wood windows throughout with the exception of steel windows at bathrooms and the lowest level. The addition of a brick shed to house the gas meter was made at a later date.

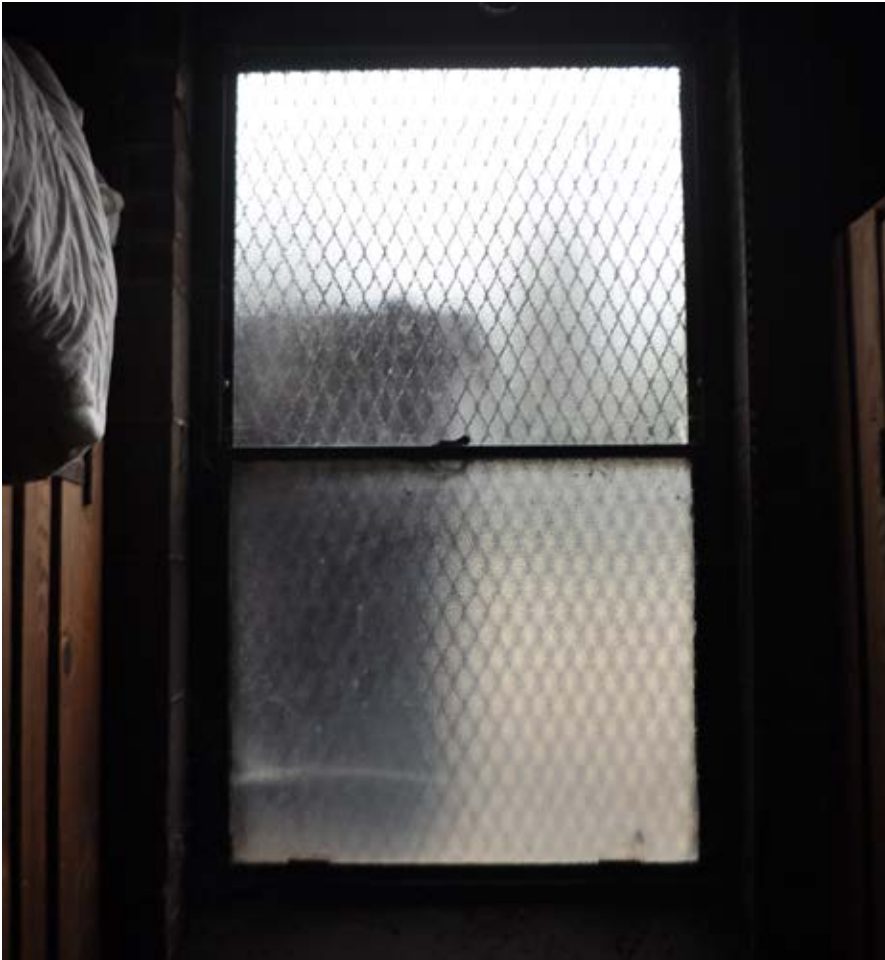
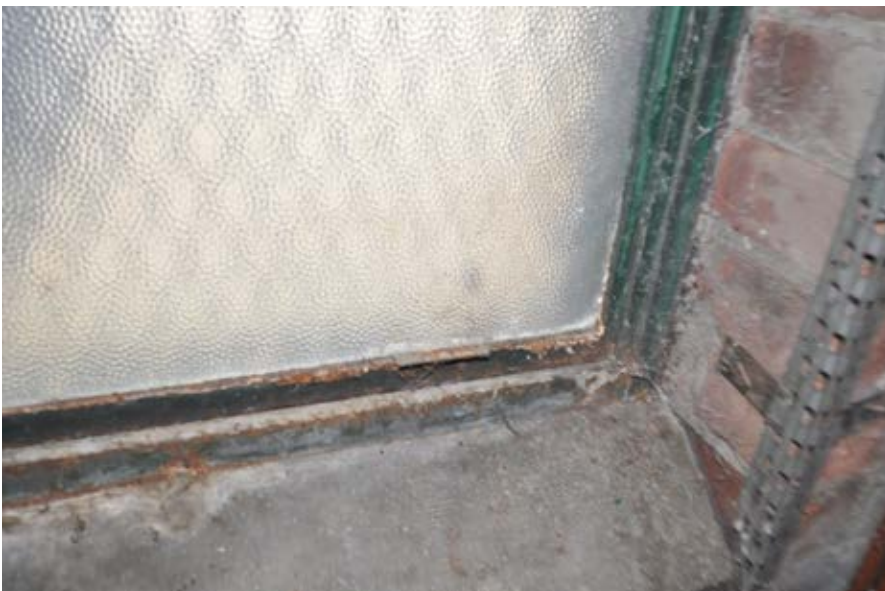
Window V1, Type M2

- Badly Corroded
- Note: Extent of exterior deterioration, corrosion, and loss of operability is not fully apparent in interior photos. Replacement parts for existing windows are unavailable, making restoration of thermal and operable functionality impossible, and long-term maintenance infeasible. Recommendation is for replacement, for quality of life of future tenants and for feasibility of long-term maintenance.
- See Window Assessment (Blackberry) in appendix for further detail and information, including further notes on deterioration beyond repair
- See Appendix for Window Schedule & Measurements

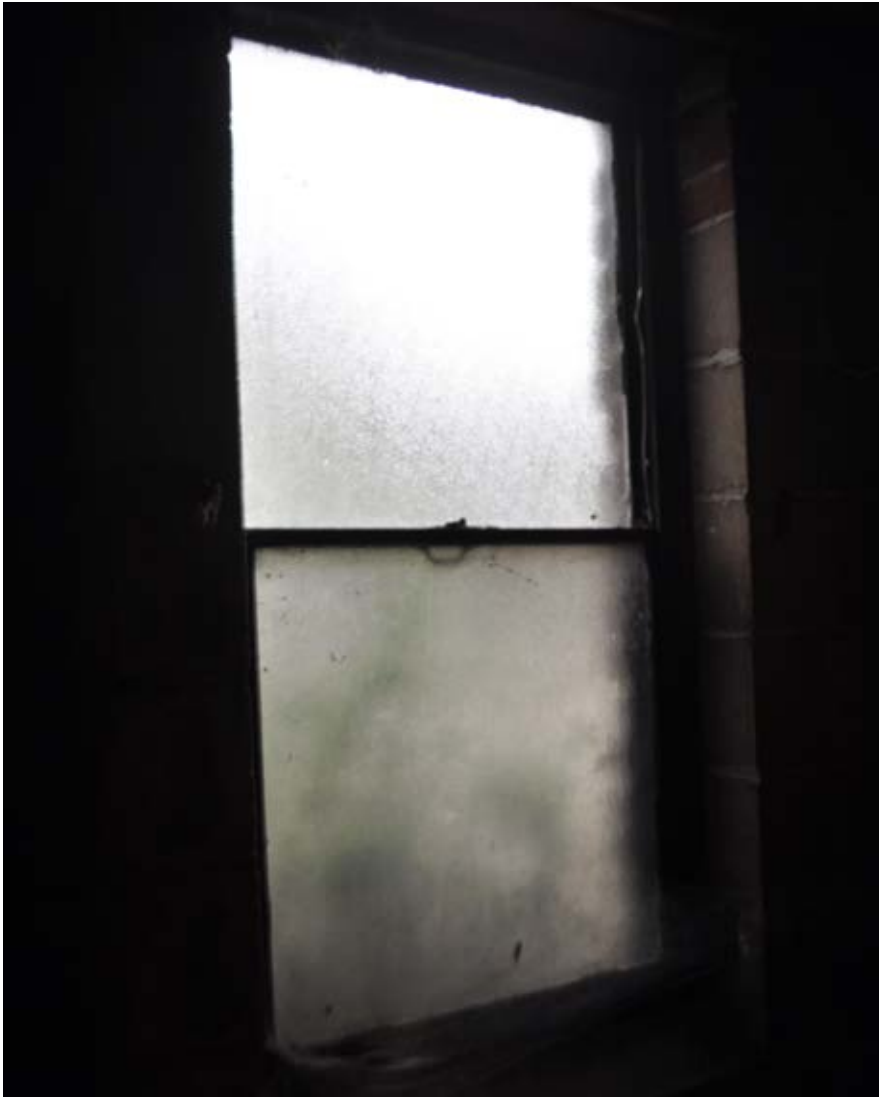
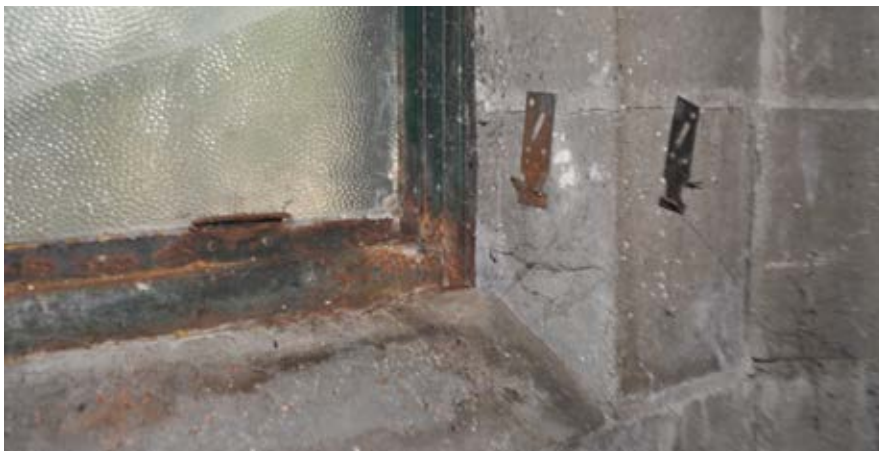
Window V6, Type M2

- Badly Corroded
- Note: Extent of exterior deterioration, corrosion, and loss of operability is not fully apparent in interior photos. Replacement parts for existing windows are unavailable, making restoration of thermal and operable functionality impossible, and long-term maintenance infeasible. Recommendation is for replacement, for quality of life of future tenants and for feasibility of long-term maintenance.
- See Window Assessment (Blackberry) in appendix for further detail and information, including further notes on deterioration beyond repair
- See Appendix for Window Schedule & Measurements

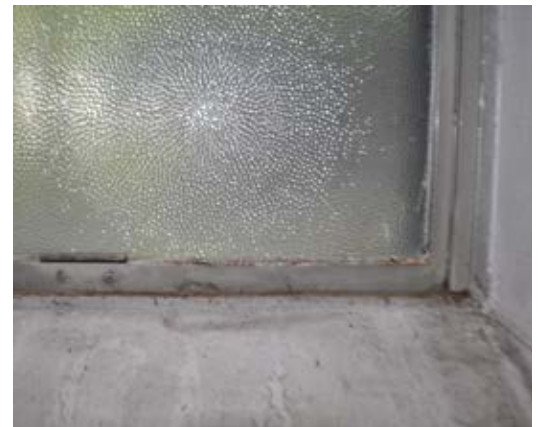
Window DEMO 01, Type Q2

- Badly Corroded
- Note: Extent of exterior deterioration, corrosion, and loss of operability is not fully apparent in interior photos. Replacement parts for existing windows are unavailable, making restoration of thermal and operable functionality impossible, and long-term maintenance infeasible. Recommendation is for replacement, for quality of life of future tenants and for feasibility of long-term maintenance.
- See Window Assessment (Blackberry) in appendix for further detail and information, including further notes on deterioration beyond repair
- See Appendix for Window Schedule & Measurements

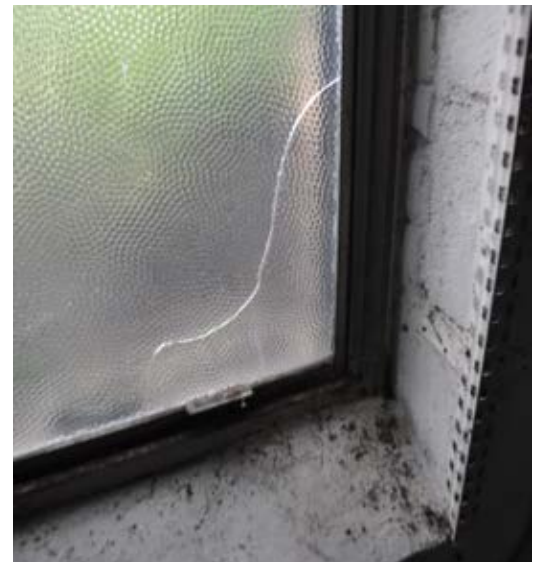
Window V9, Type M2

- Broken Glass
- Badly Corroded
- Note: Extent of exterior deterioration, corrosion, and loss of operability is not fully apparent in interior photos. Replacement parts for existing windows are unavailable, making restoration of thermal and operable functionality impossible, and long-term maintenance infeasible. Recommendation is for replacement, for quality of life of future tenants and for feasibility of long-term maintenance.
- See Window Assessment (Blackberry) in appendix for further detail and information, including further notes on deterioration beyond repair
- See Appendix for Window Schedule & Measurements

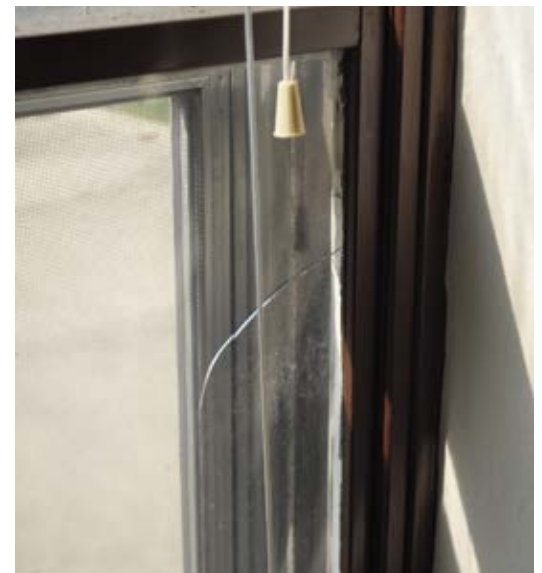
Window W1, Type N2

- Broken Glass
- Note: Extent of exterior deterioration, corrosion, and loss of operability is not fully apparent in interior photos. Replacement parts for existing windows are unavailable, making restoration of thermal and operable functionality impossible, and long-term maintenance infeasible. Recommendation is for replacement, for quality of life of future tenants and for feasibility of long-term maintenance.
- See Window Assessment (Blackberry) in appendix for further detail and information, including further notes on deterioration beyond repair
- See Appendix for Window Schedule & Measurements

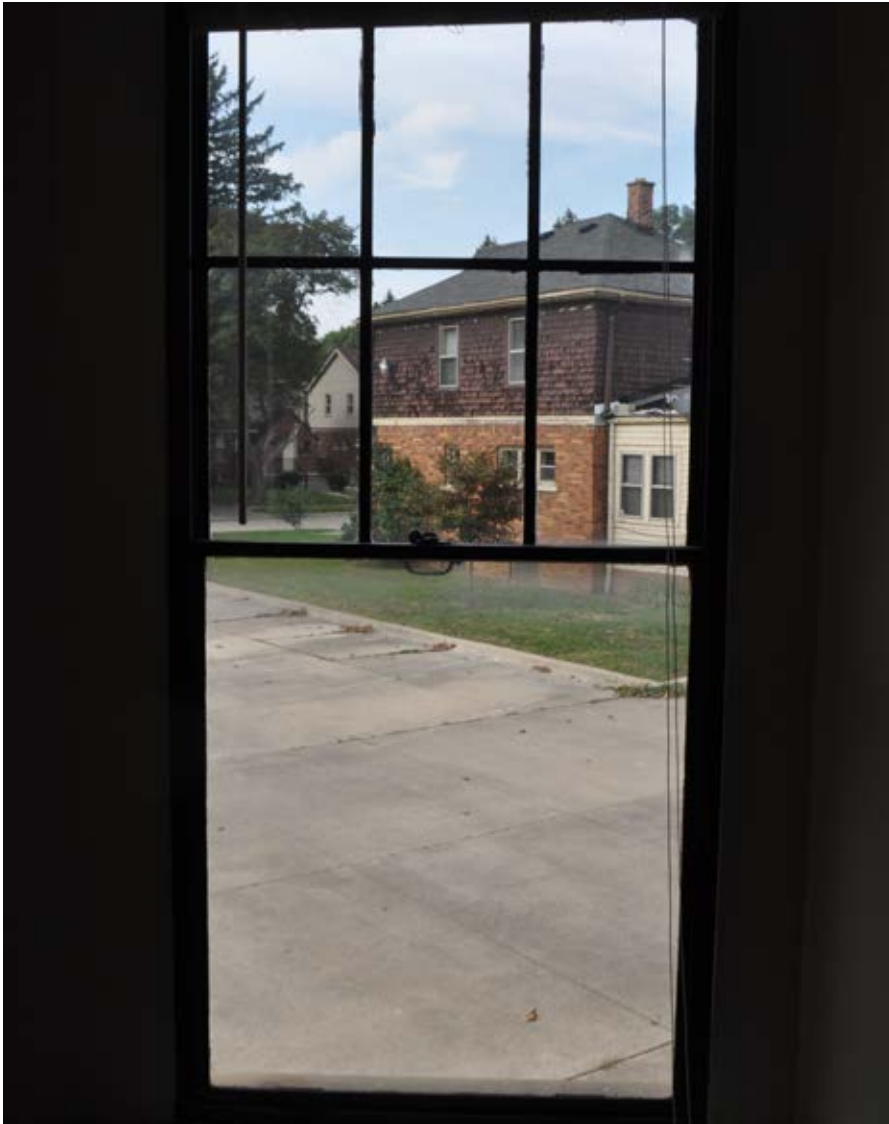
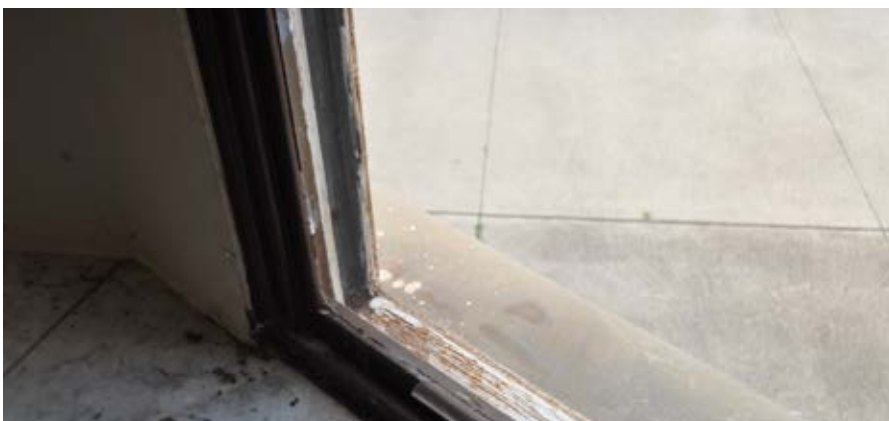
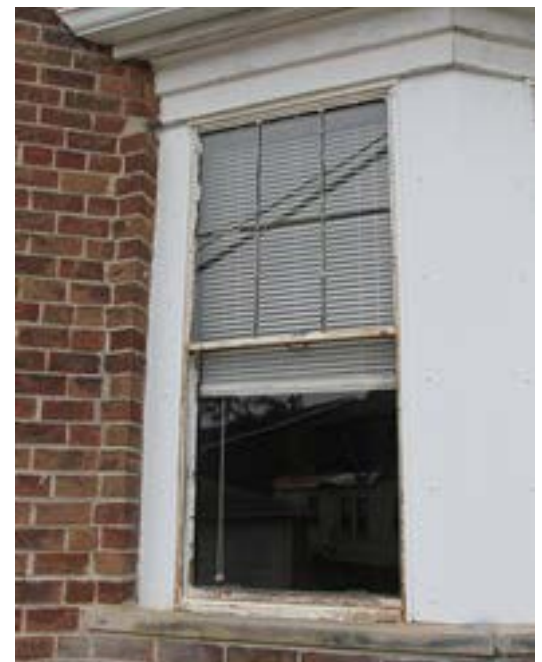
Window W2, Type V1

- Note: Extent of exterior deterioration, corrosion, and loss of operability is not fully apparent in interior photos. Replacement parts for existing windows are unavailable, making restoration of thermal and operable functionality impossible, and long-term maintenance infeasible. Recommendation is for replacement, for quality of life of future tenants and for feasibility of long-term maintenance.
- See Window Assessment (Blackberry) in appendix for further detail and information, including further notes on deterioration beyond repair
- See Appendix for Window Schedule & Measurements

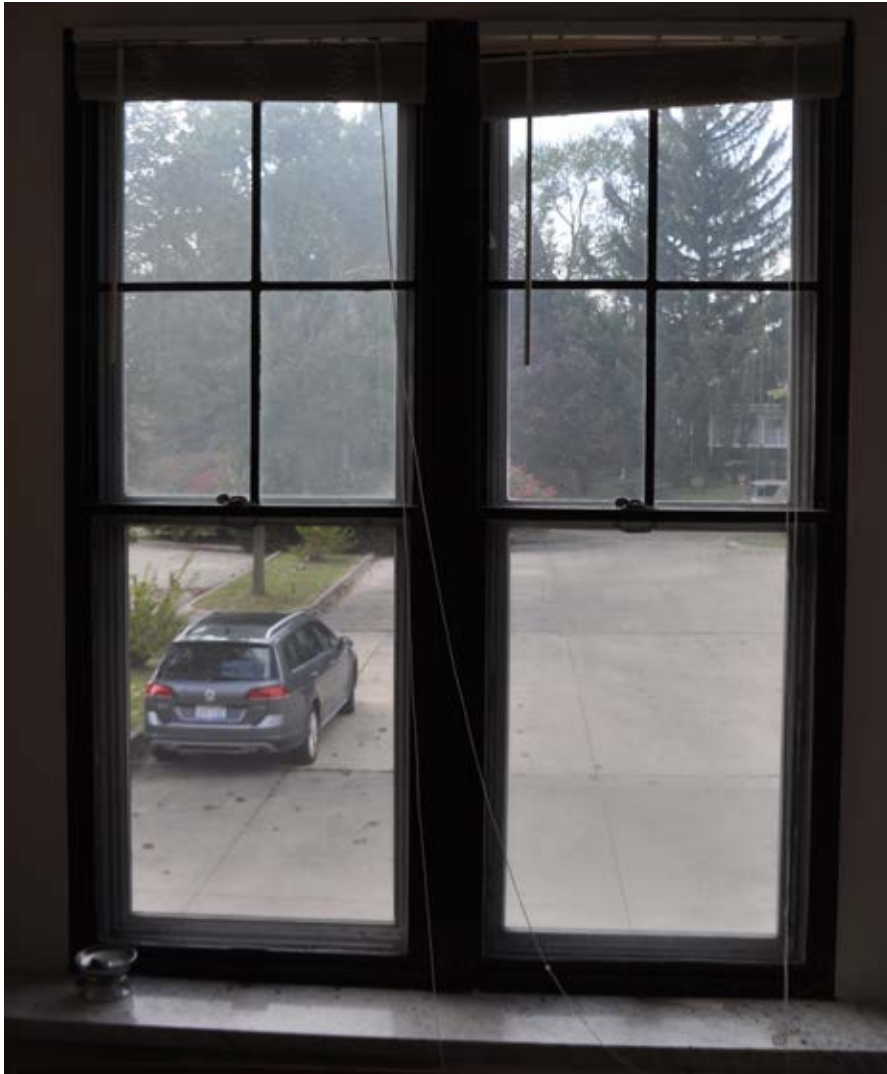
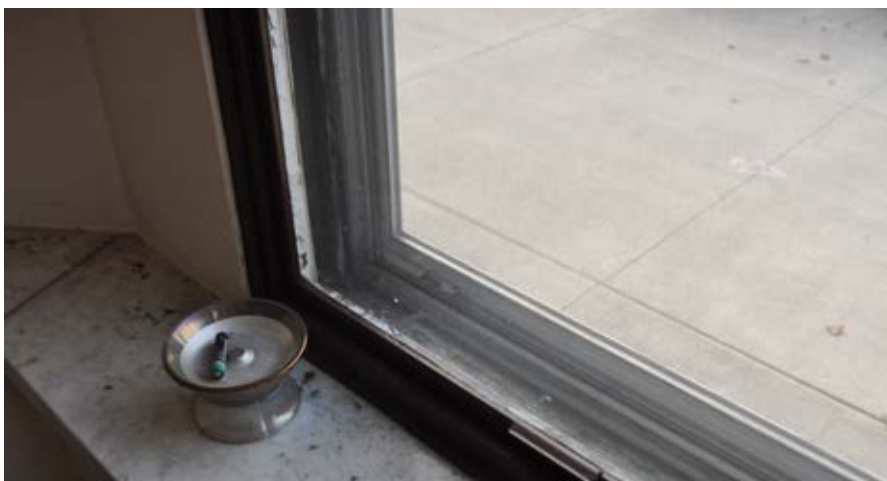
Window W3 & W4, Type X1

- Note: Extent of exterior deterioration, corrosion, and loss of operability is not fully apparent in interior photos. Replacement parts for existing windows are unavailable, making restoration of thermal and operable functionality impossible, and long-term maintenance infeasible. Recommendation is for replacement, for quality of life of future tenants and for feasibility of long-term maintenance.
- See Window Assessment (Blackberry) in appendix for further detail and information, including further notes on deterioration beyond repair
- See Appendix for Window Schedule & Measurements

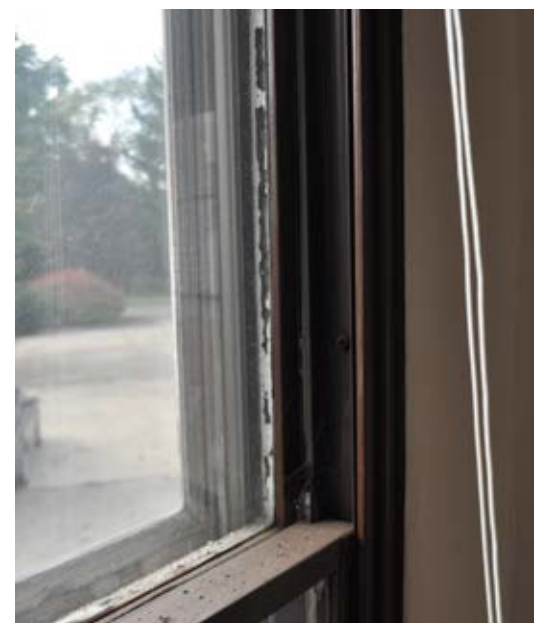
Window W5, Type V1

- Missing Balance
- Note: Extent of exterior deterioration, corrosion, and loss of operability is not fully apparent in interior photos. Replacement parts for existing windows are unavailable, making restoration of thermal and operable functionality impossible, and long-term maintenance infeasible. Recommendation is for replacement, for quality of life of future tenants and for feasibility of long-term maintenance.
- See Window Assessment (Blackberry) in appendix for further detail and information, including further notes on deterioration beyond repair
- See Appendix for Window Schedule & Measurements

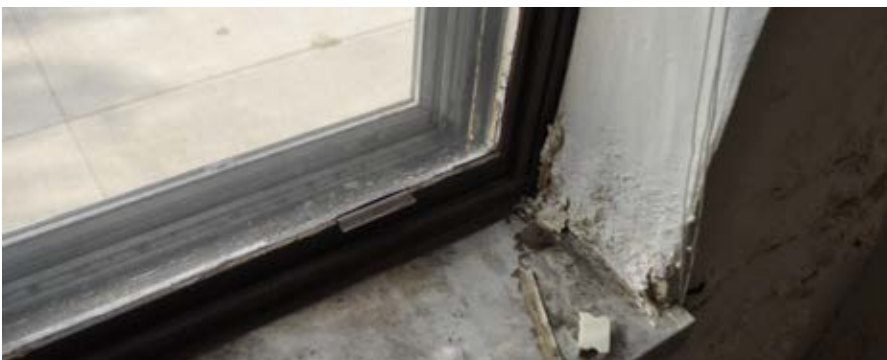
Window W6, Type R2

- Note: Extent of exterior deterioration, corrosion, and loss of operability is not fully apparent in interior photos. Replacement parts for existing windows are unavailable, making restoration of thermal and operable functionality impossible, and long-term maintenance infeasible. Recommendation is for replacement, for quality of life of future tenants and for feasibility of long-term maintenance.
- See Window Assessment (Blackberry) in appendix for further detail and information, including further notes on deterioration beyond repair
- See Appendix for Window Schedule & Measurements

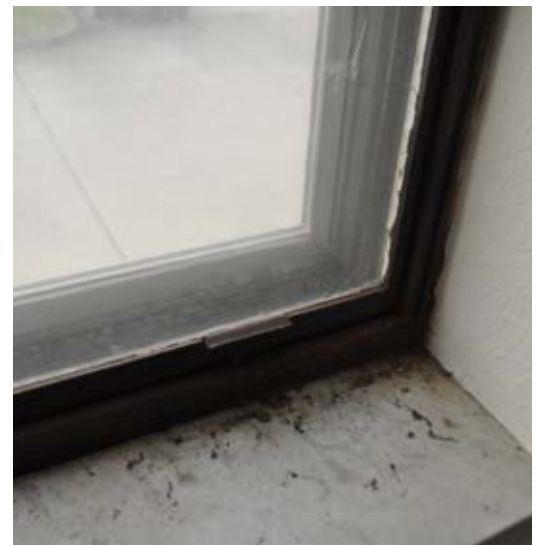
Window W7, Type R2

- Note: Extent of exterior deterioration, corrosion, and loss of operability is not fully apparent in interior photos. Replacement parts for existing windows are unavailable, making restoration of thermal and operable functionality impossible, and long-term maintenance infeasible. Recommendation is for replacement, for quality of life of future tenants and for feasibility of long-term maintenance.
- See Window Assessment (Blackberry) in appendix for further detail and information, including further notes on deterioration beyond repair
- See Appendix for Window Schedule & Measurements

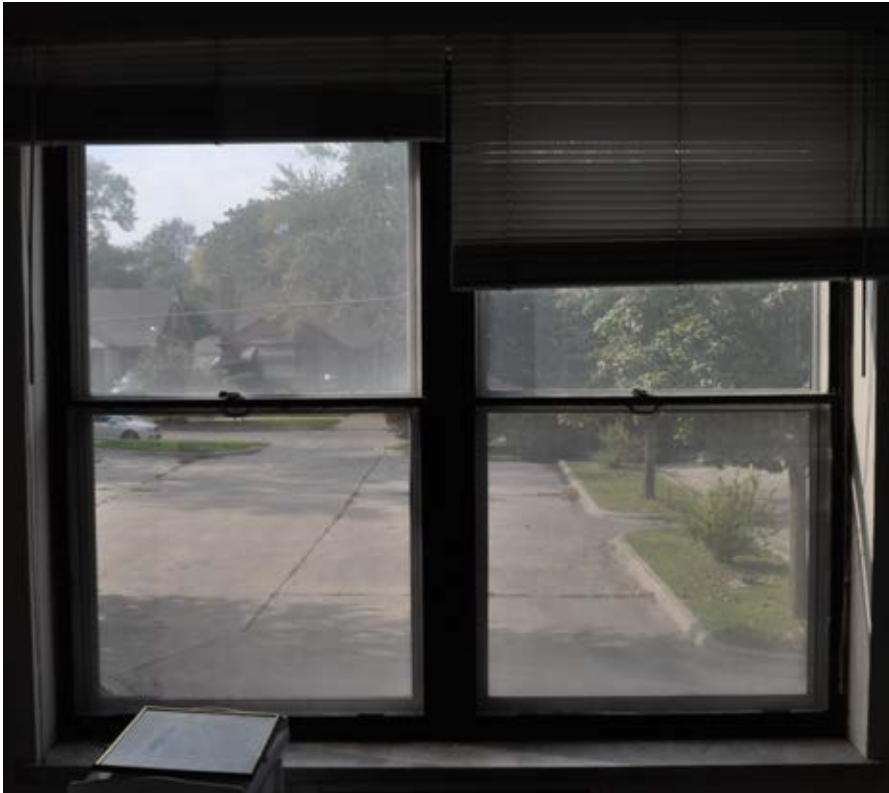
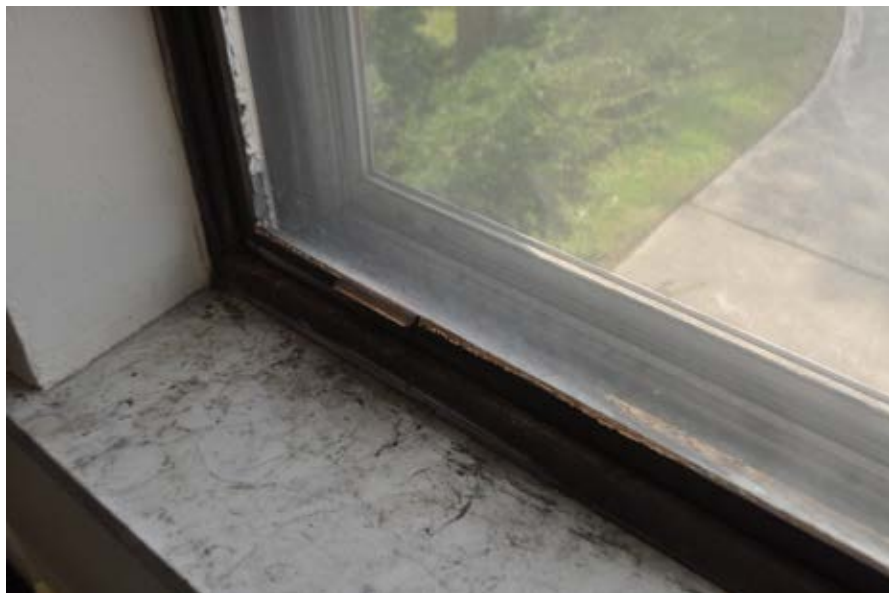
Window W8, Type P2

- Note: Extent of exterior deterioration, corrosion, and loss of operability is not fully apparent in interior photos. Replacement parts for existing windows are unavailable, making restoration of thermal and operable functionality impossible, and long-term maintenance infeasible. Recommendation is for replacement, for quality of life of future tenants and for feasibility of long-term maintenance.
- See Window Assessment (Blackberry) in appendix for further detail and information, including further notes on deterioration beyond repair
- See Appendix for Window Schedule & Measurements

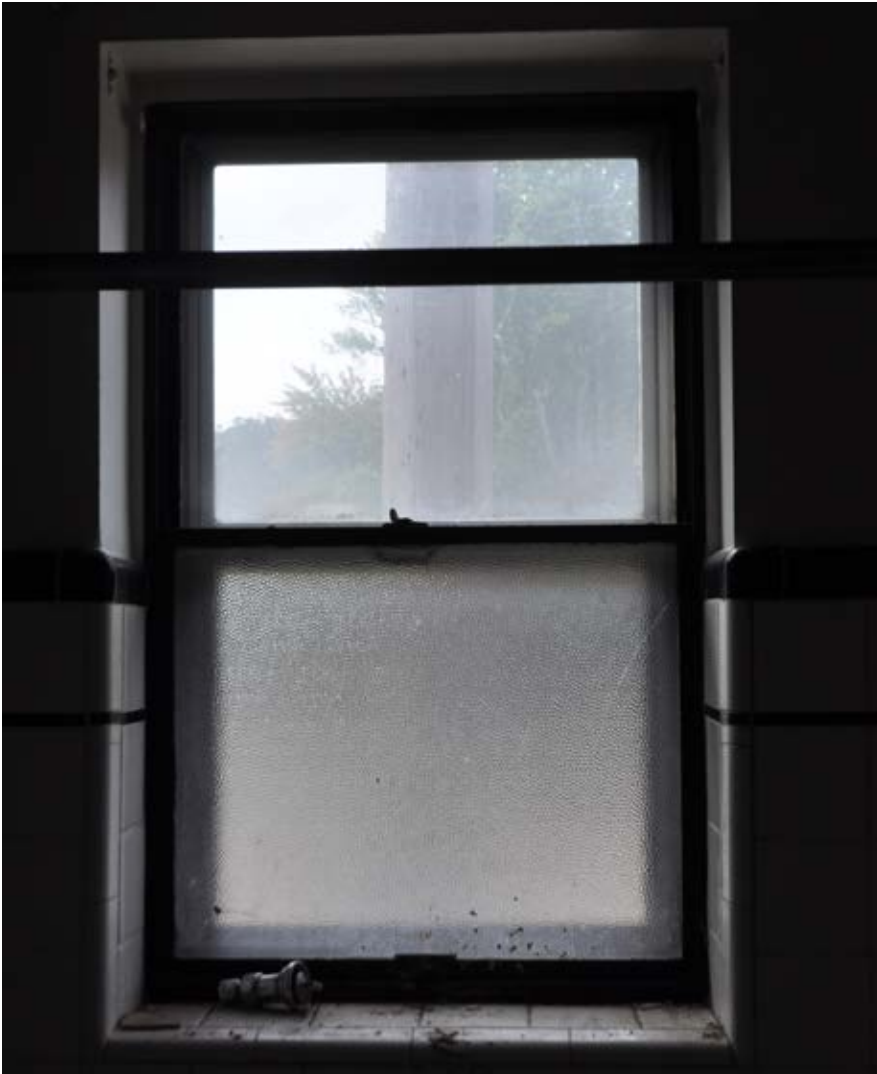
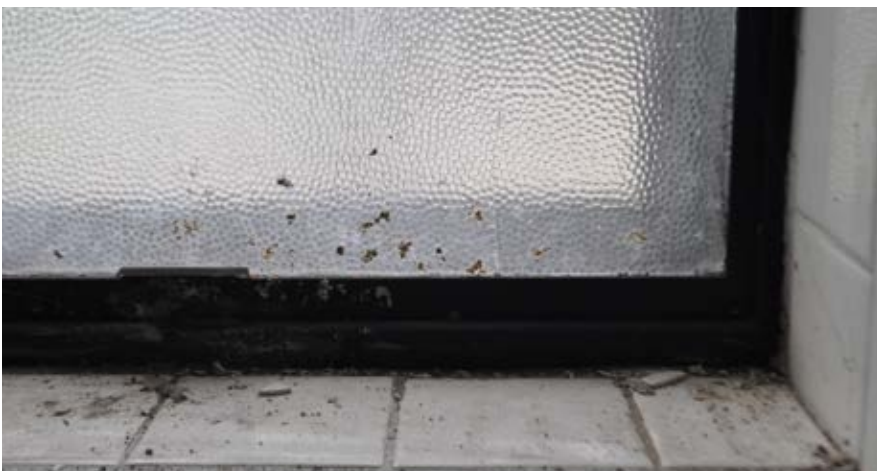
Window W9, Type U2

- Broken Glass
- Note: Extent of exterior deterioration, corrosion, and loss of operability is not fully apparent in interior photos. Replacement parts for existing windows are unavailable, making restoration of thermal and operable functionality impossible, and long-term maintenance infeasible. Recommendation is for replacement, for quality of life of future tenants and for feasibility of long-term maintenance.
- See Window Assessment (Blackberry) in appendix for further detail and information, including further notes on deterioration beyond repair
- See Appendix for Window Schedule & Measurements

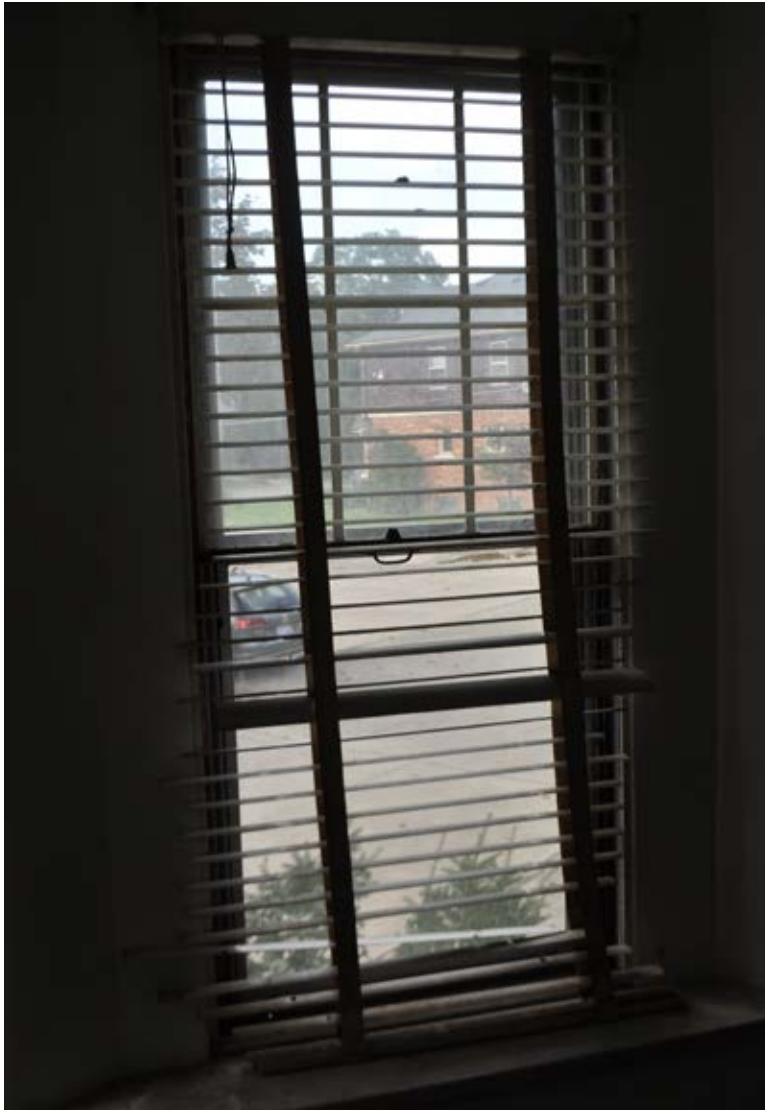
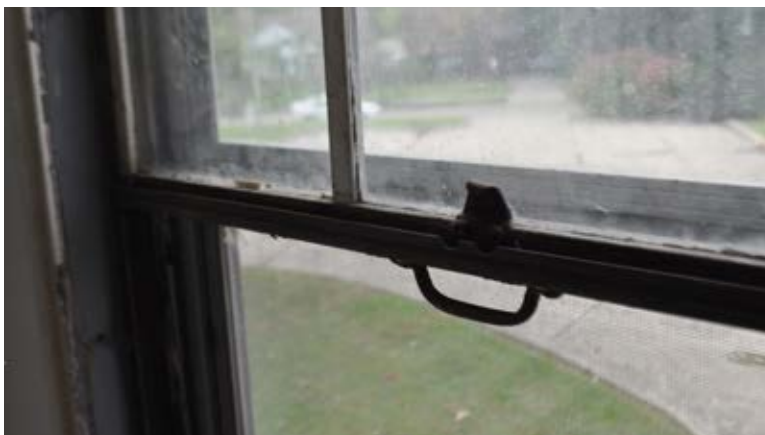
Window W10, Type V1

- Missing part of Sash Frame
- Note: Extent of exterior deterioration, corrosion, and loss of operability is not fully apparent in interior photos. Replacement parts for existing windows are unavailable, making restoration of thermal and operable functionality impossible, and long-term maintenance infeasible. Recommendation is for replacement, for quality of life of future tenants and for feasibility of long-term maintenance.
- See Window Assessment (Blackberry) in appendix for further detail and information, including further notes on deterioration beyond repair
- See Appendix for Window Schedule & Measurements

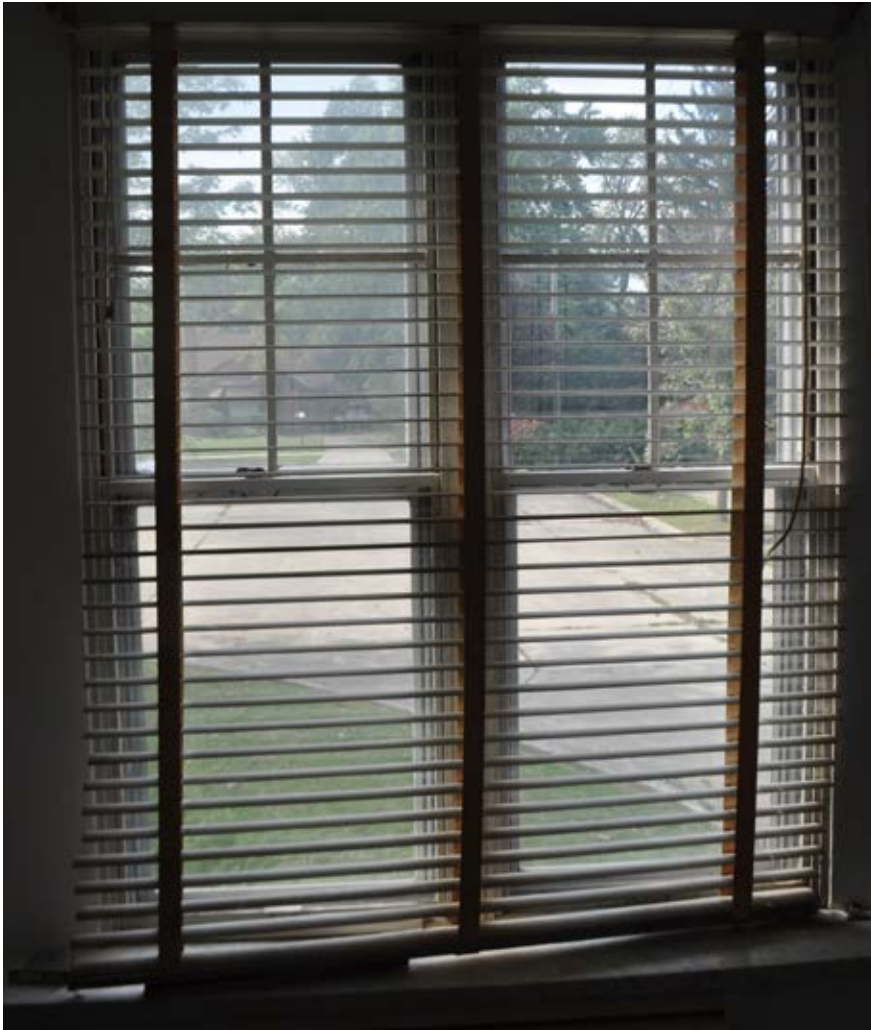
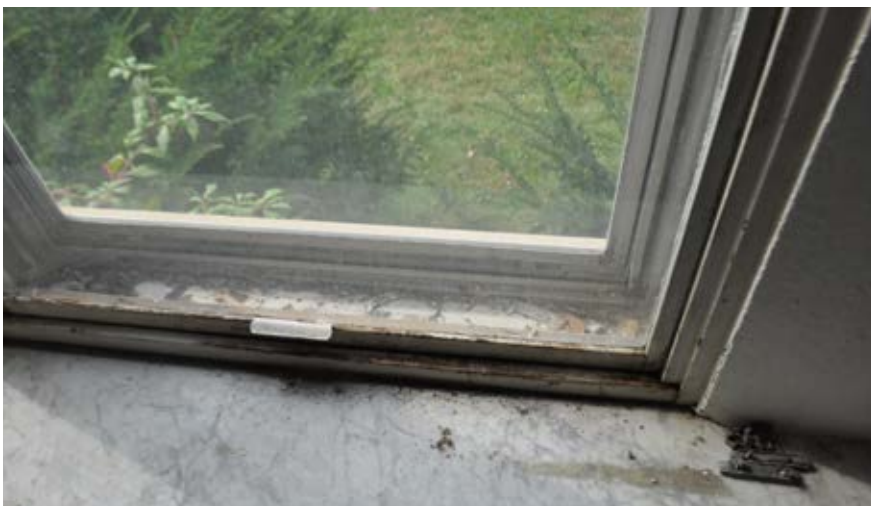
Window W11 & W12, Type X1

- Note: Extent of exterior deterioration, corrosion, and loss of operability is not fully apparent in interior photos. Replacement parts for existing windows are unavailable, making restoration of thermal and operable functionality impossible, and long-term maintenance infeasible. Recommendation is for replacement, for quality of life of future tenants and for feasibility of long-term maintenance.
- See Window Assessment (Blackberry) in appendix for further detail and information, including further notes on deterioration beyond repair
- See Appendix for Window Schedule & Measurements

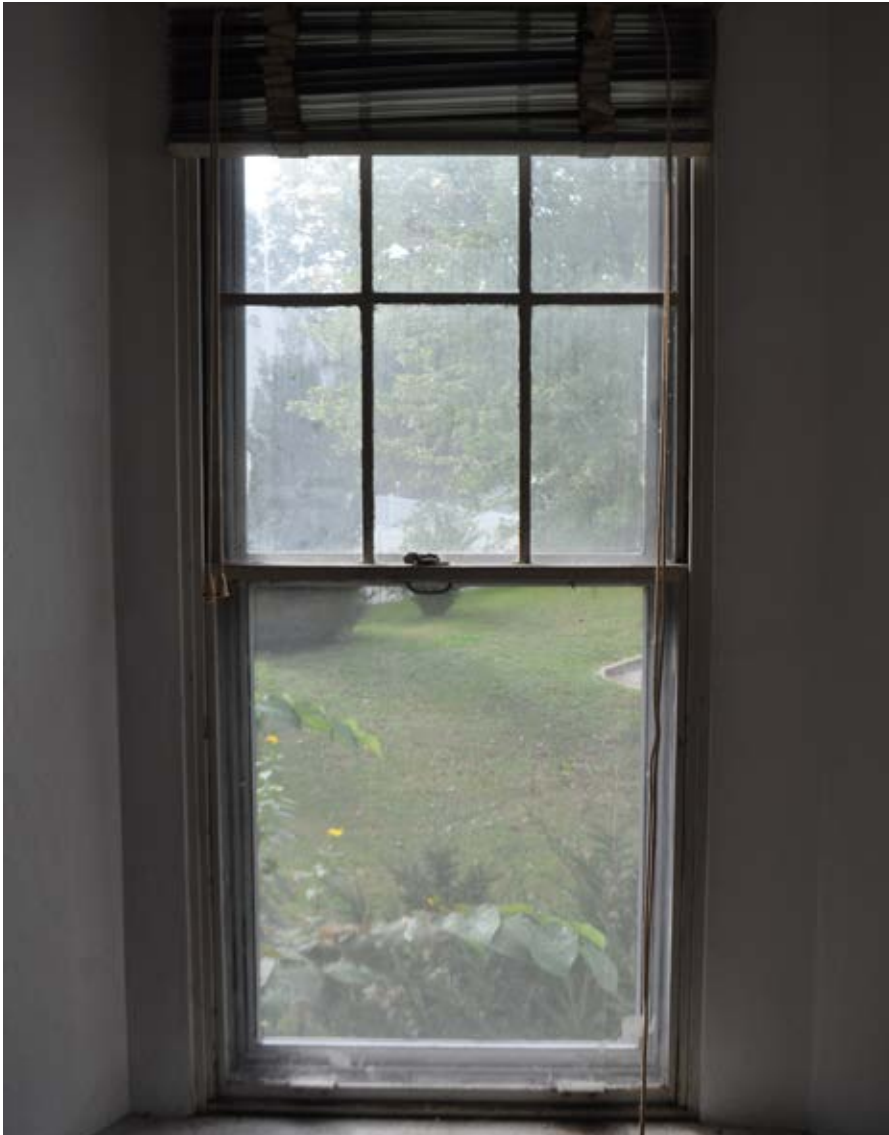
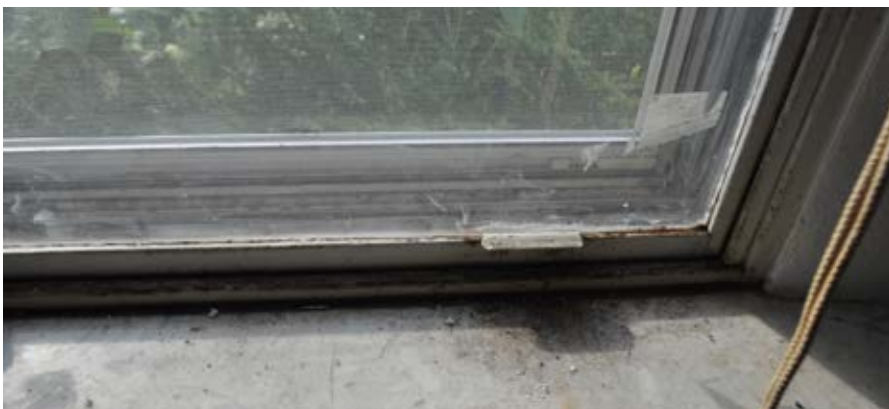
Window W13, Type V1

- Note: Extent of exterior deterioration, corrosion, and loss of operability is not fully apparent in interior photos. Replacement parts for existing windows are unavailable, making restoration of thermal and operable functionality impossible, and long-term maintenance infeasible. Recommendation is for replacement, for quality of life of future tenants and for feasibility of long-term maintenance.
- See Window Assessment (Blackberry) in appendix for further detail and information, including further notes on deterioration beyond repair
- See Appendix for Window Schedule & Measurements

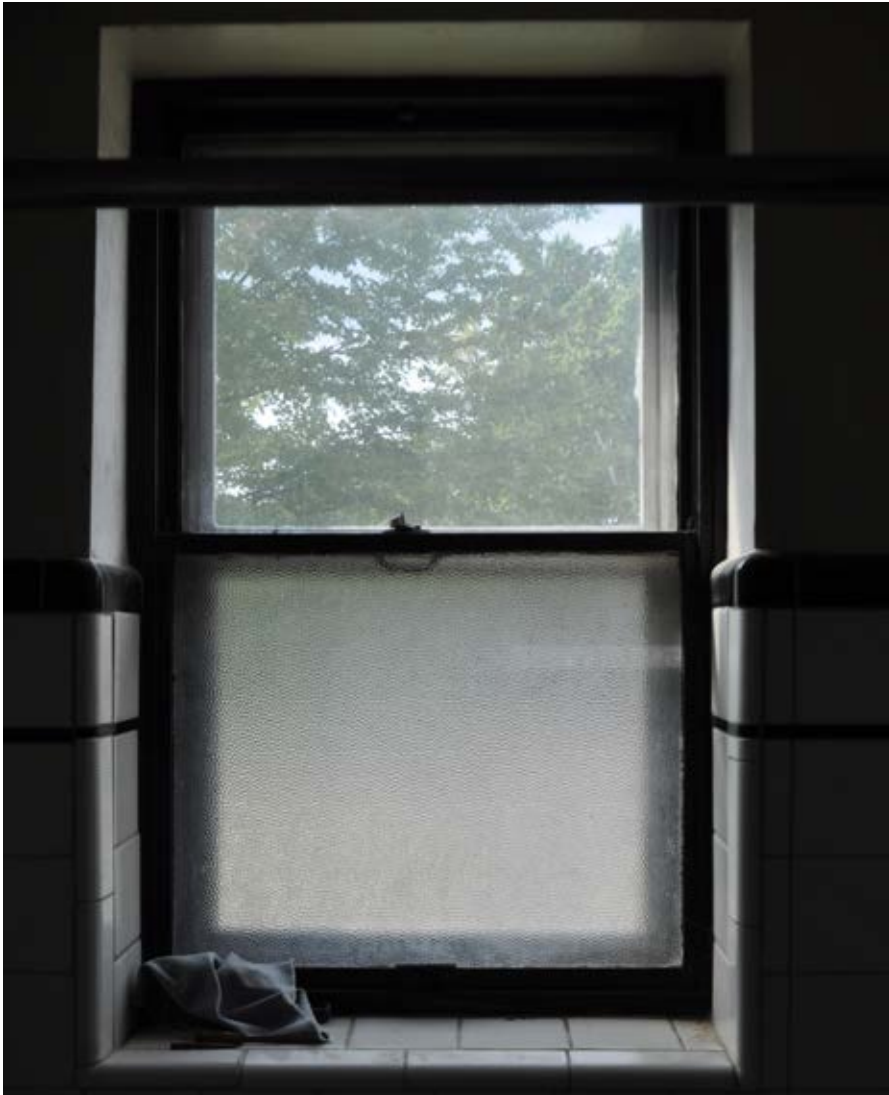
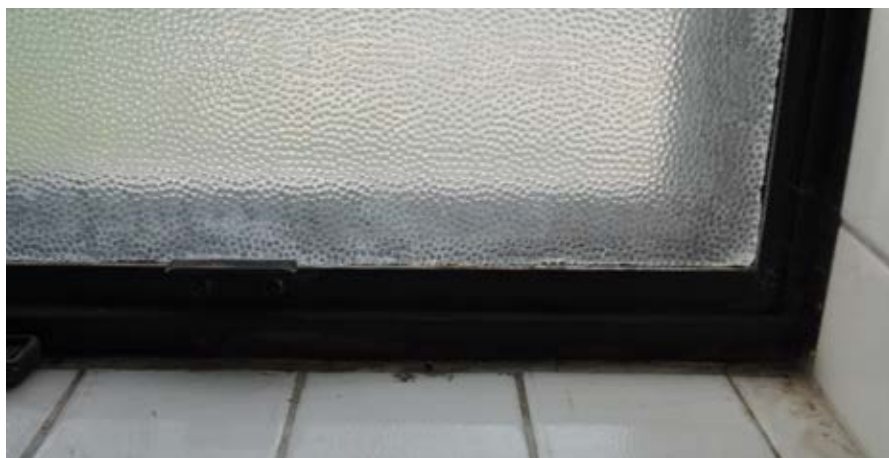
Window W14, Type U2

- Note: Extent of exterior deterioration, corrosion, and loss of operability is not fully apparent in interior photos. Replacement parts for existing windows are unavailable, making restoration of thermal and operable functionality impossible, and long-term maintenance infeasible. Recommendation is for replacement, for quality of life of future tenants and for feasibility of long-term maintenance.
- See Window Assessment (Blackberry) in appendix for further detail and information, including further notes on deterioration beyond repair
- See Appendix for Window Schedule & Measurements

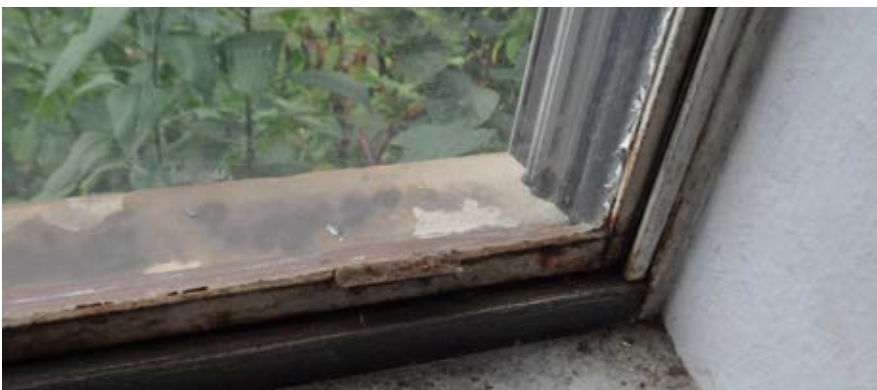
Window W15, Type R2

- Badly Corroded
- Note: Extent of exterior deterioration, corrosion, and loss of operability is not fully apparent in interior photos. Replacement parts for existing windows are unavailable, making restoration of thermal and operable functionality impossible, and long-term maintenance infeasible. Recommendation is for replacement, for quality of life of future tenants and for feasibility of long-term maintenance.
- See Window Assessment (Blackberry) in appendix for further detail and information, including further notes on deterioration beyond repair
- See Appendix for Window Schedule & Measurements

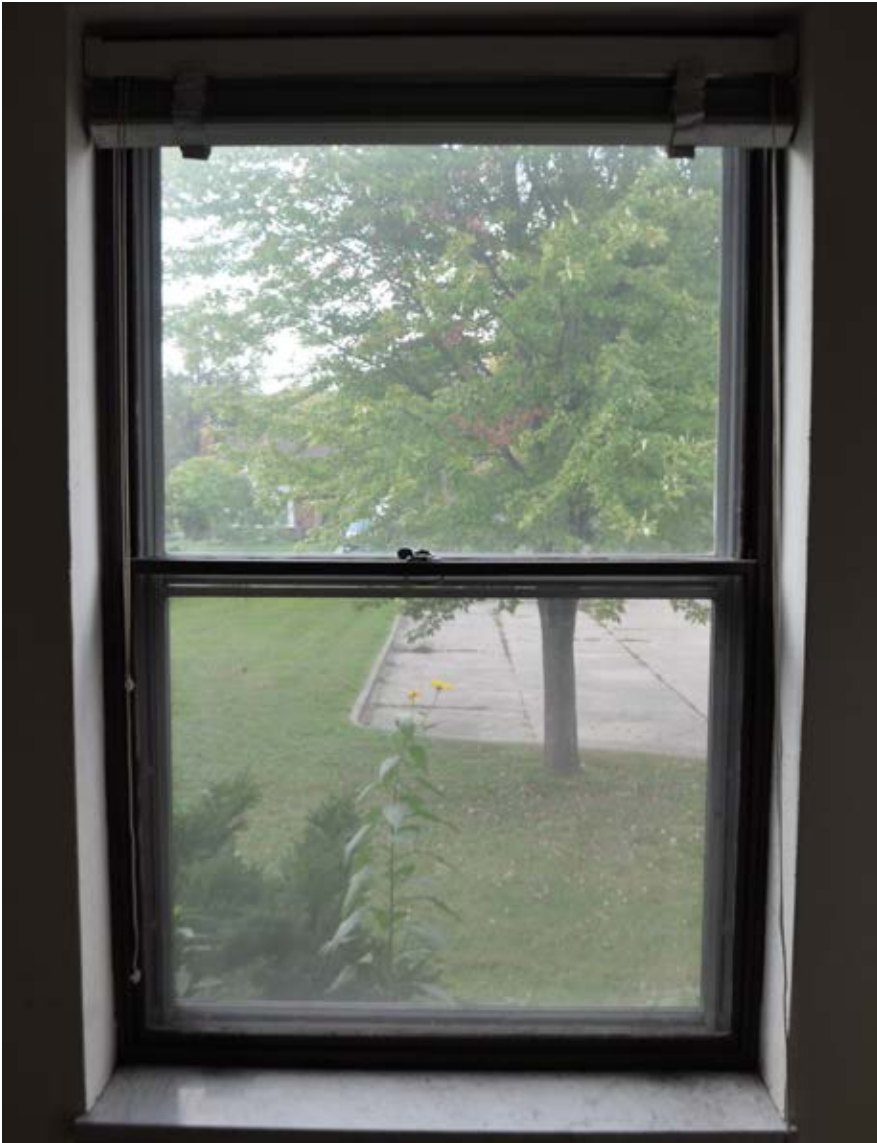
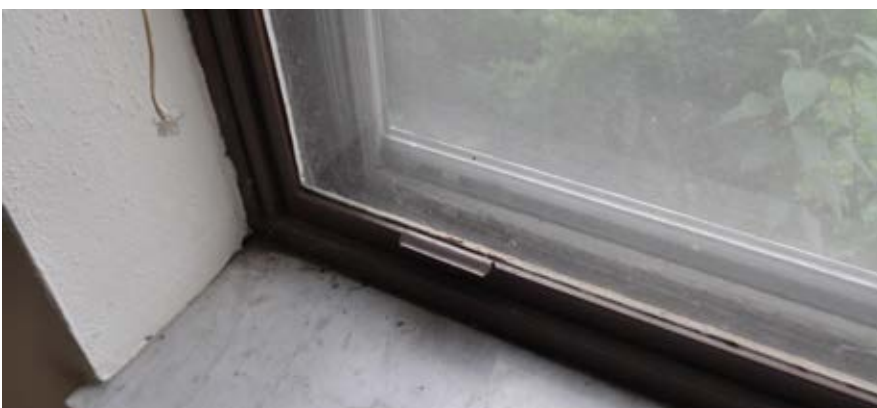
Window DEMO 02, Type R2

- Note: Extent of exterior deterioration, corrosion, and loss of operability is not fully apparent in interior photos. Replacement parts for existing windows are unavailable, making restoration of thermal and operable functionality impossible, and long-term maintenance infeasible. Recommendation is for replacement, for quality of life of future tenants and for feasibility of long-term maintenance.
- See Window Assessment (Blackberry) in appendix for further detail and information, including further notes on deterioration beyond repair
- See Appendix for Window Schedule & Measurements

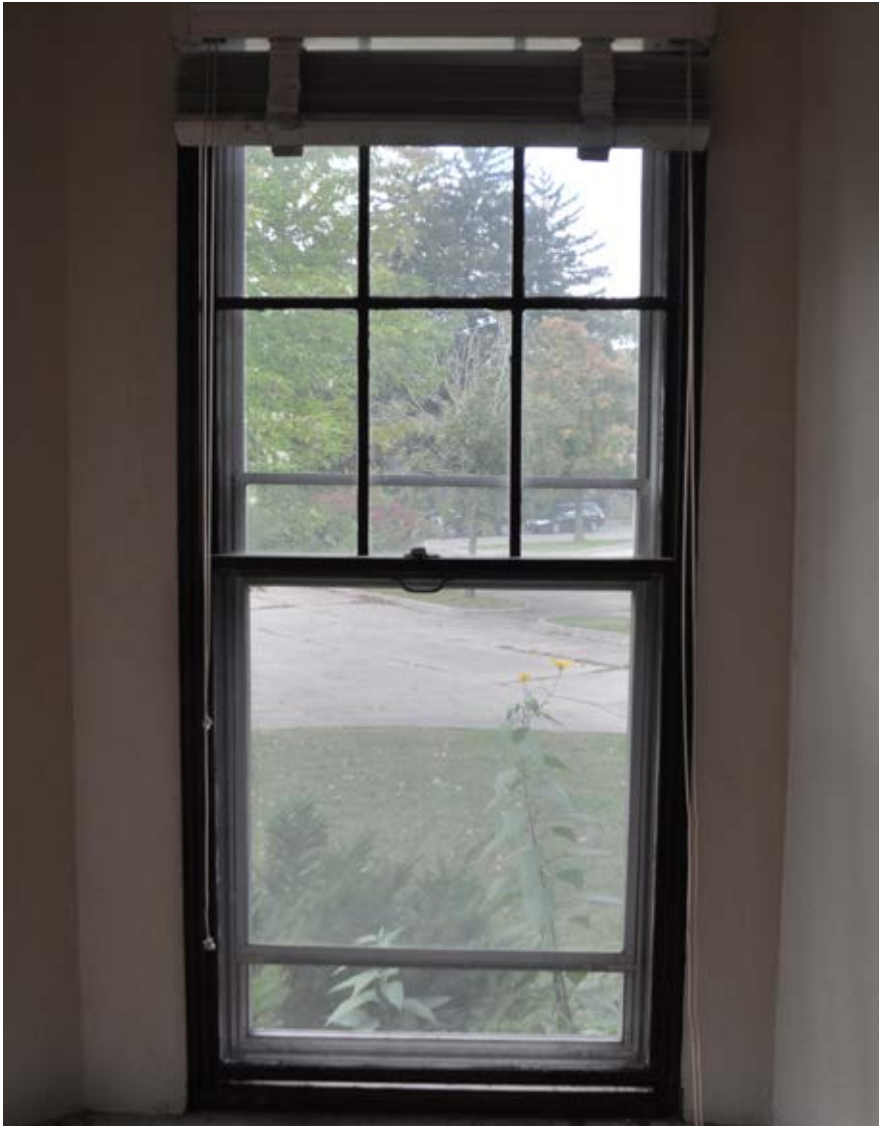
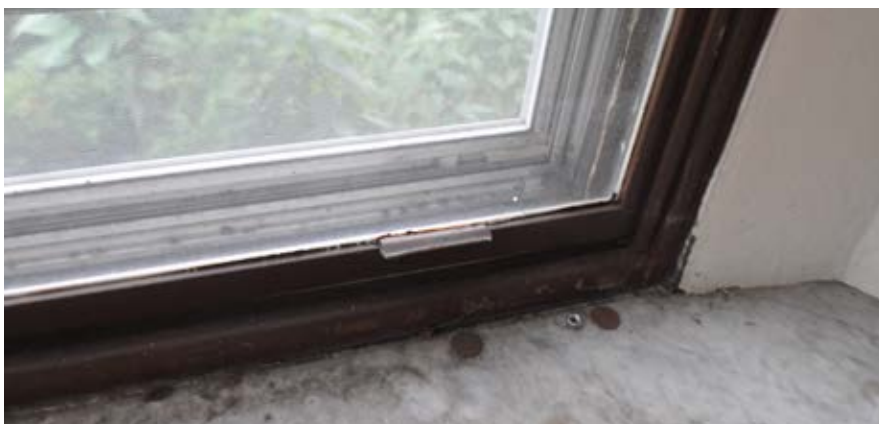
Window W16, Type V1

- Note: Extent of exterior deterioration, corrosion, and loss of operability is not fully apparent in interior photos. Replacement parts for existing windows are unavailable, making restoration of thermal and operable functionality impossible, and long-term maintenance infeasible. Recommendation is for replacement, for quality of life of future tenants and for feasibility of long-term maintenance.
- See Window Assessment (Blackberry) in appendix for further detail and information, including further notes on deterioration beyond repair
- See Appendix for Window Schedule & Measurements
