9710 W Outer Dr

Existing Condition Photos

Current Design Description

A 3-story apartment structure with 10 residential units, constructed in 1940, brick on wood stud wall construction, shingle roof, stone corner details, stone details at palladian window, stone sills, wood detailing at front entry, steel and wood canopy at back entry, wood windows throughout with the exception of steel windows at bathrooms and the lowest level. The addition of a brick shed to house the gas meter was made at a later date.

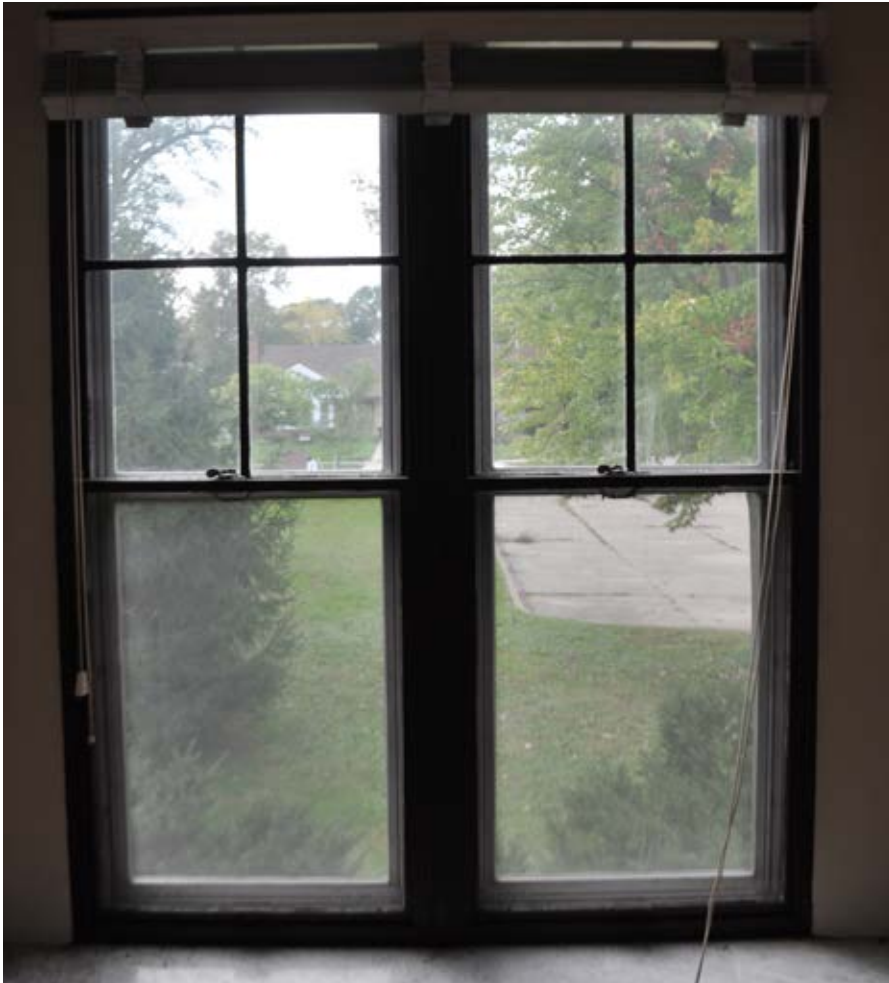
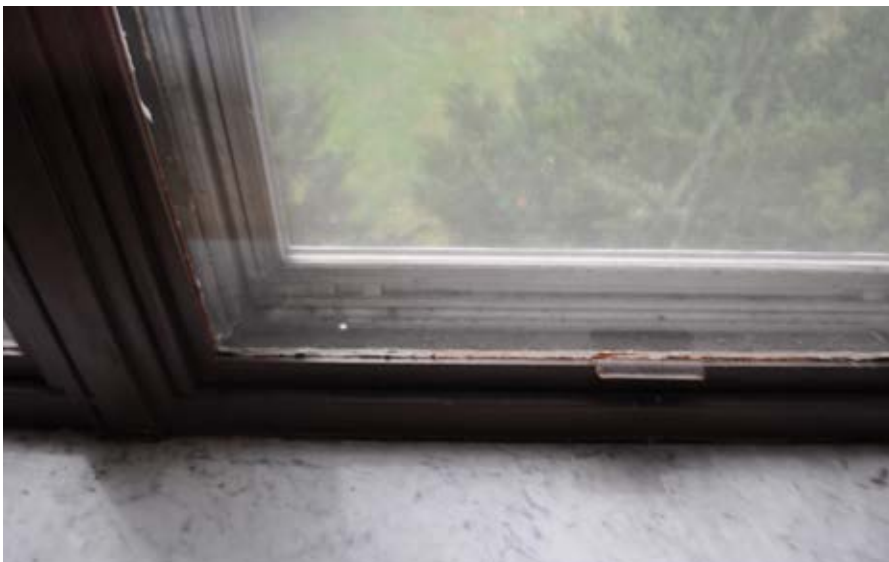
Window W17 & W18, Type X1

- Note: Extent of exterior deterioration, corrosion, and loss of operability is not fully apparent in interior photos. Replacement parts for existing windows are unavailable, making restoration of thermal and operable functionality impossible, and long-term maintenance infeasible. Recommendation is for replacement, for quality of life of future tenants and for feasibility of long-term maintenance.
- See Window Assessment (Blackberry) in appendix for further detail and information, including further notes on deterioration beyond repair
- See Appendix for Window Schedule & Measurements

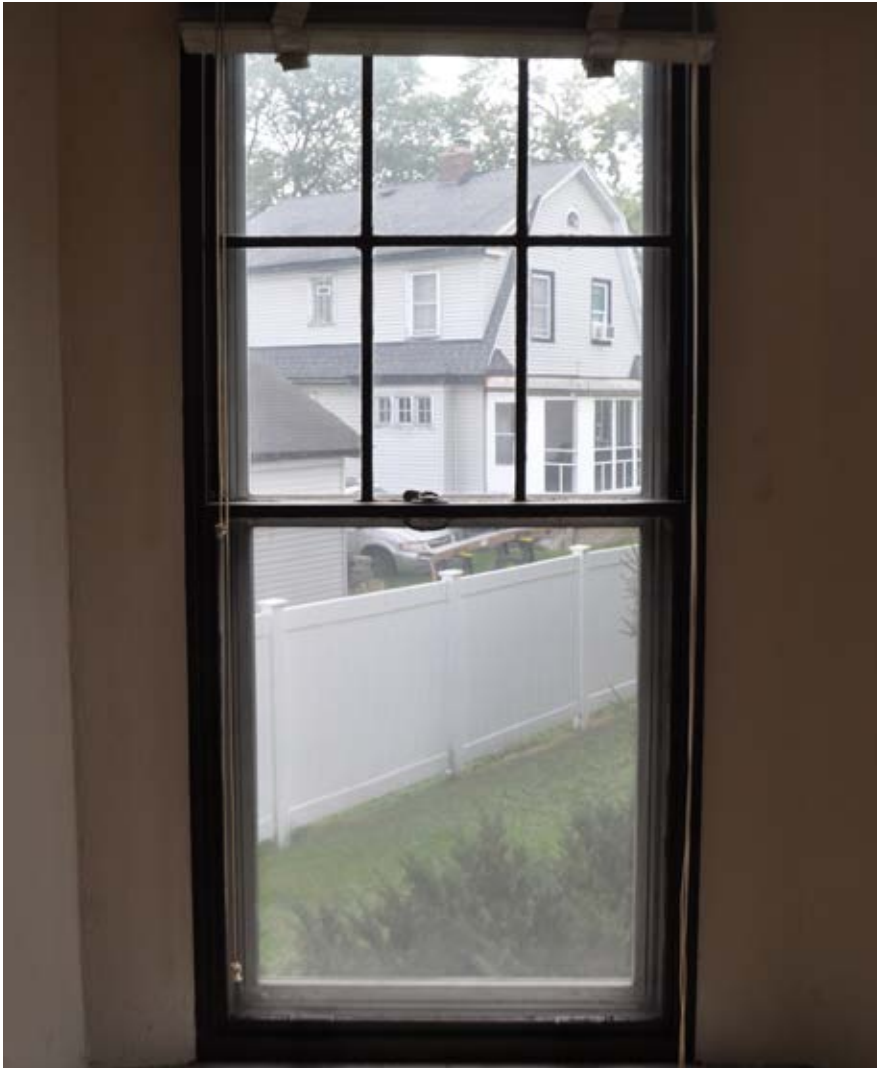
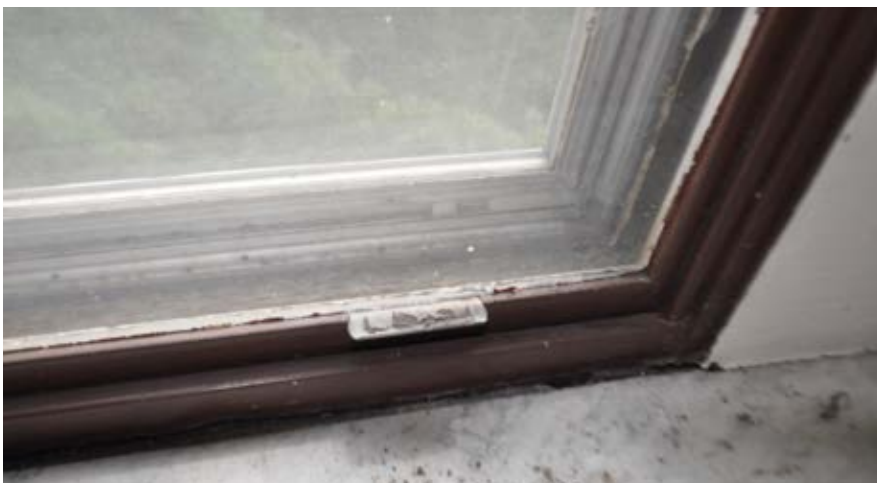
Window W19, Type V1

- Note: Extent of exterior deterioration, corrosion, and loss of operability is not fully apparent in interior photos. Replacement parts for existing windows are unavailable, making restoration of thermal and operable functionality impossible, and long-term maintenance infeasible. Recommendation is for replacement, for quality of life of future tenants and for feasibility of long-term maintenance.
- See Window Assessment (Blackberry) in appendix for further detail and information, including further notes on deterioration beyond repair
- See Appendix for Window Schedule & Measurements

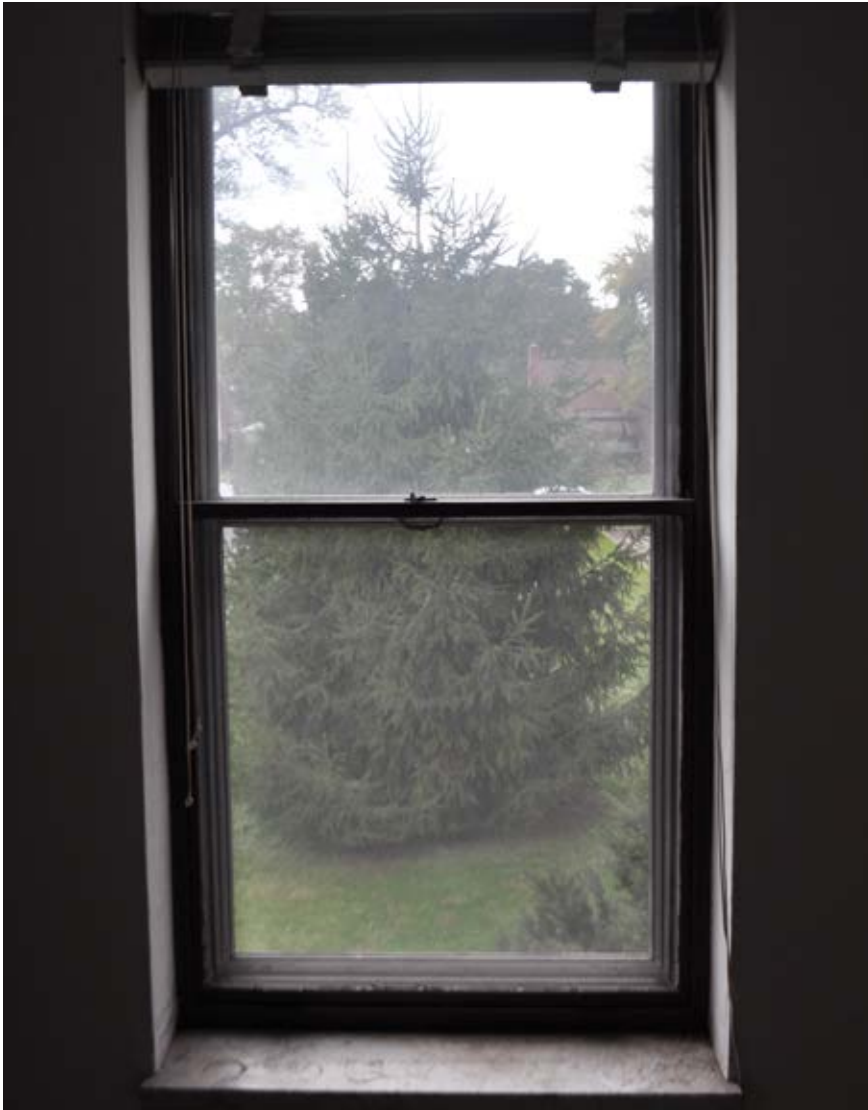
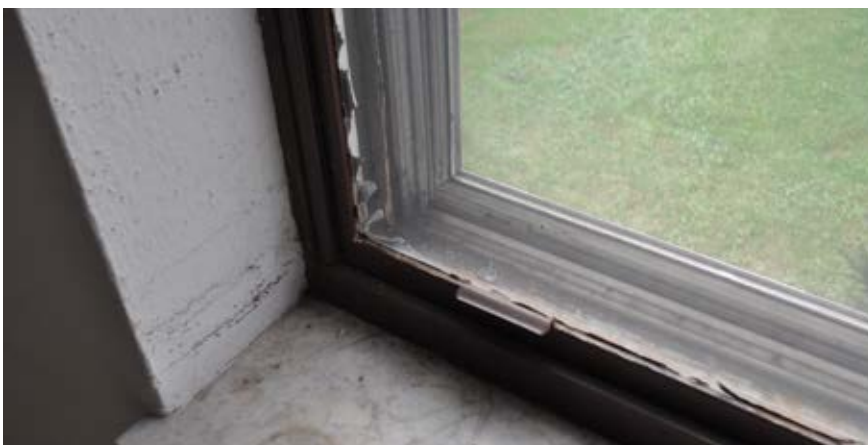
Window W20, Type N2

- Note: Extent of exterior deterioration, corrosion, and loss of operability is not fully apparent in interior photos. Replacement parts for existing windows are unavailable, making restoration of thermal and operable functionality impossible, and long-term maintenance infeasible. Recommendation is for replacement, for quality of life of future tenants and for feasibility of long-term maintenance.
- See Window Assessment (Blackberry) in appendix for further detail and information, including further notes on deterioration beyond repair
- See Appendix for Window Schedule & Measurements

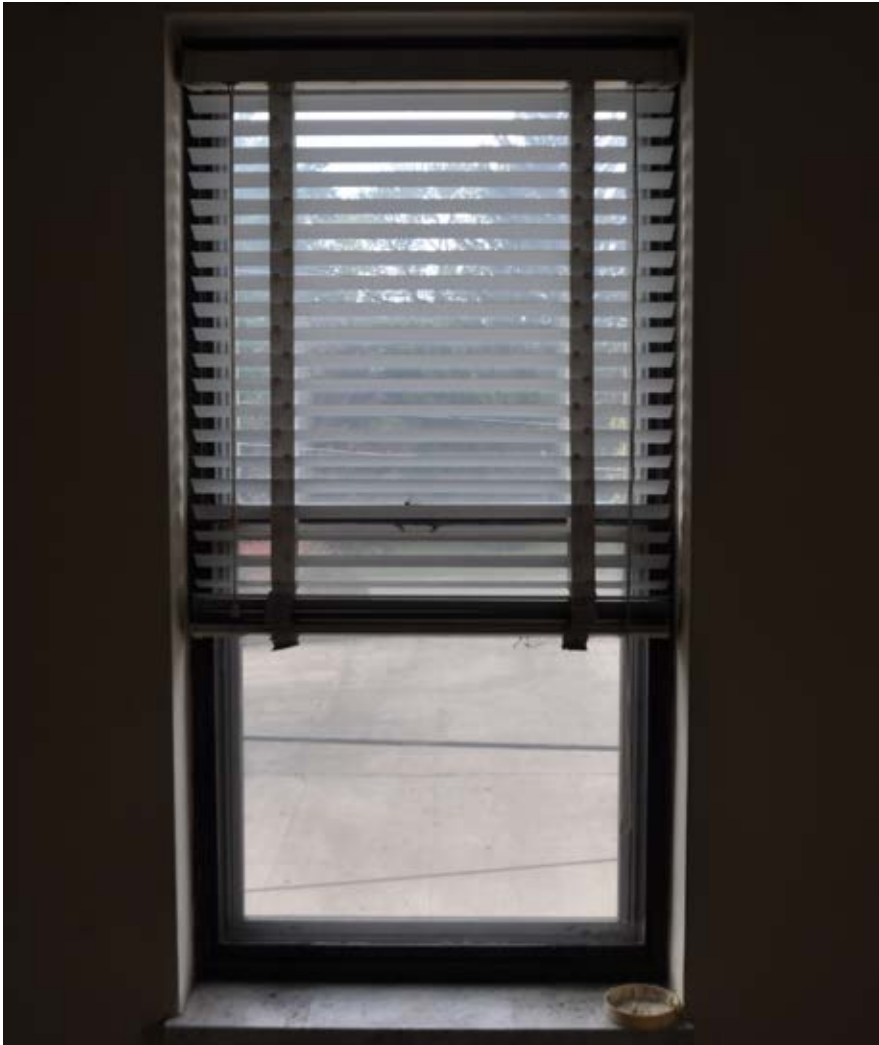
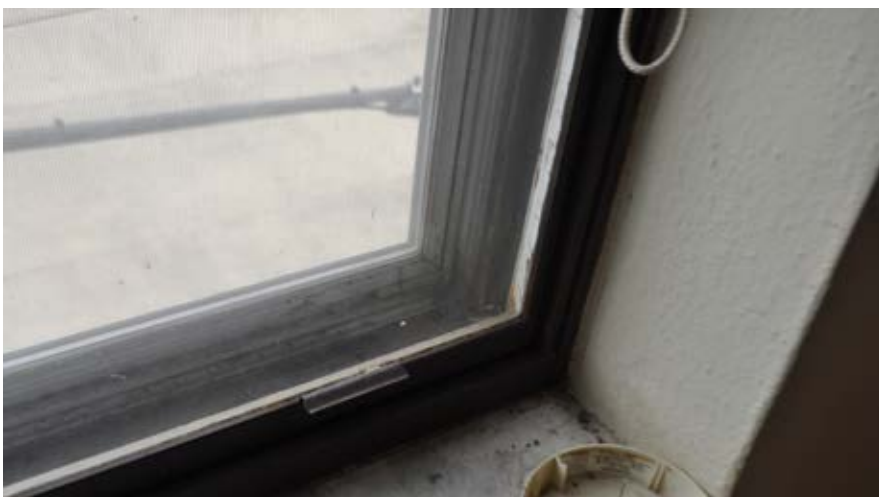
Window X1, Type N2

- Note: Extent of exterior deterioration, corrosion, and loss of operability is not fully apparent in interior photos. Replacement parts for existing windows are unavailable, making restoration of thermal and operable functionality impossible, and long-term maintenance infeasible. Recommendation is for replacement, for quality of life of future tenants and for feasibility of long-term maintenance.
- See Window Assessment (Blackberry) in appendix for further detail and information, including further notes on deterioration beyond repair
- See Appendix for Window Schedule & Measurements

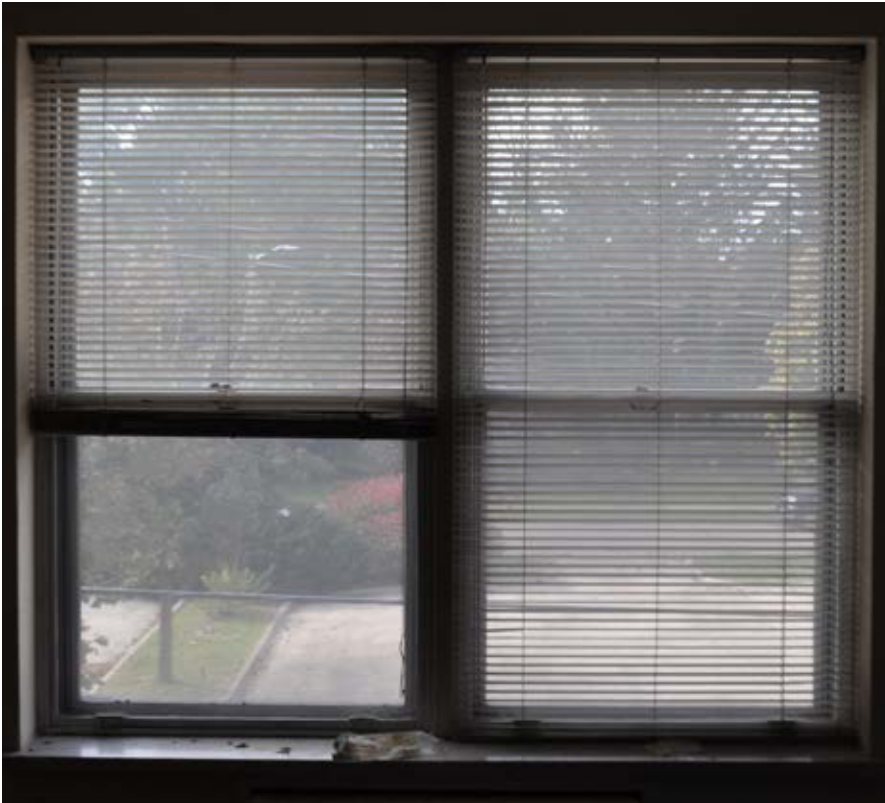
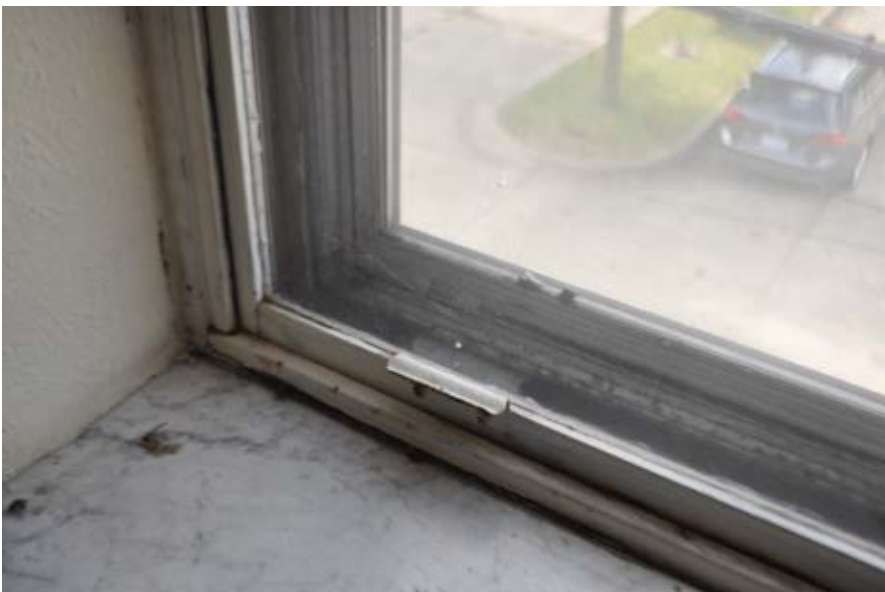
Window X2, Type P2

- Note: Extent of exterior deterioration, corrosion, and loss of operability is not fully apparent in interior photos. Replacement parts for existing windows are unavailable, making restoration of thermal and operable functionality impossible, and long-term maintenance infeasible. Recommendation is for replacement, for quality of life of future tenants and for feasibility of long-term maintenance.
- See Window Assessment (Blackberry) in appendix for further detail and information, including further notes on deterioration beyond repair
- See Appendix for Window Schedule & Measurements

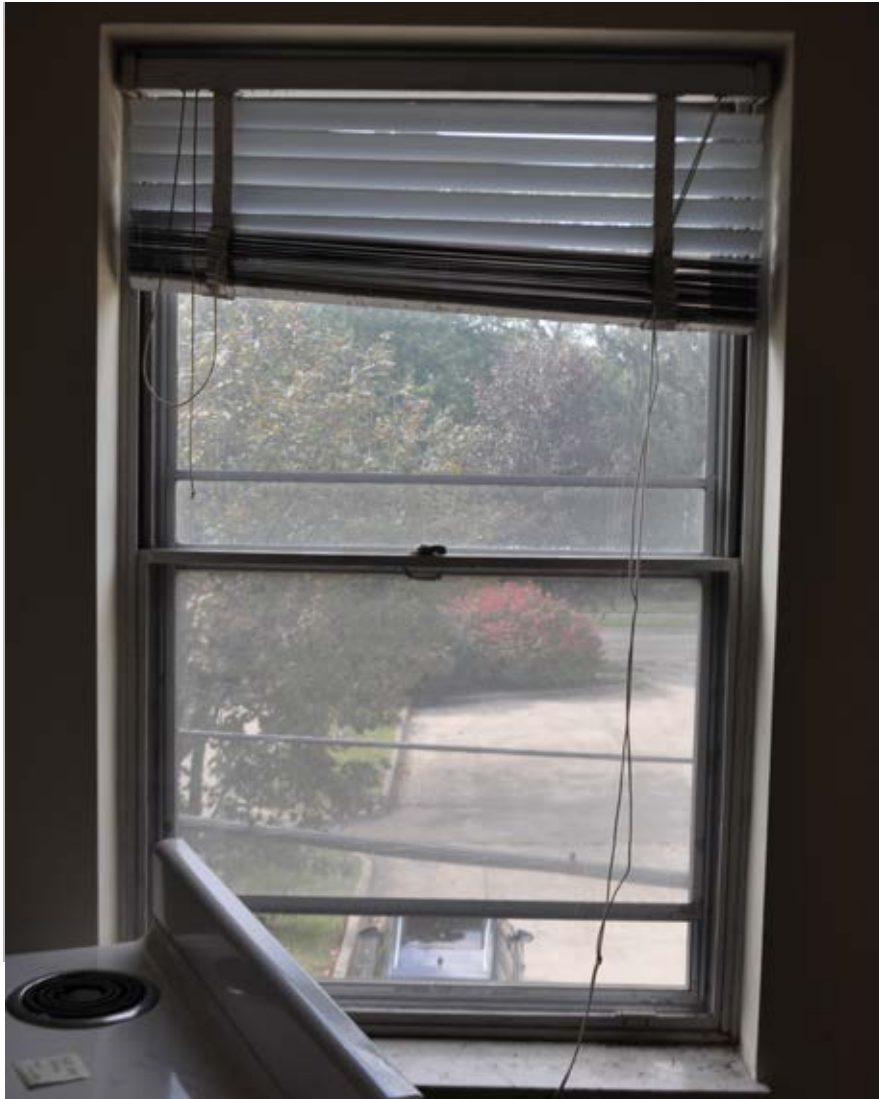
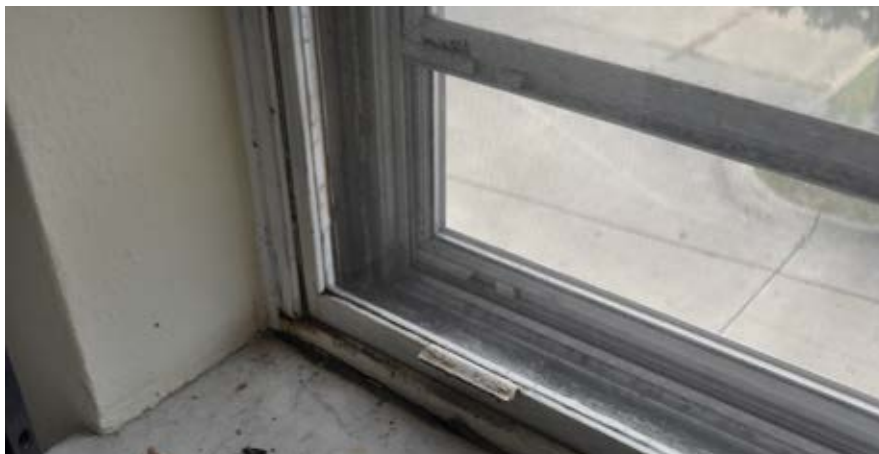
Window X3, Type R2

- Note: Extent of exterior deterioration, corrosion, and loss of operability is not fully apparent in interior photos. Replacement parts for existing windows are unavailable, making restoration of thermal and operable functionality impossible, and long-term maintenance infeasible. Recommendation is for replacement, for quality of life of future tenants and for feasibility of long-term maintenance.
- See Window Assessment (Blackberry) in appendix for further detail and information, including further notes on deterioration beyond repair
- See Appendix for Window Schedule & Measurements

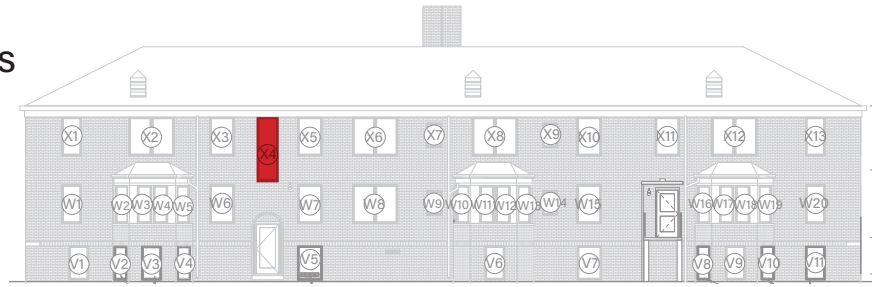
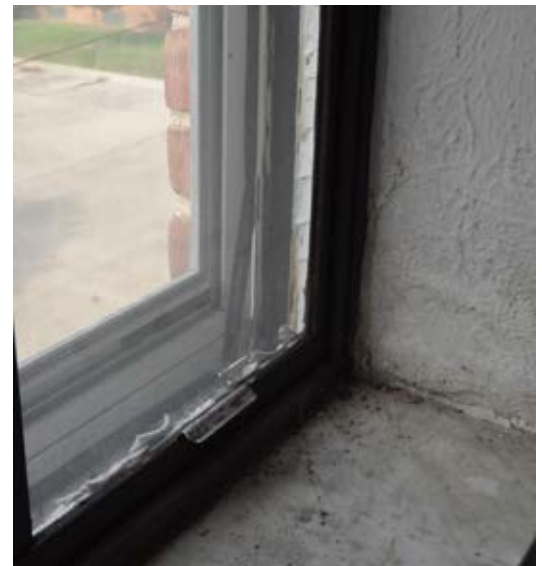
Window X4, Type S7

- Existing Fixed Window at Common Area Stairwell to be repaired
- See Appendix for Window Schedule & Measurements
- See Window Assessment & Survey by Blackberry in appendices for further details and information

Window Replacement

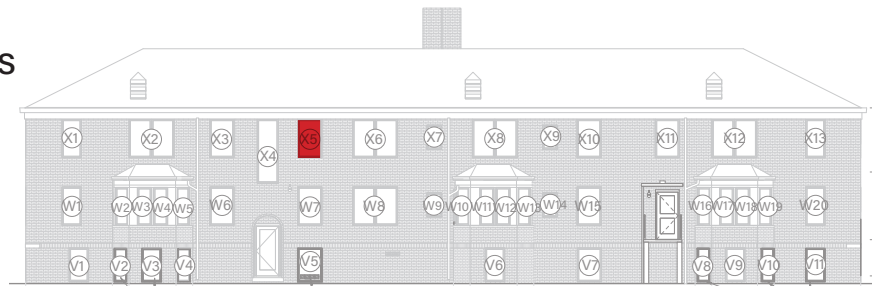
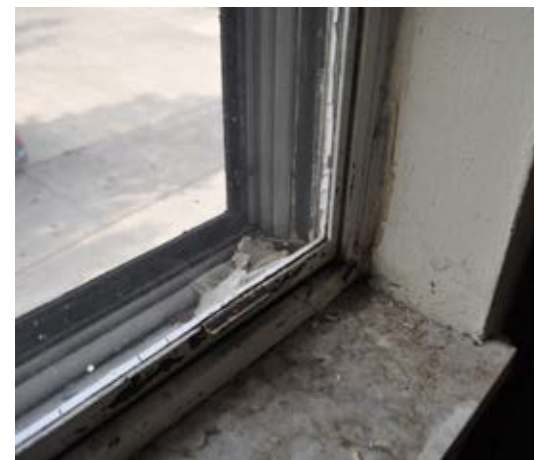
Window X5, Type R2

- Note: Extent of exterior deterioration, corrosion, and loss of operability is not fully apparent in interior photos. Replacement parts for existing windows are unavailable, making restoration of thermal and operable functionality impossible, and long-term maintenance infeasible. Recommendation is for replacement, for quality of life of future tenants and for feasibility of long-term maintenance.
- See Window Assessment (Blackberry) in appendix for further detail and information, including further notes on deterioration beyond repair
- See Appendix for Window Schedule & Measurements

Window Replacement

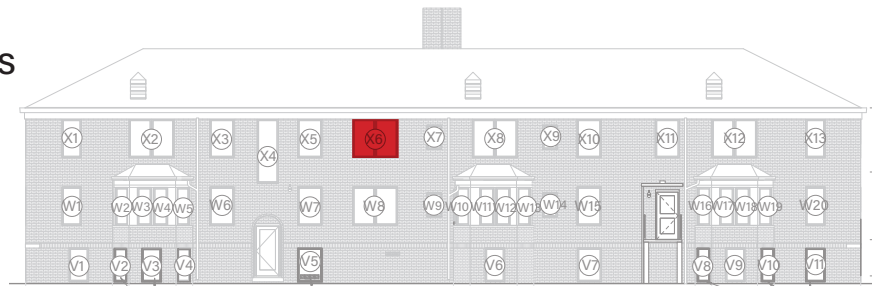
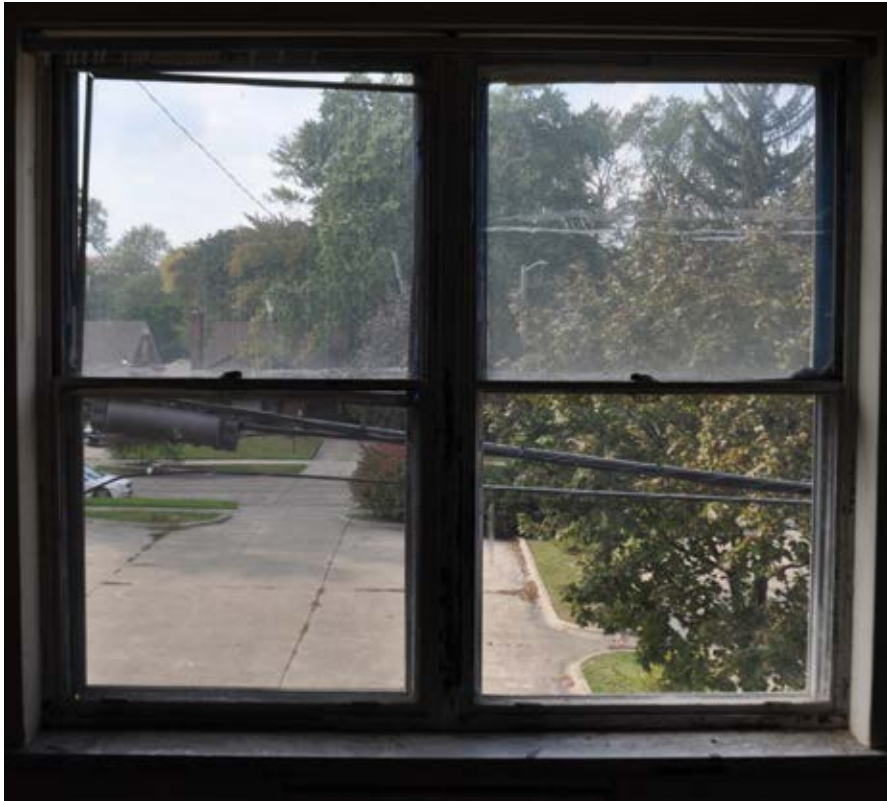
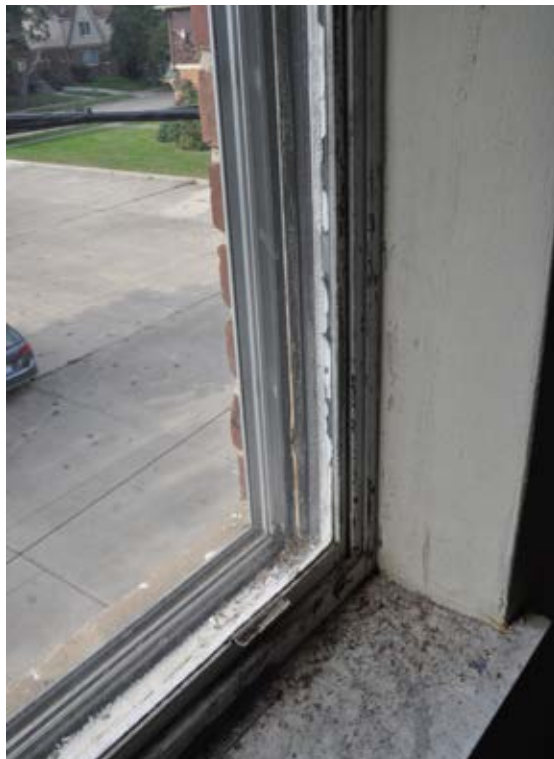
Window X6, Type P2

- Note: Extent of exterior deterioration, corrosion, and loss of operability is not fully apparent in interior photos. Replacement parts for existing windows are unavailable, making restoration of thermal and operable functionality impossible, and long-term maintenance infeasible. Recommendation is for replacement, for quality of life of future tenants and for feasibility of long-term maintenance.
- See Window Assessment (Blackberry) in appendix for further detail and information, including further notes on deterioration beyond repair
- See Appendix for Window Schedule & Measurements

Window Replacement

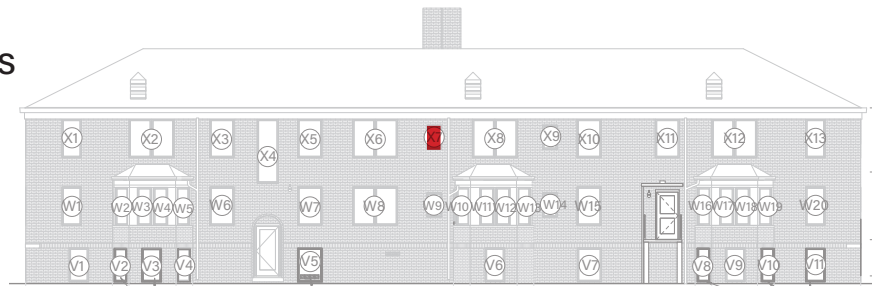
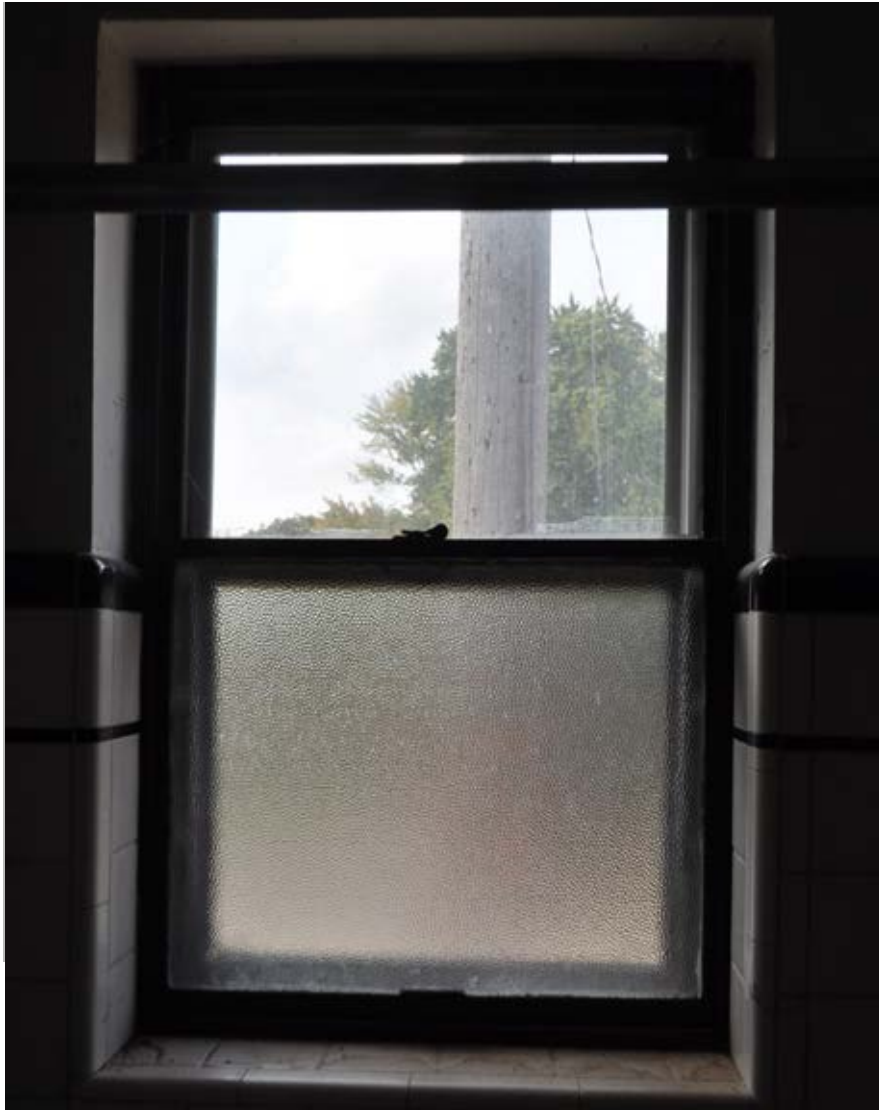
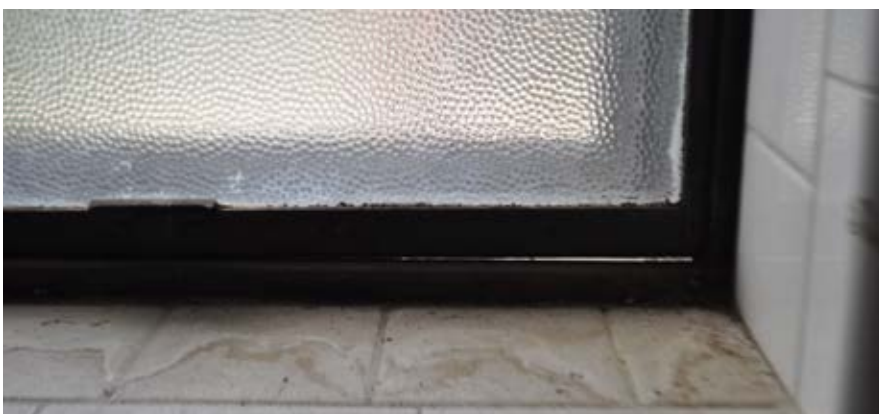
Window X7, Type U2

- Note: Extent of exterior deterioration, corrosion, and loss of operability is not fully apparent in interior photos. Replacement parts for existing windows are unavailable, making restoration of thermal and operable functionality impossible, and long-term maintenance infeasible. Recommendation is for replacement, for quality of life of future tenants and for feasibility of long-term maintenance.
- See Window Assessment (Blackberry) in appendix for further detail and information, including further notes on deterioration beyond repair
- See Appendix for Window Schedule & Measurements

Window Replacement

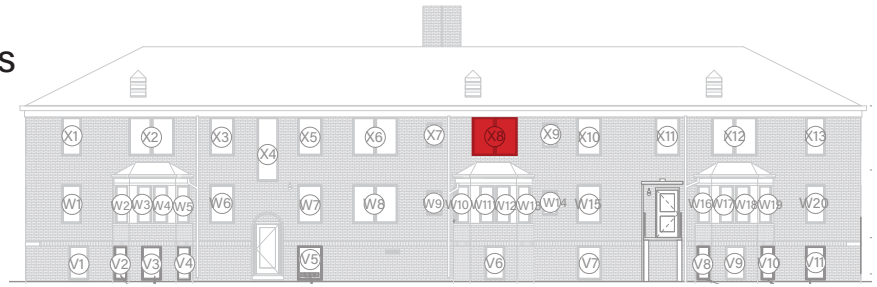
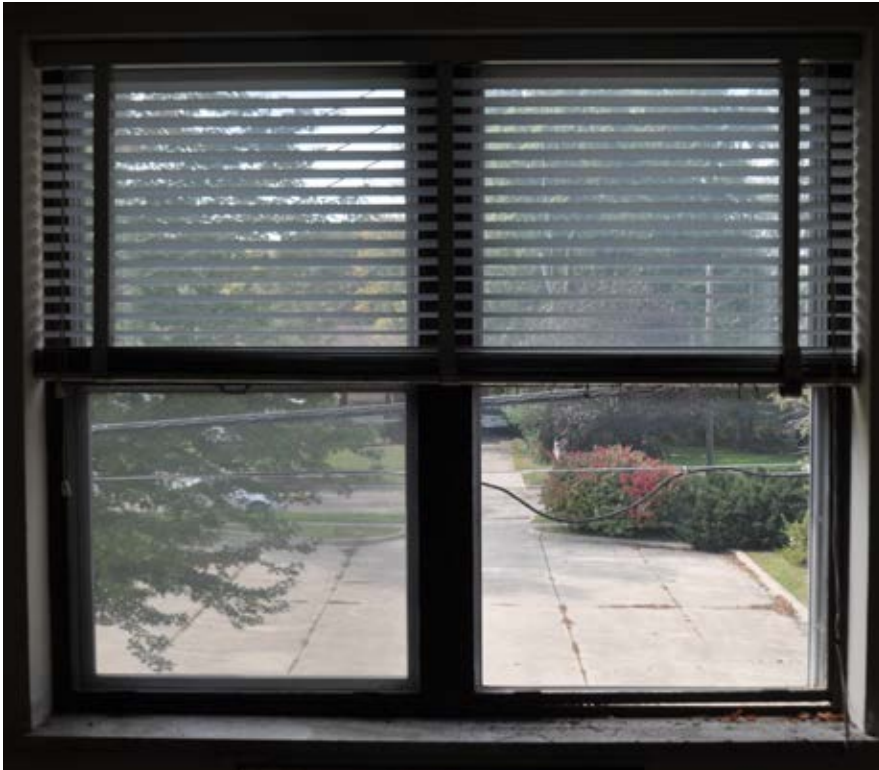
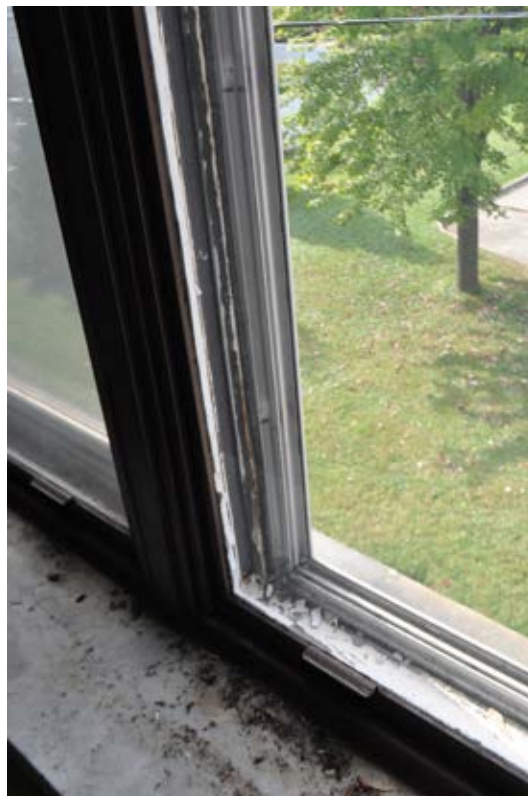
Window X8, Type P2

- Note: Extent of exterior deterioration, corrosion, and loss of operability is not fully apparent in interior photos. Replacement parts for existing windows are unavailable, making restoration of thermal and operable functionality impossible, and long-term maintenance infeasible. Recommendation is for replacement, for quality of life of future tenants and for feasibility of long-term maintenance.
- See Window Assessment (Blackberry) in appendix for further detail and information, including further notes on deterioration beyond repair
- See Appendix for Window Schedule & Measurements

Window Replacement

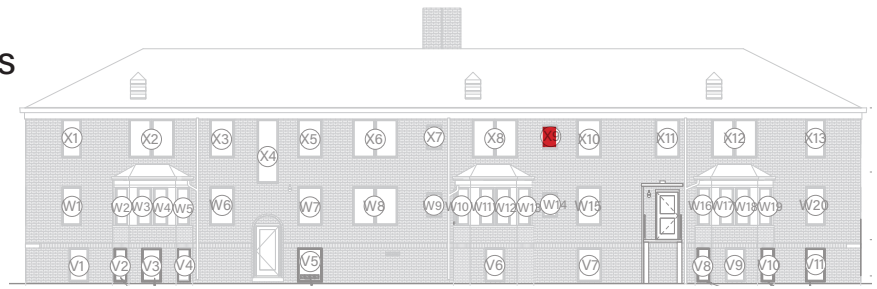
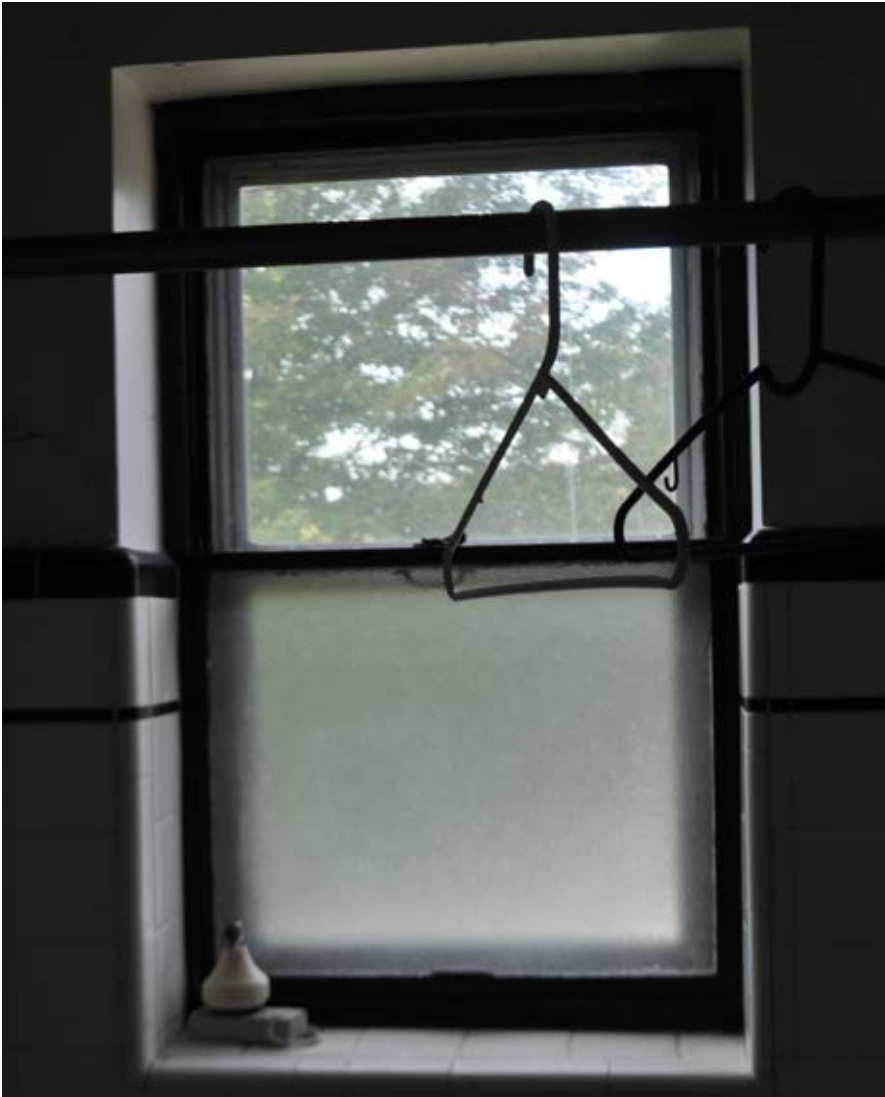
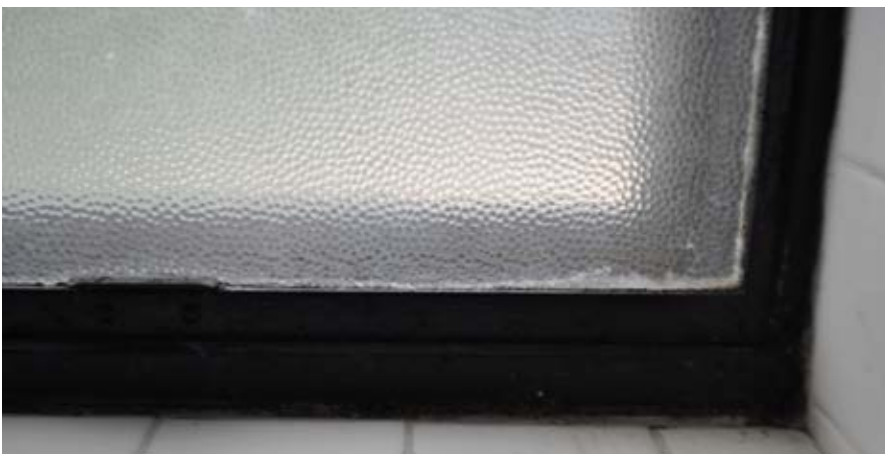
Window X9, Type U2

- Note: Extent of exterior deterioration, corrosion, and loss of operability is not fully apparent in interior photos. Replacement parts for existing windows are unavailable, making restoration of thermal and operable functionality impossible, and long-term maintenance infeasible. Recommendation is for replacement, for quality of life of future tenants and for feasibility of long-term maintenance.
- See Window Assessment (Blackberry) in appendix for further detail and information, including further notes on deterioration beyond repair
- See Appendix for Window Schedule & Measurements

Window Replacement

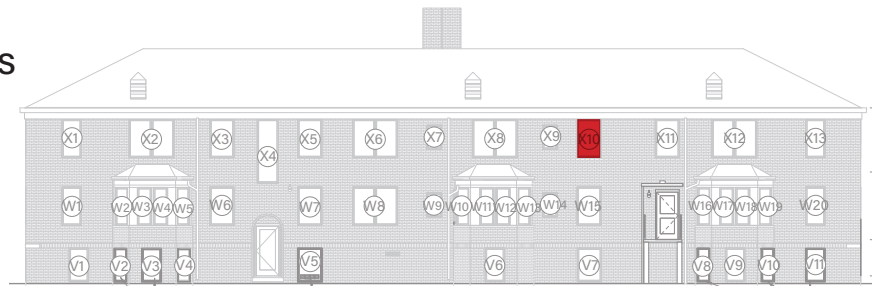
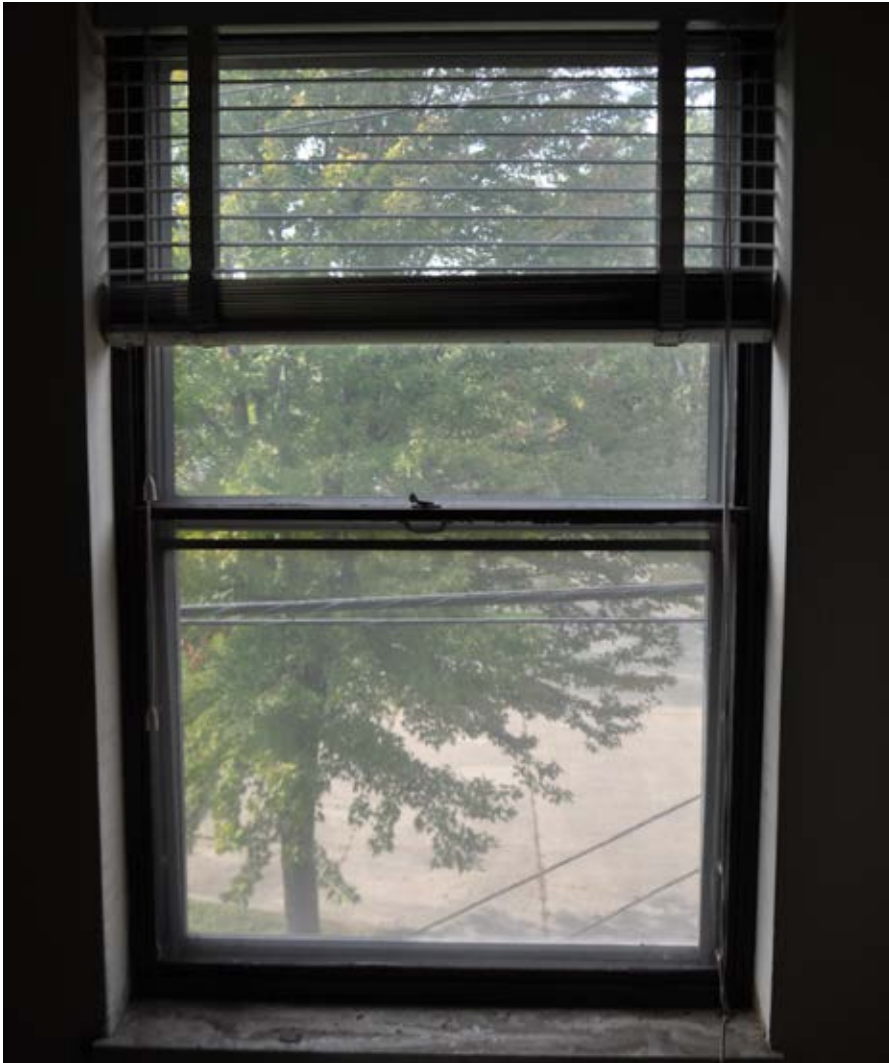
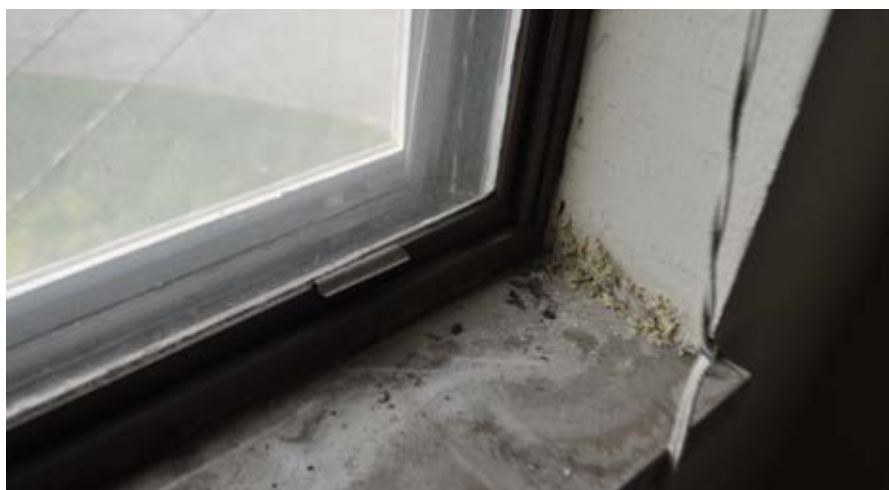
Window X10, Type R2

- Note: Extent of exterior deterioration, corrosion, and loss of operability is not fully apparent in interior photos. Replacement parts for existing windows are unavailable, making restoration of thermal and operable functionality impossible, and long-term maintenance infeasible. Recommendation is for replacement, for quality of life of future tenants and for feasibility of long-term maintenance.
- See Window Assessment (Blackberry) in appendix for further detail and information, including further notes on deterioration beyond repair
- See Appendix for Window Schedule & Measurements

Window Replacement

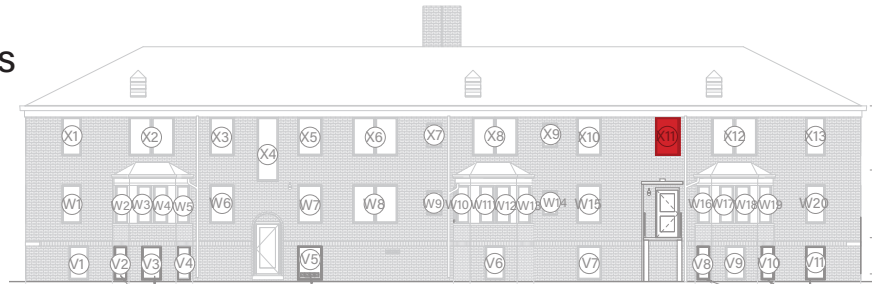
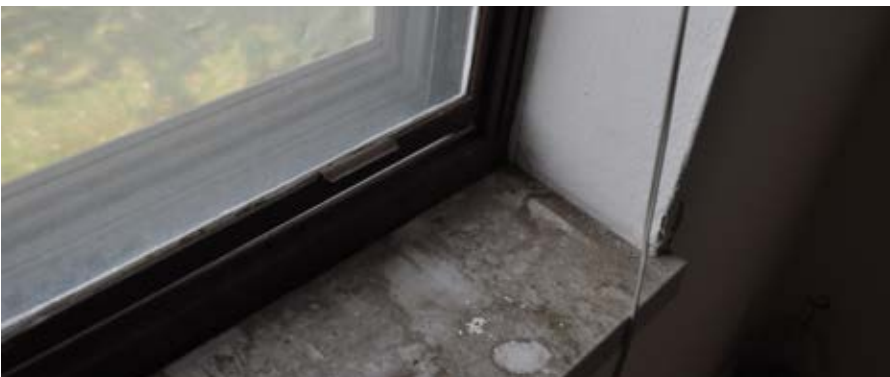
Window X11, Type R2

- Note: Extent of exterior deterioration, corrosion, and loss of operability is not fully apparent in interior photos. Replacement parts for existing windows are unavailable, making restoration of thermal and operable functionality impossible, and long-term maintenance infeasible. Recommendation is for replacement, for quality of life of future tenants and for feasibility of long-term maintenance.
- See Window Assessment (Blackberry) in appendix for further detail and information, including further notes on deterioration beyond repair
- See Appendix for Window Schedule & Measurements

Window Replacement

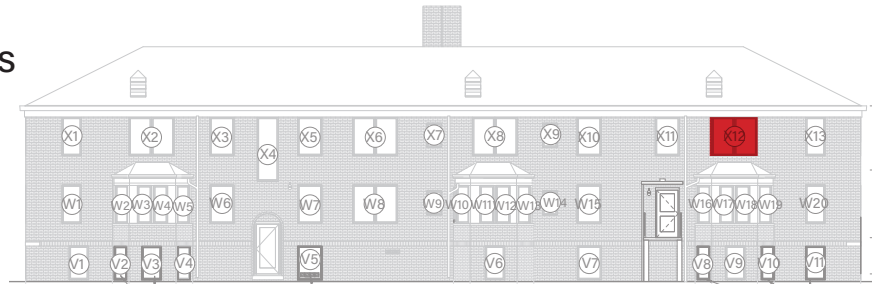
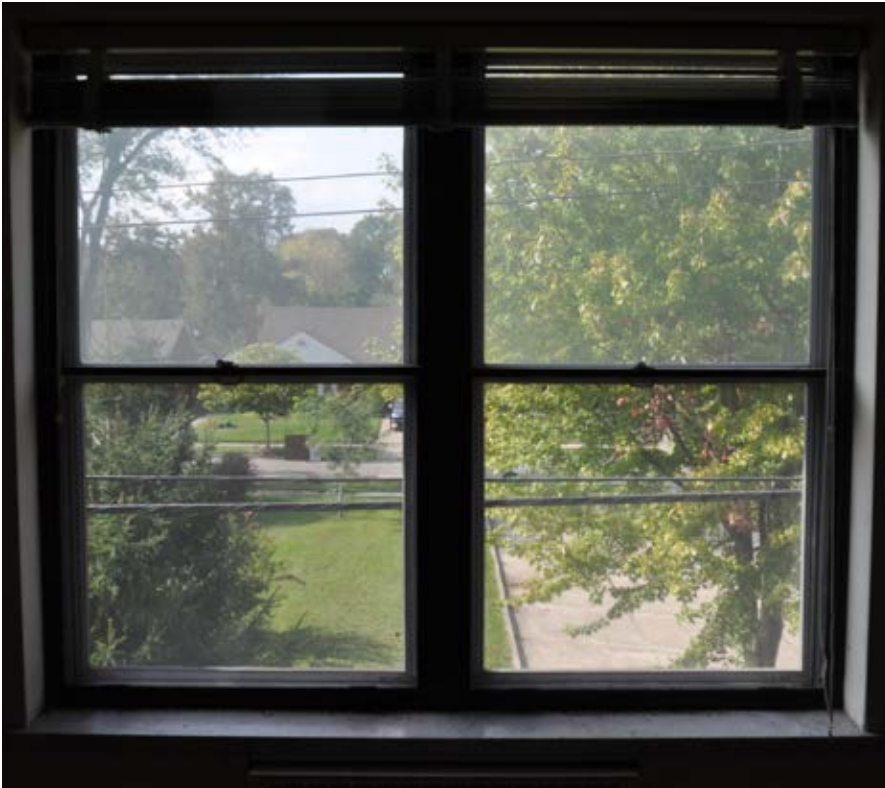
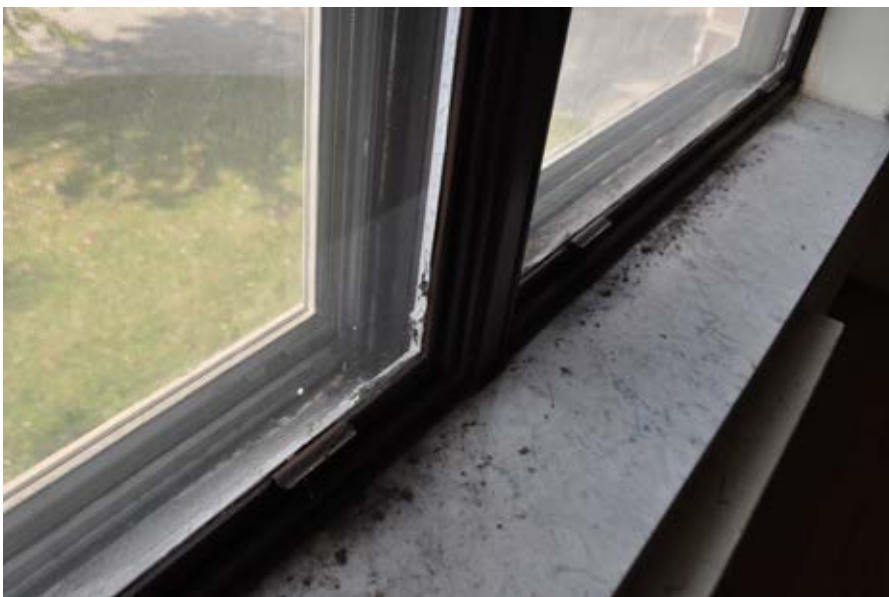
Window X12, Type P2

- Note: Extent of exterior deterioration, corrosion, and loss of operability is not fully apparent in interior photos. Replacement parts for existing windows are unavailable, making restoration of thermal and operable functionality impossible, and long-term maintenance infeasible. Recommendation is for replacement, for quality of life of future tenants and for feasibility of long-term maintenance.
- See Window Assessment (Blackberry) in appendix for further detail and information, including further notes on deterioration beyond repair
- See Appendix for Window Schedule & Measurements

Window Replacement

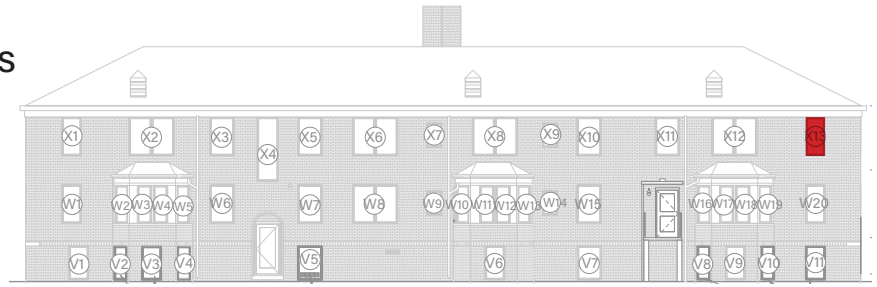
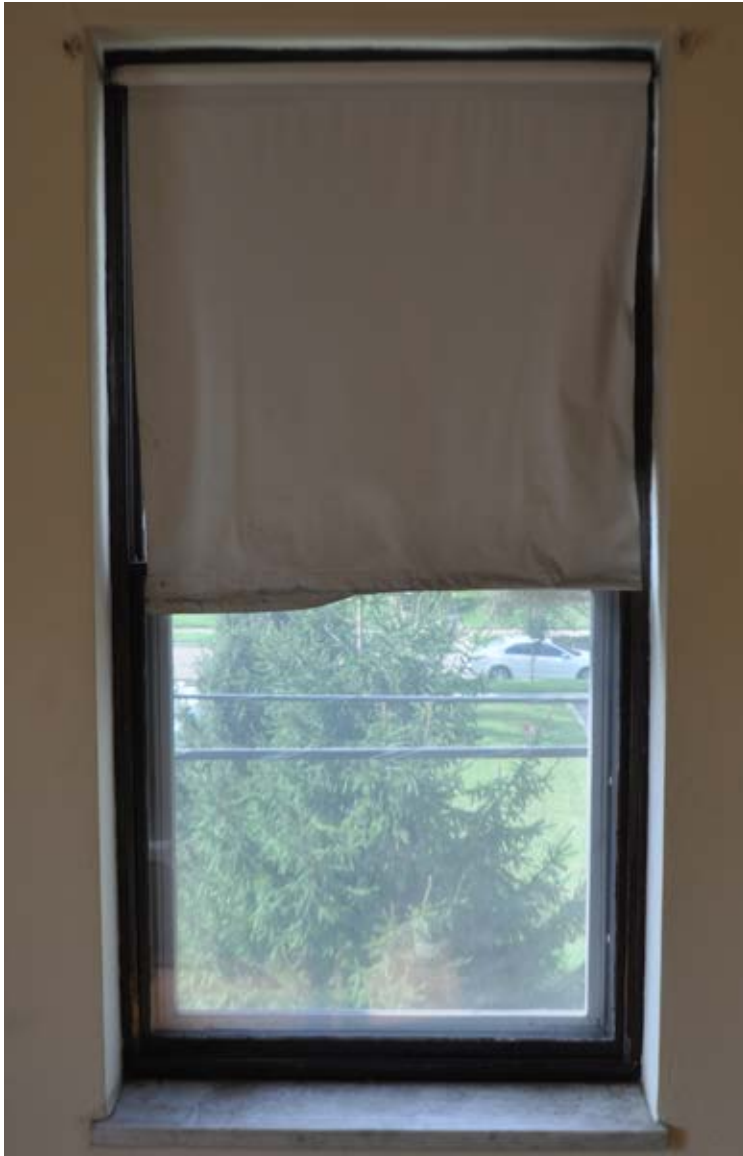
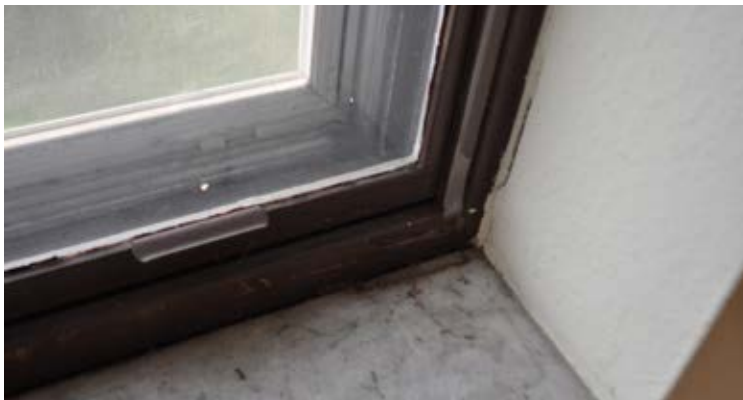
Window X13, Type N2

- Note: Extent of exterior deterioration, corrosion, and loss of operability is not fully apparent in interior photos. Replacement parts for existing windows are unavailable, making restoration of thermal and operable functionality impossible, and long-term maintenance infeasible. Recommendation is for replacement, for quality of life of future tenants and for feasibility of long-term maintenance.
- See Window Assessment (Blackberry) in appendix for further detail and information, including further notes on deterioration beyond repair
- See Appendix for Window Schedule & Measurements

Detailed Scope of Work
