9710 W Outer Dr

Existing Condition Photos

Current Design Description

A 3-story apartment structure with 10 residential units, constructed in 1940, brick on wood stud wall construction, shingle roof, stone corner details, stone details at palladian window, stone sills, wood detailing at front entry, steel and wood canopy at back entry, wood windows throughout with the exception of steel windows at bathrooms and the lowest level. The addition of a brick shed to house the gas meter was made at a later date.

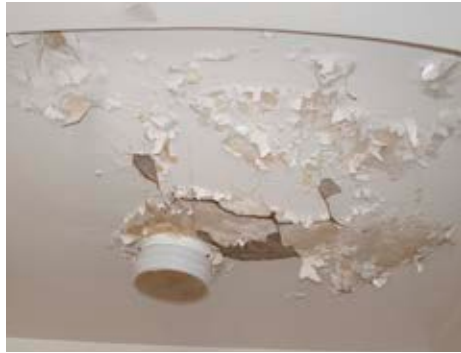
Level 02 ceiling, water damage *proposed asphalt shingle type*

- Due to existing roof leaks in multiple locations and the age of the existing roof, the gray asphalt shingle roof will be replaced in kind
- See photo of one of several instances of water damage caused by roof leaks (left)
- See photo of existing roof color & materials (top)

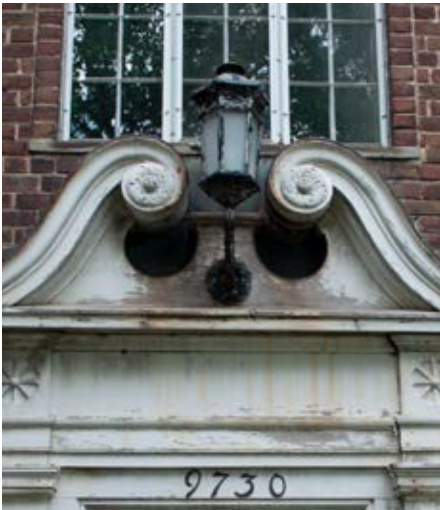
9730 Front Entry

existing conditions

- Fixture Restoration
- Rewire and replace bulb with 3000K LED

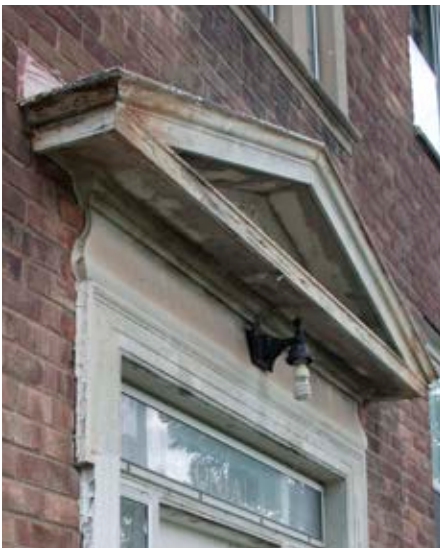
9710 Front Entry

existing conditions

- New fixture; original is missing
- Replace bulb with 3000K LED
- Proposed Product: Generation Lighting, 8753EN3-15 One Light Outdoor Wall Lantern, 9.3 Watt LED bulb, 800 Lumens, White Glass, Black Polycarbonate finish, Dimensions: 6"W X 7.25"H
- See appendix for cut sheet

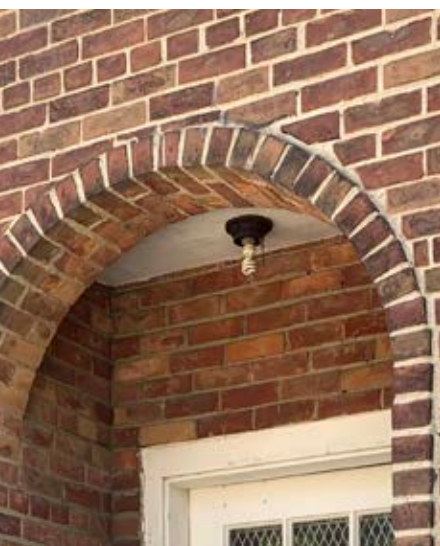
9730 Back Entry

existing conditions

- New fixture at back entry door; original is missing
- Replace bulb with 3000K LED
- Proposed Product: Niveous LED Outdoor Flush-mount by dweLED, Small Option: 9.5 Watt (800 Lumens) 120 Volt Integrated LED: CRI: 90 Color Temp: 3000K Lifespan: 45000 hours, White Aluminum, Mouth Blown Etched Glass, Dimensions: 6"H, 6" Diameter, Weight 2.38Lbs
- See appendix for cut sheet

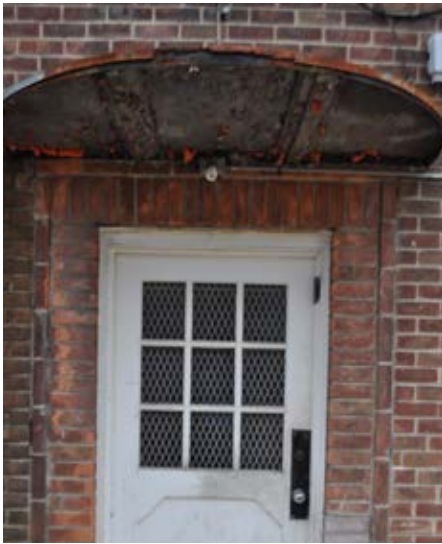
9710 Back Entry

existing conditions

- New fixture; original is missing
- Replace bulb with 3000K LED
- Proposed Product: Generation Lighting, 8753EN3-15 One Light Outdoor Wall Lantern, 9.3 Watt LED bulb, 800 Lumens, White Glass, Black Polycarbonate finish, Dimensions: 6" W X 7.25" H
- See appendix for cut sheet

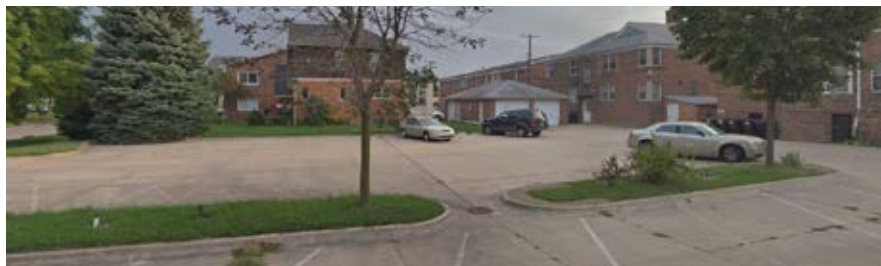
Parking Lot Islands

existing conditions

- New LED Shoebox fixtures at perimeter of parking lot and positioned to light the ramp
- Proposed Product: D-Series Size 0 LED Area Luminaire, EPA: 0.95 sf, 16 lbs, Dimensions: 26" L x 13" W x 3" H - 7" H
- See appendix for cut sheet

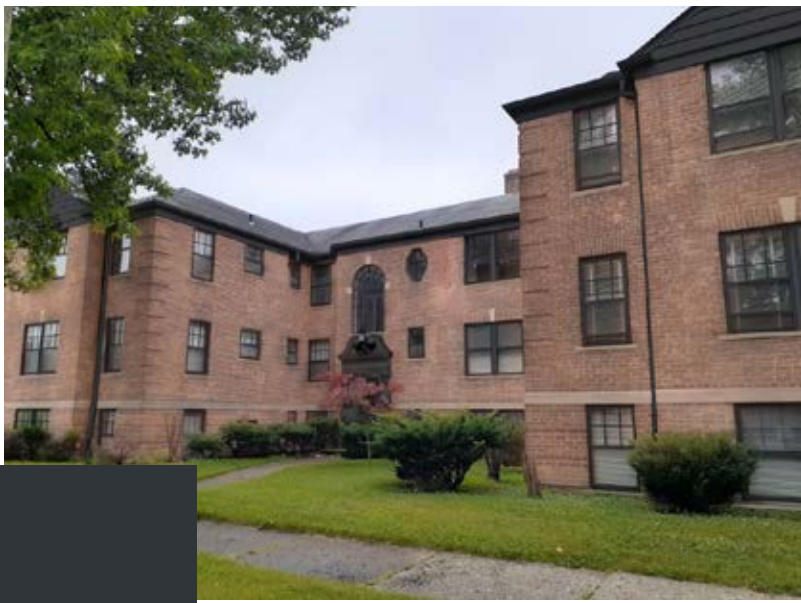
- Paint brick vents (see photo of brick color and existing recessed brick vents)
- Color: SW to match "cleaned" brick color

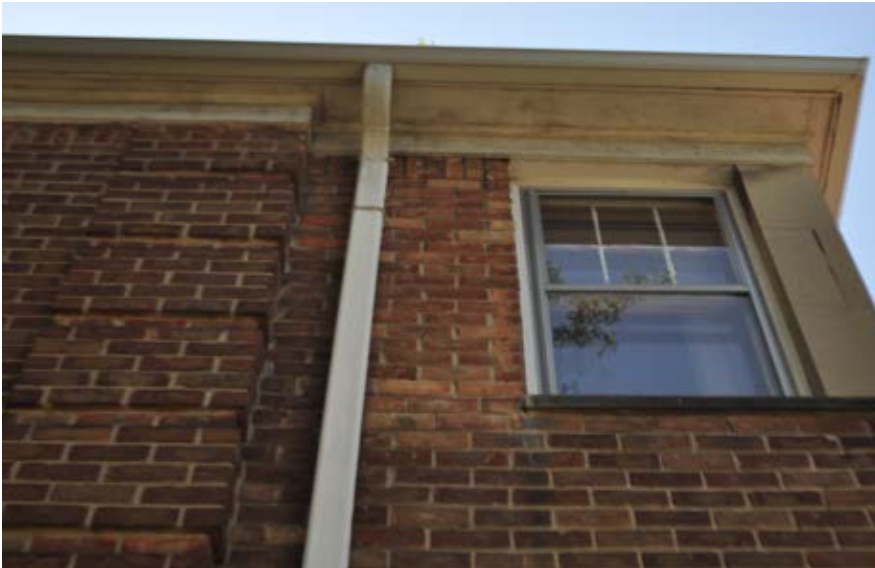
- Tuckpointing is needed in small areas throughout the brick facades of both buildings
- Examples of areas in need of tuckpointing_9710 W Outer Dr
- (see photos of existing conditions, left)

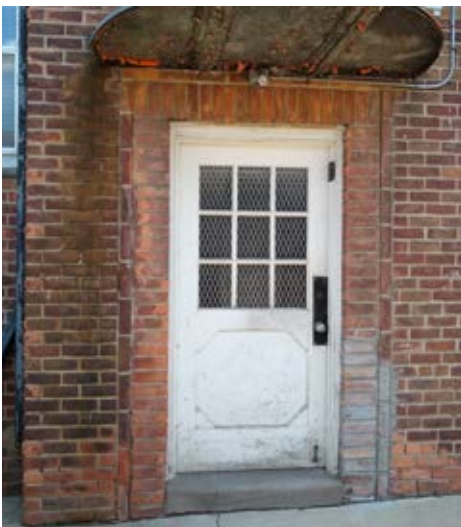
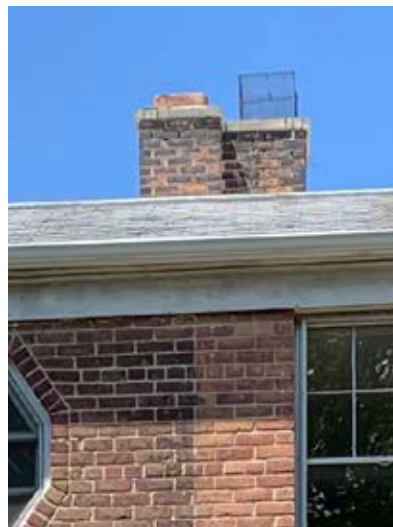
- Repointing is required at 9730 at the chimney (see photo of existing condition, left)
- Repointing is required at water damaged section of masonry at 9710 back entry (see photo of existing condition, left)
- Mortar will match existing in strength, color, and profile
