**ROOF INSPECTION REPORT**

**KING  
SOLOMON  
BAPTIST  
CHURCH**

**NOVEMBER 19, 2021**

**MICHIGAN STRATEGIC FUND**

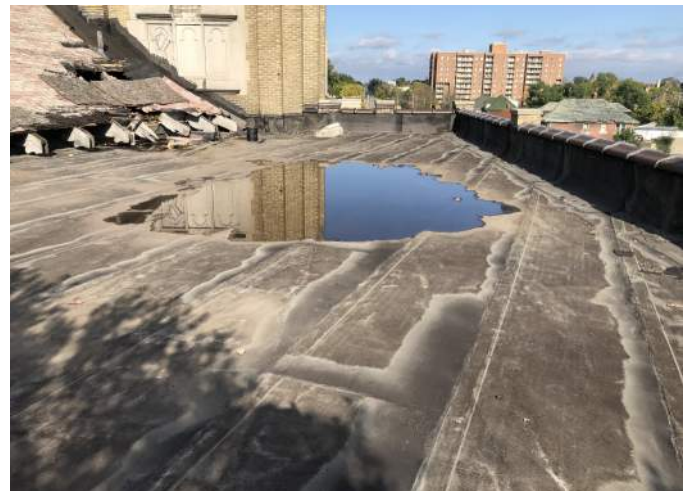
**FIGURE A1.2** OVERVIEW LOOKING NORTH AT THE FLAT ROOF WITH STANDING WATER; FRAYED RUBBER ROOF SEAMS; PARAPET FLASHING

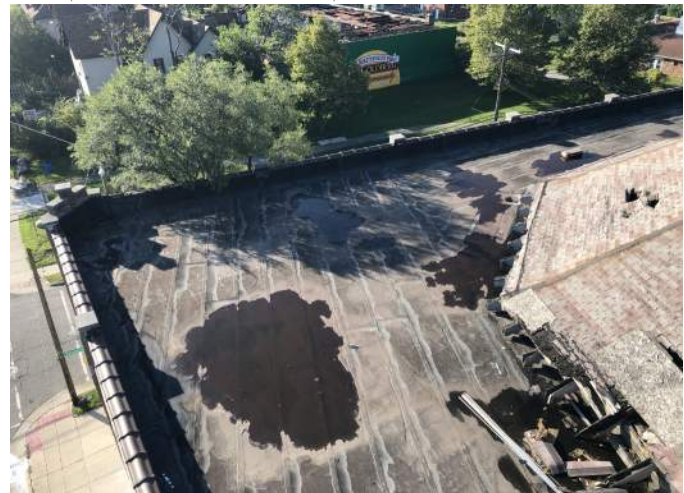
**FIGURE A1.3** EAGLE VIEW OF THE SOUTH FLAT ROOF; VARIOUS AREAS OF STANDING WATER

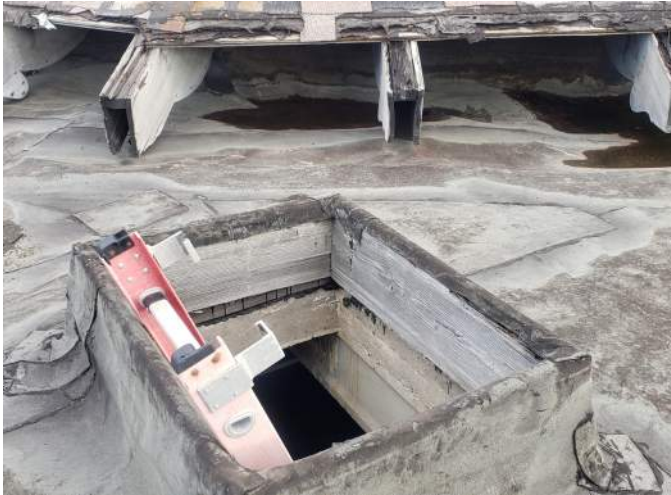
- Cracked and detached masonry column surround at west elevation
- Detached and metal roof hatch door; weathered wood hatch curb (see figure A1.5)

FIGURE A1.5 EXISTING ROOF HATCH WITH DETACHED ROOF HATCH CAP

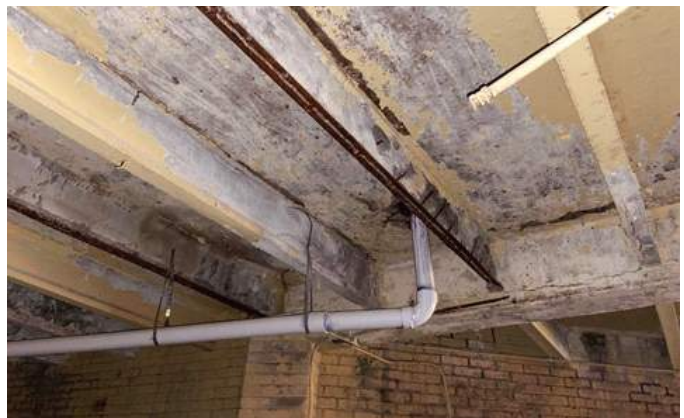
FIGURE S1.1

- Moderate to severe damage and deterioration of the thin concrete slab, observed in areas near the three roof drain locations. The full extent of the concrete deterioration can only be determined after the existing roofing is removed and the top surface is exposed for inspection.(see figure S1.1)

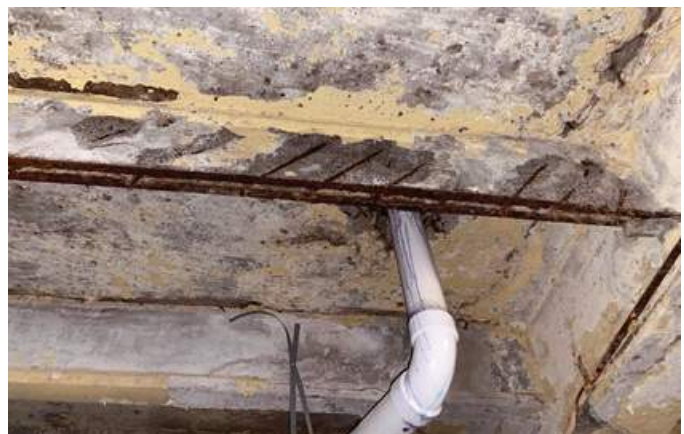
FIGURE S1.2

- Moderate to severe damage observed in many of the precast beams. This has resulted in the spalling of the concrete cover below the bottom tension reinforcing steel. There is moderate to severe deterioration of the web concrete and on a few joist the shear reinforcement is exposed. (see figure S1.2)

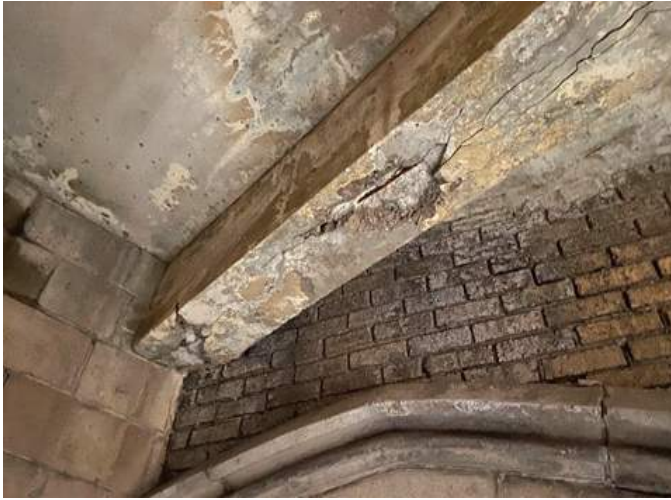
FIGURE S1.3

- Observed at two beam locations, spalling concrete and corrosion of the exposed reinforcing bars. It appears the structural frame is steel that is encased in concrete. In these locations the cracked and spalling concrete should be removed to ensure no loose concrete fall in occupied space. Additional repair work will be required if the beam is reinforced concrete or if the embedded steel beam is severely corroded. (see figure S1.3)

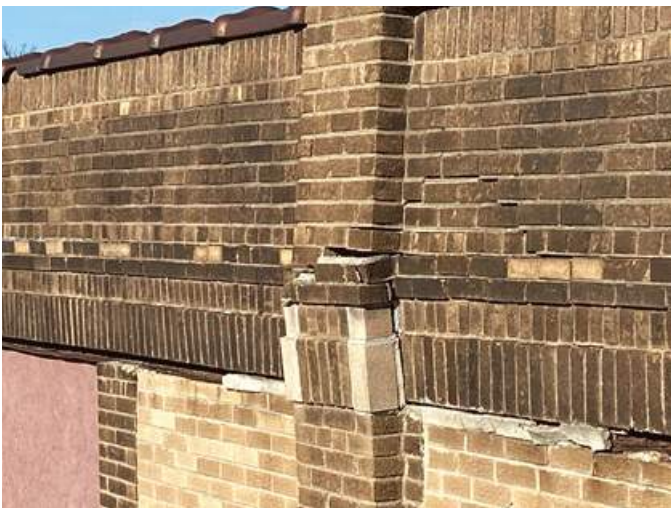
FIGURE S1.4

- Displaced masonry parapet wall with detached masonry units along third floor ceiling/roof junction (see figure S1.4)
- Visible step cracking along the masonry brick wall along the parapet and buckling of the top of the piers(see figure S1.4)

- Precast joists frame into the exterior masonry wall and are supported by steel lintels that are embedded in the masonry walls. The steel lintels support the masonry above the window openings. The embedded steel lintel beams are severely corroded with a thick rust pack. The thick rust pack, results in an excessive expansion of the corroded steel. This has caused severe movement, damage and deterioration of exterior masonry and rollover of the parapet walls (see figure S1.4)

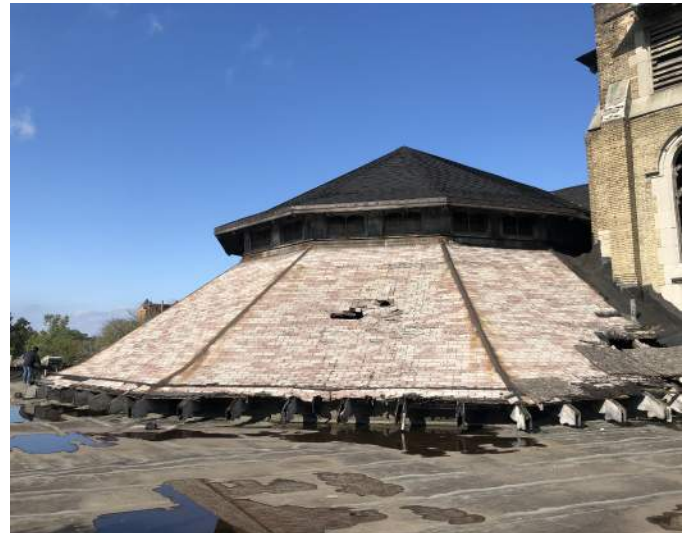
- Asphalt shingles worn, well beyond the end of their useful life
- Large, visible holes in the roof, exposing deteriorating wood structural framing; deteriorated plywood patching (see figure A2.1 and A2.7)

**FIGURE A2.1** OVERVIEW OF THE TWO TIERED HEPTAGON ROOF; ROOF DECAY AND WATER INFILTRATION, WORN AND MISSING ASPHALT TILES, WEATHERED AND ROTTED DECORATIVE EAVE OUTRIGGERS/RAFTER TAILS.

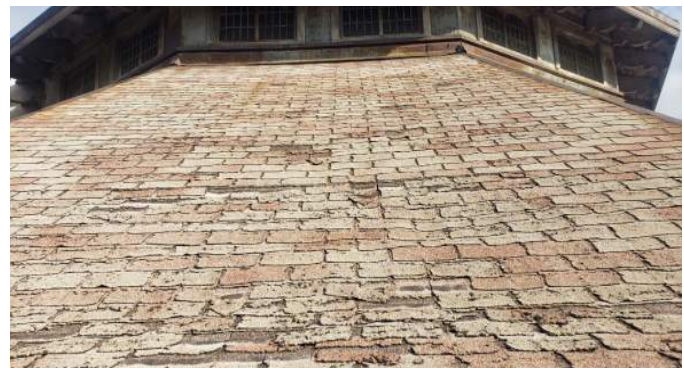
- Pronounced waviness to the roof surface which may indicate damage to the roof decking and structural framing below (see figure A2.2)
- Extensive deterioration of the decorative wooden eave brackets, particularly along the lower tier where the decking has mostly deteriorated completely away at the overhang (see figure A2.8)

**FIGURE A2.2** SURFACE DEPRESSIONS ALONG THE ROOF; CURLED, DISCOLORED AND FRAYED ASPHALT SHINGLES; RUSTED METAL FLASHING UNDER THE UPPER WINDOWS

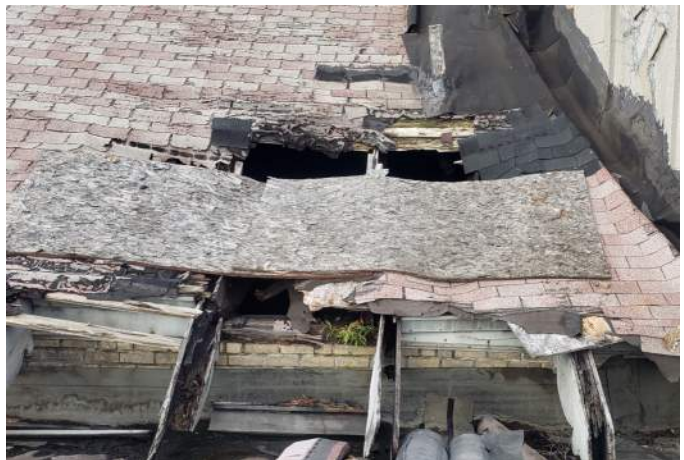
- Flashing failure along the supporting masonry wall under the eaves (see figure A2.7)
- Patched valley flashing with improper terminations along bell tower masonry wall and of asphalt roofing. Excessive mastic on masonry wall. (see figure A2.13)

**FIGURE A2.7** COMPLETE DETERIORATION AND DECAY OF THE DECORATIVE WOOD EAVES AND DECORATIVE RAFTER TAILS; THE LEVEL OF DETERIORATION MAY REQUIRE LOCALIZED REPAIRS TO ADJACENT ELEMENTS SUCH AS THE BRICK WALL BELOW

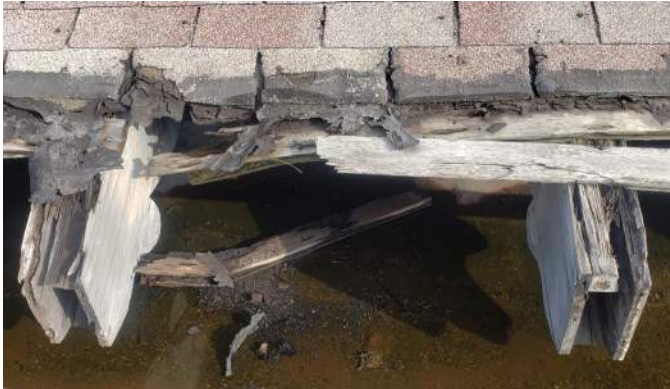
FIGURE A2.8 SIGNIFICANT DETERIORATION AT THE PERIMETER (TERMINATION OF DECORATIVE EAVES); EXTENSIVE WOOD ROT OF THE DECORATIVE EAVE OUTRIGGERS/RAFTER TAILS; PONDING WATER BELOW

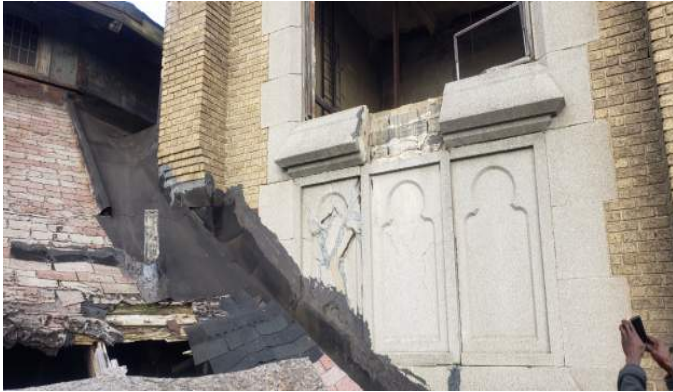
**FIGURE A2.6** FAILURE OF THE FLASHING AT THE INTERSECTION WHERE THE POLYGONAL ROOF INTERSECTS WITH THE BELL TOWER; STAINING OF THE DECORATIVE STONE BY FLASHING SEALANT

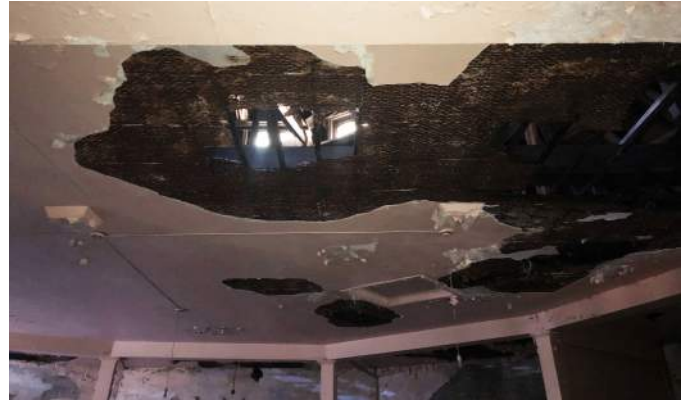
**FIGURE A2.14** DETERIORATING INTERIOR PLASTER BELOW THE HEPTAGONAL ROOF STRUCTURE; SUN LIGHT IS VISIBLE THROUGH THE HOLE IN THE ROOF ABOVE

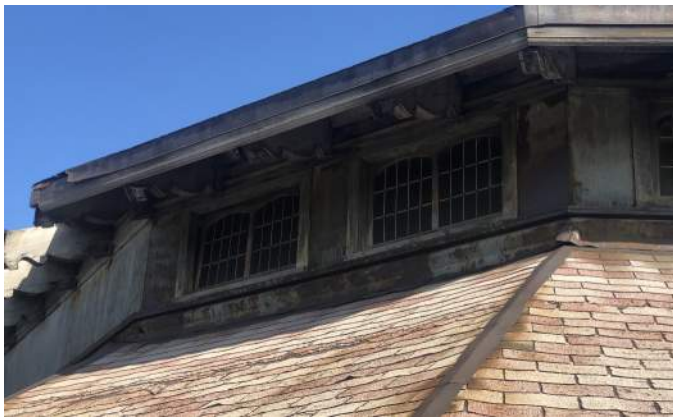
- Clerestory glazed windows set between metal trim between two roof tiers appear to be in fair to good condition, with metal trim exhibiting surface rust and worn paint (see figure A2.11)

**FIGURE A2.11** THE UPPER TIER OF THE POLYGONAL ROOF; VISIBLE RUST ON THE METAL WINDOW FRAMING AND ROOF HIPS; METAL FLASHING IS CORRODING AND DETACHING FROM THE FASCIA BOARD AND HEAD OF LOWER ROOF

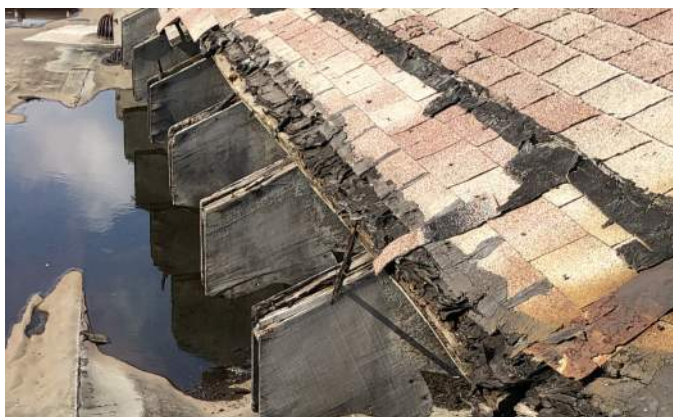
**FIGURE A2.13** DECORATIVE WOOD EAVE SHOW SIGNS OF DECAY AND ROT; SIGNIFICANT DETERIORATION OF THE ROOF PERIMETER EDGE; WITH POOLS OF WATER GATHERING UNDER THE EAVES

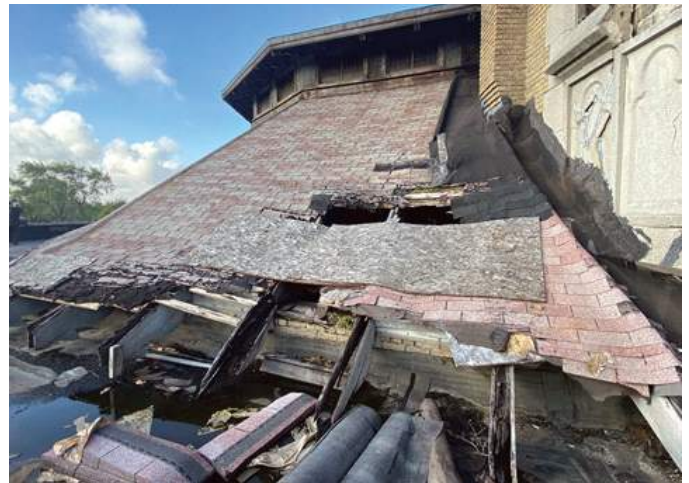
FIGURE S2.2

- The lower roof area up to the intermediate windows conditions varies. There is a large hole with severely deteriorated and damaged sheathing and support framing on the east side and in the valley behind the bell tower. The condition of the roof framing appears to improve towards the south side will only localized signs of damaged, deteriorated sheathing. The condition of the roof further deteriorates toward the northwest corner where the sheathing is visibly sagging between the support rafters. (see figure S2.2)

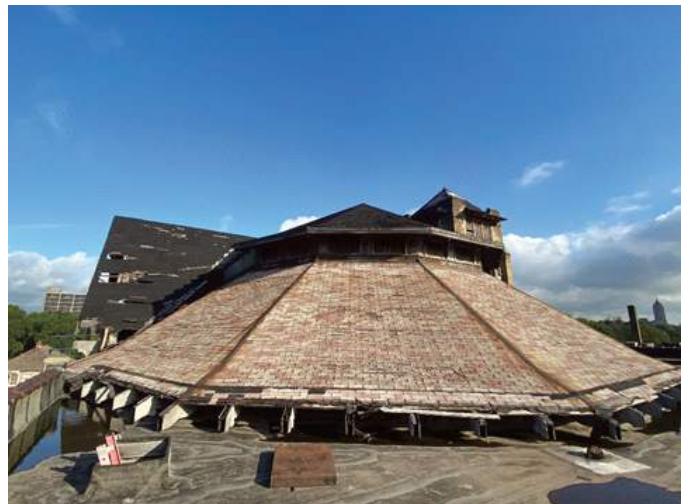
FIGURE S2.3

- The condition of the vertical walls, framing and windows at the intermediate window level appear in to be structurally functional. (see figure S2.3)
- The roof overhang above the intermediate windows appears intact for all segments except at the northwest corner where the overhang had been removed with only the exposed outrigger brackets remaining. It can be assumed that the exposed wooden brackets are rotten and are beyond serviceable condition. (see figure S2.4)

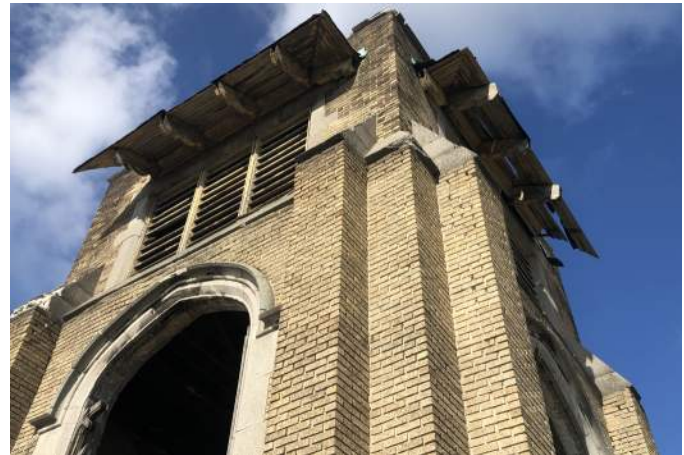
- Large arched windows in the bell tower are missing glass and framing, leaving the underside of the roof and bell tower interior exposed to the elements and increased deterioration. Wood louvers above the windows are weathered with worn pain, in poor to fair condition, with some sections missing. (see figure A3.1 and A3.2)

**FIGURE A3.2** THE EAVE OVERHANG SHOWS EXTENSIVE WOOD DECAY AND DETERIORATION

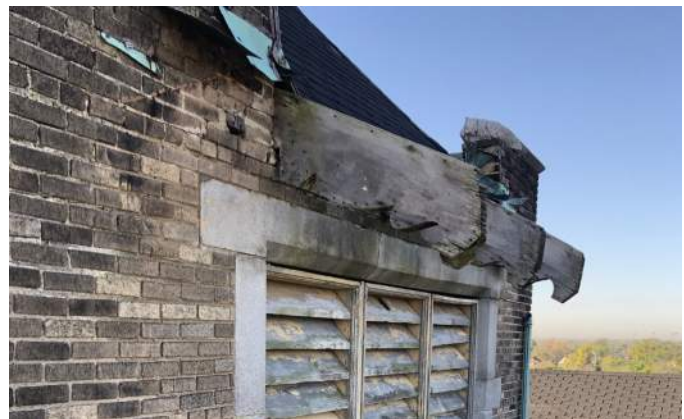
- Extensive roof damage at extended eave overhangs
- Decorative wood rafter tails are rotted or missing; wood frieze board and trim is detaching from the masonry wall where still existing, weathered with worn paint. (see figure A3.4 and A3.6)

**FIGURE A3.6** DIFFERENTIAL BRICK MOVEMENT UNDER EAVES; REMNANTS OF THE ORIGINAL STEPPED COPPER FLASHING; (NORTH ELEVATION)

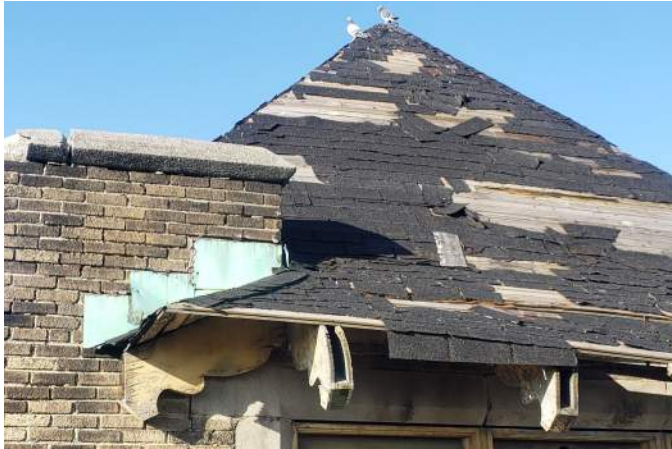
- Asphalt shingles are work, well beyond the end of their useful life, with a significant quantity missing and exposing the sheathing below
- Weathered, rotted, or missing roof decking and painted soffit trim (see figure A 3.7 and S3.0)

**FIGURE A3.7** HIP ROOF IS IN VERY POOR CONDITION; WEATHERED AND DECAYED WOOD DECKING, MISSING/FALLEN SHINGLES AND EXPOSED DECKING AND ORIGINAL STEPPED COPPER FLASHING (EAST ELEVATION)

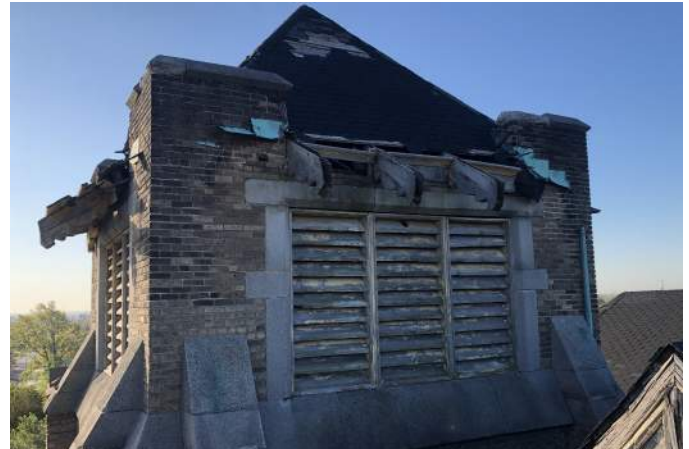
- Missing or detaching, deteriorated copper step flashing at the overhang returns and brick piers; original copper gutters are missing and remnants of some disconnected copper downs[pouts remain (see figure A3.10)

**FIGURE A3.10** OVERVIEW OF THE BELL TOWER'S ROOF AND DECKING; THE DECKING ON TOP OF THE DECORATIVE EAVE HAS COMPLETELY DECAYED AND DETACHED FROM THE ROOF ASSEMBLY (NORTH ELEVATION)

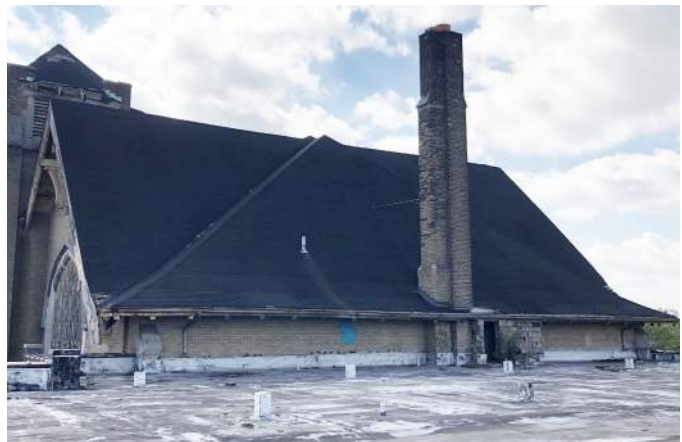
FIGURE A4.00 OVERVIEW OF NORTHERN SIDE OF THE CROSS GABLE ROOF

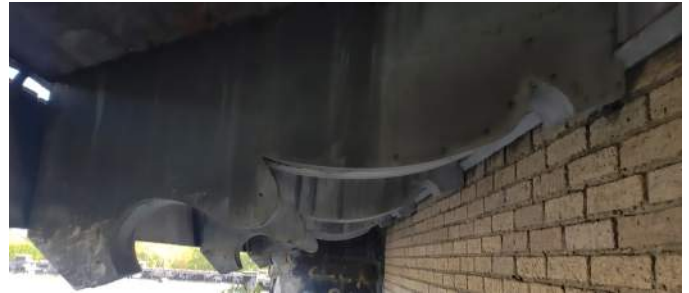
**FIGURE 4.2** DECORATIVE WOOD EAVE, SIDE ELEVATION APPROX. LENGTH 3'-4"; IN FAIR CONDITION

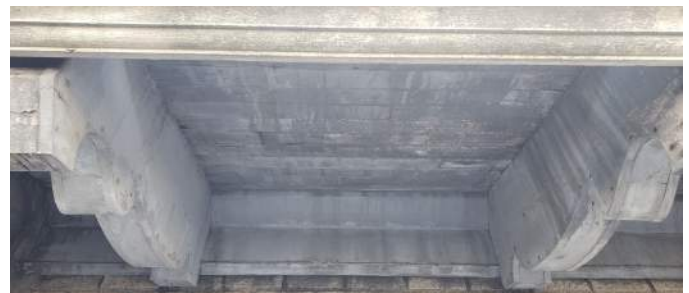
**FIGURE A4.3** DECORATIVE WOOD EAVE IN FAIR CONDITION; (NORTH ELEVATION)

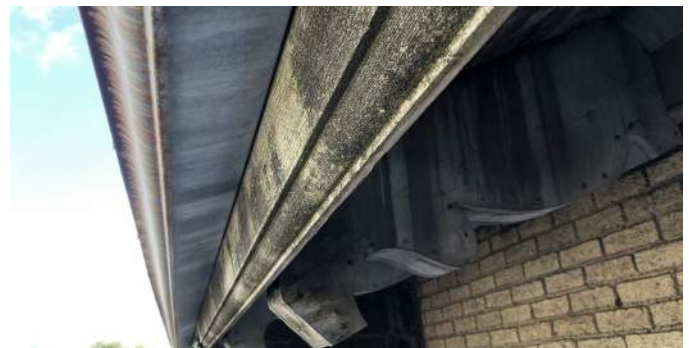
**FIGURE A4.4** WEATHERED FASCIA BOARD WITH ATTACHED METAL GUTTER

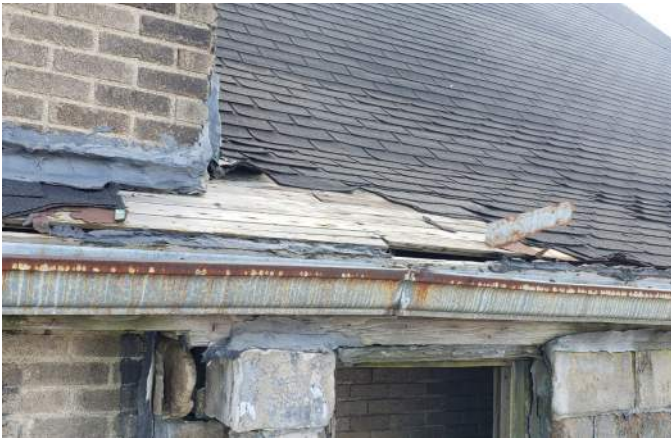
**FIGURE A4.9** WEATHERED FASCIA BOARD; DECAYED WOOD DECKING; CURLLED, FRAYED AND MISSING ASPHALT SHINGLES ABOVE ROOFTOP STAIR ENTRY.

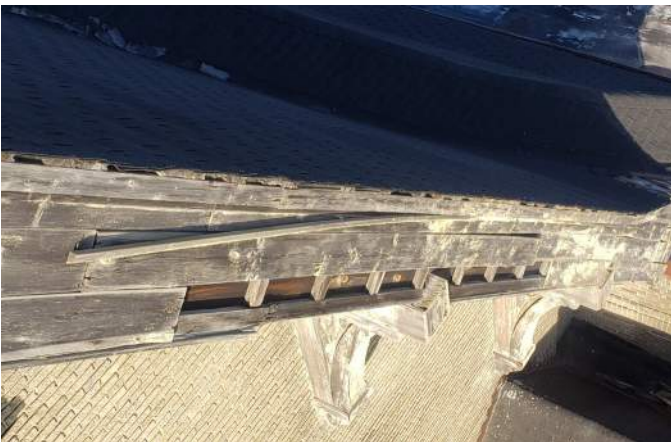
**FIGURE A4.14** MISSING WOOD FASCIA BOARDS AT EAST ELEVATION

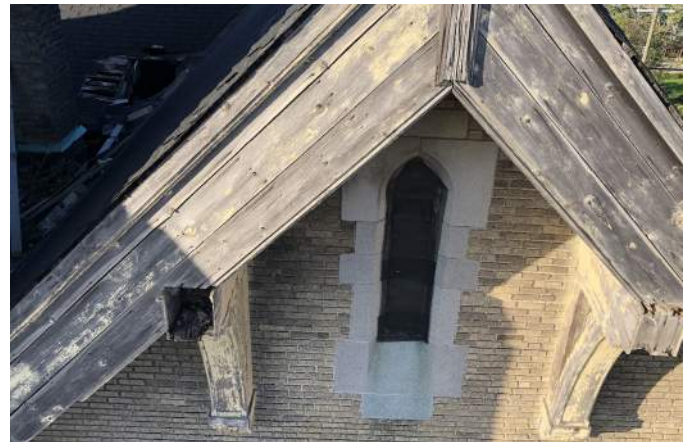
**FIGURE A4.24** WEATHER AND FADED FASCIA BOARDS; DECAYED HOLLOWED WOODEN SUPPORT BRACKET

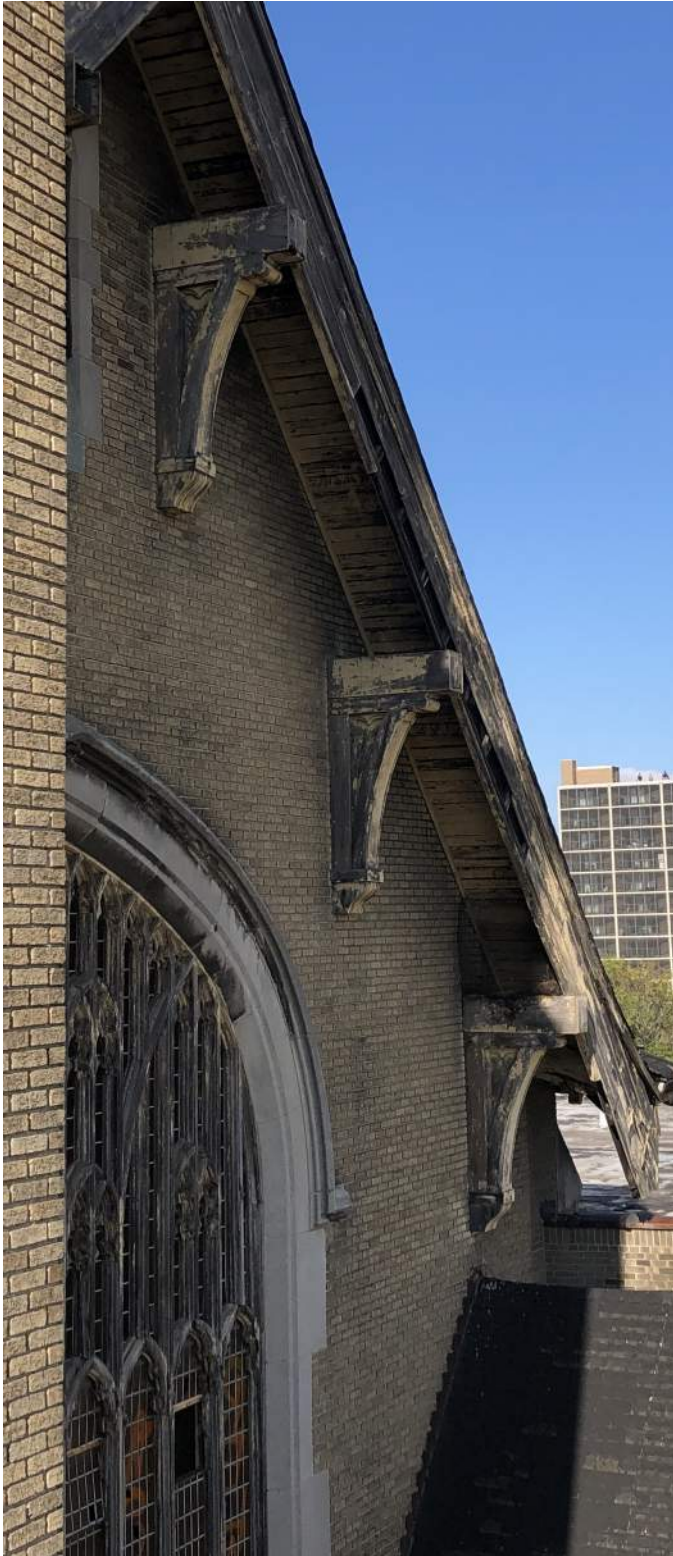
FIGURE 4.22 WEATHER AND FADED FASCIA BOARDS, FADED WOOD DECKING AT THE UNDERSIDE OF THE EAVES ON THE EAST ELEVATION AT THE MAIN ENTRANCE

- Remove existing metal downspouts
- At east rake edge (front façade): Remove and salvage for reinstallation (4) 4' x 8' decorative wood support bracket enclosures around deteriorated wood structural outriggers along rake edge (see structural scope below). Existing wood fascia and soffit boards/trim to remain in place along 4-foot deep rake edge overhang – provide temporary shoring/support during replacement of outriggers. (see figure A4.22)

- Replace (4) wood outriggers on east façade supporting overhang along rake edge. Replace deteriorated sheathing, bracket framing fascia assembly and trim. Provide temporary shoring as required to continue to support existing rake overhangs to remain.  
(see figure A4.22)
  - **ALTERNATE:** Replace (6) additional outriggers supporting west rake edge
- Large zone of damaged roof sheathing and potentially damaged rafters in southwest roof area. Replace all sheathing and replace or sister damaged rafters
- Remove and replace saddle framing between sloping roof area and bell tower
- After removal or remain roofing, inspect sheathing over entire roof and replace damaged and deteriorated areas
- Removed spalled and damaged masonry from chimney
  - **ALTERNATE (All Zones):** Provide copper flashings in lieu of prefinished aluminum

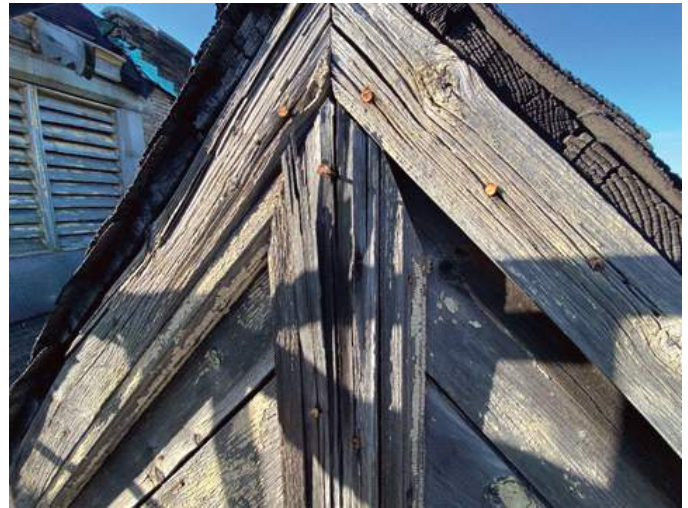
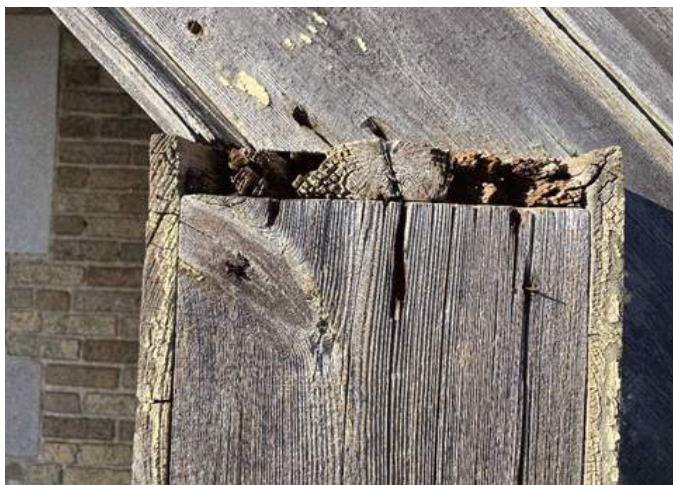
FIGURE S4.1

- The condition of the east overhang varies. The sheathing and a sloping beam that appears to be in moderate condition. The top members and inside structural members within the decorative brackets are in poor condition due to water leaking into the top of the brackets. (see figure S4.1)
- The main roof structure beyond the east overhang appears in moderate condition at the north and southeast slopes. The area at valley between the sloped roof and the bell tower is damaged, the structural members below the roofing may show some level of deterioration. (see figure S4.2)
- The southwest slope of the main roof area is in poor condition with many holes and areas of deteriorated sheathing and rafters. (see figure S4.3)
- The west overhang is in poor condition. The decorative support varies in condition. (see figure S4.4)

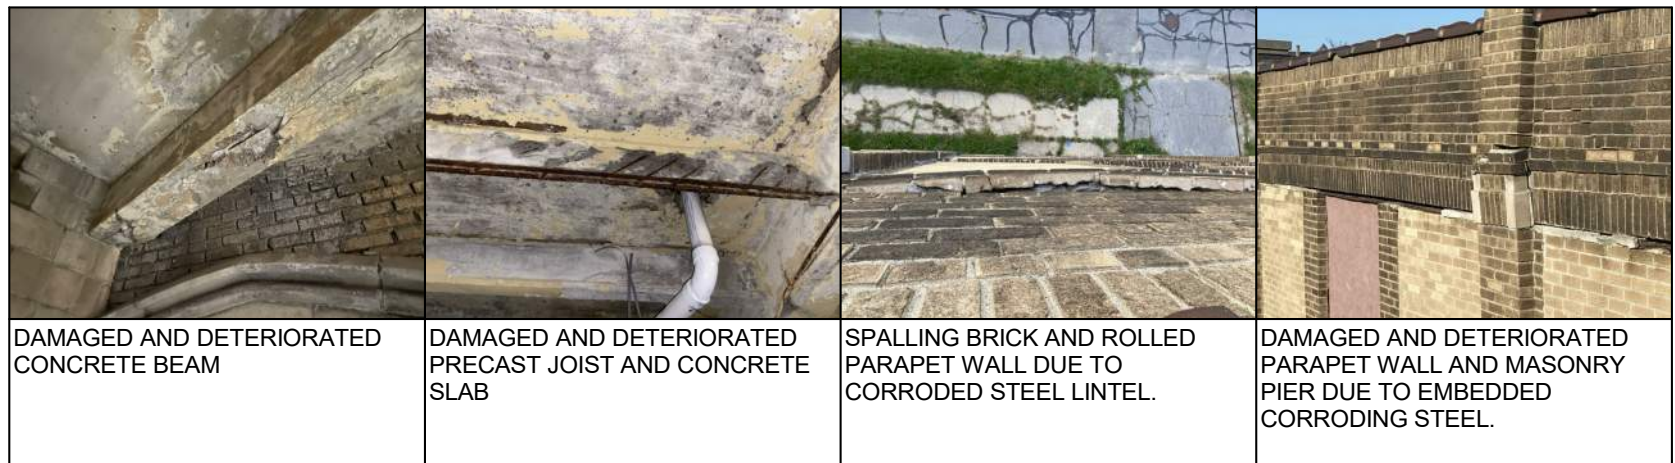
DAMAGED AND DETERIORATED CONCRETE BEAM	DAMAGED AND DETERIORATED PRECAST JOIST AND CONCRETE SLAB	SPALLING BRICK AND ROLLED PARAPET WALL DUE TO CORRODED STEEL LINTEL.	DAMAGED AND DETERIORATED PARAPET WALL AND MASONRY PIER DUE TO EMBEDDED CORRODING STEEL.
--	--	--	---

STRUCTURAL ITEMS REQUIRED FOR ROOFING INTEGRITY AND SAFETY			
HATCH AREA	DESCRIPTION	UNITS	COMMENT
	DETERIORATED AND DAMAGED 2" TO 3" THICK CONCRETE ROOF SLAB. AFTER REMOVING ROOF, HAMMER SOUND CONCRETE. CHIP AWAY DETERIORATED CONCRETE ADD 6X6W2XW2 WWF. APPLY CEMENTITIOUS BONDING AGENT. OVERLAY WITH CONCRETE PATCH.	280SF	REPAIR REQUIRED TO PROVIDE STRUCTURALLY SOUND SUPPORT FOR ROOFING.
	DAMAGED AND DETERIORATED PRECAST ROOF SUPPORT JOISTS. HAMMER SOUND CONCRETE. CHIP AND REMOVE DAMAGED AND DETERIORATED CONCRETE. CLEAN CORRODED STEEL. ADD (2)#5 HORIZONTAL BARS IF BOTTOM BARS ARE CORRODED MORE THAN 10%. DOWEL SHEAR BARS AS REQUIRED. APPLY TROWEL APPLIED CONCRETE PATCH OR SHOTCRETE TO PROVIDE MIN 1" COVER TO EXISTING AND NEW REBAR.	440LF	STRUCTURAL INTEGRITY OF JOISTS HAVE BEEN COMPROMISED. CURRENT STRUCTURAL LOAD CAPACITY OF JOIST CANNOT BE DETERMINED IN CURRENT CONDITION. REQUIRED TO SAFELY HAVE CONSTRUCTION ACTIVITY ON ROOF.

DAMAGED AND DETERIORATED CONCRETE BEAM. REMOVE ANY LOOSE CONCRETE AND CONFIRM CONDITION OF ENCASED STEEL BEAM.	440LF	CONFIRM STRUCTURAL STEEL FRAMING. IF STEEL FRAMING IS PRESENT NO ADDITIONAL WORK IS REQUIRED OTHER THAN REMOVING FALL HAZARDS.

STRUCTURAL ITEMS REQUIRED FOR ROOFING DURABILITY			
HATCH AREA	DESCRIPTION	UNITS	COMMENT
	EXISTING STEEL LINTELS OVER 3RD FLOOR WINDOW OPENINGS ARE SEVERELY CORRODED AND BEYOND REPAIR, RESULTING IN SEVERE ROLLING AND DAMAGE TO PARAPET WALLS. SHORE EXISTING ROOF STRUCTURE. REMOVE AND REPLACE STEEL LINTELS AND PARAPET WALL. INSTALL NEW GALVANIZED STEEL LINTELS AND RE-CONSTRUCT PARAPET WALLS.	180LF 30 WINDOW OPENINGS	ROOFING WILL NOT BE DURABLE IF PARAPET WALL CONTINUES TO DETERIORATE AND MOVE. HIGH RISK OF FALLING DEBRIS TO PEDESTRIANS AND PROPERTY IN STREET.
	CORRODED STEEL LINTELS HAVE RESULTED IN SEVERE DAMAGE TO MASONRY PIERS COVERING STEEL BUILDING COLUMNS. REMOVE DAMAGED MASONRY, REPAIR EMBEDDED STEEL COLUMNS AND CONNECTION. RE-CONSTRUCT MASONRY PIERS	13	HIGH RISK OF FALLING DEBRIS. AT MINIMUM LOOSE AND UNSTABLE MASONRY TO BE REMOVED FROM PIERS TO REDUCE RISK.
	RECONSTRUCT MASONRY PIER FULL HEIGHT	1

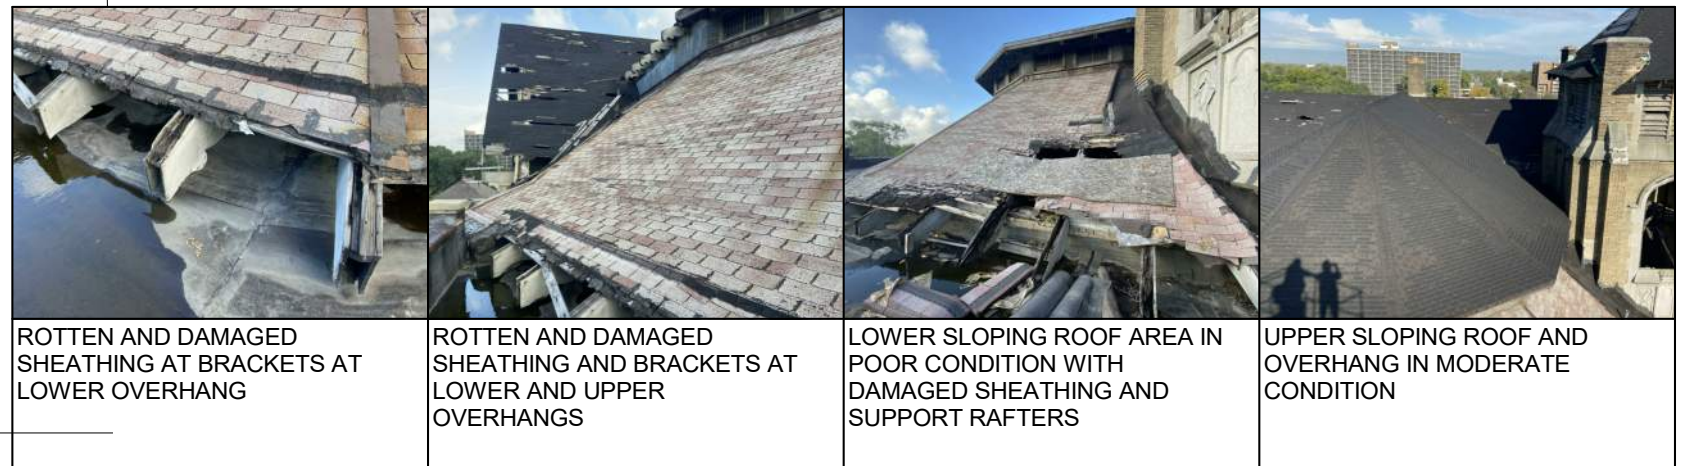
ROTTEN AND DAMAGED SHEATHING AT BRACKETS AT LOWER OVERHANG

ROTTEN AND DAMAGED SHEATHING AND BRACKETS AT LOWER AND UPPER OVERHANGS

LOWER SLOPING ROOF AREA IN POOR CONDITION WITH DAMAGED SHEATHING AND SUPPORT RAFTERS

UPPER SLOPING ROOF AND OVERHANG IN MODERATE CONDITION

HATCH AREA	DESCRIPTION	UNITS	COMMENT
[Grey Hatch]	EXISTING ROOF FLARED OVERHANG WITH DECORATIVE WOOD BRACKETS CANTILEVERING OUT FROM BEARING WALL. REMOVE ROOF SHEATHING AND BRACKETS. MEASURE AND PRESERVE BRACKET GEOMETRY AND DETAIL FOR FUTURE REPLICATION.	550SF	OVERHANG NOT REQUIRED FOR ROOF ENCLOSURE.
[Pink Hatch]	SLOPING LOWER ROOF AREA APPEARS IN MODERATE TO POOR CONDITION. ASSUME 30% OF SHEATHING AND 15% OF SUPPORT RAFTERS NEED TO BE REPLACED OR REINFORCED.	SHEATHING: 350SF RAFTERS: 65LF	EXTREME CARE NEEDED DURING CONSTRUCTION. REMOVAL OF ROOFING NEEDS TO BE CARRIED OUT FROM SAFE PLATFORM OR LIFT.
[Brown Hatch]	SLOPING LOWER ROOF AREA IN VERY POOR CONDITION. ASSUME REPLACEMENT OF 100% OF SHEATHING AND 30% REPLACEMENT OR REINFORCING OF SUPPORT RAFTERS.	SHEATHING: 600SF RAFTERS: 50LF	EXTREME CARE NEEDED DURING CONSTRUCTION. REMOVAL OF ROOFING NEEDS TO BE CARRIED OUT FROM SAFE PLATFORM OR LIFT.

[Blue Hatch]	UPPER ROOF FLARED OVERHANG APPEARS IN MODERATE CONDITION. ASSUME REMOVAL OF 15% OF TOTAL AREA ON WEST SIDE.	REMOVE: 50SF	EXTREME CARE NEEDED DURING CONSTRUCTION. REMOVAL OF ROOFING NEEDS TO BE CARRIED OUT FROM SAFE PLATFORM OR LIFT.
[Green Hatch]	UPPER ROOF FLARED ROOF AREA APPEARS IN MODERATE CONDITION. ASSUME 20% OF SHEATHING AND 10% OF SUPPORT RAFTERS NEED TO BE REPLACED OR REINFORCED.	SHEATHING: 130SF RAFTERS: 30LF	EXTREME CARE NEEDED DURING CONSTRUCTION. REMOVAL OF ROOFING NEEDS TO BE CARRIED OUT FROM SAFE PLATFORM OR LIFT.
[Red Hatch]	UPPER ROOF AREA APPEARS IN MODERATE CONDITION. ASSUME 15% OF SHEATHING AND 10% OF SUPPORT RAFTERS NEED TO BE REPLACED OR REINFORCED.	SHEATHING: 300SF RAFTERS: 80LF	EXTREME CARE NEEDED DURING CONSTRUCTION. REMOVAL OF ROOFING NEEDS TO BE CARRIED OUT FROM SAFE PLATFORM OR LIFT.

1. REPLACE EXISTING TONGUE AND GROOVE ROOF SHEATHING WITH 3/4" EXTERIOR RATED PLYWOOD SPANNING TO 2X6@16" OC. 2X6 SPANNING TO RAFTERS AT APPROXIMATELY 4'-0" OC.
2. REPLACE BADLY DAMAGED RAFTERS SPANNING UP TO 16 FT WITH (3)2X12.
3. REINFORCED MODERATELY DAMAGED RAFTERS WITH (2)2X12.

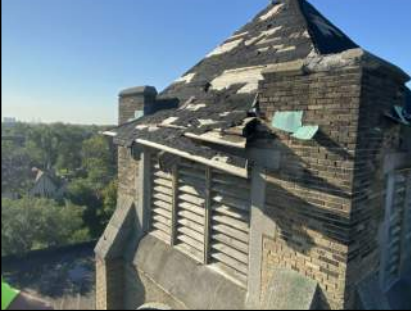
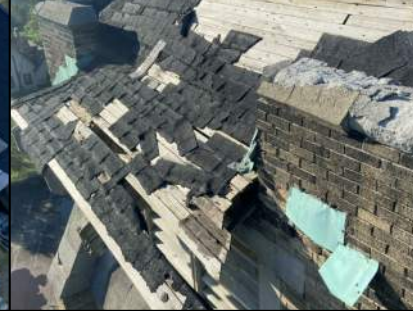
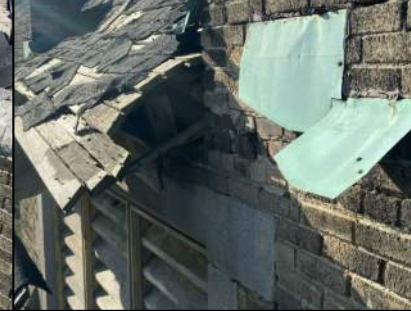
ROTTEN AND DAMAGED SHEATHING, BRACKETS AND RAFTERS	DETERIORATING MASONRY COPING. REMOVE LOOSE AND DAMAGED MATERIAL. FALLING DEBRIS HAZARD.	ROOF STRUCTURE BEYOND REPAIR.	MASONRY JOINTS REQUIRED RE-POINTING AND REPAIRS TO RESTORE FACADE. (FUTURE WORK)

STRUCTURAL ITEMS REQUIRED FOR ROOFING INTEGRITY AND SAFETY			
HATCH AREA	DESCRIPTION	UNITS	COMMENT
	FUTURE DECORATIVE BRACKETS AND ROOF OVERHANG. NOT IN CURRENT SCOPE.	240SF	
	REMOVE EXISTING ROOF FRAMING. REPLACE WITH RE-ENGINEERED WOOD TRUSSES AT 2'-0" OC WITH 3/4" SHEATHING. REFER TO ARCHITECTURAL FOR ROOFING DETAILS AND INFORMATION.	500SF	
	MASONRY AND STONE REQUIRES STABILIZATION TO REMOVE POTENTIAL FALLING DEBRIS (4 CORNERS)		ASSUME 3 DAYS OF WORK FOR MASONRY RESTORATION CONTRACTOR TO REMOVE LOOSE MATERIALS

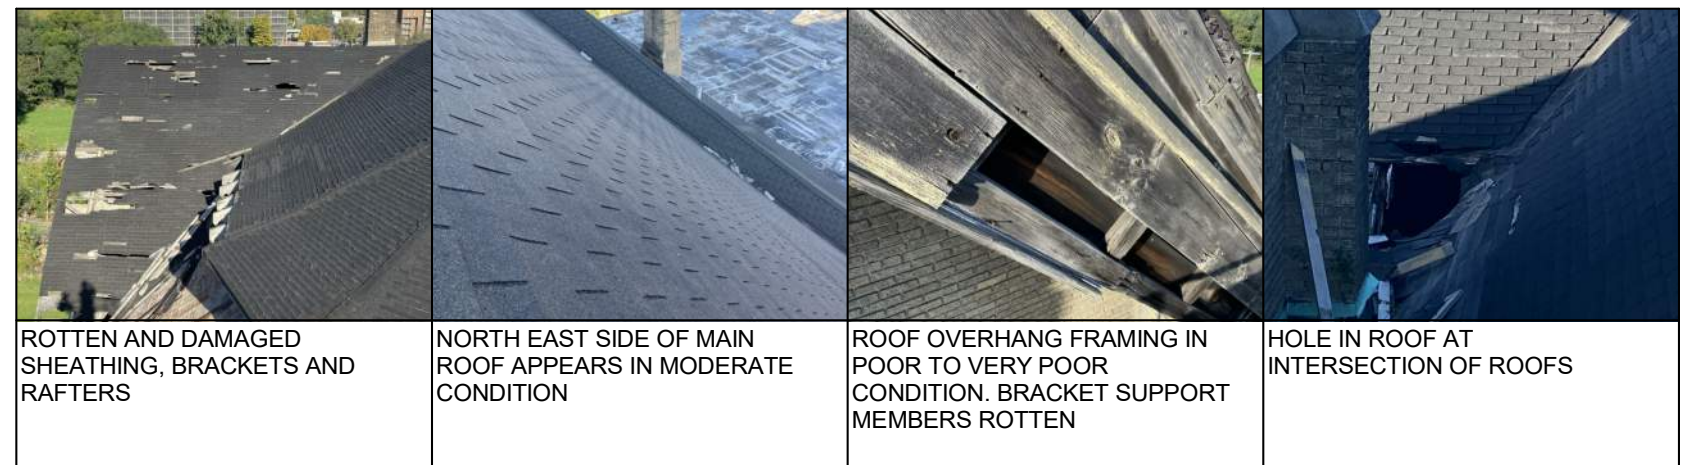
ROTTEN AND DAMAGED SHEATHING, BRACKETS AND RAFTERS

NORTH EAST SIDE OF MAIN ROOF APPEARS IN MODERATE CONDITION

ROOF OVERHANG FRAMING IN POOR TO VERY POOR CONDITION. BRACKET SUPPORT MEMBERS ROTTEN

HOLE IN ROOF AT INTERSECTION OF ROOFS

STRUCTURAL ITEMS REQUIRED FOR ROOFING INTEGRITY AND SAFETY			
HATCH AREA	DESCRIPTION	UNITS	COMMENT
	EXISTING ROOF OVERHANG WITH DECORATIVE WOOD BRACKETS CANTILEVERING OUT FROM WALL. REMOVE ROOF SHEATHING AND BRACKETS. MEASURE AND PRESERVE BRACKET GEOMETRY AND DETAIL FOR FUTURE REPLICATION.	REMOVE: 280SF	OVERHANG NOT REQUIRED FOR ROOF ENCLOSURE.
	SLOPING LOWER ROOF AREA APPEARS IN MODERATE TO POOR CONDITION. ASSUME 15% OF SHEATHING AND 10% OF SUPPORT RAFTERS NEED TO BE REPLACED OR REINFORCED.	SHEATHING: 600SF RAFTERS: 80LF	EXTREME CARE NEEDED DURING CONSTRUCTION. REMOVAL OF ROOFING NEEDS TO BE CARRIED OUT FROM SAFE PLATFORM OR LIFT.
	SLOPING LOWER ROOF AREA IN VERY POOR CONDITION. ASSUME REPLACEMENT OF 100% OF SHEATHING AND 30% REPLACEMENT OR REINFORCING OF SUPPORT RAFTERS.	SHEATHING: 600SF RAFTERS: 50LF	EXTREME CARE NEEDED DURING CONSTRUCTION. REMOVAL OF ROOFING NEEDS TO BE CARRIED OUT FROM SAFE PLATFORM OR LIFT.

ROOF SHEATHING IN VALLEY IN VERY POOR CONDITION REPLACE 100% OF SHEATHING AND 50% OF SUPPORT RAFTERS.	SHEATHING: 100SF RAFTERS: 20LF	EXTREME CARE NEEDED DURING CONSTRUCTION. REMOVAL OF ROOFING NEEDS TO BE CARRIED OUT FROM SAFE PLATFORM OR LIFT.
	EXISTING ROOF OVERHANG WITH DECORATIVE WOOD BRACKETS CANTILEVERING OUT FROM WALL. REPAIR IN PLACE. MEASURE AND PRESERVE BRACKET GEOMETRY AND DETAIL FOR FUTURE REPLICATION.	REPAIR : 250SF	EXTREME CARE NEEDED DURING CONSTRUCTION. REMOVAL OF ROOFING NEEDS TO BE CARRIED OUT FROM SAFE PLATFORM OR LIFT.
	REMOVE LOOSE AND SPALLING MASONRY FROM CHIMNEY		ALLOW ONE DAY OF MASONRY CONTRACTOR WORKING FROM LIFT

1. REPLACE EXISTING TONGUE AND GROOVE ROOF SHEATHING WITH 3/4" EXTERIOR RATED PLYWOOD SPANNING TO 2X6@16" OC. 2X6 SPANNING TO RAFTERS AT APPROXIMATELY 4'-0" OC.
2. REPLACE BADLY DAMAGED RAFTERS SPANNING UP TO 16 FT WITH (3)2X12.
3. REINFORCED MODERATELY DAMAGED RAFTERS WITH (2)2X12.

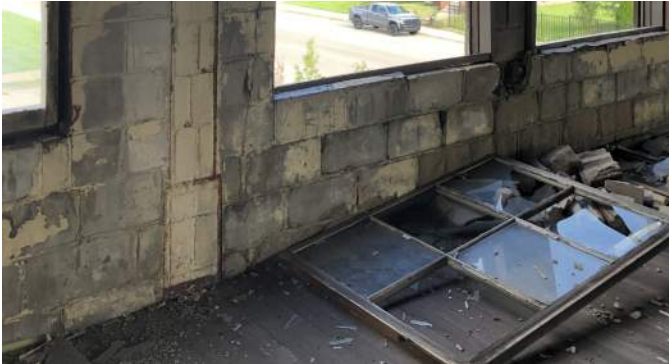
**FIGURE INT 1.1** FALLEN OR MISSING WINDOWS; DETERIORATED MASONRY WALLS AND DEBRIS
