# HISTORIC DISTRICT COMMISSION PROJECT REVIEW REQUEST

ADDRESS(ES): 603 East Milwaukee AKA: Peerless Building

# EXTERIOR RENOVATION FOR PROJECT PEERLESS

**RE: 603-609 E. Milwaukee, Jam Handy/North End- East Grand  
Boulevard Historic District Window Replacement Request:  
Replace existing steel and wood windows**

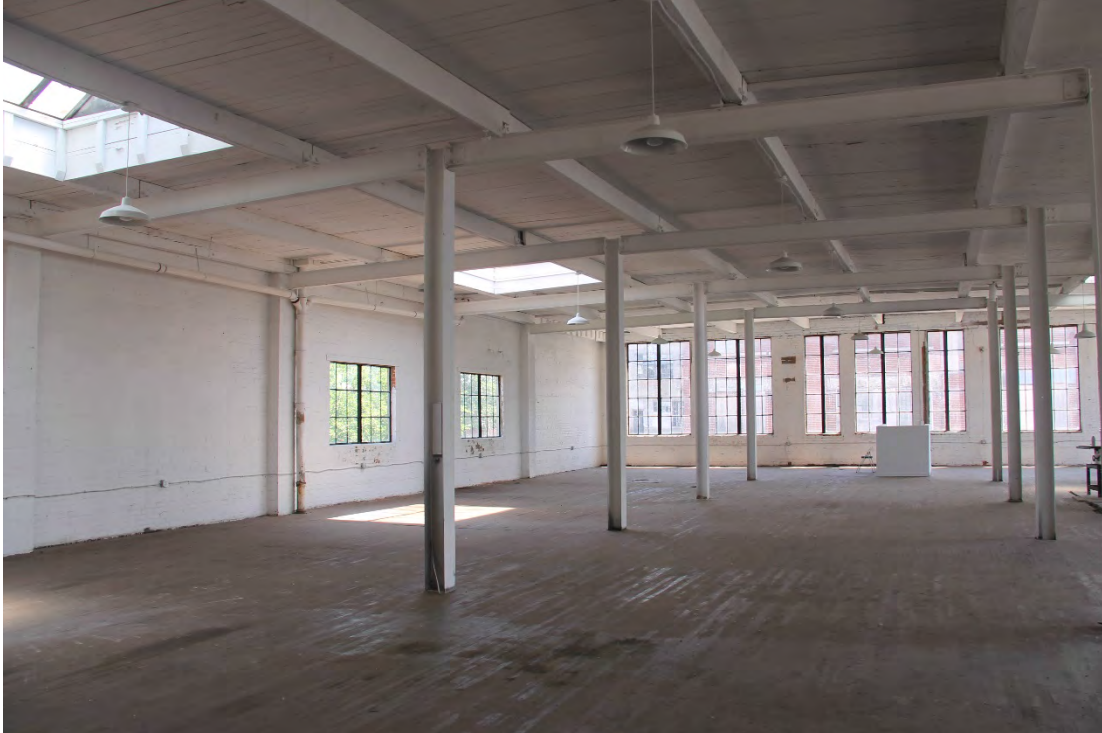
*Interior View 2nd Floor West and South Walls*

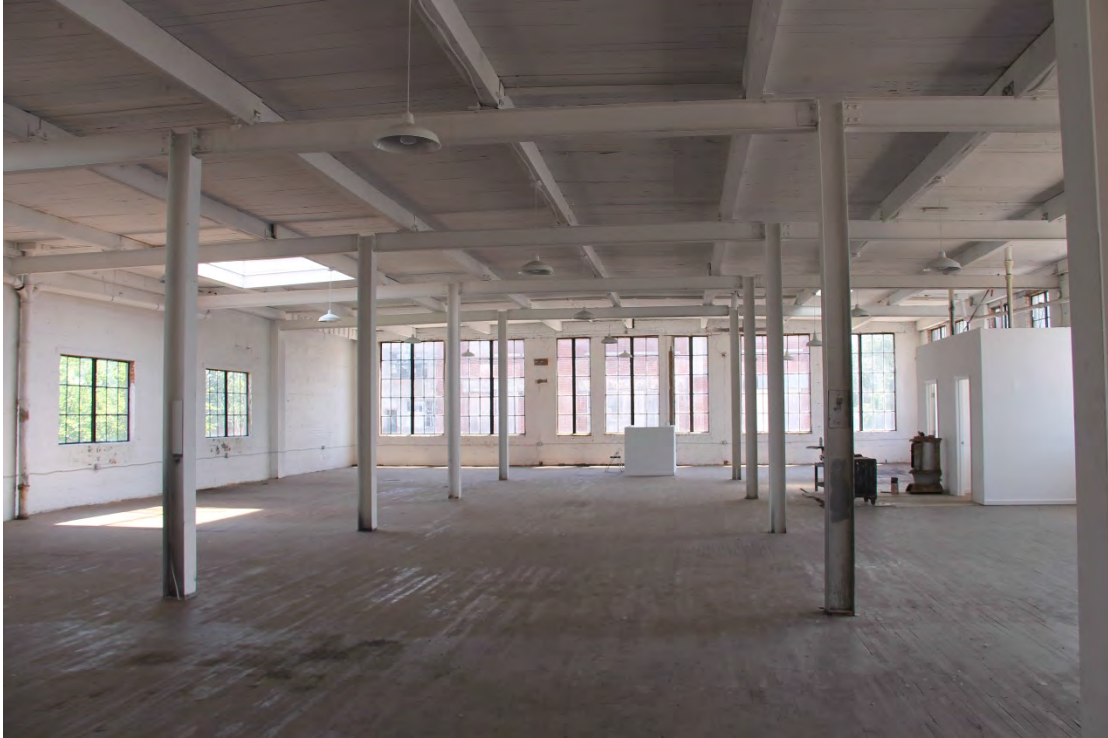
*Interior View 2nd Floor East and South Walls*

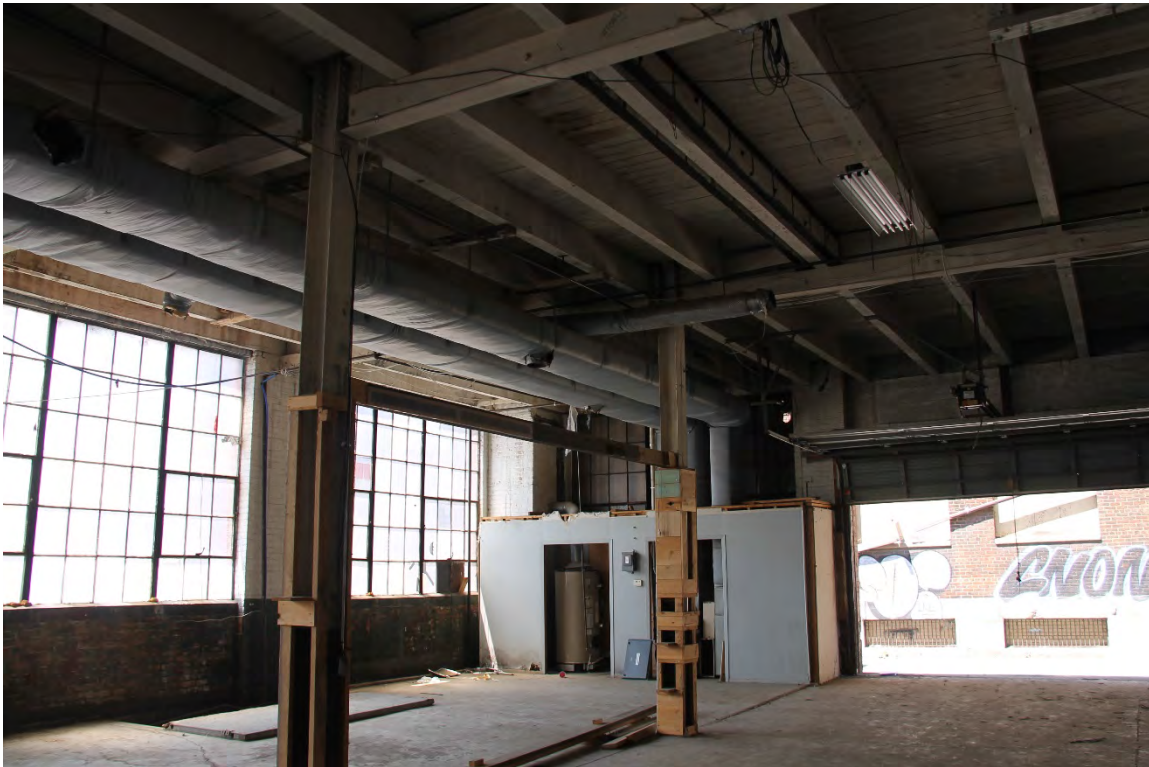
*Interior View 2nd Floor South Wall Partial East and West Walls*

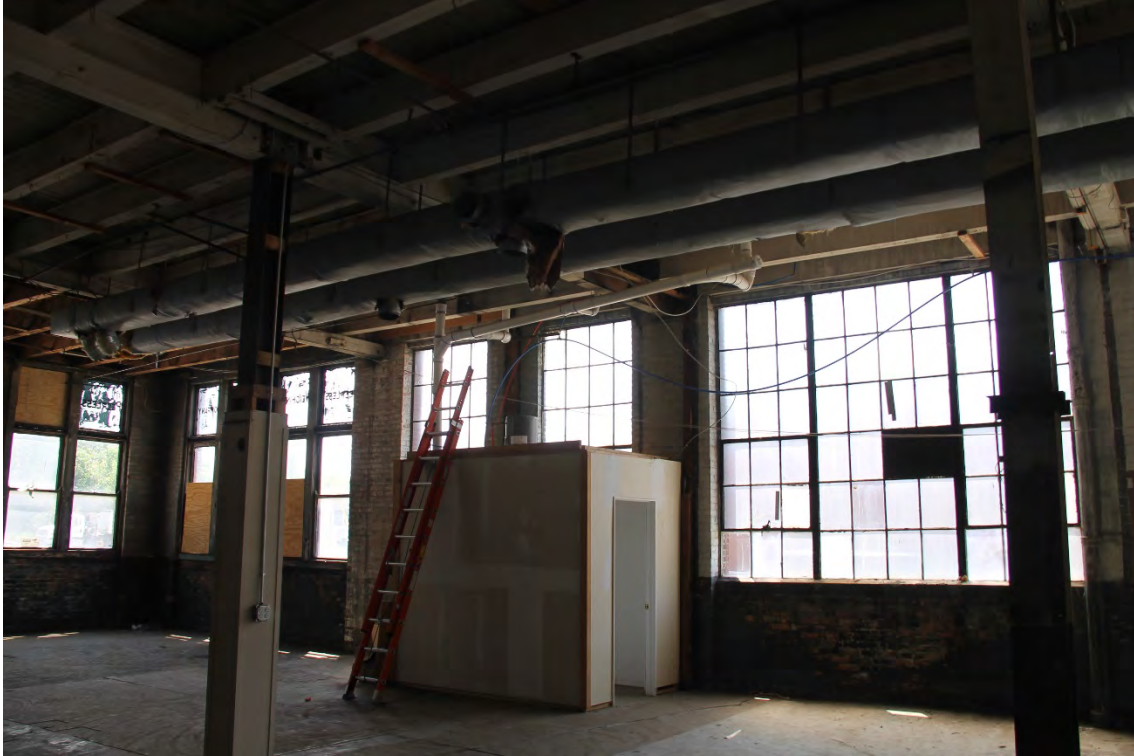
*Interior View 1st Floor West Wall Partial, and North Wall Partial*

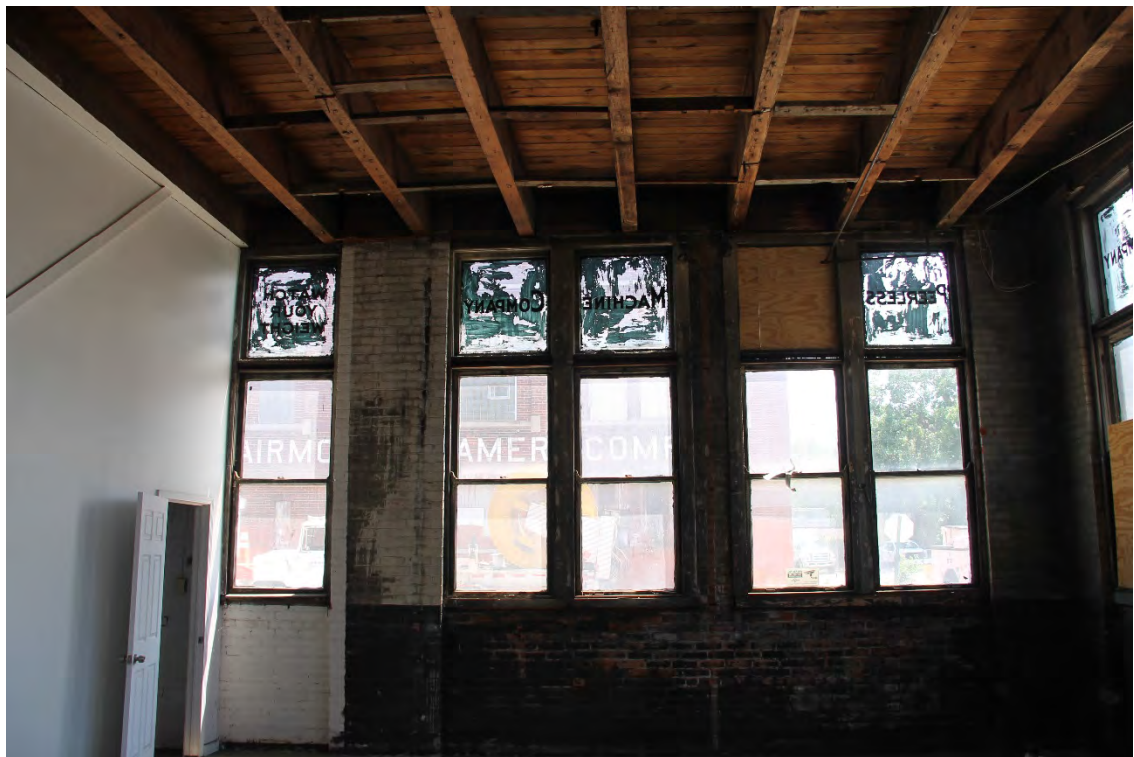
*Interior View 1st Floor West Wall Partial, and South Wall Partial*

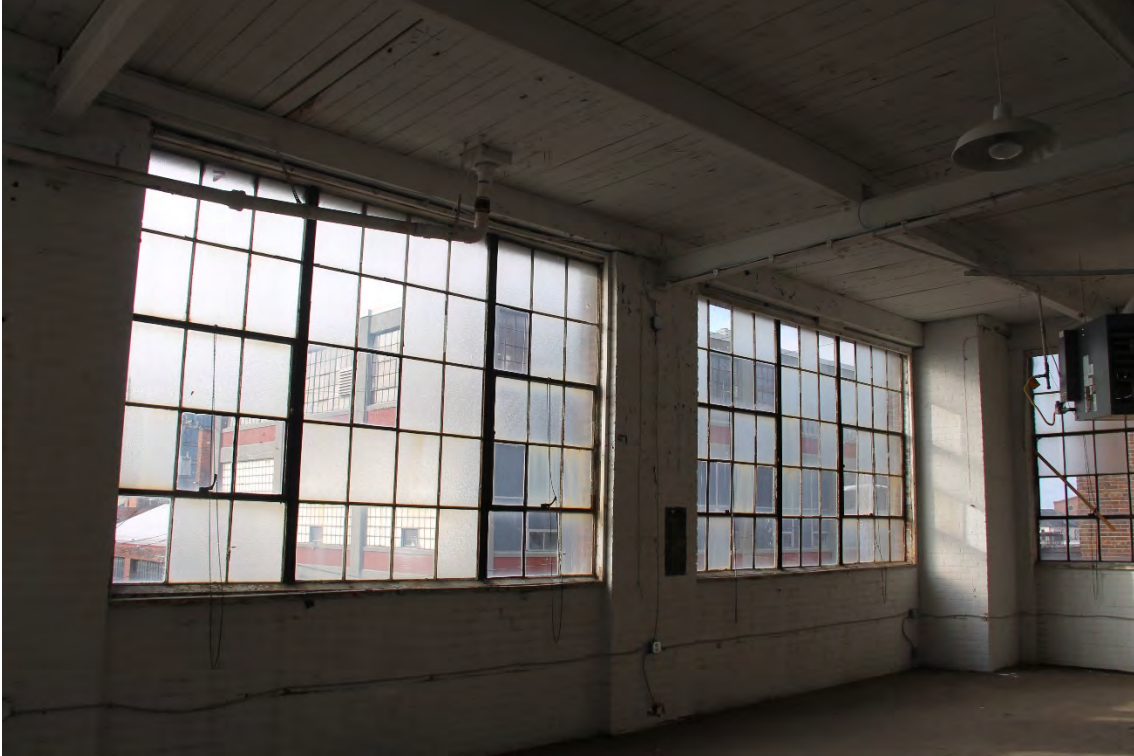
*Interior View 1st Floor South Wall Partial*

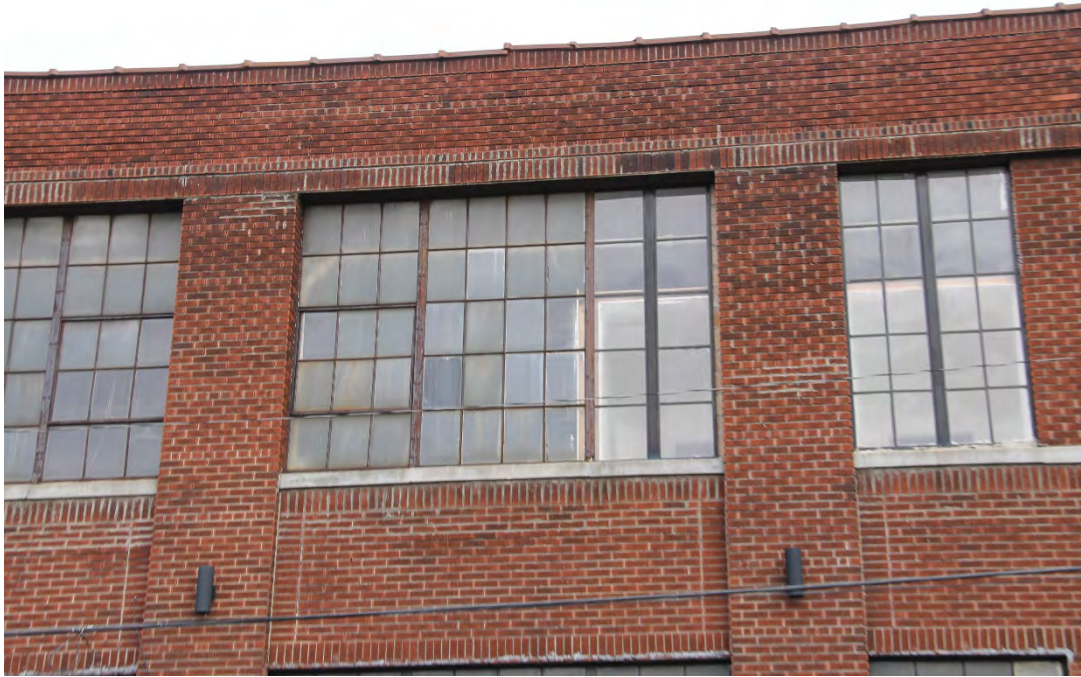
*Example of Incorrect Replica of Steel Windows. Existing Original Window on 1st Floor.  
Incorrect Replication on 2nd Floor.*

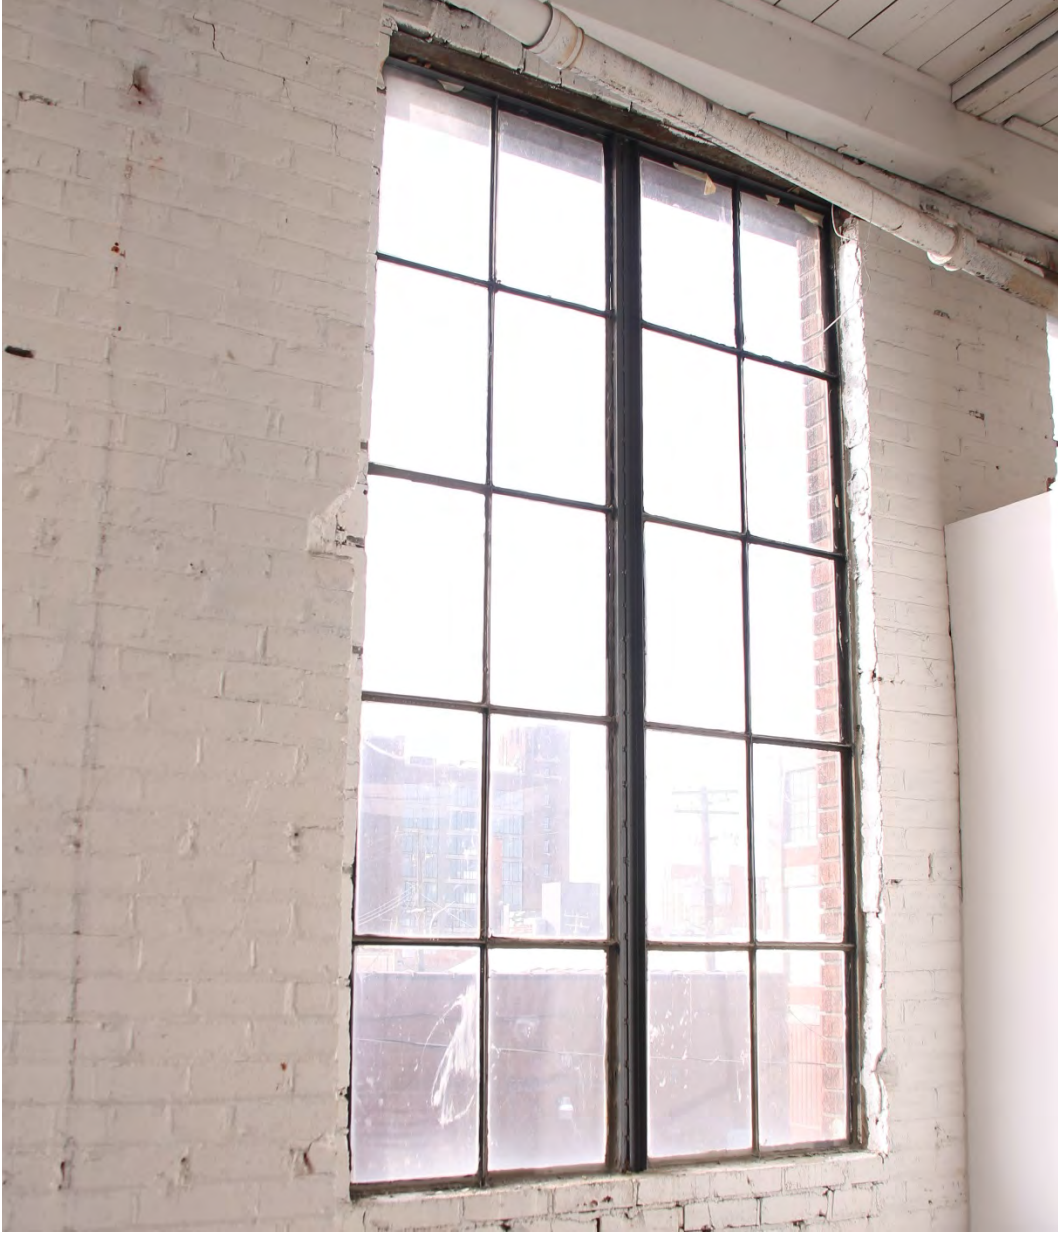
*Exterior of Replica Steel Windows*

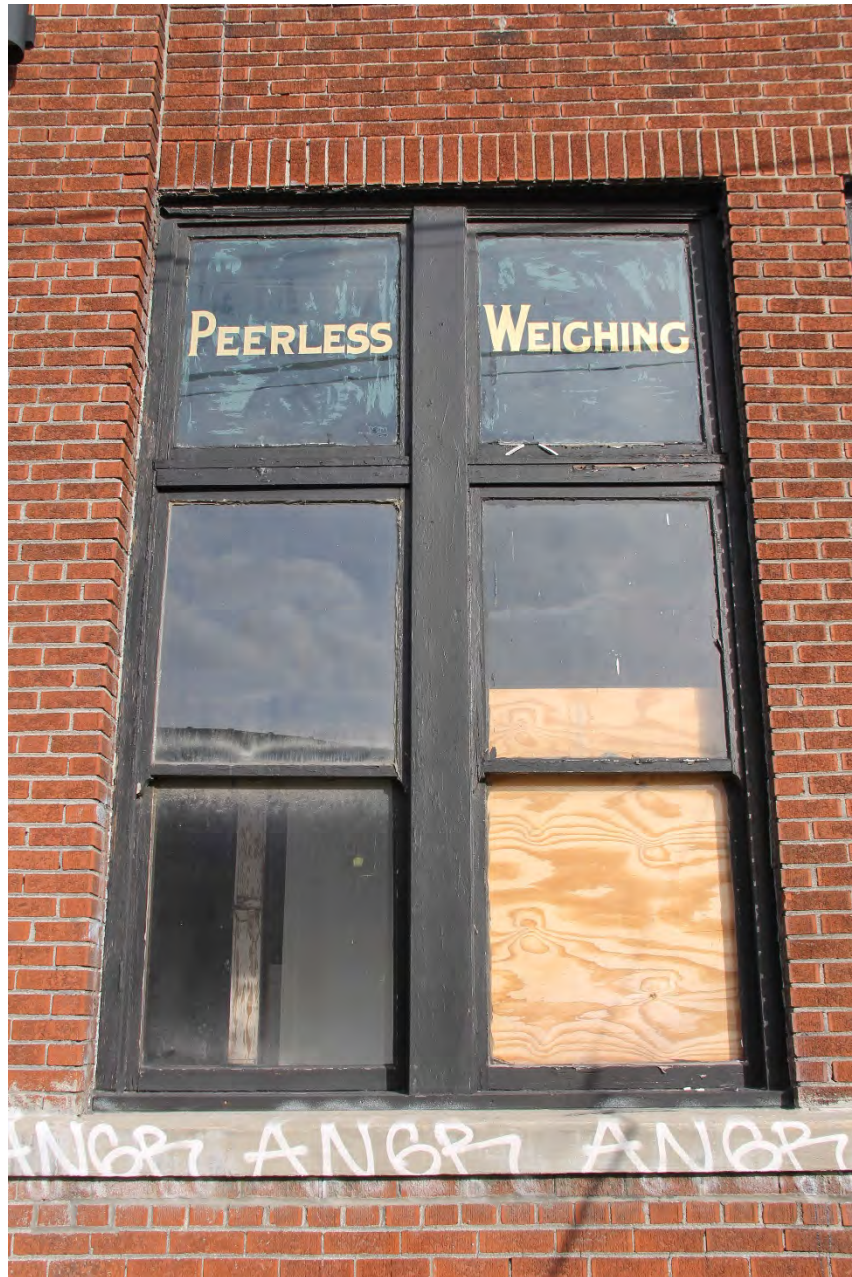
“Wood Windows”

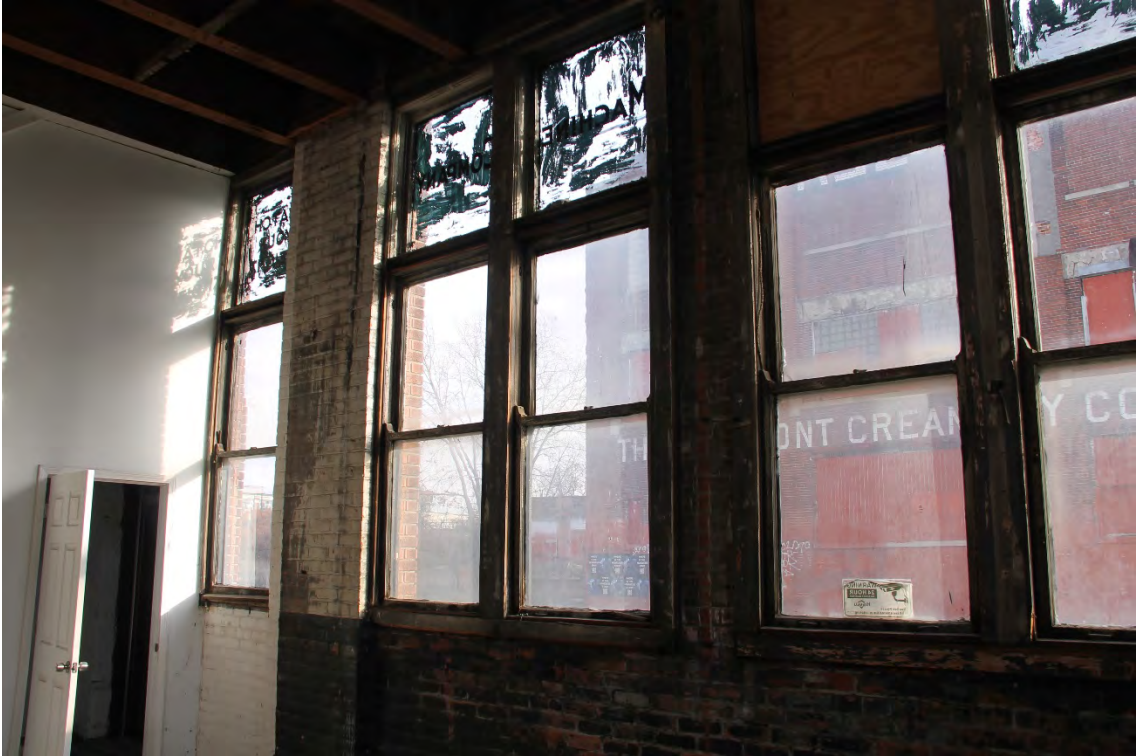
- All exterior sills are split through, running the full width of the opening. In the past, work was done to repair by cutting back the sills and face screwing a 2 x 2 wood piece to replace the rot and decayed face edge. Water is penetrating the attachment and allowing the damage to continue. Many of the existing sills have continued to decay and dry rot is present.
- The intersection of the exterior sill and weight boxes joinery is failed because of water penetration. Once this takes place a window unit is usually
- considered needing full replacement.
- Bottom rails on 30 % of the windows exterior side have failed corner joinery.
- 70% of the brickmould has been removed and no longer on site.
- Some of the mullion covers are split and missing allowing water penetration.

*Exterior View of Broken Mullion Cover Allowing Water Penetration*

The overall condition of the wood double hung windows and transoms is poor to fair. There are a few options in addressing these openings. The overall key concerns as listed above is the poor condition of the exterior sills which are split running the full width of the opening and incorrectly repaired. The breakdown of the material extends into the weight boxes in the master frame. Because the sill extends under the weight box and mullions, replacement is not typically done since to do the work correctly and mortice new joinery requires full removal. Often this work is done by trying to use epoxy consolidation, but the joinery is not adequate and fails. There would be all new brick mould, mullion covers, and interior sash stop required, as well since these components have been removed or damaged.

**Option I. Full removal and replacement with an historical replication using a thermally broken aluminum window assembly. This would include replication of the profile and dimension to NPS standards. Suggested products are available and can be detailed to show a comparison of existing and proposed drawings. The budget pricing includes removal, abatement, and disposal of existing material, new window product and installation.**
