HITSVILLE USA

FRONT PORCH GUARDRAIL

PORIS ASSOCIATES 10.12.22

DETROIT HISTORIC DISTRICT COMMISSION

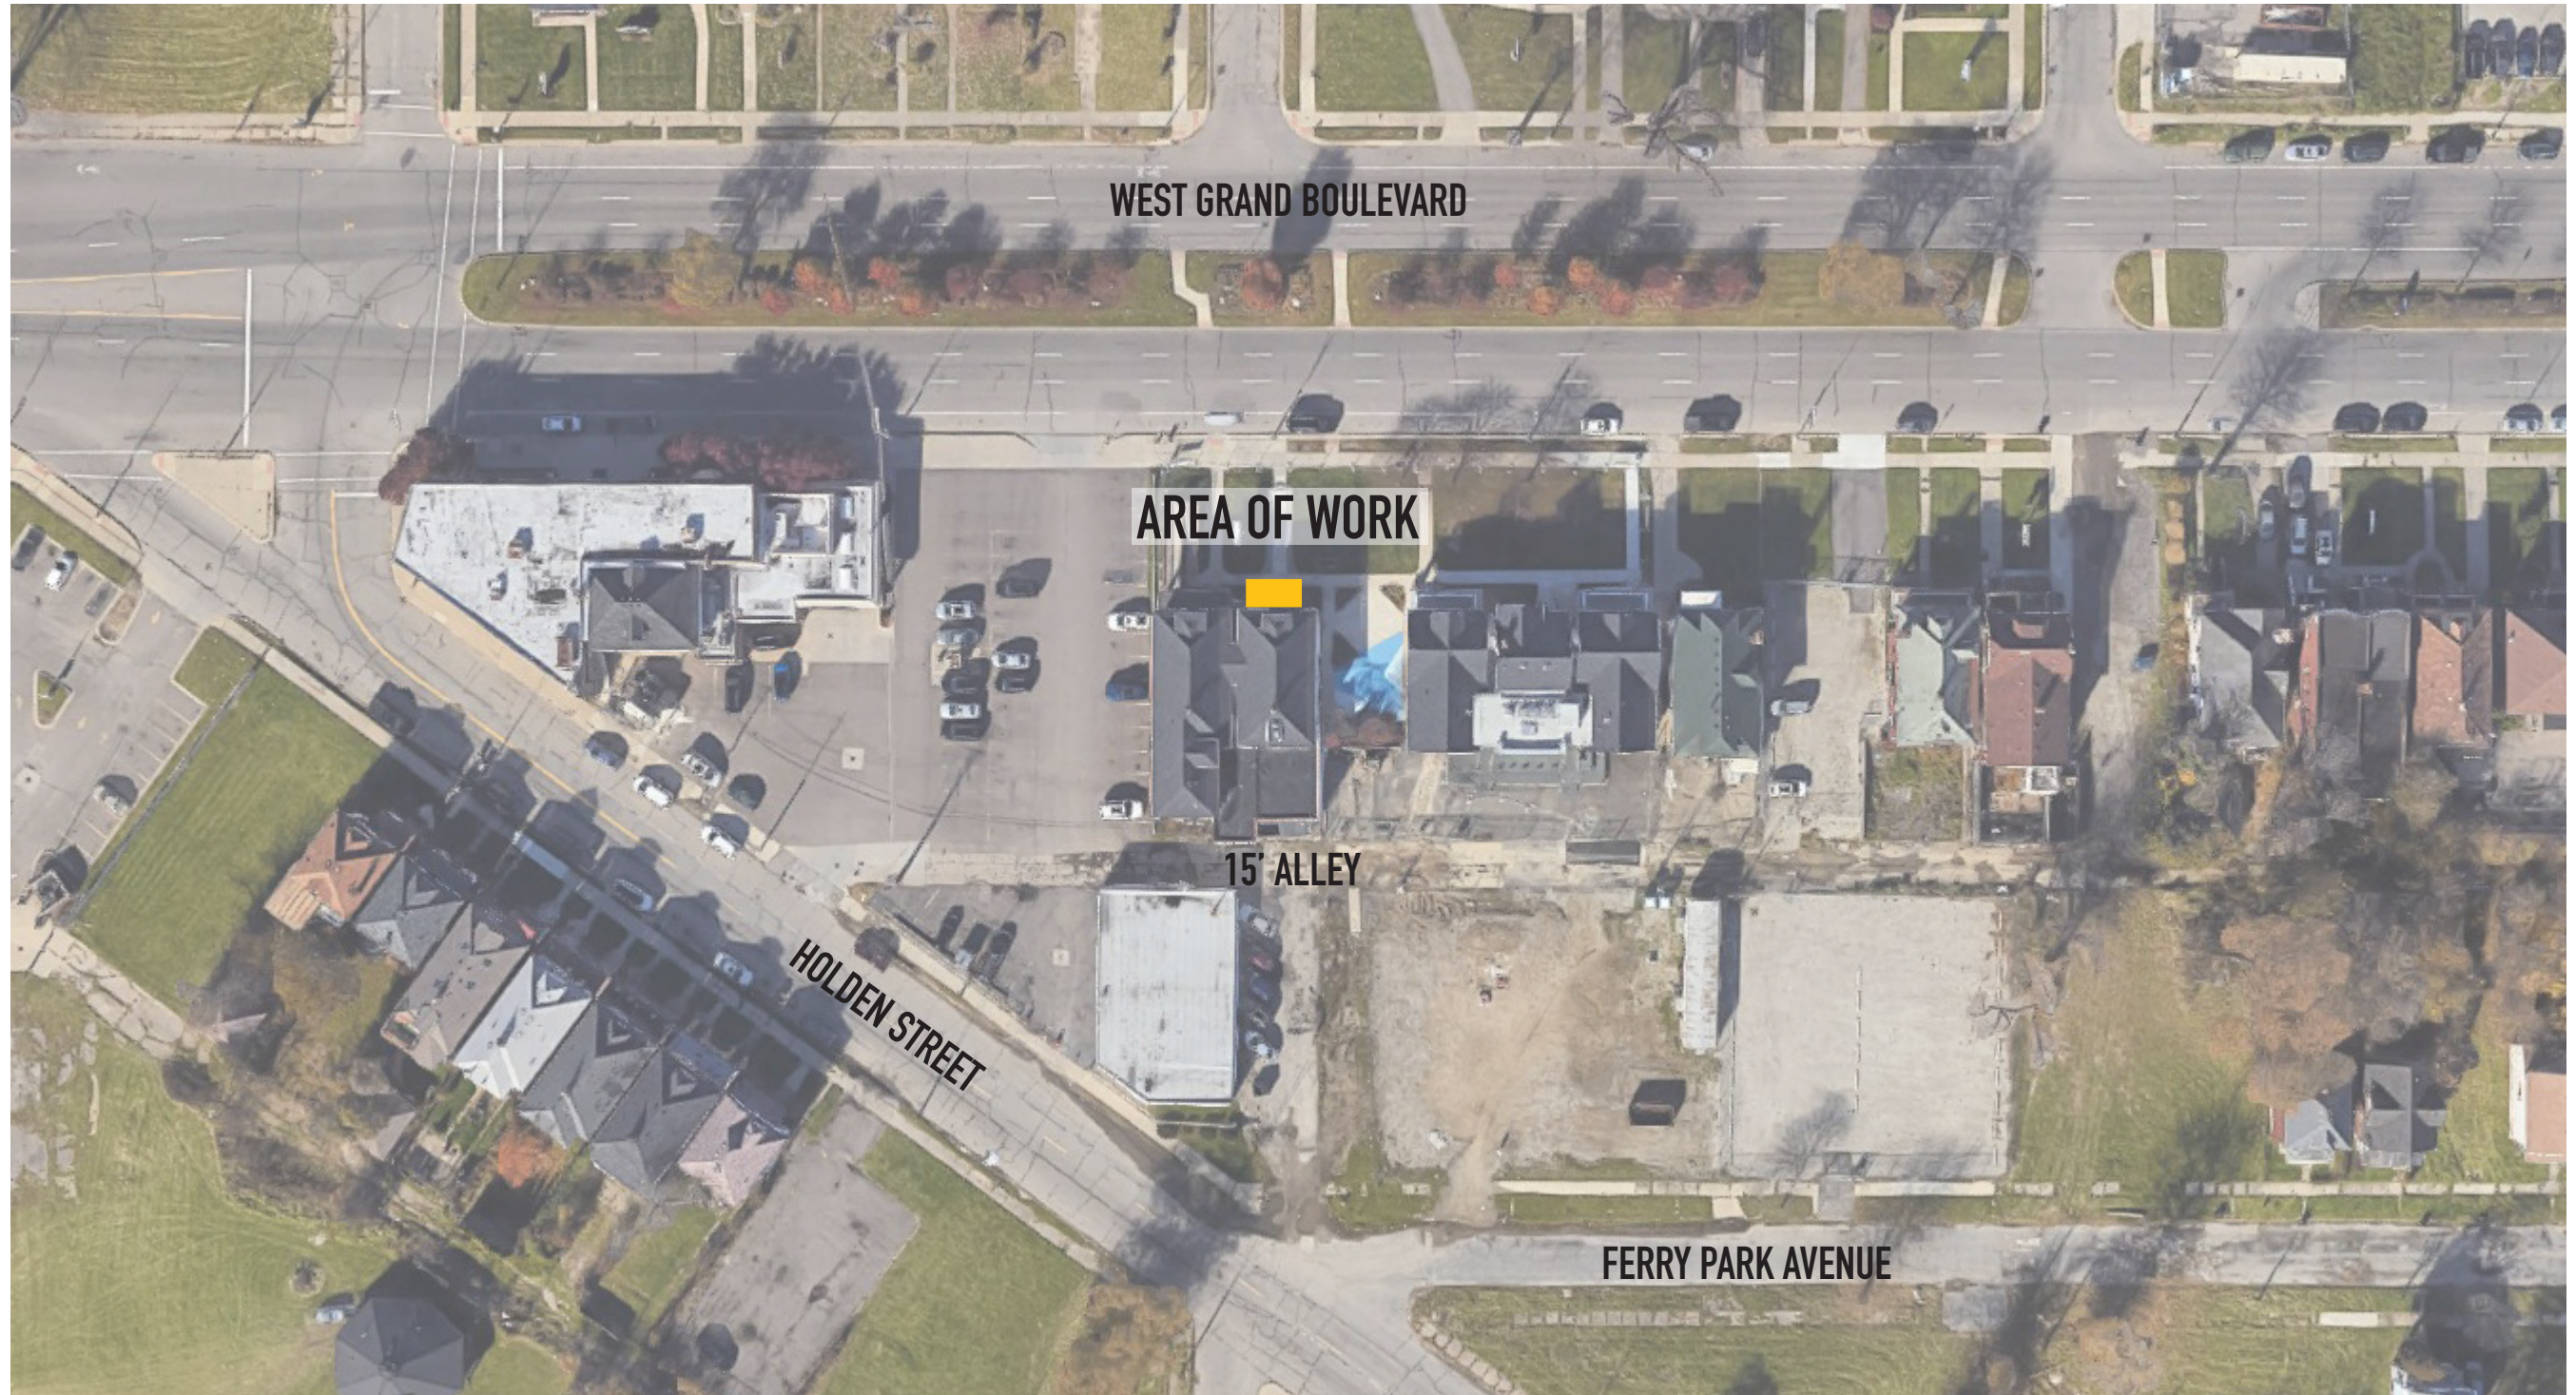
INTERMEDIATE RAILING PEG RUSTED THROUGH AND IS NOT PROVIDING ANY ATTACHMENT

CORNER POST ANCHOR EXPOSED - REPLACEMENT REQUIRED

BOTTOM SLAB SPAWLING AND RE-BAR EXPOSED

CEMENTITIOUS PARGE COAT SPAWLING DUE TO SEVERE WATER INFILTRATION AND SLAB WASHOUT BEHIND

>70% OF MORTAR IS NON-EXISTENT AT ALL EXPOSED PORCH MASONRY
