HamiltonAnderson

**Re: Detroit Midnight Golf- 7441 Second Ave Detroit
Existing Building Windows replacement, removing existing roofing and installing
new roofing.**

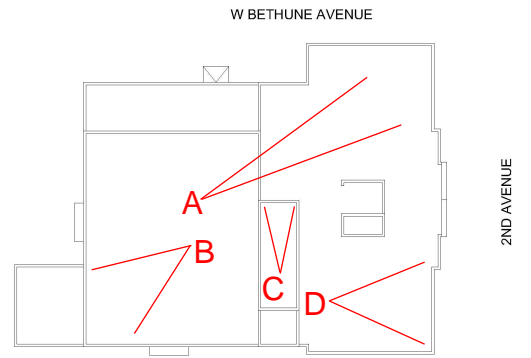
Roof Plan

Existing Roof – The existing roof has failed in many places and will be replaced with new tapered insulation and a new membrane roof. The roof leaks have damaged the exterior walls and interior finishes and has caused flooding in the basement.
