6/20/2023 Revised from 5/13/2019

Job Name: 1332-1336 Broadway
Job Location: Detroit, MI

Historic Window Site Review:

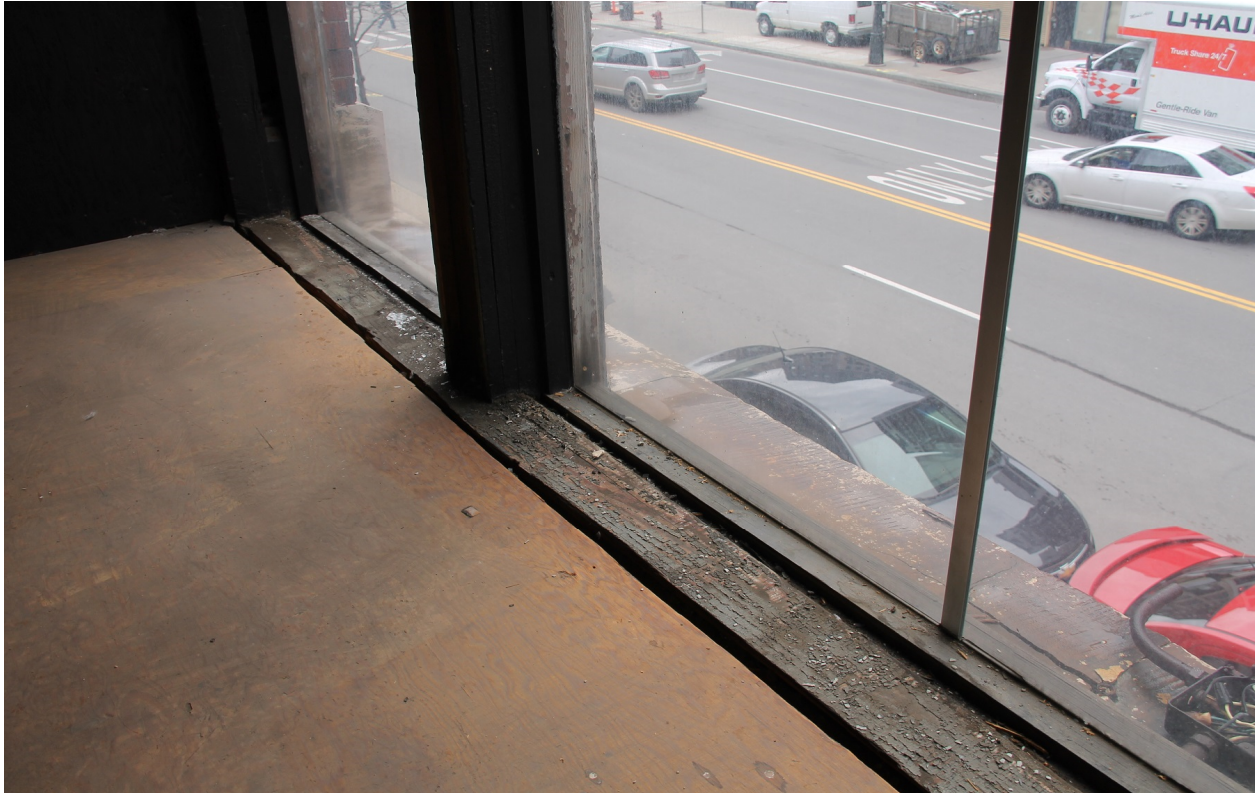
Interior 1336 Broadway, 2nd Floor

Steel Windows: The hot rolled steel windows on the 2nd and 3rd floors are in poor condition. The sash frames are corroded at the bottom rails, and the top rails and jambs are bent, and joinery is failing on about 50% of the openings. 30% of the frames have been removed and not in the building. The glazing method is unique using a lead
