1405 Chicago Blvd elevations with windows

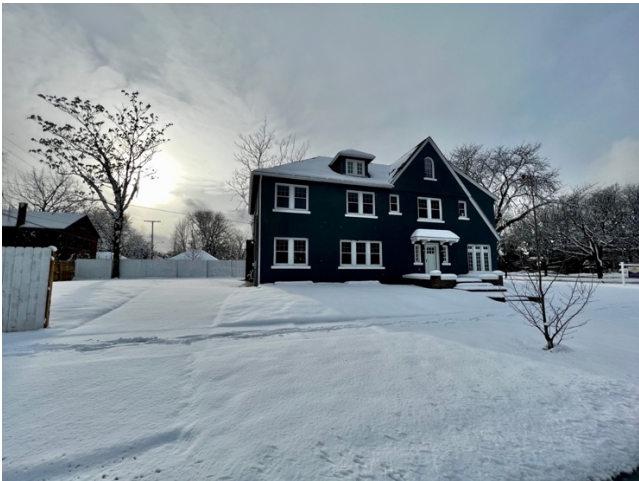
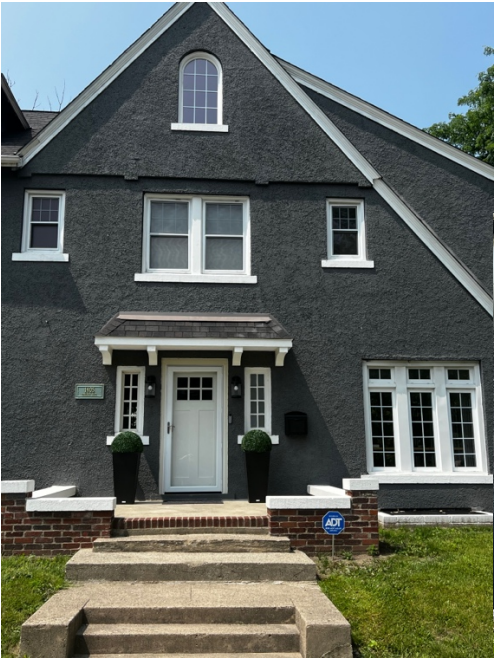
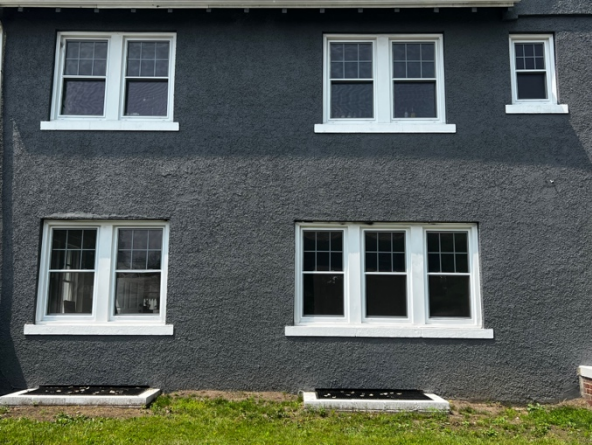
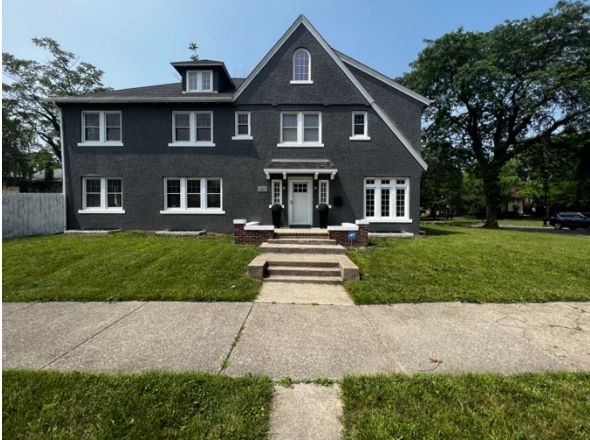
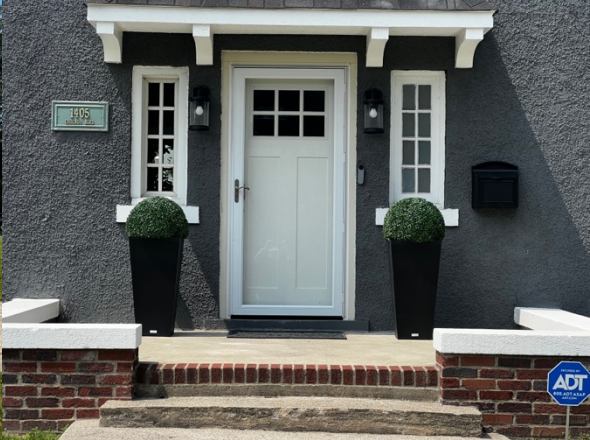
East side facing Byron St.

Main floor; family room, dining room and main entry.

Family room (right side taller window) is the same style as all the ones facing North, and installed clearly at same time, PVC material, assuming 2017.

Main entry, small window to the right of the door is original to the house (see detailed photos attached)

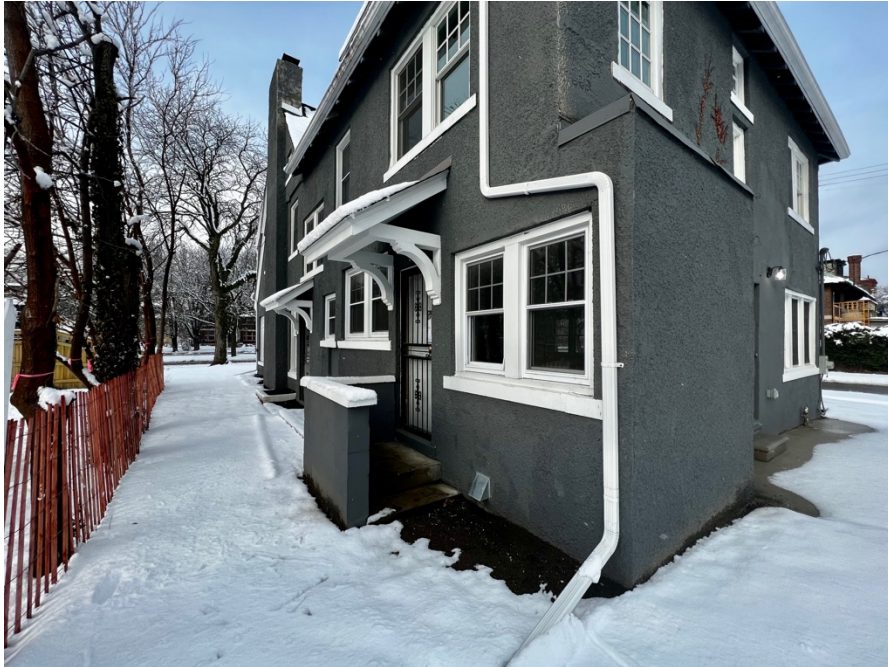
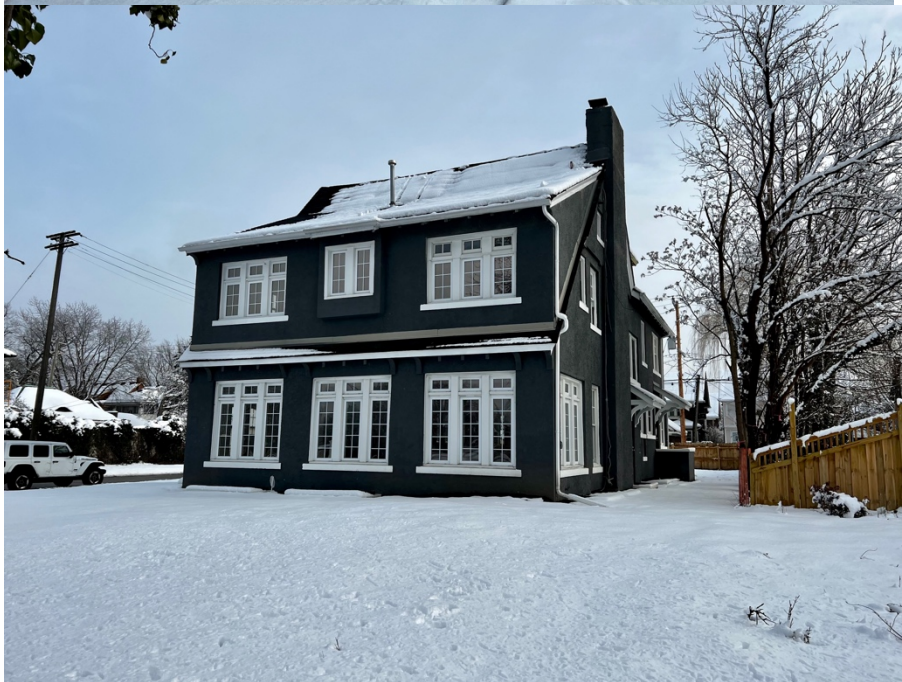
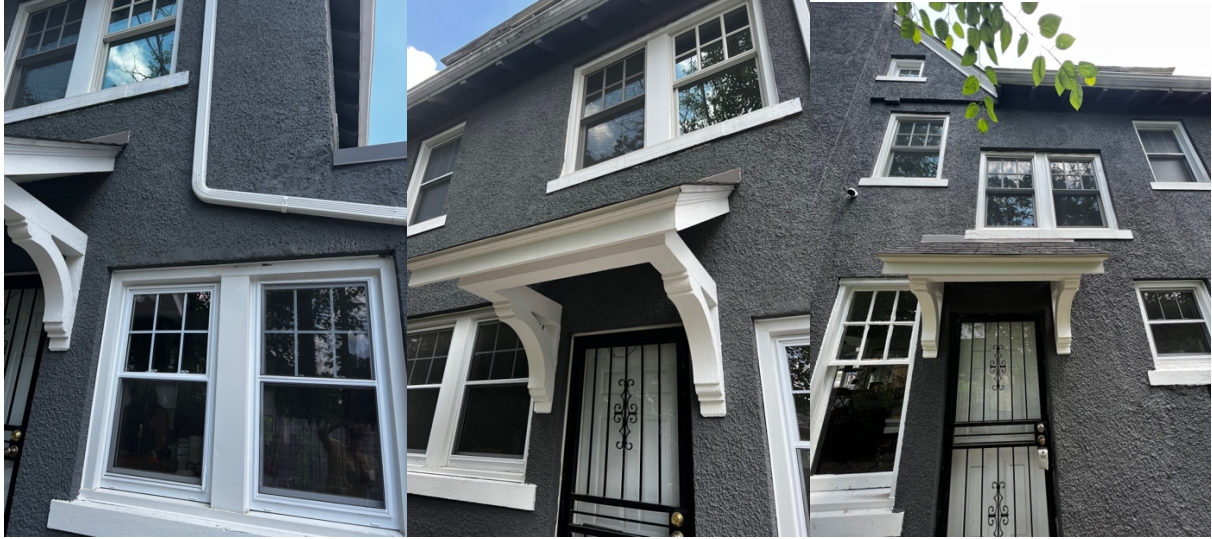
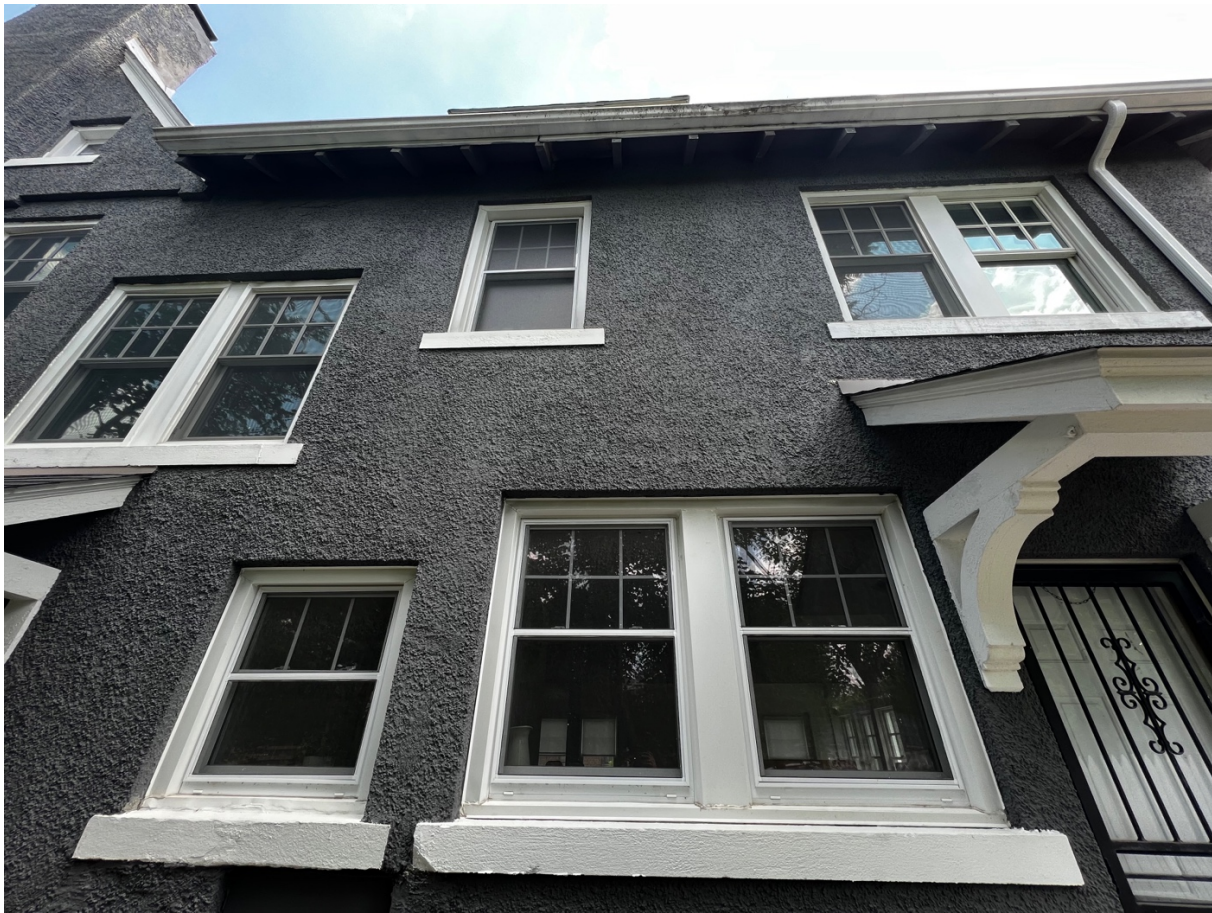
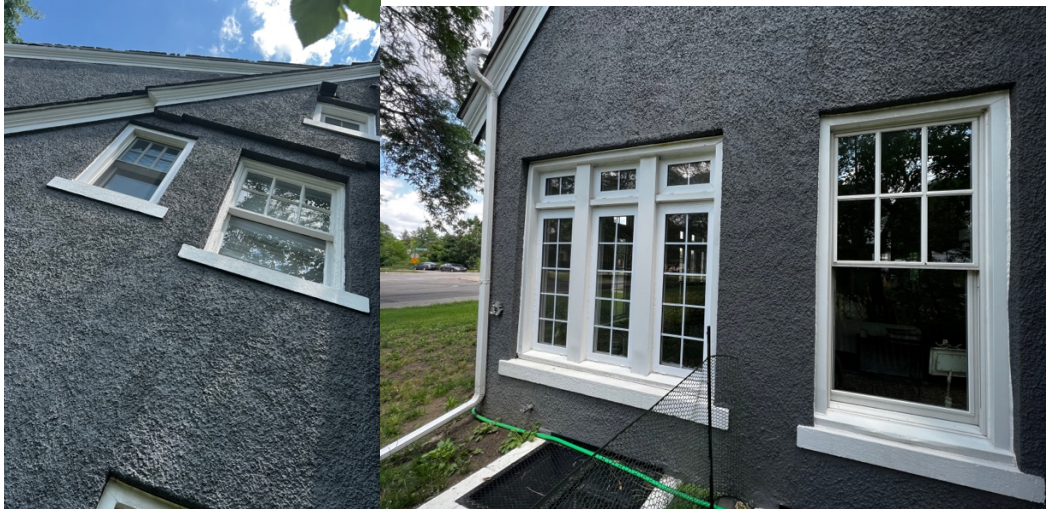
East side facing neighbors in Chicago Blvd.

(here I have multiple photos as I can't get far enough to cover all in one photo due to proximity to neighbors property)

Main floor, facing west we have the kitchen and part of family room.

Kitchen area, two windows, both are PVC material, and windows are dated 2017.

Family room, two windows around fireplace, left one is original, and quite damaged. Right one is wood and dated 2010.
