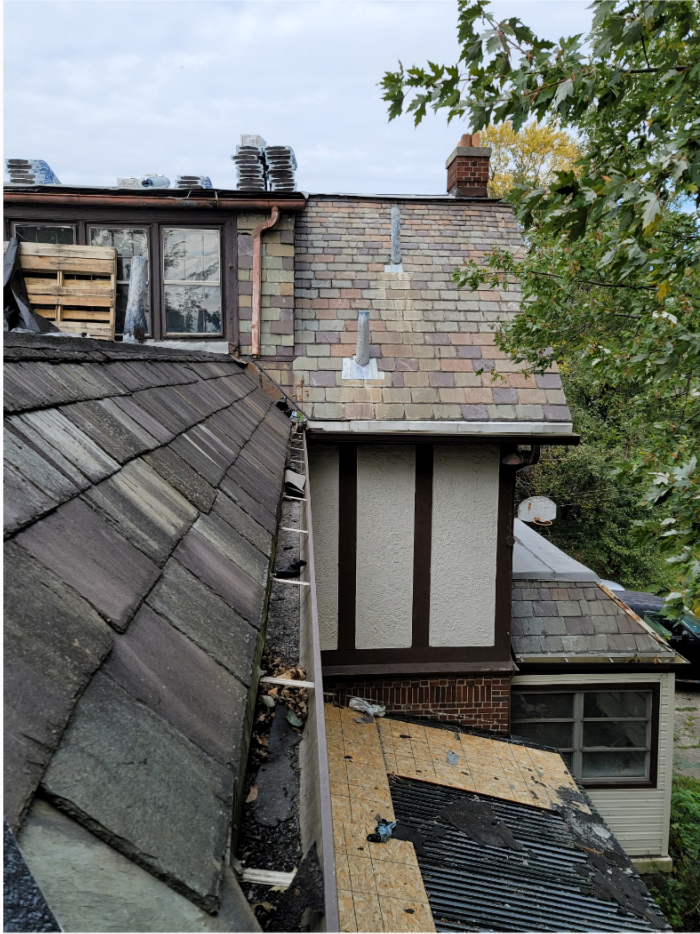
Exhibit 5. Flatroof was repaired or replaced not with metal wide drip edges to keep edges from coming up from wind stomp.

Aslo on dormer wall tiles are not connected and attach to wall
