HISTORIC DISTRICT COMMISSION APPLICATION FOR WORK APPROVAL

APPLICATION ID
HDC2024-00658

ADDRESS(ES): 15107 Minock
HISTORIC DISTRICT: Rosedale Park

<p>BRIEF PROJECT DESCRIPTION: Remove and haul away existing shed. Build new detached garage approx 22x20 on new cement floor and ratwall.</p>
--

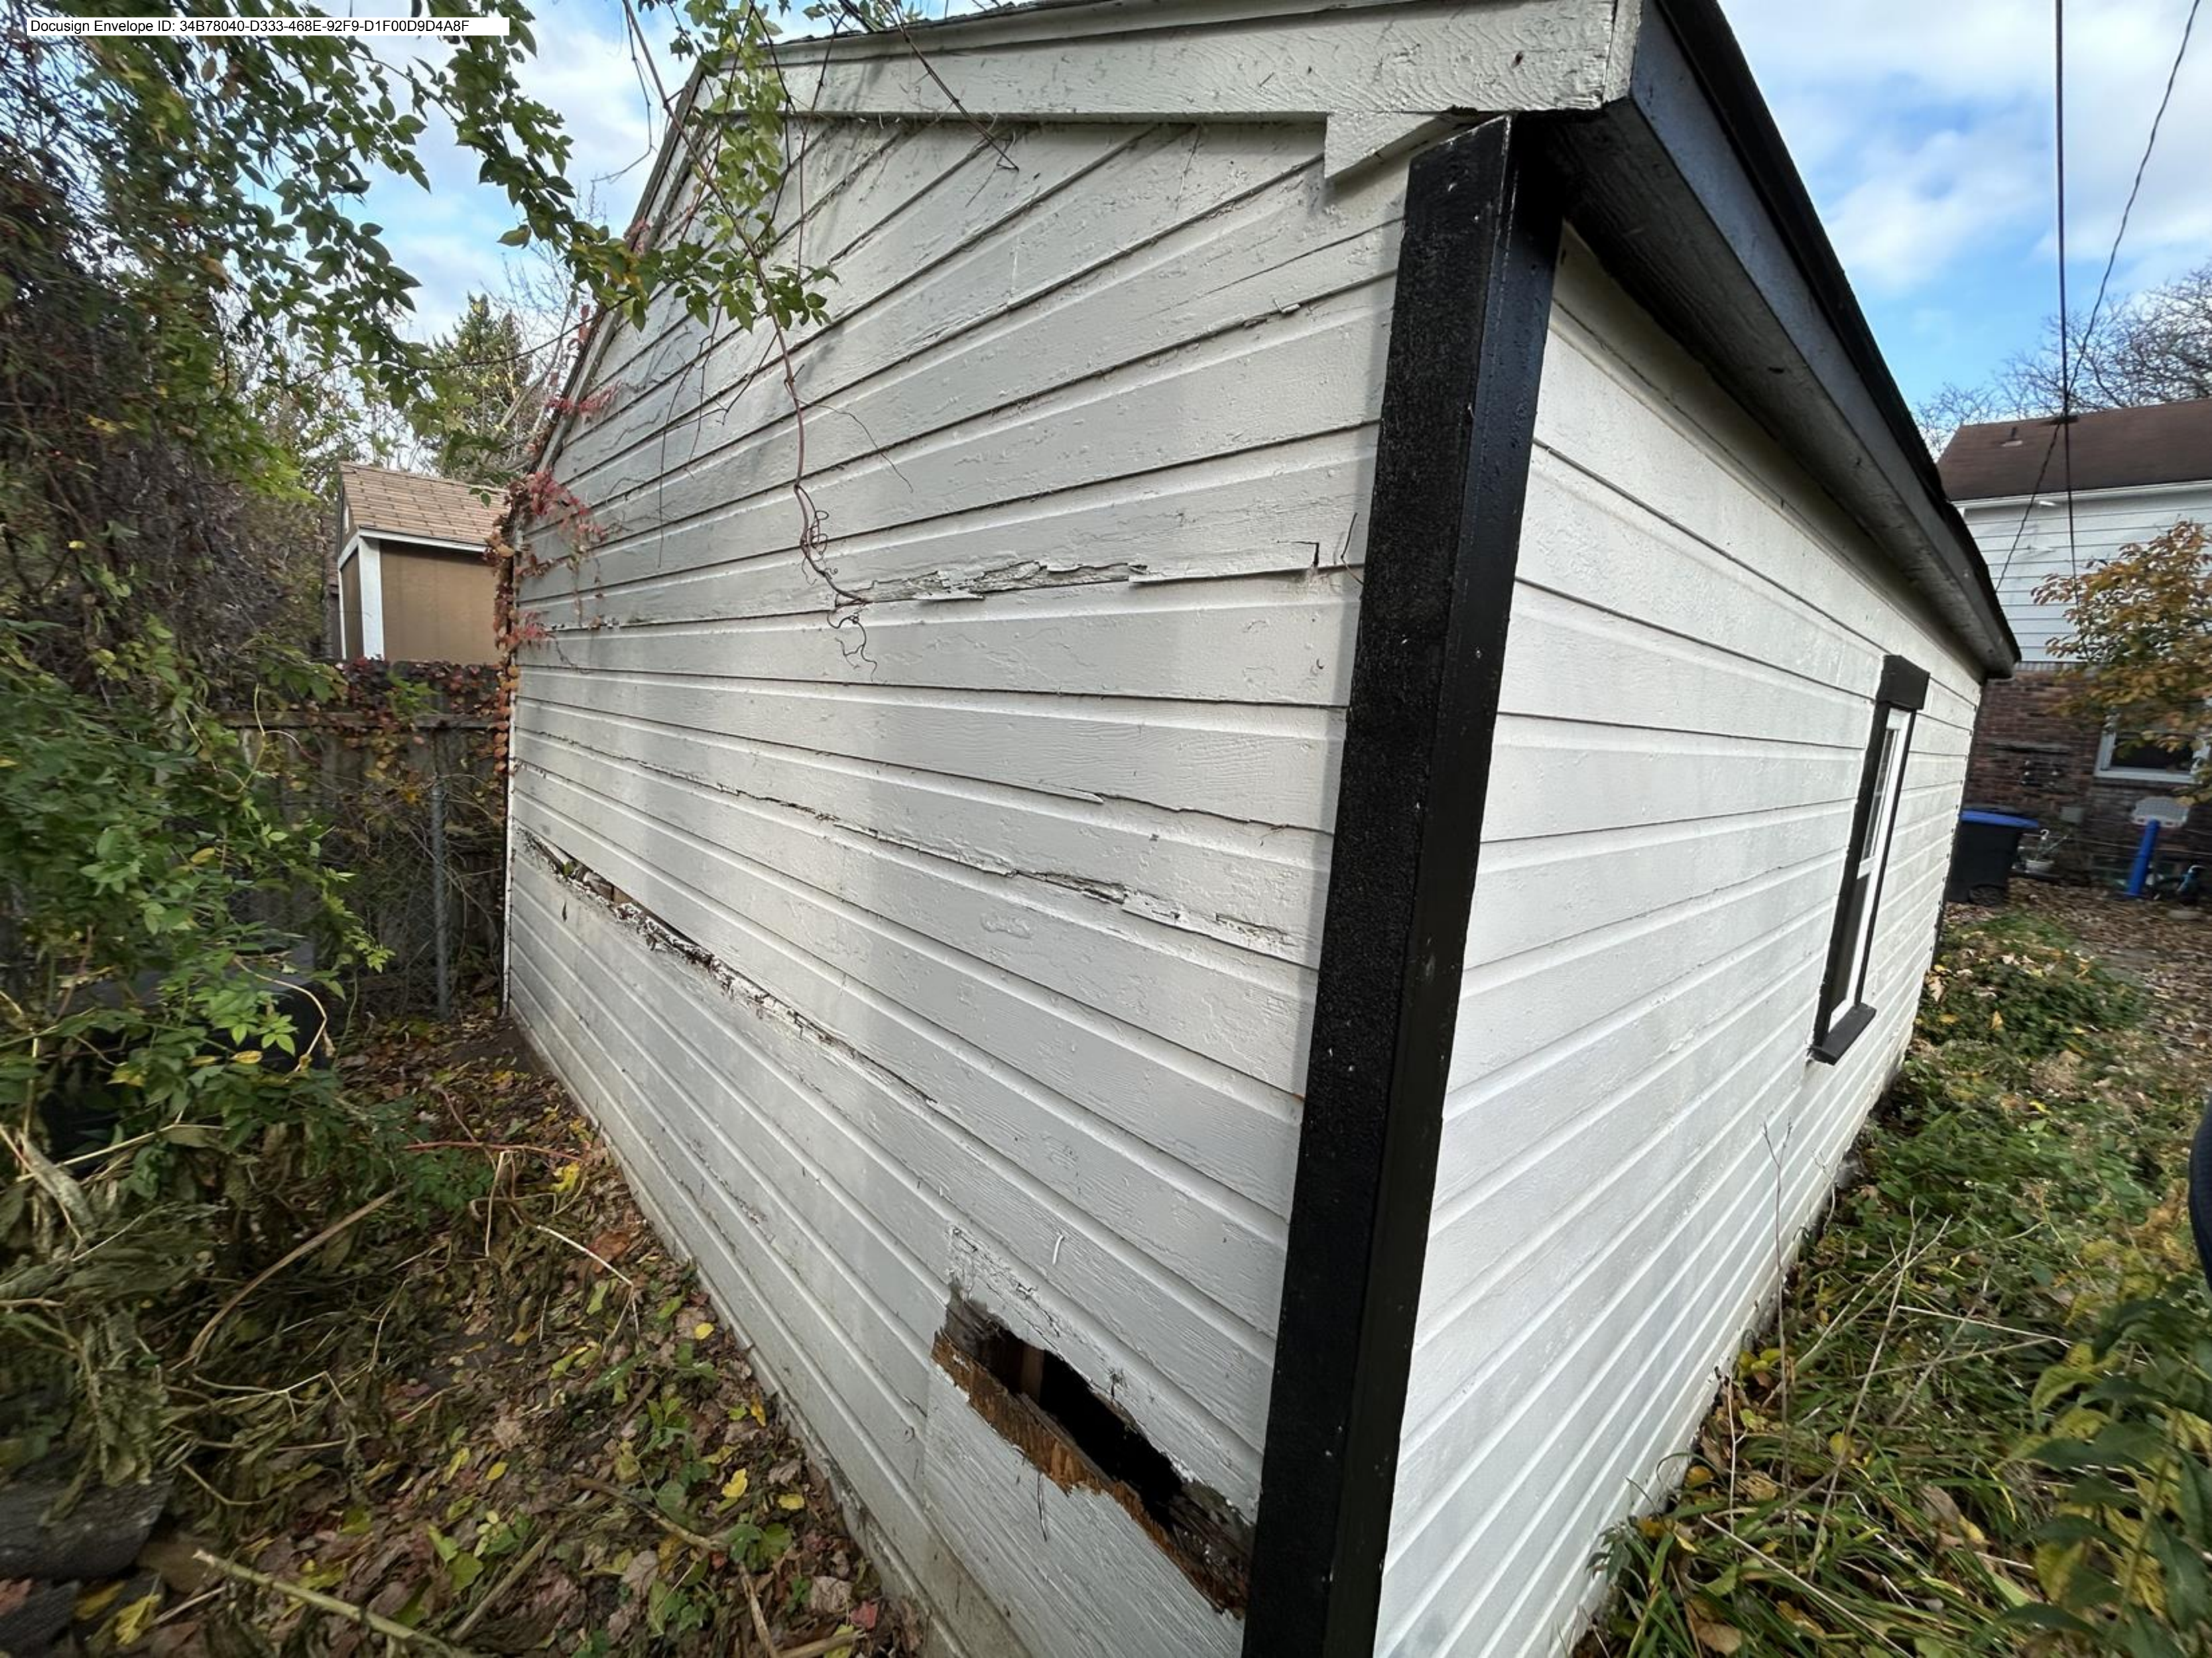
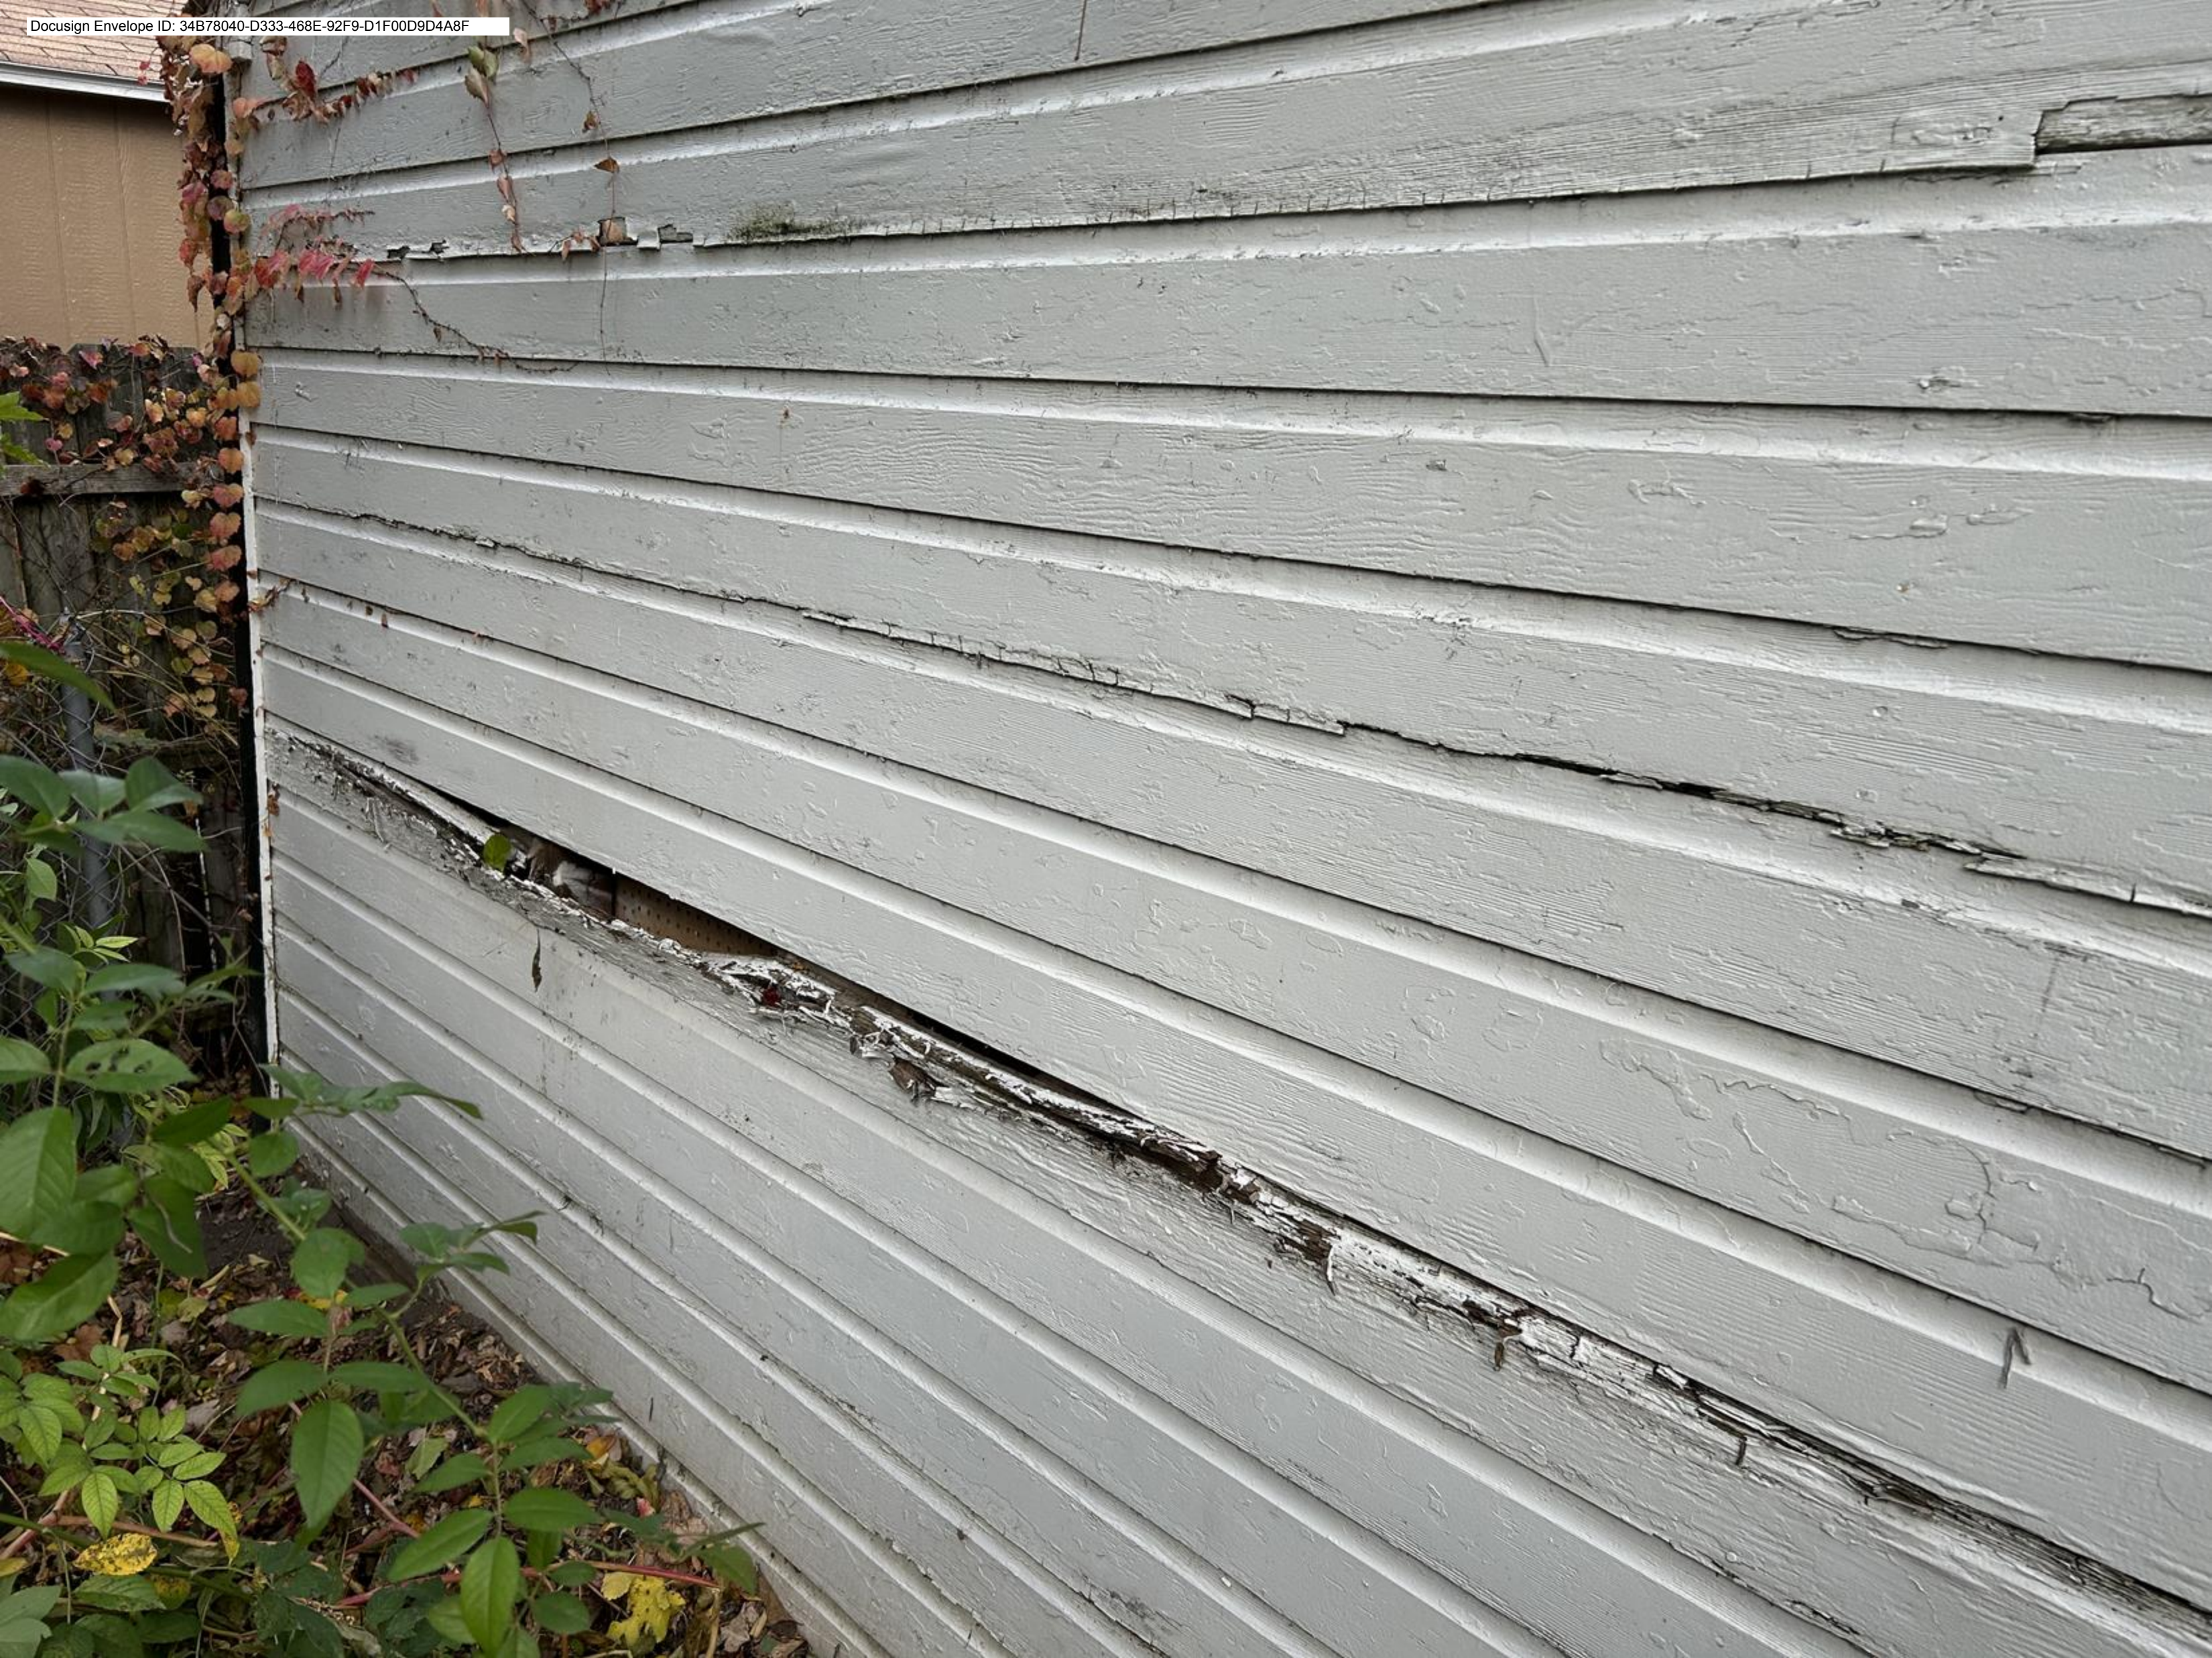
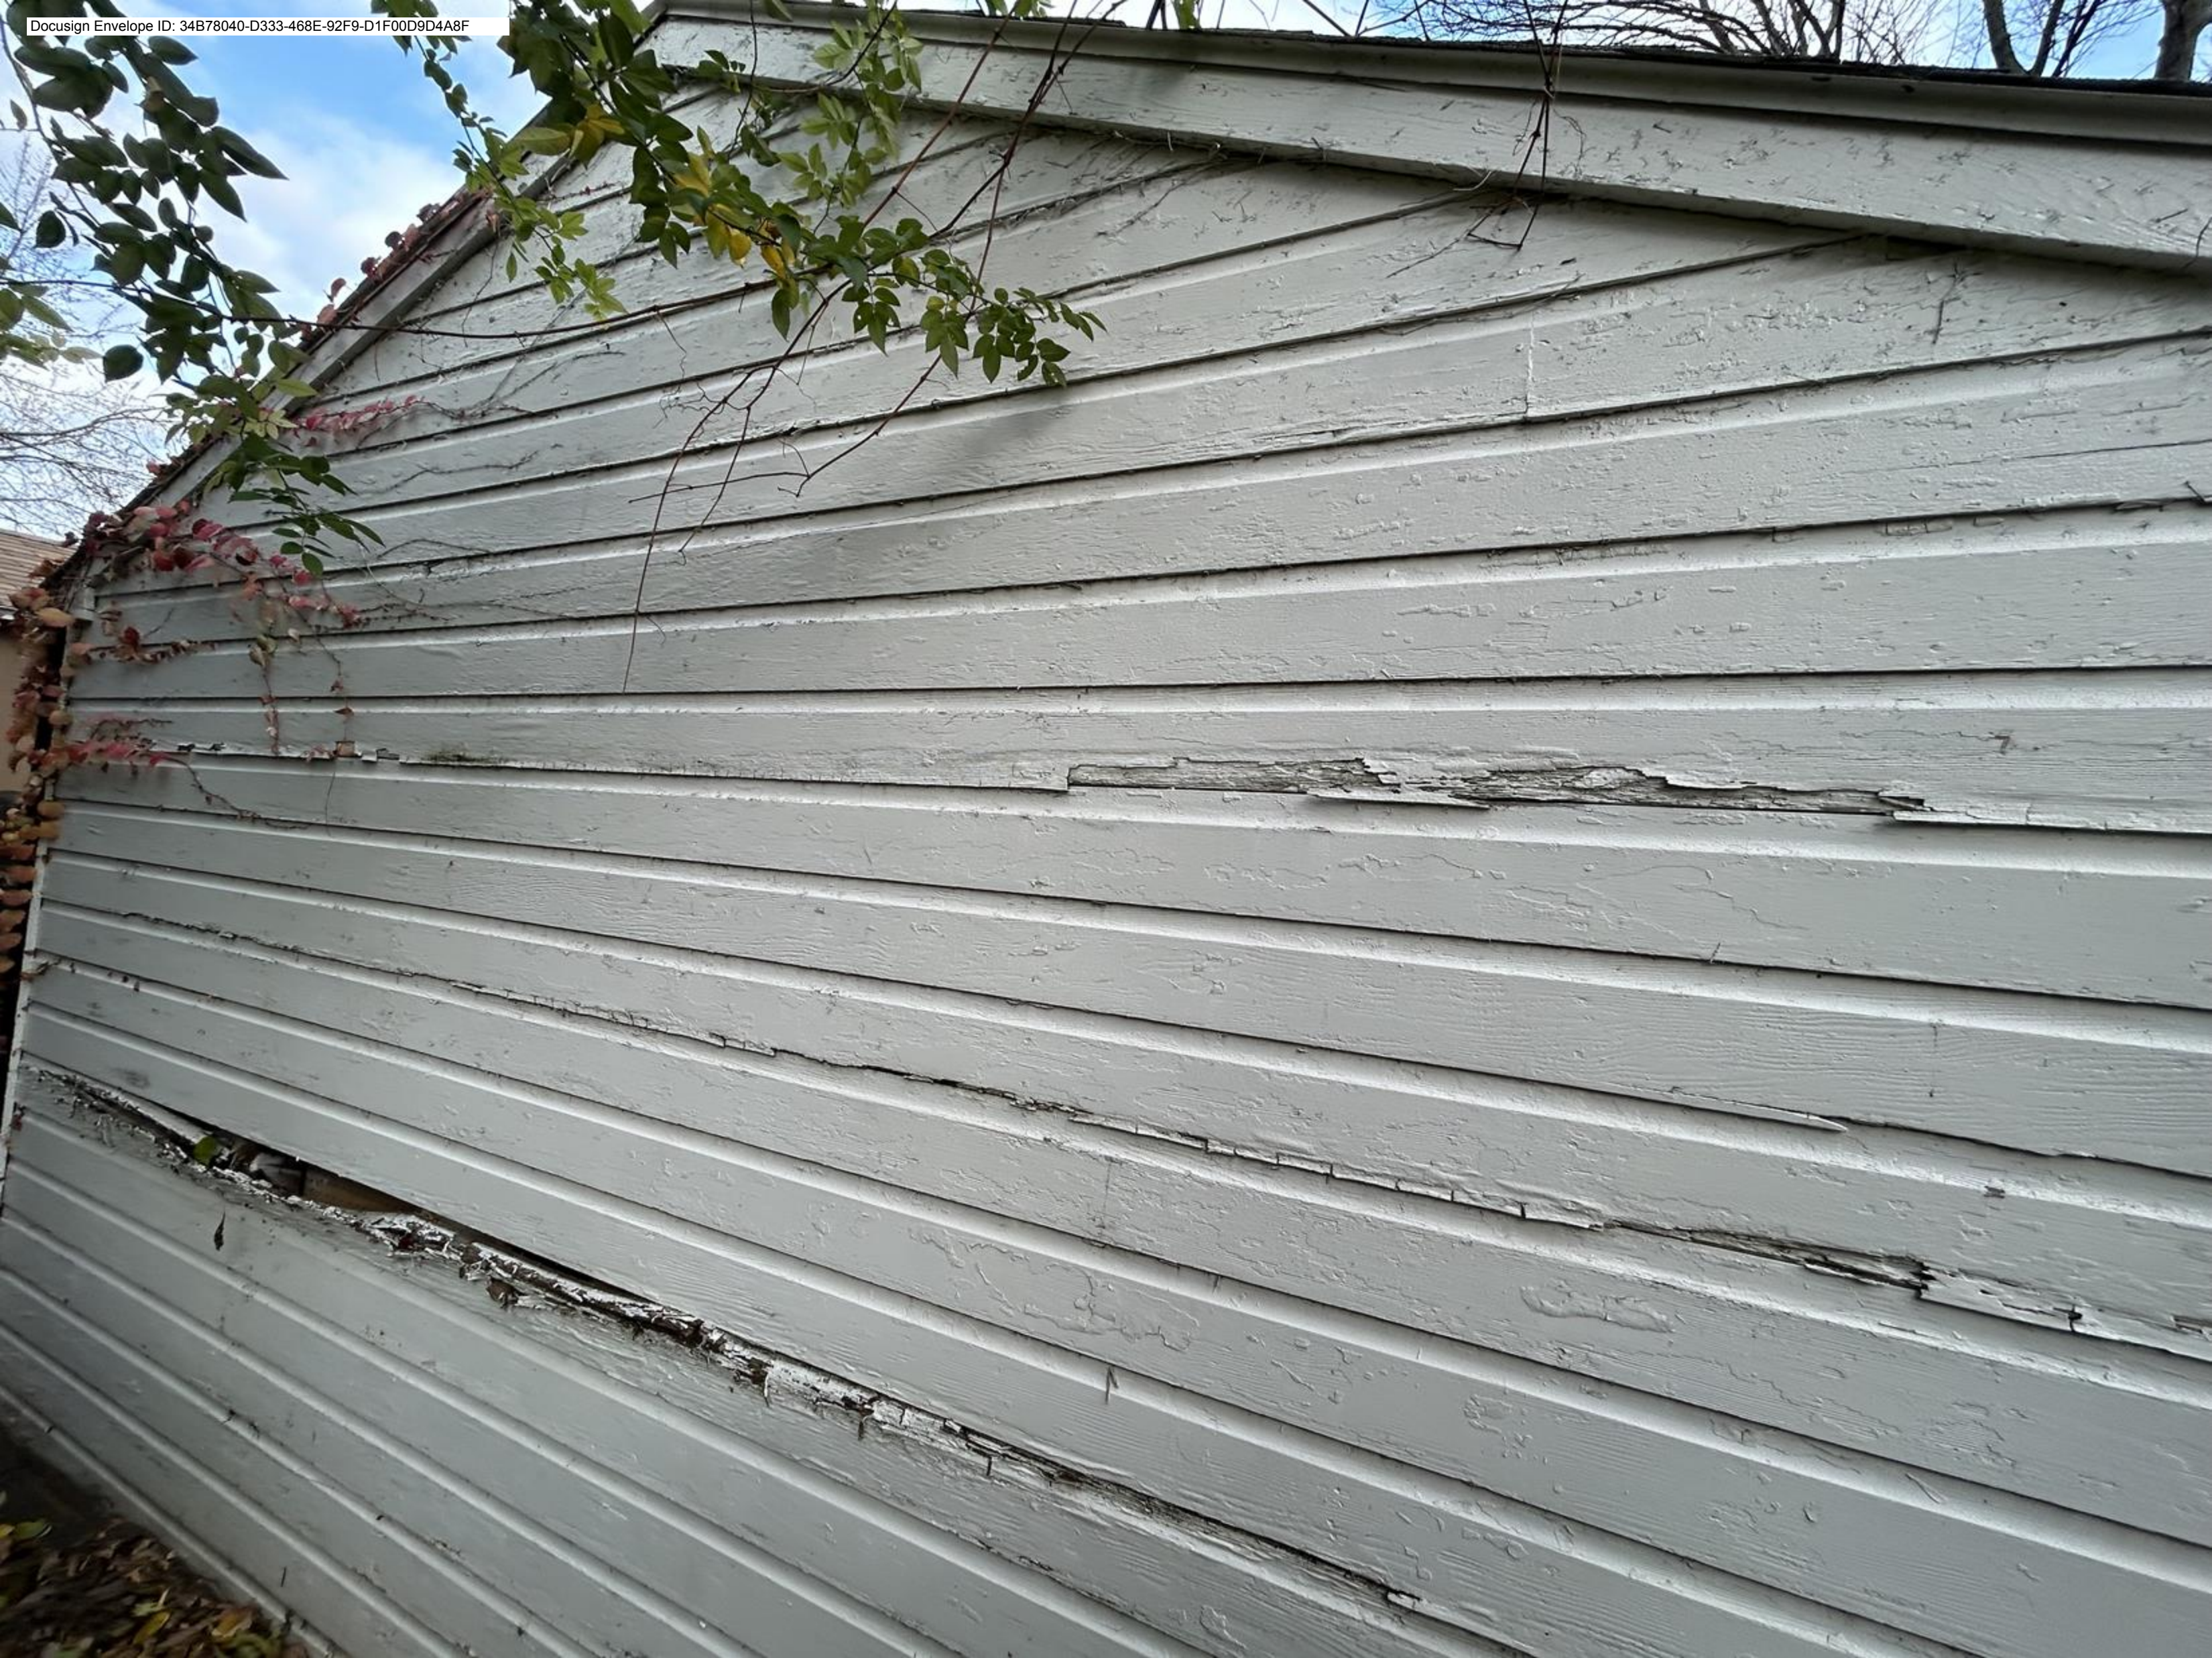
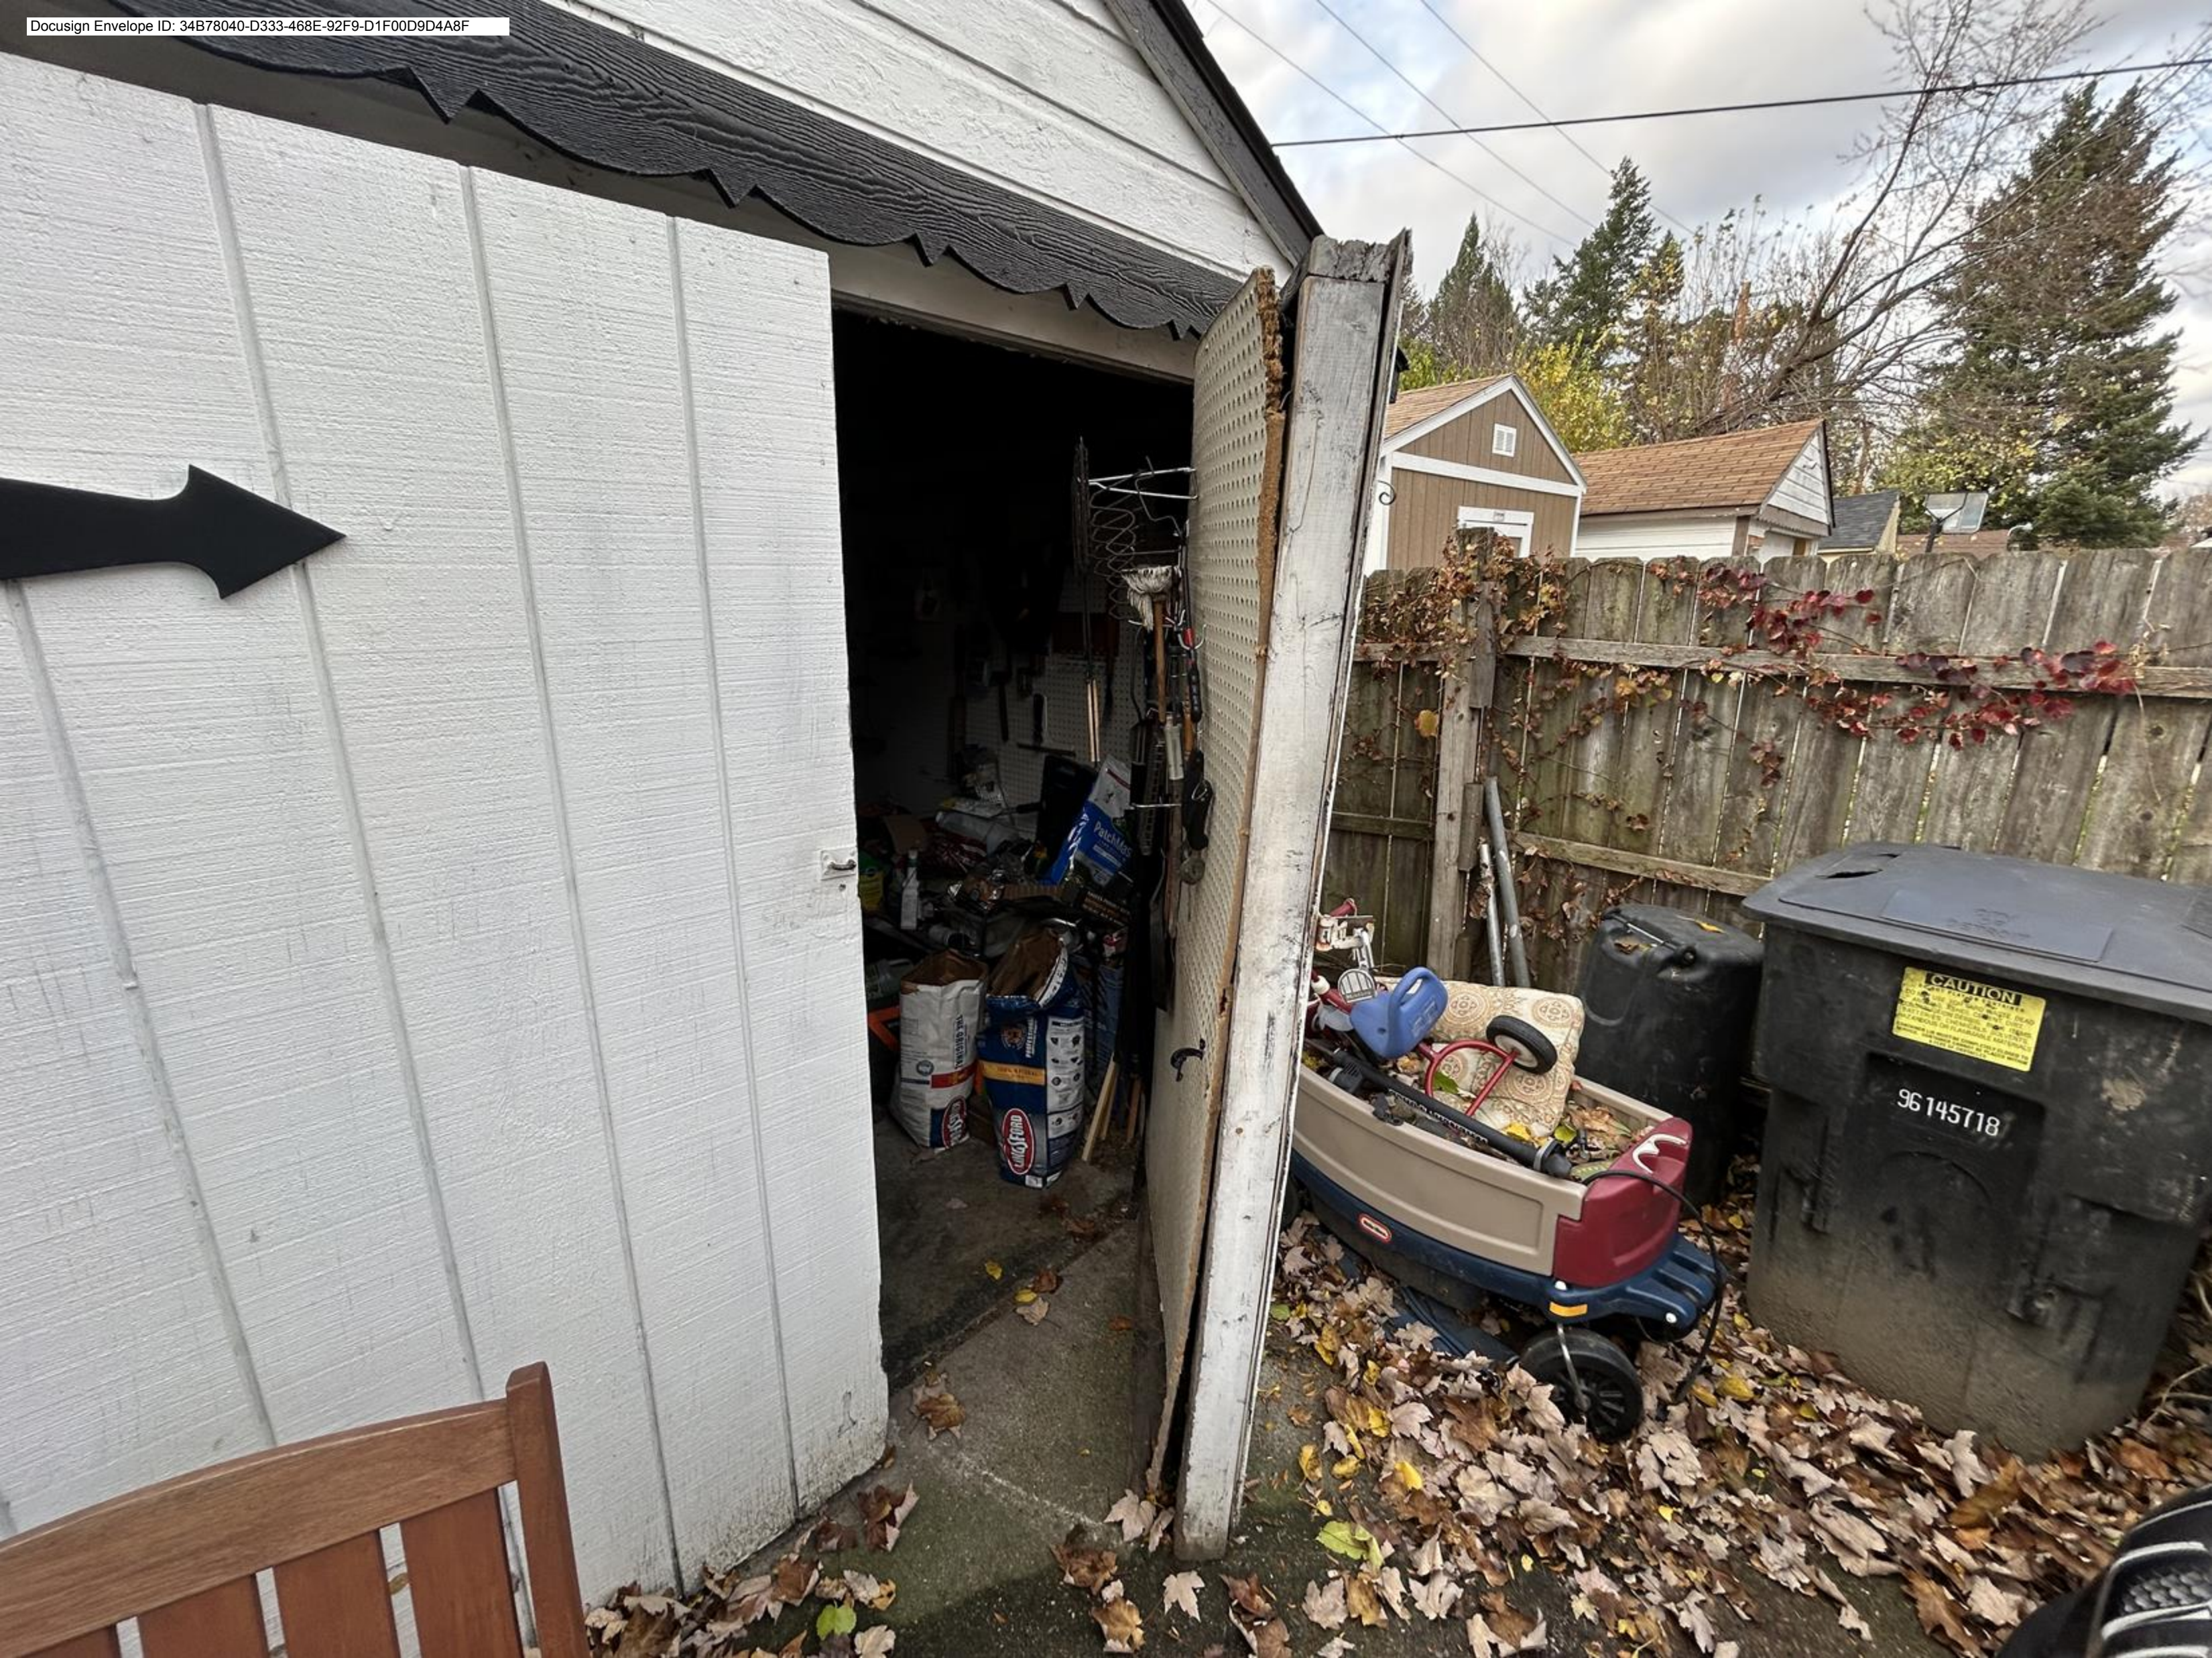
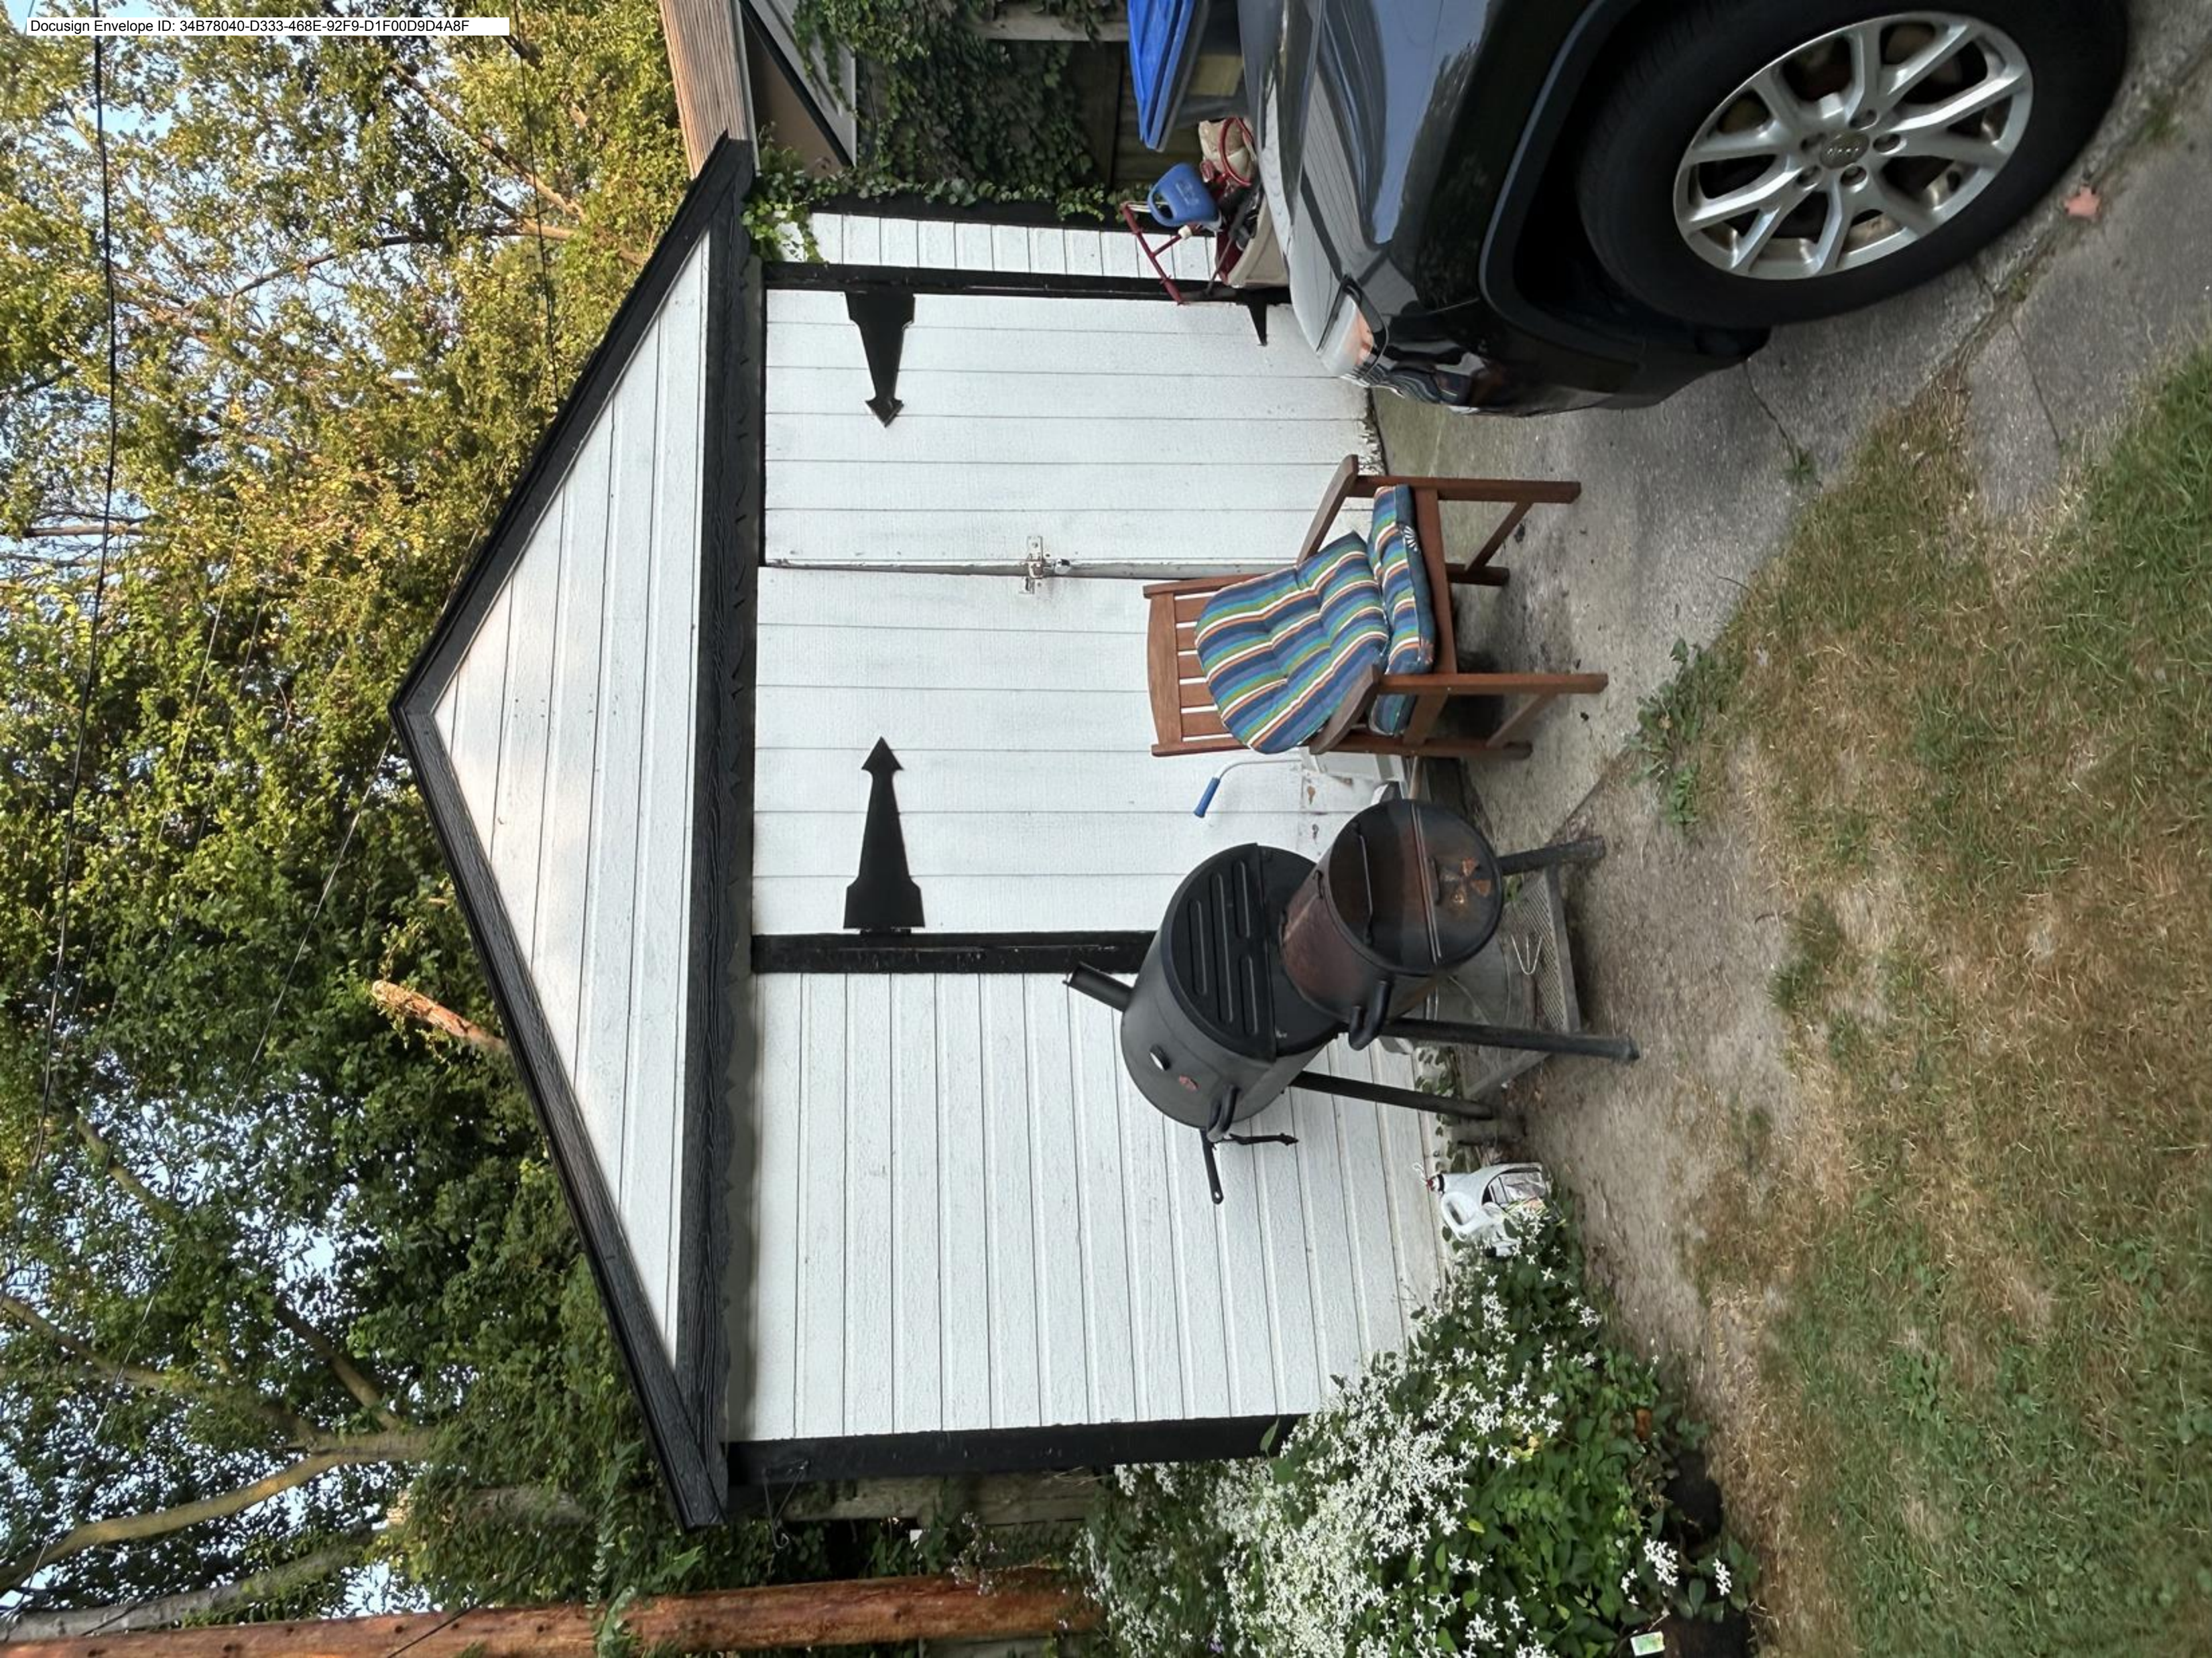
PICTURES SHOWING UNSOUND STRUCTURAL INTEGRITY REVIEW OF GARAGE AT BACK OF HOUSE

The superstructure of the Garage is not in good shape -- Joints of roof structural members are not secure, ridge board is undersized and is deflecting; rafter connections are not sound; walls are leaning, there are breaks and gaping holes in the siding. The Garage floor is below finished grade; surface runoff is shedding towards Garage floor

I visited the job site on Nov-08-2024 accompanied by Lunar Construction (586-709-2761) to look at the condition of the detached Garage at the back of the house from structural integrity viewpoint. The Garage is structurally unsound and needs to be demolished.

Based on my field inspection, the information provided to me, my engineering judgment and my practical experience, I believe the Garage is structurally unsound and needs to be demolished.
