STAFF REPORT: 12-11-2019 MEETING
APPLICATION NUMBER: 19-6526
ADDRESS: 1155 CLARK
HISTORIC DISTRICT: HUBBARD FARMS
APPLICANT: KOBLAR JACKSON
DATE OF COMPLETE APPLICATION: 11/5/2019
DATE OF STAFF SITE VISIT: 12/6/2019

SCOPE: REPLACE PORCH AT REAR ELEVATION

Historic District Commission Project Review Request—1155 Clark Street, Detroit, MI 48209

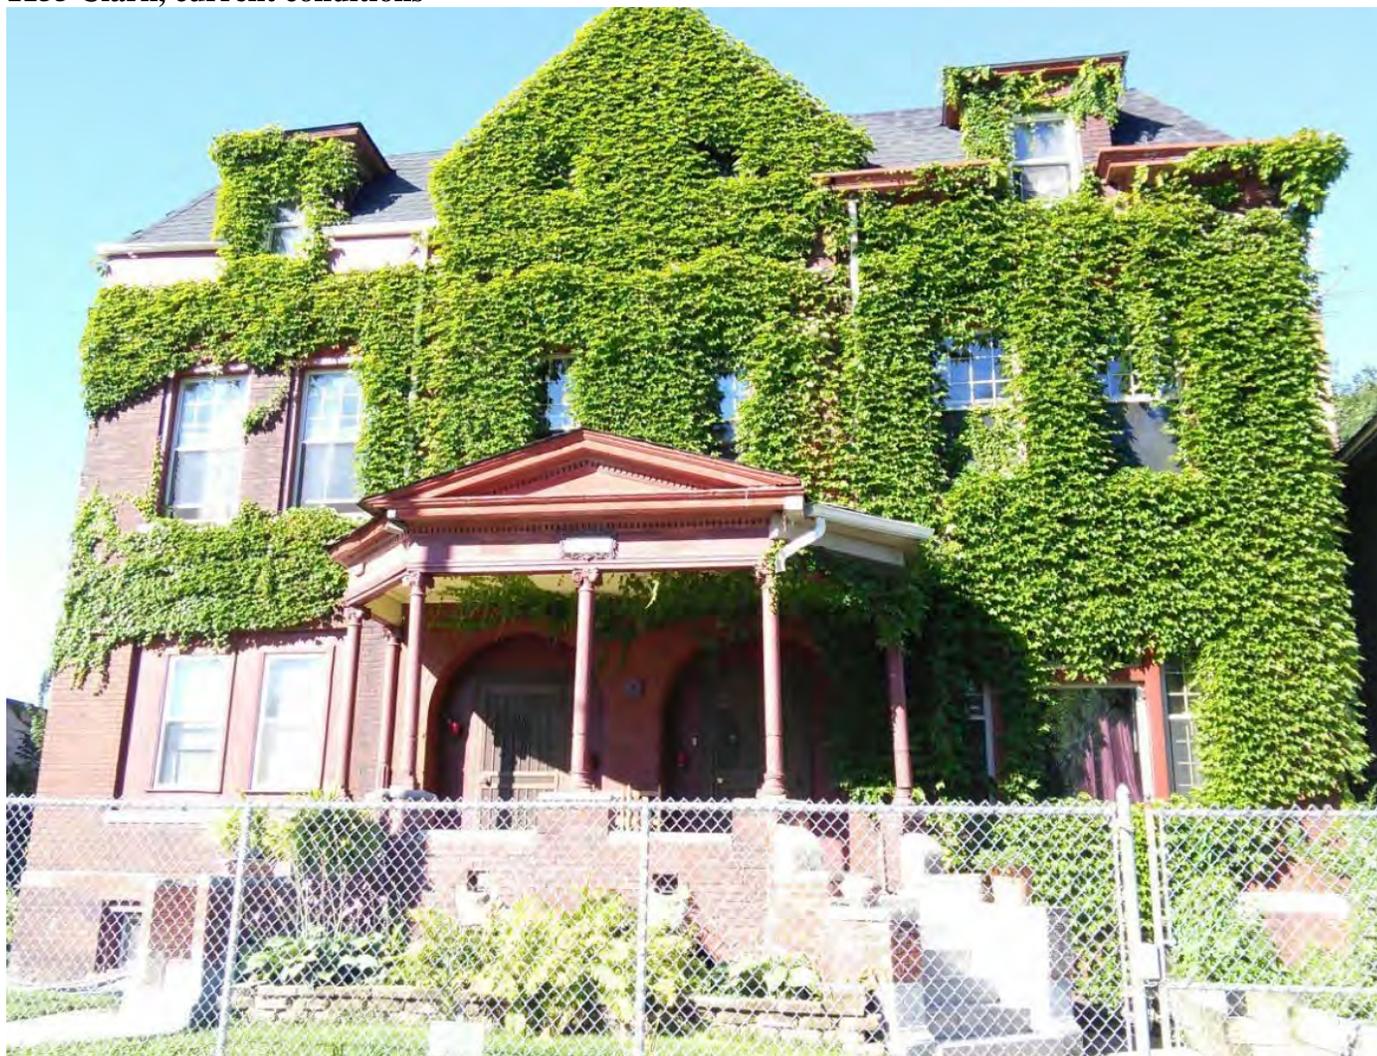
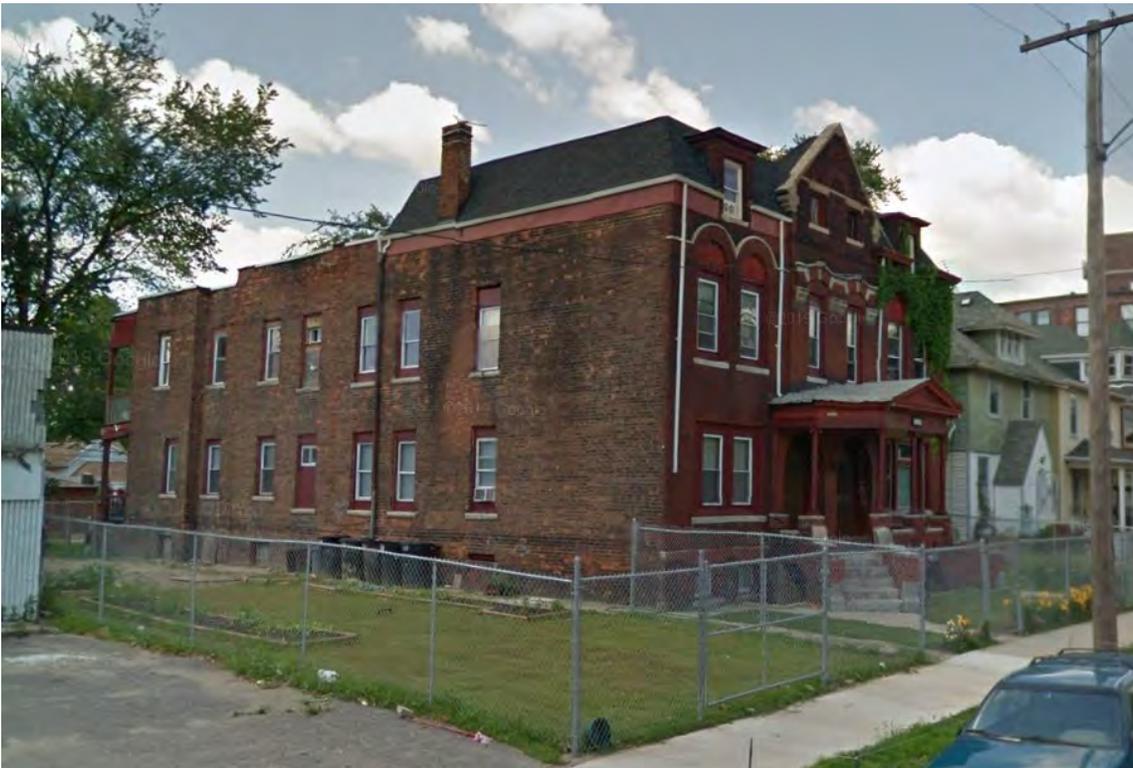
1155 Clark, current conditions

Erected ca. 1916, the property at 1155 Clark is a 2 ½-story apartment building. Exterior walls are brick with stone detailing. An historic-age, one-story, central, gabled and hipped-roof porch is located at the building's primary elevation. The rear elevation features a full-width, flat-roof porch wood porch. A one-story, wood-frame enclosed stair is centrally-located within the rear porch. The stair enclosure is currently clad with vinyl and metal siding. The rear porch, included the central stair enclosure, is in poor condition. Windows are non-historic vinyl units.

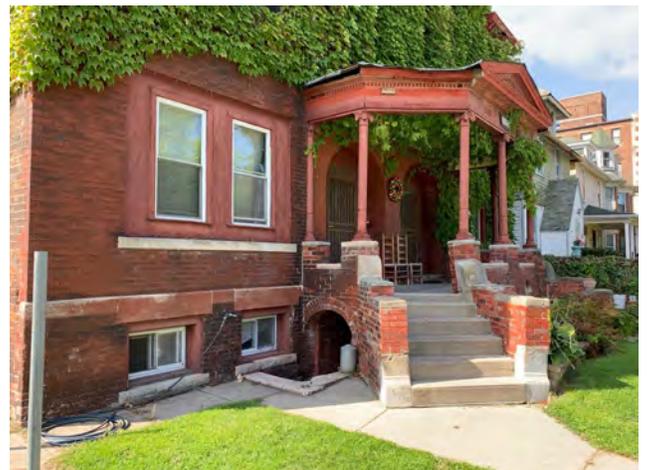
Right: (F3) Detail Shot of Front porch (Same layout and design both sides, this porch is NOT included in this permit for work, though will be applied for in a separate permit and HDC Application after the rear porch is completed)

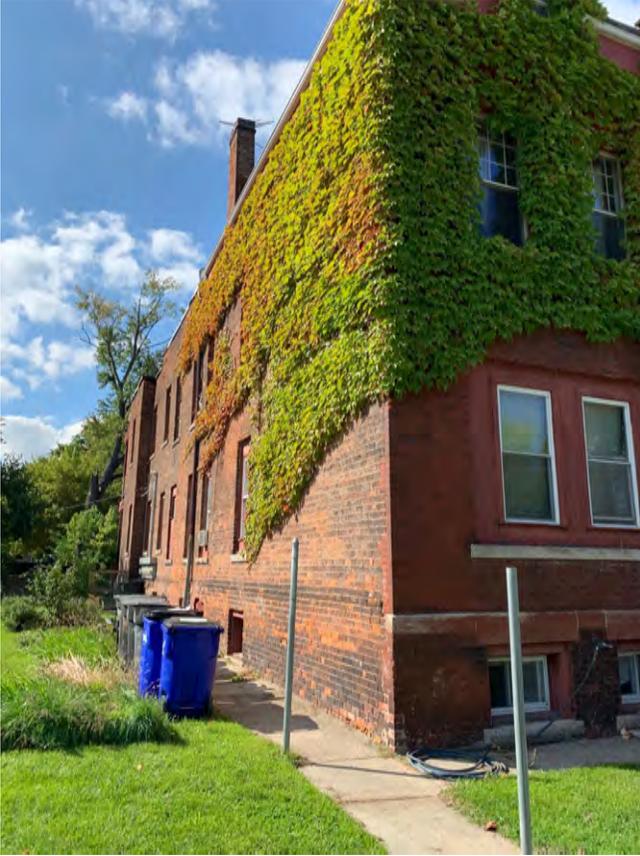
Left: (LH1) Front Left Corner leading into Left Side Wall

Right: (LH2) Main Face of Left Side Wall. Rear Porch visible at rear of Building

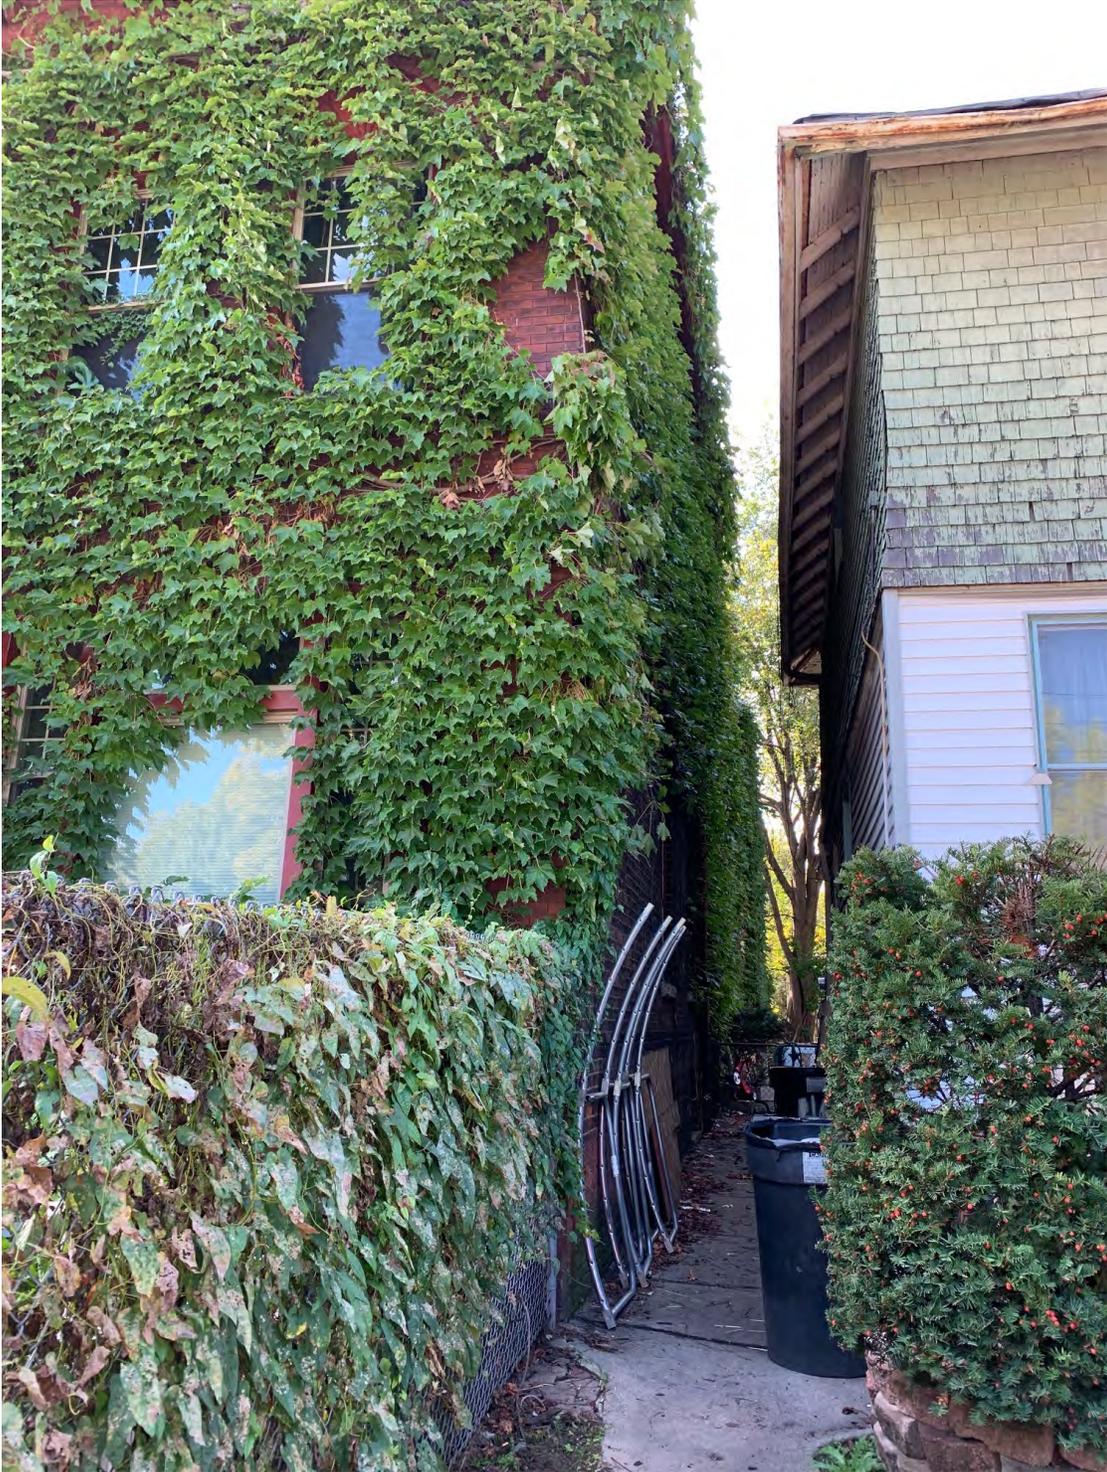
Above: (RH1) Right hand side of Building. Neighbors property line appears to be Right Side of Building. Did not have neighbor access for more detailed photos.

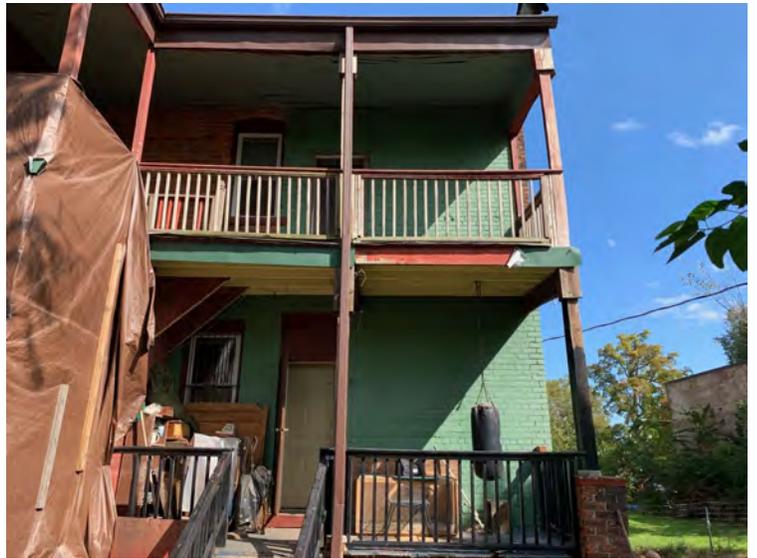
Above: (B2) RH Side (Viewed from alley) of Existing Deck

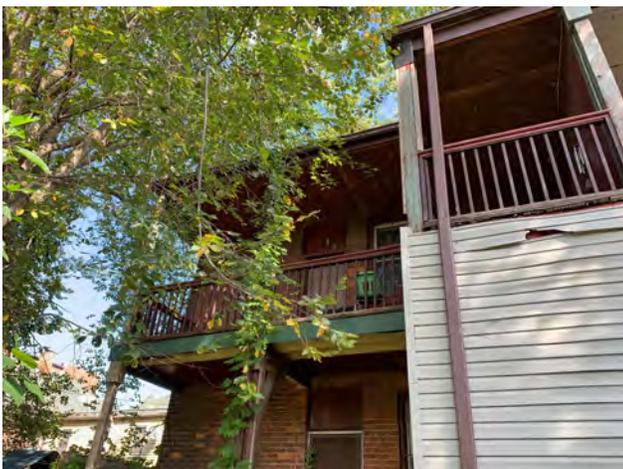
Below: (B4) LH Side of rear Deck

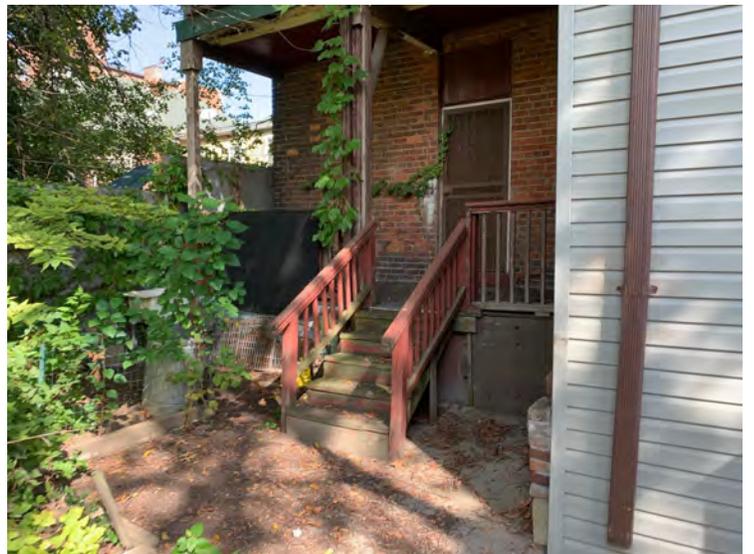
Above: (B3) Typ. Detail of existing First level access. Proposed Deck to match existing style and placement, at new proposed extents.
