**STAFF REPORT:** 01-22-2019 MEETING

**APPLICATION NUMBER:** 20-6607

**ADDRESS:** 3470 CAMBRIDGE

**SCOPE:** WORK DONE WITHOUT PERMIT

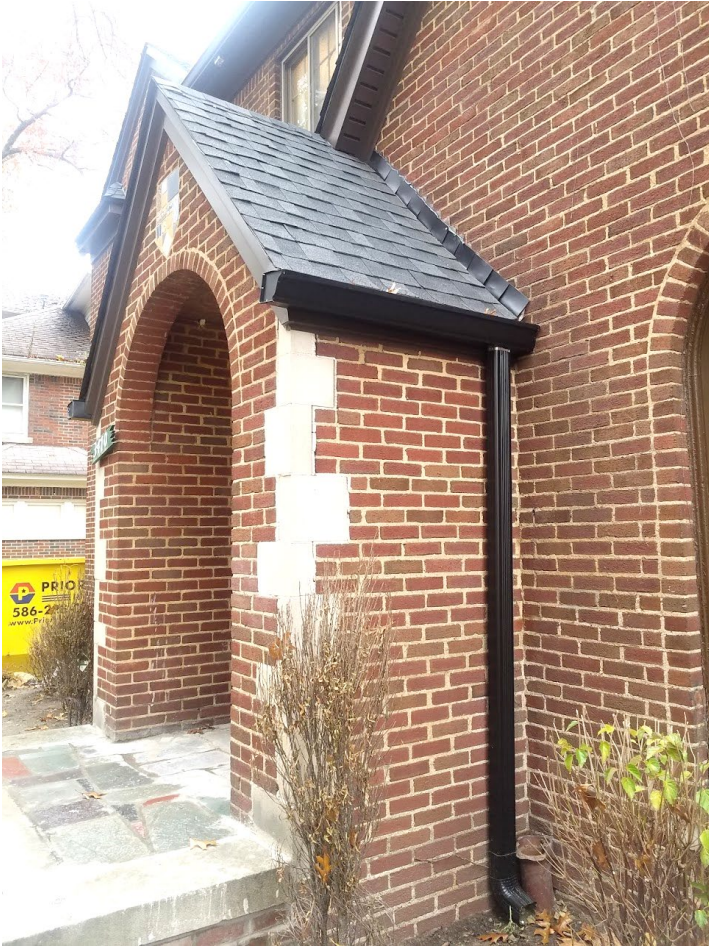
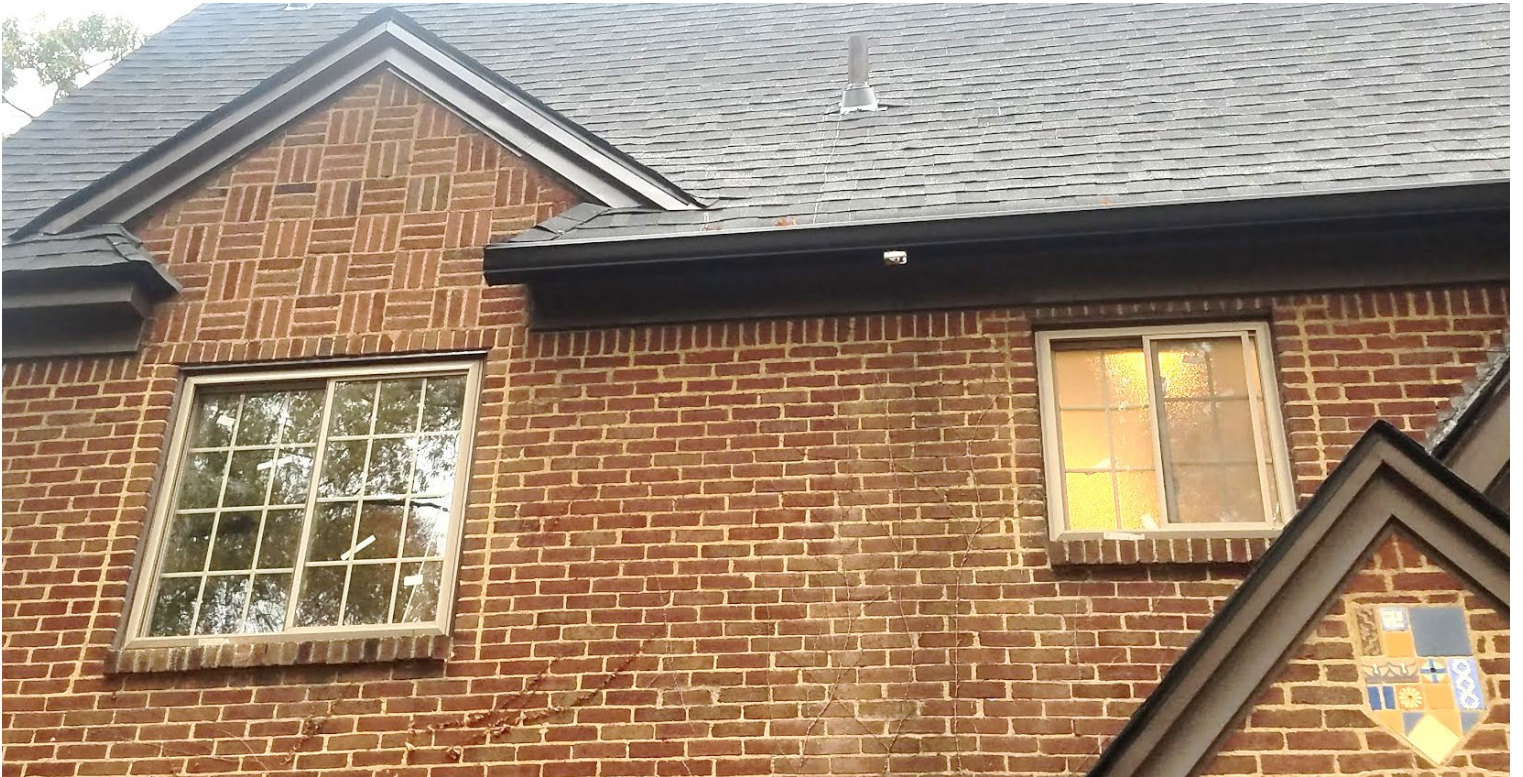
Install Black Gutters & Downspouts/Wrap Wood Fascia, Soffits, with Dark Brown Aluminum - Page Two

- Aluminum gutters and downspouts (reddish brown) replaced with 4" gutters and downspouts (black). *These were missing from most areas and damaged badly in the remaining spots; needed replacement (See before pics link). They are halfway done (See current pics link) but we were stopped by the city saying we needed approval for these too (we didn't know). The gutters we bought and started to hang are commercial grade black 4" gutters. The home is so big that regular grade gutters wouldn't flow water efficiently. If we can get this one approved quickly by staff so we can finish the job that would be ideal as they are needed to avoid water damage.*

- No collector boxes were identified on the “before” photographs – gutters and downspouts looks to be an in-kind replacement
- The removal of the vent in the west gable is an improvement to the west-facing gable, however additional work should be done to correct the window casing.

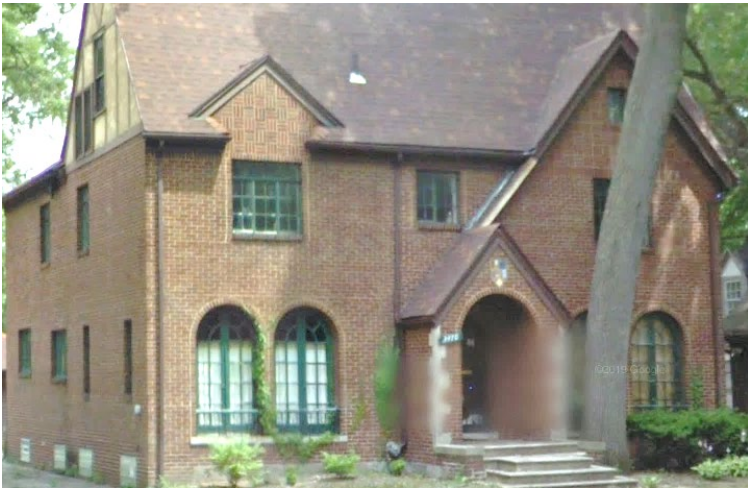
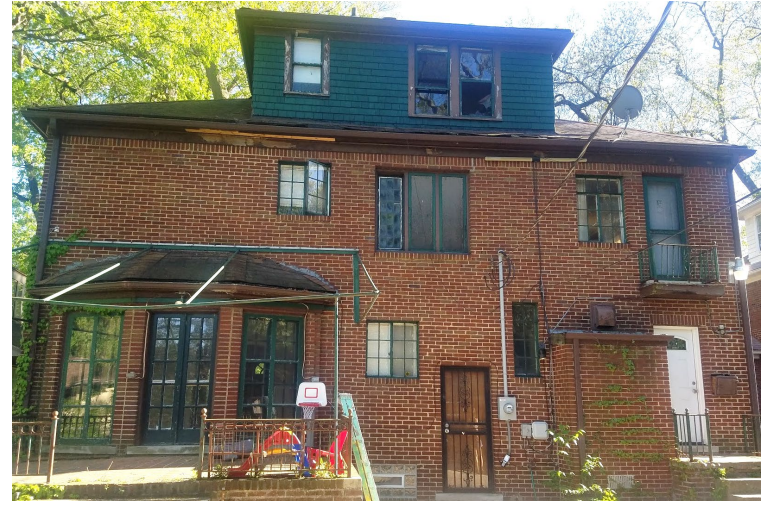
# Exterior Color Scheme

- The color selected for the windows is close to a color found in Color System D, but the system specifies this color as an option for stucco, not window sash. The sash should match the half-timbering (which most options on the color chart are shades of dark brown/black).

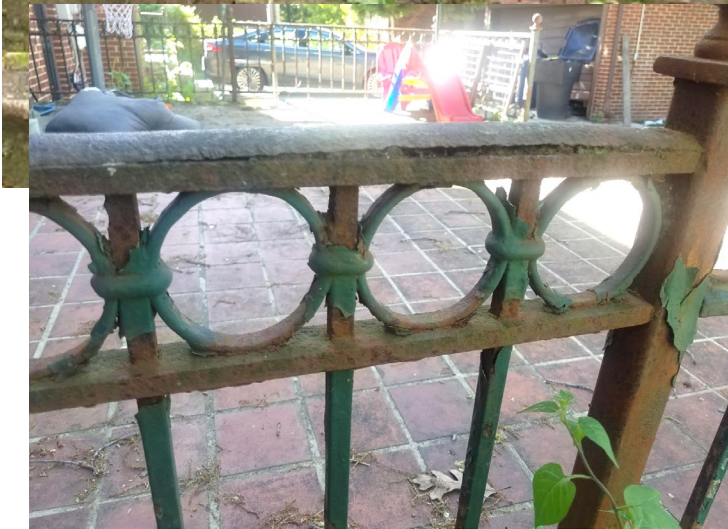
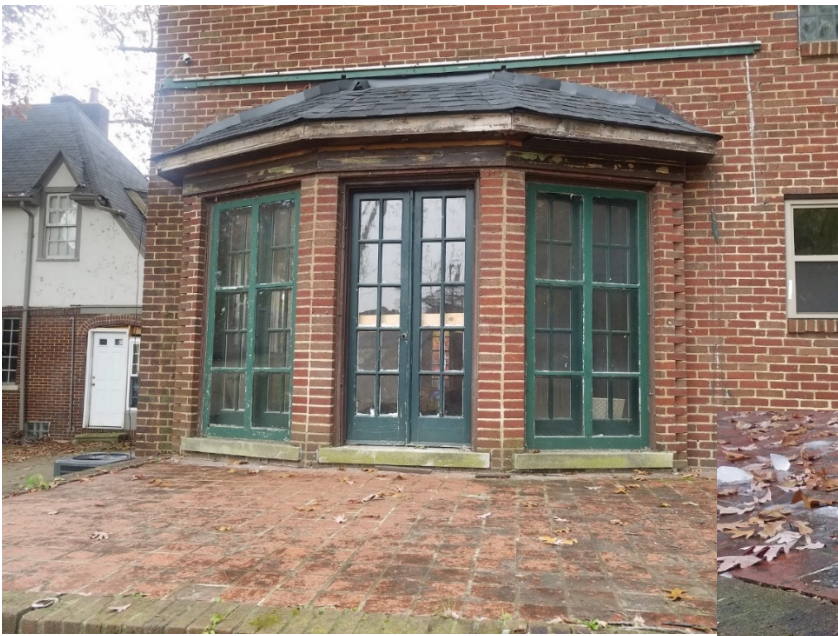
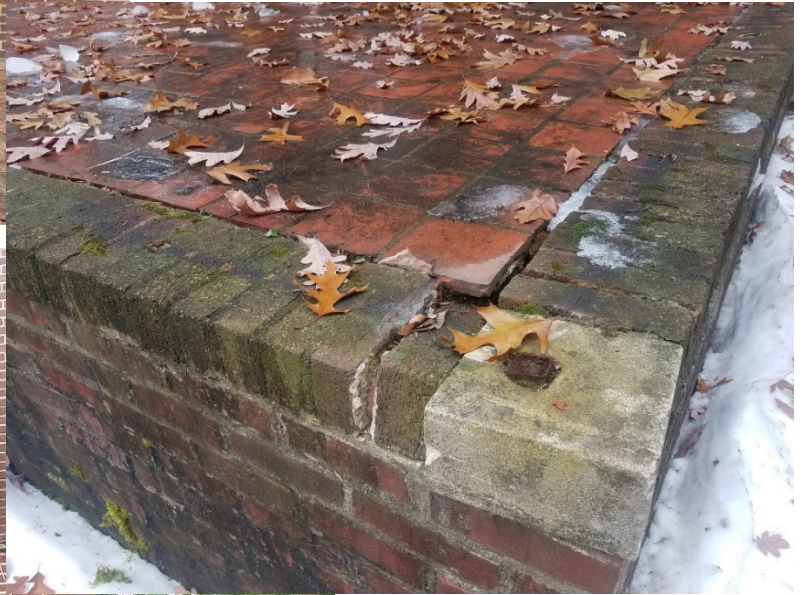
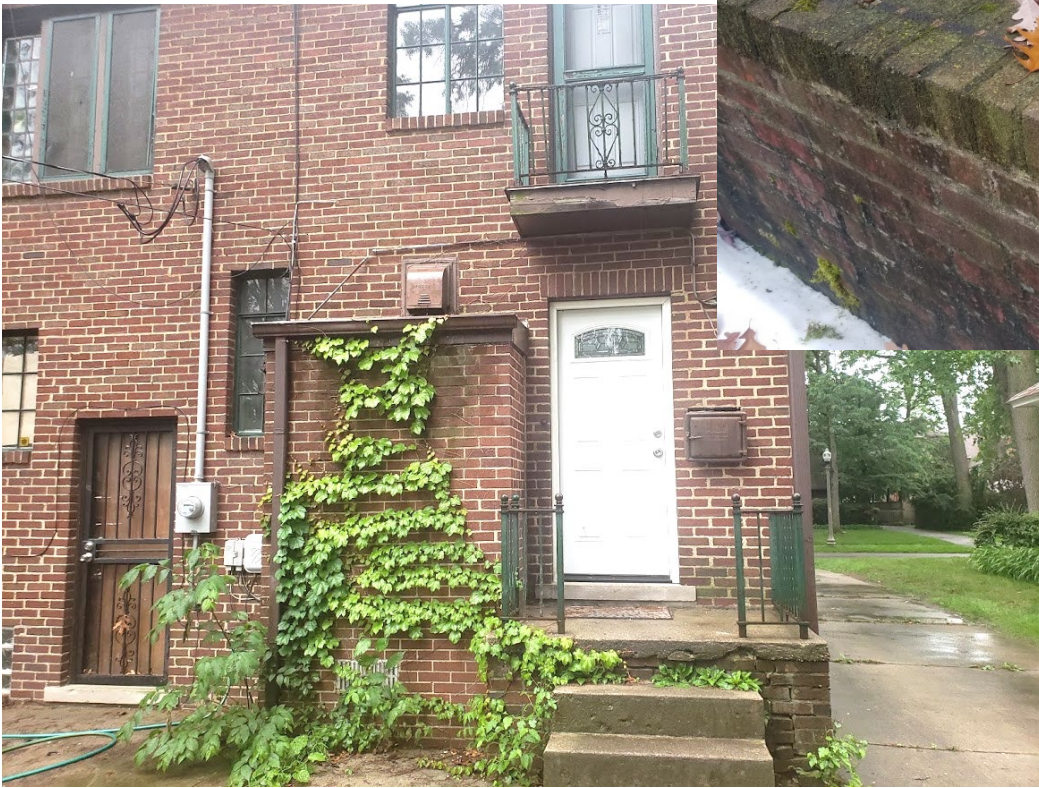
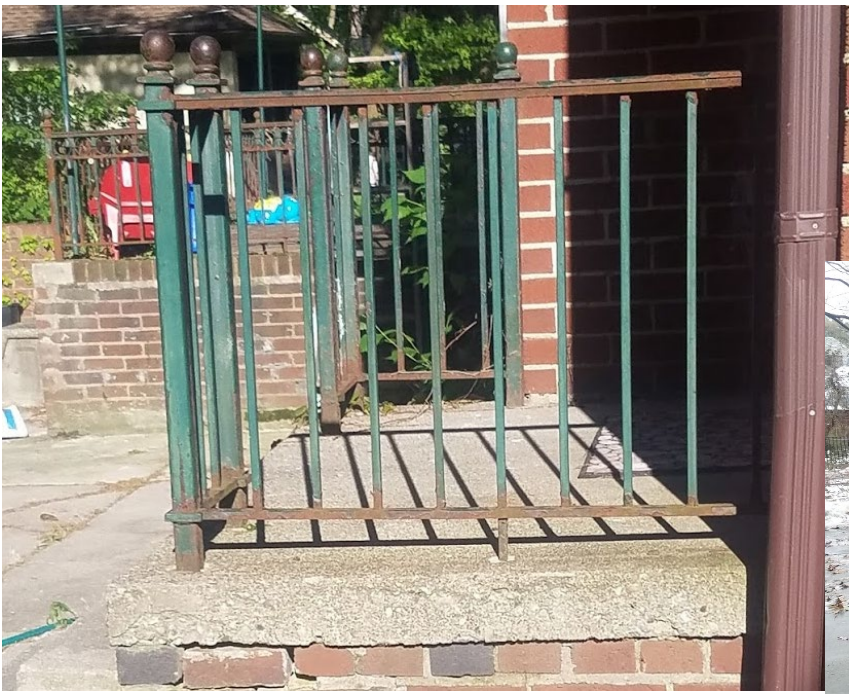
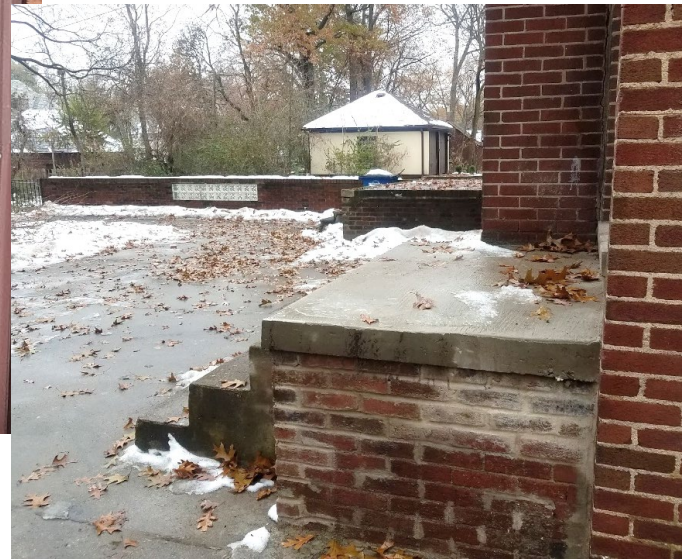
### Rear Porch Railings

- Railings removed at front arched windows, rear raised porch, rear entry and second floor balcony. Applicant proposes to install a standard spindle black railing.  
*The railings on the house and patio were rusted and rotted. Some were missing. They were not safe nor repairable. The second story platform, albeit small for a back bedroom door, was repaired. There wasn't a railing there but it is the same railing being installed as the patio. I believe the railings I have chosen will satisfy the Commission. I am currently looking at railings for the front windows but it is a difficult item to find. Suggestions to possible suppliers would be appreciated.*

Porch, rear entry and second floor rear porch railings have been removed. Concrete platform poured at rear door entry. Straight black

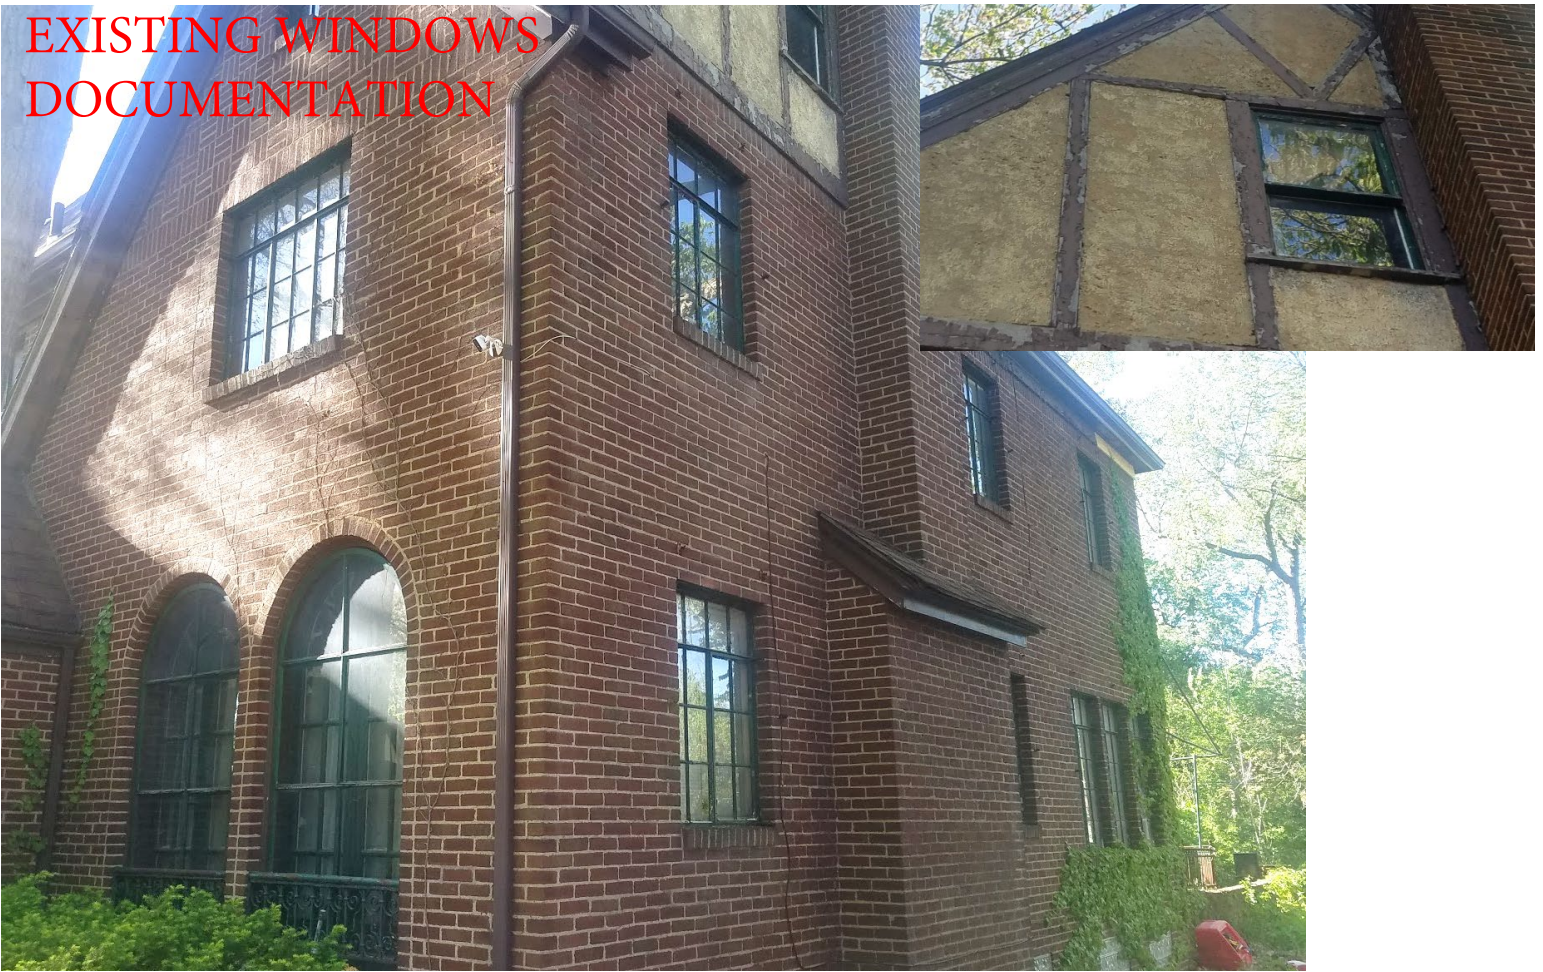
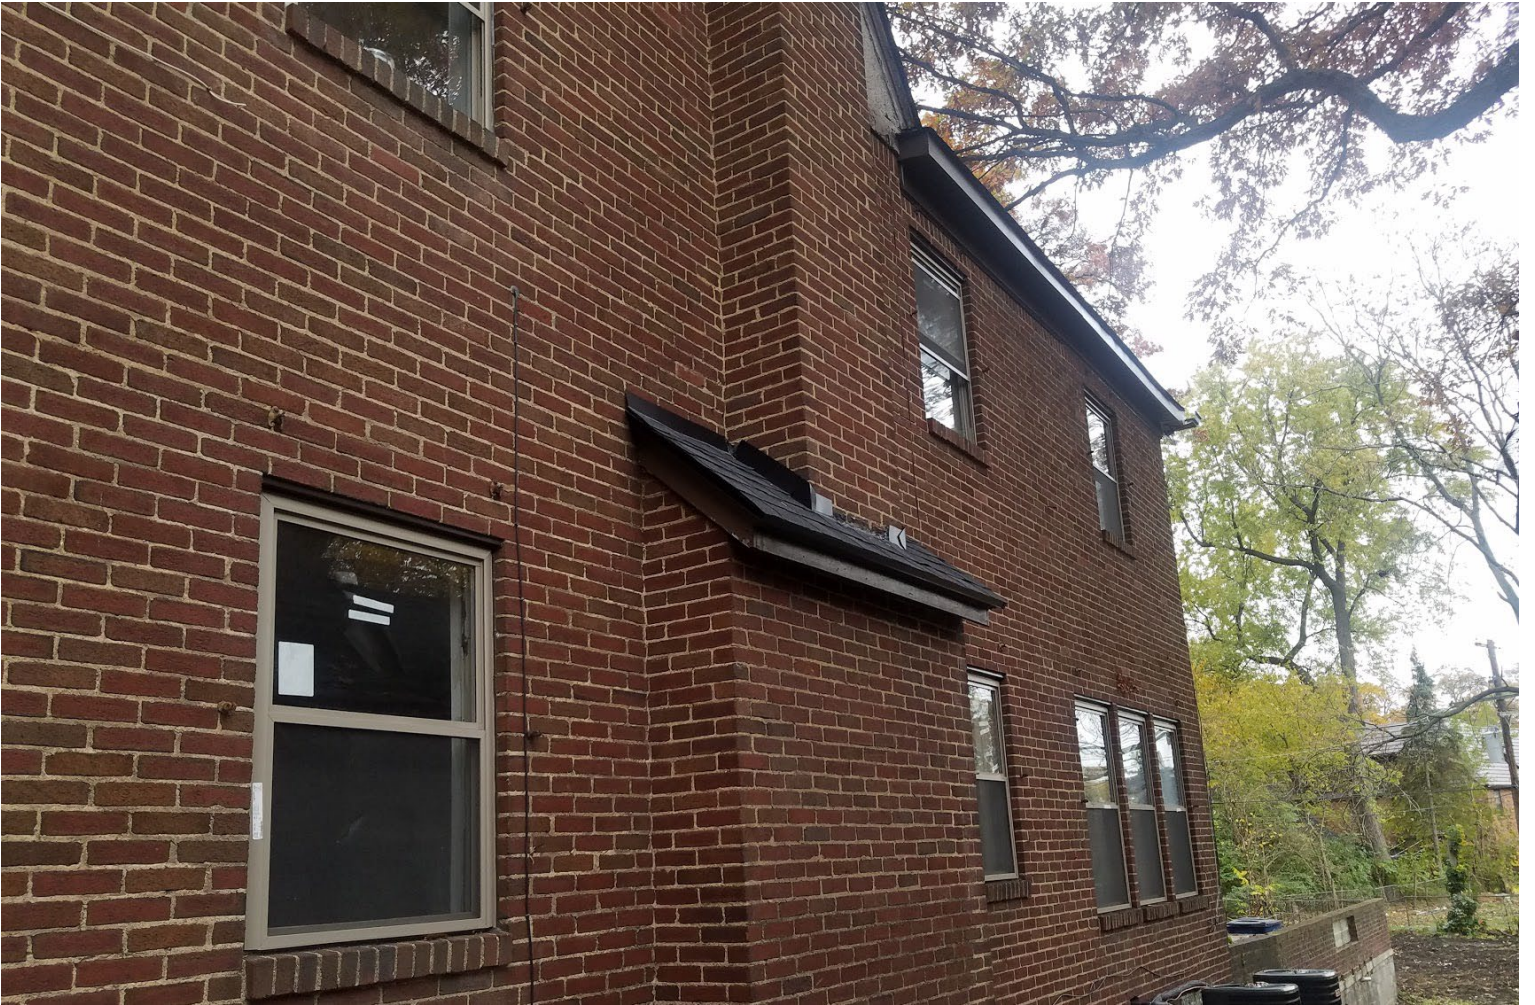
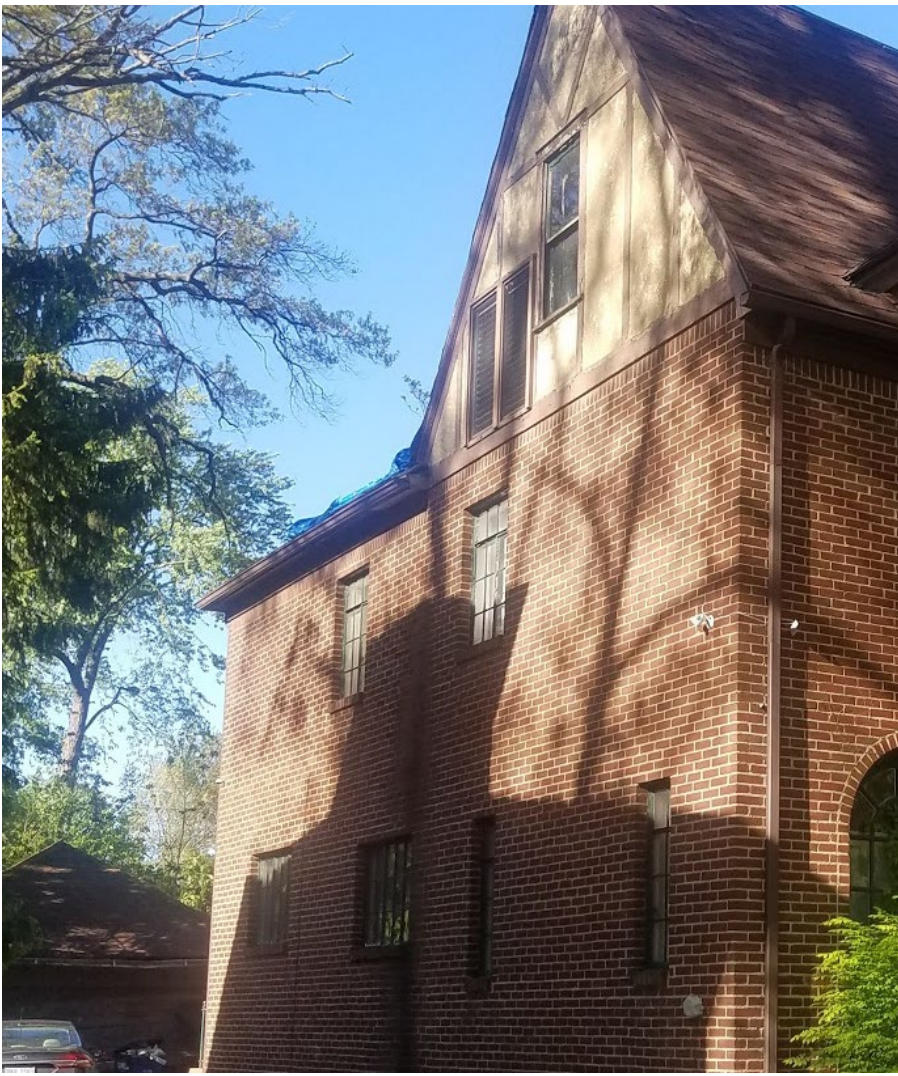
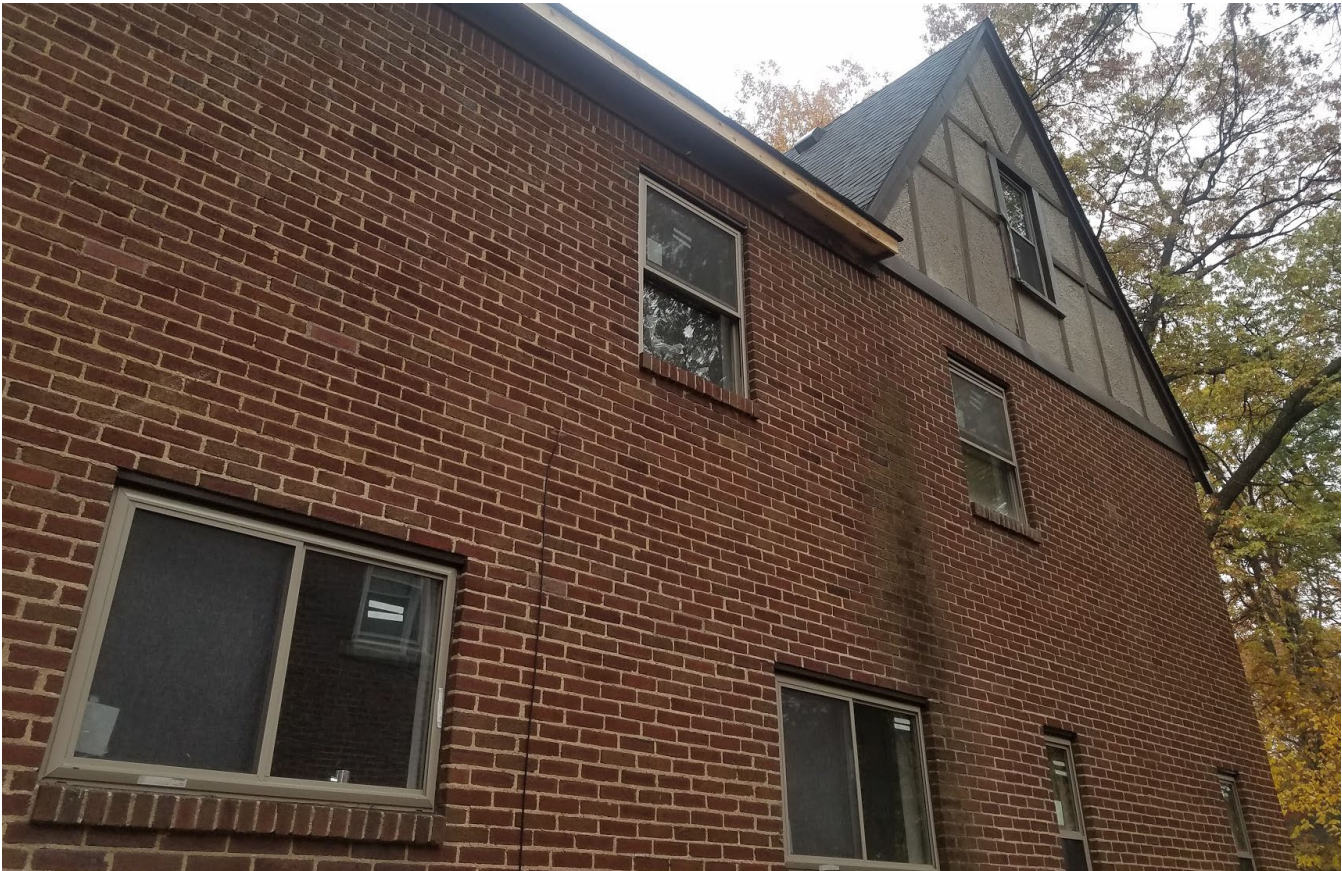
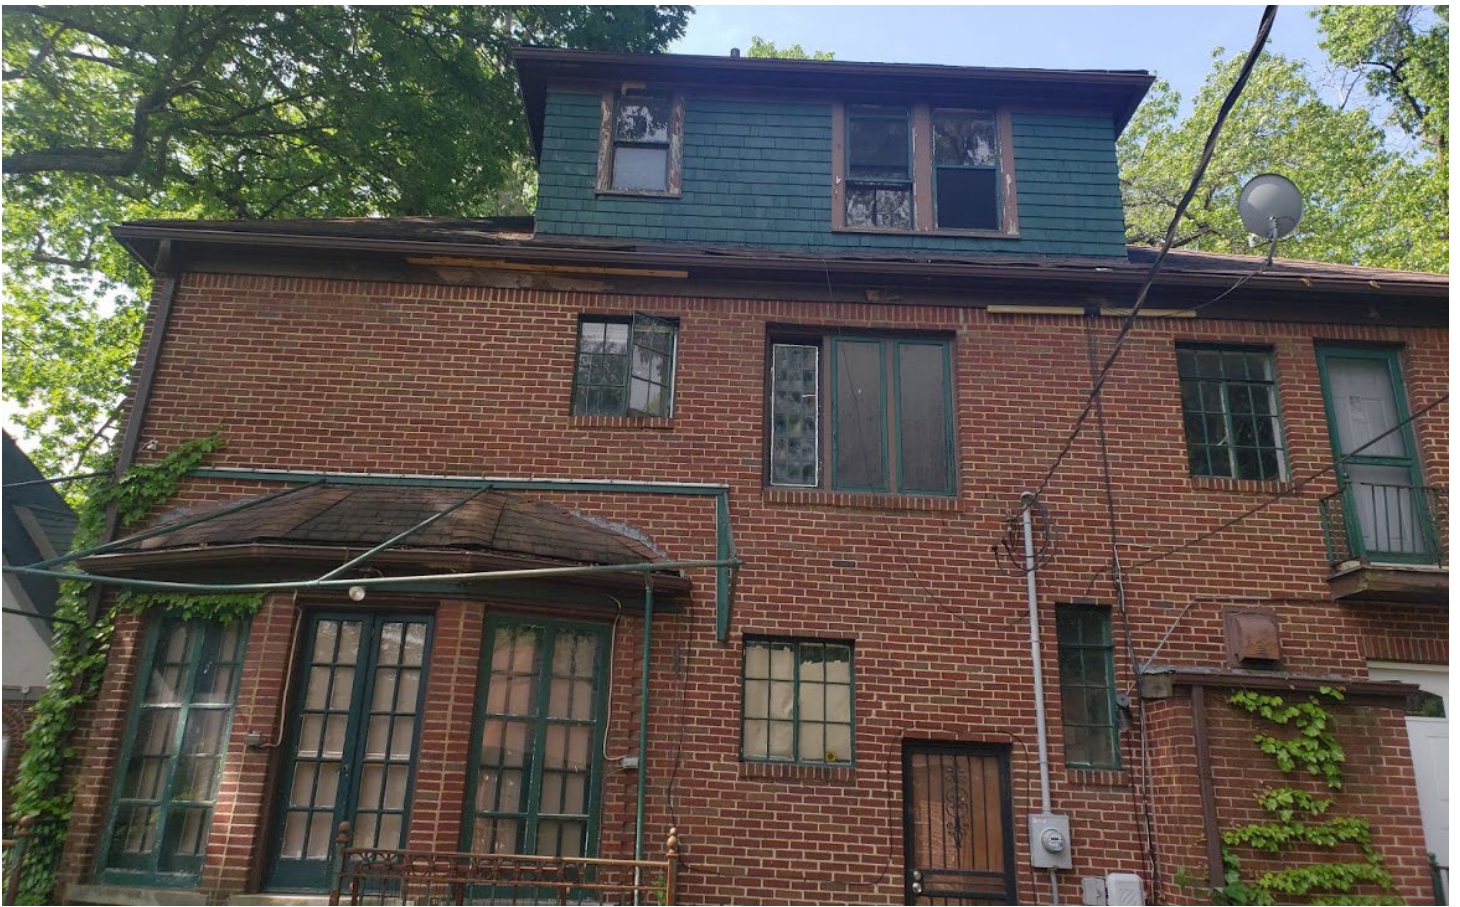
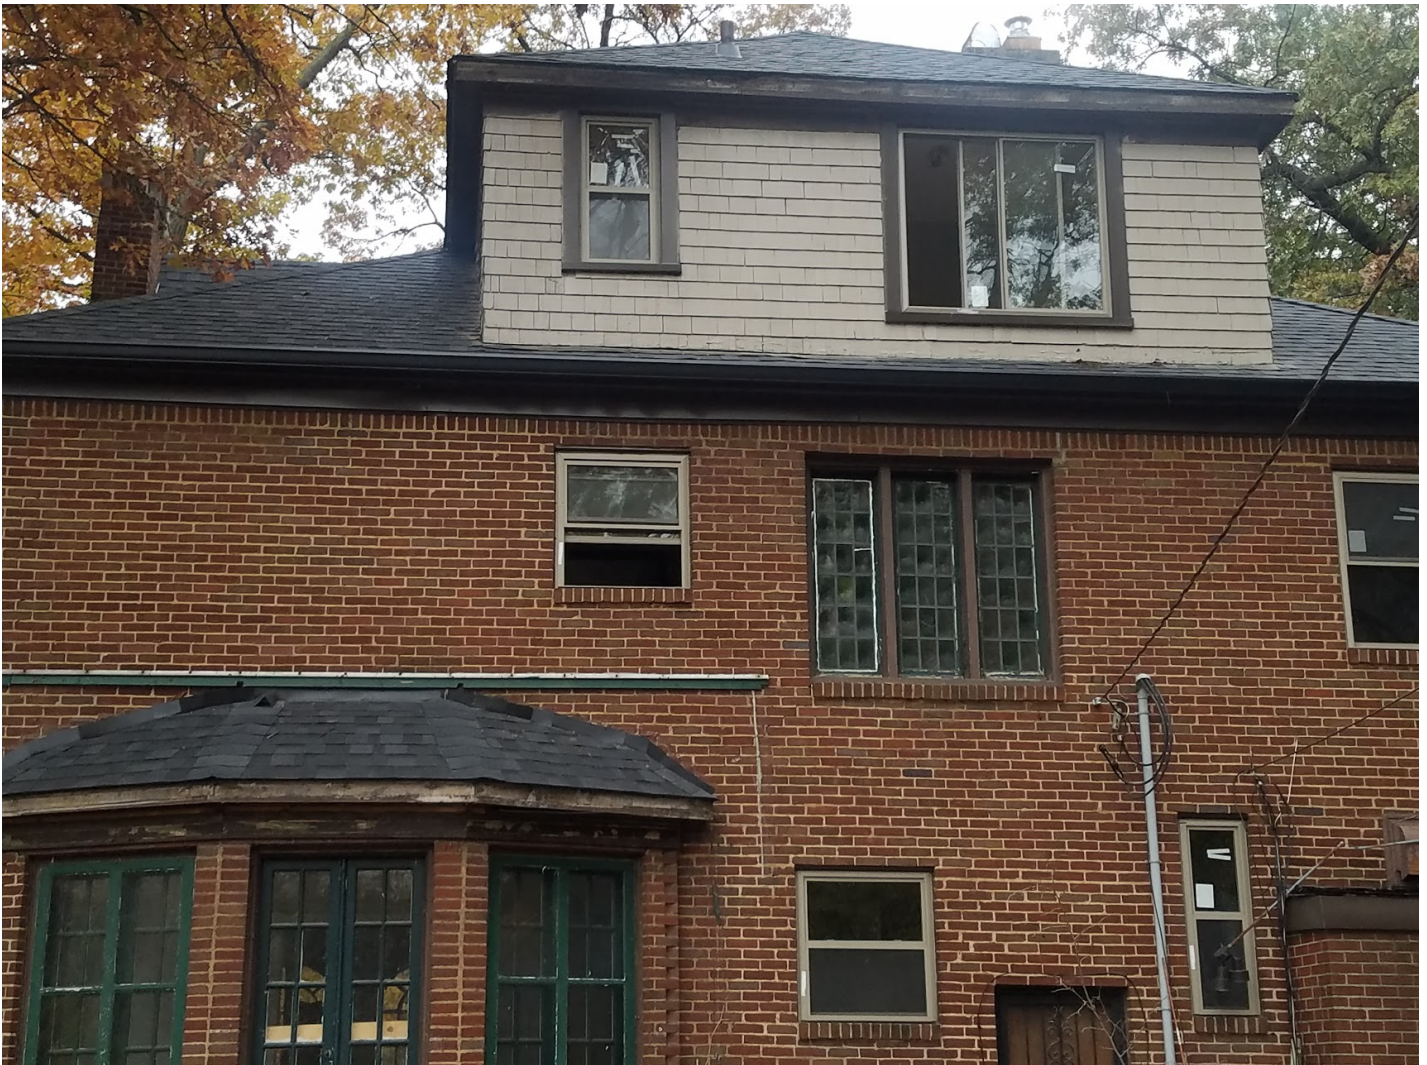
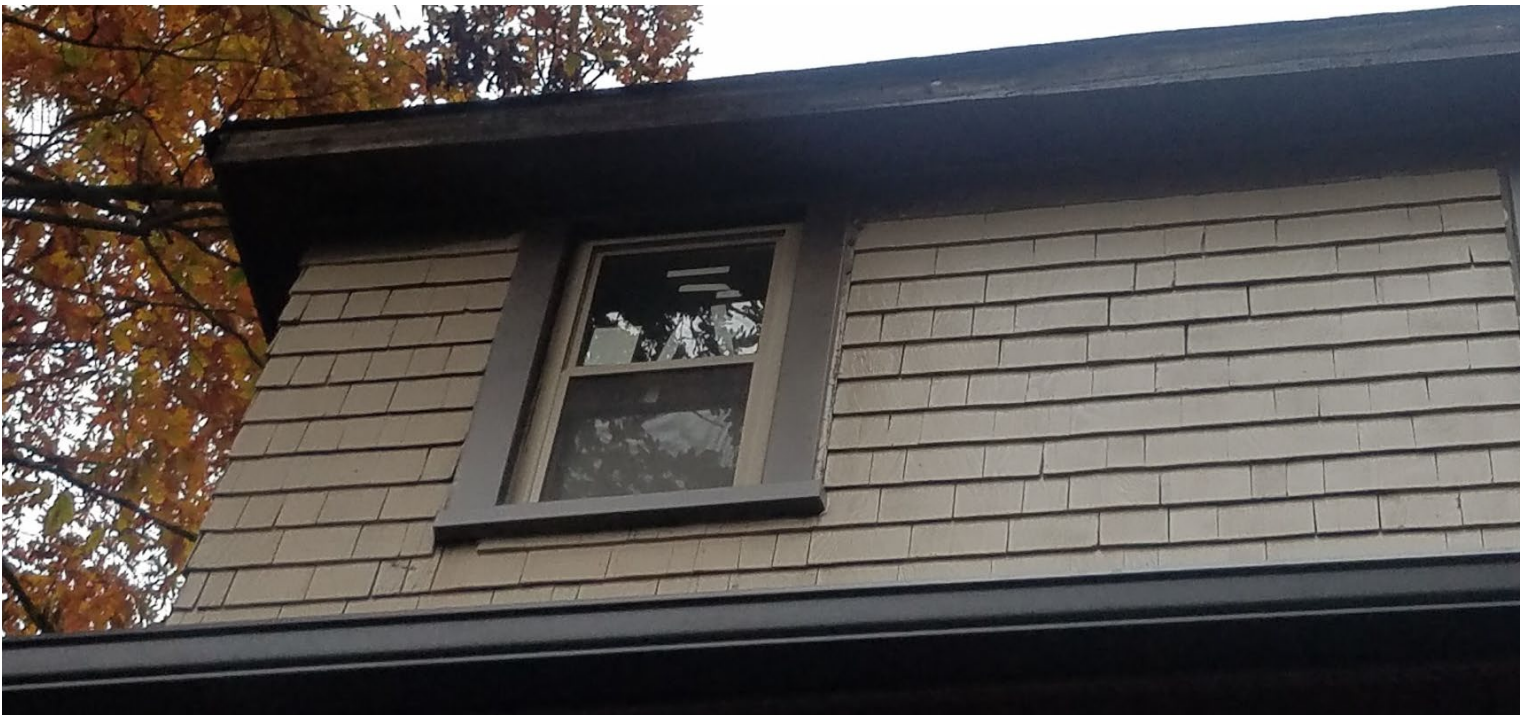
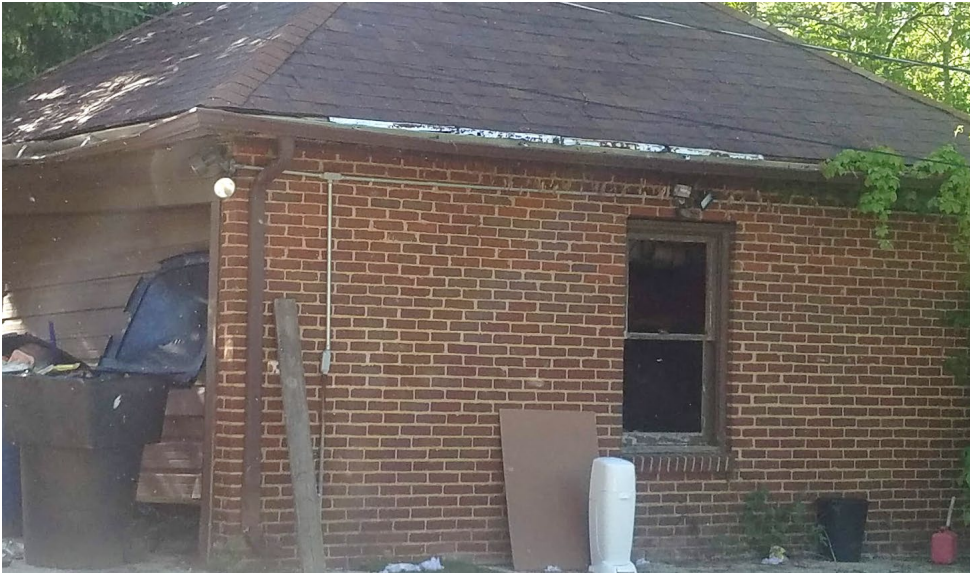
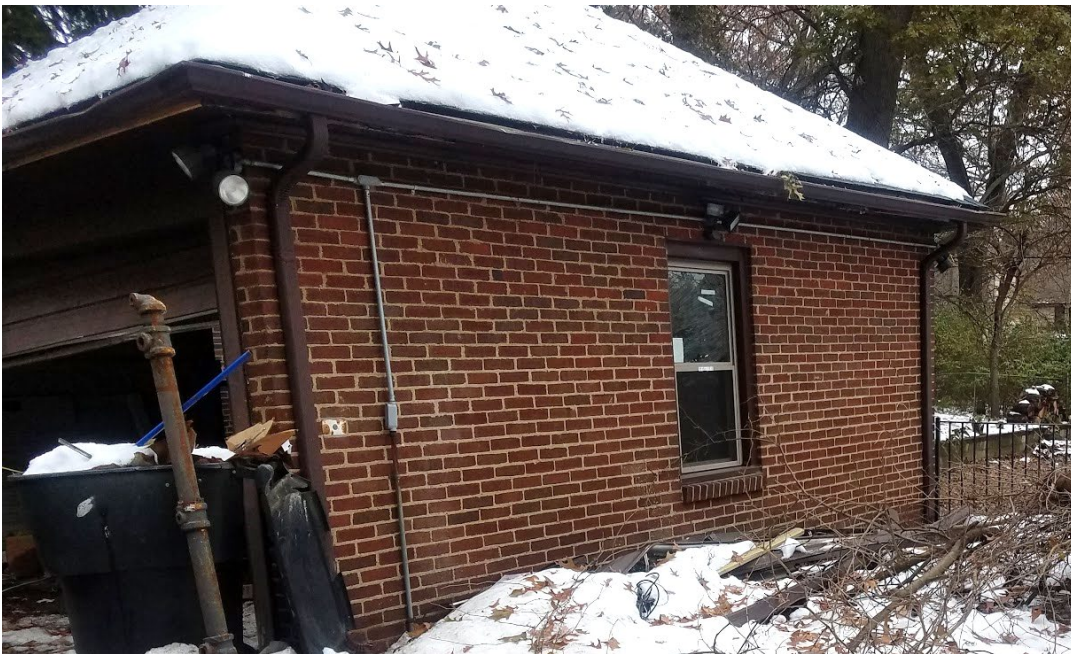
EXISTING WINDOWS  
DOCUMENTATION

- The windows were replaced without detailed analysis as to the existing conditions and repair options/pricing from window companies with experience in steel window repair. Staff requested additional photographs of the windows before they were replaced showing the deterioration levels of the windows. They follow the photo narrative of the multiple projects.
