**STAFF REPORT:** 01-22-2019 MEETING

**APPLICATION NUMBER:** 20-6607

**ADDRESS:** 3470 CAMBRIDGE

**SCOPE:** WORK DONE WITHOUT PERMIT

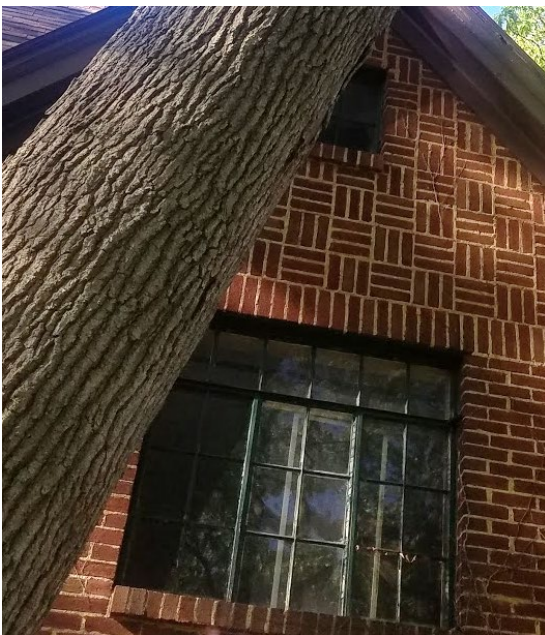
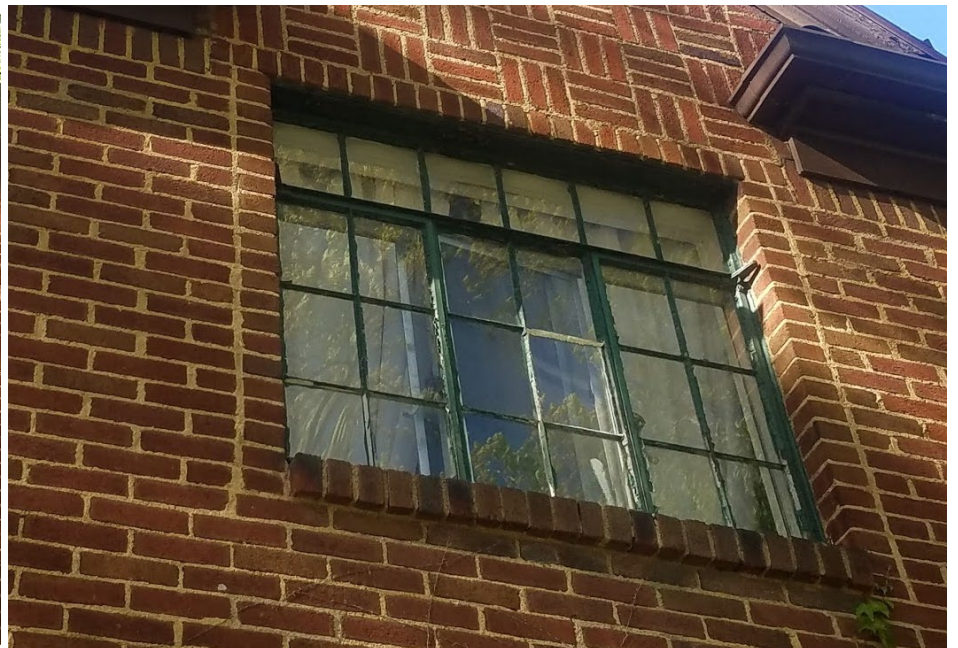
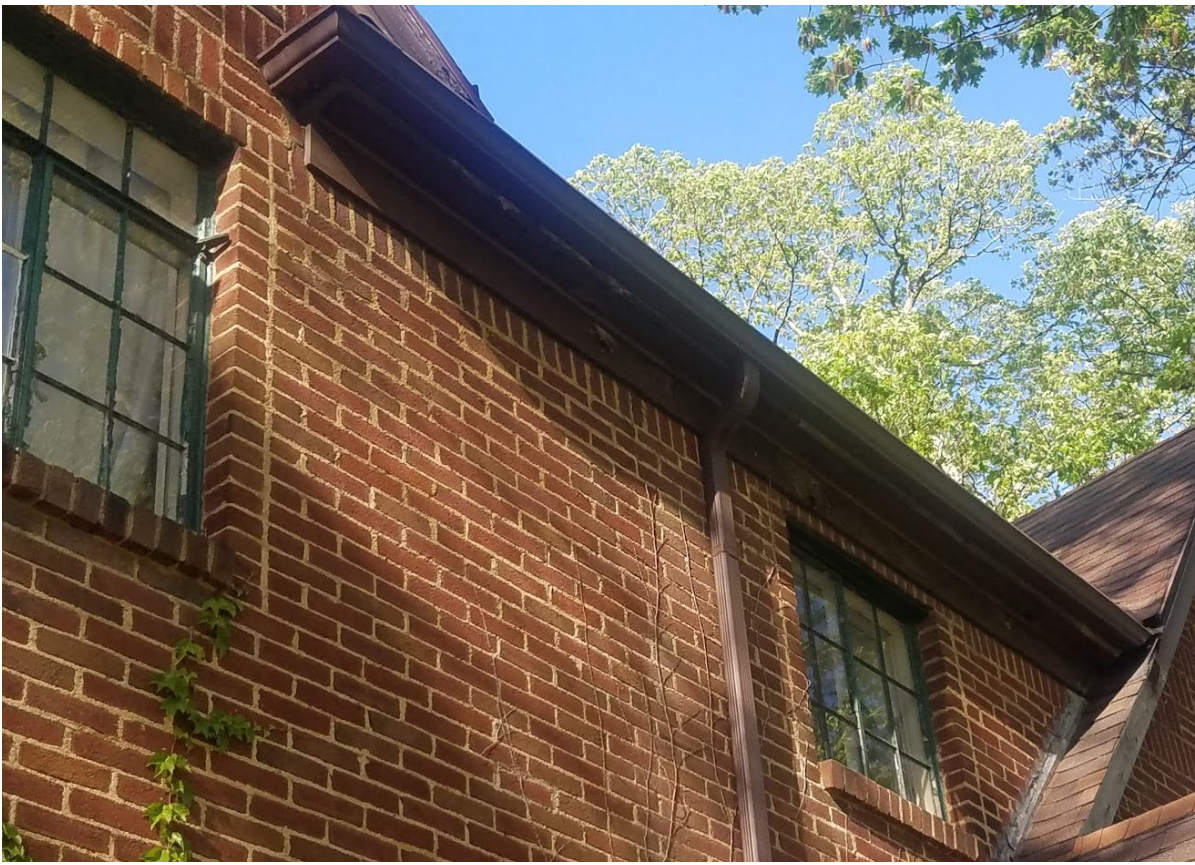
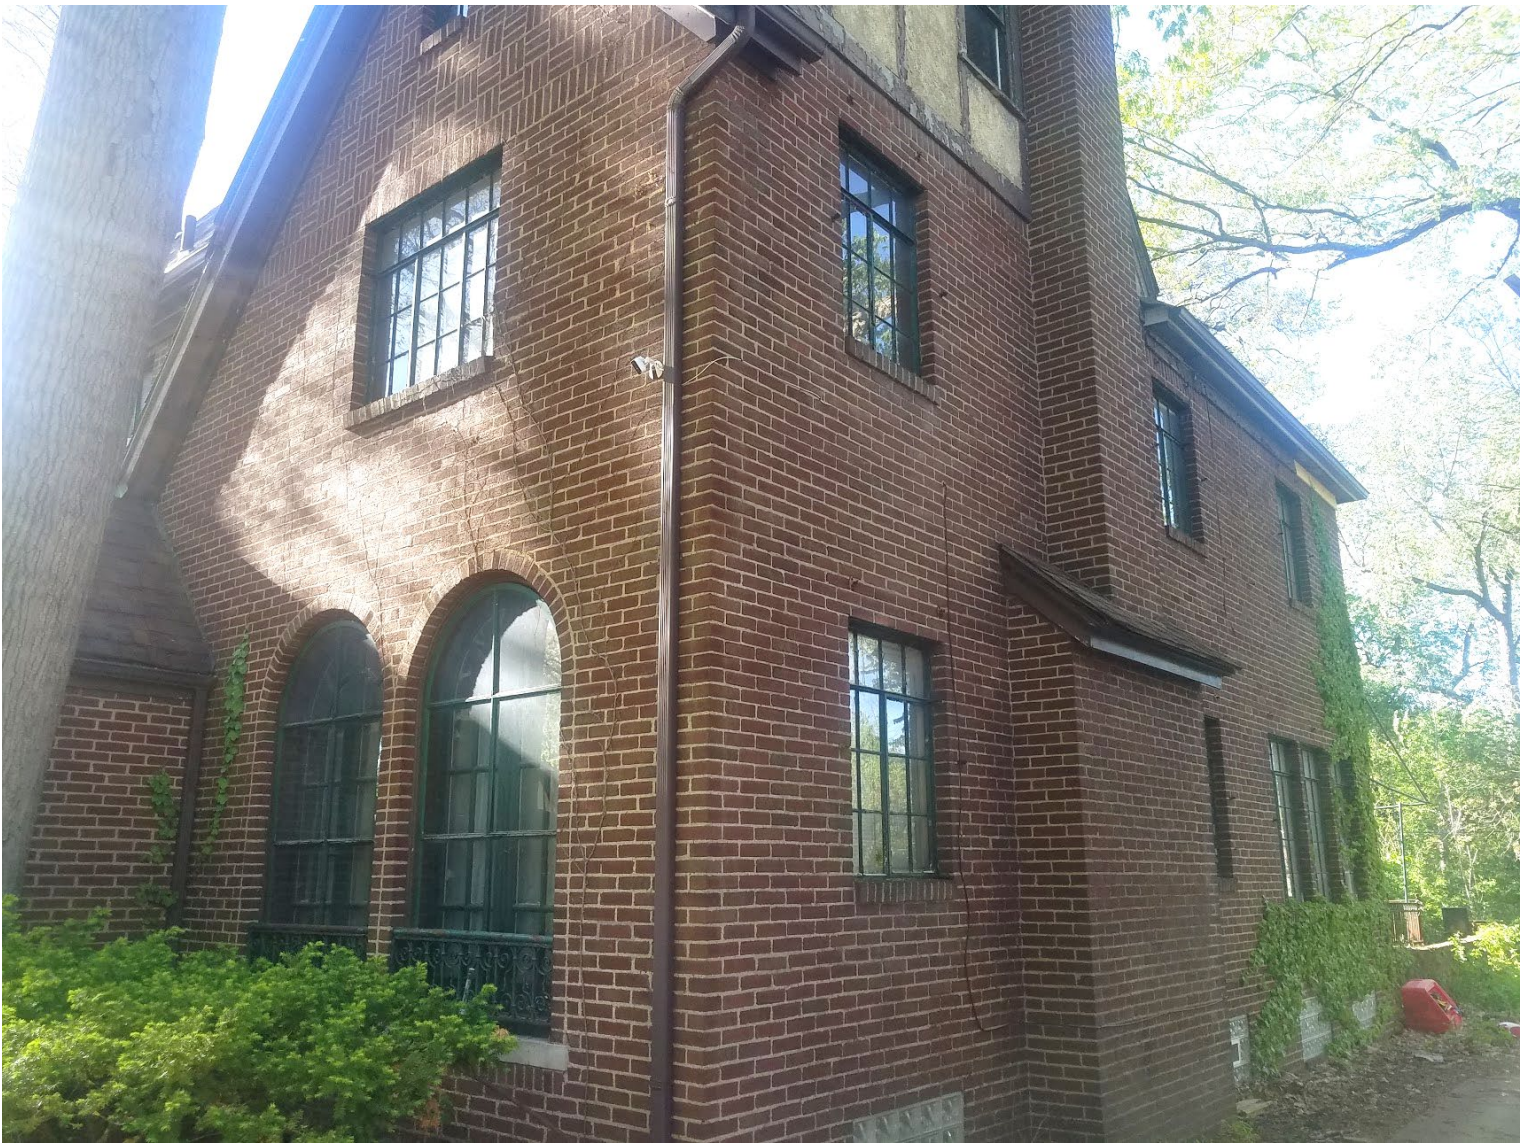
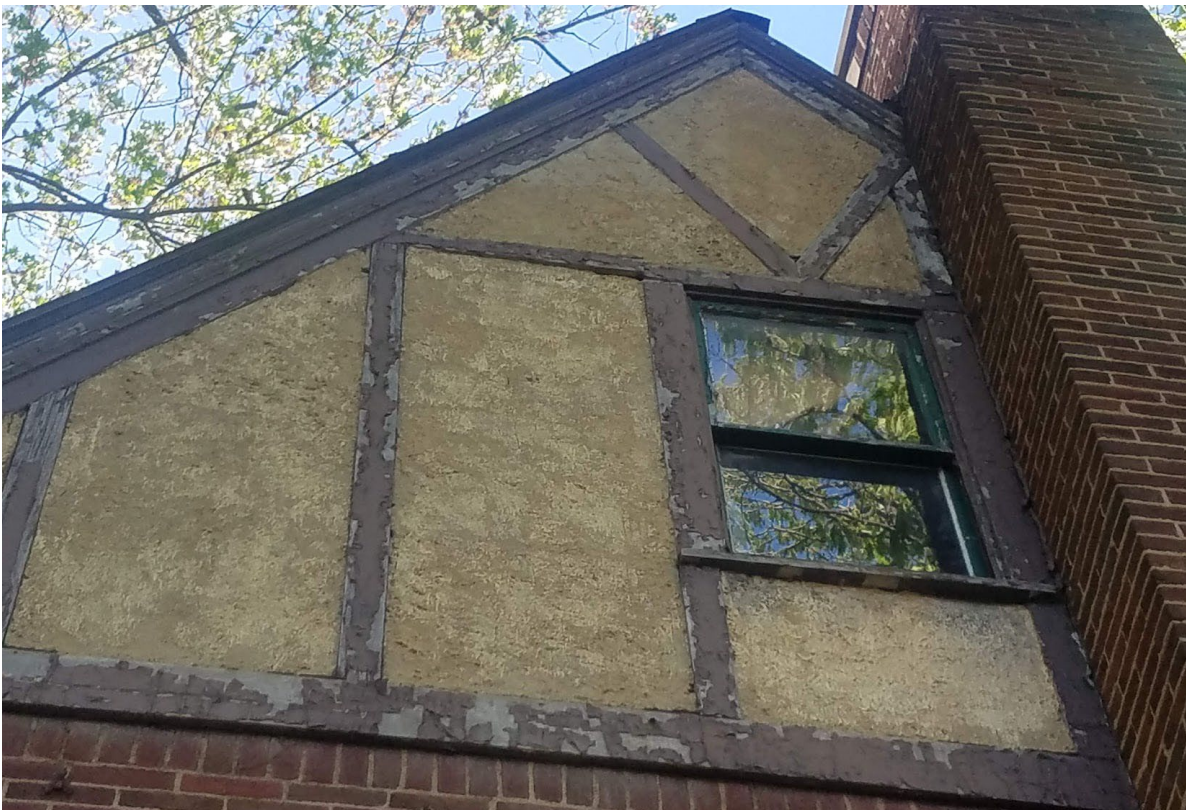
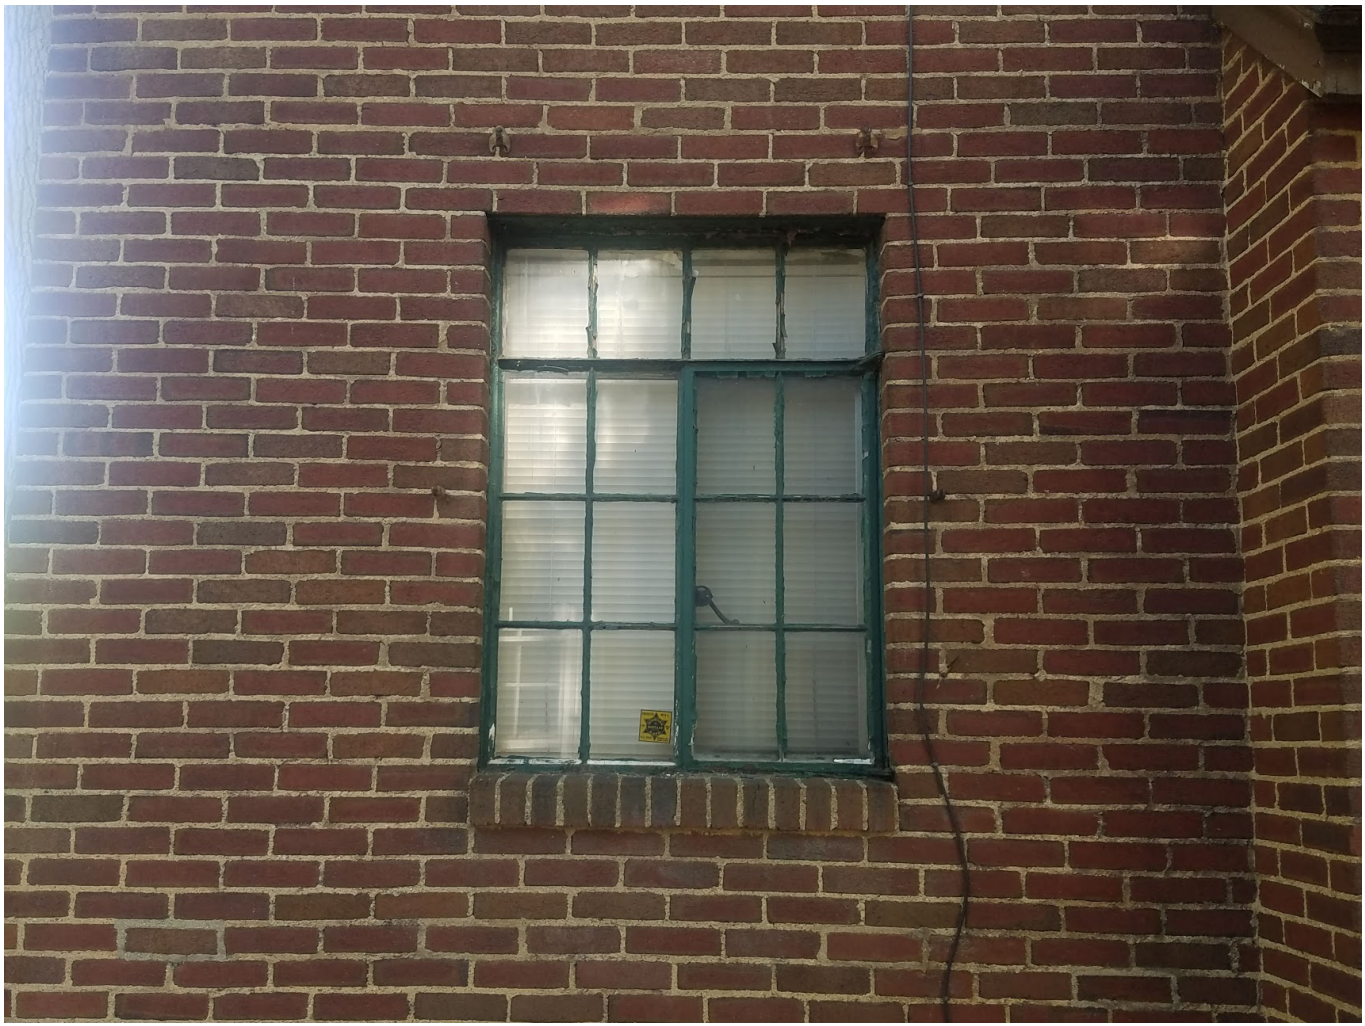
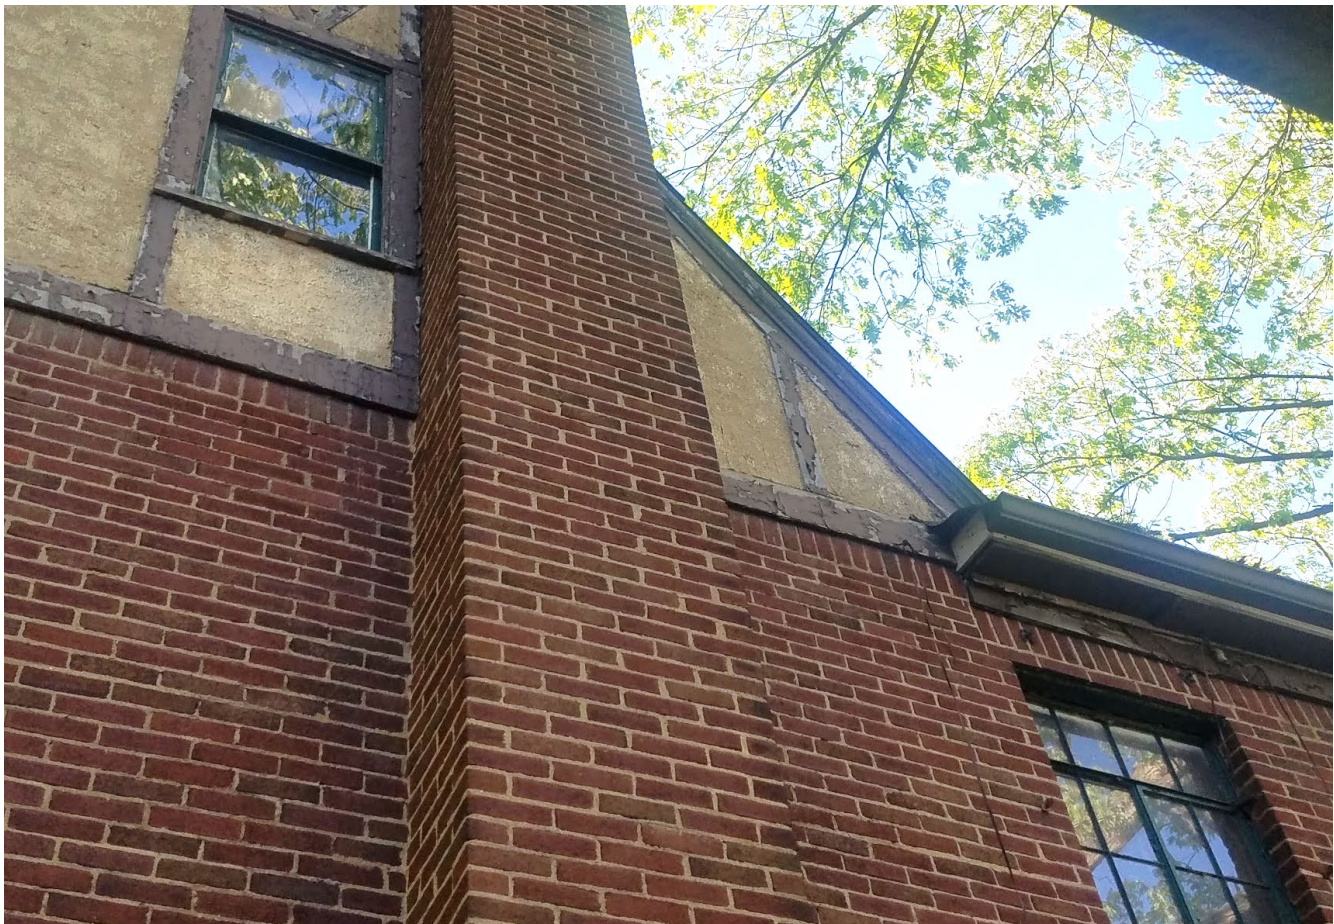
Original Windows – additional photos supplied by applicant

- The windows were replaced without detailed analysis as to the existing conditions and repair options/pricing from window companies with experience in steel window repair. Staff requested additional photographs of the windows before they were replaced showing the deterioration levels of the windows. They follow the photo narrative of the multiple projects.
