OLD BUISNESS: 2-12-2020 MEETING  
APPLICATION NUMBER 19-6464  
VIOLATION NUMBER 19-322  
ADDRESS: 4801 STURTEVANT  
HISTORIC DISTRICT: RUSSELL WOODS - SULLIVAN  
APPLICANT: WAYNE GROLEAU  
DATE OF APPLICATION: 9-23-2019  
DATE OF VIOLATION: 9-26-2019

PREPARED BY: B. CAGNEY

STAFF REPORT 11-13-2019 MEETING  
APPLICATION NUMBER 19-6464  
ADDRESS: 4801 STURTEVANT  
HISTORIC DISTRICT: RUSSELL WOODS - SULLIVAN  
APPLICANT: WAYNE GROLEAU  
DATE OF APPLICATION: 9-23-2019  
DATE OF VIOLATION: 9-26-2019  
DATE OF STAFF VISIT: 11-6-2019

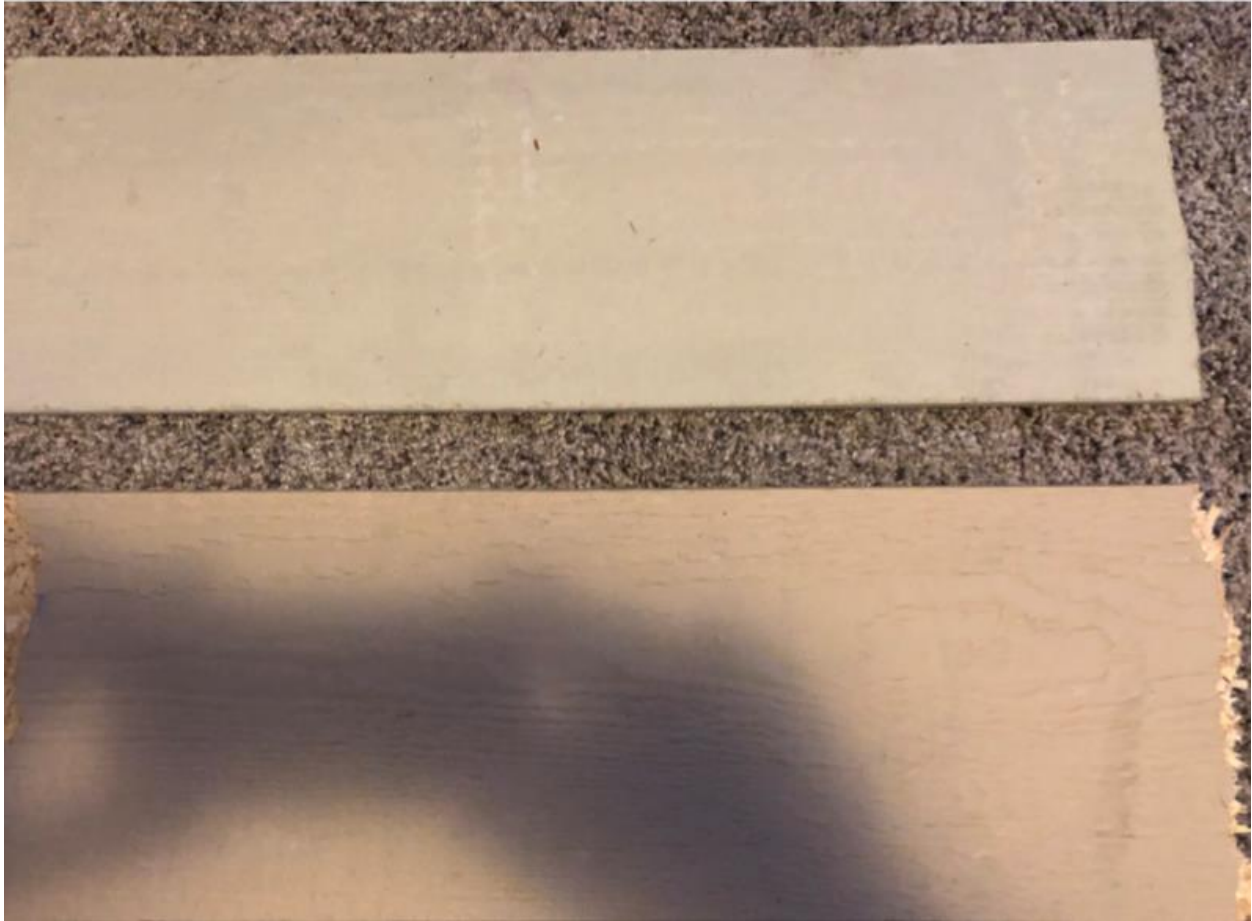
Applicants put in the application that the lap siding was wood. The staff represented to the commission that applicants had applied “synthetic siding.” If staff is not certain what the siding is, they should just admit it. Applicants’ credibility is maintained because the lap siding is wood and the physical evidence will be brought to the HDC meeting (see below).

Top – Allura Textured Fiber cement lap siding approved by HDC for 2215 W. Boston 5/08/19

Bottom – Wood lap siding used on 4801 Sturtevant

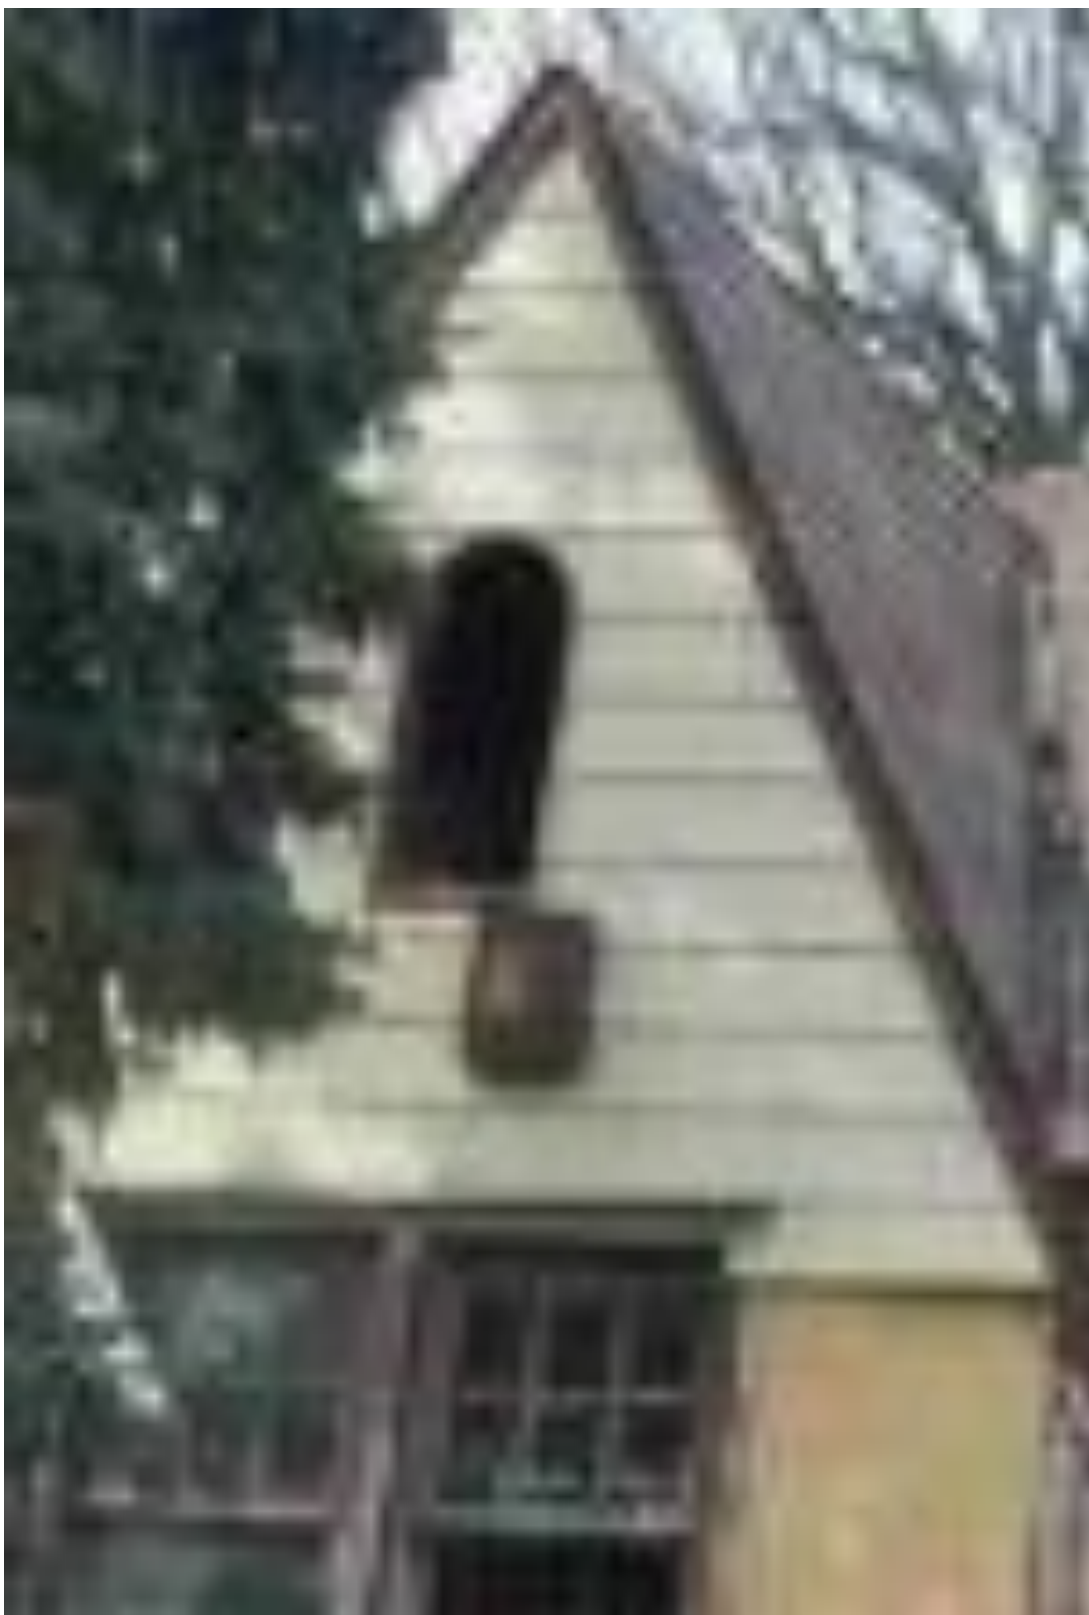
4220 Sturtevant where the original stucco was sided over

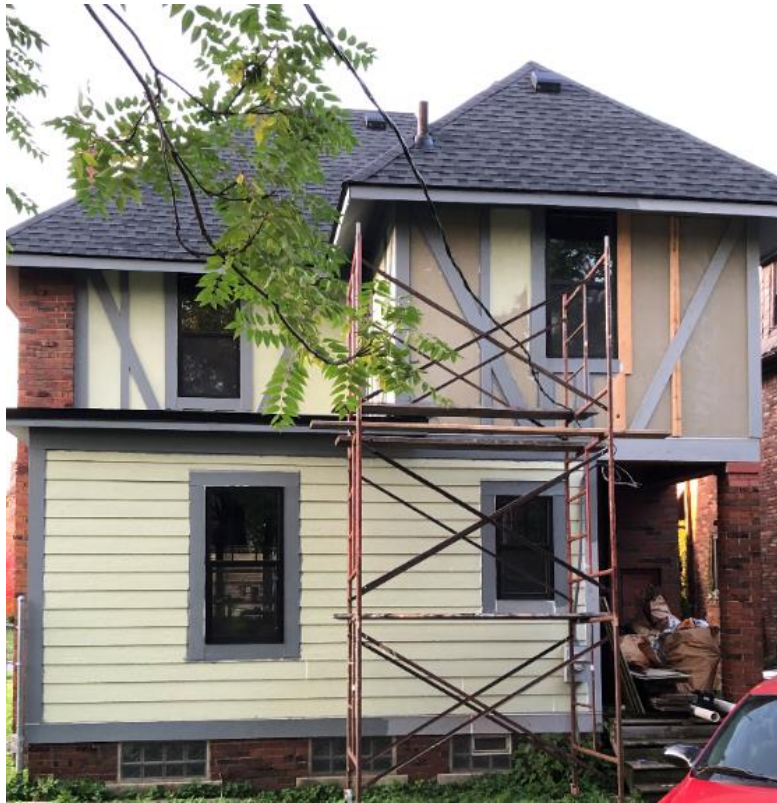
4801 Sturtevant Wood windows per color chart, wood siding lower, and stucco upper

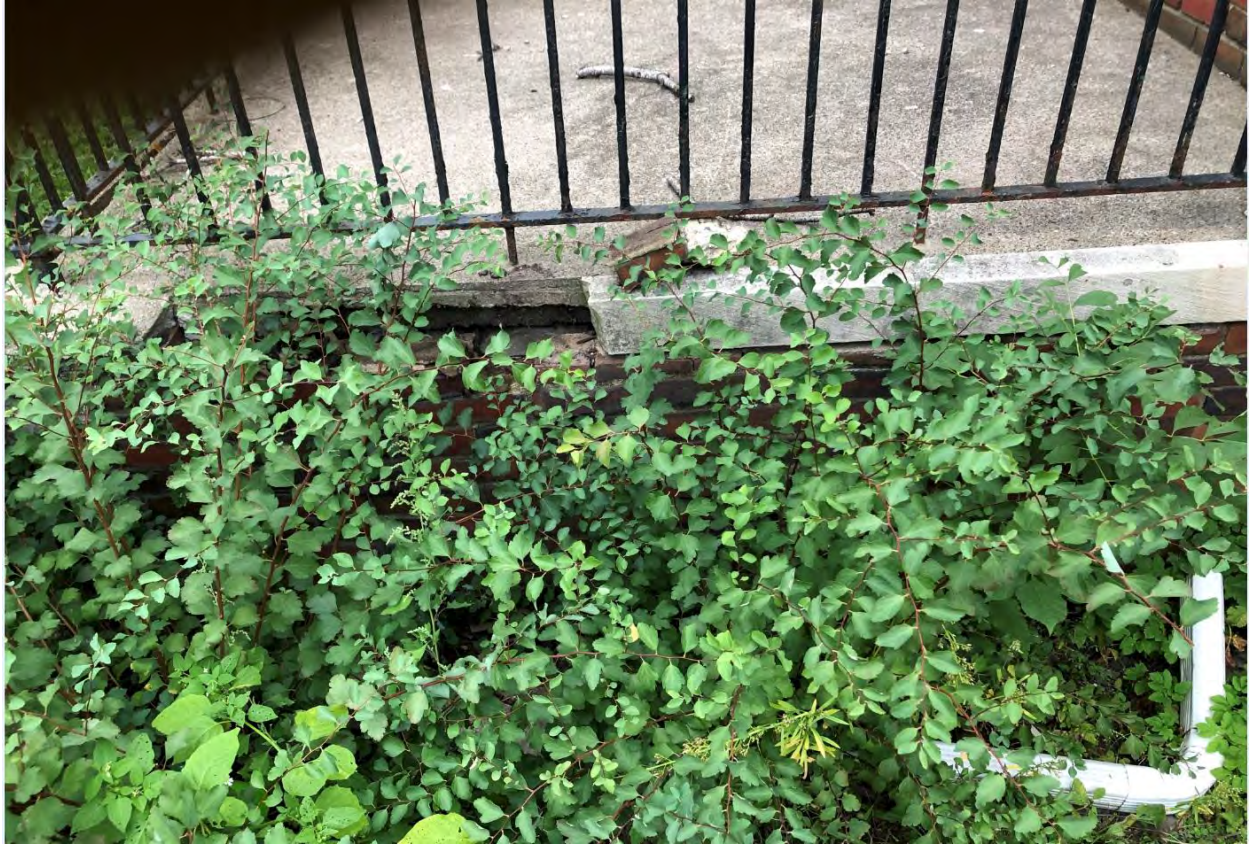
2. Existing conditions – per photos, porch is falling apart.
3. Project – re-build porch with existing bricks
4. Details
  - Remove existing brick
  - Clean off old mortar
  - Rebuild walls with this same salvaged brick
  - Use existing footprint
  - Concrete Cap repaired as necessary
5. Brochures – NA (attempting to salvage original brick)
