STAFF REPORT: 02-12-2020 MEETING

APPLICATION NUMBER: 20-6623

ADDRESS: 4060 STURTEVANT

SCOPE: REMOVAL OF STEEL CASEMENT/TRANSOM/SIDELIGHT WINDOWS; INSTALLATION OF FIBREX CASEMENT WINDOWS

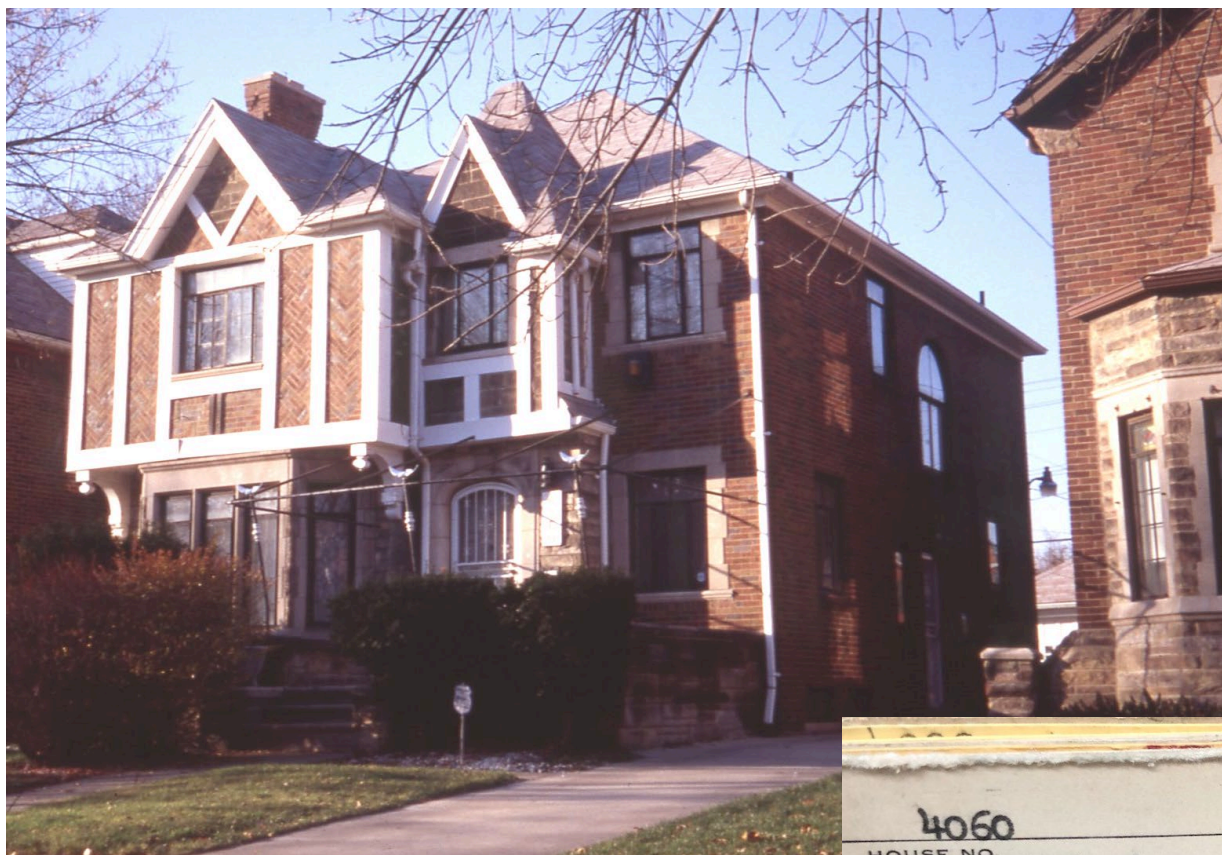
District Designation Photo – 1999

Constructed in 1938, this English Revival style house has a brick and stone front façade, stone window and door surrounds, half-timbering with either stone and (three different styles of) brick infill, leaded glass windows, culminating with a decorative brick chimney stack. Indicative of its era of construction, the house has steel windows with a multitude of sash types (casement, transom, sidelights), creating a holistic, ornate residential design.

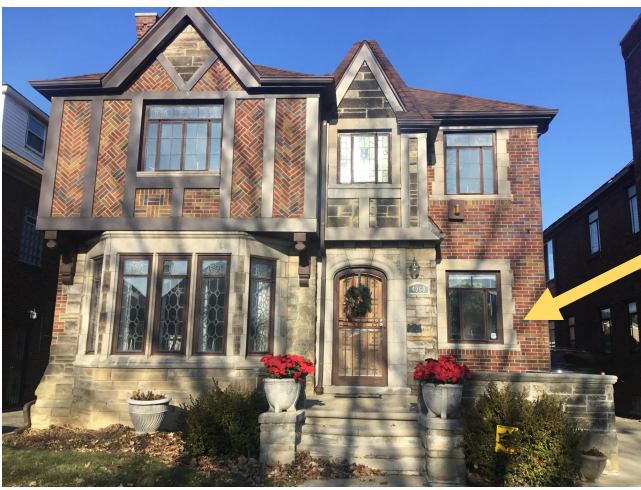
Unit 101

Existing:

- Unit does not have stained glass
- Center window opens

- Casement Single
- Grille - Colonial 3w x 4h

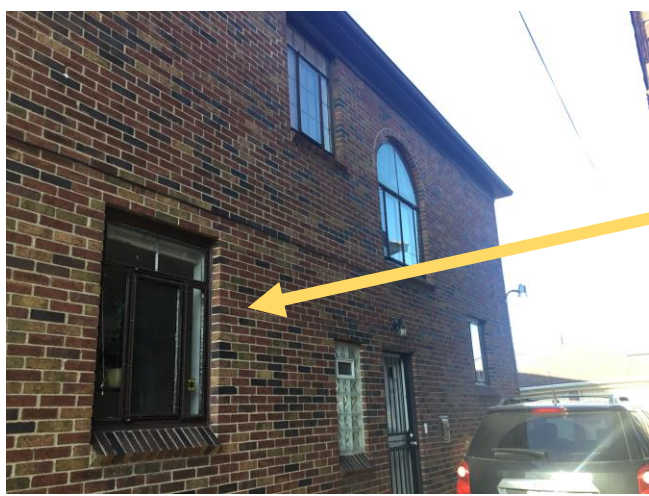
Unit 102

Existing:

- Unit does not have stained glass
- Center window opens

- Casement Single
- Grille - Colonial 3w x 4h

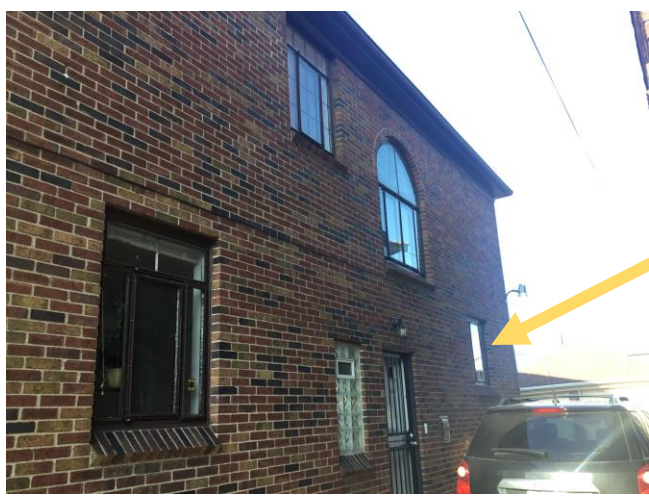
Unit 103

Existing:

- Unit does not have stained glass
- Center window opens

- Casement Single
- Grille - Colonial 3w x 3h

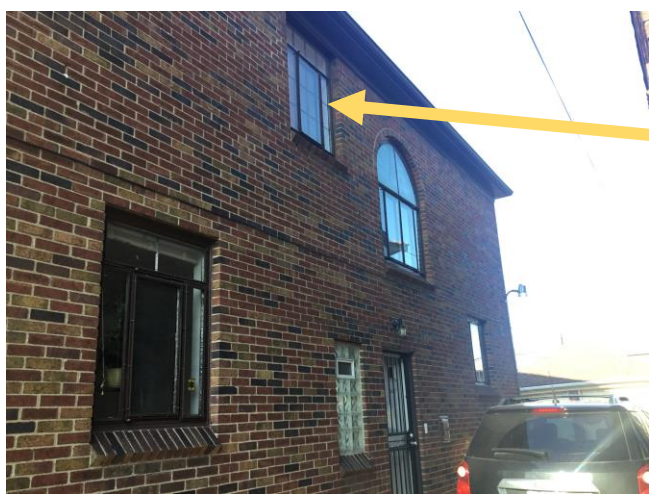
Unit 201

Existing:

- Unit does not have stained glass
- Center window opens

- Casement Single
- Grille - Colonial 4w x 4h

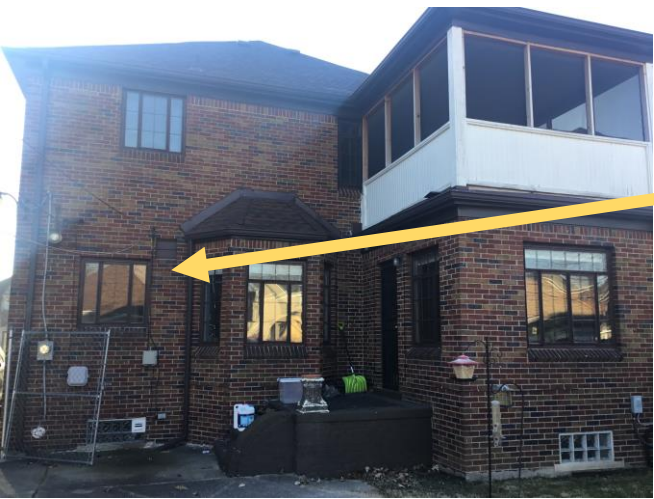
Unit 104

Existing:

- Unit does not have stained glass
- Center window opens

- Casement Single
- Grille - Colonial 3w x 3h

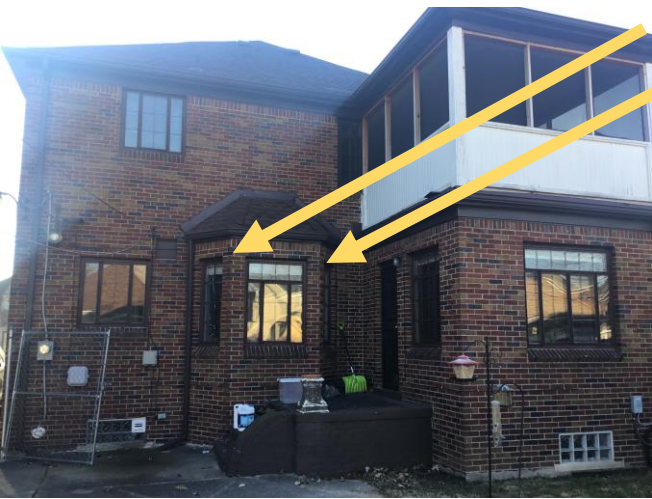
Unit 105, 107

Existing:

- Unit does not have stained glass
- Fixed window

- Fixed Window
- Grille - Colonial 2w x 4h

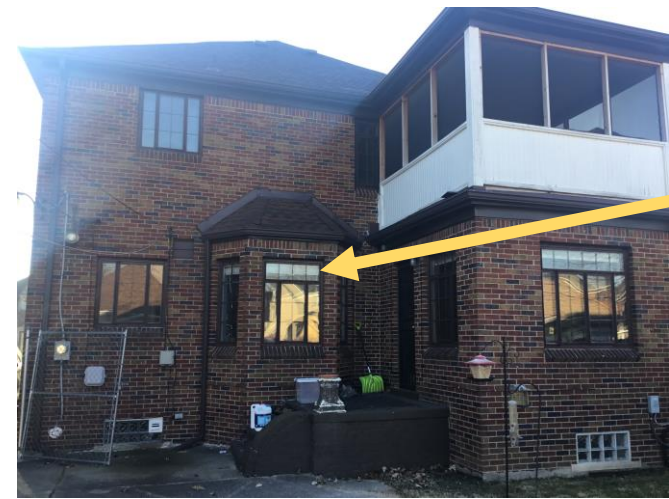
Unit 106

Existing:

- Unit does not have stained glass
- Center window opens

- Casement Single
- Grille - Colonial 4w x 4h

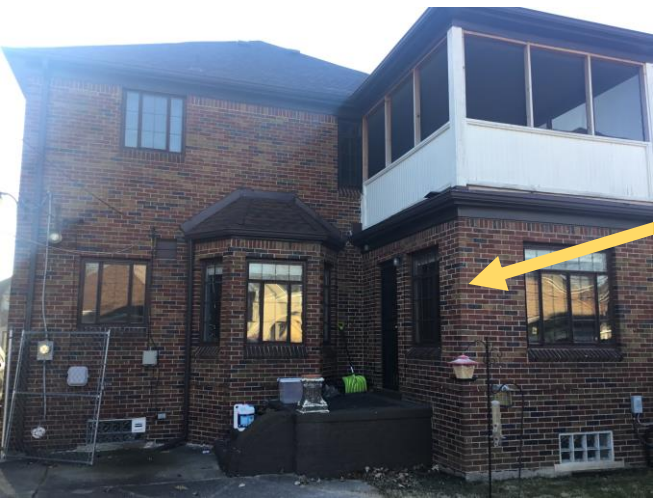
Unit 108

Existing:

- Unit does not have stained glass
- Center window opens

- Casement Single
- Grille - Colonial 4w x 4h

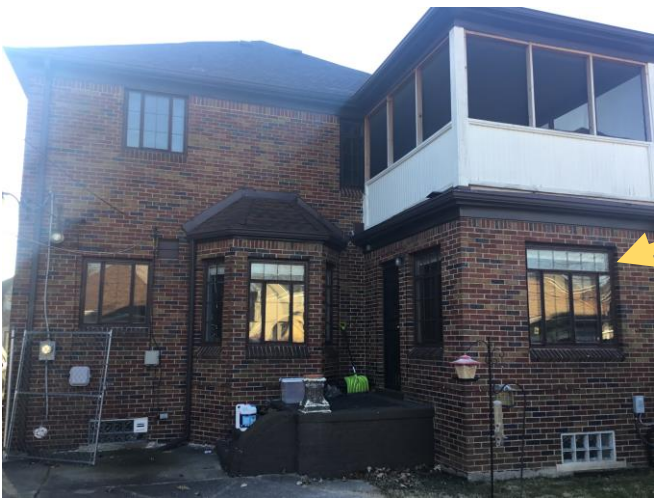
Unit 109

Existing:

- Unit does not have stained glass
- Center windows (2) open

- Casement Double
- Grille - Colonial 4w x 4h

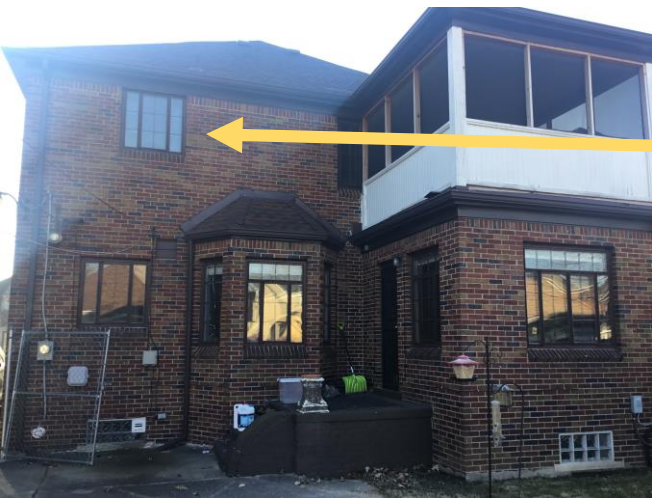
Unit 202

Existing:

- Unit does not have stained glass
- Center window opens
- Window is broken on interior

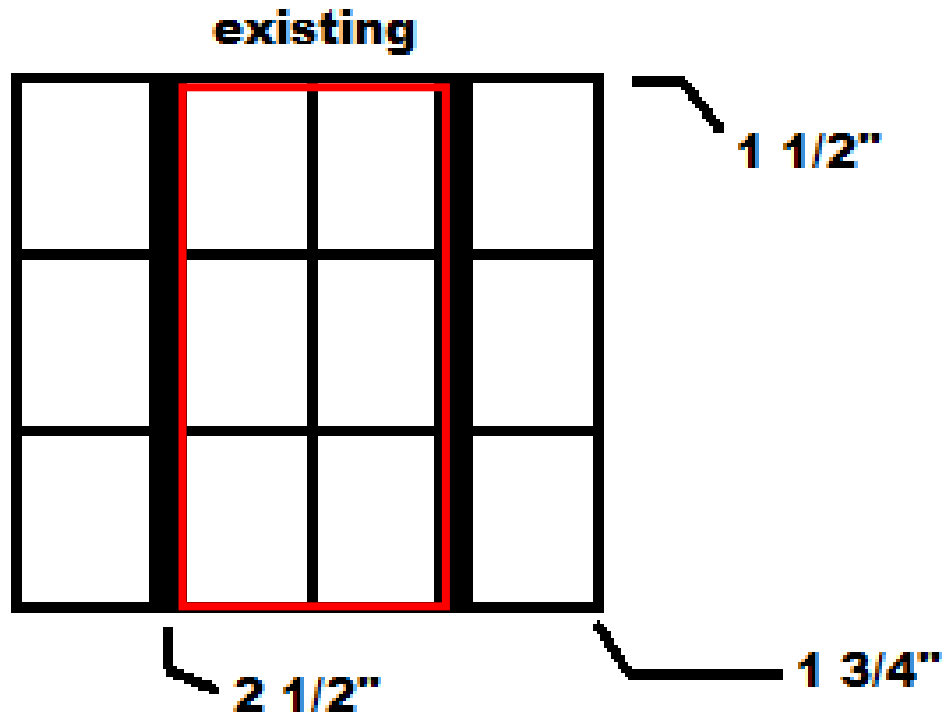
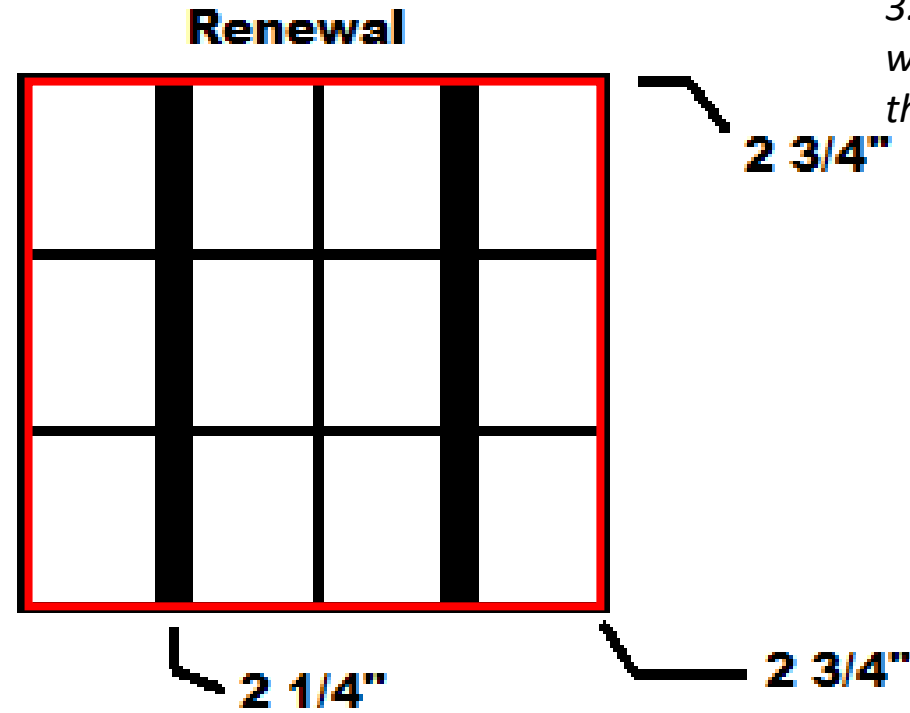
• Installing a fixed window at the top and the sides of a casement window is possible, but it would cause a huge 3.5-4" mull between all of the windows joined together, so I don't think this is an option.

- Renewal:
- 1 large casement single window with a 2 1/4" simulated check rail to mimic the wide bars

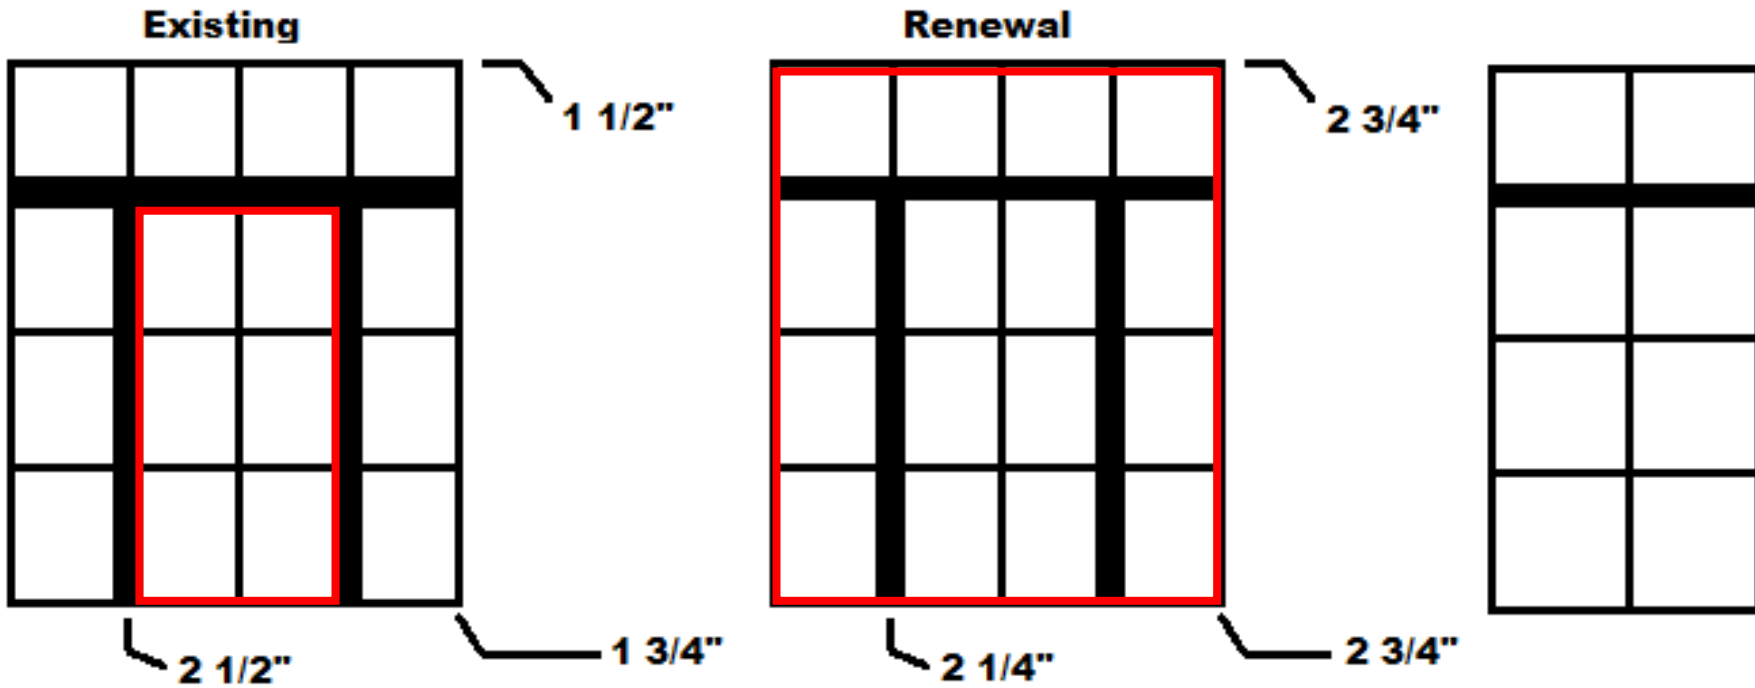
Comparisons

- Units 103, 104, 202
- Center window should open

- Renewal:
- 1 large casement single window with a 2 1/4" simulated check rail to mimic the wide bars

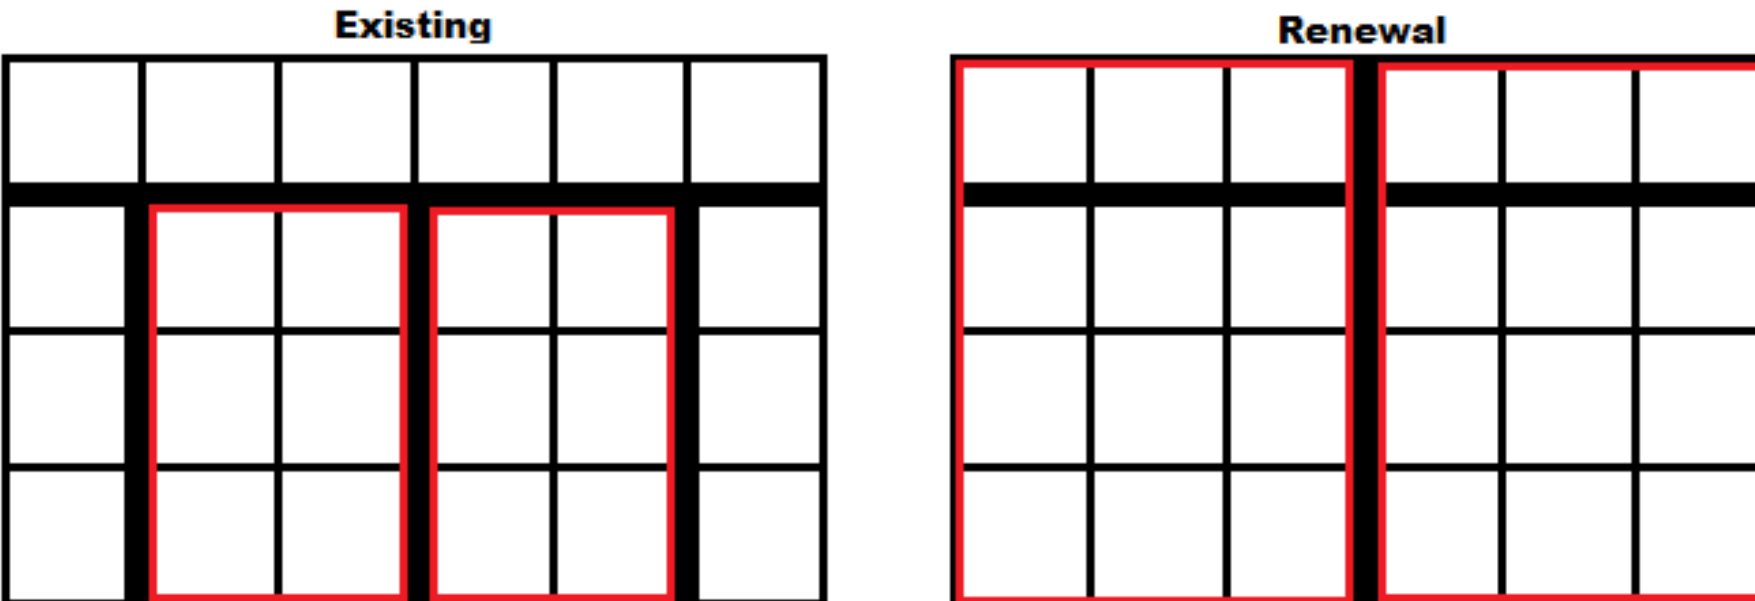
Comparisons

- Units 106, 108, 202
- Center window should open
- Units 105 and 107
 - 2w x 4h window
- Renewal:
- 1 large casement single window with a 2 1/4" simulated check rail to mimic the wide bars

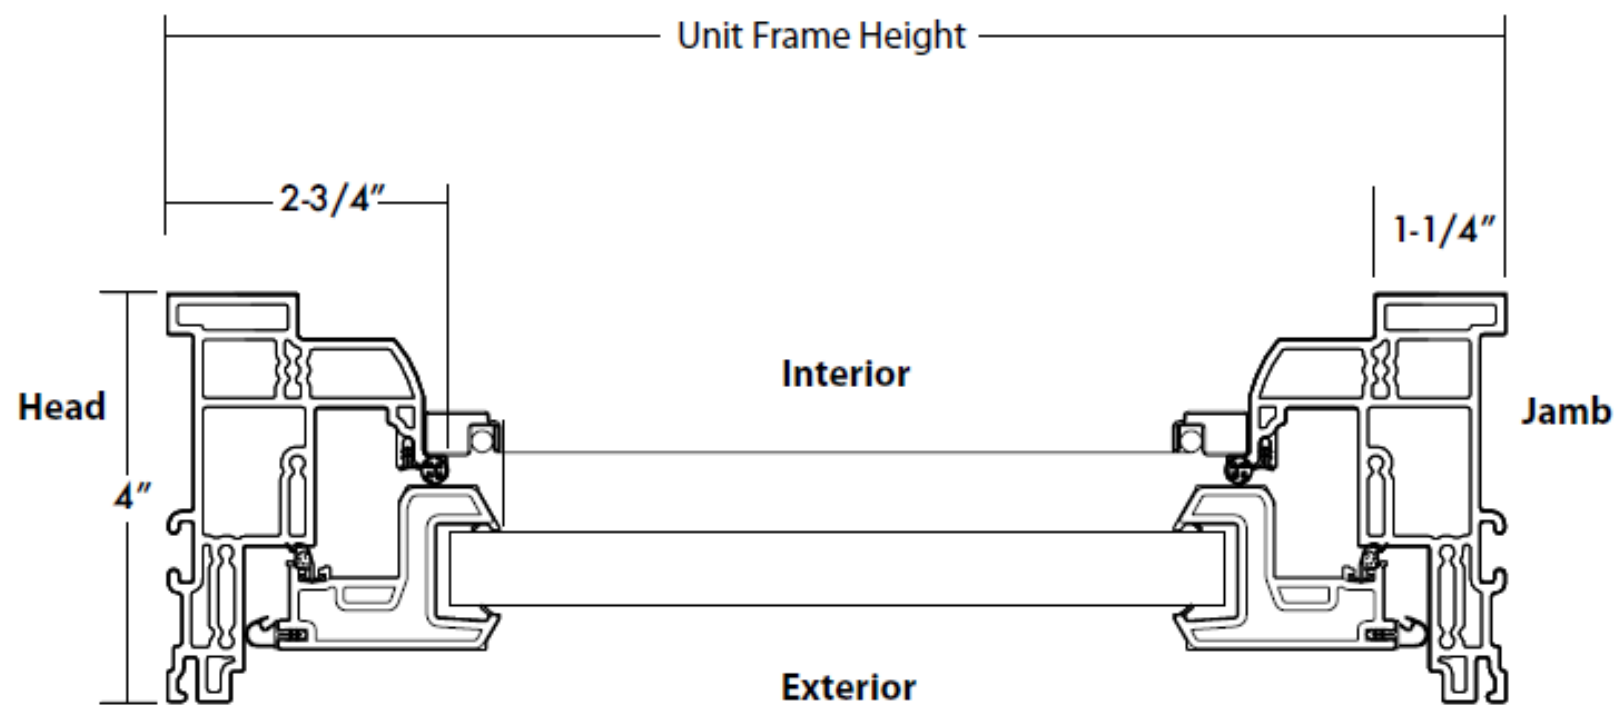
Comparisons

- Units 105 and 107
- Center window should open
- Renewal:
- 1 large casement single window with a 2 1/4" simulated check rail to mimic the wide bars
