STAFF REPORT: 01-22-2020 MEETING

APPLICATION NUMBER: 20-6648

ADDRESS: 8116 - 8130 KERCHEVAL/THE KERCHEVAL 3

HISTORIC DISTRICT: WEST VILLAGE

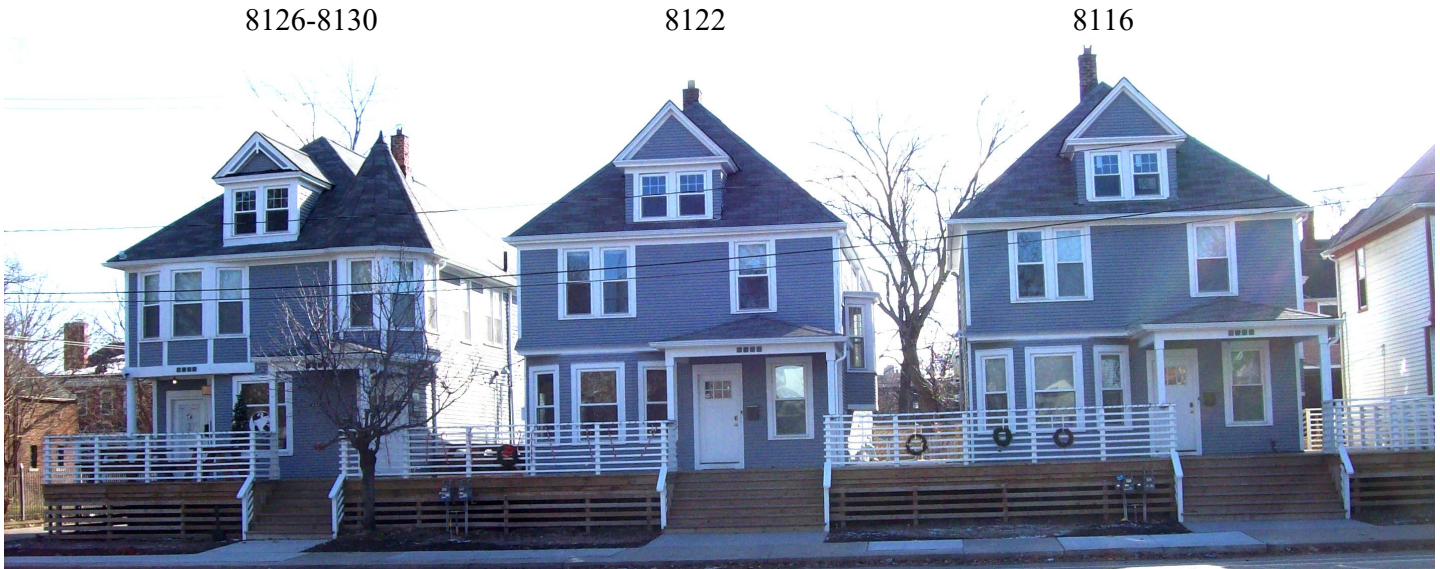
- Vinyl window installation. The wood windows on the three structures were replaced with vinyl windows in the summer of 2018.

- The double-hung wood windows in the front gables and west elevation bay windows of 8116 and 8122 had a nine-over-one pattern. The replacement windows in these locations have a six-over-one pattern (with muntins between-the-glass). The remaining windows on the three houses were one-

over-one double-hung wood windows. The replacement window are also one-over-one double-hung windows, but they have vinyl frames.

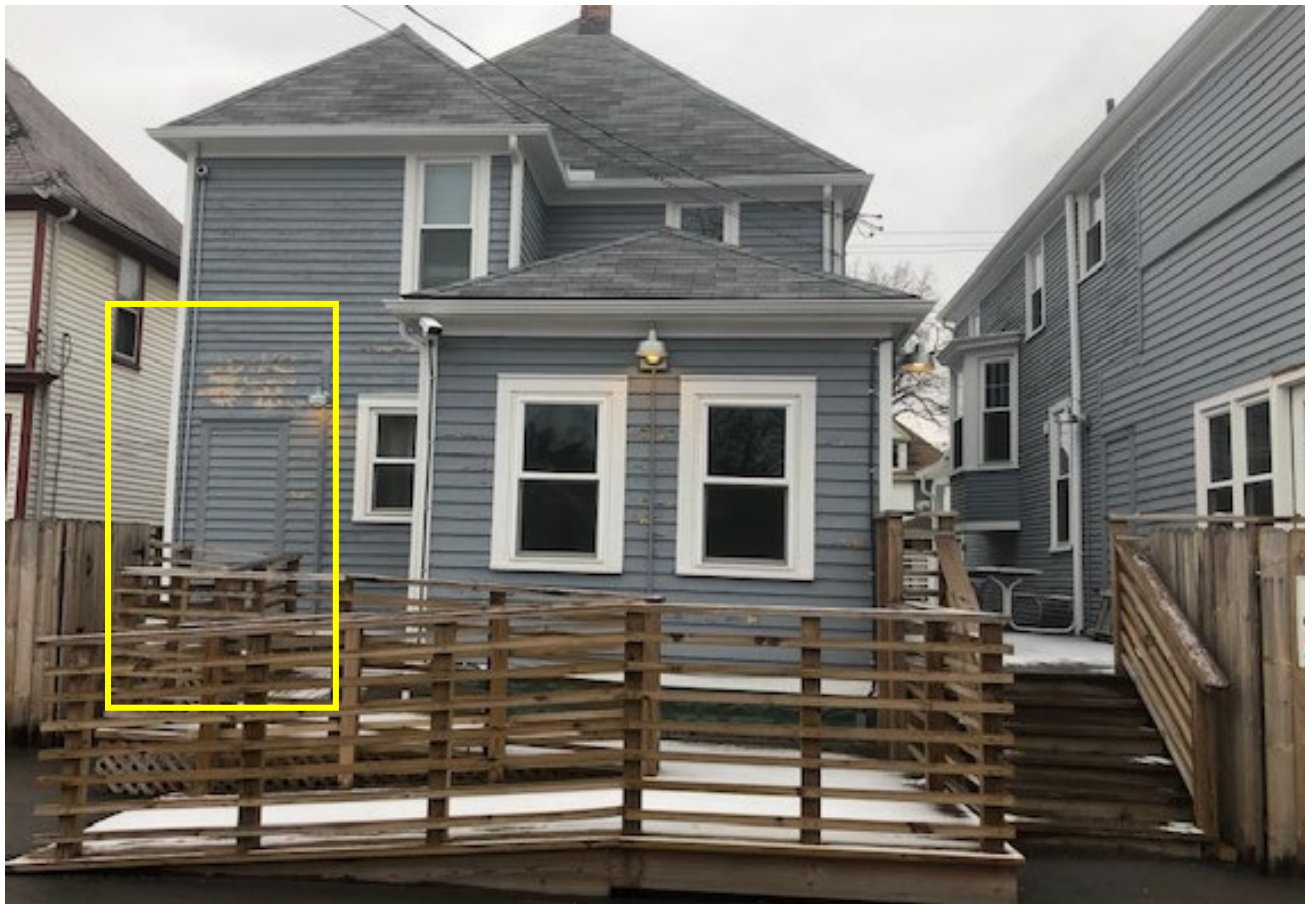
The removal of the door was approved by the HDC in 2017.

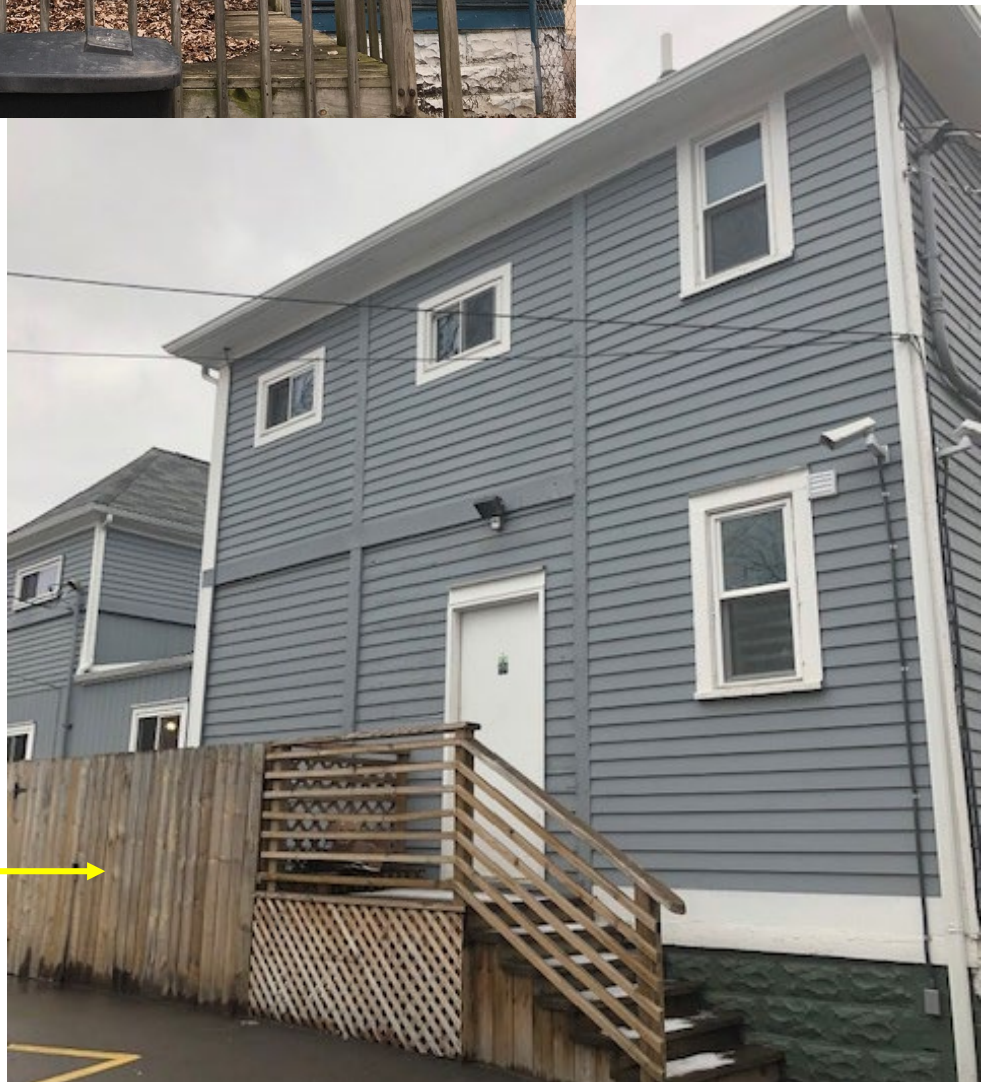
- Mechanical Unit Enclosure: A free-standing enclosure, constructed of gray CMU, was to be constructed. Instead, the units were placed adjacent the rear wall of 8126-30 and enclosed with a wood fence (six-feet?) that was left with a natural finish.

Wood fence enclosure – installed in
place of free-standing CMU enclosure.

4. New fencing around rear condensers
 - a. Reason for the existing condition: Our condensers were all stolen, and it was clear that we needed additional security measures to prevent further theft.
