STAFF REPORT 03-11-2020 REGULAR MEETING PREPARED BY: A. PHILLIPS

APPLICATION NUMBER: 20-6654 **ADDRESS:** 3453 BURNS AVENUE

HISTORIC DISTRICT: INDIAN VILLAGE

SCOPE: REPLACE 35 HISTORIC WOOD WINDOWS WITH NEW WOOD, ALUMINUM-CLAD

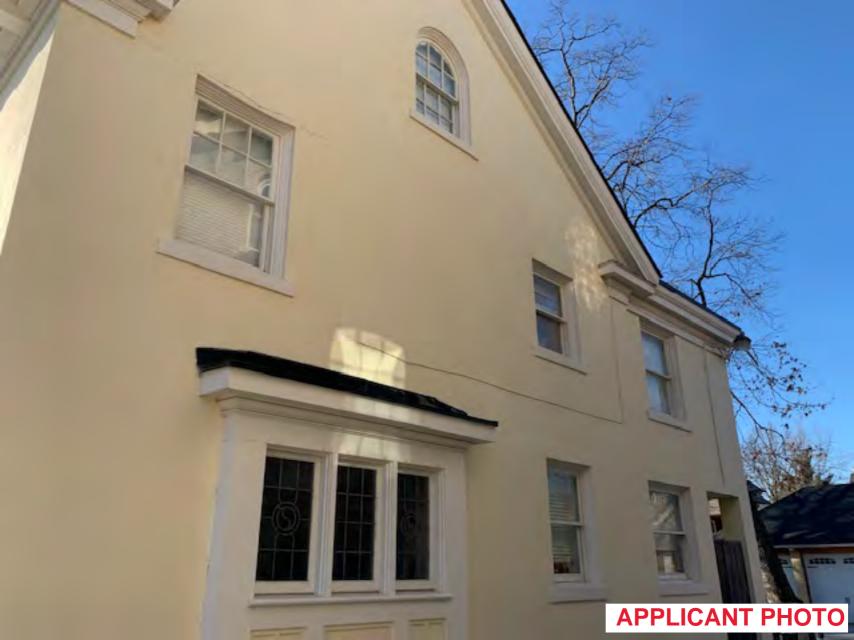
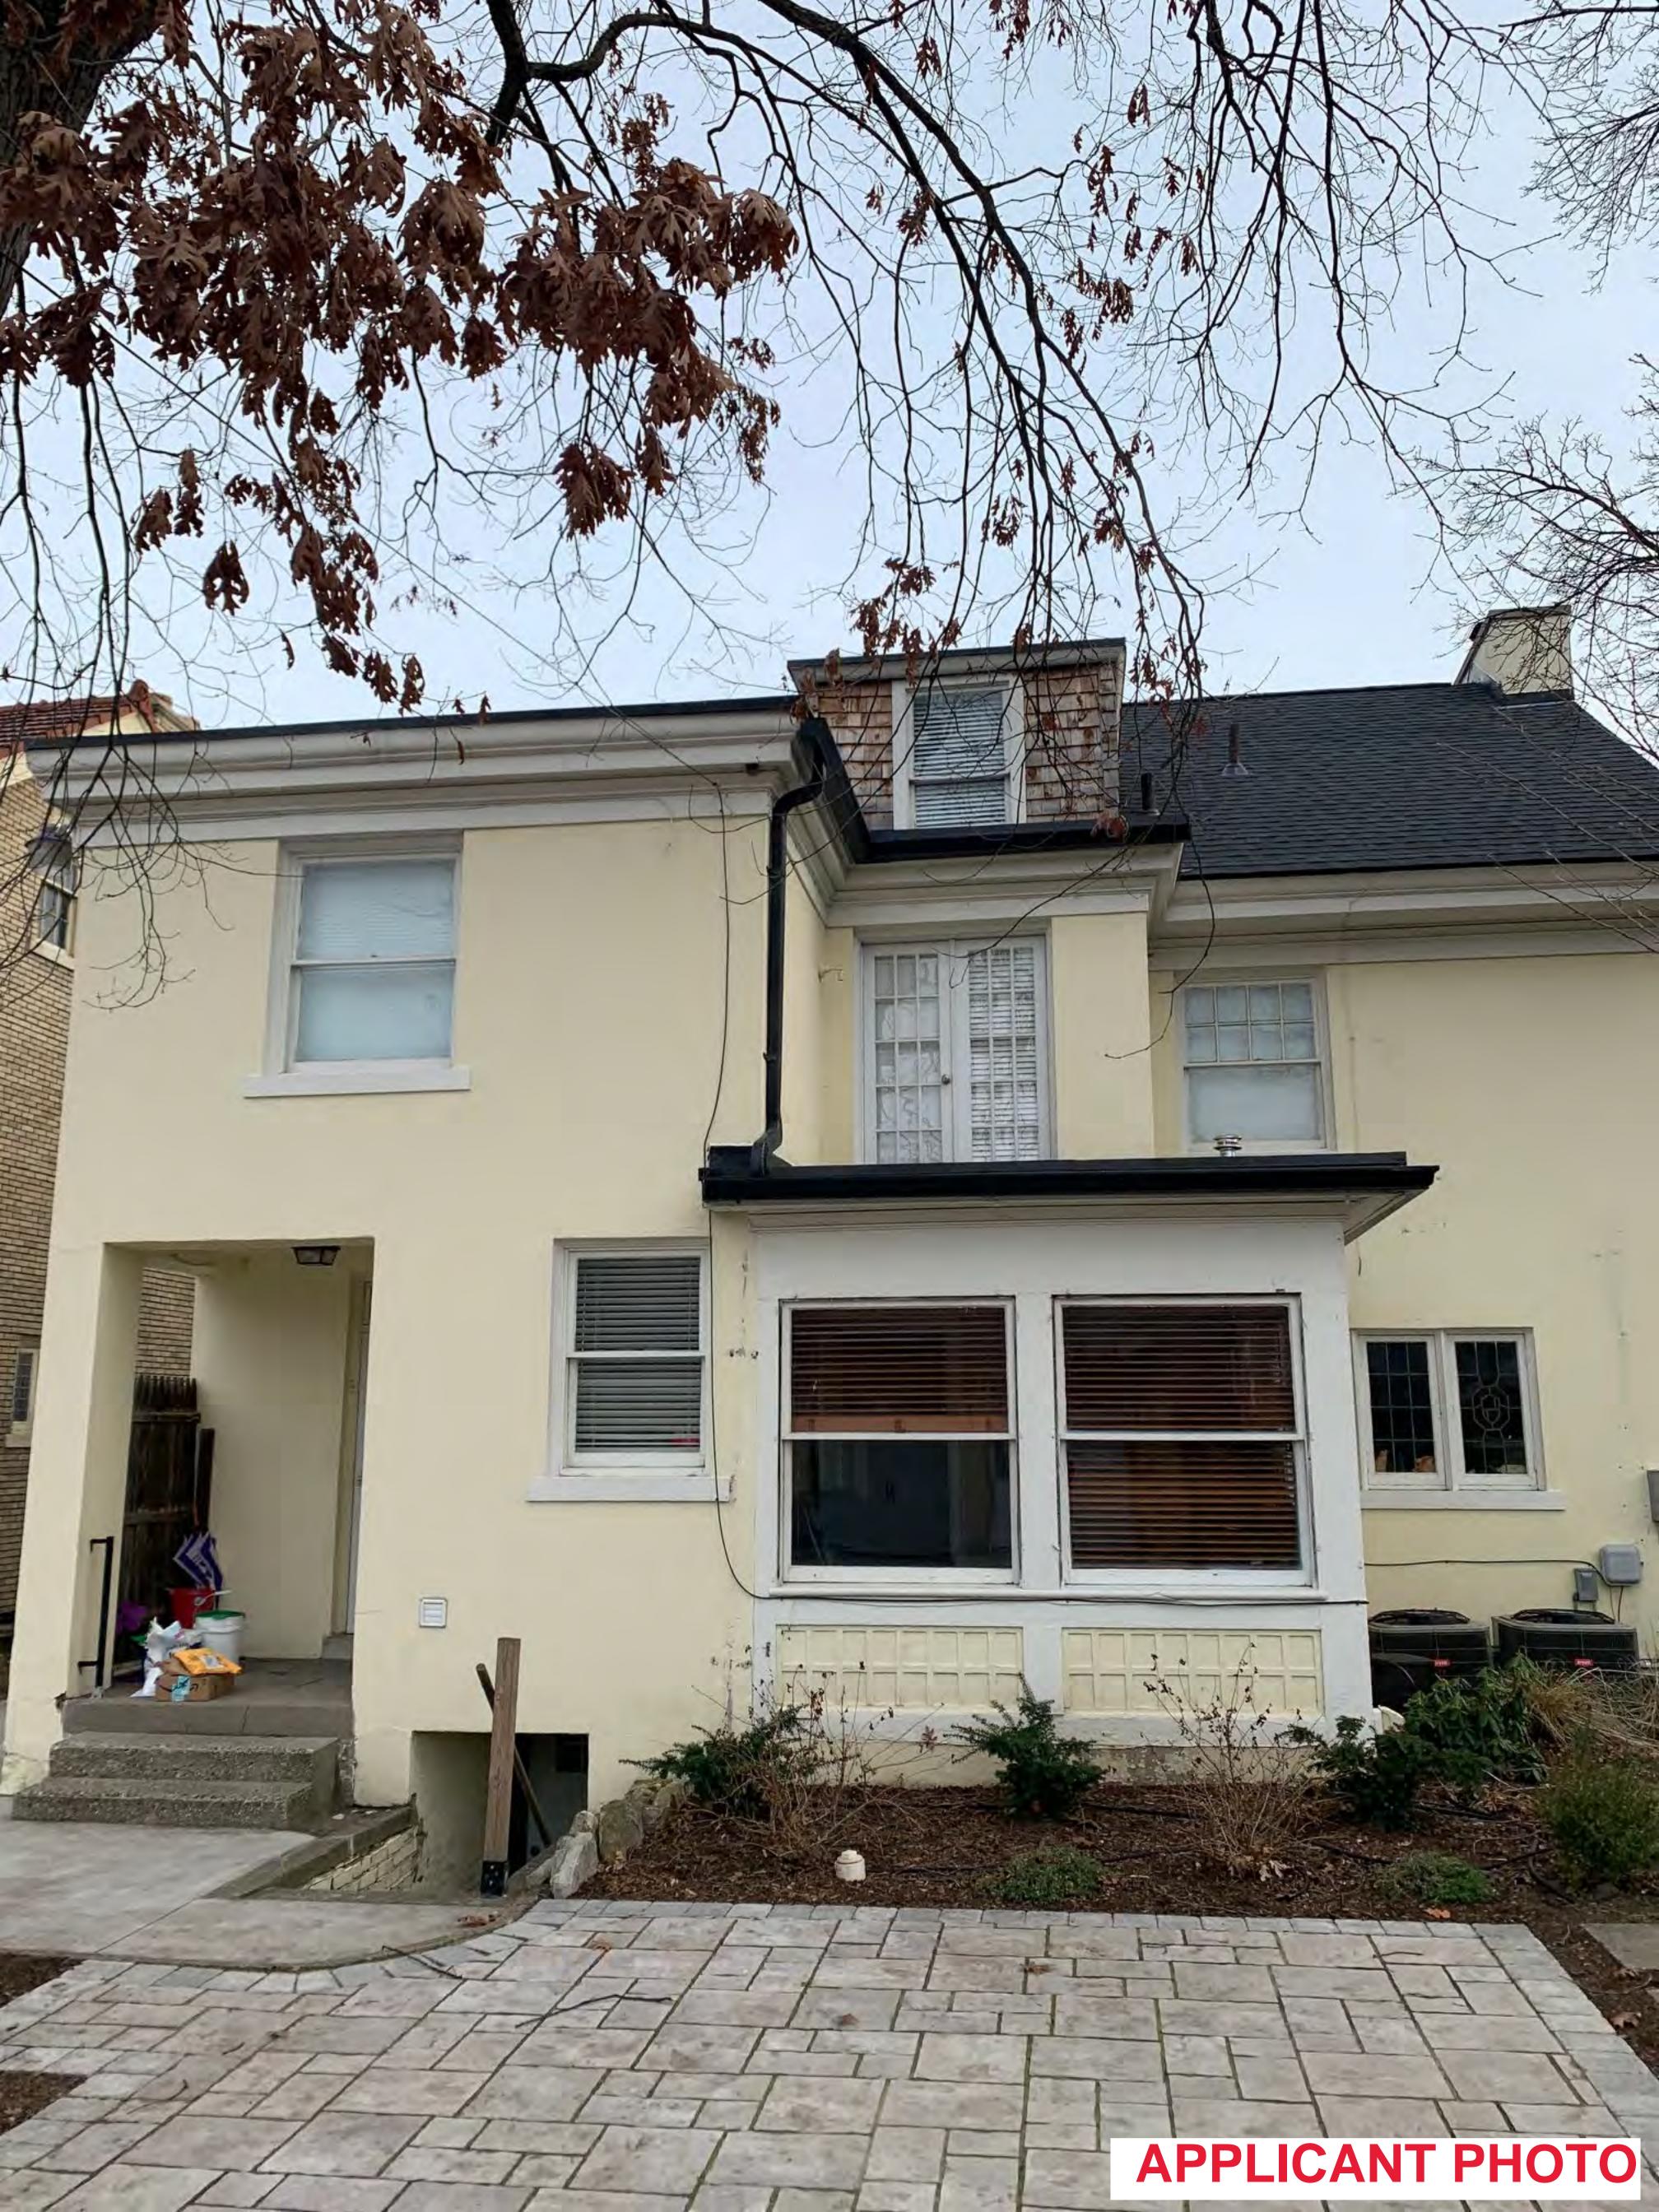
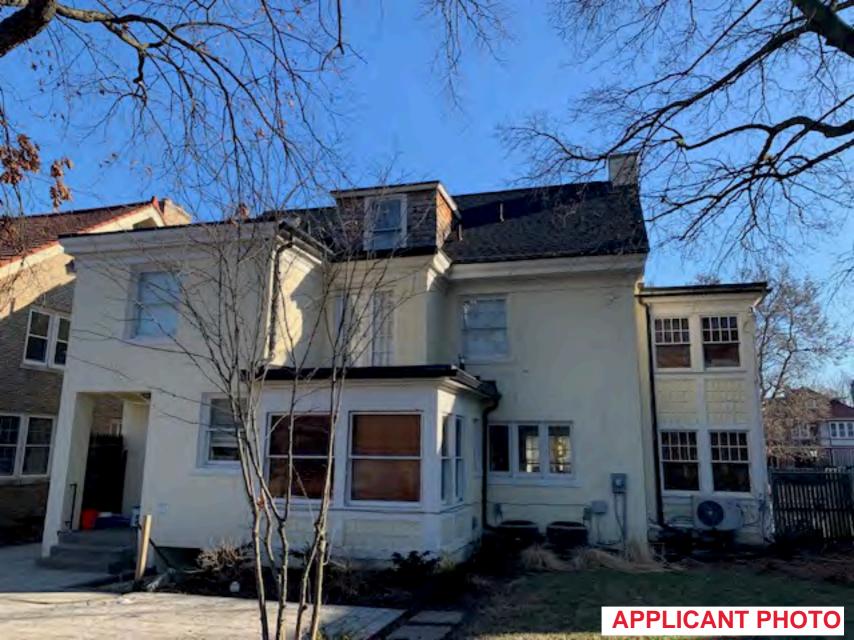
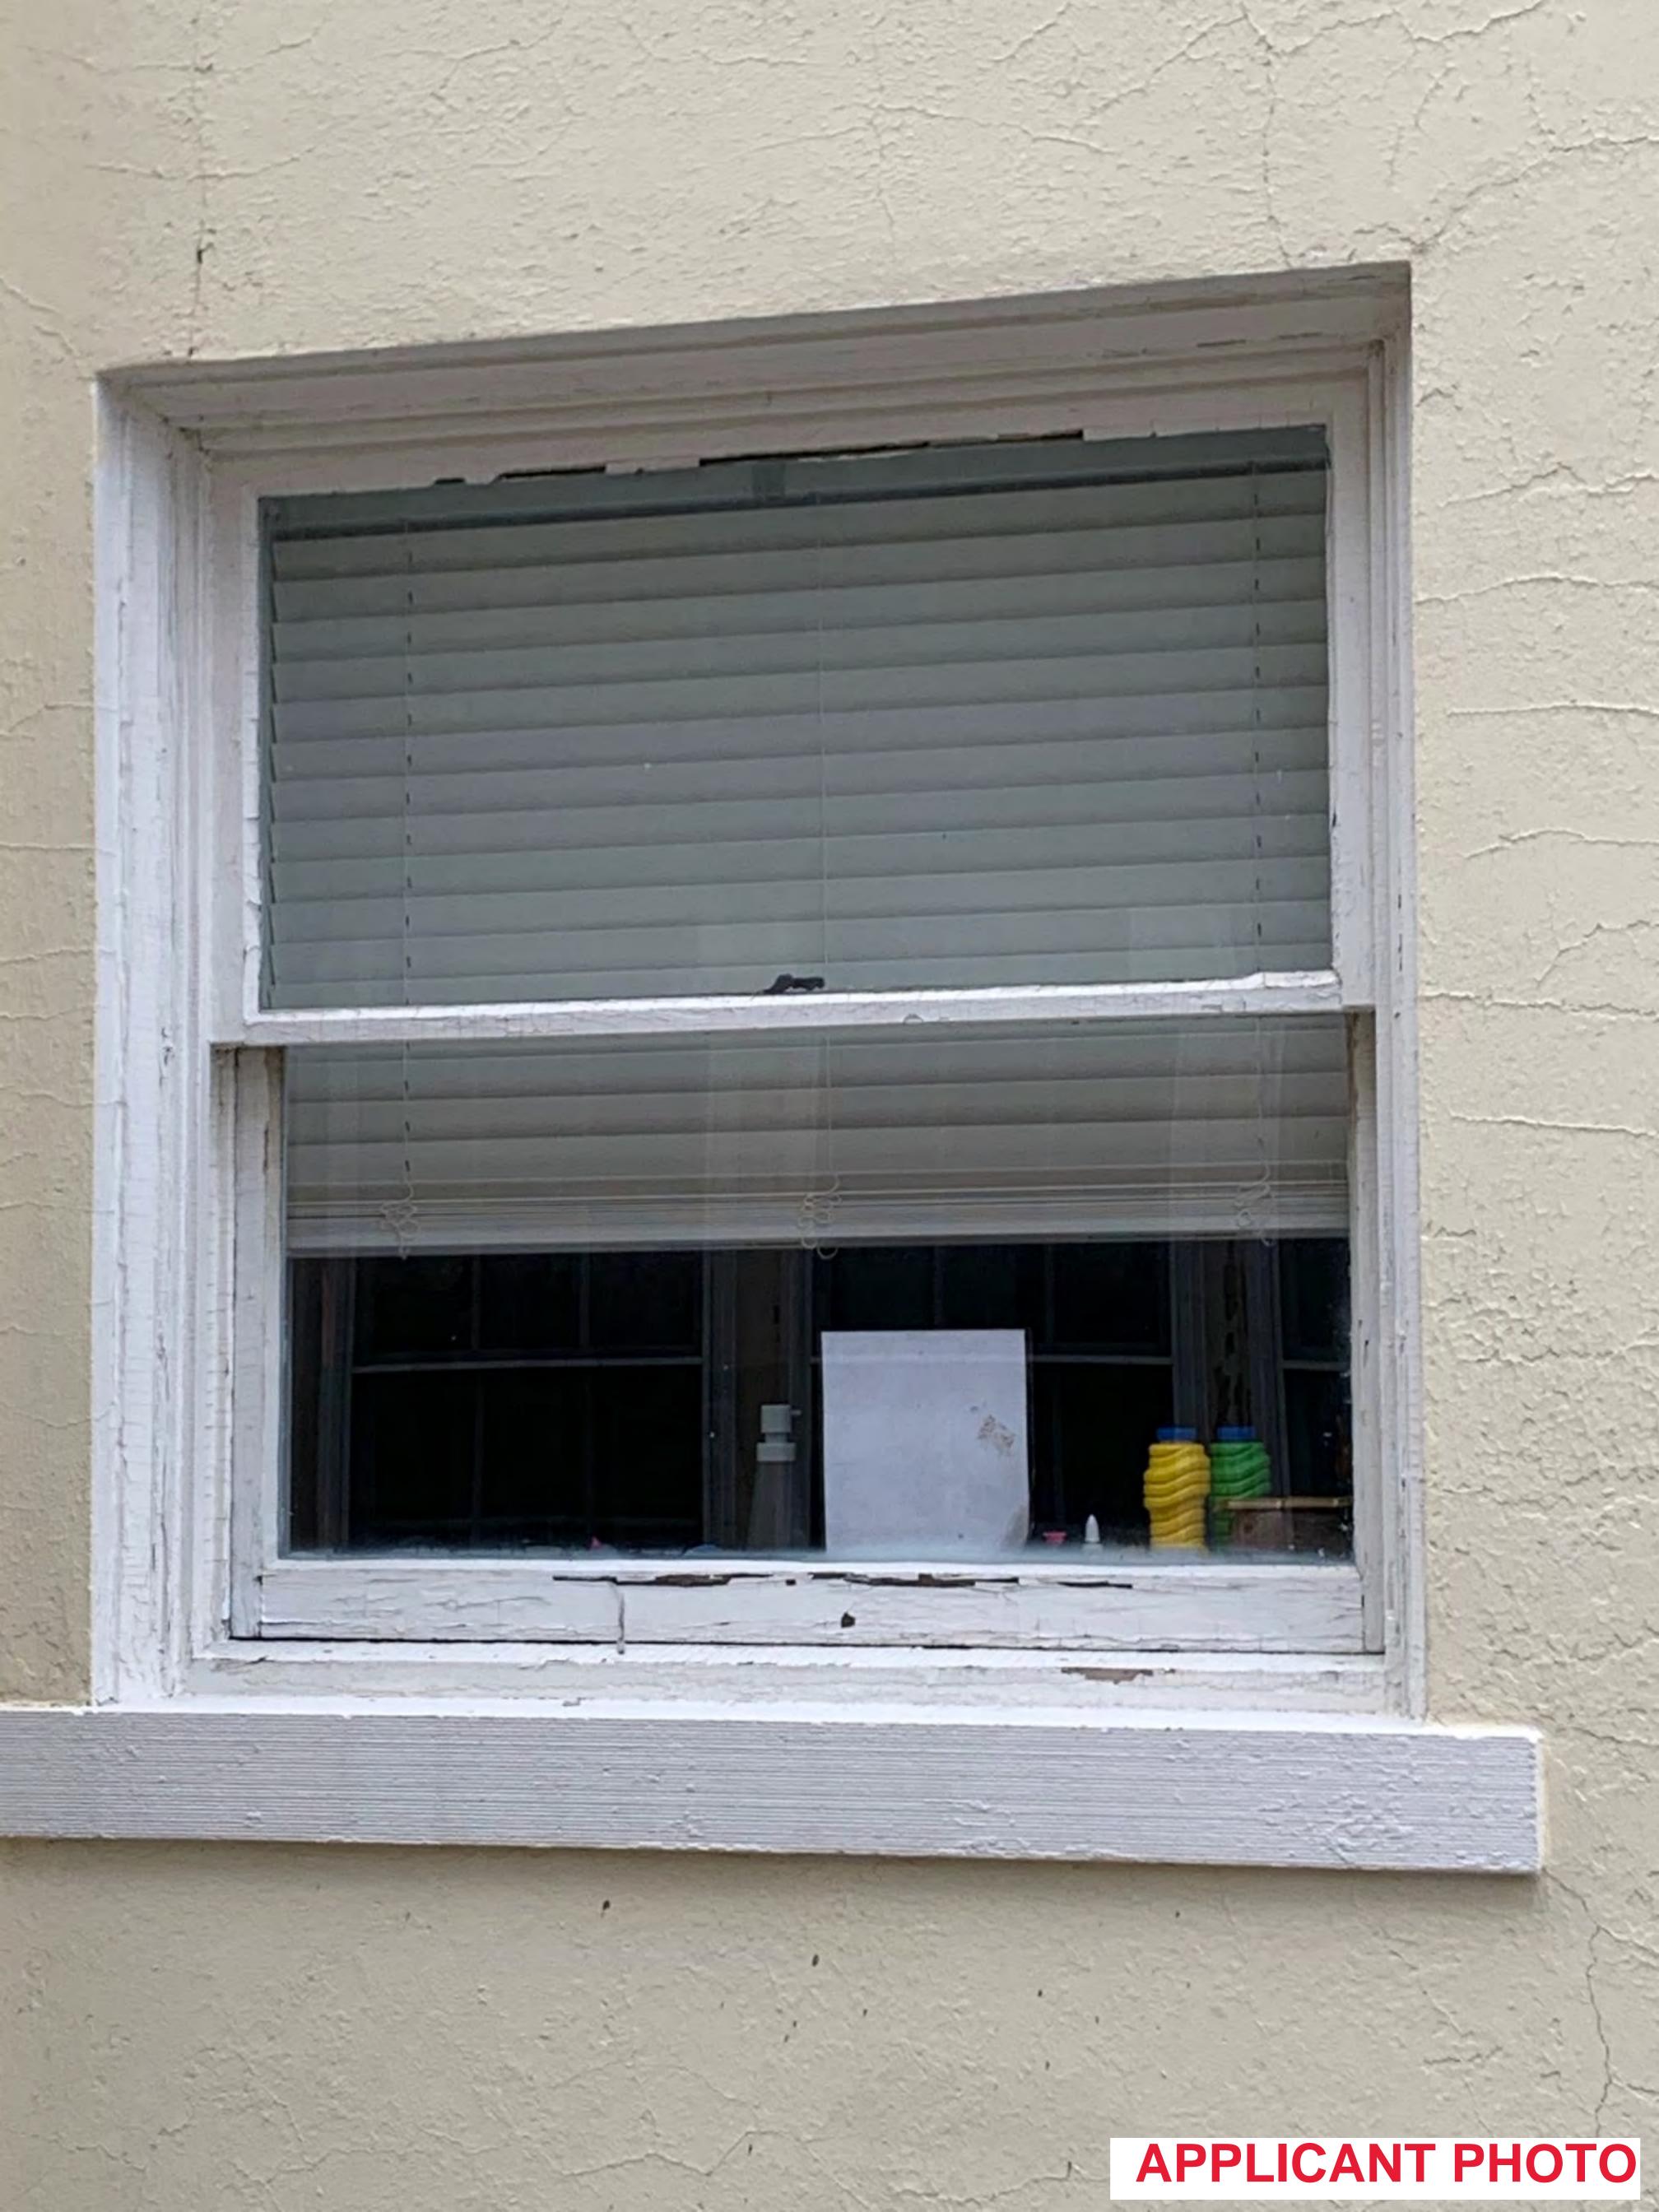
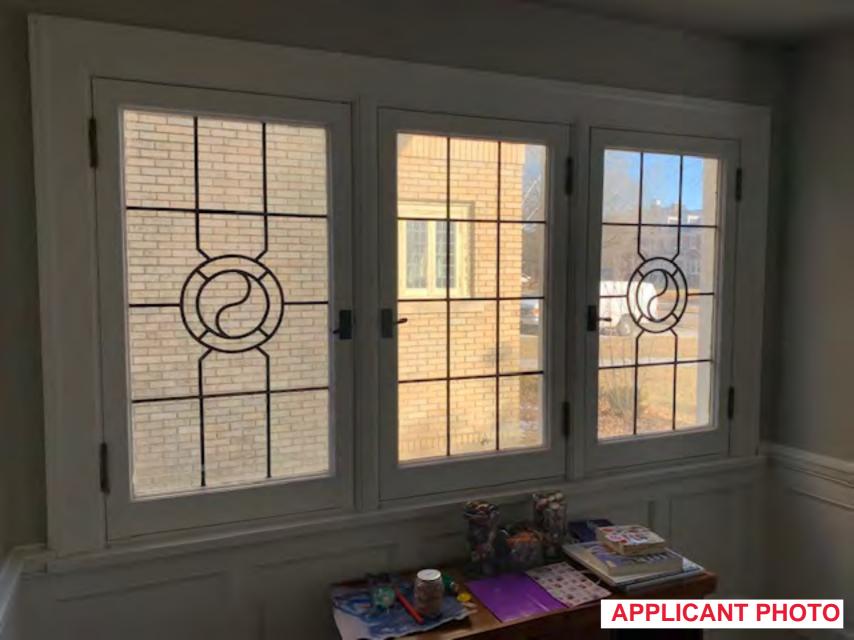
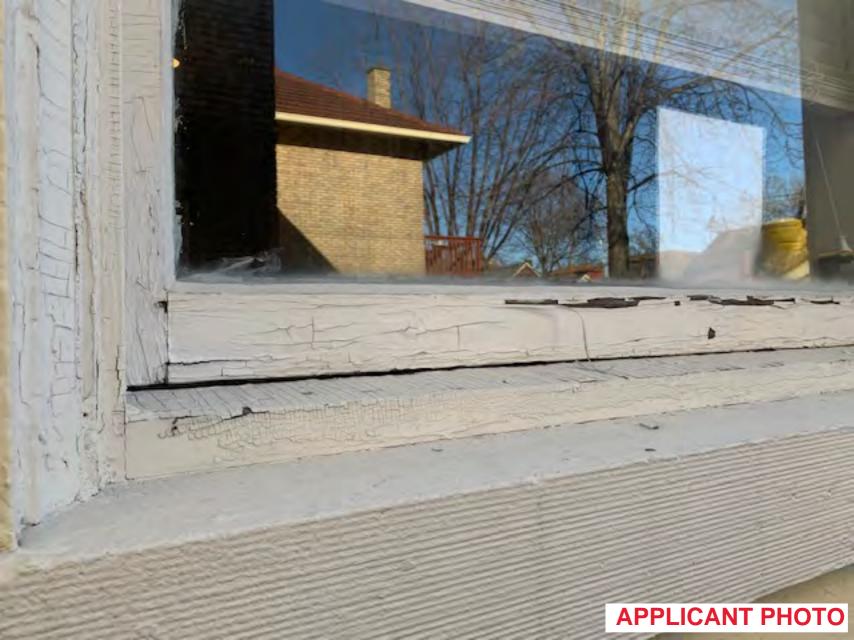
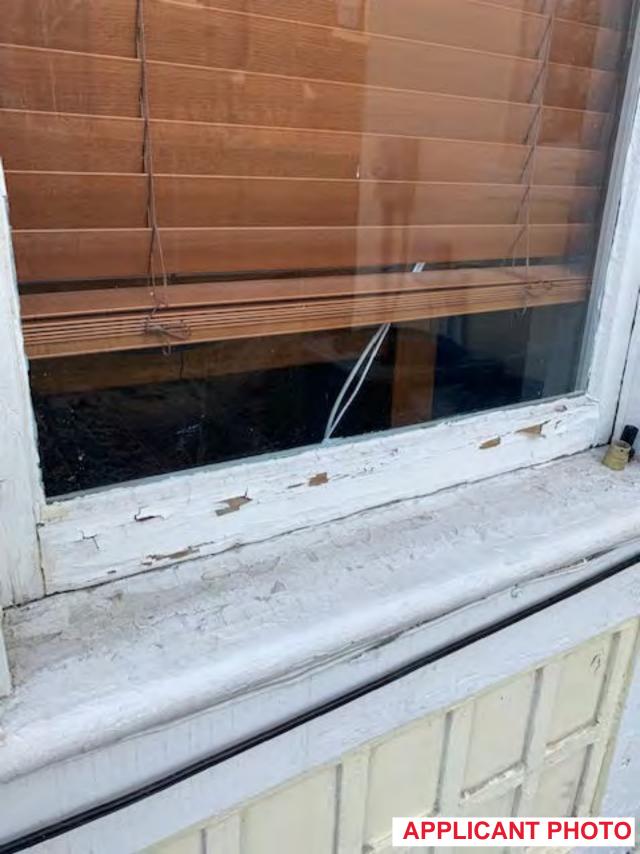
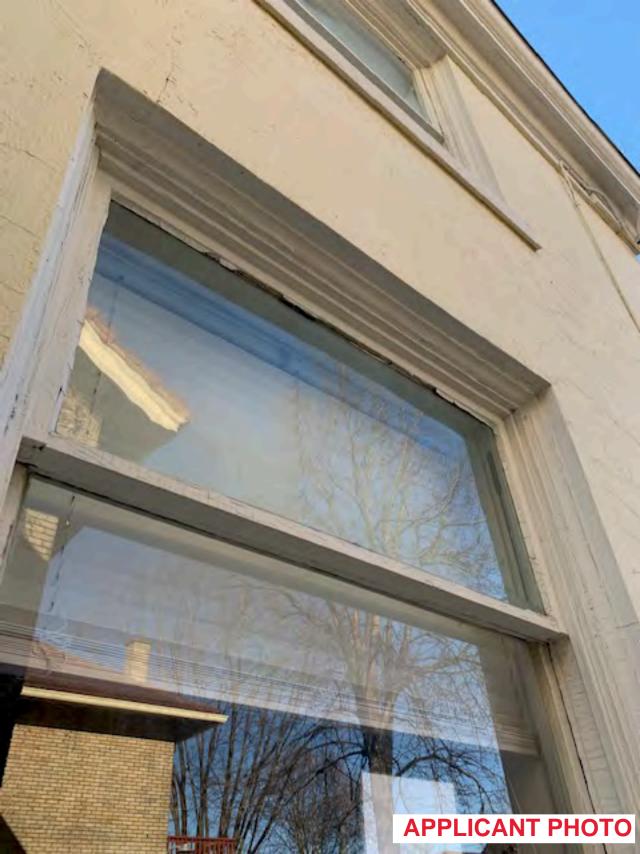
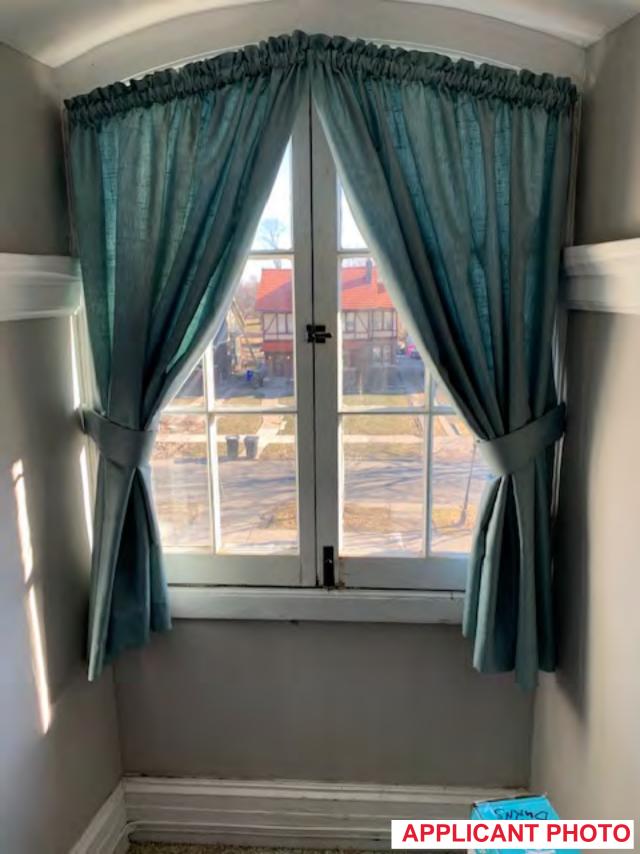
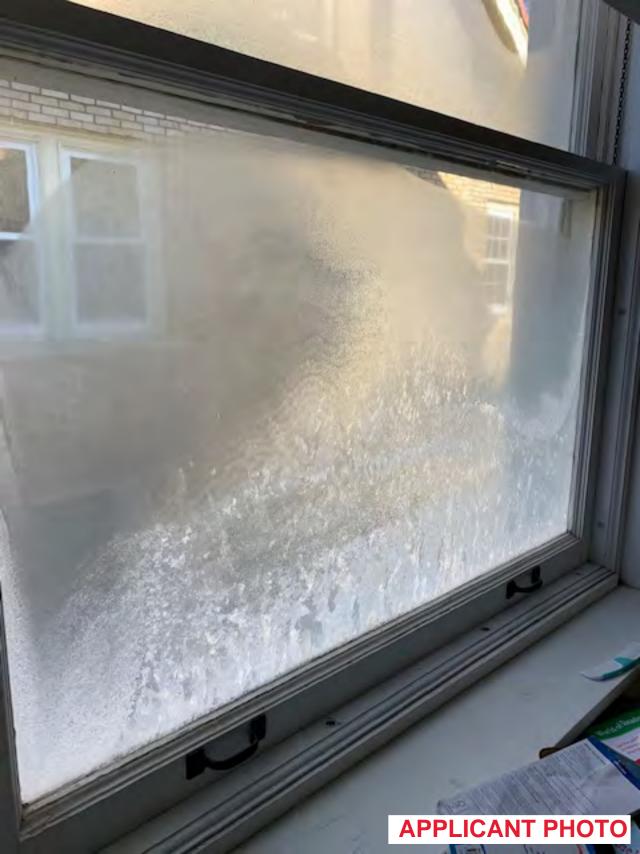
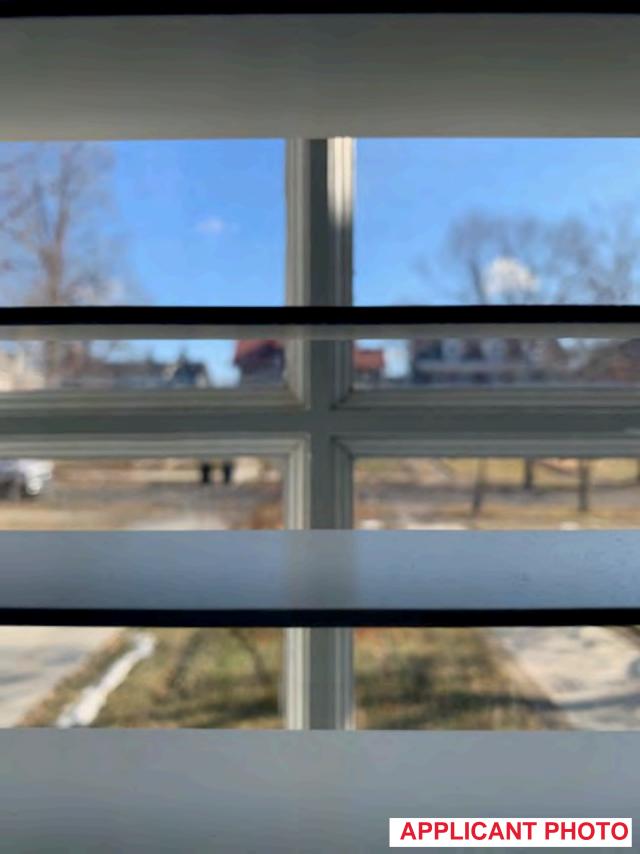
EXISTING CONDITIONS: Existing condition of the double hung can be described as rough (see photos). The subject windows had gone thru a restoration which has now failed, wood filler and glaze is popping and revealing the rotted sashes that were covered. On the interior, water damage from non insulated glass; condensation has continued to damage the interior and cause mold issues.

All windows show obvious signs of zero maintenance. Double hung units showing signs of lower sash rot, exterior sill rot and weather stripping failures. Severe ice/moisture build up on interiors contributing to mold growth and wood rot. Customer states that previous owner was an investor "flipped" house and an effort to restore windows was made 5 years ago, efforts are visible of wood putty failure, caulking installed in place of missing putty and peeling paint. See attached photos. Original decorative will be restored properly and wood rot will be removed and replaced with new wood. Contractor advises replacement of double hung units, existing conditions are rough and restoration will not last long enough vs expense to restor being equivalent to historically accurate replacements.

DESCRIPTION OF PROJECT: We will contract Quaker windows to custom make us replacement wood windows using insulated glass panels from their "Historic Fit" product line to replace 34 double hung units. Quaker will replicate SDL grid patterns to match the original size and quantity. Grids will be present on both the interior and exterior of windows. Contractor will carefully remove existing windows to not disturb exterior original moldings, new windows will be installed, insulated and caulk sealed from exterior and interior. NOTE: Decorative, casement, awning and leaded glass windows will remain and be restored not replaced. Exterior color of windows will match existing, best described as an "off white".
