STAFF REPORT: 3-11-2020 MEETING **ADDRESS: 2405 EWALD CIRCLE** HISTORIC DISTRICT: ADJACENT TO OAKMAN BOULEVARD **INTERESTED PARTY: TYLER TINSEY (DETROIT BUILDING AUTHORITY)** DATE OF SUBMISSION: 2/17/2020 DATE OF STAFF SITE VISIT: 3/6/2020

SCOPE: DEMOLISH BUILDING (ADVISORY OPINION PER 21-2-5)

2405 Ewald Circle Residence

Historic Structural Assessment Report

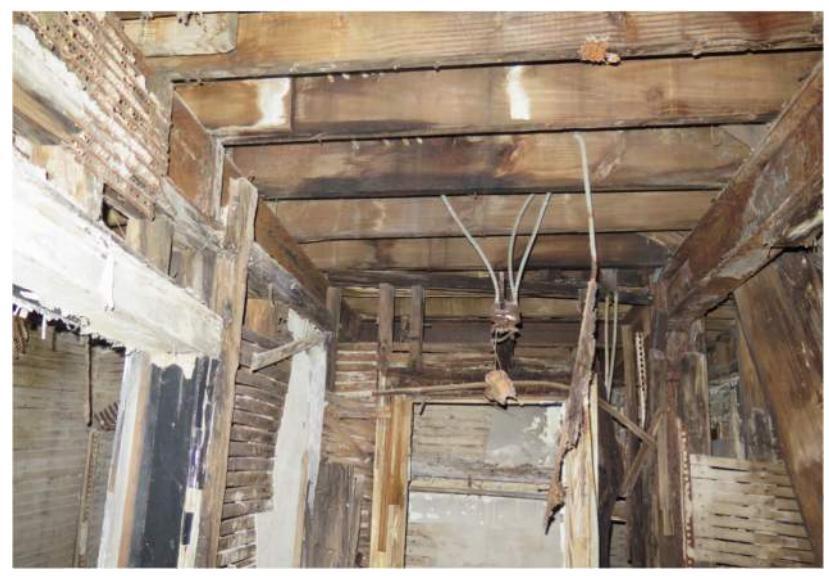
Figure 14 Third Floor Joist Framing at Hallway of Central Building

Due to the extensive water damage at the joists and large portions of the first floor that have collapsed, Silman's observation of the second-floor joist from the first floor below was restricted to the local vicinity of the stairwell. The observable joists within the hallway appeared to be in fair condition exhibiting moderate amounts of water staining (Figure 13). When observing the underside of the third floor framing from the floor below, Silman had observed similar deficiencies within the joist spanning over the hallway (Figure 14). In addition, Silman had observed a collapse of the local framing directly west of the stairwell (Figure 15). Note that observations of these joist were also made primarily from the stairwell. From the exterior, Silman observed a portion of the third floor framing to be collapsed (Figure 23).

- Observation of the upper floors was extremely restricted due to the unsafe nature of the first-floor framing and stair. Due to the amount of water infiltration observed in the building and views of upper floors from the exterior we suspect that large portions of the upper floors are also severely deteriorated. Access to the upper floors should be provided so that the upper floors can be surveyed to confirm the extent of damage.

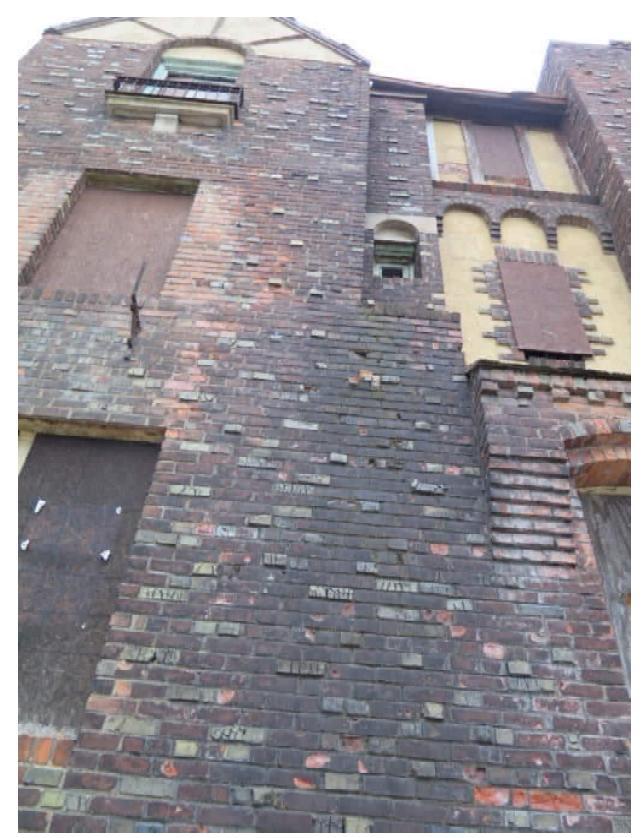
Figure 17 North Façade of Central Building

The north façade of the main building was generally in fair condition. There were bricks throughout the façade that were observed to have severe spalling, were missing or were broken (Figure 15 and Figure 16). Rusting of the steel lintels was observed at the first-floor openings and cracking was observed at the brick surrounding the opening (Figure 20).

- Areas at the façade with mortar deterioration should be repointed and cracked, loose, spalled or missing bricks should be replaced. Cracks in the masonry should be repaired.
- At window openings where rusting of the lintels or displacement at the surrounding brick was observed, the lintels should be exposed to determine the extent of rusting. At this time an engineer should review the lintels to determine if they can be repaired in place or must be replaced.

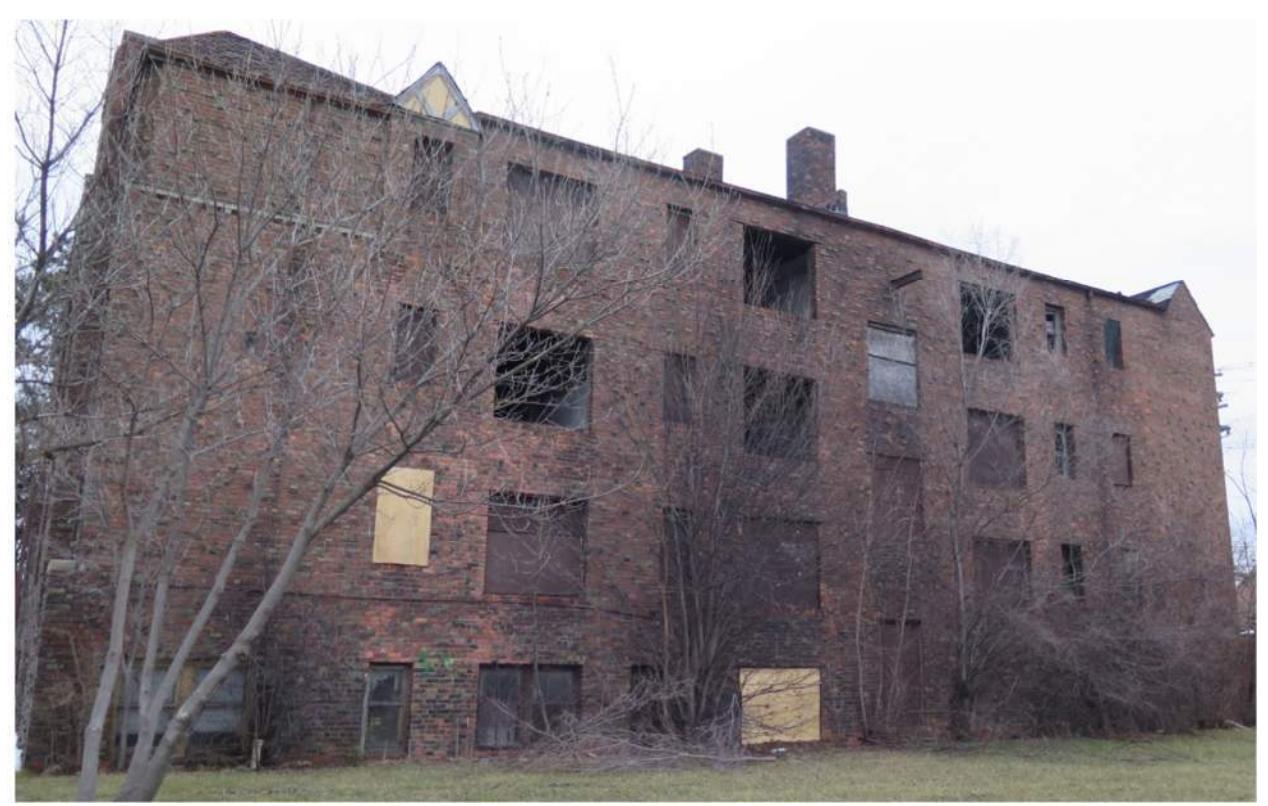
Figure 21 West Façade of Central Building

The west façade was in similar condition. Rusting of the steel lintels at openings was visible with brick deterioration observed at the lintel bearings and above the opening (Figure 23 to Figure 25). Water staining was visible below a roof gutter (Figure 26).

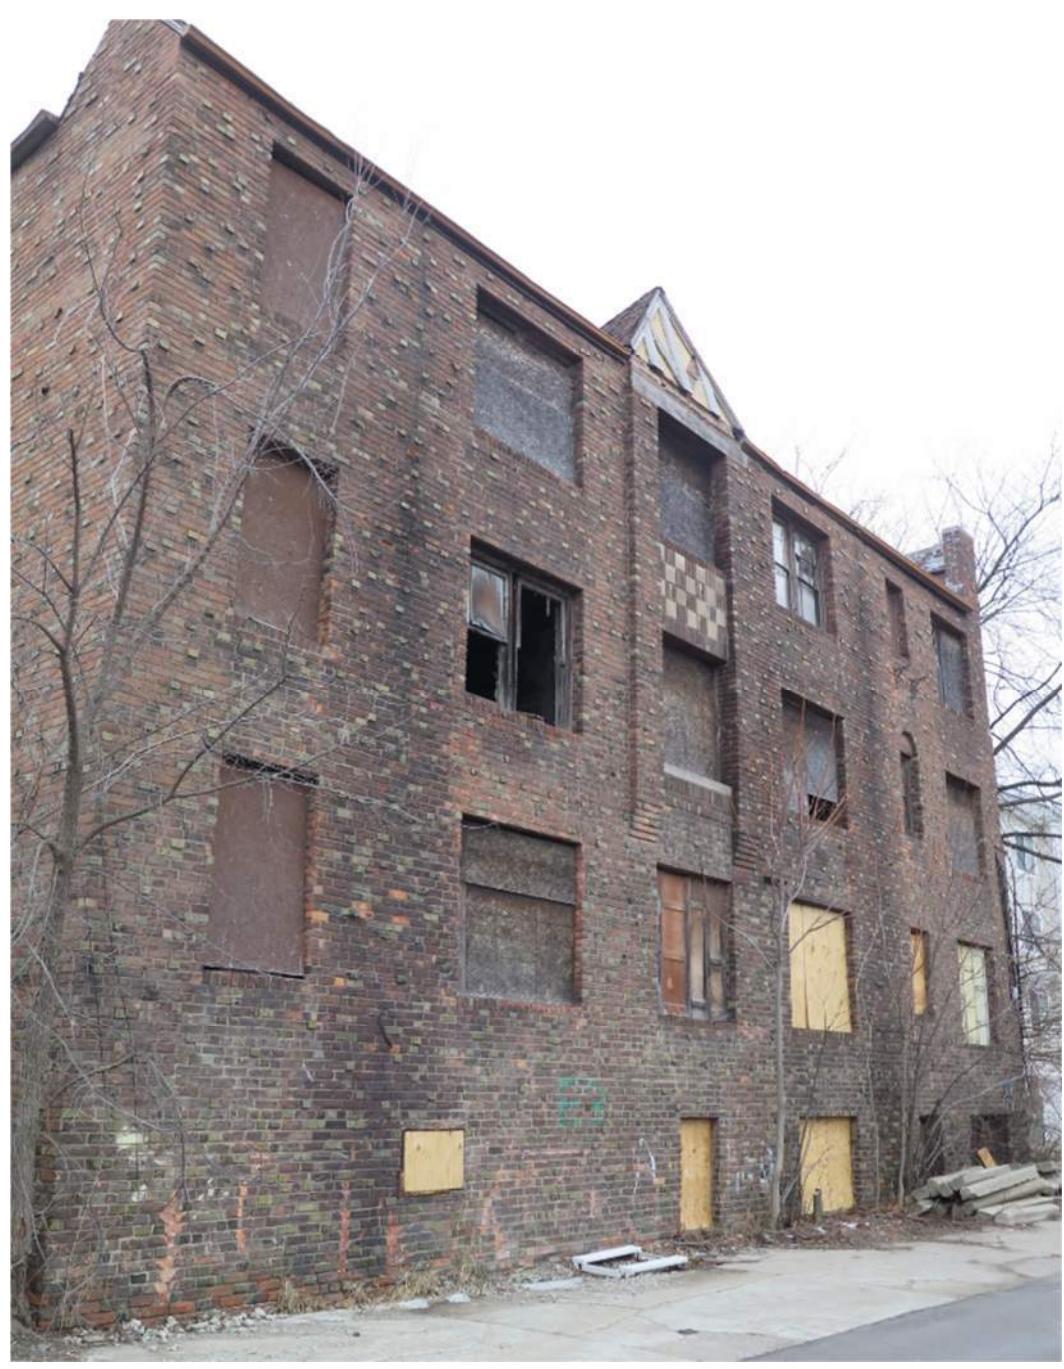
Figure 2718 South Façade of Central Building

The brick masonry at the east façade was in similar condition to the north and west. The steel lintels appeared to be in better condition at this façade with no visible rust or rust-jacking observed (Figure 29). The dormer at the south façade appeared to be leaning back, it was unclear if this was intentional or a deformation of the framing.

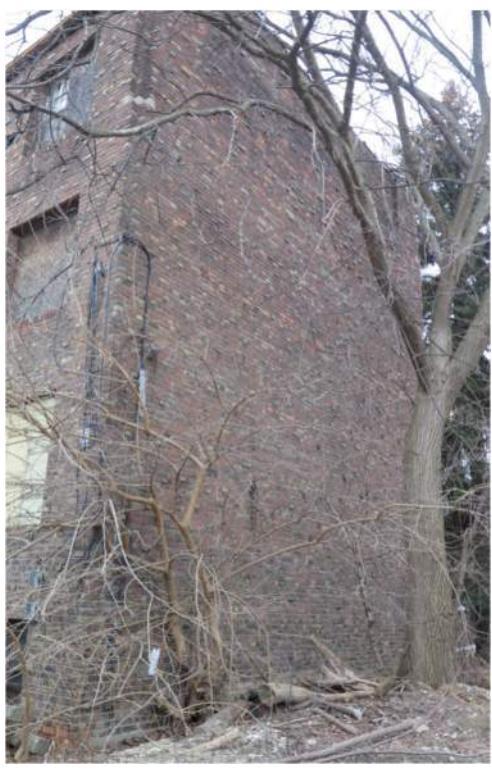
Figure 31 East Façade of South-East Building Wing

The east façade of the south-east wing appeared to be in good to fair condition. There are no windows at this façade, the only deficiency observed was local spalling of the bricks throughout the façade. There appeared to be areas with mortar deterioration at the parapet.

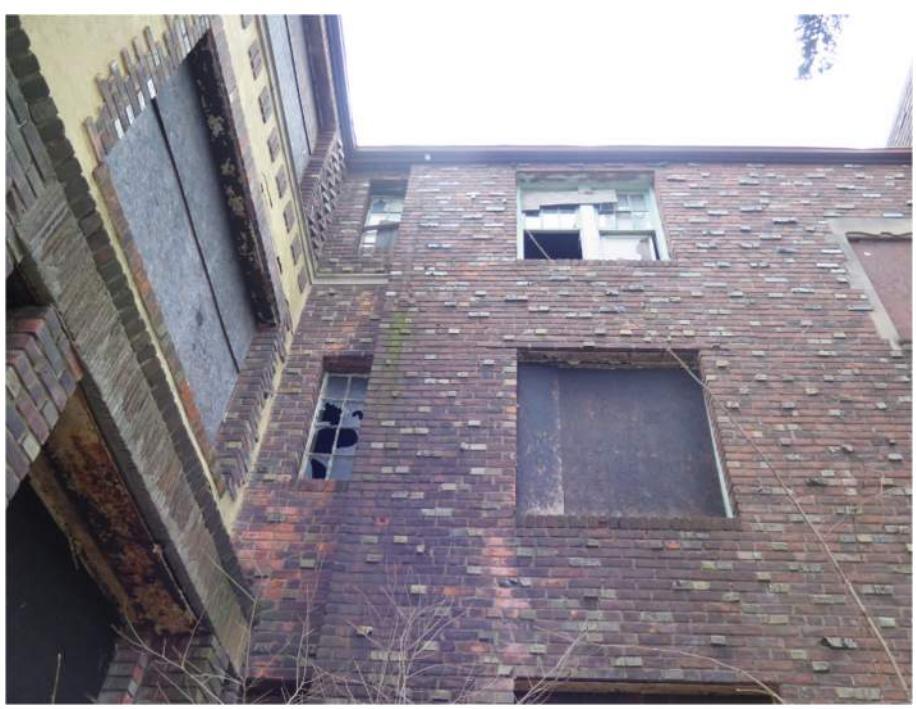
Figure 34 Southern Portion of East Façade of Central Building

The east façade was in similar condition with brick spalling observed throughout. Local deterioration of the brick was observed around window openings (Figure 36 and Figure 37). At the entrance at the east façade, deterioration and voids in the roofing was observed (Figure 38).
