NOTICE OF DENIAL

RE: Application Number 20-6894; 1991 Chicago; Boston Edison Historic District

CERTIFICATE OF APPROPRIATENESS

STAFF SITE VISIT PHOTOS: 1991 Chicago, Detroit, MI OCTOBER 1, 2020

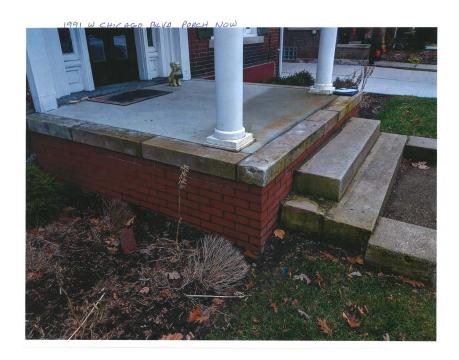
Front Porch Detail (AFTER) 2020

- 1) Wings of porch removed. The wings were collapsing due to failing footings (See attached photo). The wings could not have been repaired. They would have had to be completely re-built. In order for us to do so we would have had to dig out the old footings and pour new ones and re-build from that point. Rebuilding the wings would have added \$20,000 to the cost of the porch rebuild. This would not have made financial sense considering the value of the home. The main porch's footings were in good shape so we were able to just rebuild the brick work etc. for the center porch. In respect to the old footings, we dug them out and removed to accommodate installation of the new landscaping and grading from the exterior walls of the house. We also used as much of the original porch materials as possible in the re-build which is evident in the photos.

- 3) Columns reduced from 4 to 2. The two interior columns were rotted out and could not be salvaged. The exterior columns were able to be salvaged and re-built/repaired.

- 1. Rebuild porch to its original dimensions using matching materials, including wings with iron railings to match original, and including wood columns to match originals.
- 2. Correction work must receive a COA in order to receive a Building Permit, prior to beginning work.
- 3. Correction should be completed by June 2021

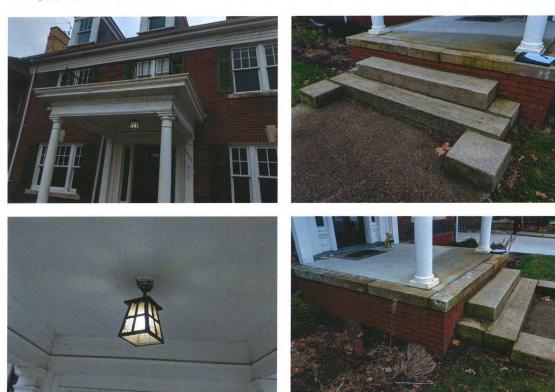
Front Porch Details (AFTER) 2020

- 2) Railings on wings of porch removed. The railing was corroded and damaged, but intact, on the left wing but none attached to the right. The vintage of the railing was undetermined.

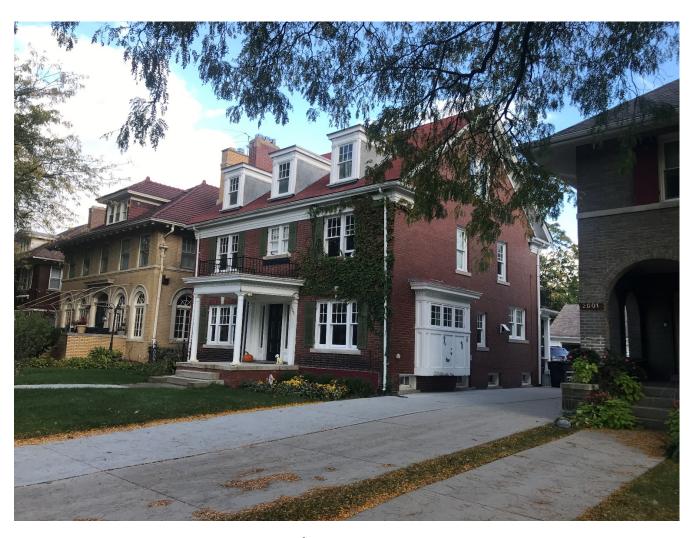
Northwest/ Front-Right Elevation

• The removal of porch wings, columns and railings and front elevation wall treatment without permit and/or approval of the Historic District Commission.
