STAFF REPORT 11-13-2019 MEETING
APPLICATION NUMBER 19-6464
ADDRESS: 4801 STURTEVANT
HISTORIC DISTRICT: RUSSELL WOODS - SULLIVAN
APPLICANT: WAYNE GROLEAU
DATE OF APPLICATION: 9-23-2019
DATE OF VIOLATION: 9-26-2019
DATE OF STAFF VISIT: 11-6-2019

PREPARED BY: B. CAGNEY

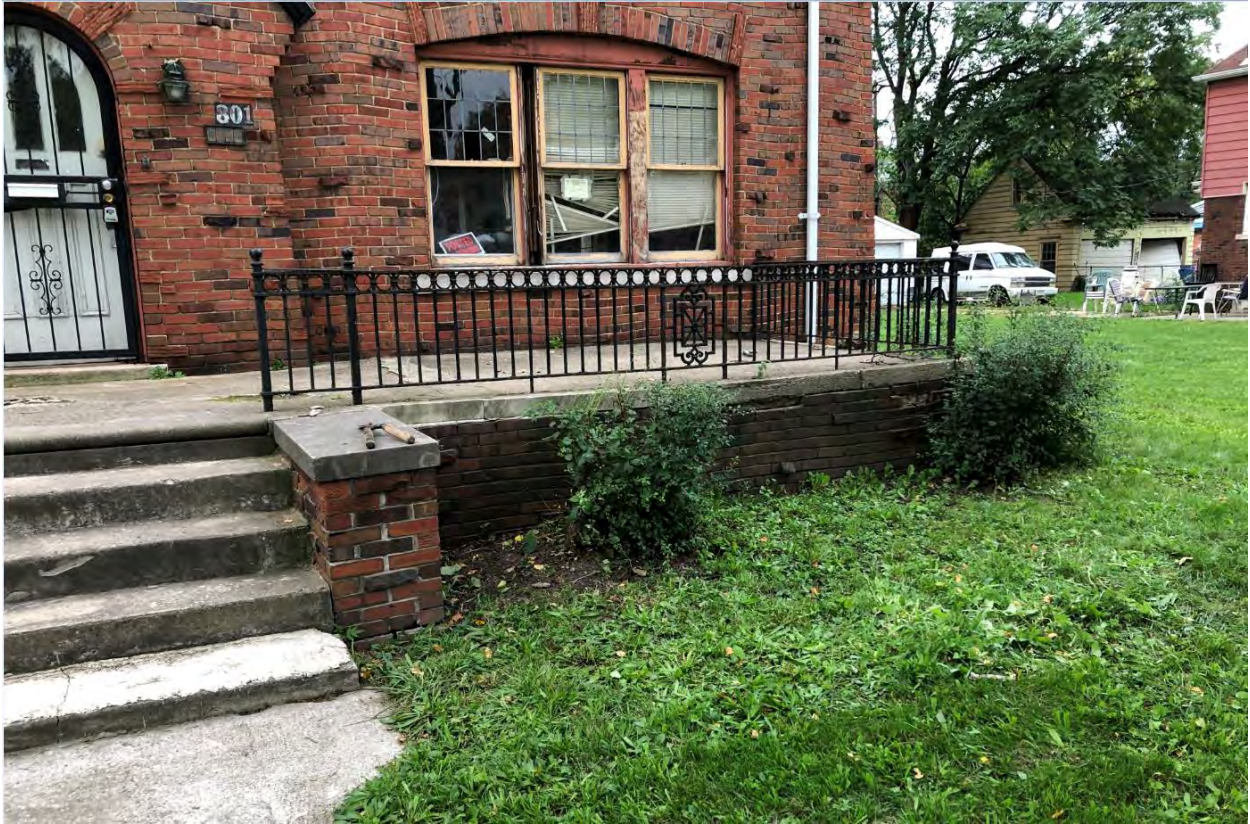
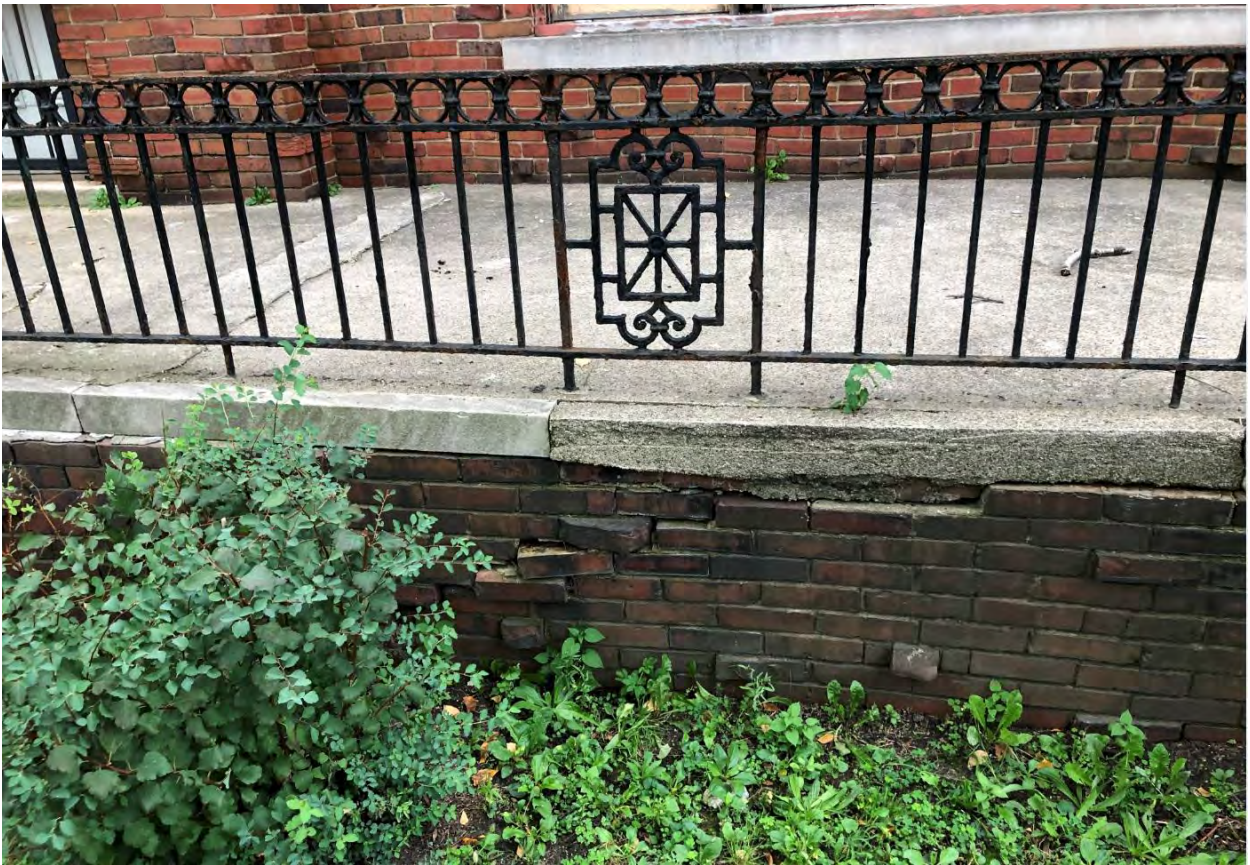
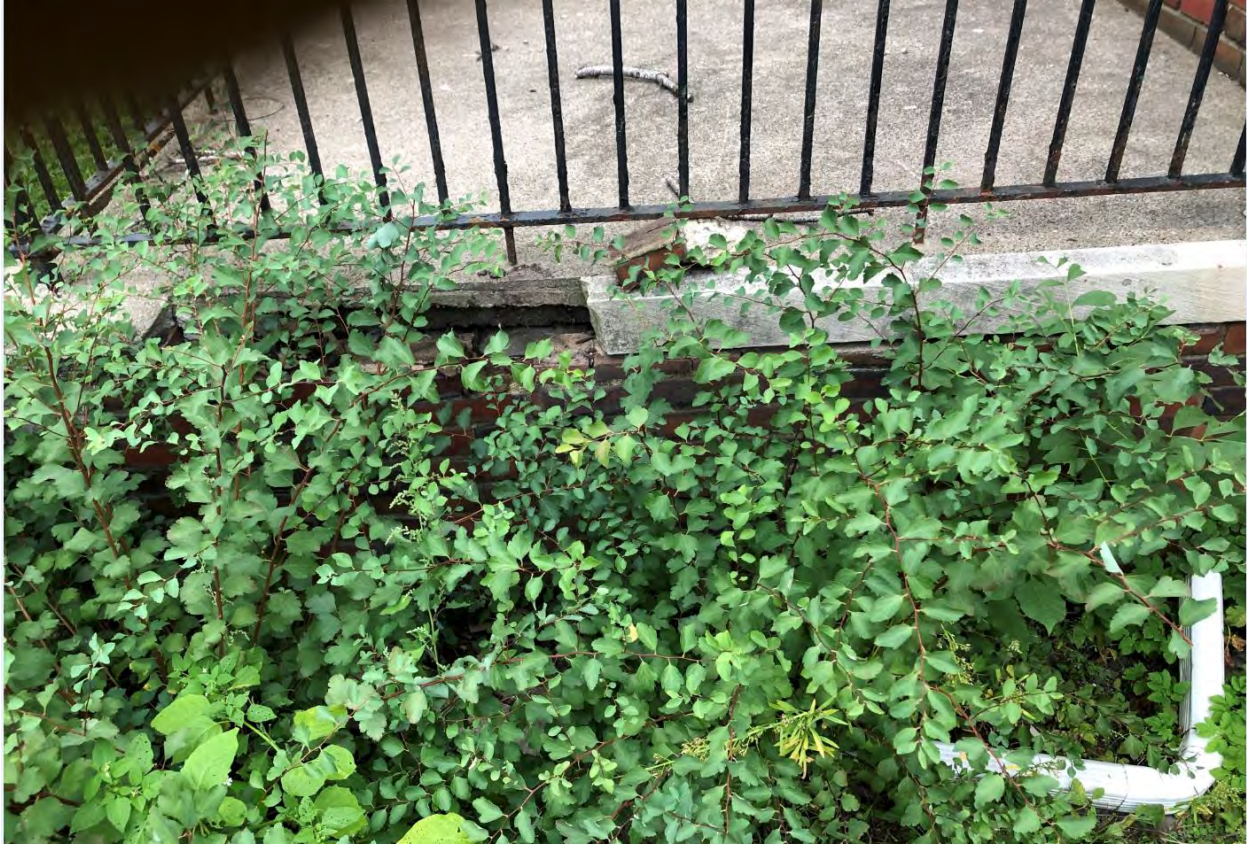
2. Existing conditions – per photos, porch is falling apart.
3. Project – re-build porch with existing bricks
4. Details
 - Remove existing brick
 - Clean off old mortar
 - Rebuild walls with this same salvaged brick
 - Use existing footprint
 - Concrete Cap repaired as necessary
5. Brochures – NA (attempting to salvage original brick)
