CERTIFICATE OF APPROPRIATENESS

Application Number: HDC2026-00018

Project Address: 4324 (4314-4316) W. Vernor

RE: 4314 W Vernor – Structural Evaluation Report
4314 Vernor W
Detroit, MI 48209
Use Group: Commercial
Project No. 25-1086

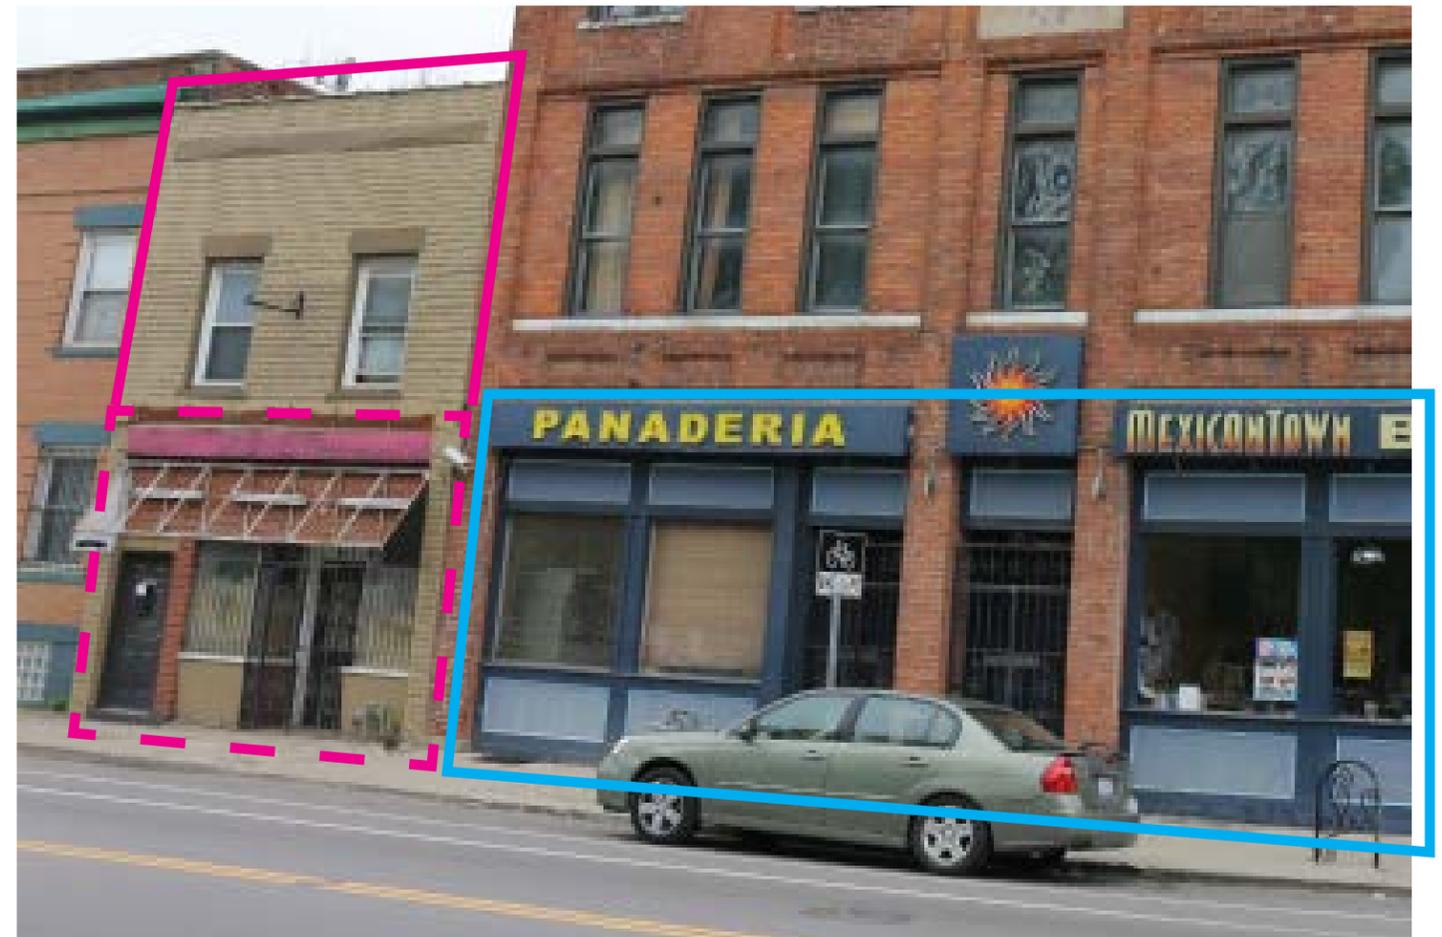
The main objective of the new window design is to enlarge the opening and bring natural light into the space, creating a façade that provides continuity while improving ambience and enhancing the flow and alignment of historic elements.

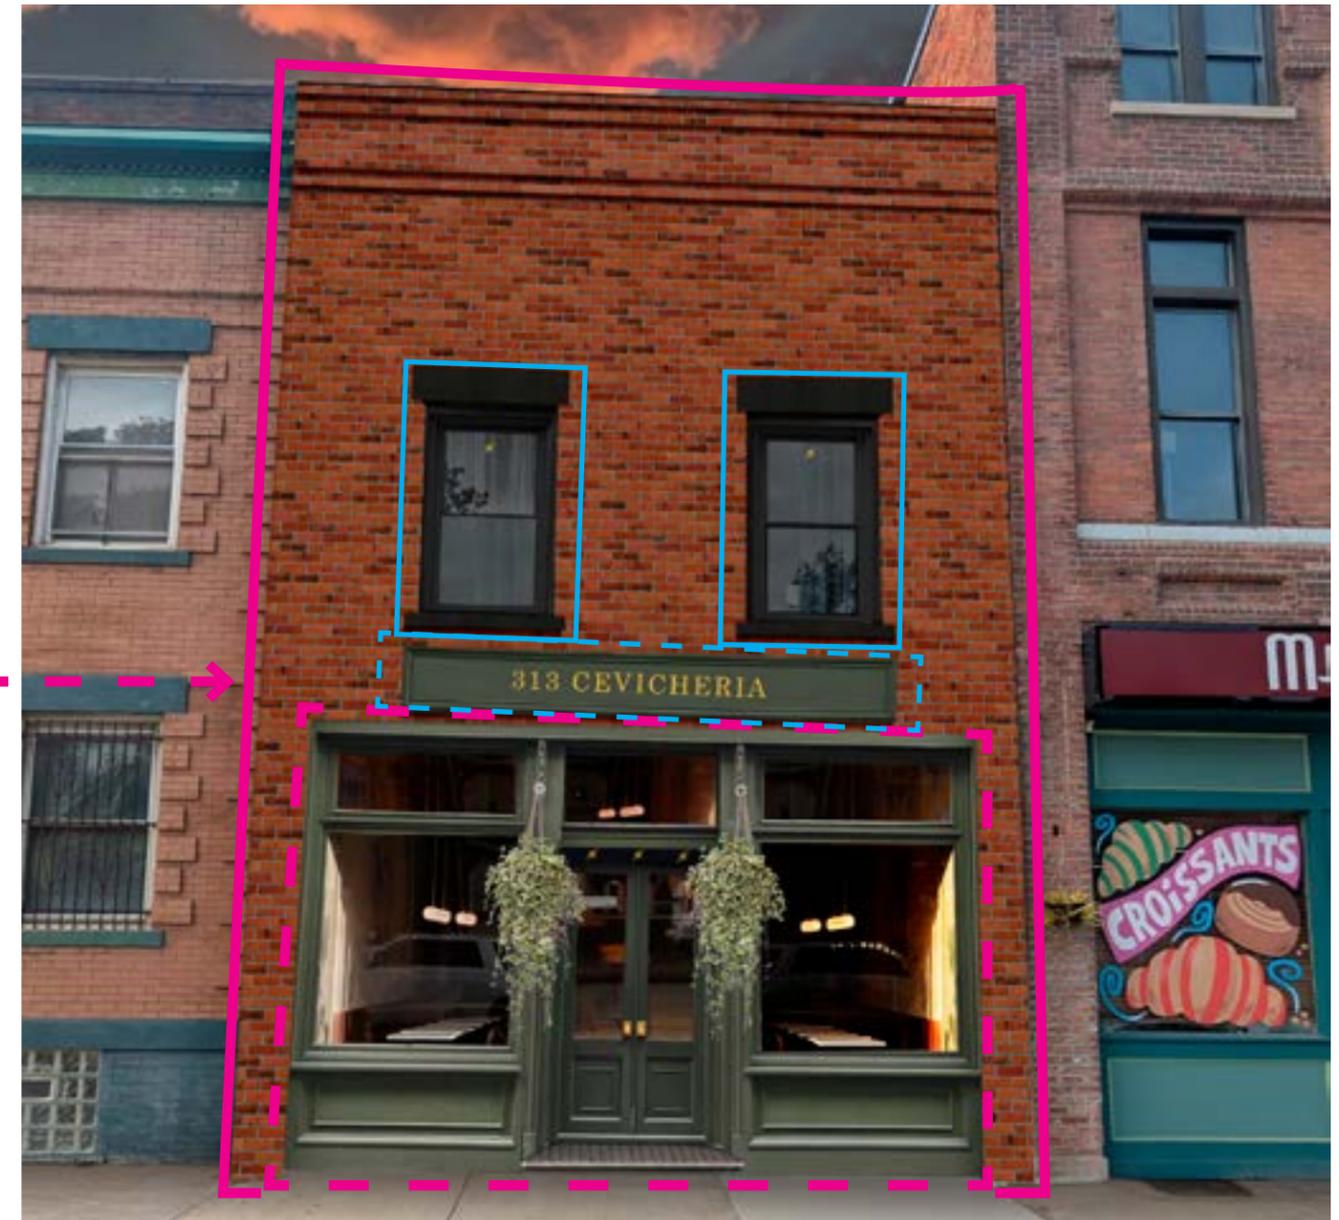
Front View South Wall

The project incorporates a new steel structure to support the existing wall while replicating the proportions and details of the front façade window, using materials such as wood, glass, and matching paint finishes.

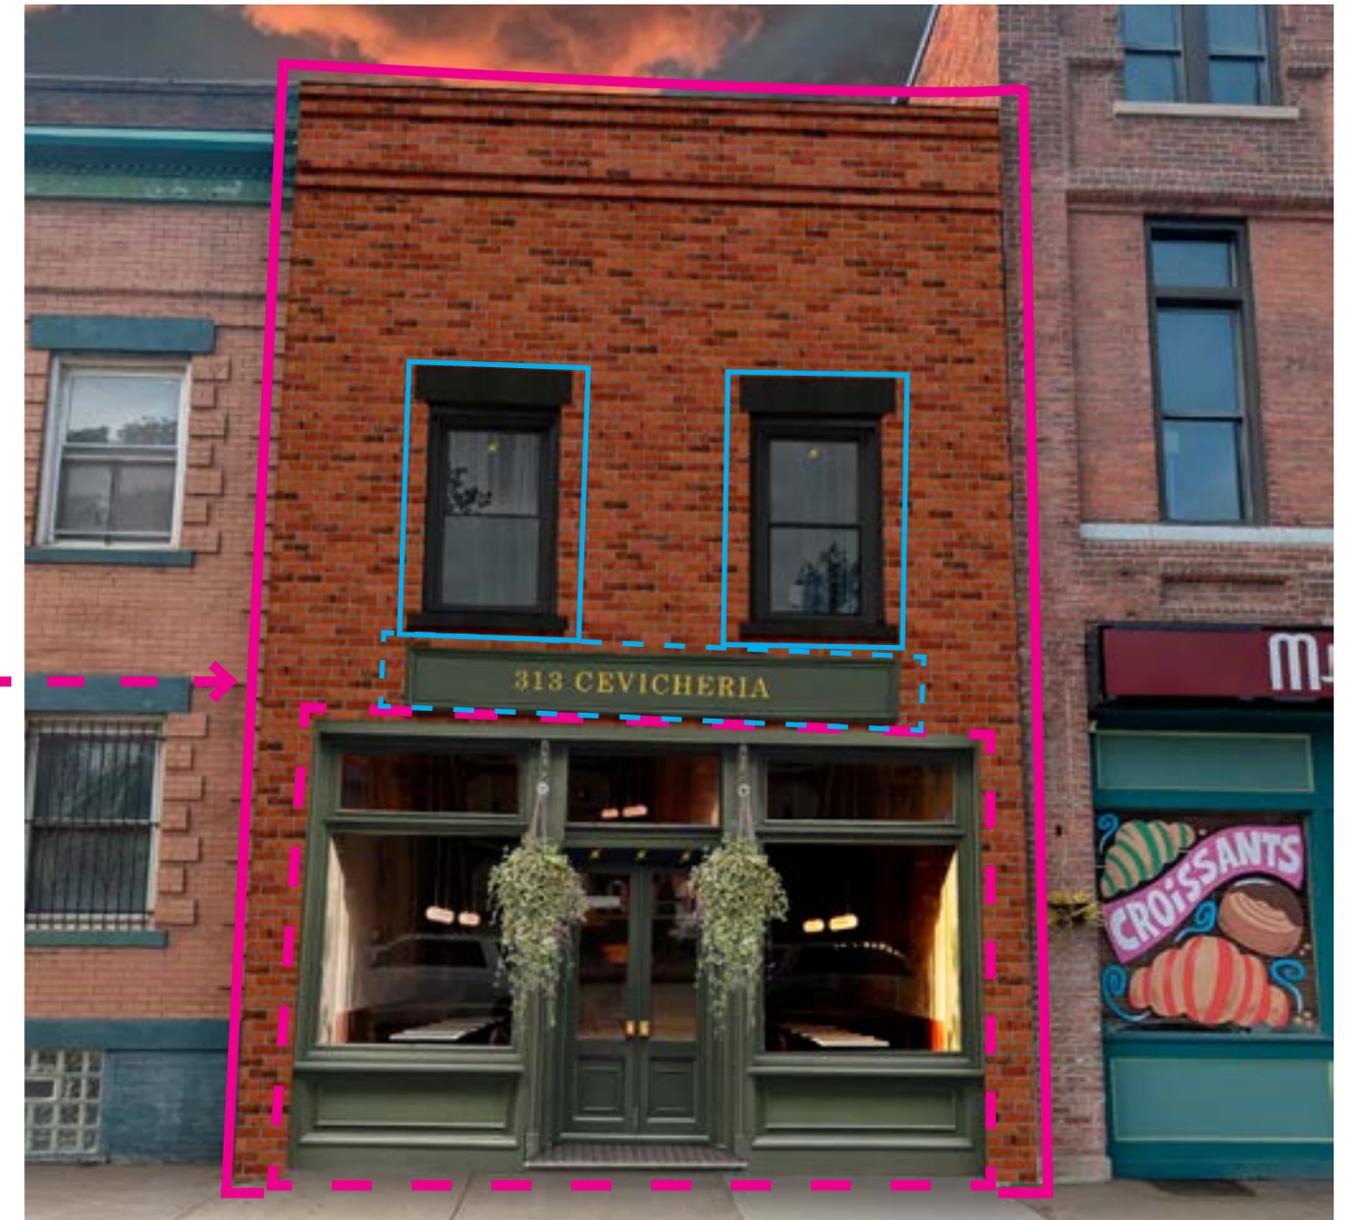
Front View South Wall

The project incorporates a new steel structure to support the existing wall while replicating the proportions and details of the front façade window, using materials such as wood, glass, and matching paint finishes.
