SR-2 – ADVISORY STAFF REPORT (5-08-2026)

ADDRESS: 892 W. BOSTON BOULEVARD (EDWARD FISHER RESIDENCE)

APPLICATION NUMBER: HDC2026-00193

SCOPE: INSTALL LANDSCAPING AND HARDSCAPING, CONSTRUCT POOL

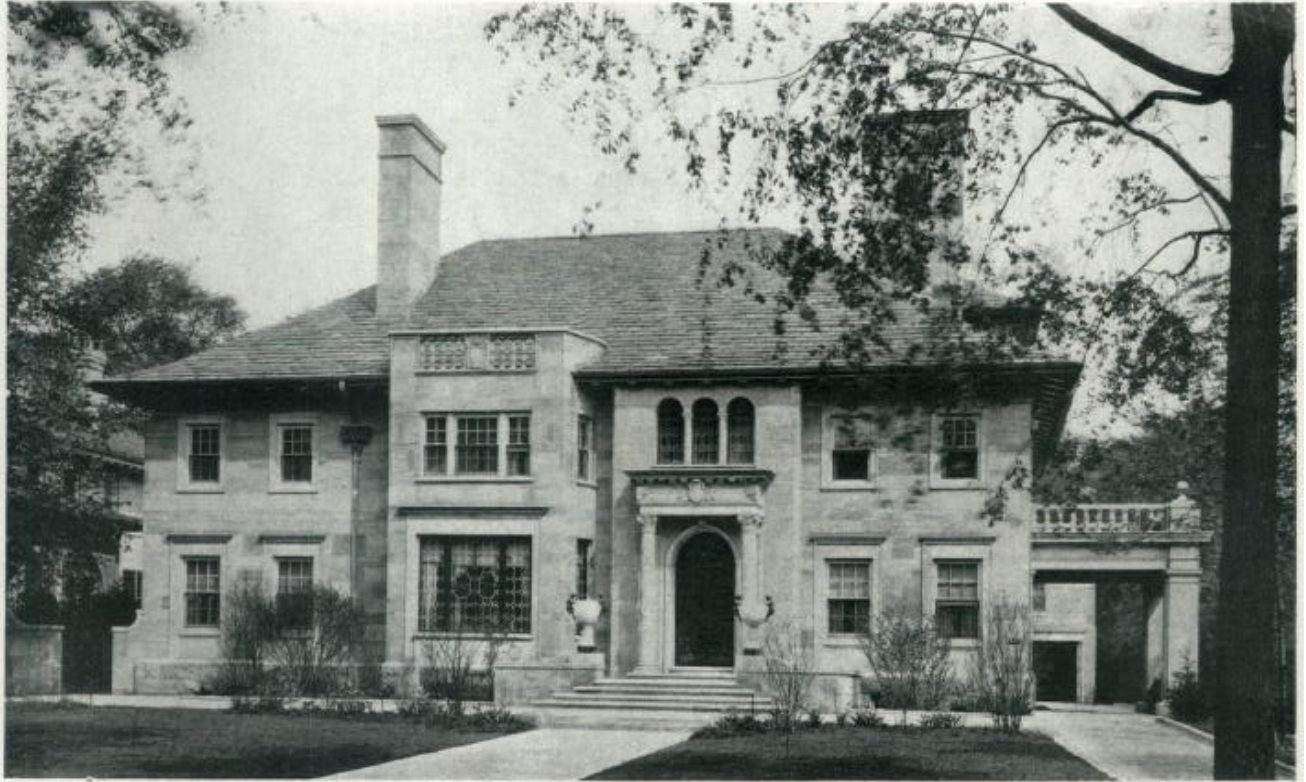
The house, featured in The Architectural Record (February 1926). The house remains the same. The shrubs have changed (evergreens are in their place) and the urns on the front terrace have been replaced.

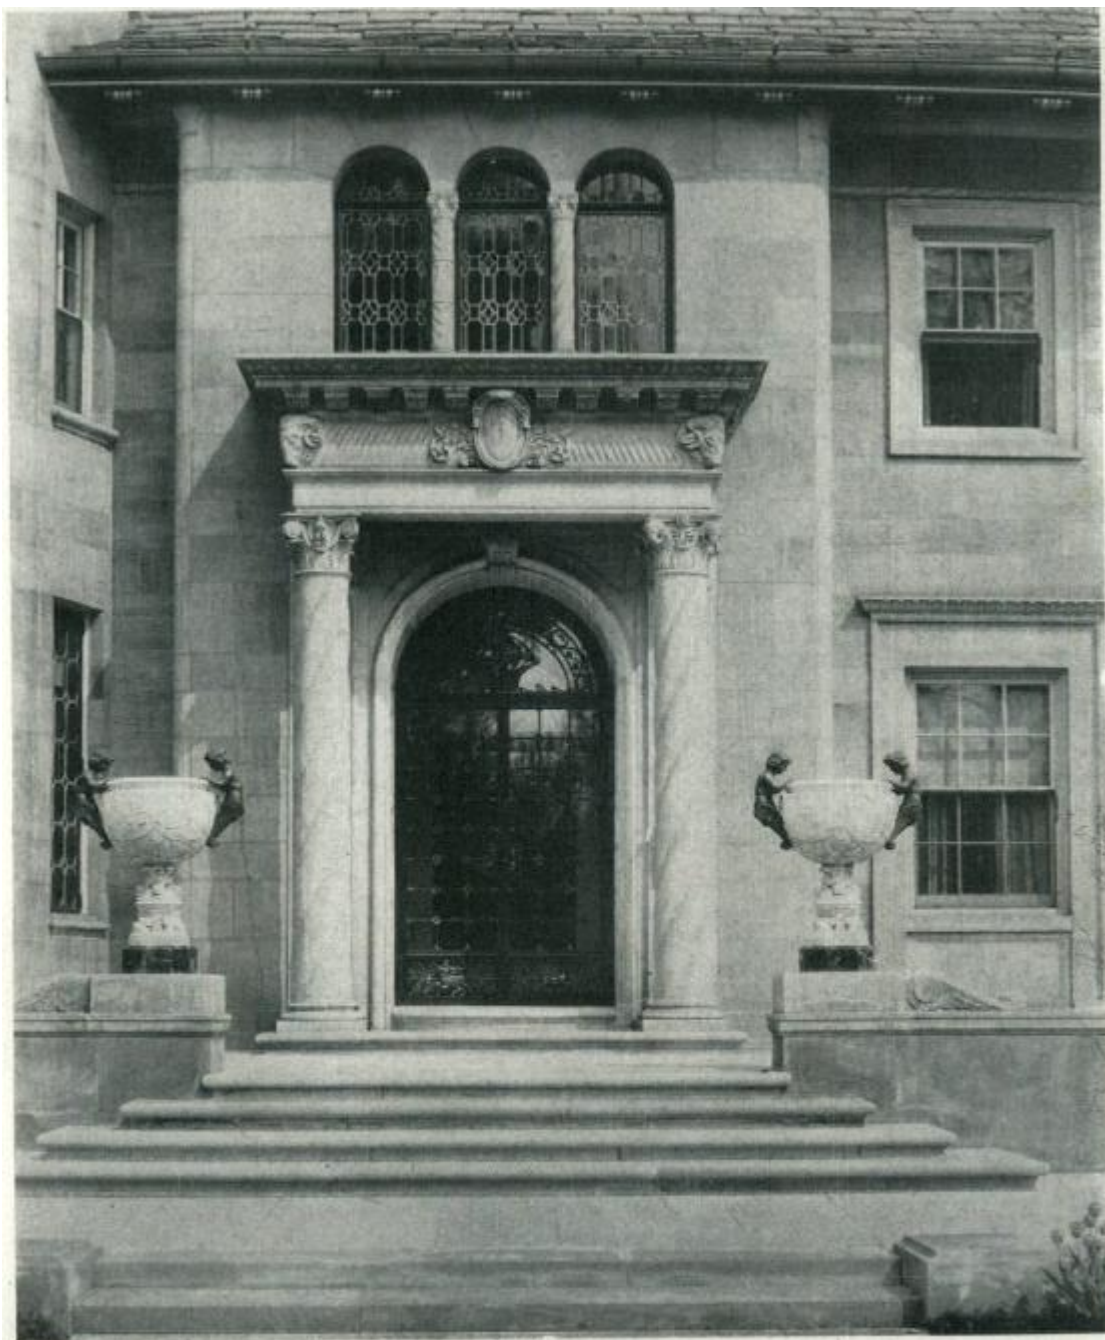
The house's entrance and front terrace and steps. All of the features shown remain intact other than these urns, which have been replaced. (The Architectural Record, February 1926)

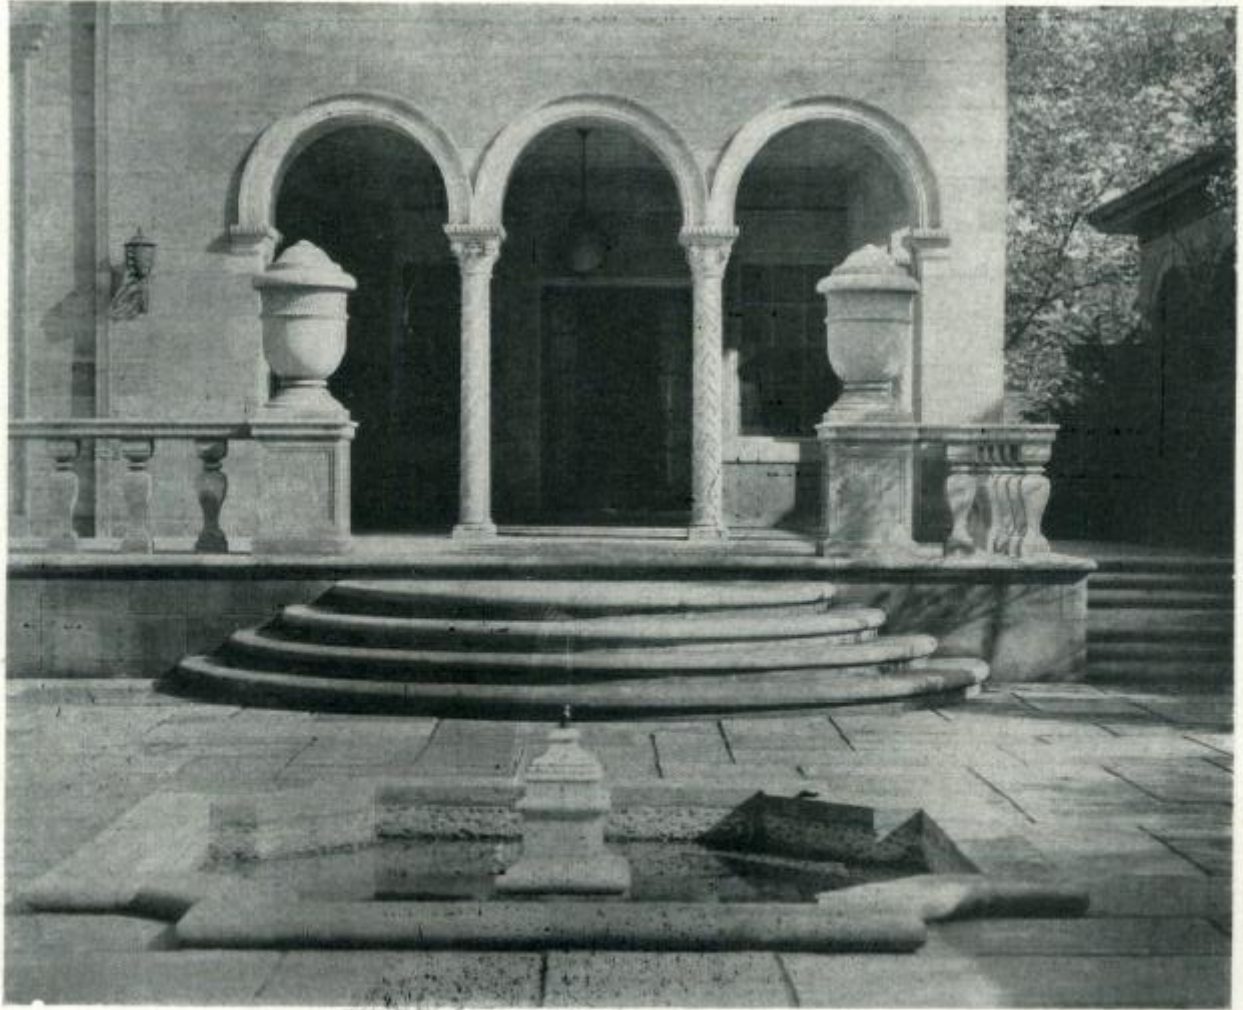
Rear of the house (north end), terrace, and south water feature. The round arches to the sheltered porch just outside the conservatory remain as shown, but doors have been installed between them to enclose the porch. The limestone fountain has been replaced by a more decorative fountain with a sculpture and bowl on a base, but the simpler limestone fountain shown here is proposed to be replicated and reinstalled. The limestone terrace and steps remain, and the pavers have been replaced with pavers. (The Architectural Record, February 1926)

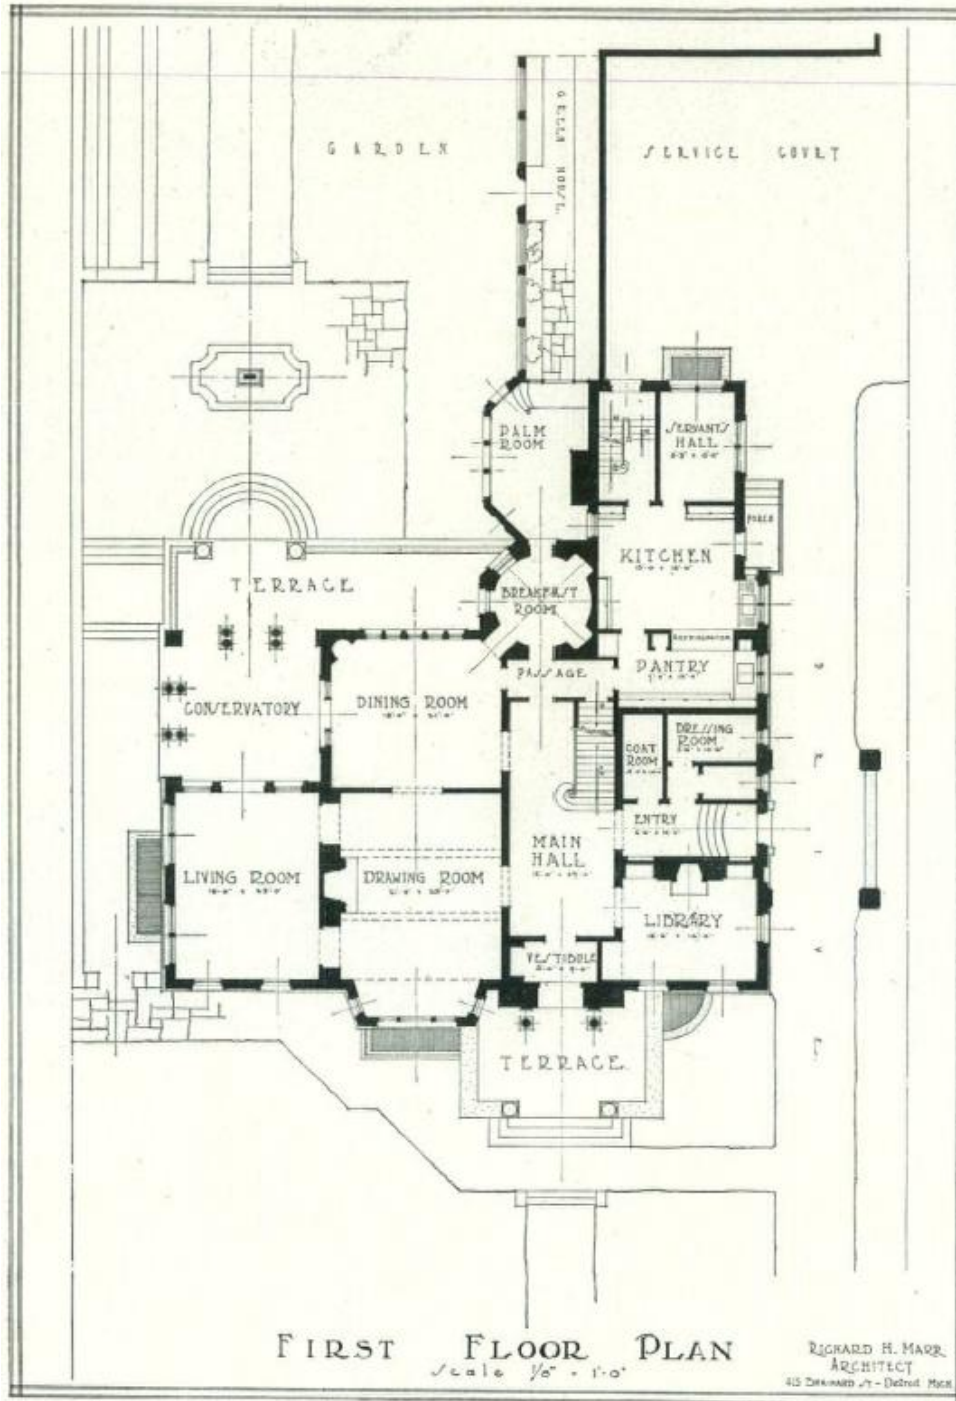
First-floor plan as shown in the February 1926 Architectural Record. The south water feature is shown, along with stone pavers on paths. The rear terrace, steps, south water feature, and paved path to the north water feature (north of this plan) create an axis and an intentional view. Shown is a greenhouse that connected the palm room to the garage. That connector has been removed, but staff has not been able to determine when. Also shown is the service court, small kitchen porch, porte-cochere, drive, front entry walk/terrace/plaza, and west-side walk/courtyard. These spaces are all included in the proposed scope of work.

The historic plan indicates that the geometric circulation paths that Mr. Fleming designed of stone pavers that complement the house and the water features deliberately placed on an axis impose a formal order to the property that integrates the yards with the Italian Renaissance house and its architectural details. Staff finds that, at this property, the landscape features greatly contribute to the property's historic character are nearly as important as the house's architectural features. This finding aligns with Boston-Edison's Element of Design #14, which states, "Where an original or early arrangement of house and grounds included, and still includes, landscaped lots which form part of the landscaping plan for the residence, such landscaped lots have significant landscape features."

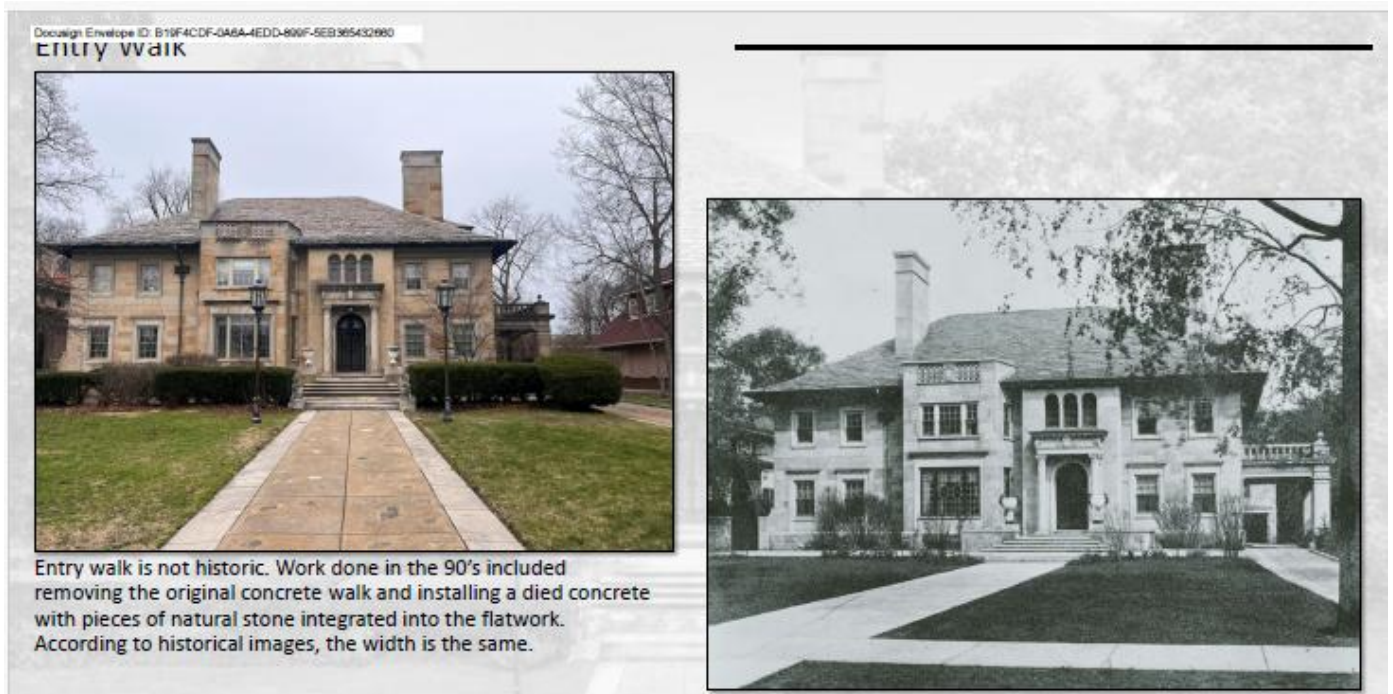
- **Replace front entry walkway**
 - Remove existing concrete and pavers.
 - Install new exposed aggregate concrete in the same width as existing.
 - **Staff analysis:** The existing front walk, in staff's opinion, is a replacement that has been insensitively patched. The historic photo below shows that the original walk had been close in color to the sidewalk, and it appears to staff that it was concrete, without a dyed portion. As such, staff finds that the proposed concrete installation for the front entry walk is a restoration of a missing feature, meeting the Secretary of the Interior's Standards and Guidelines for Rehabilitating Historic Buildings.

From application materials. The existing dyed concrete and paver combination is shown on left. In the historic photo to the right, the entry walk looks like concrete, similar to the public sidewalk, but it is difficult to discern the material with certainty. The drive was brick in historic photos.

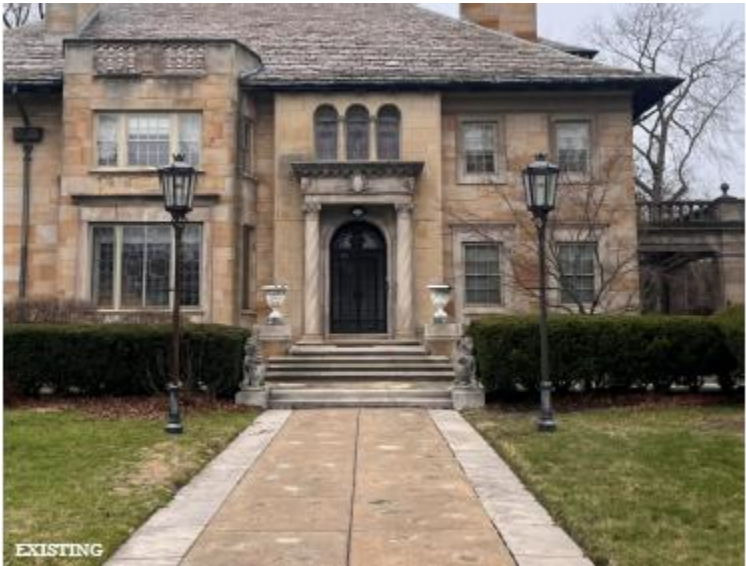
unknown. Staff does not find that they have acquired historic significance or are character defining. Staff finds the proposed gas lights to be compatible with the house and site in size, scale, proportion, and materials (copper and cast aluminum).

Photo of the front of the house with the existing gas lanterns on poles, from applicant’s materials.

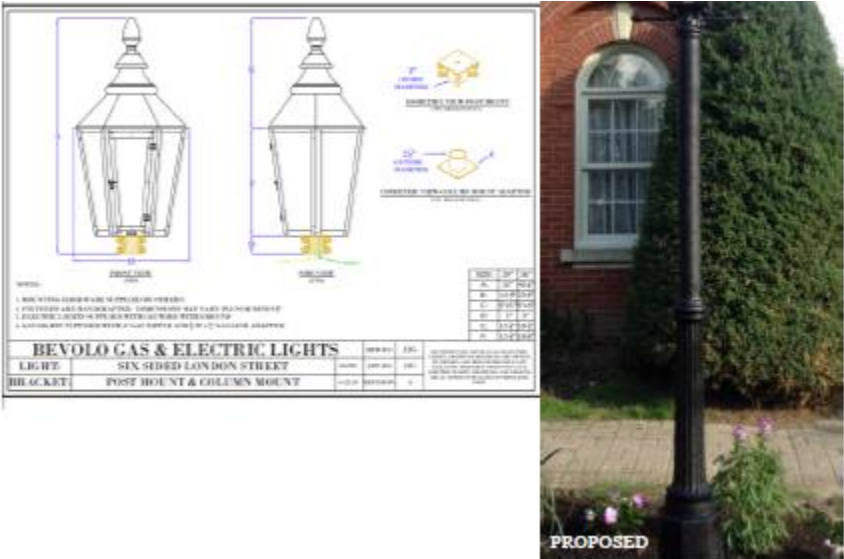
Proposed gas lanterns and pole, in the same size as the existing lantern and pole. From applicant materials.

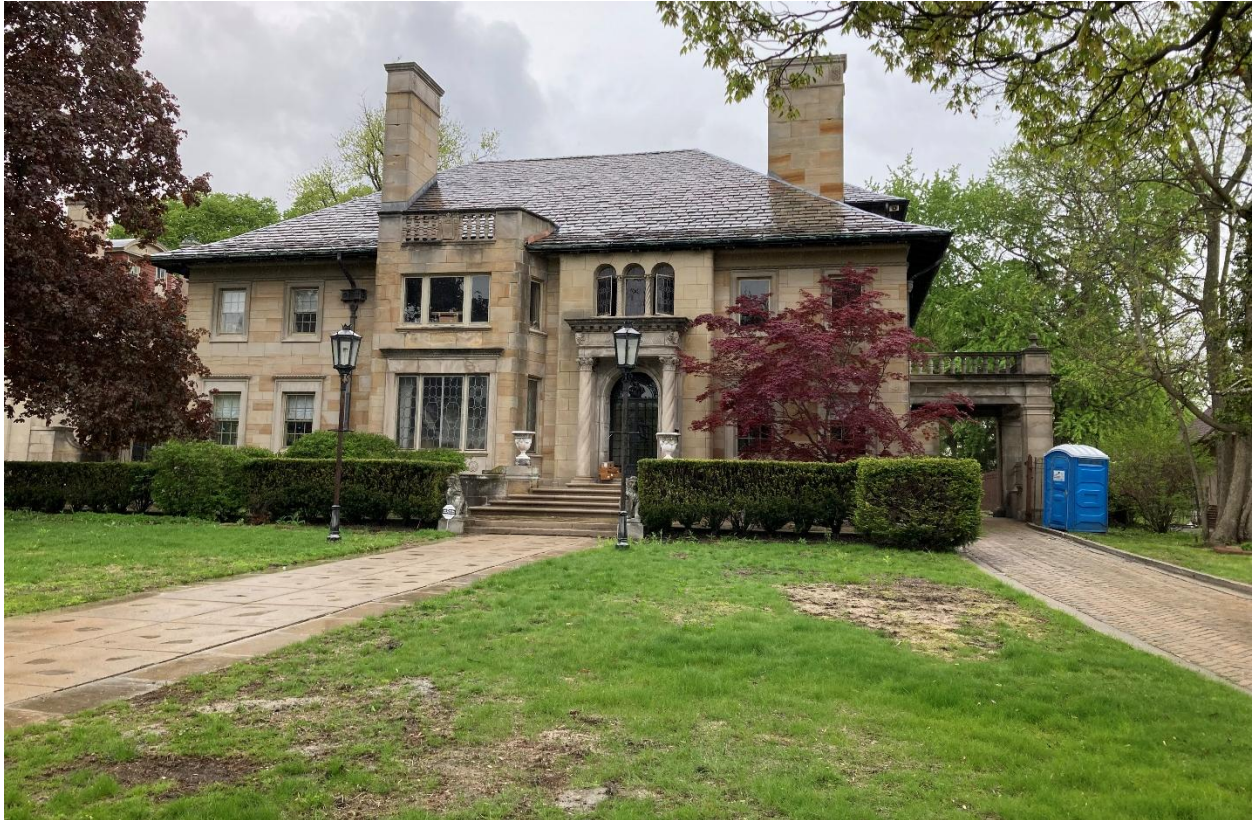
The existing, historic driveway is about 9'6" wide at the sidewalk and remains that width up to the porte cochere, curving westward slightly toward the house to tuck under the porte cochere.

3. Any mortar used in the stone repairs needs to match historic mortar and be softer than the stone.
4. The driveway at the front of the house will be expanded by less than the proposed 5'8". The widened driveway will be no wider than 9' 6" at the sidewalk and 12' along its length and at the porte cochere.

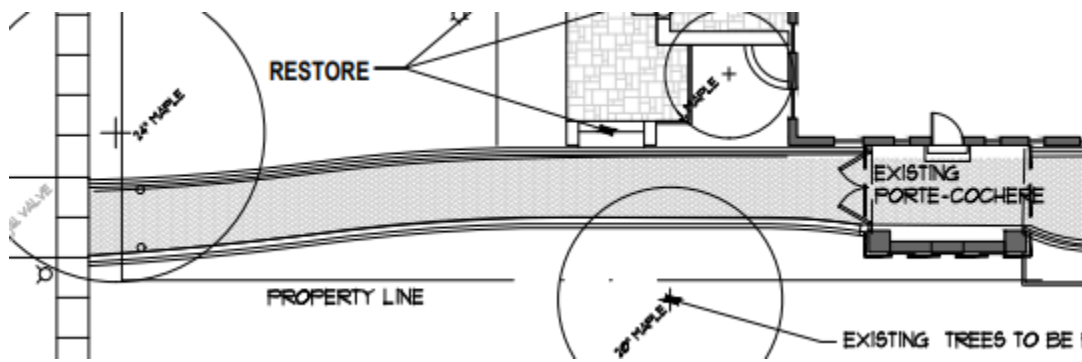
Existing configuration of driveway, as shown in applicant materials. This configuration matches the photo above.

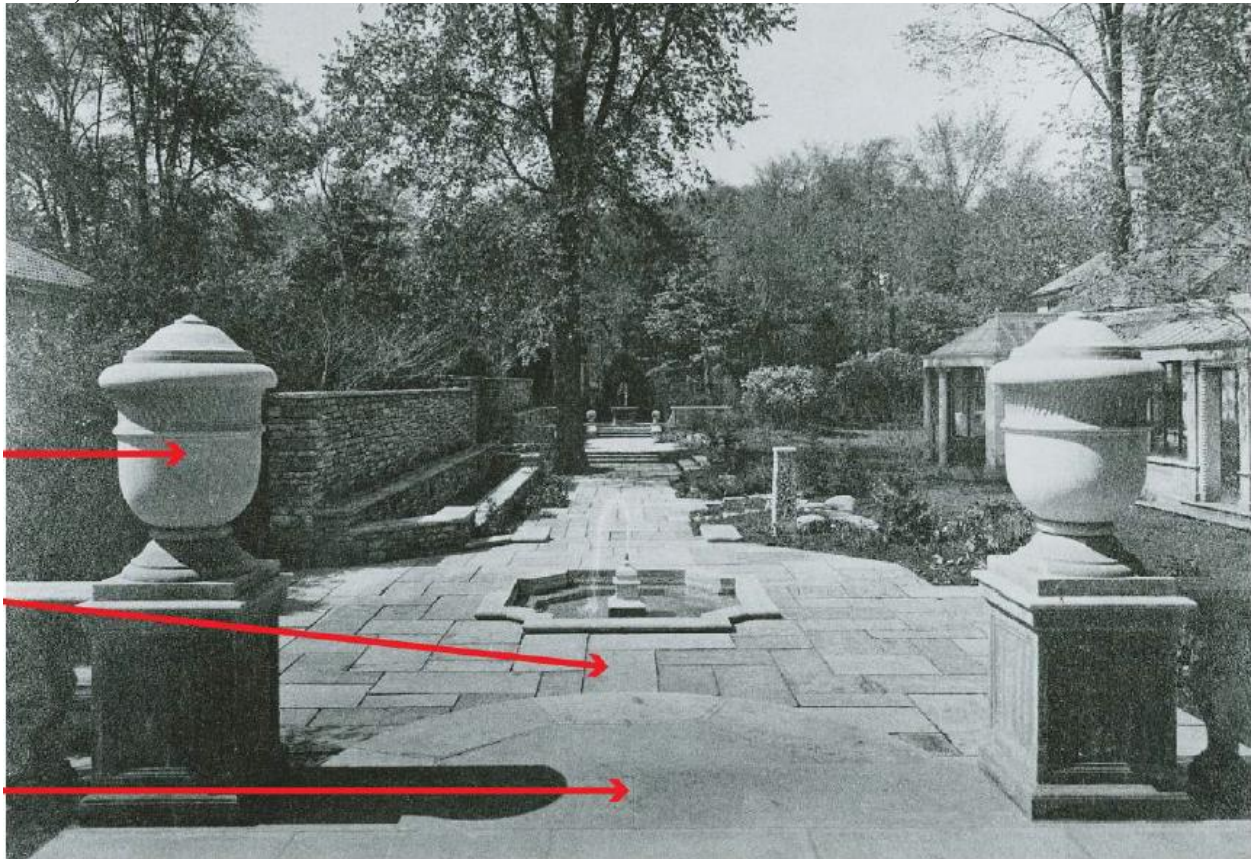
This photo was taken from the upper terrace at the rear of the house looking north, and it reveals many of the essential components of Fleming's formal, geometric design. The axis is evident, punctuated by the near (south) water feature and the distant, north water feature, and the large-scale, discrete stone pavers provide the base of the design. The rustic stone wall to the west (left) also featured a low water feature, but that particular water feature will not be restored; instead, those low walled pools will be used as planters. The elm tree halfway up the vista is no longer there, and the swimming pool is proposed for that location. (Historic photo provided by applicant in a previous application. Please disregard the red arrows.)

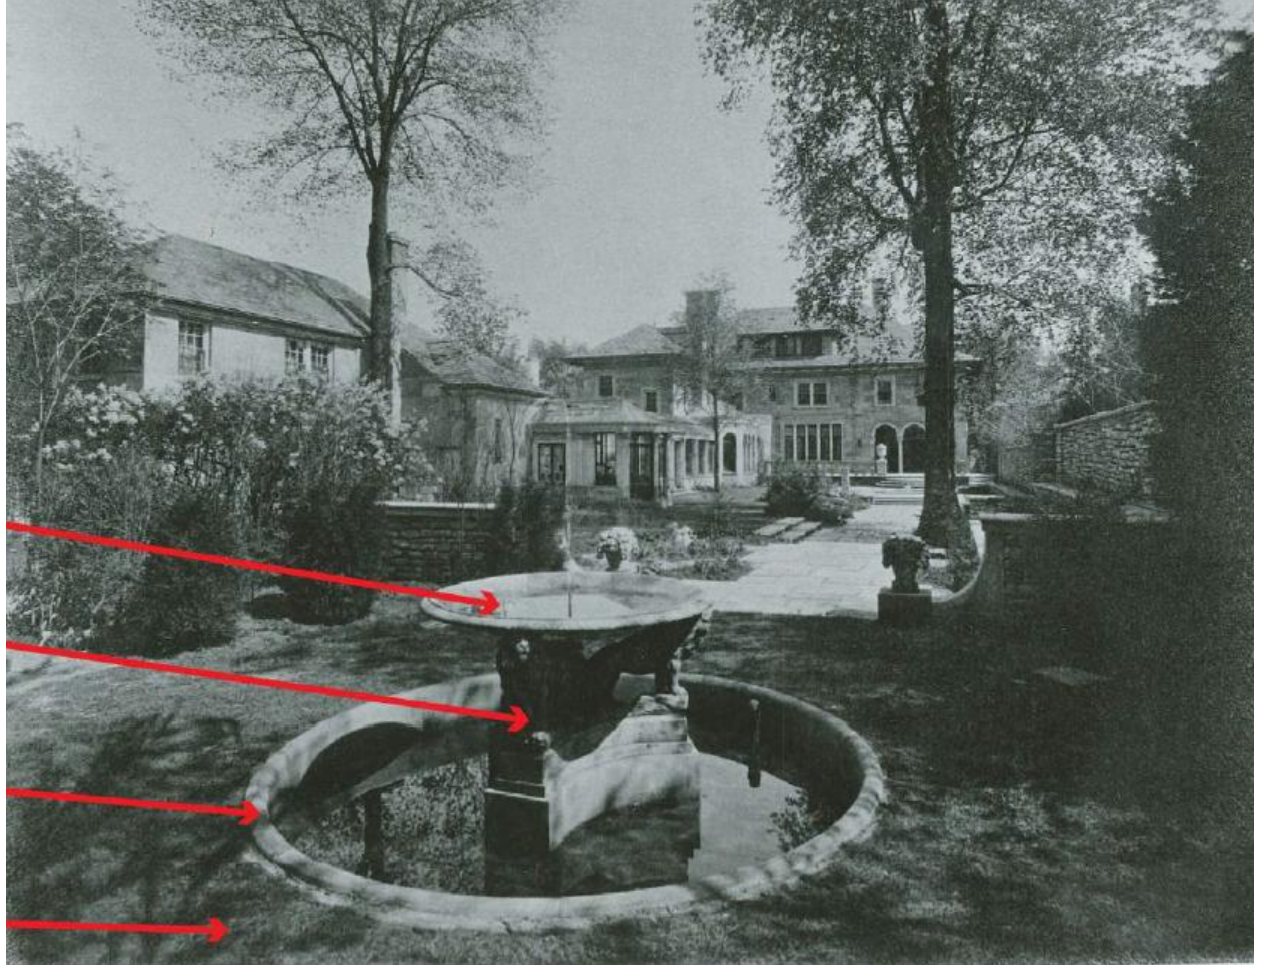
This historic photo, also provided by the applicant in a previous application, shows a very similar view as the photo above, but from the opposite perspective. This photo was taken from the north fountain looking south, and the formal stone paths and terraces are evident from this perspective as well. The grass around the north fountain is proposed to be restored. (Please disregard the red arrows.)

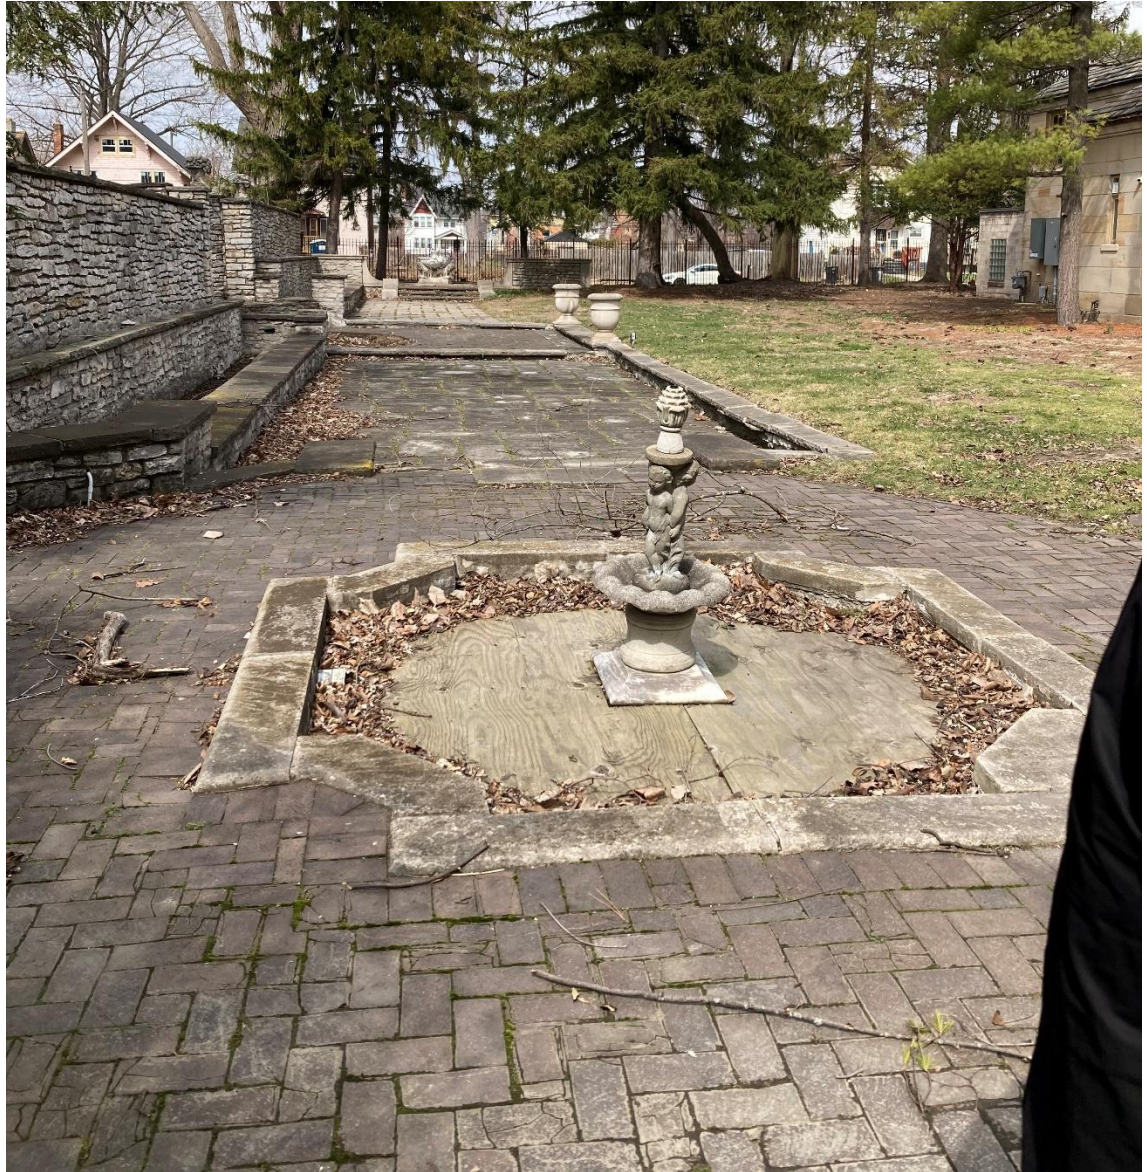
In this photo taken from the upper terrace at the rear of the house looking north, from the south fountain to the north fountain along the west stone wall, the axis Mr. Fleming established is still evident, despite the replacement of stone pavers. (Staff photo, April 2026)

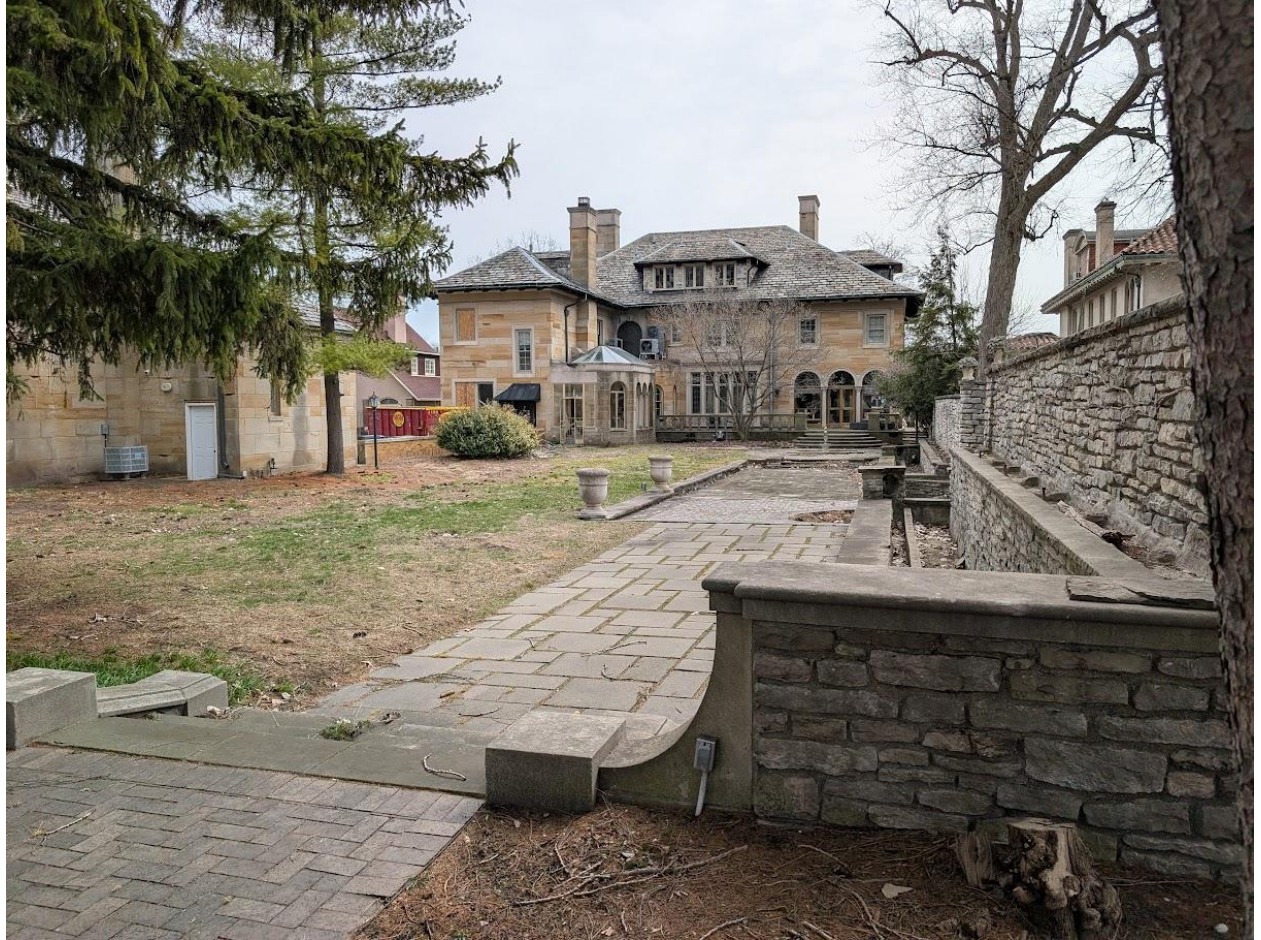
This photo from the north looking south to the south fountain and house shows the axis and historic stone features still intact. (Staff photo, April 2026)

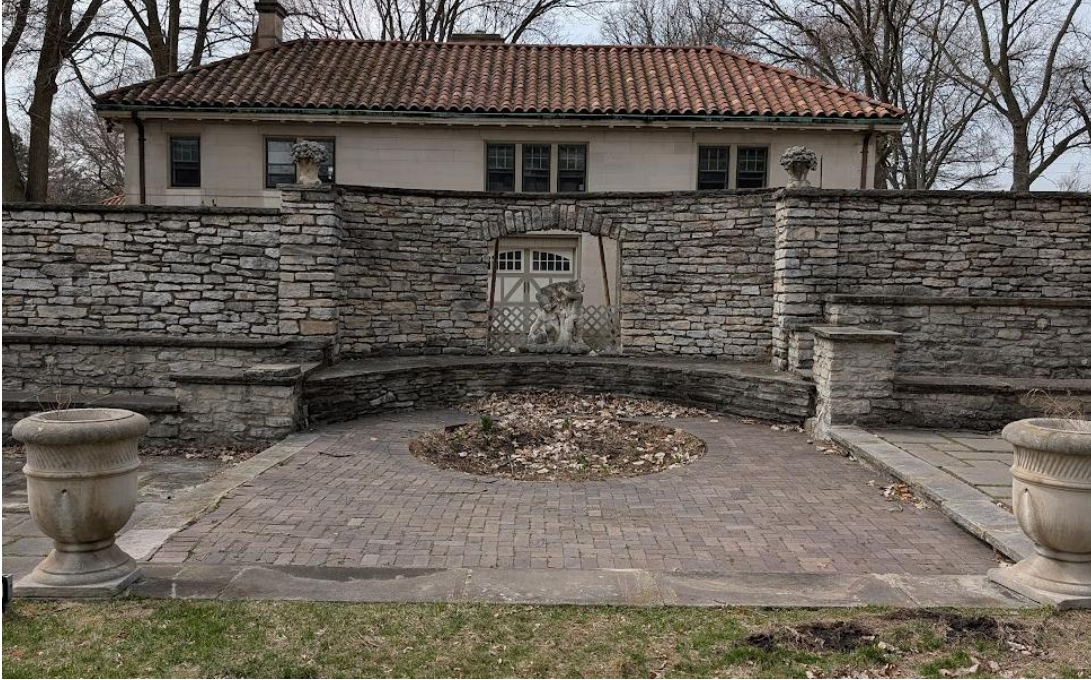
A staff photo from March 2026 shows the west stone wall, rounded alcove, and statue. (The building visible behind the wall is at the adjacent property.)

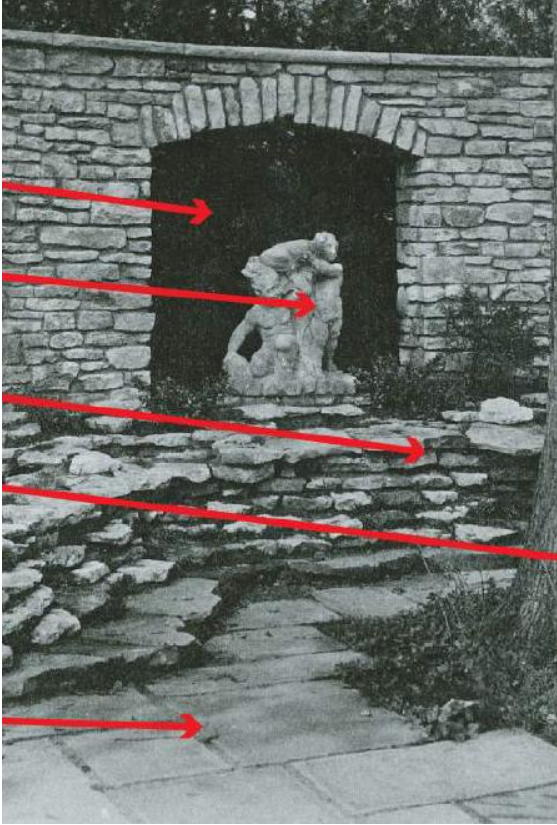
This historic photo was provided by the applicant in a previous application, and was marked up by the applicant with red arrows. The evergreen trees behind the statue give the statue a contrasting backdrop, and evergreens are proposed to be planted again, to restore this statue's historic appearance. Also visible are the large-scale stone pavers, and those are also proposed to be restored.

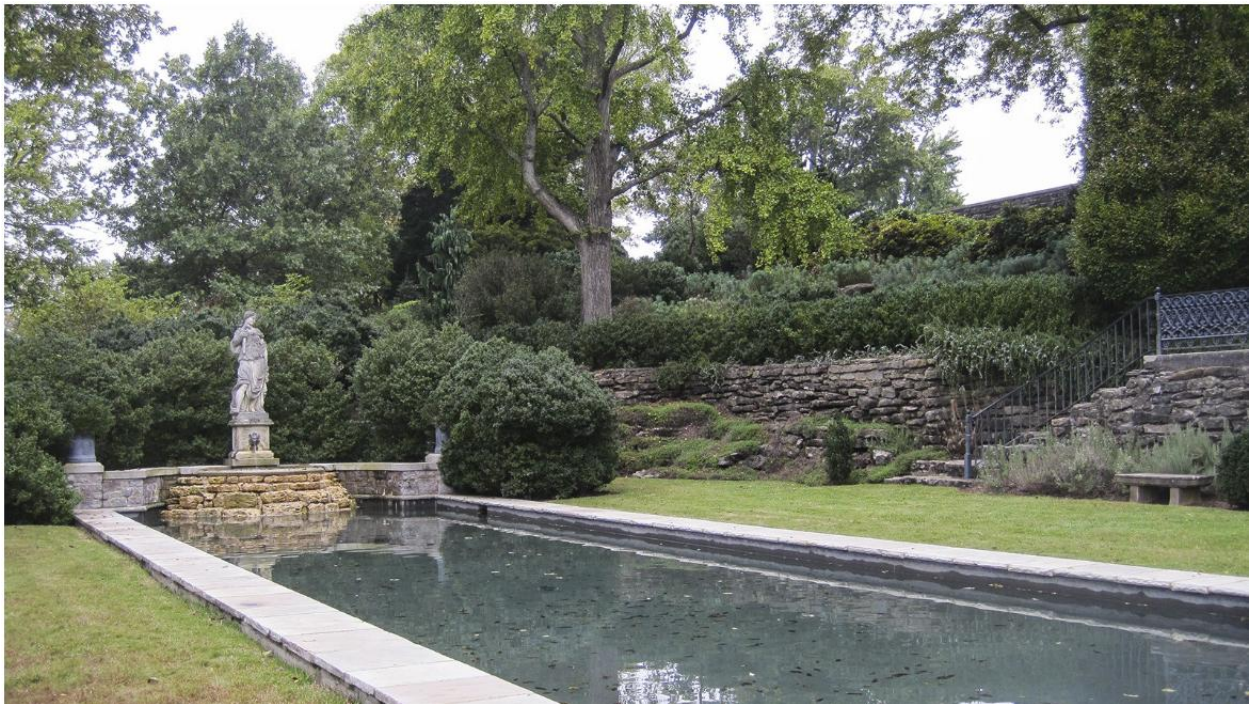
Photo of the reflecting pool at Cheekwood Botanical Gardens and Museum of Art, Nashville, TN. Photo by Charles Birnbaum, 2009, at the Cultural Landscape Foundation’s website, available at <https://www.tclf.org/pioneer/bryant-fleming>. Mr. Fleming designed both the house and the gardens for the Cheeks and was hired by the Cheeks in 1929. For reference, 892 W. Boston was built about 1923.

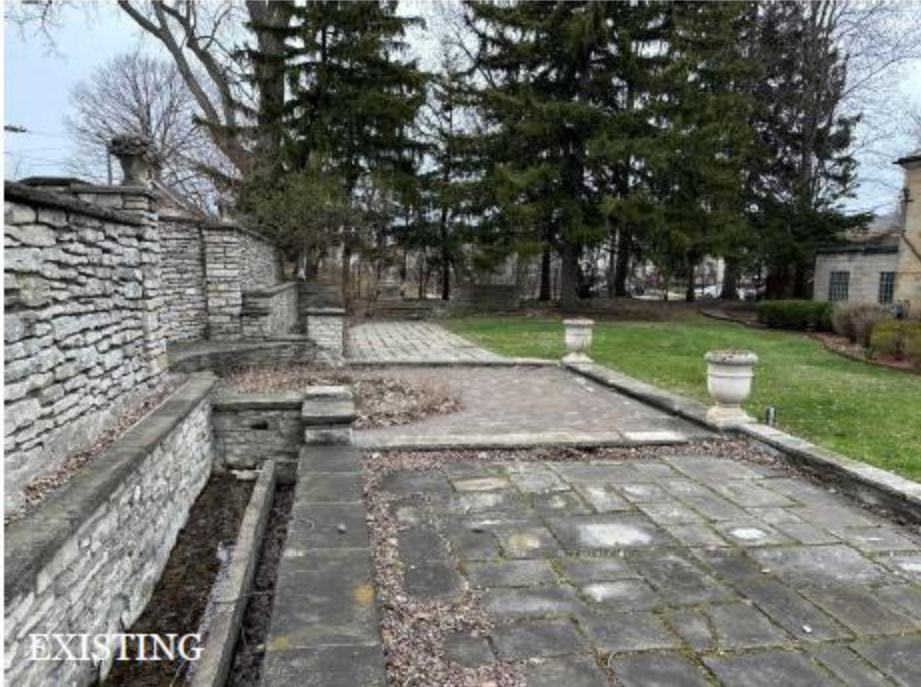
From the application materials, this photo shows the approximate proposed location for the pool. A variety of paving materials is shown, but the proposal would install all stone pavers, restoring the original appearance of the patios, terraces, and paths, while introducing a new pool element. The patio and pool deck area would be enlarged from the current layout; this area between the low wall on the left where plants will be planted and the low stone border on the right is currently 16' 3" wide. The new proposed surface for the large stone pavers and the swimming pool would be 18' 9" wide. The pool is proposed to have limestone coping at the deck, gray interior pool finish on the bottom, and glass mosaic pool tile in pale blues and greens.

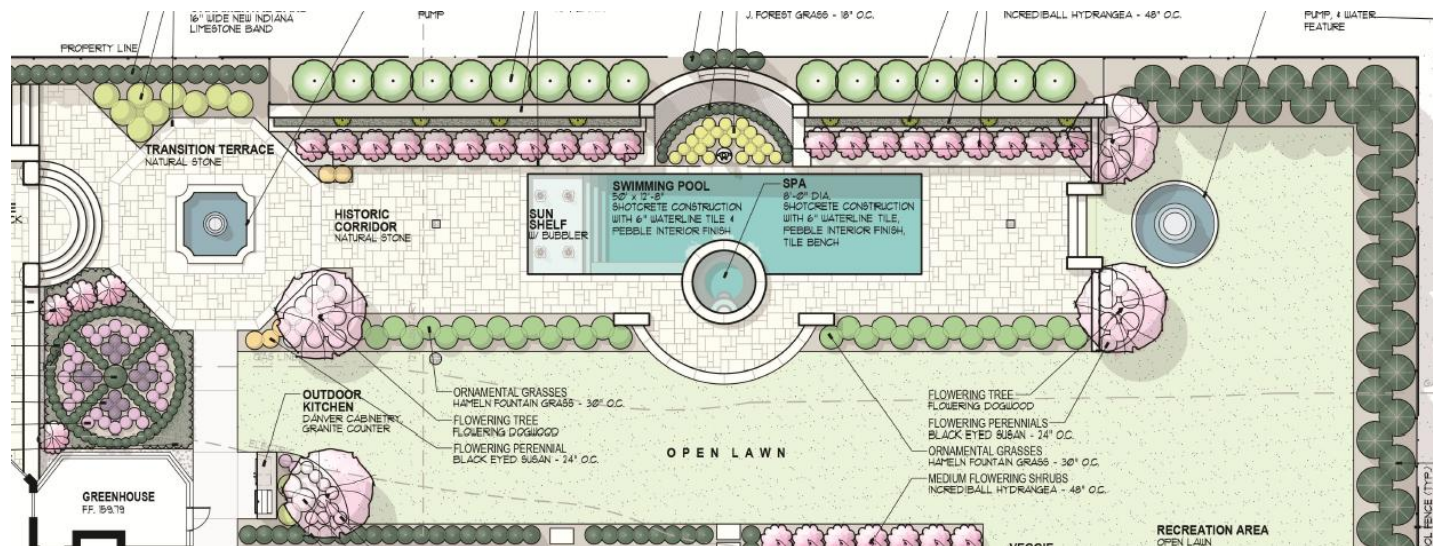
From the application materials, the proposed swimming pool is shown among the stone pavers between the south and north fountains. The pool is proposed to measure 50 feet long by 12' 8" wide.

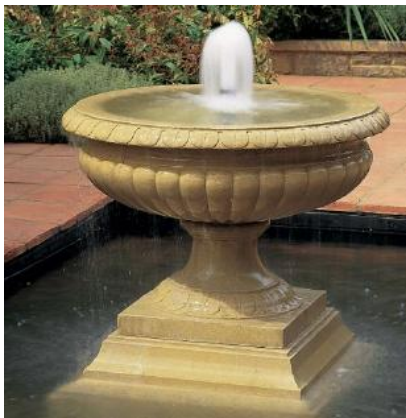
Proposed replacement bowl for the north fountain. (The bowl would be supported by the historic lions base instead of this pedestal.) This bowl is precast concrete and is closer in shape to the existing bowl, but is more detailed than either the historic or current bowl.

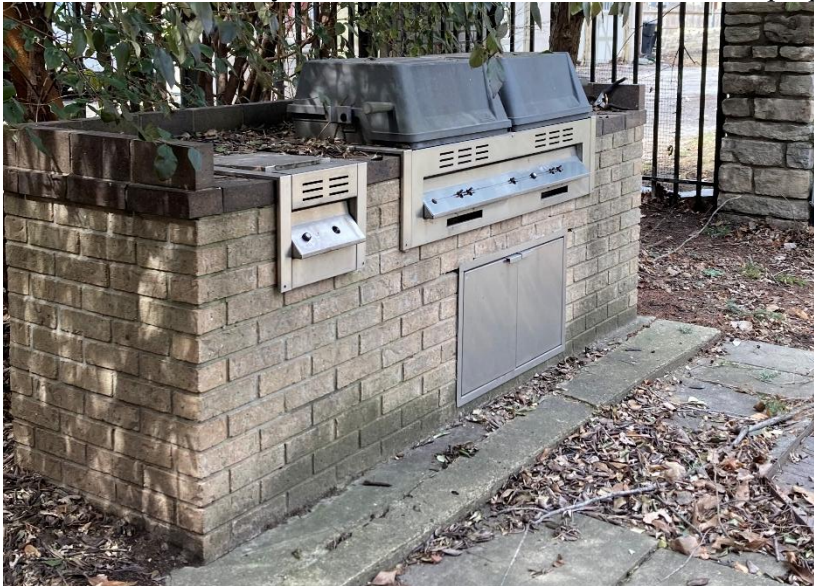
The existing outdoor kitchen, located west of the transition terrace and just south of the rustic stone wall along the western boundary of the yard. The kitchen is not original to the property and has not acquired significance in its own right. Staff considers the current kitchen non-historic and, as such, staff does not object to its removal.
