**SR-2 – STAFF ADVISORY REPORT (05-08-2026)**

**ADDRESS:** 470 MARTIN LUTHER KING JR. BOULEVARD

**APPLICATION NUMBER:** HDC2026-00162

**SCOPE:** REPLACE WOOD WINDOWS WITH ALUMINUM WINDOWS, BUILD RETAINING WALLS/INSTALL FENCING, INSTALLATION OF CMU BLOCK IN BUILDING’S EXTERIOR WALLS, (WORK STARTED WITHOUT APPROVAL)

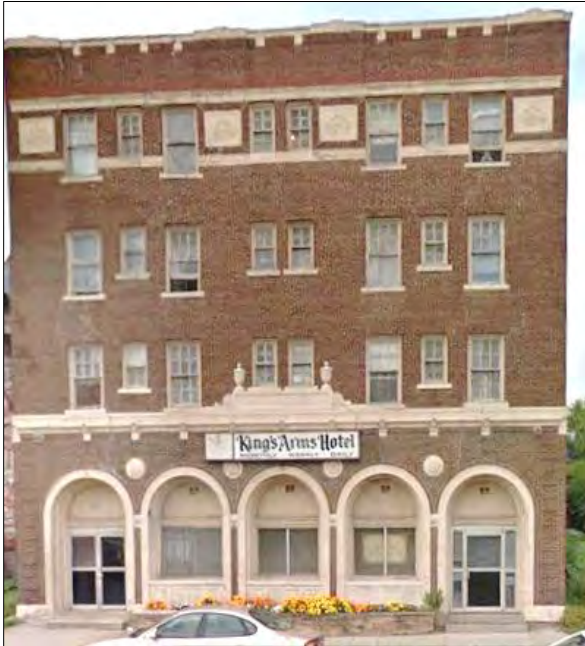
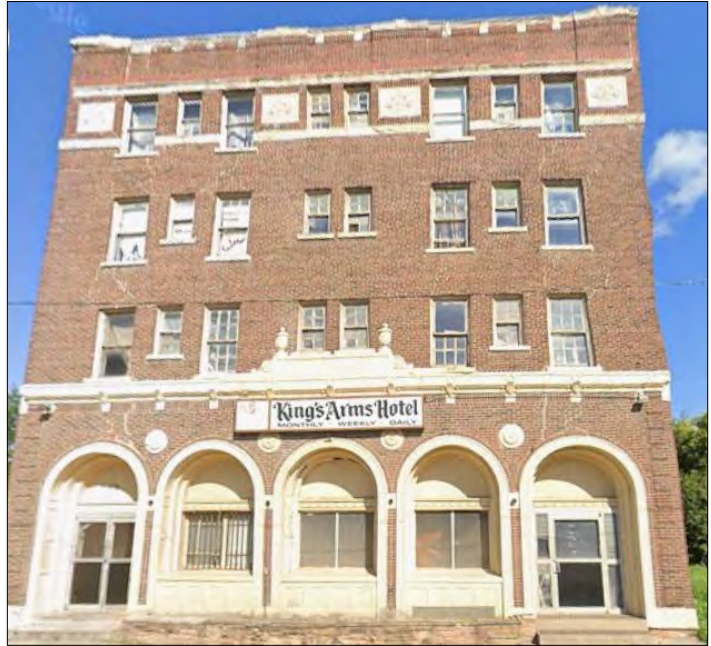
- By November 2024 (last street view image available), the cast stone at the parapet has crumbled and is mostly missing, and the number of window openings that had at least one sash of undivided replacement glass increased to 16 (from 13), with six windows (increased from two) having undivided glass in the upper and lower sash. This increased change of glass occurred after district designation and without HDC review/approval. However, it is important to note that the wood sash, frames and wood brickmould remained intact within every opening on the façade, apart from half-circle windows and two first floor window openings where only the brickmold appears to remain intact.

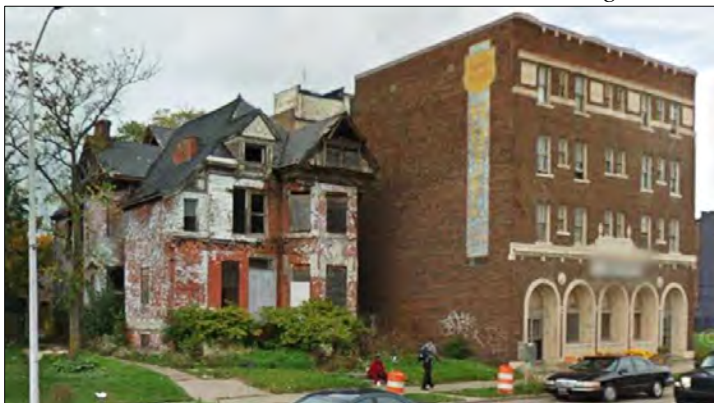
Google Streetview, October 2011. West wall of King's Arms. The adjacent ca. 1870s house was demolished by 2017; the four bays/three lightwells of the subject building are now fully visible and accessible.

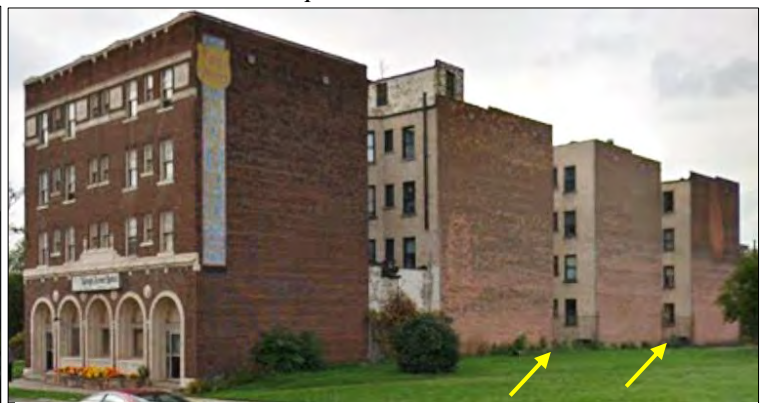
Google Streetview, October 2011. East wall of King's Arms. The four bays are visible due to earlier demolitions of adjacent buildings. You can see the chain link fencing enclosing the central and rear courtyards/lightwells.

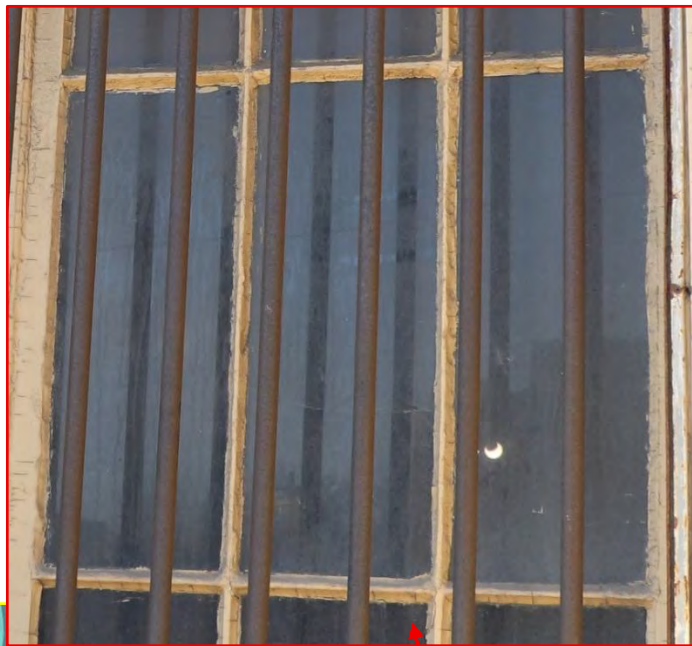
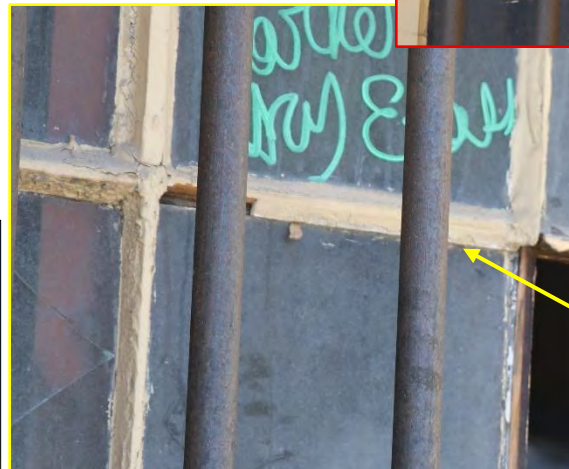
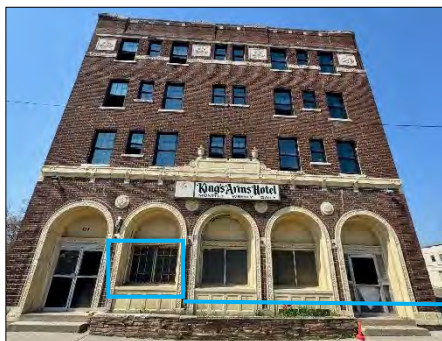
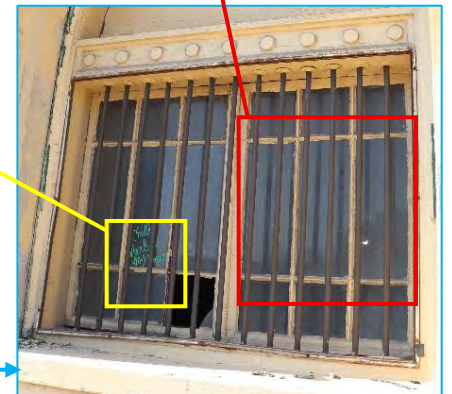
- Even though this product may be applied to the exterior, it appears to extend from the glass surface about 1/8-of-an-inch and is flat surfaced.
- Pages 11 & 12 from applicant document "Compiled Submittal red" states depths for the grilles at .15" and .45" for different windows. Staff isn't clear why different dimensions are listed; the above sample is likely for the .15" grille.

- The full glass photo also shows a tint which reduces transparency and contrast between the grilles and glass. Staff isn't clear if this glass matches the glass used within the new windows.

- There is one window remaining at the façade that offers clarity on the profile/ dimensionality of a historic muntin and is likely identical to what was in place within the façade's historic-age double-hung windows. The angled surface and almost pointed outer edge of the historic muntins offers an entirely different expression than the almost flat proposed grilles.

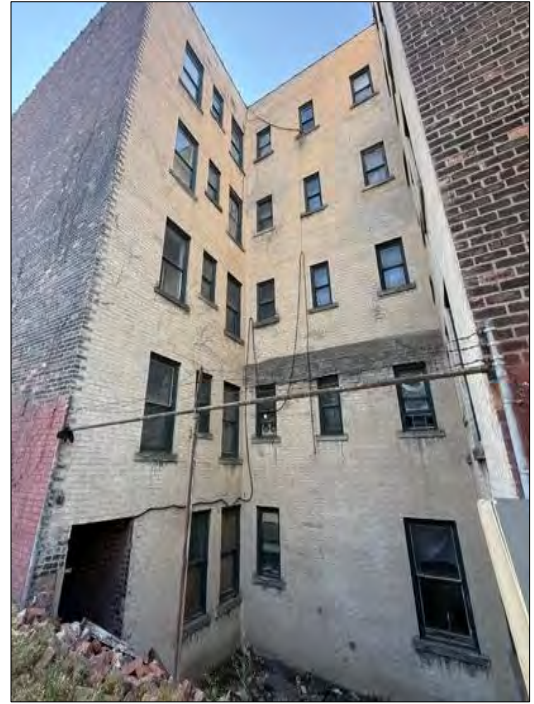
*Above and below right: Undated applicant photos of one side (top) and rear (bottom) walls, prior to the window replacement beginning.*

- The applicant stated in the “*Window Condition Status Report*” that “The building has 261 wood frame single pane windows. 212 of those are not operable. The remaining 49 are missing glass or destroyed.” Staff notes this is the building owner’s assessment and is not from an experienced window repair company. Also, “not operable” does not immediately equate to “deteriorated beyond repair” as individual parts for wood window repair are readily available for purchase. The photos within the status report show all the window openings appear to have full-frame windows present (even if some of the historic divided-light glass on the façade, as stated earlier, had been replaced with clear, undivided glass). The only openings that were and remain covered, and possibly absent of windows, are the half-circle window openings and two large openings at the façade’s first floor.

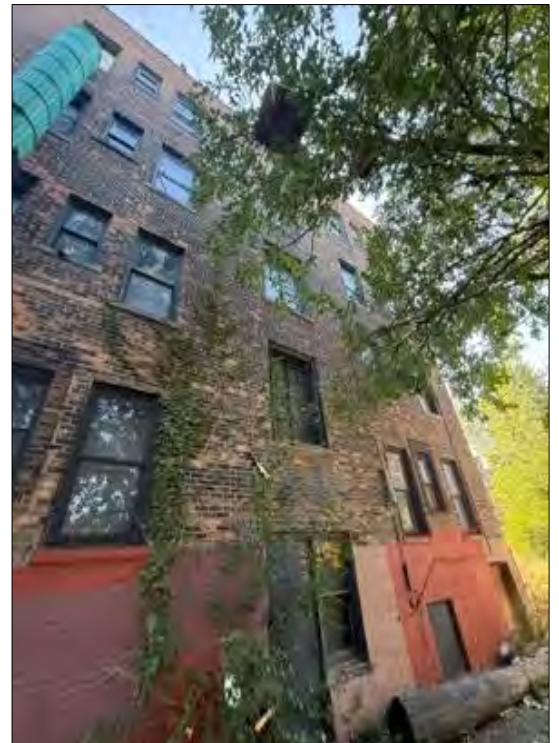
- The replacement of the building’s windows was noticed in early April and continued later in the month after BSEED had issued a stop work order. Now, only a few original wood windows remain.
- It is staff’s opinion that the windows did not appear to be deteriorated beyond repair. The undivided glass on the façade removed without HDC approval between time of district designation and May 2026 could have been replaced with fabricated true-divided light sash.

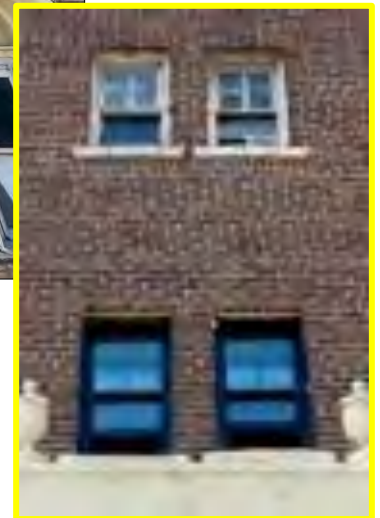
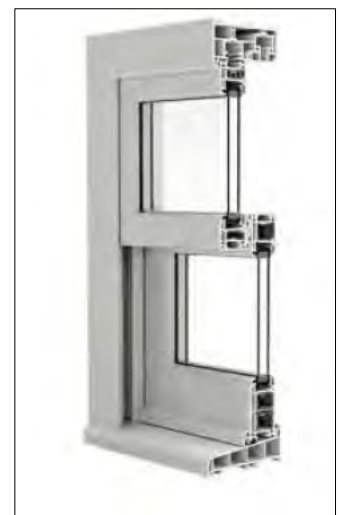
- Although the expansion of a portion of the above photo is a bit blurry, the difference between the historic and new windows remains quite evident. The dimensionality of the historic divided-lights has been lost and the flatness of the new window frames and loss of dimensional brickmold creates a heavy, thick appearance to the new windows. **Even with an applied exterior grille it is wide and flat, unlike the dimensional quality of the historic muntin, and the** contrast between the dark brick and black window frames causes the window openings to look like dark holes in the wall, rather than an integral component of the wall.

- The applicant submitted a measurement comparison in the “*Compiled Submittal Red*” document, and it states there is no visible difference in sash dimensions. However, the photo comparisons on this and the following page attest to a noticeable change in appearance due to the profiled dimensional loss.

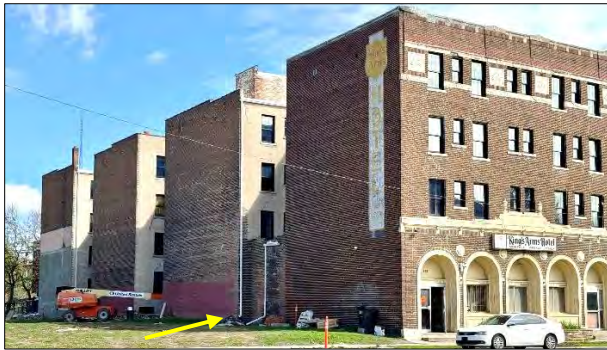
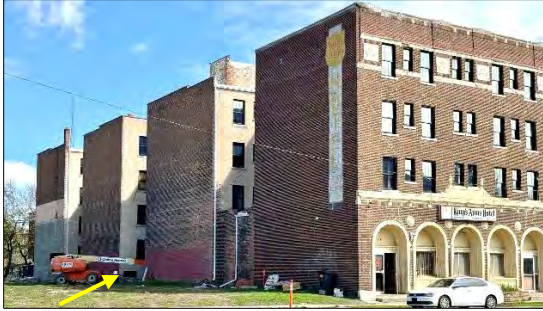
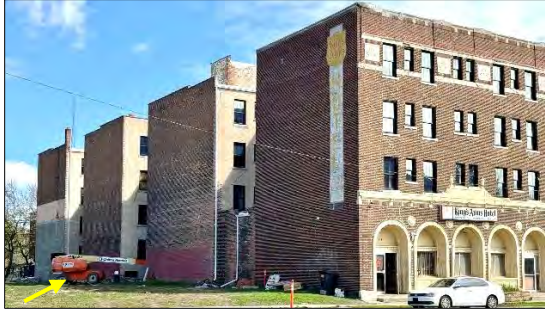
- Regarding the CMU blocks used for many of the retaining walls, the applicant stated they will be raising the grade around the building and the CMU will not be visible.
- However, staff's analysis of the five completed retaining walls shows the east and west retaining walls were constructed differently from each other: the three walls at the west side lightwells are composed of 4-6 courses of brick, whereas the east side lightwells have three courses of brick and CMU block. Therefore, staff is concerned that one or more rows of CMU may be visible on the east side when the grade for the lot is leveled.

*Full west side of building. Staff photo, 04/30/2026.*

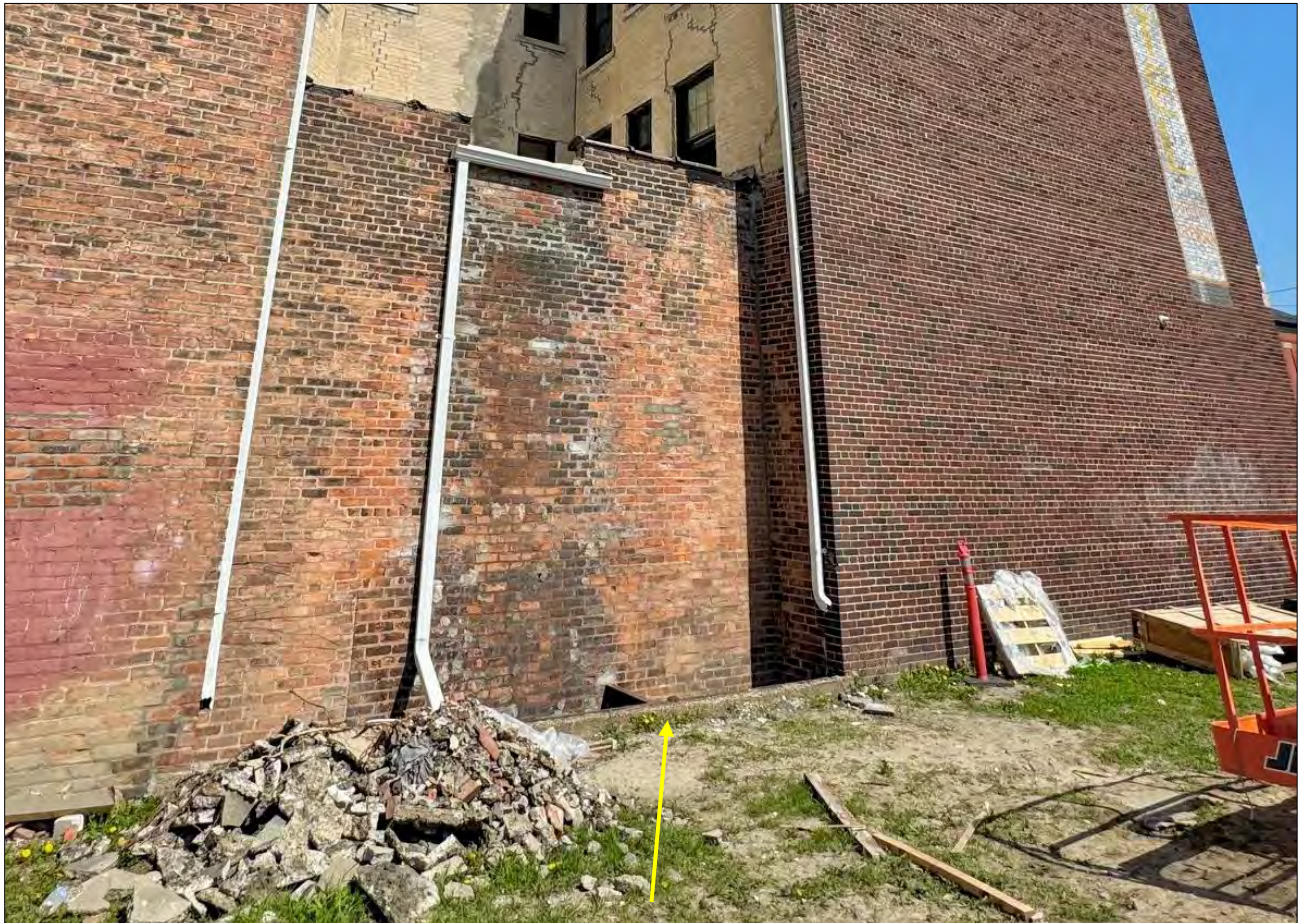
*At this historic enclosure spanning the front two bays, the historic age concrete retaining wall/foundation remained in place during staff's first site visit. Staff photo, 04/22/2026.*

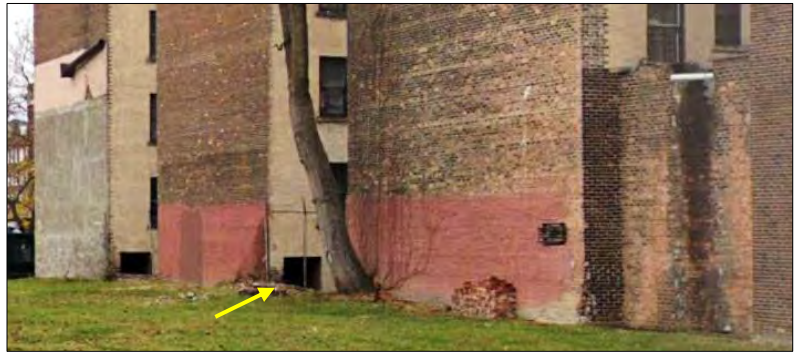
View of previous low height retaining wall/chain link fence.  
Google Streetview, 11/2024

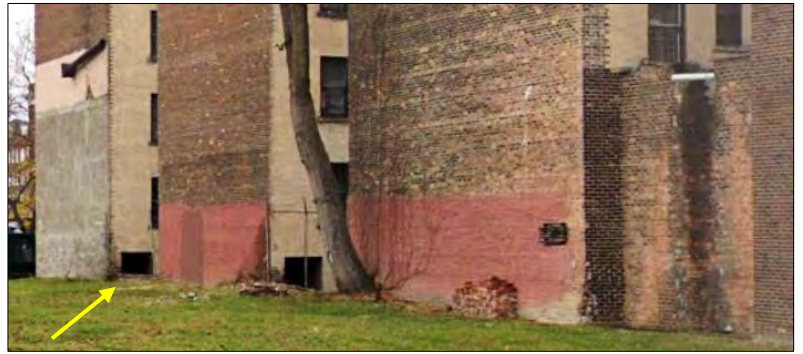
*View of previous retaining wall/fence condition - it appears that the fence was no longer in place at this rear location. Google Streetview, 11/2024.*

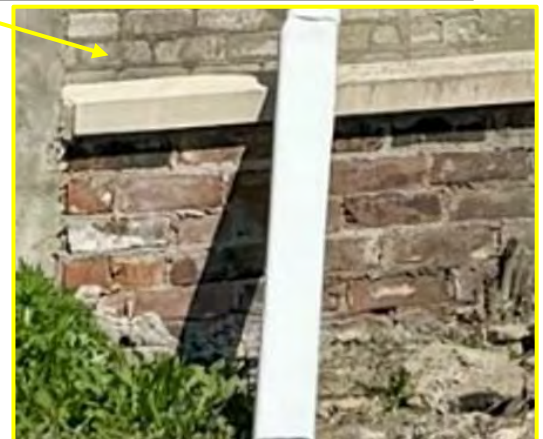
*Top right: View of east side of building. Staff photo, 04/30/2026.*  
*Top: Retaining wall at front lightwell, between the front and center-front bays.*  
*Middle: Retaining wall at center lightwell.*  
*Bottom: Retaining wall at rear lightwell. Staff photos, 04/22/2026.*

- Staff generally supports the applicant's proposal to erect low masonry retaining walls (which are higher than the historic condition) and a mostly transparent railing, as it would be a materially and architecturally compatible solution to address safety concerns while keeping the lightwell mostly open (rather than installing tall privacy fences or masonry walls), closely matching the historic condition.
