SR-2 – ADVISORY STAFF REPORT (06-05-2026)

ADDRESS: 4254 TYLER

APPLICATION NUMBER: HDC2026-00252

SCOPE: REHABILITATE DWELLING (SOME WORK COMPLETED WITHOUT APPROVAL),
REPLACE WOOD WINDOWS WITH VINYL WINDOWS

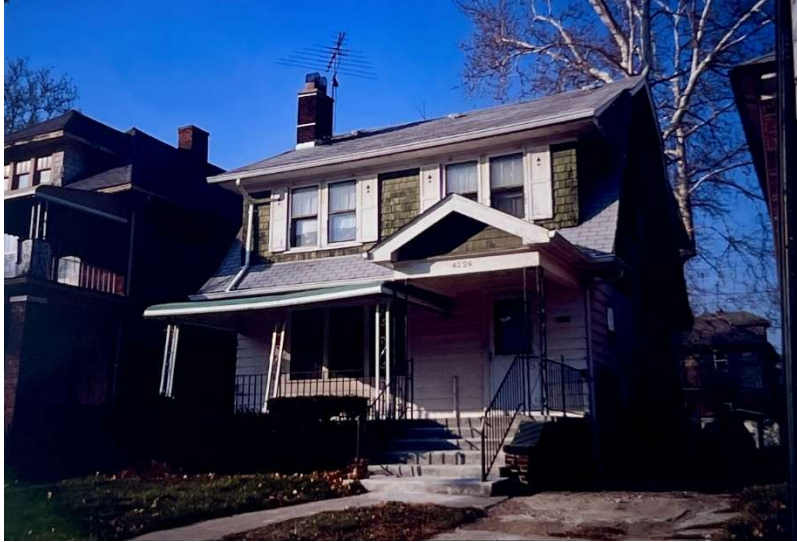
HDAB designation photo, 1999

HOUSE NO.	4254		
STREET	Tyler 93		
PERMIT NO.	3670	LOT NO.	3-21-23
USE	dwelling	DATE	
CONST.	frame		
REMARKS	Frame garage Permit No. 3671
