**STAFF REPORT:** 10-14-2020 MEETING

**APPLICATION NUMBER:** #20-6894

**ADDRESS:** 1991 CHICAGO

**SCOPE:** DEMOLITION / REPAIR WORK OF FRONT PORCH (WORK DONE WITHOUT PERMIT)

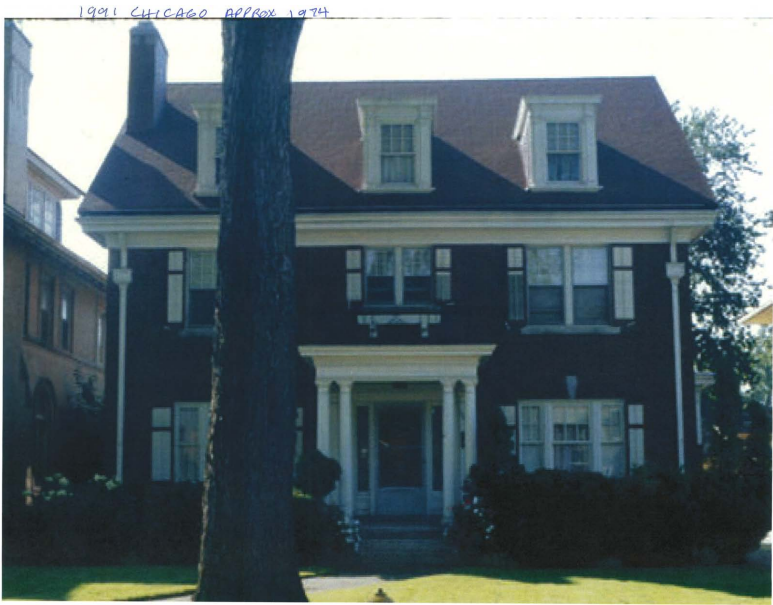
**North/Front Elevation (BEFORE) 1974**

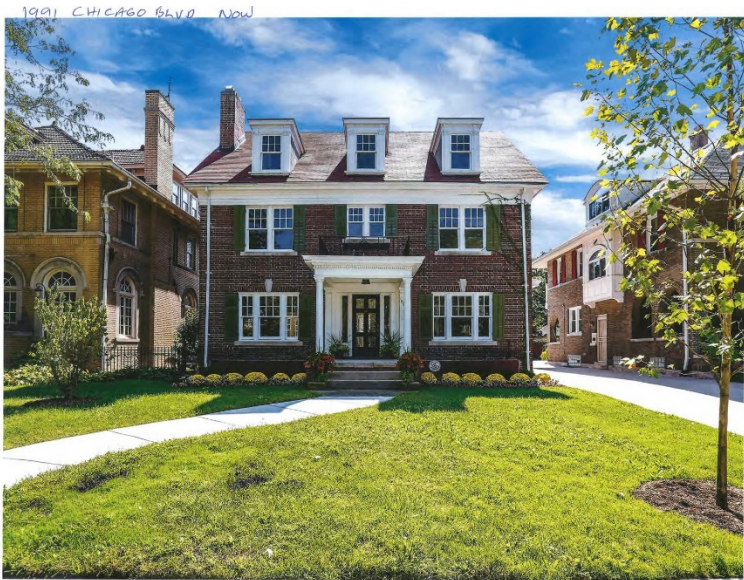
- The work undertaken at/proposed for the front porch to include the removal of the side wings and railing at the deck
- The current treatment of the "scars" at the front elevation wall surface below the first-story windows which resulted from the unapproved porch deck removal/replacement

**North/Front Elevation (AFTER) 2020**

Finally, if the Commission does approve the porch as it remains in its existing condition, without the side deck extensions, staff does recommend that the body do so with the condition that the exterior wall surface "scars" that flank the front porch be repaired by installing brickwork that matches the existing in scale, color, texture and mortar composition.

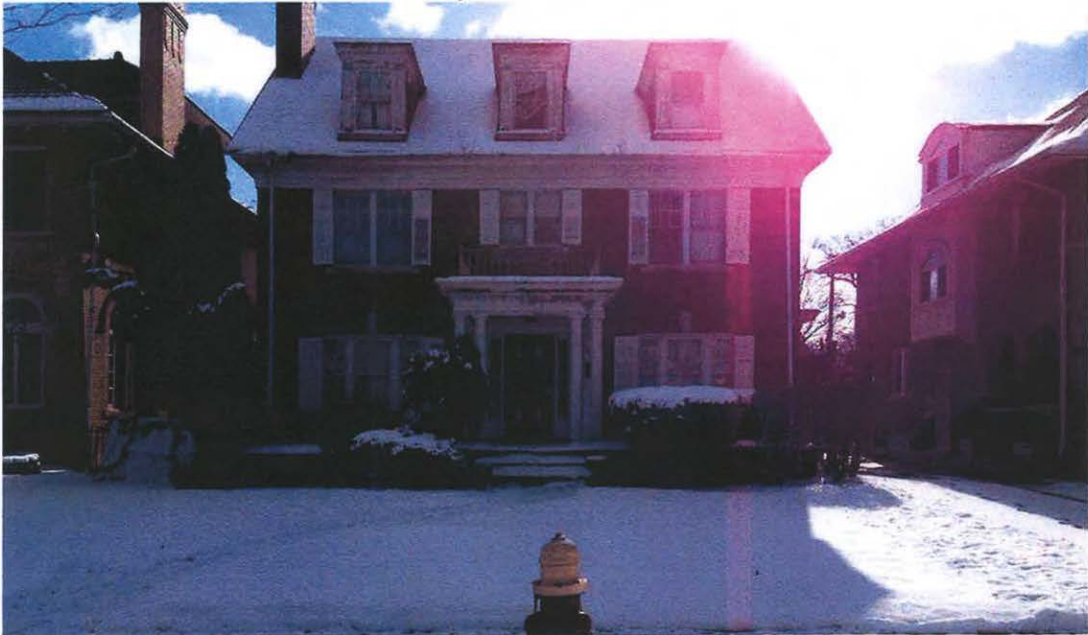
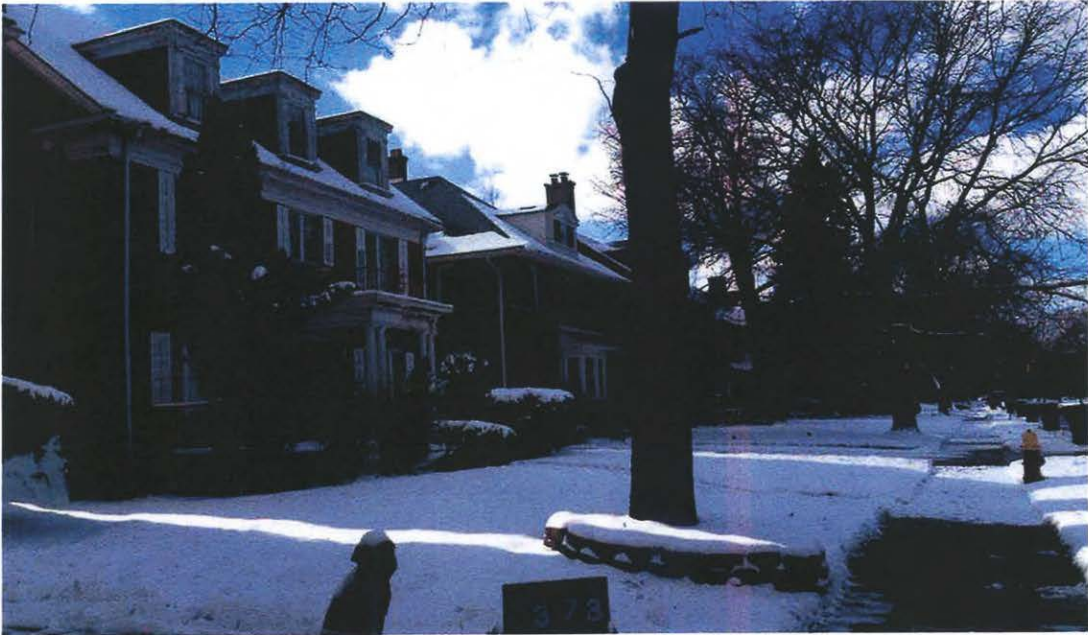
1991 CHICAGO BLVD 2017

1) Wings of porch removed. The wings were collapsing due to failing footings (See attached photo). The wings could not have been repaired. They would have had to be completely re-built. In order for us to do so we would have had to dig out the old footings and pour new ones and re-build from that point. Rebuilding the wings would have added \$20,000 to the cost of the porch rebuild. This would not have made financial sense considering the value of the home. The main porch's footings were in good shape so we were able to just rebuild the brick work etc. for the center porch. In respect to the old footings, we dug them out and removed to accommodate installation of the new landscaping and grading from the exterior walls of the house. We also used as much of the original porch materials as possible in the re-build which is evident in the photos.

**North/Front Elevation (BEFORE) 2017**

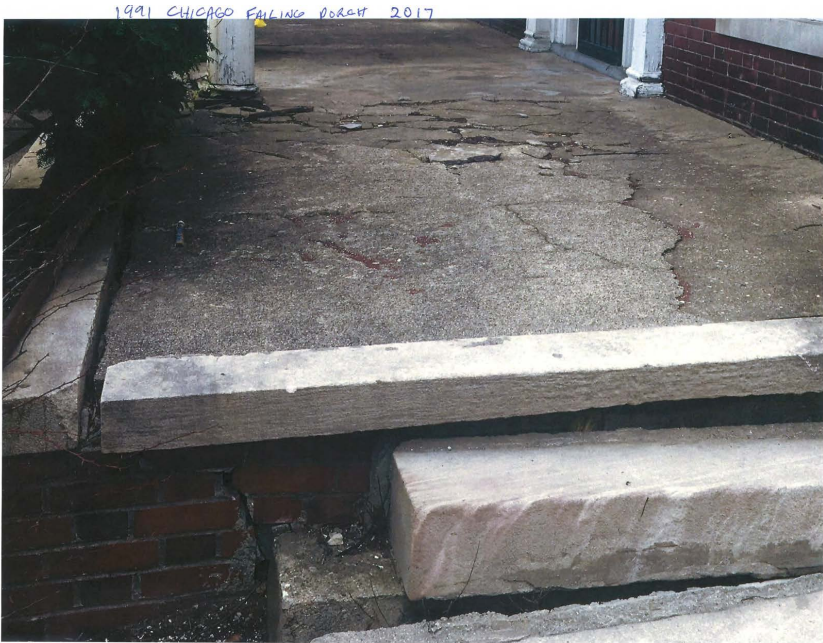
2) Railings on wings of porch removed. The railing was corroded and damaged, but intact, on the left wing but none attached to the right. The vintage of the railing was undetermined.

**Front Porch Detail (BEFORE) 2017**

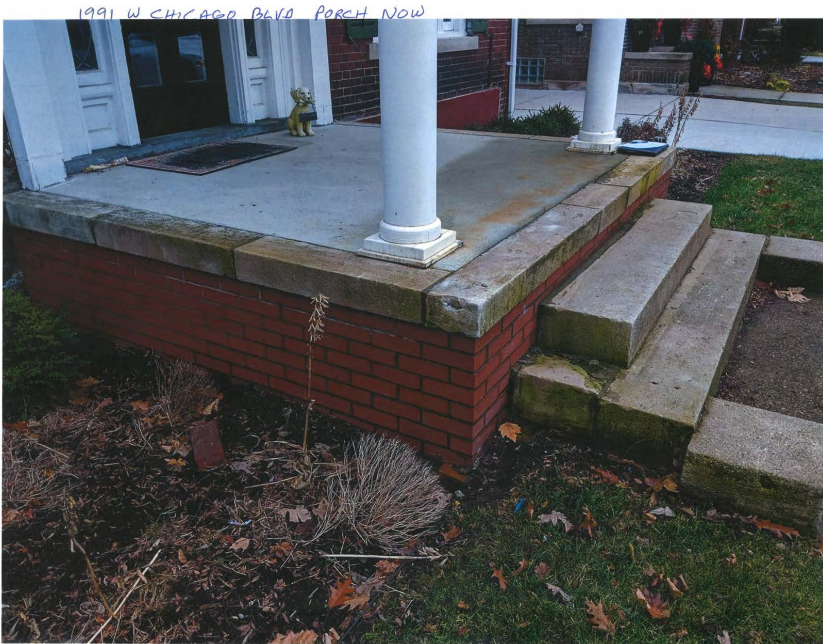
**Front Porch Detail (AFTER) 2020**

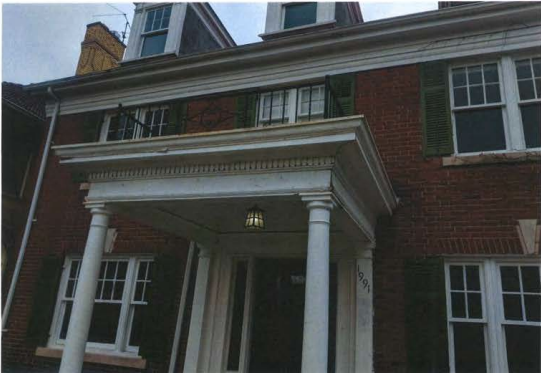
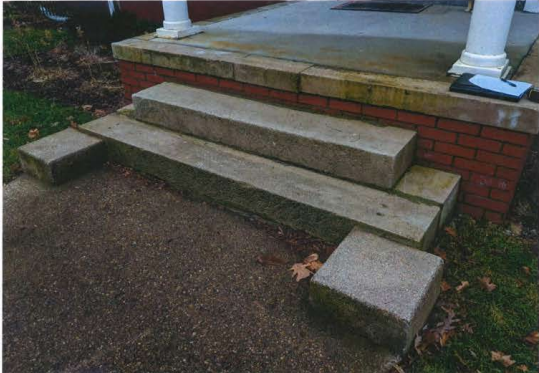
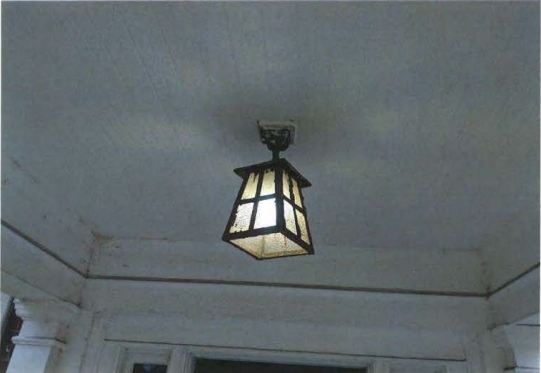
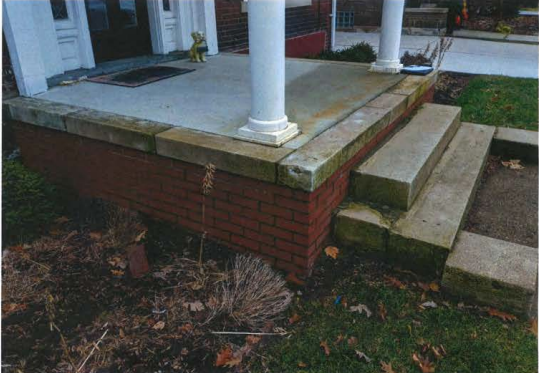
*1991 CHICAGO BLVD NOW*

**Front Porch Details (AFTER) 2020**

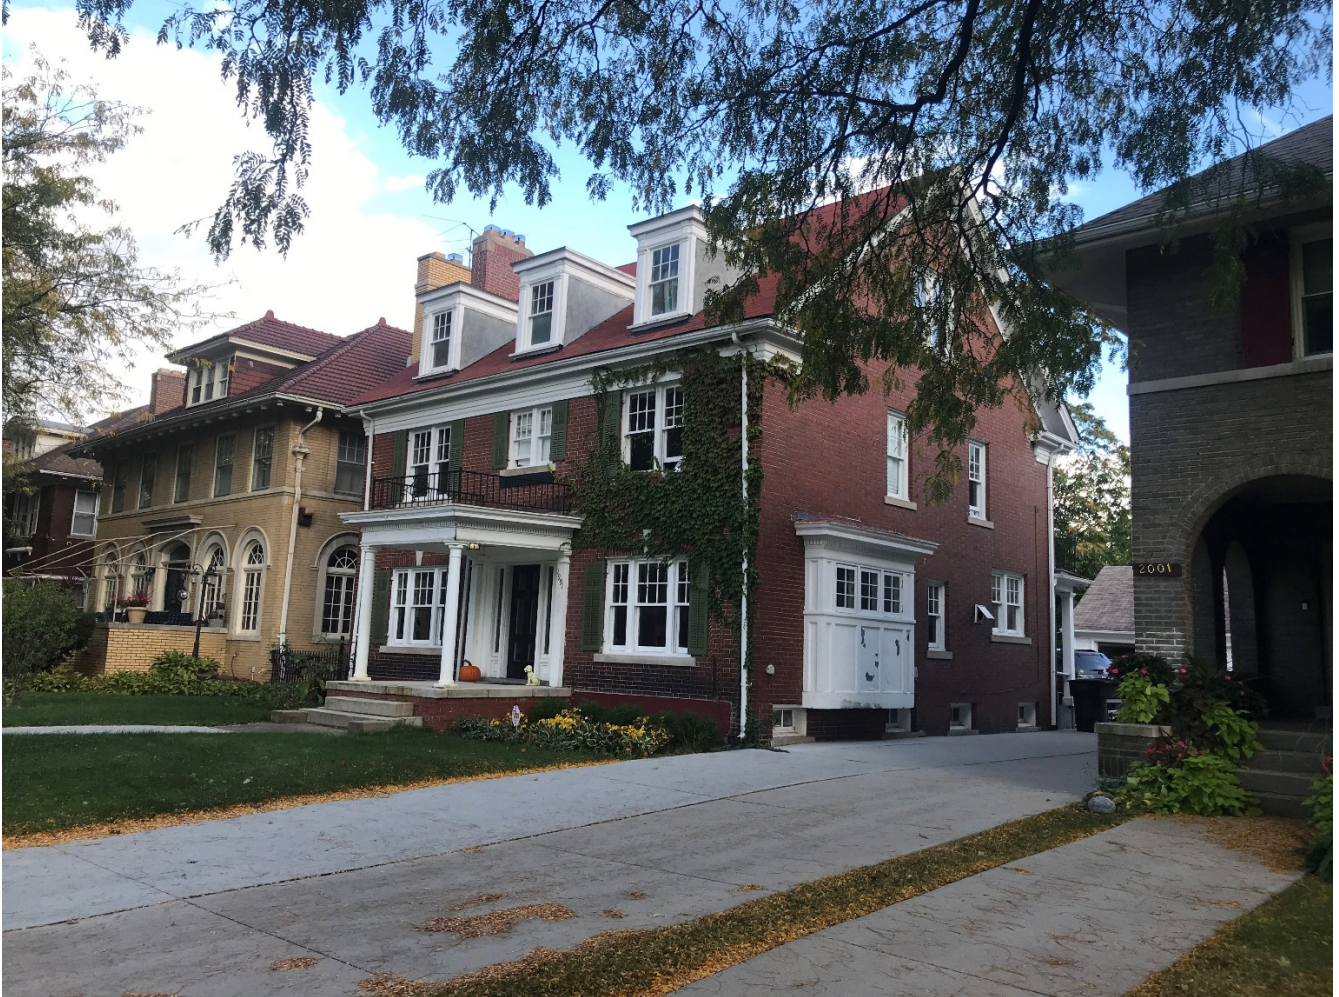
- As previously noted, it is staff's opinion that the former full-width porch was a character-defining feature of the home. The alteration of removing, rather than replacing the winged front porch has altered the character of the home's primary façade. Therefore, the current porch deck (sans the side extensions) does not conform to the Standards.
- The proposal fails to address the remaining "scars" at the front elevation, which resulted from the unapproved removal of the porch side wings. It is staff's opinion that the scale, design, color and location of the remaining scars does not conform to the distinctive features or finishes of the property, and therefore are in conflict with the Elements of Design of the Boston Edison Historic District and detracts from the building's historic appearance.

**Northwest/ Front-Right Elevation**

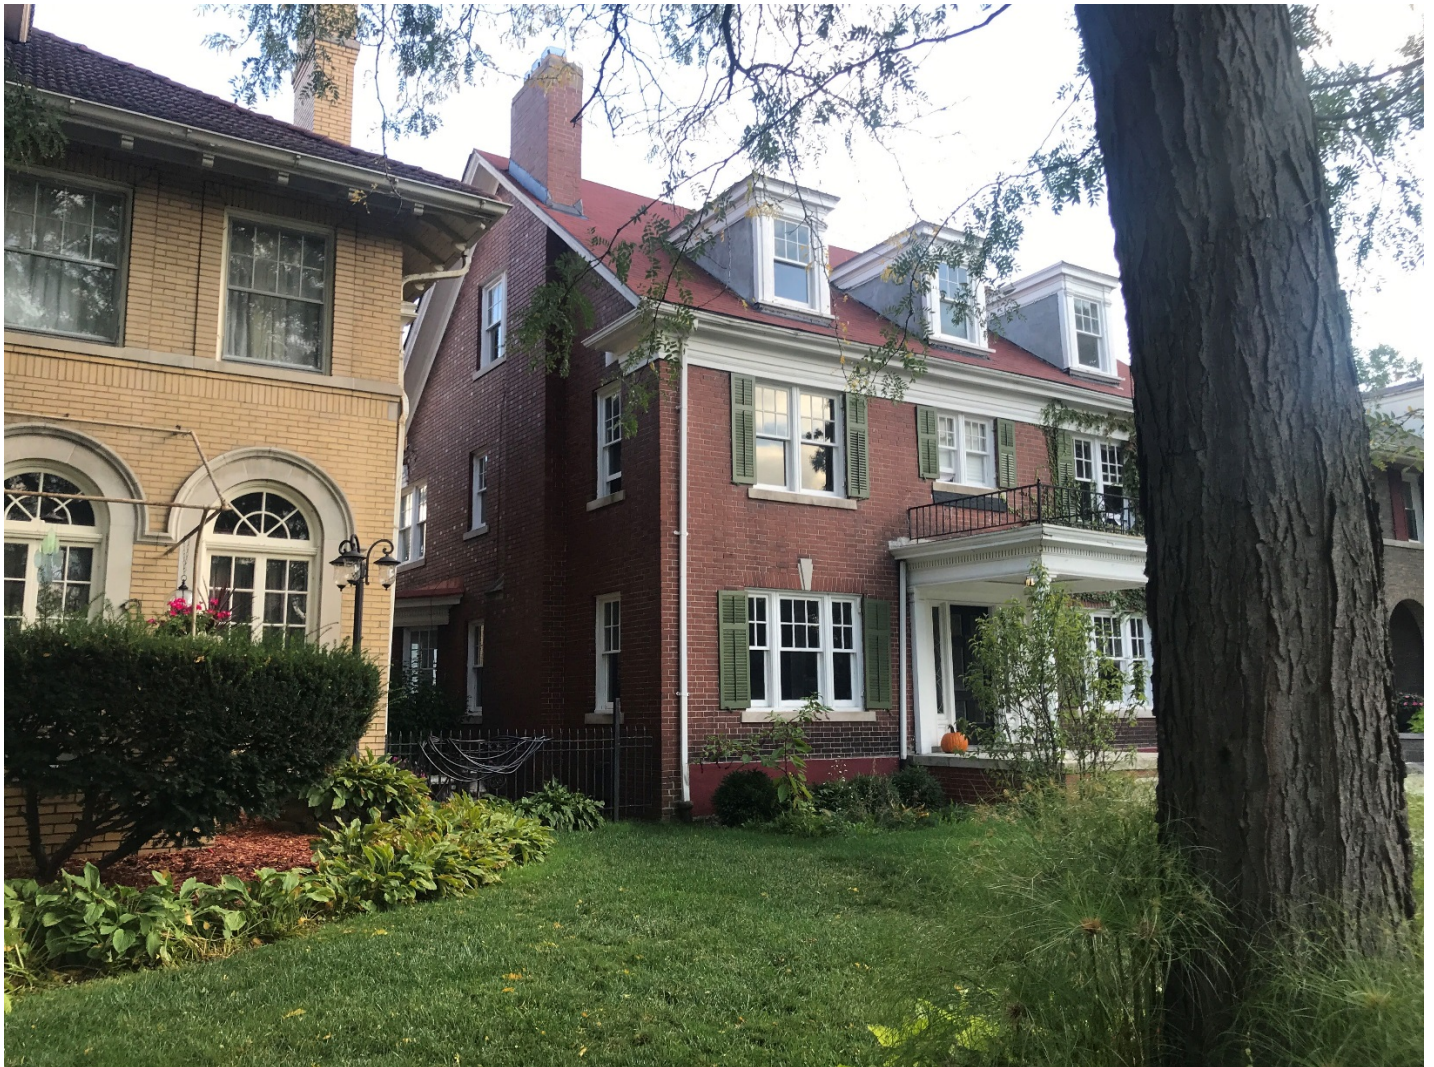
**Northeast/ Front-Left Elevation**
