STAFF REPORT: 05-12-2021 MEETING
APPLICATION NUMBER: 21-7211
ADDRESS: 14854 ASHTON
HISTORIC DISTRICT: ROSEDALE PARK
APPLICANT: JASON TRUDGEON, SUNGLO SERVICES
PROPERTY OWNER: THOMAS KEMP
DATE OF PROVISIONALLY COMPLETE APPLICATION: 04-19-2021
DATE OF STAFF SITE VISIT: 04-28-2021

SCOPE: DEMOLISH EXISTING GARAGE; ERECT NEW GARAGE

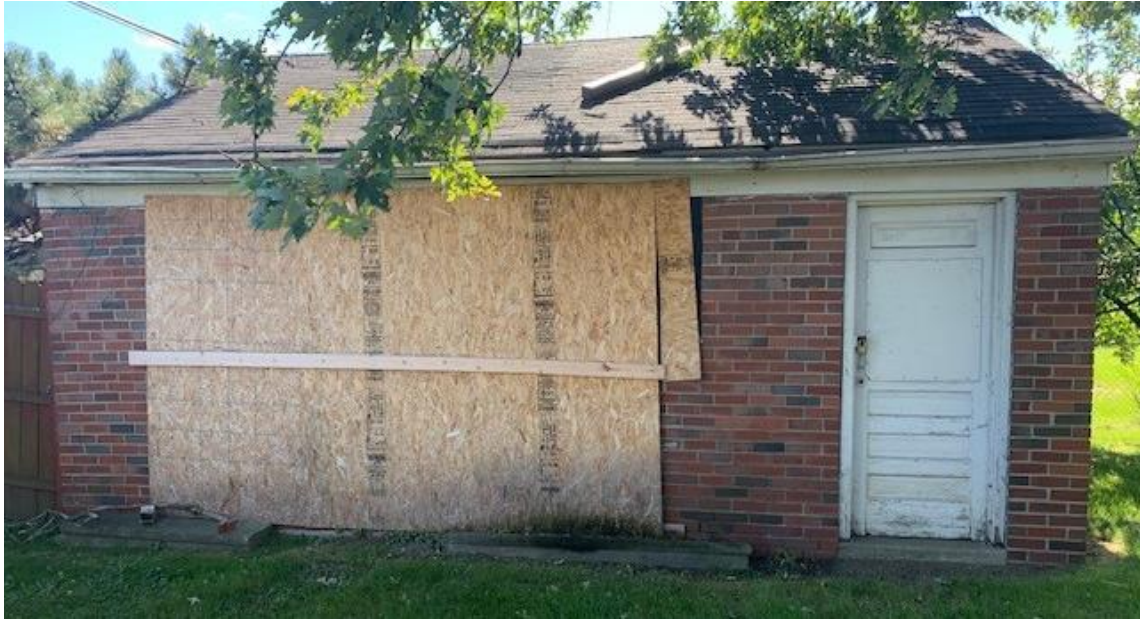
Side/North elevation

The North wall of this two-car garage was struck by a vehicle, causing unreparable structural damage. There is about a 12'x 8' section of wall that was destroyed causing an unstable structure. We would like to proceed with the demo as promptly as possible as this has become a safety concern.

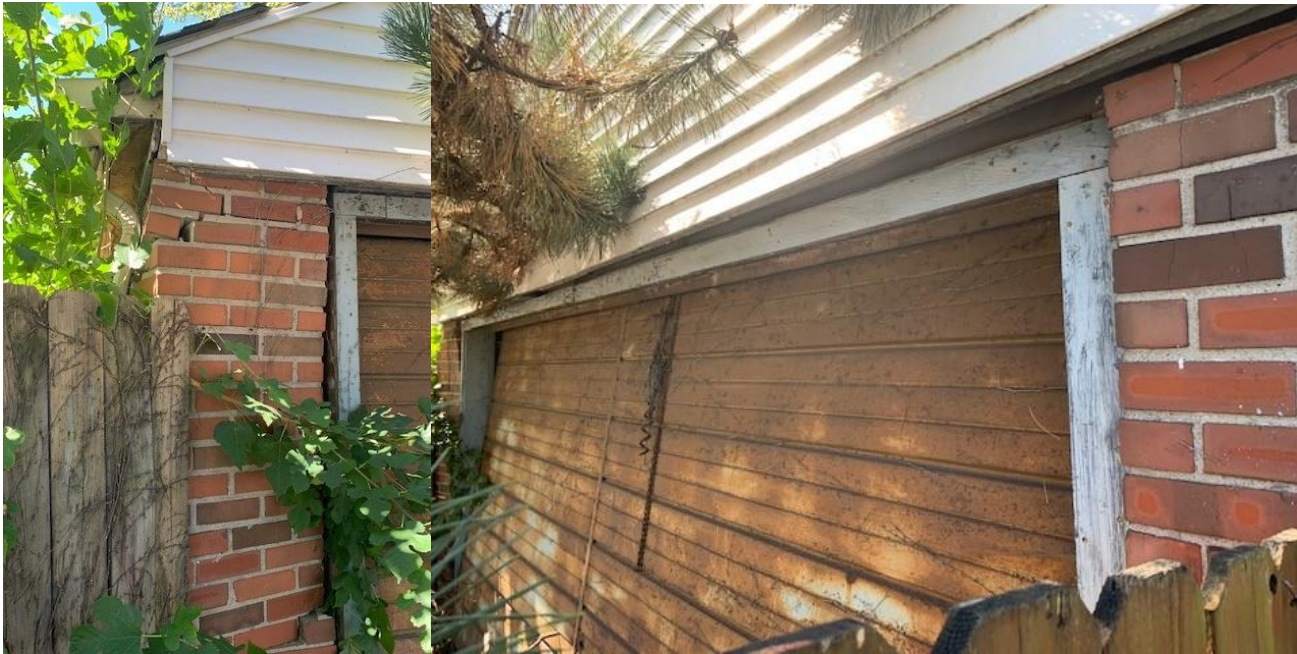
Rear/East elevation – facing service drive

- It is staff's opinion, the structural damage evident on the north, east and south walls offers compelling evidence as to the severe condition of the existing structure.
- The dimensional asphalt shingles on the house look to be brown, but the roofing material selected for the garage is a three-tab dark gray asphalt shingle.
- It is staff's opinion that vinyl siding is not appropriate for use in local historic districts due to its plastic appearance and minimal representation of wood siding.
- The material/placement of window sills was not noted in the scope of work. It looks like the existing sills may be stone.
- The finish for the wood pedestrian door and the roof trim (fascia/freeze board) was not noted.

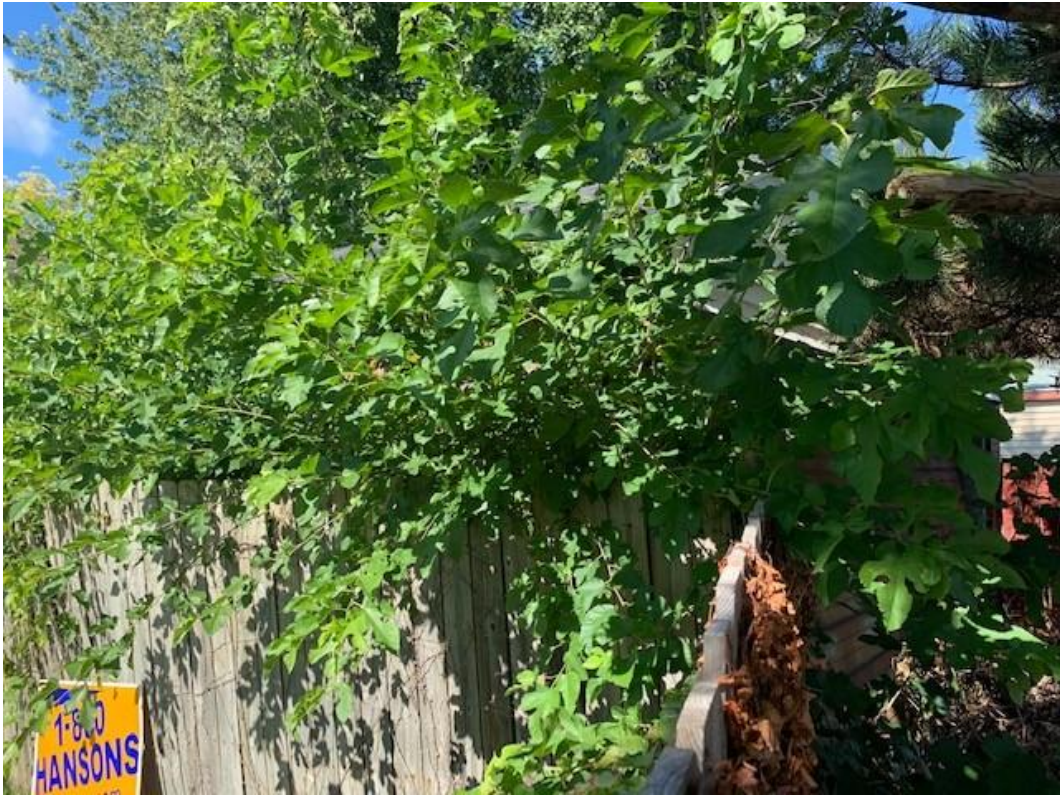
South elevation

- During the recent site visit, staff observed a portion of the now-collapsed south/side wall. (Photos taken from the service drive sidewalk).
