STAFF REPORT: JULY 14, 2021 MEETING

APPLICATION NUMBER: 21-7360

ADDRESS: 1321 LABROSSE

SCOPE: WINDOWS REPLACED WITHOUT APPROVAL

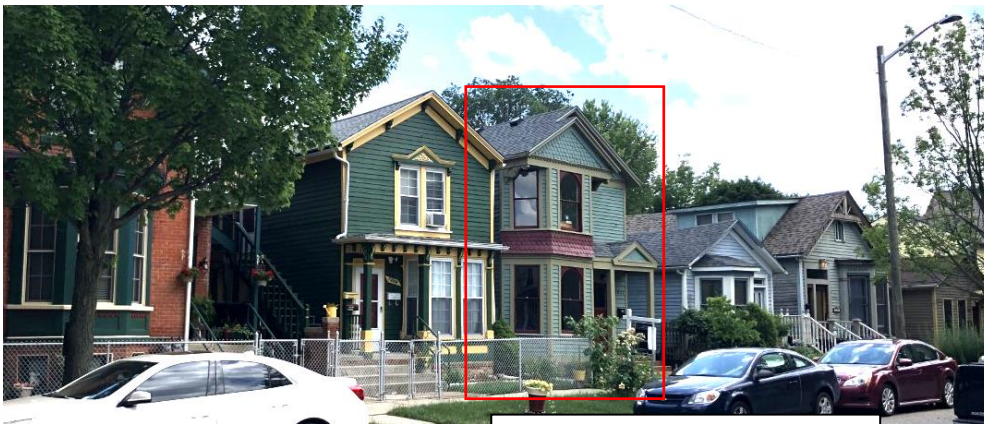
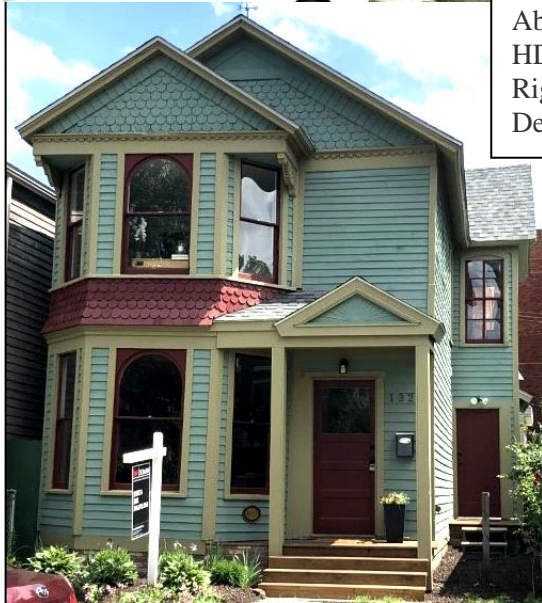
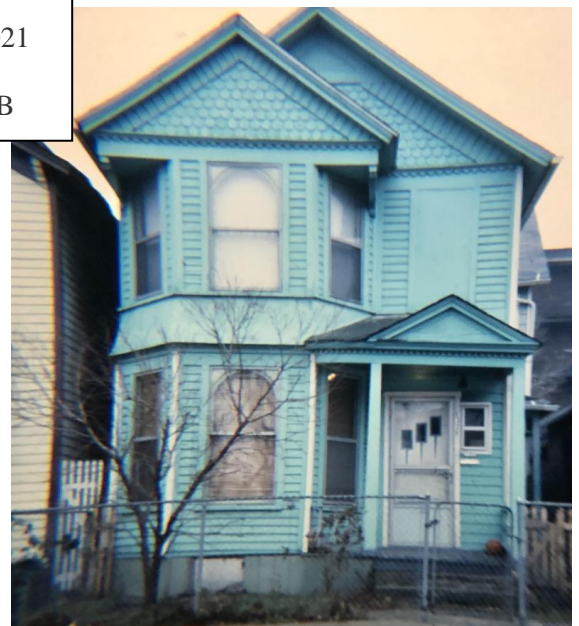
Above and left:
HDC Photos, June 28, 2021
Right:
Designation photo, HDAB

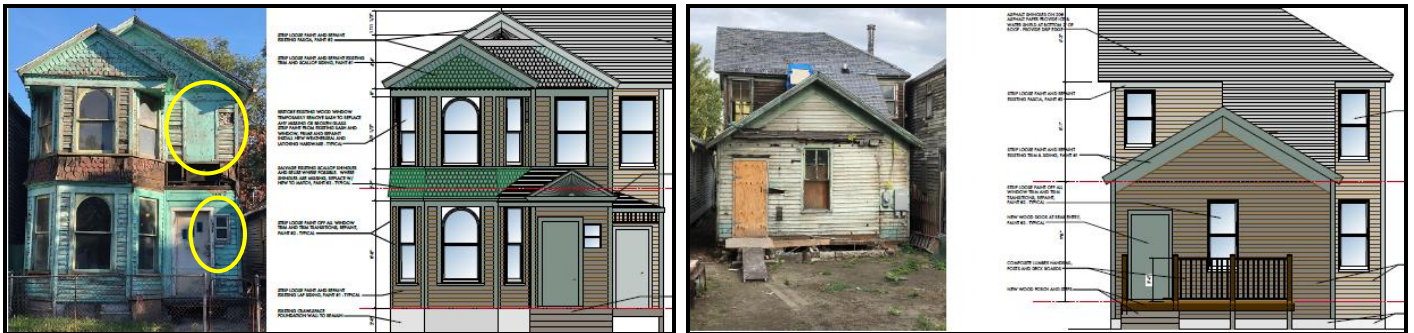
- The Corktown Historic District was established in 1984.
- In 2019, HDC staff issued a Certificate of Appropriateness for the rehabilitation of the house, which included the repair of the existing wood windows as well as exterior painting. (#19-6555)
 - As shown on the applicant's renderings below, the boarded up window opening on the front elevation was to be re-opened and the small window opening adjacent the front door was to be retained. On the rear elevation, double-hung windows were to be retained in the window openings.
