STAFF REPORT: JUNE 8, 2022 MEETING

APPLICATION NUMBER: 22-7850 VIOLATION NUMBER: 22-592

ADDRESS: 1814 – 1820 CHURCH

SCOPE: REPLACE WINDOWS (WORK COMPLETED WITHOUT APPROVAL)

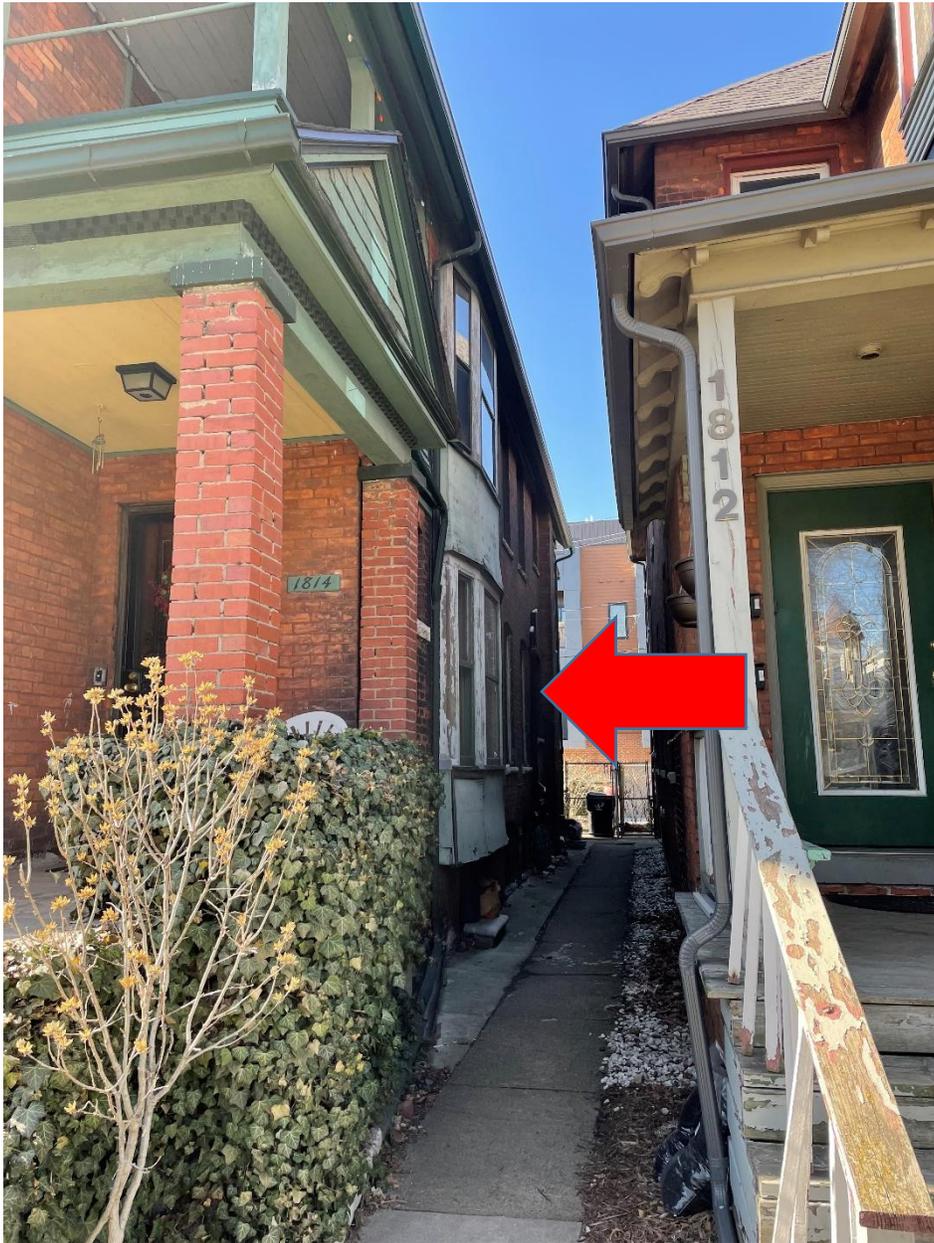
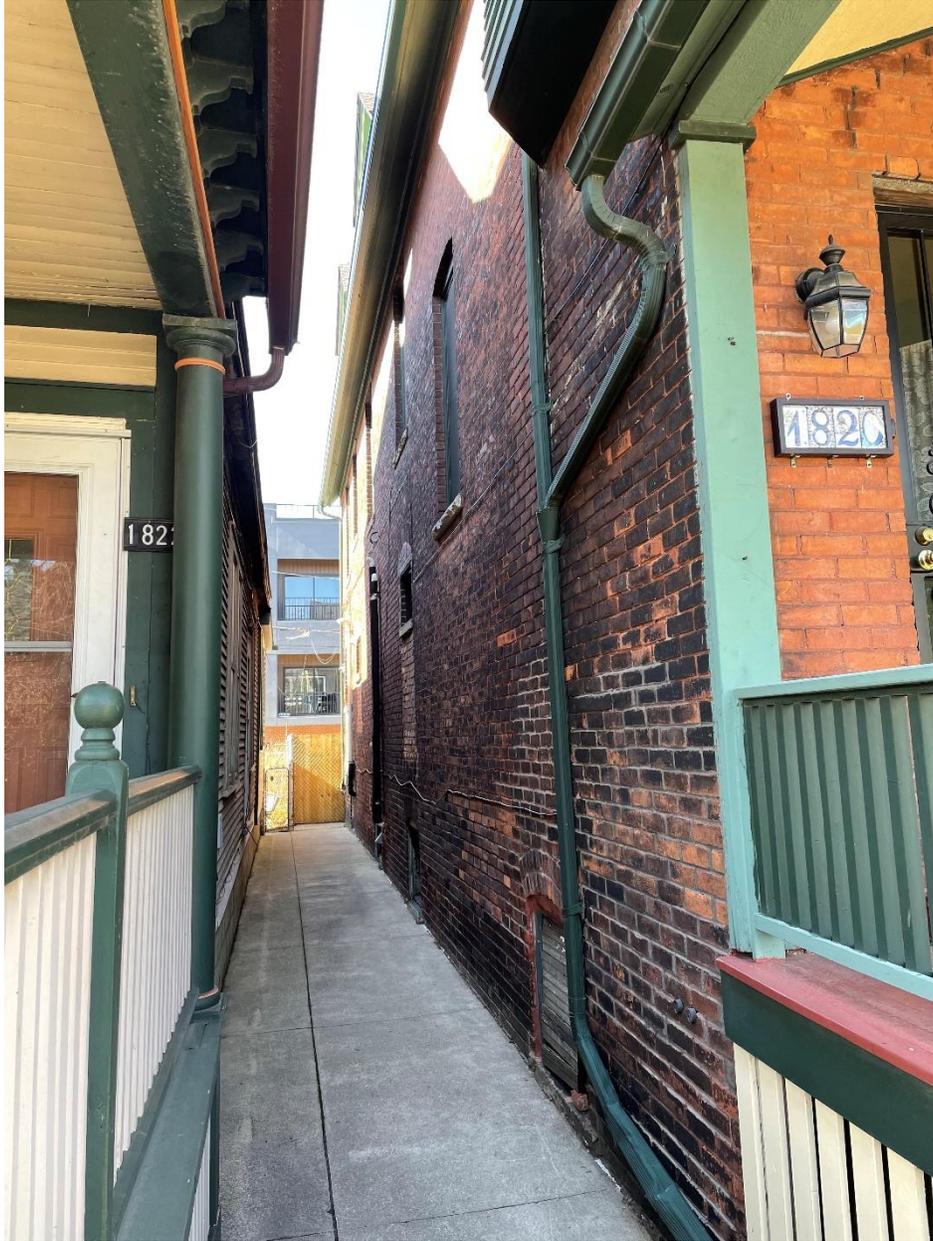
- The first floor, 1814 Church, dining room windows that were replaced on the east wall, were original to the house that was built in 1901. Wooden then aluminum storms were added sometime later during the history of the house. The condition of double-hung originals as seen in accompanying photos are with significant decayed wood, non-functioning window weight systems, mostly inoperable for opening and closing, with several layers of paint, much of it lead based, with acid-etched and cloudy single-pane windows, all of which make the Marvin replacements the most cost effective, energy efficient, ambient noise reducing and environmentally responsible option.

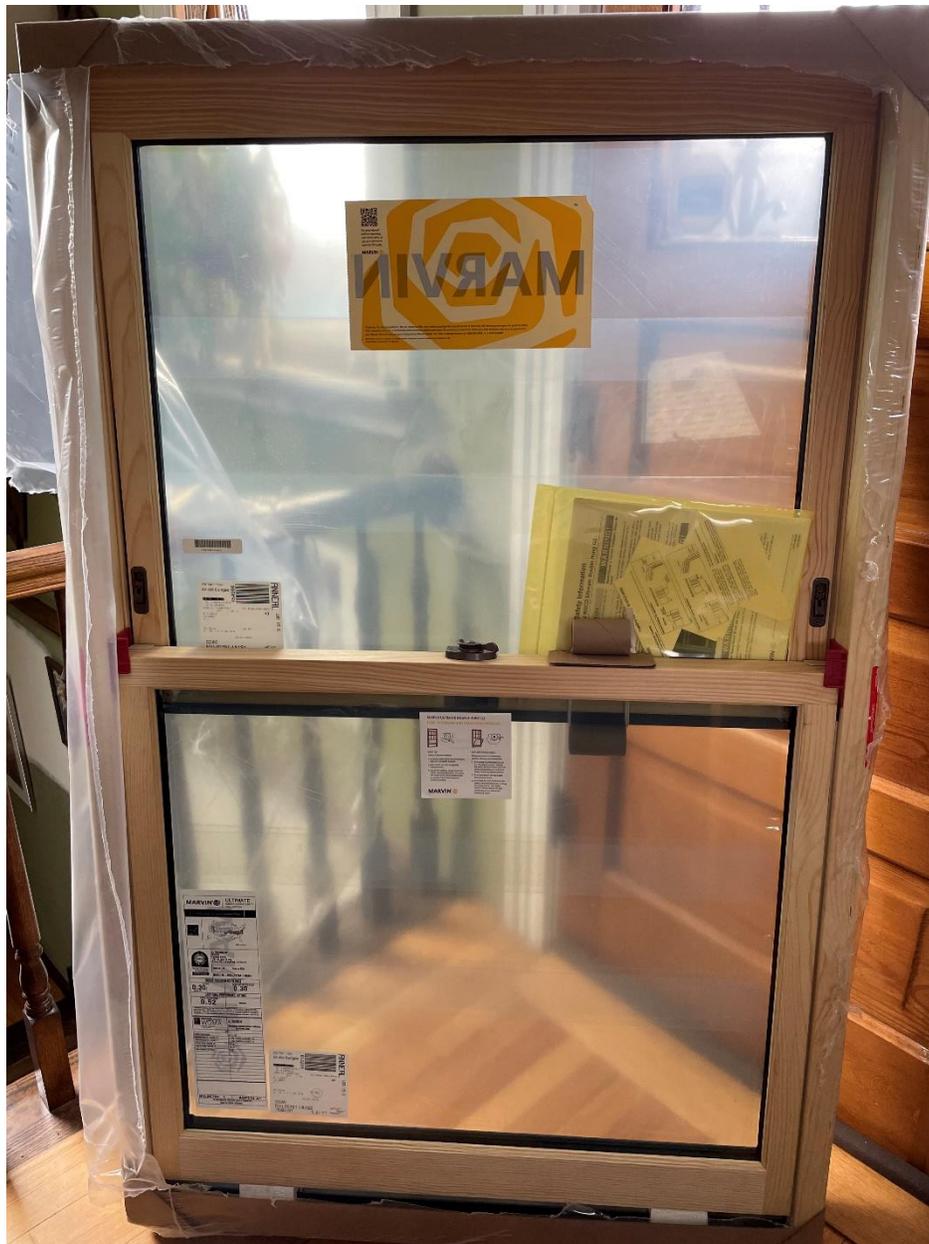
1814-1820 Church, Double-Hung Marvin Clad
Interior

- The applicant provided a photograph of an existing wood window with an aluminum storm frame (below left), as well as a photograph of one of the recently replaced window units (center). The original opening retains the wood brickmold (wood framing) around the window sash. Brickmold fills some of the depth between the outer masonry wall and window unit while adding additional detail to the opening. The recently installed window does not have brickmold in place, so the window appears to sit very far back within the masonry opening and the dimensional framing of the sash has been lost. The double-hung with divided light upper sash (below right), taken by staff, shows a previously replaced unit with a narrow brickmold applied to the sides and top of the sash. While offering some detail, the narrow brickmold is only noticeable due to the contrasting paint color and does not match the dimensions and visual balance (within the full opening) of the original brickmold.

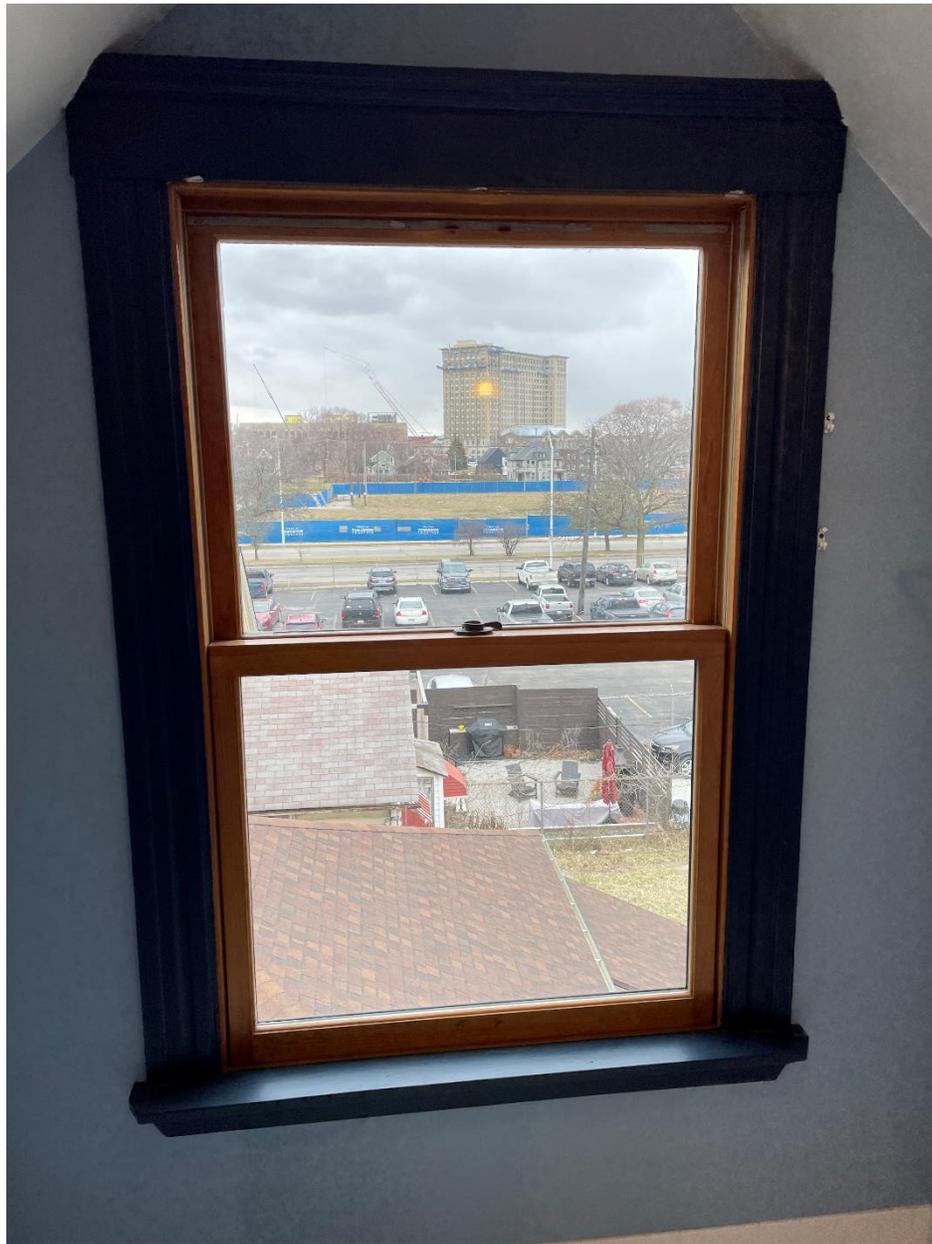
1820 Church, Current Interior,
3rd floor, NW dormer

- The 21 year-old third floor double-hung bathroom window on the NW dormer of 1820 Church has yet to be replaced. It measures 37½" x 60¼". The Marvin wood, aluminum clad double-hung window currently in place was installed with others that were approved as appropriate by HDC in 2001 during the attic conversion. This window and frame has warped to where it is inoperable and air and water seeps through failing seals. See attached diagram in slides for the complete dimensions of this window.
- The finished opening dimensions of all three windows will remain as they are now with no alterations to original sills, casings, jambs, frames, exterior and interior moulding, and other frame detail and profiles. This will retain the same original historic look of the original 1901 structure of the house as well as of the 2001 attic conversion.

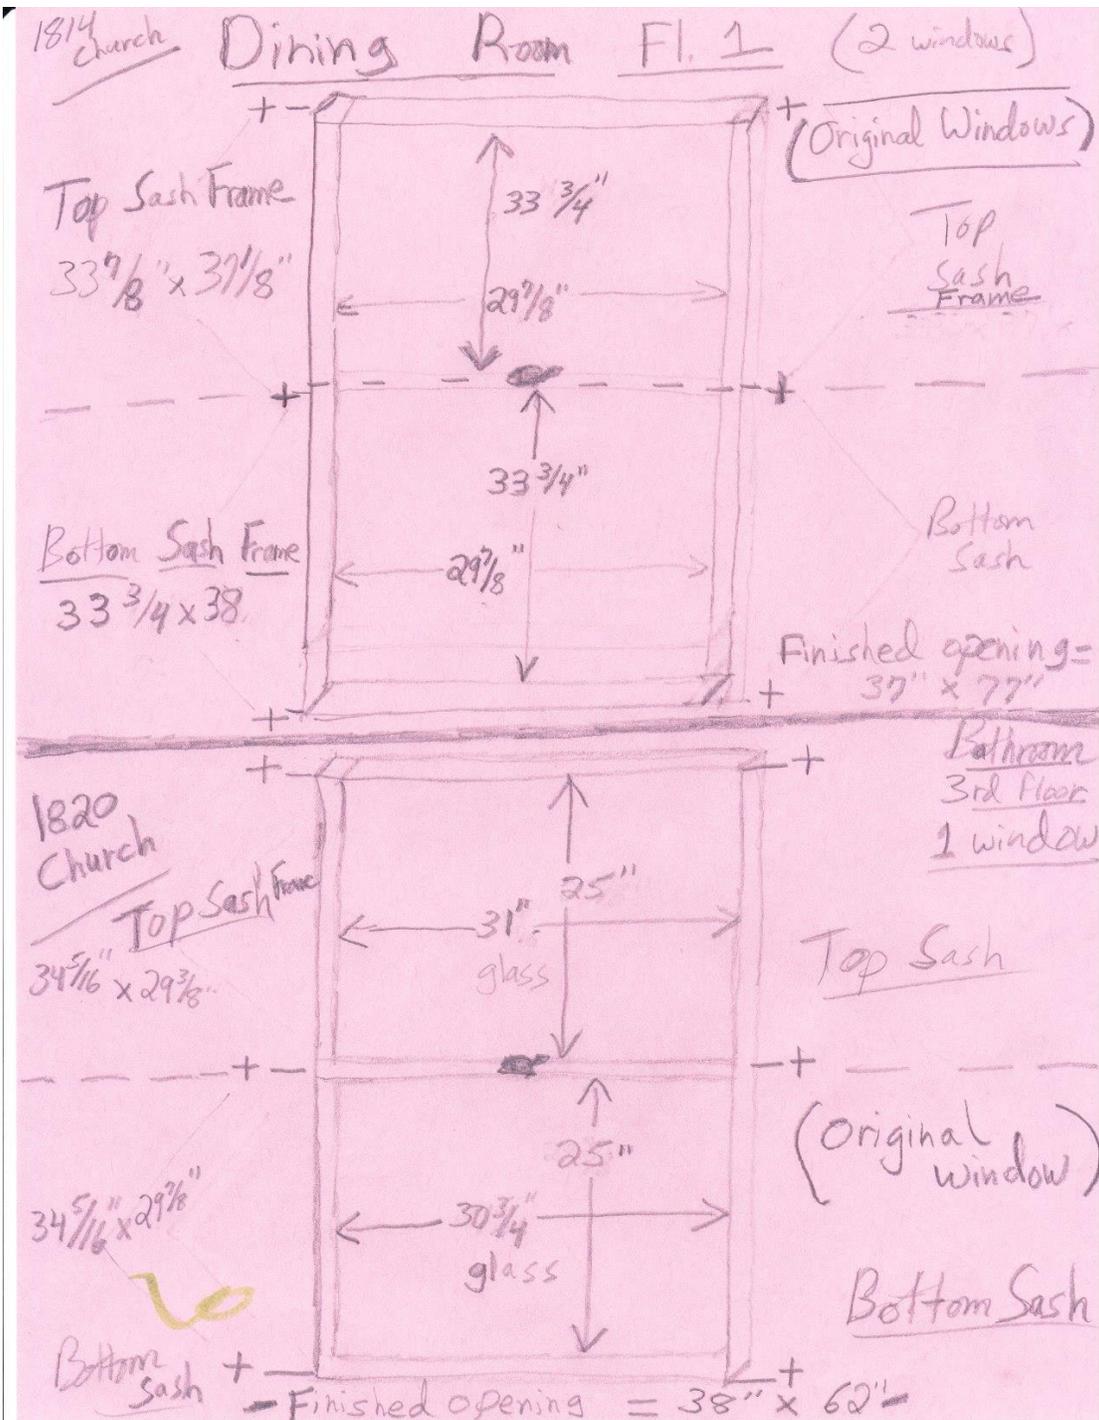
1814-1820 Church Original Dimensions

<u>Existing Glass Area</u>	<u>Replacement Glass Area</u>	<u>Dimensional and % Change</u>
33-3/4" high	31-7/8" high	1-3/4" shorter – 6% reduction in height
29-7/8" wide	26-3/4" wide	3-1/8" narrower – 10% reduction in width

- Each of these two 121 year-old first floor, east wall, 1814 Church, dining room windows have a total measurement of $33\frac{3}{4}$ " x $77\frac{7}{8}$ " inside the frame. See attached diagrams for complete original dimensions of both historic windows and sashes.
